Tree Impact On Ferguson Line On April 3rd, 2011 Leads to Critical Injuries

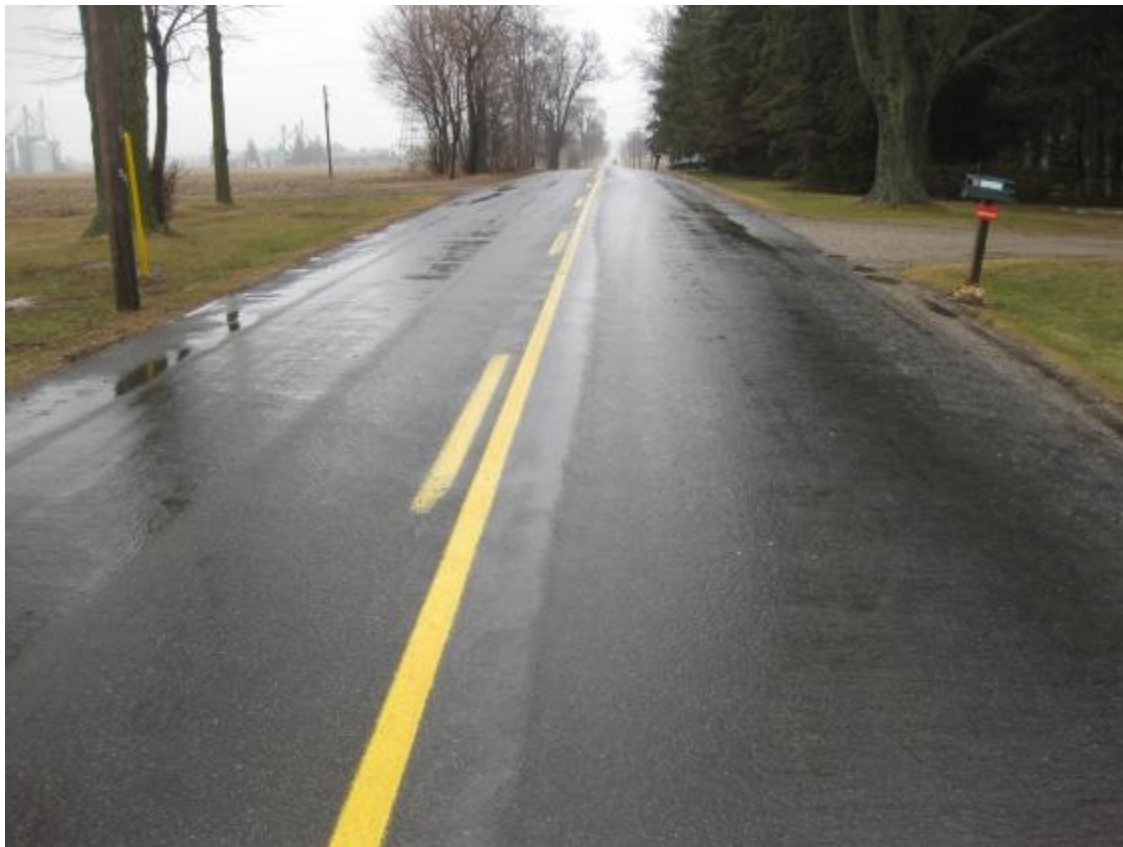
First, the photo below was taken from a distance of 150 metres west of the point of impact with the tree.

The collision reportedly occurred at about 1830 hours. It had been snowing yesterday evening therefore the roadway could have been slippery. You can see how an eastbound vehicle enters a downgrade slope just before the area of impact. Also you should note the row of tall evergreens on the south roadside. Dense trees on a south roadside means that the sun is not able to penetrate the road surface meaning that the snow or ice may have melted along portions of the road exposed to the sun but near this location the sun may have been blocked resulting in slippery/icy conditions.

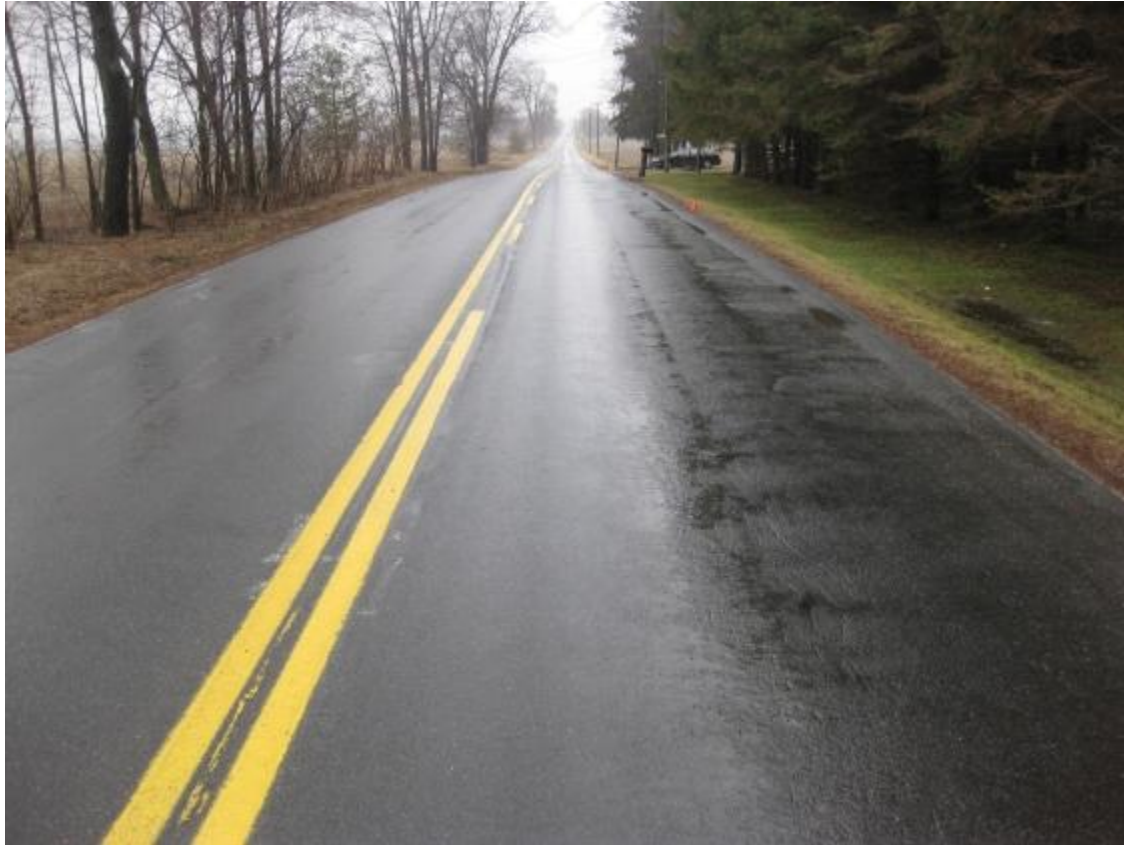
Next is a view from 100 metres west of the point of impact. You should be able to see my black Regal parked on the south roadside and just beyond that you will see the impact with a couple of fir trees. As usual the small orange cones are spaced 25 metres apart such that the last cone is adjacent to the trees where the impact occurred.

As you can see the roadway surface is wet and we would not be able to locate any loss-of-control yaw marks. Note however how the water is collecting in certain areas of the right portion of the eastbound lane. The lane was generally in good condition however.

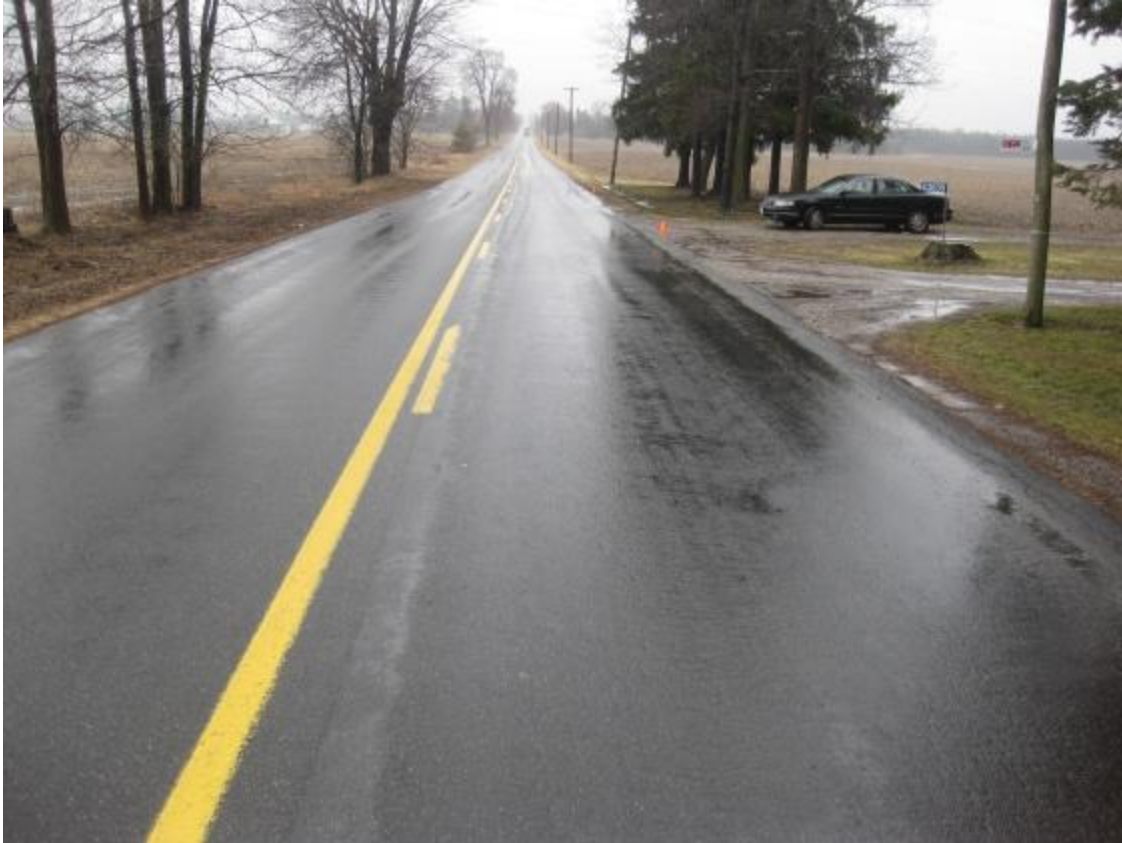
Next is a view from 50 metres west of the area of impact. Now you should be able to see the group of evergreens on the south roadside just past the parked position of my car. This is where the vehicle slid off the road surface and travelled into the trees.

Again, the road surface itself does not appear to be in bad condition.

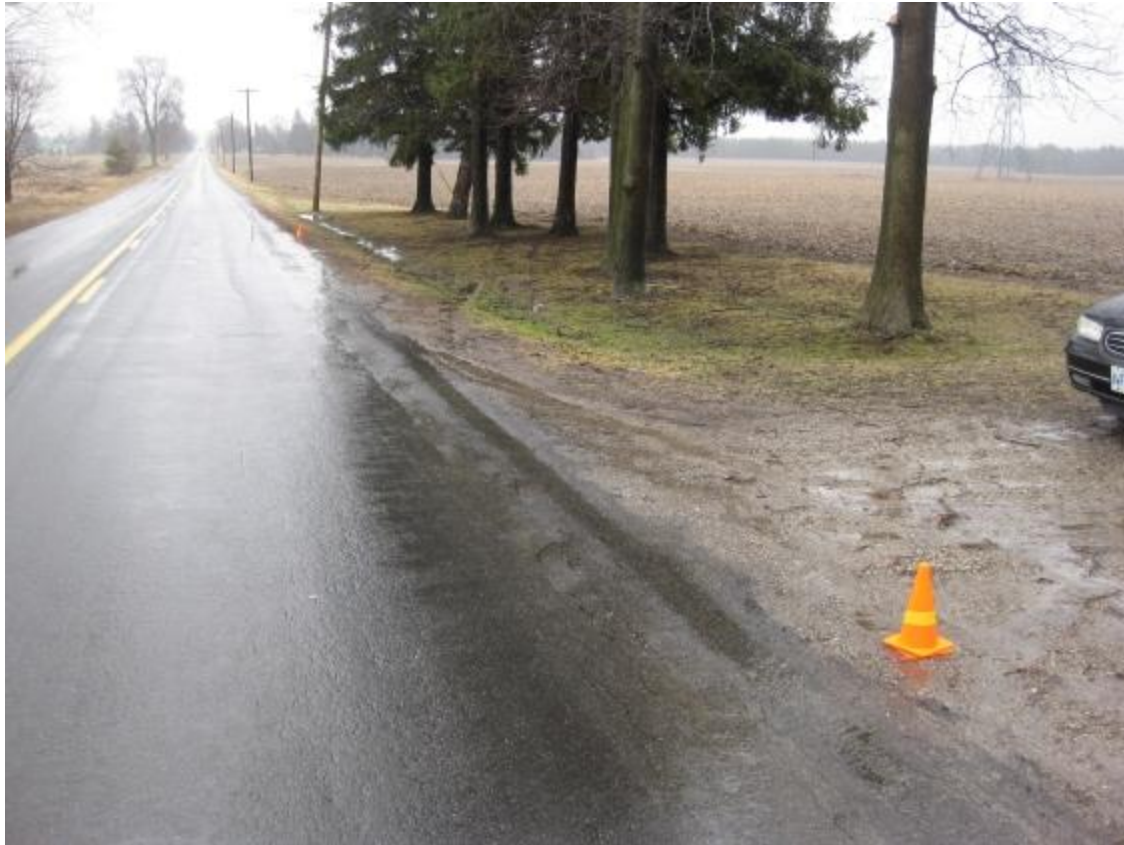
Next is a view from about 25 metres west of the area of impact. Now you should be able to see the tire marks in the wet soil on the south roadside, just past the driveway.

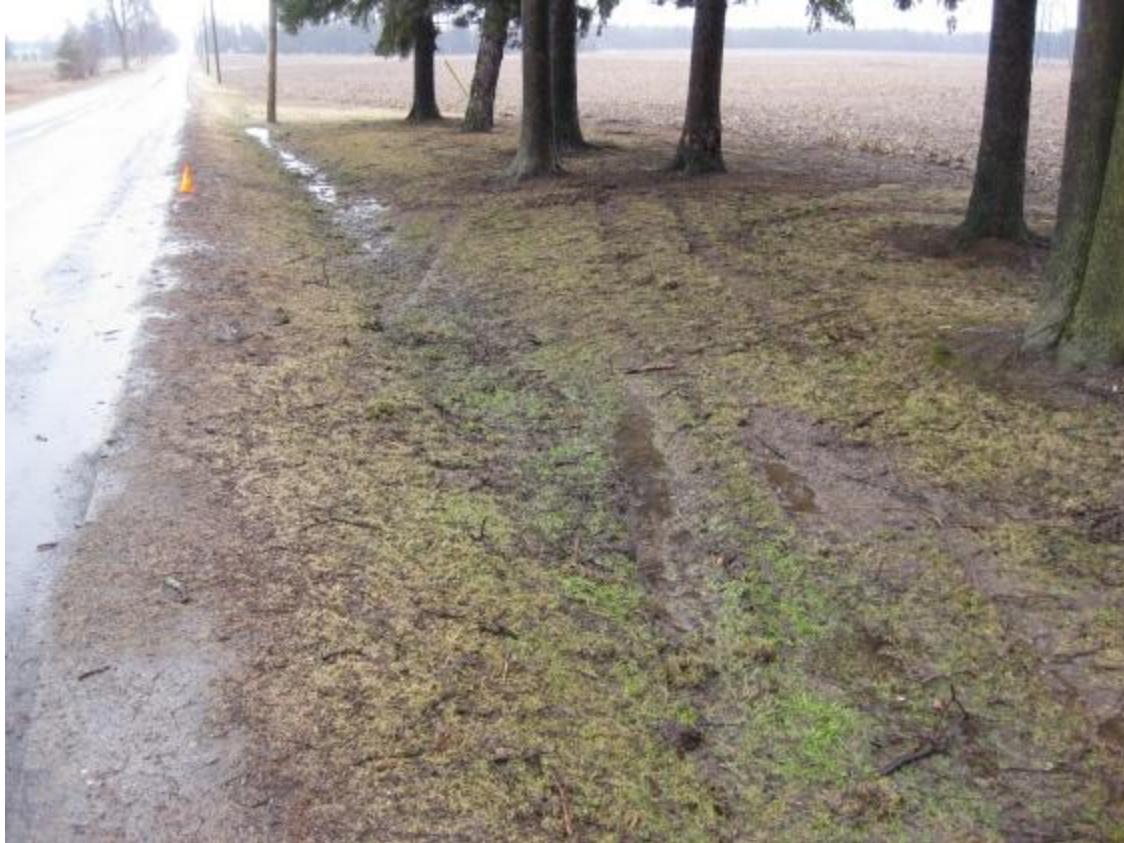
Next, we see a view through the south roadside and the tire-marks leading up to the impact with the trees.

If many of you have been examining my other articles where vehicles slide sideways into impact with a tree or pole you should be able to recognize how the vehicle slid into this impact. You should certainly see three tire marks while the fourth might be more difficult to decipher. Now, two marks close together suggest they are either the two front or the two rear tires. Let me expedite things - the two marks on the right are from the two front tires. We don't see any tire marks crossing so we know that the crossing took place somewhere on the road. The only thing remaining is to decide whether the vehicle is almost at 90 degrees as it hits the trees or is it just slightly more than 90 degrees. I think we can already agree that the vehicle is coming into impact with its driver's side right?

OK, I have not studied this in great detail at this time but I can say that in the majority of cases, vehicles striking something this close to the road edge have not made it beyond a 90 degree angle, so I would suggest that the vehicle is probably at a 70 or 80 degree angle, leading somewhat with its left front corner as it comes into impact.

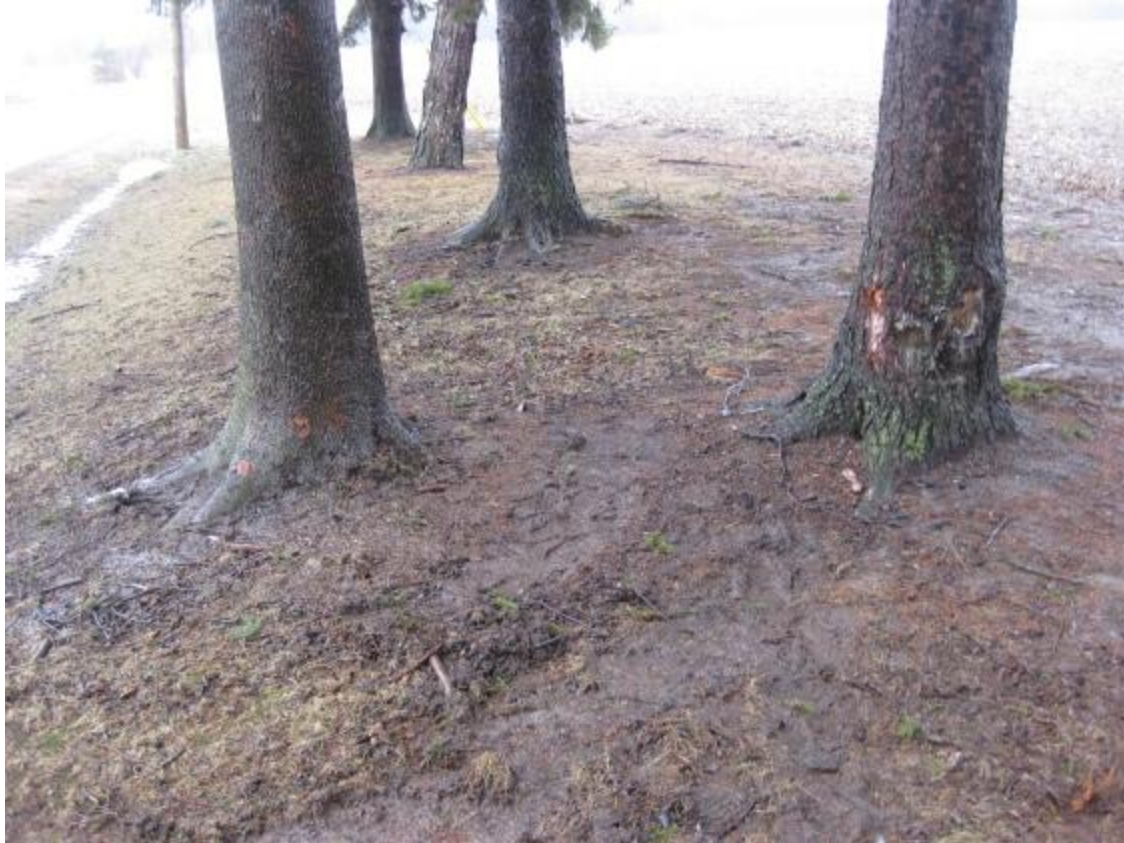
Now let us look at the two culprit trees that caused the damage, as noted in the photo below.

There is not much bark missing on the trees and that is sometimes a general sign of the severity of impact. Also the collision severity can be estimated by noting the angle at which the vehicle left the roadway. It was a fairly steep angle suggesting the vehicle was not "booming it" down the road. But it was an unlucky situation that too often occurs that the tree impact is right at the point where the driver is seated.

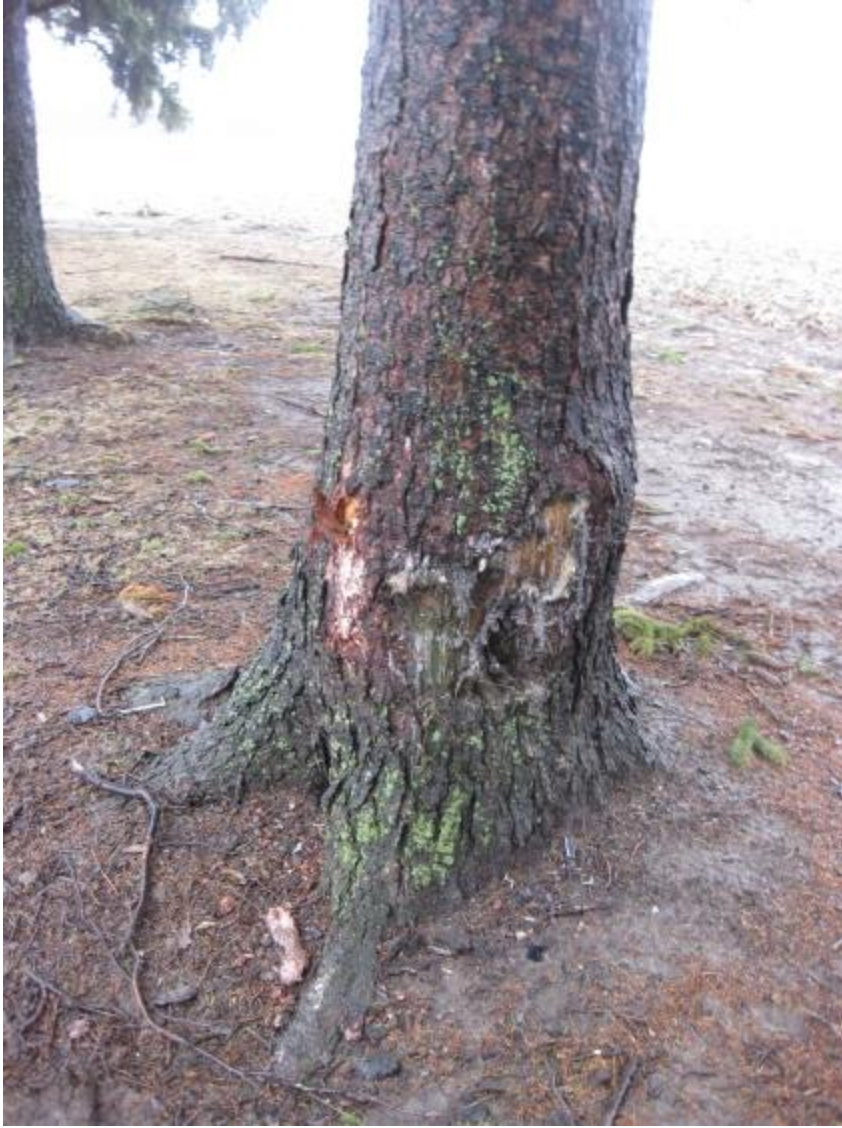
Now the photo below is of the damage evidence to the south tree. This is the one that was likely struck by the front bumper or fender area of the vehicle. You can see some fresh damage, but do you see anything else? Look a little closer at that damage.

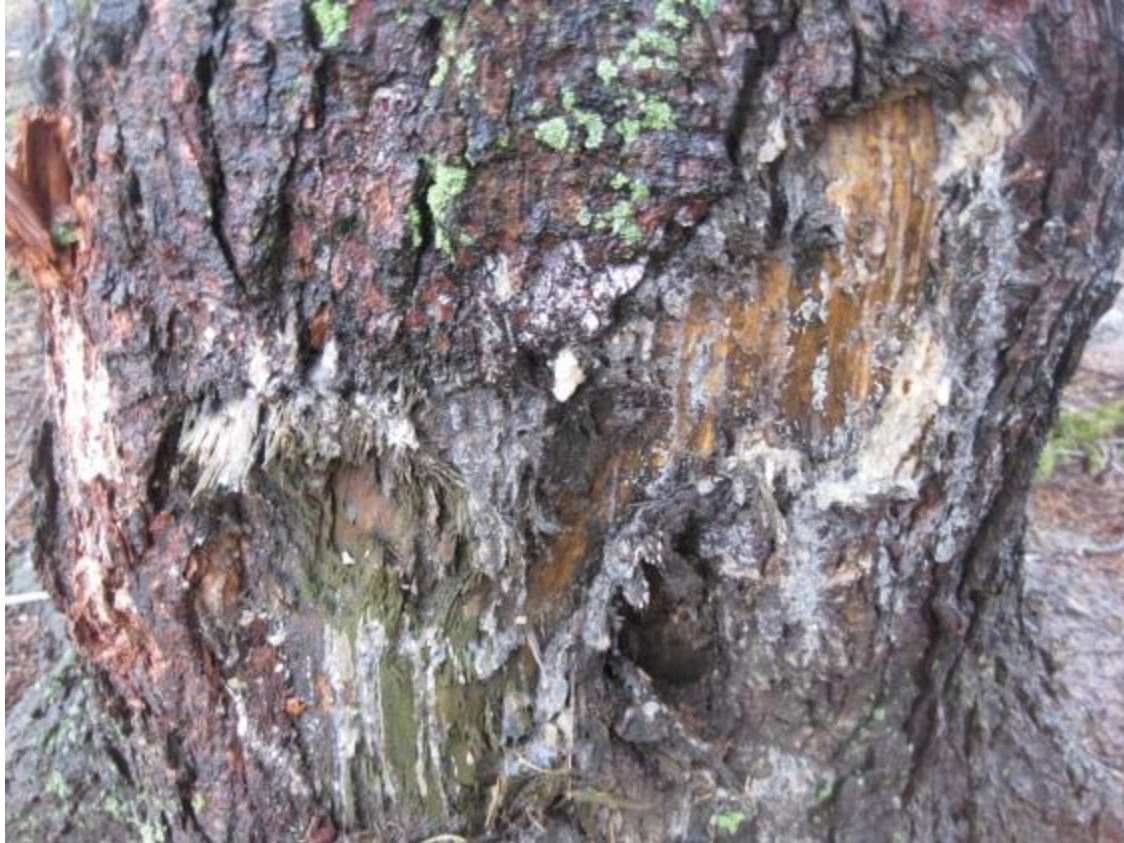
Time is up. What you should see in the photo above is that there is old damage of the tree likely from a previous impact. Hmm, that is interesting. But I looked at all the other trees in this clump of evergreens and no other tree has this impact damage. So this is the second time this tree has been struck by an eastbound vehicle that went out of control coming over the slight downgrade. Now this particular tree did not do all the injury damage, it just helped to slow the vehicle down. The tree that caused the injuries was likely the north tree as shown below.

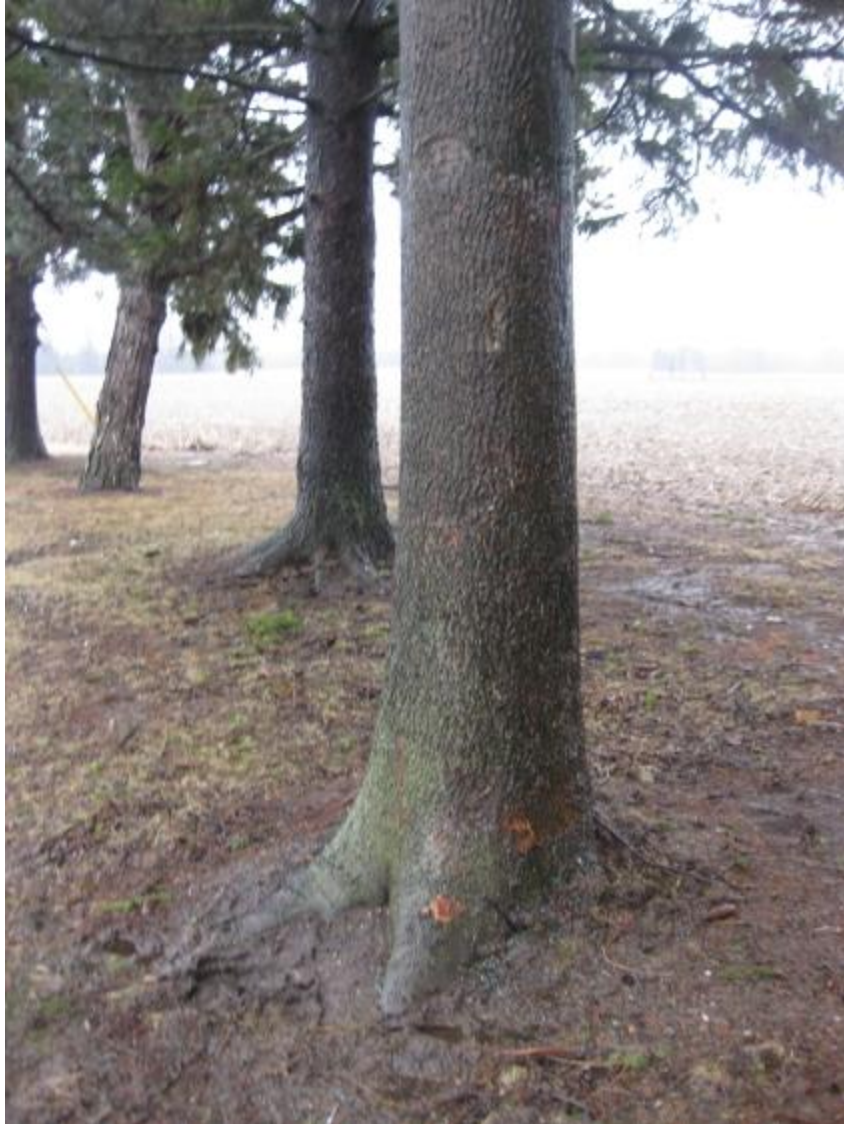
Now this north tree does not show much evidence of damage. It is likely to survive to be a danger to future drivers. You can see some bark is missing near the base but otherwise you might not notice the markings and transfers imbedded in its bark. One thing I like to do is to place a tape measure against a tree or pole so that I can document the height of any impact damage or transfers. So below is the same tree with a tape measure attached.

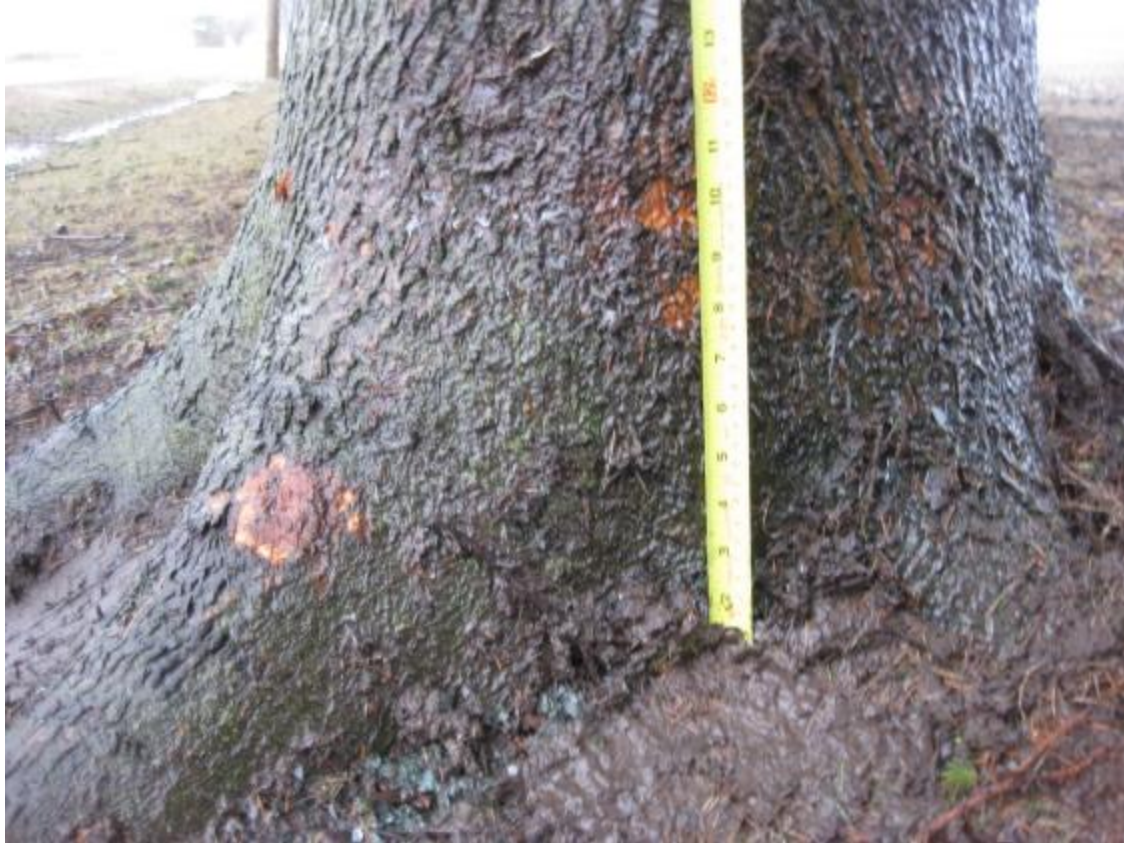
Now let's look at some close-up views of the tree to determine what we see there. First a view near the base of the tree.

Nothing too dramatic here since the lower cowl of the vehicle would have contacted this area. But let's look further up.

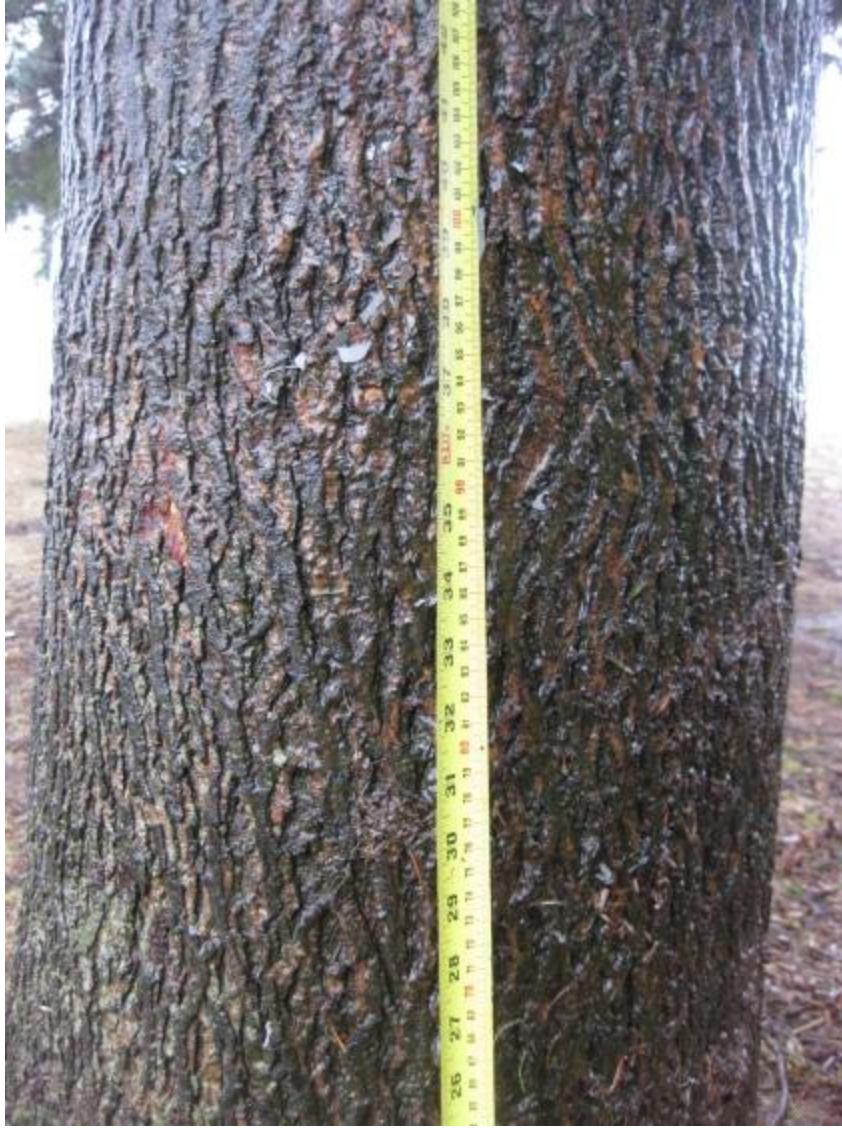
Now I have no idea what kind of vehicle struck this tree. I could have looked more closely at the debris and I would have found out but I did not. But generally, the top edge of a passenger car door, just at the bottom of the side window is about 90 centimetres above the ground. You can examine the 90 centimetre point on the tape measure and see what you find. I can see a variety of paint chips clinging to the bark and higher up I can see the tempered glass fragments likely from the side windows of the vehicle.

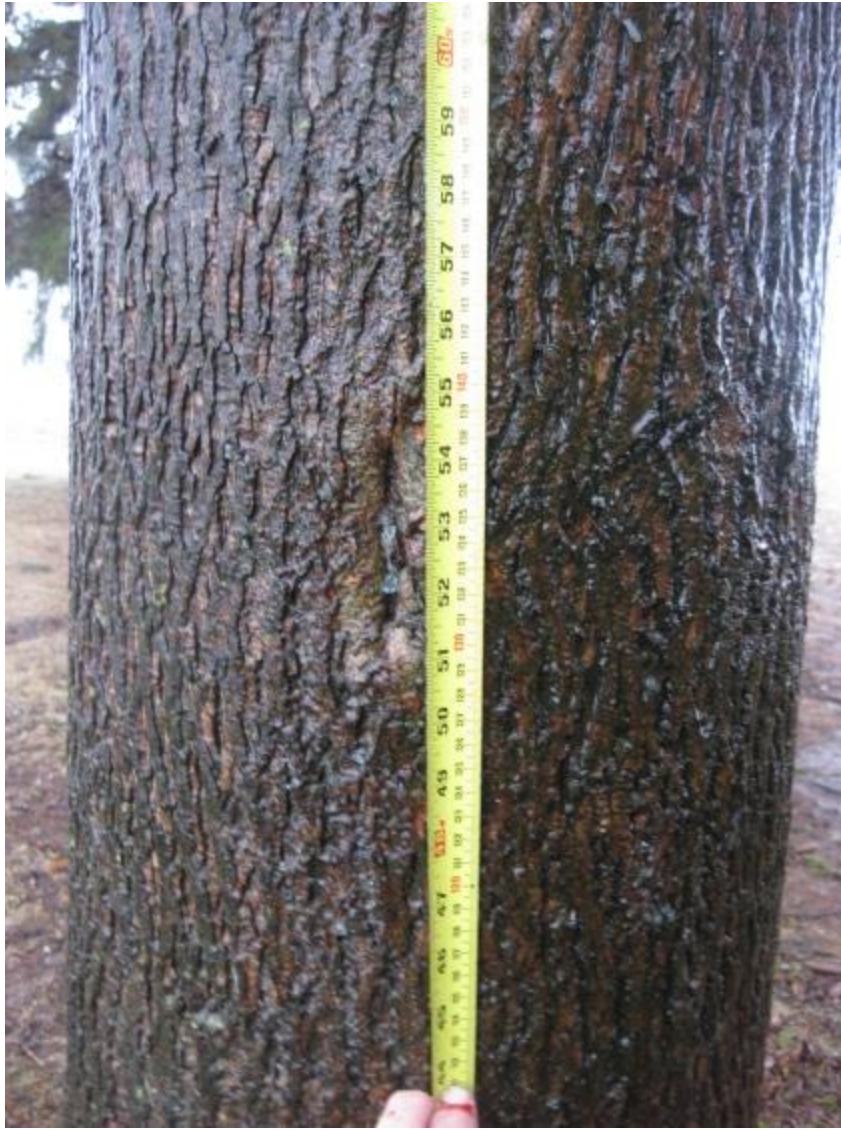
Now we are looking in the vicinity of 120 to 150 centimetres above the ground. I apologize for the bloody finger at the bottom of this view but even I get caught by surprise sometimes when I poke my finger into tempered glass fragments. You can see some of that tempered glass in the crevice of the bark at about 135 centimetres. I did not study the markings in any great detail but I did not observe any indication of a head impact to this tree.

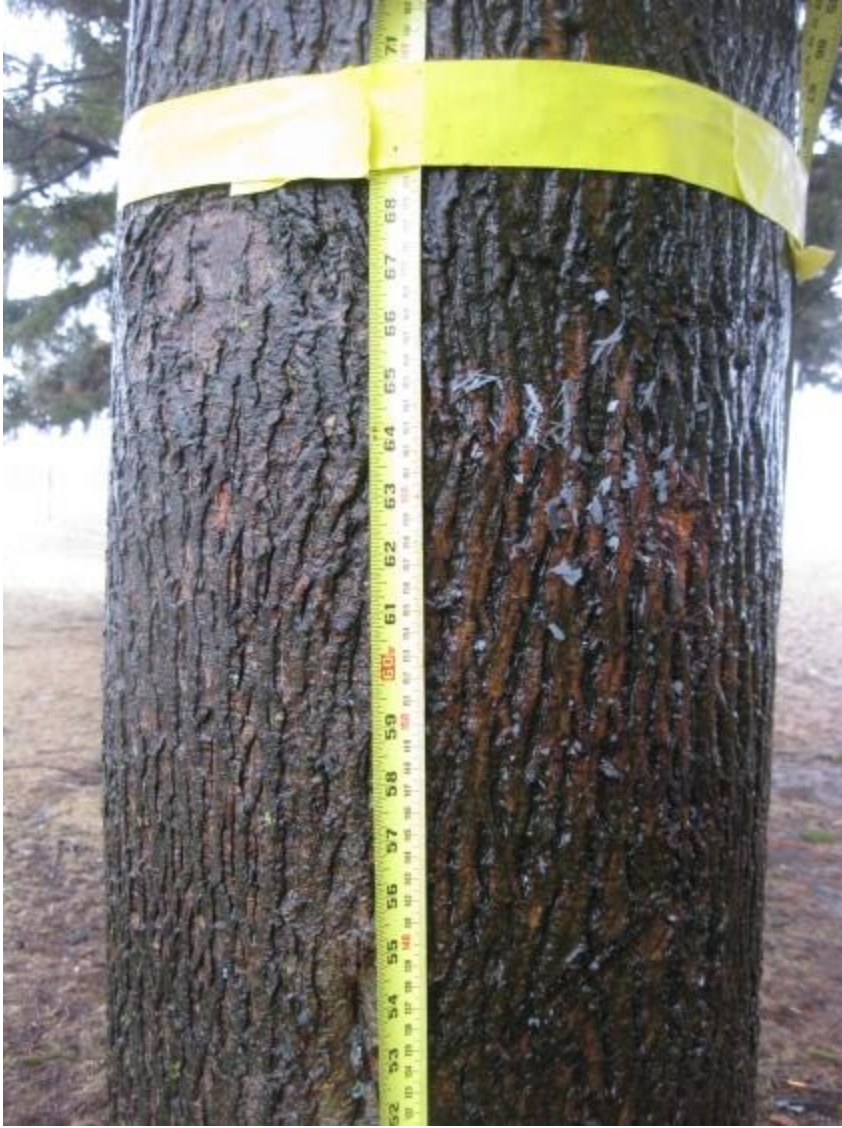
Certainly we can go even higher, as shown in the photo below and note that we have more paint fragments clinging to the tree in the range of 150 to 170 centimetres. This is often from the roof of a vehicle. I know that light trucks and vans can reach these heights but my experience is that when the roof of a car is crushed in a side impact its height is raised from the normal height of about 145 centimetres such that a height of 170 centimetres for a passenger car impact is not unusual.

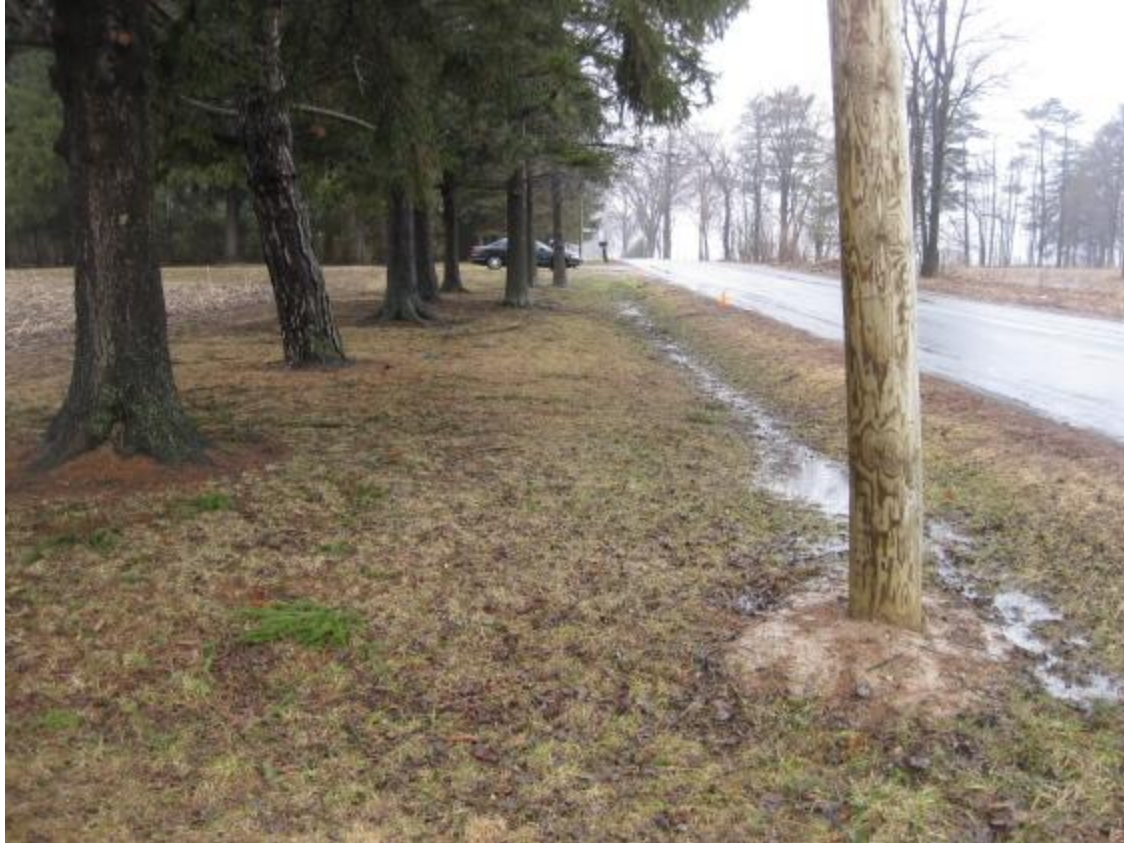
I want to show you one additional thing before closing off of this case. A utility pole has been freshly replaced just east of the collision area as shown in the photo below.

The view above is looking westward on the south roadside and the area of impact is in the background. You can see that the utility pole in the foreground has been recently replaced because of the fresh digging of the earth around it. Being of a suspicious mind set I am thinking that this could relate to another collision on this south roadside. So there could be three impacts at this location. It leads back to thinking about the effects of that stand of evergreens on the south side of the road and how the road surface would remain frozen while other areas along the road might be melted by the sun. It is more important that this frozen zone could be located in the vicinity of this down slope and you might have noticed the slight deterioration of the south edge of the eastbound lane. All these minor things add up and one would not think to put it all together. Just something to think about next time your are cruising along on a sunny March day when the temperature has been close to the melting point. Look out for clumps of trees on the south side of east/west roadways because sometimes you may not know what hit you.
