# Trinity ET-PLUS Guardrail Terminals - Revelations From Real-Life Impacts

*Posting Date: 30-Mar-2015; Revised Aug 9-15*

## ET-PLUS Impact #1: Eastbound Highway 401 Exit Ramp to Highbury Avenue, London, Ontario

## **ET-PLUS Impact #2: Northbound Wellington Road East Guardrail on South Side of Overpass to Highway 401, London, Ontario**

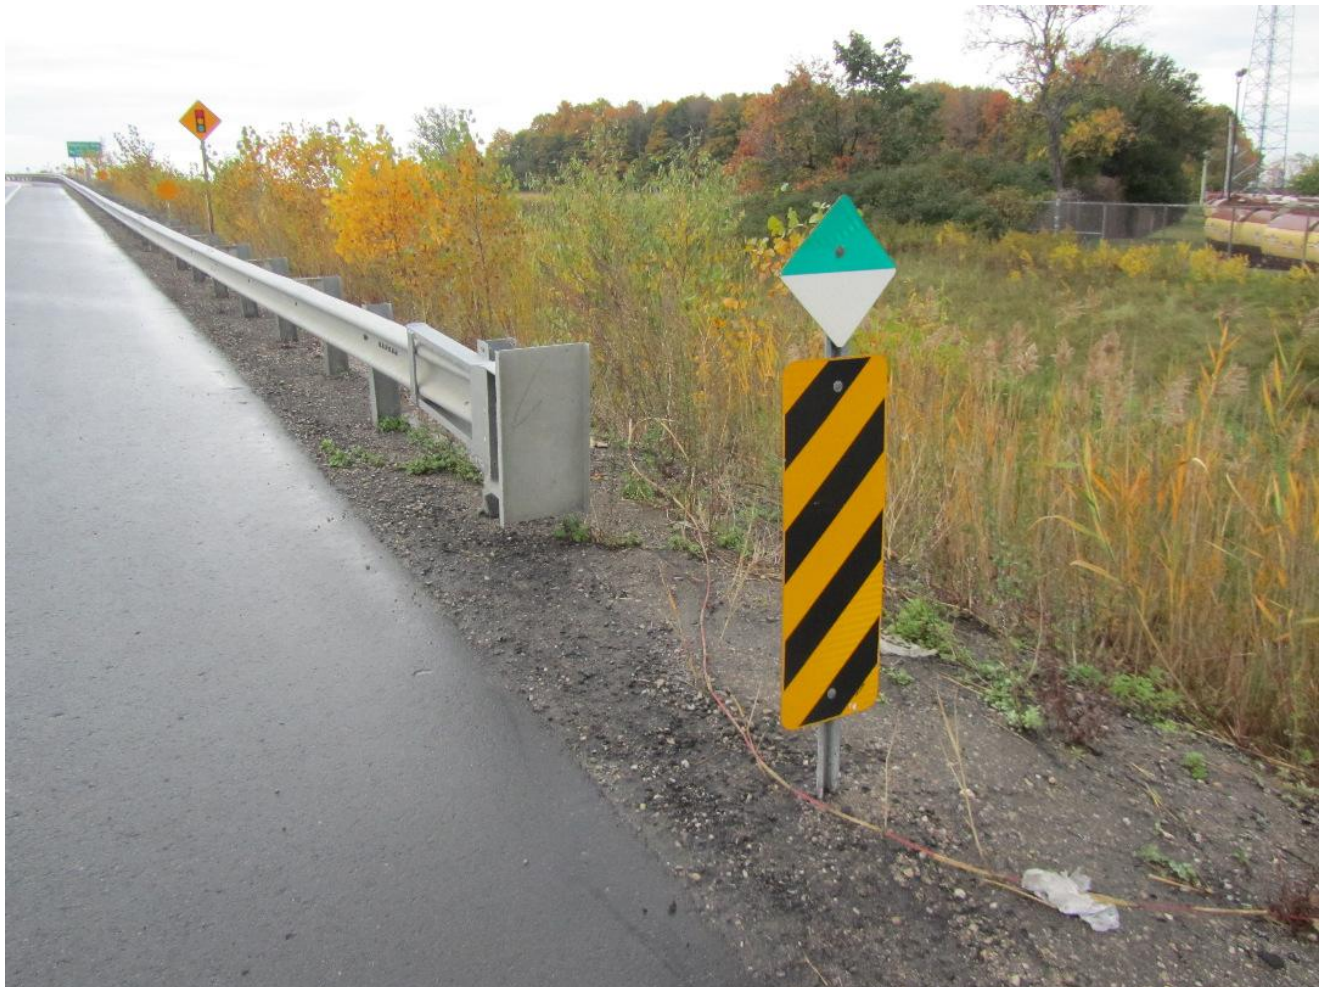
Figure 1: View of a typical ET-PLUS guardrail terminal located on the eastbound exit ramp from Highway 401 to Highbury Avenue in London, Ontario.

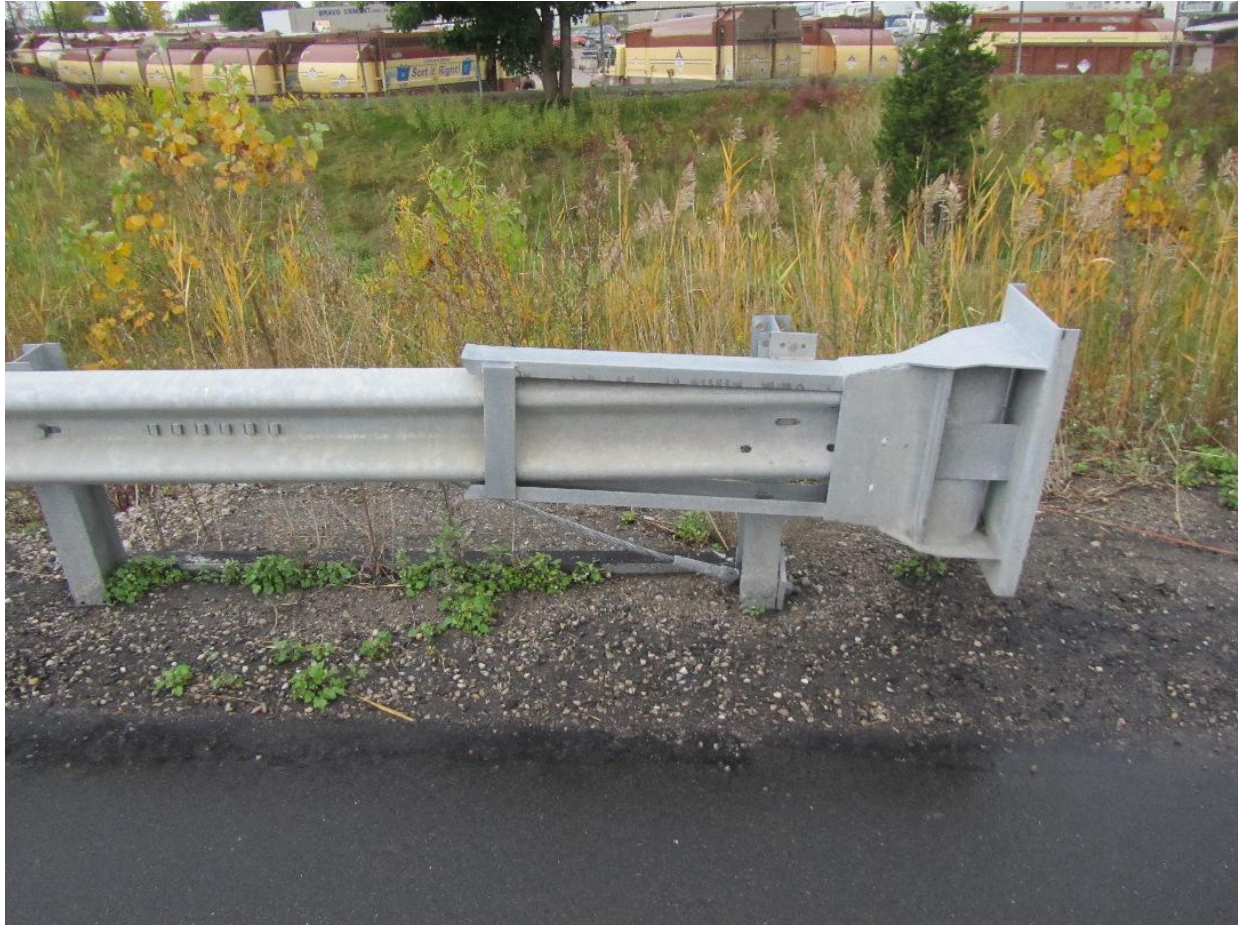
Figure 2: Side view the ET-PLUS guardrail terminal showing the plate (head) on the right and the channel attached behind it. The end of the guardrail fits within the channel.

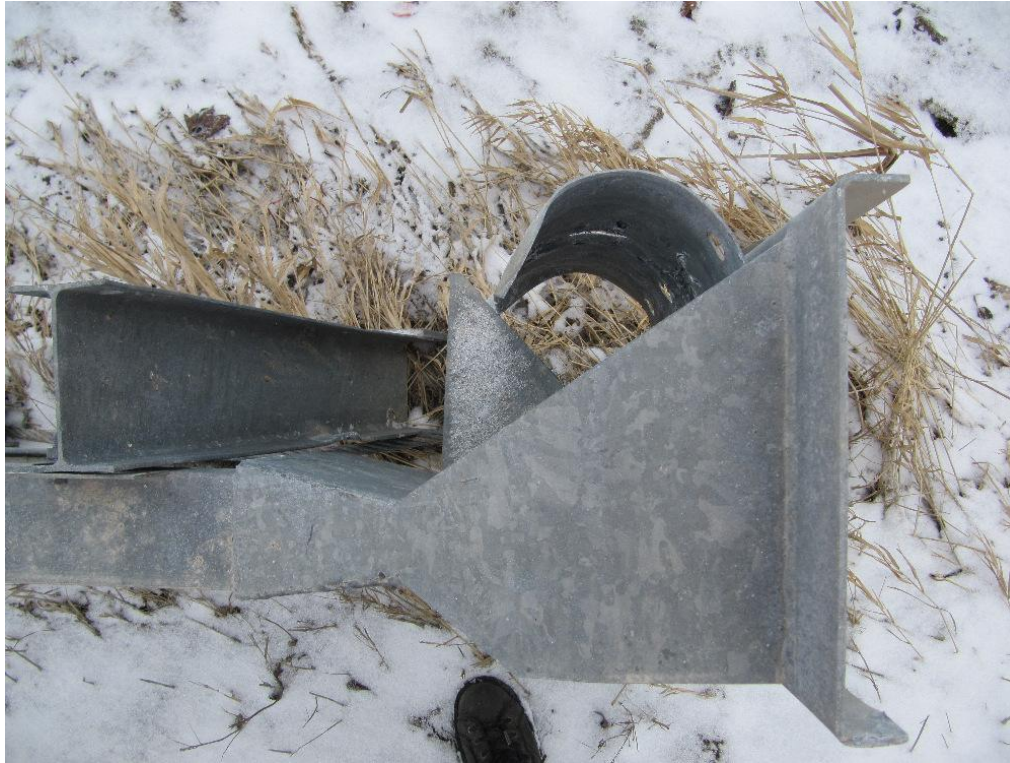
Figures 3 and 4 show an example of an ET-PLUS terminal on Dingman Drive in London, Ontario that was struck and sustained damage. Figure 3 shows a top view where the end of the flattened guardrail can be seen extruding from the side of the terminal head. Figure 4 shows the same terminal from a ditch-side view and we can also see a small portion of the guardrail as it has passed through the head and become flattened by its squeezing action.

Figure 3: Top view of the ET-PLUS terminal showing how a minor impact has caused the head and channel to be displaced along the guardrail. Consequently the end of the guardrail has been squeezed out the side of the head.

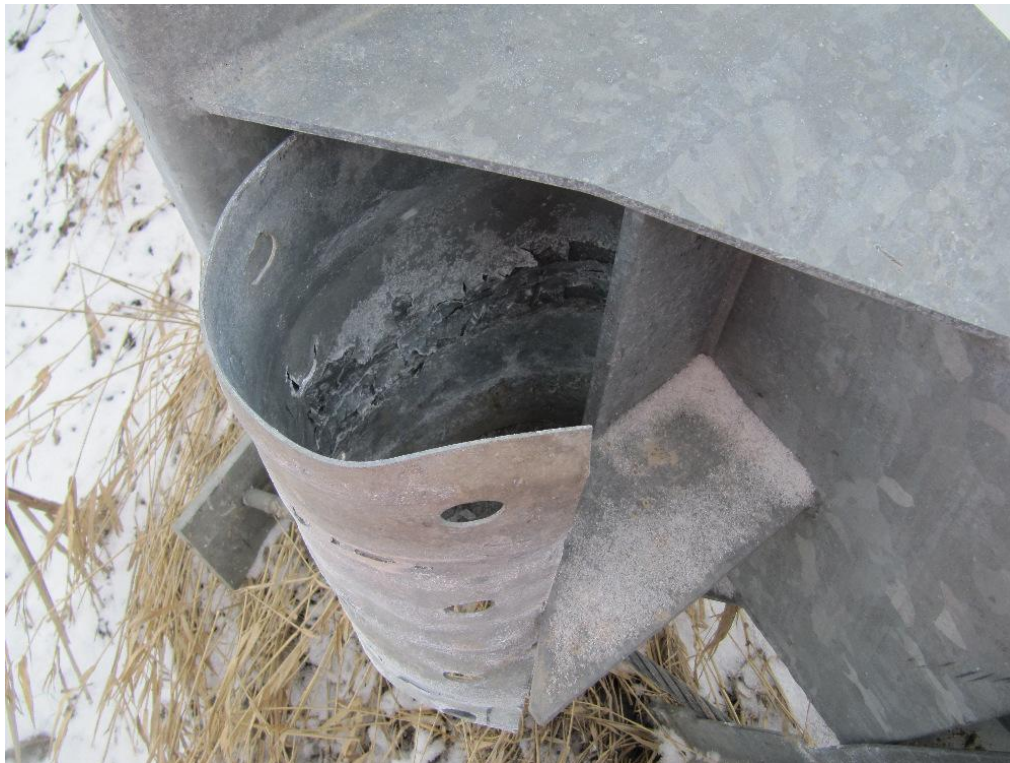
Figure 4: Ditch-side view of the end of the guardrail as it has been squeezed and deformed from passing through the narrow opening in the head.

Close-up views of the terminal have already been shown in Figures 3 and 4 near the beginning of this article. Those figures provide a good indication of how the guardrail is flattened as it passes through the narrow channel of the head. This process of deformation causes kinetic energy to be dissipated and this is what causes the striking vehicle to ride down the collision in a controlled manner. However, if the rail becomes jammed along the channel or inside the head then it cannot pass through and it does not perform the action of energy dissipation that it was designed to do. More importantly, critics have argued that when the rail becomes jammed, it folds over itself and creates a spear that harpoons the striking vehicle. Thus it becomes important to study the results of real life collisions with these terminals to capture any evidence that supports or disproves this argument.

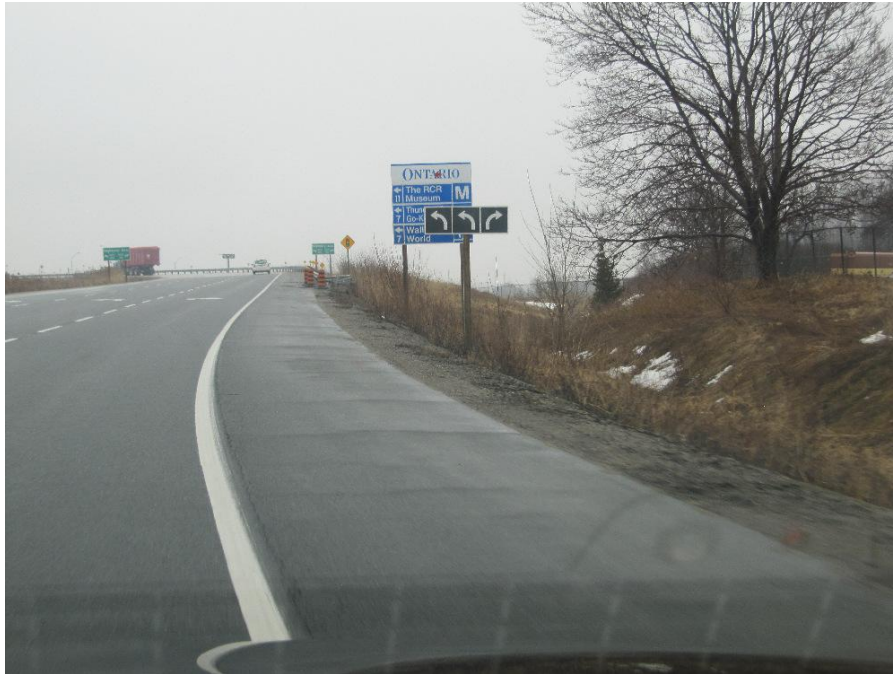
Figure 5: View looking along the exit ramp toward the impacted ET-PLUS guardrail terminal.

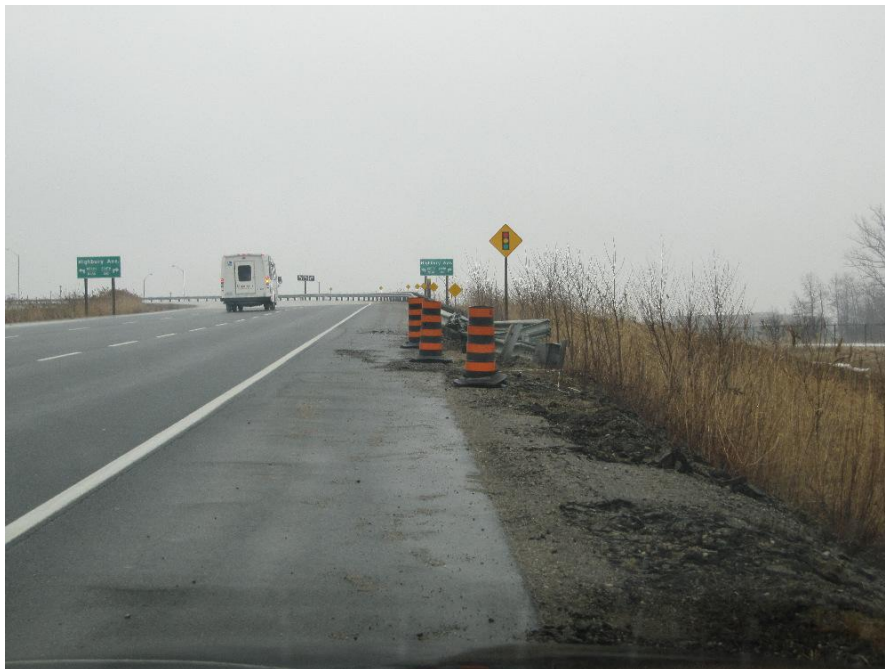
Figure 6: Overall view of the impacted ET-Plus terminal.

This evidence was identified on March 24, 2015 and the impact likely occurred within the previous 24 hours. Judging by the extent of damage, along with other evidence, the impacting object was likely a large truck. This interpretation is also supported by the extensive damage to the guardrail system suggesting that a large amount of kinetic energy was dissipated, as shown in Figure 7.

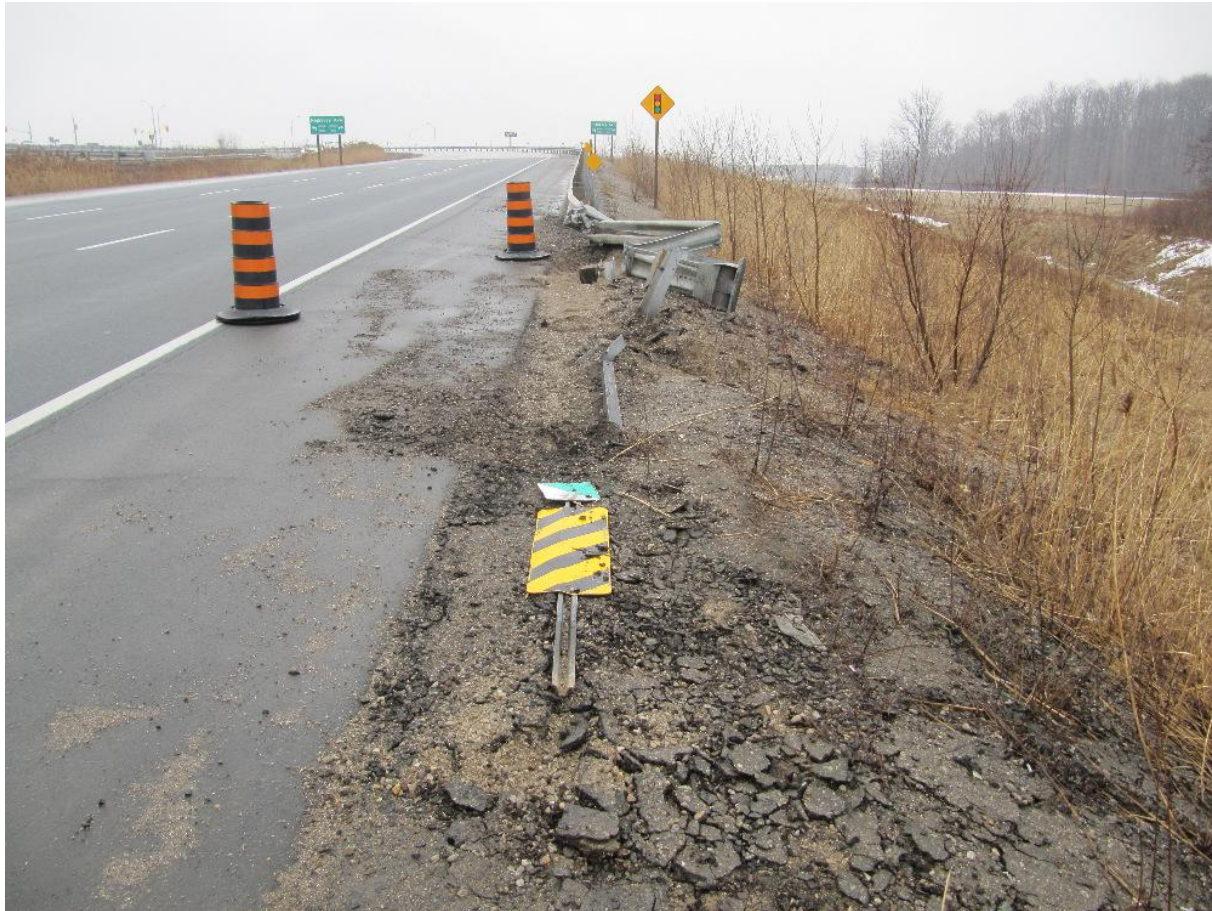
Figure 7: Overall view of damaged ET-PLUS terminal including a substantial length of guardrail.

In the foreground of Figure 7 one can see the yellow/black hazard marker post that was located just in front of the face of the terminal plate (head). The original position of the head would have located very close to the resting position of the hazard marker yet we see that the head's damaged position is a substantial distance away, confirming that the system was carried that distance as a result of the post-impact motion of the vehicle.

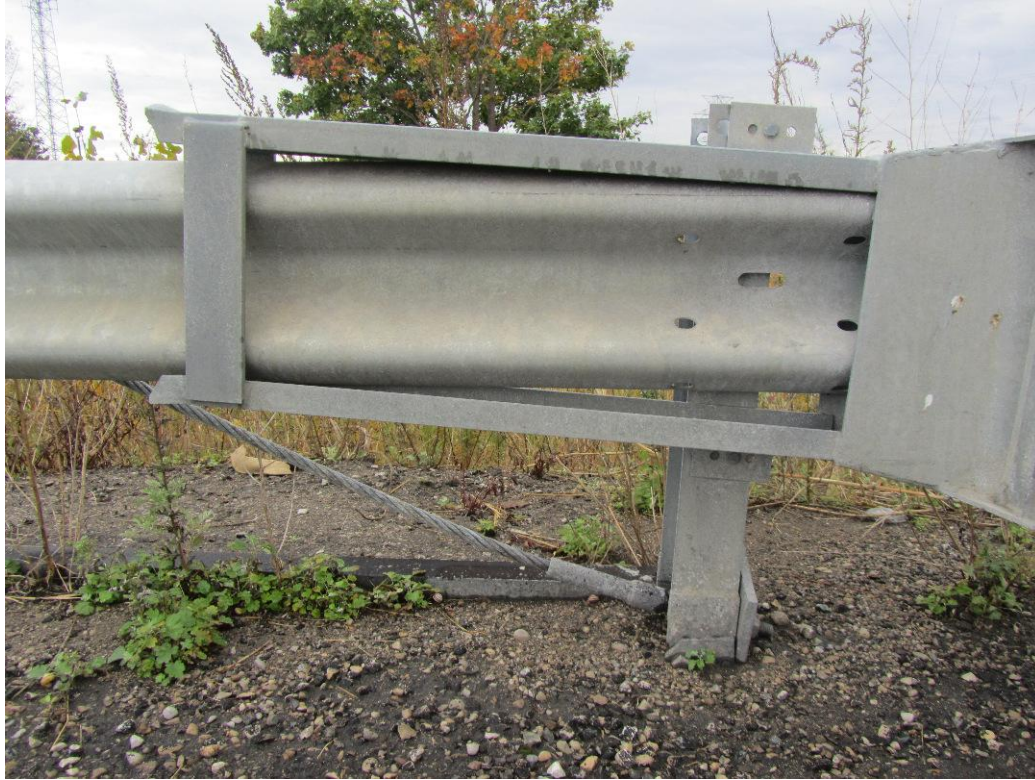
Figure 8 is another view of that installation from October 14, 2014. One concern is that the horizontal angle of the channel of the ET-PLUS is at a substantially different angle than the guardrail that is inserted into that channel.

Figure 8: Note the substantial difference in the horizontal angle of the head and channel of the ET-PLUS versus the angle of the guardrail.

This is a common occurrence that we have observed in a majority of the installations that we have surveyed. It is as if the weight of the head of the terminal causes it to lower over time while raising the rear end of the channel. It is unlikely that this is the manner in which the system is set-up during the controlled tests that the ET-PLUS passed during its recent compliance testing. This is why it is important for certifying agencies such as the U.S. FHWA to conduct studies of the performance of the ET-PLUS in real life collisions because such differences could affect how the system performs in those real life collisions.

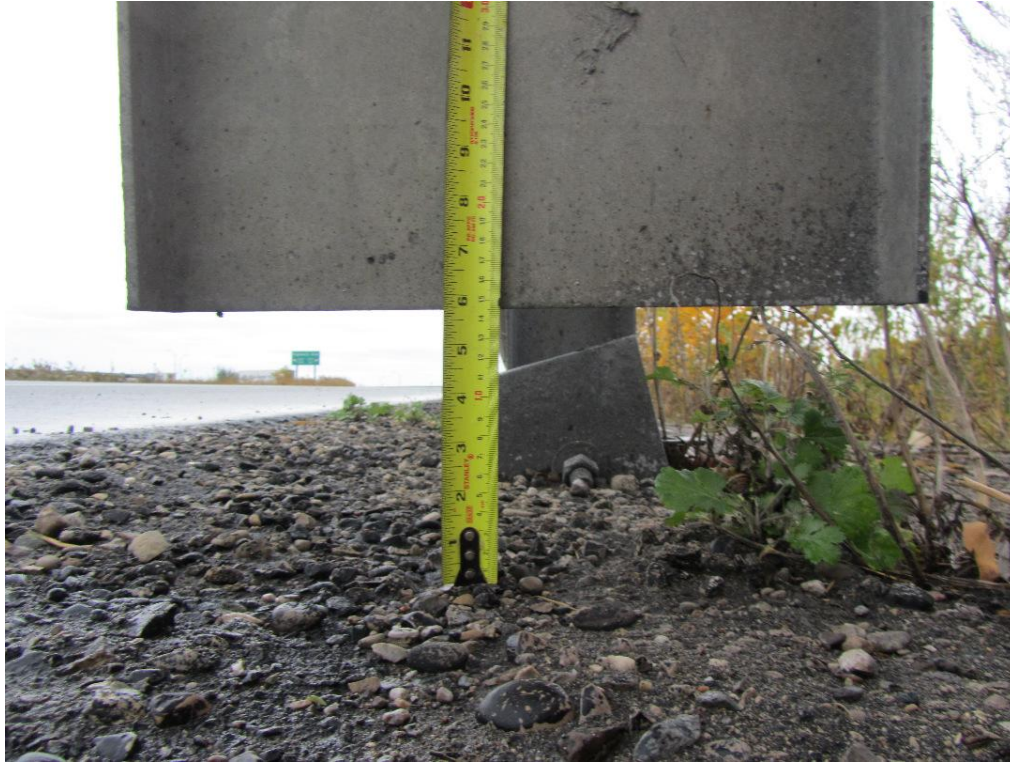
Figure 9 shows that at the time that the system was inspected on October 14, 2014, the base of the terminal head was located about 6 inches (15 centimetres) above the gravel shoulder.

Figure 9: Measurement of the installation height of the terminal head during an inspection on October 14, 2014.

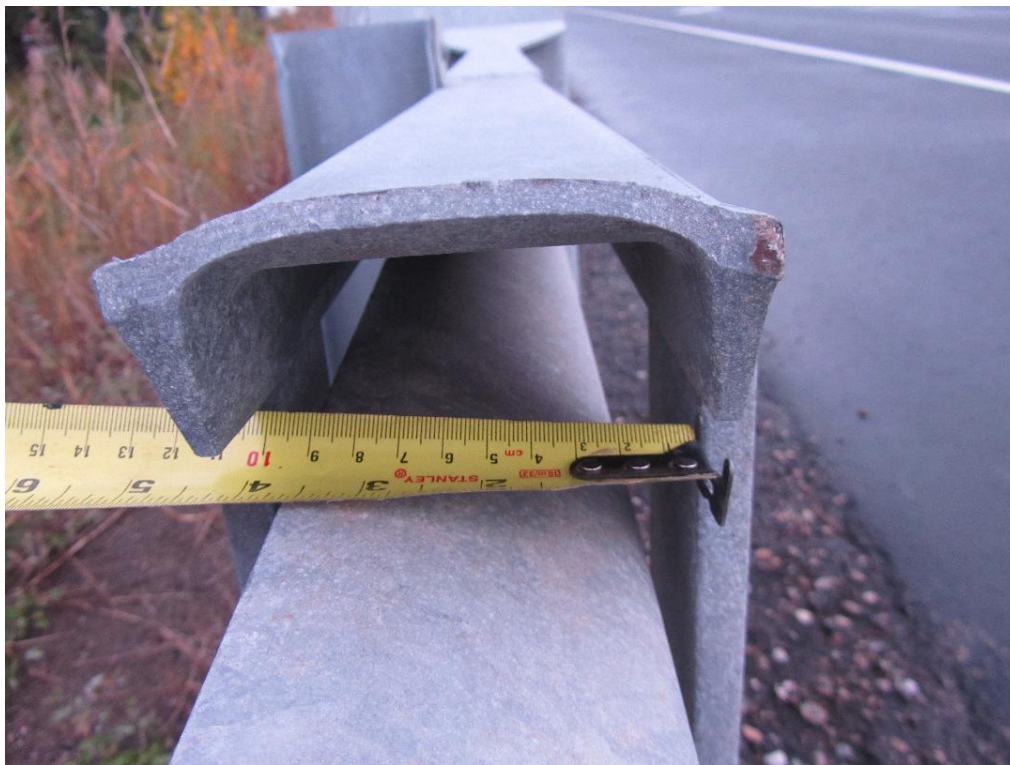
The measurement in Figure 10 confirms the 4-inch width of the channel. What is also apparent in Figure 10 is the large gap between the top of the channel and the top of guardrail, which confirms the differing horizontal angles of the two.

Figure 10: Measurement confirming the 4-inch-wide channel of the ET-PLUS terminal (Photo taken on October 14, 2014).

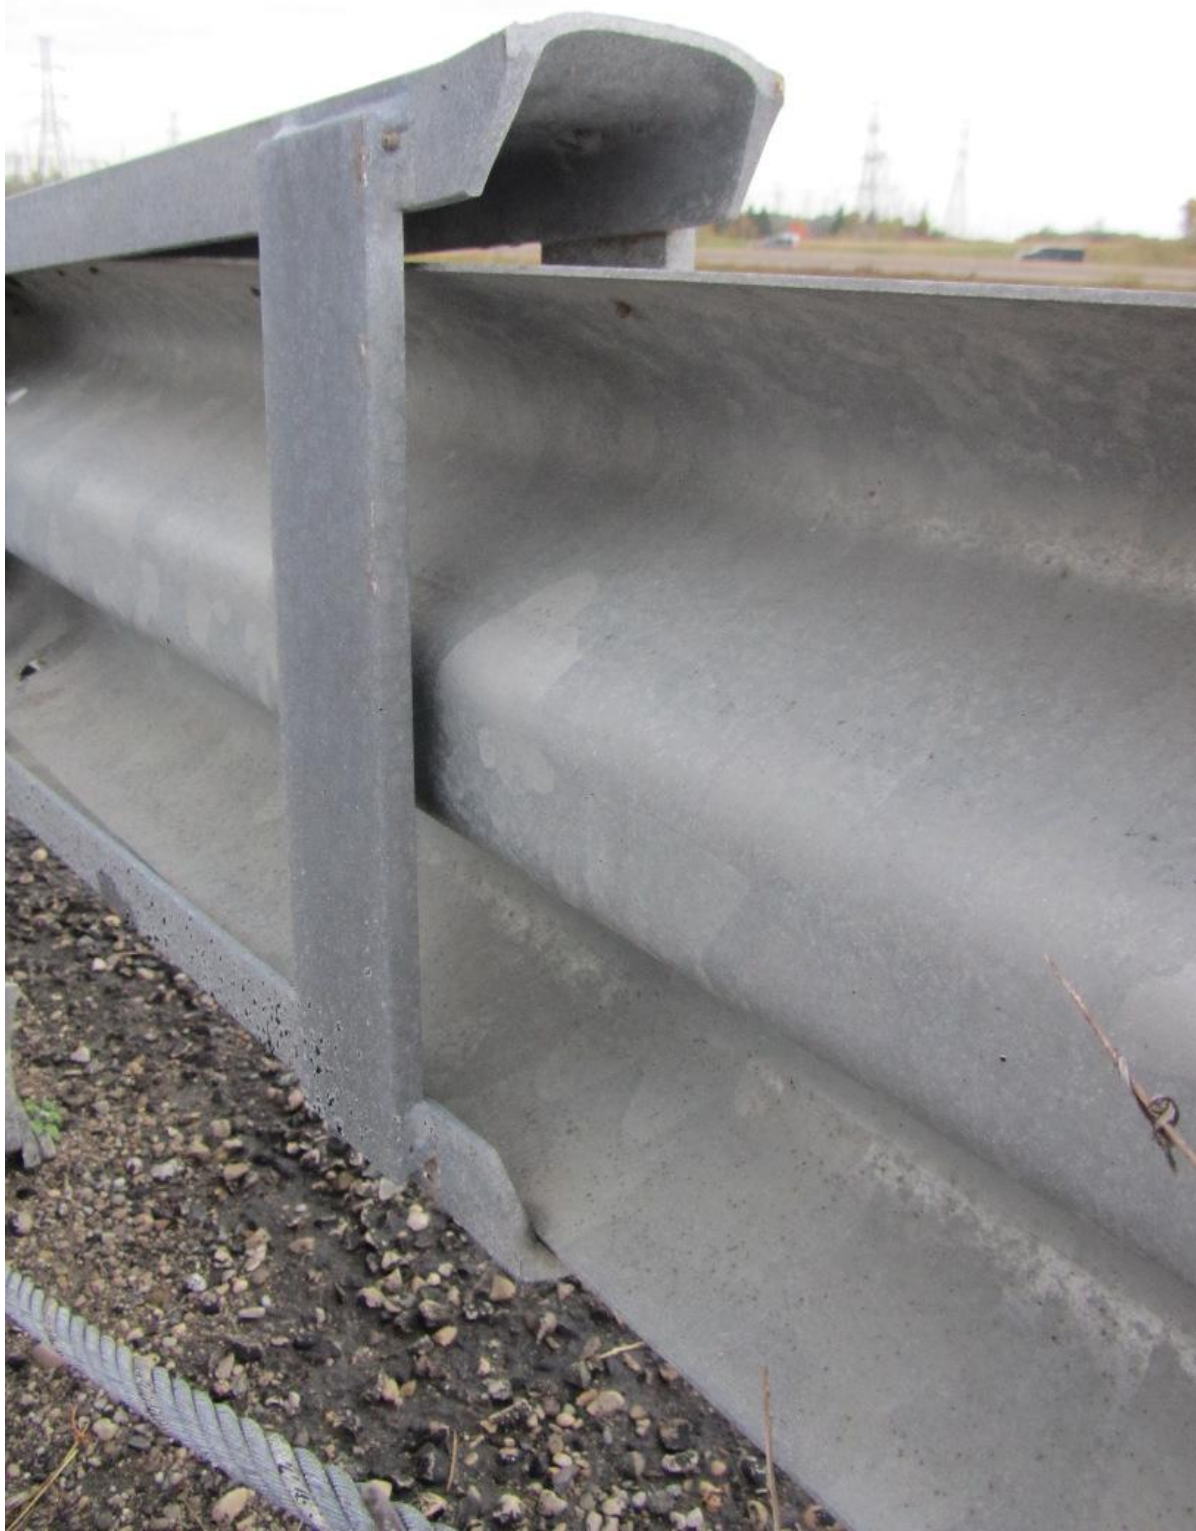
Meanwhile Figure 11 shows that the bottom edge of the guardrail is resting on the bottom edge of the channel.

Figure 11: View of the ET-PLUS terminal on October 14, 2014. Note that the substantial difference in the horizontal angle of the terminal and guardrail causes the bottom edge of the rail to rest on the bottom of the channel while there is a large gap at the top.

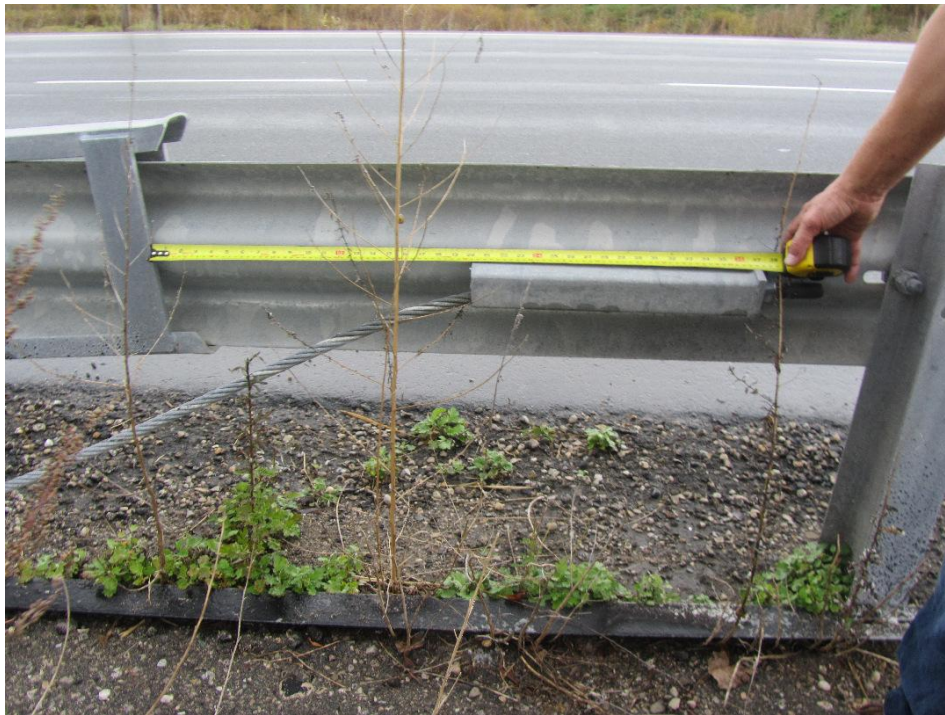
Figures 12 and 13 show that the position of the rear edge of the channel was measured to the rear portion of the anchoring bracket that anchors the rail to a slip-fit vertical post near the terminal head.

Figure 12: Measurement taken to locate the channel and head with respect to the guardrail.

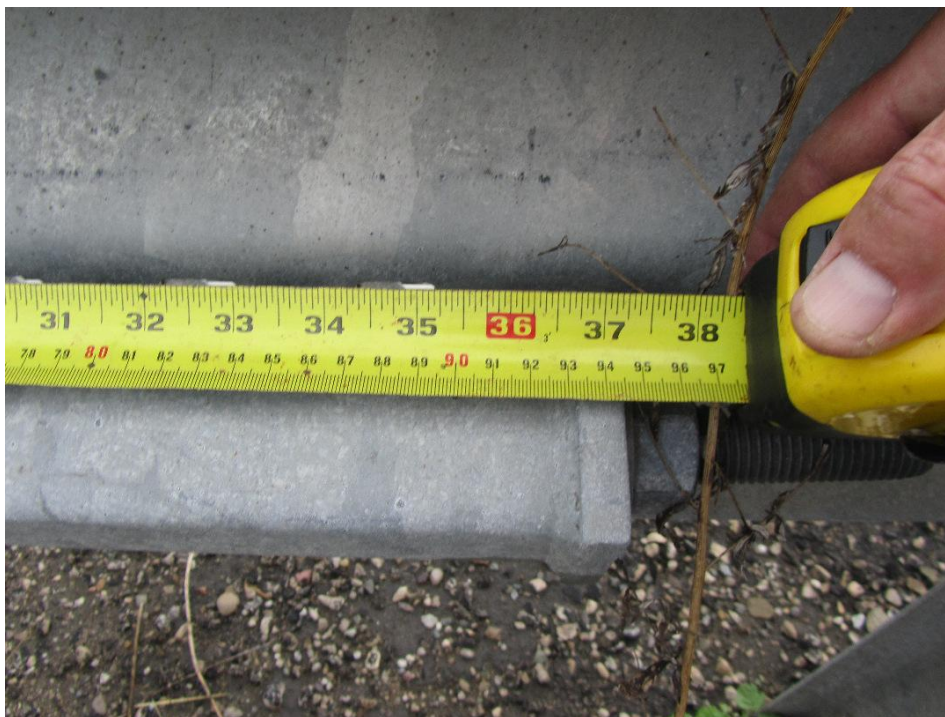
Figure 13: View showing that the measured distance to the rear edge of the anchor bracket is about 37 inches.

Figure 13 demonstrates that this distance is about 37 inches. This distance usually differs by one or two inches from installation to installation. It can be used as a general estimate of the length of guardrail that was squeezed through the narrow opening of the terminal head in this real life collision.

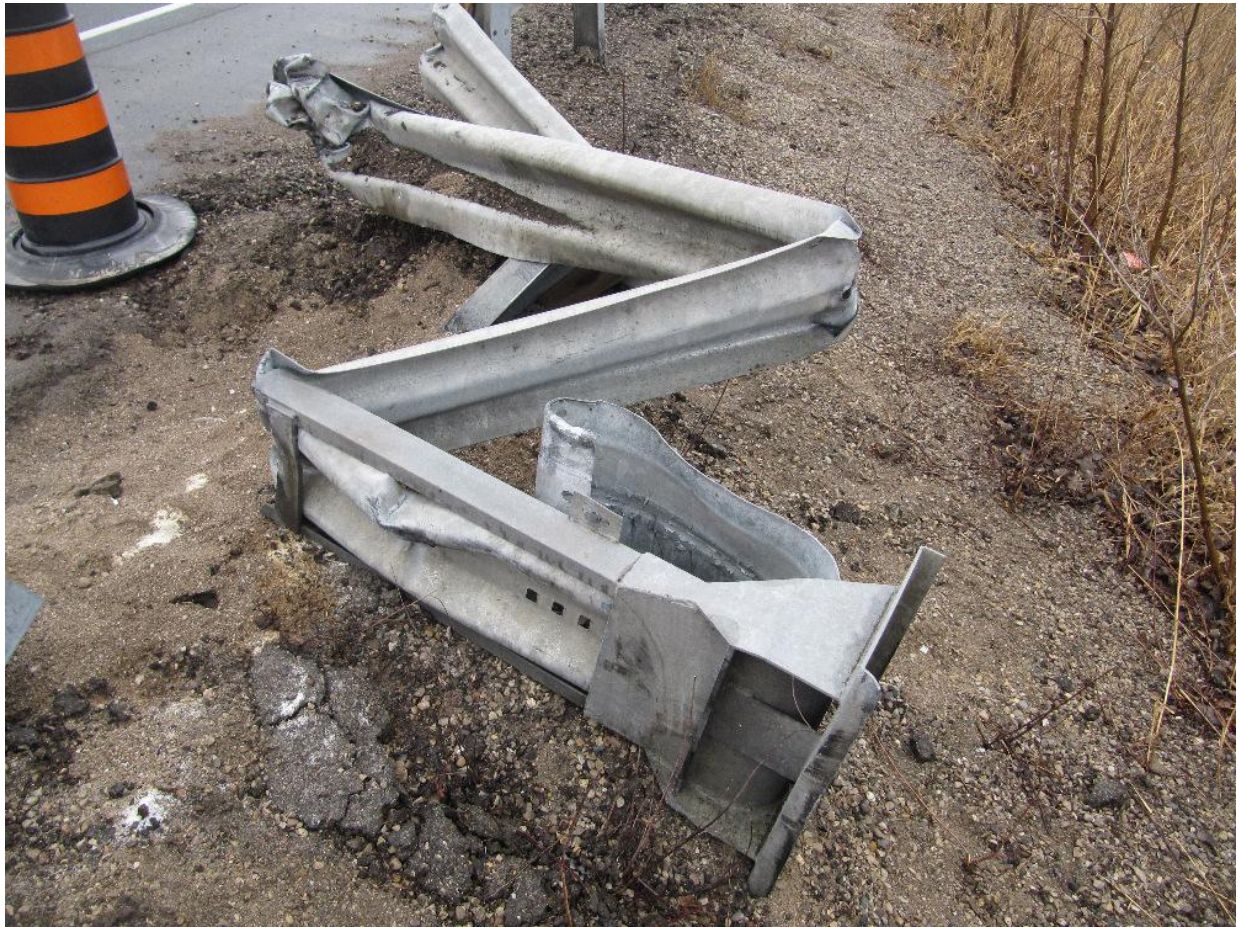
Figure 14 shows an overall view of the buckled guardrail along with the terminal head and channel. One can note that a length of the rail passed through the head, was flattened, and is seen extruded out the side of the head.

Figure 14: Overall view of buckled guardrail and a short length of rail that has been extruded out the side of the terminal head.

The question that needs to be answered is why there was only a short length of rail which passed through the terminal head when clearly there was much more energy available to be dissipated as demonstrated by the long length of buckled rail. A large truck such as a tractor with a semi-trailer is one of the objects used in the controlled compliance testing (NCHRP-350). One might conclude that this installation was unable to manage the huge energy of such an impact.

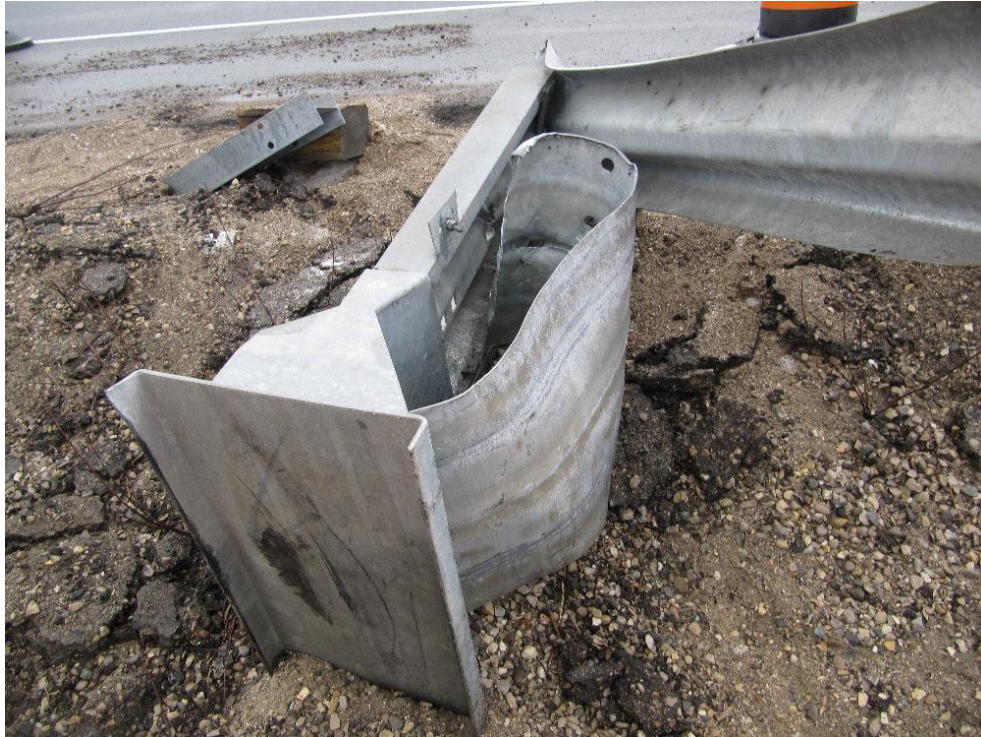
Figures 15 and 16 show further views of the rail and its relationship to the head and channel. In particular, Figures 14 and 16 show a set of holes in the rail near the back of the terminal head. These holes are what the teeth of the anchor bracket fit into. The last hole would have been near the end of the anchor bracket or about 37 inches to the rear of the channel. The length of the channel from its rear edge to the rear edge of the head is about 36 inches. So the rail has travelled less than  $(37+36)$  73 inches or less than 2 metres through the head. This is not a long distance given the overall extent of energy dissipated by the long length of buckling of the rail.

Figure 15: View of the terminal head and the short distance of rail that was extruded out of its side.

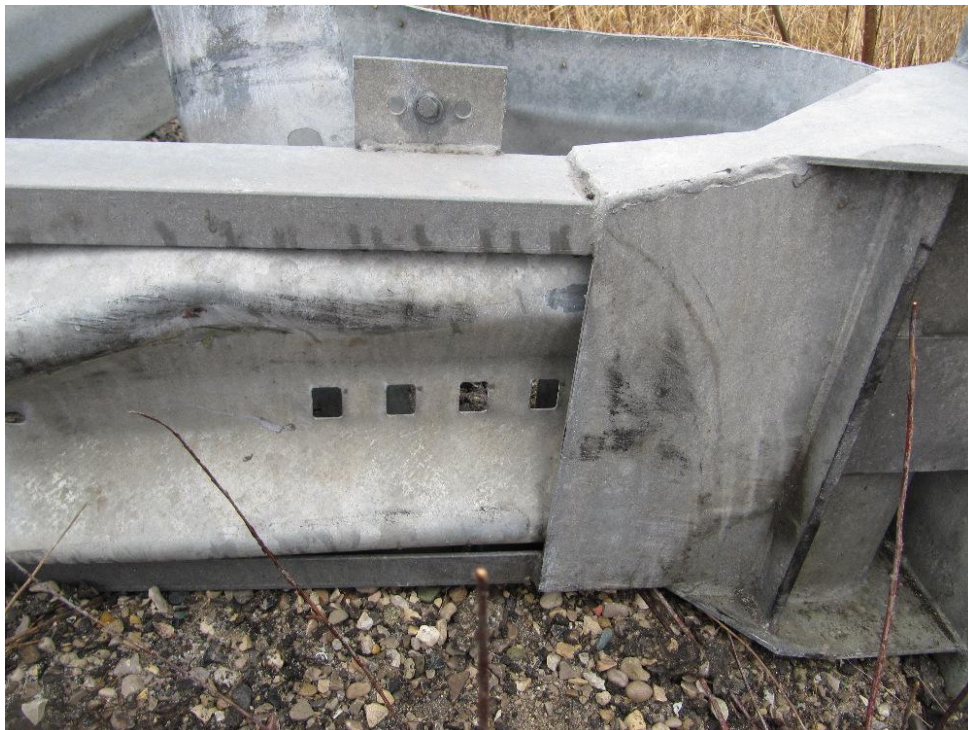
Figure 16: View of anchorage holes in the rail where the teeth of the anchorage bracket would have fit. This indicates the extent of travel of the rail through the head as a result of the impact.

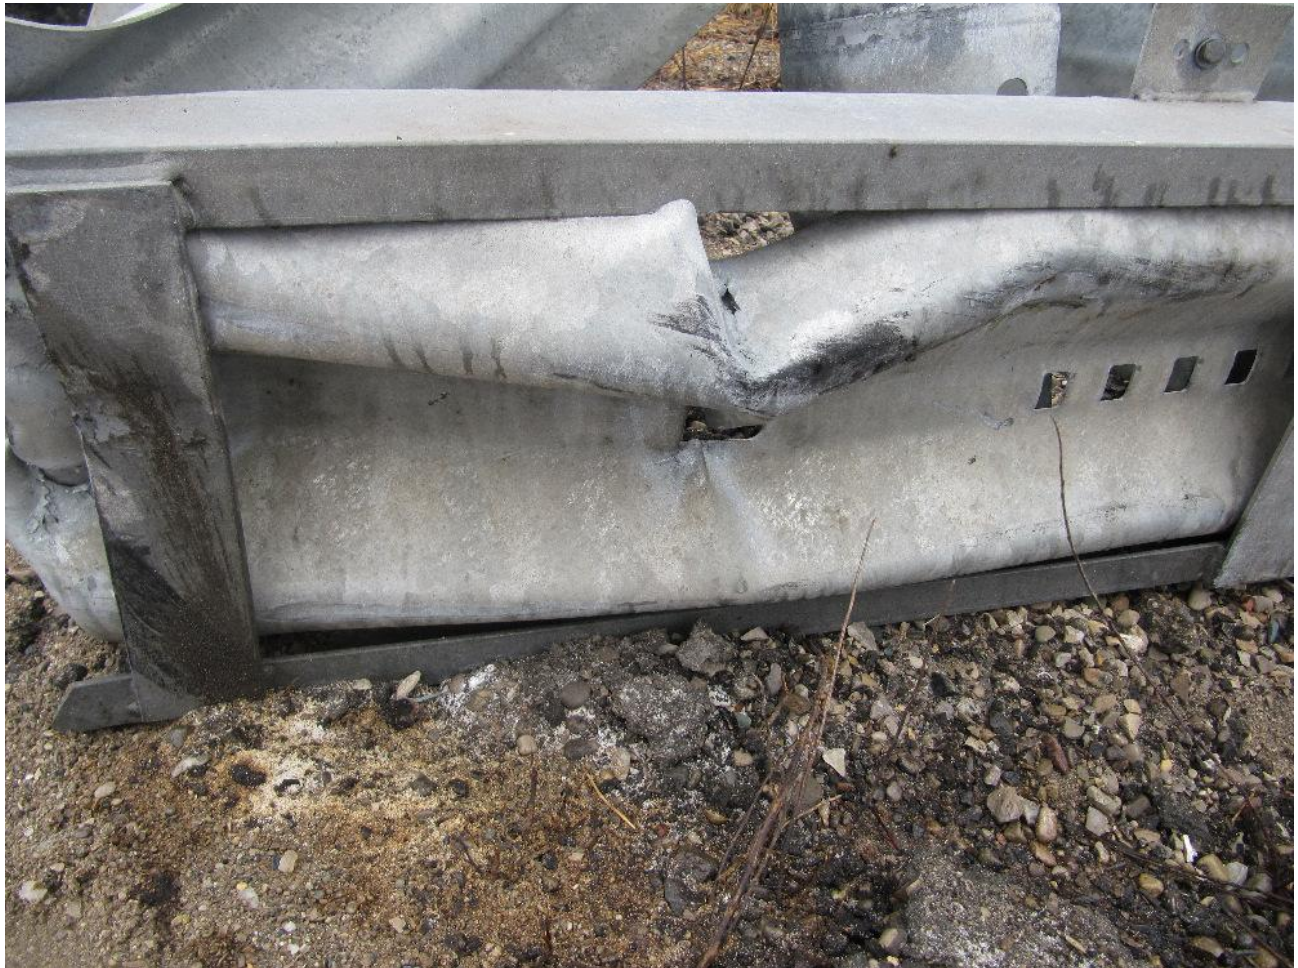
There is evidence that the rail was buckled and may have jammed within the channel. Figures 17 and 18 show that the rail is buckled at the location where it rests within the channel.

Figure 17: View of buckling of the rail while resting within the channel.

Clearly, the rail has buckled at the rear edge of the channel as the rail is beyond a 90 degree angle with respect to its original orientation. Some study would be required to evaluate when, and how, this buckling occurred and whether this can be solely related to excessive energy of the large striking vehicle. Given that the collision occurred at the curve of an exit lane it is unlikely that the terminal was struck at highway speed.

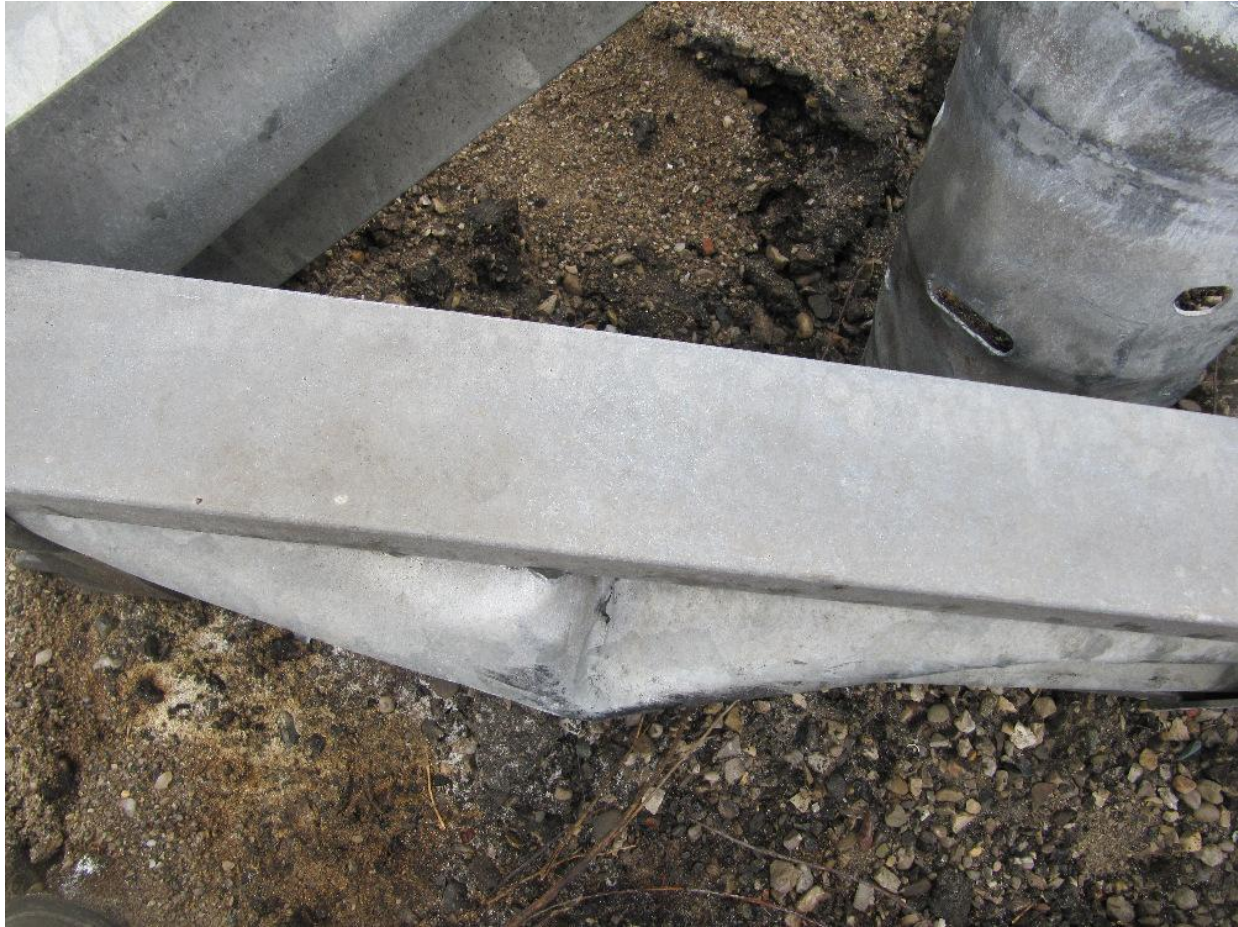
Figure 18: View looking down at the guardrail within the channel showing how it is deformed and is protruding out of the side of the channel.

This conclusion is also borne by the fact that there is no evidence of post-impact travel of the striking vehicle past the buckled guardrail. So it would suggest that the vast majority of the vehicle's kinetic energy was dissipated by the guardrail system. Even though the energy dissipation is large it does not equate, in our opinion, to a very high impact speed of the large truck. Given this lower impact speed it becomes questionable why the terminal head was not capable of passing the rail through its opening.

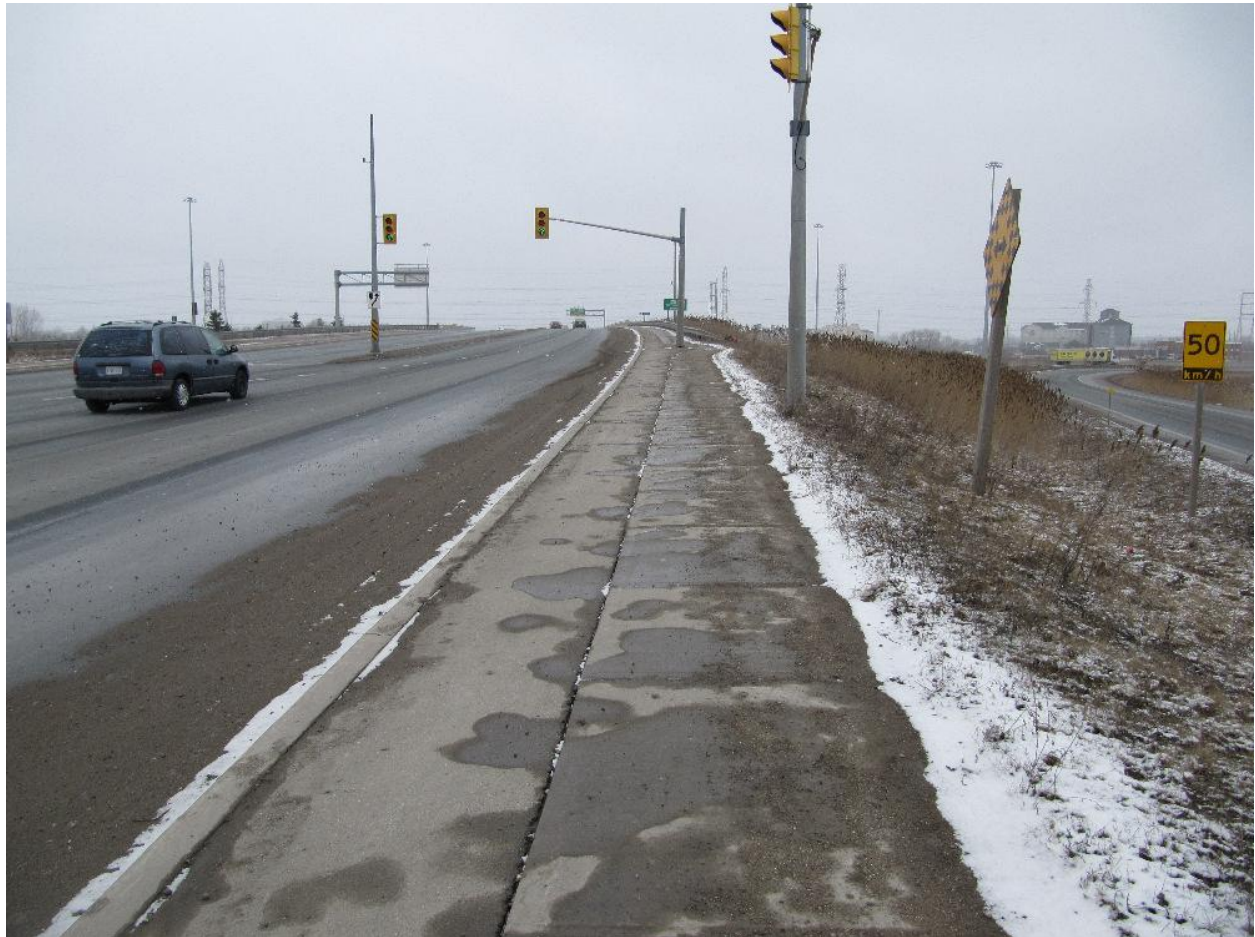
Figure 19 shows a view, looking north, along Wellington Road in London, Ontario, at a location just south of the overpass to Highway 401. On the right roadside there is a guardrail where an ET-PLUS guardrail terminal was struck and became detached from the rail.

**Figure 19: View, looking north, along the east edge of Wellington Road toward the overpass of Highway 401 in London, Ontario.**

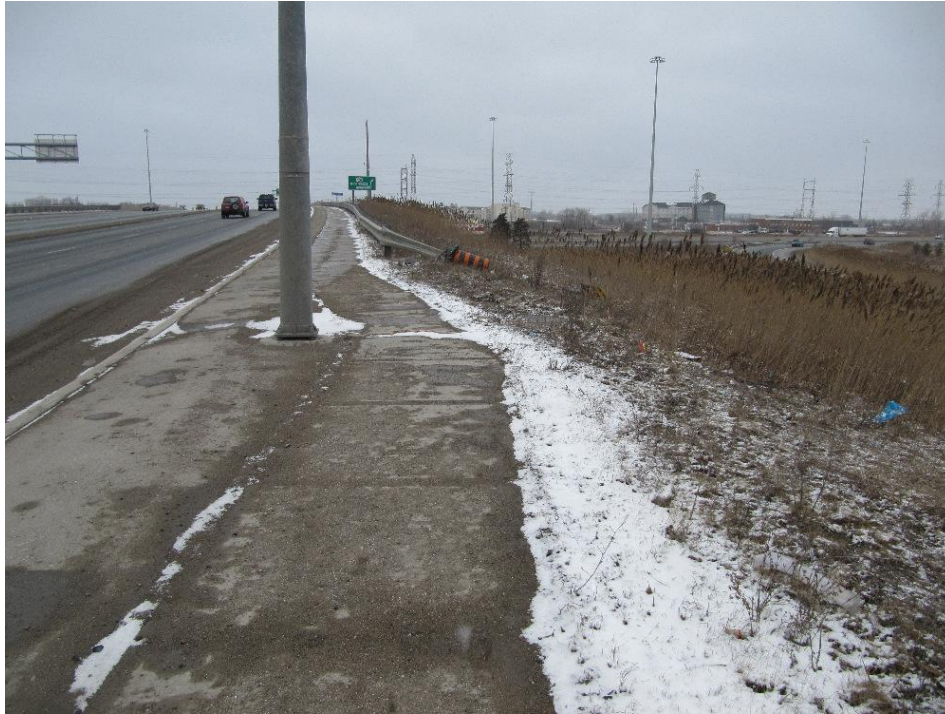
As we come closer to this area, Figures 20, 21 and 22 show that the end of the guardrail has been bent away from the roadway. This may not be solely related to the impact as it is a common procedure of road works personnel to bend the rail away from traffic as a way of preventing a possible harpooning of a striking vehicle. The ET-PLUS terminal can be seen in Figure 21, lying in the brush at the right edge of the view.

Figure 20: View, looking north, toward the damaged guardrail end on the east side of Wellington Road.

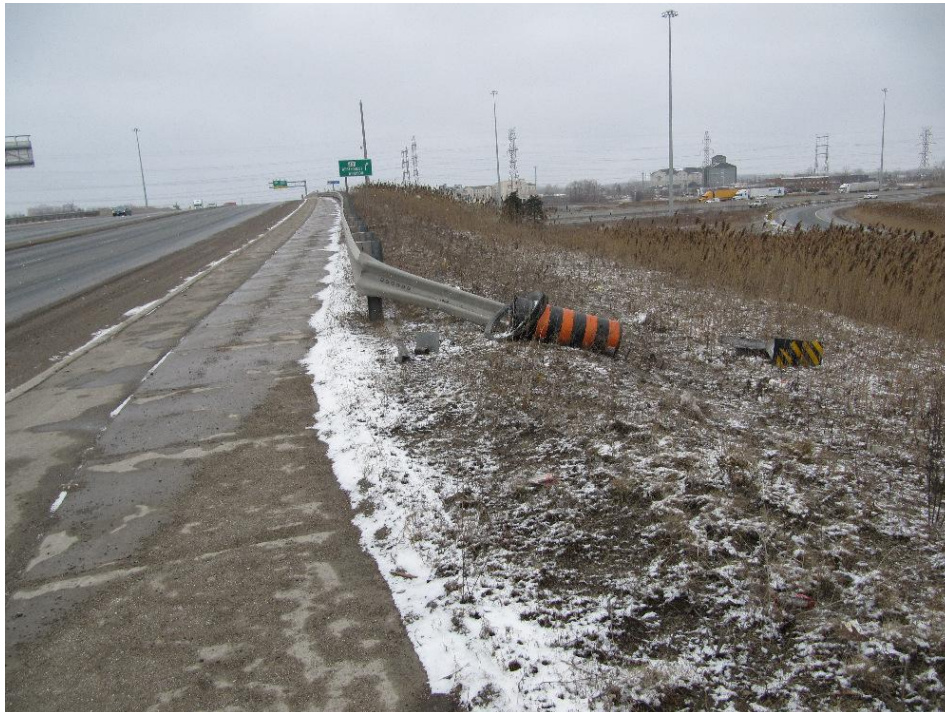
This finding is interesting as it demonstrates the ease with which the terminal can become separated from the rail.

Figure 21: Closer view of the damaged guardrail end.
