# Trinity ET-PLUS Guardrail Terminals - Revelations From Real-Life Impacts

*Posting Date: 30-Mar-2015; Revised Aug 9-15*

## ET-PLUS Impact #1: Eastbound Highway 401 Exit Ramp to Highbury Avenue, London, Ontario

## **ET-PLUS Impact #2: Northbound Wellington Road East Guardrail on South Side of Overpass to Highway 401, London, Ontario**

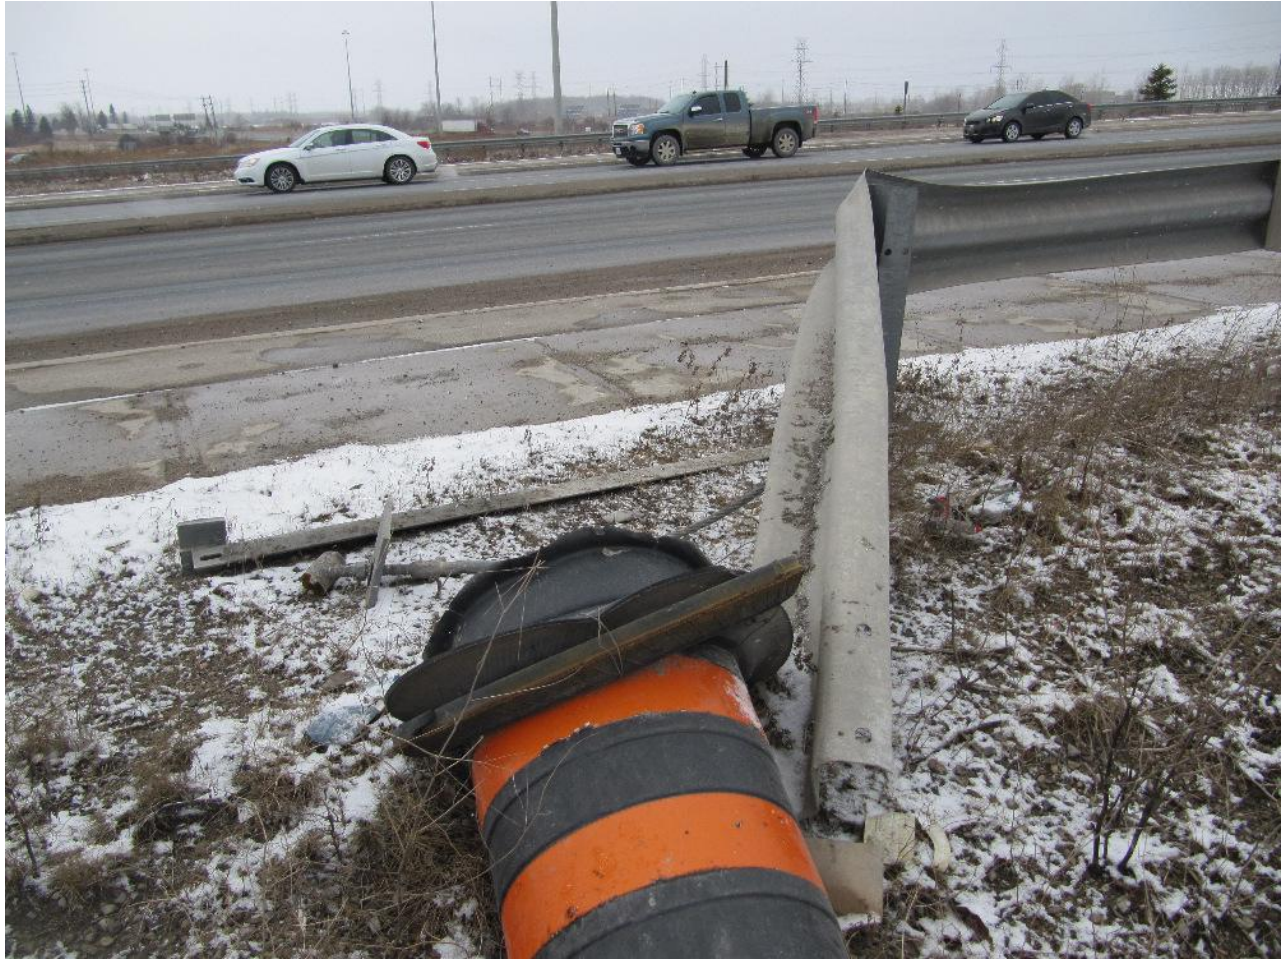
Figure 22: View showing that the end of the guardrail has been bent at its anchorage post however there is little evidence of additional damage to it.

As can be seen in Figure 22, the guardrail itself shows only minor evidence of deformation. In fact the rail is simply bent at the anchorage post.

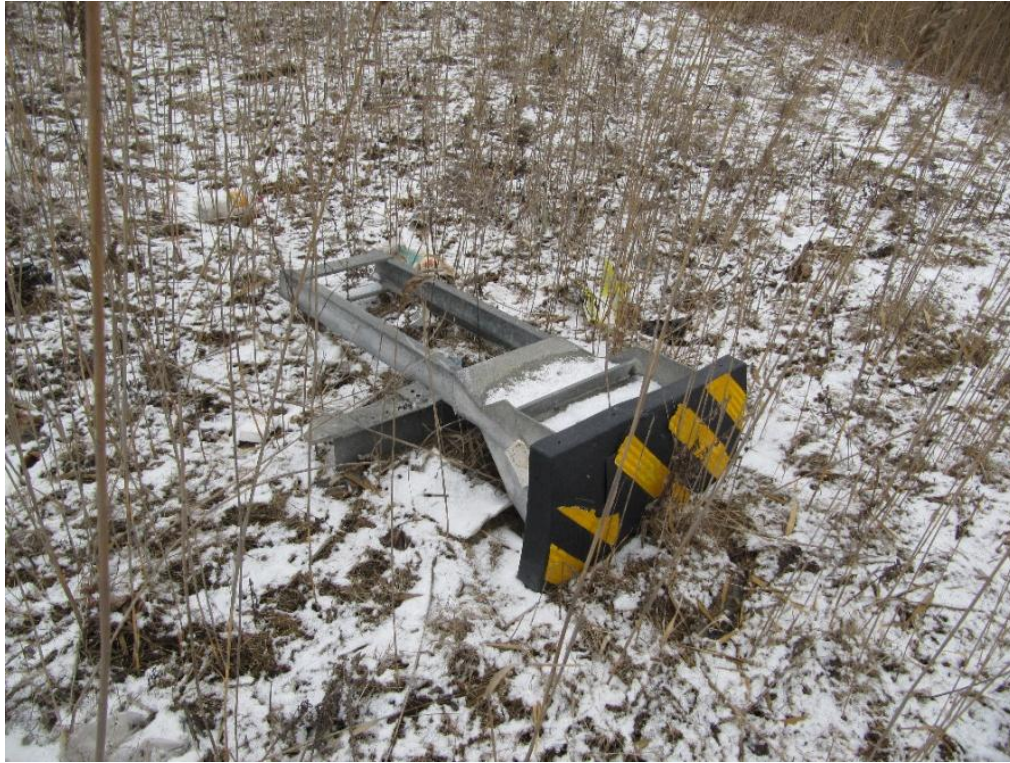
Figures 23 through 26 show views of the detached ET-PLUS terminal lying in the brush. Again, there is no evidence of any deformation to its structure. The only evidence of damage is that the black covering of the head (plate) shows some tears that are visible in Figure 26.

It is likely that the terminal and guardrail were struck at a large angle with respect to the length of the rail. The impact force would therefore contain a substantial lateral component that would not normally exist at higher speeds in highway situations. In most instances it may be beneficial to have the terminal separate allowing an impacting vehicle to push it freely along the rail. However, when this freedom causes the terminal to actually fall off the end of the guardrail then there is the possibility that a striking vehicle could become harpooned by the exposed end of the guardrail. The issue is that the head and channel should stay attached to the guardrail and ride along the guardrail but not become detached from the guardrail, as shown in this example.

Figure 23: View of detached ET-PLUS terminal lying in the brush near the damaged guardrail.

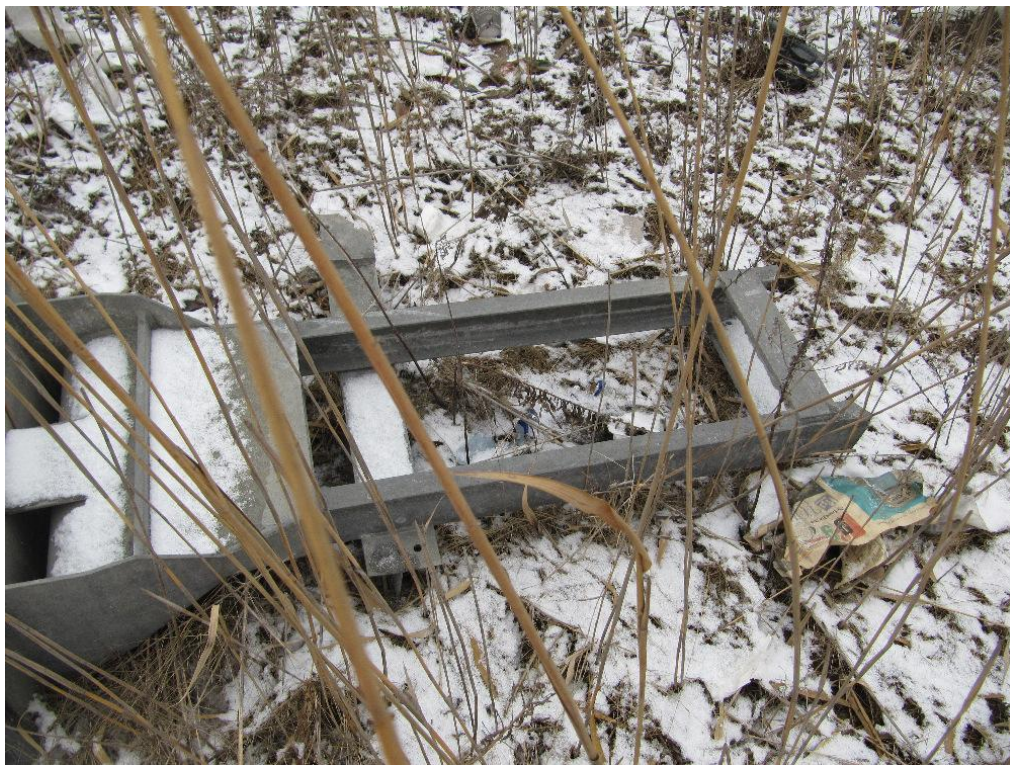
Figure 24: Note the lack of any structural deformation to the terminal.

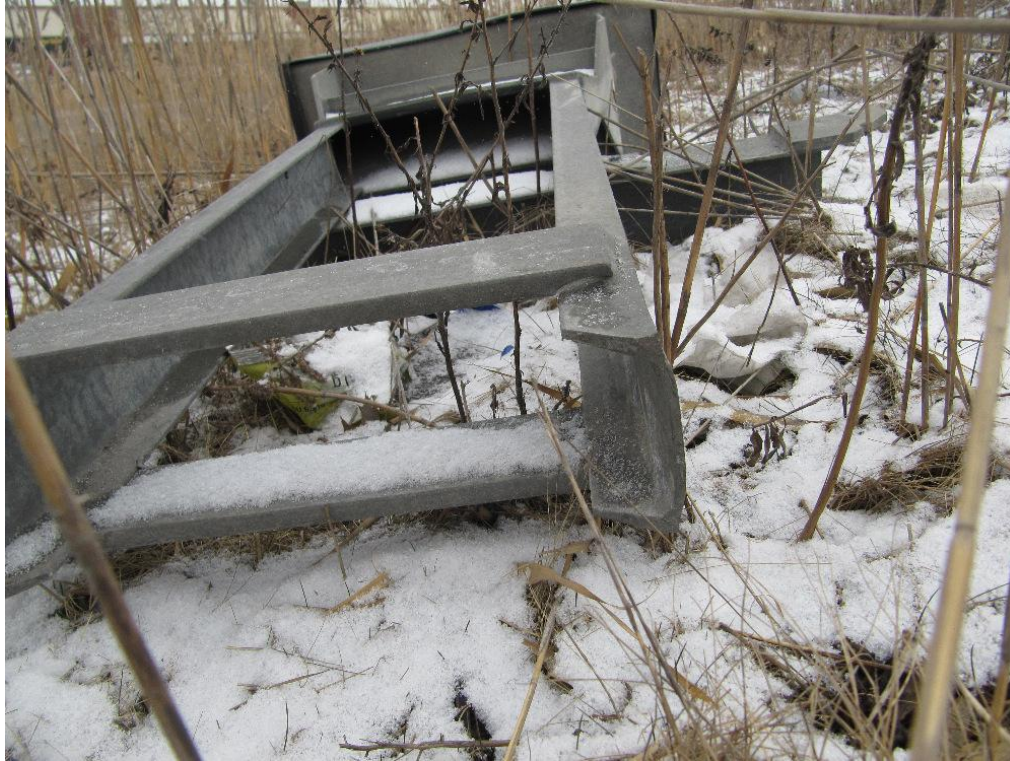
Figure 25: View of the length of the channel of the terminal indicating a lack of structural damage.

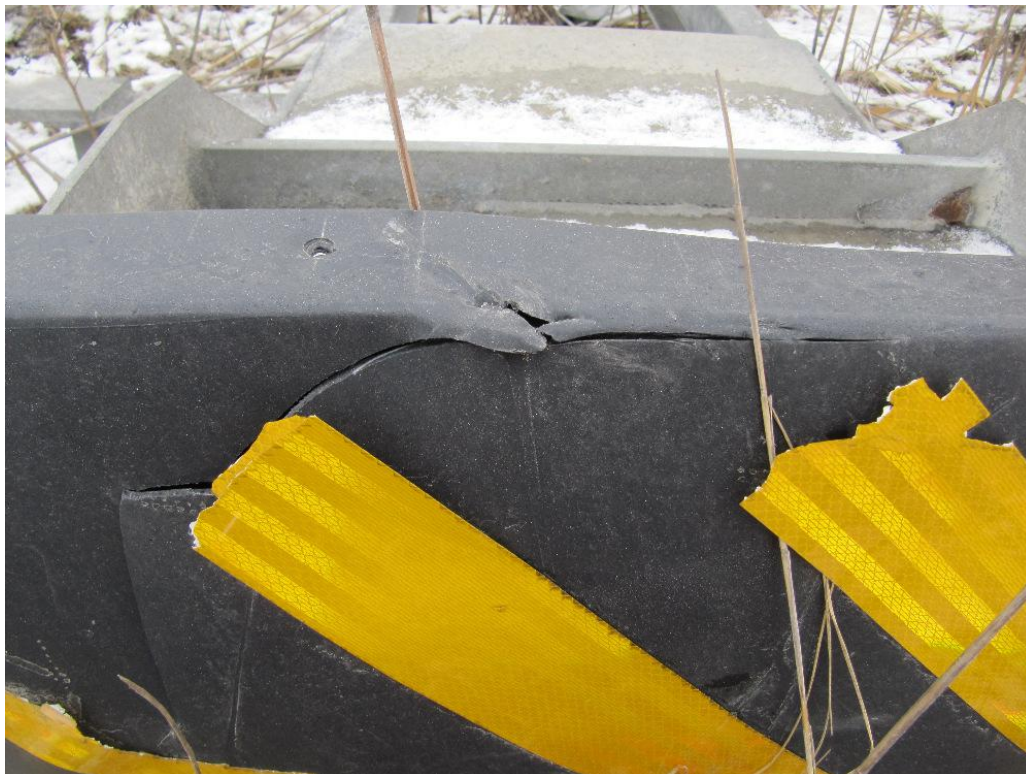
Figure 26: View of the minor tears to the cover of the head (impact plate) confirming that an actual impact occurred to the unit.

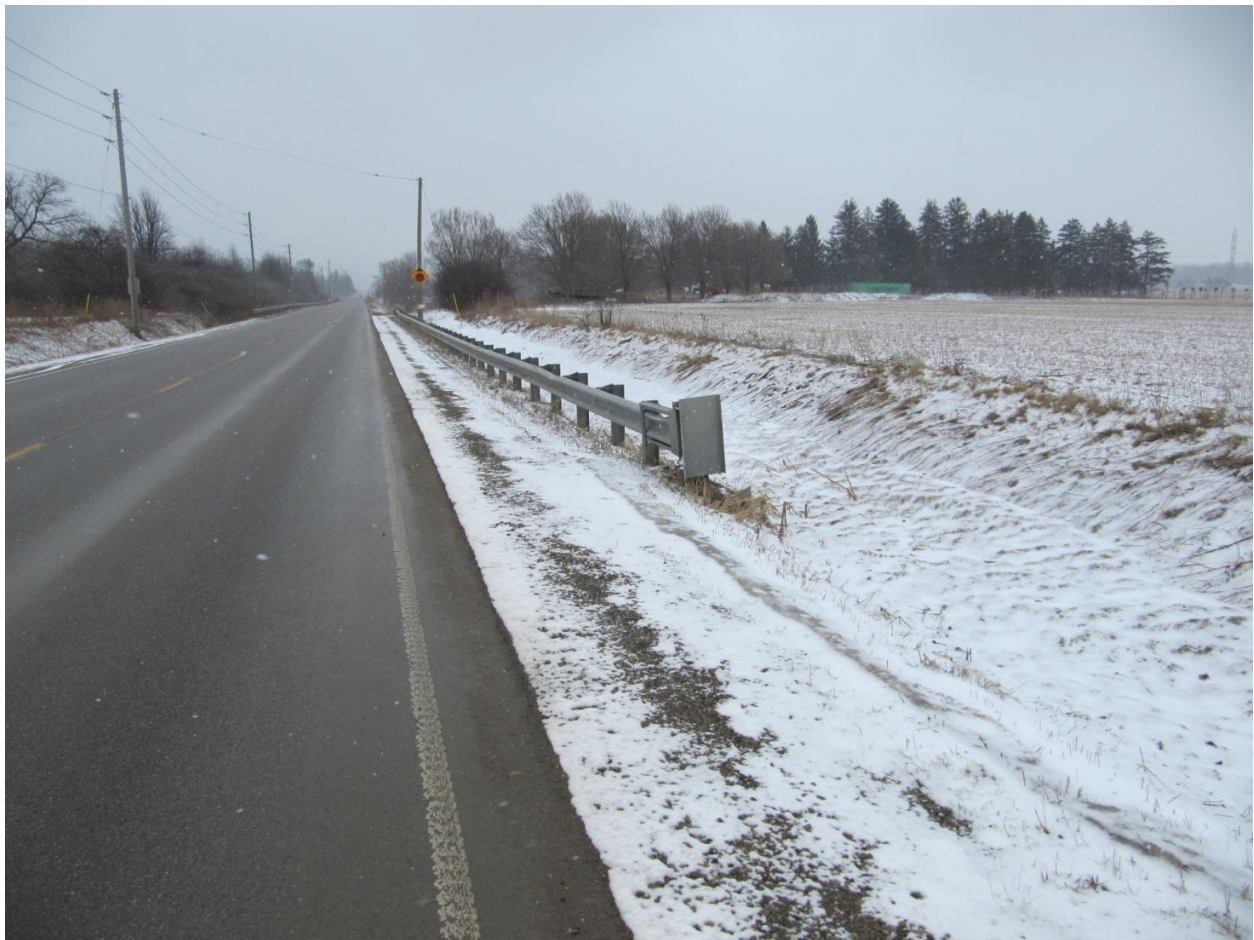
Figure 27: View, looking east, at the south guardrail on Dingman Drive, just west of White Oak Road in London, Ontario.

Even looking from a short distance the guardrail appears to be straight and undisturbed. The head (impact plate) of the ET-PLUS terminal also appears to be upright and positioned fully onto the end of the rail.

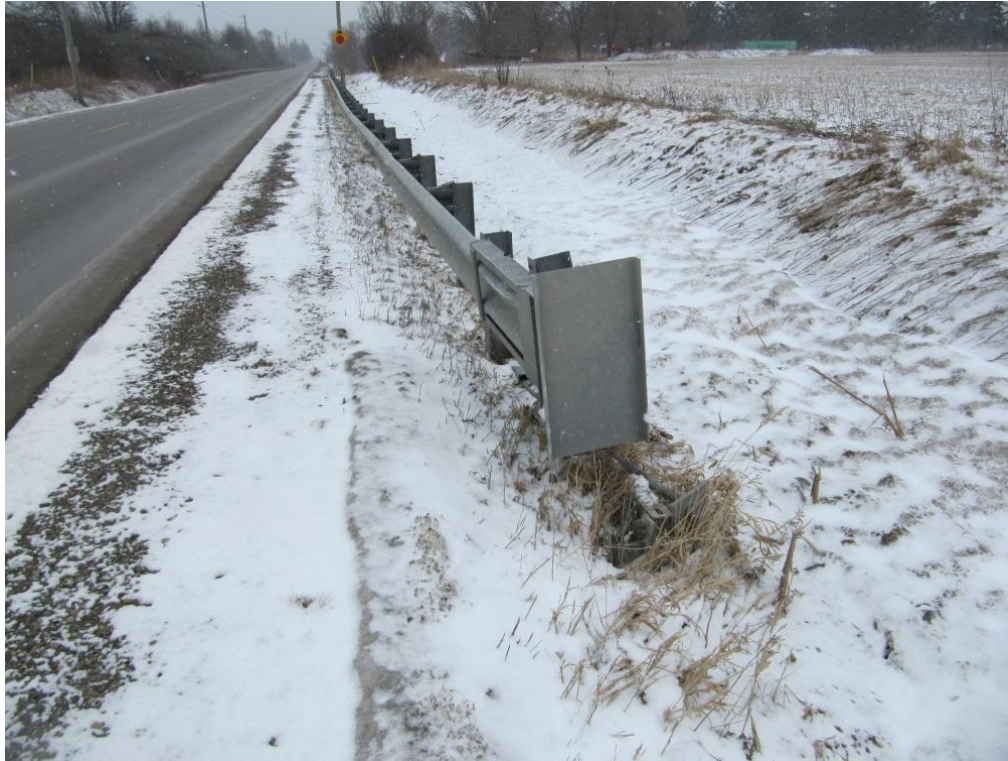
Figure 28: View of the ET-PLUS terminal and guardrail initially suggests there is no damage to it.

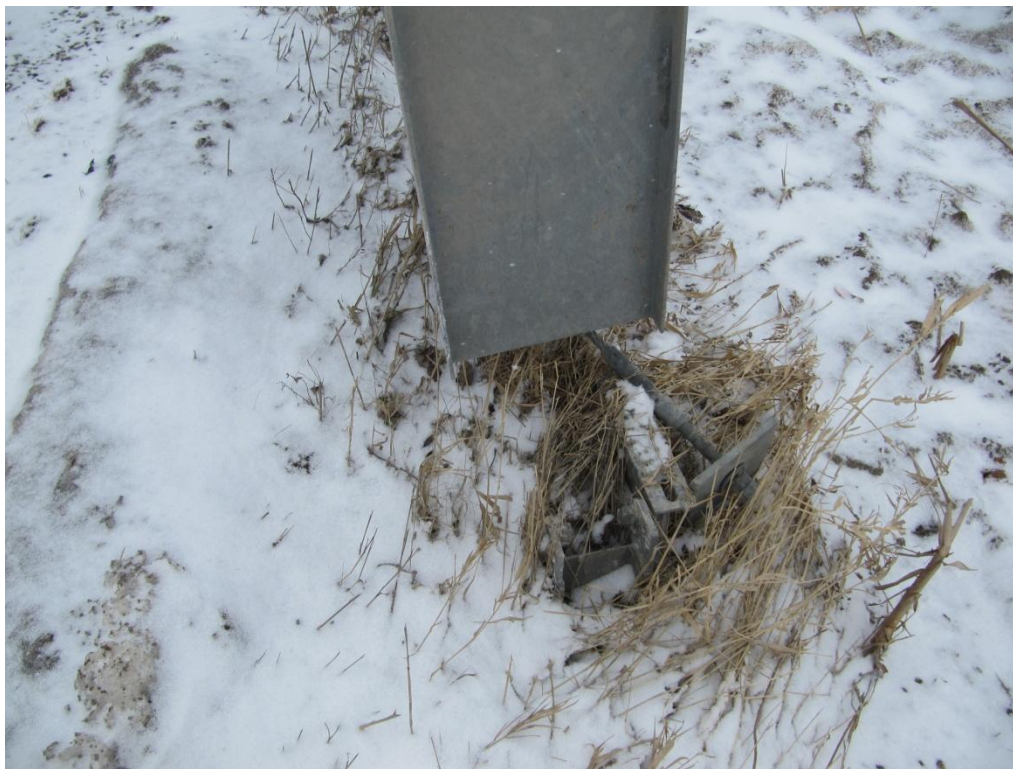
However as we come closer to the terminal, as shown in Figure 29, we can see the ground-based anchorage bar lying in the grass ahead of the terminal head. Normally this anchorage bar lies behind the terminal when the system is undamaged. So, already, this is an indication that the terminal has been pushed back along the rail.

Figure 29: View of the anchorage bar that normally lies beneath and behind the terminal head. Since the head is behind the forward end of the bar it clearly indicates that the terminal has been pushed backwards.

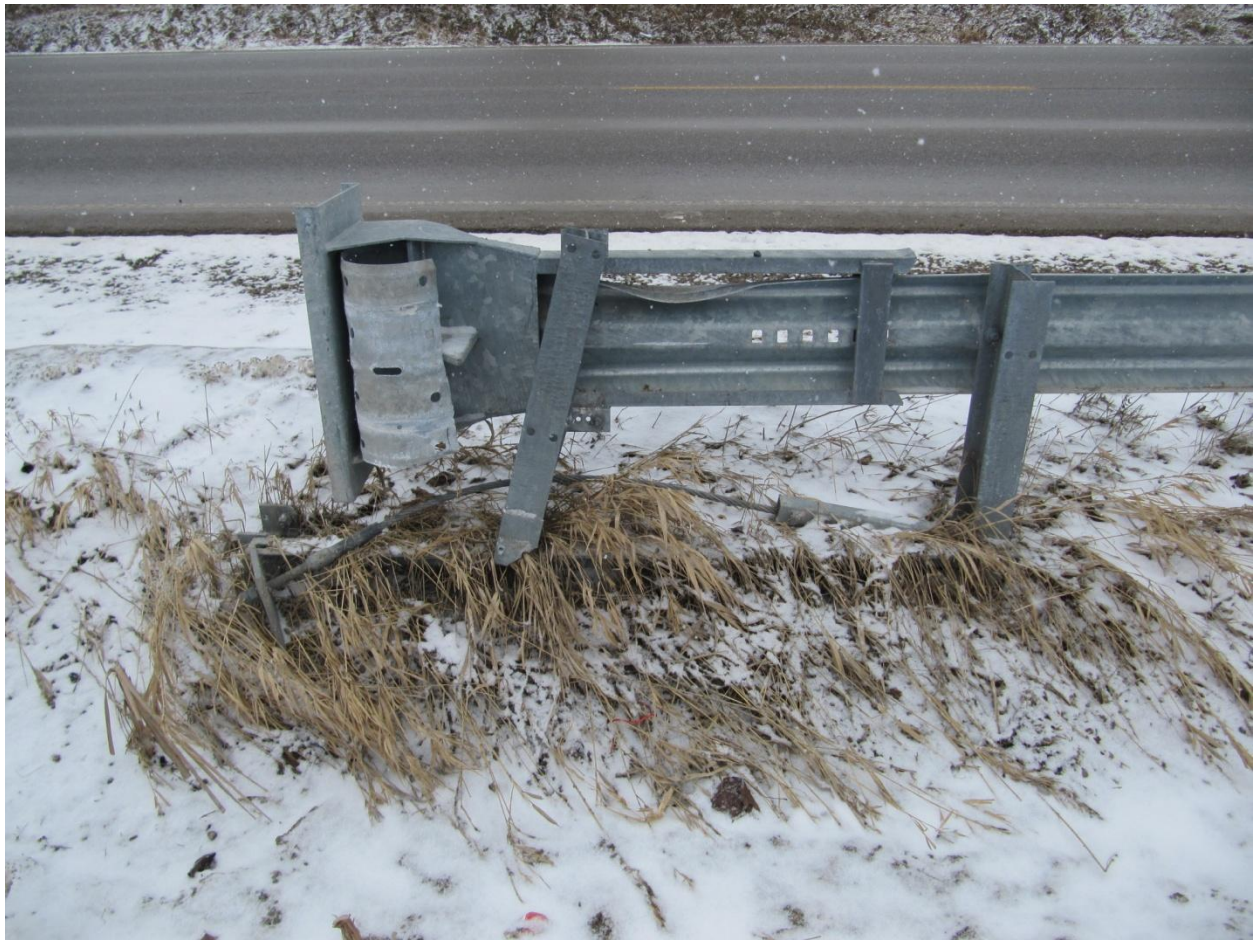
As we move around to look at the installation from a ditch-side view (Figure 30) it becomes obvious that the terminal was impacted and sustained damage. A small length of the end of the guardrail is seen protruding out of the side of the terminal.

Figure 30: A ditch-side view of the terminal indicates that a small length of the guardrail has passed through the terminal head and has been extruded out of its side.

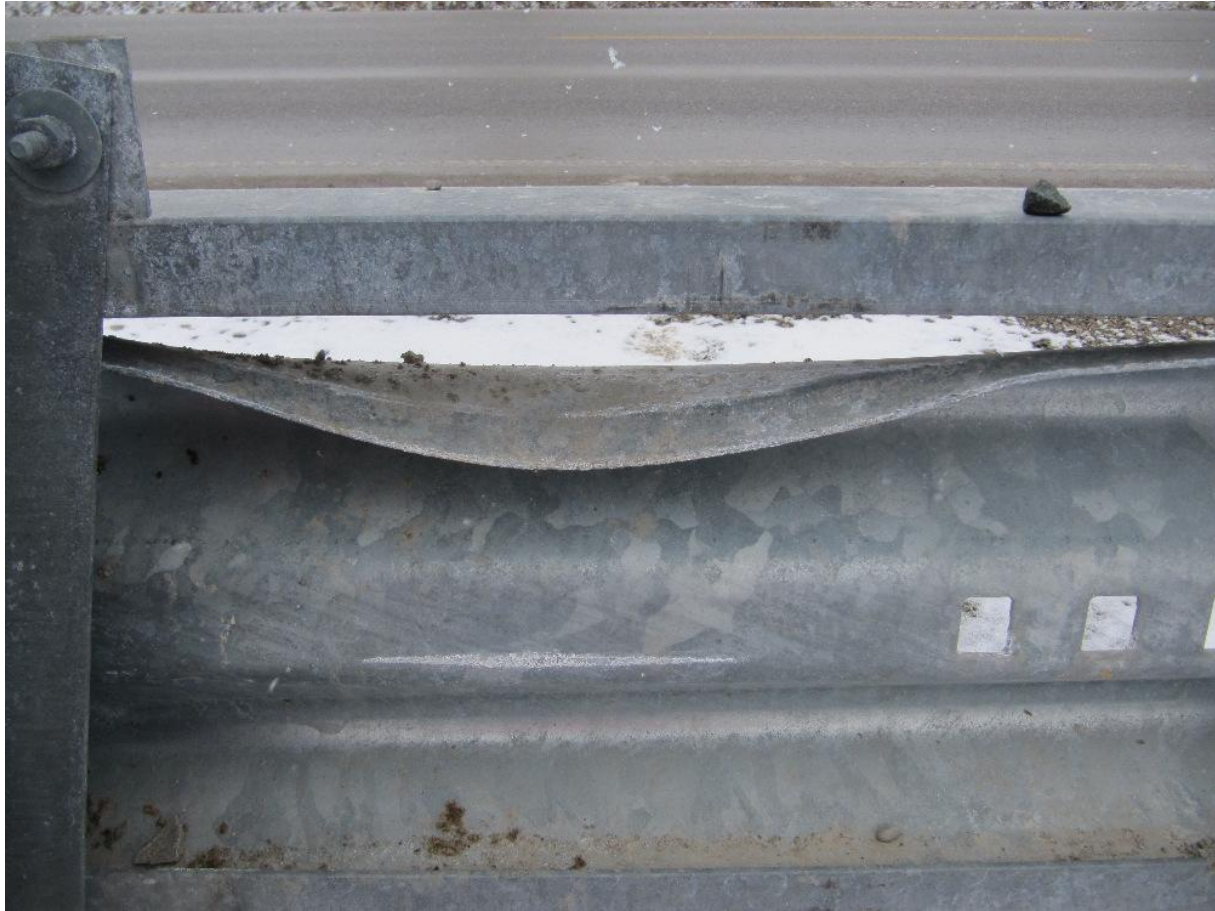
In our example there is an unusual deformation in the top edge of the rail at the location where the rail is within the channel of the terminal, as shown in Figure 31.

Figure 31: View of an unusual deformation to the top of the guardrail in the vicinity where it is encompassed by the channel of the terminal.

Looking directly below this dent in the rail is a small, light-coloured scrape on the side of the rail.

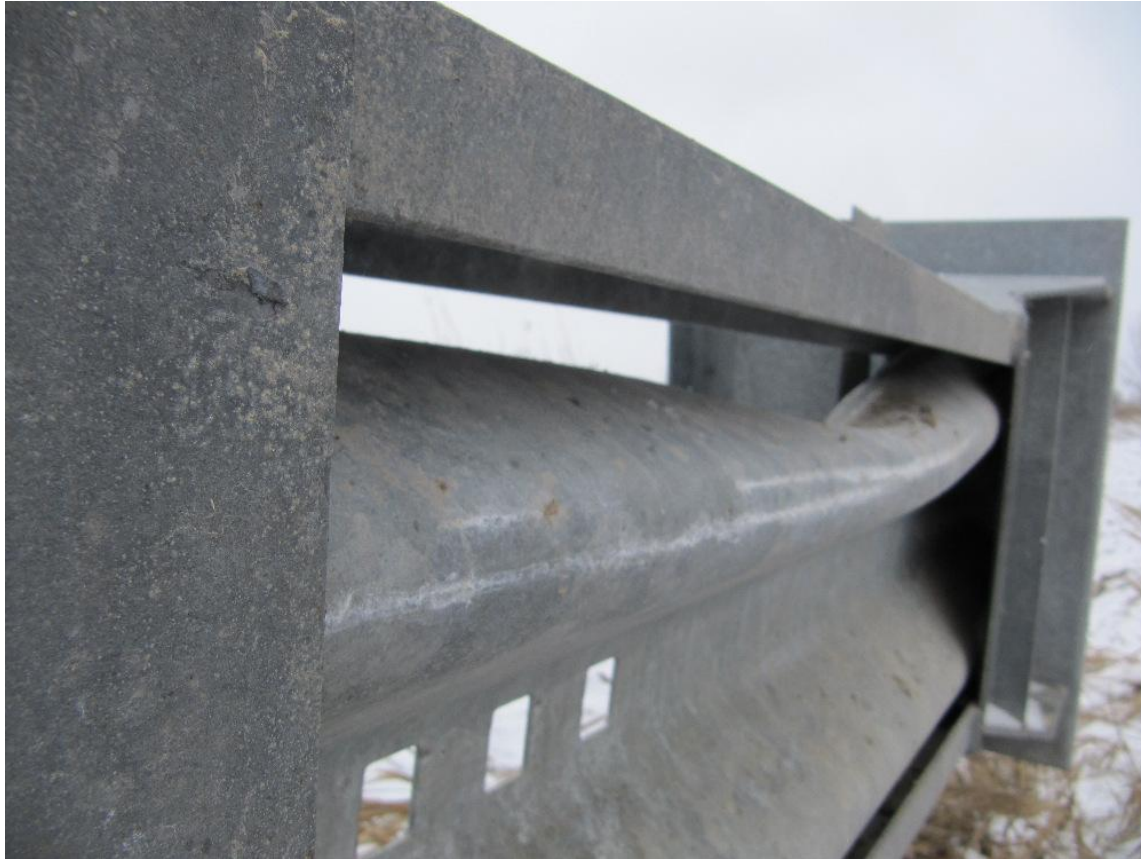
Similarly, when we look at the other side of the rail, in Figure 32, we can see another longer scrape that extends from the rear vertical bar of the channel all the way to the terminal head. As this portion of the rail has not reached the interior of the terminal head this damage cannot be the result of the designed, narrowed channel that is supposed to flatten it and extrude it out the side of the head. The only logical conclusion is that this damage must have occurred from the rail's contact in the vicinity of the rear end of the channel. As the top of the rail is bent downward the only logical conclusion is that there must have been contact between the top of the rear edge of the channel and the rail. This contact could be from the rail being lifted up or by the rear end of the channel moving down. Since the head and channel would become loose once they began their rearward motion the most logical belief is that the rear edge of the channel came down onto the top of the rail.

Figure 32: View of a light-coloured scrape on the rail that extends from the rear vertical bar of the channel through to the terminal head.

Regardless of the precise mechanism, the deformation of the rail before it enters the narrowed confines of the terminal head should not be viewed as a desirable outcome. If the rail is deformed it may not fit as designed within the narrowed channel and could become jammed.

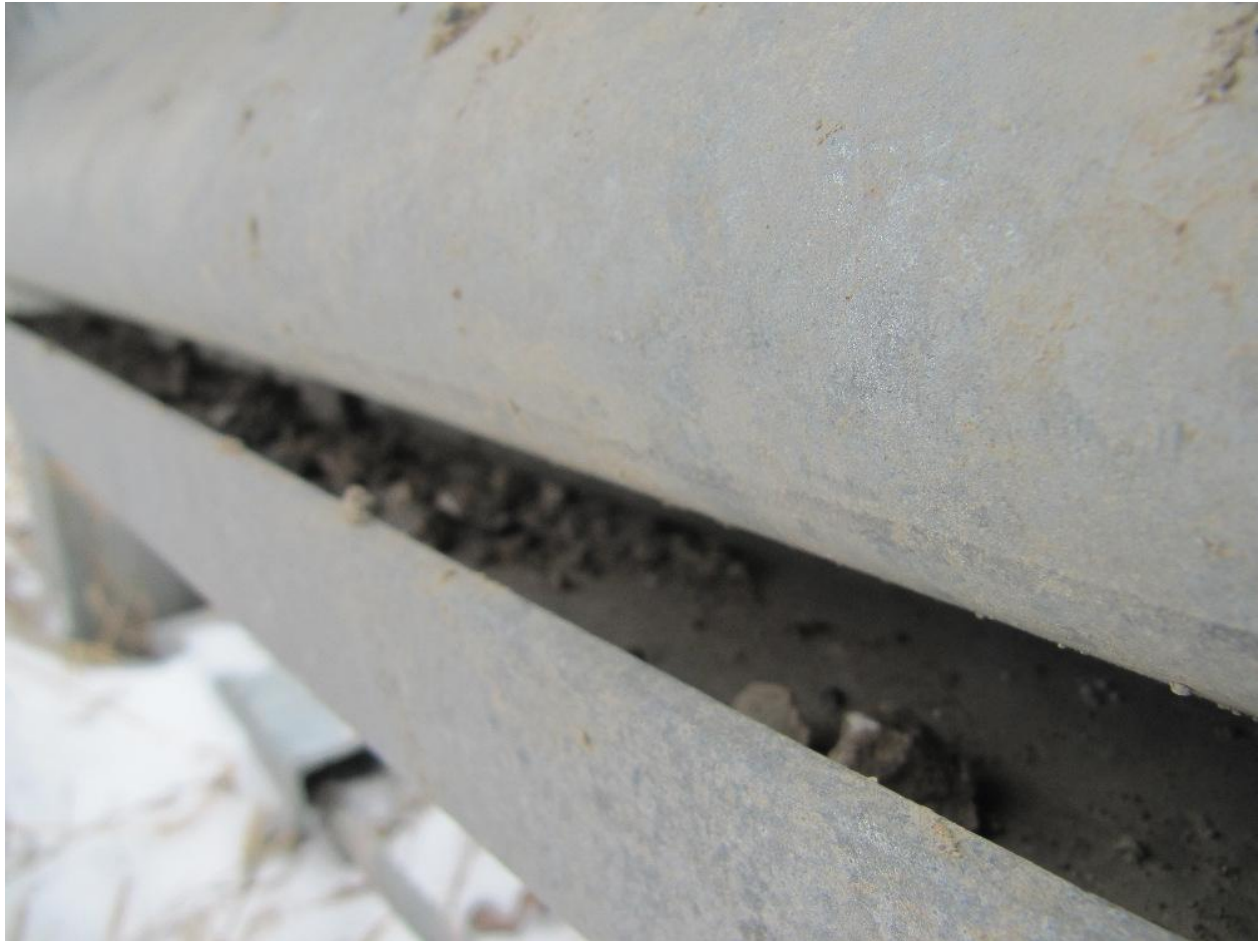
On numerous occasions we have also found debris within the open channel that could interfere with the sliding of the terminal on the rail. Typically this debris is in the form of gravel as shown in Figure 33. It is believed that in winter months snow plows may throw snow and gravel against the terminal and some of the gravel falls inside the channel. But the precise mechanism by which this deposit is made is unknown. The point is, regardless of the mechanism, the existence of the contaminating gravel is a potential hazard that could lead to the jamming of the system.

**Figure 33: View of gravel resting along the bottom of the terminal channel. Such debris could help in restricting the sliding of the channel and head along the rail or it could become jammed in the narrow opening of the terminal head.**

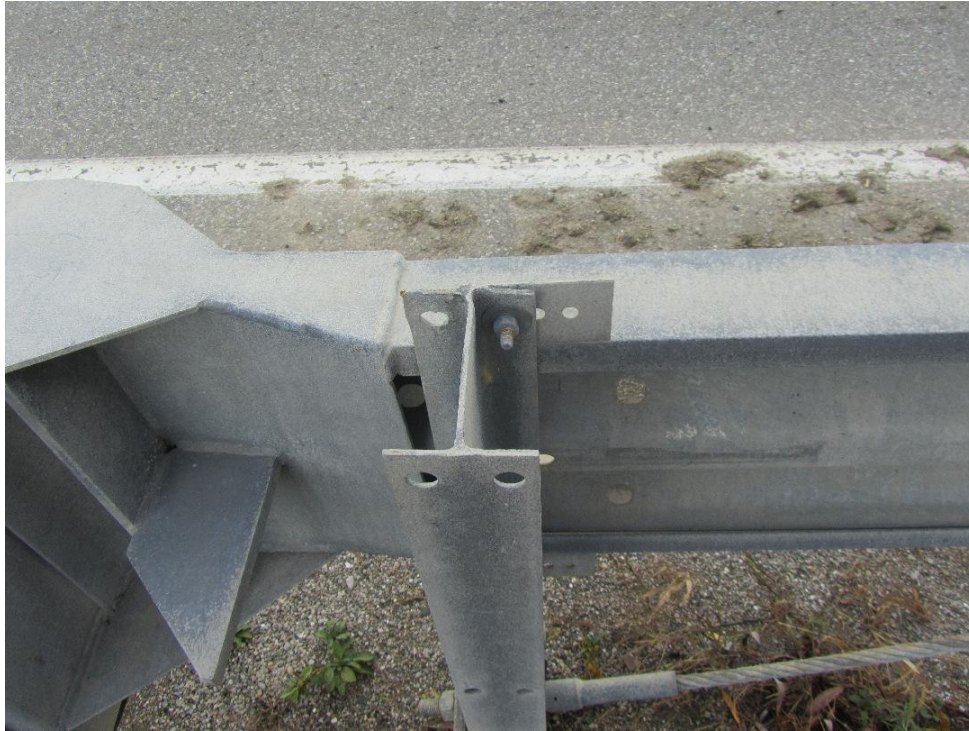
Figure 34: View of an ET-PLUS installation on Ilderton Road near Adelaide Street, north of London, Ontario. This view shows the upper anchorage of the terminal to the vertical anchorage post. A single bolt is the only attachment of the terminal to the post.

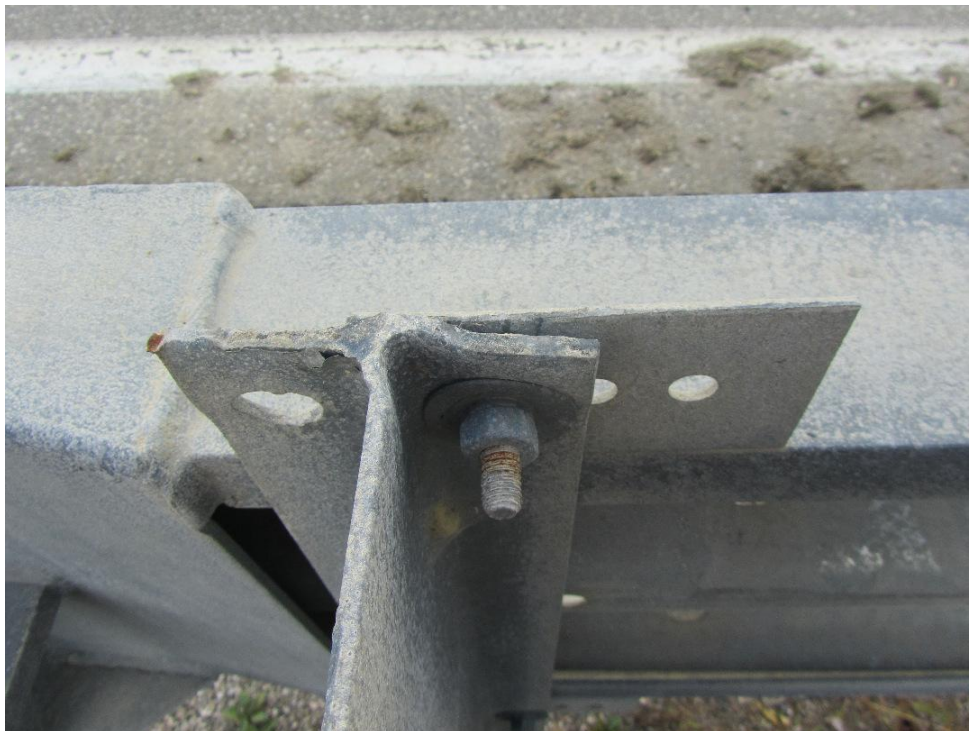
Figure 35: Close-up view of the point of attachment of the terminal to its vertical anchorage post.

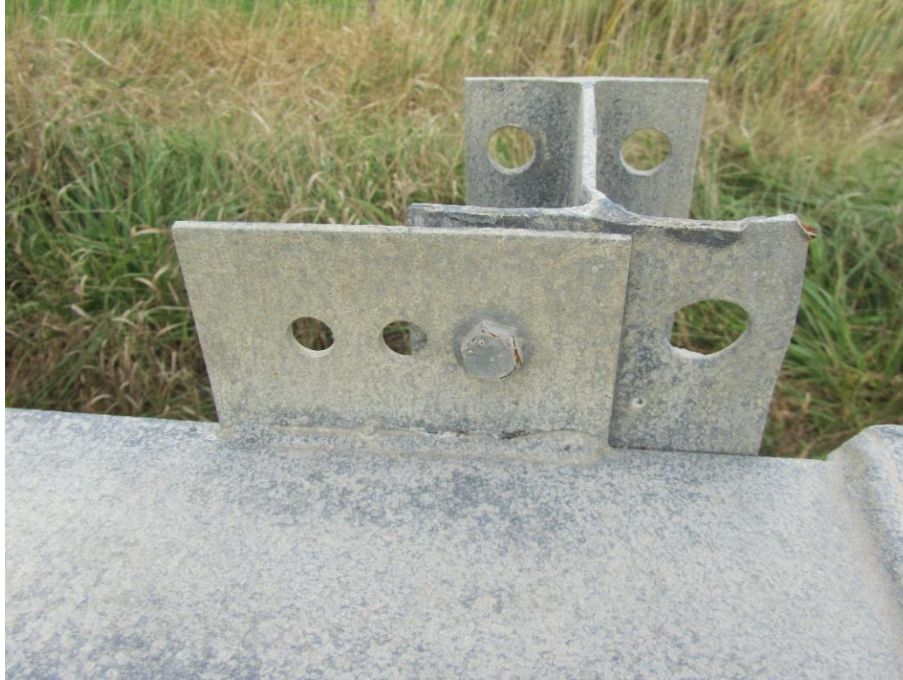
Figure 36: Opposite view showing the anchorage bracket extending from the terminal and how a single bolt attaches the bracket to the vertical anchorage post.
