## Trinity Guardrail End Cap Survey - Part II

*Posting Date: 19-Oct 2014*

## Survey of Trinity End Caps

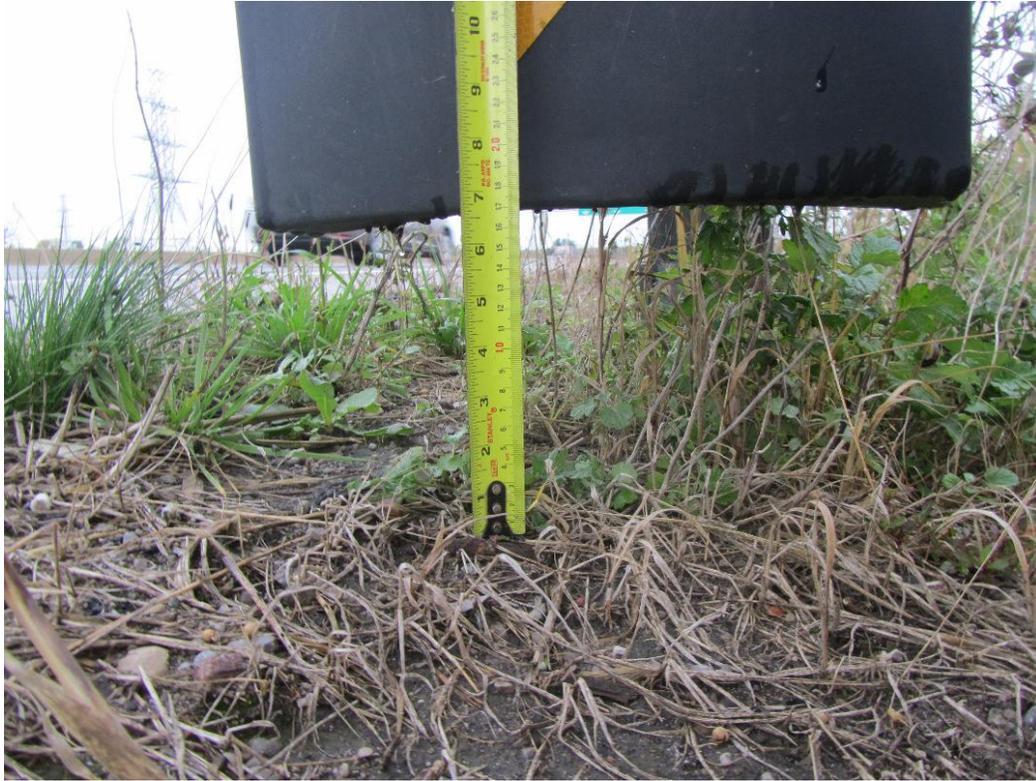
Figure 5: Base of cover is about 6.75 inches above the ground.

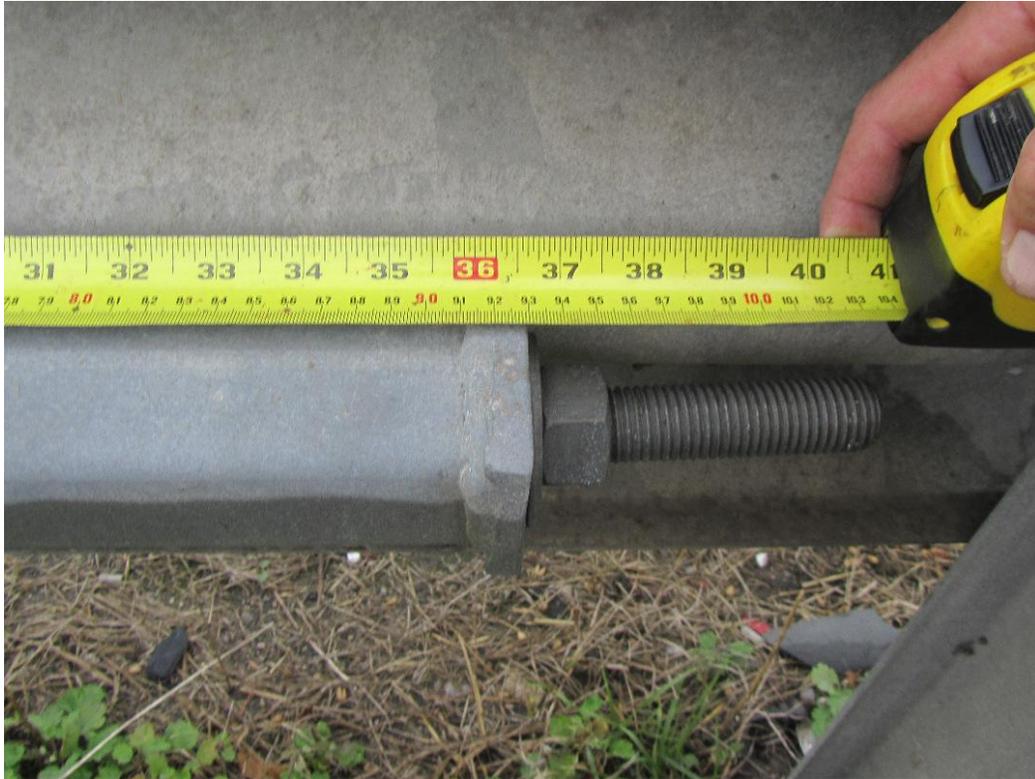
Figure 9: Result of standard measurement indicating a distance of 36.5 inches.

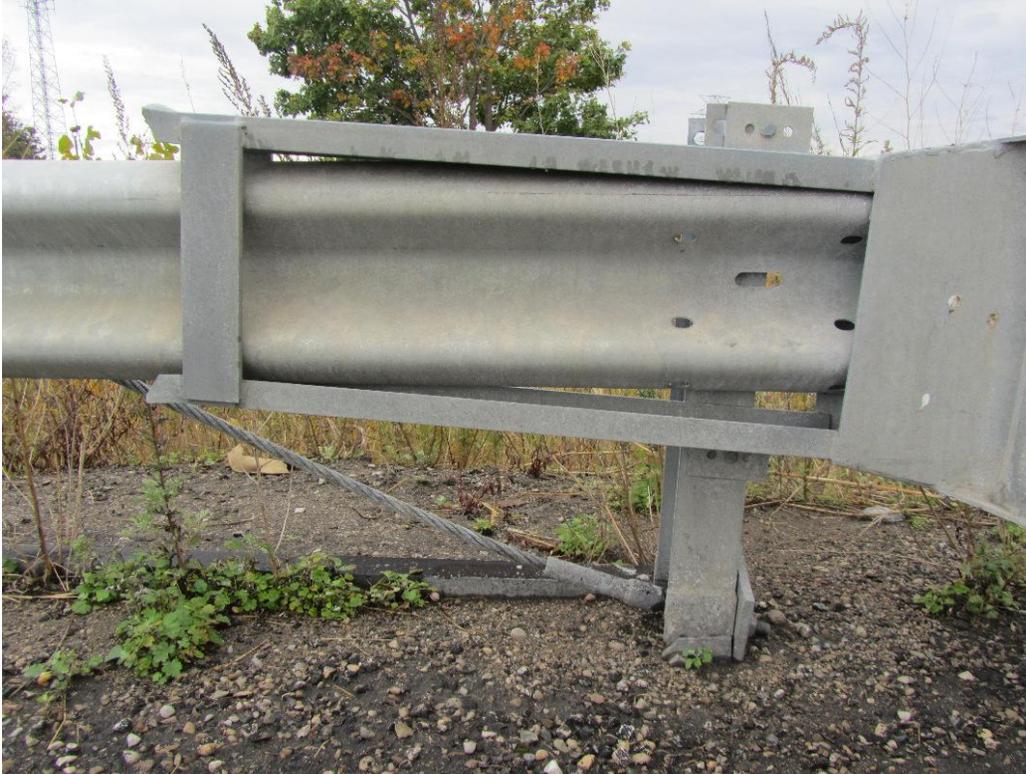
Figure 12: View of difference in angle of end cap versus the rail.

We also continue to see minor differences in each installation. There were several installations where the horizontal angle of the rail was significantly different than the angle of the channel. In another installation the anchorage cable at the back and bottom of the channel was loose, allowing us to be able to shake the unit sideways with minimal force applied by hand.

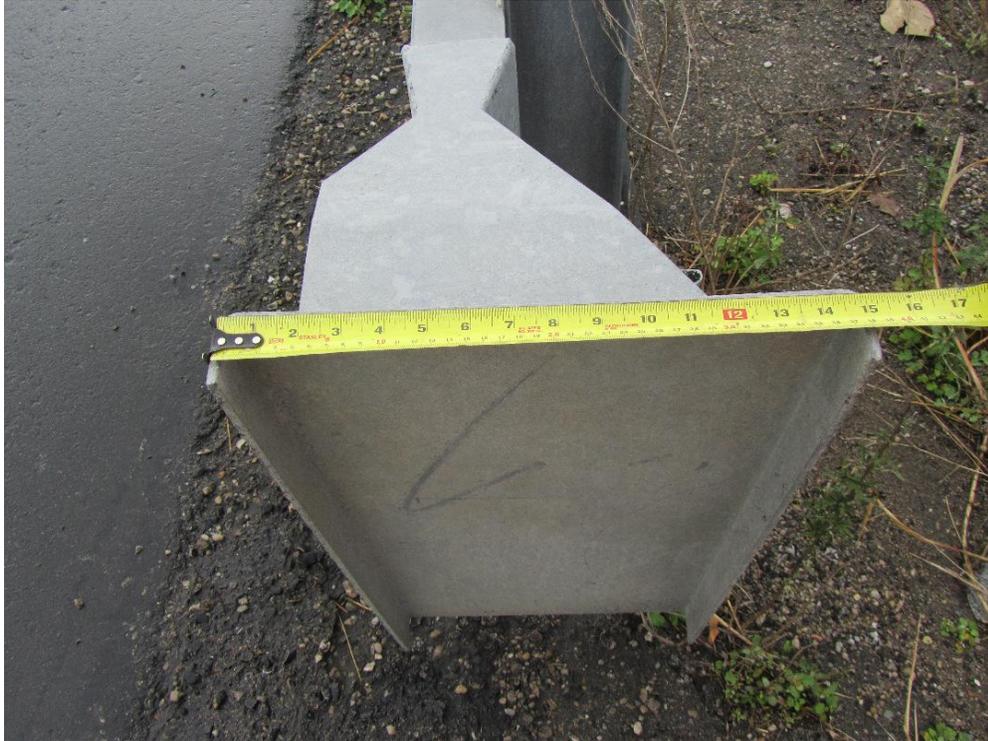
Figure 13: View of end plate showing standard width of 15 inches and missing black cover.

There continue to be installations that are missing the black cover over the metal end cap.

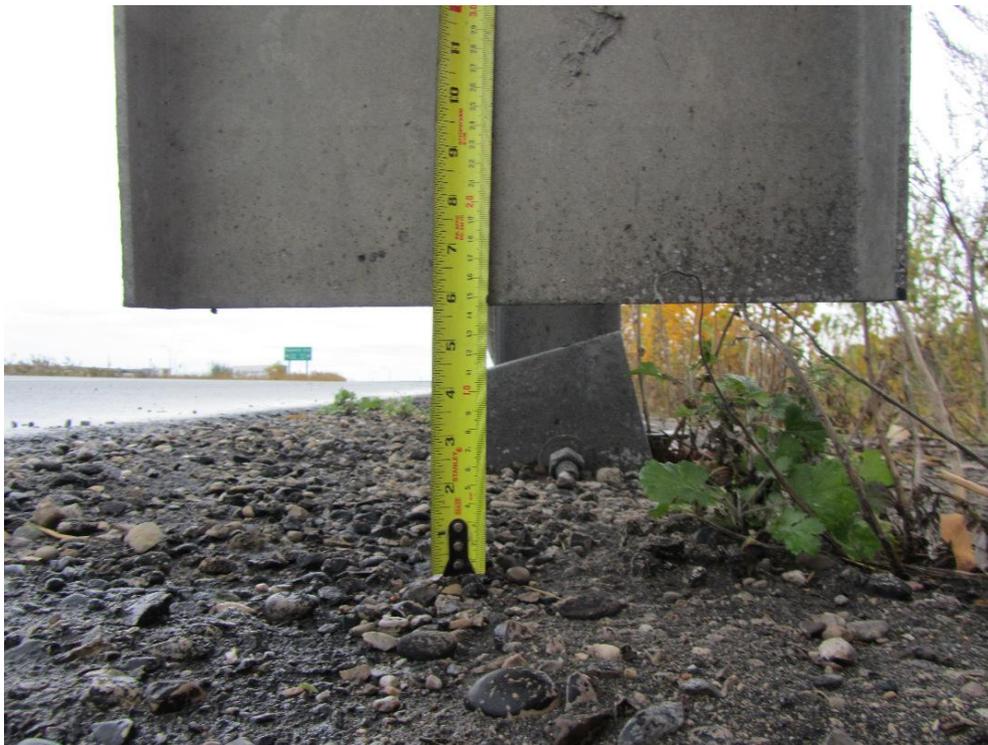
Figure 14: Base of end plate measures about 6 inches above the ground.

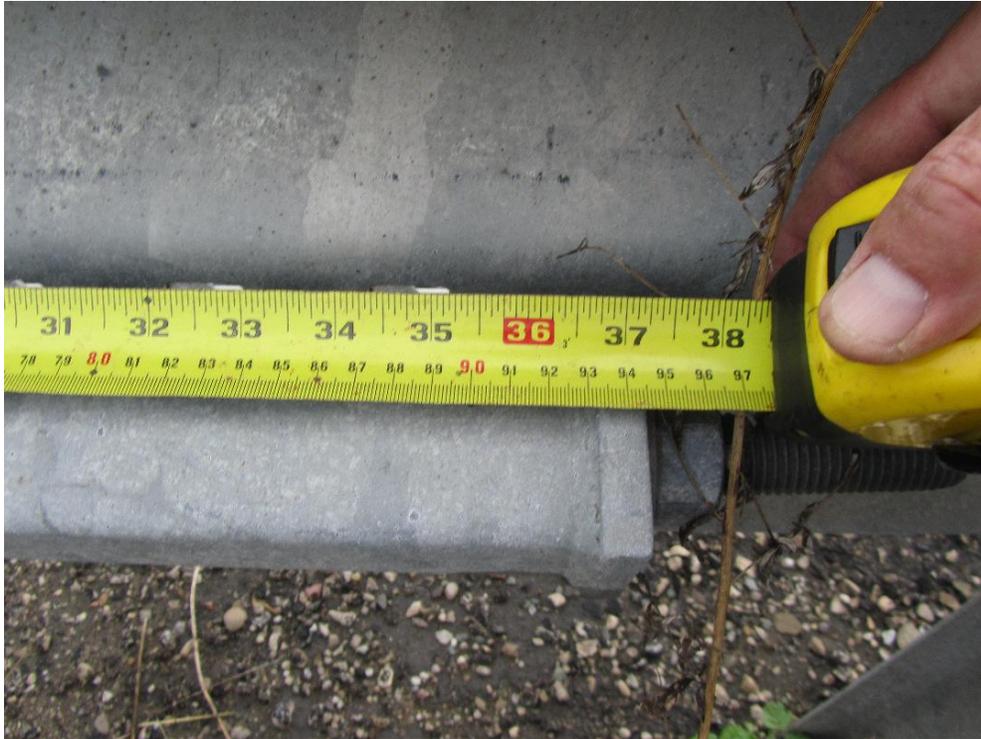
Figure 17: Result of measurement indicates 37.25 inches.

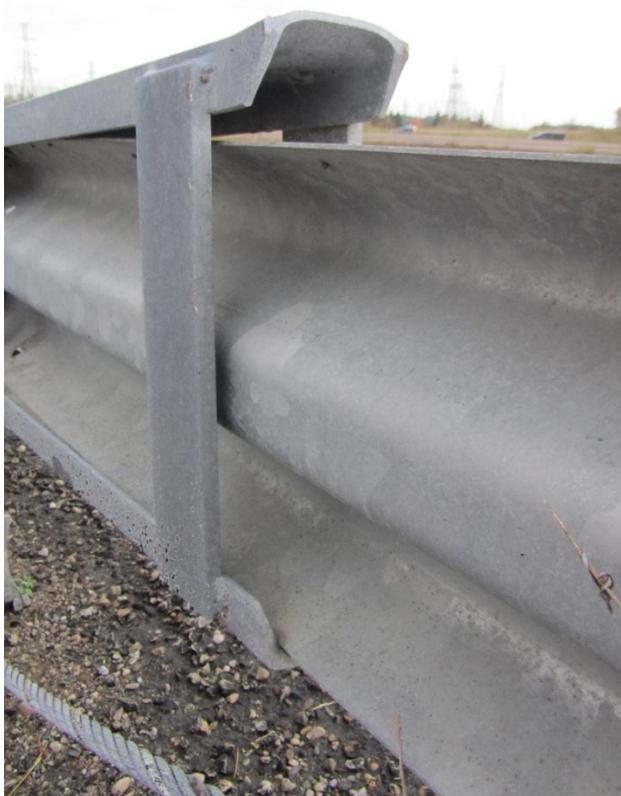
Figure 18: View of base of rail touching channel while there is a wide gap at the top.

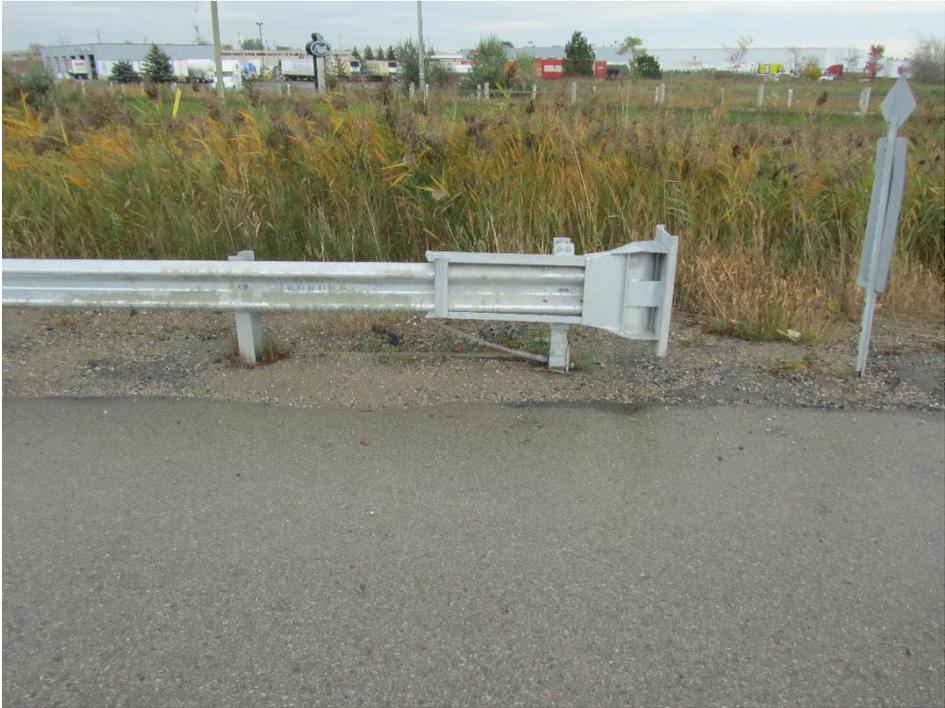
Figure 20: Street side view of guardrail and end cap. Note the presence of the post of the hazard marker positions in front of the end plate.

The findings that were discussed in the initial article were repeated in this continuation of the survey. We remain concerned with the anchorage of metal posts that have a hazard marker attached to them and these appear to be too close to the end cap.

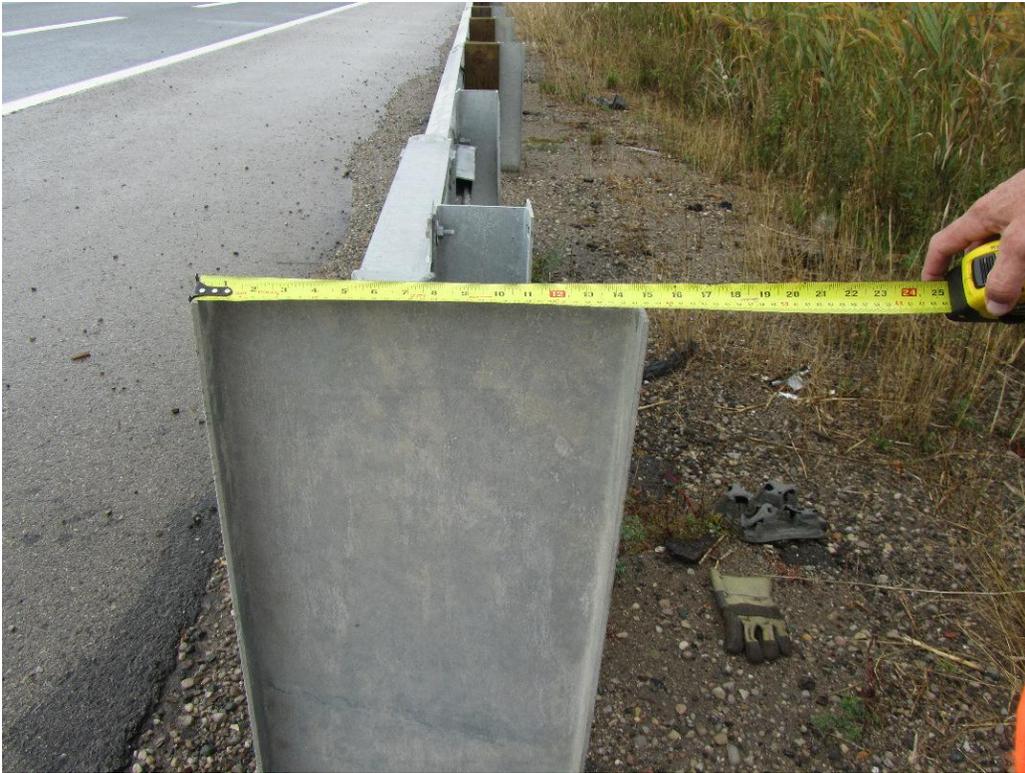
Figure 22: Measurement indicates a typical, 15 inch wide end plate with no black cover.

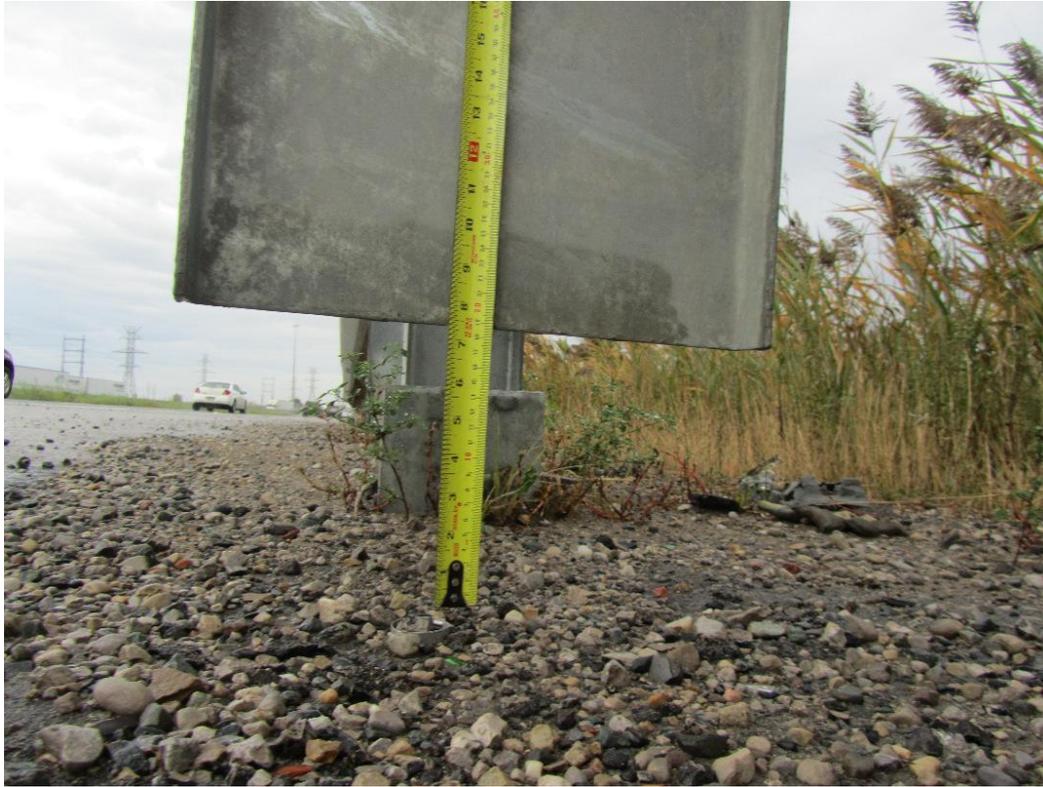
Figure 23: Base of end plate is 7.5 inches above the ground.

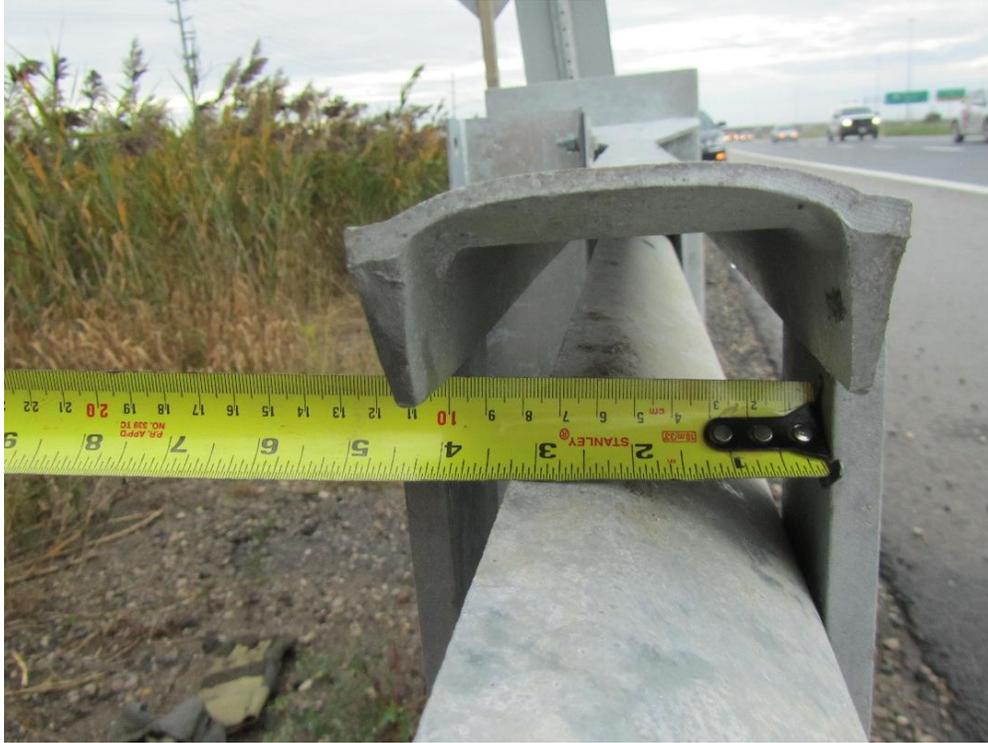
Figure 25: Measurement of typical 4 inch wide channel with rail positioned low at the channel's rear edge.

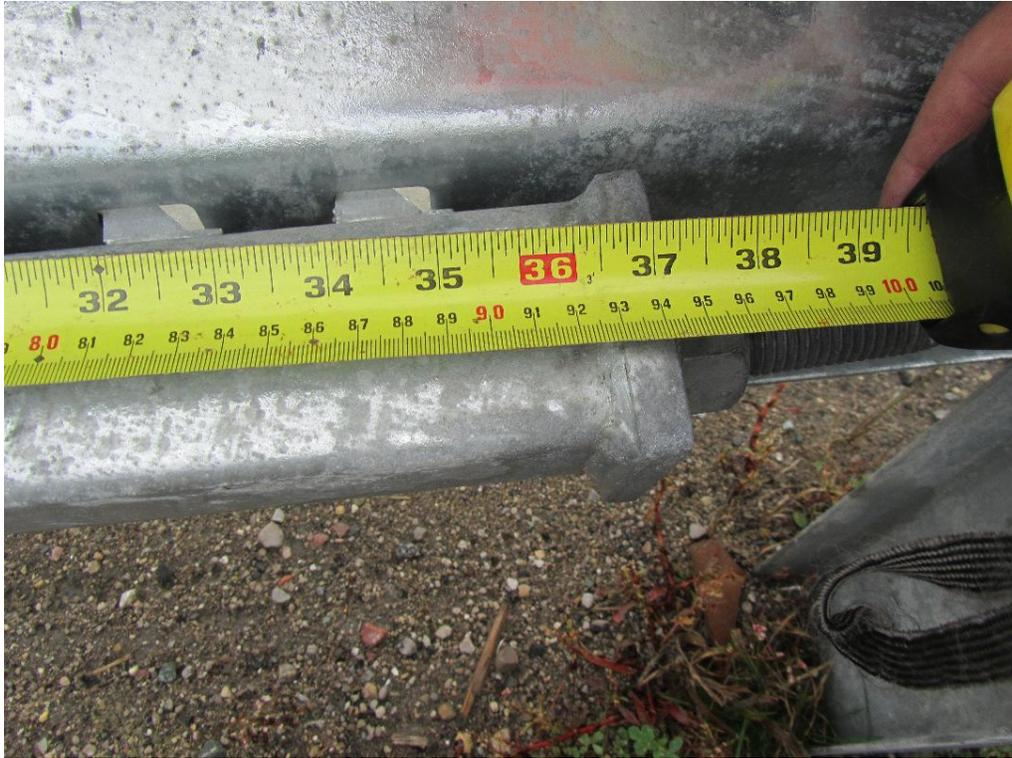
Figure 27: Result of measurement indicates 37 inches.

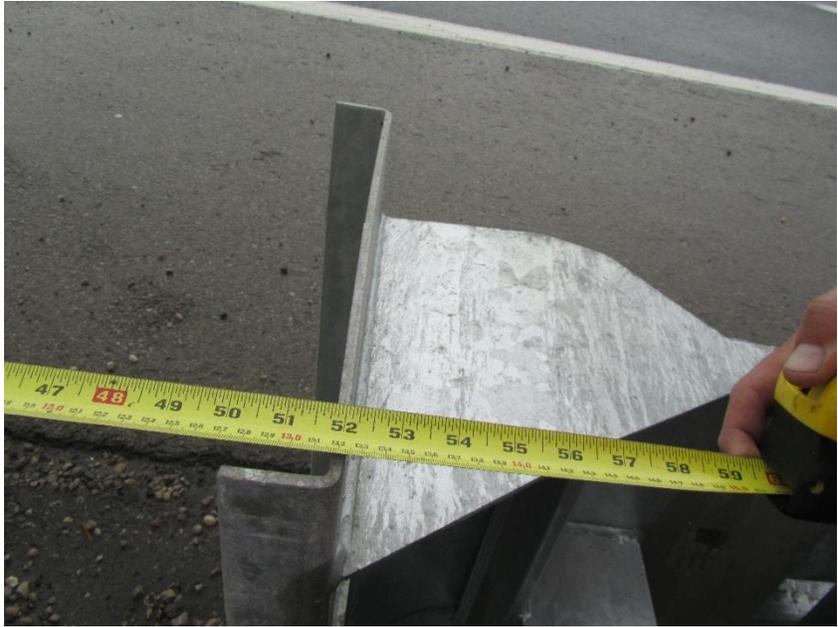
Figure 29: Result indicates hazard sign is about 52 inches distance from the end plate.

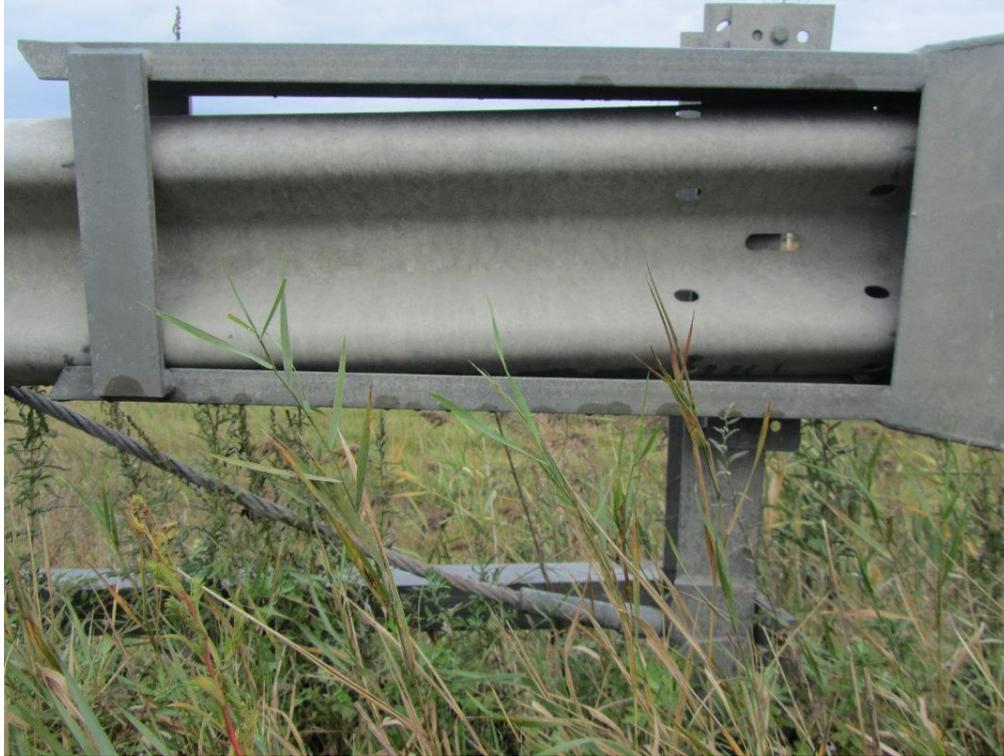
Figure 33: View of difference in horizontal angle of end cap channel in comparison to the rail.

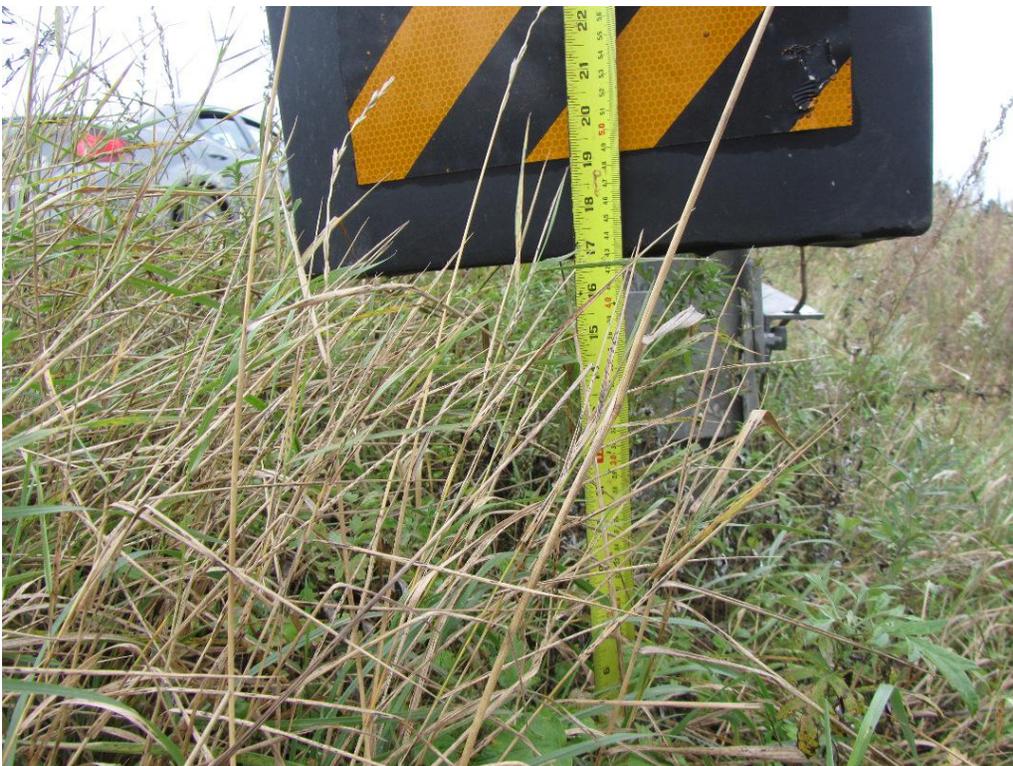
Figure 36: Base of end plate cover located 16.75 inches above the ground.

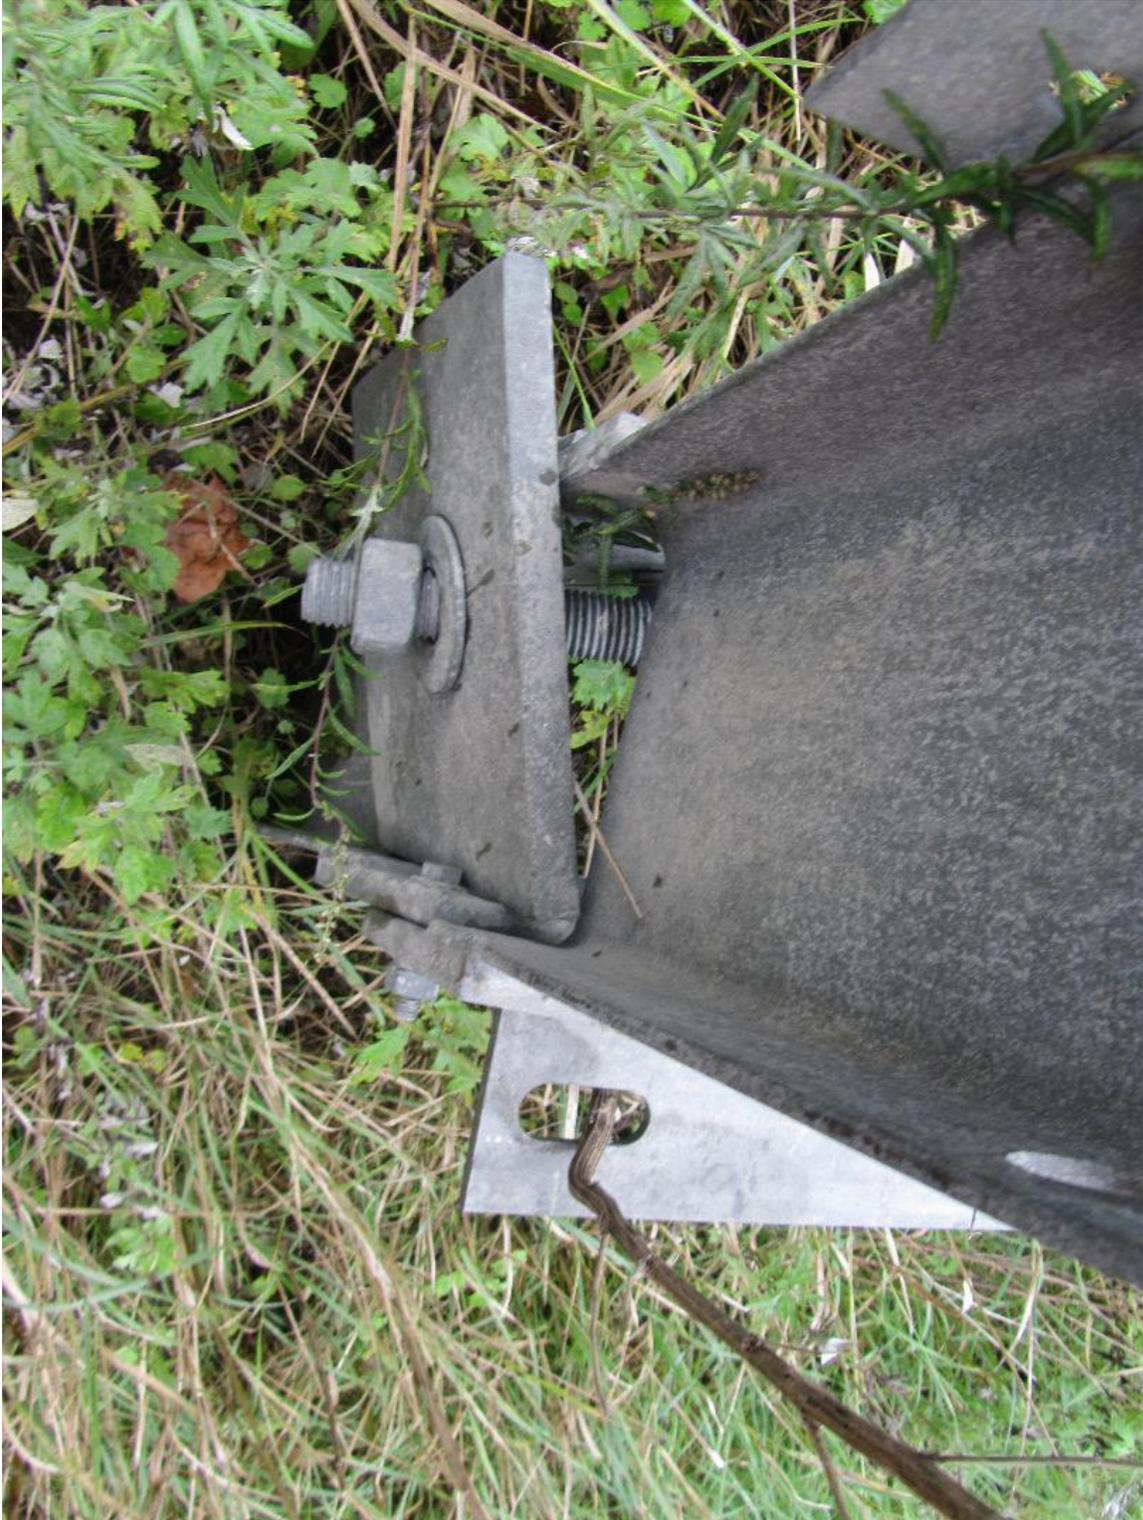
Figure 37: View of misaligned and loose anchorage plate

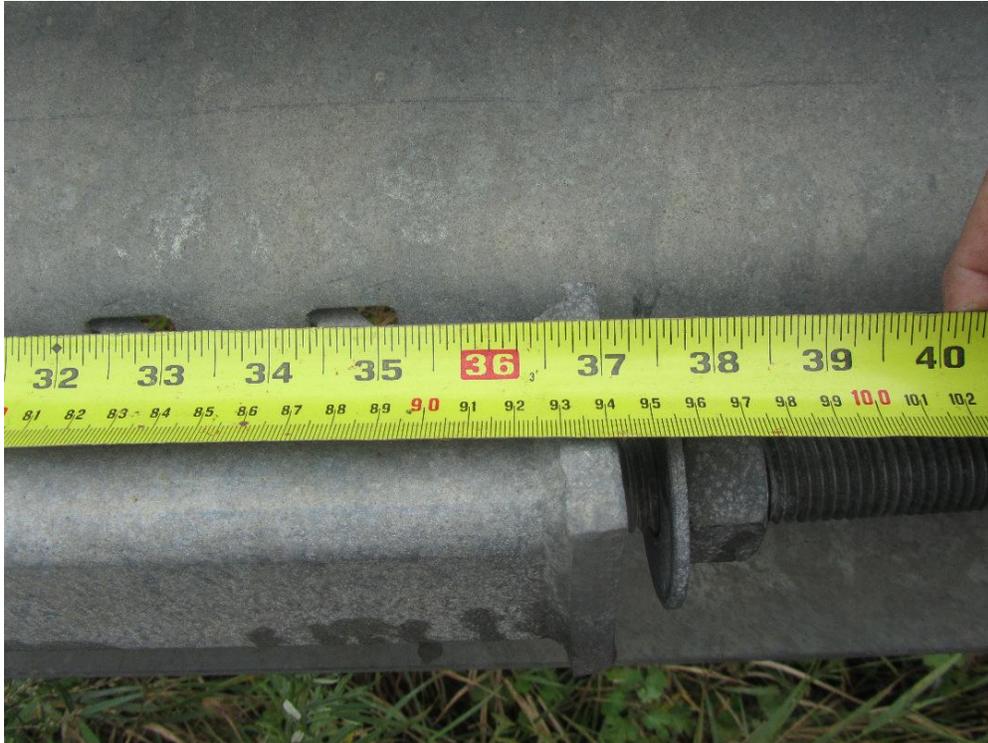
Figure 40: Result of standard measurement indicates a distance of 37 inches.

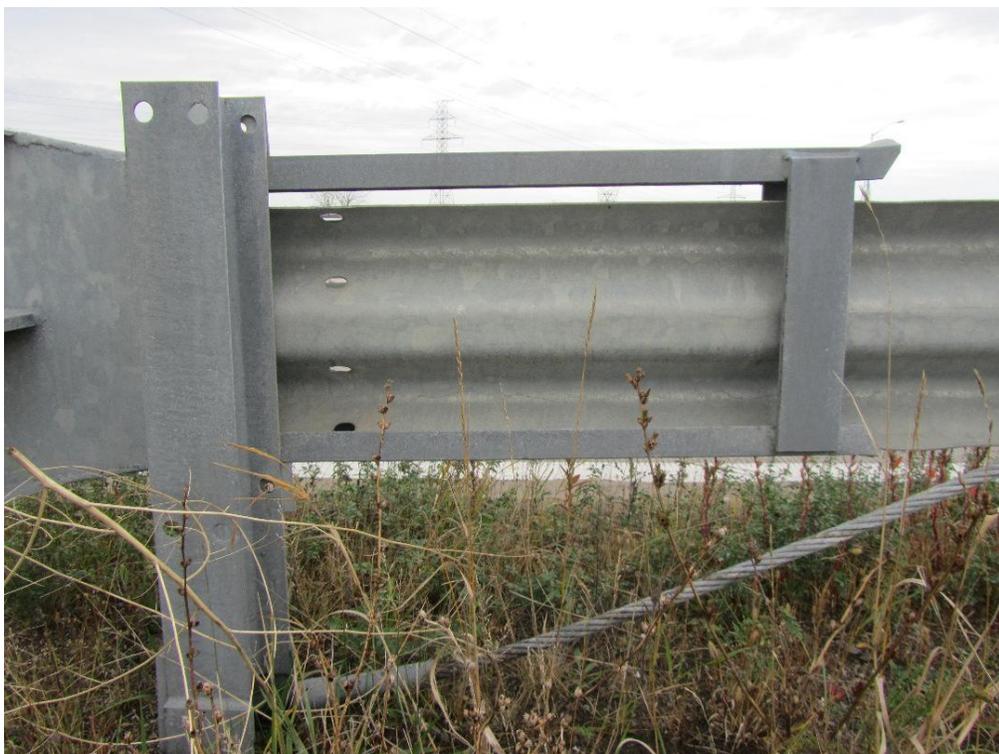
Figure 45: Ditch side view of channel showing the low position of the rail within the channel.

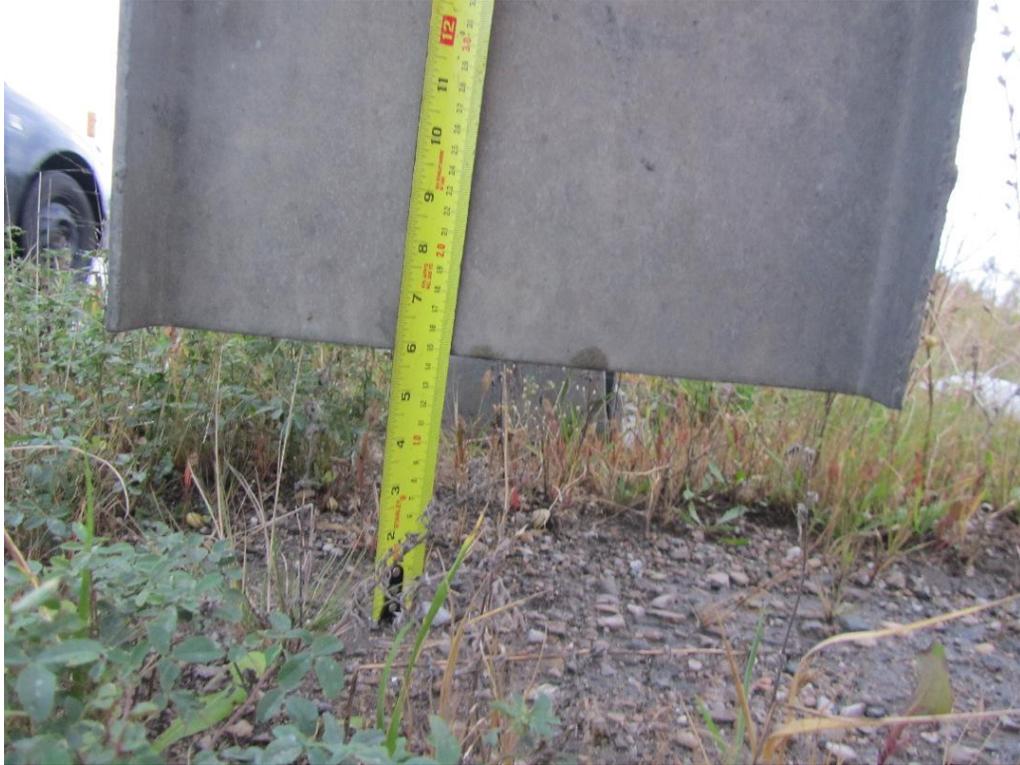
Figure 47: Base of the end plate is 6 inches above the ground.

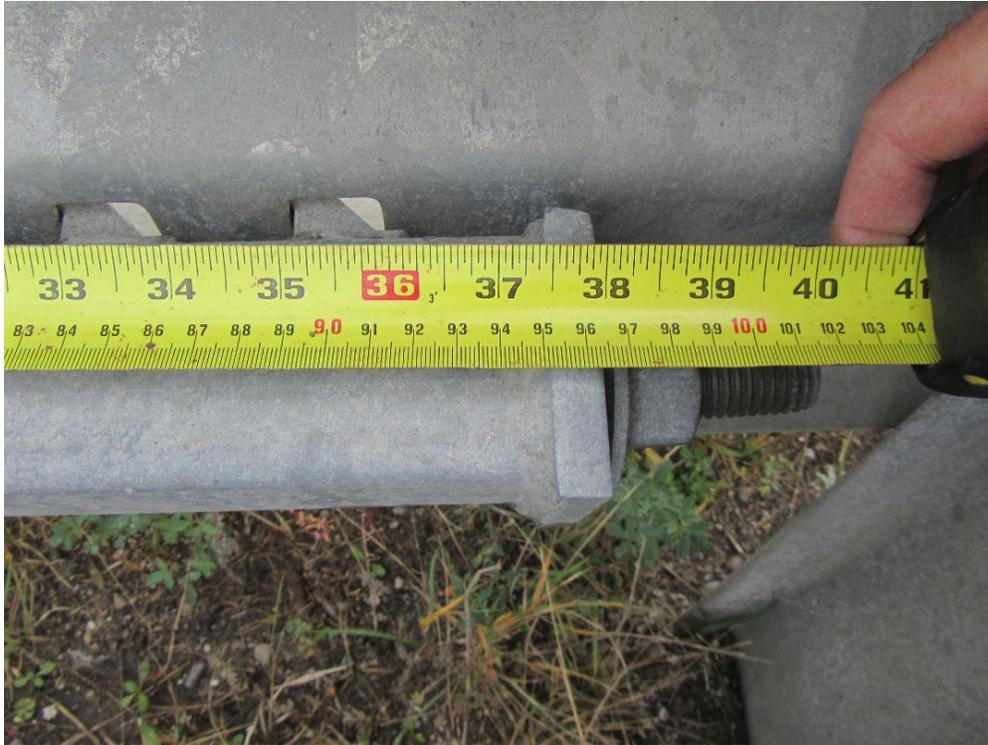
Figure 50: Result of standard measurement indicates a distance of 38 inches.

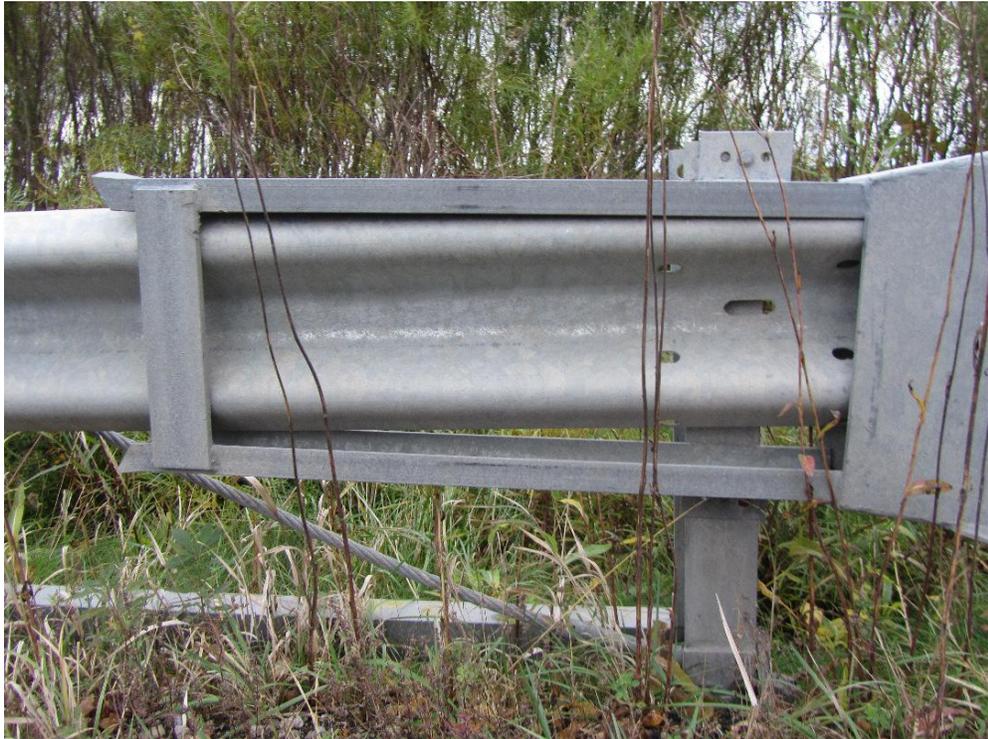
Figure 55: View of substantial difference in horizontal angle of the rail and channel.

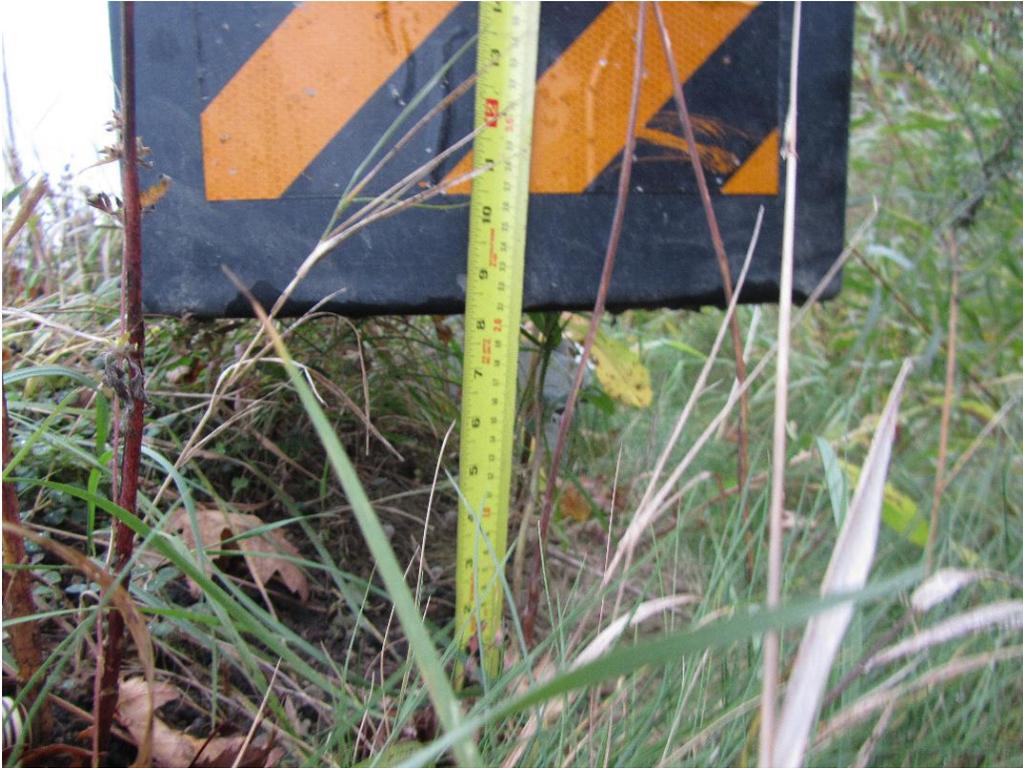
Figure 57: Base of end cap cover is 8.25 inches above the ground.

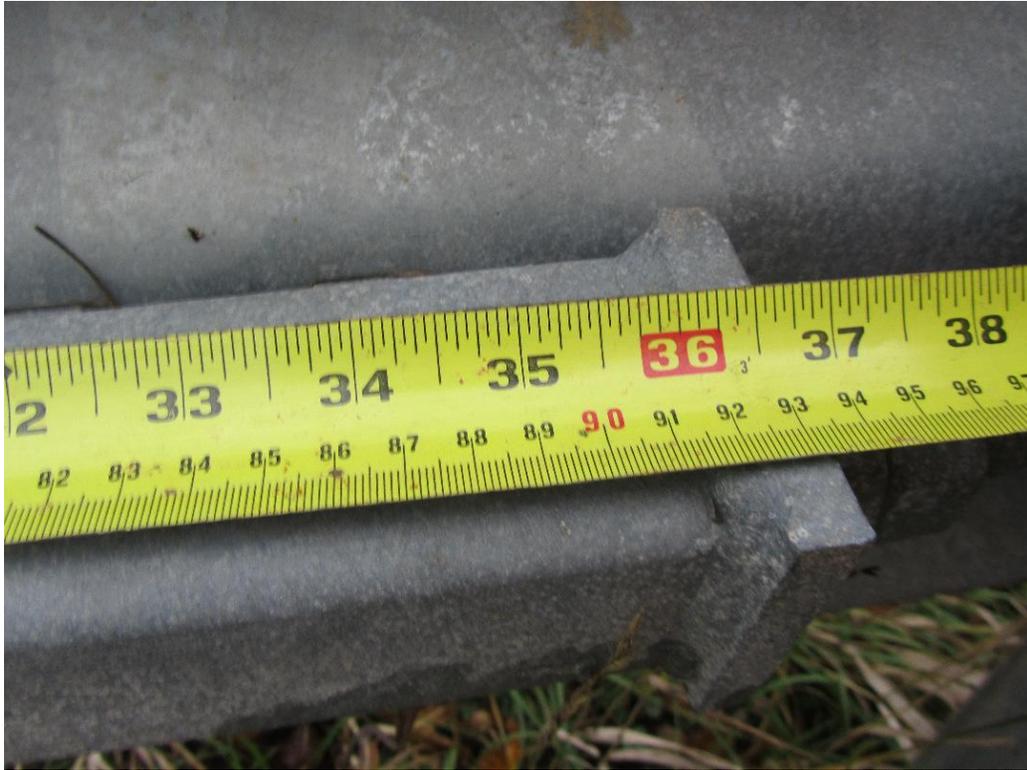
Figure 60: Result of measurement indicates a distance of 36.75 inches.
