Trinity Guardrail End Cap Survey - Part III

The present article will review 10 end caps at three sites whose installations were found primarily north-east of London, Ontario, mostly along Highway 7.

16. Highway 7 at Railway Bridge West of Cobble Hills Road, Middlesex & Perth Counties Border

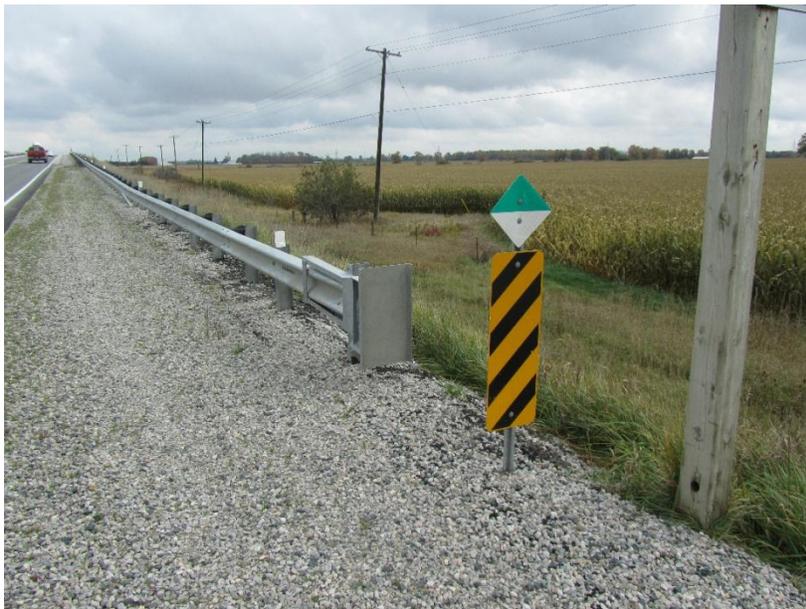
Figure 1: View looking east on Highway 7 toward the west end cap on the south guardrail.

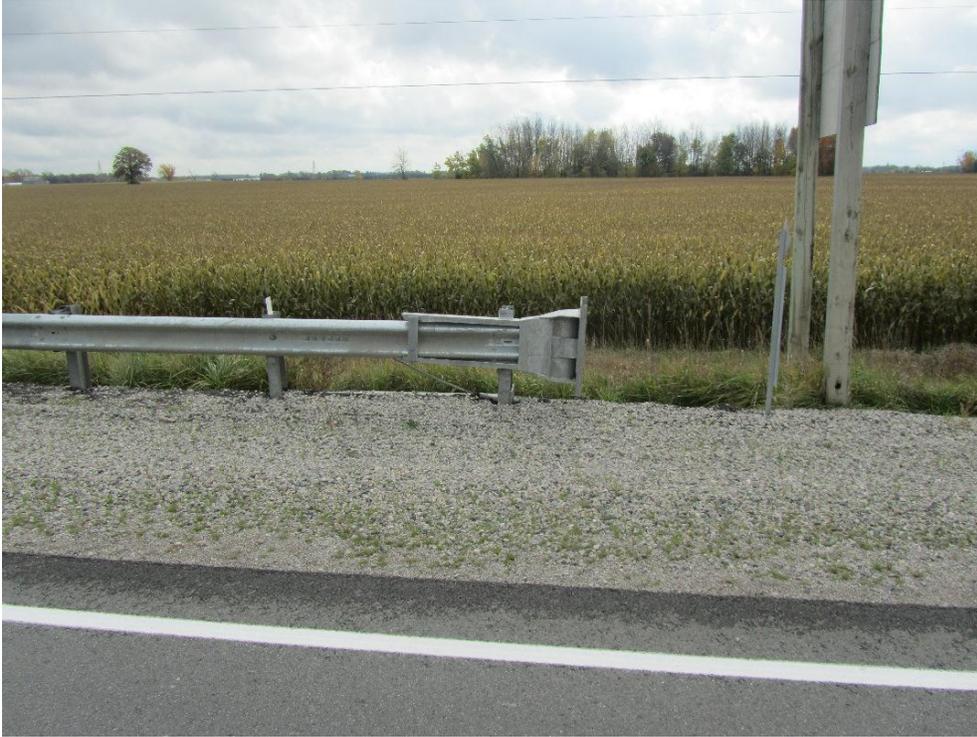
Figure 2: View of west end cap and hazard marker post at the south guardrail.

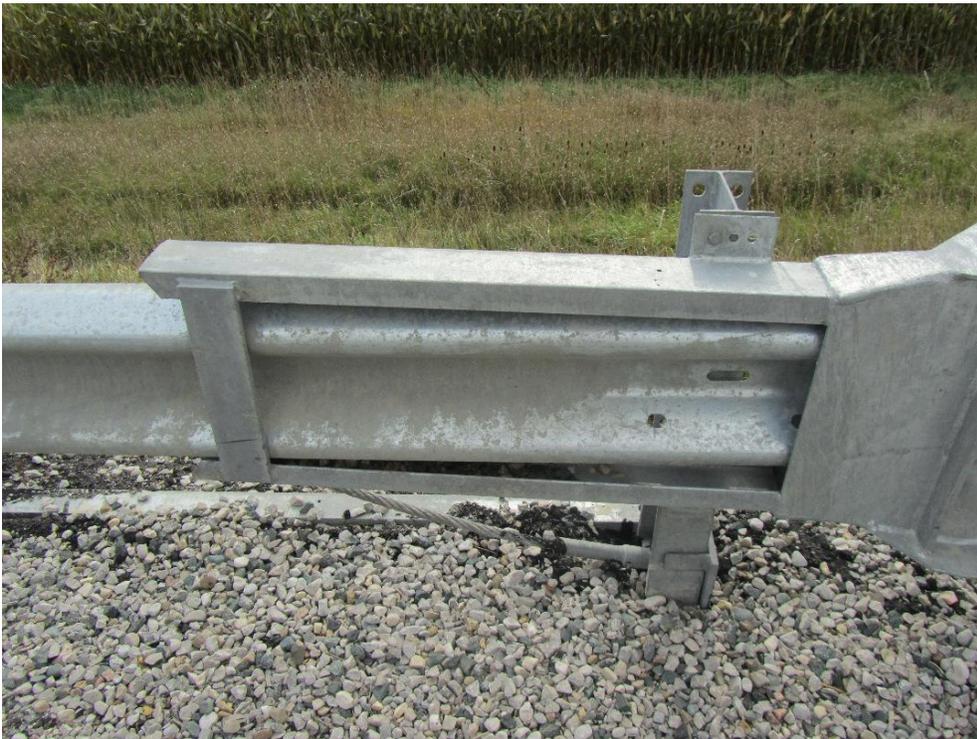
Figure 3: Street side view of guardrail, end cap and hazard marker post.

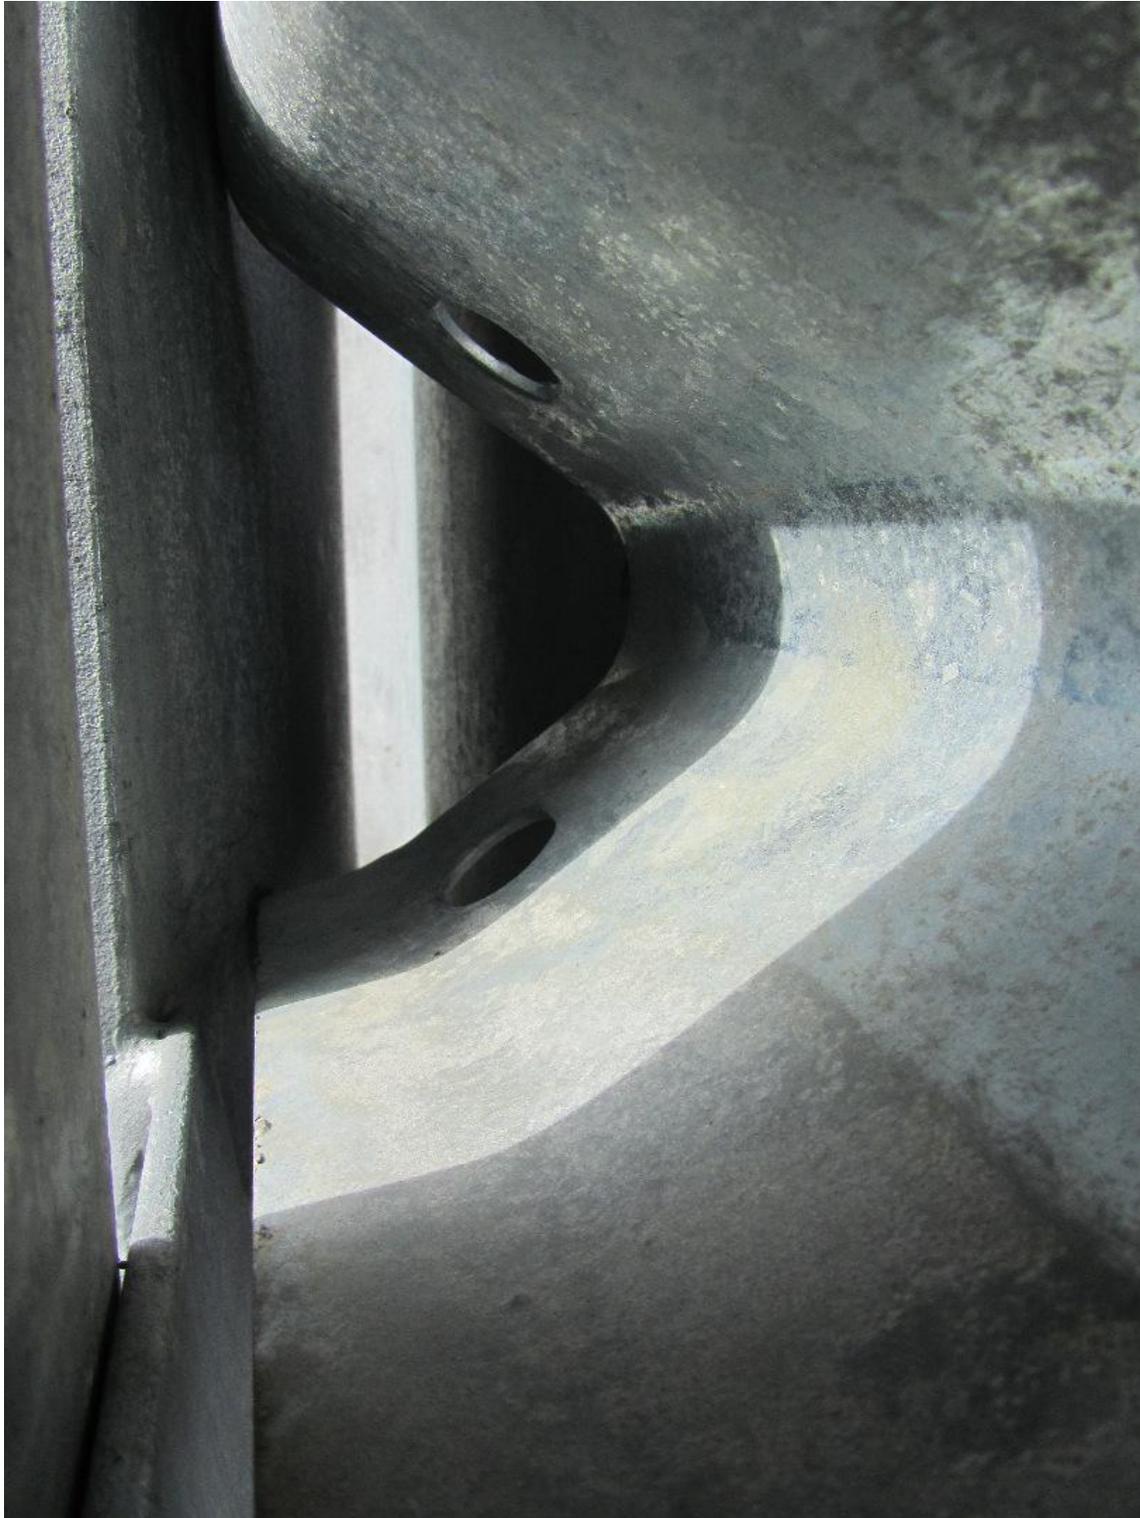
Figure 14: View of Trinity label whose writing has been weathered away but that is typically located on the end plate.

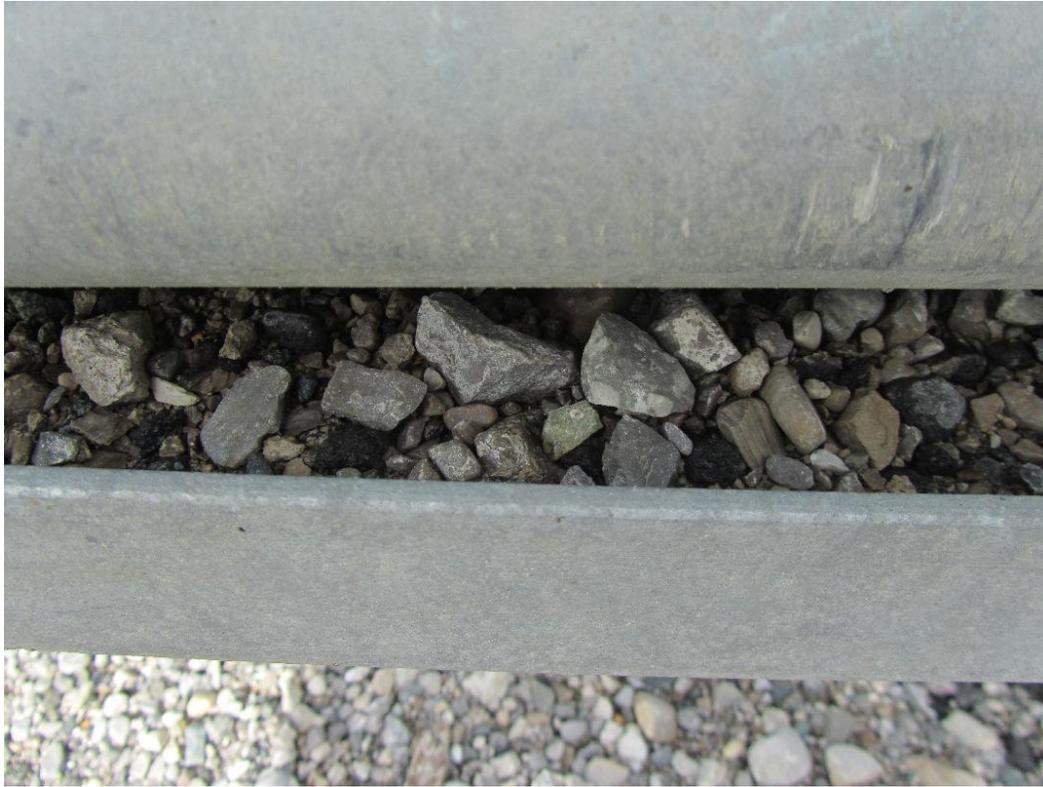
Figure 55: View of substantial deposit of gravel in the recess of the bottom of the rail and channel.

The unusual finding about this set of end caps is that 8 of the 10 units contained contaminants of gravel within the crevice between the bottom of the rail and channel. This finding would appear to be significant as it is vital that the end cap ride in an unobstructed manner along the rail when it is displaced by the impact of a wayward vehicle. It is this motion of the end cap that allows the rail to pass through the narrowing throat, flattening out the rail and then bailing the rail out the side of the end cap. From our understanding, the basis of the defect allegations against the ET-Plus system is that modifications that narrowed the dimensions of its channel caused the rail to become jammed and the rail would not pass through the end cap as it was designed. If extraneous materials such as gravel are placed in the channel where the unobstructed motion is critical, such jamming of that motion would seem likely. It would seem that, aside from any other potential defects, the design of the ET-Plus system with its open channel, can cause foreign objects to enter into the channel and obstruct the motion of the system, thus making it fail.

While we have no specific knowledge of how so much gravel could become lodged within the channels of these end caps, we surmise that this could be related to snow plowing activities. Highway 7 in this region is known for its snow squalls that spill off of Lake Huron and thus larger quantities of snowfall are experienced. At the same time, snow plows along this rural highway are known to travel at substantial speed. Thus, while throwing the accumulated snow off the road surface, the plows also pick-up the gravel that is adjacent to the paved surface and this gravel is thrown against the nearby guardrails. As the end caps are also rained upon by this mixture of snow and gravel the material becomes deposited into the open crevice of the bottom of the channel. As the snow melts the gravel remains behind and thus we eventually see this deposit of gravel. Whether this is what actually happens remains to be determined as further study is needed.

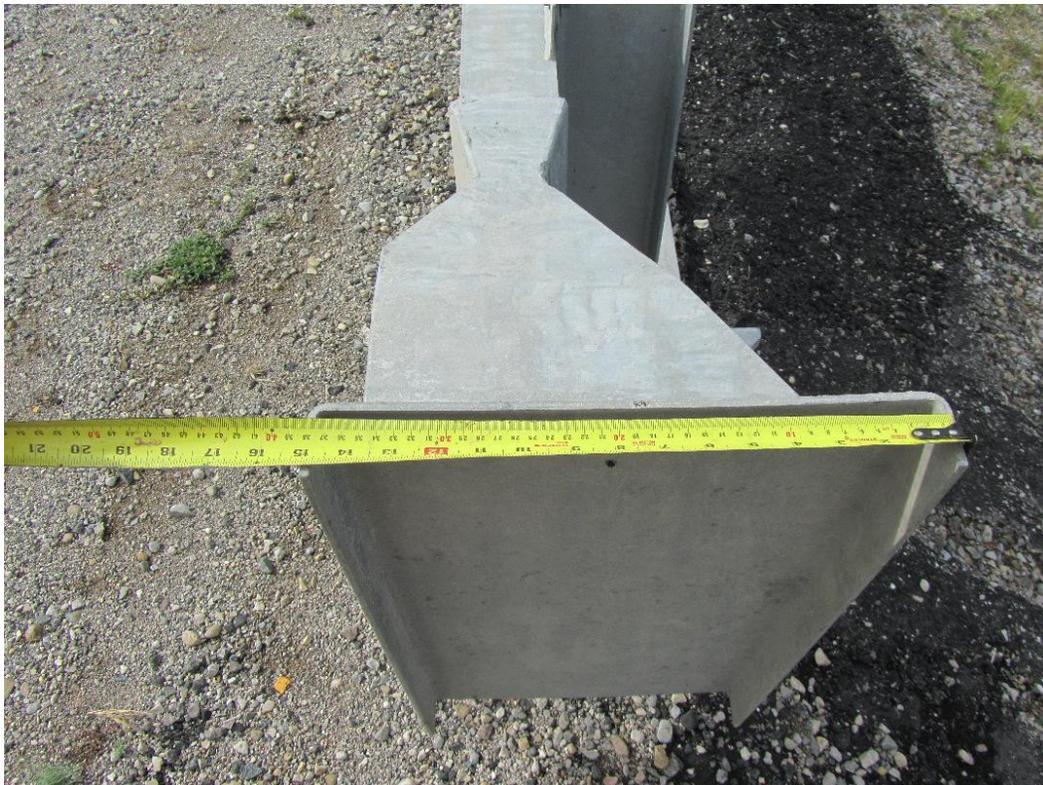
Figure 56: Close-up view of the substantial amount of gravel lying the recess between the bottom of the rail and channel.

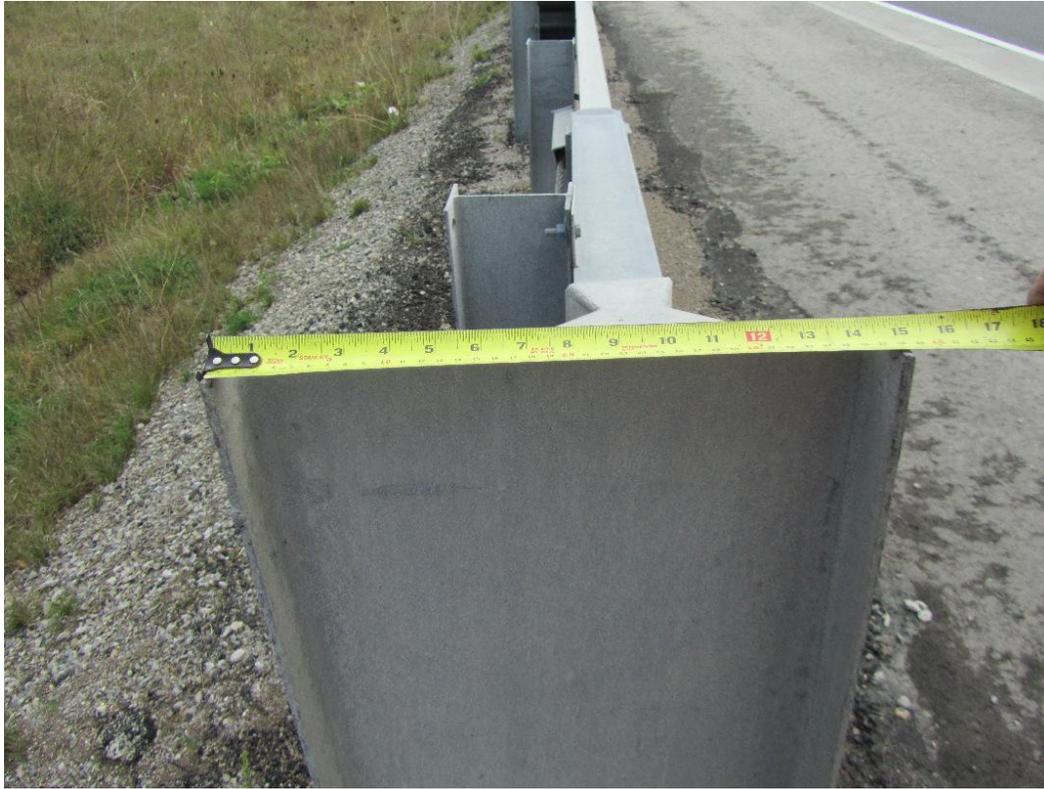
Figure 82: Close-up view of large quantity of gravel deposited in the recess at the bottom of the rail and channel.

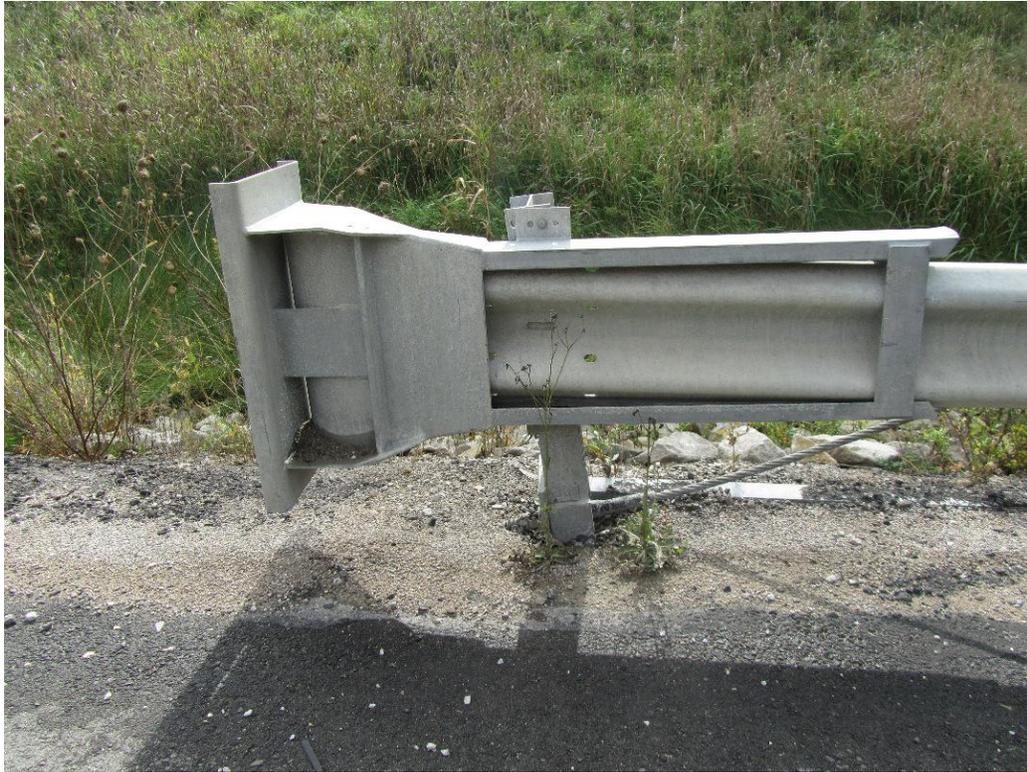
Figure 94: Street side view of hazard warning sign, end cap and south guardrail.

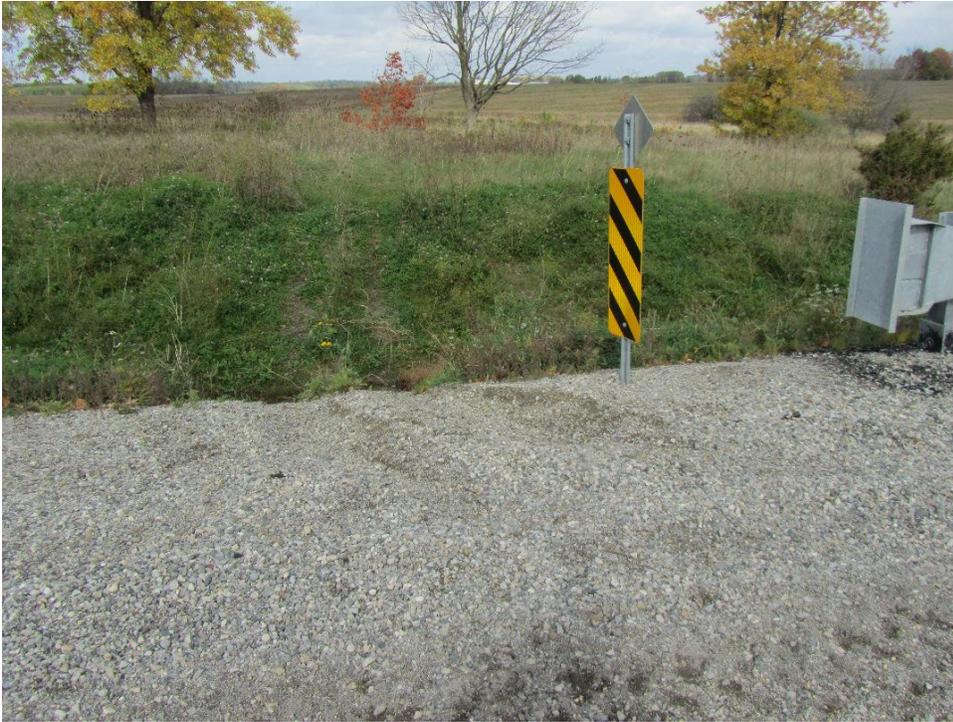
Figure 132: Eastward view showing channels dug in the gravel in front of the hazard warning sign likely caused by off-roading vehicles.
