Trinity Guardrail End Cap Survey - Part IV

Posting Date: 23-Oct 2014

Survey of Trinity End Caps

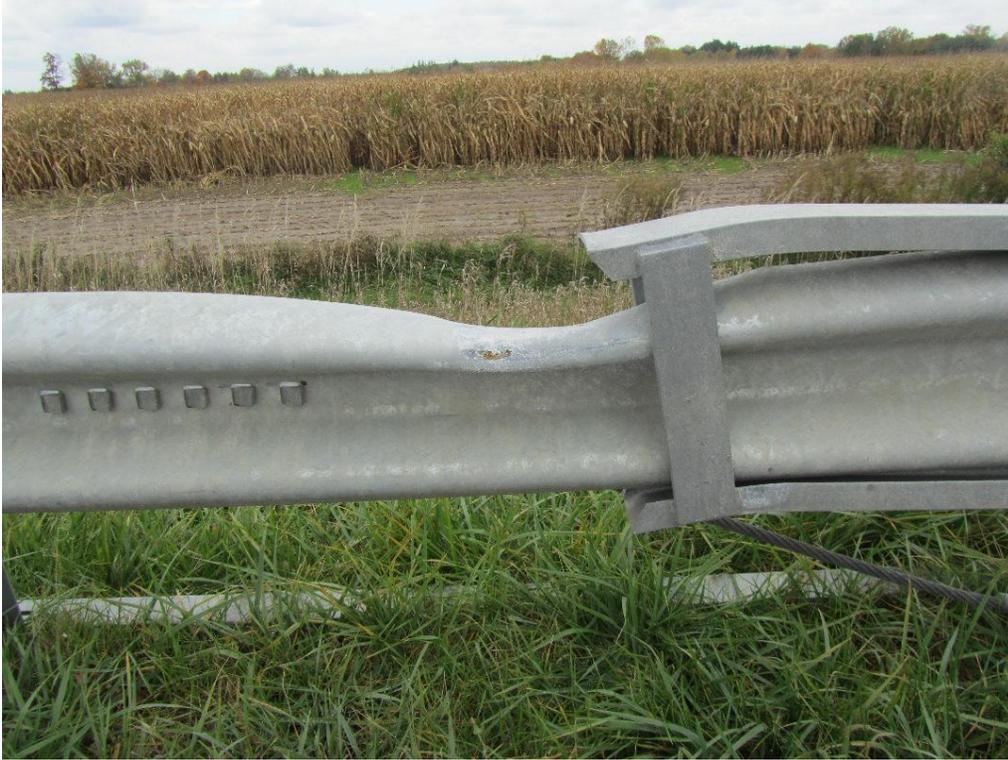
Figure 4: Street side view of unusual deformation to the guardrail and rear edge of channel.

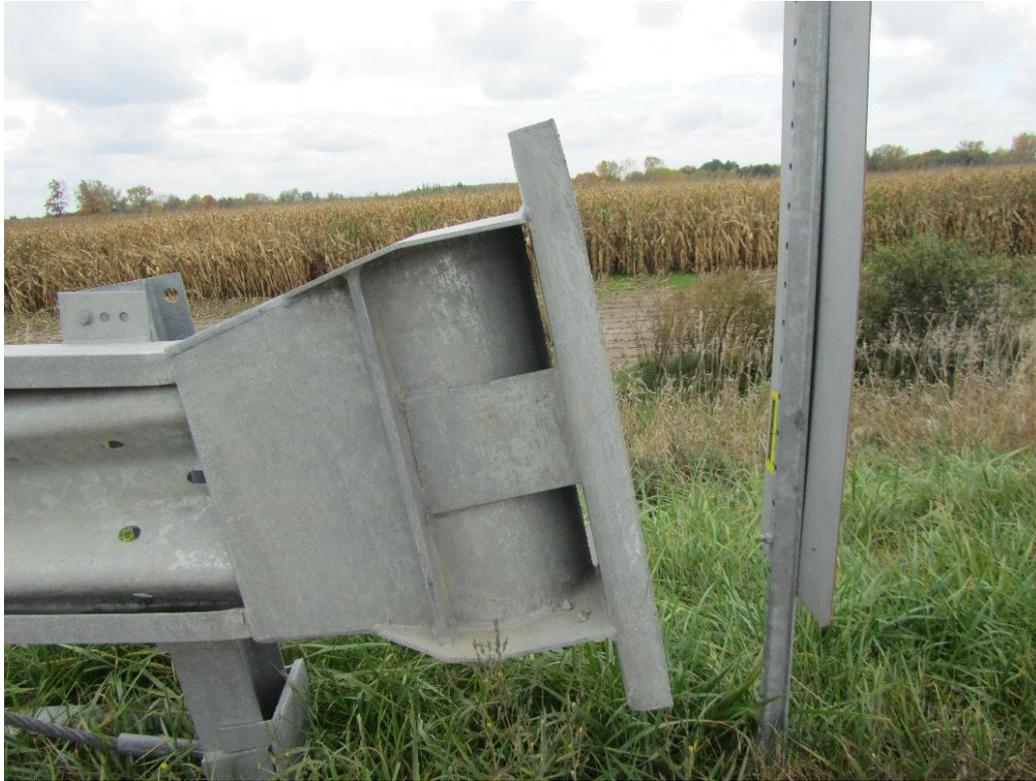
Figure 6: View of rotated end plate as part of damage to the system.

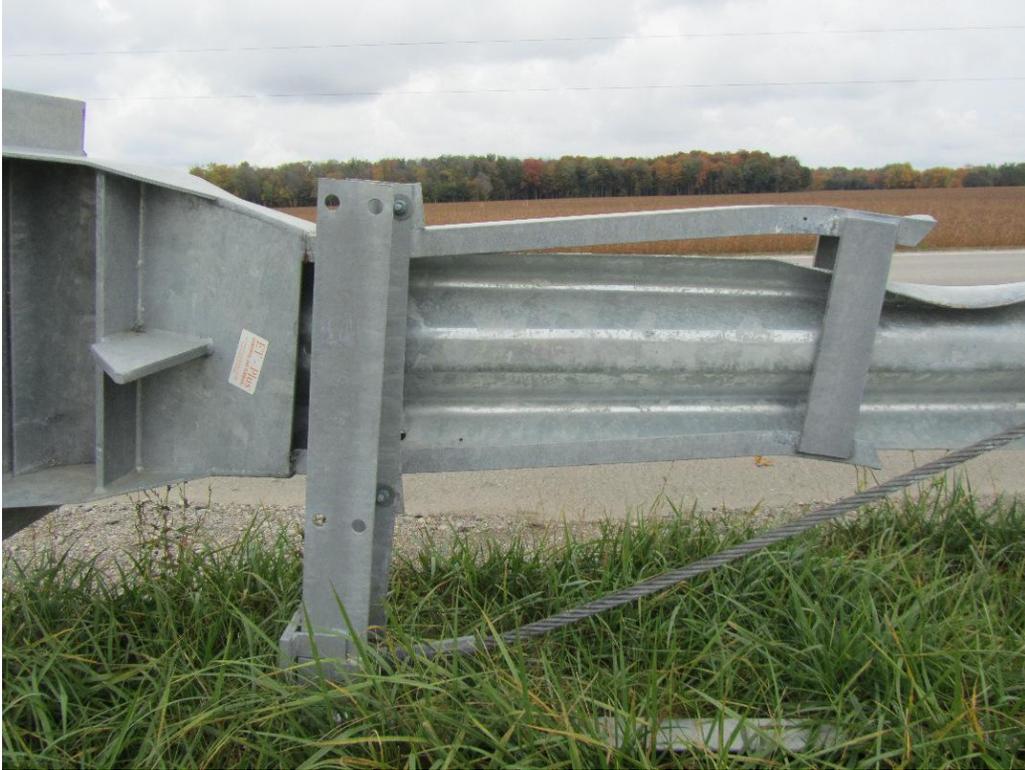
Figure 10: View of deformed status of channel.

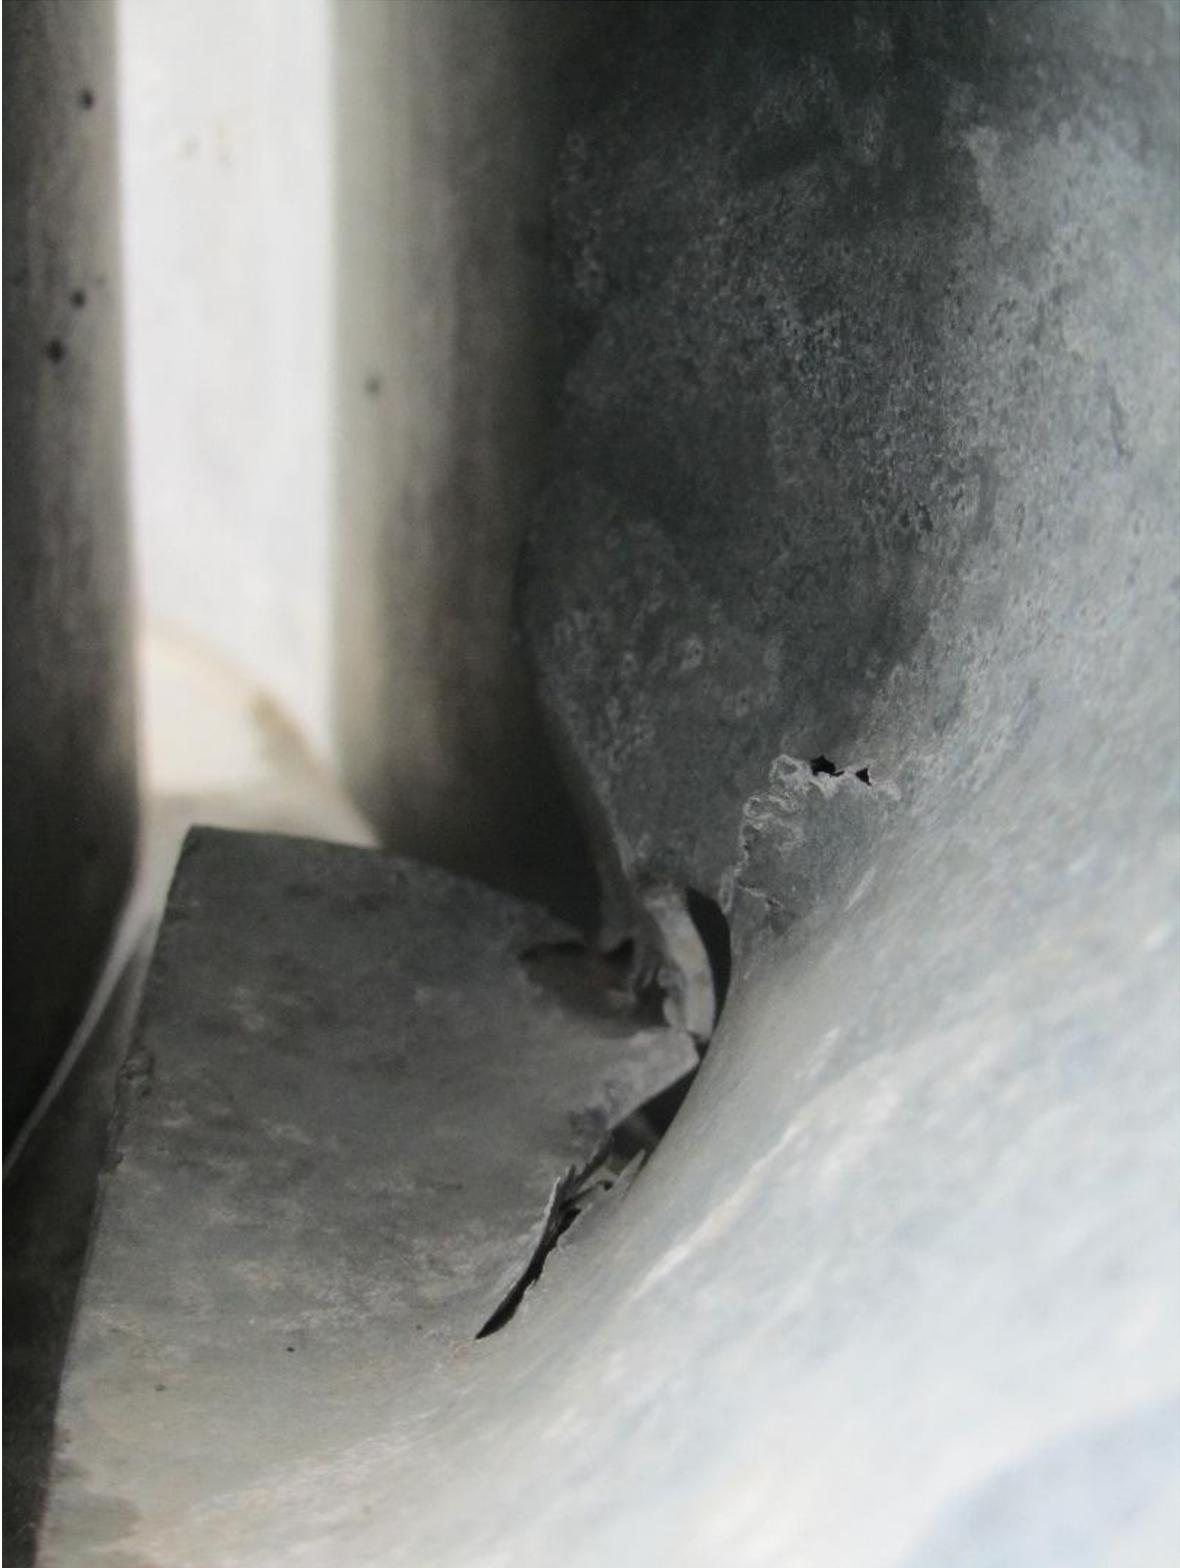
Figure 16: Close-up view of front edge of rail inside the channel showing the buckling and rupture of the rail.

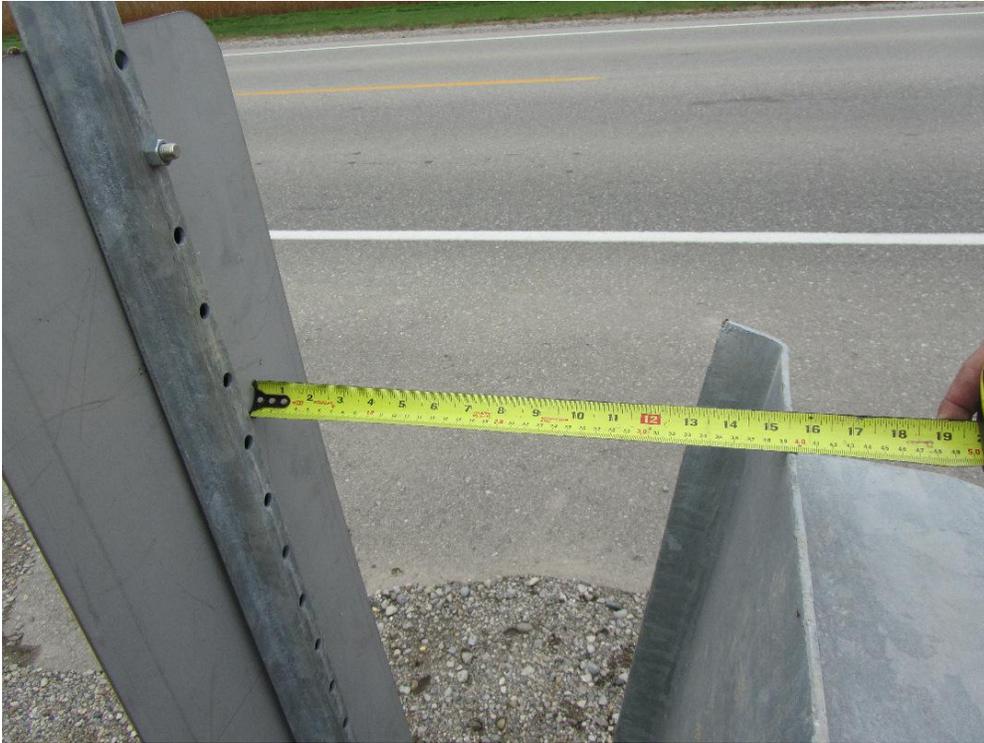
Figure 19: Measurement indicating that the hazard warning sign is only approximately 15.5 inches distance from the end plate.

The findings that were discussed in the earlier articles were repeated in this continuation of the survey. We remain concerned with the anchorage of metal posts that have a hazard marker attached to them and these appear to be too close to the end cap.

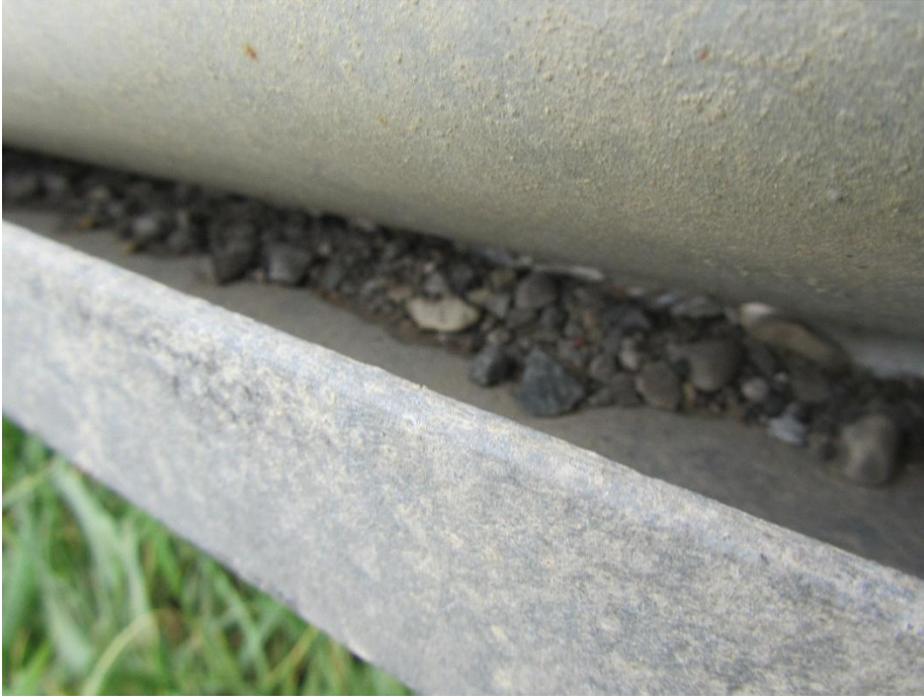
Figure 25: View of gravel lying in the crevice between the bottom edge of the rail and channel.

We continue to be concerned with the number of installations that have gravel trapped within the crevice between the bottom of the rail and channel. If the system is to function properly the end cap must be able to slide freely along the rail without being jammed. When gravel is present in the interface where that sliding is to take place, and if the channel is narrowed as is allegedly the case with the Trinity ET-Plus unit, then there should be a logical concern that the gravel will jam the system.

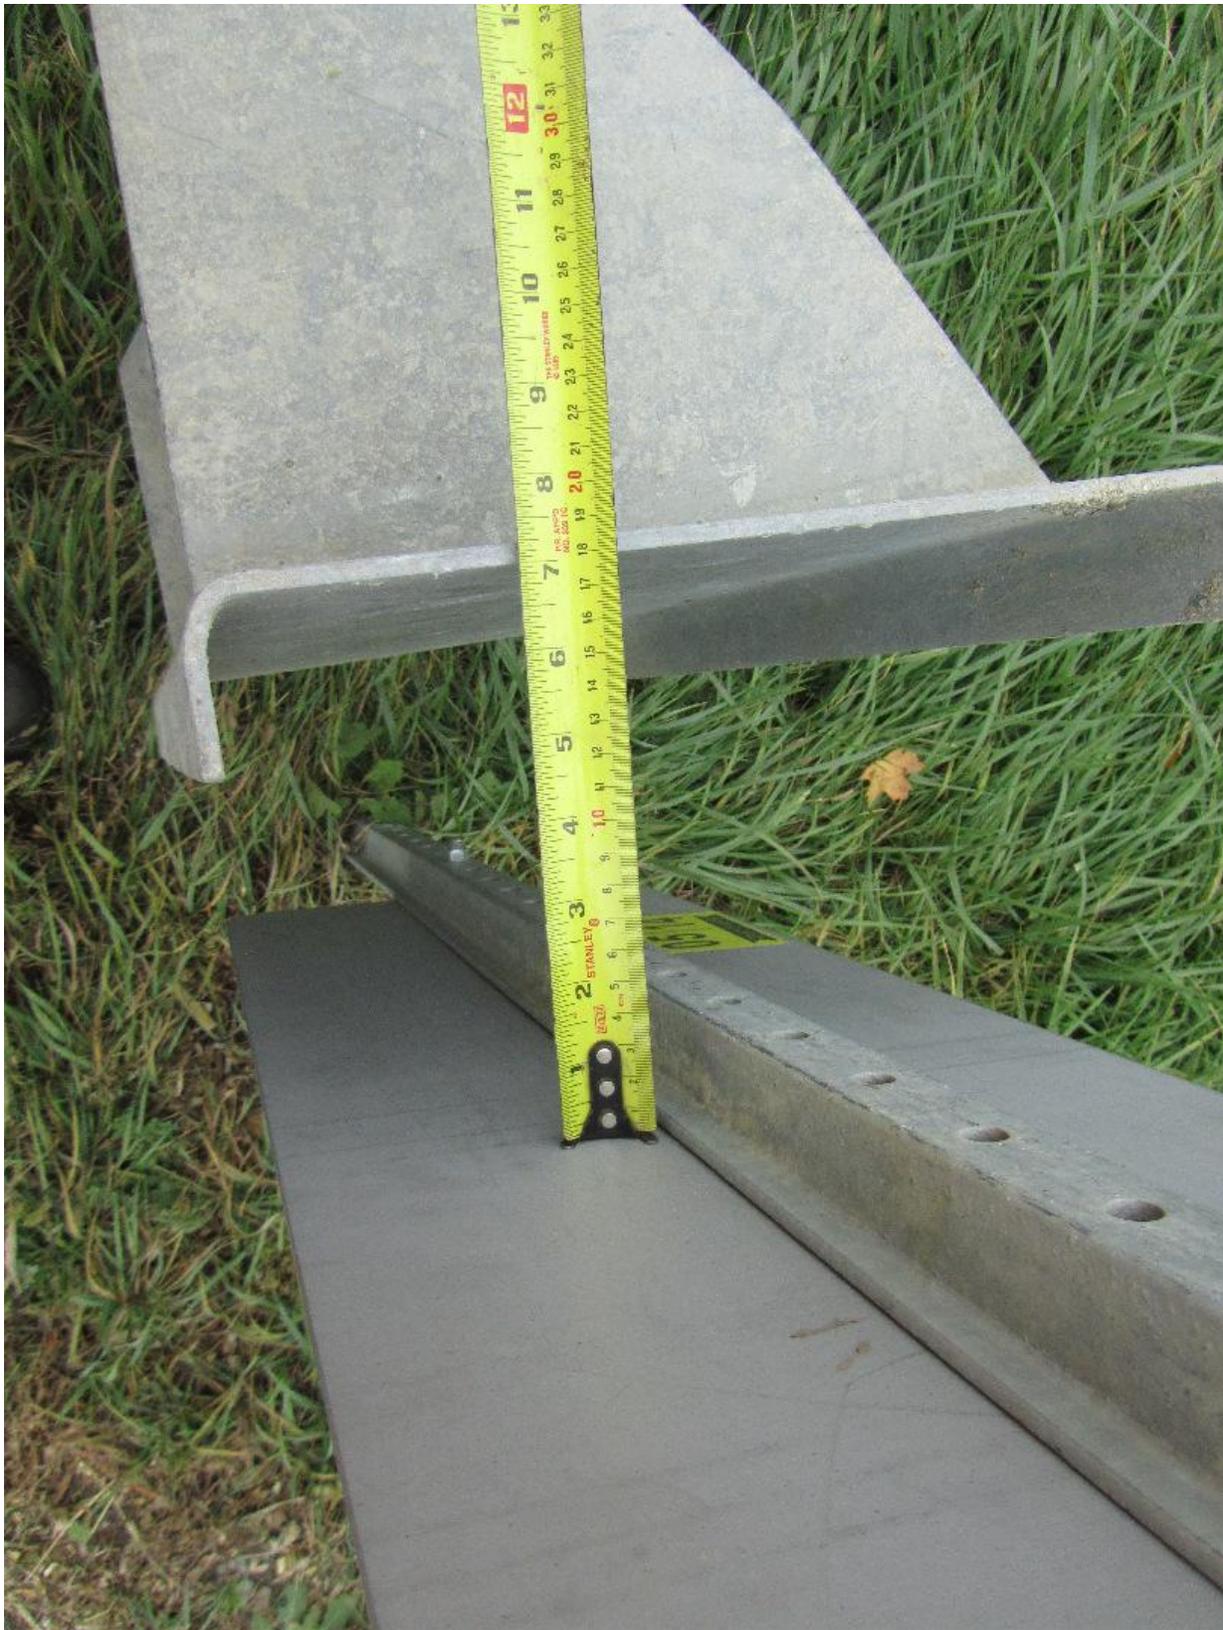
Figure 33: Measurement indicating the distance between the end plate and hazard sign is only about 7 inches.

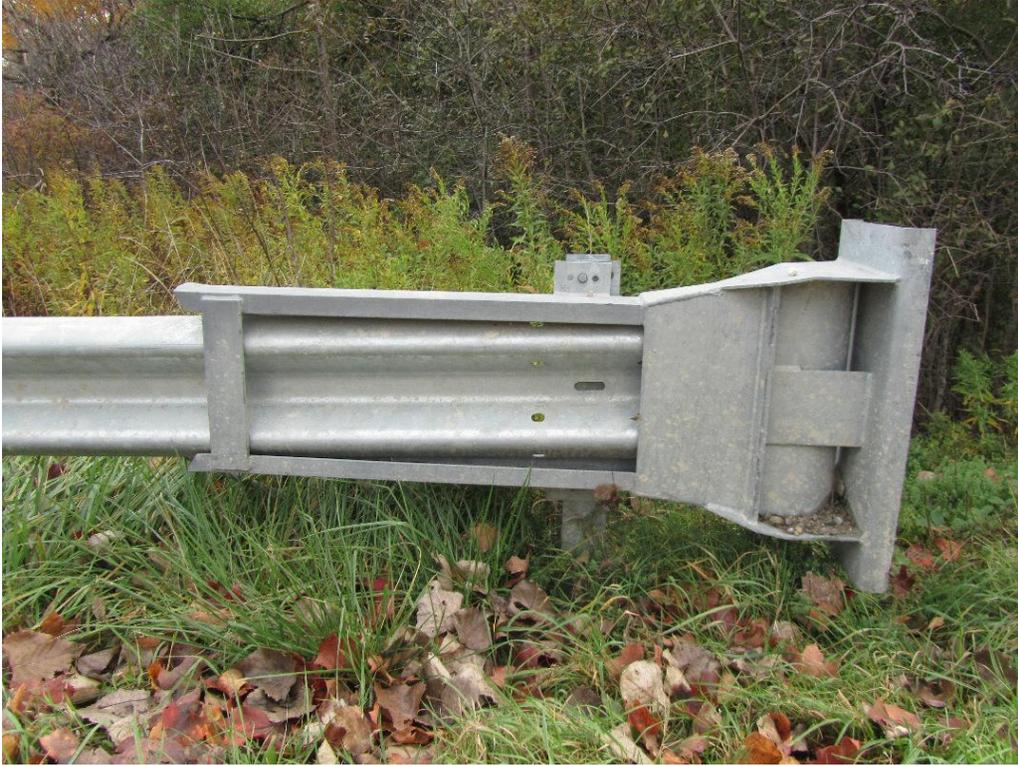
Figure 36: View of rail and end cap showing the substantial difference in their horizontal angles.

We also continue to see minor differences in each installation. There were several installations where the horizontal angle of the rail was significantly different than the angle of the channel. We reason that the end cap may be heavy and it might pivot downward and thus raising the back end of the channel. It needs to be determined how this might affect the proper functioning of the units.

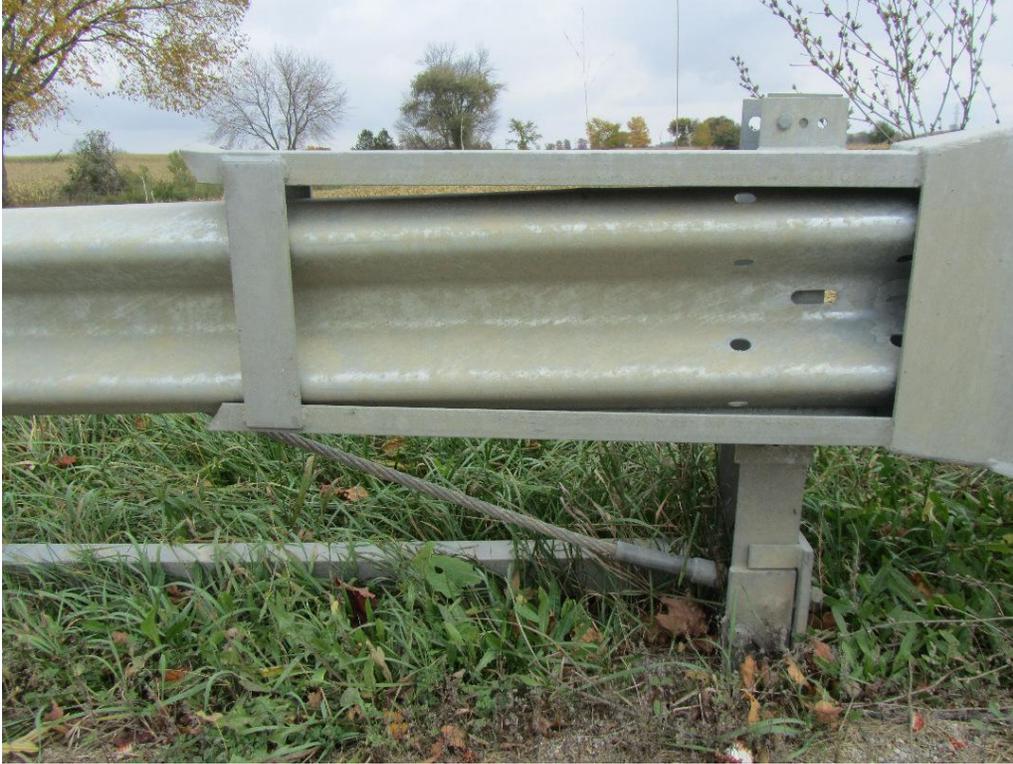
Figure 60: Street side view of end cap showing substantial difference in horizontal angle between end cap and rail.

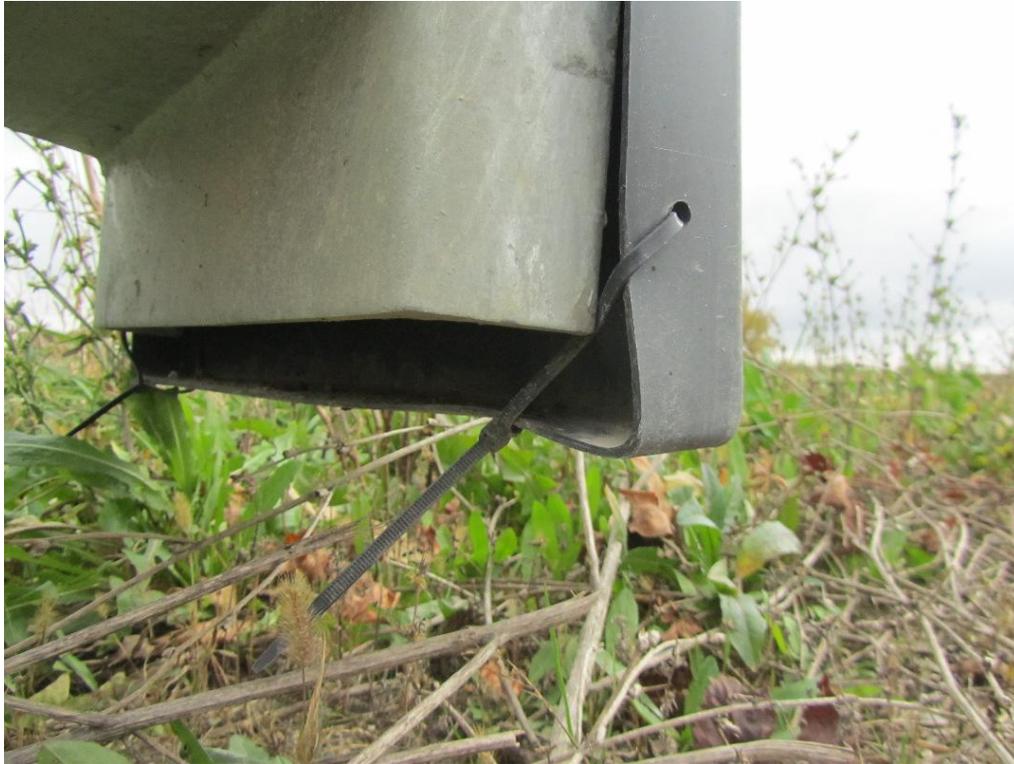
Figure 62: View of typical plastic tie which has become dislodged and will likely cause end plate cover to become loose.

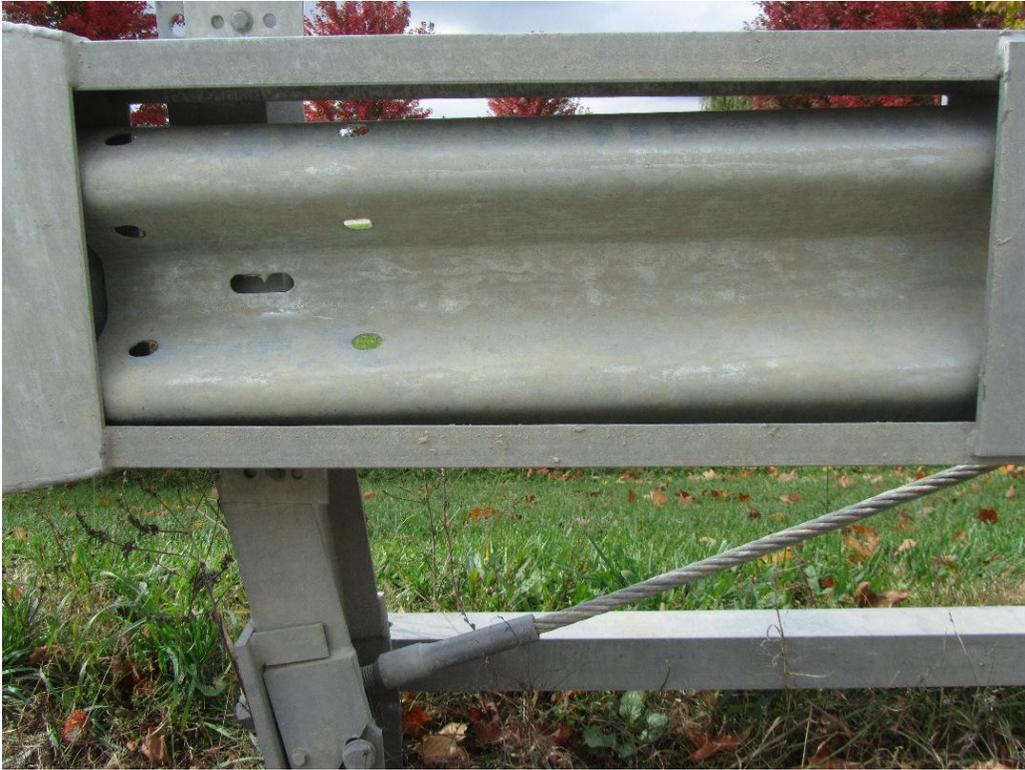
Figure 74: View of non-vertical post that is located beneath the rail and directly behind the end plate.

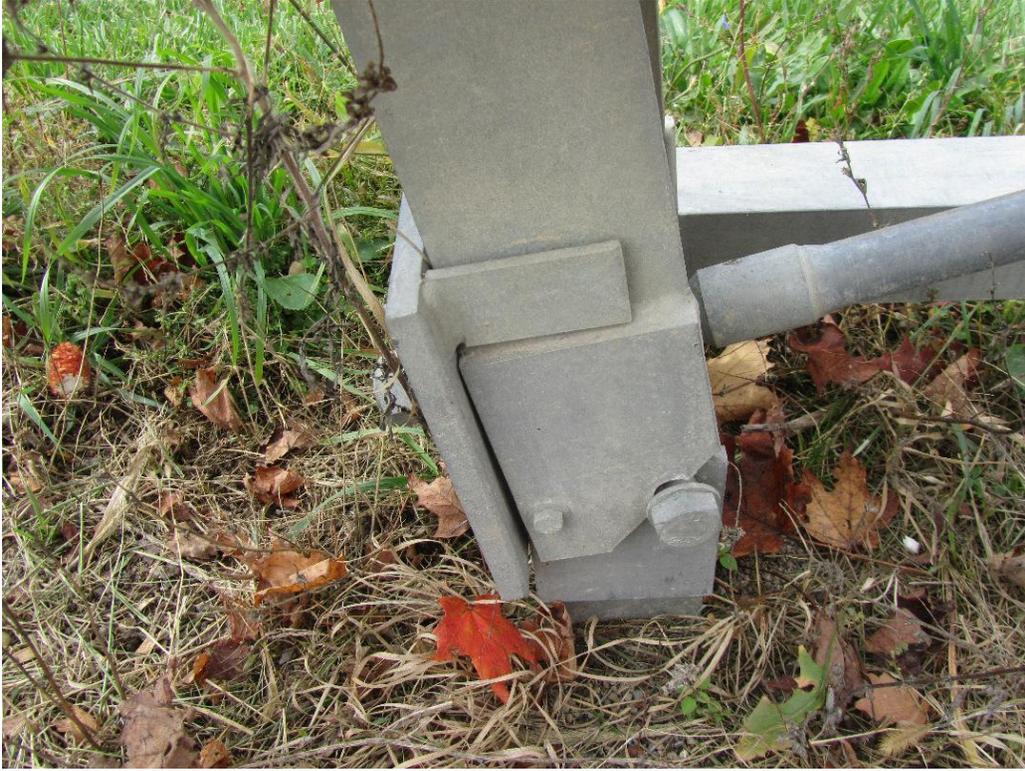
Figure 75: View showing that the vertical post has slipped out of its press fitting near its base.

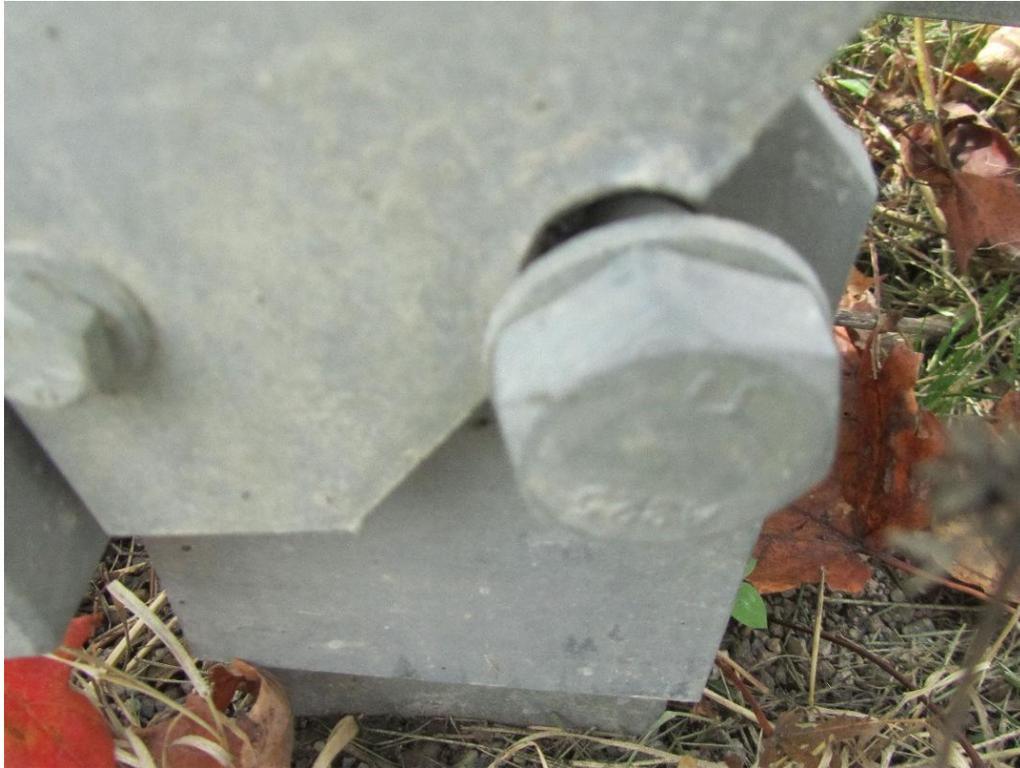
Figure 76: Close-up view showing how the vertical post has been displaced out of its press fitting at its anchorage bolt.

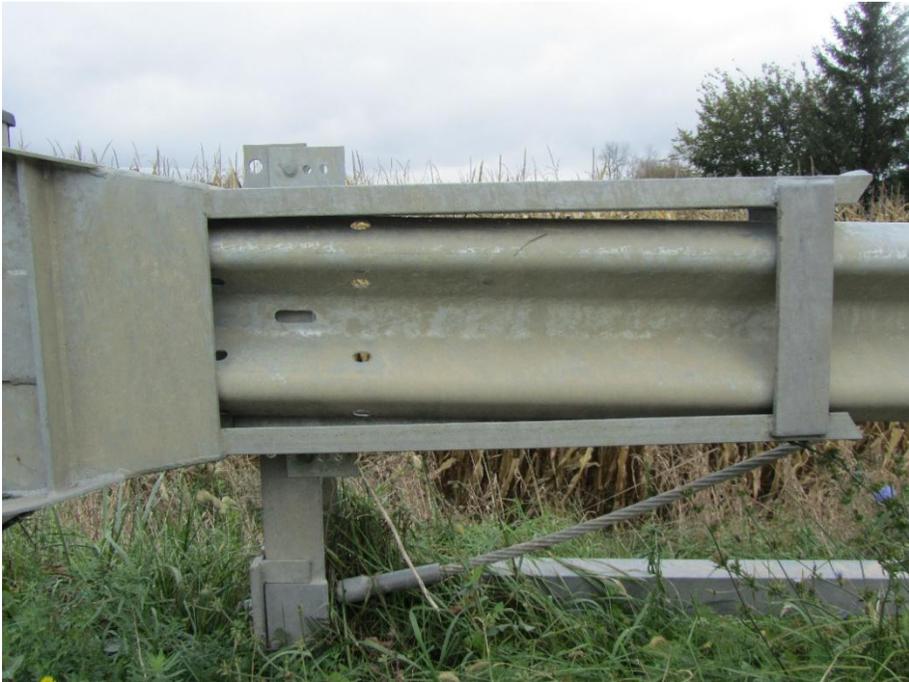
Figure 96: View showing the substantial difference in horizontal angle between the channel and rail.

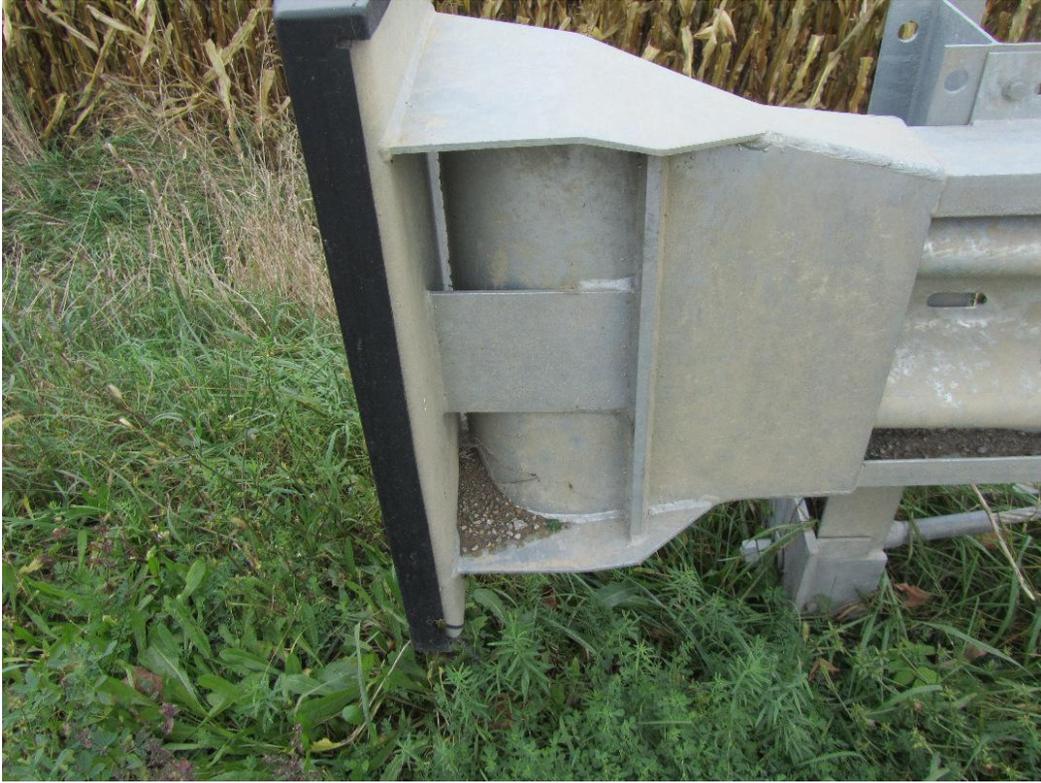
Figure 97: View of black cover on the end plate gravel lying on the horizontal platform just behind the end plate.

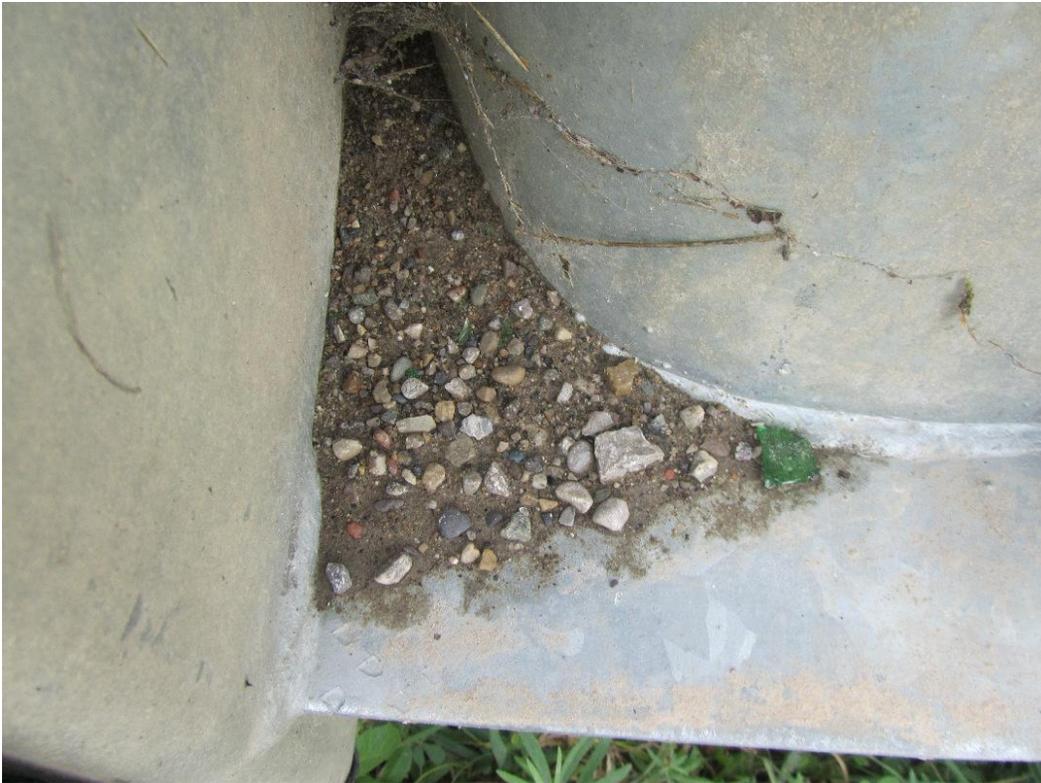
Figure 98: Close-up view of gravel lying on the horizontal platform just behind the end plate.

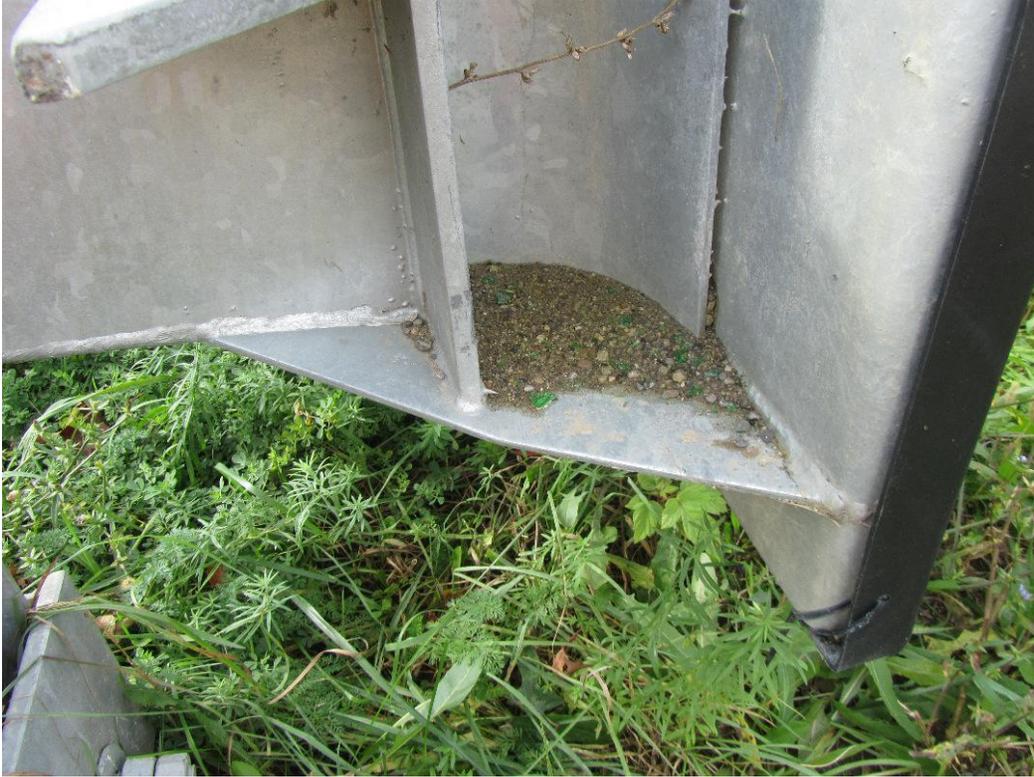
Figure 105: View of deposit of gravel on the horizontal platform on the ditch side of the end cap.
