Trinity Guardrail Terminal Performance Evaluation From 2013 U.S. National Automotive Sampling System (NASS) Cases

Posting Date: 9-Dec 2014

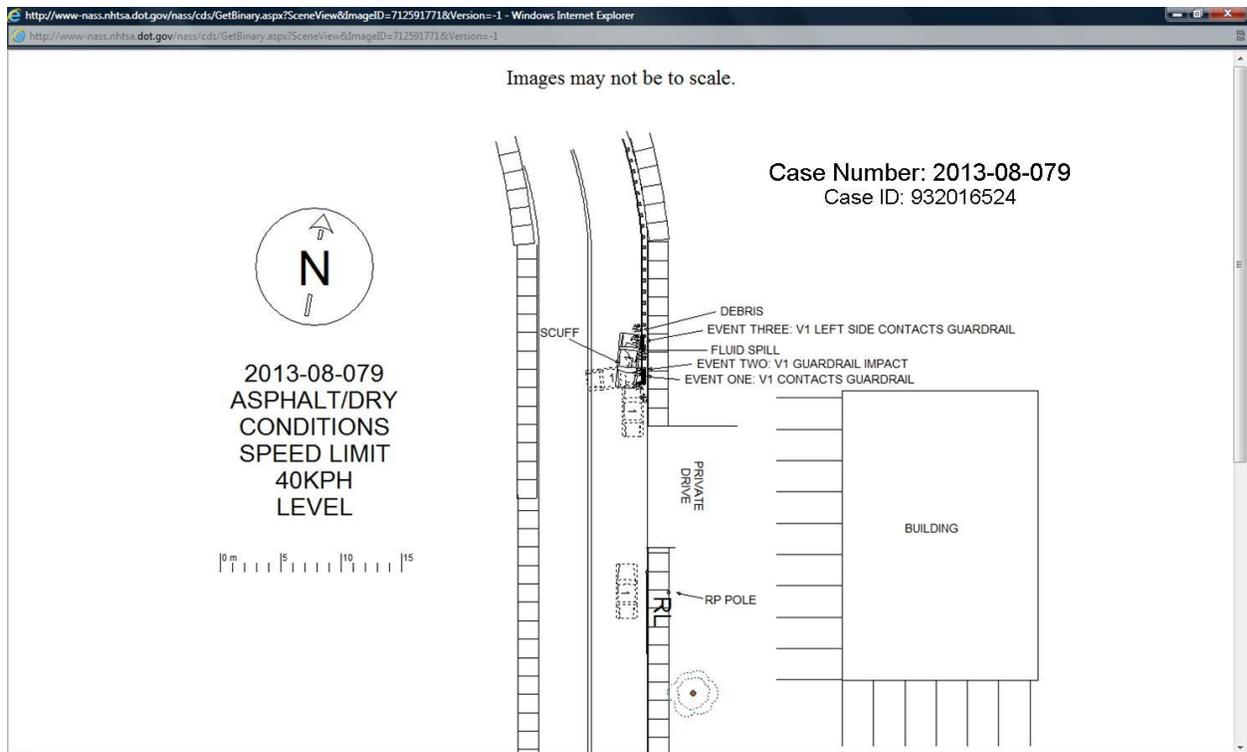
Figure 1 is a site drawing created by the NASS investigators to provide a general indication of how the collision transpired. It shows that, upon impact the case vehicle rotated clockwise and came to rest very close to the area of impact.

Figure 1: Site diagram produced by the NASS investigators.

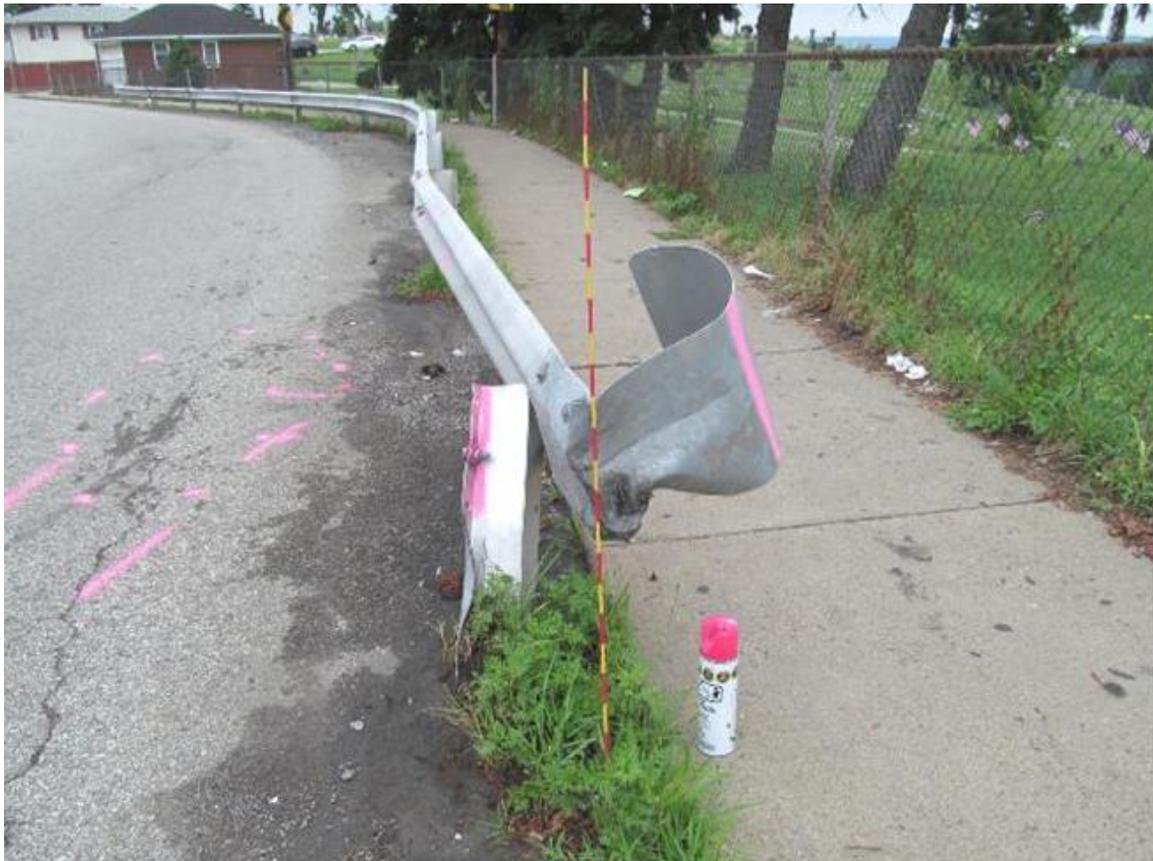
It is interesting to note that the "Inspection Interval", or delay in inspection, was "0 days" and this is an exceptionally short delay compared to other NASS cases where the delay is often substantial. The result is that the damage to the guardrail was able to be documented. Figure 2 shows a view of that damaged guardrail. This installation was not one of those manufactured by Trinity. The damage suggests that this was a rather low-severity impact.

Figure 2: View of damaged end of guardrail.

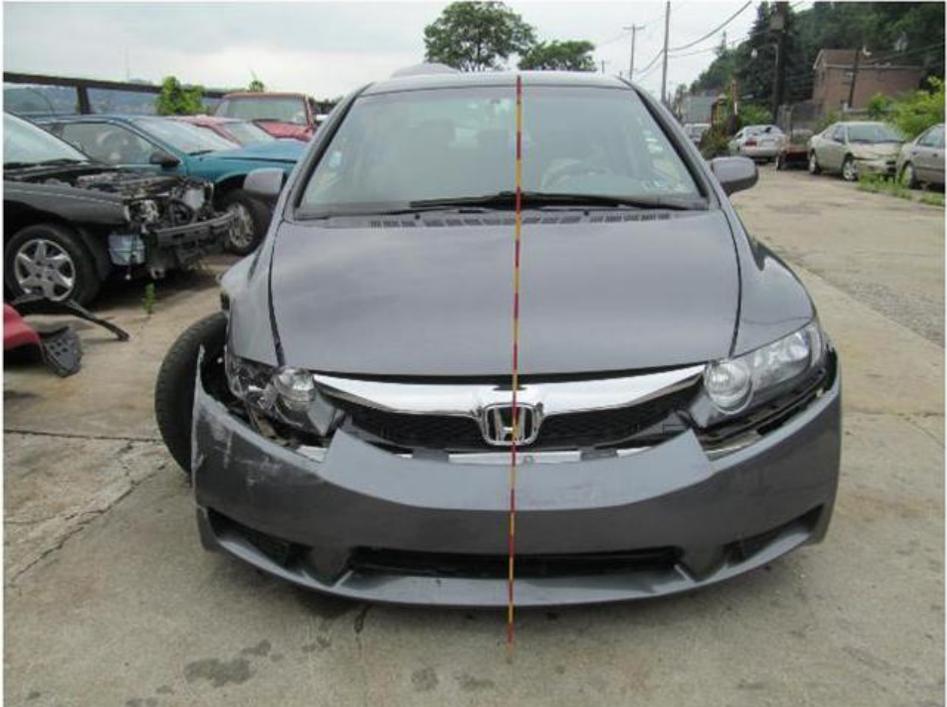
Figure 3 shows a front view of the damaged vehicle. The contact damage exists at the extreme right edge of the front end. This is more-clearly visualized in the right front view of Figure 4.

Although the vehicle damage appears to be relatively minor, there has been interaction with the right front wheel as evidenced by that wheel's extreme, outward angle. Contact to the stiffer wheel area would normally result in a higher collision severity than if there had only been side-swiping damage along the right side. Unfortunately there is no information about the injuries to the driver so the performance of the barrier system cannot be fully assessed.

Figure 3: Front View of 2009 Honda Civic.

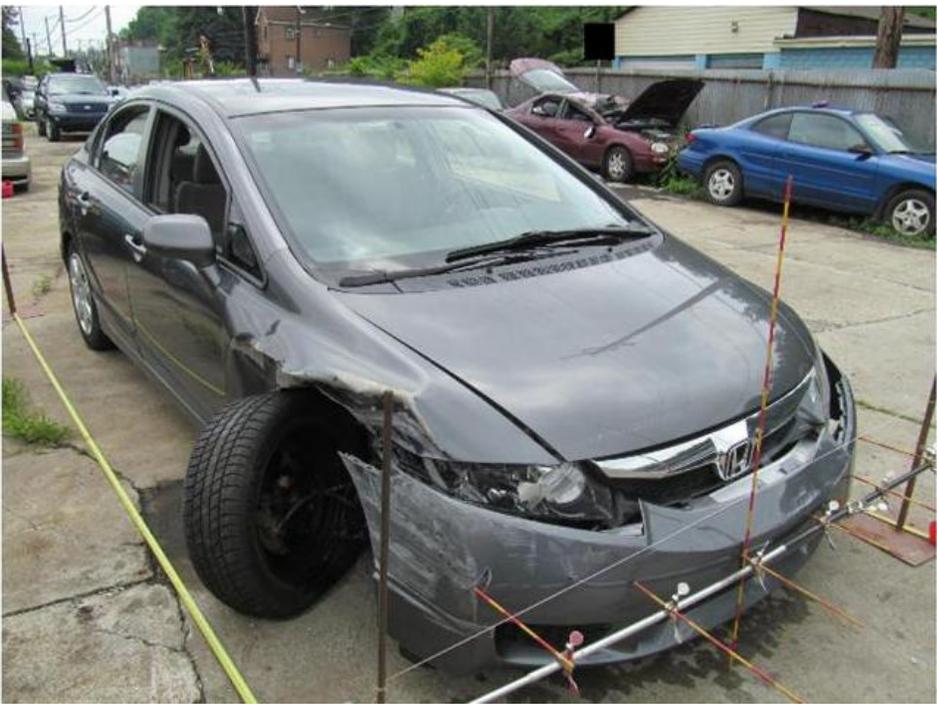
Figure 4: Right front view of Honda Civic.

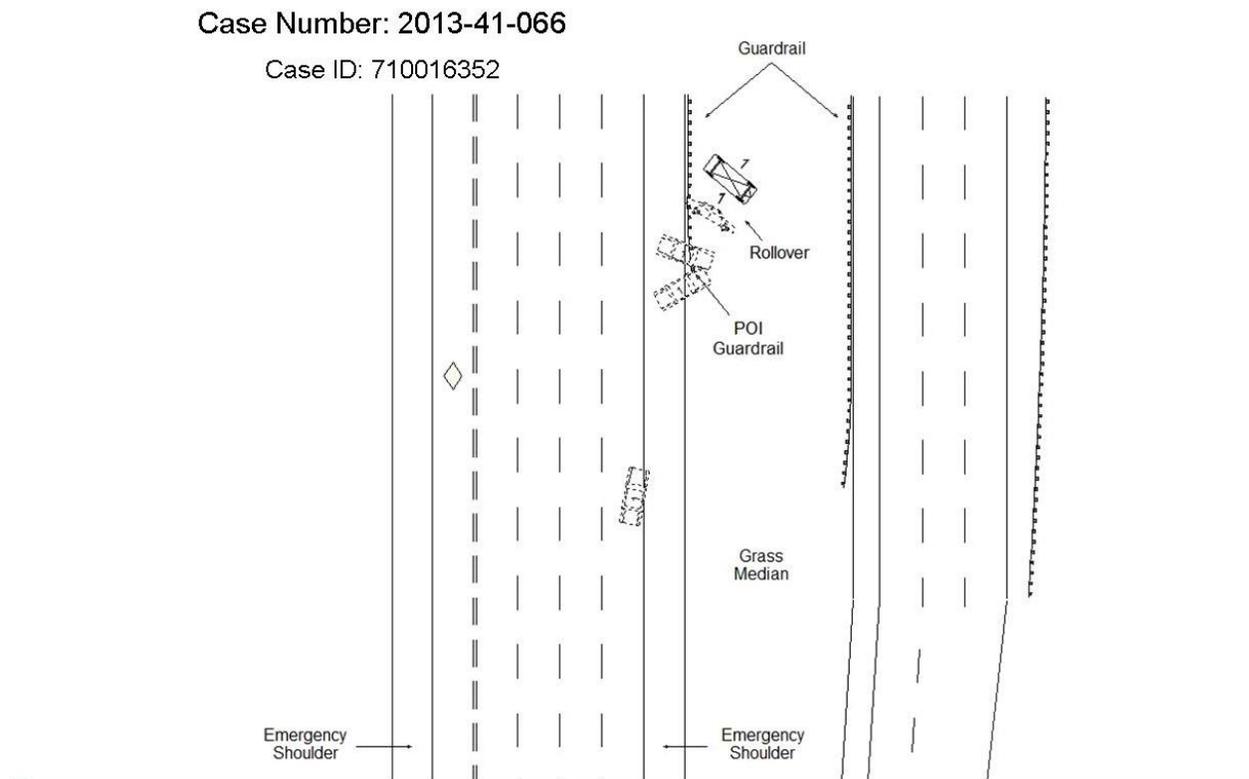
Figure 5 is a site drawing created by the NASS investigators to provide a general indication of how the collision transpired. It shows that, upon impact the case vehicle rotated clockwise and then rolled over behind the guardrail.

Figure 5: Site diagram created by the NASS investigators

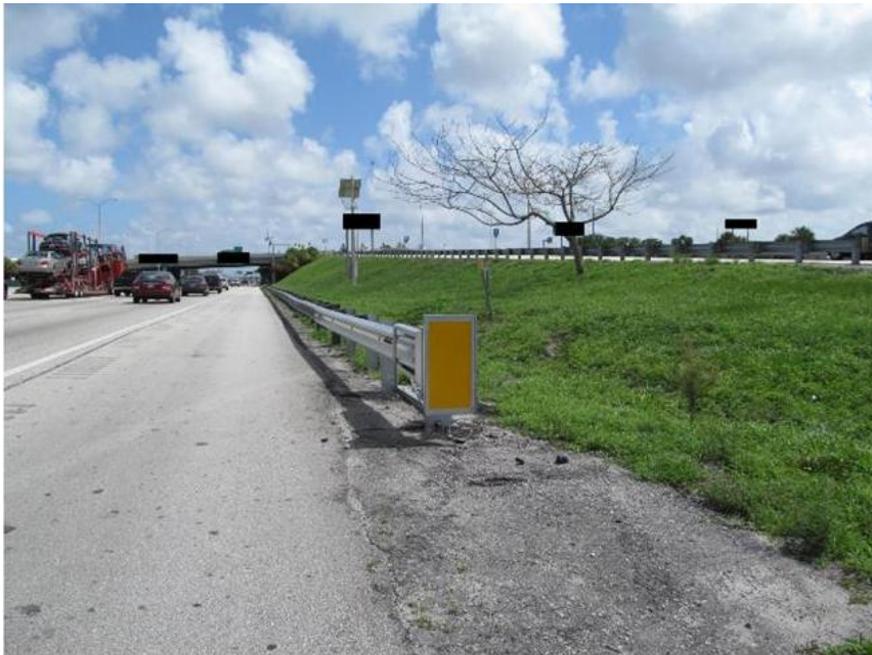
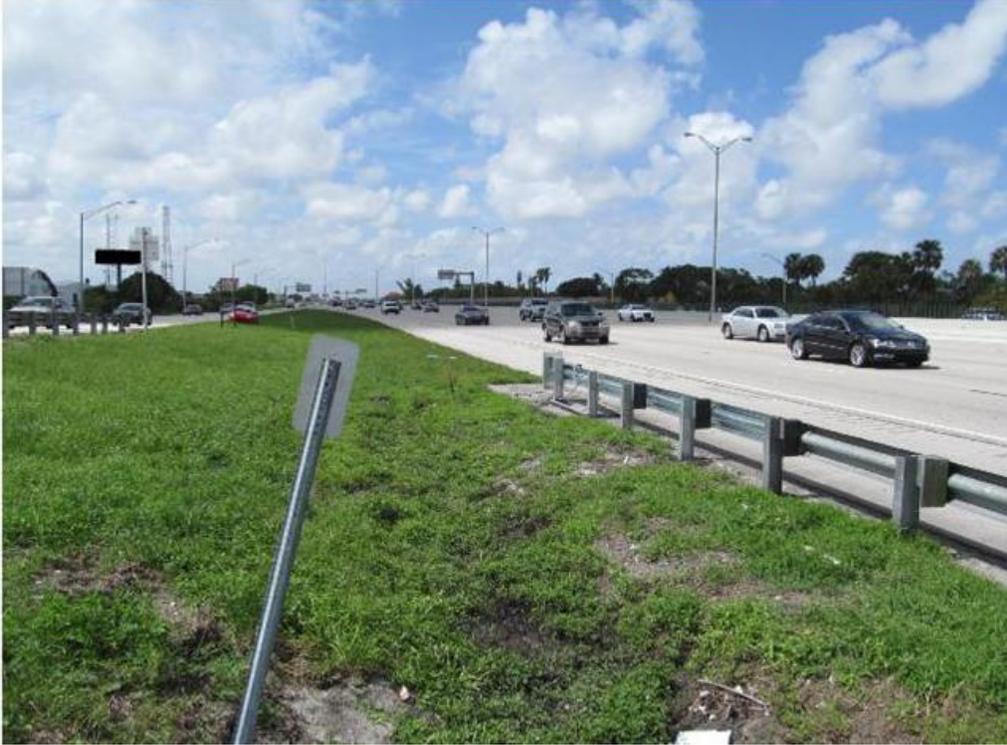
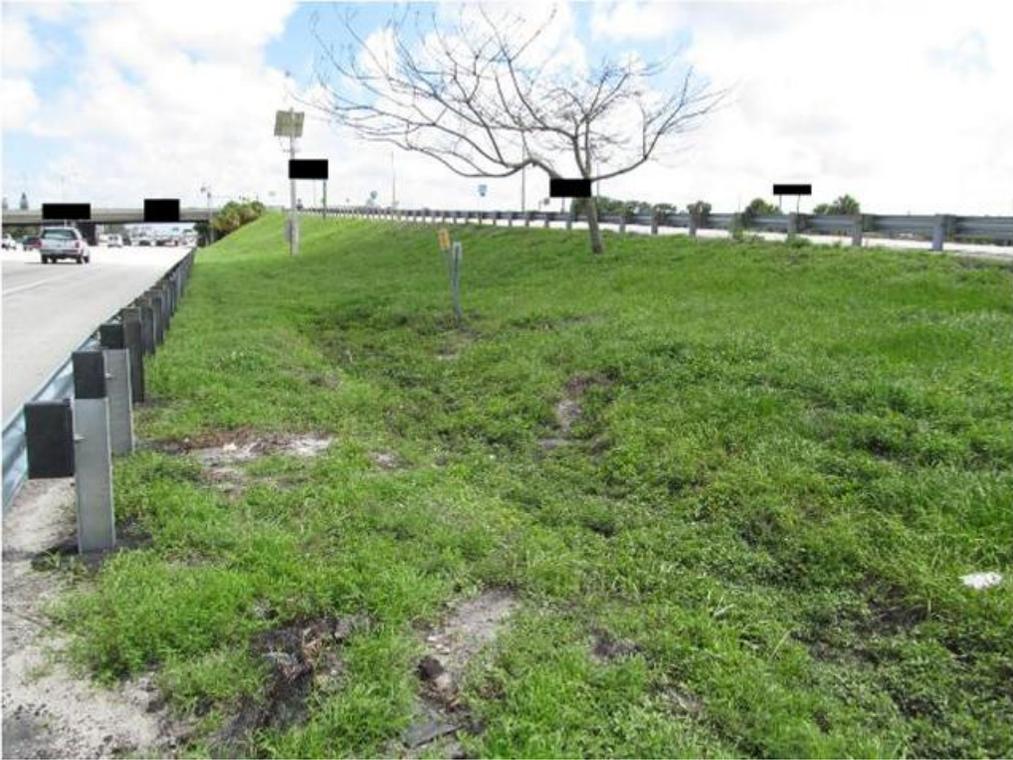
A delay of 43 days is quite substantial and it would normally lead to a loss of valuable information and evidence. This loss of information is exemplified by the site photographs, such as Figures 6, 7 and 8.

Figure 6: View, looking toward the repaired guardrail that contains a Trinity ET-Plus end terminal.

Figure 7: View looking back from the rest position of the striking vehicle toward the area of impact at the ET-Plus end terminal.

Figure 8: View looking from the area of impact toward the rest position of the striking vehicle.

The site photographs show that the guardrail has already been repaired and there is little evidence on the ground to determine how the striking vehicle moved from impact to its rest position. This is the result of the 43 days delay in commencing the investigation.

As mentioned earlier, although the site photos show that an ET-Plus end terminal is installed at the end of the guardrail, that does not mean that the same kind of terminal existed at the time of impact. If photographs had been taken while the guardrail was still in its damaged state there would not be this ambiguity.

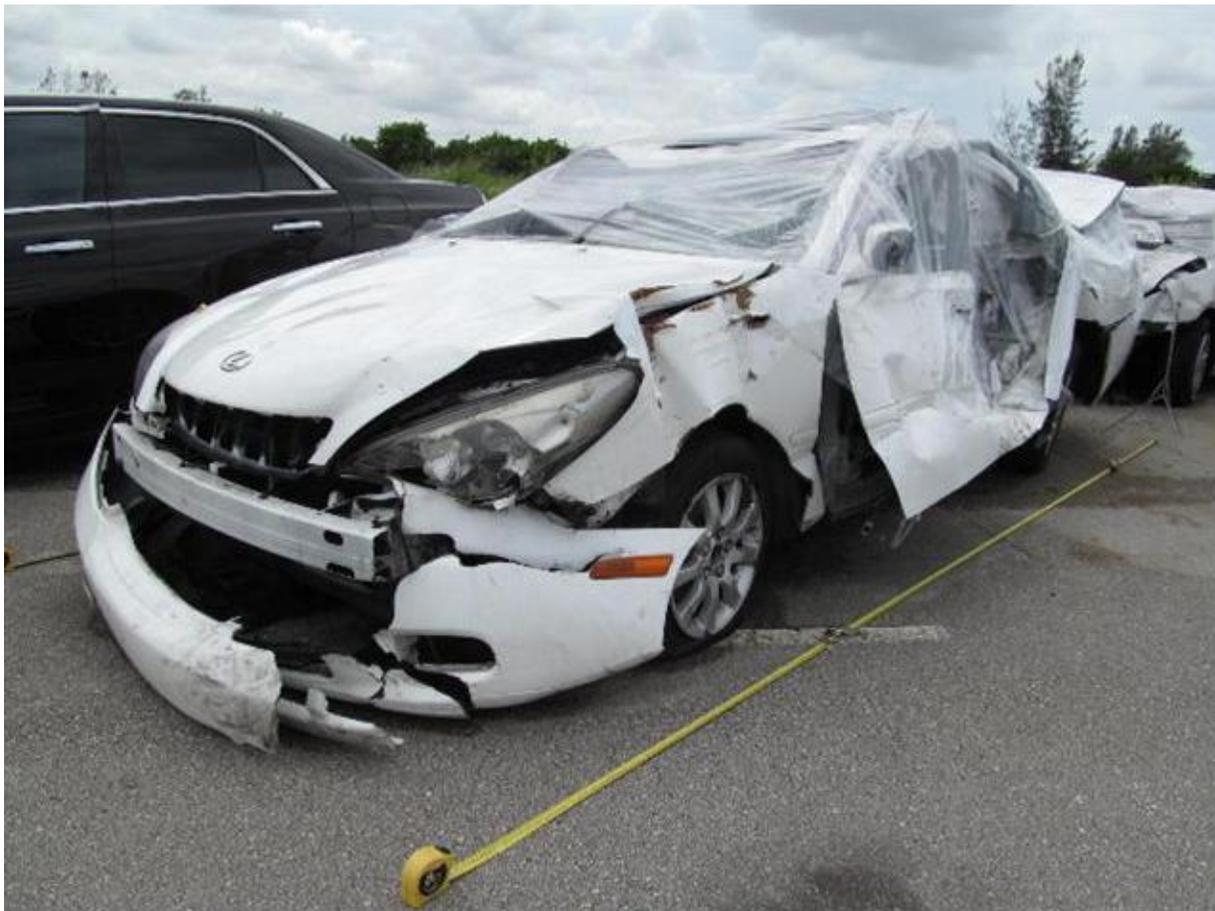
Figure 9: Left front view of 2003 Lexus.

There is a clear imprint just above the left-front wheel that appears to have dimensions similar to the ET-Plus terminal. Therefore, the damage on the vehicle may suggest that the it was an ET-Plus terminal that was installed at the end of the guardrail at the time of this impact.

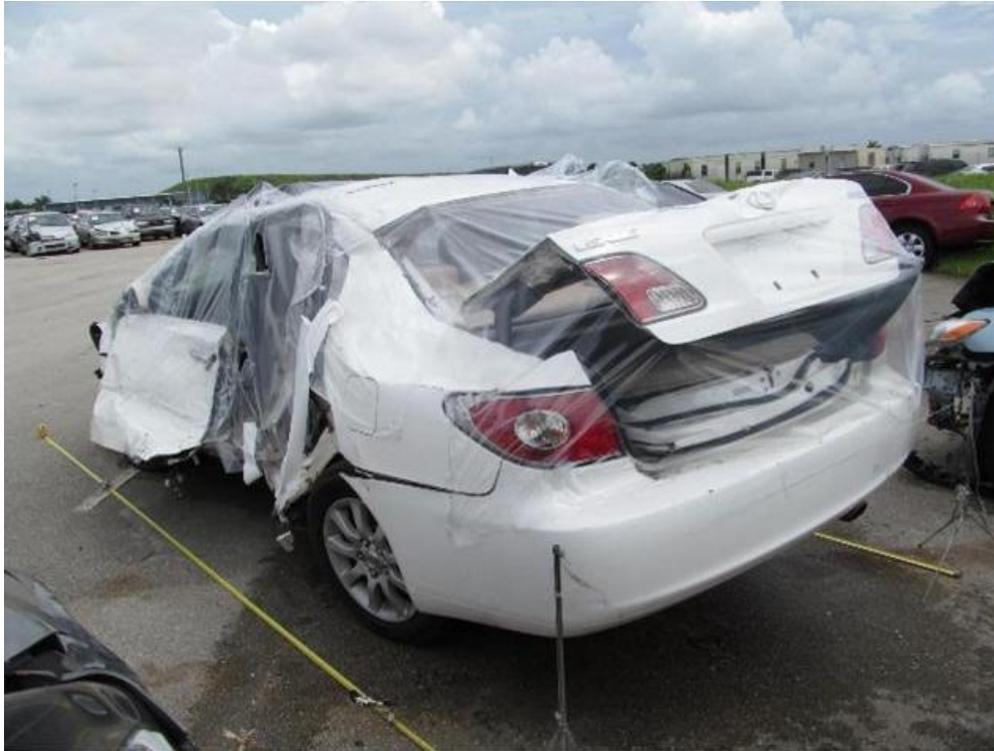
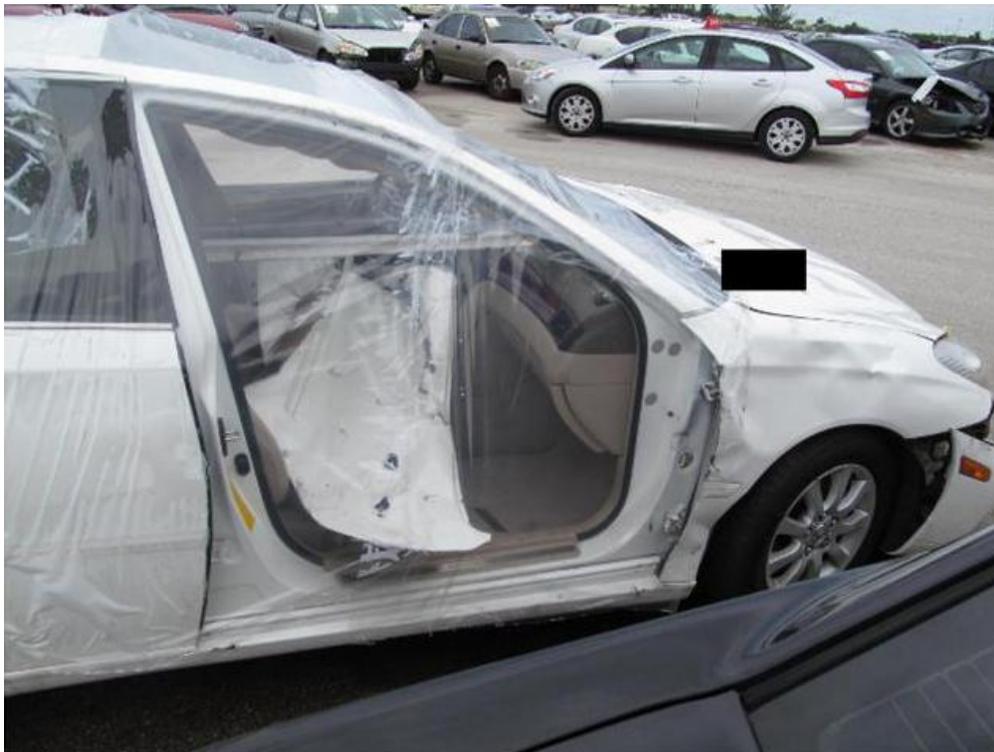
Figure 10 shows a left rear view of the Lexus and Figure 11 shows the right side of the vehicle. The damage evidence leaves one to question how the interaction occurred between the guardrail and vehicle as there is some unusual damage on the vehicle.

Figure 10: Left rear view of 2003 Lexus.

Figure 11: View of right side of Lexus.

As concern has been expressed with respect to the jamming of the guardrail within the ET-Plus terminal resulting in harpooning of the vehicle by the rail, there appears to be sufficient evidence in the photographs of the vehicle to question whether such harpooning occurred in this instance. There appears to be a linear object lying within the interior of the vehicle and this leads to the question whether this is part of the guardrail and terminal system that entered into the interior during the impact. If there was no opening of the vehicle to the exterior then we would be less inclined to believe that such harpooning occurred. However, the photos show that there appears to be an opening at the left rear door, such that the door appears to be removed. The view of the right side shows that the right front door is removed and a damaged door appears to be lying loose on the right front seat. The damage to this door is not typical of what one would expect from a low-speed rollover and it suggests that the damage was caused during the interaction with the guardrail. Further information is needed to determine if the ET-Plus terminal failed to perform properly however the available evidence suspiciously tends toward that conclusion.

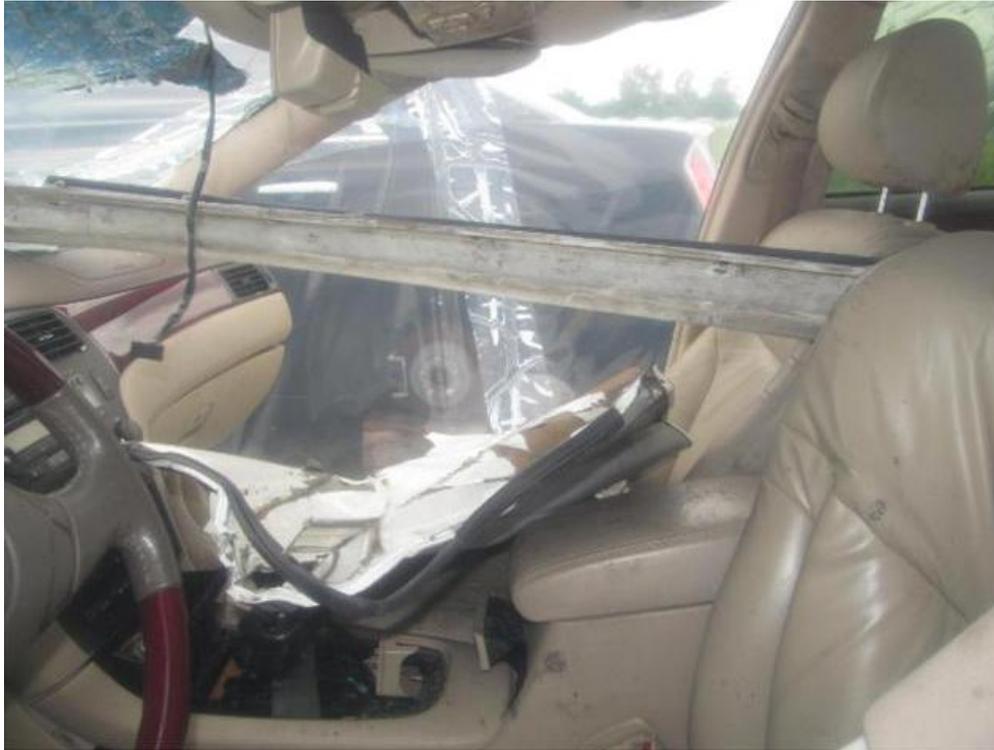
Figure 12 shows the interior of the Lexus.

Figure 12: View of interior of Lexus.

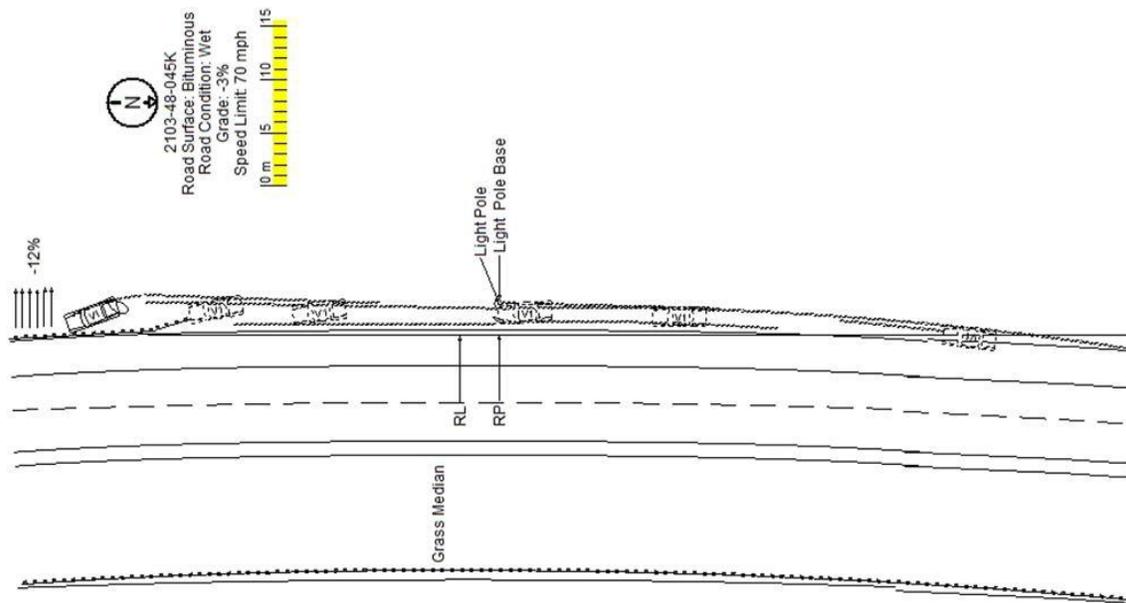
Case Number: 2013-48-045
 Case ID: 834016595

Figure 13 is a site drawing created by the NASS investigators to provide a general indication of how the collision transpired. It shows that the vehicle exited the right side of the road struck a lamp pole and the collided with the end of the guardrail.

Figure 13: Site Diagram drawn by NASS investigators.

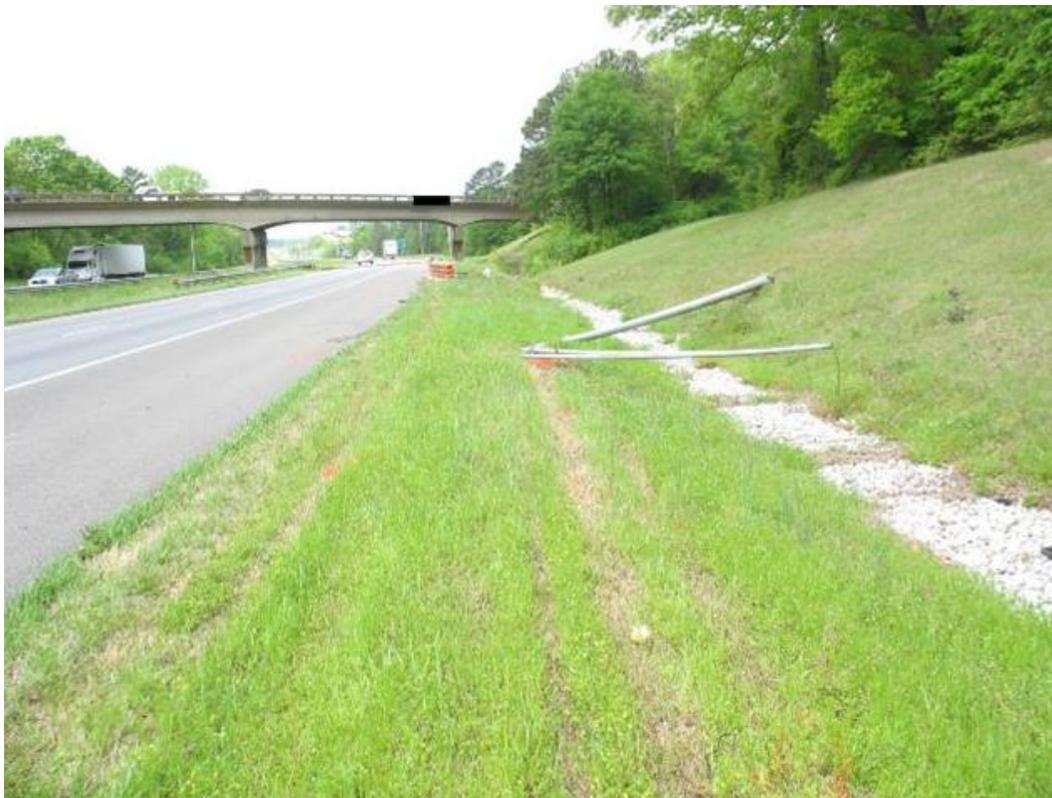
Figure 14 shows a view of the right side of the highway and we can see tire marks in the grass. The tire marks pass through the area of a fallen light pole and then we can see in the background that a temporary, orange barrier has been set up at the location where the vehicle struck the end of the guardrail.

Figure 14: View looking toward the struck guardrail with the damaged light pole in the foreground.

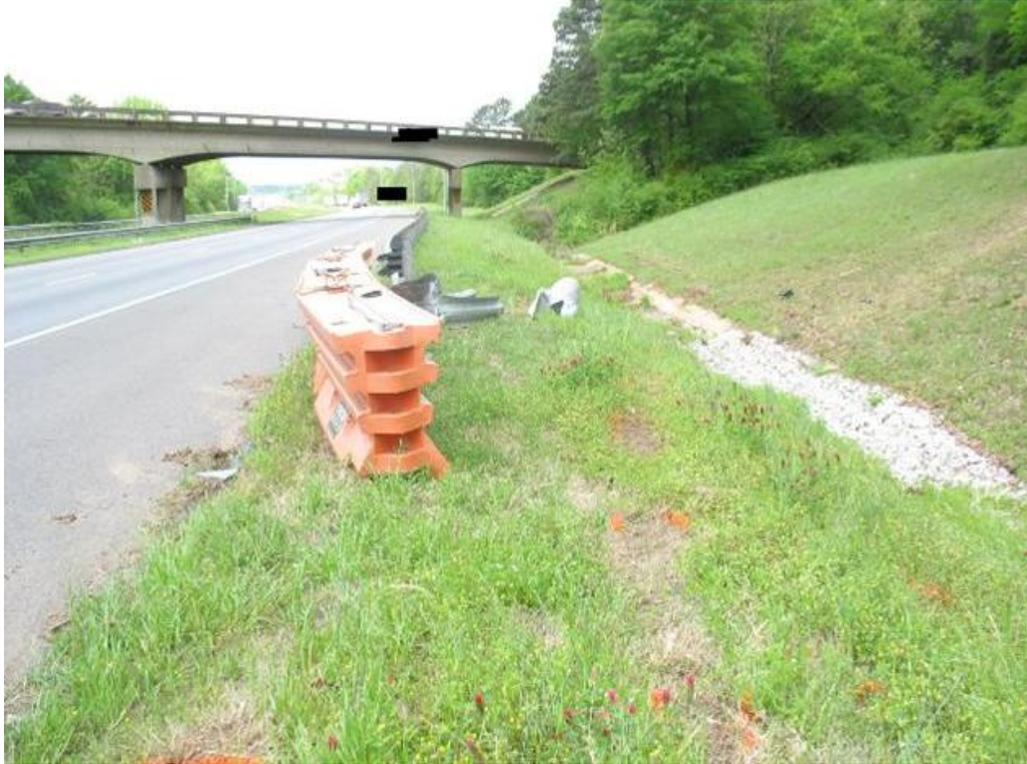
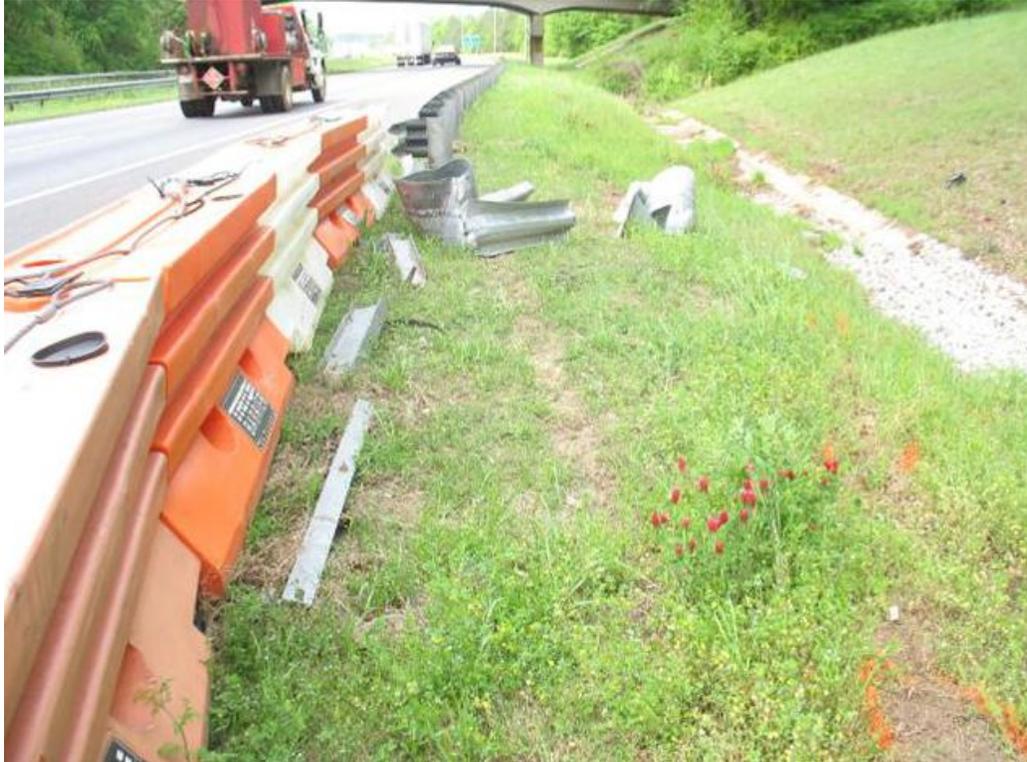
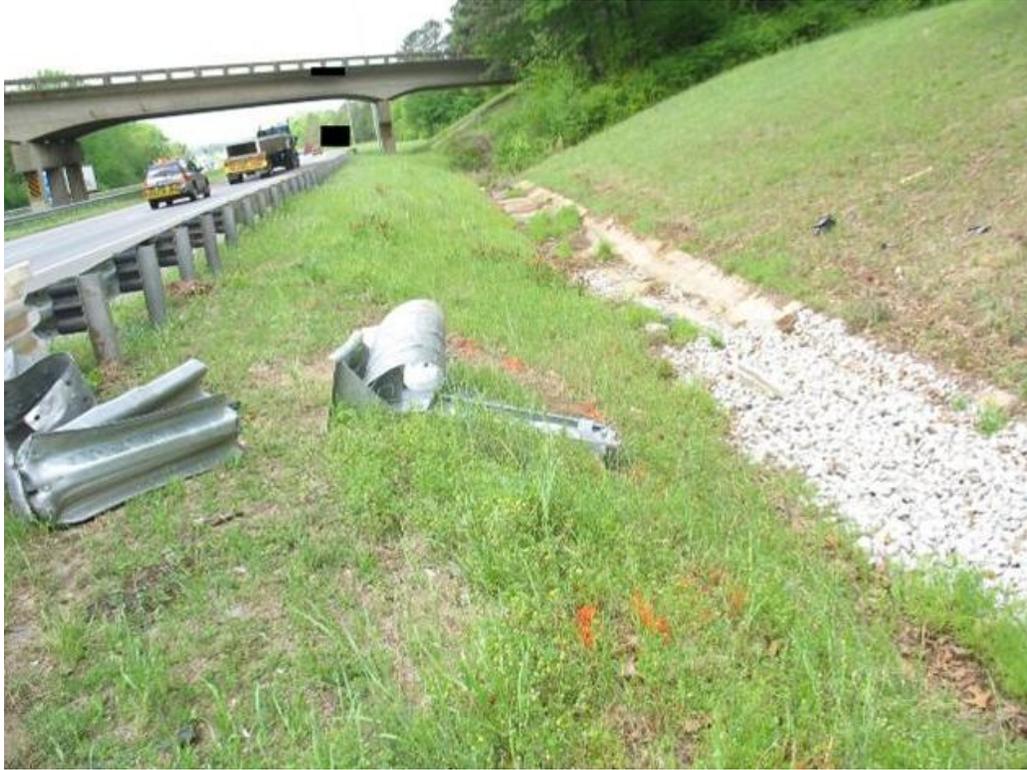
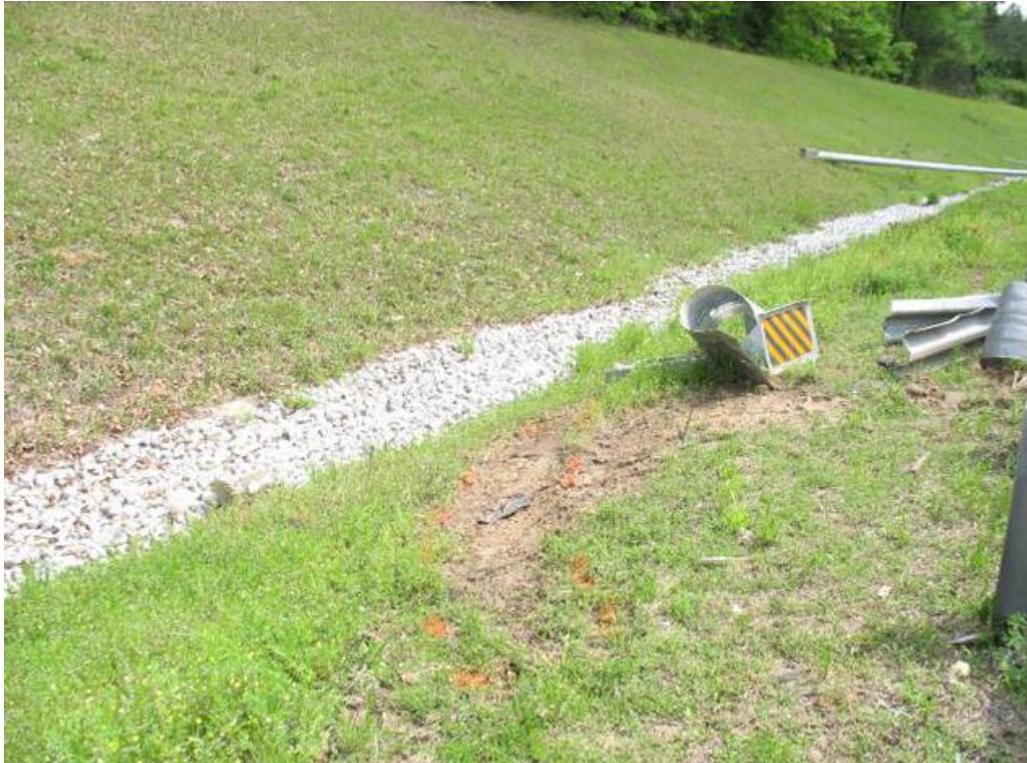
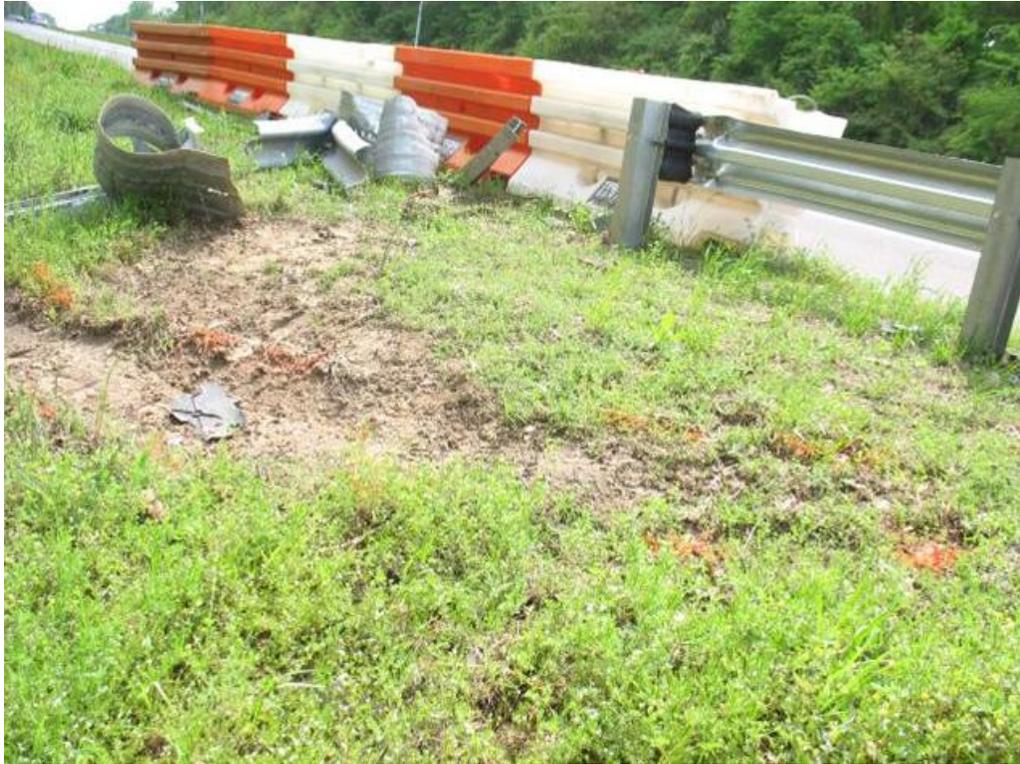
Figures 15 through 19 provide closer views of the damage to the guardrail.

Figure 15: View of temporary, orange barrier in the foreground and the damaged guardrail in the background.

Figure 16: View of the orange, temporary barrier and the parts of the damaged guardrail.

Figure 17: View of the Trinity ET-Plus end terminal that is lying to the right, separated from the rest of the "w" rail.

Figure 18: View looking back in the direction of the vehicle's approach. The diagonal striped orange and black face of the ET-Plus terminal is visible separated from the rest of the guardrail.

Figure 19: View of the backside of the guardrail showing the separated ET-Plus end terminal in the upper left of the photo.

The guardrail photos suggest a combination of damage from the impact and possible post-impact work by road maintenance personnel. The post-impact work appears to be the cutting of the damaged "w" rail as the separation appears to be too uniform to have been caused by the collision. There was no indication in the case file that explained how the guardrail damage visible in the photos was caused.

Sections of the guardrail have been flattened indicating that they passed through the end terminal which is designed to flatten the railing as a means of absorbing the collision energy. The rail's deformation and flattening are important and desirable safety features provided that it occurs in a controlled manner and does not pierce into the interior of a vehicle. Thus the system needs to be designed in such a way that deformation occurs progressively over an extended time creating a relatively constant level of negative acceleration (deceleration) of the striking vehicle.

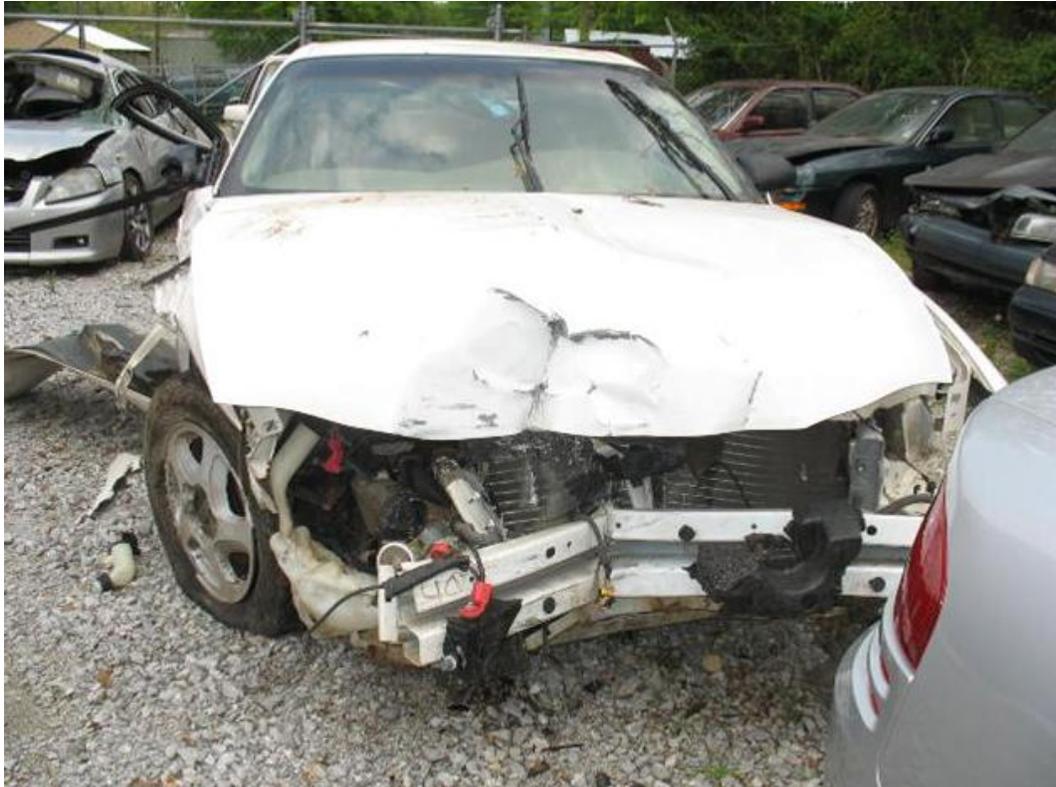
Figure 20 shows a frontal view of the 2002 Chevrolet Monte Carlo that was involved in this impact. There are two diagonal creases the front edge of the hood which delineate the location where the Trinity ET-Plus end terminal made contact.

Figure 20: Front view of Monte Carlo.

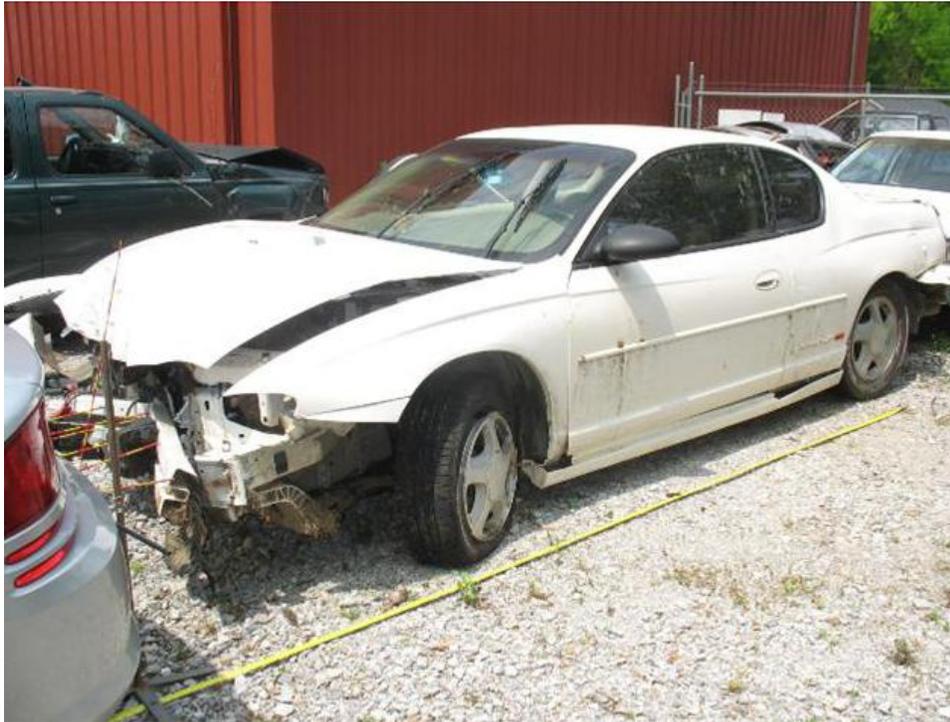
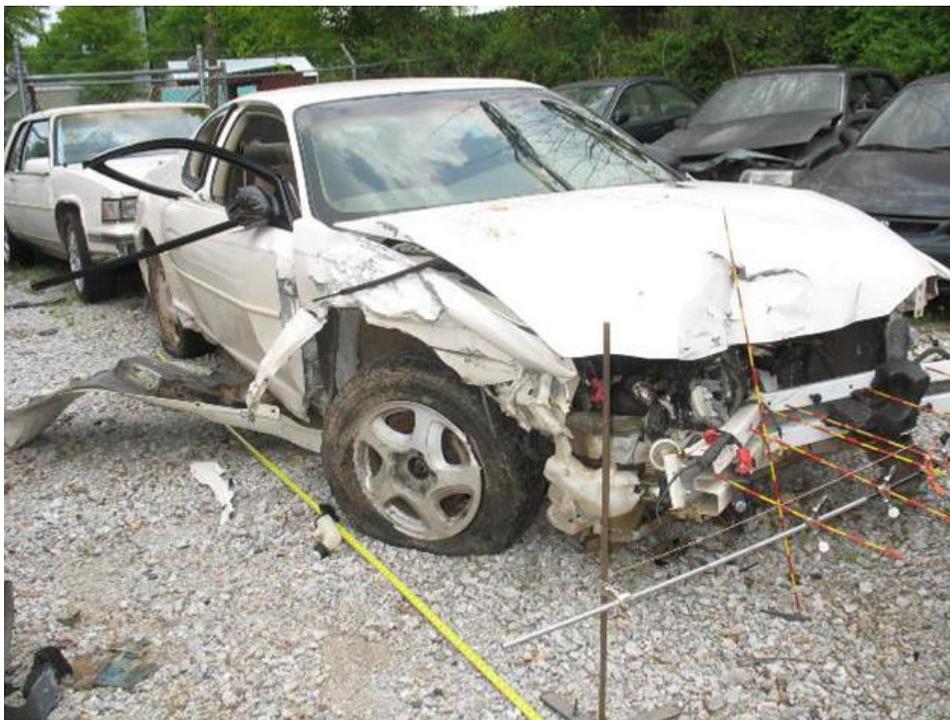
Figures 21 and 22 show that there is no other significant, direct contact damage to the sides of the vehicle.

Figure 21: Left front view of Monte Carlo.

Figure 22: Right front view of Monte Carlo.

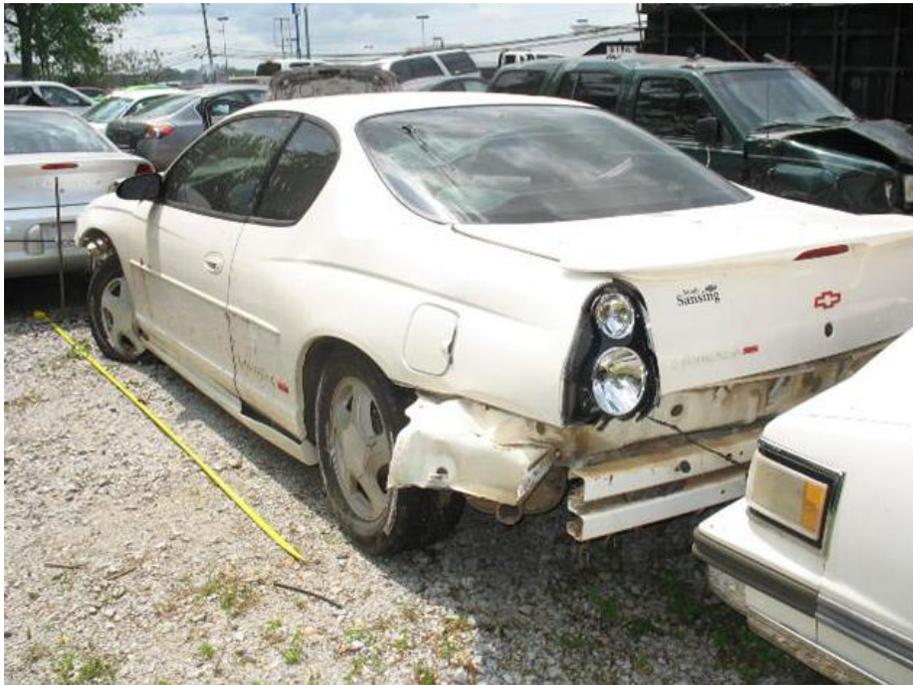
Figure 23 shows that there is minor damage to the rear of the vehicle as the cover to the rear bumper has been torn off. This would not be a threat to the safety of the vehicle occupants.

Figure 23: Left rear view of Monte Carlo.

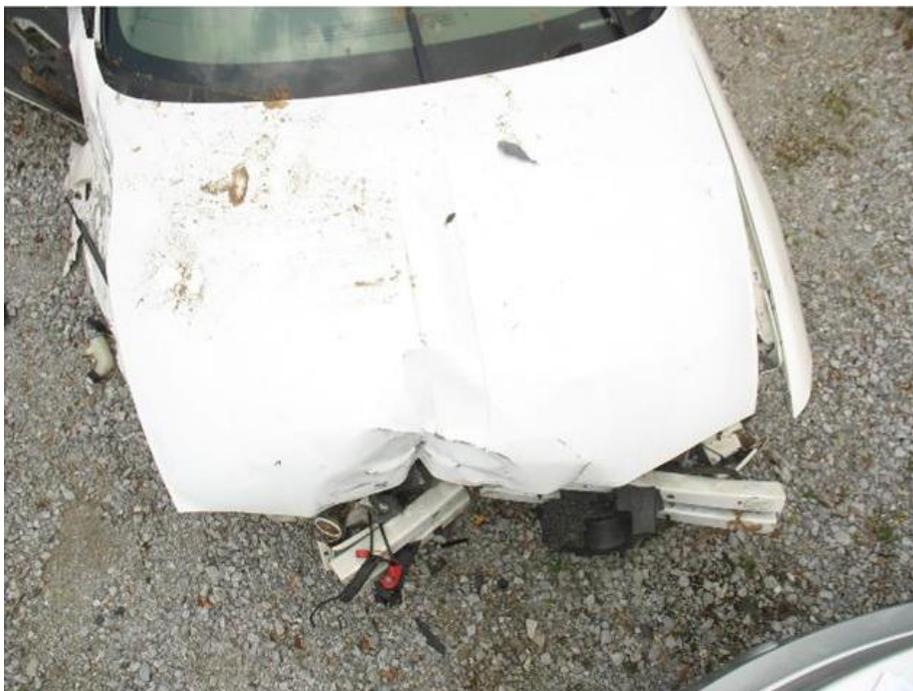
Figure 24: Top view of Monte Carlo.

The top view in Figure 24 shows the notch in the front edge of the hood which came from contact by the end plate of the ET-Plus terminal. However the damage is confined to the front end and there is essentially no deformation at the rear of the hood and windshield area. Thus this could be classified as a fairly innocuous, moderate severity impact.
