# Vague Official Explanation For OPP Police Cruiser Rollover In Lambton County - A Review of the Physical Evidence

*Posting Date: 3-October- 2013*

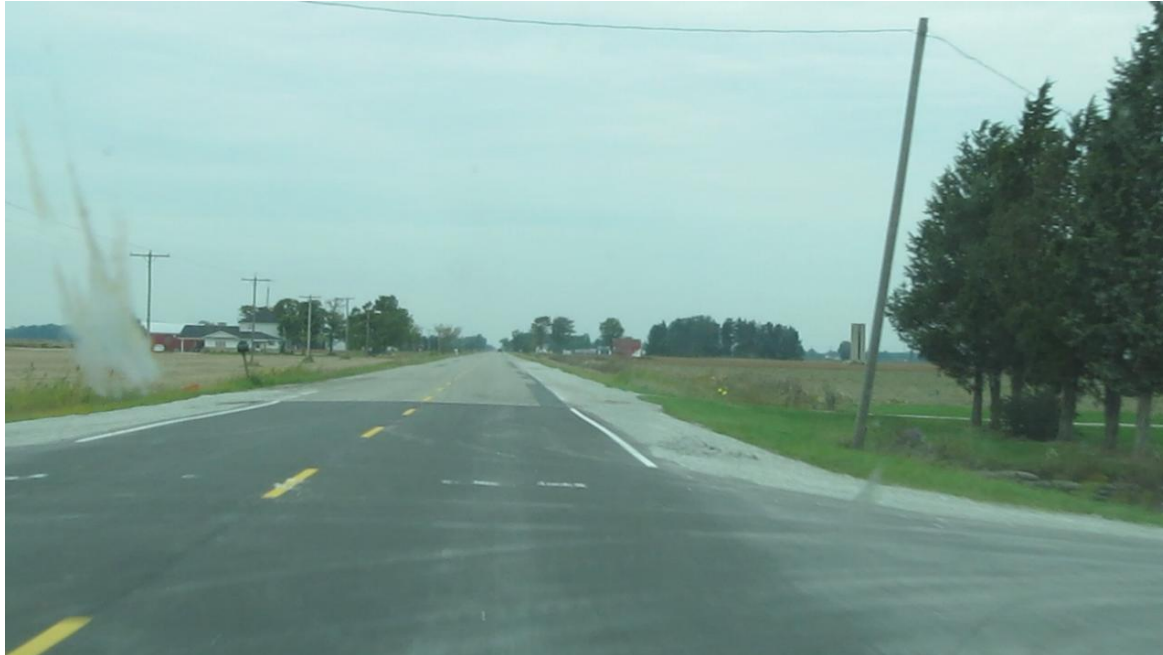
Up to the location where we crossed Black Ash Road, Courtright Line was observed to be freshly paved and the gravel on both shoulders was also new as can be seen in Figure 1.

Figure 1 - Frame exported from our video while westbound on Courtright Line at intersection with Black Ash Road.

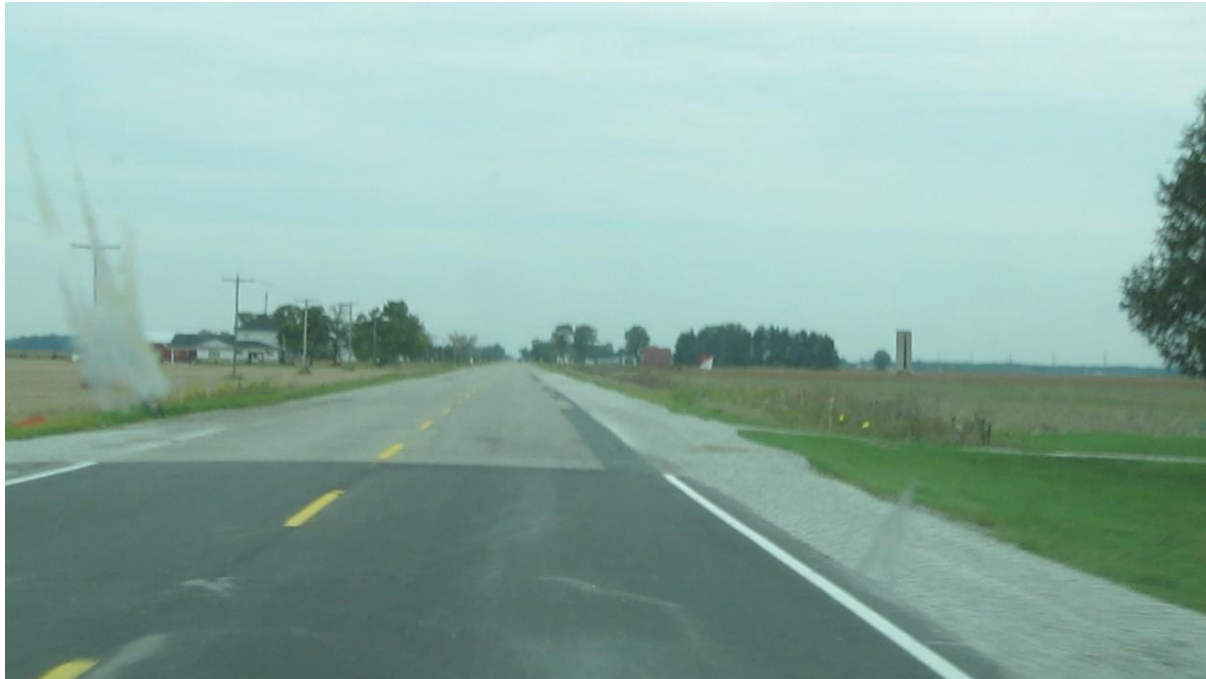
However, just beyond that intersection the new paving ended, as shown in Figure 2. As we crossed onto this older portion of pavement it became clear that there was a large difference in the road surface quality. There were significant lateral cracks in the pavement that were causing a loud "thump, thump, thump" as our vehicle crossed each of these. As an example, Figure 3 is a frame take from our video at approximately 150 metres prior to the location where we observed the loss-of-control tire marks of the police cruiser. It can be seen how the view is out of focus and this was caused by the vibration of our vehicle travelling over one of the noted lateral cracks. This is how the rest out video looked like as we passed through the accident site. There would be short periods where the video was clear and there were short bursts where the video went fuzzy as the vehicle was jolted by the interaction with the lateral cracks in the pavement.

Figure 2: View of end of new paving of Courtright Line just west of Black Ash Road.

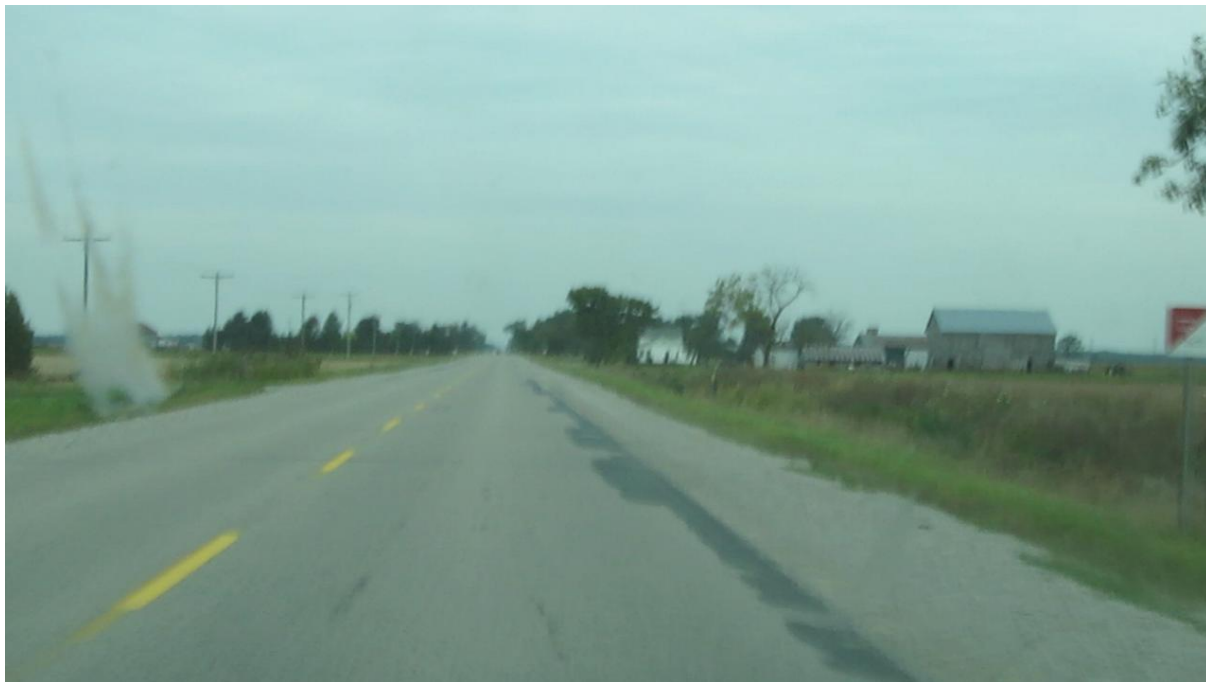
Figure 3: Out of focus view caused by the vibration of our vehicle travelling over one of the lateral cracks in the pavement.

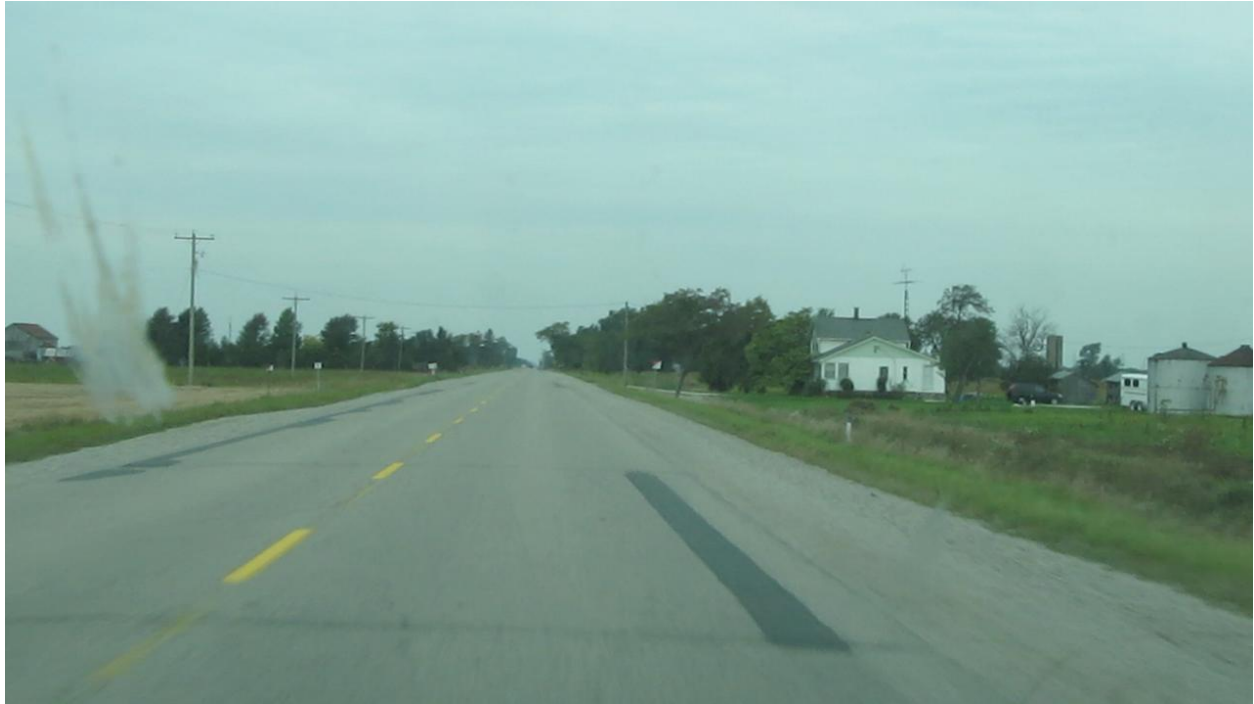
At approximately 350 metres west of Black Ash Road we observed the first evidence of the police cruiser's loss-of-control tire marks at the location shown in Figure 4. Remember that Figure 4 is taken from our video and it is not as clear as the still photos of this location that we will be showing further in this article.

Figure 4: View, looking west, from the beginning of the visible tire marks of the police cruiser.

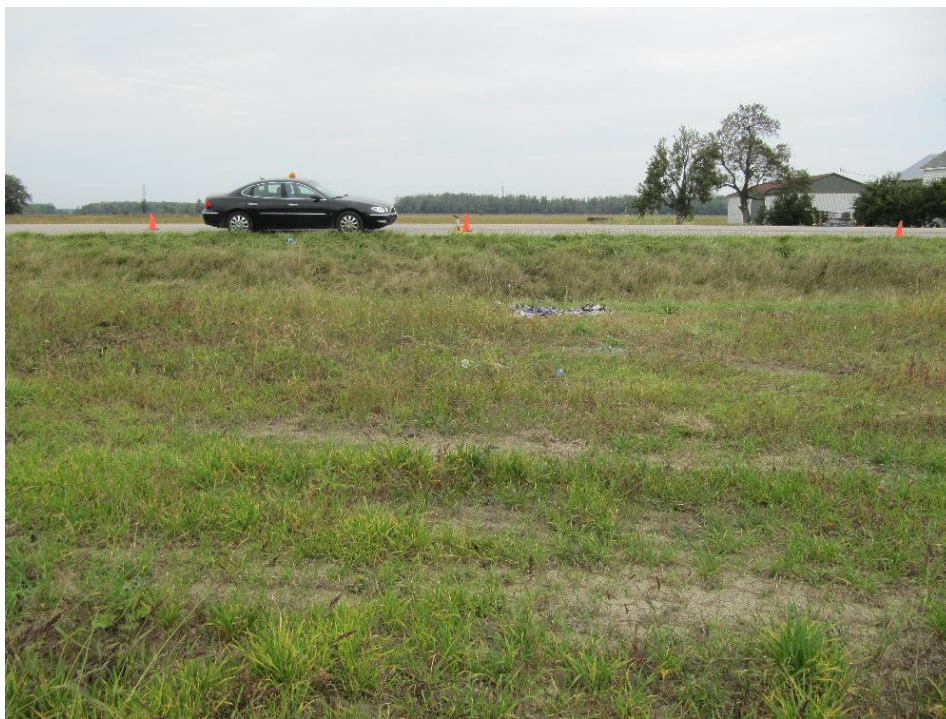
Figure 5 shows our vehicle parked on the south shoulder of Courtright Line, facing eastbound with the debris of the cruiser's FRP lying in the grass of the ditch.

Figure 5: View, looking north, at our vehicle parked on the south shoulder of Courtright Line next to the final rest position of the police cruiser.

Examination of the evidence near the vehicle's FRP indicated that it had slid sideways, leading with its right side, over a small embankment . The distance between where the rollover commenced and the vehicle's FRP was quite short, in range of 10 metres. Generally, this was a low severity rollover because of this reduced speed.

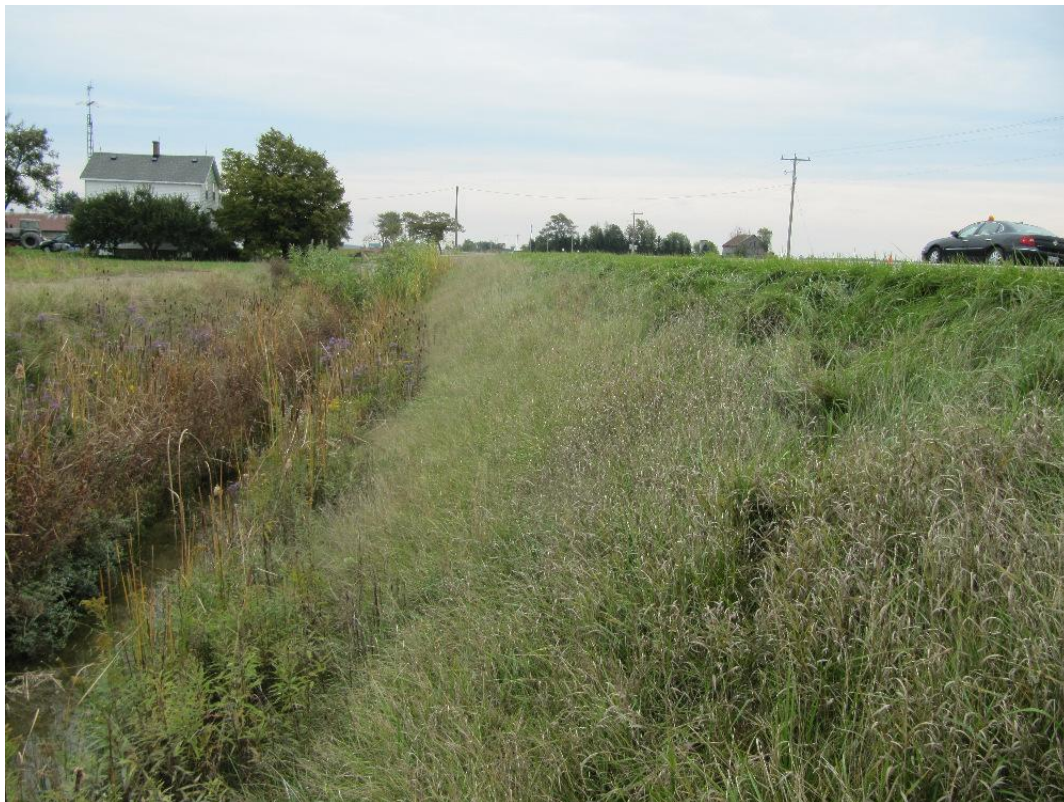
For example, Figure 6 is a view looking east along the north ditch and our parked car can be seen at the extreme upper right of the photo. Comparing the size of our car to the embankment it can be seen that this drop was well over 10 feet and the embankment is steep.

Figure 6: Eastward view of depth of north ditch and steepness of its embankment, on the opposite side of where the police cruiser came to rest.

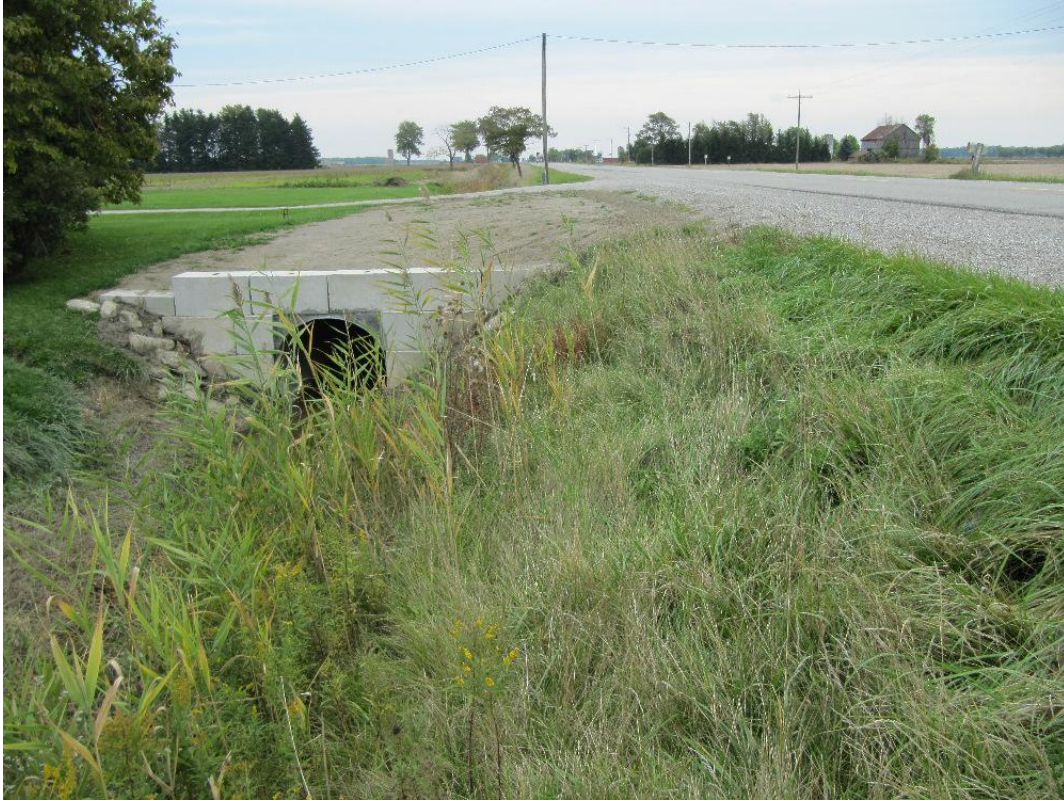
Furthermore, Figure 7 shows a culvert and that indicates the presence of water that is hidden by the tall grasses within the ditch.

Figure 7: Eastward view of north ditch and a source of standing water that is hidden by tall grasses.

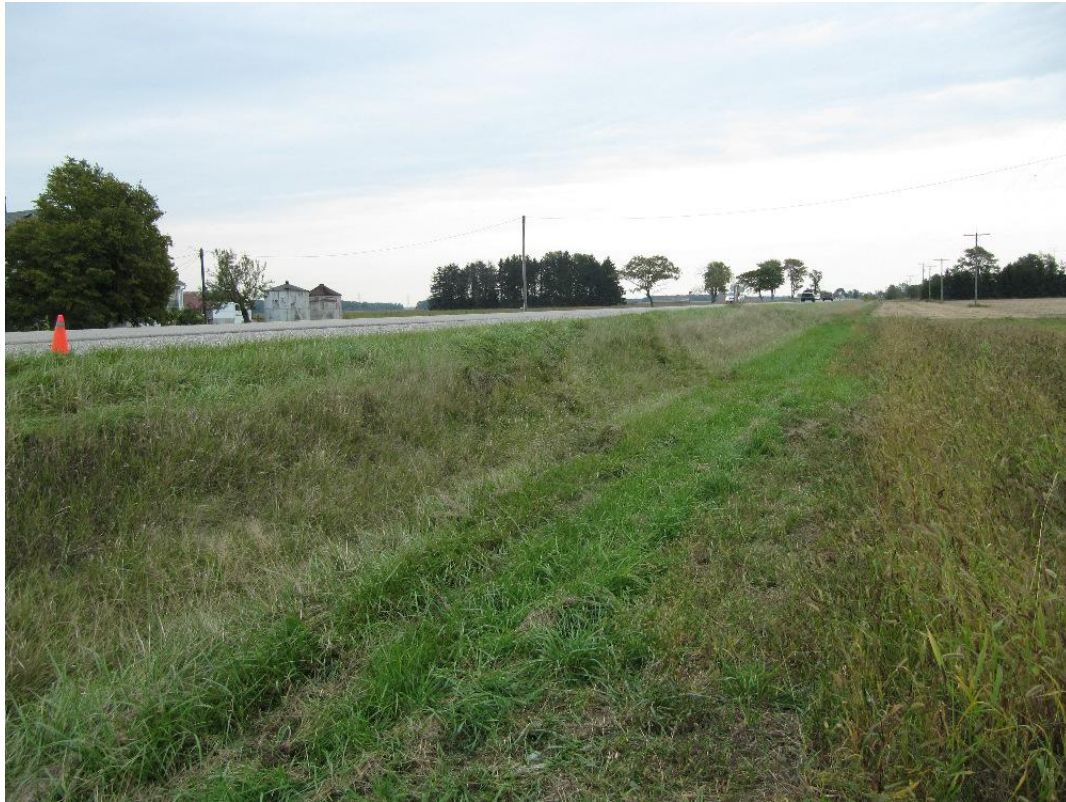
and where it commenced its loss-of-control. Figure 8 shows an easterly view from the police cruiser's FRP toward the tire marks on the south embankment indicating the location where the cruiser left the roadway.

Figure 8: View, looking east, from the final rest position of the cruiser, toward the location where it left the roadway.

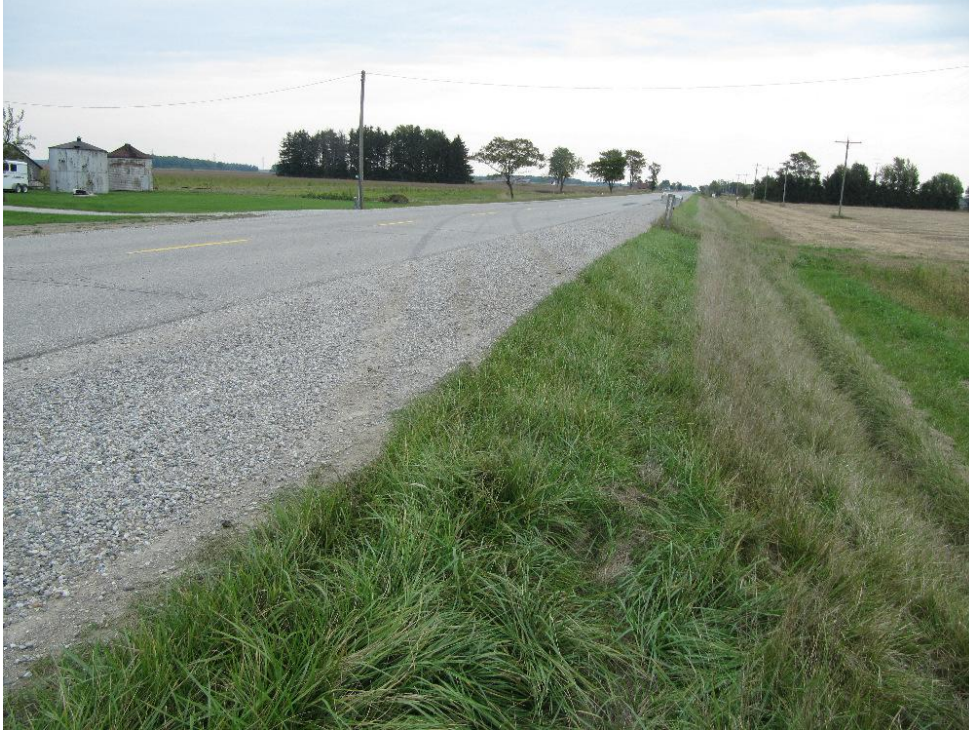
Figure 9, is an easterly view from the top of the south embankment showing the tire marks of the cruiser on the road surface as they come toward the camera and into the south ditch. Examining the relationship between the curved yaw marks one can get an appreciation of the angle of the cruiser as it exited the paved surface. Figure 10 takes us further to the east and we now have a clearer view of the yaw marks as they approach the south shoulder. We can clearly see that the cruiser was coming from the westbound lane across the eastbound lane and then down into the south ditch.

Figure 9: View, looking east, at the yaw marks of the cruiser coming toward the camera.

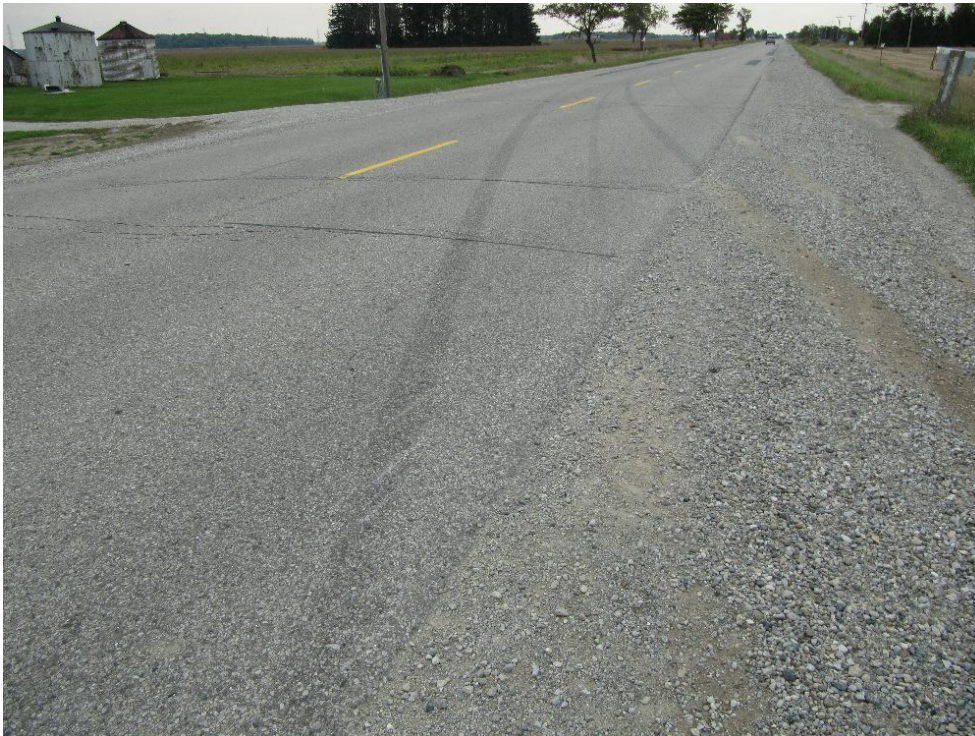
Figure 10: View, looking east, of yaw marks passing through the eastbound lane as they travel toward the south ditch behind the camera.

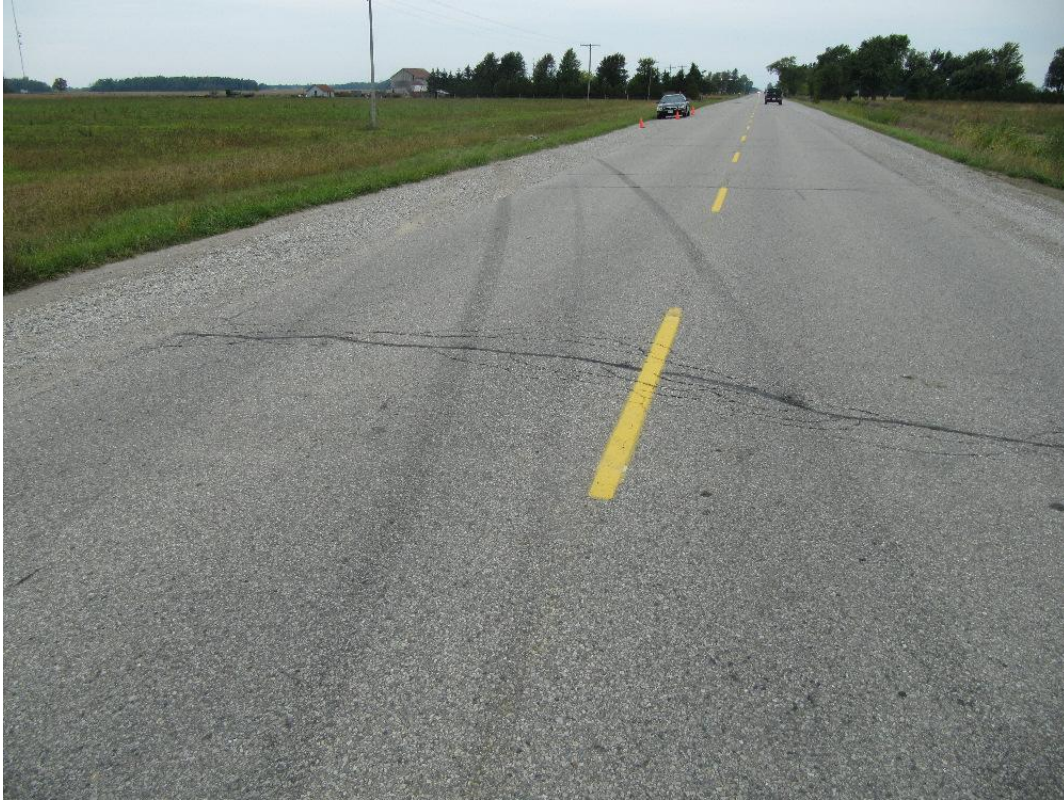
In Figure 11 we turn around to face westward and show the view of those yaw marks as they leave the westbound lane, cross the eastbound lane and travel into the south ditch. One can appreciate the distance involved by noting that our car is shown in the background and it is at the cruiser's FRP. The cruiser left the south pavement edge about 33 to 46 metres east of where it came to rest. In calculating a vehicle speed we would use a level of deceleration that takes into account the advanced stage of rotation and the fact that it made gouges in the earth during the rollover. A tumble number of 0.5 g or a value slightly less than that of 0.4 g would best approximate this level of deceleration over an average distance of about 40 metres. This would indicate that, as the vehicle was exiting the south asphalt edge, its speed would be in the general range of 67 km/h.

Figure 11: View, looking west, at the yaw marks travelling from the westbound lane, across the eastbound lane and into the south ditch.

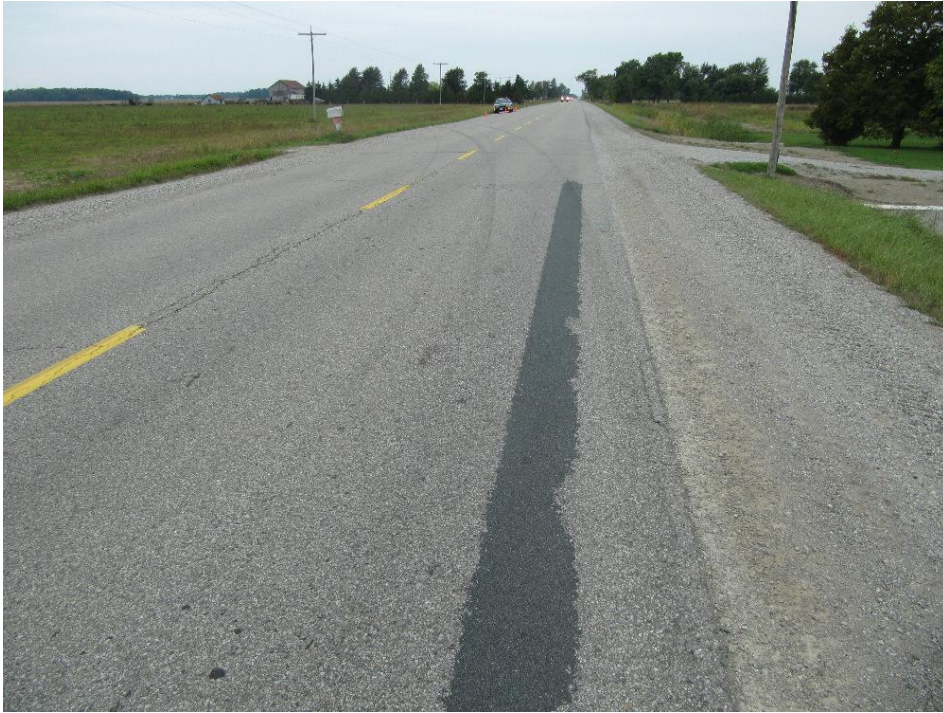
As we move further to the east and look back toward the final rest position, Figure 12 shows us what was happening to the cruiser as it was in the westbound lane. We can see how the tire mark from its right rear tire comes very close to the north edge of the asphalt before it veers across the centreline. The apex of its curved tire mark at the north asphalt edge was about 88 metres east of the cruiser's FRP. However, when we turn around to face eastward Figure 13 shows that it becomes difficult to see the tire marks in the westbound lane, mostly due to the position of the camera with respect to the position of the sun. Despite this difficulty we can state that we were capable of seeing those tire marks and we can indicate that, further to the east, the cruiser was positioned in the passing lane. Looking further to the east we could see where those yaw marks had crossed the centreline from the eastbound lane and that there were yaw marks further to the east in that eastbound lane. The location where those yaw marks crossed the centreline was about 105 metres east of the cruiser's FRP.

Figure 12: View, looking west, at the yaw marks in the westbound lane as they come close to the north asphalt edge.

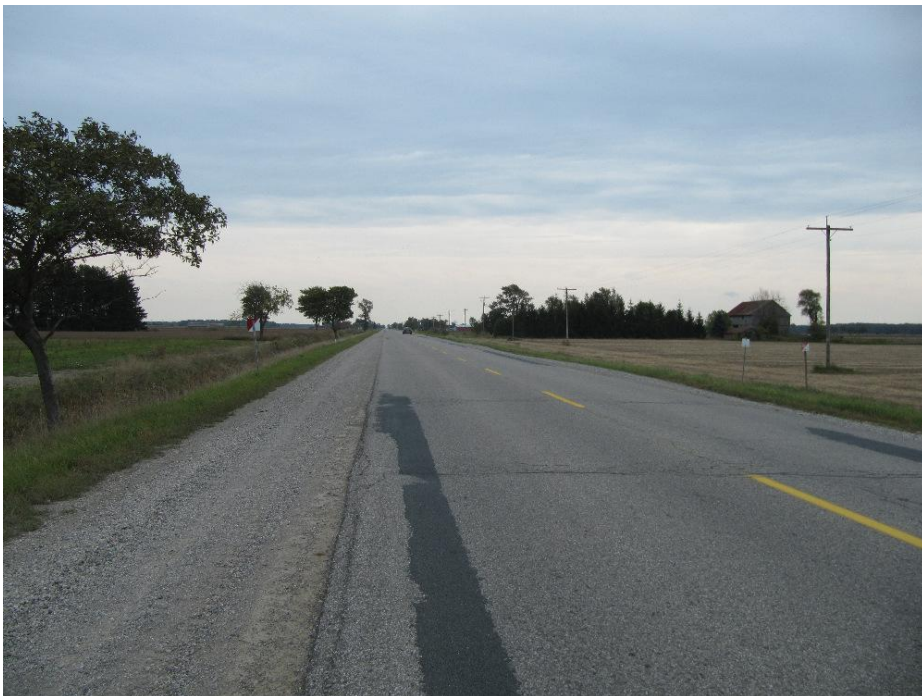
Figure 13: View, looking east, from the location where the yaw marks came close to the north asphalt edge.

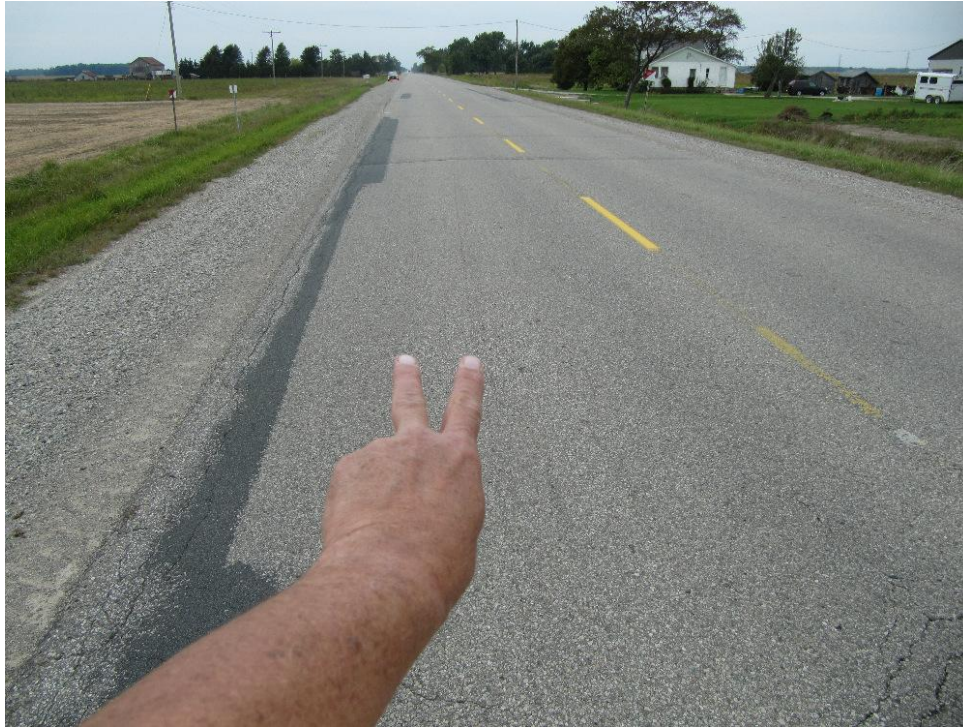
In Figure 14 we attempt to highlight the location of the yaw marks in the eastbound lane by placing two fingers of our left hand in the view at the general location of the two marks.

Figure 14 indicates that the cruiser was rotating clockwise as it was travelling toward the centre-line. Then, as the vehicle crossed that centre-line those yaw marks were not visible briefly because the rotation was transitioning from clockwise to counterclockwise as the vehicle moved into the westbound lane.

Figure 14: Westward view with investigator's fingers pointing out the two yaw marks in the eastbound lane indicating that the cruiser was rotating clockwise at this location.

The apex of the curvature of the yaw marks in the eastbound lane was about 187 metres east of the cruiser's FRP. In calculating a speed at this location we would use a deceleration rate in the range of 0.2 to 0.3 g over the distance between 40 and 187 metres or travel distance of 147 metres resulting in a speed loss of about 97 km/h. Combining this with the speed loss in the last 40 metres of travel (67 km/h) results in a speed of about 117 km/h in the general location shown in Figure 14.

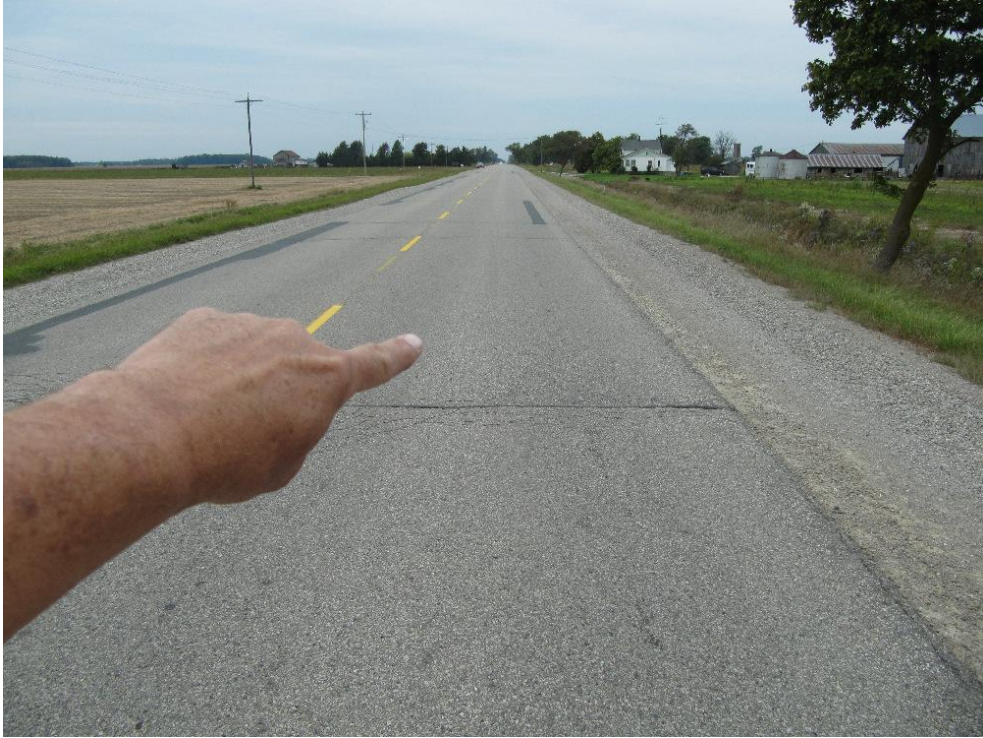
Figure 15 shows a westward view where the investigator's finger is pointing the area of the beginning of the visible yaw marks adjacent to the tree visible on the right (north) roadside. Again, the faintness of those tire marks makes it difficult to make them visible in Figure 15.

Figure 15: View, looking west, with investigator's finger pointing to the location where the cruiser's yaw marks first became visible in the westbound lane.

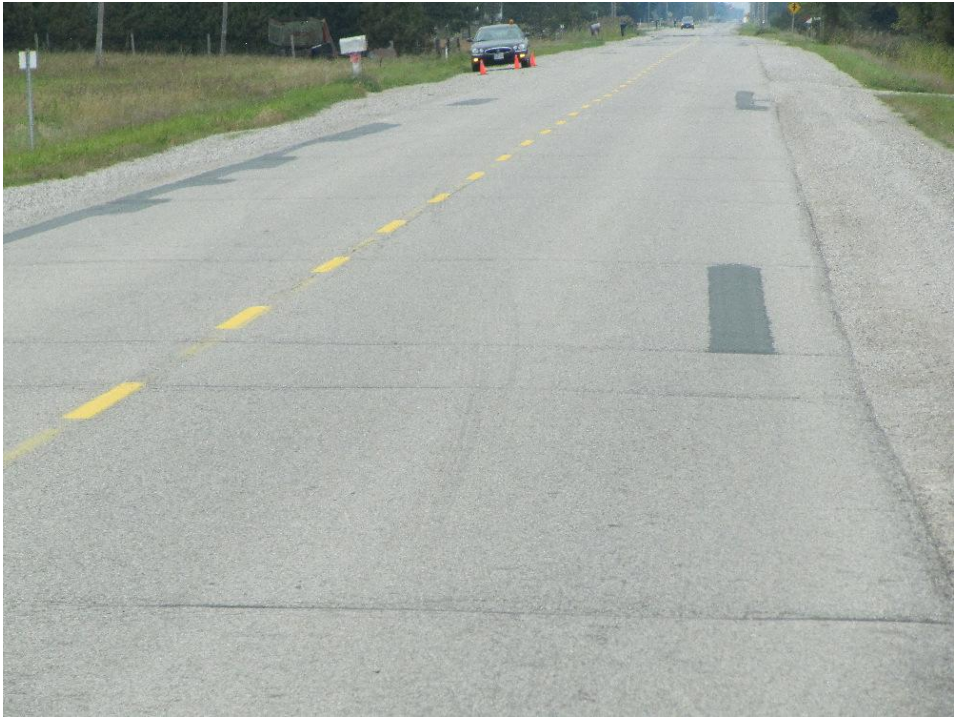
One way of making the tire marks more visible is to use a longer focal length or to "zoom in" as shown in Figure 16. This procedure compresses the objects in the distance and it compressed the dark tire marks into a small area of the view and thus making them stand out more from the rest of the road.

Figure 16: Westward view showing how a longer focal length (zooming in) causes the compression of the dark transfers from the tire marks and therefore makes them more visible.

By looking closely at Figure 16 one can detect the two faint yaw marks in the centre of the westbound lane, roughly in the middle of the Figure. We noted that those yaw marks began to be visible to us at a distance of about 218 metres east of the cruiser's FRP. Considering a speed at this location we can take the 178 metre distance between 40 and 218 metres and, using a deceleration rate of 0.25 g, estimate a speed loss of about 106 km/h. Combining that with the previously calculated speed loss of the last 40 metres (67 km/h) results in a cruiser speed of about 126 km/h at the beginning of the visible tire marks.

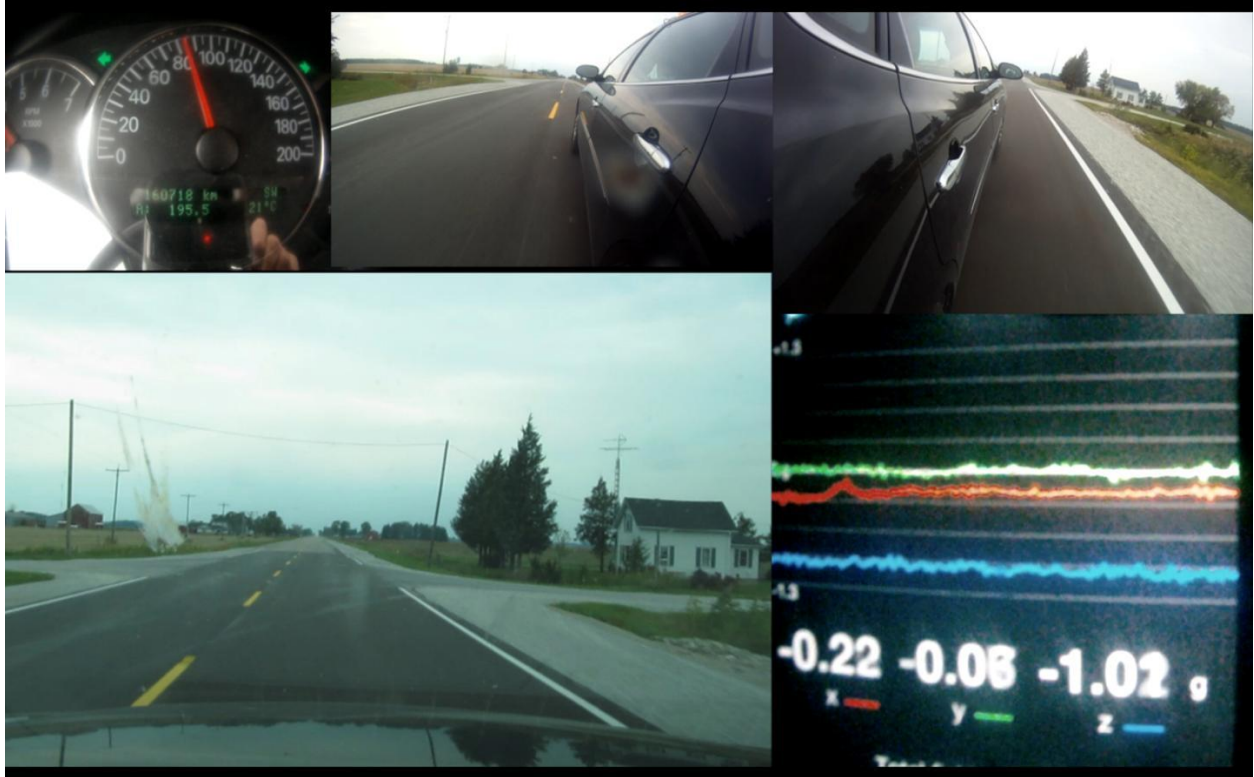
Figure 17 is a screenshot taken from the Adobe Premiere project that we created from our testing and it shows the views from five video cameras attached in our test vehicle. This instant in time is where we are accelerating westbound in preparation to conduct our test at 110 km/h. At the upper left you can see a view of the speedometer and it shows our vehicle travelling about 85 km/h at this precise instant but the vehicle is increasing speed to the target speed of 110 km/h.

Figure 17: View showing a westbound test just as the vehicle is approaching the older road surface which is located just west of the intersection of Black Ash Road.

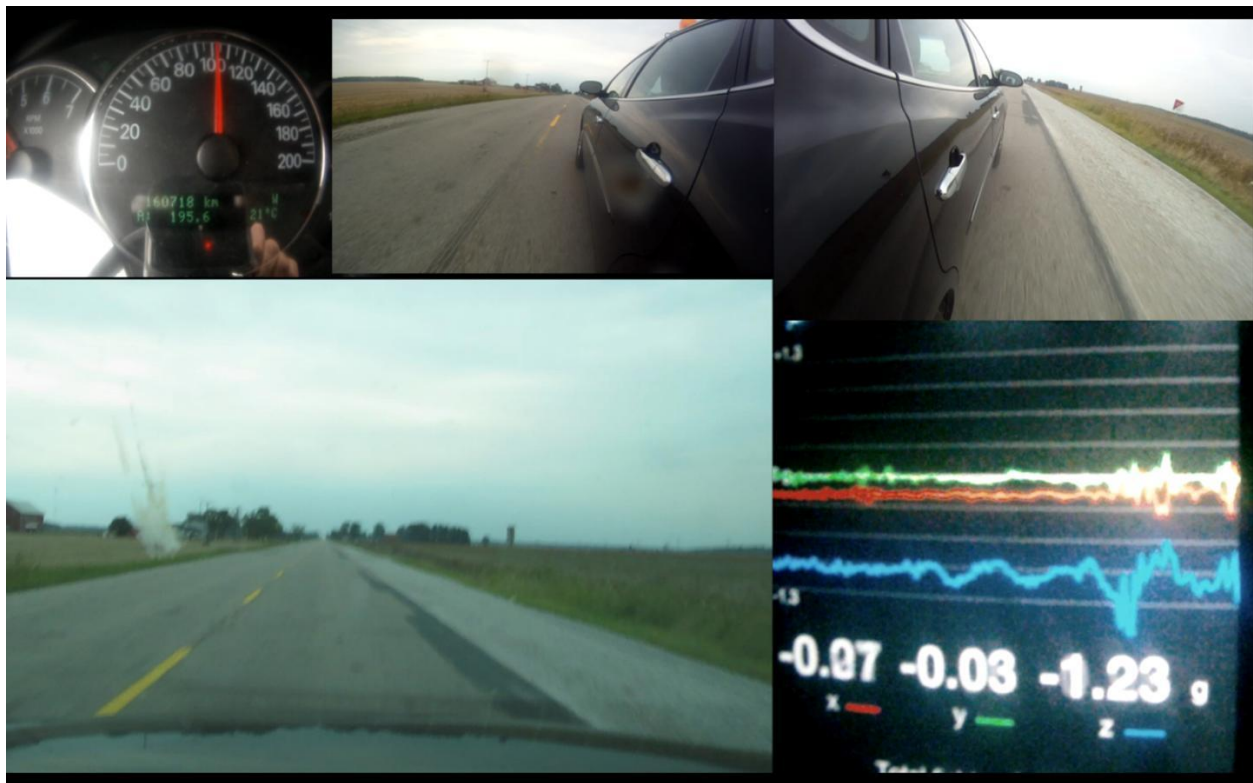
Figure 18 shows us the status just after our vehicle has travelled onto the old pavement surface just west of the intersection of Black Ash Road. The view of the speedometer indicates that the vehicle has now increased in speed to just over 100 km/h and it is still accelerating toward the desired speed of 110 km/h. But note what has happened to the relatively straight horizontal lines that are now showing some large "spikes" of acceleration, particularly in the blue line which documents the vertical acceleration.

Figure 18: View of accelerations just after the test vehicle enters the old asphalt surface.

The most recent data on the horizontal lines is at the right end of the lines. Note that the actual numerical value of the X-axis acceleration is reading "-1.23 g" at this point so the vehicle is being lifted toward the sky. You can also observe a large spike in the blue line just shortly before this and our analysis of the video indicates that this spike occurred precisely when our vehicle crossed the junction between the new and old surfaces. So, as the vehicle crossed onto the old surface it was suddenly lifted up toward the sky, relatively speaking.

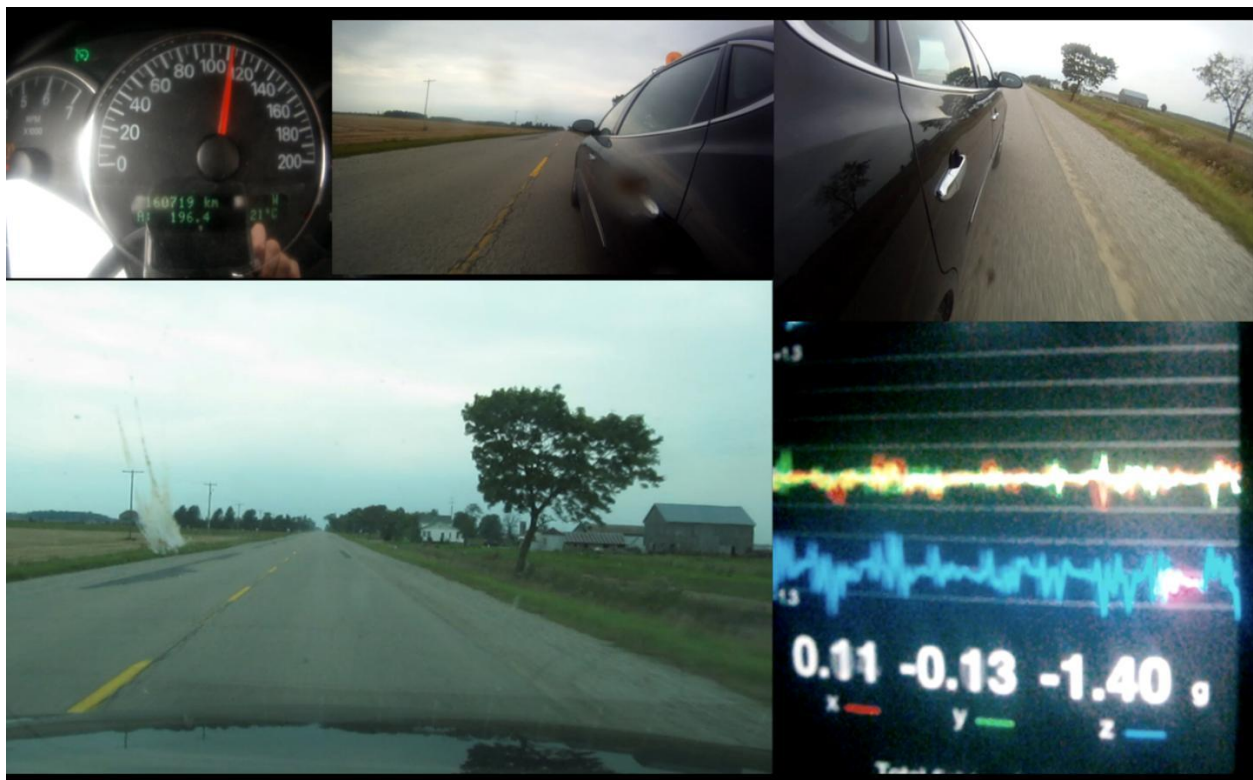
Figure 19 shows the status as the test vehicle is approaching the tree where the cruiser's yaw marks first became visible. Looking at the view of the speedometer one can note that the vehicle is travelling at approximately the desired speed of 110 km/h. The spikes in all three horizontal lines are significant. The value of the forward acceleration at this precise instant in time is "0.11" and this value is expected to fluctuate up and down. Similarly, the lateral acceleration is "-0.13" indicating that there is a substantial lateral force. The value for the vertical acceleration is "-1.40" which is a very high spike, but then, this is just a single data point and the individual values are expected to spike up and down. But it indicates that there are large spikes occurring in this vertical acceleration.

Figure 19: View of the test vehicle approaching the area where the first visible yaw marks of the cruiser were found.
