Viper Rollover On Hwy 402 Results in Fatal Injuries to Driver

Posting Date: 29 Nov 2010

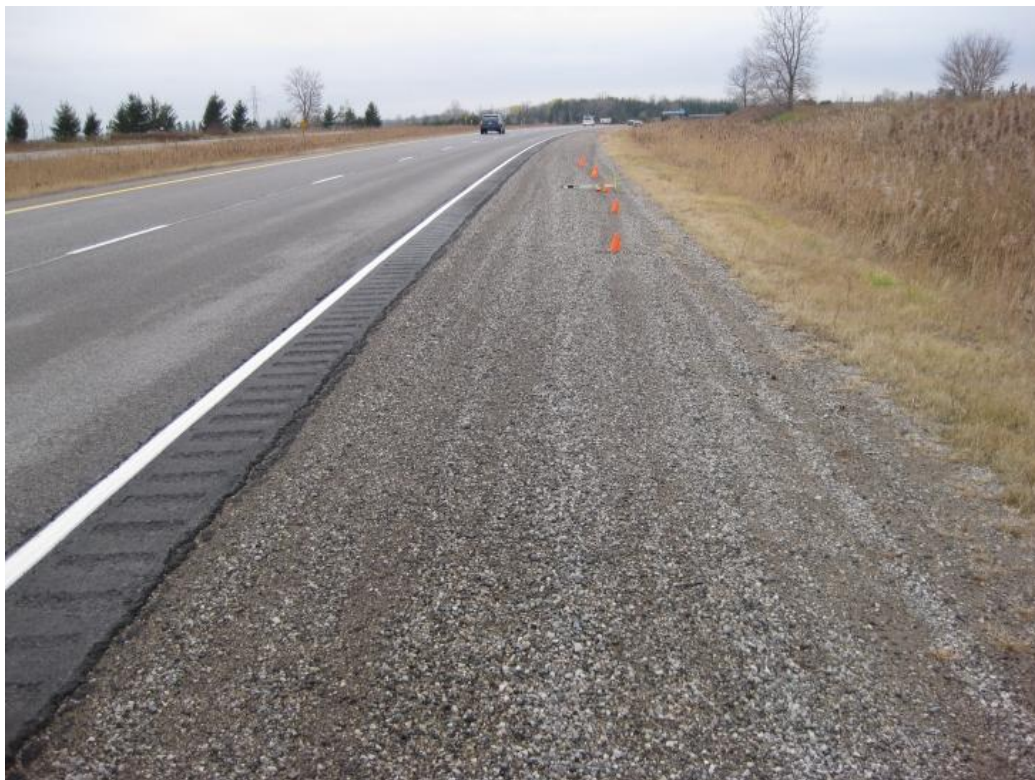
The view below is taken looking westbound from the north shoulder of Highway 402.

The small cones that I placed in the arced fashion is an attempt to delineate a set of tire marks that I felt could be related to the collision. There are a set of more-prominent tire marks on the shoulder in the distant background where the Viper's path off the road is quite clear. But here in the foreground it would appear that a vehicle may have rotated

counter-clockwise on the shoulder and then the driver over-corrected causing the vehicle to rotate clock-wise partially back onto the road and then off the road. You can see in the above photo that I have laid down a carpenter's level and my usual technique of placing a tape measure to document the slope shoulder. A close-up view of the measurement is shown in the photo below.

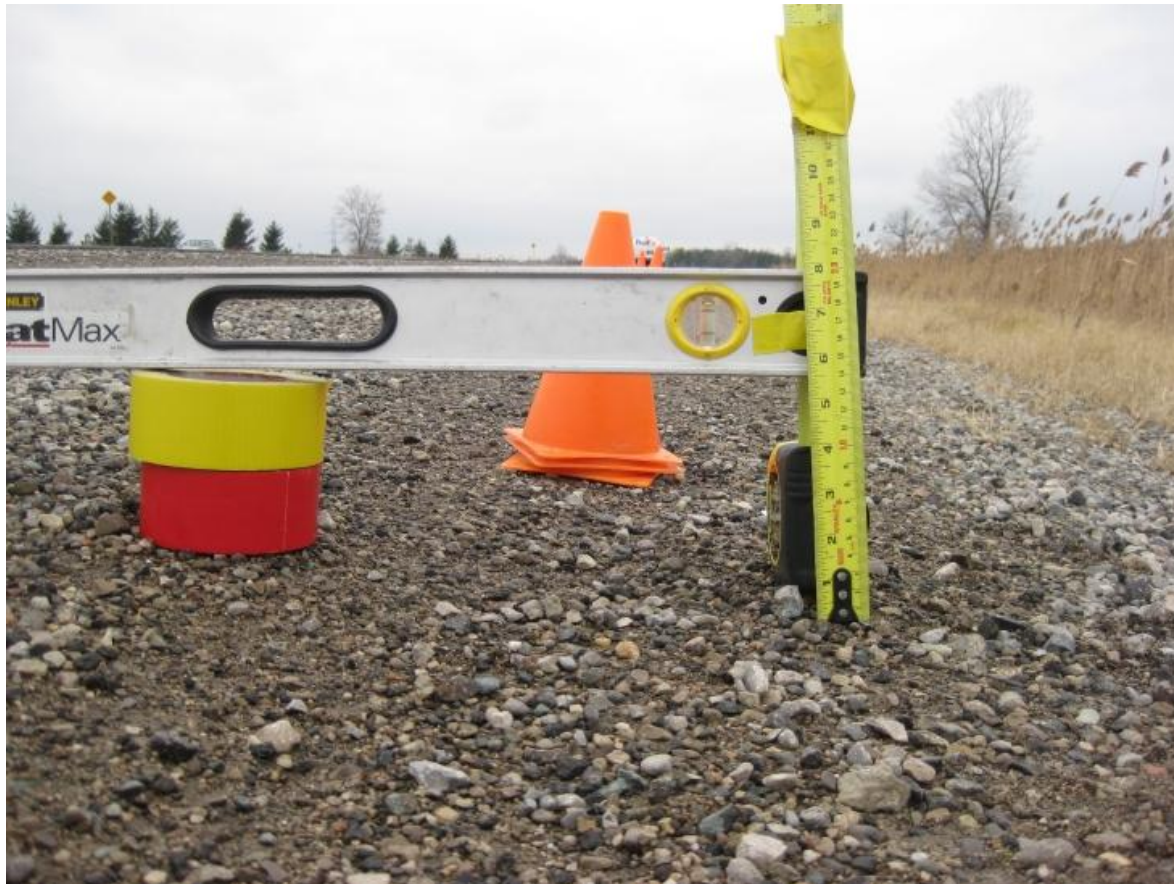
This The slope was about 11.5 % which is well beyond the typical value of 4 to 6%. One must consider however that this is a high speed highway and we are in a right curve so the designers of the road would be placing a higher cross-slope in the road to allow vehicles to pass through the curve with greater ease. Yet, while searching for this site I travelled onto the shoulder several times and observed that even at 60 km/h I was in jeopardy of losing directional control. Something to think about when you are on one of these highways and decide to pull over.

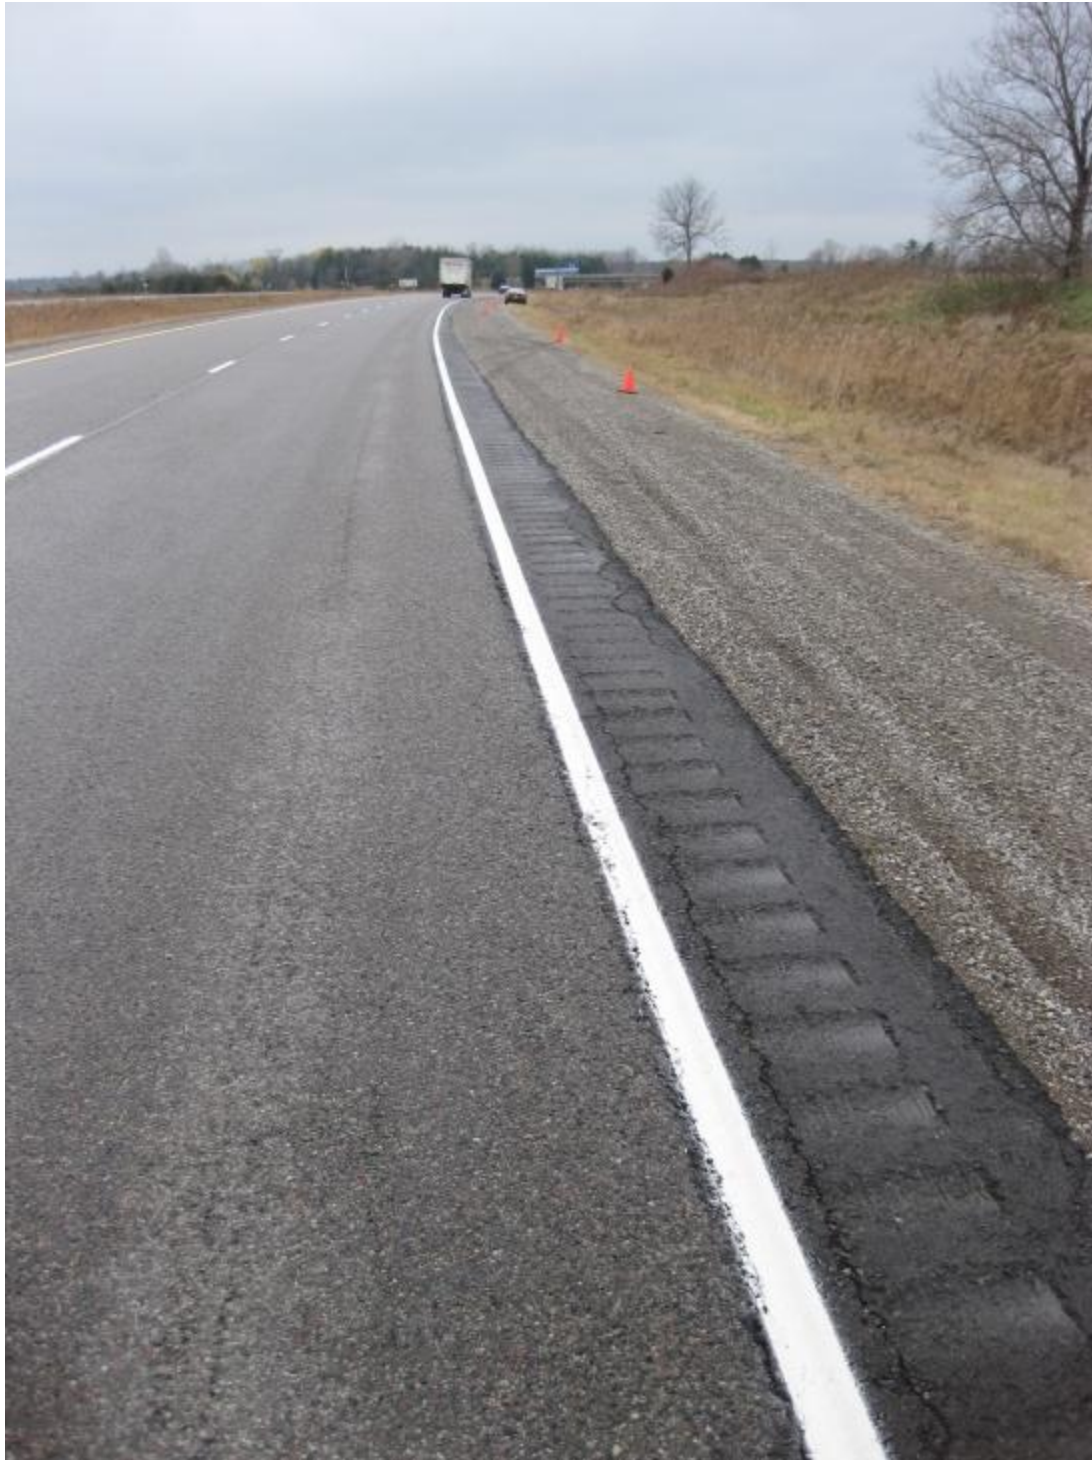
The actual tire marks that show the Viper travelling off the road are shown in the photo below.

The closest cone was placed off-set to the north from the beginning of the tire mark caused by the right front tire because if I placed the cone at the asphalt edge it would be blown away by the wind gusts caused by passing trucks.

The second cone indicates the crossing point between the left front and right rear tires and such evidence is pretty standard in loss-of-control collisions. Notating where this

crossing point exists enables the investigator to compare this collision to many others since this crossing point is approximately where the vehicle's pointing angle is about 30 degrees to the right of its travel path. Think of a vehicle's beginning to rotate out of control and picture, as it rotates clock-wise, how the path of the right rear tire eventually crosses over the path of the left front tire - this is the crossing point that I am showing in the above photo.

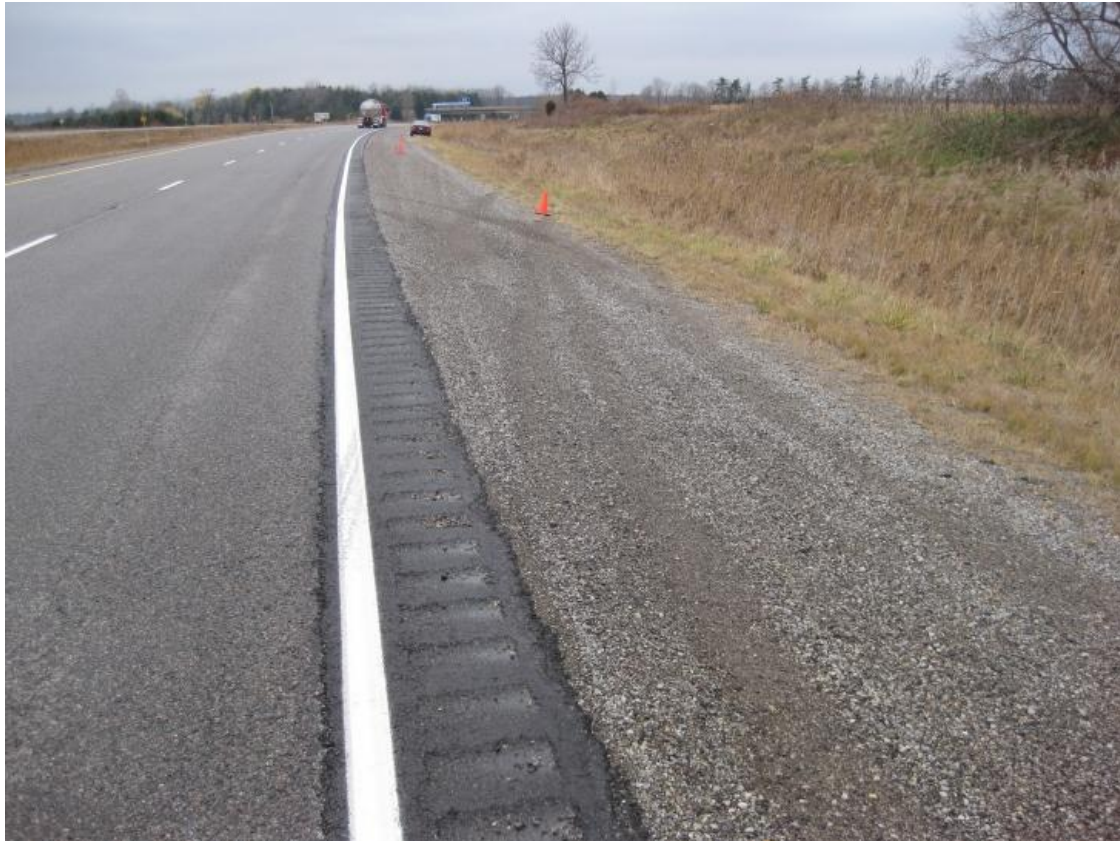
That crossing point may be a little more clear in the photo below as we see the cone in the foreground placed at that crossing point.

The two cones in the background are just there to warn drivers that my car is present on the shoulder and they do not reference any collision evidence. The position of my car is adjacent to the final rest position of the Viper which ended up against a small embankment near the fence line in the background.

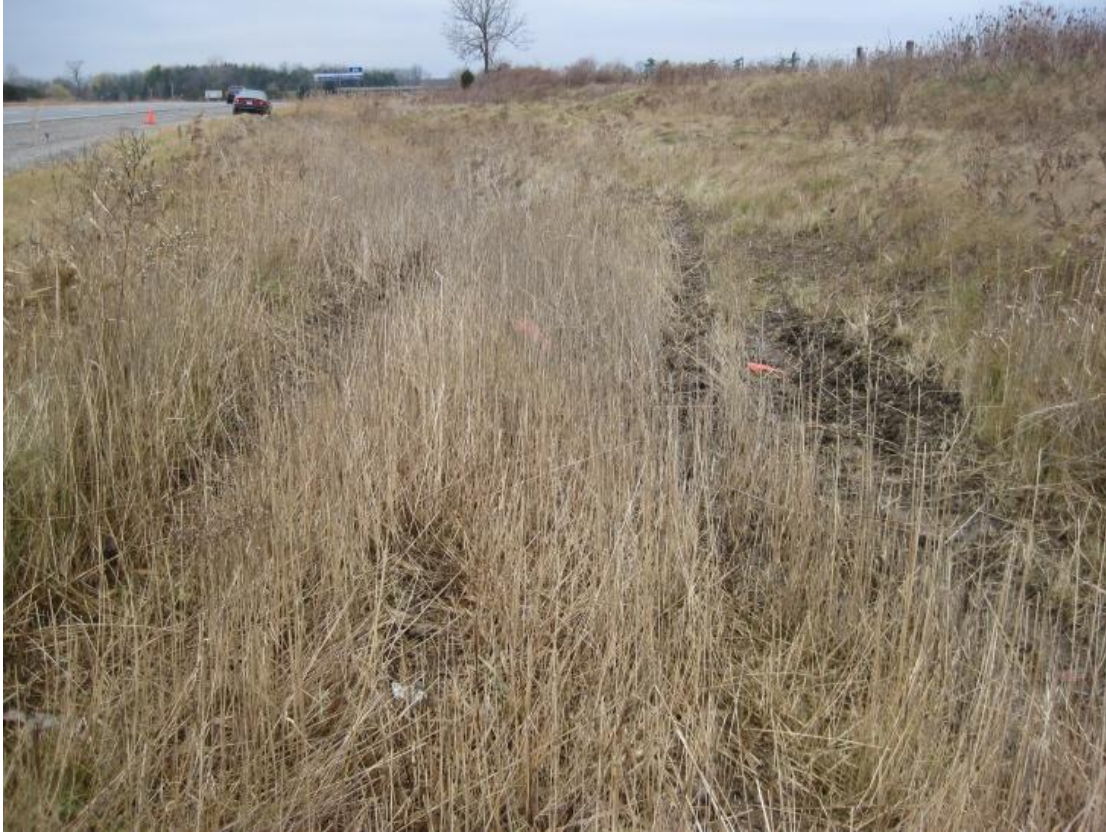
The photo below shows the location where the Viper travelled through the ditch and the contact of its under-carriage caused it to be vaulted in the air for a distance about 28 metres. Upon landing it then travelled an additional distance of 33 metres to where it came to rest.

From an investigative viewpoint it is useful to take several distances to enable the comparison of this collision to others. For example, we might want to know the distance from when the vehicle made its last exit from the road to where it came to rest. This distance was about 114 metres. We might also want to know what distance it travelled laterally from the north asphalt edge to its rest position. That lateral (northward) distance was 20.8 metres.

From these distances of 114 metres along the road and 20.8 metres perpendicular to the road we have a general angle of travel of about 10 degrees. Similar measurements on the north shoulder, where the vehicle initially left the roadway, led to a calculated departure angle of about 8.5 degrees. This is fairly typical that the initial departure angle will be shallower than the travel angle of the vehicle further in its path toward final rest. The 8.5 degrees tells us that the driver of this vehicle likely did not fall asleep as a departure angle in the range of 1 to 4 degrees would be expected from such a cause. This is how we use travel distances and angles to compare one loss-of-control event to another.
