Was Speed The Primary Factor That Led To The Fatal Injuries of Matthew Hartle?

Posting Date: 16 May 2012

Gorski Consulting
London, Ontario, Canada

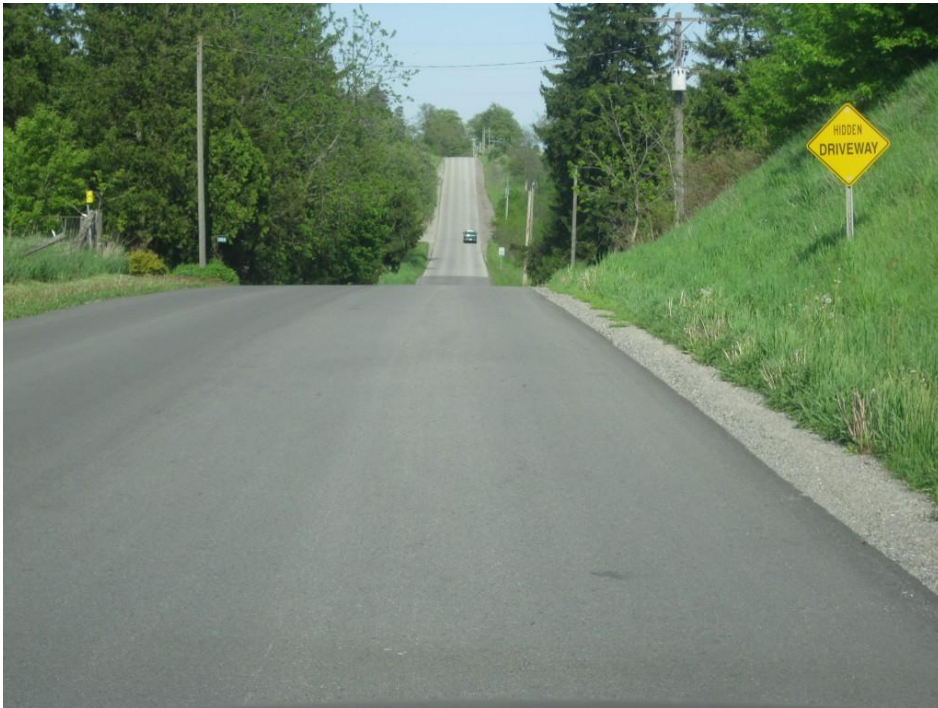
Also there are warning signs posted on the roadside such as shown in the bottom photo on the following page. Such a warning sign is common on many rural roads but is does not

provide any particular warning that a driver should be travelling substantially slower than one would normally travel on a rural road.

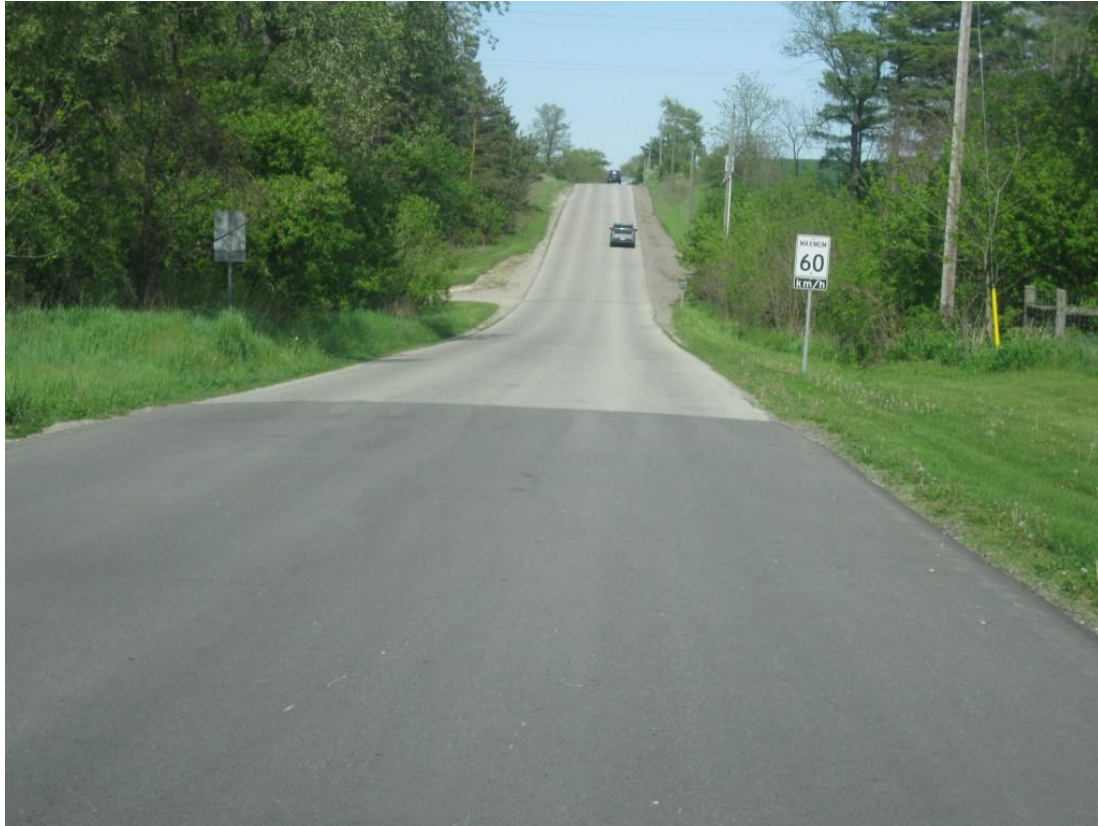
But the visibility issue causes the roadway authority to post a reduced maximum speed of 60 km/h as shown in the top photo on the following page.

The impact of the tree occurred just beyond the upgrade that you see in the background of the bottom photo on the following page. So one would think that the regulatory sign would have been sufficient warning for a driver to follow that advice. But that is rarely the case. It is human nature for a large number of us to ignore advice and laws if we do not understand the meaning or reasoning for them. This was confirmed to us, once again, while standing at this site just beyond the hillcrest and watching the speed of vehicles passing us. Rarely did any vehicle travel below the speed limit even though we had our vehicle on the roadside with our flashing yellow beacon and orange cones laid out along the road edge.

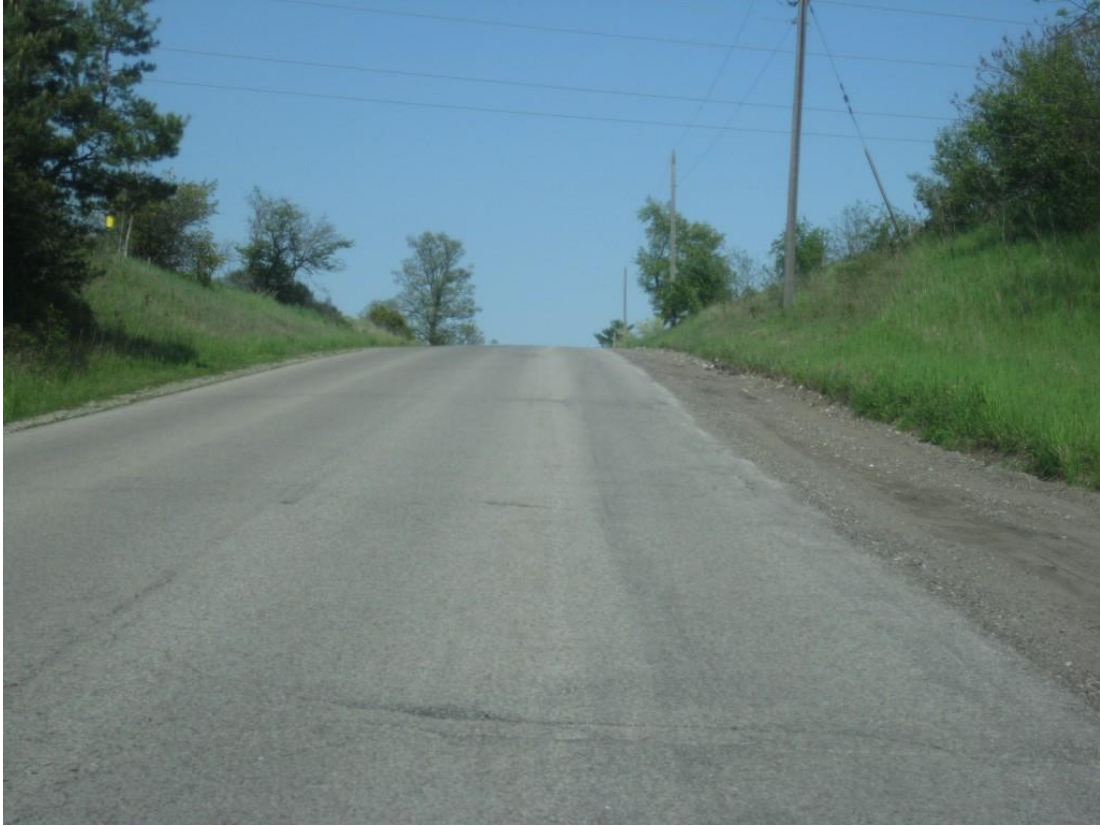
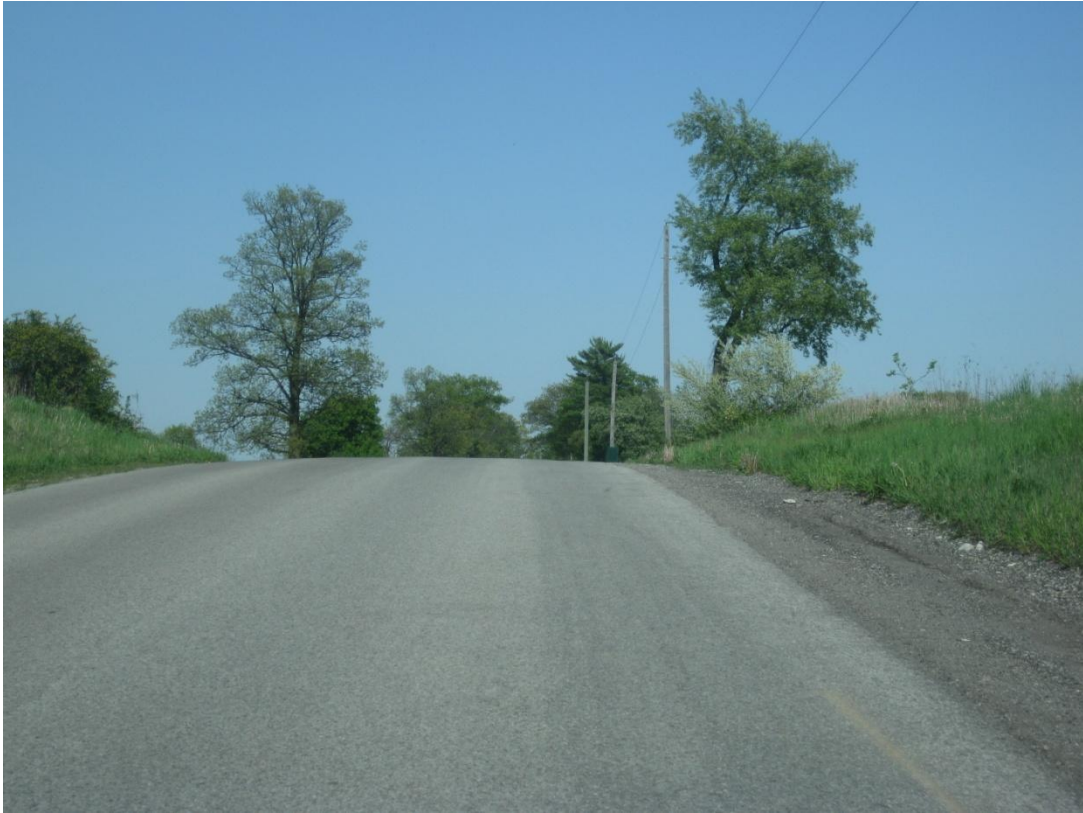
At the present site, an eastbound driver exiting the sag now begins to see less distance of roadway ahead and cannot judge what danger may lie there, as shown in the two photos on the following page. Yet the roadway ahead appears to be straight and there are no warning signs to tell the driver otherwise.

In fact we can look at the above photos and even at the photos at the crest of hill and we would believe that there was nothing to be concerned about. Because the two photos above were taken from a camera mounted in the centre of our test vehicle, a 2007 Buick Allure. And the photo below was also taken from that same camera location and we have now come to the crest of the hill. Can you honestly say, upon first viewing of the photo below, that you recognize a dangerous situation? And what would a typical driver detect, travelling through this site, at an "incredibly high" speed of just 80 km/h or even 90 km/h?

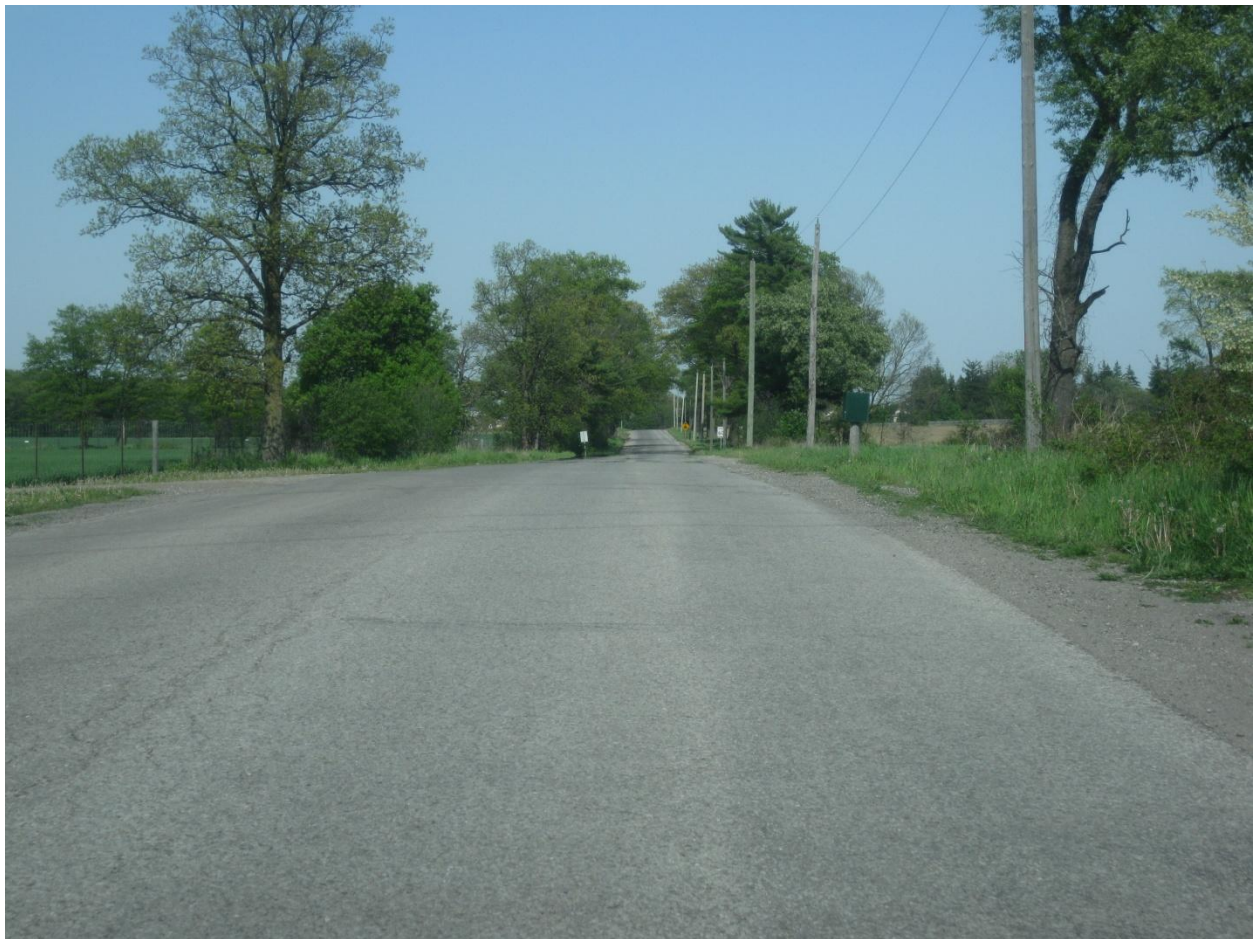
We venture to say that there is nothing in the above photo that would attract a typical driver's attention and that the reader would also not detect a problem.

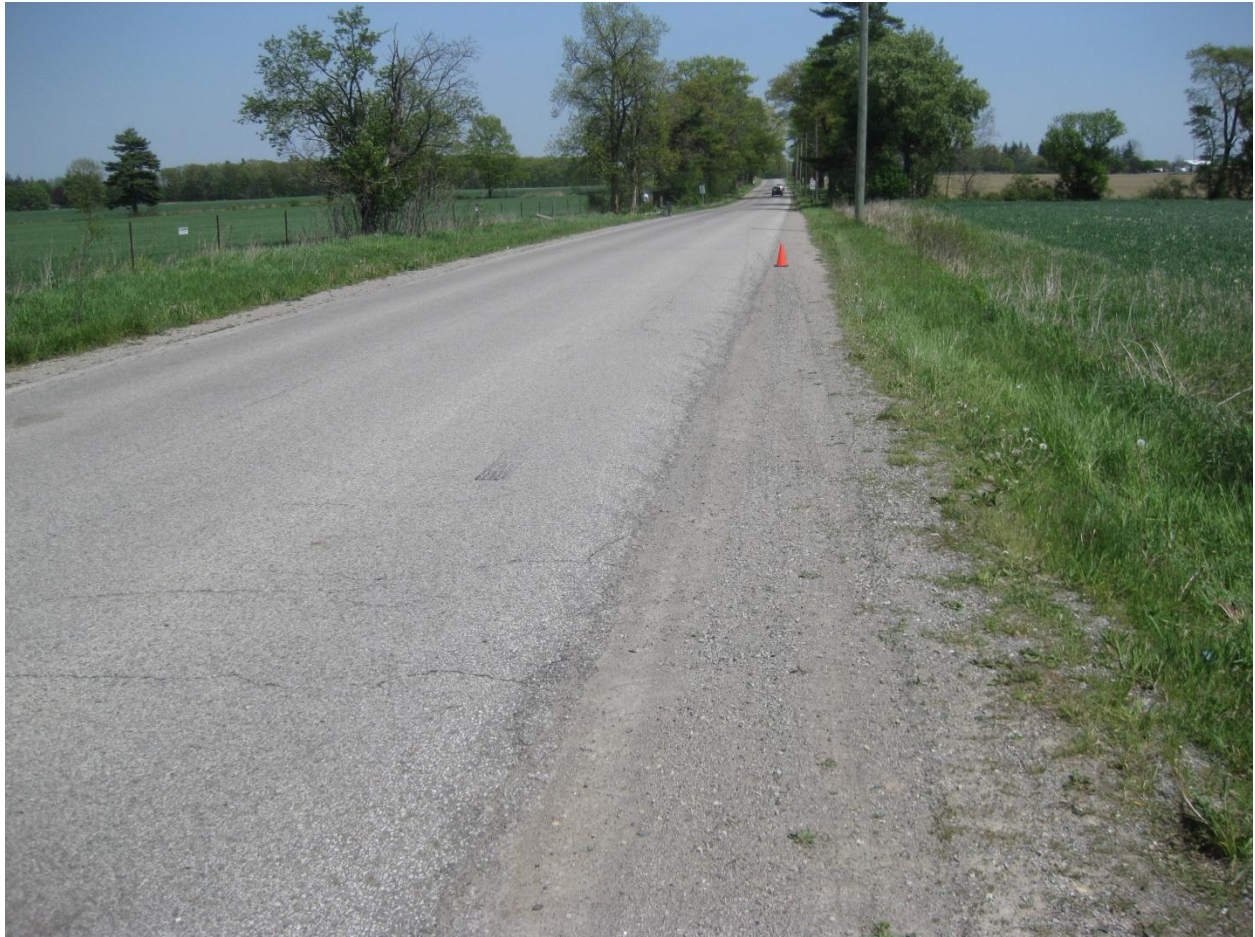
When we uncompress the view it shows up as per the photo on Page 12. The Hartle Mitsubishi travelled onto the right gravel shoulder and produced some typical yaw marks before it crashed into the tree on the opposite side of the road. The last cone (most easterly) is in view in the photo and it represents the point at which the yaw marks exited the south shoulder and began coming back on the road surface as the vehicle travelled toward the tree. If you look very closely you might be able to

detect those yaw marks on the gravel of the shoulder but that would be quite difficult.

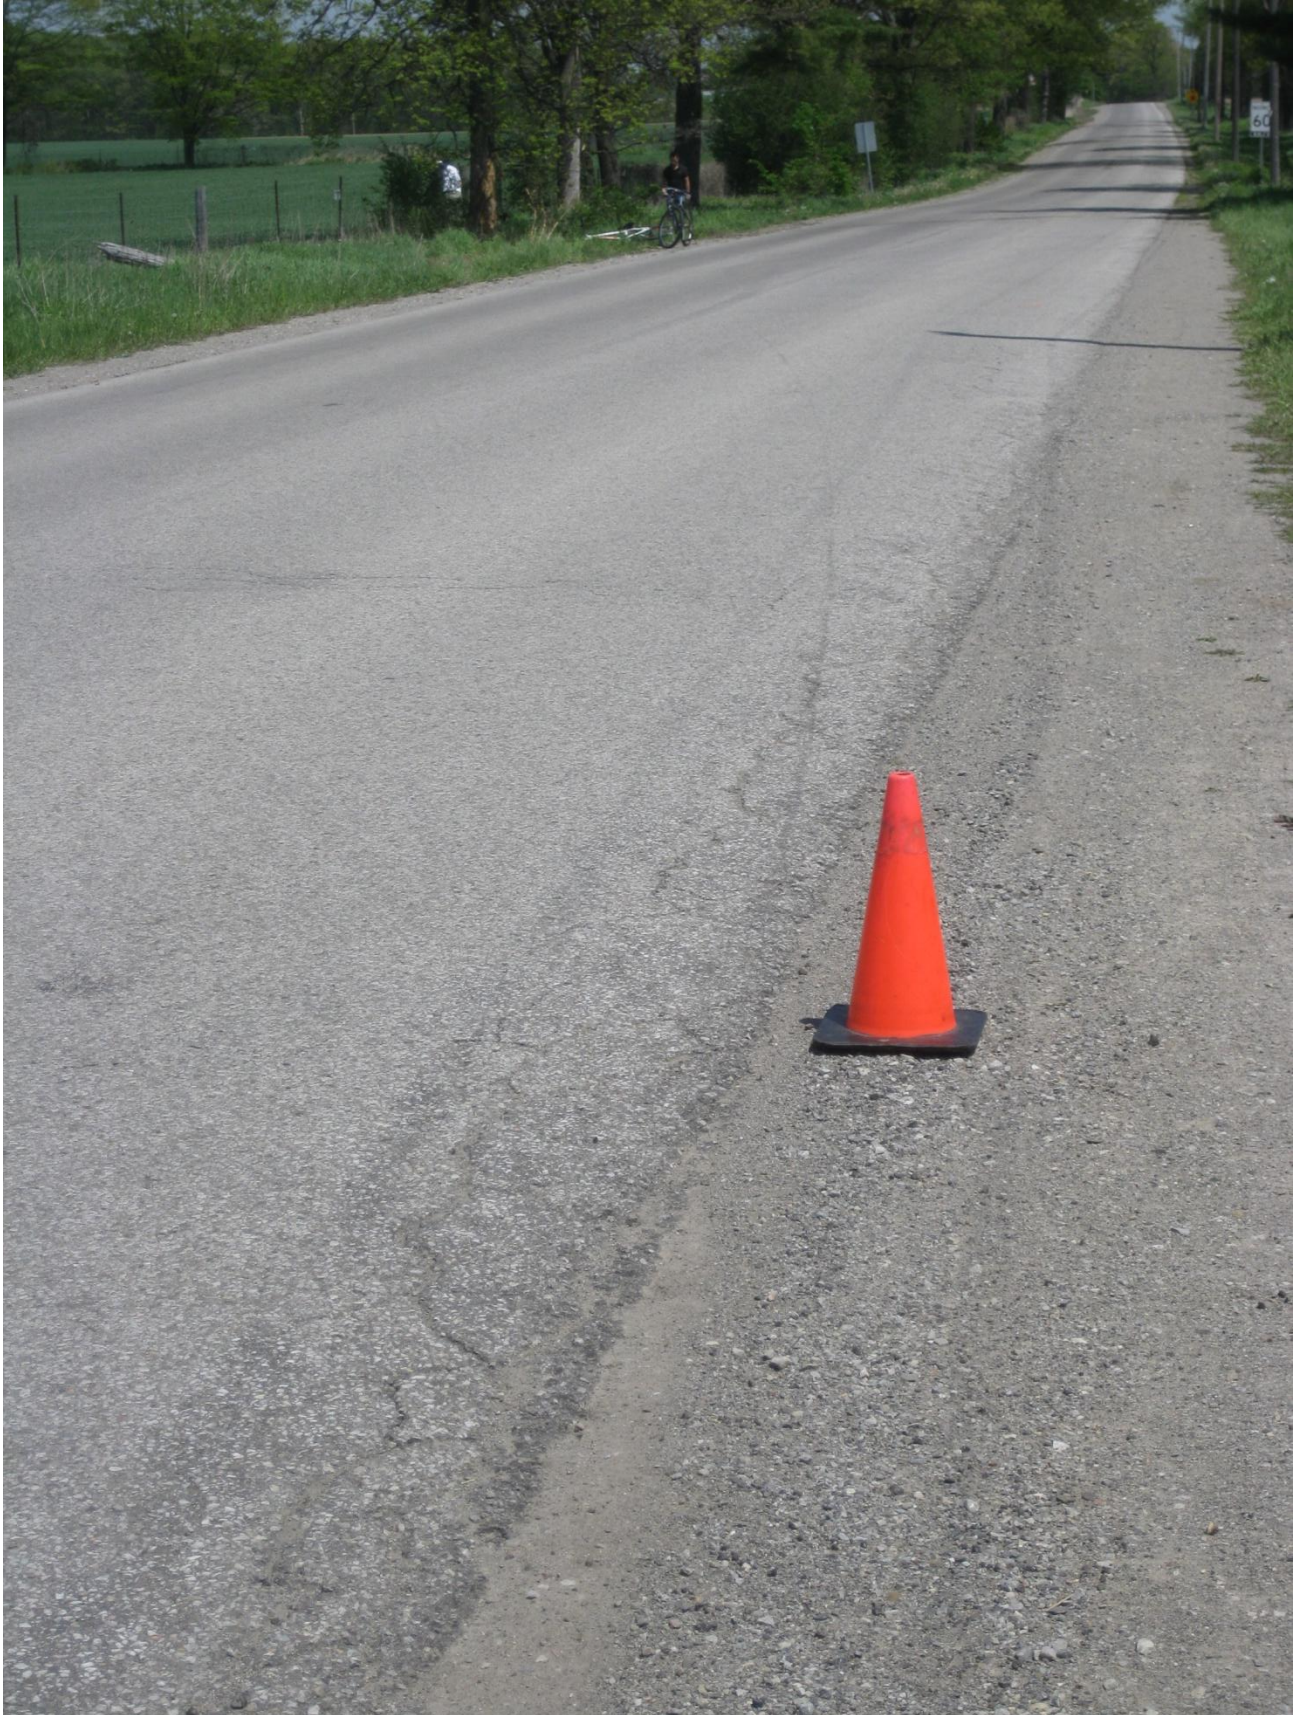
Instead, we can stand just west of that cone and see the eastbound view as shown on the following page. From this position you should clearly be able to see the curving yaw marks on the pavement as they exit from the south shoulder. The view of the tire marks is somewhat complicated by the curving shadows caused from the power lines that exist on the south side of the road. In the background you should be able to see two trees on the north roadside with some bark that is missing on them and these were the trees that were struck by the subject vehicle.

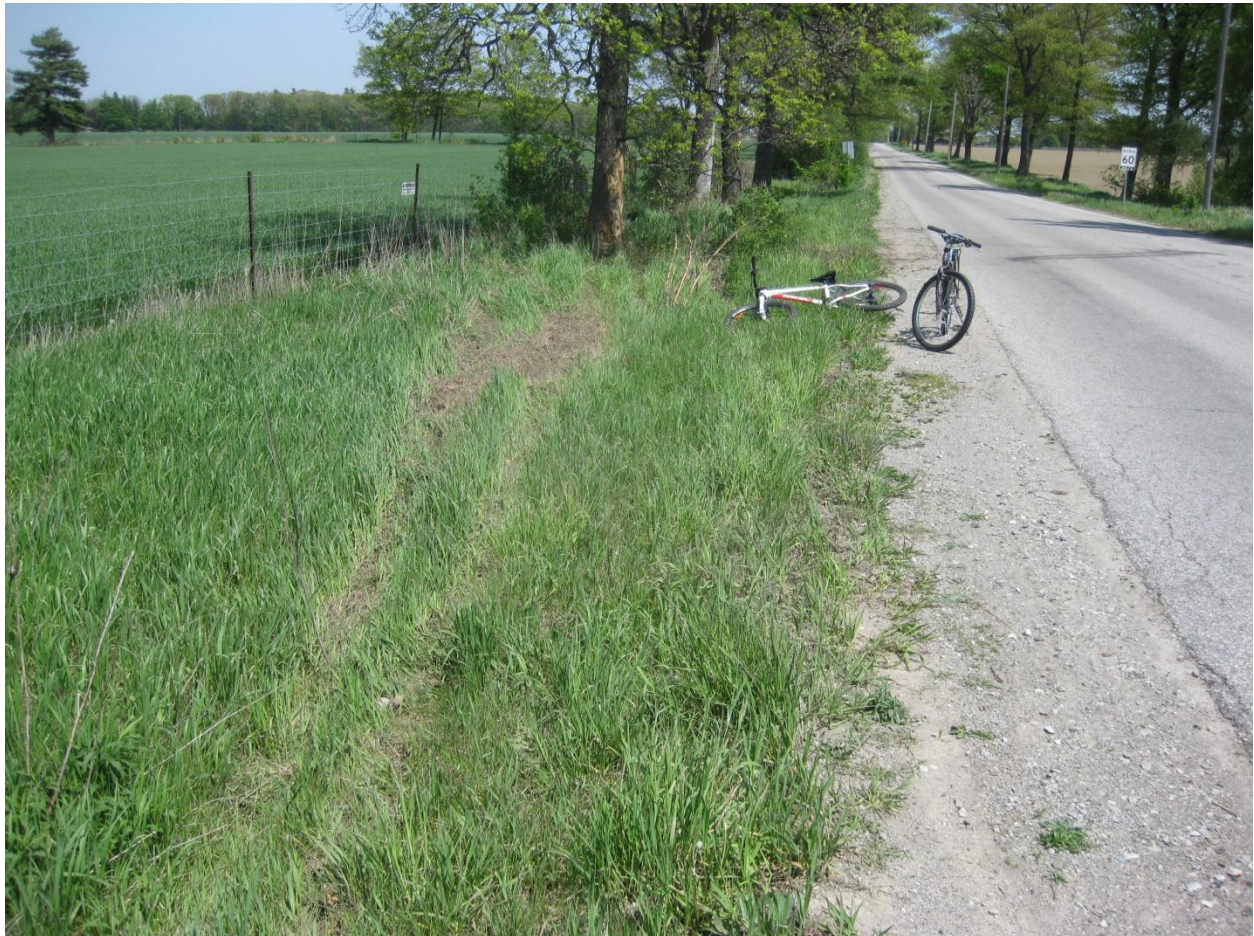
As we move over to the area of impact we can see the trees that were struck as shown below. You can also see the tire marks in the grass on the north roadside produced by the vehicle as it approached the point of impact

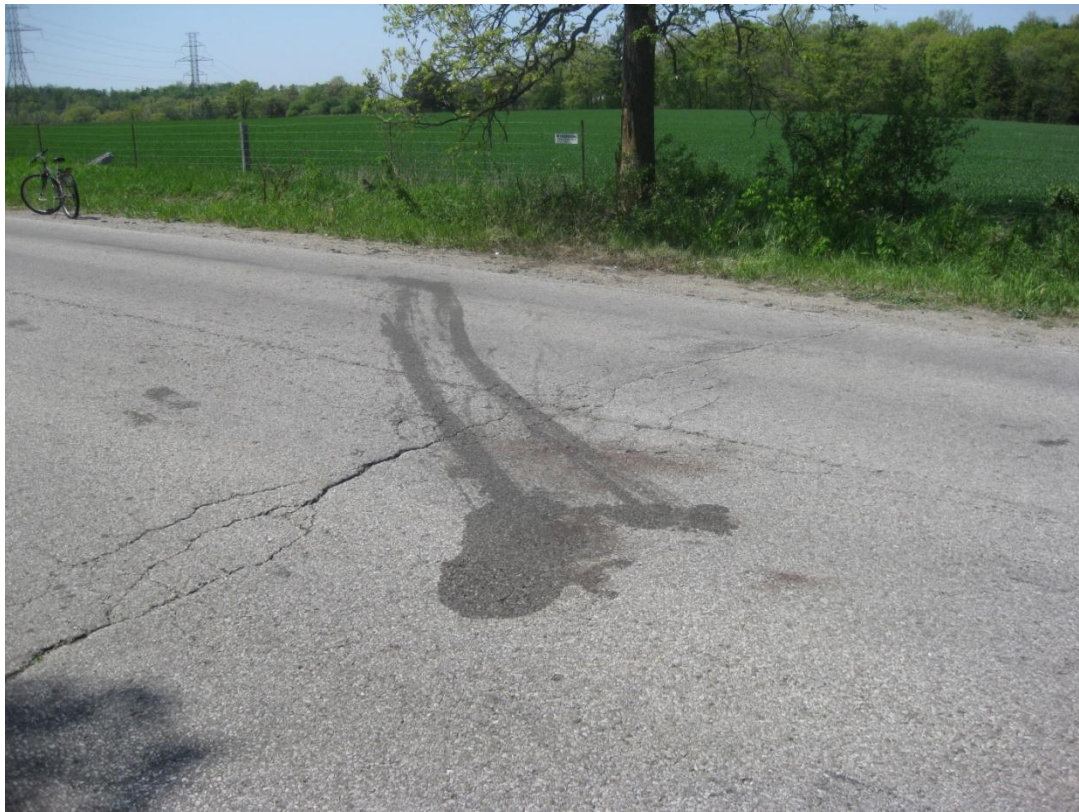
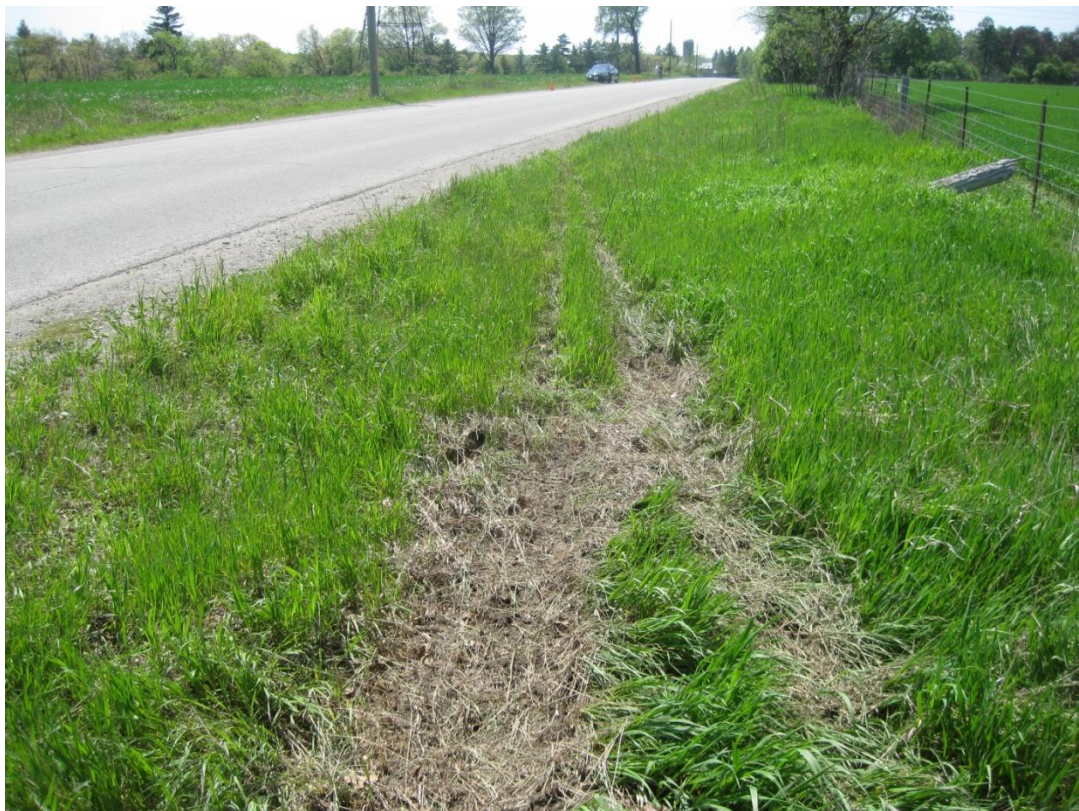
After glancing off the first tree the vehicle also struck a second tree and then spun away back onto the road surface where it came to rest. The top photo on the following page shows the oil stain produced as the vehicle left the tree impacts and came to rest on the roadway. The bottom photo on the following page shows a view looking westward from the area of impact back toward the direction from which the vehicle came.

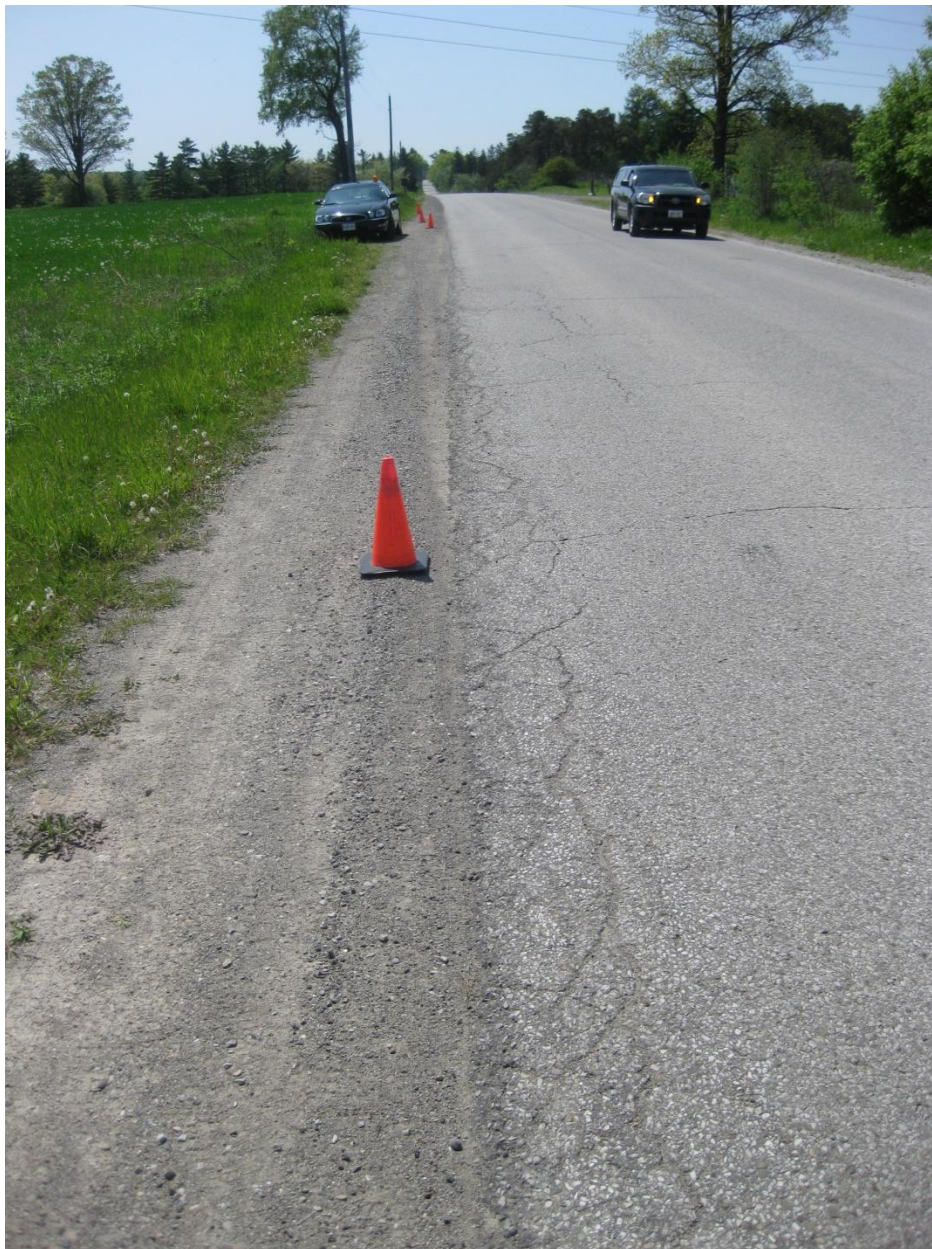
Below is a photo of the south shoulder looking westbound or back toward the direction from which the vehicle came. The closed cone to the camera is where the vehicle's tires returned to the roadway after travelling a distance on the gravel shoulder.

You can also see our vehicle parked on the shoulder in the background with three other cones surrounding it. Now for some distances...

The distance from the first tree impact to the cone in the above photo is about 61 metres and the distance from that tree to the front end of our parked car is about 87 metres. Certainly the vehicle was on this south shoulder for the distance between the cone and the front end of my vehicle. Where it actually entered the shoulder is uncertain because that marking was already destroyed by the time we arrived. But based on our experience the entry onto the south shoulder was somewhere west of our parked car. You might want to study the shoulder in the area so we have provided two additional photos on Page 19 and 20, showing the area near our parked car and the character of the south shoulder in that vicinity. The photo on Page 19 is looking westward while that on Page 20 is looking eastward.

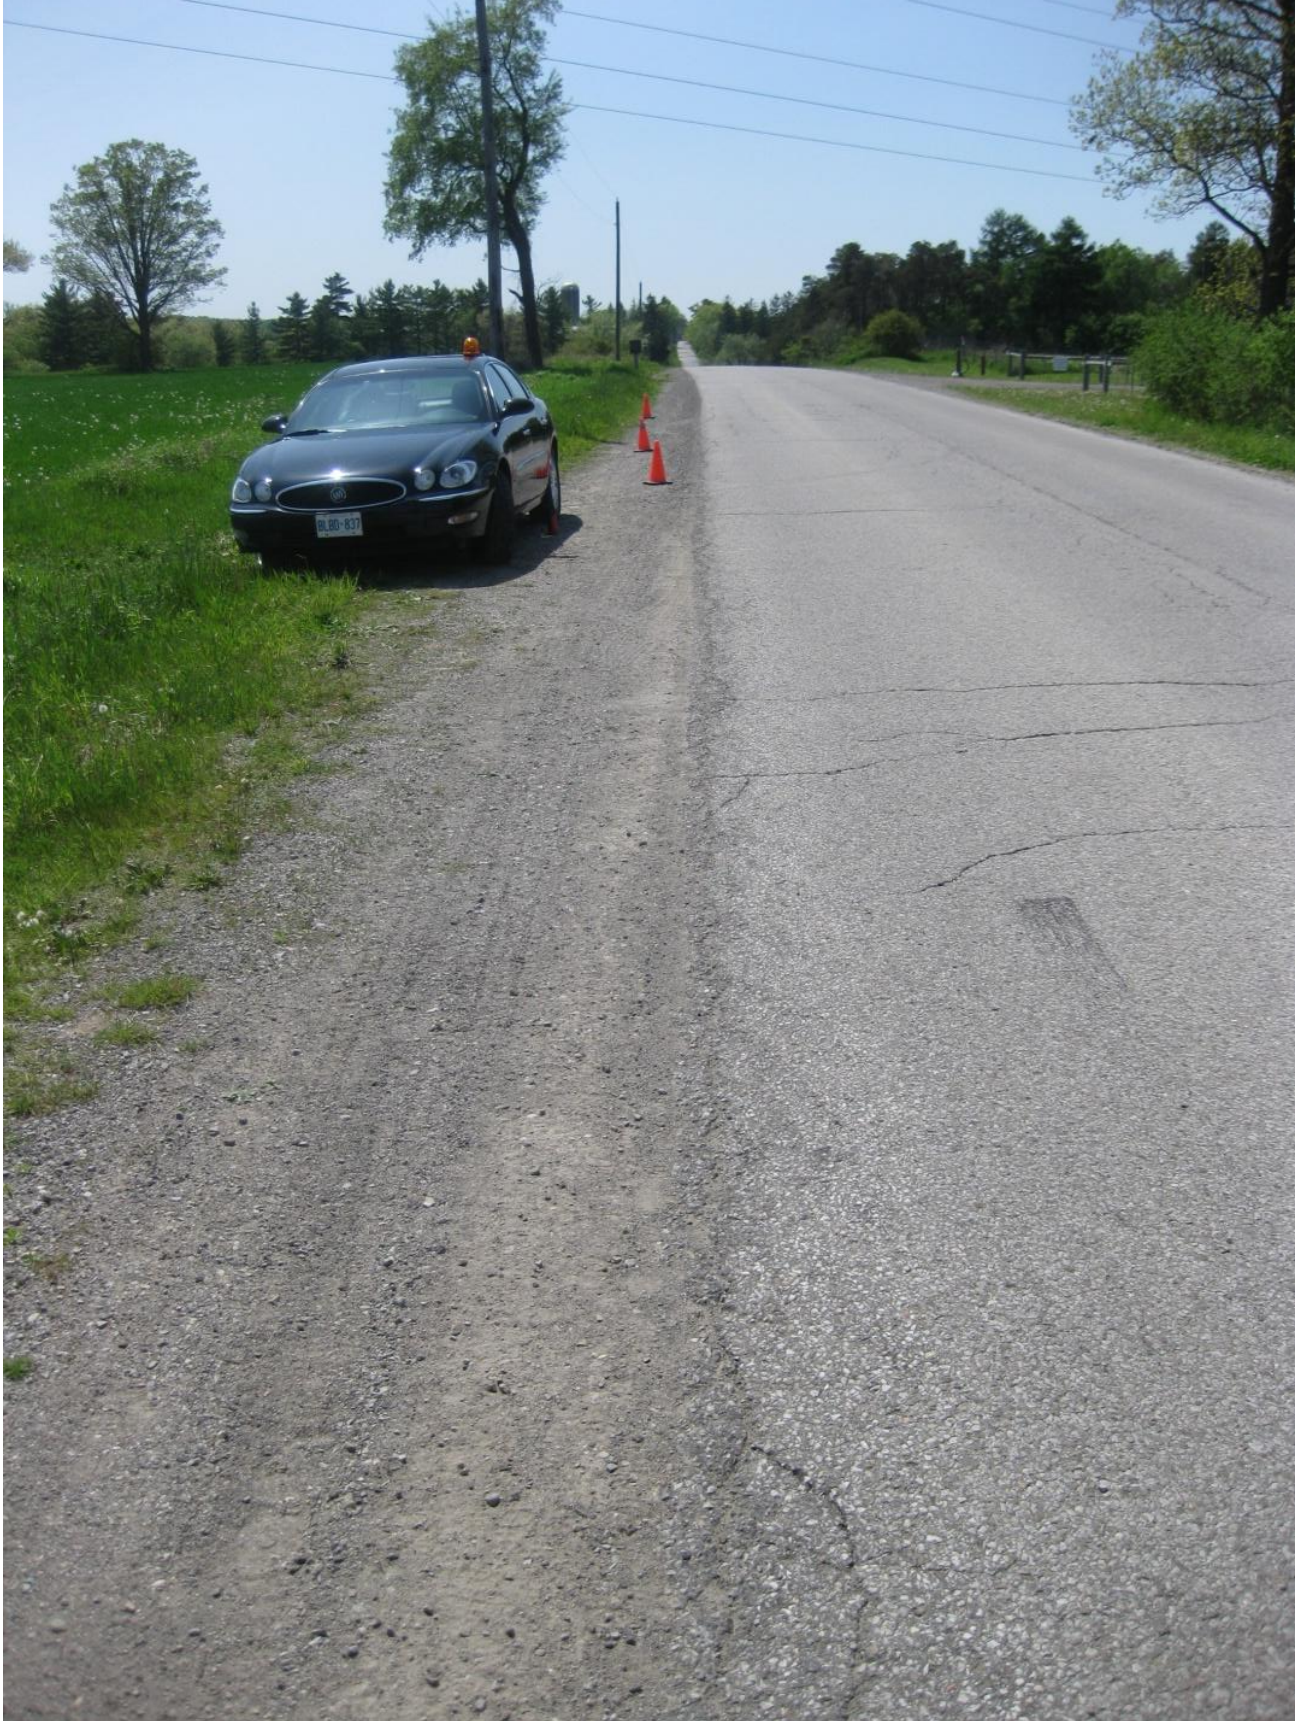
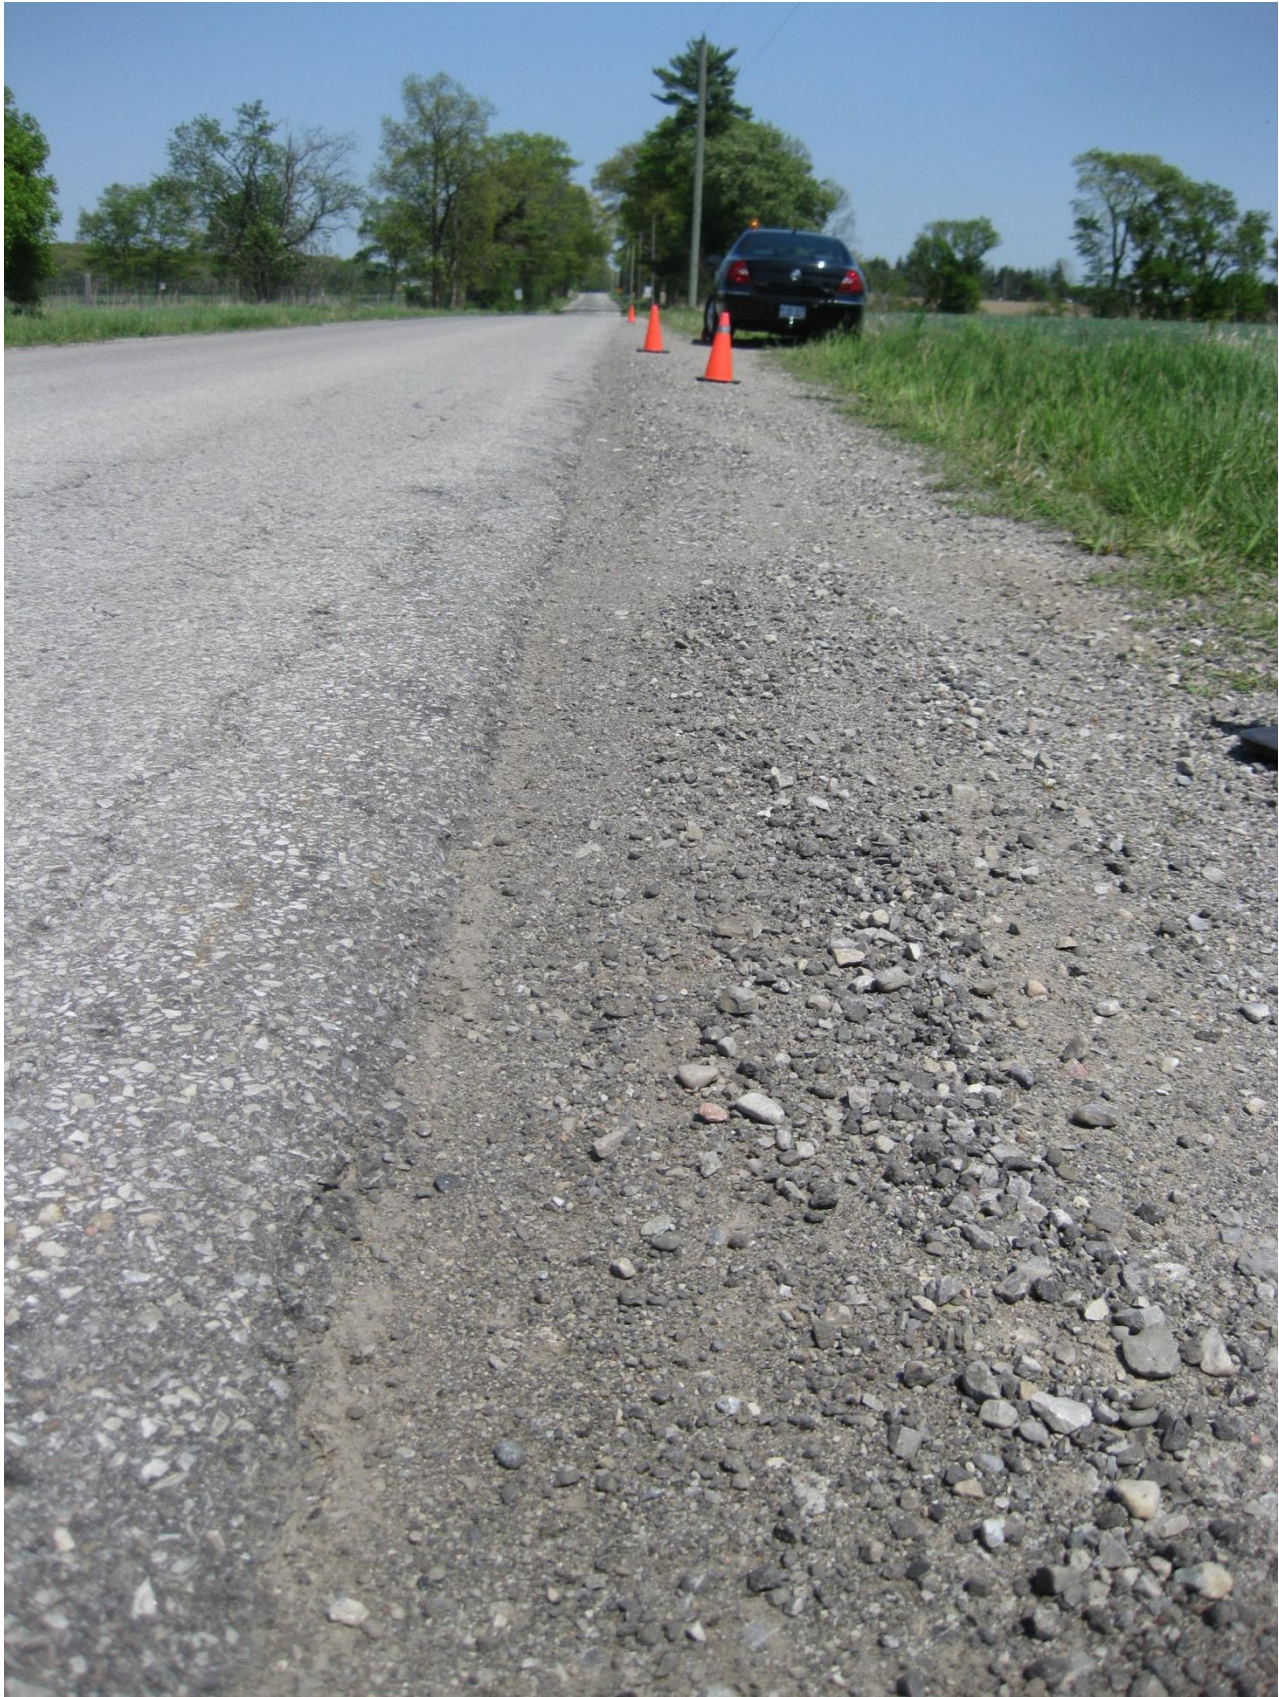
A curious fact is that in the short distance just west of our parked vehicle we observed that there was a significant edge drop off. In other words, the surface of the gravel shoulder dropped down with respect to the edge of the pavement. For example we measured out equal distances of 10 metres beginning at the 100 metre mark and took some measurements of the edge drop off through to 170 metres. Those edge drop offs are noted in the table on Page 21.

What you should observe is that, in the vicinity of 110 to 130 metres the edge drop off is most prominent and then is slowly diminishes toward the west. Although the measurements do not indicate it, we also observed that the edge drop off diminished as we progressed eastward from the 100 metre location.

What this evidence indicates is that, for some reason, vehicles are travelling off the paved surface of the road and their travel reach an apex in around 110 to 130 metres, or at approximately 120 metres. Looking at the numbers, the vehicles must start entering the shoulder at approximately 170 metres or about 50 metres from the apex and likely leave that shoulder about 50 metres east of 120 metres, or at about 70 metres. Note that the 70 metres is very close to the 61 metres that we measured as the point where our vehicle exited the south shoulder.

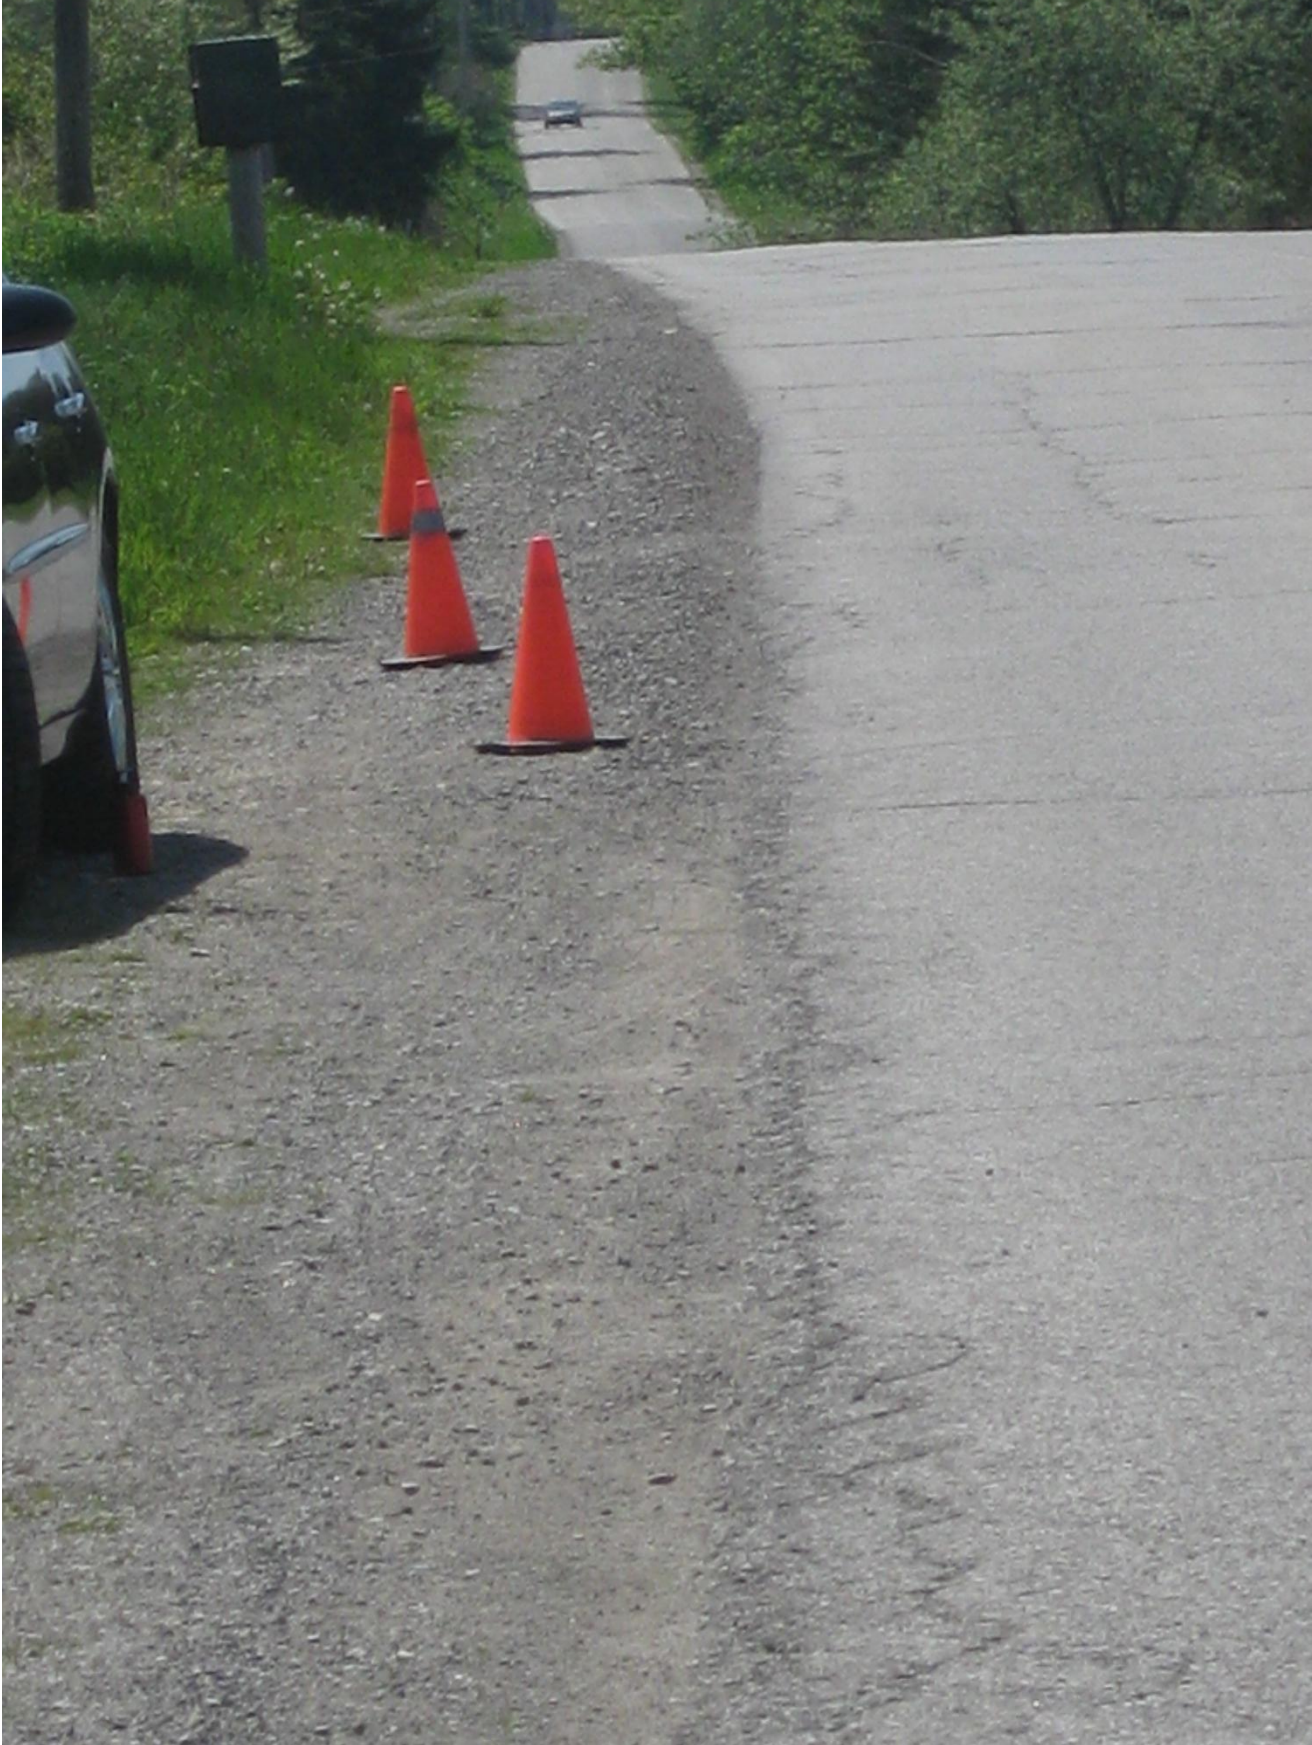
The photo on the following page is looking westward along the south shoulder back toward the sag in the road, west of where the vehicle collided with the trees. Unlike the previous photos however we have zoomed in with our camera lens thus shrinking the length of the road. Do you see anything different now?

Look at the vehicle in the background approaching the sag in the road and then match up the south edge of the road as it approaches the camera. Notice that you do not see the bottom of the sag so the vehicle will disappear for a period of time before emerging again on the near side of the sag. How do you think the vehicle will be oriented with respect to the south road edge as it comes out of the sag. When the camera cannot see the vehicle it also means that the eastbound driver will not see the camera, or more importantly, the driver will not see the road surface.

The obvious fact you should see in the above photo is that the south pavement edge just west of our parked vehicle is not in line with the roadway further in the sag. And the eastbound driver cannot see that the south edge of the pavement has moved to the north or into the driver's lane so if the driver is travelling straight ahead it is more likely that the vehicles right side wheels will travel off the paved surface of the road and onto the south shoulder. And this is exemplified by the edge drop off that we measured - precisely where the road edge deviates.
