Was Speed The Primary Factor That Led To The Fatal Injuries of Matthew Hartle?

Posting Date: 16 May 2012

Gorski Consulting
London, Ontario, Canada

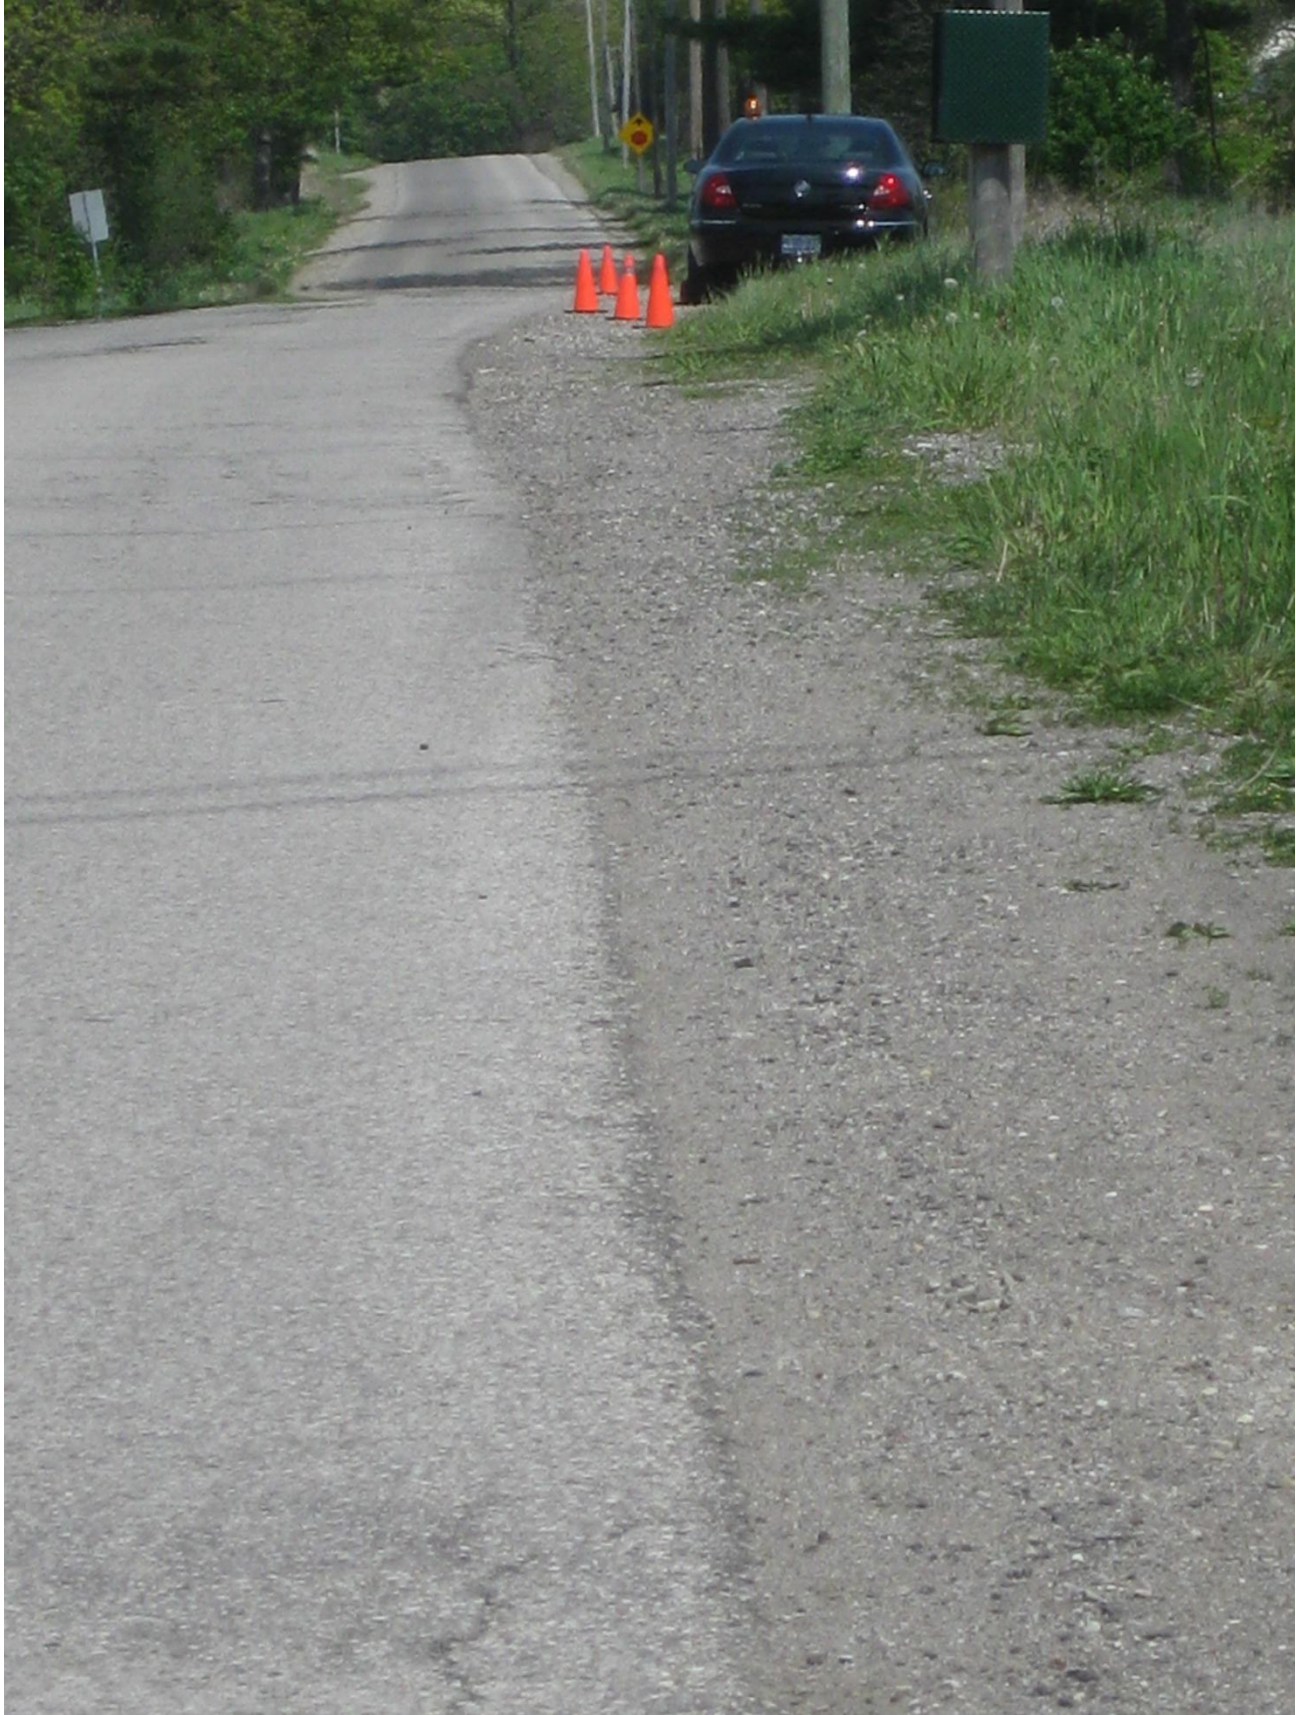
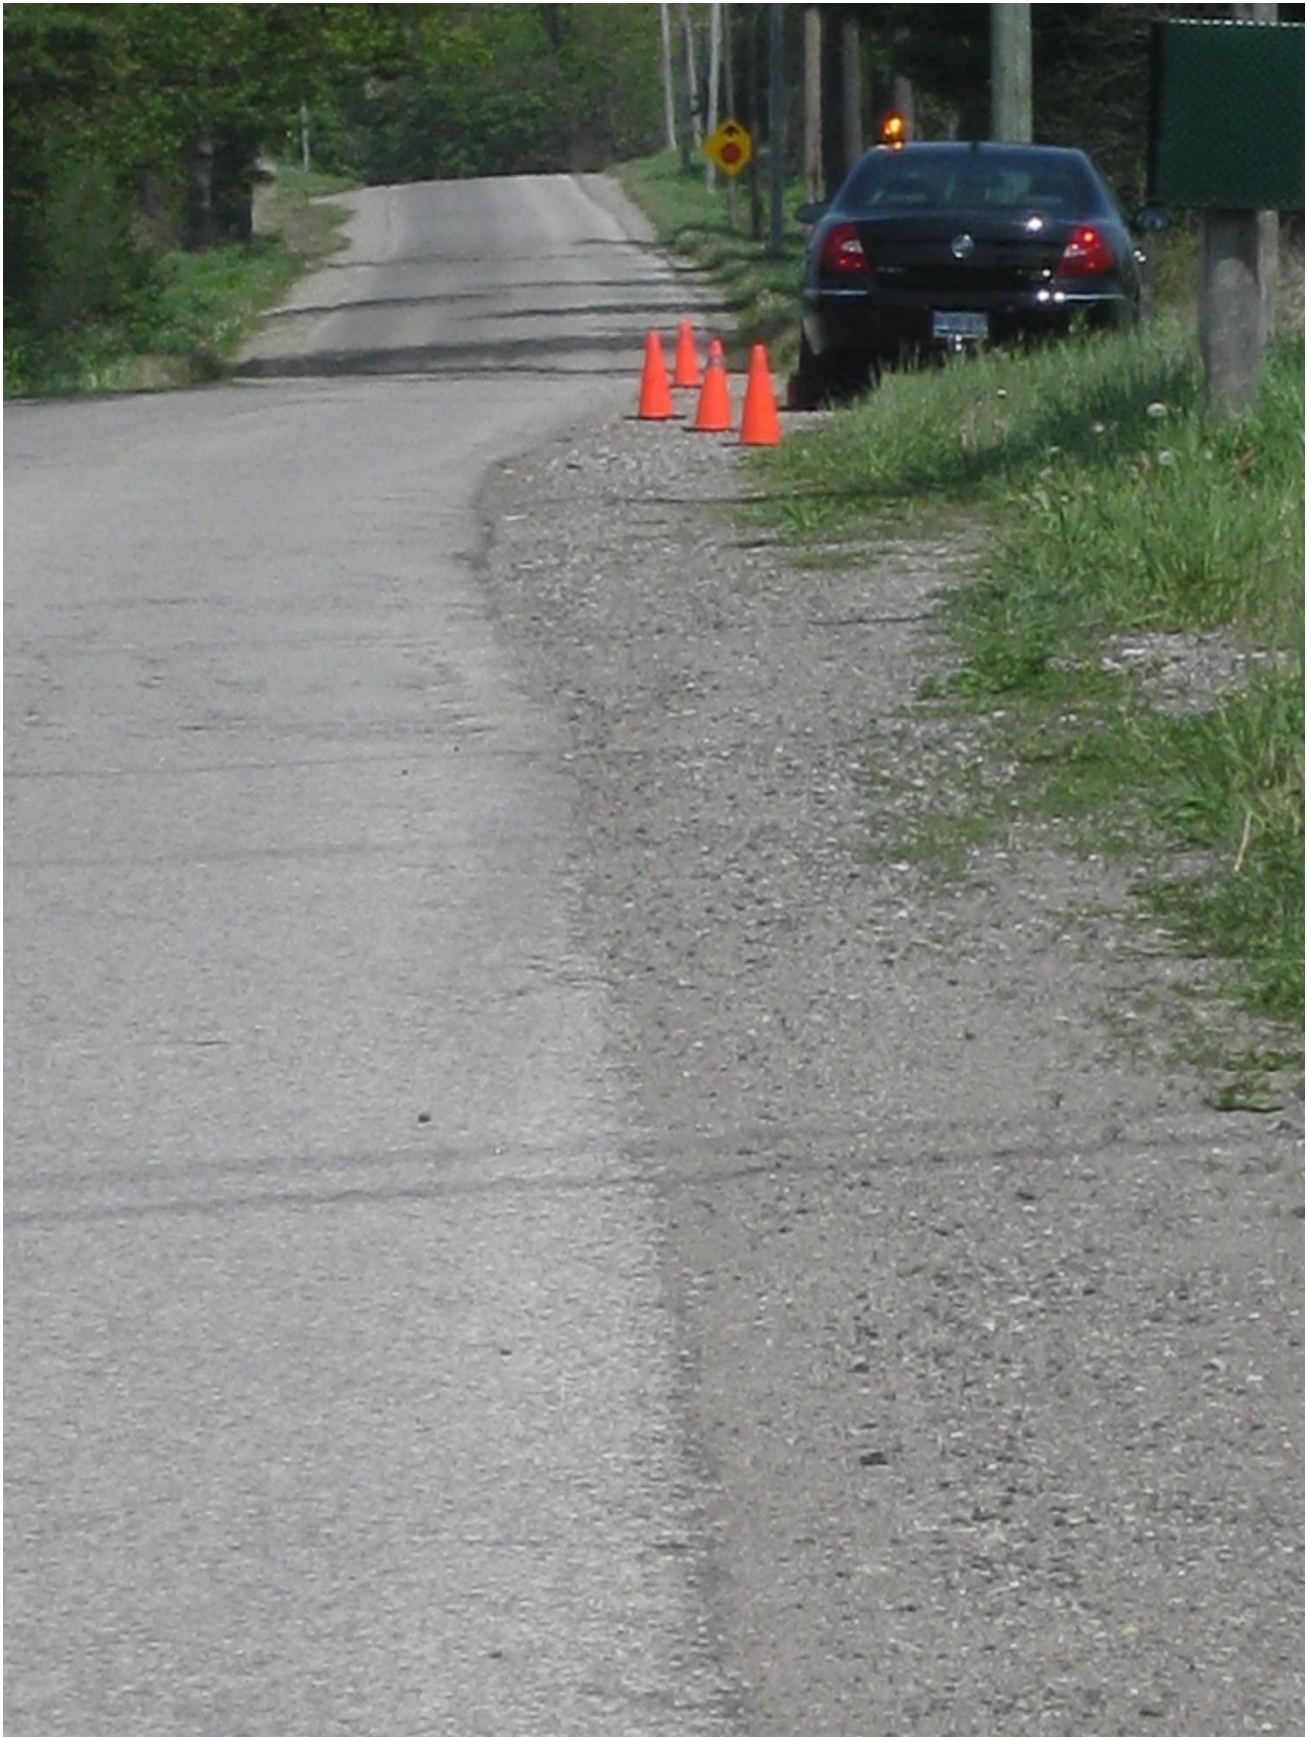
Let's take a couple more looks at this road edge with the camera lens zoomed in like we showed above. This time we present two photos below taken looking in an easterly direction along the south road edge. Is it not obvious that the roadway is not straight and that this deviation would not be visible until an eastbound driver crests the sag? But there is no warning of this deviation. To some degree speed is a relevant issue in our case, but is speed the only issue? Matthew Hartle's vehicle entered the south shoulder because the road way deviated at a point when he could not see its change in direction and there was no warning of that deviation.
