## Woman Dies in Single-Vehicle Collision on Kent Bridge Road East of Chatham, Ontario

*Posting Date: 15 Oct 2010*

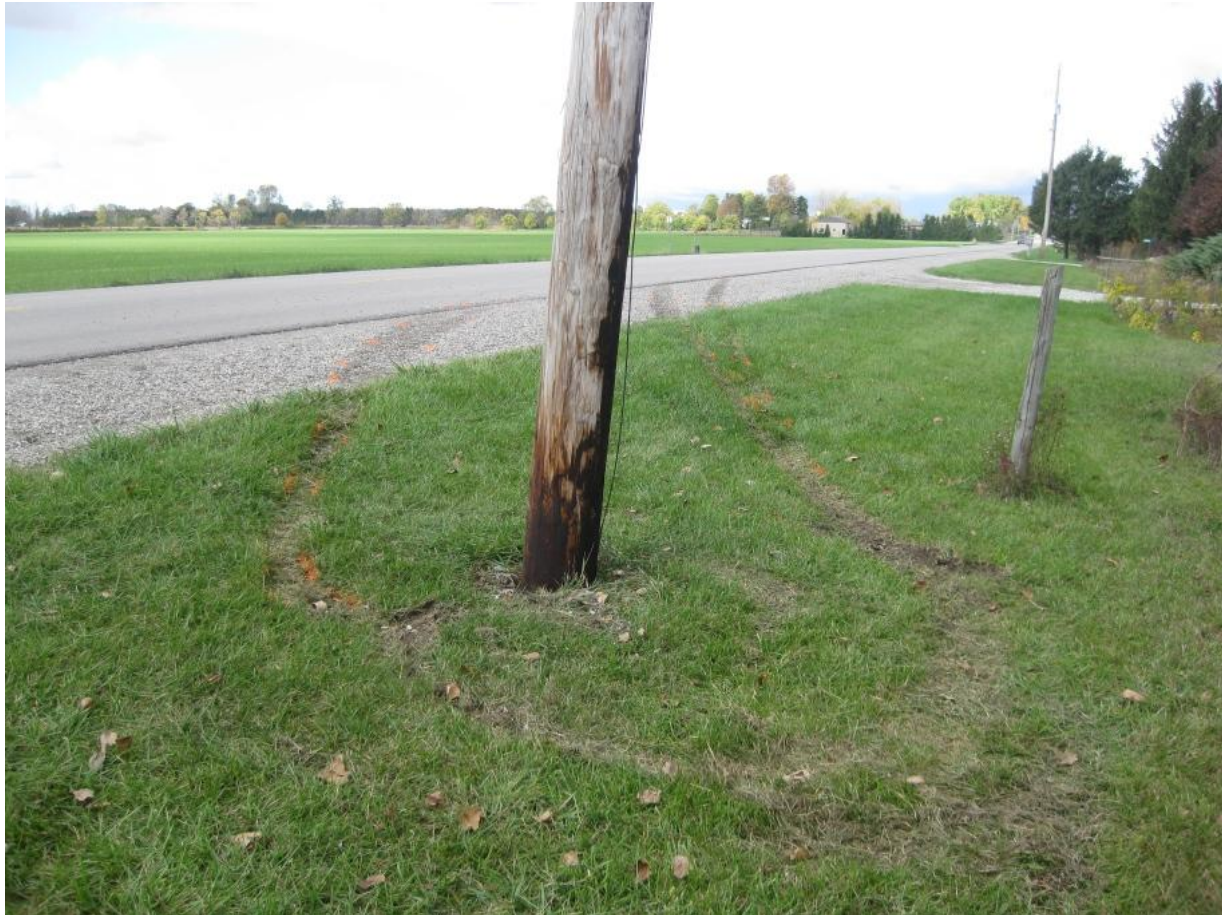
I travelled to the accident site this afternoon and have a number of photos that will be presented in the following days. First, I want to show you a view looking approximately northeast from just beyond the pole that was struck.

The tire marks leading to the pole impact have been outlined in orange paint by the police during their investigation. Note that it was the right side of the vehicle that collided with the pole, so what you are seeing is the marks from the rear tires on the left side of the pole and the marks from the front tires are on the right side of the pole. Note the spacing of the tire marks with respect to the pole and you will realize that the pole impact was approximately in the middle of the wheelbase and therefore the pole impact was likely near the right B-pillar.

You can also decipher that the left side tires were following the path of the right side tires. In other words the vehicle was sliding directly sideways when the impact occurred. What I can tell you from experience is that by the time a vehicle reaches this point (of sliding directly sideways) it will undoubtedly rollover if it does not strike something beforehand. There was a steep-sided culvert directly behind the camera in the above photo therefore if the vehicle did not hit the pole it would have begun to rollover as it approached the steep-sided culvert. I can also tell you that, in a rollover scenario, a vehicle leading with its right side will generally make first contact with the ground with the upper corner of the left roof side rail. The left roof side rail is that portion of the roof that is just above a driver's head but at the top of the driver's door. I am saying all this because regardless of whether the pole was struck this driver would still have been in a difficult situation if the pole had not been there.

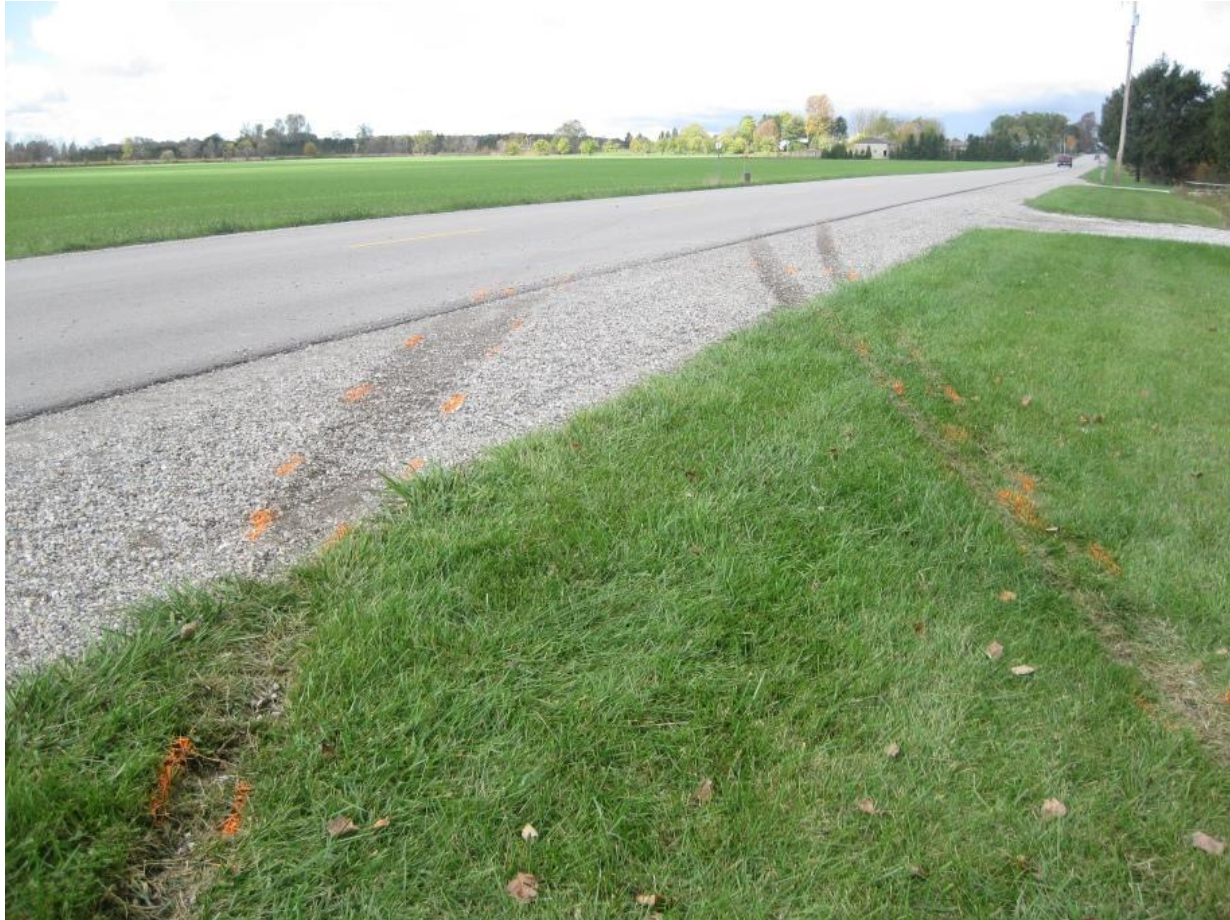
Now let's follow the tire marks away from the area of impact and out toward the road from which the vehicle came. Below you can see a photo showing the curved tire marks as they come off the roadway and into the east roadside. The struck pole is directly behind the camera.

Note above how the tire marks are curved, this is an indication that the vehicle is rotating about its vertical axis. One might say it is rotating counter-clockwise. These curved tire marks are typical of what you would expect from a loss-of-control vehicle and we call them "yaw" marks. The two tire marks on the left are from the rear of the vehicle and the two on the right are from the front of the vehicle. The rear tire marks are converging because the vehicle is rotating and approaching a condition where it is sliding directly sideways. Similarly the two front tire marks are doing the same.

The angle at which all the tire marks are coming off the road surface should be an indication to you of the speed of the vehicle. A fast-moving vehicle does not change direction "very much" in a "short distance". So this amount of curvature and this amount of change in direction indicates a relatively slower speed compared to other loss of control collisions. But don't let my comment fool you, many vehicles are out of control because their drivers are going too fast and therefore most yaw marks are observed when vehicles are travelling at high speed. Let's look further up the road.

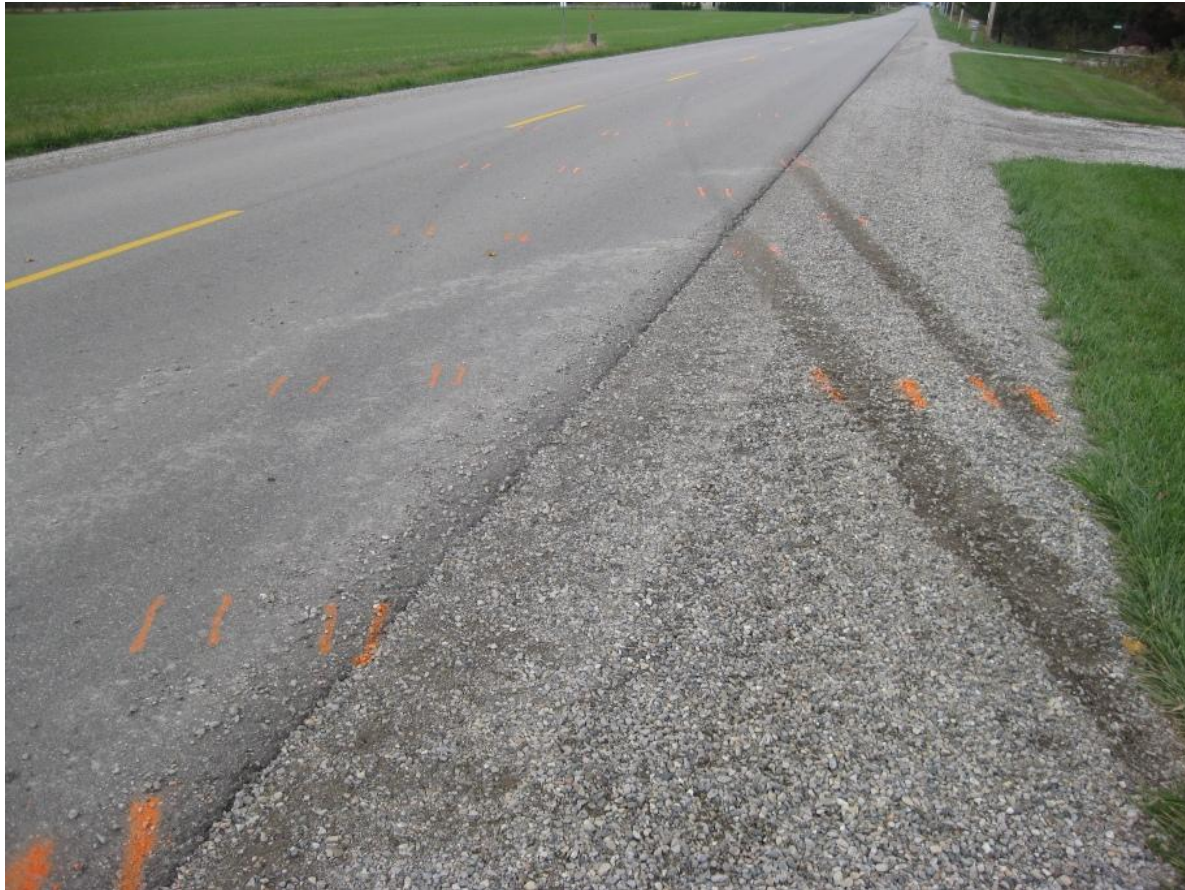
The photo below shows the tire marks further onto the road and you can see that the vehicle came from the southbound lane before travelling off the road.

The above is interesting because in many loss-of-control collision scenarios this is the only physical evidence that is visible: the tire marks come out of the proper, southbound lane and the conclusion is drawn that the driver simply lost control at that point. But in this case that is not the end of the story because there is additional physical evidence as demonstrated in the following photos.

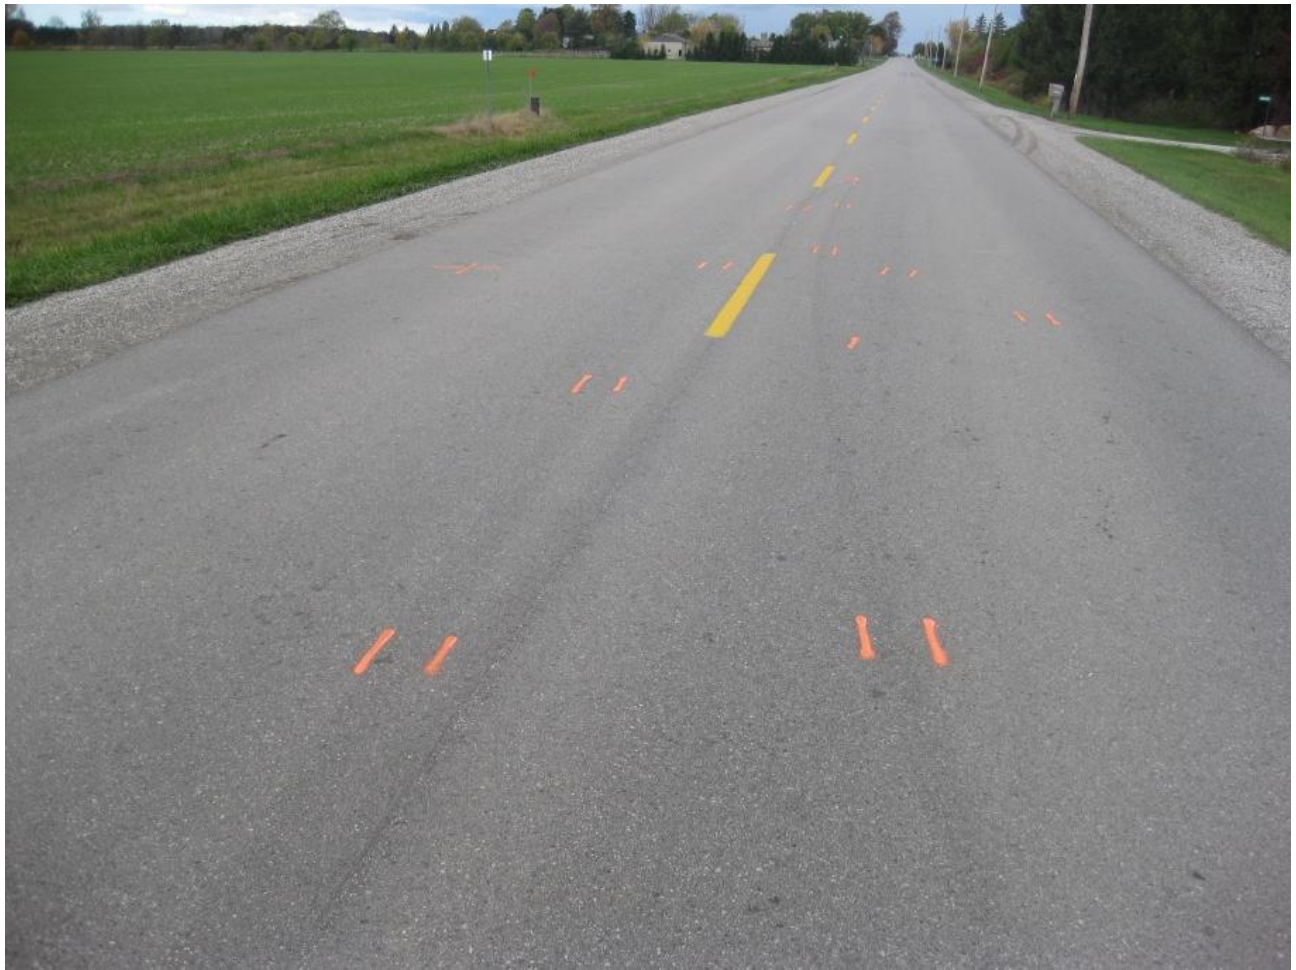
In the photo below we see how the Sunbird came close to the southbound lane but in the background you can see that the tire marks actually originate from the northbound lane and that there is something on the east shoulder.

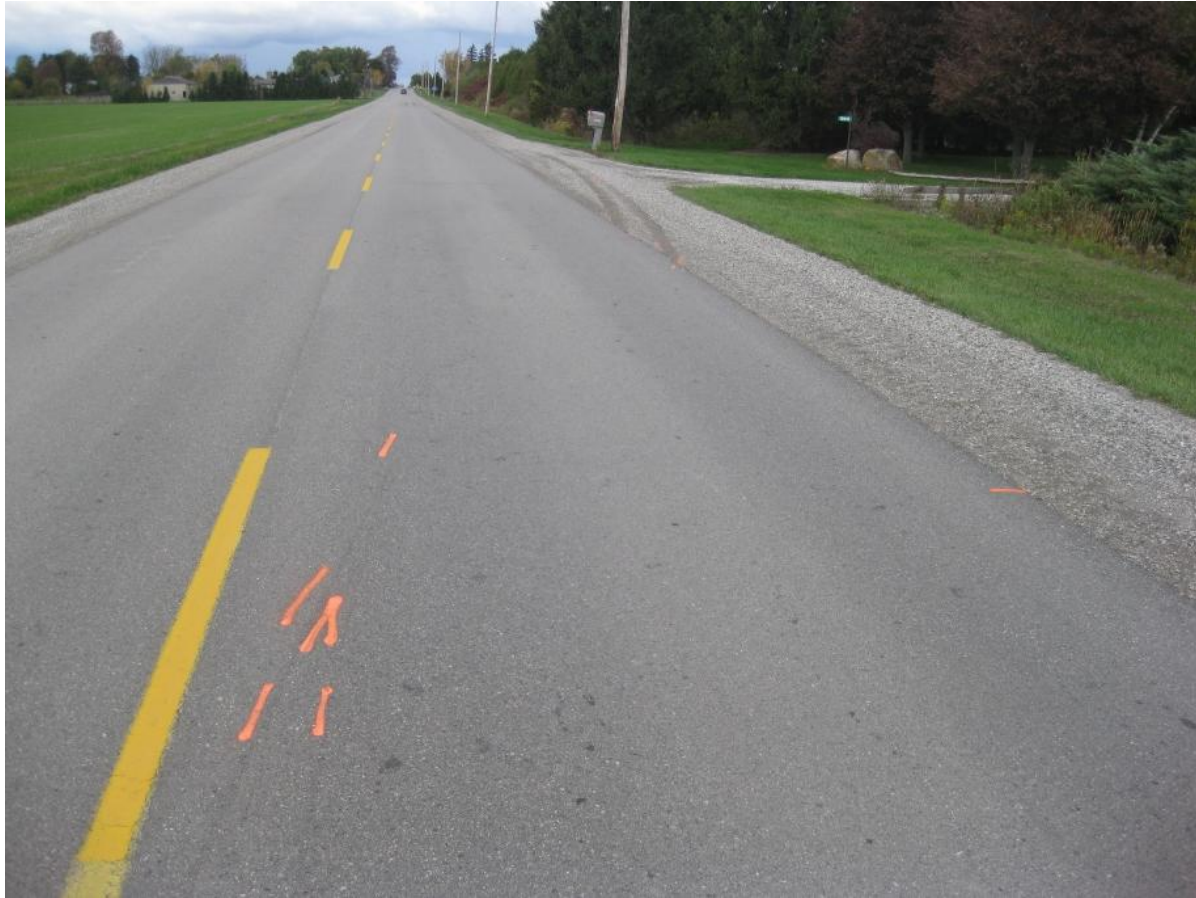
And as we look further northward along the road we can see in the photo below what appear to be additional tire marks near the driveway on the east side of the road.

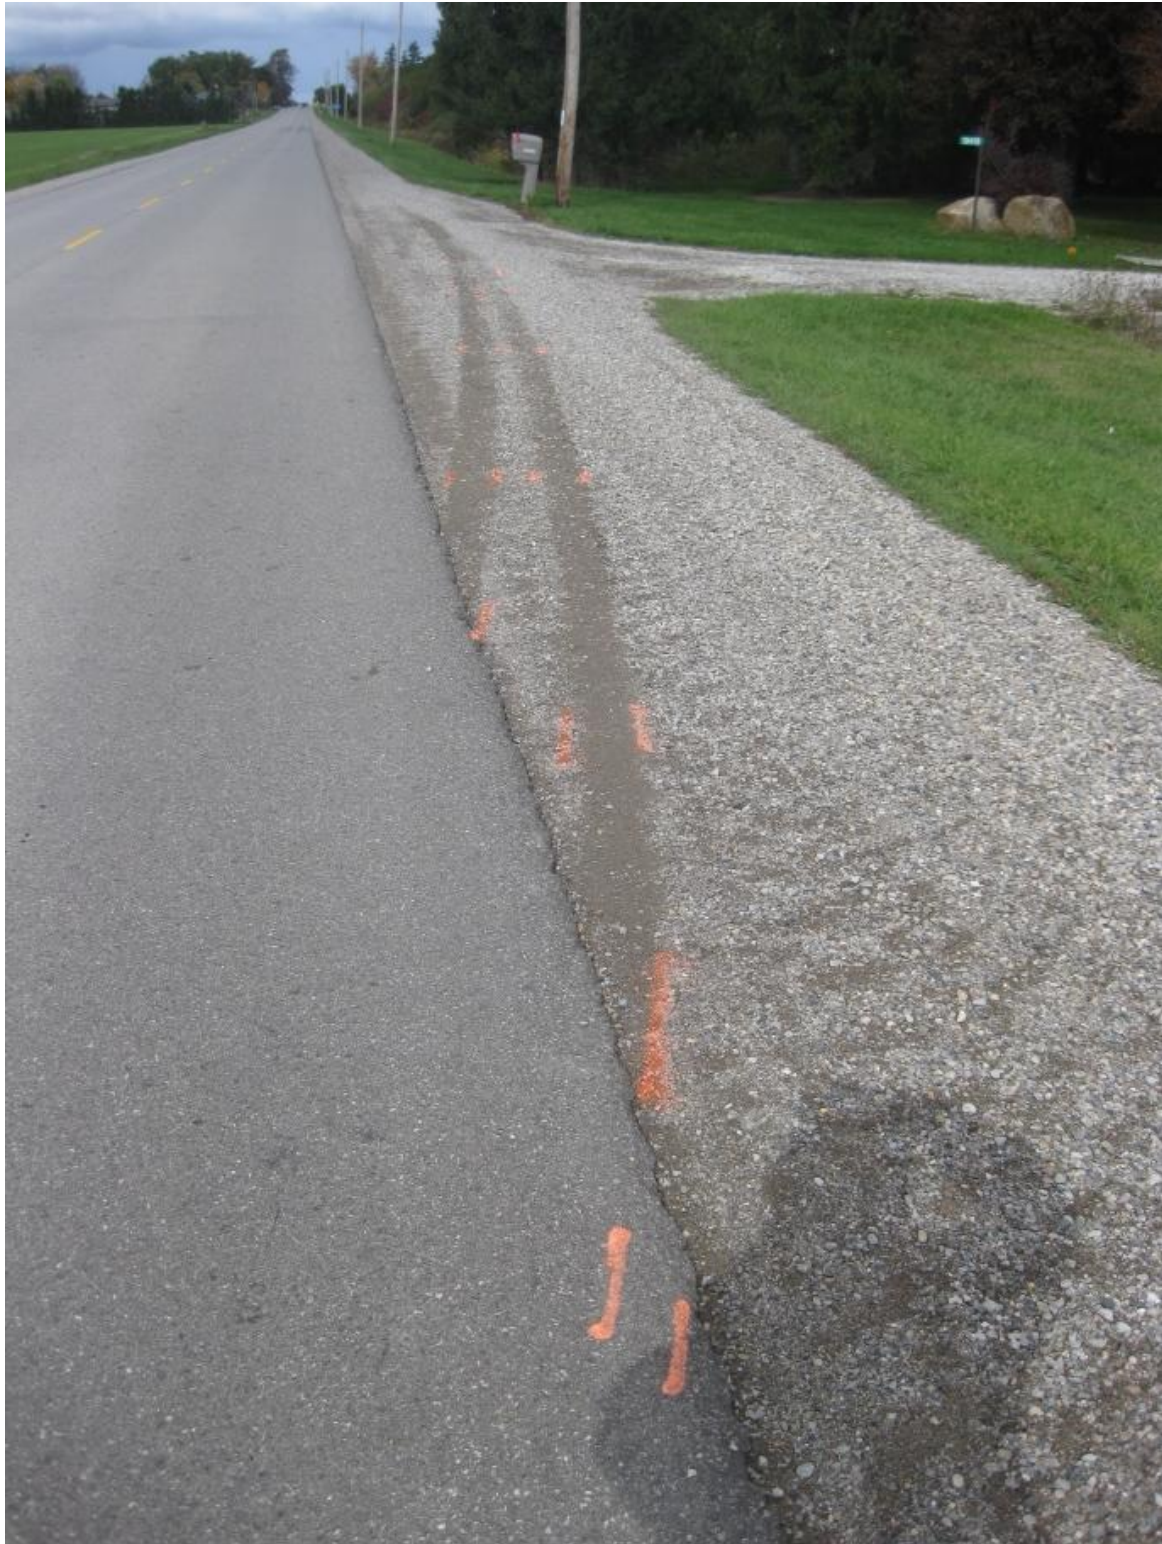
And as we look in the photo below we can clearly see that the police have outlined additional tire marks on the east shoulder.

Note in the above photo that the tire marks on this east shoulder are also curved and therefore they are also yaw marks and they indicate the vehicle is rotating.

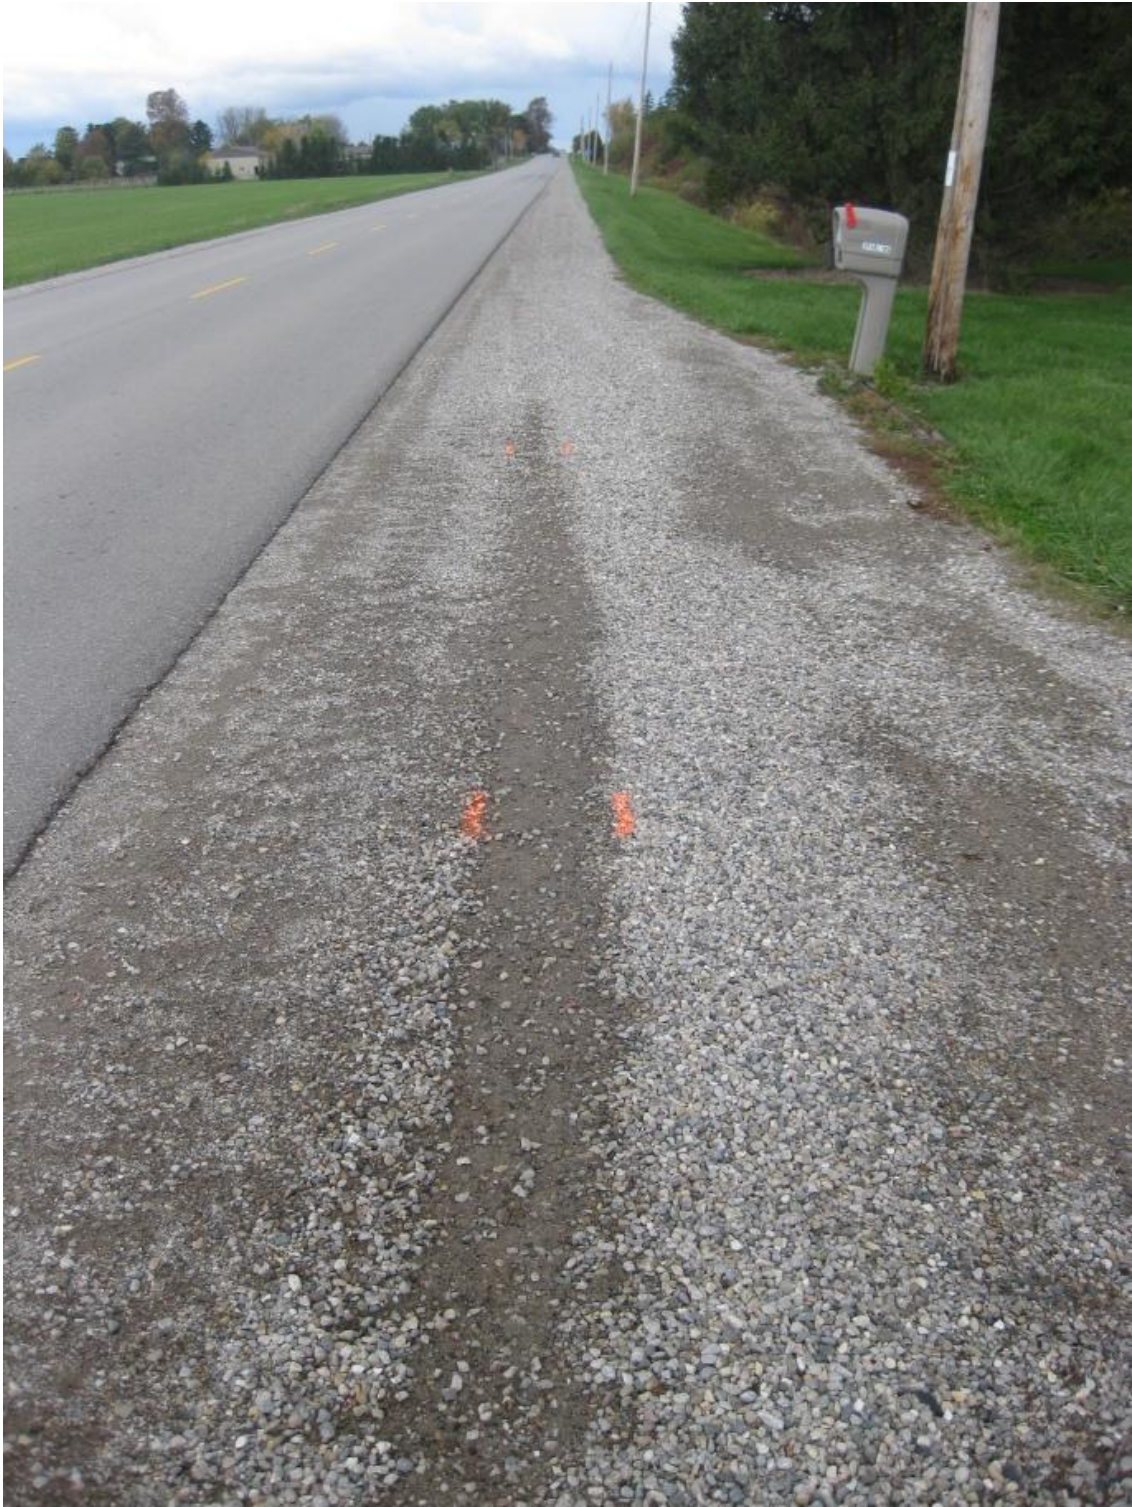
The photo below looks toward the beginning of those tire marks as outlined by the orange paint markers.

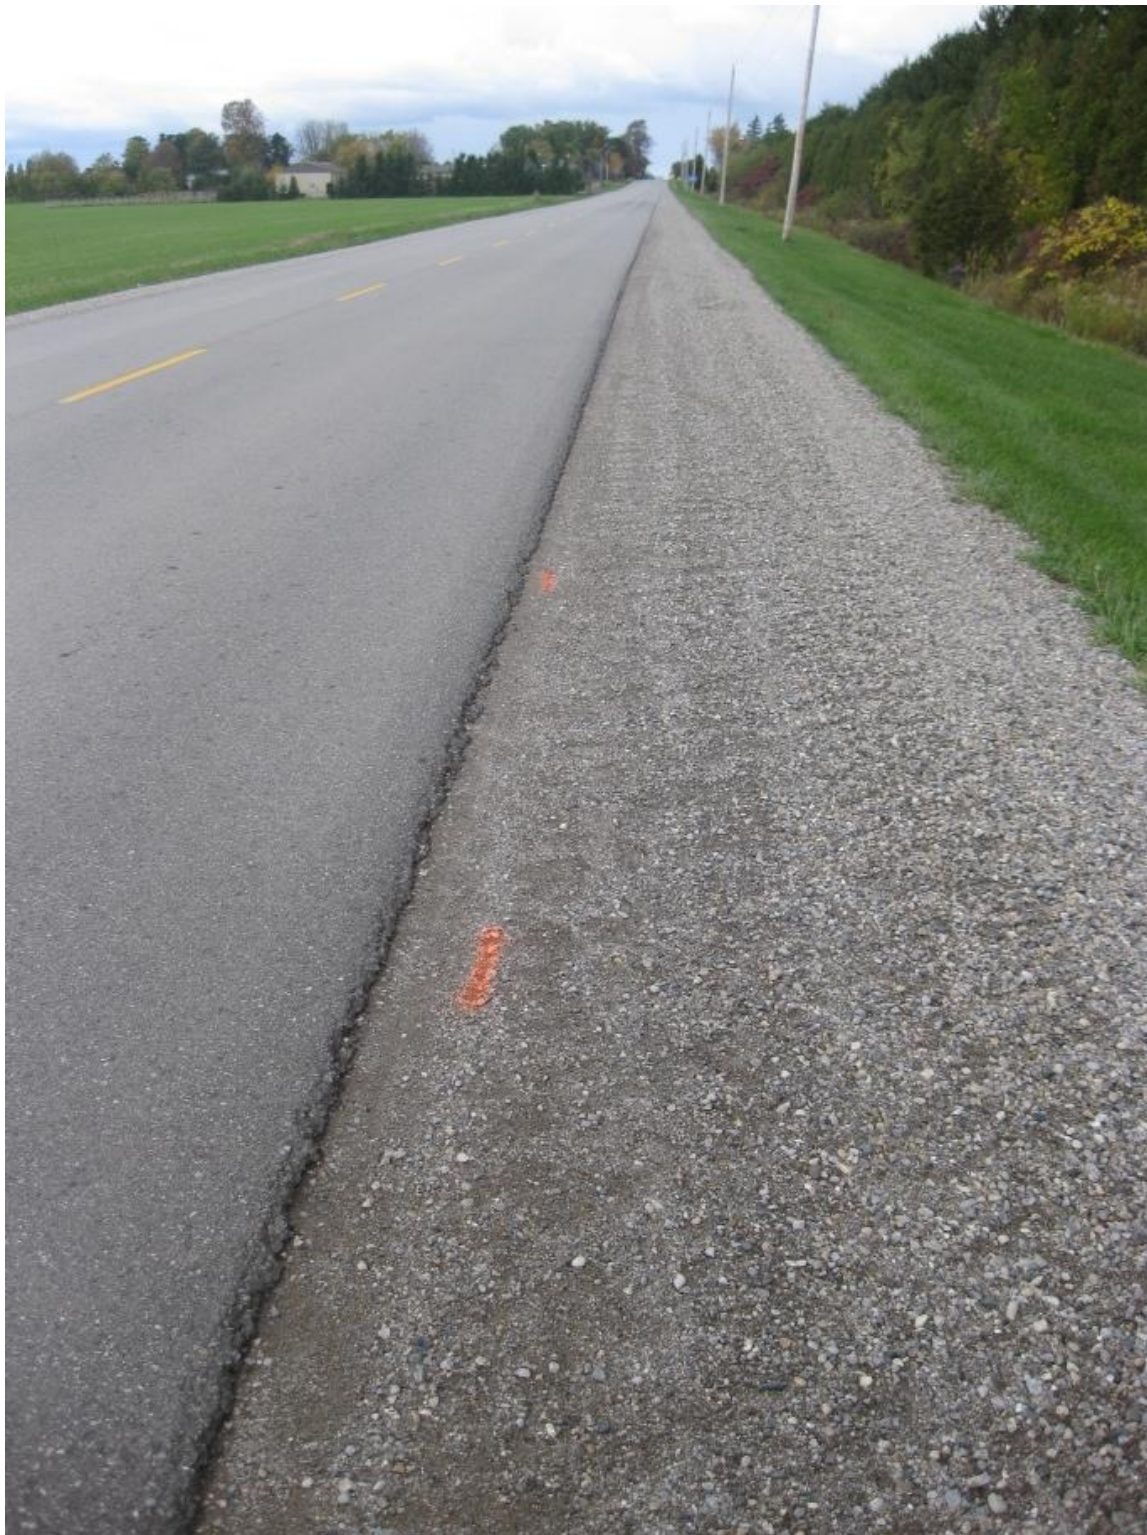
And the photo below shows the first orange paint marker on the east shoulder and in the background you can see the conditions of the road. The road appears straight, level and the surface appears to be in good condition.

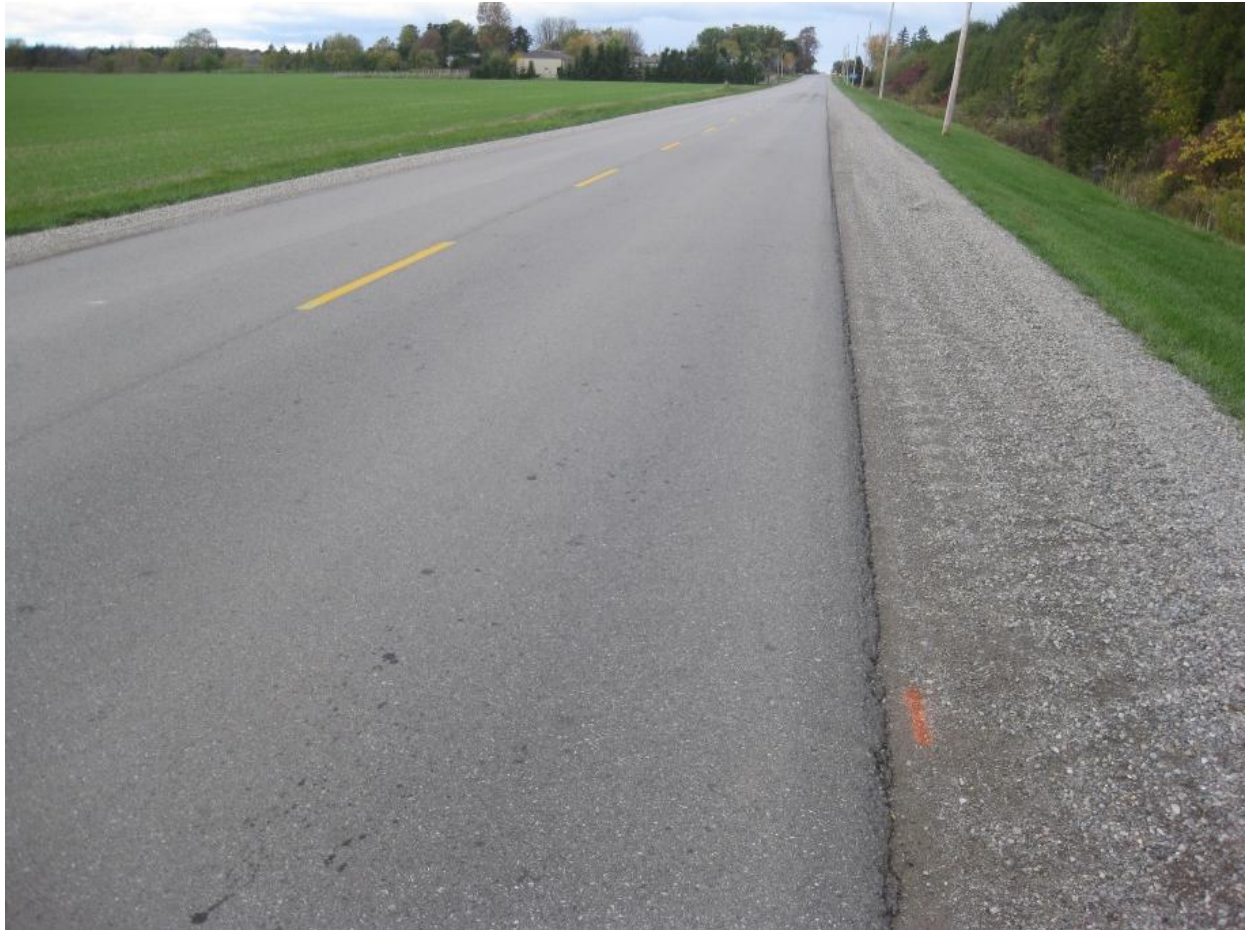
And below is another, similar, view looking northward from the point where the Sunbird began to exit onto the east shoulder.

There is no additional physical evidence yet one would question why the vehicle would be on the wrong side of the road without producing any other physical evidence. I think this is why the newspaper article quoted the police with the words "At this stage in the investigation, police said they believed the vehicle came into contact with the east shoulder of the road causing the vehicle to rotate..."

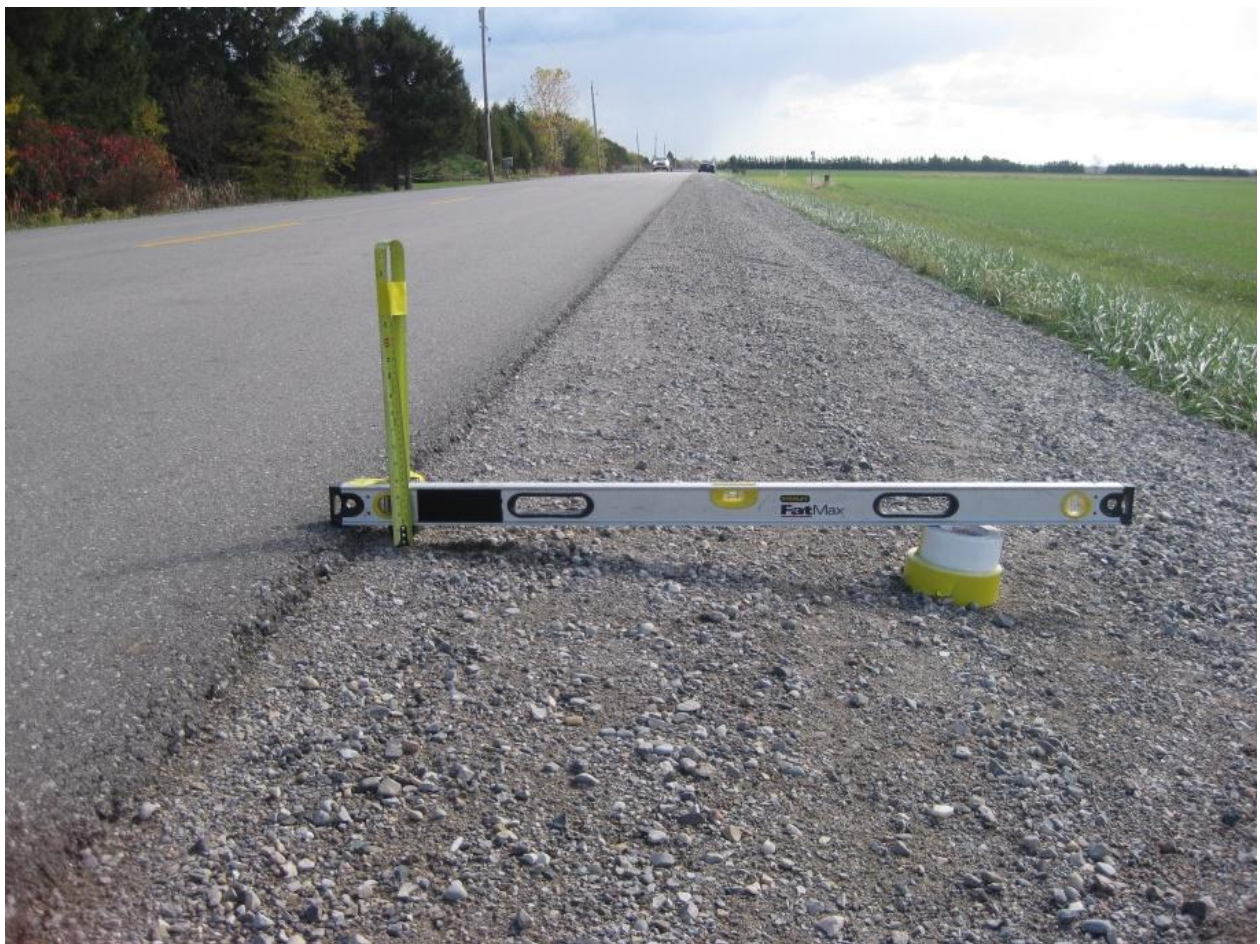
My advice had been to study the road some distance further from the beginning of the physical evidence. In the present case the physical evidence was laid out as follows. From the struck pole northward the point where the vehicle came of the east shoulder was distance of about 48 metres. Then the tire mark on the east shoulder was about 50 metres long. So the distance from the pole to where the vehicle entered the east shoulder was about 98 metres. I took the length of the tire marks on the east shoulder, about 50 metres, and I walked that distance northward on the west shoulder such that I took up a position about 148 metres north of the struck pole. From this position of 148 metres north of the pole I laid out markers on the west shoulder, six equal distance of 20 metres each. From each of these positions I took measurements of the condition of the west shoulder. Below is an example of the apparatus I used at one of these measurement stations.

As noted above I took measurements of the edge drop off from the asphalt edge. But I also took a measurement at the far end of the carpenter's level to determine the slope of the shoulder.

My measurements indicated that the drop off from the asphalt edge was in the range between 2.5 and 4.0 centimetres - not great, but certainly within a reasonable range

since a drop off of about 5 centimetres (2 inches) is a value that is often quoted as something that should be repaired.

My measurements of the slope of the west shoulder however indicated values of 10.75, 7.5, 9.5, 9.25, 10.0 and 8.5 centimetres at each of the measurement stations. Noting that my length of the carpenter's level was 120 centimetres, the resultant slope in percent was 9.0, 6.25, 7.9, 7.7, 8.3 and 7.1 centimetres. These slopes are excessive. Particularly so because a typical cross-slope of a travel lane is about 2.0 percent. Next you consider that a vehicle's right side tires fall off the asphalt edge about 2.5 to 4.0 centimetres thus increasing the angle at which the vehicle is tilted onto its right side wheels. And finally you introduce a slope of the shoulder that could be in the range of 9.0 percent. That is not a good thing, even if one believes the vehicle should be travelling straight ahead.
