ET-Plus Terminal Impacts – Further Evaluation of Their In-Service Performance

Posting Date: 1-May-2017

In a previous Gorski Consulting article (“ET-Plus Terminal Impacts – Evaluation of Their In-Service Performance”), dated March 12, 2106, six instances of impacts of ET-Plus terminals were reported. The present article is a report on an additional 4 instances.

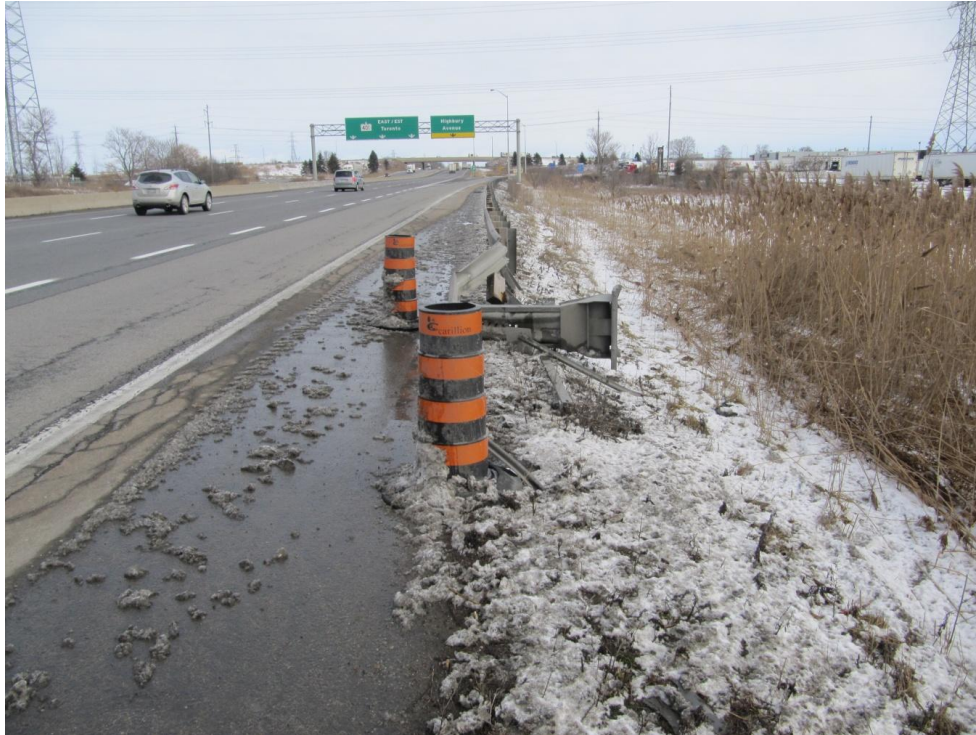
The present incident was documented on January 27, 2016. Figure 1 shows the impacted ET-Plus terminal located on the south side of the eastbound lanes of Highway 401, just west of the Highbury Avenue interchange in London, Ontario. Figure 2 shows how the guardrail has buckled and the terminal has rotated to a ninety degree angle.

Figure 1: View, looking east, at the damaged ET-Plus terminal located on the south side of the eastbound lanes of Highway 401 just west of Highbury Avenue.

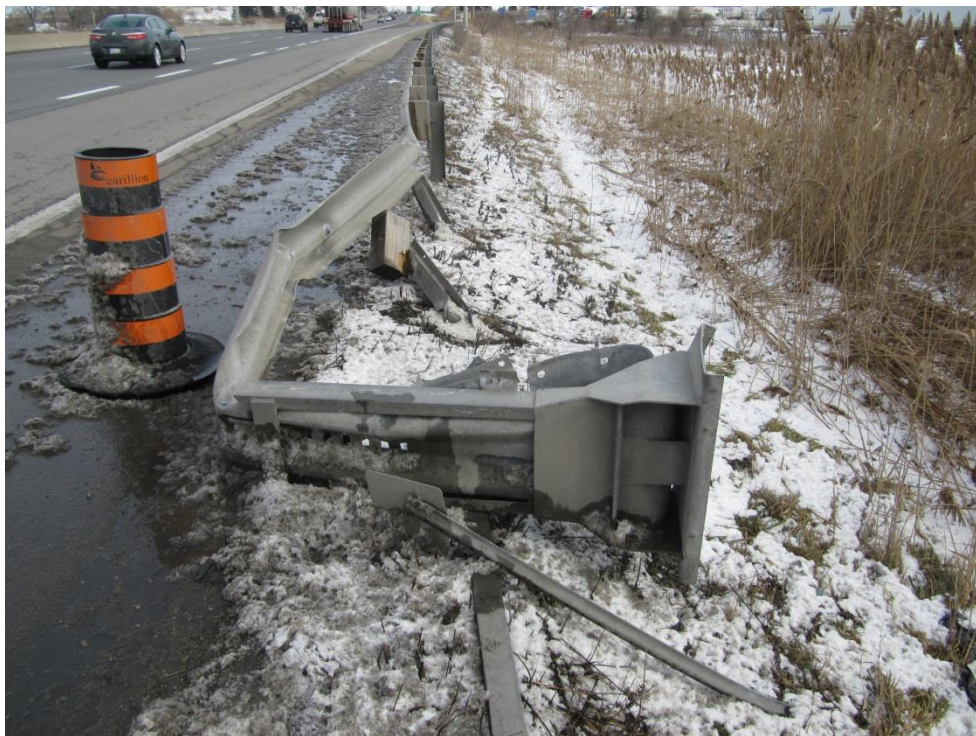
Figure 2: View looking east at the ET-Plus terminal showing it has rotated to a ninety degree angle as the guardrail has buckled and prevented passage through the throat of the terminal.

Figure 2 also shows how the rail has buckled in the further distance behind the terminal demonstrating that the preponderance of energy was not being dissipated through the passage of the rail through the terminal but that a significant portion of the energy was being dissipated through deformation of the guardrail system distant from the terminal.

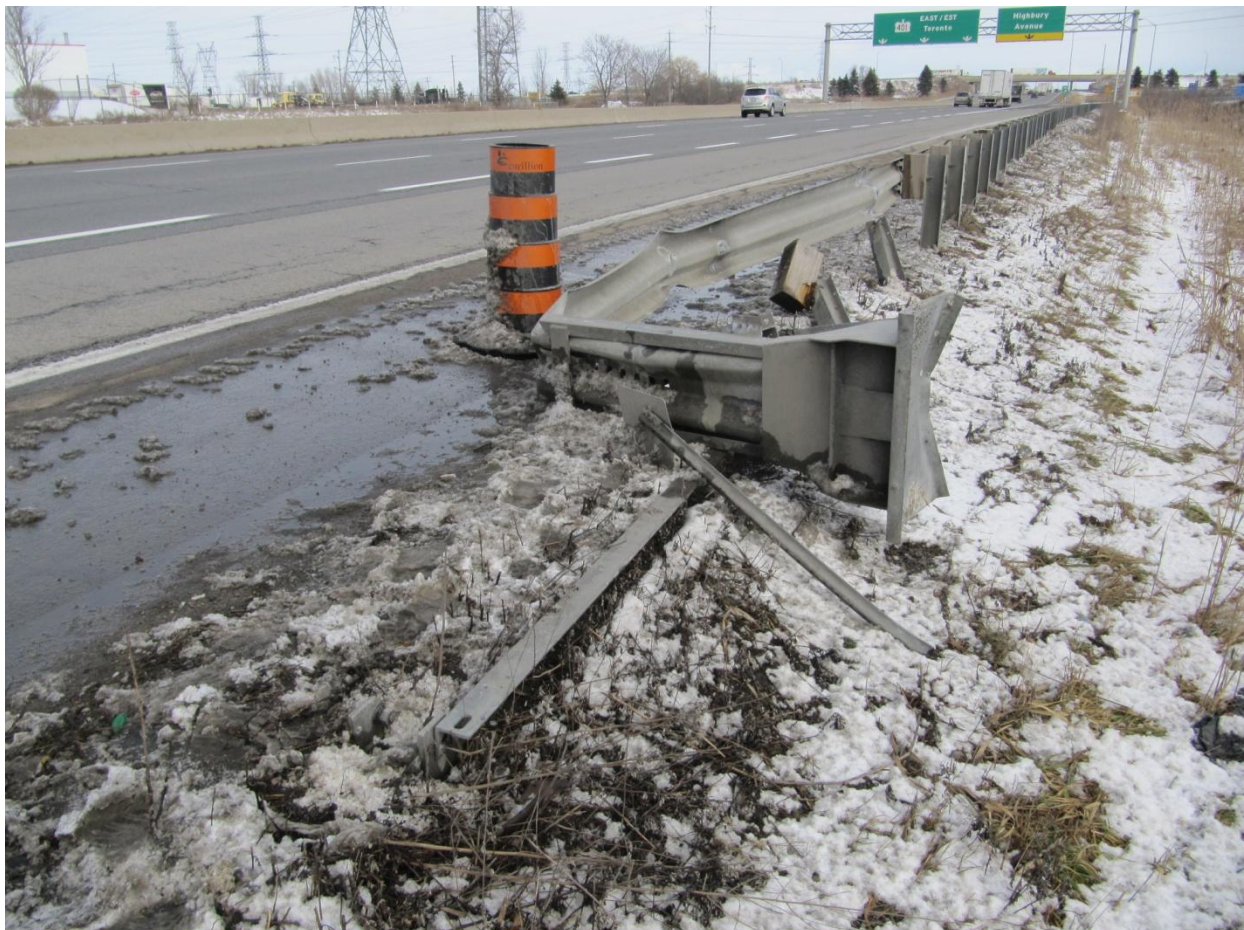
Figure 3: View showing how the ET-Plus terminal has rotated ninety degrees with respect to the length of the rail. Clearly, if any additional energy had to be dissipated it would not take place via the passage of the rail through the throat of the terminal.

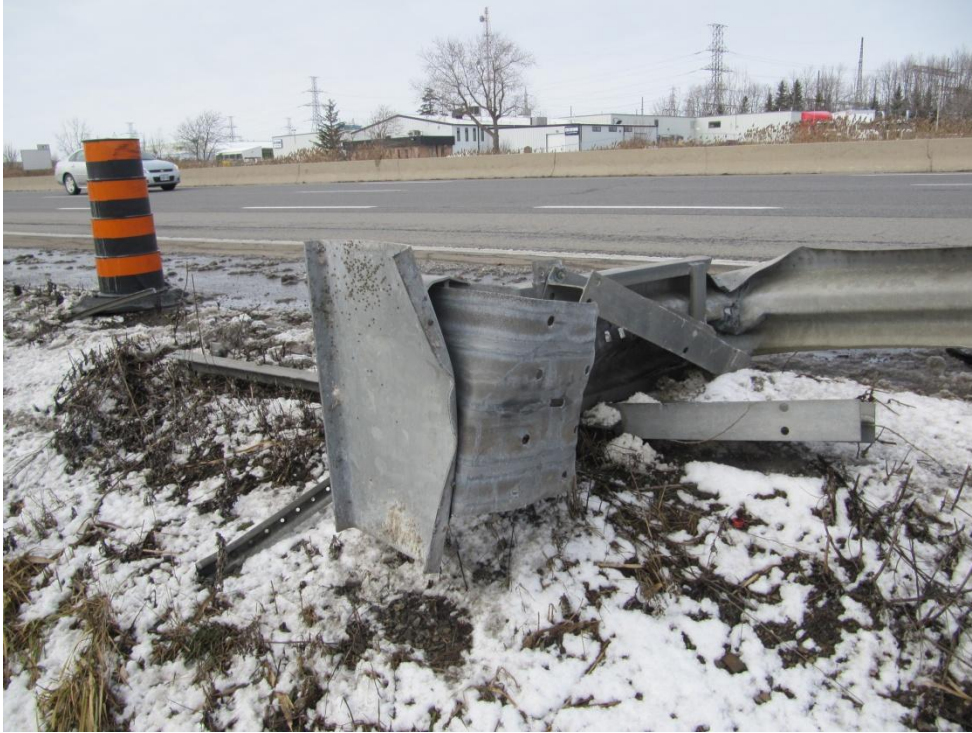
Figure 4: View of the deformed end plate of the ET-Plus terminal and the short length of the rail that has passed through the throat of the ET-Plus terminal.

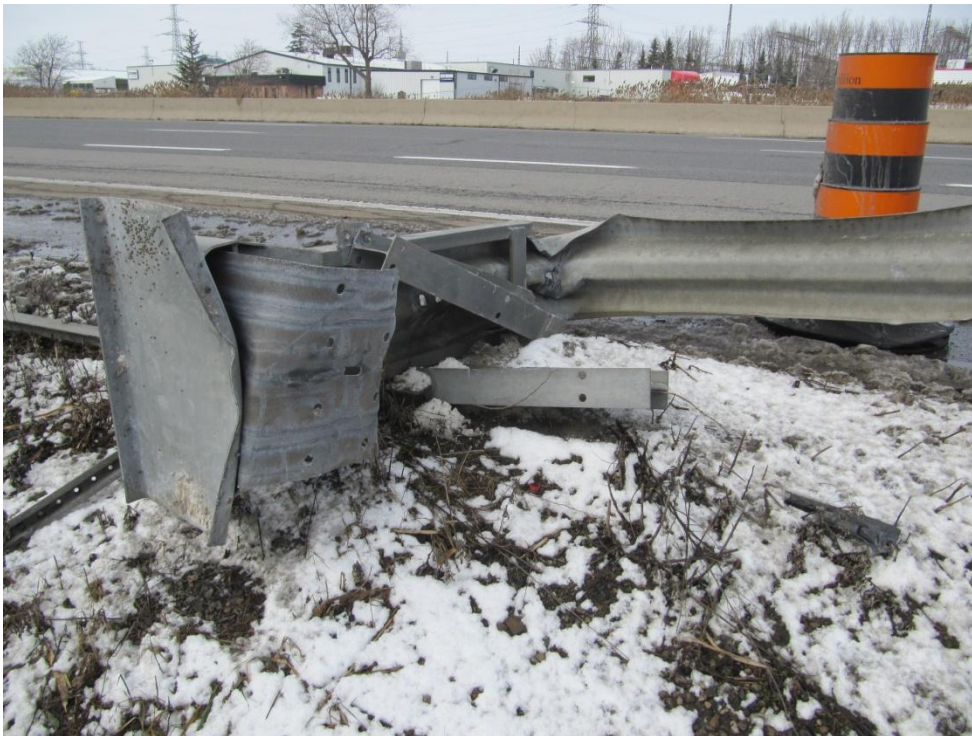
Figure 5: View of the ditch side of the terminal showing the short length of the rail that passed through the throat thus demonstrating the small amount of energy that was dissipated by this mechanism.

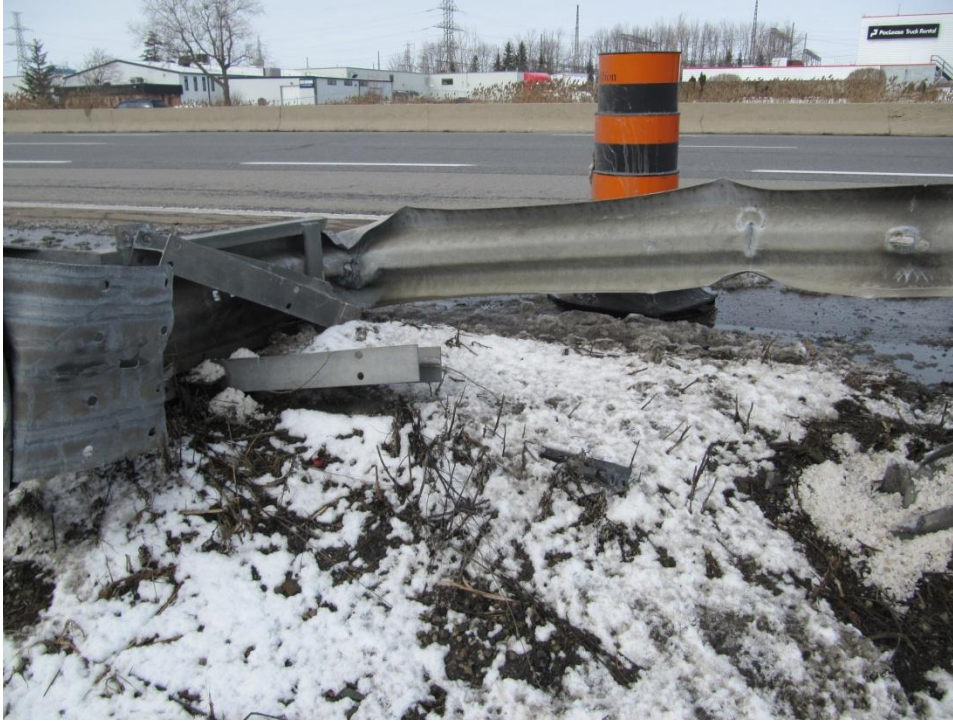
Figure 6: View showing the portion of the rail just behind the rear edge of the terminal. An obvious downward buckling of the rail exists at the rear of the terminal demonstrating that no additional length of rail would pass through the terminal.

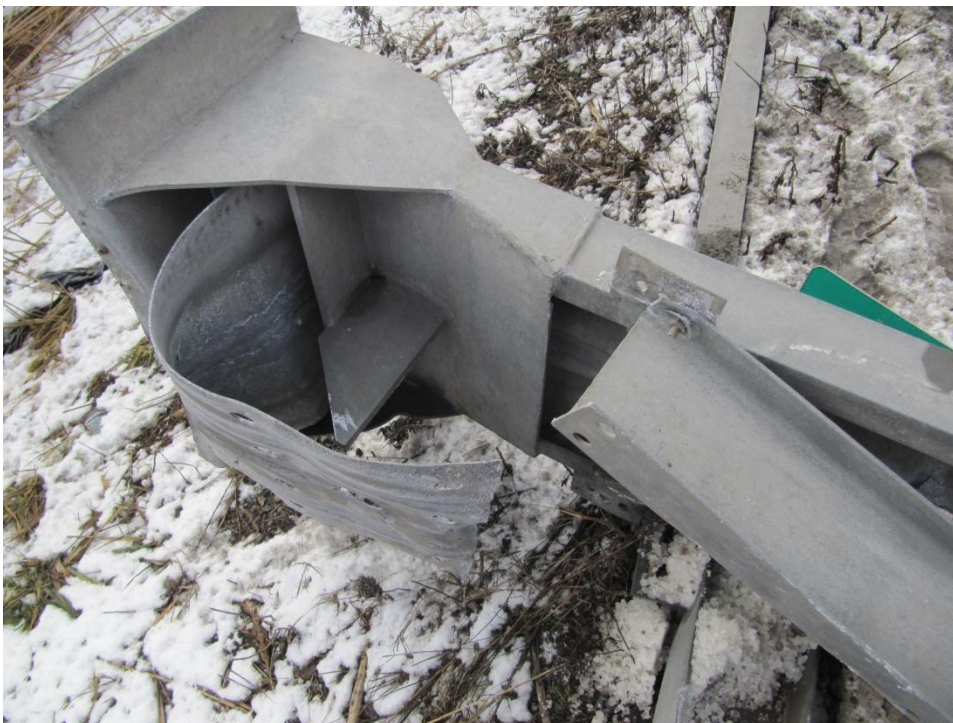
Figure 7: View looking down at the short length of rail that has been squeezed through the throat of the terminal. The flattening and coiling of the rail as it is squeezed through the narrow throat of the terminal is the mechanism that is shown to dissipate a large portion of the kinetic energy in controlled, compliance tests. Yet, in this real-life example that mechanism is largely nonfunctional.

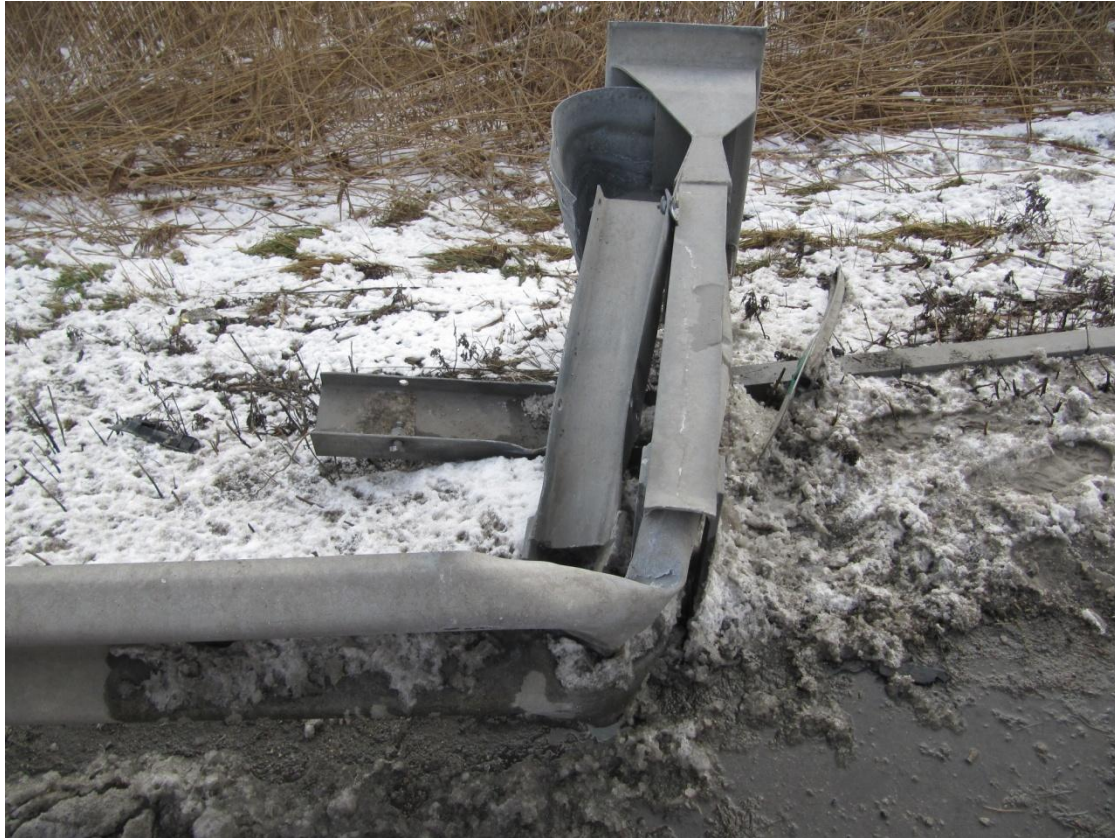
Figure 8: View showing how the terminal has rotated to a ninety degree angle with respect to the guardrail. Clearly no additional length of the rail could be expected to pass through the terminal.

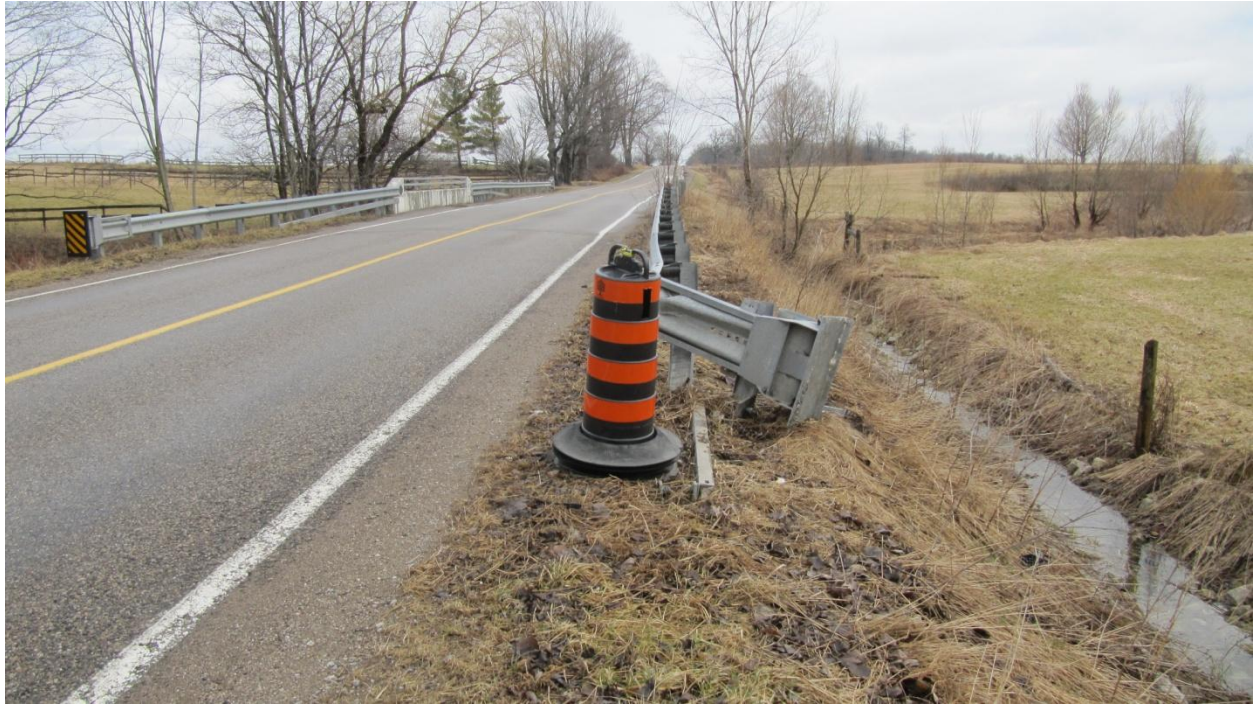
Figures 9 through 13 show how the ET-Plus terminal has been rotated to a position almost perpendicular to the length of the guardrail. The rail is buckled at the rear edge of the terminal such that no additional length of the rail is capable of passing through the terminal's throat. These Figures also show that there is almost no additional buckling of the guardrail in the distance south of the terminal thus this is not a high severity impact.

Figure 9: View looking south at the struck ET-Plus terminal on the west side of Wonderland Road.

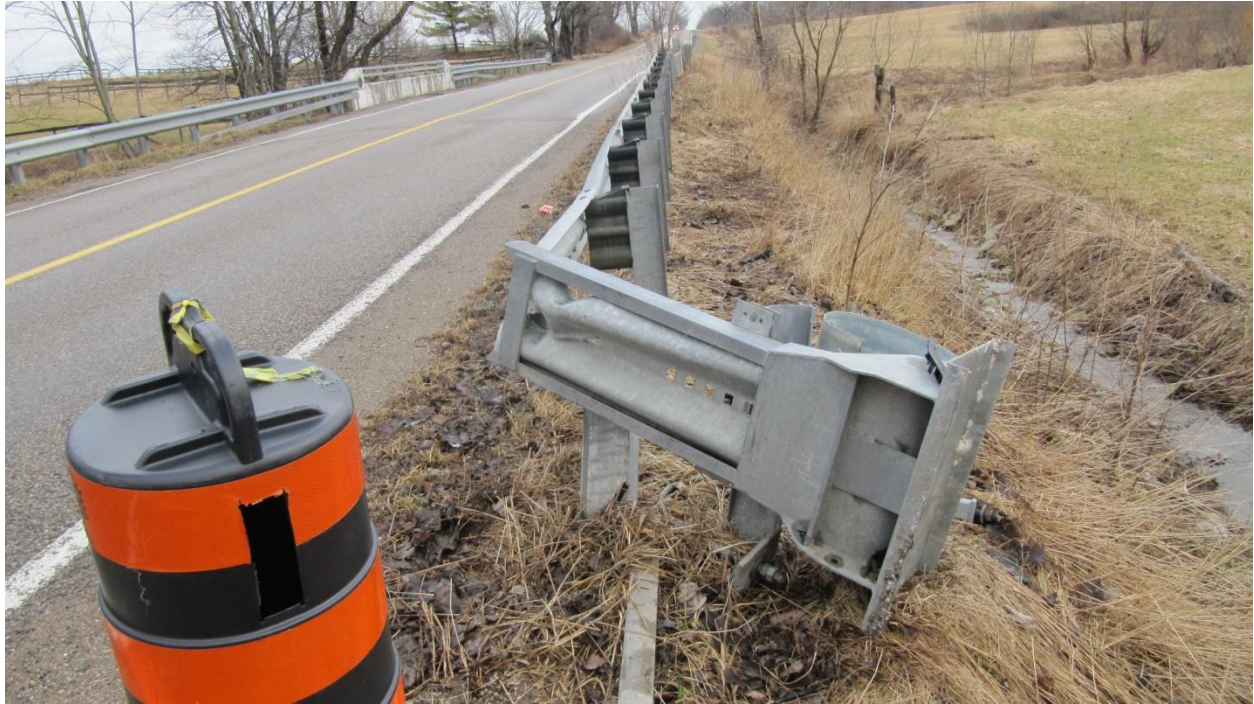
Figure 11: View, looking south, at the ET-Plus terminal which has been rotated allow to a ninety degree angle with respect to the length of the guardrail.

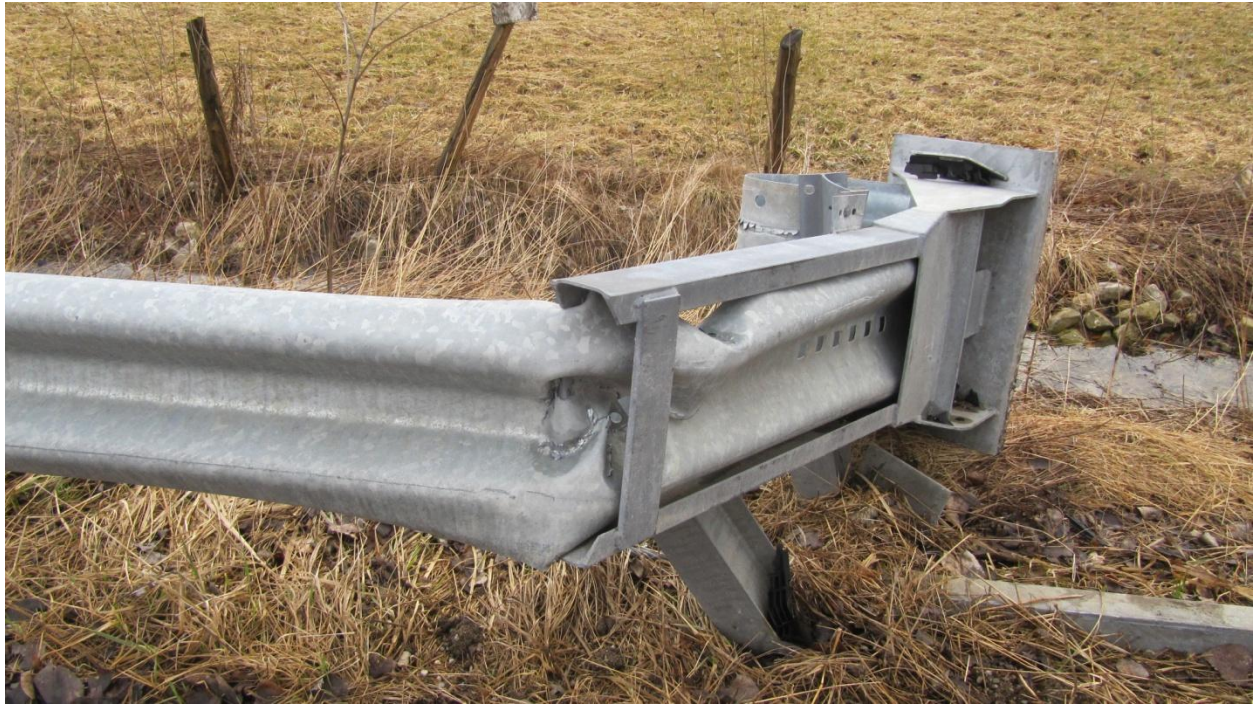
Figure 12: A view of the location at the back of the ET-Plus terminal where the guardrail has buckled thus not allowing any additional length to be squeezed through the throat of the terminal.

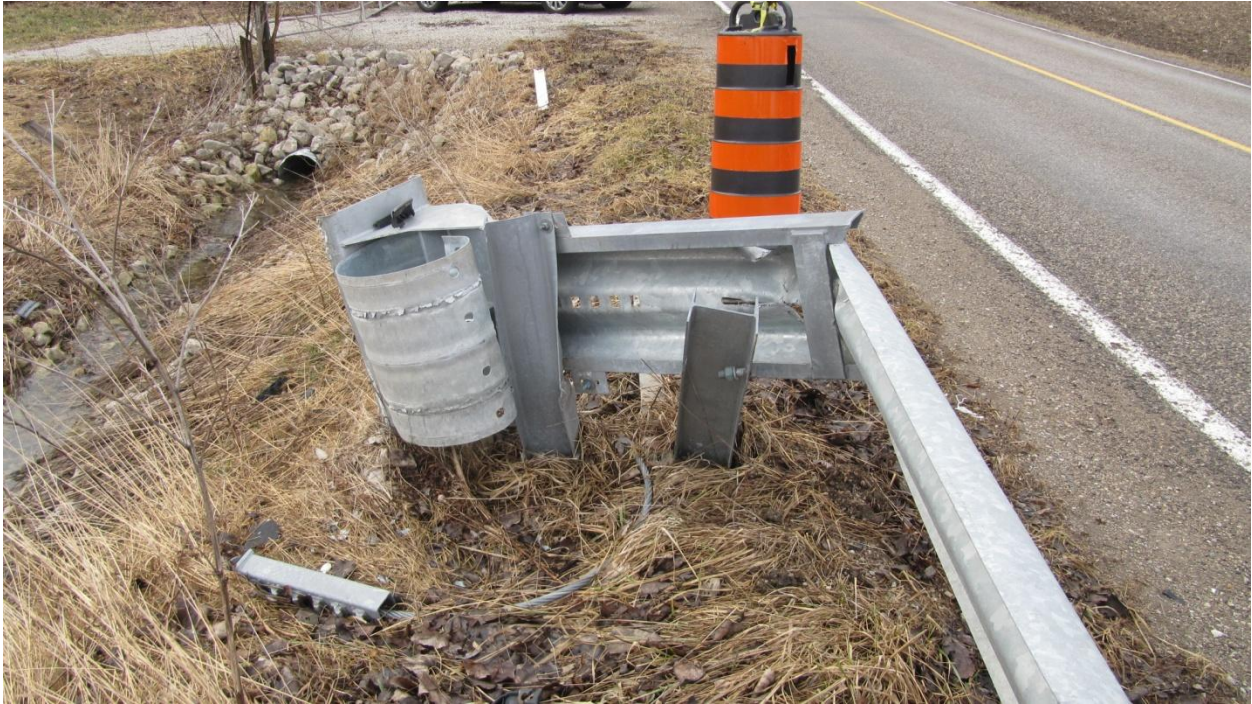
Figure 13: View, looking north, at the ET-Plus terminal which has been rotated almost ninety degrees preventing any further riding of the terminal along the rail and thus preventing any further energy dissipation by this mechanism.

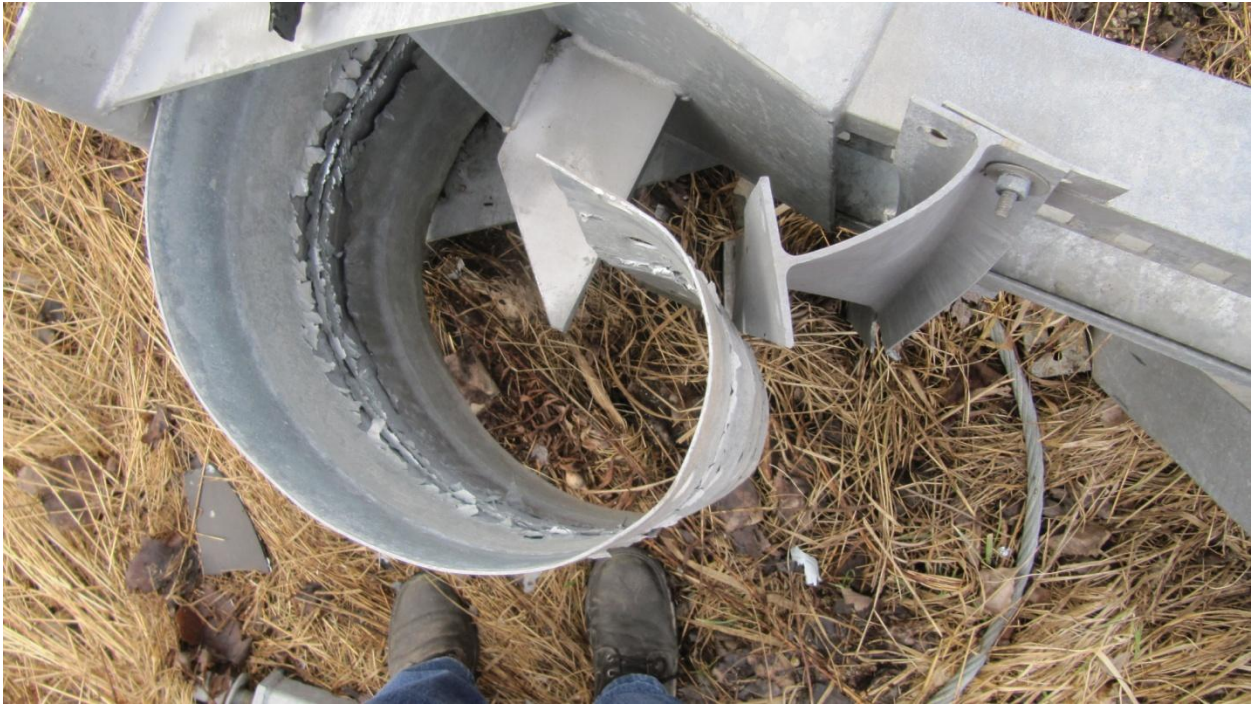
Figure 14 shows a view looking at the length of the rail that has been squeezed through the throat of the terminal. The measurement method shown in Figures 15, 16 and 17 indicates that only 114 centimetres of the rail has passed through the terminal yet we observe that the terminal is already in an extreme state of rotation.

Figure 14: View, looking down, at the short length of guardrail that has passed through the throat of the ET-Plus terminal.

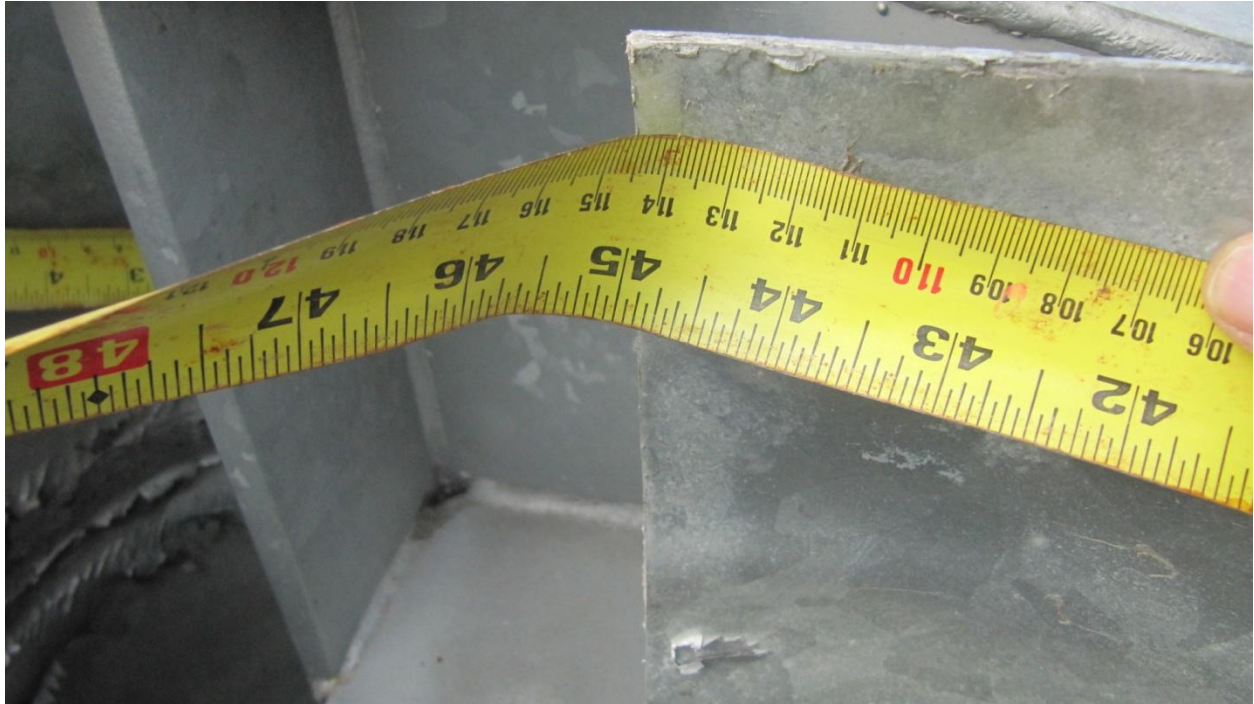
Figure 17: View of the end result of the measurement method shown in Figures 15 and 16, indicating that 114 centimetres of the rail had been squeezed through the throat of the terminal.

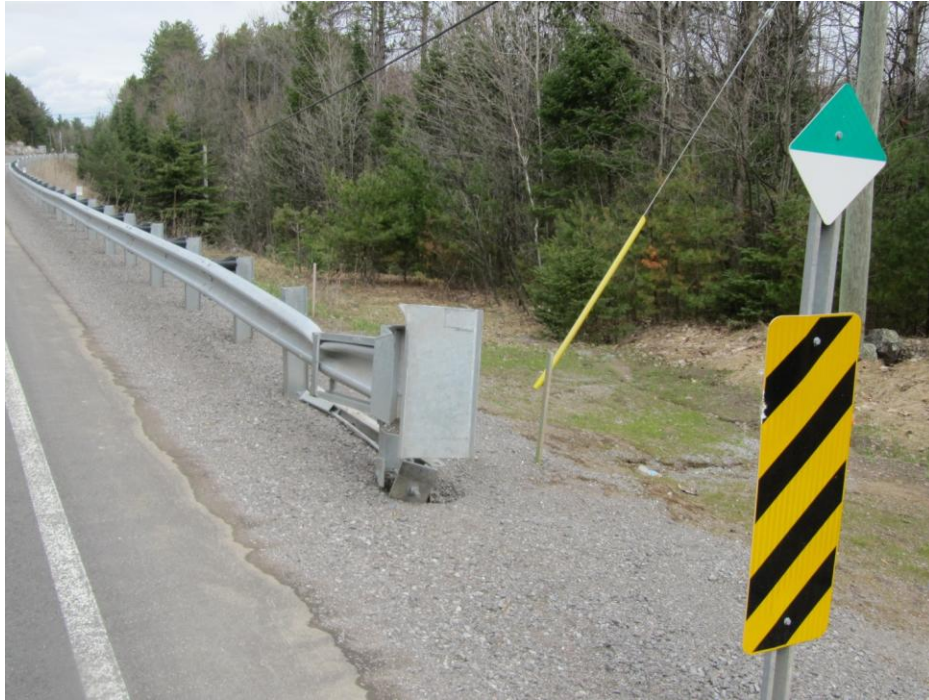
This scenario demonstrates a common method by which the ET-Plus terminal fails to perform in the manner shown in its compliance testing. Figures 18 through 21 show that the principal deformation of this installation is the dramatic impact of the rear edge of the channel onto the top edge of the guardrail. Figure 22 shows that only a very short length of the leading edge of the rail has passed through the throat of the terminal. Once the deformed portion of the rail reaches that throat the rail is likely to become jammed in the throat preventing any further dissipation of energy via that mechanism. Thus this impact has caused a significant deformation to the top edge of the rail **before** the terminal and channel have had a chance to slide along the rail and dissipate any significant energy. If the system was struck with greater severity it is highly unlikely that any of the rail could pass through the narrow throat of the terminal and that mechanism of energy dissipation would be nullified. This failure is not an isolated event as a number of previous incidents have shown the same failure mechanism. Previous incidents have shown this deformation of the top edge of the rail at very low severities of impact.

Figure 18: View, looking north, at the impacted ET-Plus terminal located on Highway 28. Note that there is very little evidence of damage yet there a major buckling of the guardrail just at the back of the terminal channel.

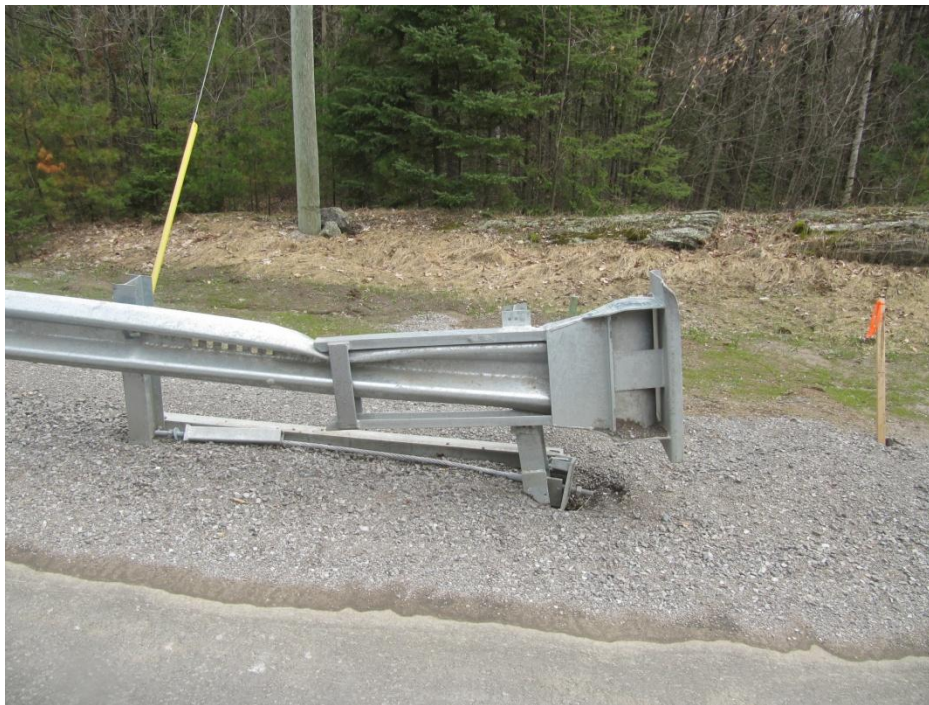
Figure 19: View of the impacted terminal showing that the plate has been rotated upward while the rear of the channel has been rotated downward onto the top edge of the guardrail causing the significant deformation in the rail.

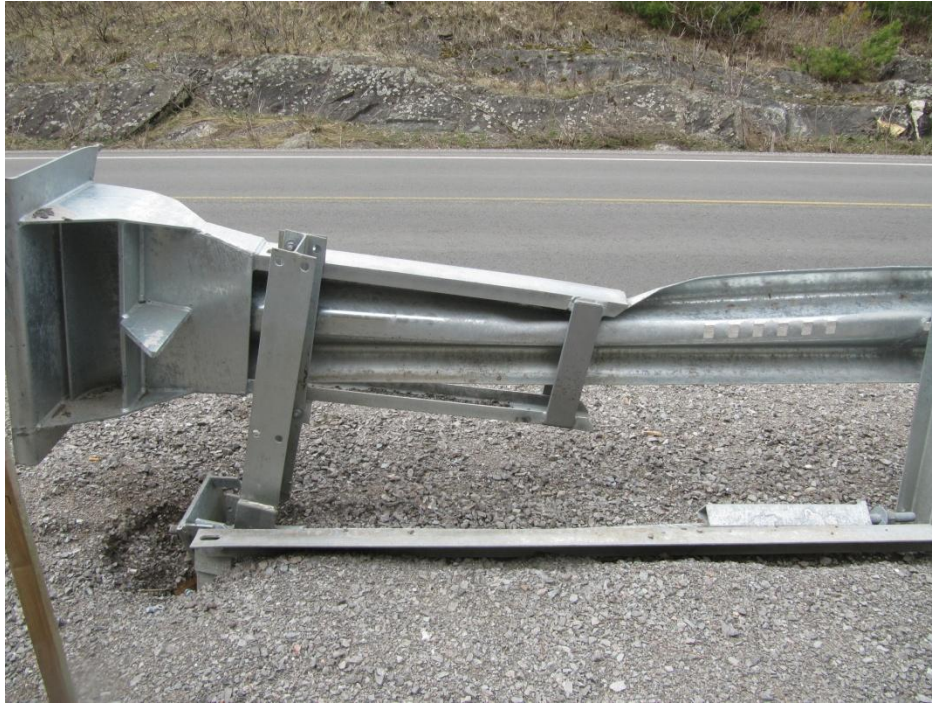
Figure 20: Ditch side view of the impacted terminal. This view illustrates the common manner in which the rear edge of the terminal channel impacts the top edge of the rail causing the rail's deformation.

In one of the instances (Incident #3:Highway 28) the impact was not as severe and a common problem was evident: that the rear edge of the terminal channel came down onto the top surface of the guardrail and deformed the rail before the rail reached the throat of the terminal. This is not an isolated incident but it has been documented by Gorski Consulting in previous incidents. This prior deformation of the rail could be one way in which the rail becomes jammed in the throat of the terminal thus preventing the terminal and channel from riding on the rail while also preventing the rail from being squeezed through the throat of the terminal as it is designed. This mechanism of failure is unlikely to be detected in higher severity impacts because of the magnitude of the resultant deformation which hides the progress of that failure.

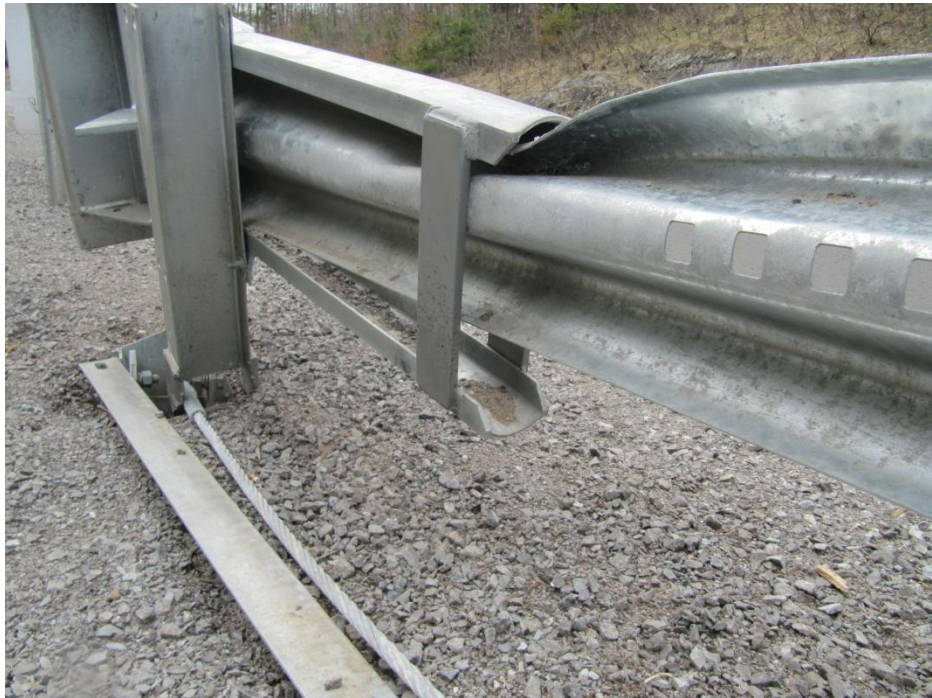
Figure 21: View of the rear edge of the terminal channel and the extent of the deformation to the top of the guardrail. The deformation of the rail prevents it from passing through the throat of the terminal and thus jamming which prevents the energy from being dissipated in the manner that is demonstrated in the controlled compliance tests.

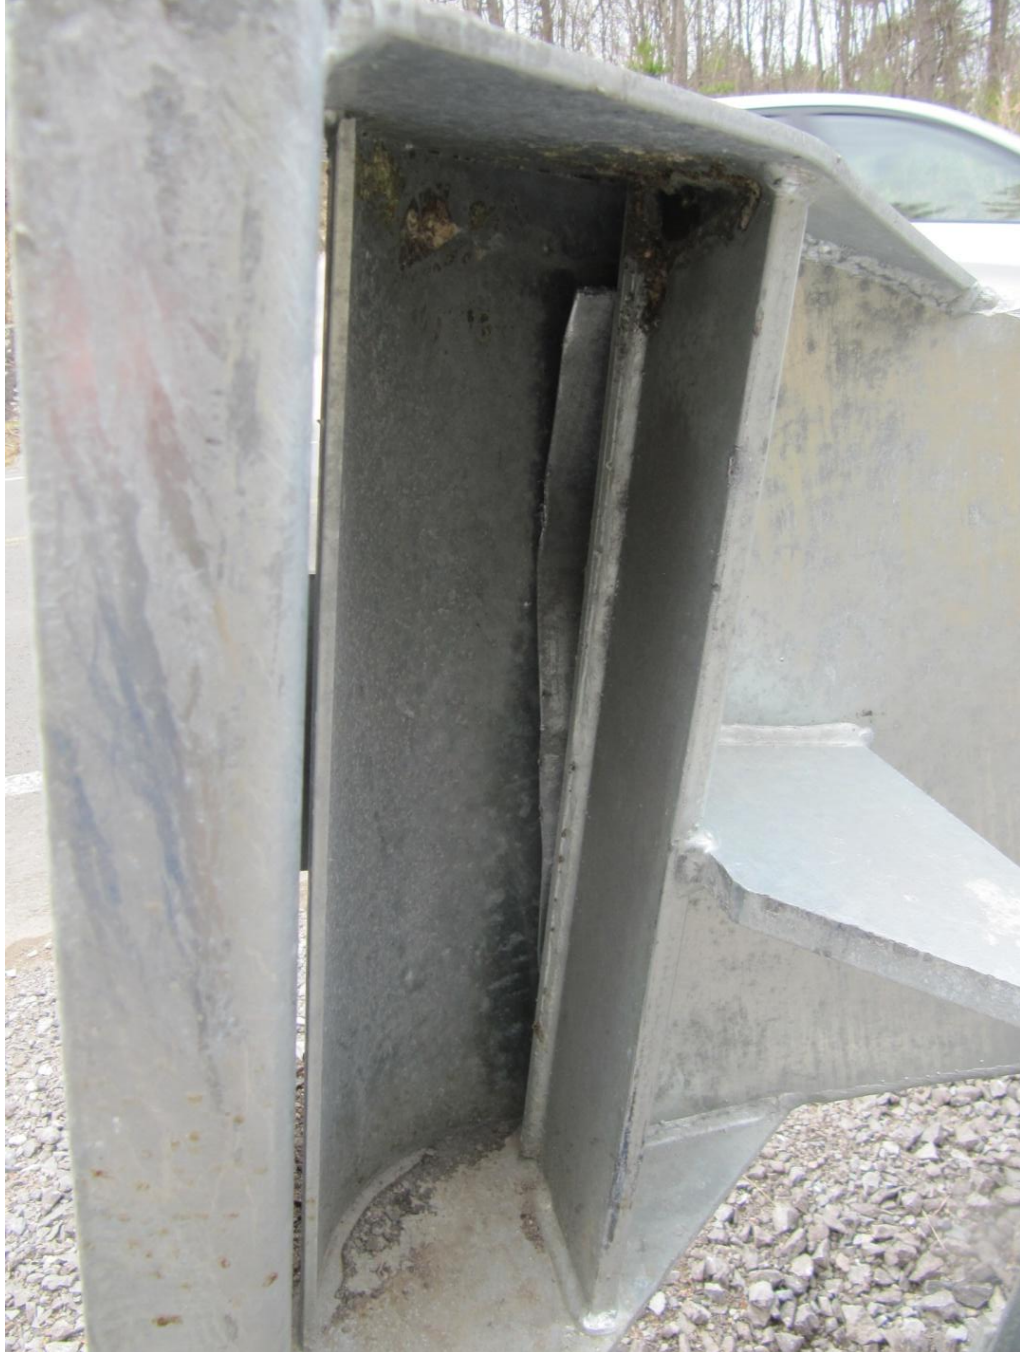
Figure 22: Close-up view of the throat of the terminal showing a very short portion of the leading edge of the rail beginning to be squeezed through the narrow throat. With the deformation of the top of the rail there is little hope that any additional length of rail will pass through this narrow opening and thus the designed method of energy dissipation has failed.

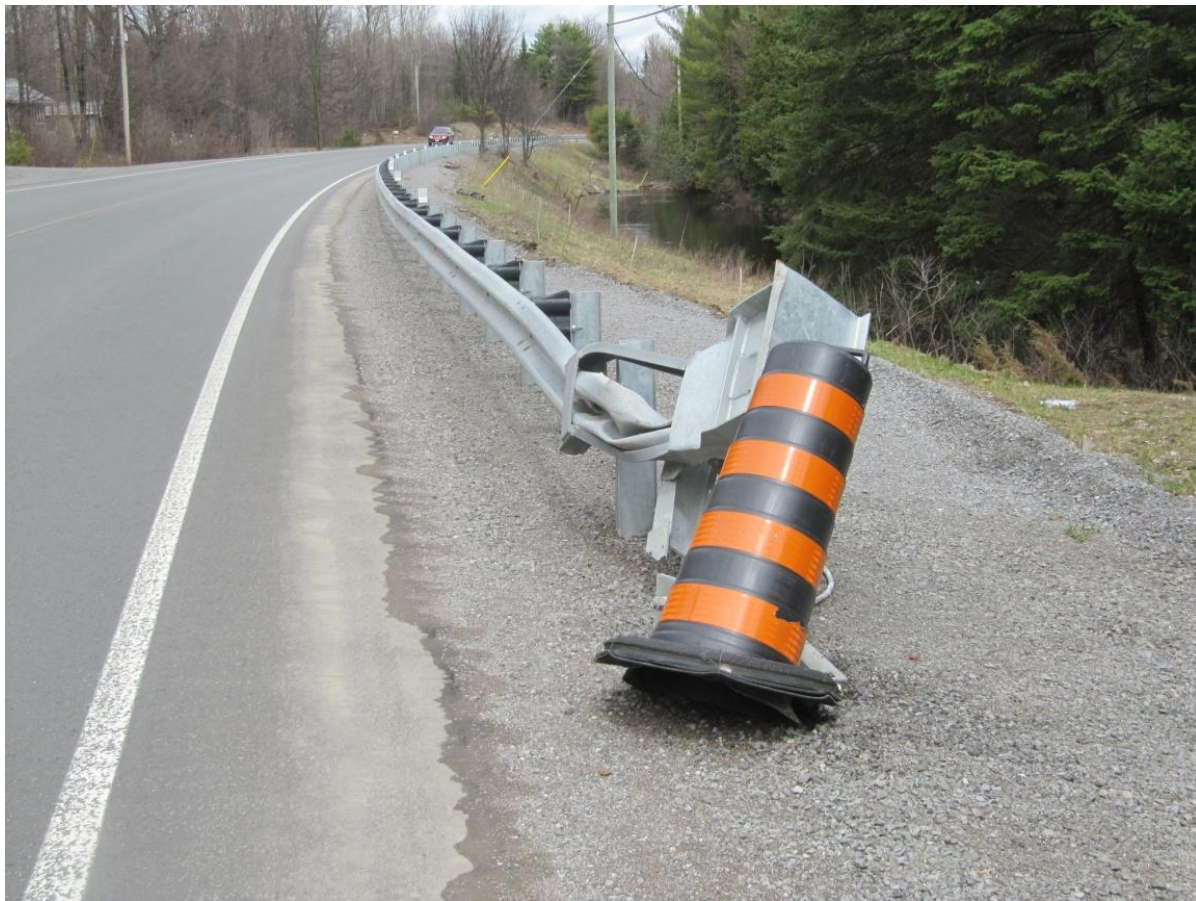
Figures 23 through 27 show how the terminal, channel and guardrail have all sustained major deformations yet there is only a small amount of rail that has managed to pass through the throat of the terminal. Thus a significant amount of energy was dissipated by the haphazard deformation of the system but not via the mechanism shown in the compliance testing. Obviously it cannot be known how the striking vehicle and its occupants fared in the event. However, if this incident resulted in benign injury consequences then it has to be concluded that the result would be by way of luck rather than by design. Such luck cannot be counted on in the overall scheme of preventing injury and death.

Figure 23: View, looking north at the damaged ET-Plus terminal on the east side of Highway 28.

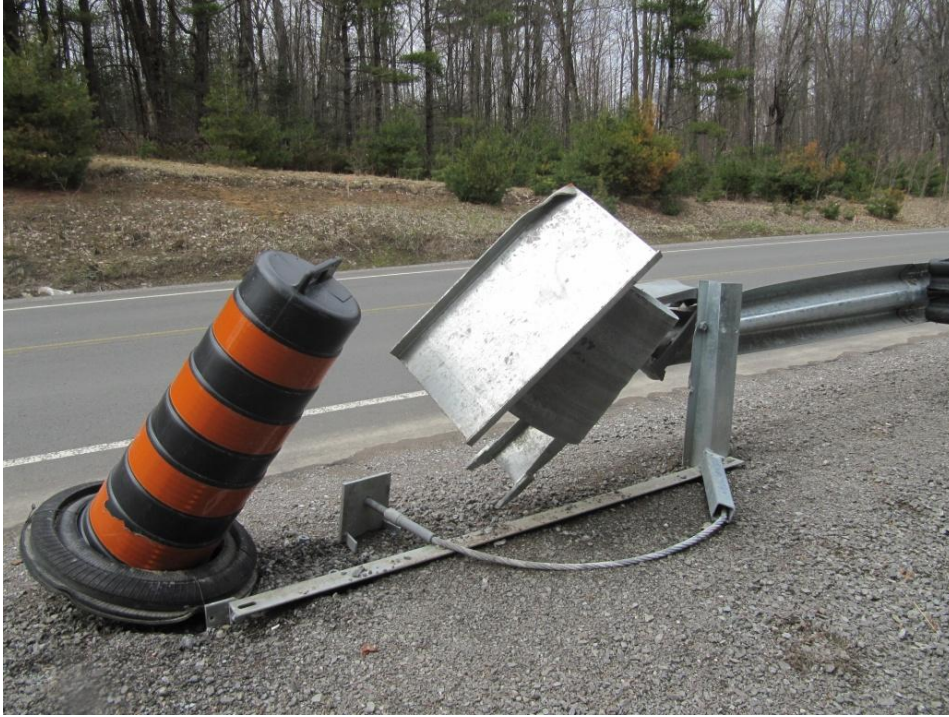
Figure 24: View showing that the terminal plate has been rotated upwards.

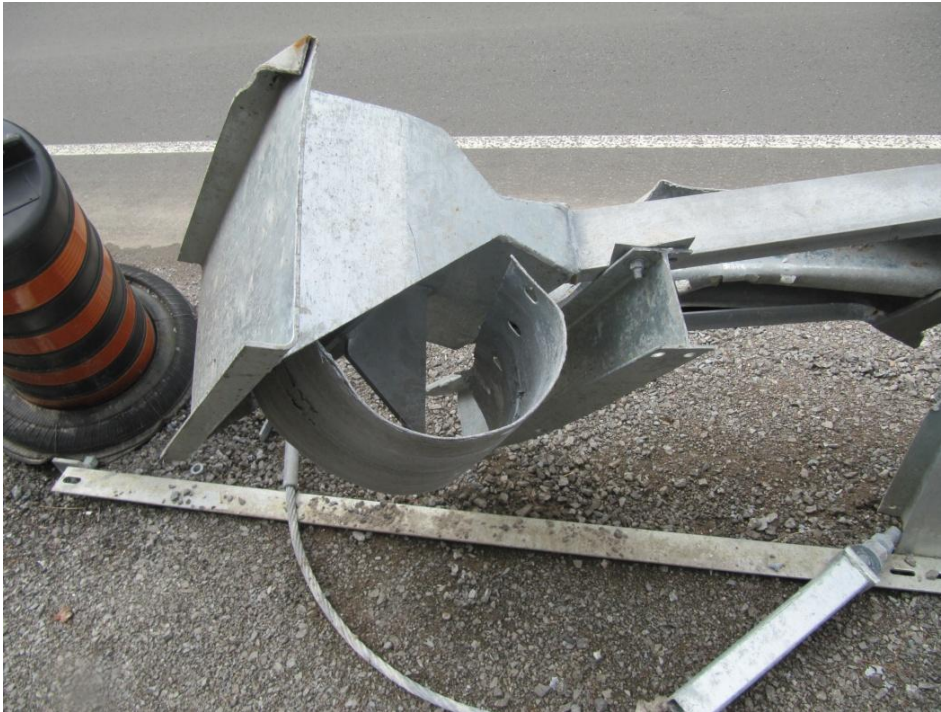
Figure 25: View showing that only a small length of the rail has passed through the throat of the terminal.

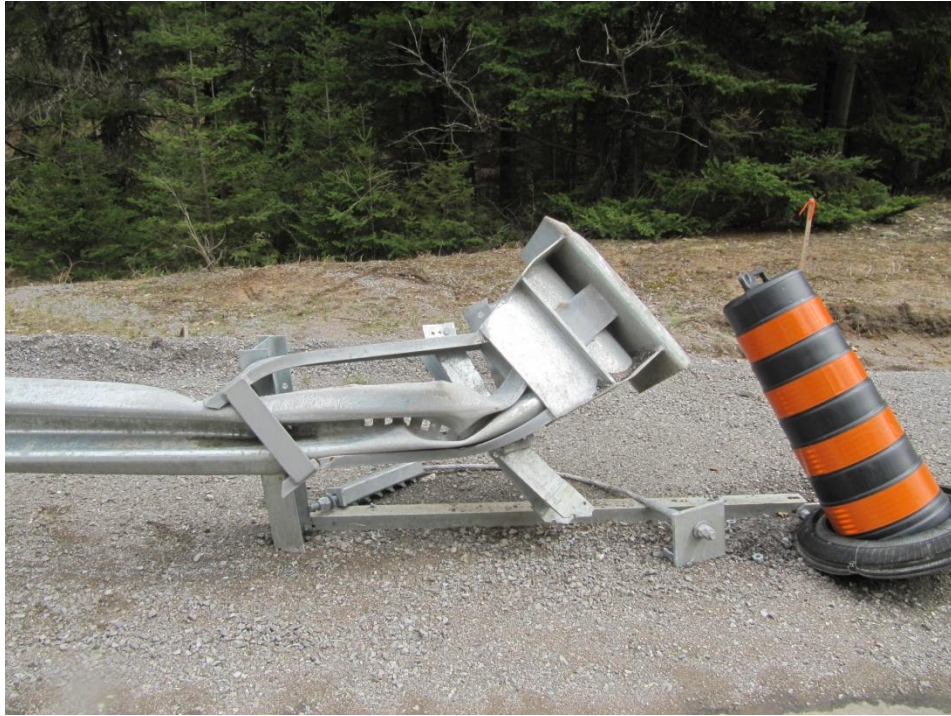
Figure 26: This view shows how the channel has been greatly deformed along with the rail within it.

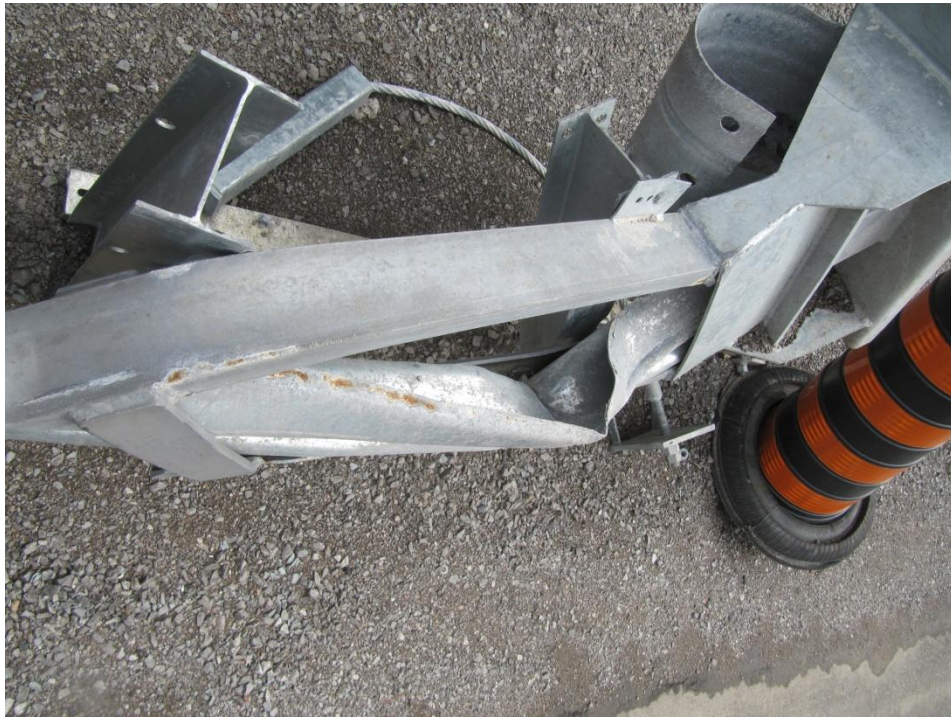
Figure 27: Top view showing that the guard rail is buckled within the channel.

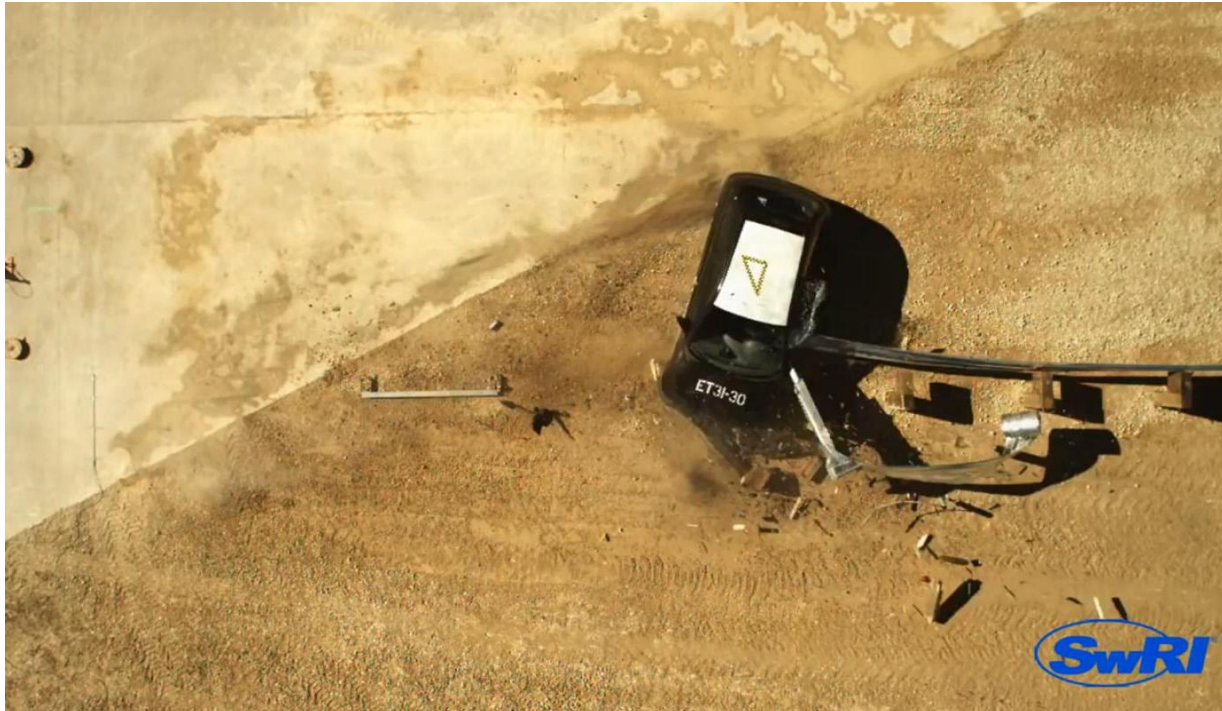
Figures 31 through 34 show the results of the compliance test as the Geo Metro rotates and the rail begins to buckle. Here we see that the rail forms a spear that penetrates the driver's side door and enters into the driver's seating space. This is an obvious injury producing consequence whose consequences to a live driver in a real-life collision could be potentially fatal if the wrong set of factors is assembled.

Figure 33: The rail doubles over just behind the terminal forming a spear that penetrates into the driver's door.
