ET-Plus Terminal Impacts – Further Evaluation of Their In-Service Performance

Posting Date: 1-May-2017

In a previous Gorski Consulting article (“ET-Plus Terminal Impacts – Evaluation of Their In-Service Performance”), dated March 12, 2106, six instances of impacts of ET-Plus terminals were reported. The present article is a report on an additional 4 instances.

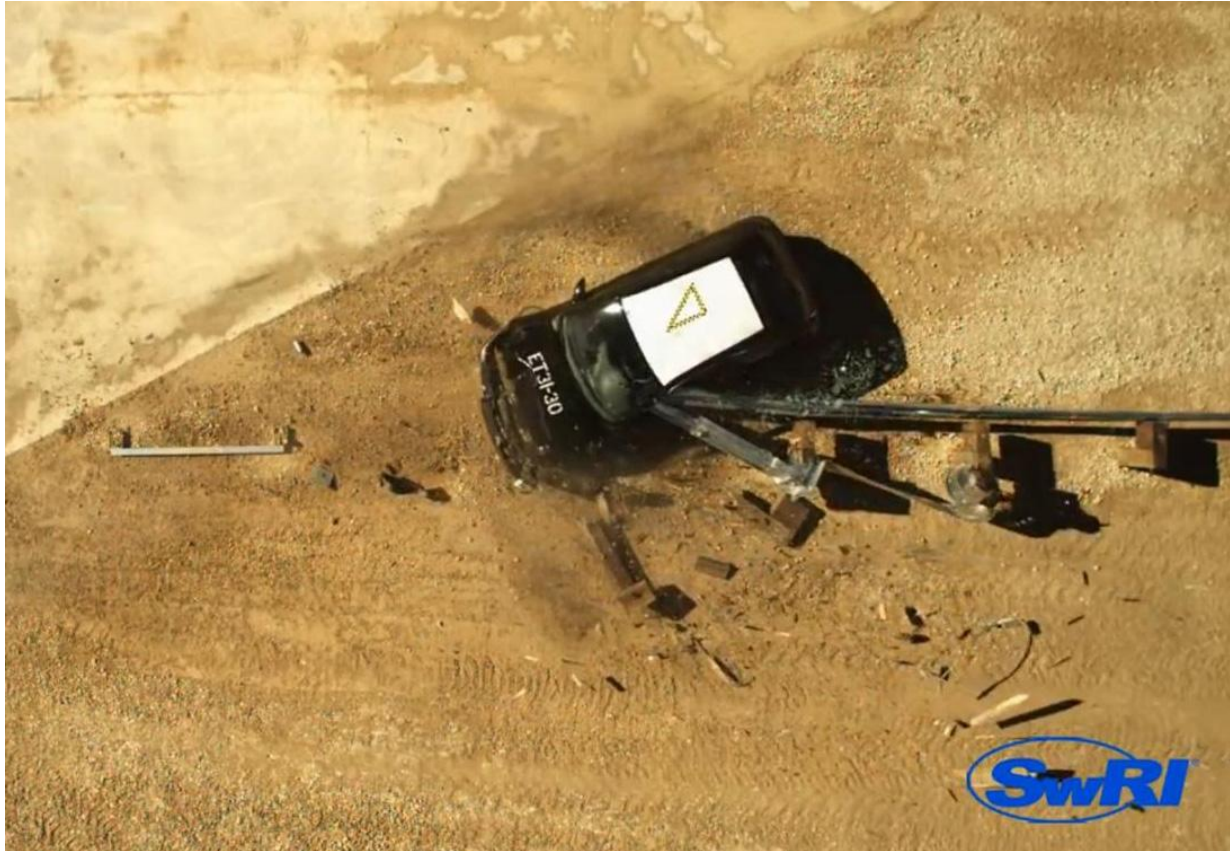
Figure 34: As the Metro continues to rotate the rail forms a spear that penetrates the driver's interior.
