Historical Patterns In Loss-of-Control Events At Specific Road Locations

Posting Date: April 2, 2018

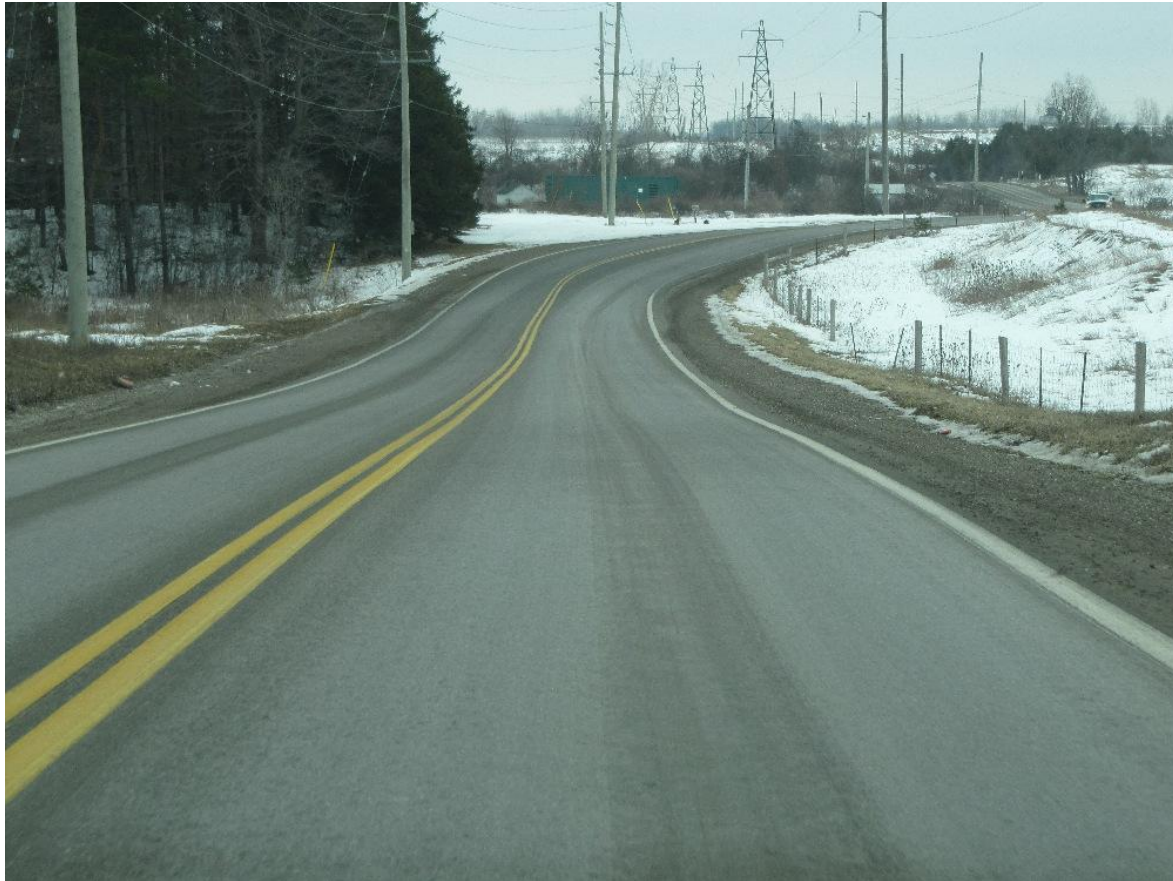
Figure 2 shows an overall view looking south from just north of the north curve. The horizontal curve to the right is also accompanied by a substantial vertical curve. Southbound drivers are travelling along a down-slope as they approach the right curve and then they also experience a rather abrupt upslope at the apex of the right curve. This results in a challenging experience for drivers who are not familiar with the geometry and especially when the road surface conditions are wet, snow-covered or icy.

Figure 2: View of the north curve of the S-curve, looking south, on March 6, 2013.

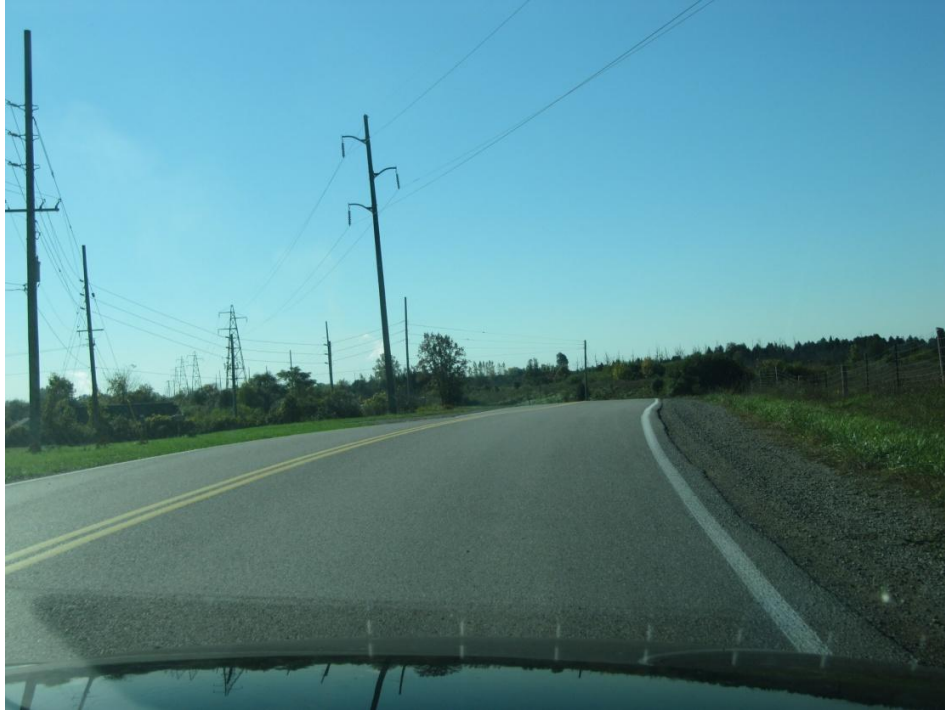
Figure 3 shows a driver's view as a southbound vehicle approaches the upslope at the north (right) curve. Drivers whose line of sight is at the level of a typical passenger car have a limited view of the road ahead at the apex of the curve yet they must navigate the curve to the right while experiencing the sudden change in vertical alignment.

Figure 3: View of the line of sight of a typical driver travelling southbound in a passenger car while passing through the north curve of the S-curve. *The view of the road ahead is limited.*

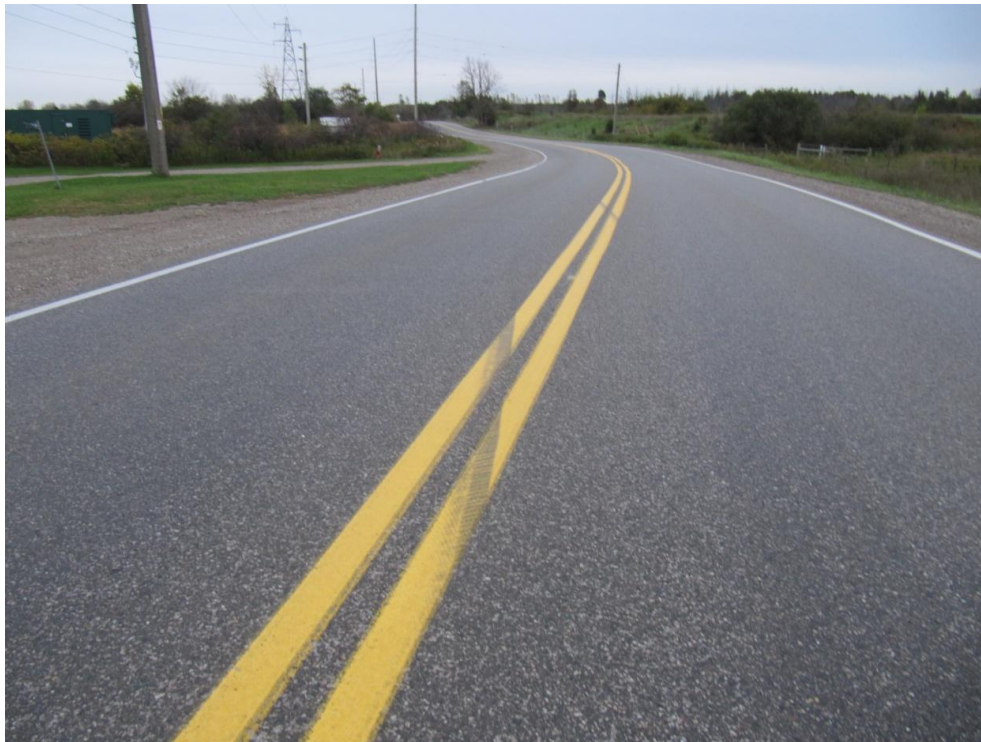
visible as the rotating vehicle crossed over the yellow centre-line as shown in Figure 6. It was not difficult from the characteristics of the yaw marks that the vehicle was rotating counter-clockwise as it entered into the opposing, northbound, lane. Figure 7 shows the tire marks of the vehicle as it passes through the east roadside and then travels toward a some bushes and a wire fence in the background. Figure 8 shows that the vehicle strikes a telephone junction box that has been subsequently wrapped in a red protective covering. The vehicle actually passed through the fence and bushes as shown in the backside (northward) view of Figure 9. Our further analysis of the police collision data revealed that this event was not officially documented in the police records. As such it is highly likely that the driver of this vehicle managed to extricate it from the roadside either by calling for assistance, or by removing the vehicle under its own power.

It can be noted that the first physical evidence of the yaw marks at the centre-line of the road indicated that the vehicle was already in an advanced stage of rotation. It has been our experience that the actual location where the driver would have encountered his/her difficulties that led to the loss-of-control was a substantial distance north of the visible yaw marks and most likely at the north curve. Rarely is it possible to confirm this conclusion based on the visible physical evidence alone.

Figure 6: View looking south at the black yaw marks produced by the southbound vehicle as its tires crossed over the paint of the yellow centre-line.

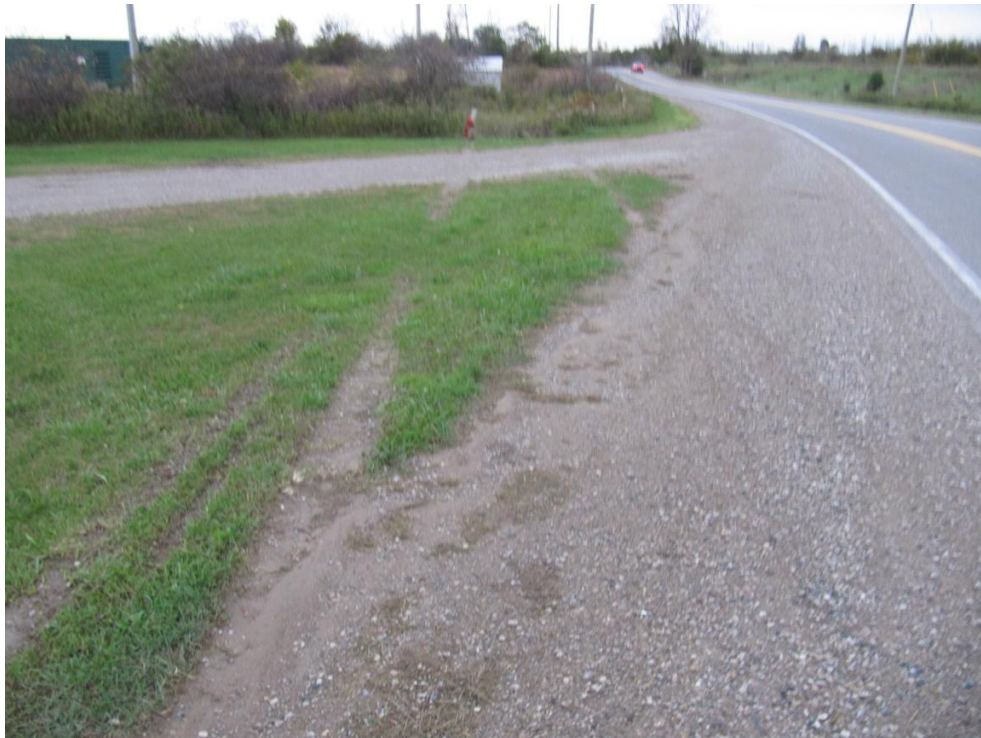
Figure 7: Tire marks in the grass of the east roadside show how the southbound vehicle progressed to line of bushes and wire fence in the background.

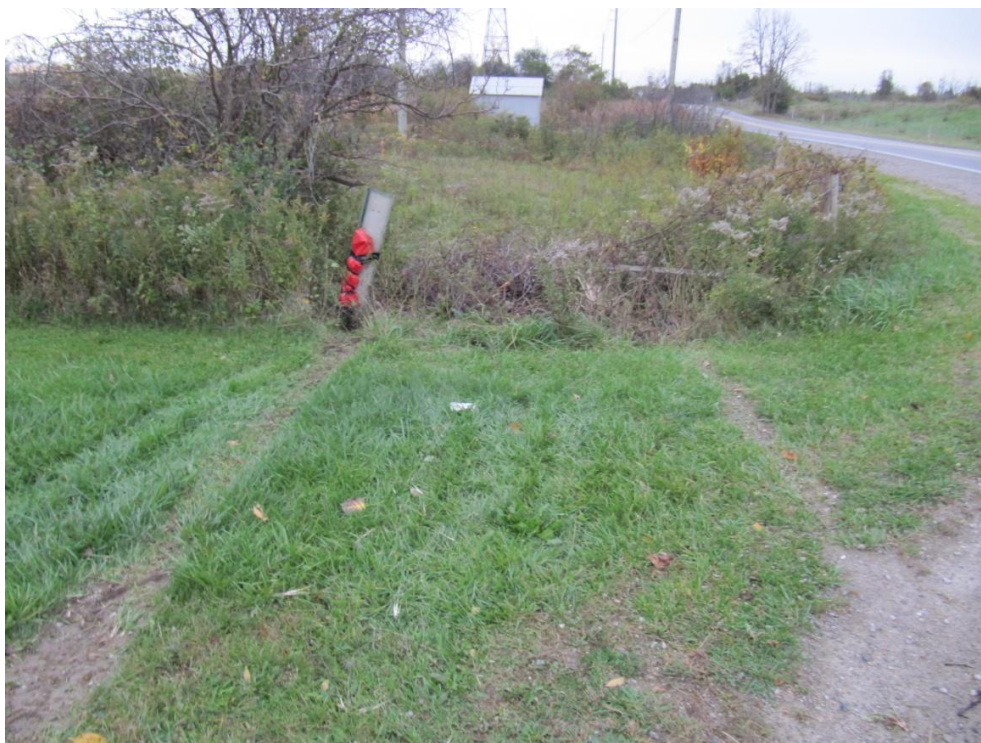
Figure 8: Tire marks show how the southbound vehicle drove into the bushes and fence and passed through these obstacles.

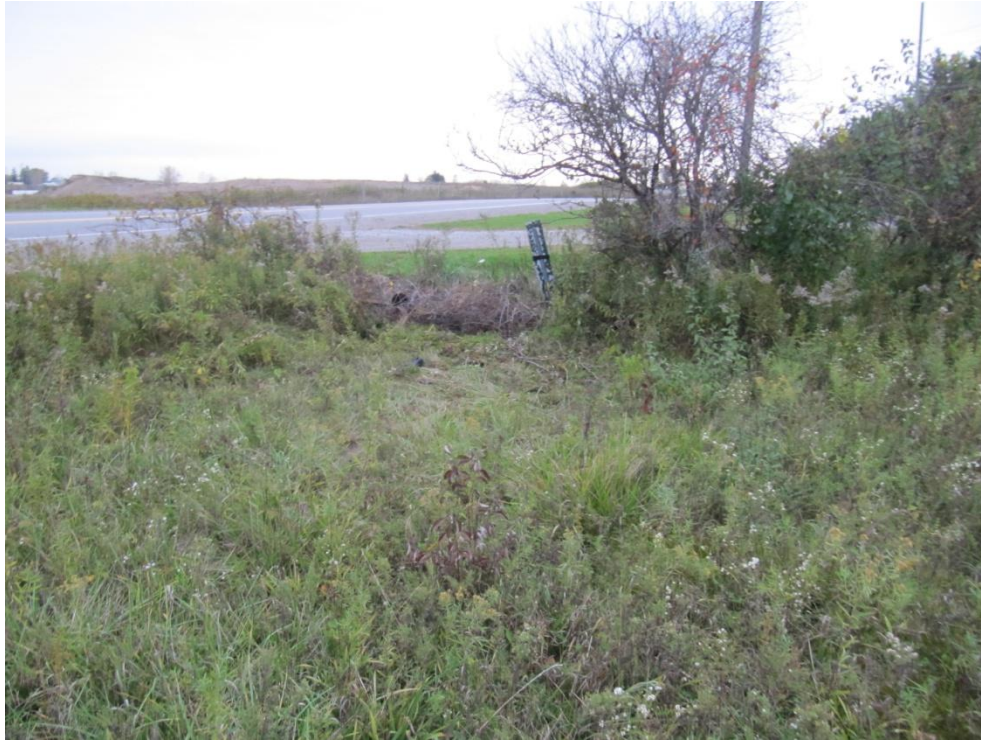
Figure 9: View looking back (northward) on the other side of the bushes and fence where the vehicle came to rest.

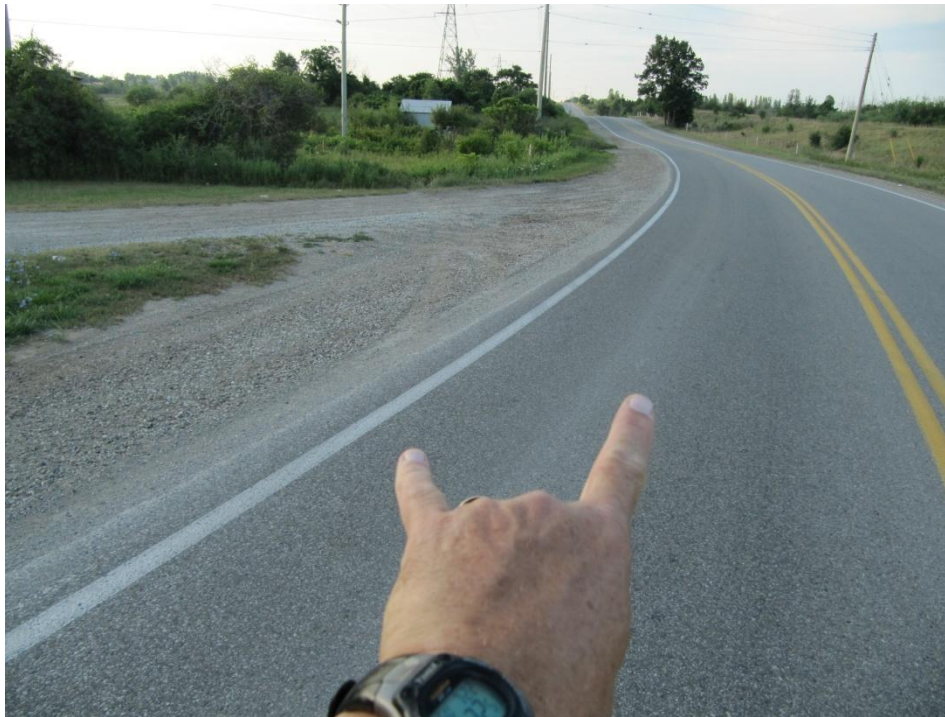
In this event the vehicle left the paved roadway at a substantial distance south of the north curve, similar to the facts of the first event described above. Figure 10 shows a view of the tire marks on the road however the investigator has to use two fingers to the show the location of the two tire marks because they are so faint.

Figure 10: View, looking south, with an investigator's two fingers pointing to the location of the faint, yaw marks indicating where the southbound vehicle exited the pavement.

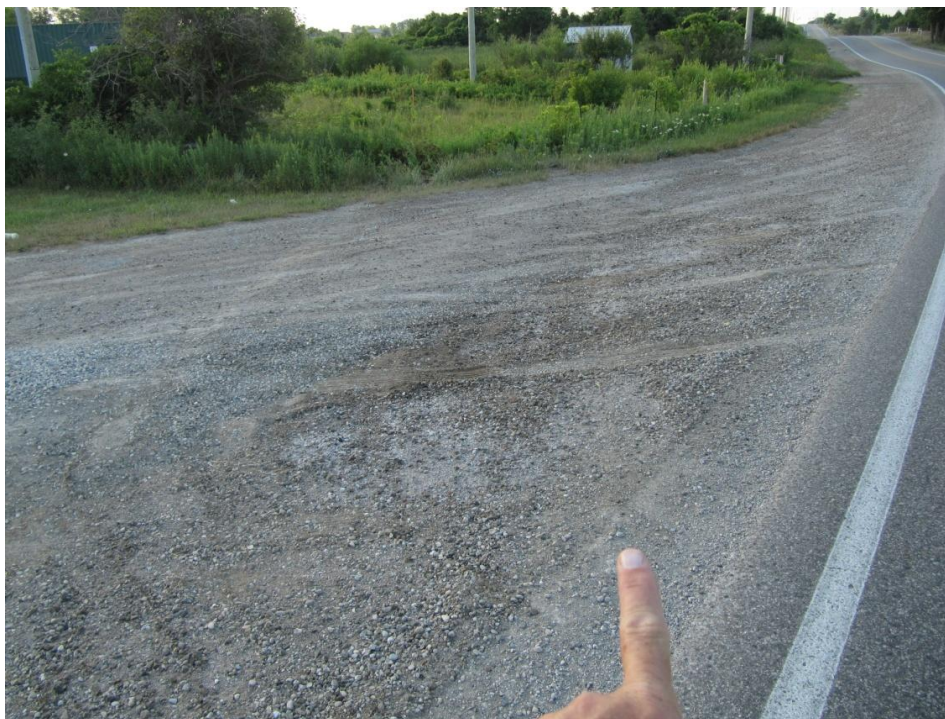
Figure 11 shows how the investigator uses another finger to point to one of the faint tire marks as the vehicle passes through the gravel of a driveway and then collides with some bushes and a wire fence in the background. The bushes and fence are only a few feet to the west of the impact area shown in first event described above.

Figure 11: View, looking south, with the investigator's finger pointing to one of the tire marks in the gravel driveway as the vehicle travelled toward the bushes and wire fence in the background.

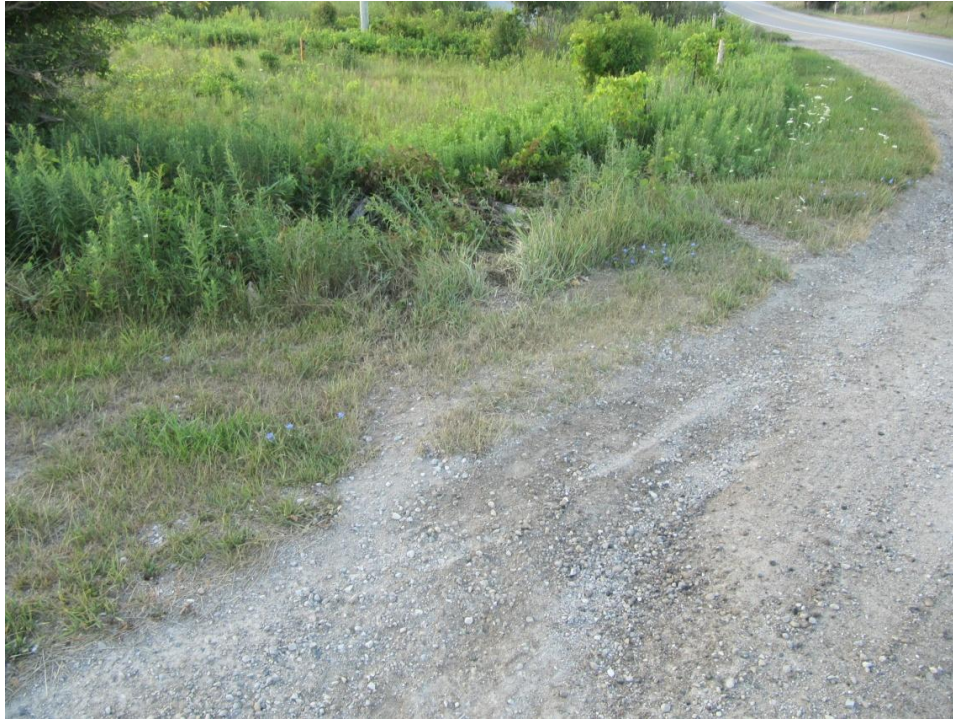
Figure 12: View of the tire marks in the grass as the southbound vehicle approaches the bushes and wire fence.

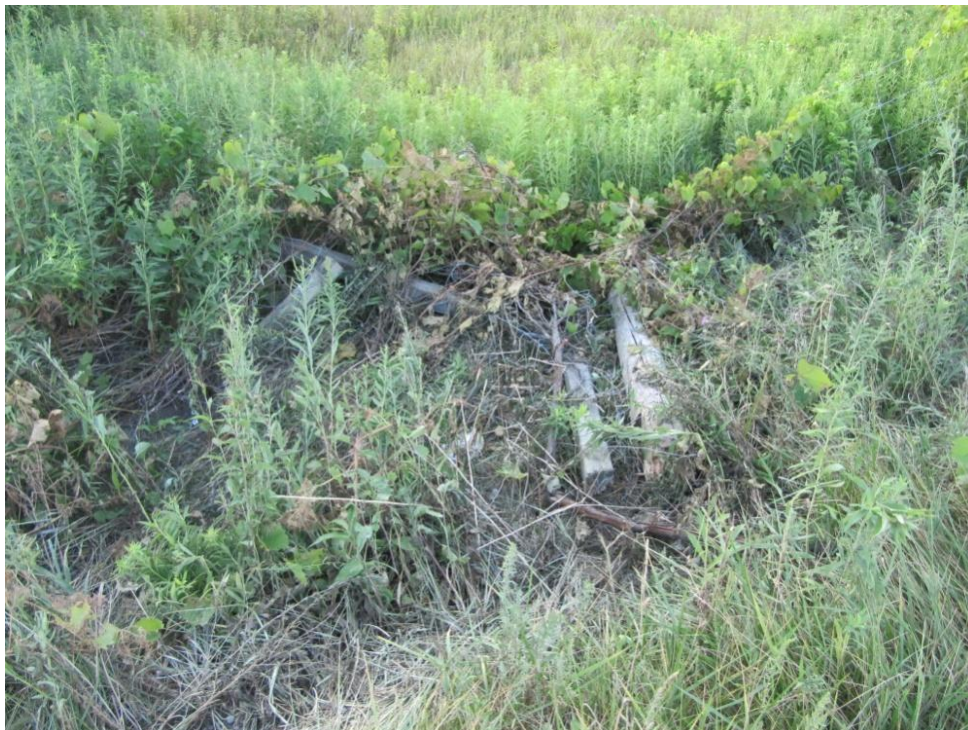
Figure 13: View of the wooden posts of the fence that were knocked over by the vehicle's contact.

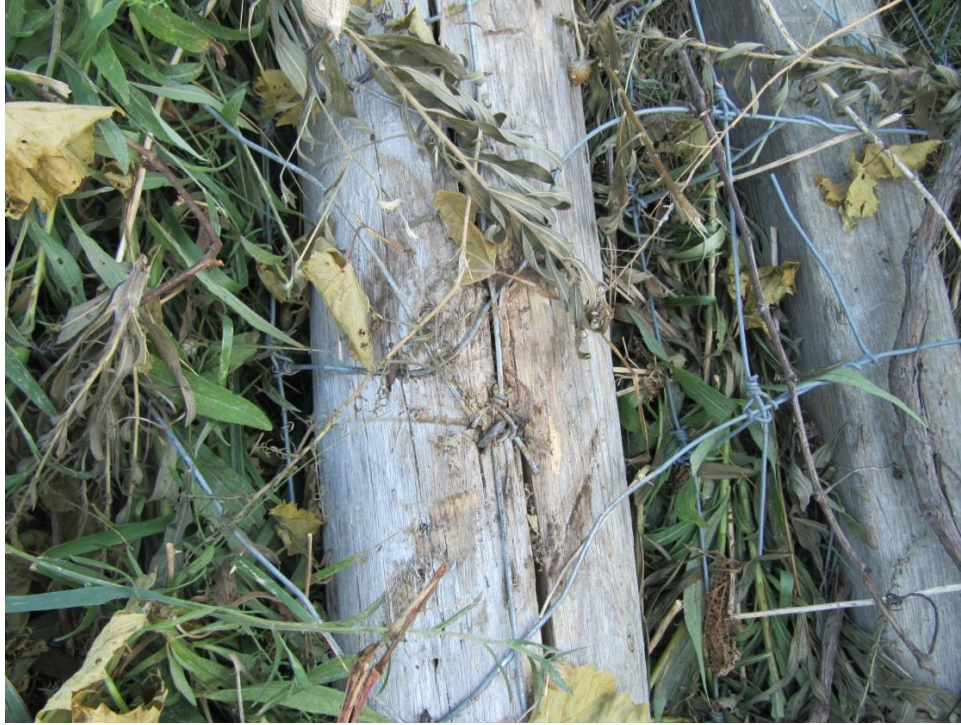
Figure 14: Close-up view of the fresh scrapes to one of the wooden posts cause by contact by the southbound vehicle.

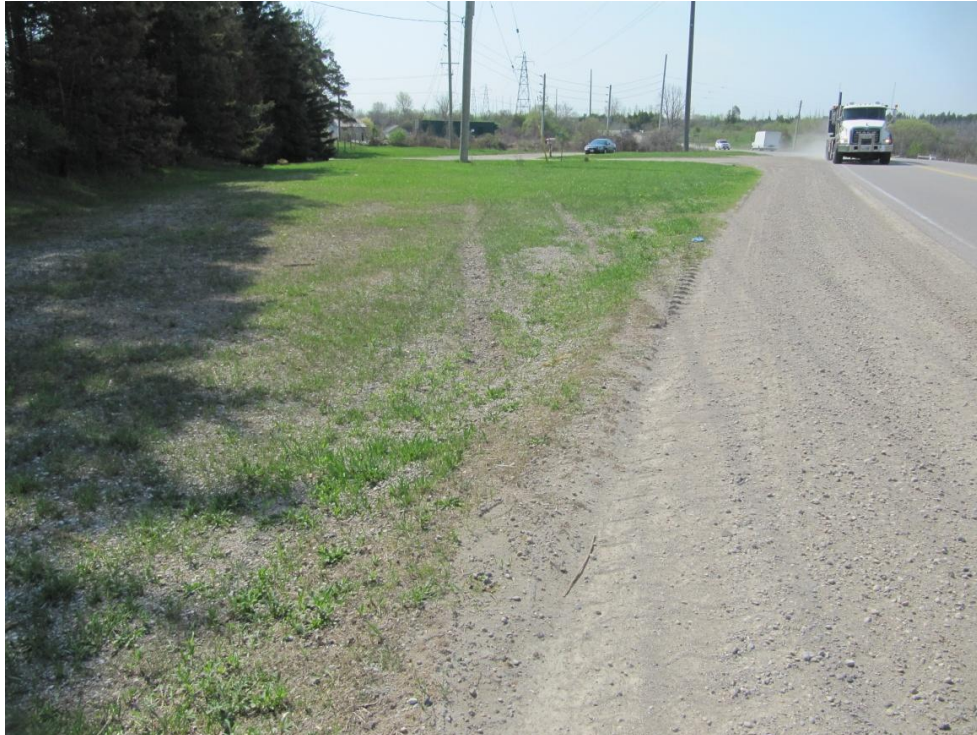
Figure 17 shows the tire marks that were detected on the east roadside just south of the north curve. These marks are not easily visible. This could be because they were created an unknown number of days before the date they were detected. This requires further explanation because it is an interested and valuable point.

Figure 17: View, looking south, at the faint tire marks in the grass on the east side of the road. The marks indicate minimal curvature and this could mean that the vehicle was either not rotating very quickly or it was travelling very quickly and therefore the rotation in a given distance would be small.

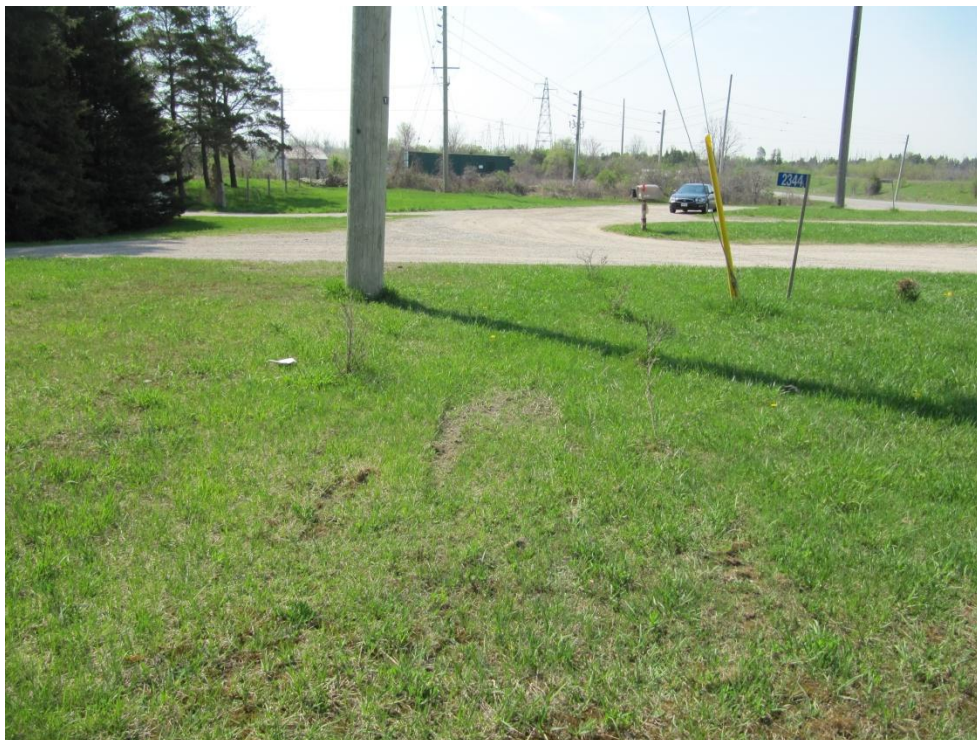
Returning to the discussion of this event, Figure 18 shows that we detected some evidence that indicated the vehicle passed between a utility pole and its guide-wire anchor.

Figure 18: View, looking south, at a disturbance in the grass indicating that the southbound vehicle passed between the utility pole and its guide-wire anchorage.

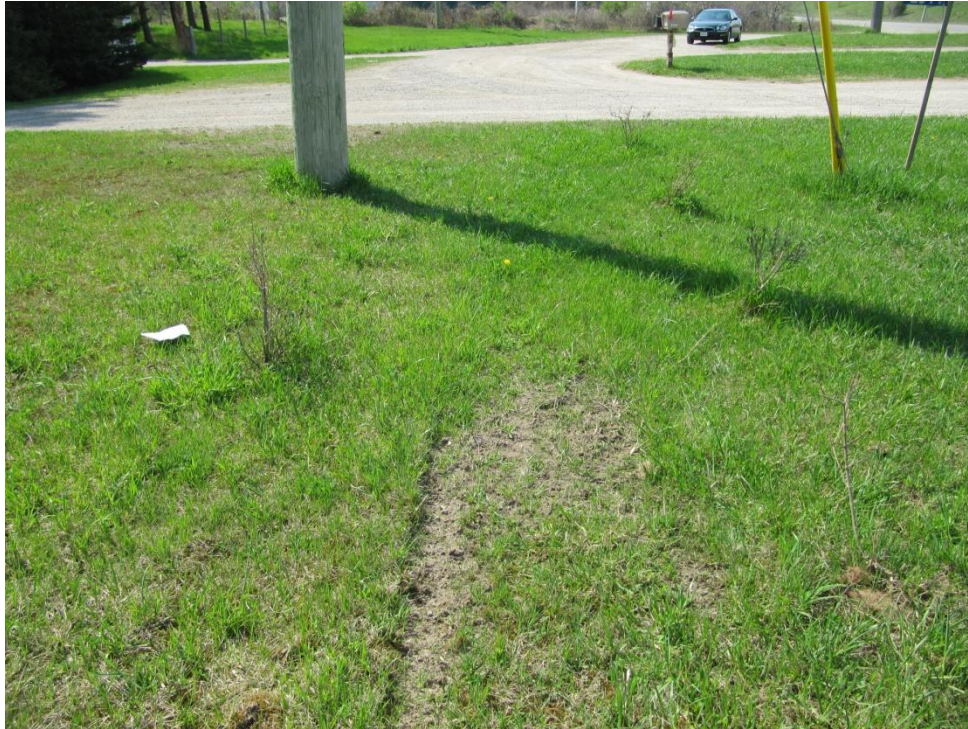
Figure 19 shows that, south of the utility pole the vehicle travelled over a long length of gravel. A gravel surface retains evidence for only a short time as vehicles passing over the gravel disturb the stones and sand. Thus, not seeing anything further, we suspected that the vehicle must have come to a halt somewhere within the gravel area. It did not occur to us to look further south because we had never observed a vehicle travel that far off the road. Even the tire marks in the grass, as shown in the northward view of Figure 20, seemed to disappear only a short distance after they commenced thus indicating the deterioration of the evidence.

Figure 19: Looking past the utility pole, the vehicle travelled over a long length of gravel. It is known that physical evidence is destroyed very quickly on a gravel surface.

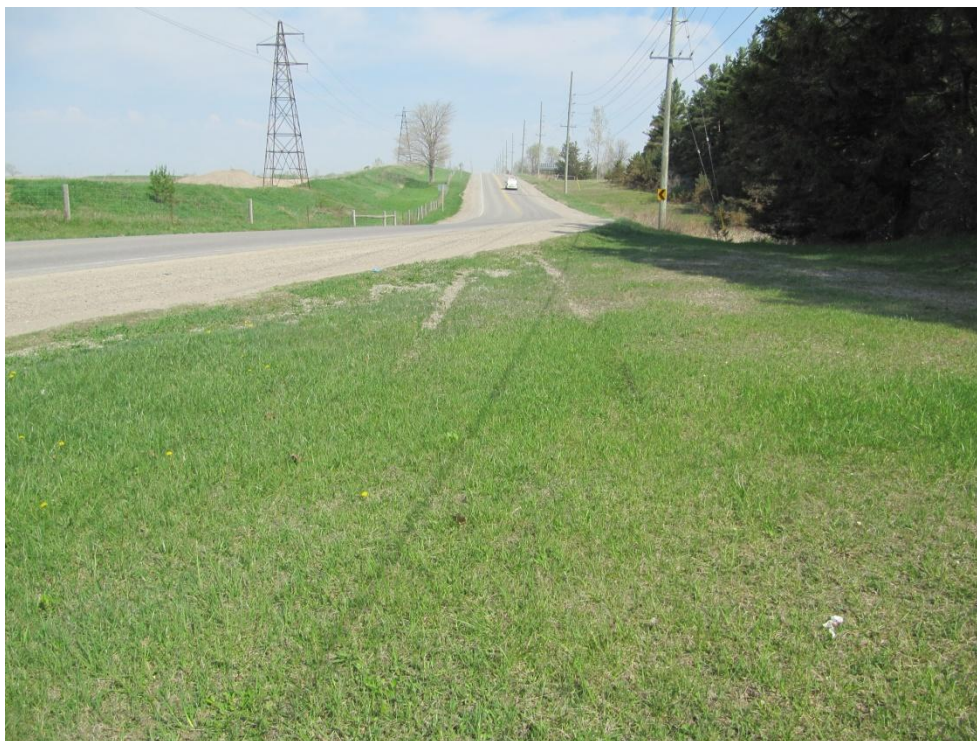
Figure 20: View, looking north, at the tire marks exiting onto the grass. The marks are no longer visible in the foreground indicating the deterioration of the evidence but also suggesting that the vehicle mass might have been partially lifted due to its speed.

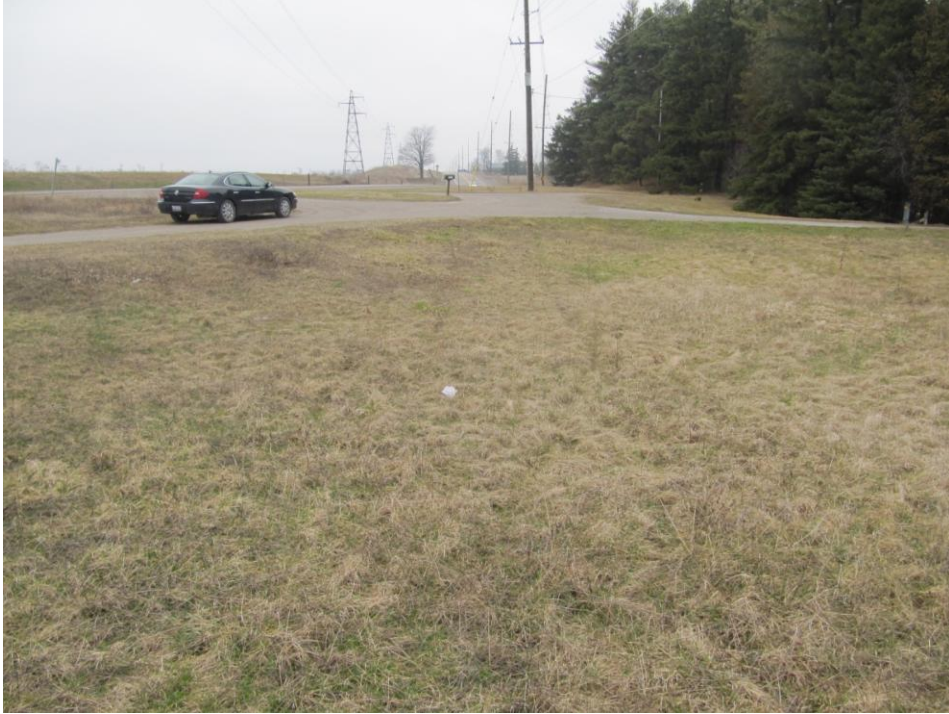
Figure 21 shows a northward view of the location of the tire marks from March 24, 2016 or about 10 months after the marks were first observed. One can still see the faint marks in the grass and this provides an indication of the persistence of some evidence marks that can be detected many months after an occurrence. This provides support for the belief that it would be possible to detect evidence of the collision in the area where we had previously failed to examine 10 months earlier near the south fence.

Figure 21: View, looking north, at the area in the grass where the tire marks were shown in Figure 21. If one looks closely the faint tire marks can still be detected in the grass.

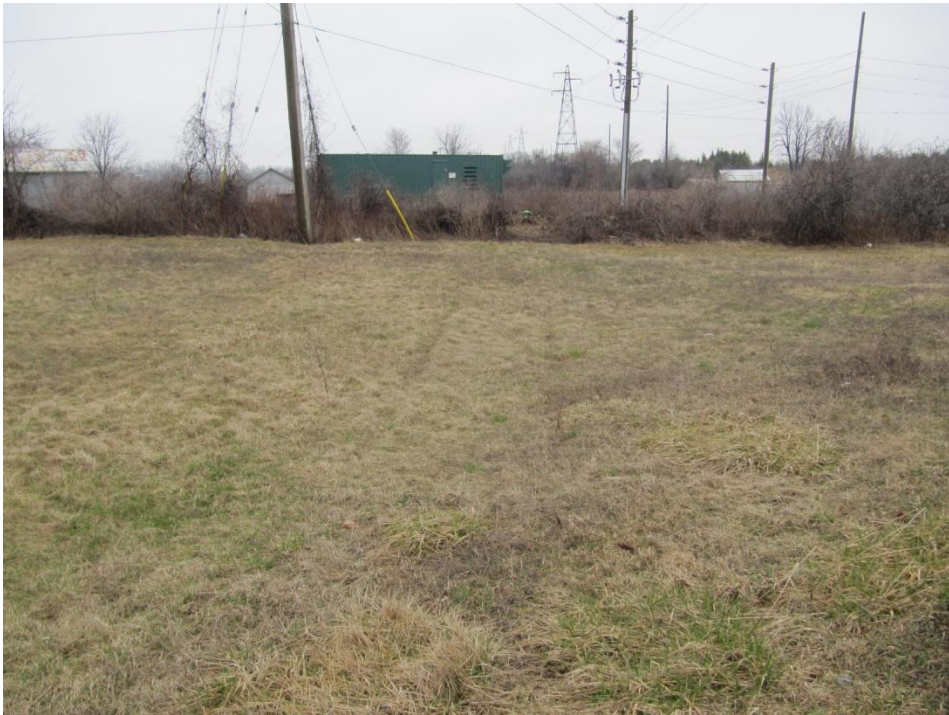
Figure 22 shown the southward view toward the south fence where the neighbor described that the vehicle passed through and into the adjoining property. If one looks closely it is possible to see the faint tire lines of two tire marks in the grass approximately in line with the right edge of the green roof of the building on the adjoining property. Figure 23 shows a northward view from an opening in the brush at the struck fence where it is believed that the vehicle passed through. Figure 24 shows a view of some damage in the brush in the property south of the struck fence suggesting that this is where the vehicle might have been extricated.

Figure 22: View, looking south, at the faint tire marks in the grass as the vehicle travelled toward the brush and fence in the background.

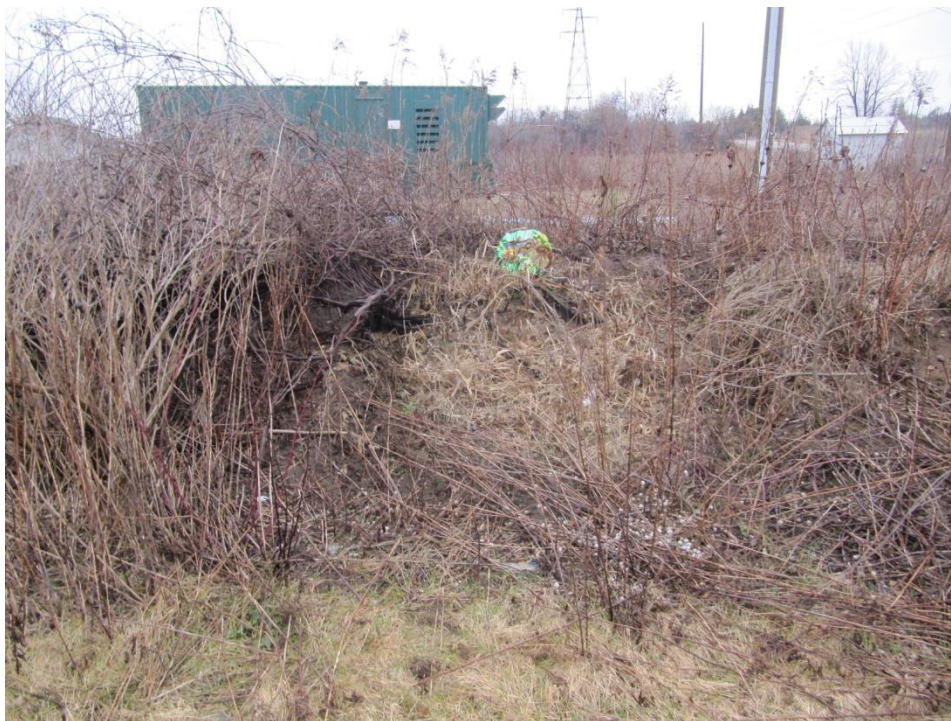
Figure 24: View of some damage in the brush on the property south of the struck fence where it is likely that the vehicle was likely extracted either by towing personnel or other means.

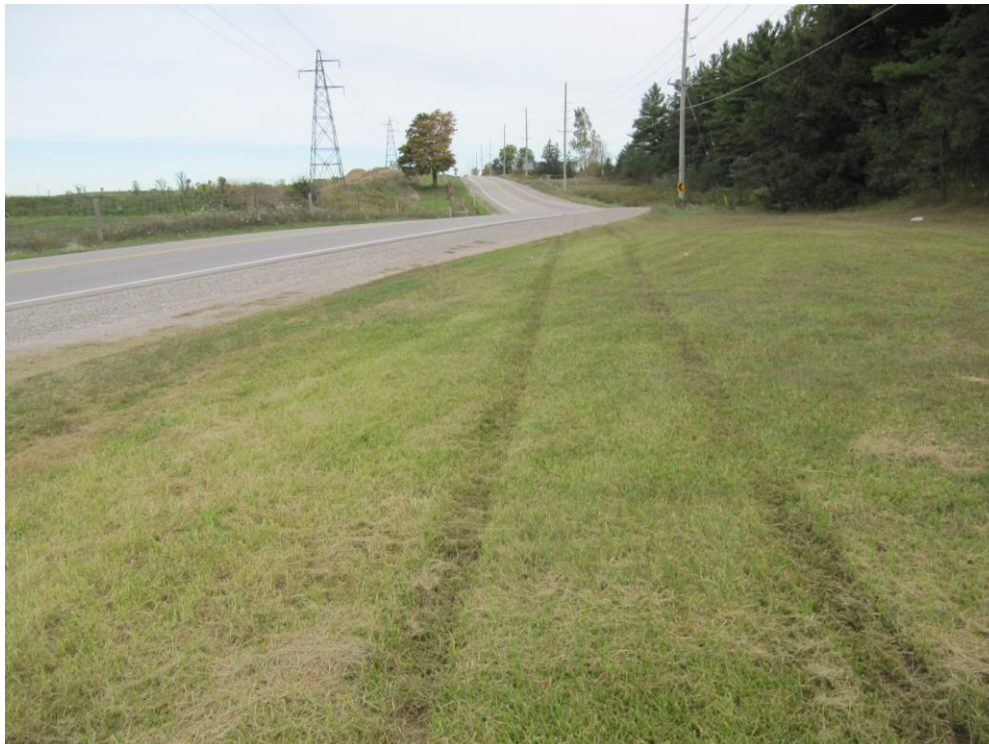
This next incident was similar to that of Event 3 in that tire marks were observed on the east roadside only a short distance south of the north curve, as noted in Figure 25. Fortunately, we had walked through the site on Tuesday, September 29th and a photo taken at that time (See Figure 26) confirmed that the tire marks were not present at that time. So, at most, these tire marks could only be about 3 days old. The freshness of the markings found on October 2nd allowed the ability to see the tire marks as they passed through the gravel driveways as demonstrated in Figures 27 and 28.

Figure 25: View, looking north, at the tire marks of a southbound vehicle which exited the roadway a short distance south of the north curve.

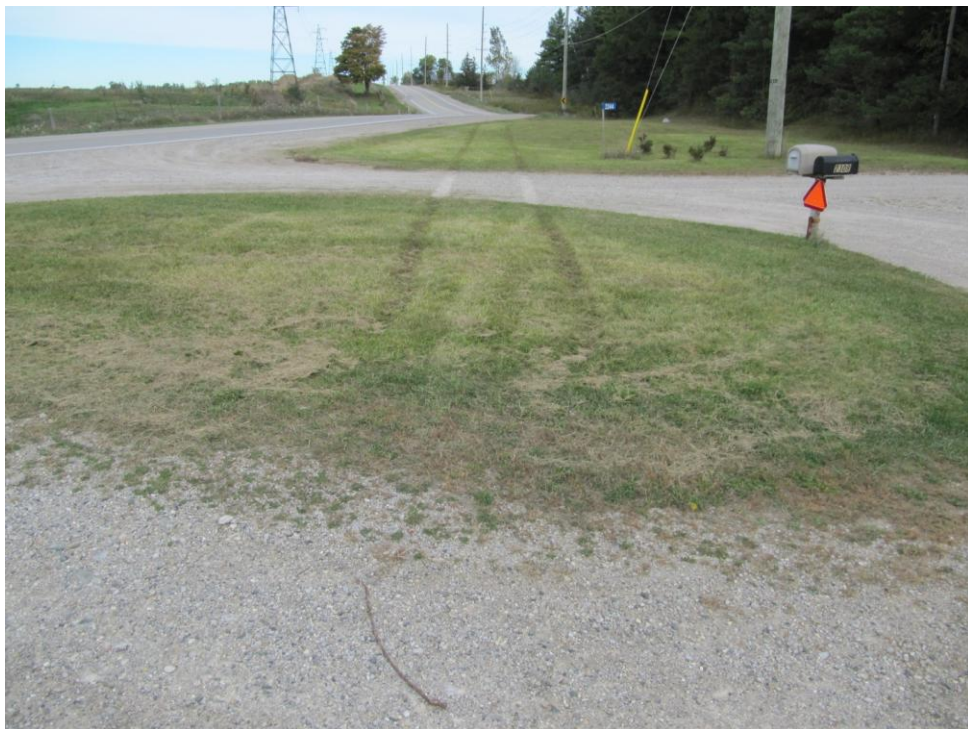
The northward view shown in Figure 29 shows how the marks are not visible in the gravel in the foreground and there were no additional photos taken further south of the parked vehicle. This leads to the belief that we determined at that time that there was no additional evidence further to the south. However, in hindsight, this is a lesson for the future and to all investigators who encounter such evidence in that, regardless of what has been concluded, additional photographs should have been taken further to the south to confirm to ourselves in some distant future, as well as any others examining this research, that indeed there was no additional visible evidence. Such lessons, and others, are learned on a regular basis as investigators encounter new situations and it is a reminder that as investigators and analysts we must always be prepared to learn and discover regardless of how long we have been examining and analyzing evidence.

Figure 29: View, looking north, showing that the tire marks terminate in the grass in the foreground and no additional marks are visible in the gravel in the foreground.

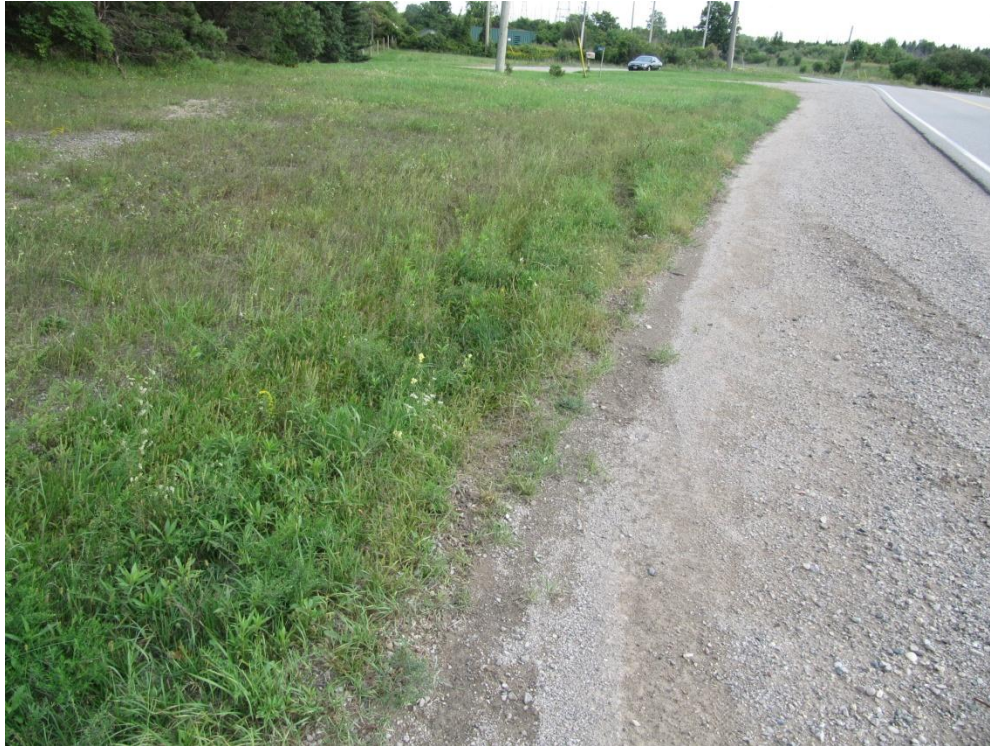
Figures 30 and 31 show views looking south at the tire marks as they exit onto the east roadside at the south end of the north curve. As the tire marks reach the grass it can be seen that the vehicle is in a clockwise rotation and the tire marks start to curve back toward the roadway.

Figure 31: View, looking south, at the tire marks showing the vehicle rotating clockwise back toward the road surface.

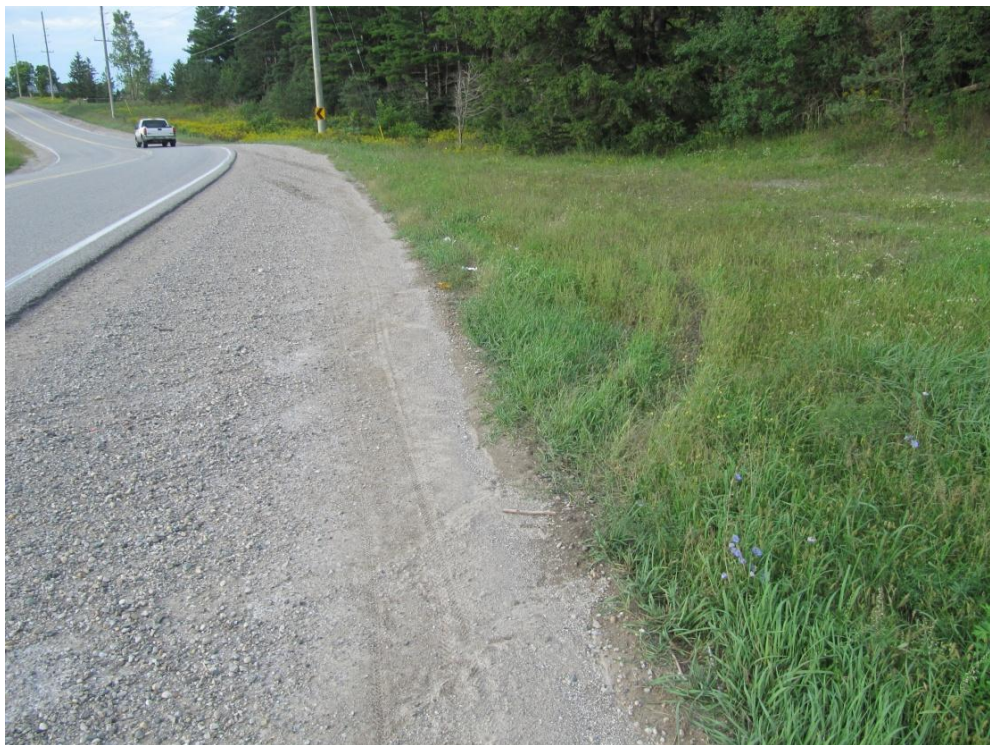
Figure 32 shows the tire marks from a northerly view and here they can be seen passing through the east shoulder as the vehicle returns to the road surface.

Figure 32: View, looking north, at the tire marks as the rotating vehicle passes through the gravel shoulder in the foreground on its return back onto the road surface.

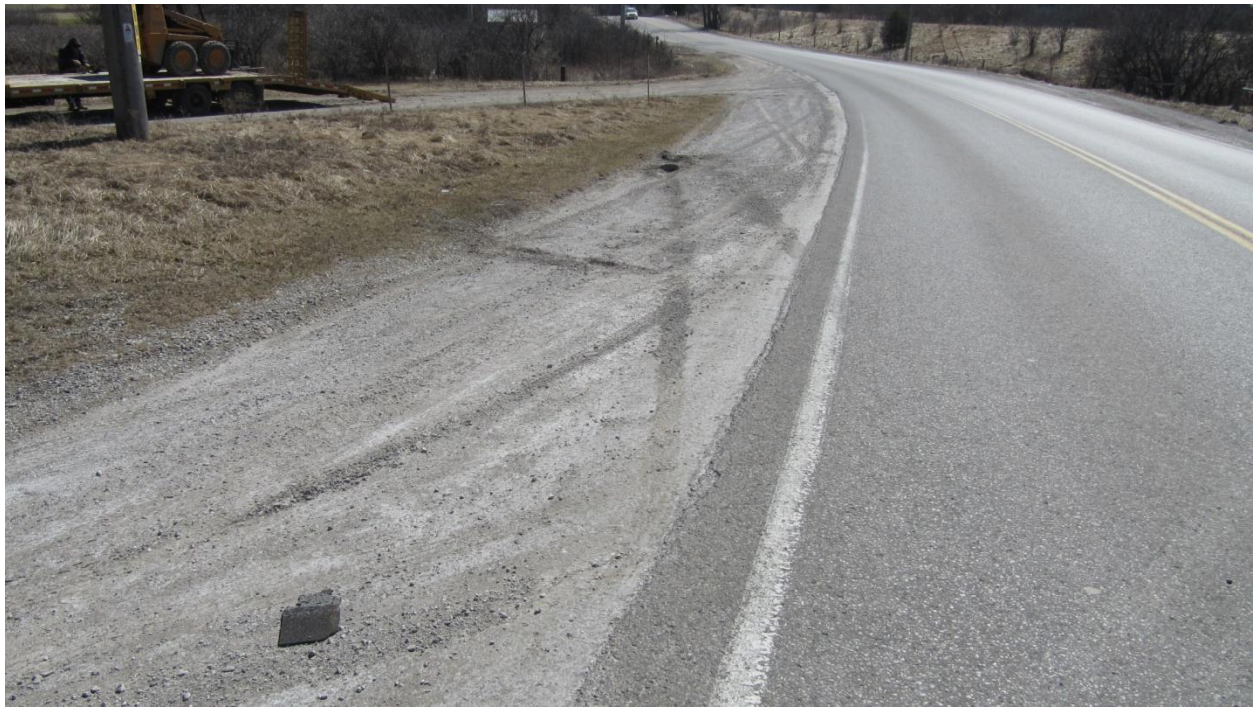
As we approach further south, Figure 34 shows a closer view of the loss-of-control yaw marks that indicate the vehicle's counter-clockwise rotation. Figure 35 provides a closer view of the tire marks in the area where the vehicle came to rotating stop on the shoulder. Figure 36 provides a close-up view of the evidence at the location where one of the tires came to stop and then a print of the tire's tread indicates that the vehicle is accelerated away from the stop position to leave the site.

Figure 34: View, looking south, at the yaw marks on the east shoulder indicating that the vehicle is rotating counter-clockwise. Additional tire marks exist because, after the vehicle came to a halt it then accelerated away and left the site.

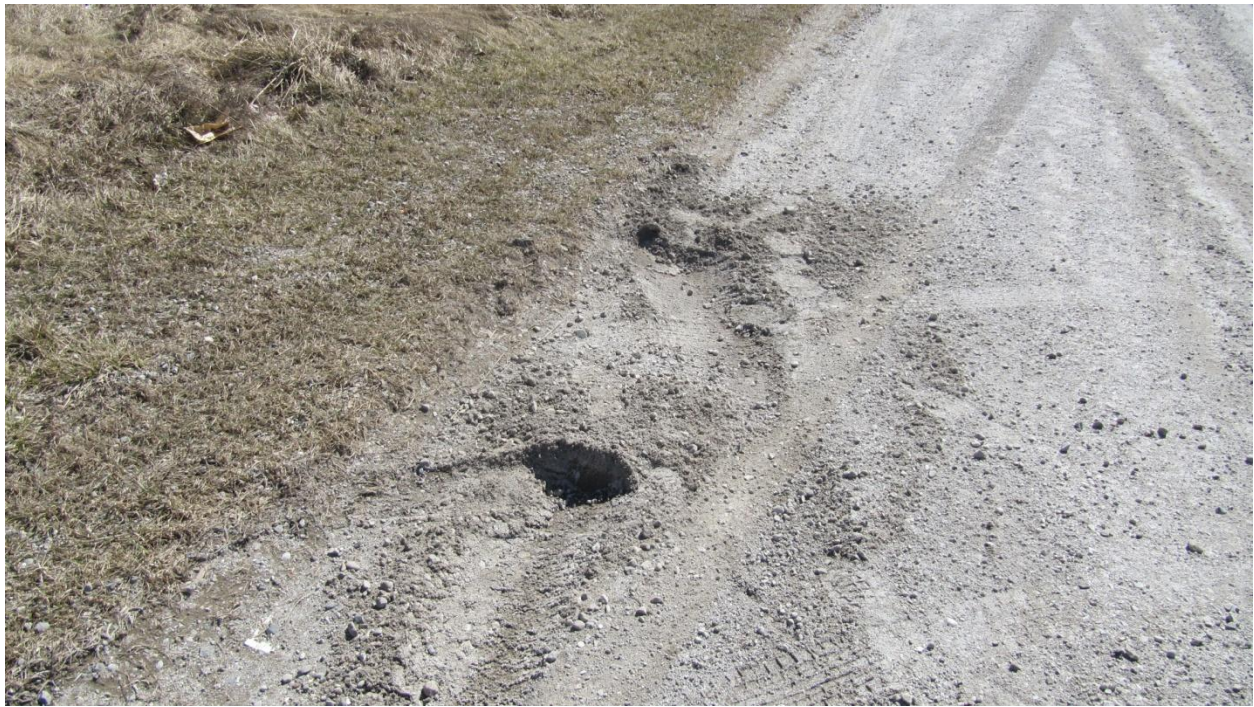
Figure 35: View showing the tire marks where the vehicle's tires gouge into the gravel as the tires slide sideways and then two mounds of gravel/earth are created at the precise location where the wheels came to stop.

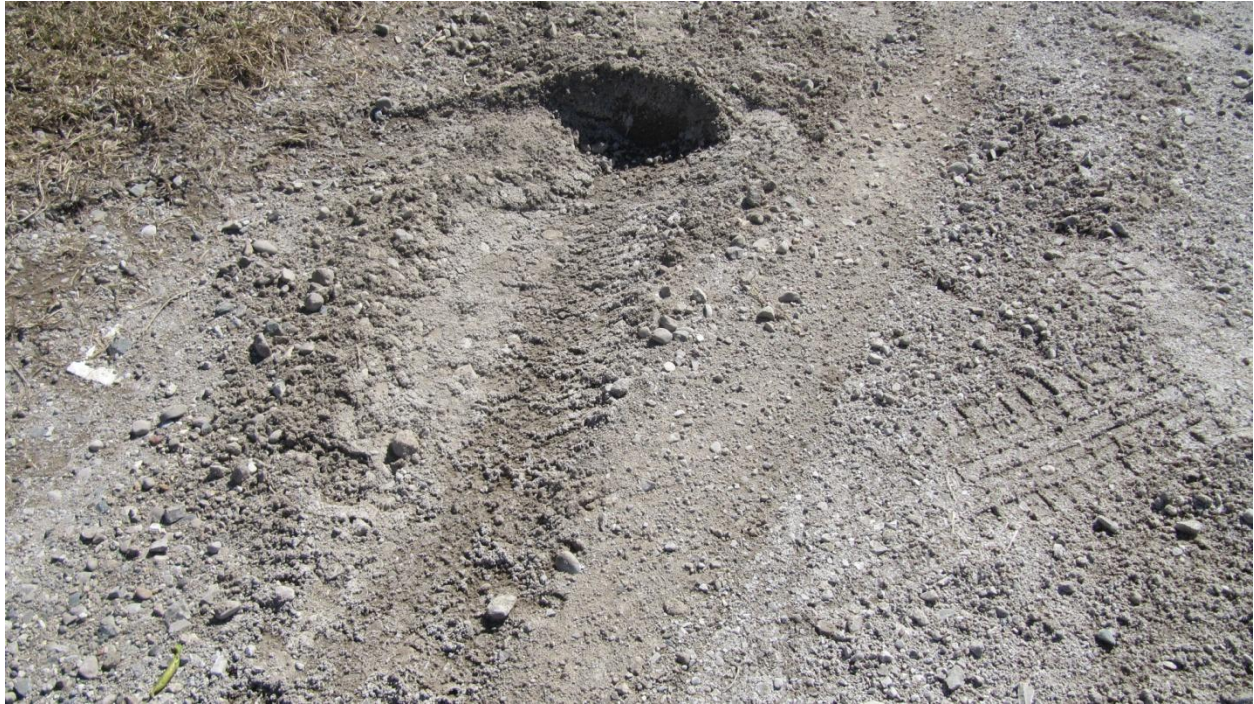
Figure 36: A close up view of one of the ends of the tire marks shows how the sliding tire comes a halt a the mound of earth and then there is a tire print progressing to the left where the rolling tire begins to move after coming to a halt as the driver moves the vehicle to exit the site.

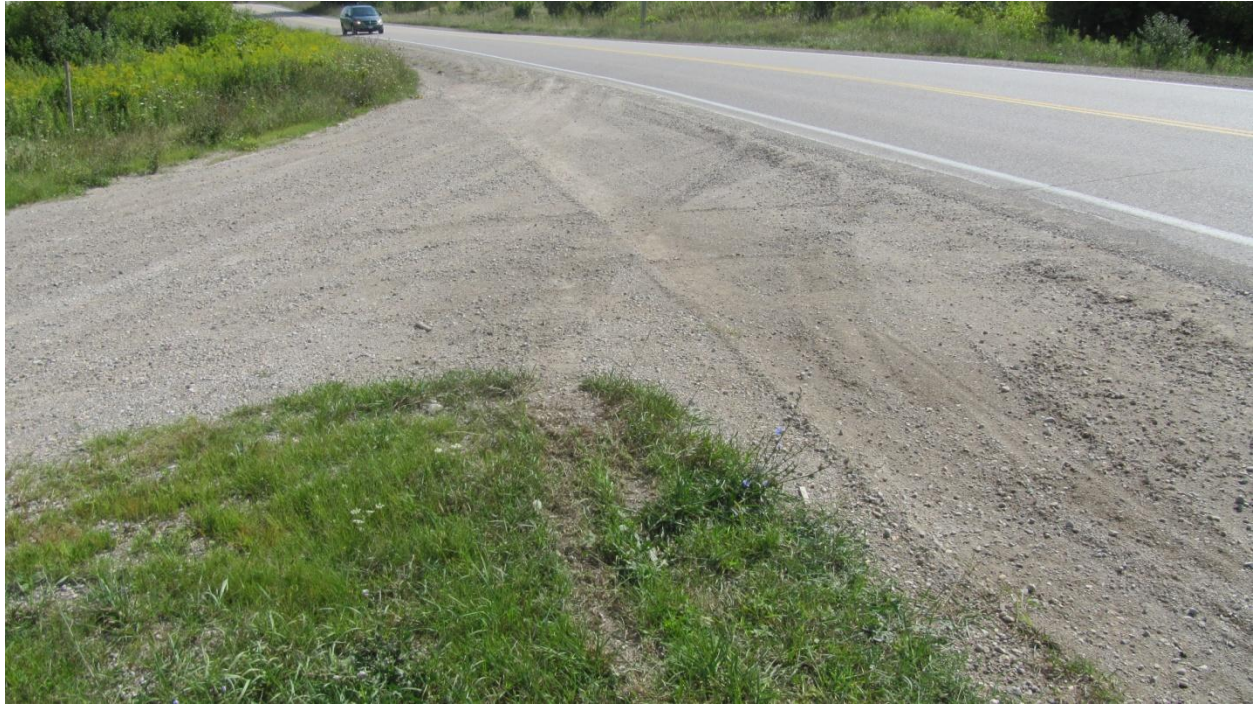
The tire marks shown in Figure 42 suggest that the driver may have regained control of the southbound vehicle without bringing it to a stop and that he then re-entered the road and continued to travel southbound.

Figure 42: The physical evidence of the curved tire marks suggests that the driver may have regained control of the vehicle without stopping and then continued to re-enter the road to proceed southbound again.
