Historical Patterns In Loss-of-Control Events At Specific Road Locations

Posting Date: April 2, 2018

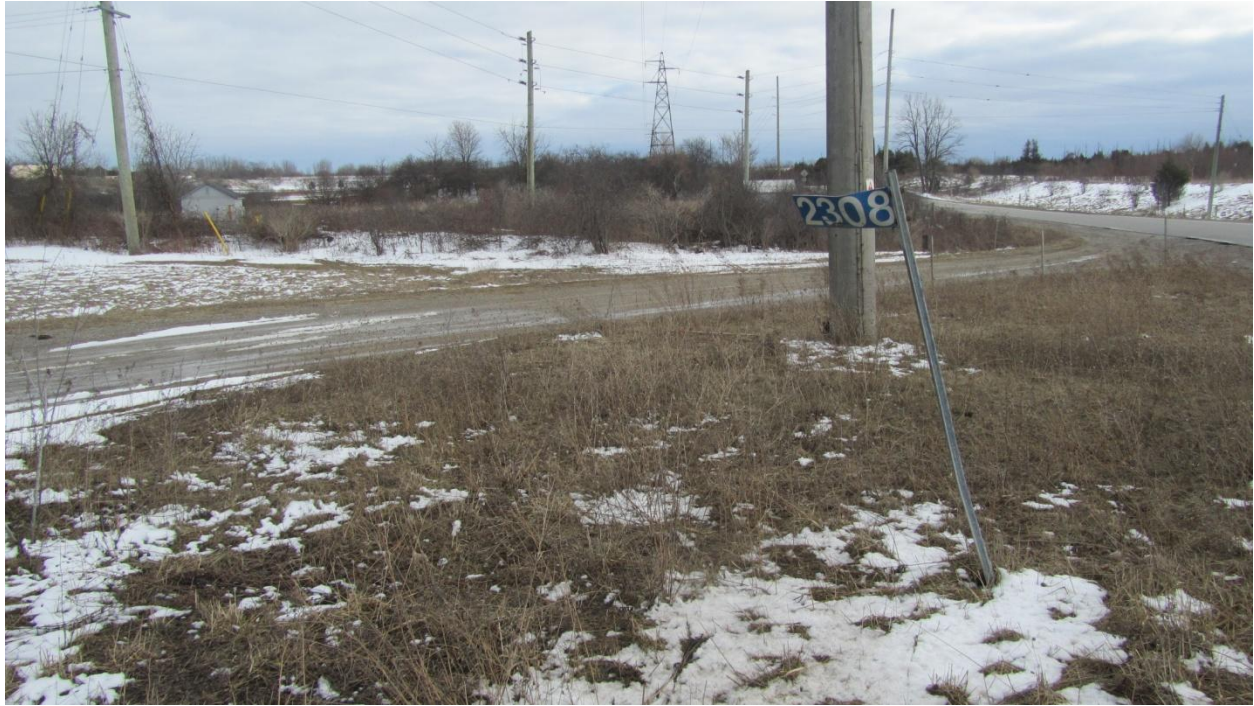
Figure 49: An address marker located just north of the utility pole sustains a minor contact as the southbound vehicle passes through.

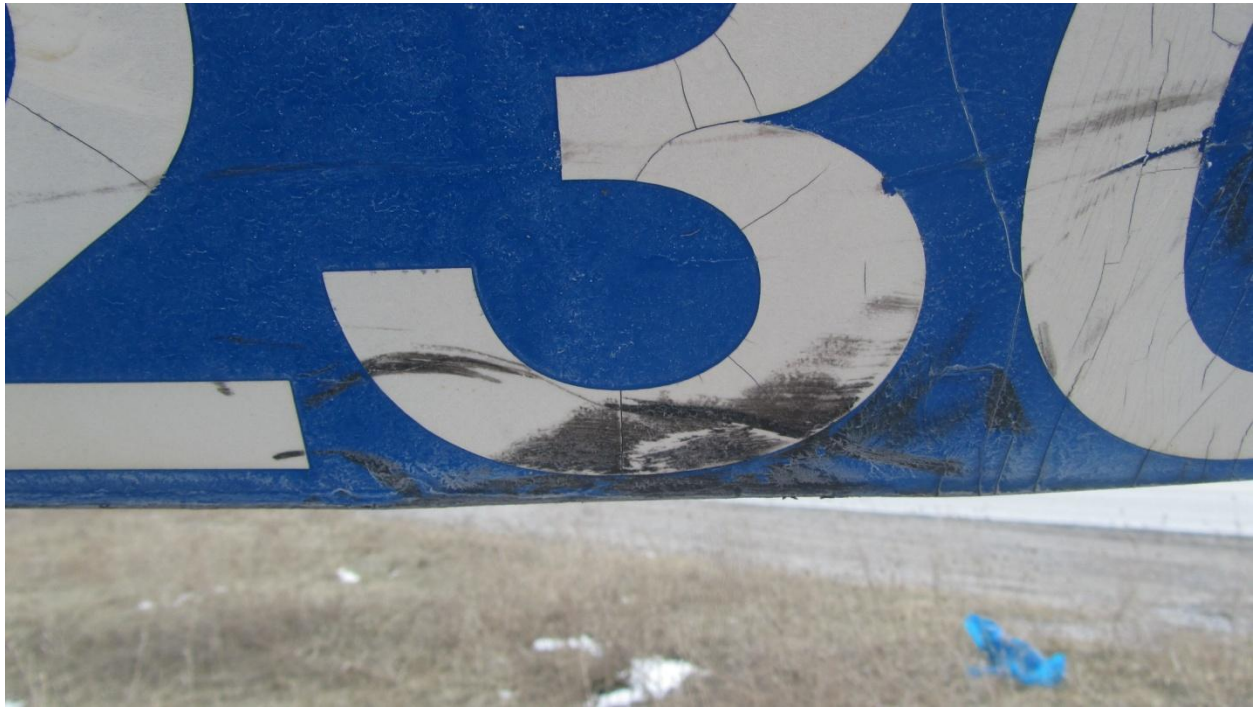
Figure 50: Close-up view of the black transfer on the address marker caused by contact by the southbound vehicle.

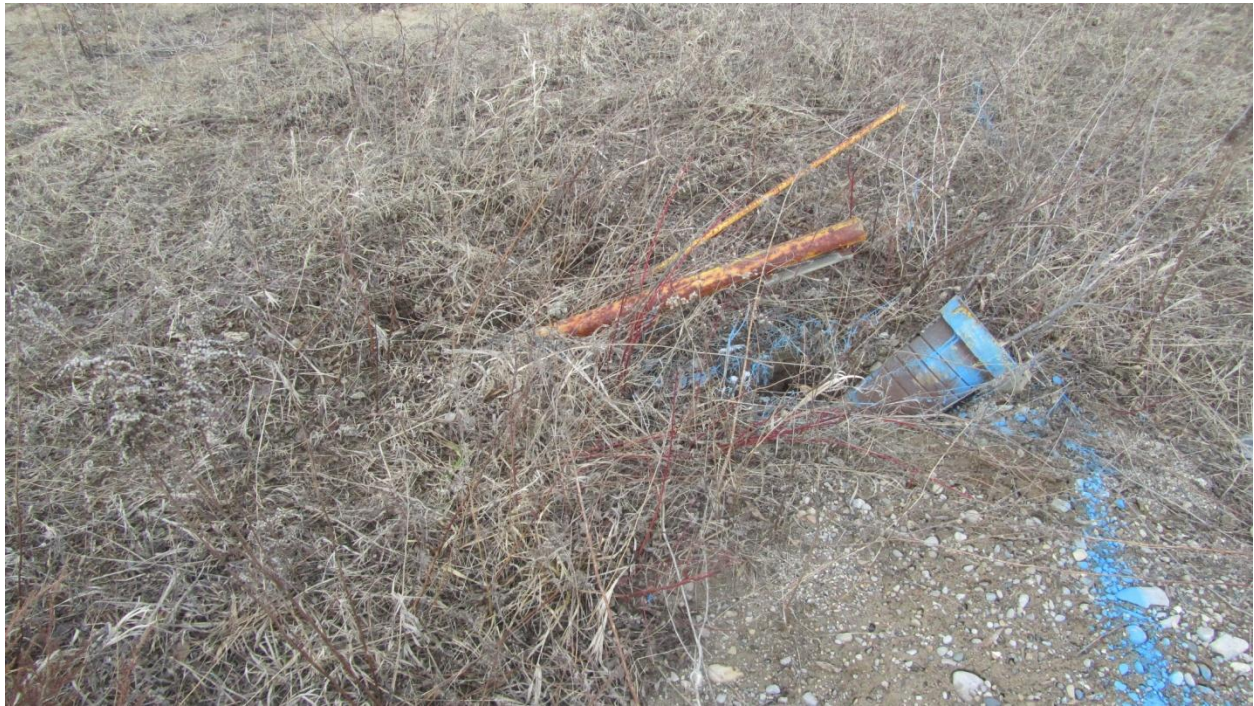
Figure 56: A side-view of the stuck pipe. The southbound vehicle was travelling from the left to the right and pushed the pipe and yellow pole to a horizontal position.

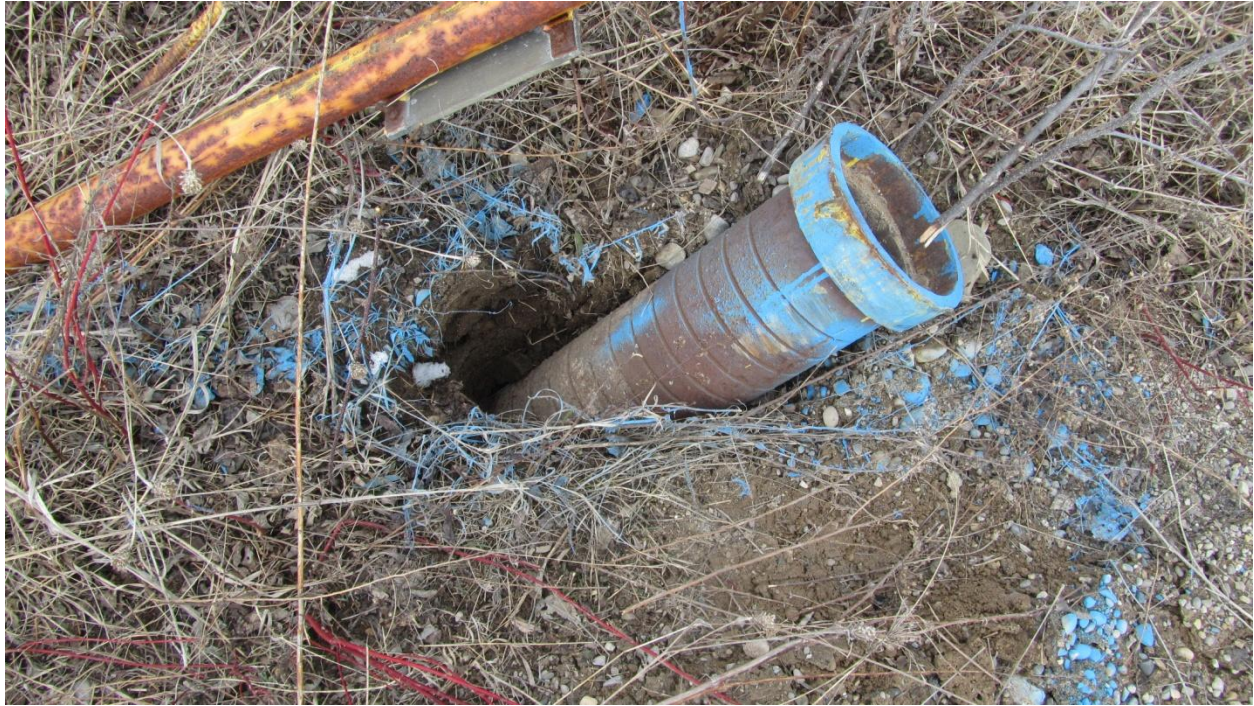
Figure 57: Close-up view of the flattened pipe and yellow pole that were struck by the southbound vehicle.
