Review of Loss-of-Control Tire Marks on a Gravel Shoulder

Posting Date: 05-Aug 2014

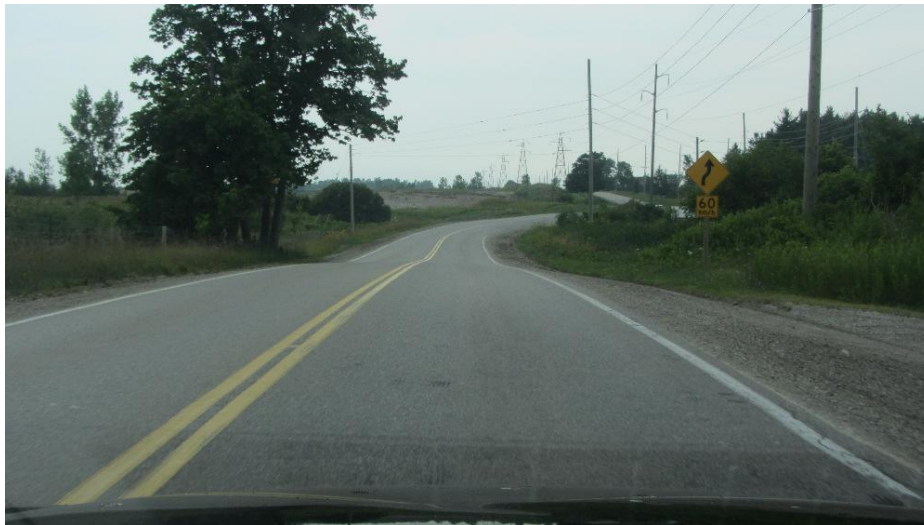
Figure 1: Since some readers may not be familiar with the S-curve, this photo is a view from a northbound vehicle approaching the curve. The tire marks which we will be studying are located at the north portion of the curve that is in the distant background.

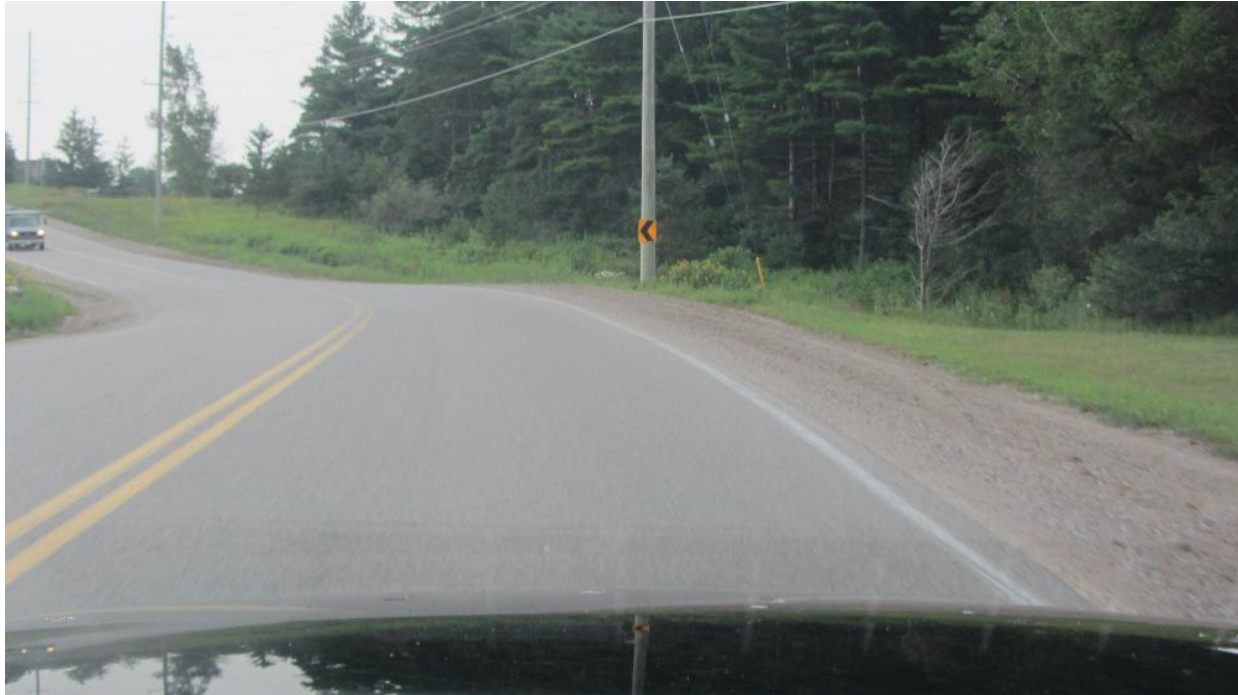
Figure 2: View, from a northbound vehicle approaching the north portion of the S-Curve. The tire marks we will be examining are near the southbound vehicle that is shown in the background.

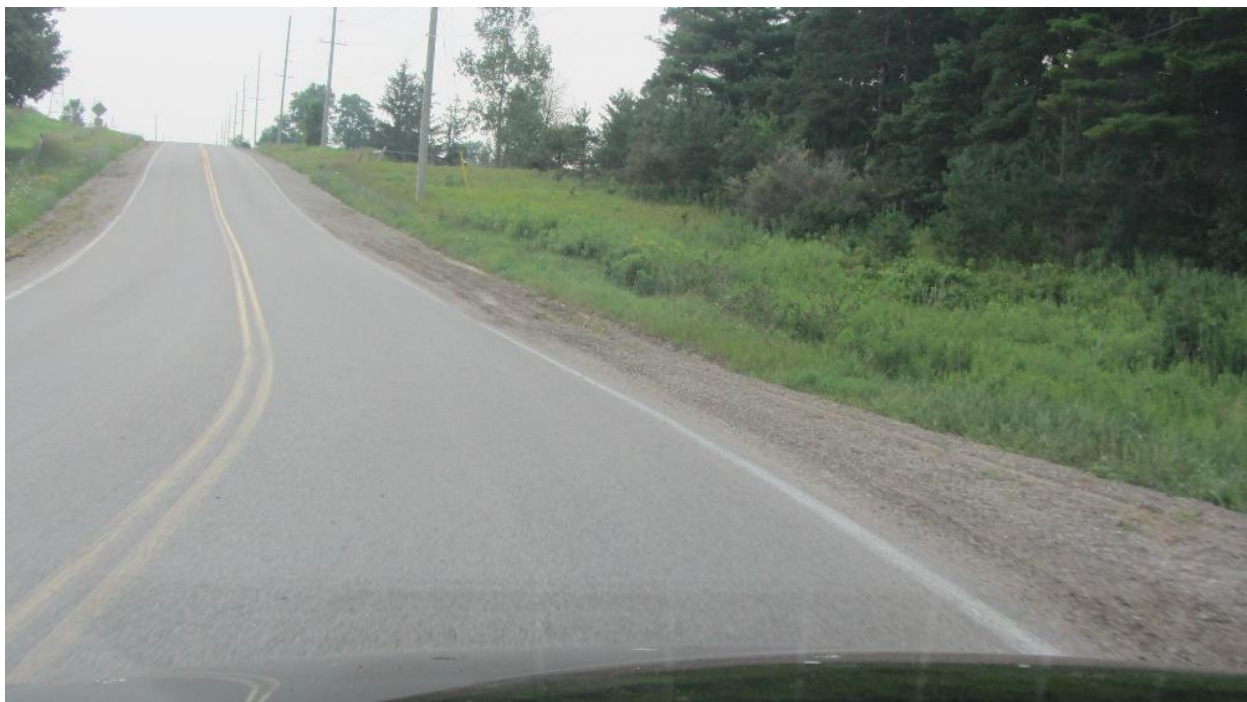
Figure 3: View, from a northbound vehicle, as it approaches the north end of the north curve. Although the tire marks are not yet visible this view proved some general information about the roadway in the vicinity of those marks.

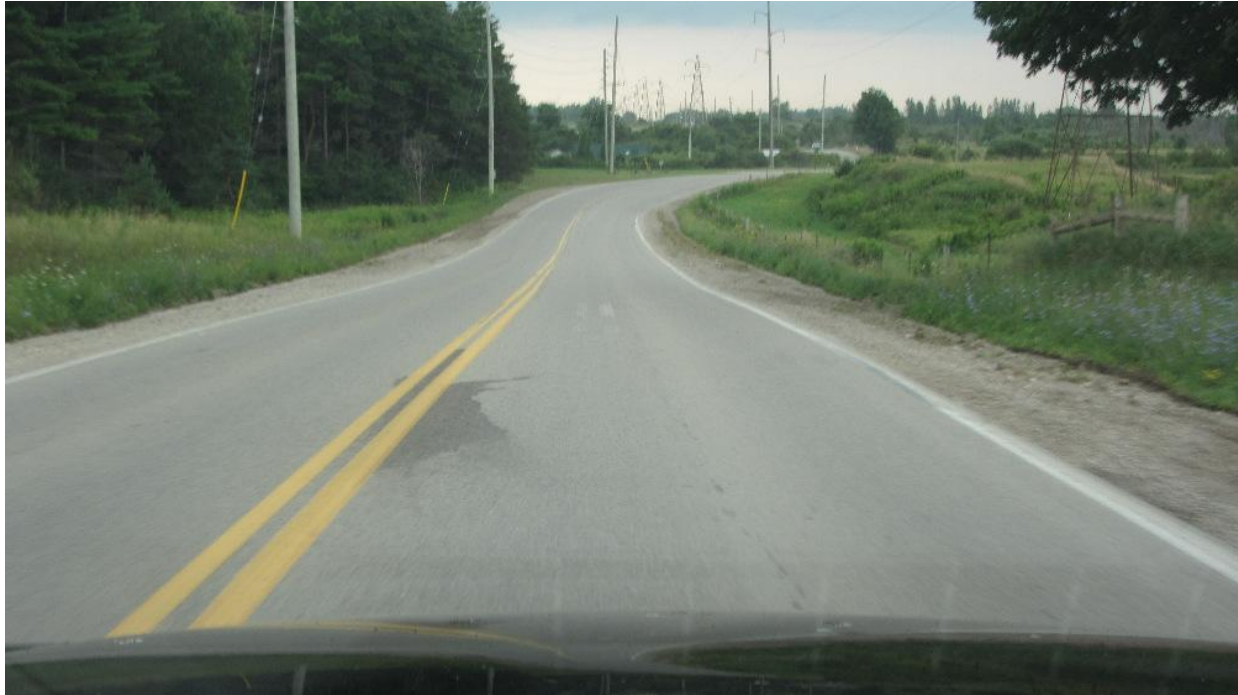
Figure 4: To complete the general description of the site this photo is from a southbound vehicle approaching the north curve. So this view is opposite to the travel direction of the vehicle that caused the tire marks.

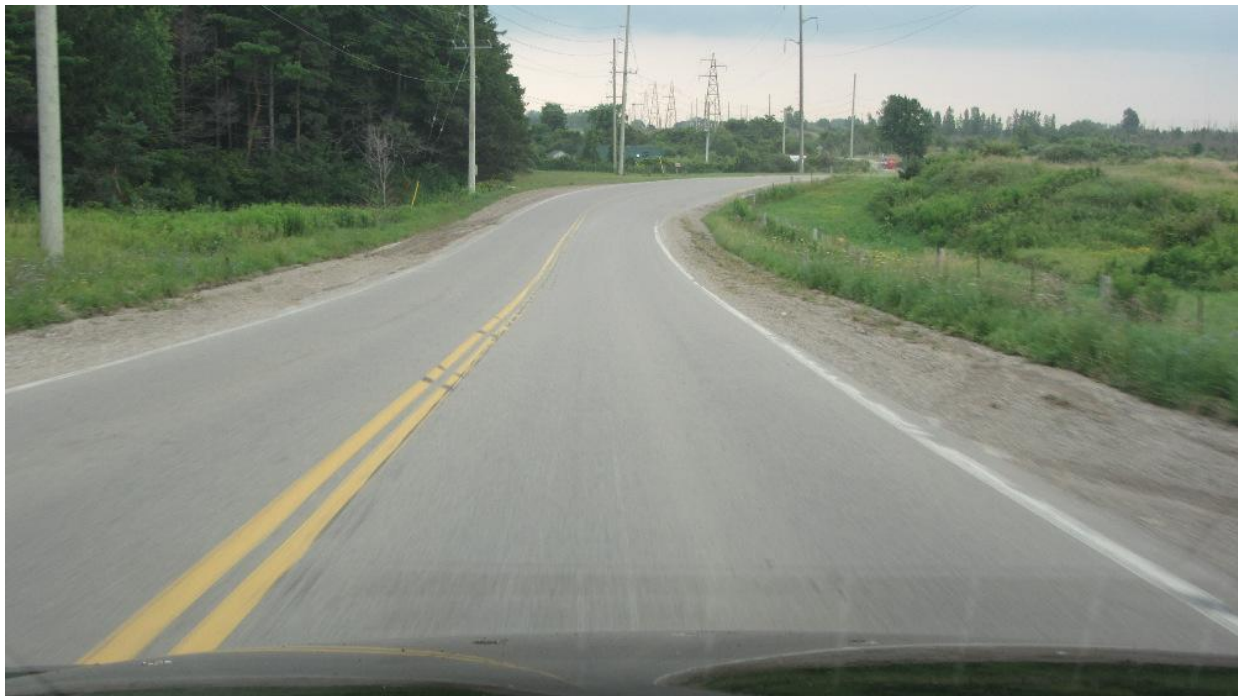
Figure 5: This is also view looking south except that it brings us closer to the tire marks. For example the reader might detect some black, curved marks on the roadway centre-line roughly in the middle of this view.

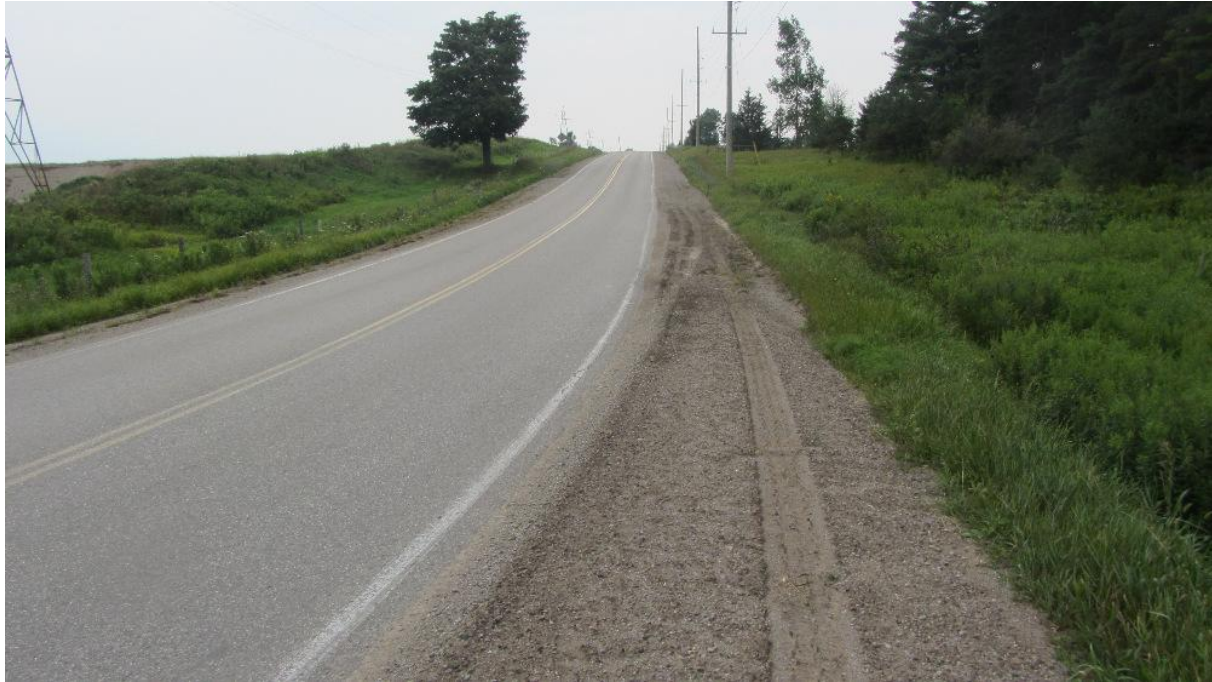
Figure 6: We already indicated that the northbound vehicle travelled onto the east shoulder so our first assignment is to detect where its tire marks are located on this east shoulder.

The shoulders of this S-curve were freshly re-graded on July 31st or about 6 days before these photos were taken. In Figure 6 we can see the tire mark of the road grader in the middle of the gravel shoulder and we can see how straight it is in comparison to some of the other tire marks in the background. So we know that this tire mark was not one of those caused by the loss-of-control vehicle. We will see shortly that the loss-of-control vehicle came to rest on the west (left of the photo) side of the just before the isolated tree visible in the background.

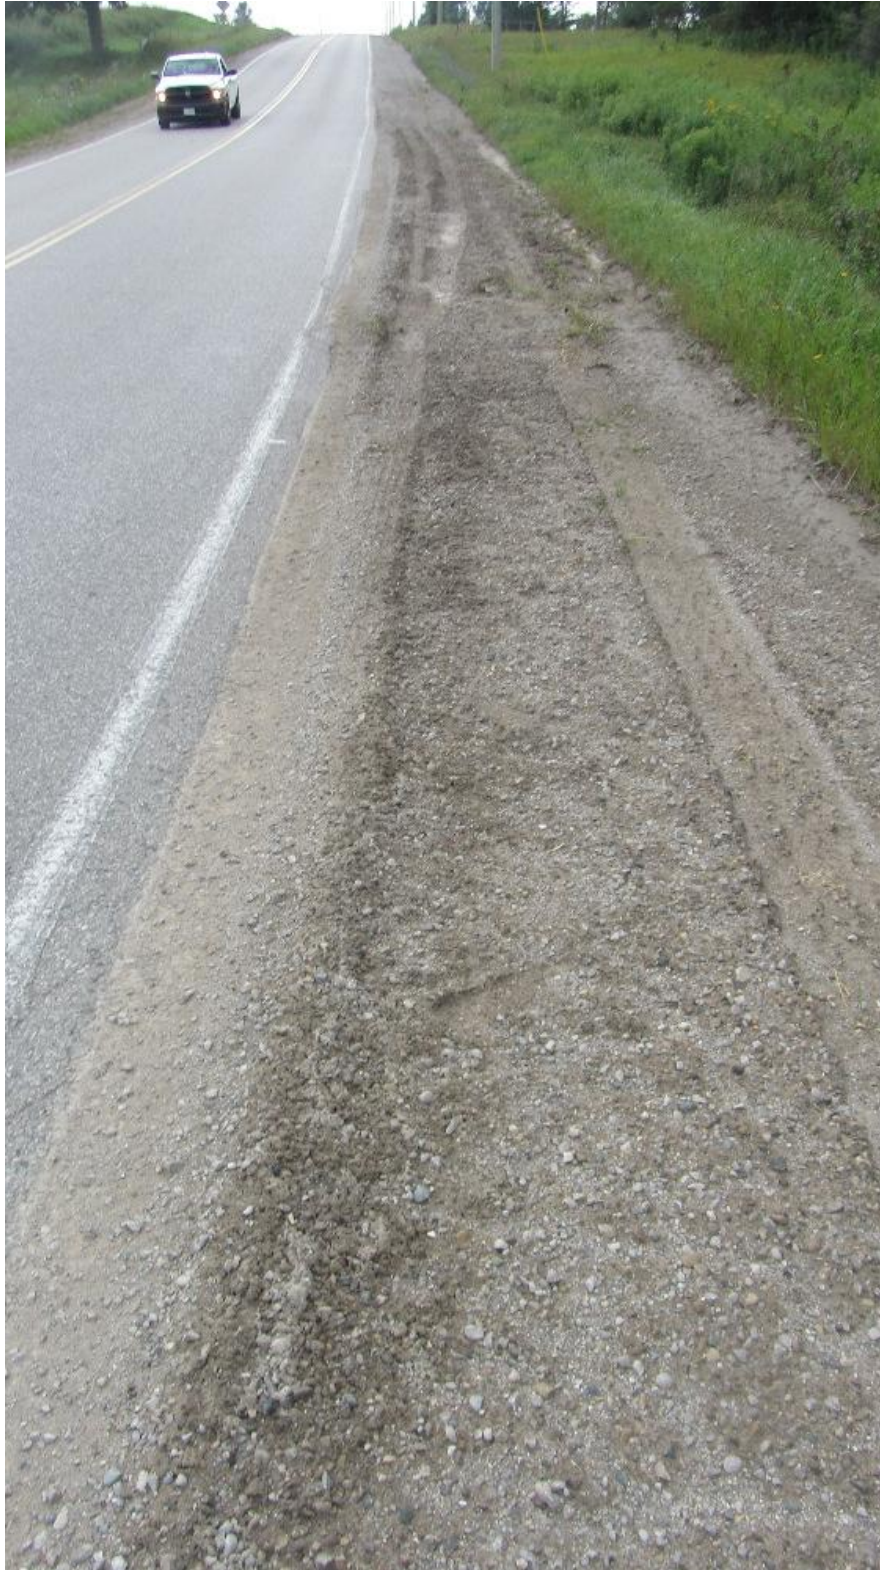
Figure 7: View looking north along the east gravel shoulder.

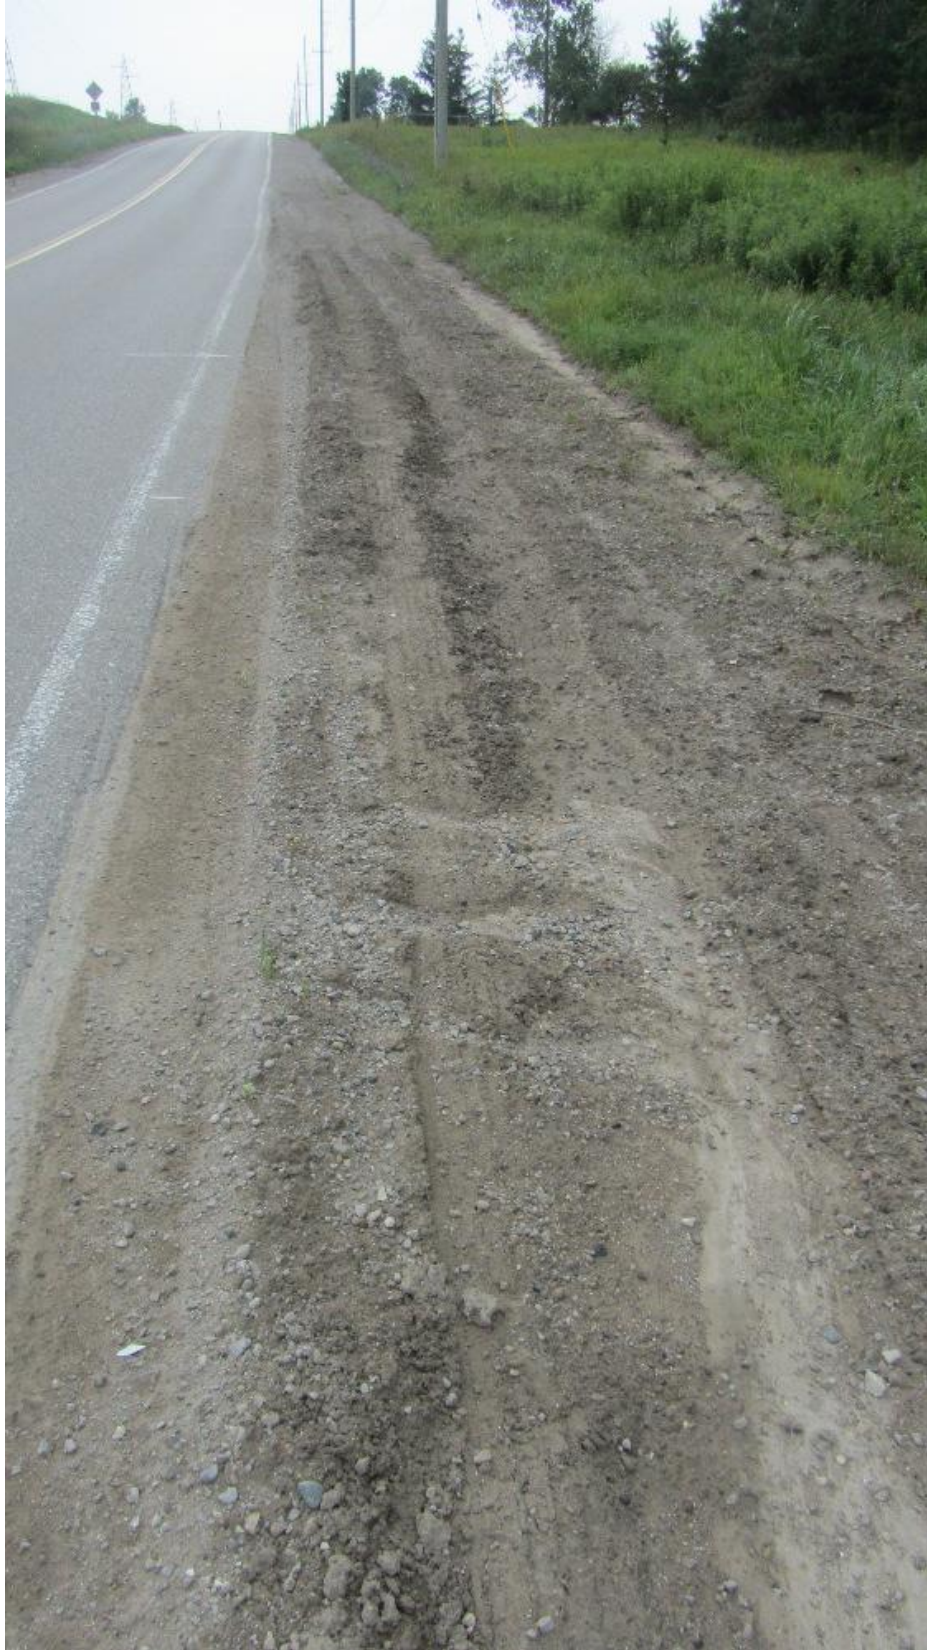
Figure 8: View, looking north, along the east gravel shoulder.

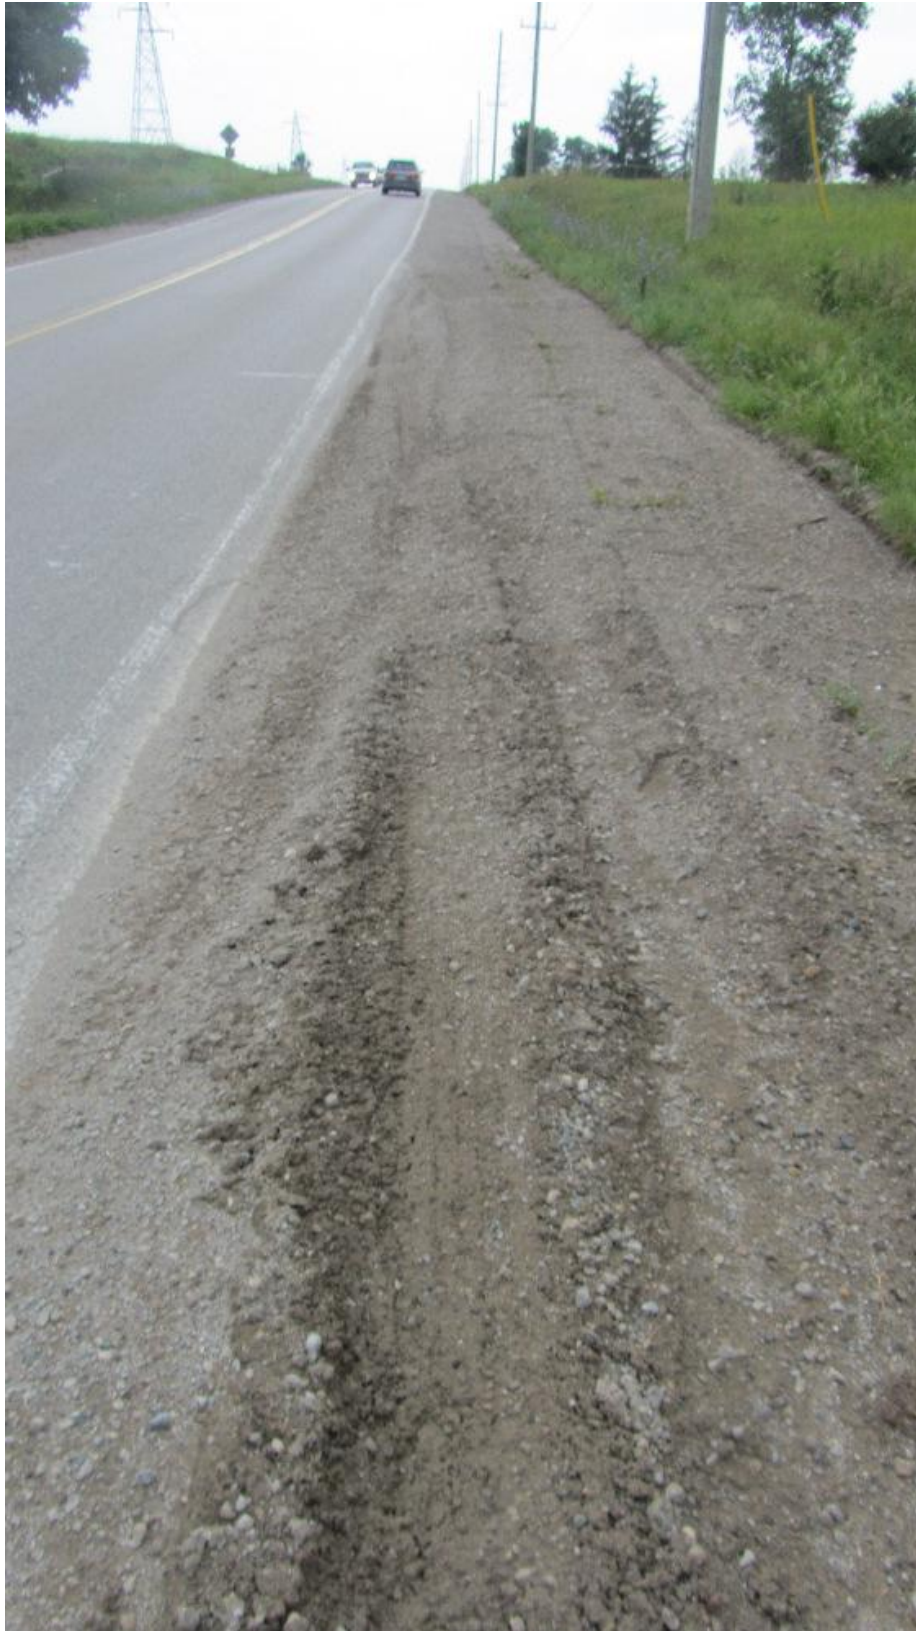
Figure 9: View, looking north, along the east gravel shoulder.

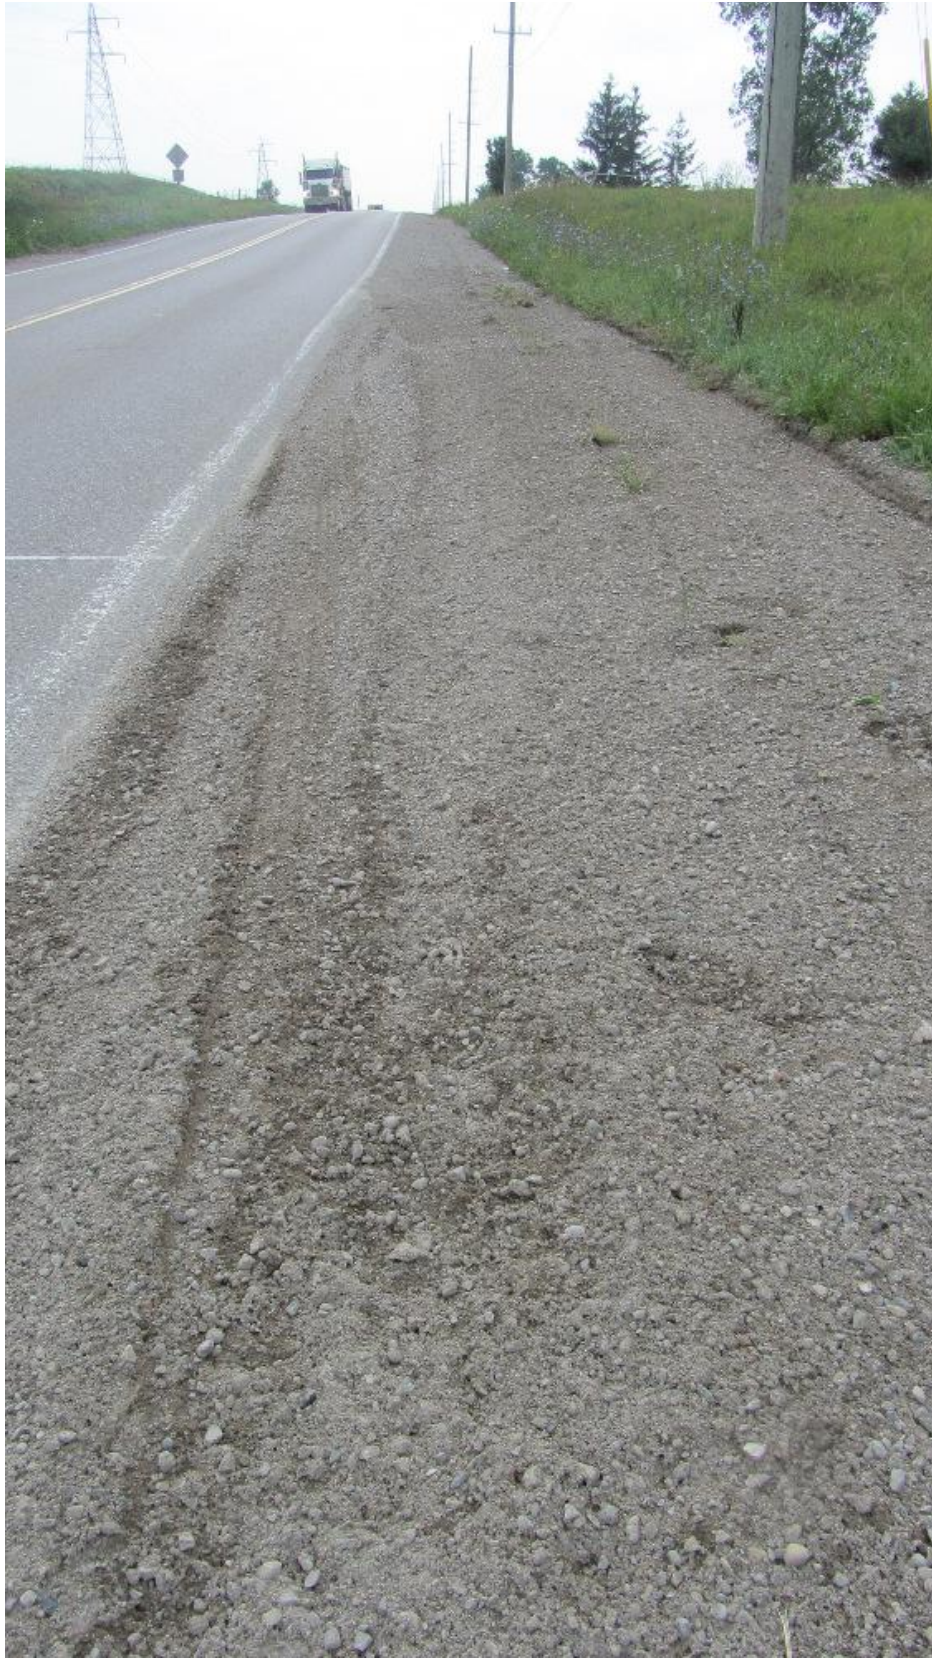
Figure 10: View, looking north, along the east shoulder.

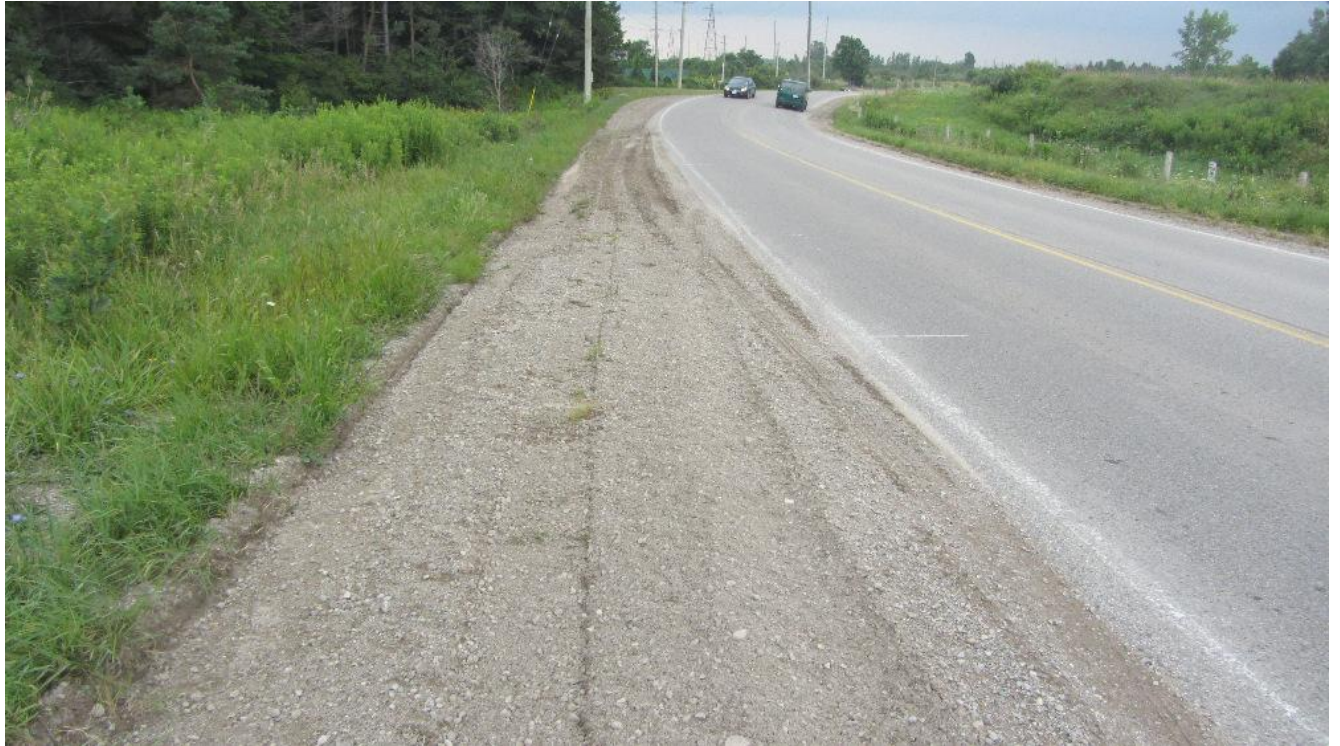
Figure 11: View, looking south, along the east shoulder.

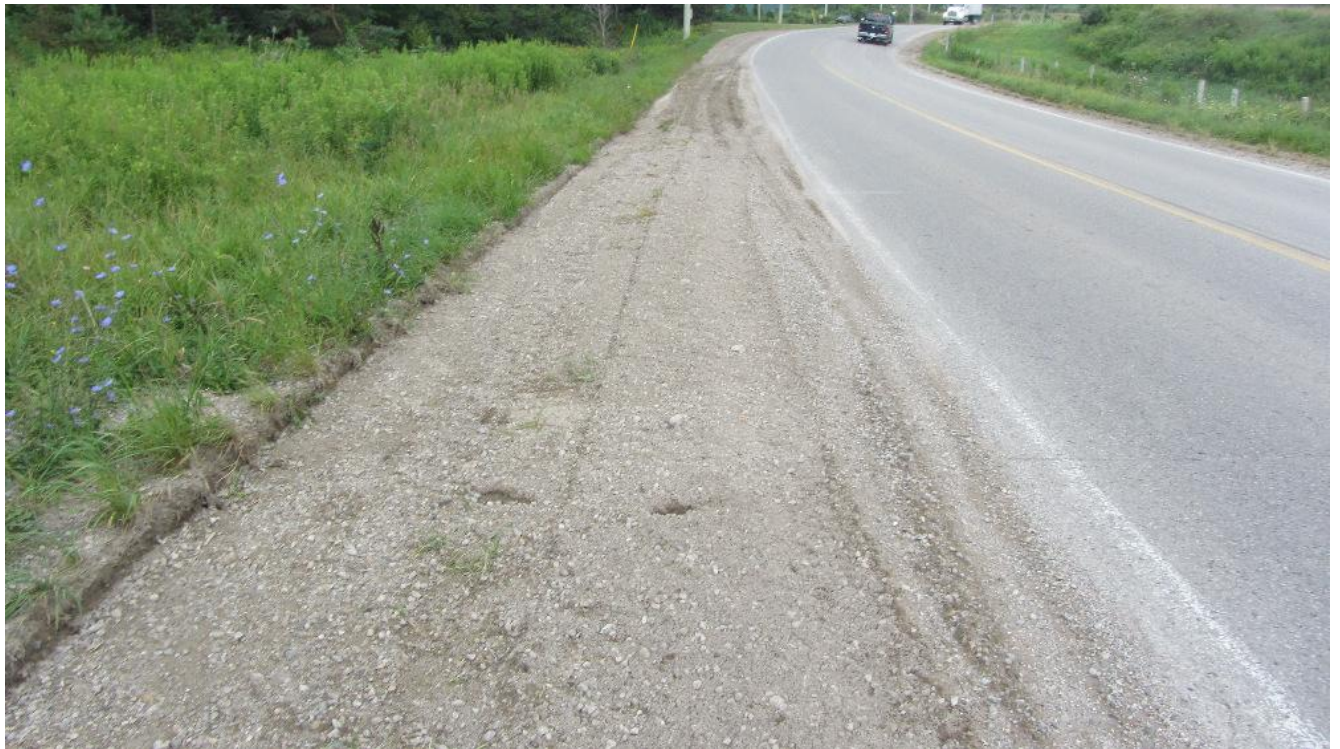
Figure 12: View, looking south, along the east shoulder.

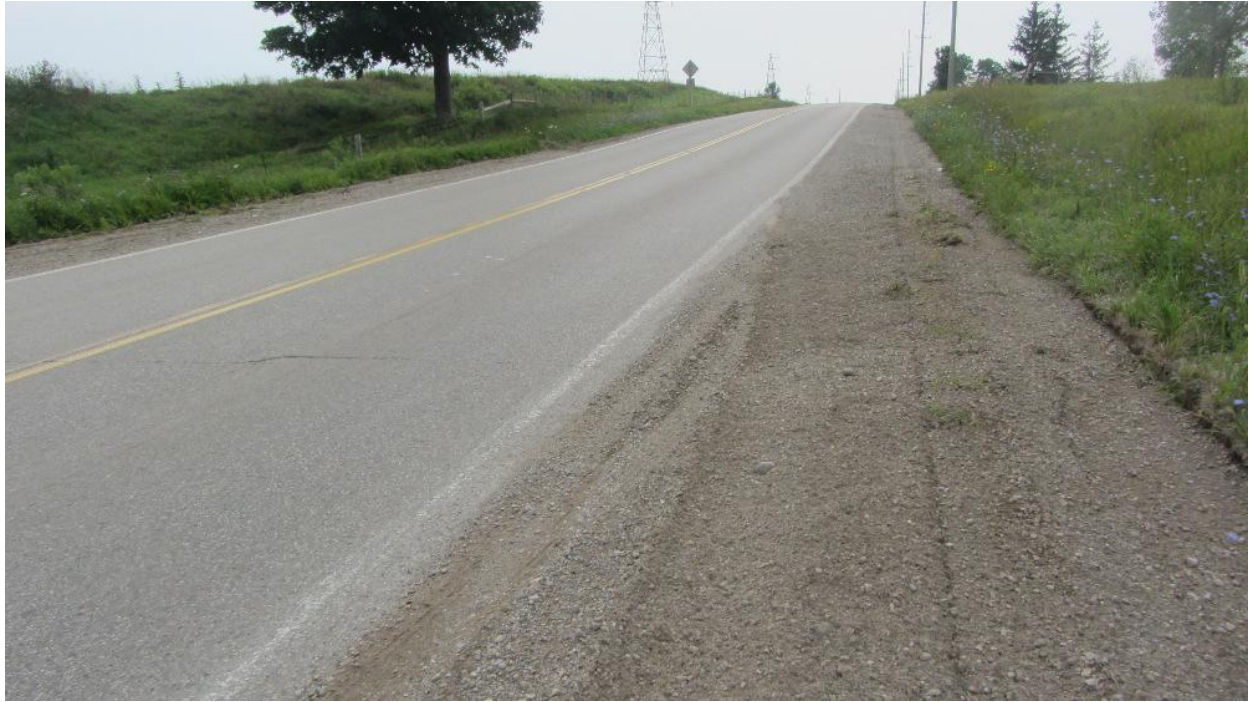
Figure 13: View, looking north-east, from the east shoulder toward the vehicle's final rest position.

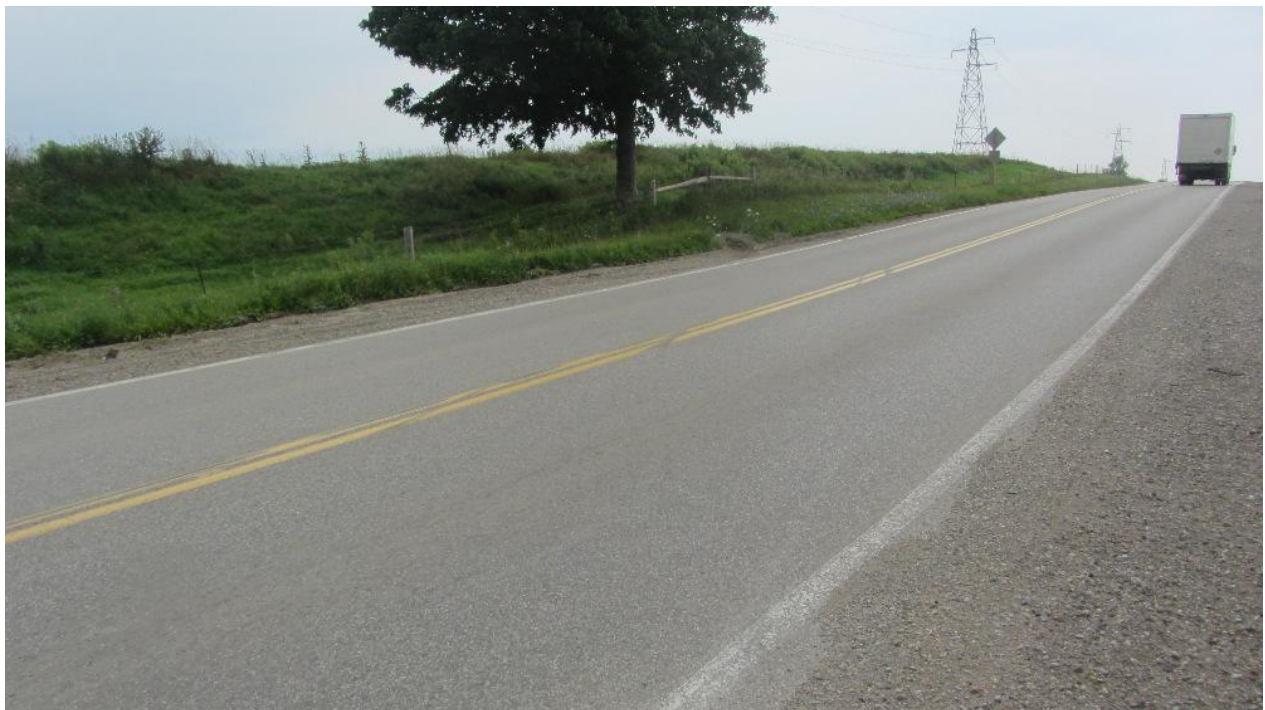
Figure 14: View, looking north-east, from the east shoulder toward the vehicle's final rest position.

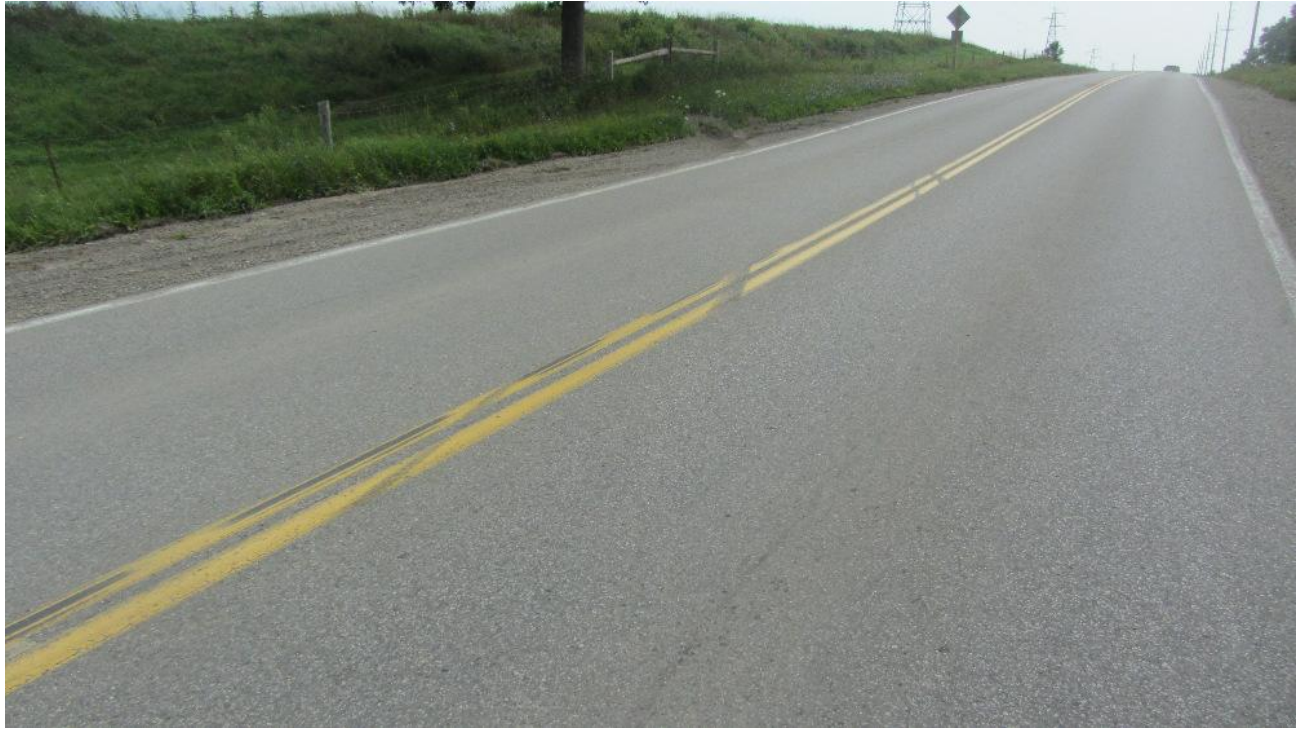
Figure 15: Looking north-east at the black yaw marks visible on the yellow centre-line.

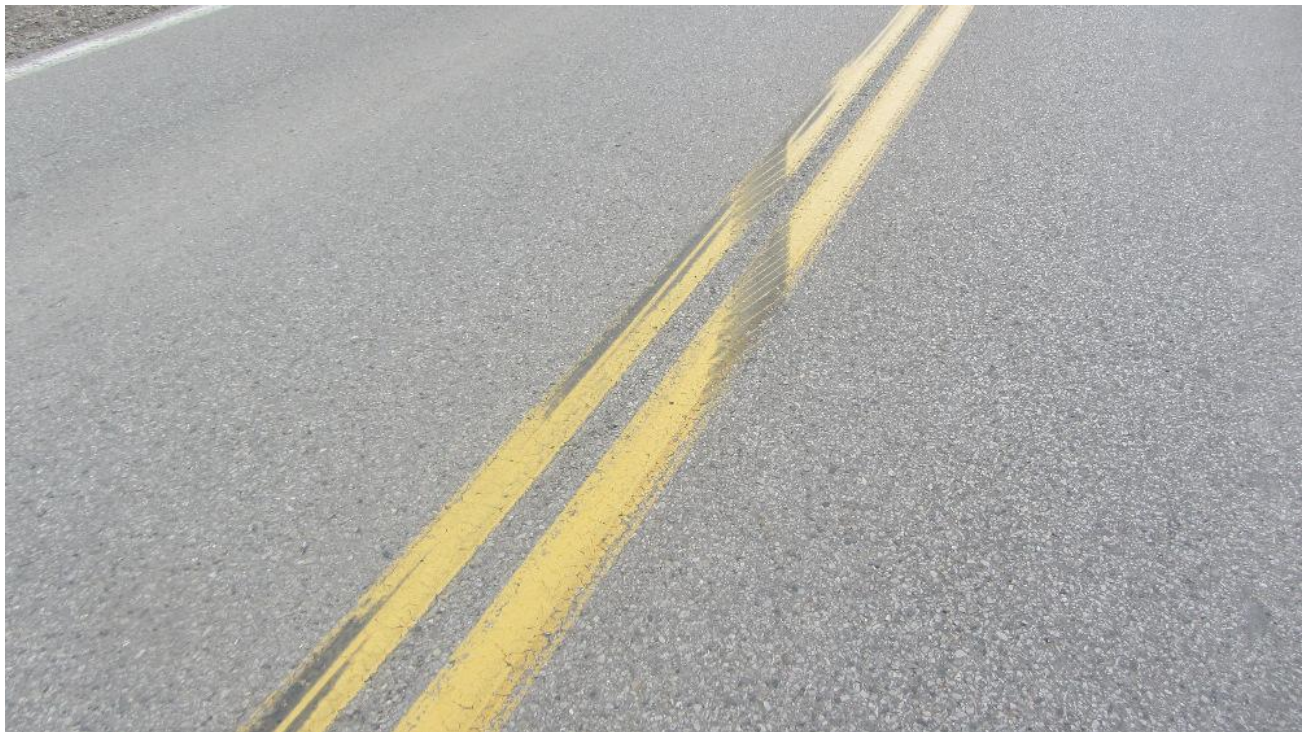
Figure 16: View of black yaw marks on the roadway centre-line.

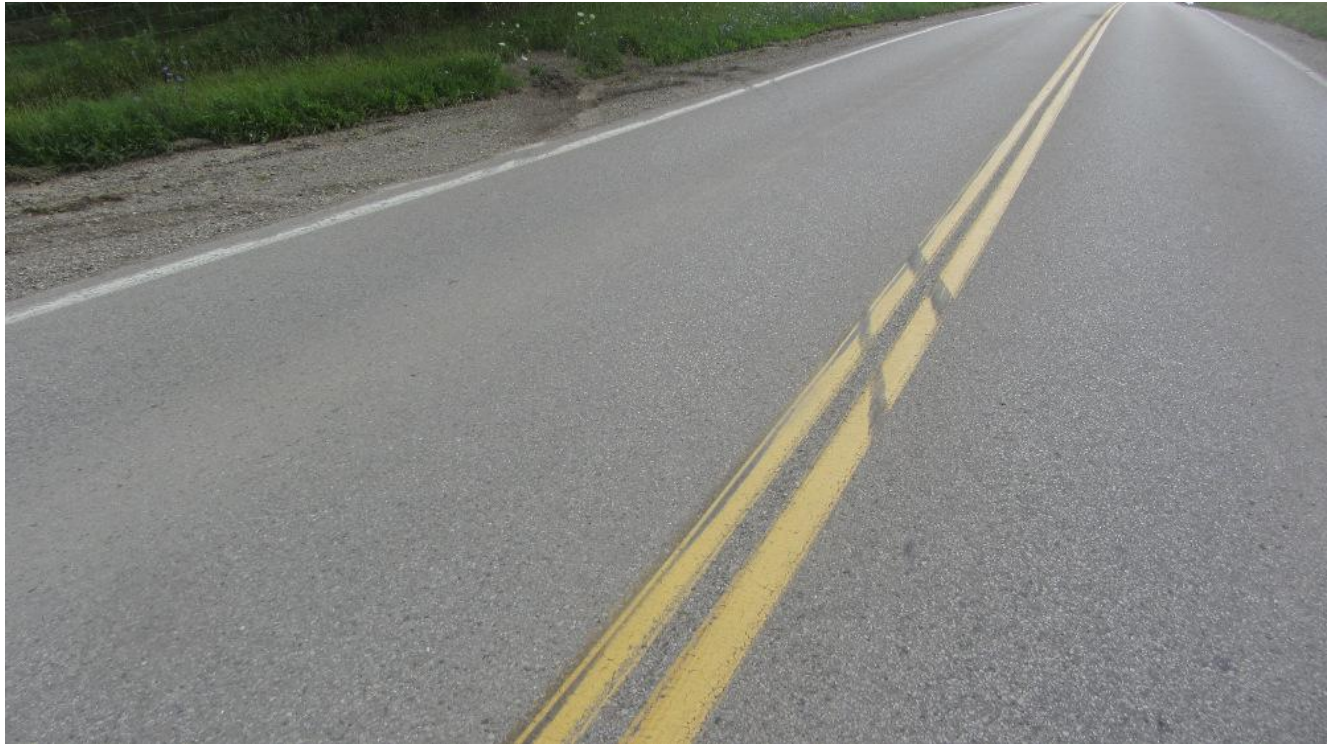
Figure 17: View of black yaw marks on the centre-line of the roadway.

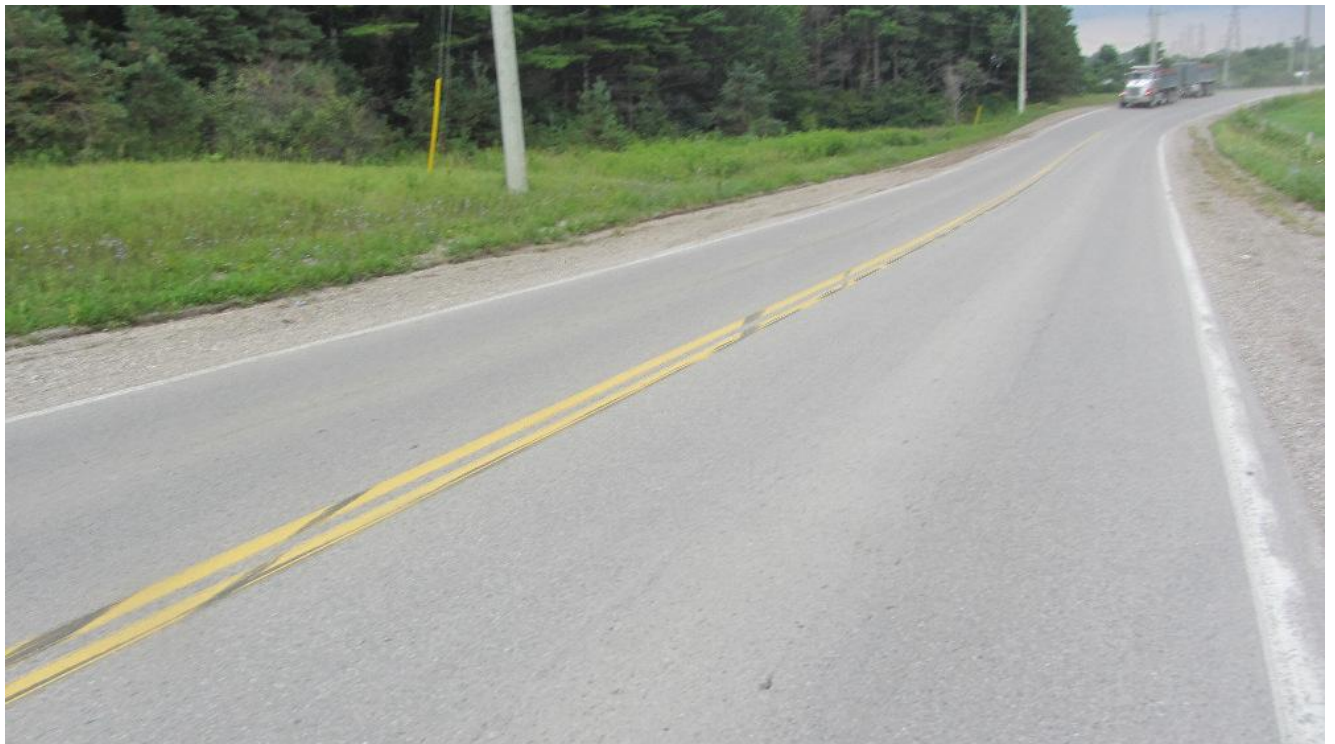
Figure 18: View, looking south-east, at the black yaw marks on the roadway centre-line.

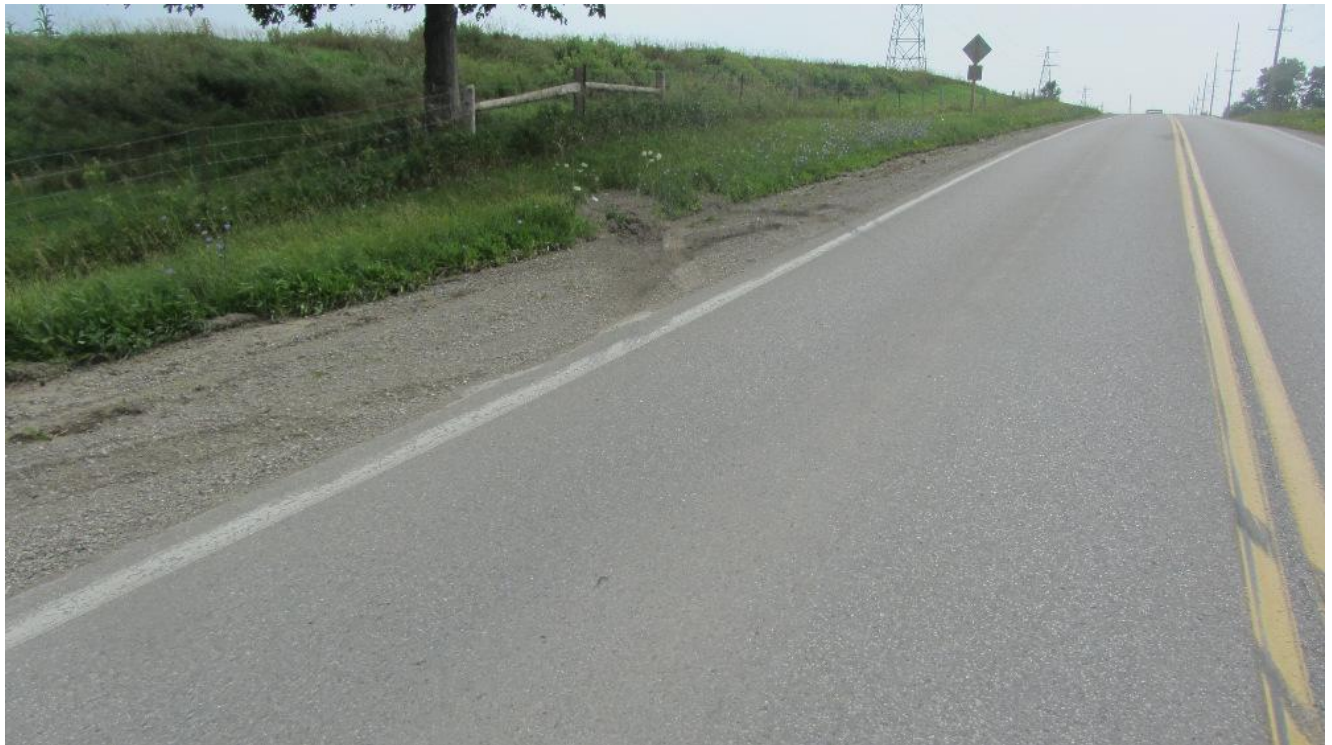
Figure 19: View, looking north-east at the tire marks near the vehicle's rest position.

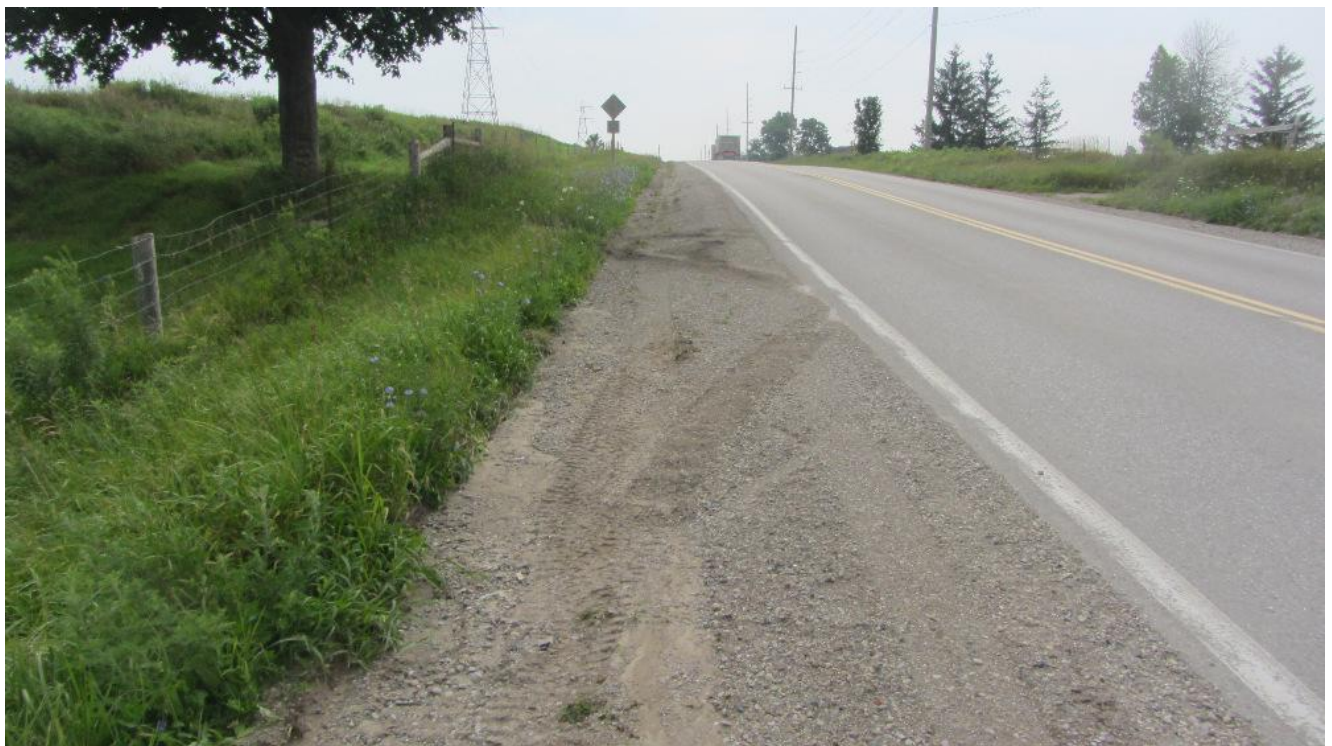
Figure 20: View, looking north along the west shoulder at the evidence at the vehicle's rest position.

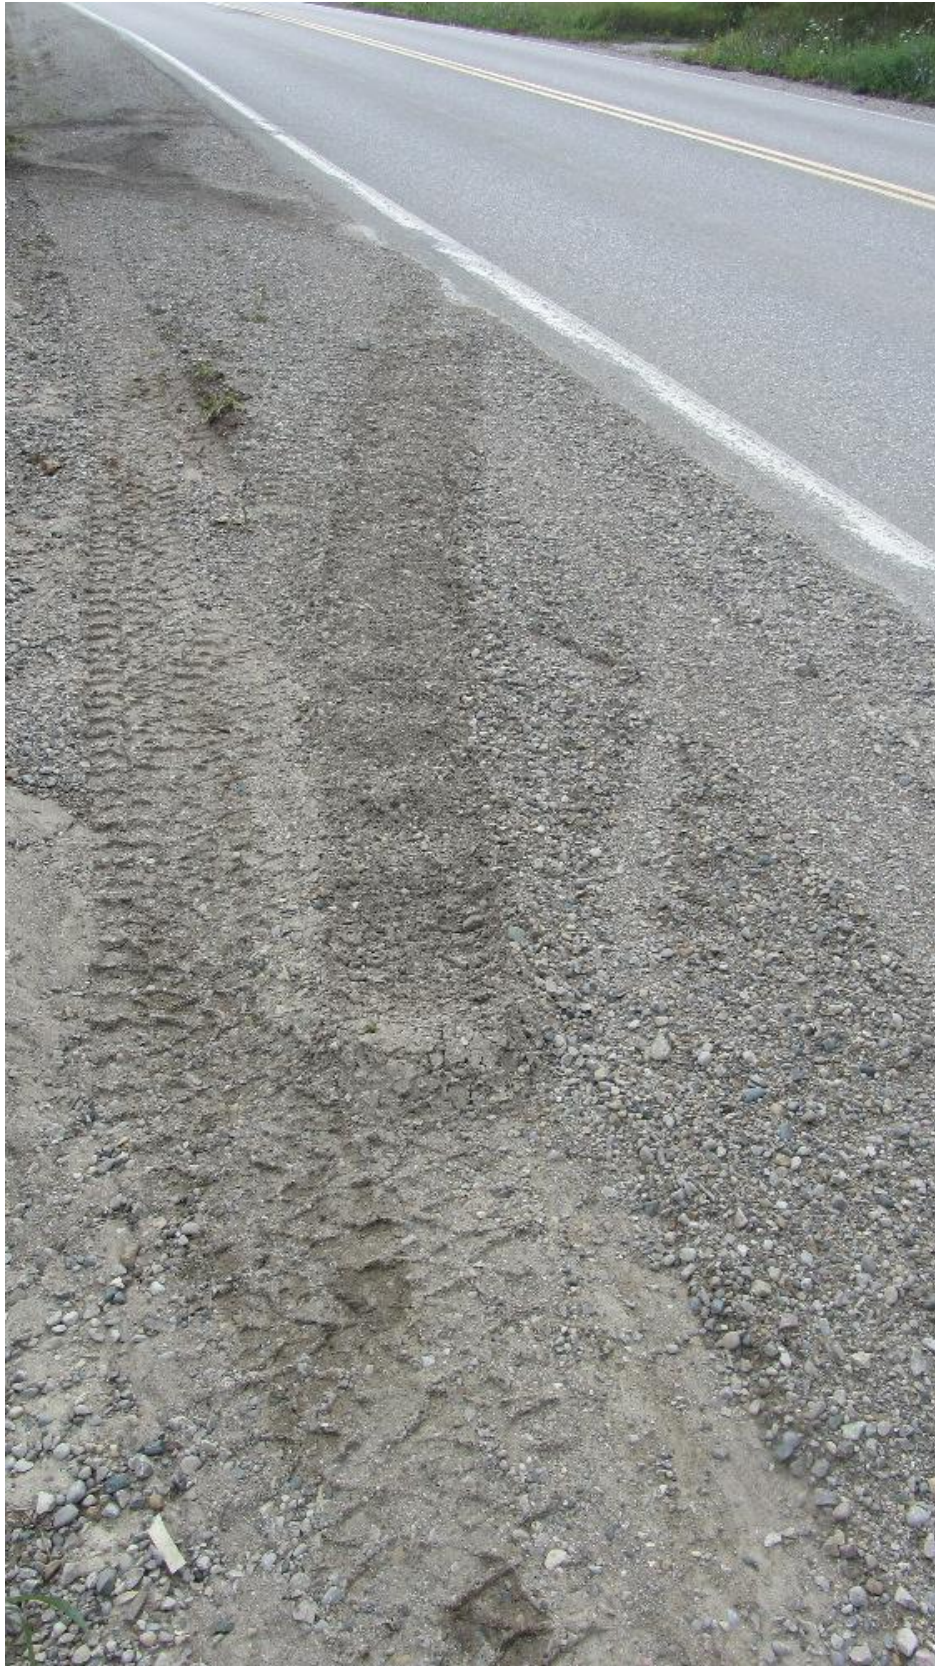
Figure 21: View, looking south at the evidence on the west shoulder near the vehicle's rest position.
