Review of Loss-of-Control Tire Marks on a Gravel Shoulder

Posting Date: 05-Aug 2014

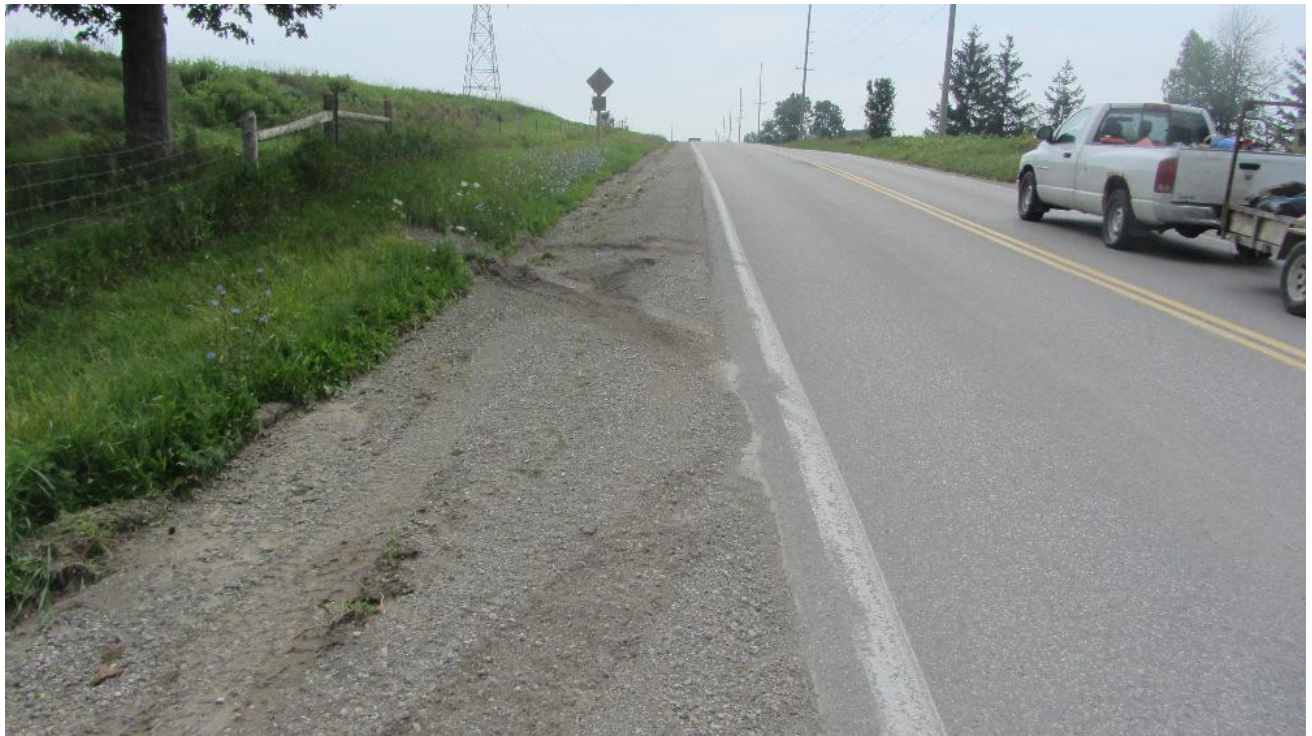
Figure 22: View, looking north, along the west shoulder, near the vehicle's rest position.

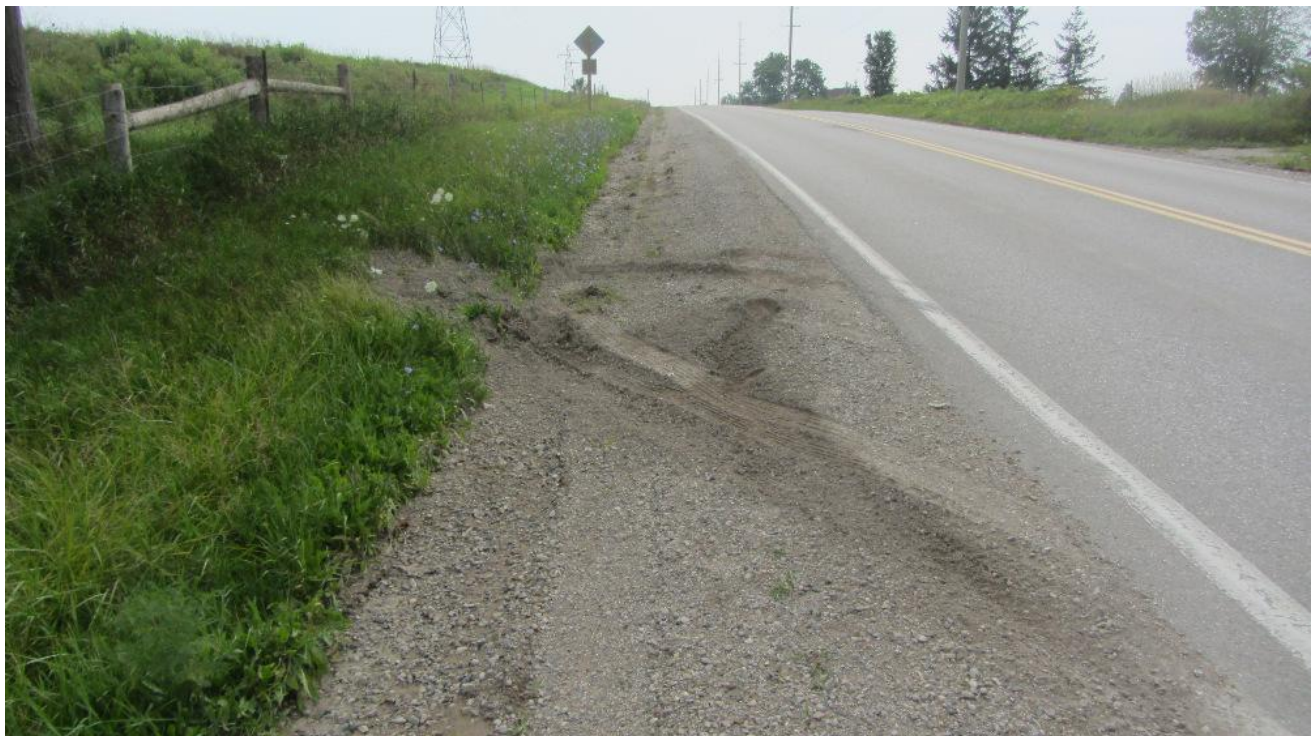
Figure 23: View, looking north, along the west shoulder, near the vehicle's rest position.

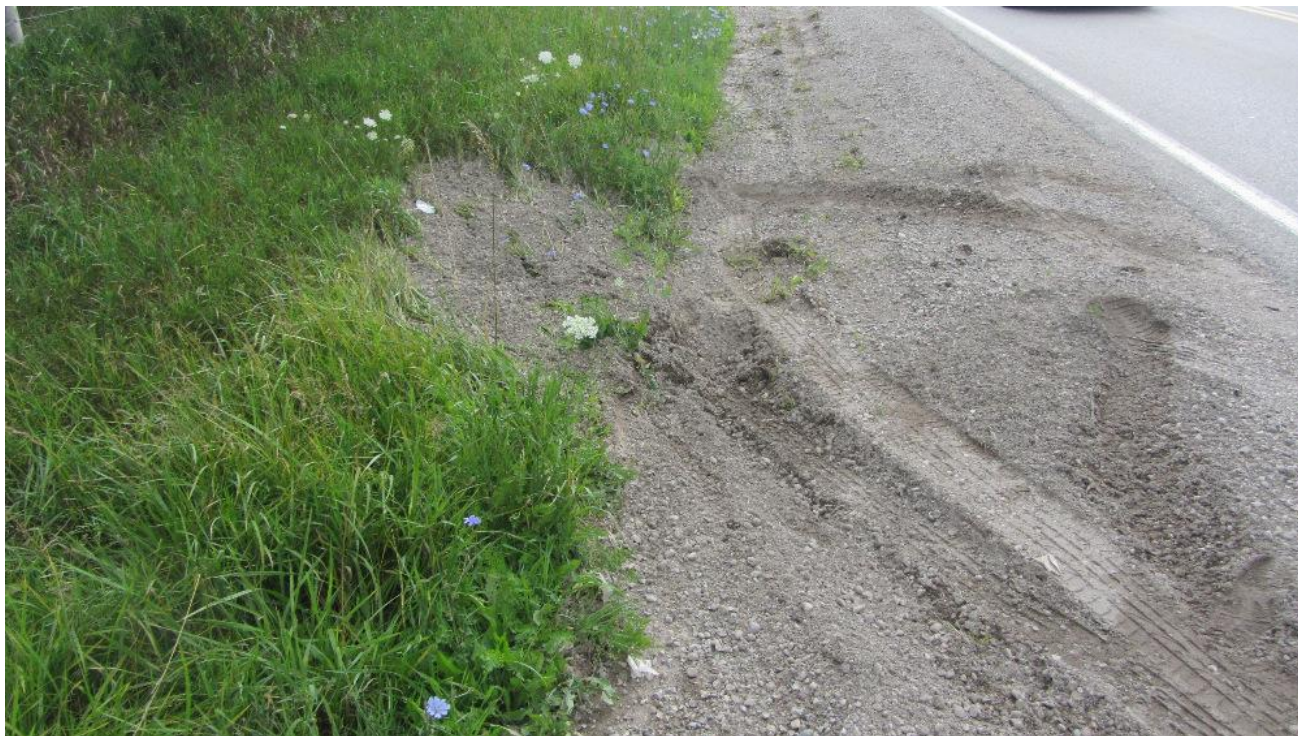
Figure 24: View, looking north, along the west shoulder, at the vehicle's rest position.

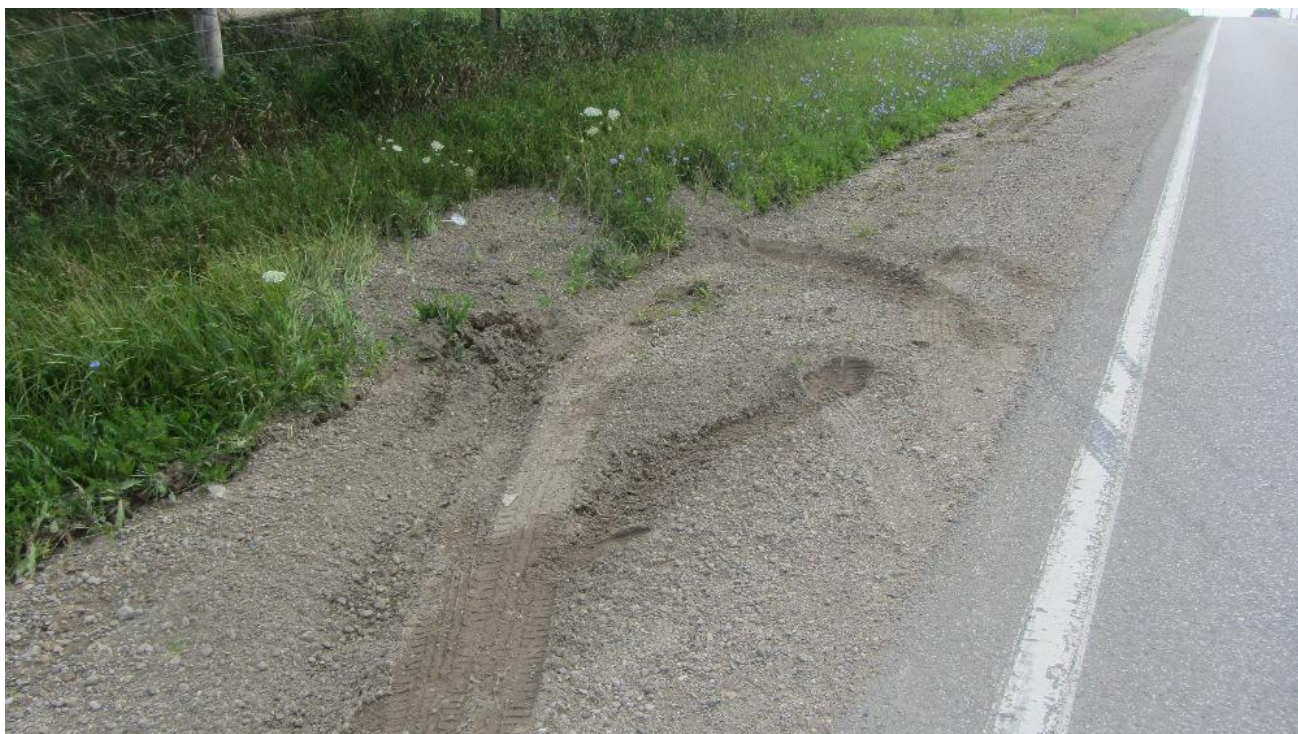
Figure 25: View, looking north-east at the evidence at the vehicle's final rest position.

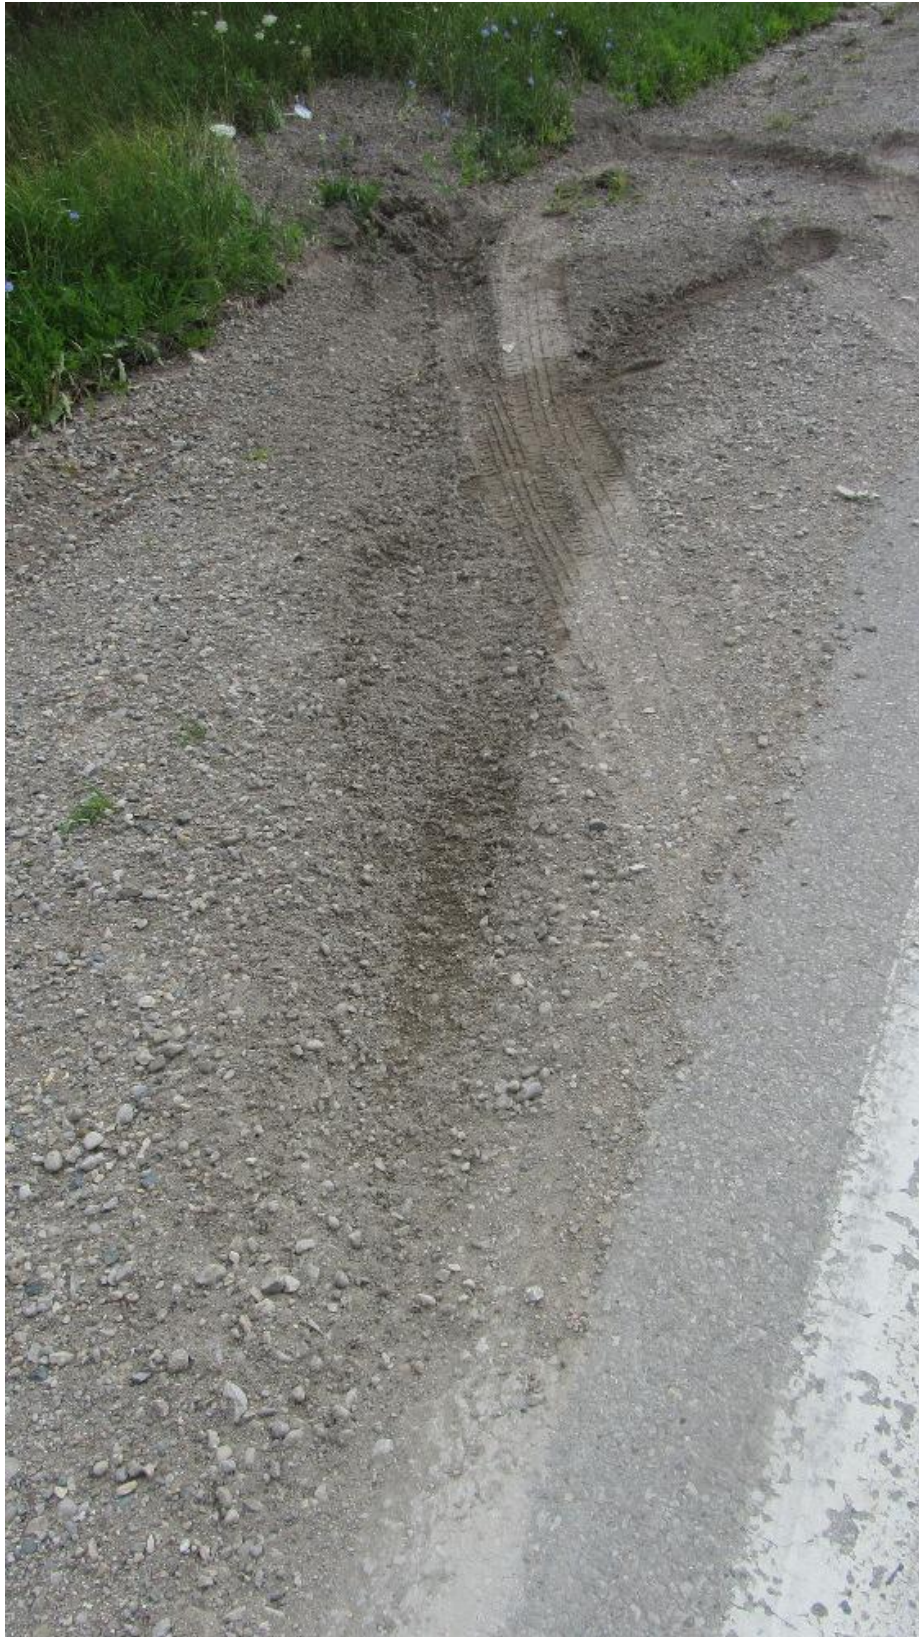
Figure 26: View, looking north-east, at the evidence at the vehicle's rest position.

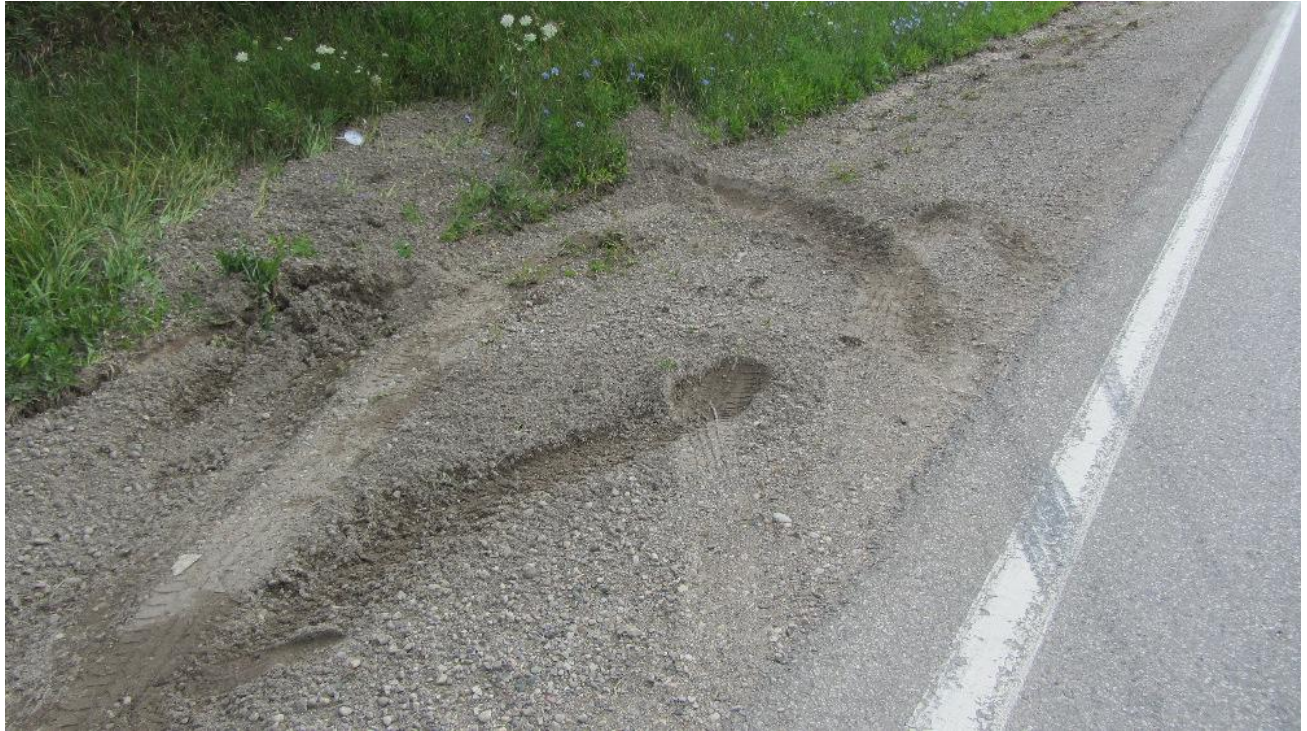
Figure 27: View, looking north-east, at the evidence at the vehicle's final rest position.

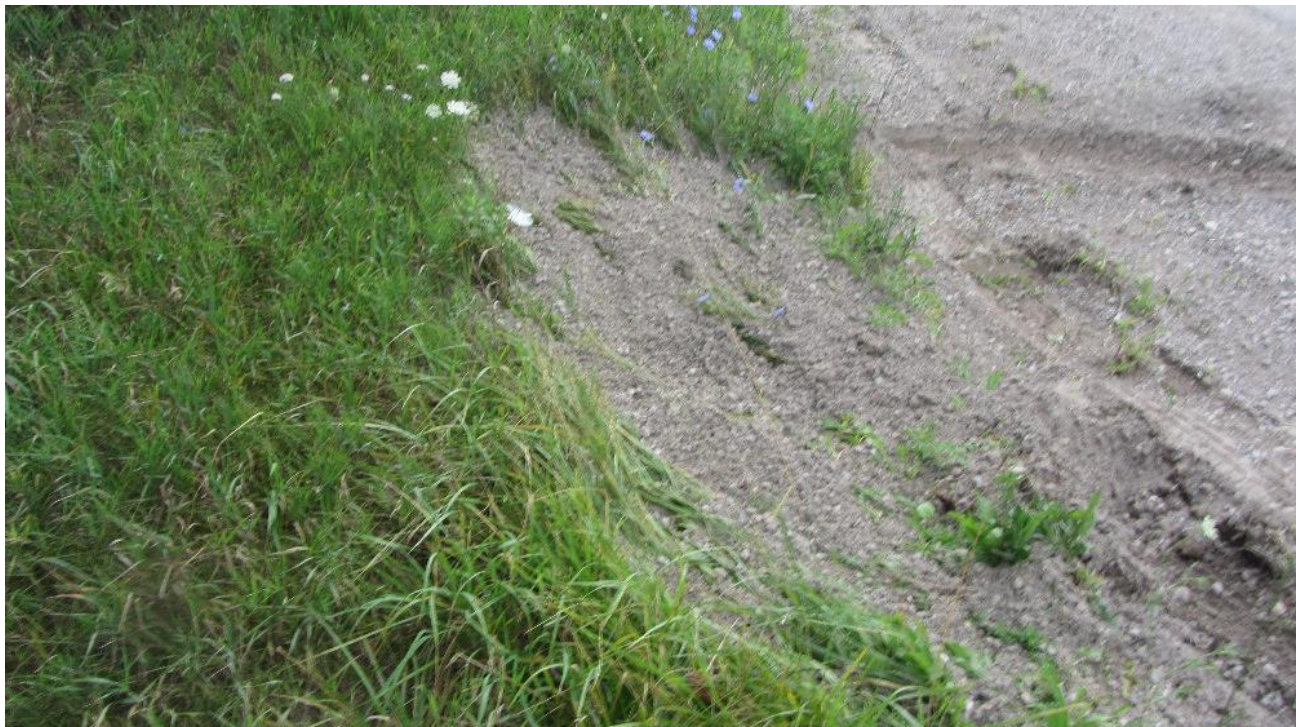
Figure 28: View, looking north, at the disbursed gravel lying in the west roadside at the vehicle's rest position.

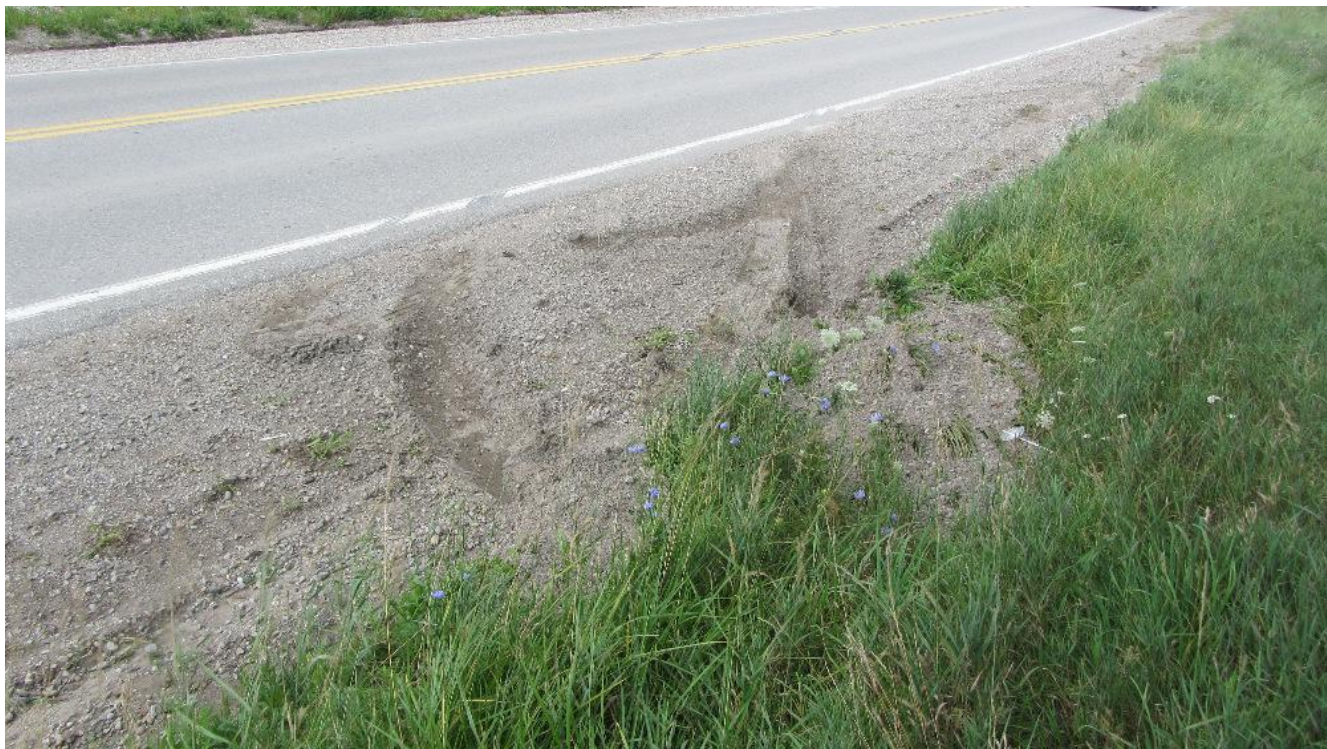
Figure 29: View, looking south-east, from just north-west of the vehicle's rest position.

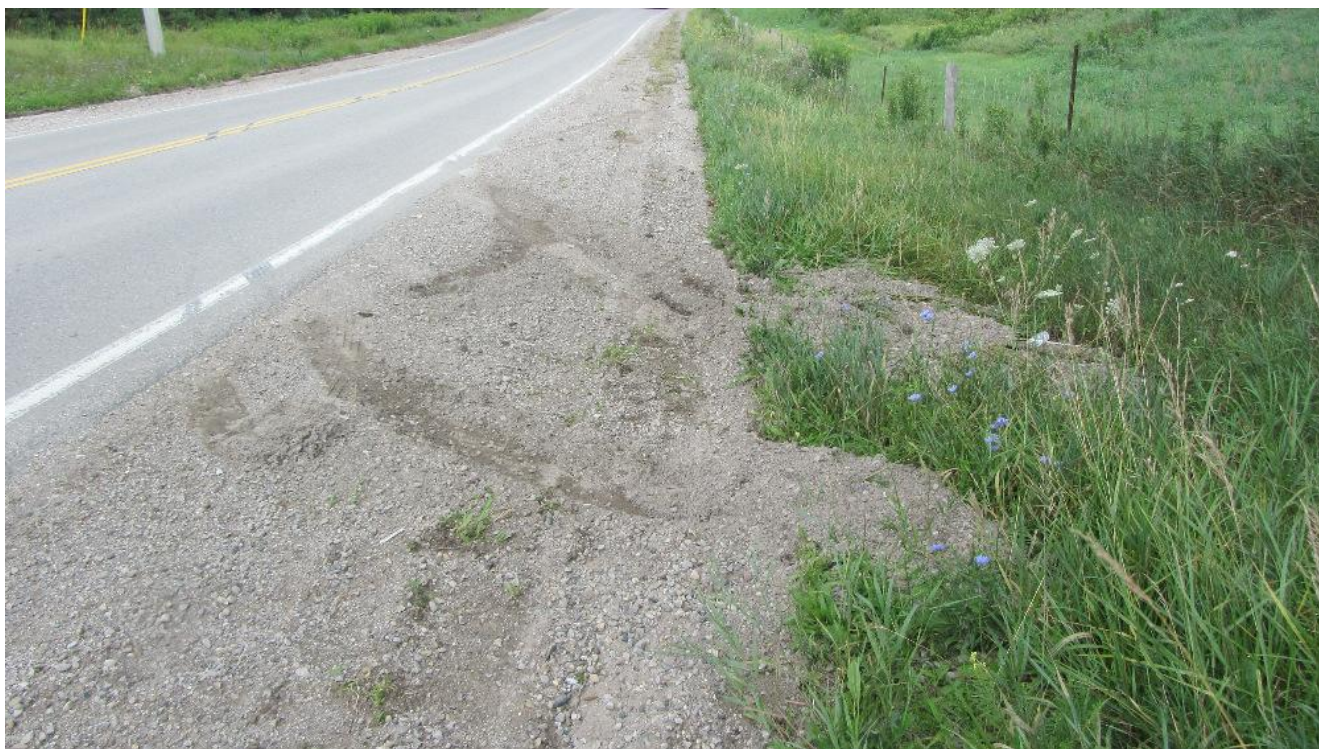
Figure 30: View, looking south, from just north of the vehicle's final rest position.

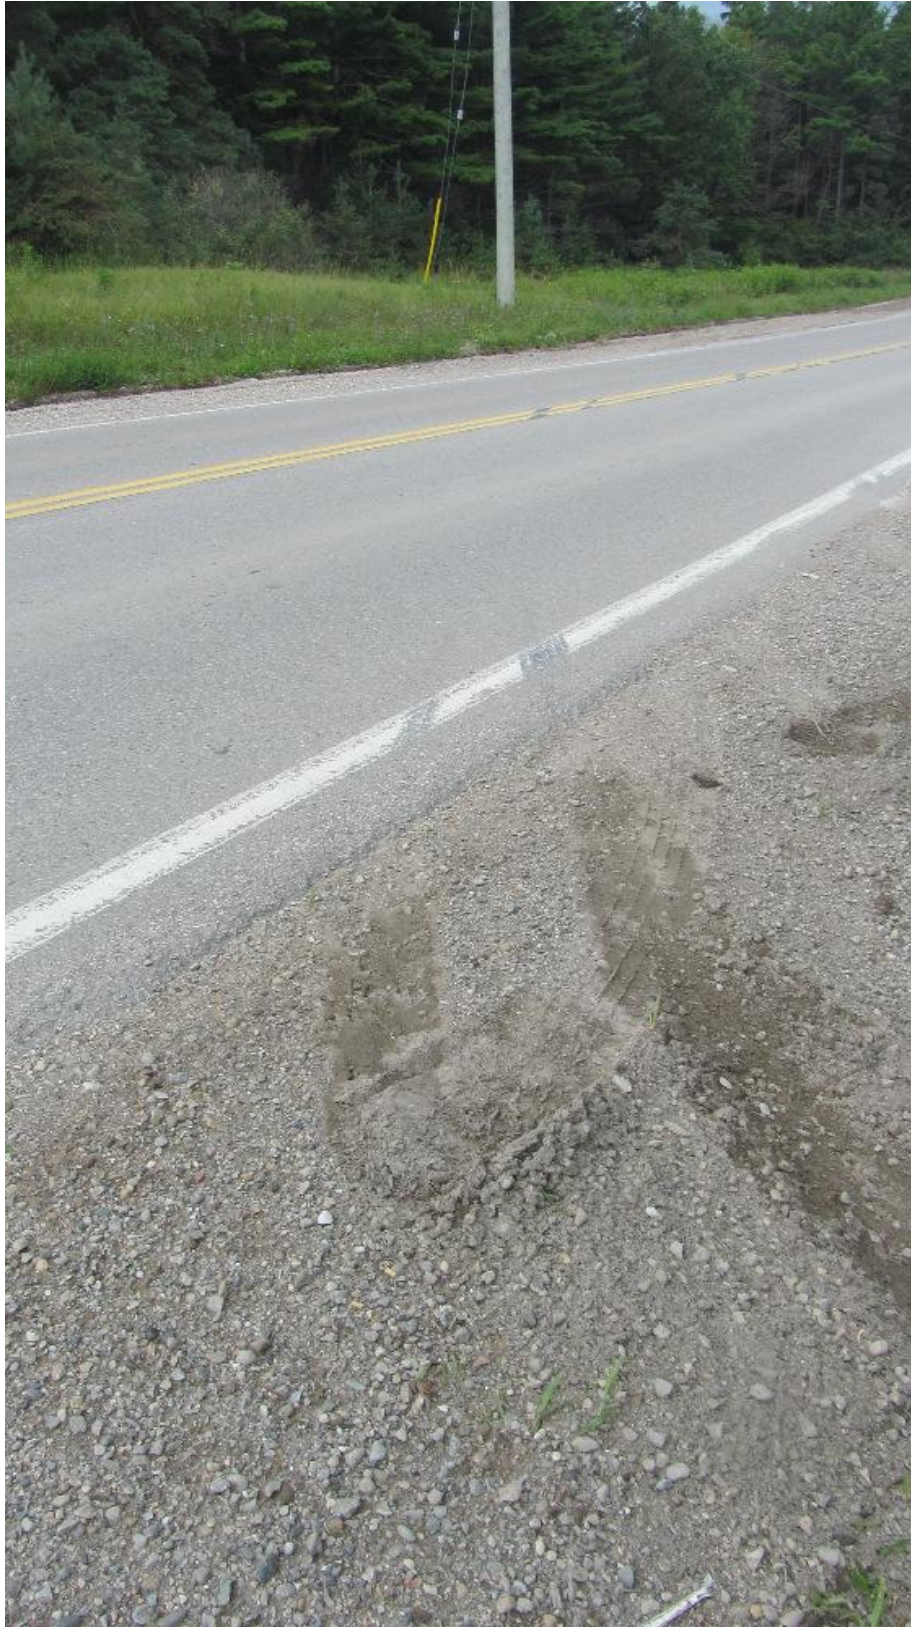
Figure 31: View, looking south-east at the tire marks on the west shoulder at the vehicle's rest position. These can be compared to the position of the yaw marks in the background.

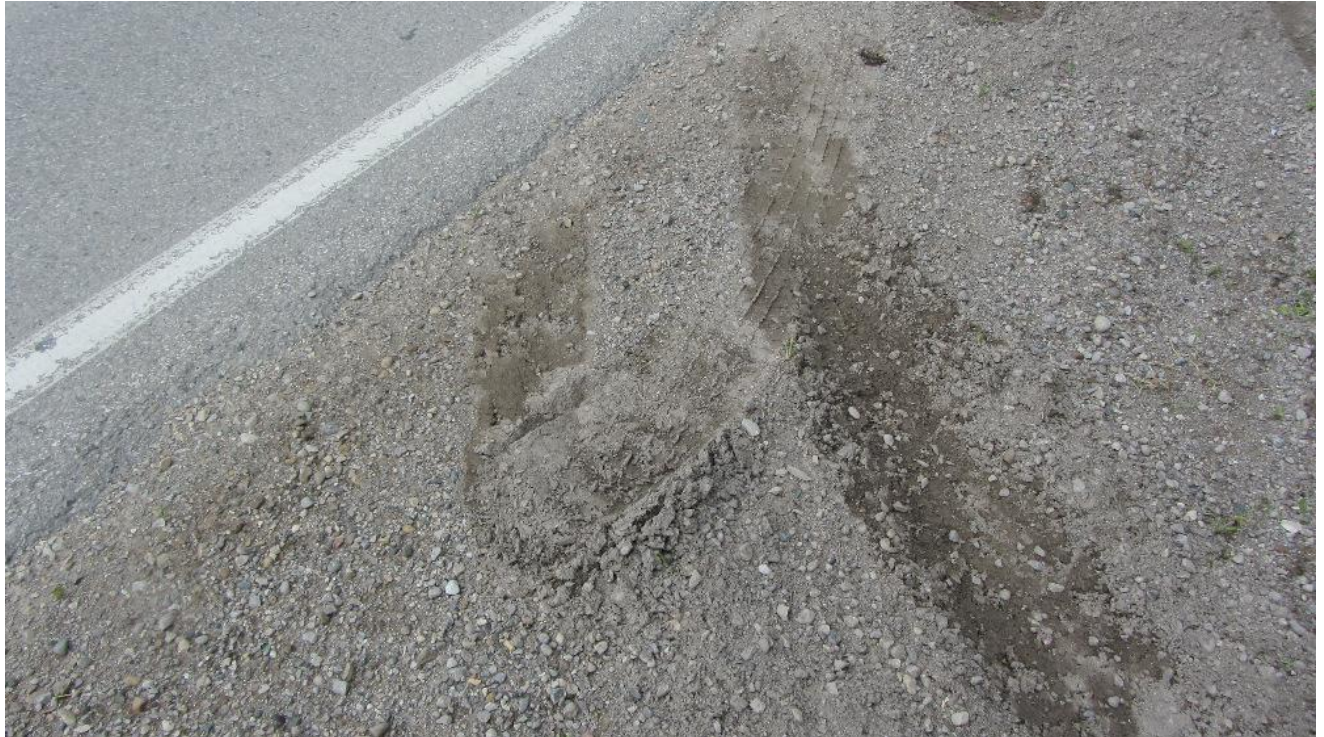
Figure 32: Close-up view of the tire marks shown in the previous (Figure 31) figure.

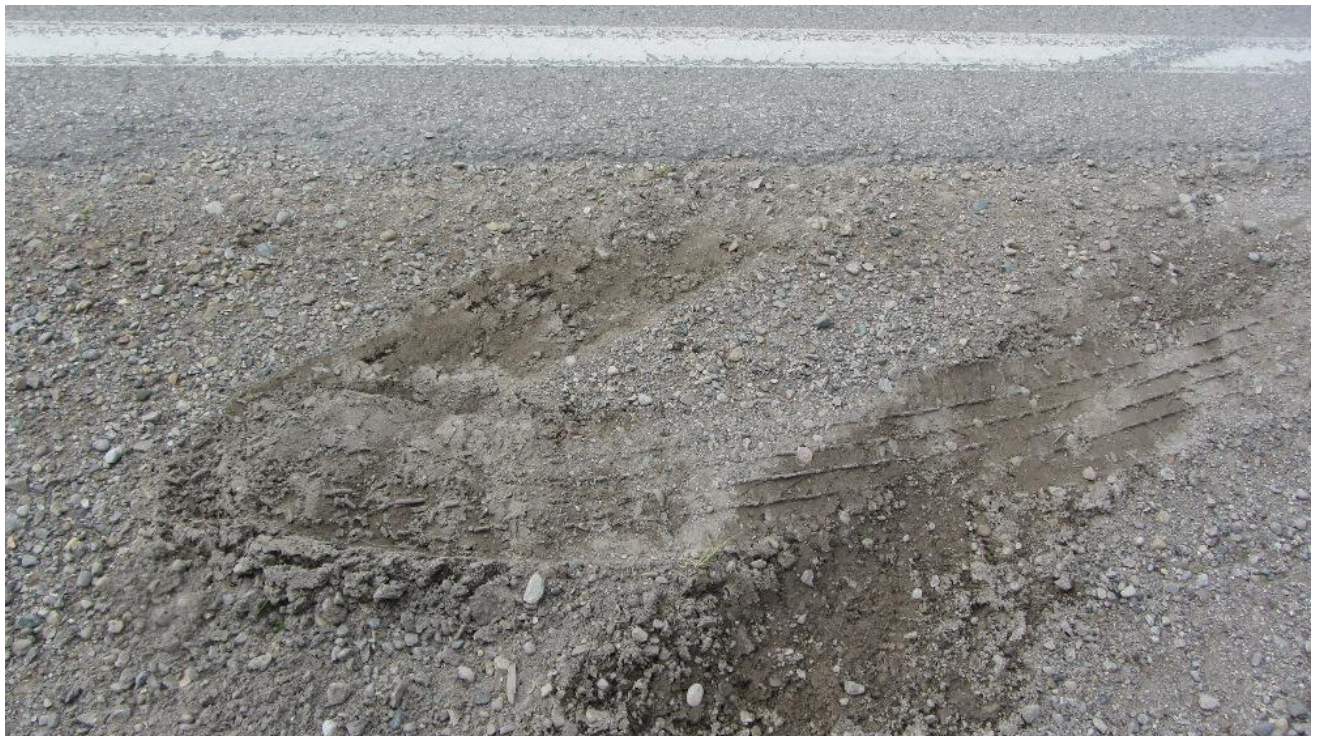
Figure 33: Close-up view of the tire marks shown in Figures 31 and 32.

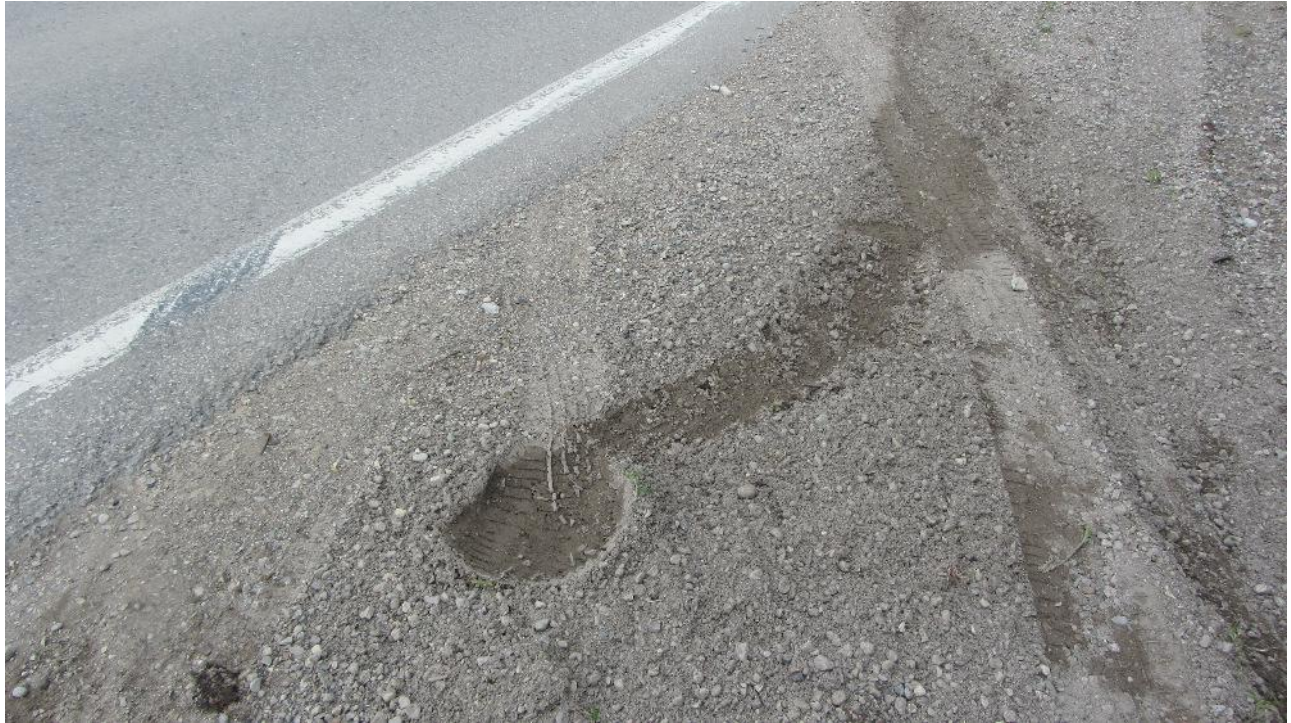
Figure 34: Close-up view, looking south-east of tire marks at the vehicle's final rest position.

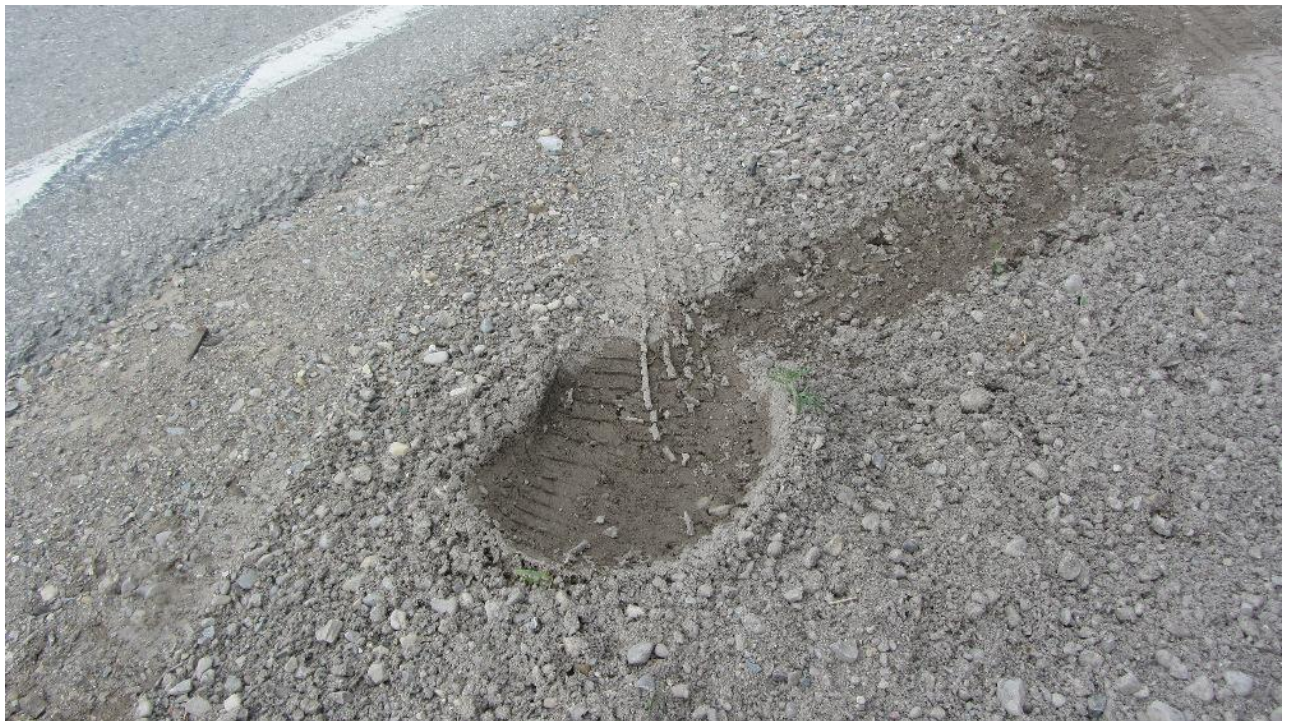
Figure 35: Close-up view of tire marks shown in Figure 34.

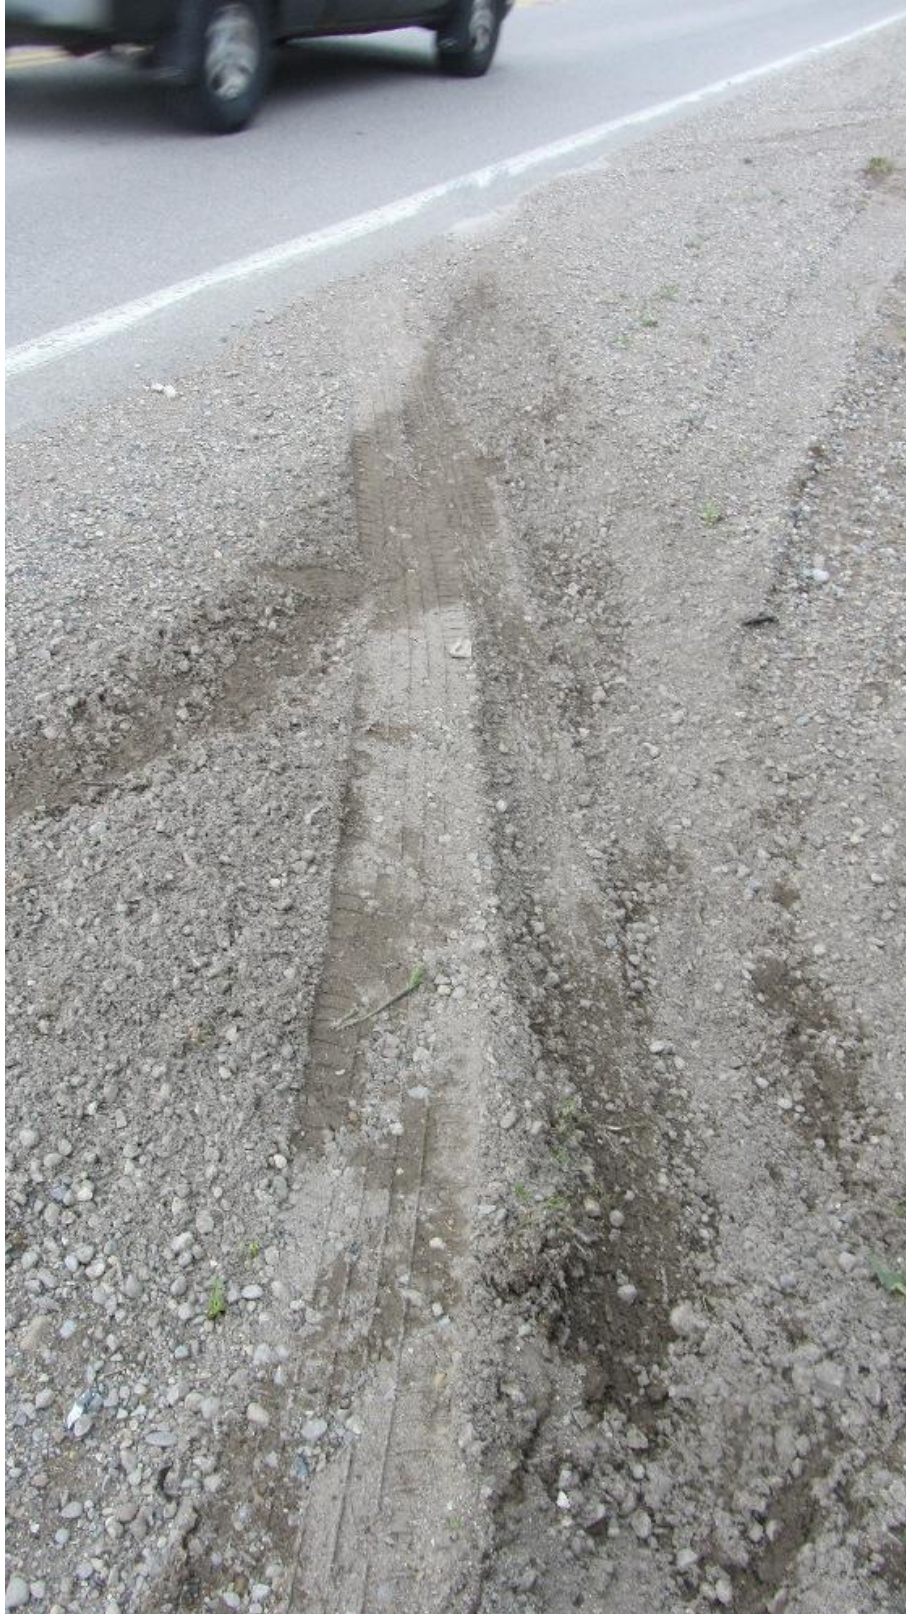
Figure 36: View, looking south-east, along the tire marks at the vehicles rest position.

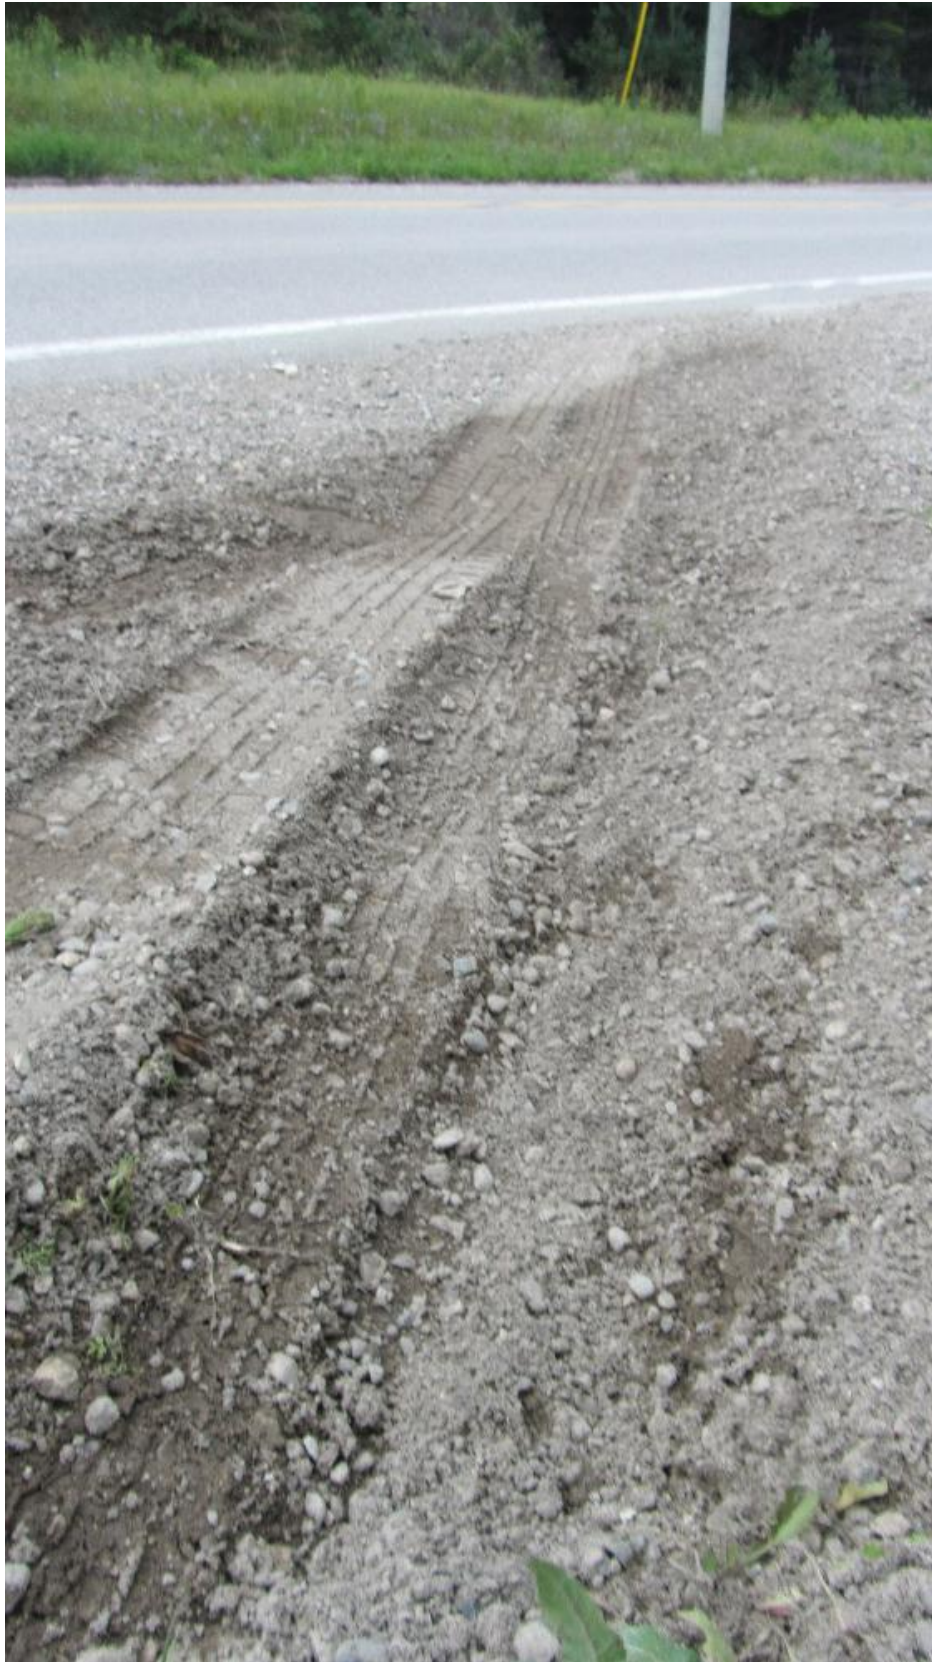
Figure 37: View, looking south-east, along the tire at the vehicle's rest position.
