Trinity Guardrail End Caps In & Near London Ontario - Survey of Locations & Condition

Posting Date: 09-Oct 2014

Survey of Trinity End Cap Location & Condition

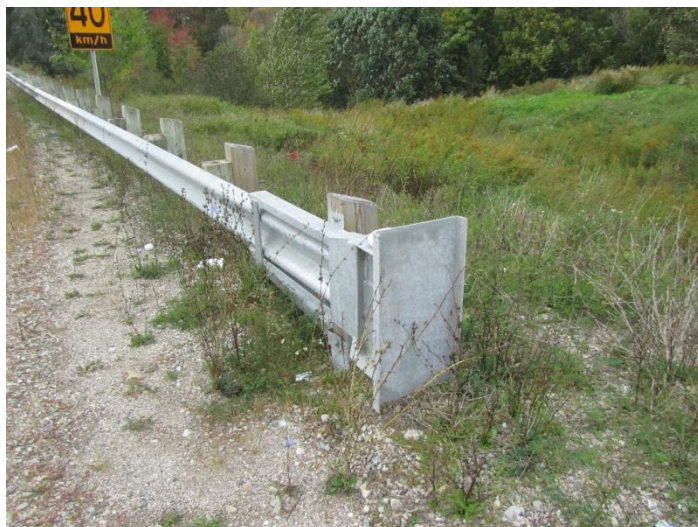
Figure 1: View of end cap of west guardrail. Evidence suggests that the original end cap was damaged and replaced by the current one which has a 4 inch wide channel.

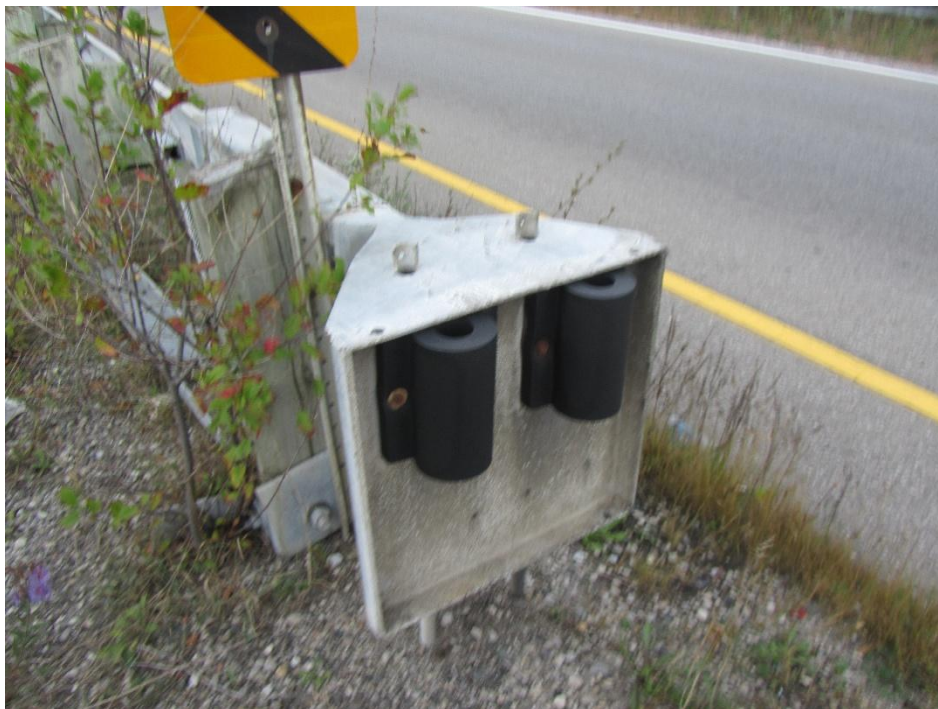
Figure 7: The end cap appears to be missing its front cover.

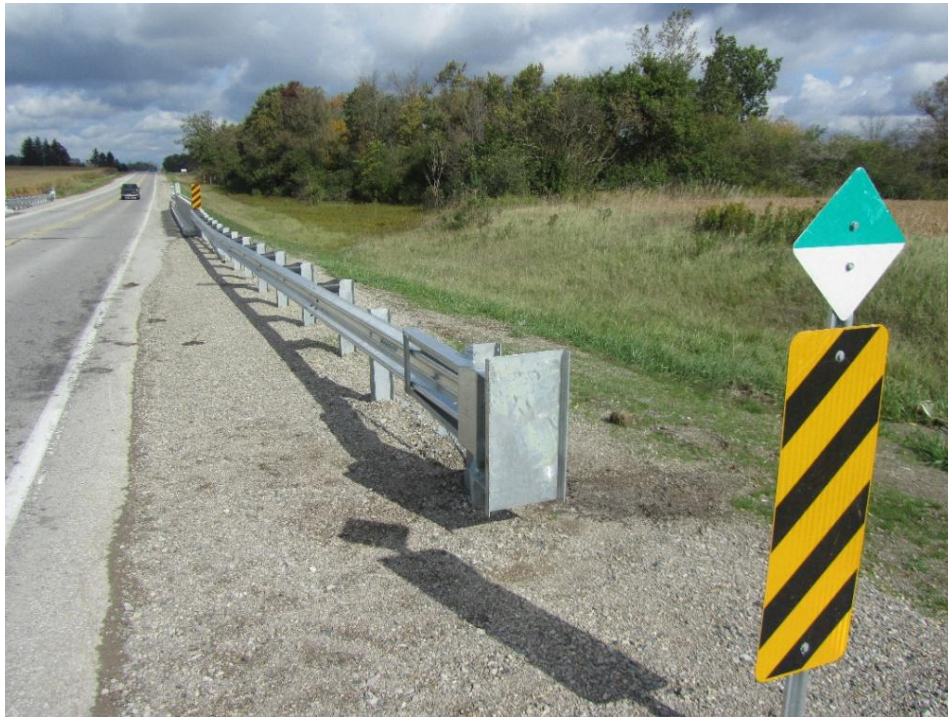
Figure 11: Overall view of east guardrail with end cap that is missing its front cover.

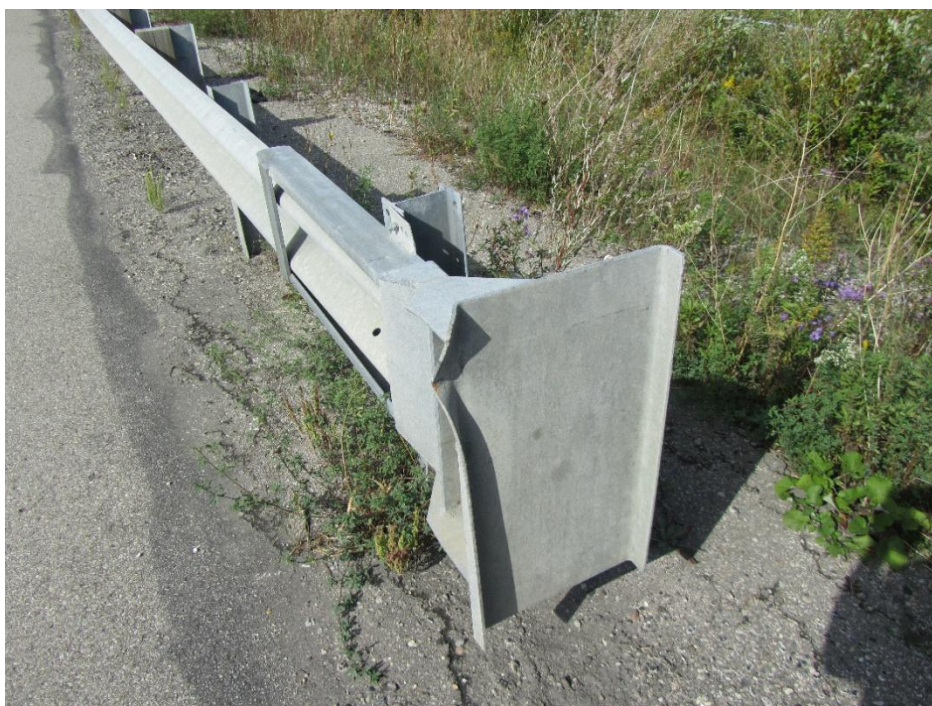
Figure 41: View of damage evidence to face of end plate.

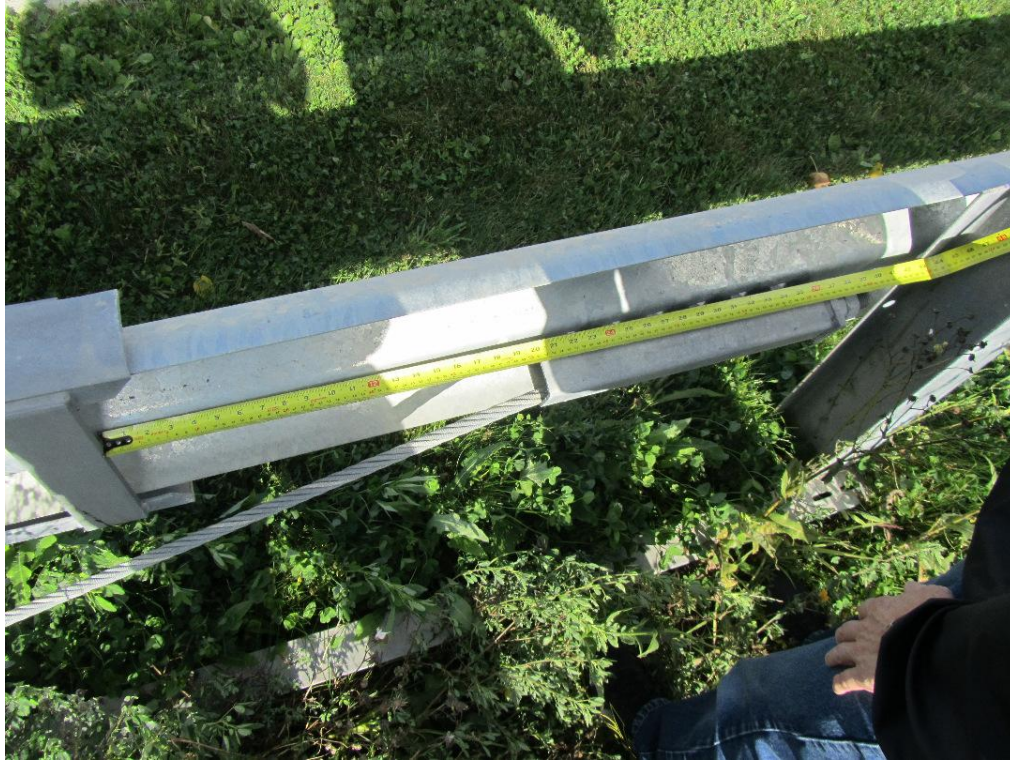
Figure 49: Closer view of channel and guardrail beam noting that they are not in vertical alignment.

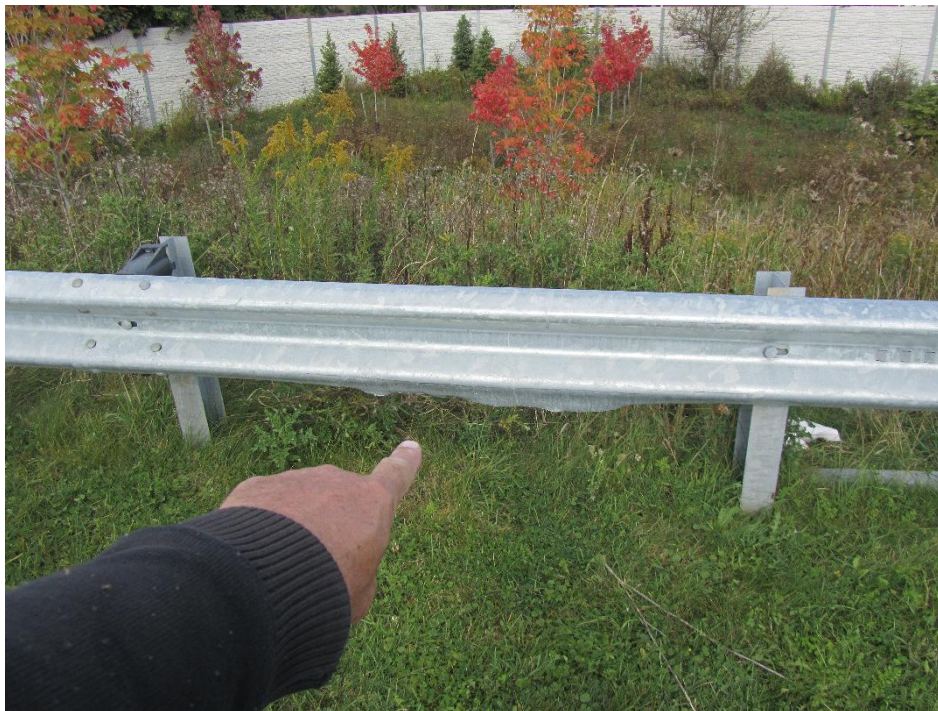
Figure 65: Evidence of damage to the rail near the channel that could affect how the rail passes through that channel.

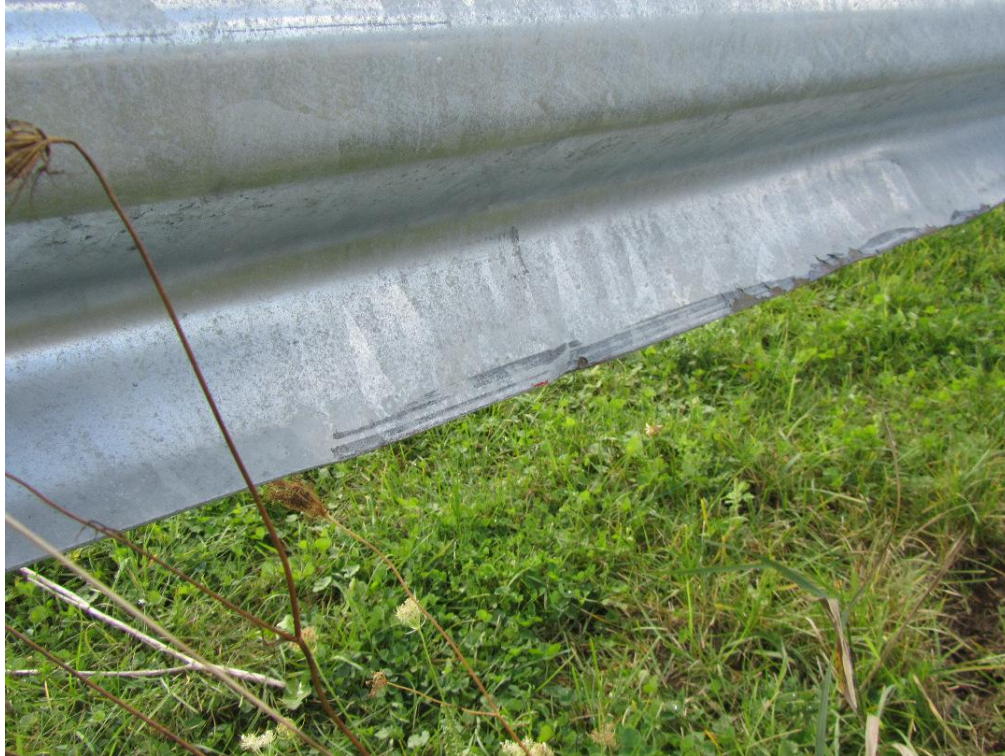
Figure 66: Evidence of scrapes to backside of rail at the location where the rail is deformed.

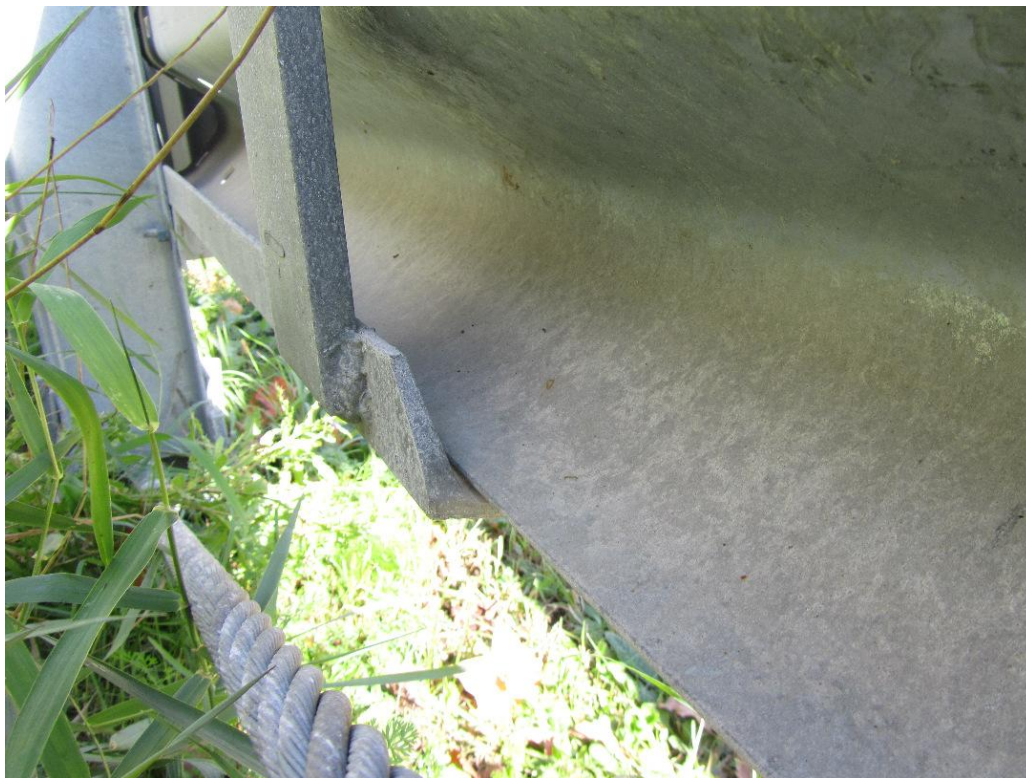
Figure 100: View showing the bottom edge of the rail resting on the bottom of the channel.

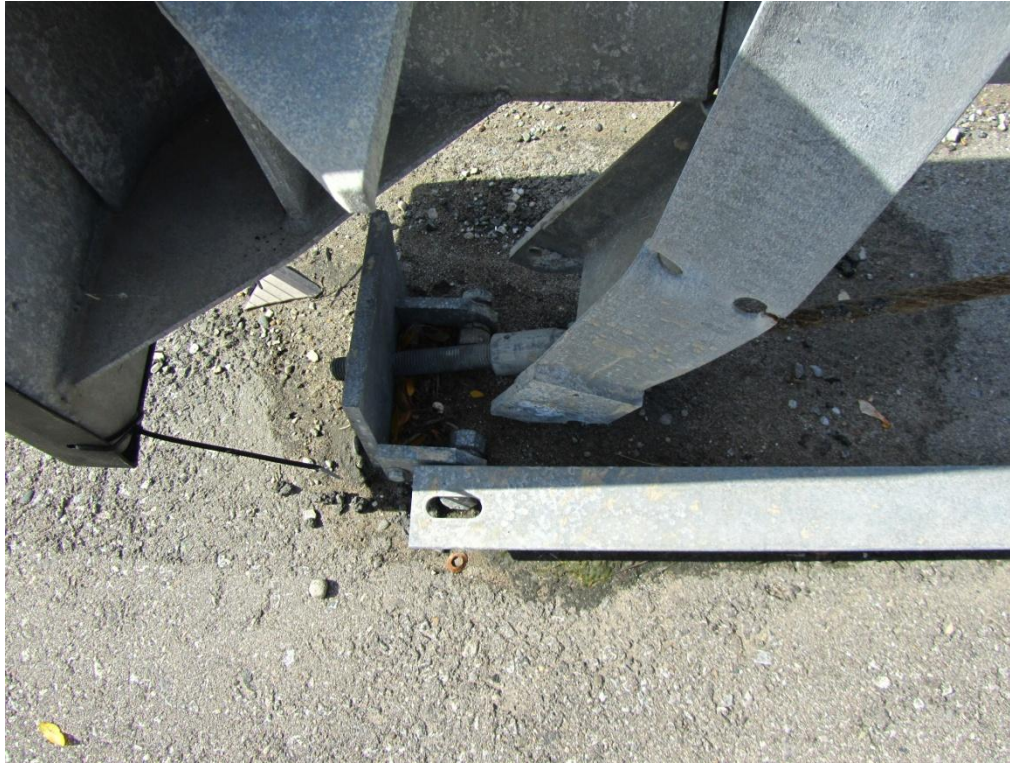
Figure 106: Vertical view of damage near the end plate indicating that the plate has been pushed along the rail, likely due to a previous impact.

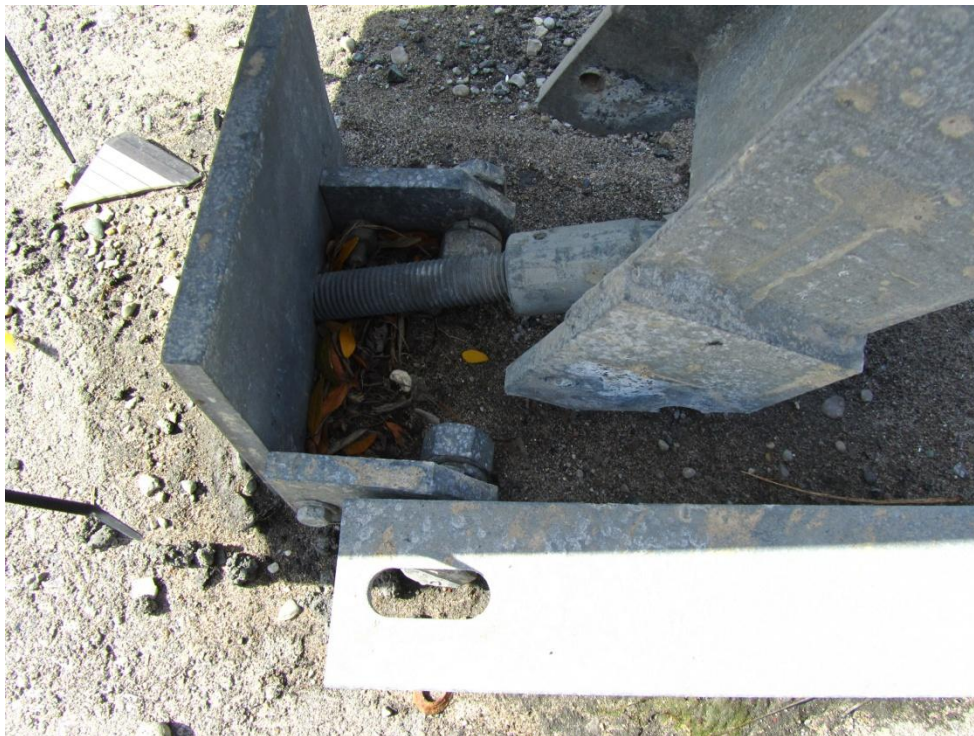
Figure 107: View of the anchorage of the guardrail just behind the end plate showing that the vertical post is deformed and it has sheared away from the anchorage bolts at its base.

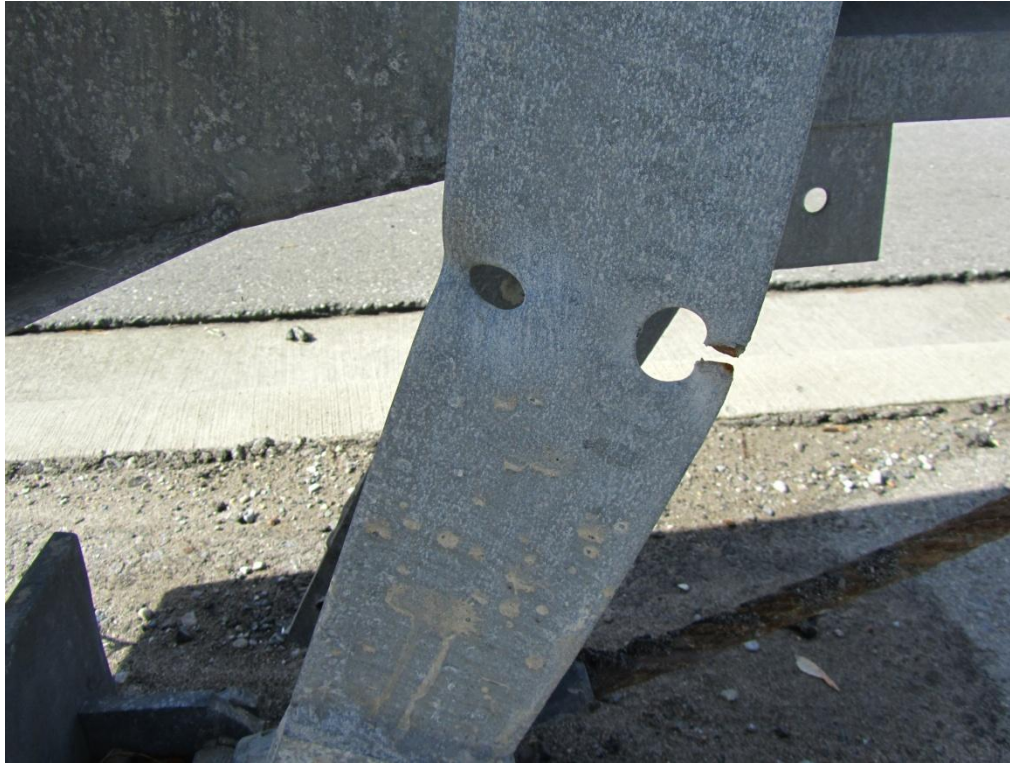
Figure 108: Close-up view showing how the base of the vertical post of the guardrail has been broken free from the bottom anchorage and has been displaced likely as a result of a previous impact.

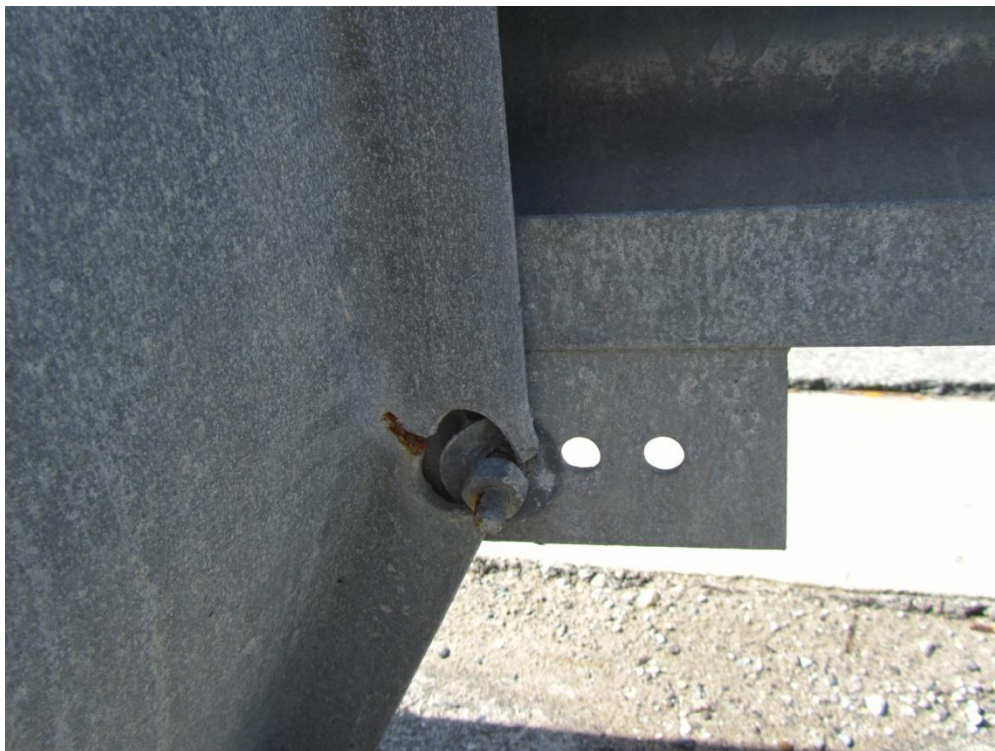
Figure 109: View of buckling and ruptures of the vertical anchorage post just behind the end plate.

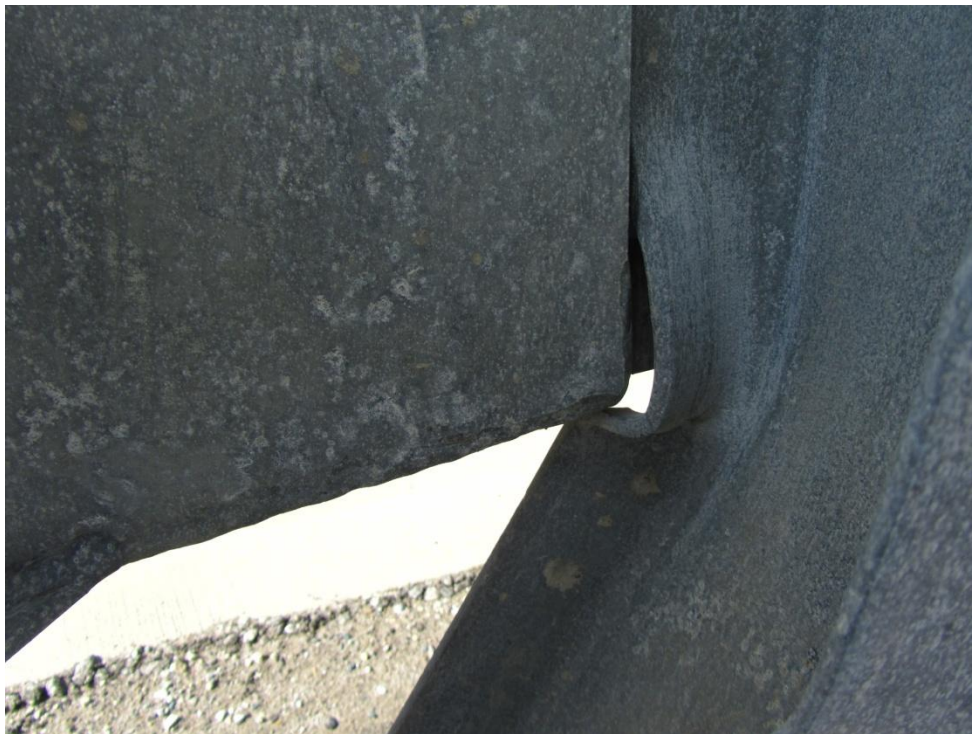
Figure 111: Top view showing how the back of the end plate has made contact with the vertical anchorage post and deformed it.

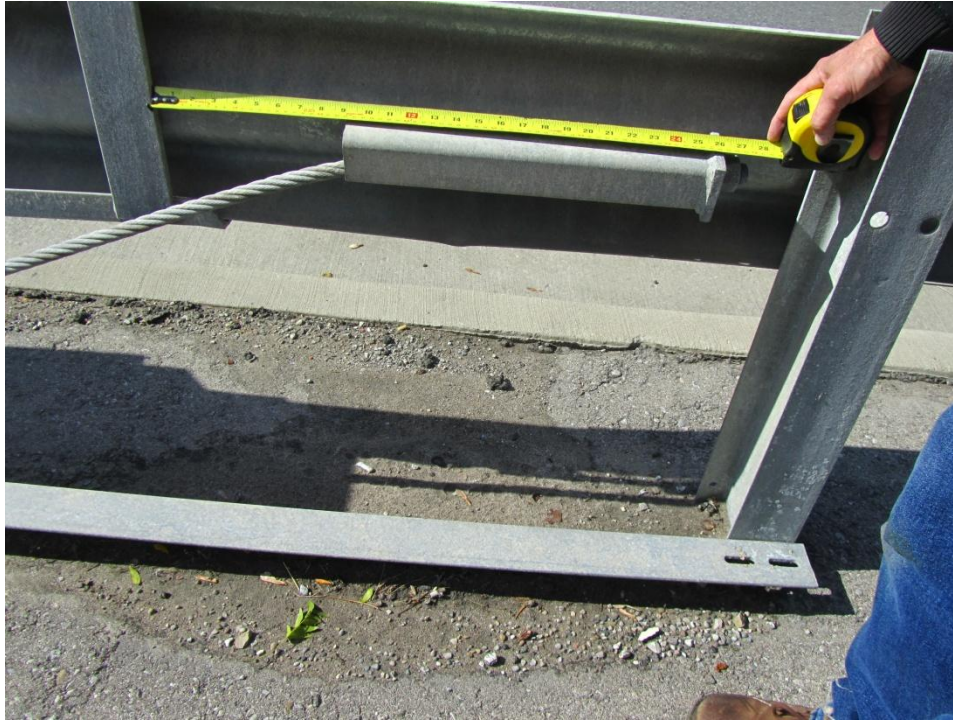
Figure 112: Close-up view of damage to the vertical post from contact with the back of the end plate which has been displaced, likely by an impact.

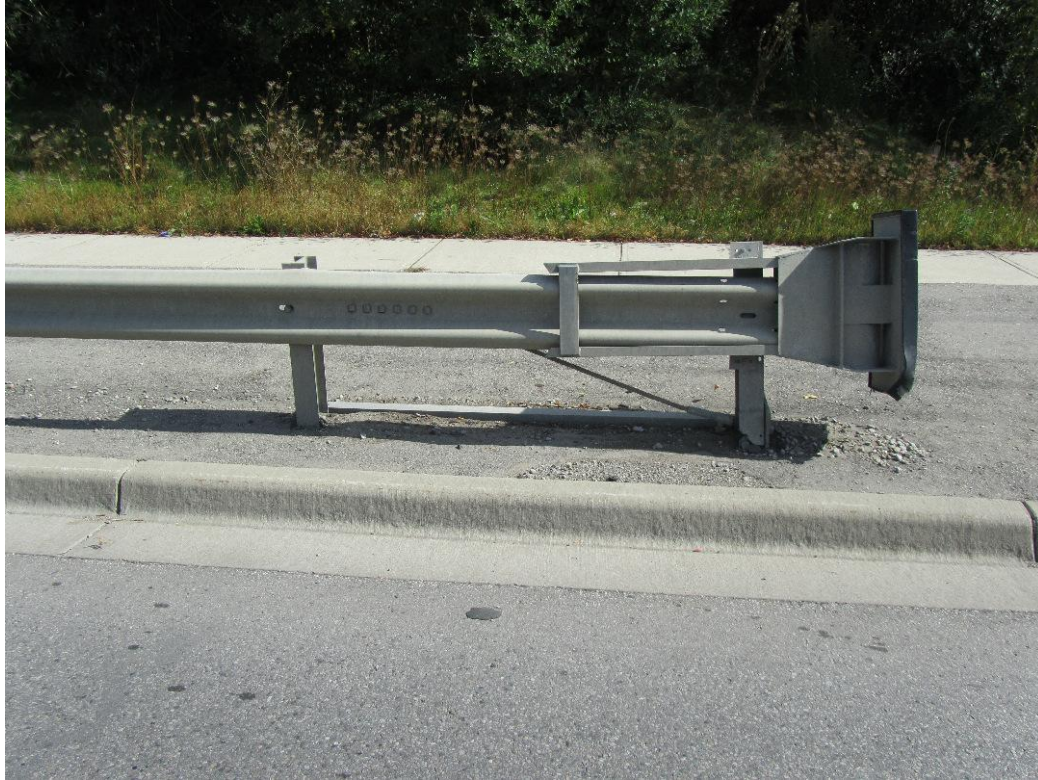
Figure 116: Closer view showing that the end plate hidden by its cover, is at a non-vertical angle.

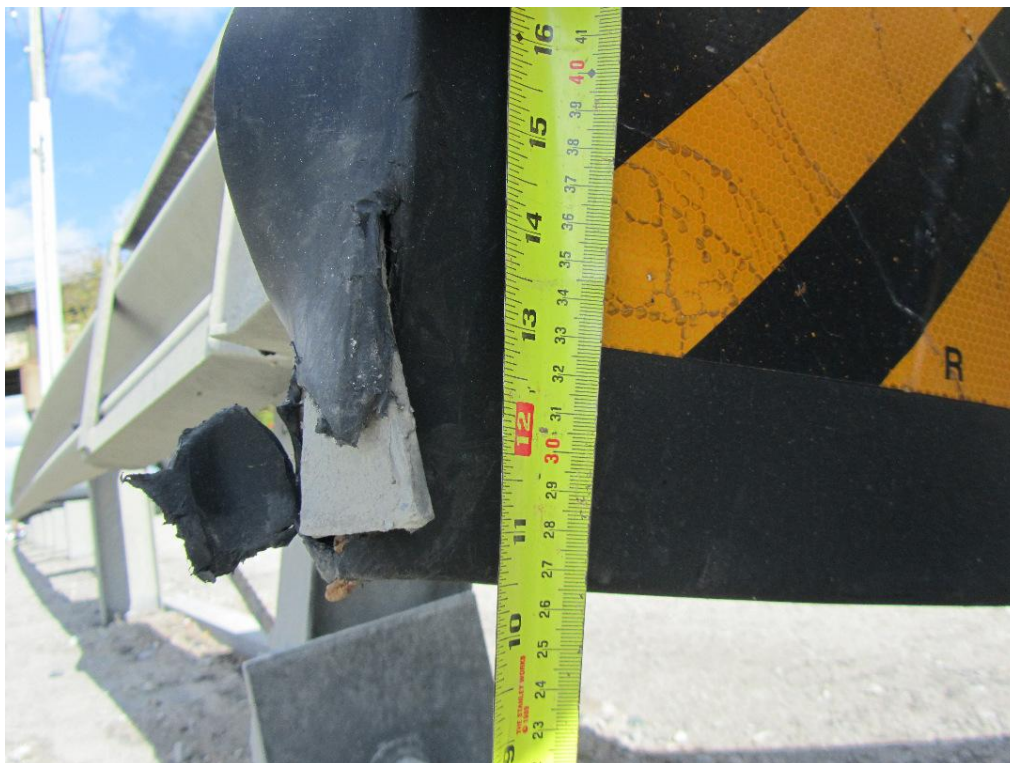
Figure 121: Measurement showing that the ditch side corner of the cover is about 7.25 inches above the ground. This indicates the substantial resting angle of the end plate.

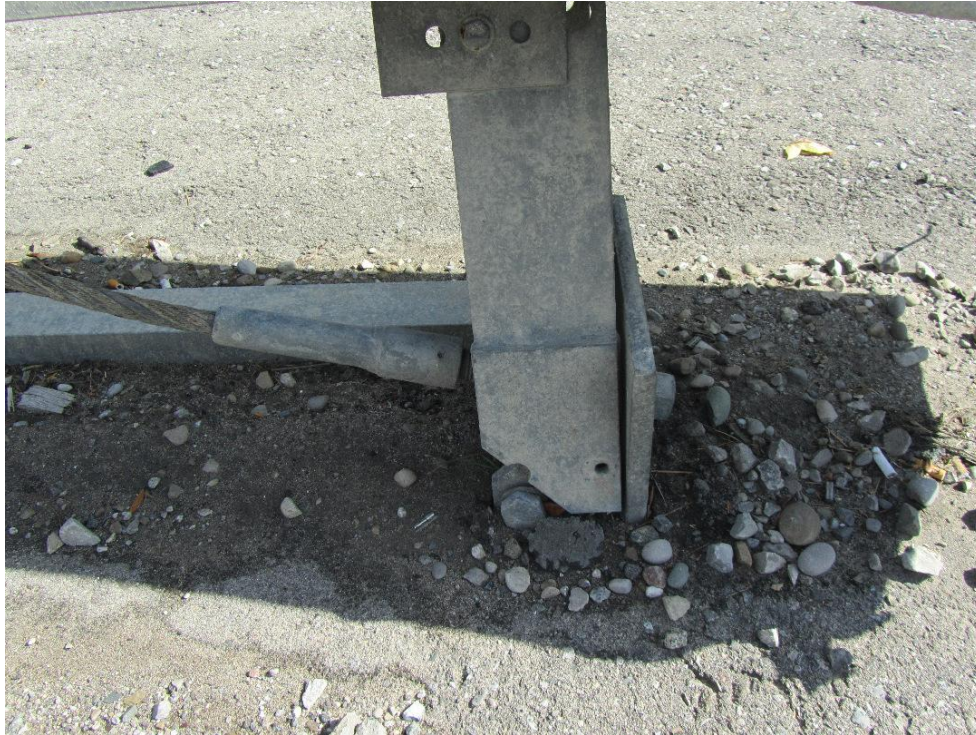
Figure 122: View indicating that there is impact damage to the bottom, street side corner of the end plate.

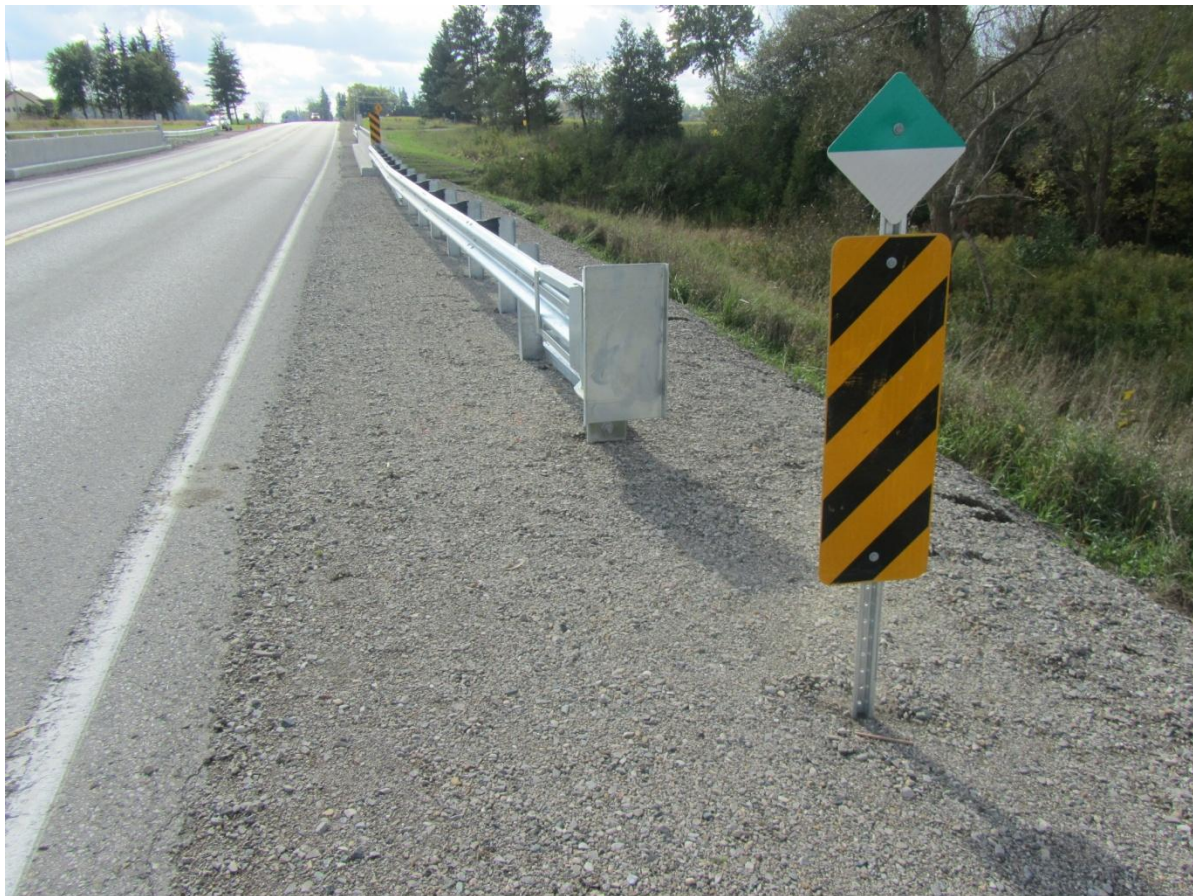
Figure 149: View of post and hazard marker placed in front of the guardrail end plate.

When the end caps were tested for compliance with federal standards the test conditions would have been idealized to isolate the system from any extraneous influences. When the post and hazard marker are struck in real-life conditions there is a good likelihood that they will be bent and possibly pushed against the end plate. The post of the hazard marker may be pulled out of the ground but that is not a guarantee. The result can be that this extraneous object could affect how the striking vehicle interacts with the end plate and how the system collapses to deform energy.

Whatever the potential problem, once a system is installed, it becomes important to confirm that the installation is as close as possible to the conditions under which it was tested for compliance. As with any roadside infrastructure, maintenance must be maintained.

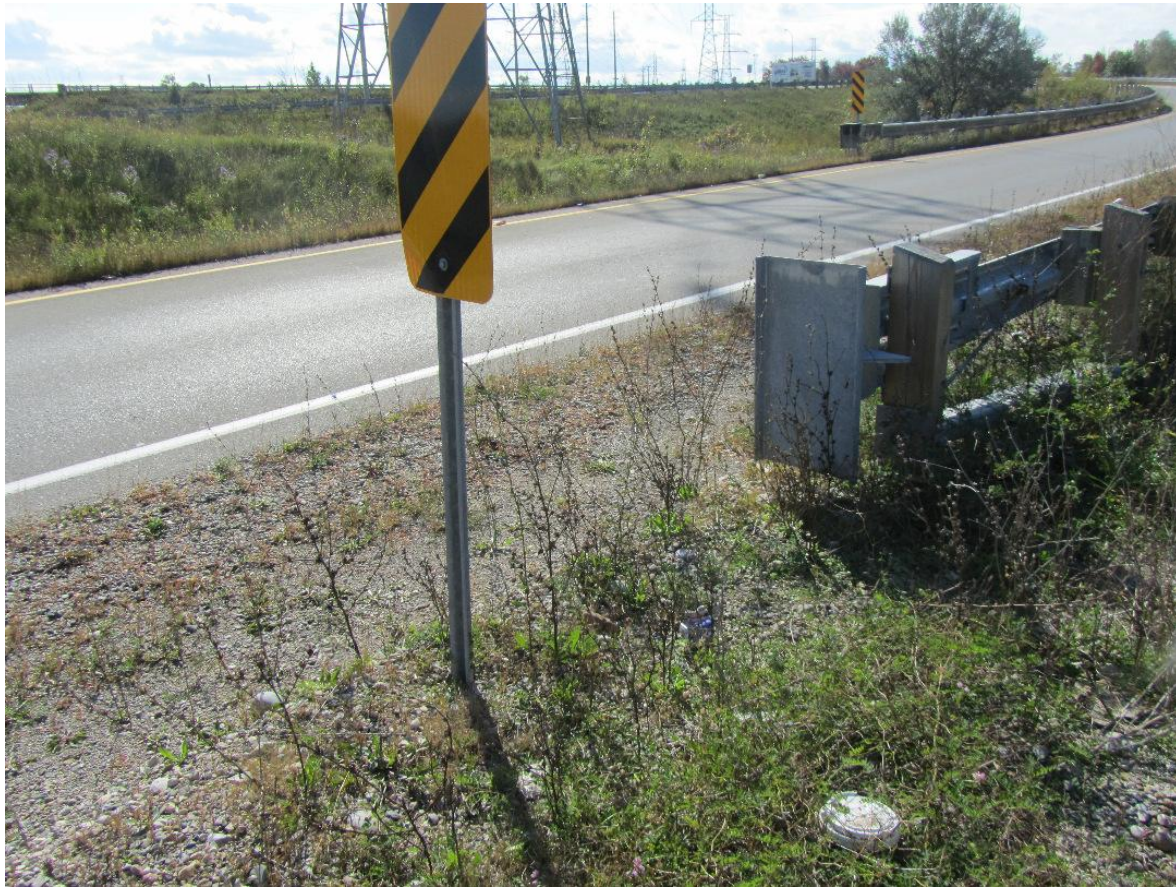
Figure 150: View of post and hazard marker placed in front of the guardrail end plate.

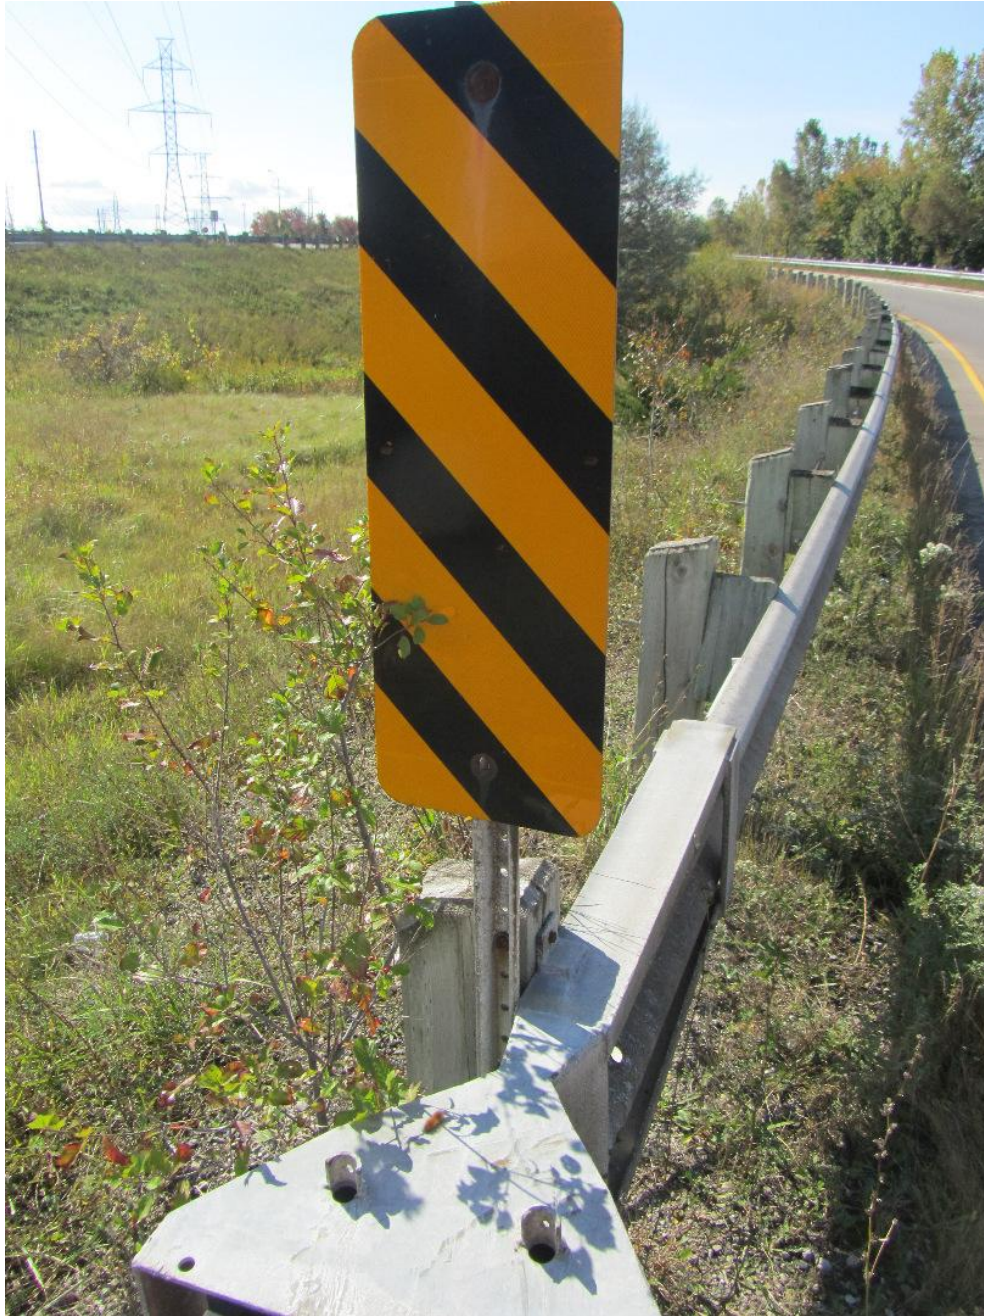
Similarly such posts and hazard markers have been observed anchored within the immediate location where the end cap must ride the rail of the guardrail system. Such an occurrence is shown below from the east guardrail on the Bradley Ave exit ramp. Again, this is an extraneous device placed in a location where it is vital that the end cap ride properly on the rail. That extraneous device could potentially jam the functioning of the system as it collapses and the system may not function properly.

Figure 151: View of post and hazard marker placed in the zone where the end cap's proper collapse along the guardrail must be isolated from any extraneous devices.
