# Difficulties Posed by Heavy Truck Slow Acceleration

*Posting Date: 26-Aug 2014*

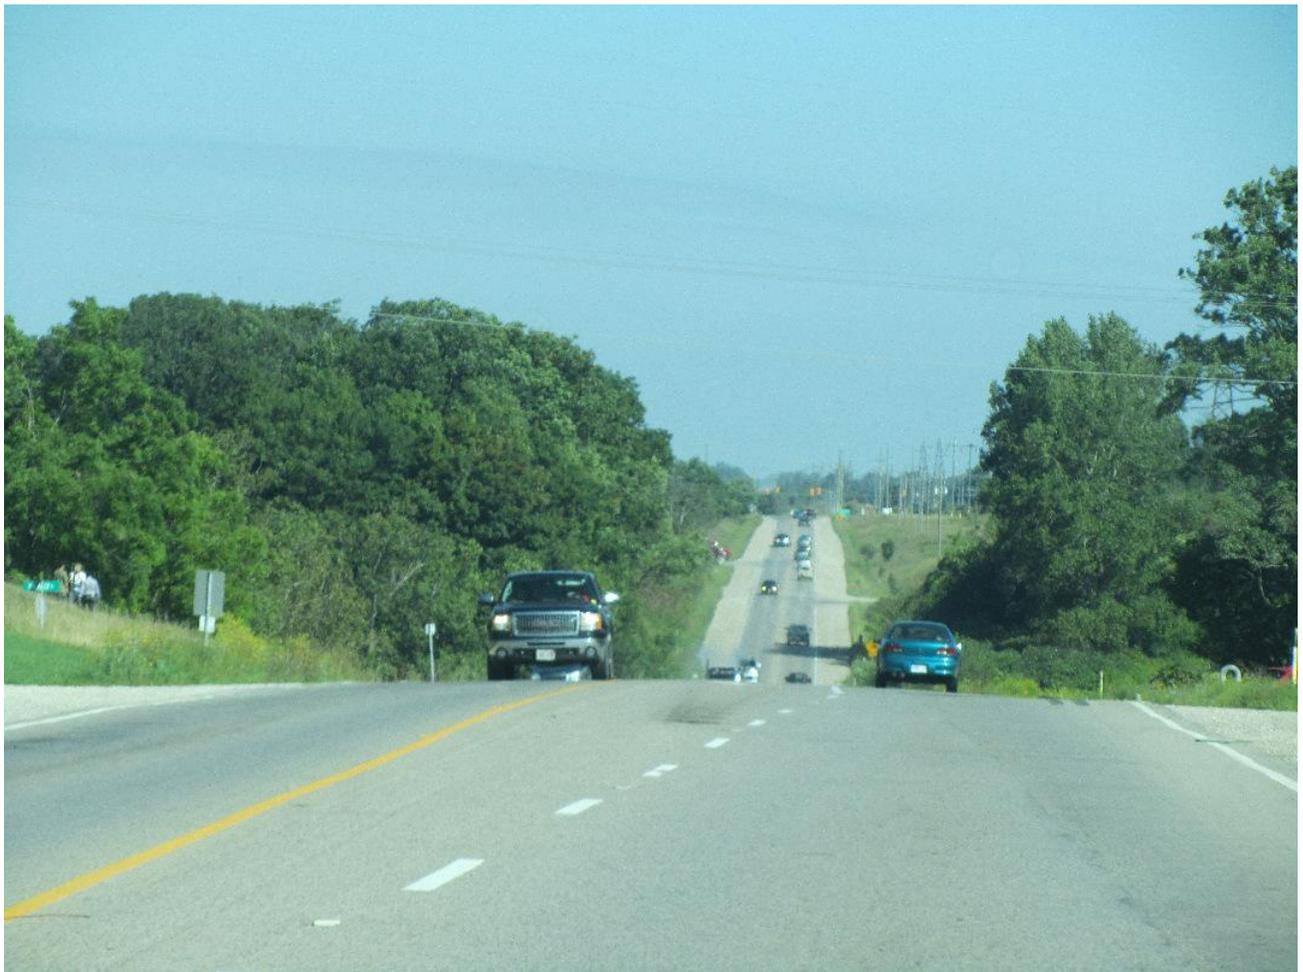
Figure 1: View, looking north along Clarke Road at the sag at the bridge over the north branch of the Thames River.

In this view there is a blue, northbound car that is just entering the sagged portion of road. In the distance, on the far side of the sag, there is a red truck that will be attempting to enter the road from the left (west) to travel northbound.

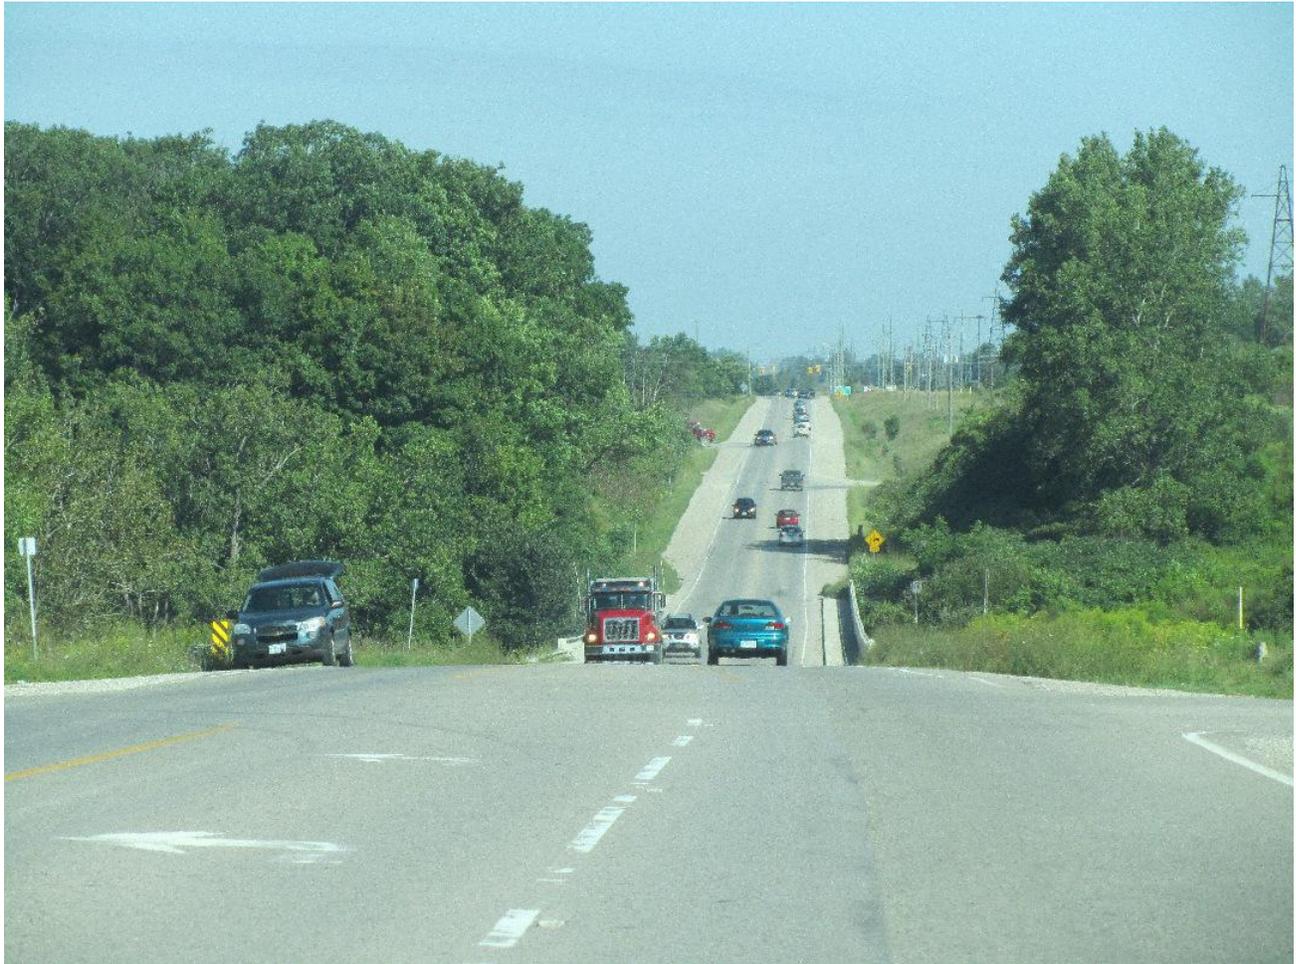
Figure 2: View, looking northward along from south of the sag of Clarke Road at the Thames River Bridge.

Figure 2 shows us that there is a substantial amount of traffic and that large gaps in that traffic are not available. A truck driver becomes pressured to select a shorter gap than optimum, or be resigned to wait a long time. If we look closely in Figure 2 we can see that there is a gap in southbound traffic developing on the far side, at the top of the sag, however there does not appear to be much of a gap in northbound traffic.

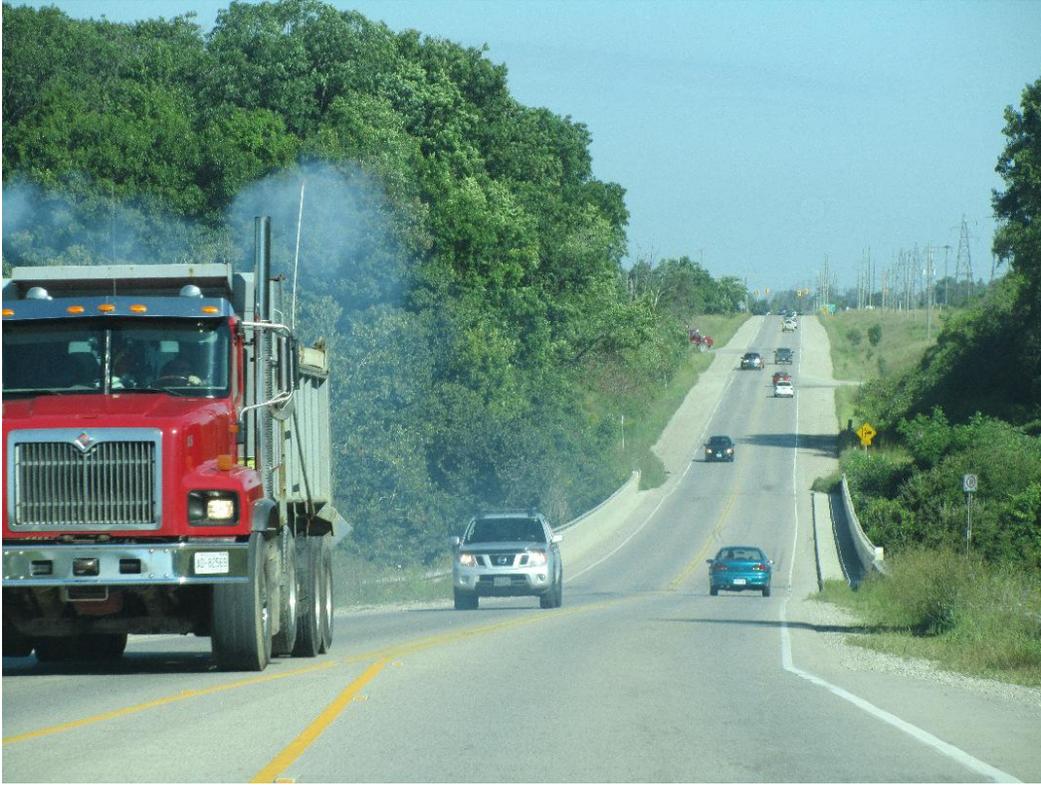
Figures 3 and 4 show closer views as we approach the bridge and we can note that there is a small gap in northbound traffic just in front of the blue car. This is the gap that the truck driver selects to enter the road.

Figure 3: Northward view showing a red truck preparing to enter traffic.

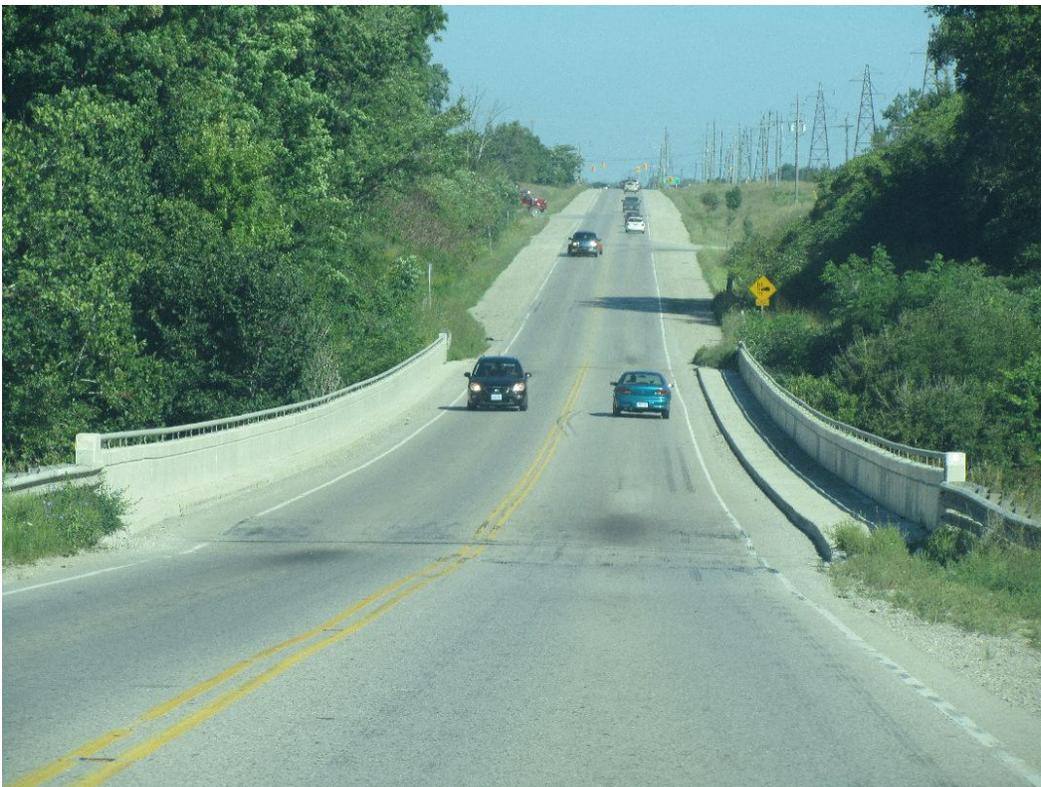
Figure 4: View showing a small gap in traffic ahead of the blue car.

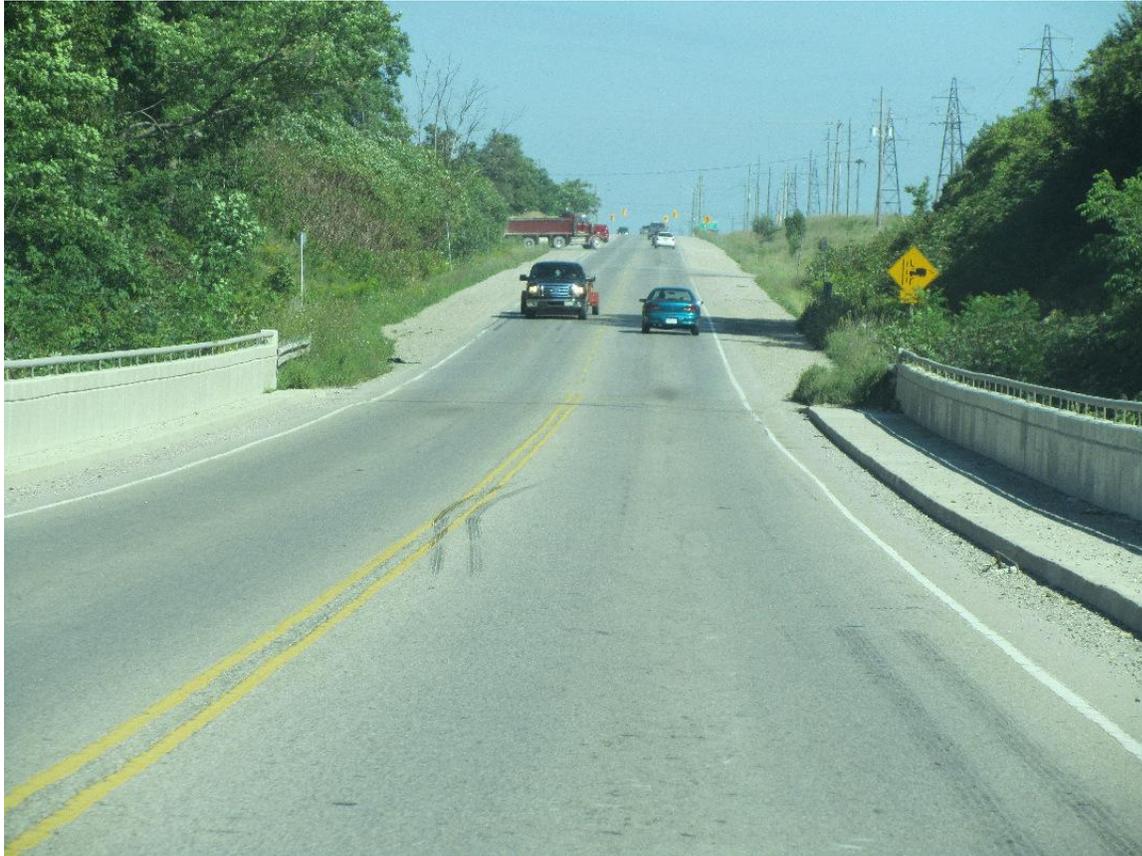
As we see in Figures 5 and 6, the red truck begins its left turn onto the roadway in front of the blue car. At this point the driver of the blue car might come to the belief that this is simply a single dump truck because, in fact, the front portion of the truck appears to be exactly that while the rear portion is blocked by trees. So the driver of the blue car believes there is plenty of time and does not apply the brake. But the situation is not what it would seem to be...

Figure 5: View of red truck making a left turn onto Clarke Road in front of the northbound, blue car.

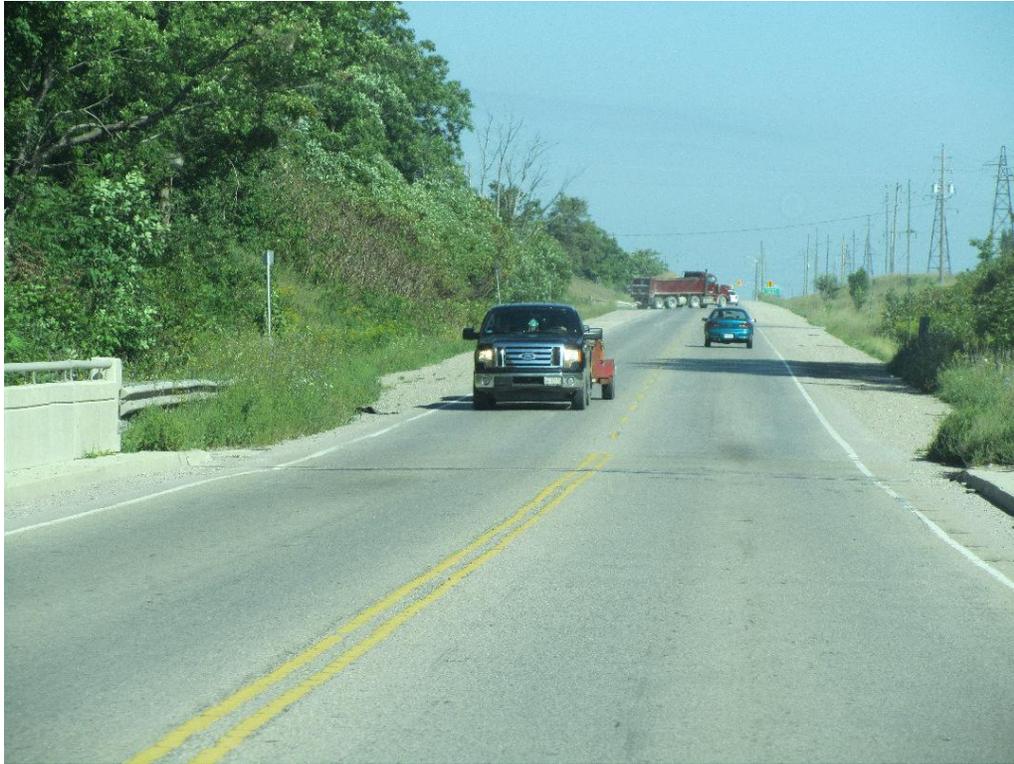
Figure 6: View of red truck making a left turn in front of the blue car.

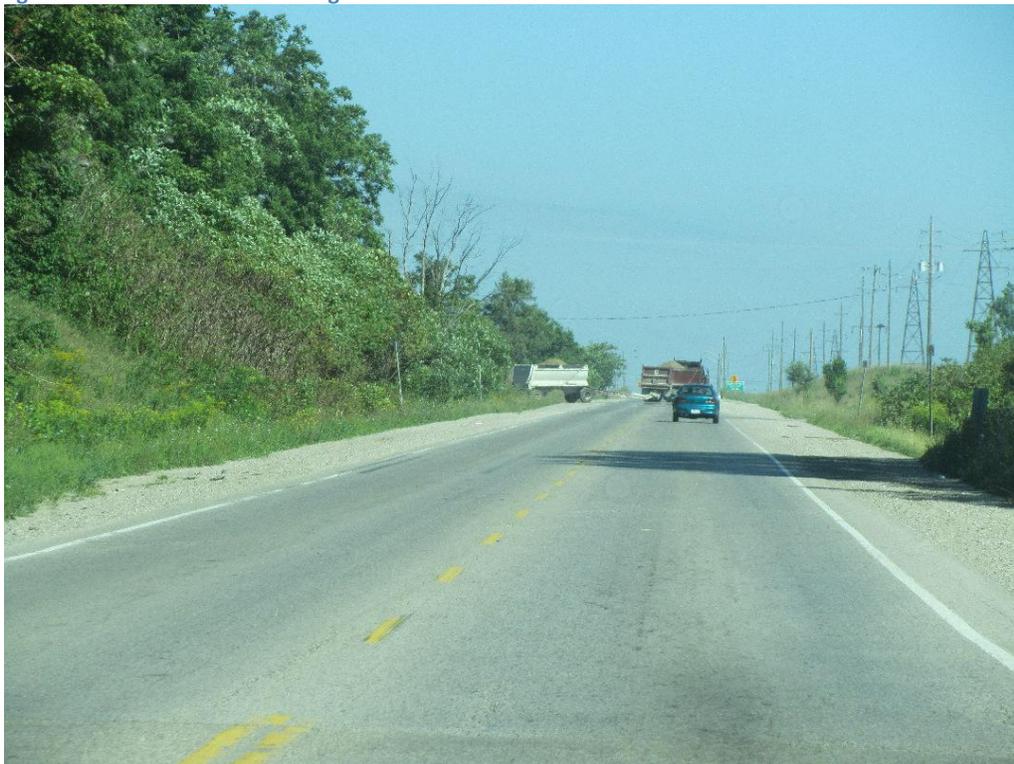
The red truck is fully-loaded. But not only that, it is not just a single dump truck, it is also hauling a pup trailer, as shown in Figure 7.

It takes time to detect that this is not just a single dump truck, therefore we see in Figure 7 that the driver of the blue car has still not applied braking even though the camera shows that the pup trailer is now fully visible. Finally, in Figures 8 and 9 we see that the car driver applies braking. However, that is not the end of the story.

Figure 7: View of the pup trailer suddenly coming into view while the driver of the blue car still does not apply braking.

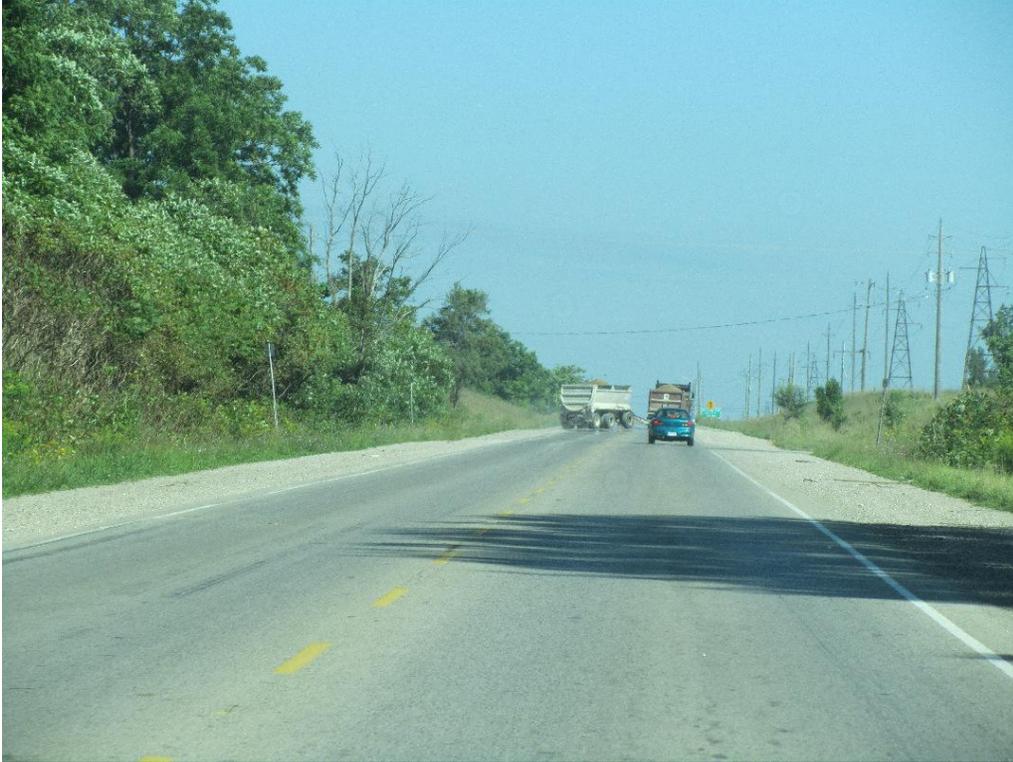
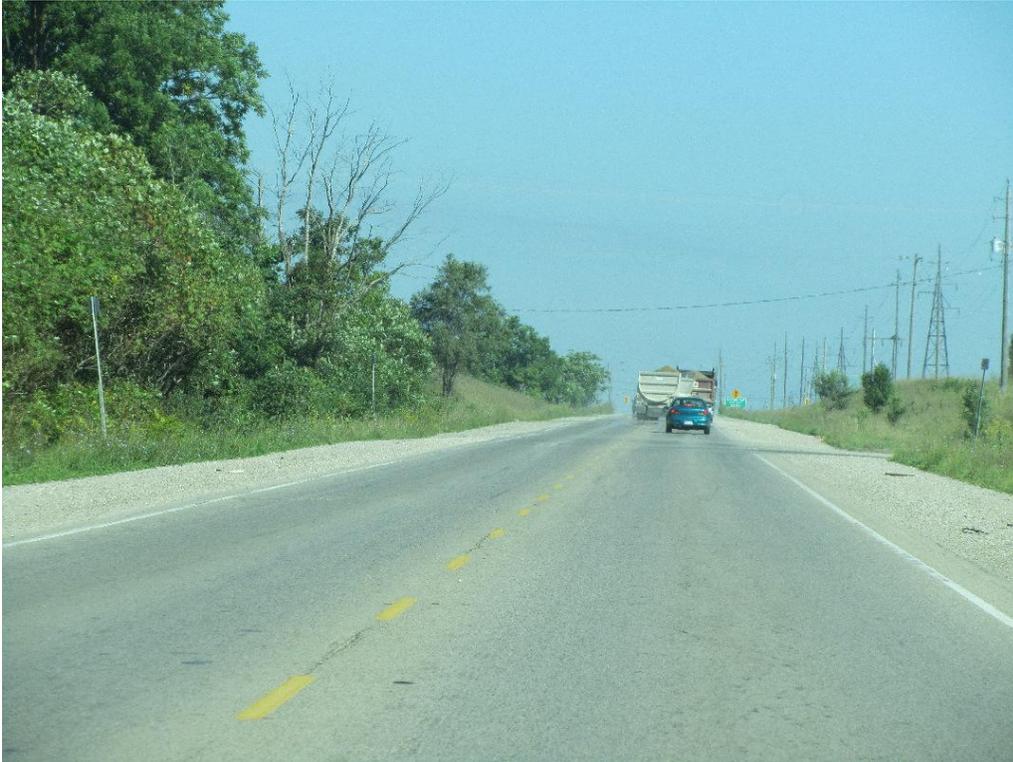
Figure 8: View of braking being applied by the driver of the blue car.

Figure 9: View of braking being applied by the driver of the blue car.

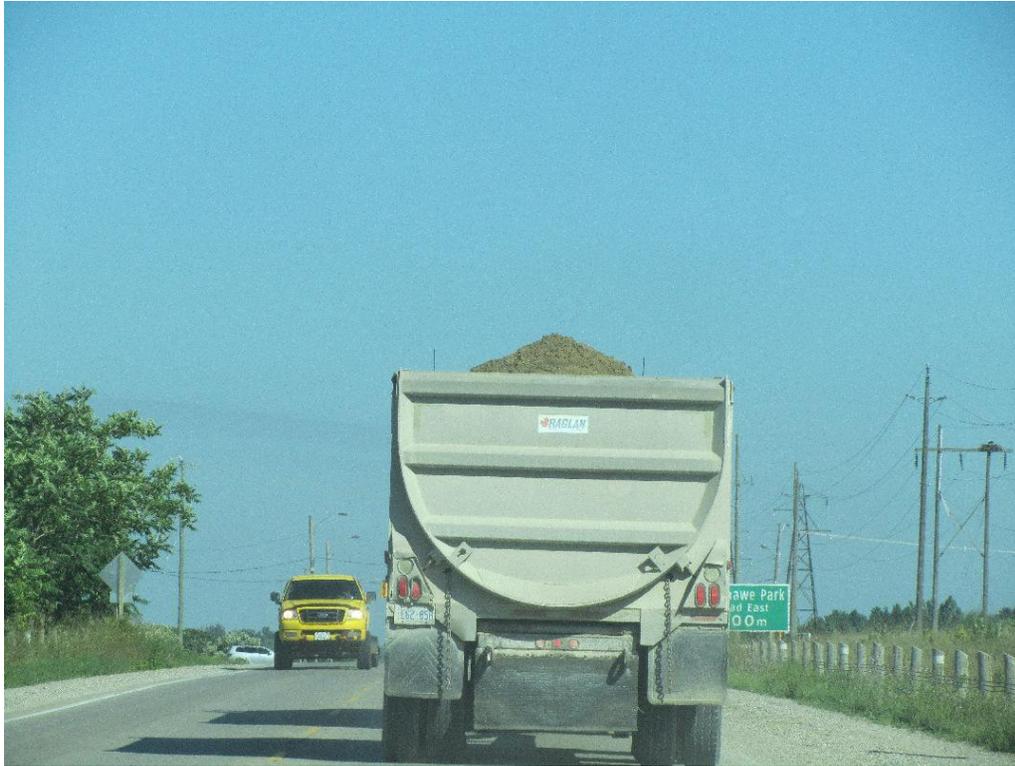
As noted in Figure 10, the truck is hauling a full load of sand therefore its acceleration up the hill is very slow...and our blue car driver is not happy with this situation.

Figure 10: View showing the load of sand visible over the top of the pup trailer indicating that the truck is heavily loaded.

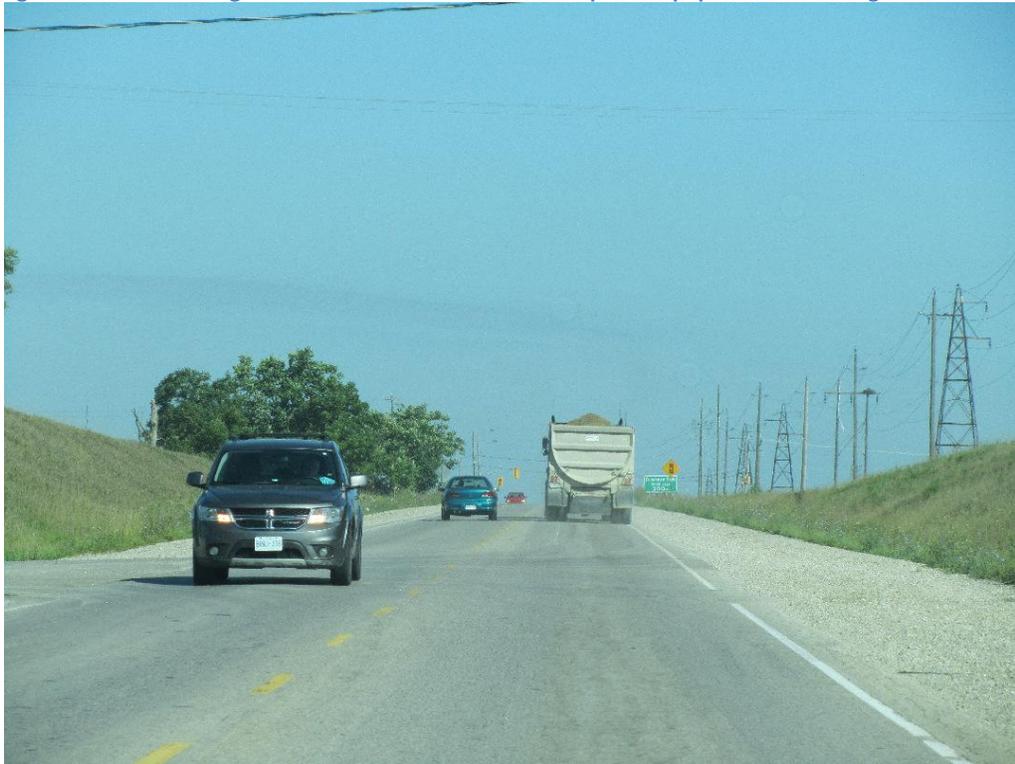
As shown in Figure 11, the driver of the blue car decides to pass this very long truck. Yet, how good was the visibility to allow the driver of the blue car to make that decision?

Figure 11: View of blue car passing the slow-moving, fully-loaded truck.

There was little opportunity for the driver of the blue car to determine whether the road ahead was reasonably clear because there was a hillcrest further north that is visible in Figure 11. One must also consider that this car has a low-powered engine. We must consider that this car is travelling up a substantial grade and that the truck combination would be quite long thus requiring more time to complete the passing motion.

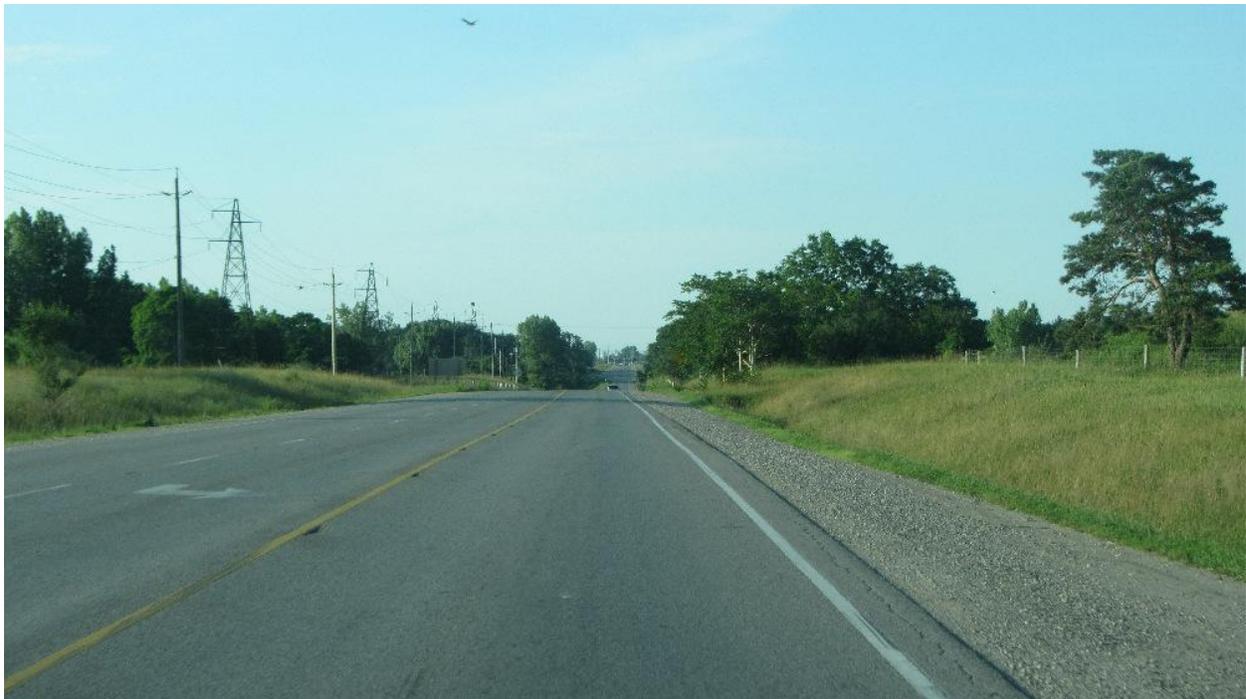
Figure 12: View, looking south from the north side of the sag. A "Truck Entrance" warning sign exists on the right roadside but it is blocked by vegetation.

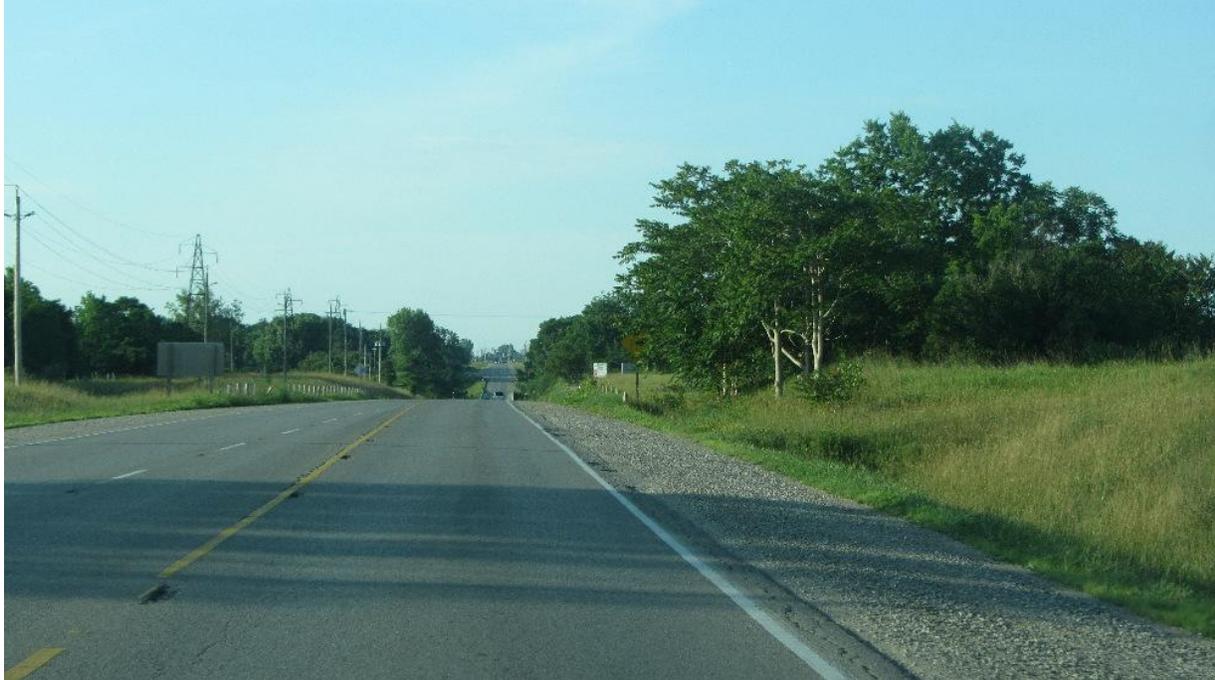
Figure 13: Southward view showing that the "Truck Entrance" warning sign is blocked by vegetation.
