Gorski Consulting Website

Archived News - 2013 - January

Police "Tight-Lipped" Over Cause of Mini-Van Loss-Of-Control Collision On Thompson Road In London, Ontario

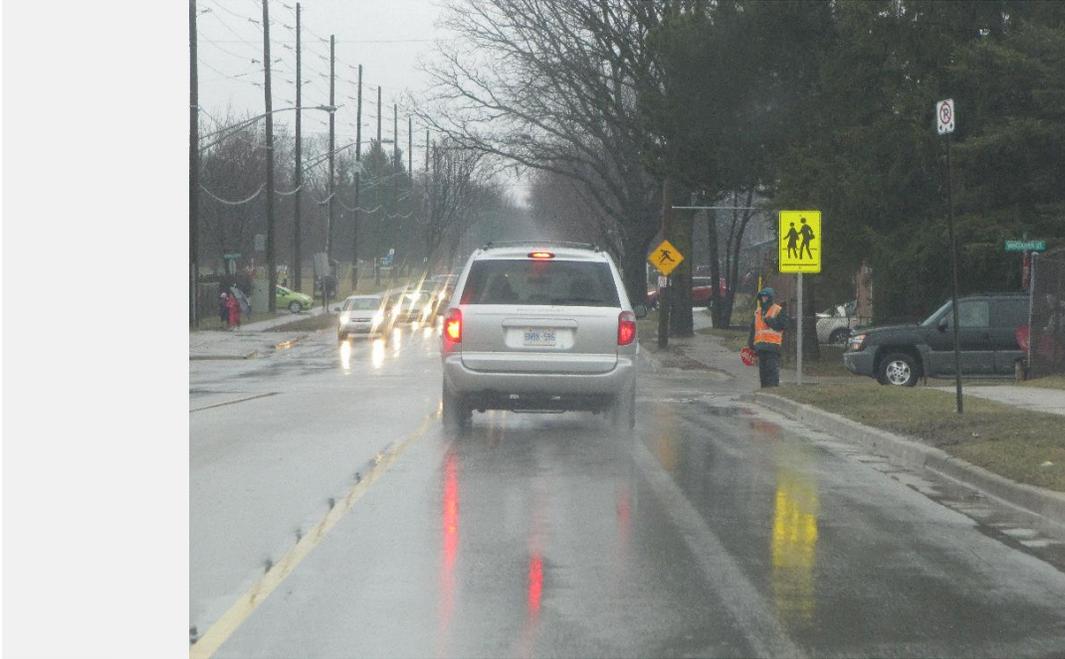
Crossing guard in school zone at busy intersection in London, Ontario on January 30, 2013.

A crossing guard was scanning the area for the next opportunity to guide children across the busy intersection. However the cold and rain made it an uncomfortable day for anyone to be outside. Naturally, the crossing guard pulled a hood on his/her head for protection from the elements. But this head protection reduces the crossing guard's ability to see as shown in the closer view below.

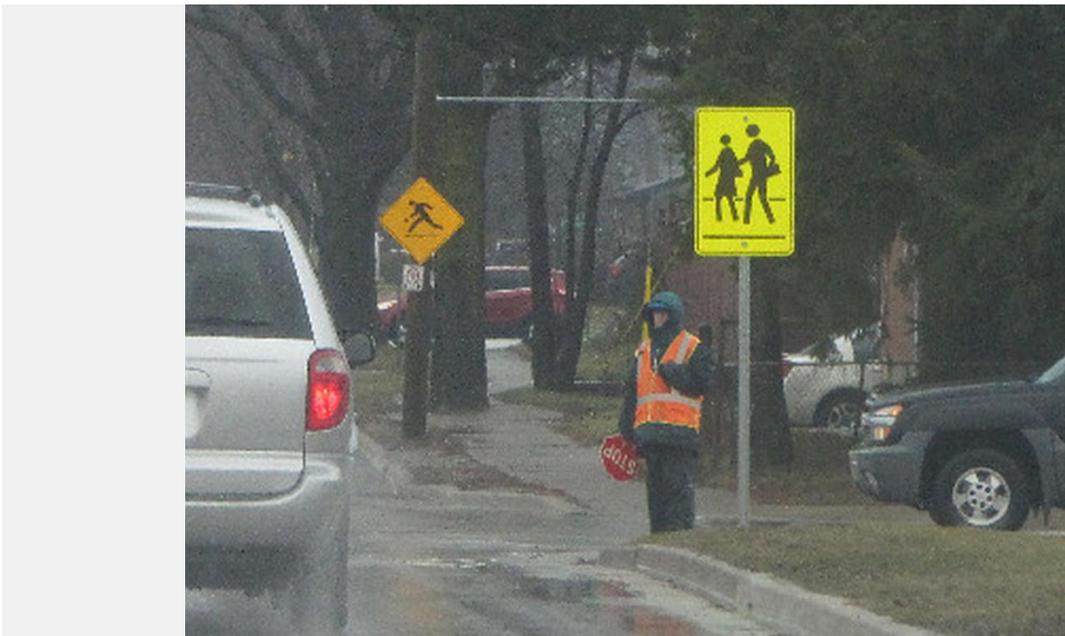
Close-up view of crossing guard wearing head protection while potentially limiting visibility.

We would be the last persons to say that this crossing guard was negligent and it would be a natural action to wear such head gear in these weather conditions, yet, it causes a complication. Children might also be wearing similar head protection with a similar lack of visibility. It is not something that has an easy solution.

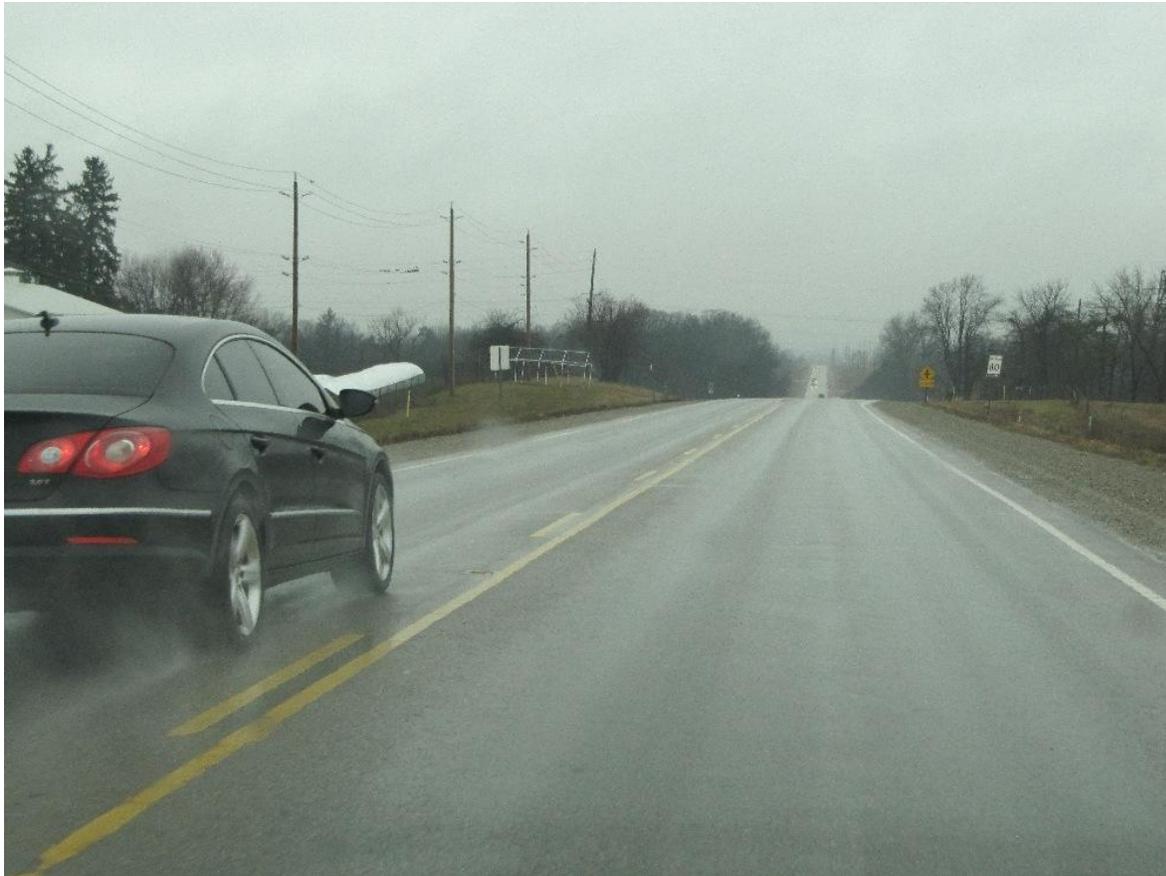
Amongst these difficulties we interact with persons who are in an exceptional hurry to meet their maker. On a nearby road just on the outskirts of London we find the driver who decided to pass our vehicle in a no-passing zone as shown in the photo below.

This individual meets up with the crossing guard and disasters happen. When possible, police will fine such reckless actions but most often their actions are successful until that fateful day when a speeding vehicle unexpectedly comes out of the dip in the background of the above photo, our speeder tries to steer back into the proper lane, but loses control of the vehicle and a crash occurs.

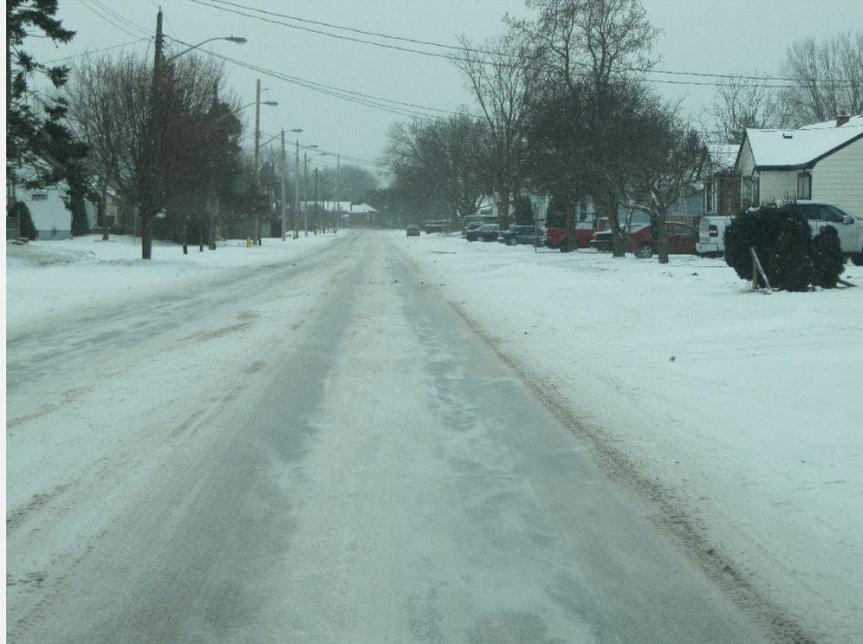
We attended the site this morning. On our way we observed that London streets were beginning to receive the 2 to 4 centimetres of snow that was forecast for the day but the roads did not appear to contain any sand or salt. For example, the photo below was taken of a typical east London Street.

Road surface condition on a typical street in London, Ontario on the morning of January 25, 2013.

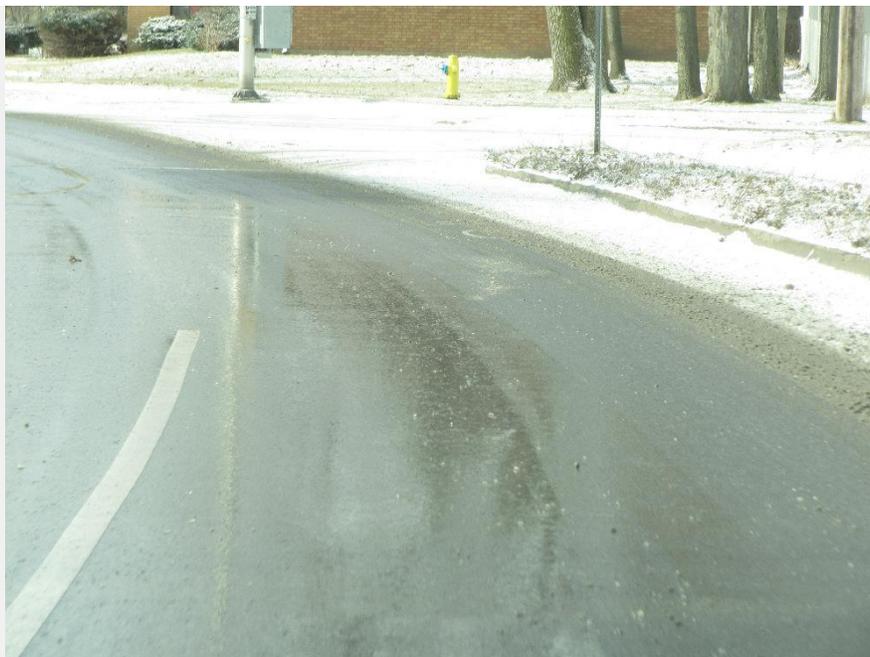
View of salt pellets on the surface of an east London road on January 22, 2013. Snow/ice have melted even through daytime temperatures were in the range of minus 14 degrees Celsius.

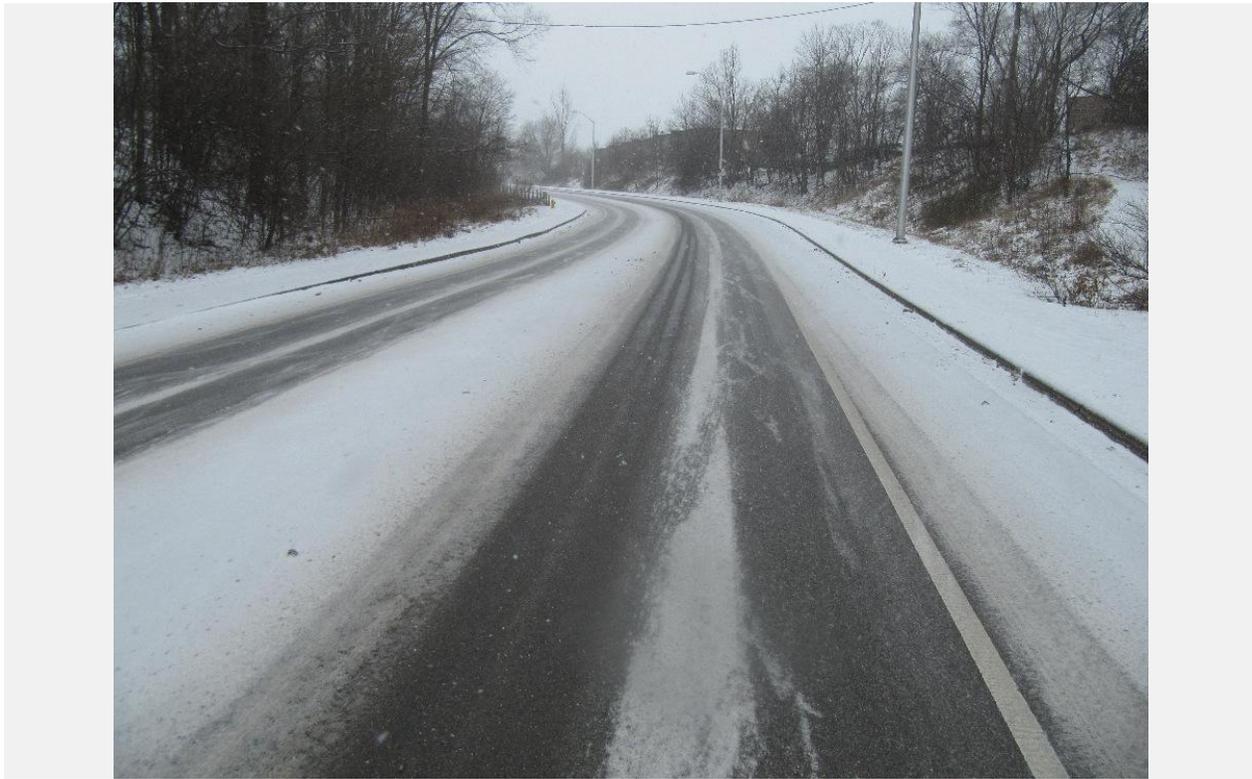
View, looking southward along Thompson Road toward the accident site. This is an upgrade with a left curve.

The temperature at this time was about minus 10 degrees Celsius. However there is no indication of any melting of snow on the road surface as shown in the previous photograph. We can confirm that we also observed no indications of any salt or sand on this road surface.

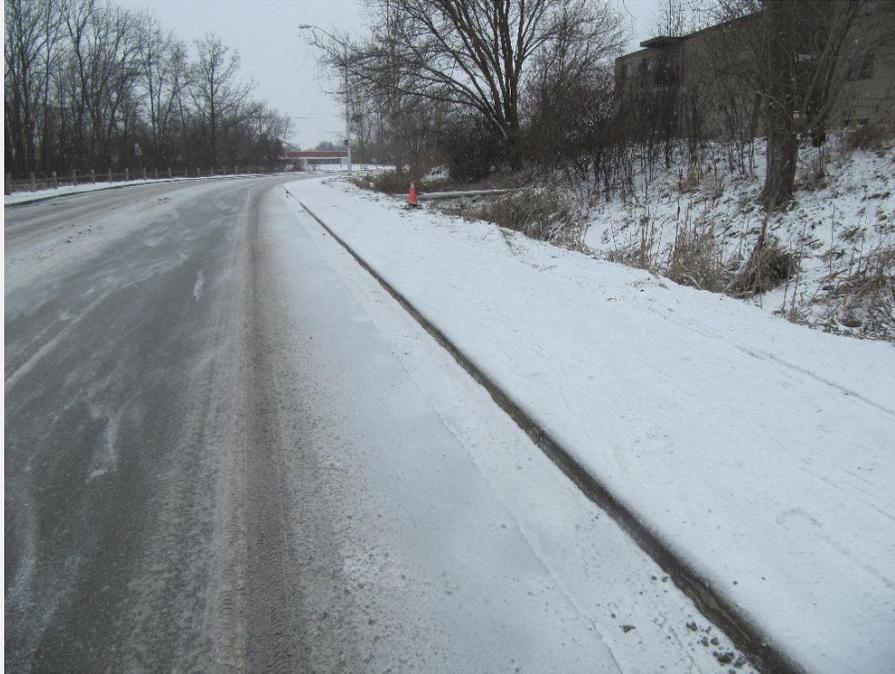
As we progressed further southbound to the end of the left curve we came across some tire marks in the snow which were typical of a vehicle that had gone out of control and slid into the right (west) ditch, as shown in the photo below.

Tire marks on right side of road indicate loss-of-control of vehicle as it slides into west ditch.

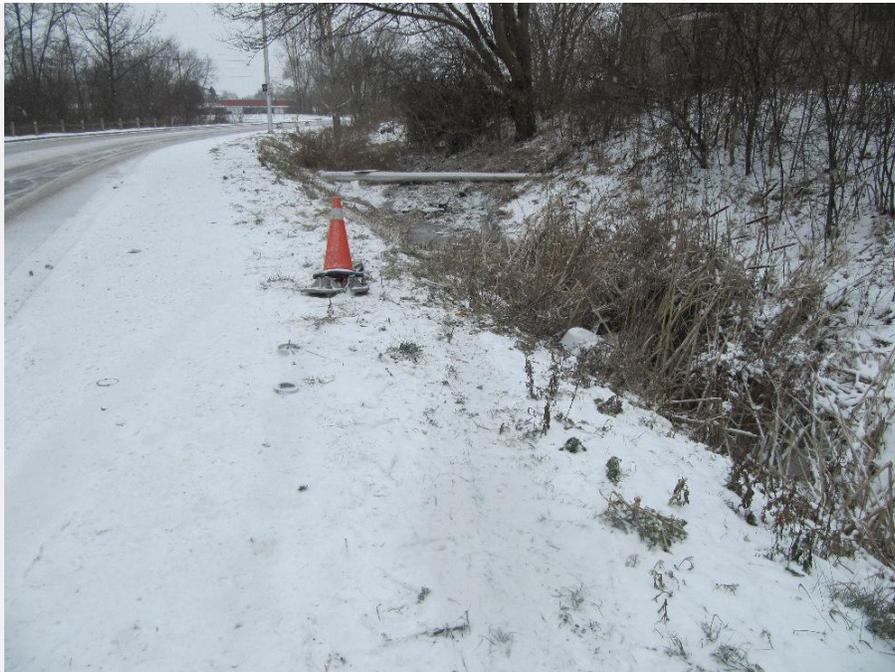
There was no question that this was the location of the minivan collision. The orange cone on the roadside sat on the base of a lamp standard that had been struck and fell into the ditch, as shown in the photo below.

Orange cone placed on the base of the struck lamp standard that rests in the ditch in the background.

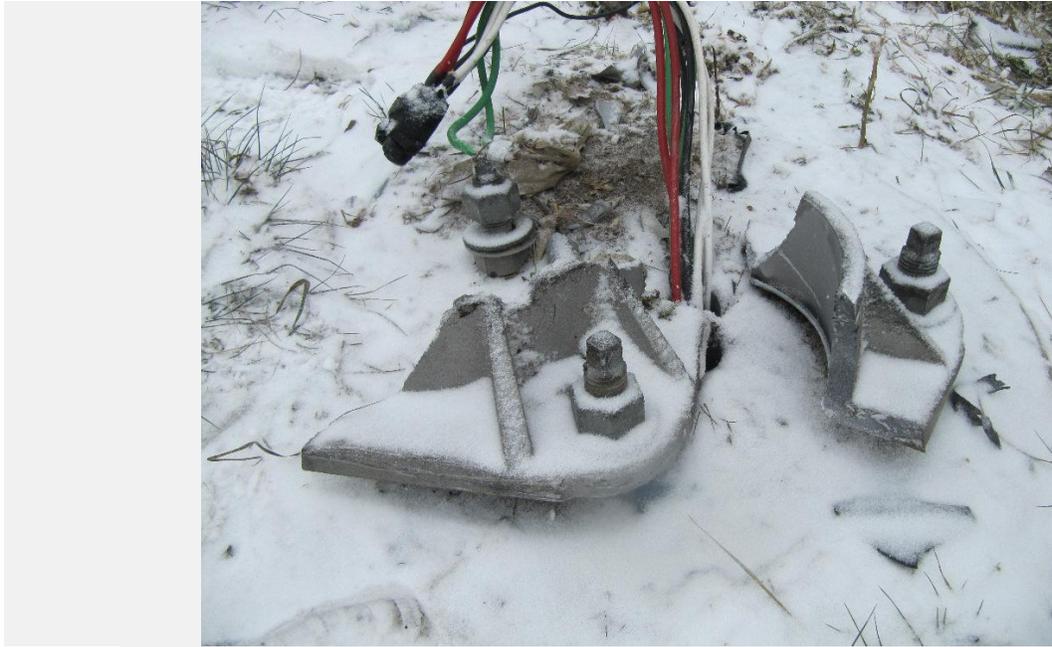
There was no mention made in the LFP newspaper article that the minivan struck this lamp standard. Fortunately, its base was designed to break away when struck, as shown in the two photos below.

View of fractured base of lamp standard that is designed to break apart and release the lamp standard to reduce the severity of the impact.

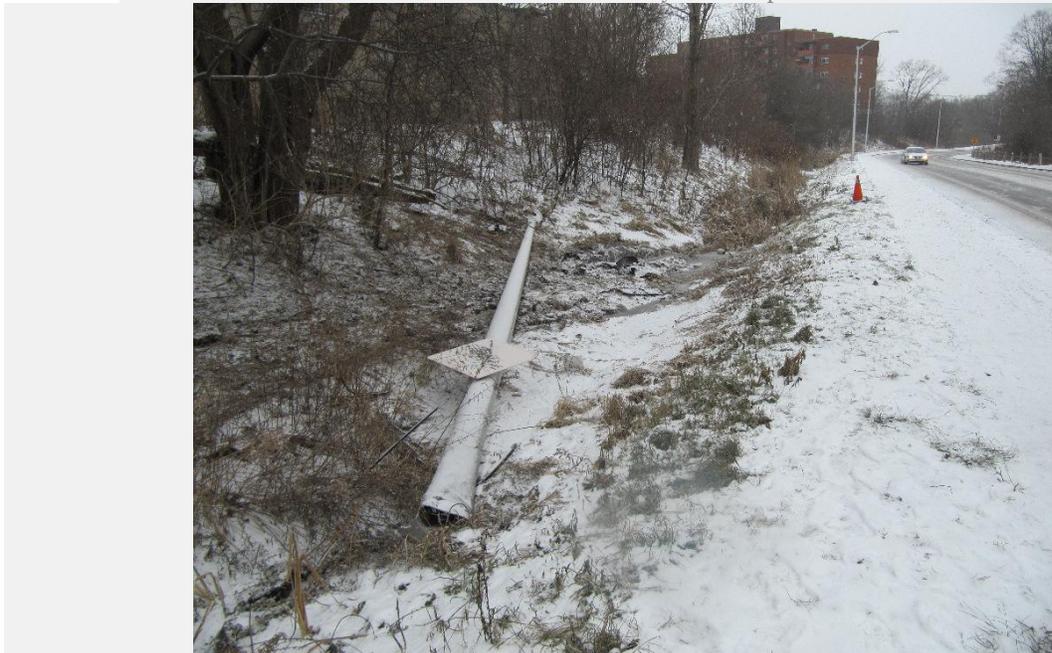
Northward view of separated lamp standard lying in the west ditch of Thompson Road and the location of its base represented by the orange cone in the background.

The separation of the pole likely lessened the severity of the impact and likely reduced the potential injuries to the occupant(s) of the van. The minivan came to rest in the

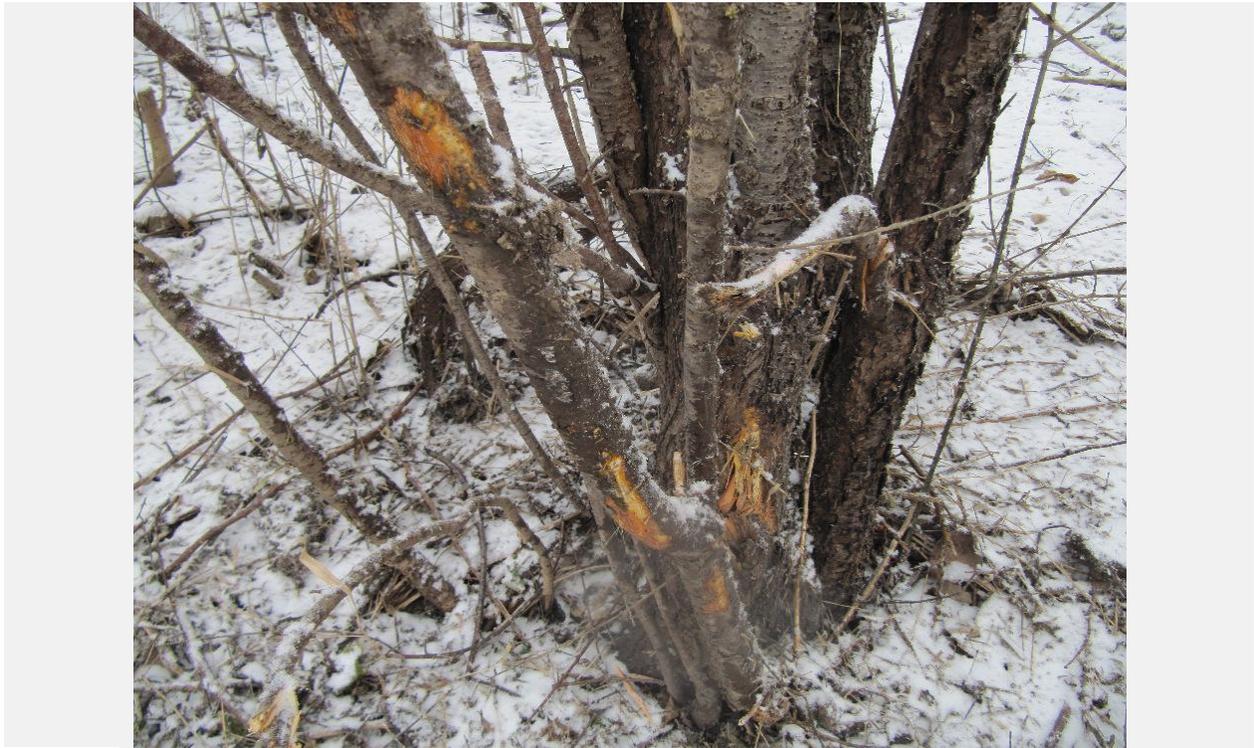
View of fresh damage to the brush near the final rest position of the van.

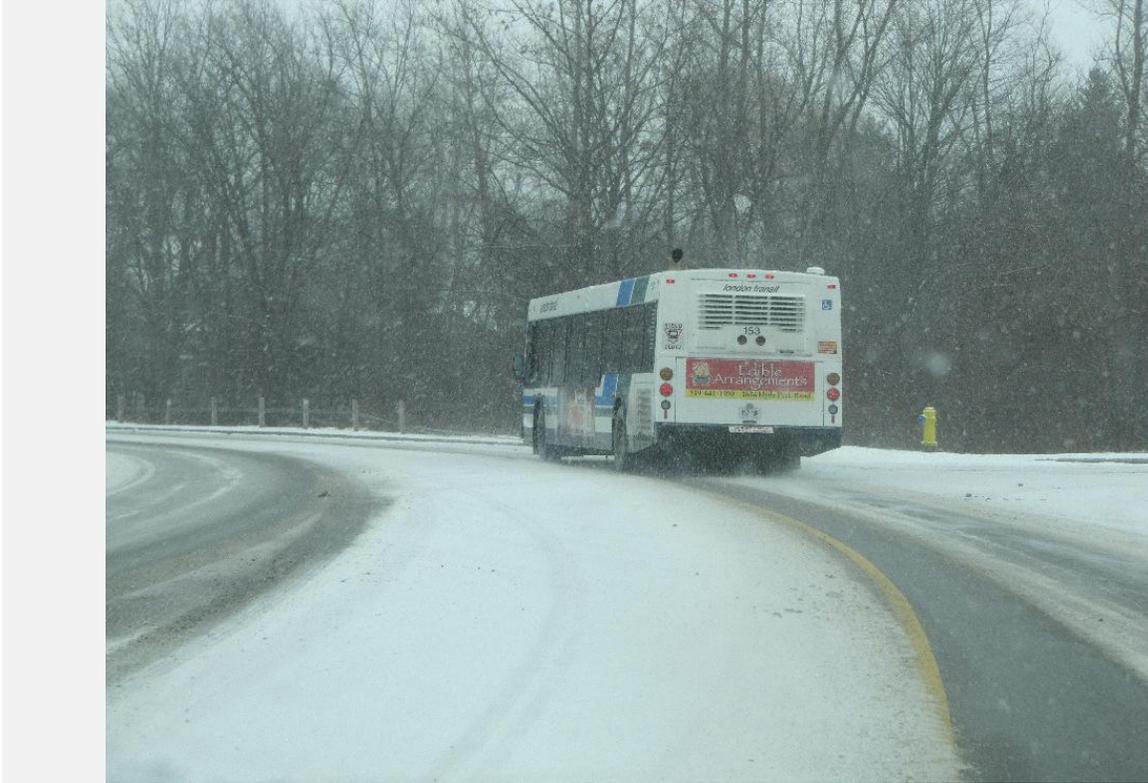
View of northbound City of London transit bus travelling along Thompson Road and toward the accident site.

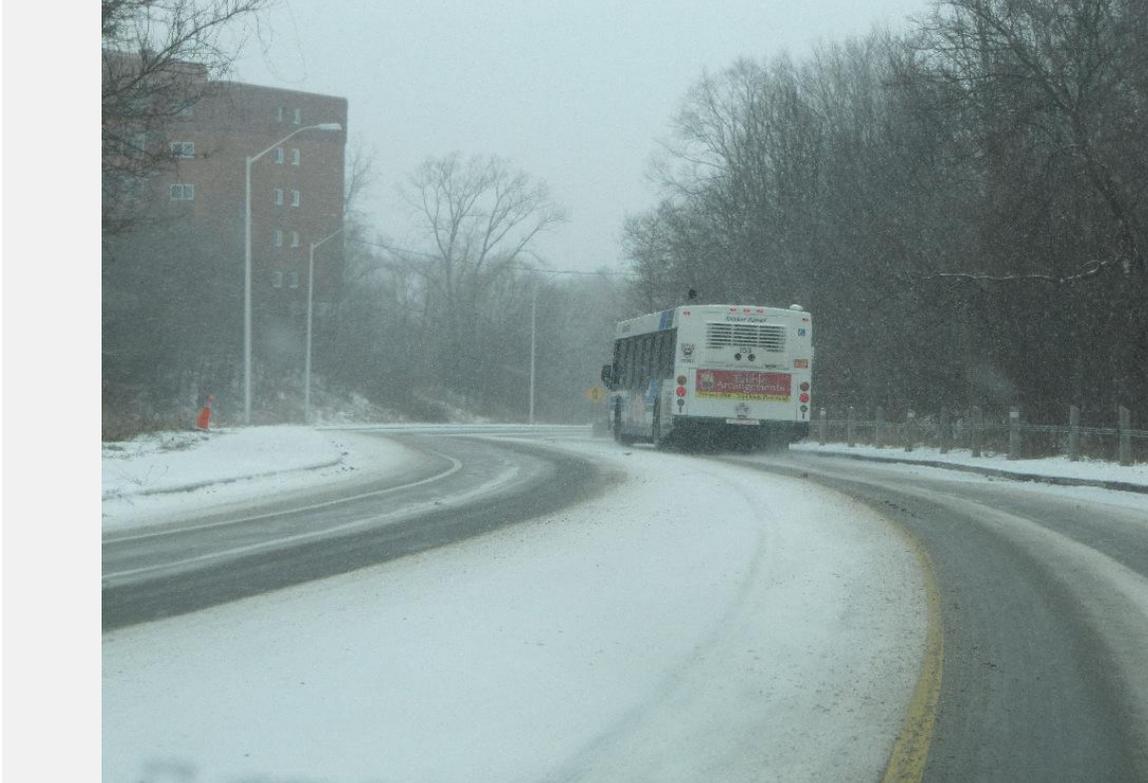
View of transit bus passing by the orange cone where the present accident occurred. What would be the consequence if a fully loaded transit bus went out of control on this curve due to a slippery road surface?

What if this bus was fully loaded and went out of control on the downgrade of the curve and crashed due to slippery road conditions? The passengers of such a vehicle would be unrestrained and the consequences could involve multiple injuries and potential deaths. Yet, we are aware from previous investigations that this curve contains a *negative* cross-slope for northbound vehicles that has existed here for decades but (fortunately) has not yet resulted in a fatal collision. What if the bus loss-of-control was due to an improperly maintained road surface that caused it to be unnecessarily icy? Would it be proper for police to ignore that factor and not report it? Is this what our society believes is proper? If not, what is the difference when less severe events occur but could be related to improper roadway maintenance, improper signage, or due to a road geometry issue? Whatever the severity of the incident the causal factors need to be documented and reported so they can be properly prioritized and dealt with. It should not matter whether the causal factor was due to driver impairment, speed or inattention, or whether it was related to a roadway issue.

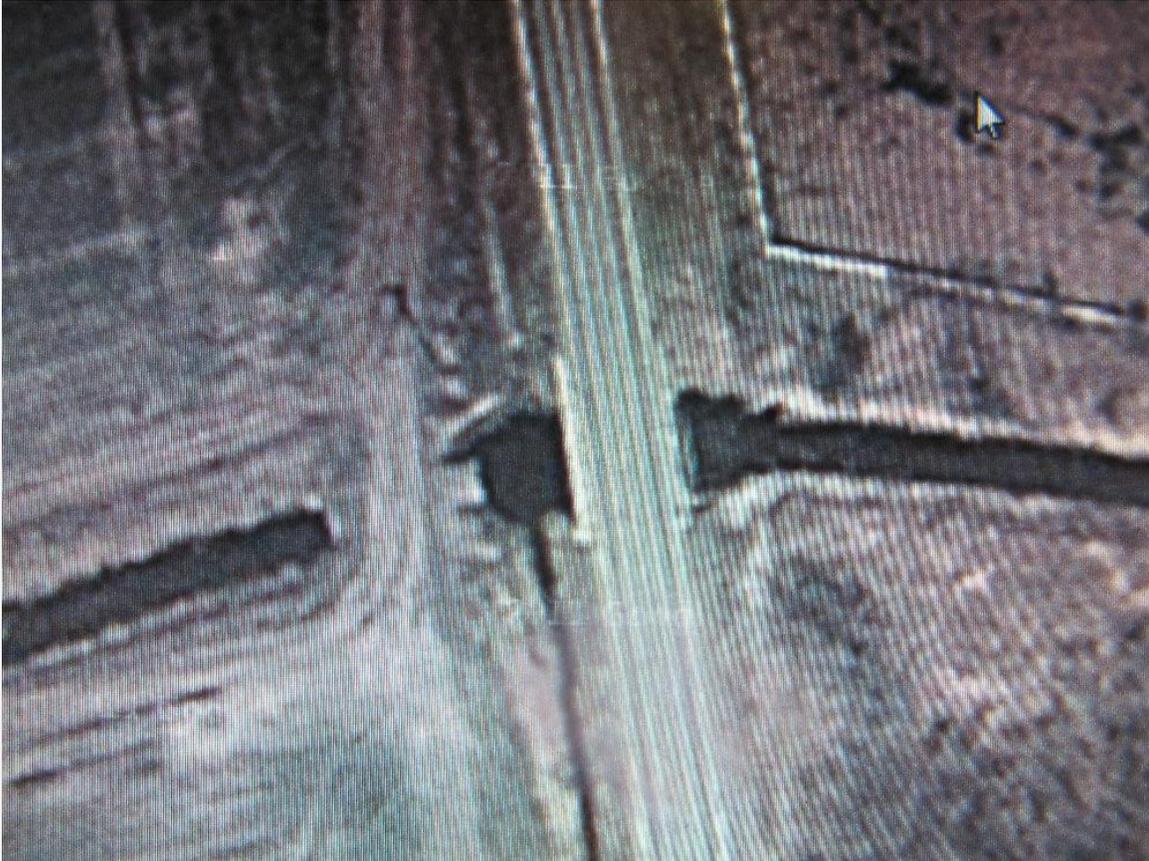
Aerial view of likely accident site taken from Google maps.

Although the image is poor because it was photographed from a computer screen, it shows a bridge but there is no indication of a guardrail that would normally attach to the bridge abutment. If the accident occurred at this location and there was no guardrail, there should be questions raised.

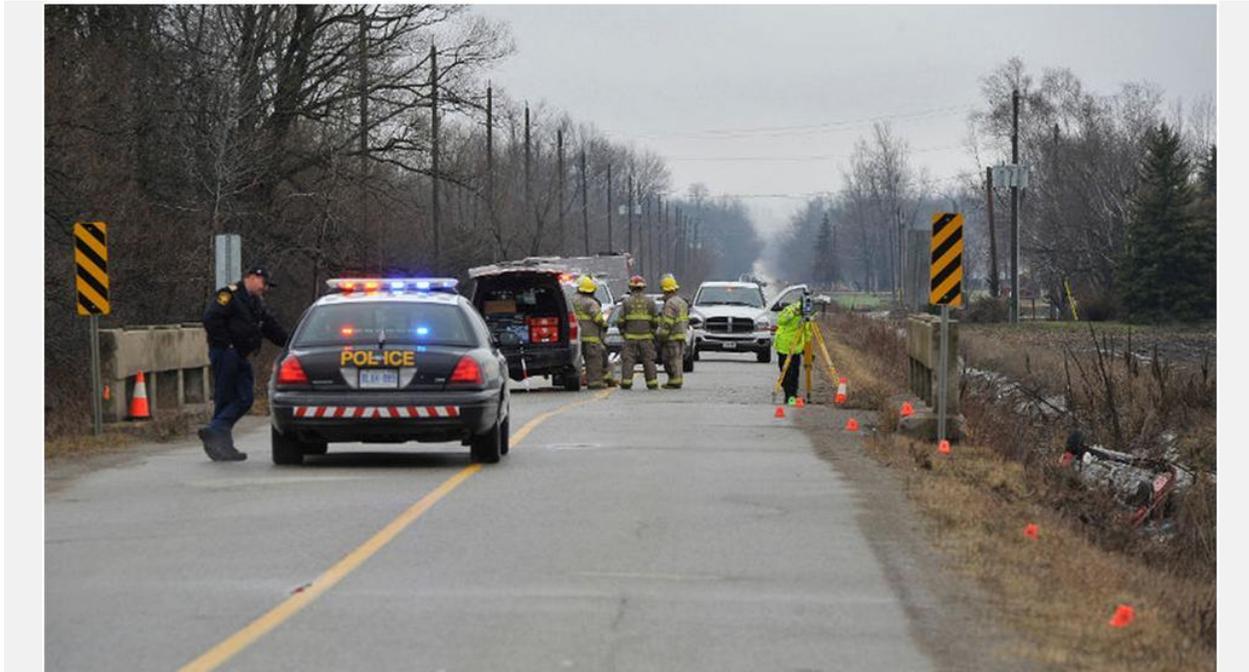
View of accident site taken by Mark Wanzel of The Barrie Examiner newspaper

The above photo clearly shows that the vehicle fell into the creek at the bridge. The question remains, why was there no guardrail next to the bridge as the drop to the creek bed looks to be considerable? Often the "level of service" provided on a roadway is based on the traffic volume. However we can see that the roadway contains a hard surface, possibly asphalt pavement and it contains a yellow centre line. We also know that it is a short distance from the town of Alliston, Ontario. So all these factors would suggest that this road is not just local, but may be a collector road that does more than service the local residents. So the police should be asking, or at least documenting the fact that the roadway may have been deficient in terms of lacking a guard rail, especially at a location where a vehicle exiting the road could easily rollover on the steep embankment and the presence of water could prove disastrous for occupants of an overturned vehicle.

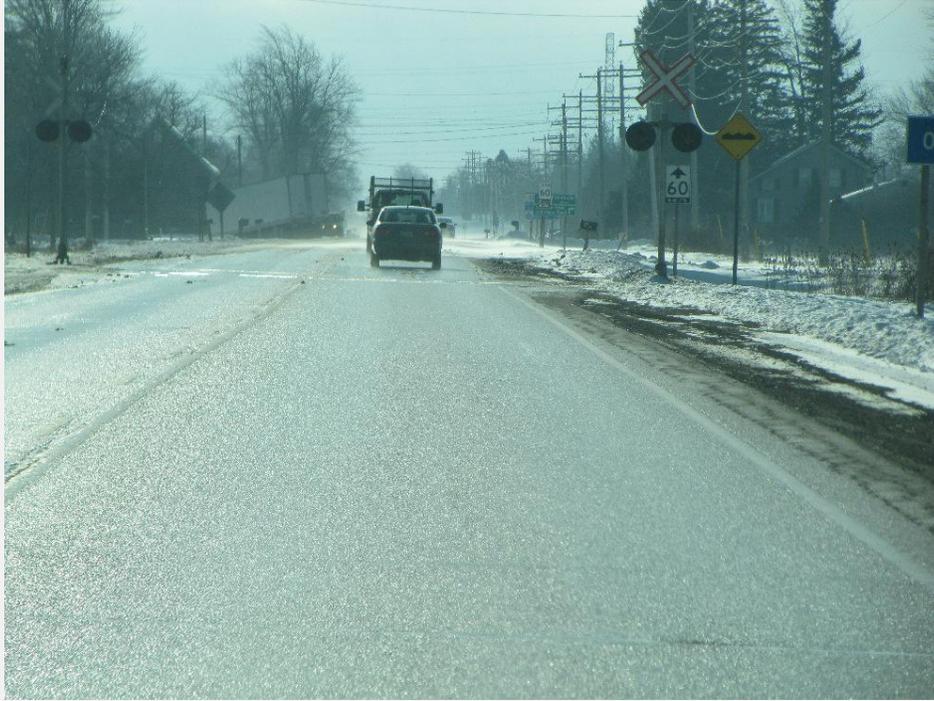
We caught one incident earlier this morning on Highway 19 just north of Tillsonburg, Ontario where the roadway appeared to be bare and pleasant as demonstrated by the southbound view along Highway 19 below.

Southbound view along Highway 19 just north of Tillsonburg, Ontario on the morning of January 4, 2013

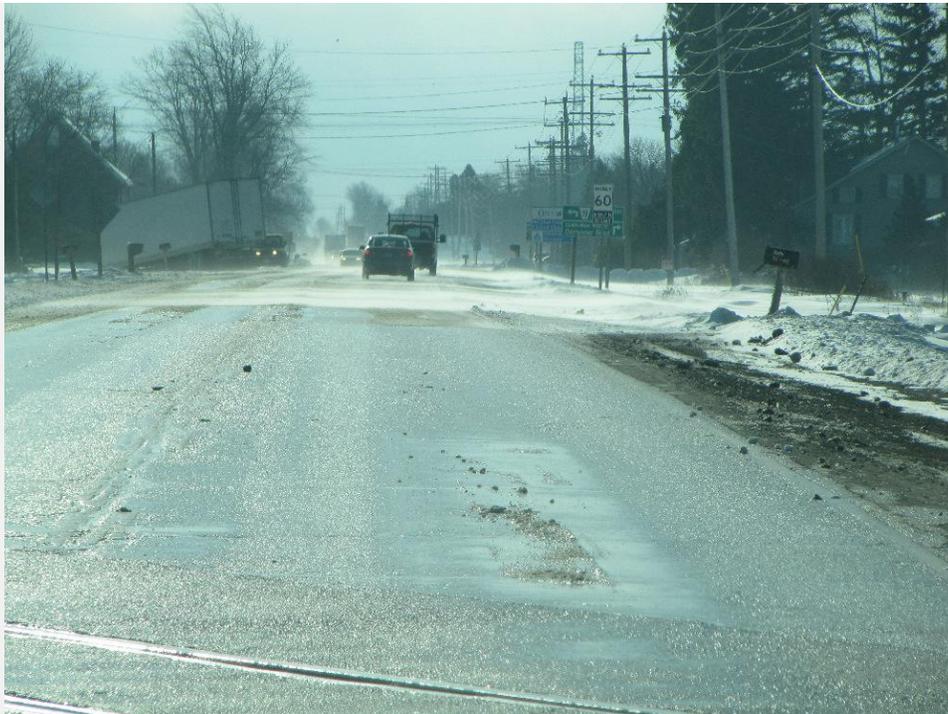
View of sudden snow drifting onto the Highway in the distance and a tractor trailer jackknifed on the left (east) ditch.

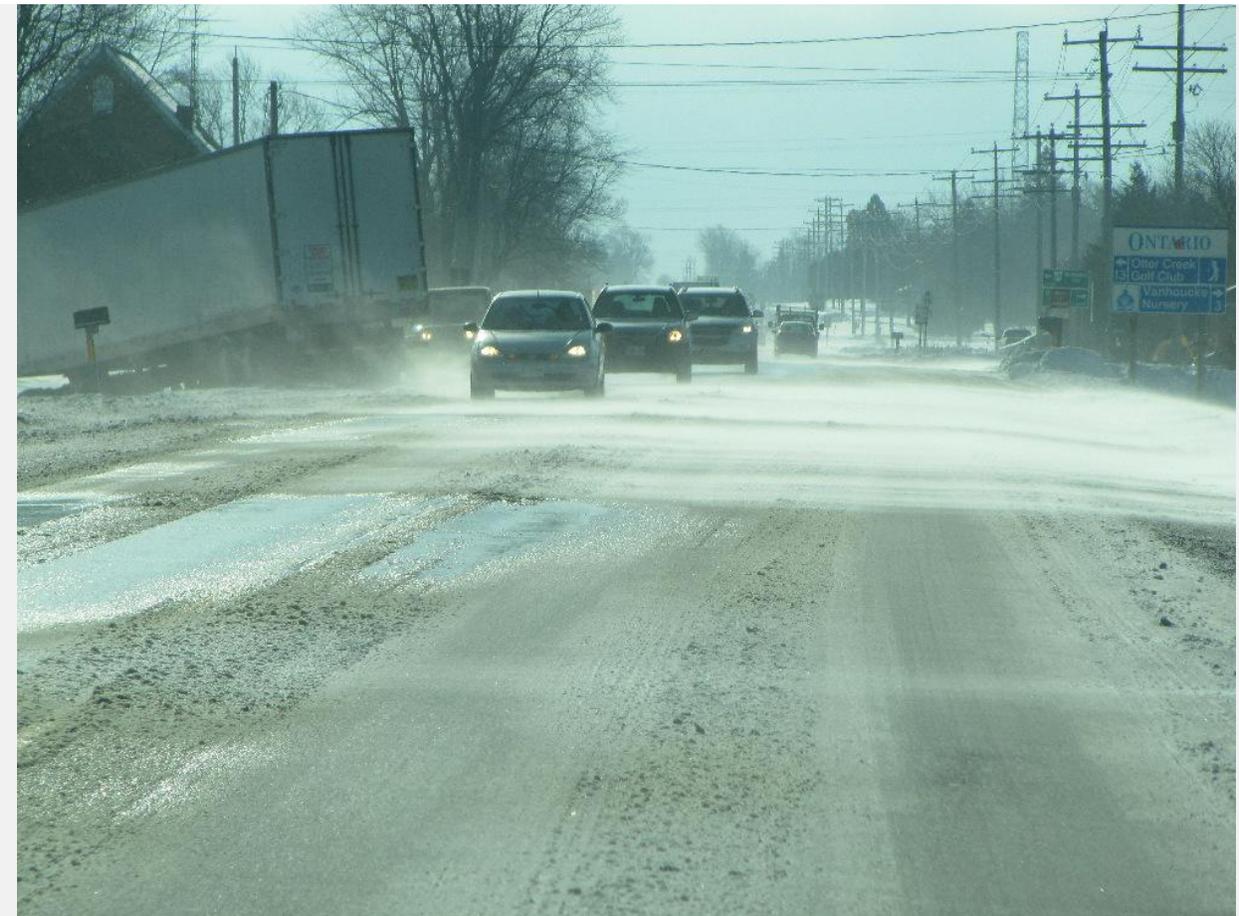
View of jackknifed tractor trailer in the east ditch.

It was likely that the truck driver was caught by surprise by the drifted snow and lost control of the rig. Luckily there was no other traffic in the on-coming lane and no one was injured. But the scenario could have been much worse. This is the kind of day it was in South-Western Ontario and it is a regular occurrence in winter months. Road conditions that appear to be excellent suddenly turn wicked and treacherous.

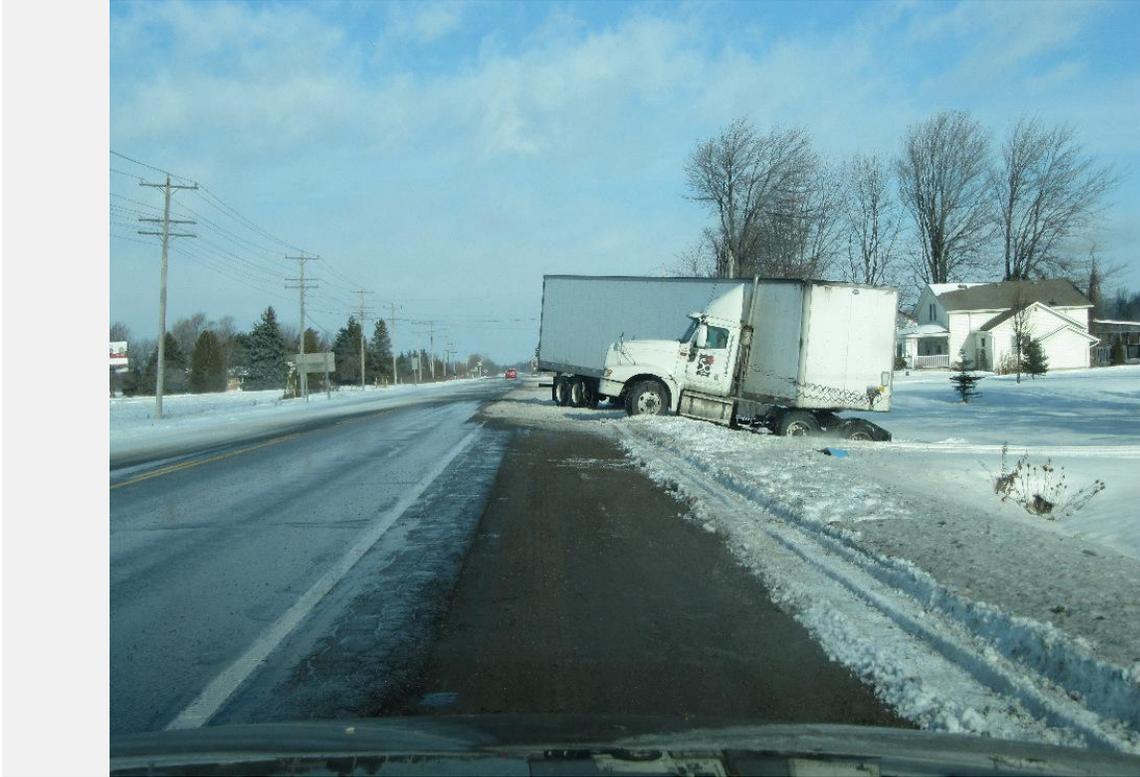
Northward view of tractor trailer shows that the road conditions just south of the truck's rest positions were pleasant and bare once again.

The irony is that, just south of the truck's rest position the road surface returned to its pleasant, bare condition. It was this kind of variable situation that awaited the unaware driver on this seemingly wonderful winter day.

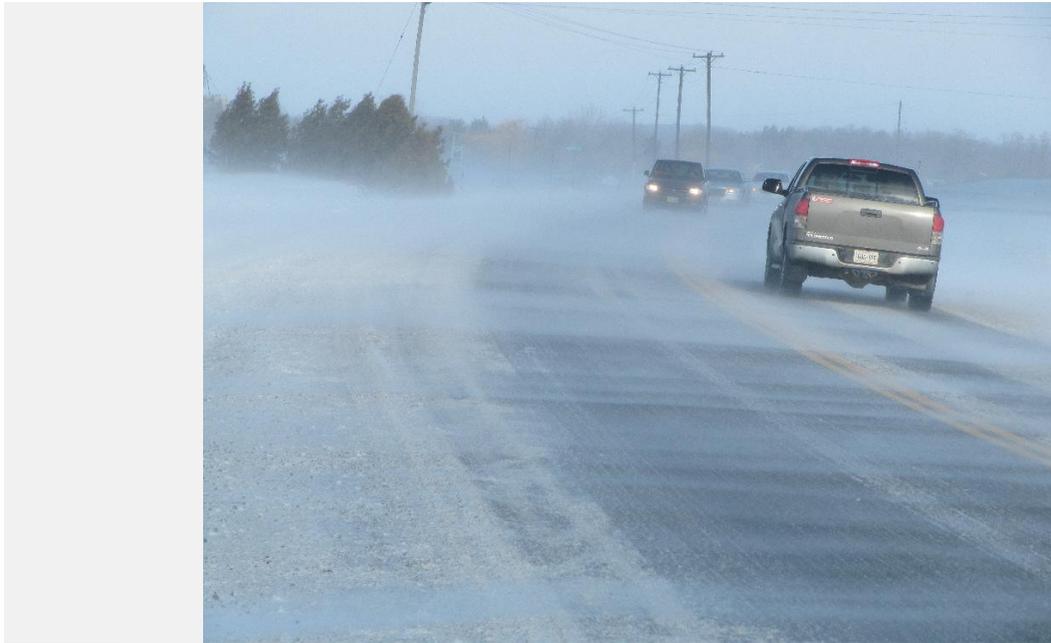
We have no information about the conditions of the site at the time of the collision however, our visit earlier this morning or about 11 hours after the collision revealed that snow was blowing across Oxford County Road 13 making visibility quite difficult. The two photos below show a view looking north from just south of the intersection with Ninth Road and this is approximately where the fatal head-on collision occurred.

Accident site at approximately 1115 hours on January 4, 2013 - Blowing snow made visibility difficult

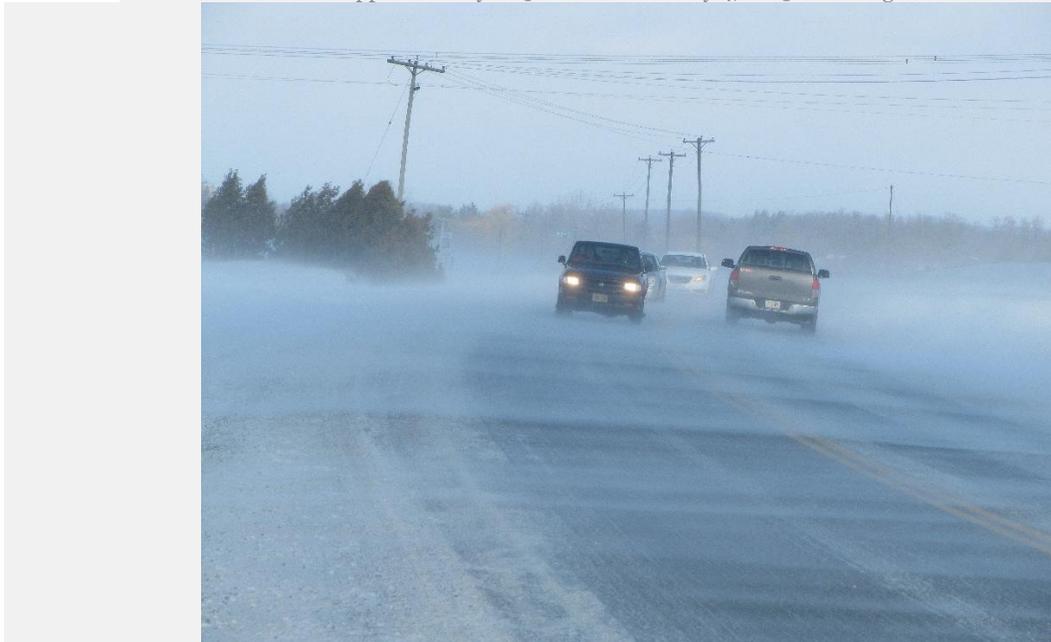
Another northbound view of accident site on Oxford County Road 13.

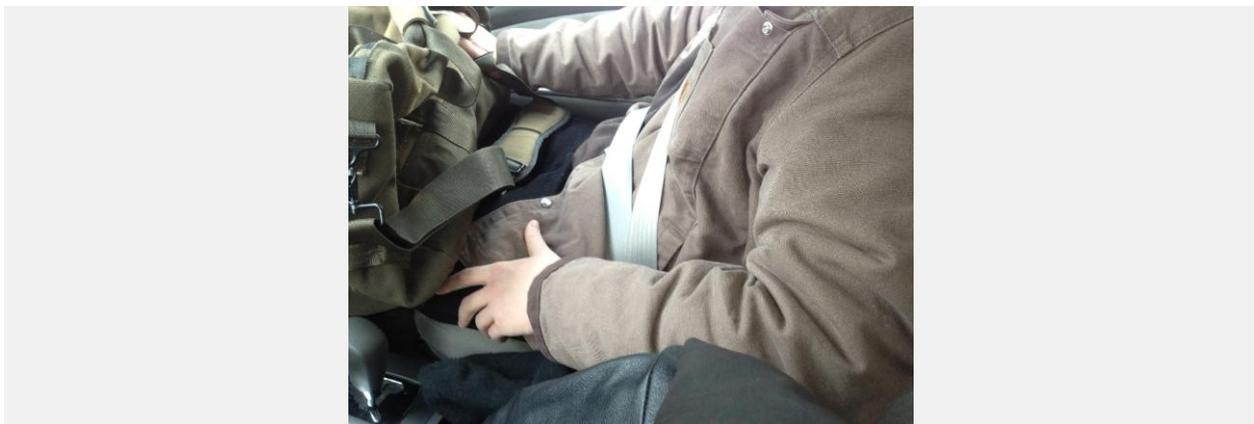
Placing a lap belt over top of a heavy coat means that there will be excessive slack in the system and during a major crash the lap belt can rupture major abdominal organs, sometimes resulting in death.

The lap belt in the above photo is obviously out of position as it is vastly too high, riding way up on this passenger's abdomen. Because the webbing has to cross over top of the thick coat the restraint system will also contain far too much slack to be of any benefit in a serious crash. More importantly this seat belt orientation may cause more injury than if the passenger was not wearing a seat-belt at all.

In winter persons must get used to the habit of un-zipping their heavy coats and pulling the coat to the left and right sides of the body while pulling the seat-belt tight and making sure that the lap belt is riding below the pelvic bones (iliac crests). Failure to do so will cause the lap belt to penetrate into the soft and unprotected abdomen where there are major organs (intestines, liver, spleen, etc) that, when ruptured can lead to critical level injuries.
