Gorski Consulting Website

Archived News - 2016 - November

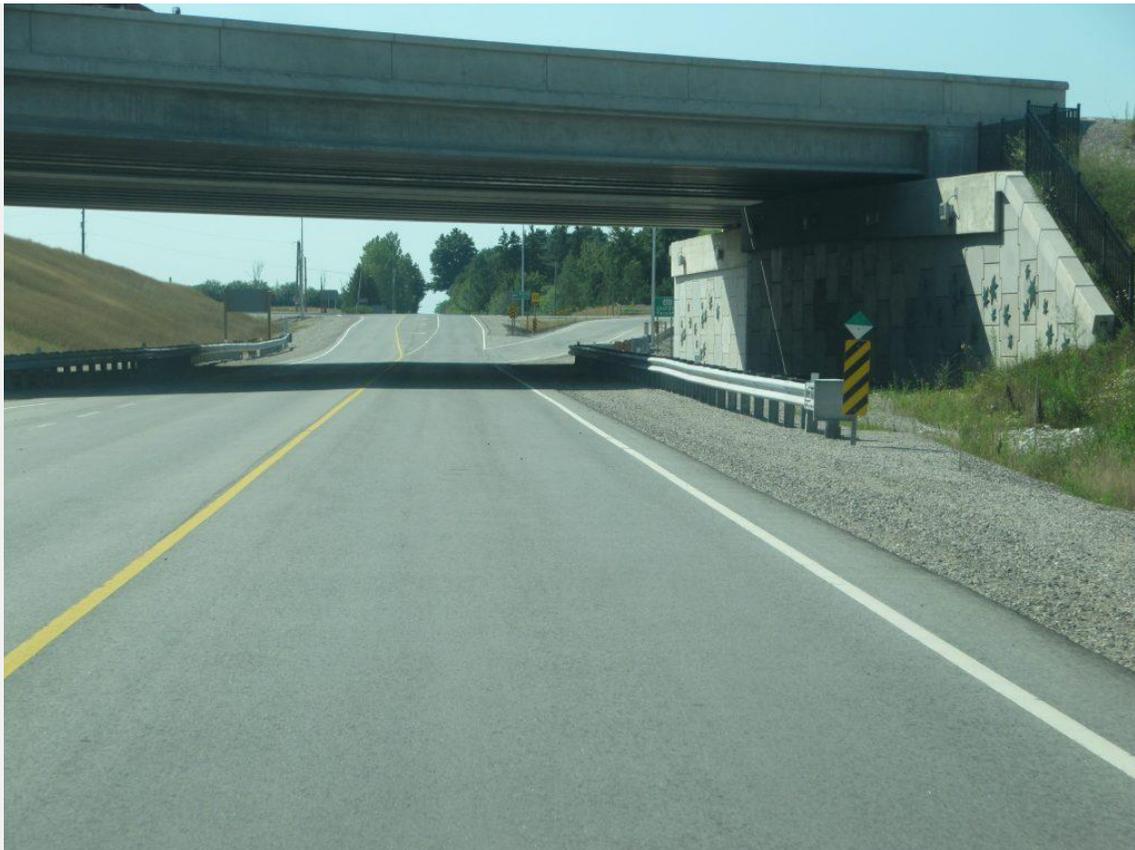
It is ironic now to see this magnificent sculpture of the interchange, built with all the modern safety designs and roadside barriers, yet, just a few hundred metres away, is a road in utter catastrophe! What is Southwold expected to do?

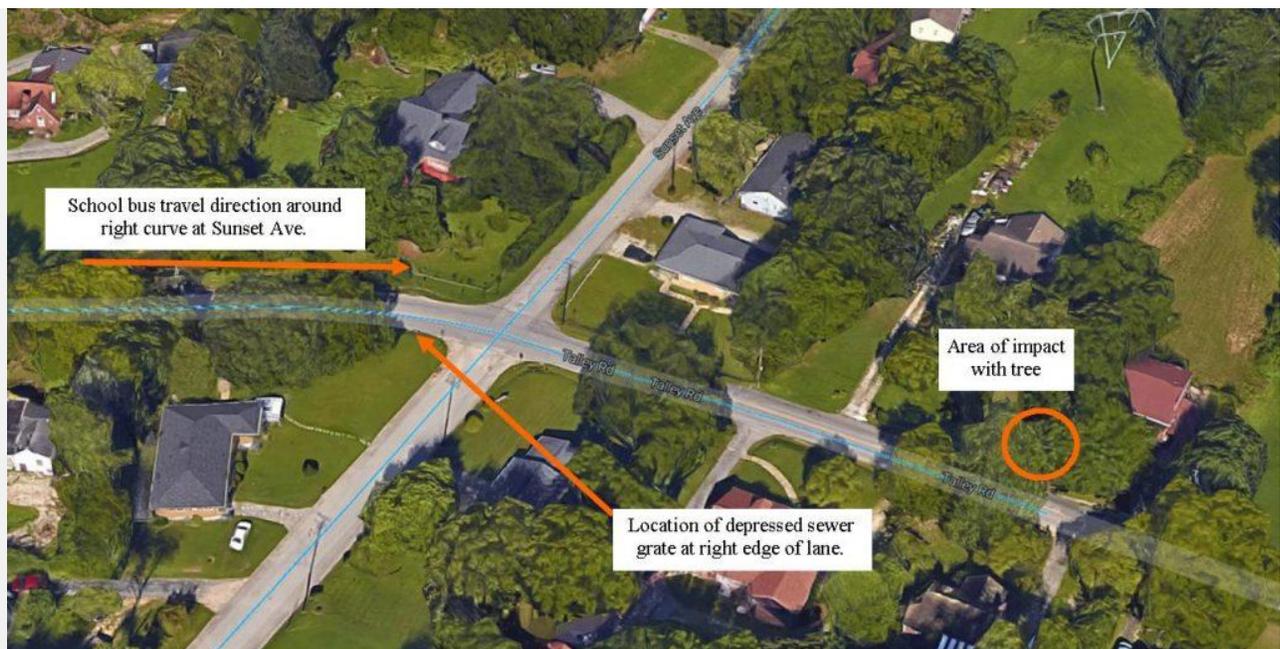
View of Talley Road at the intersection with Sunset Avenue in Chattanooga Tennessee. A depressed sewer grate may have been a factor in the bus loss-of-control.

A depressed sewer grate was located on the right side of the southbound lane of Talley Road at the location shown in the above photo. When a vehicle travels quickly around a curve it is common for the driver to “cut the corner” or bring the right side wheels close to the inside edge of the lane. Thus, if the school bus was travelling too fast its right side

wheels might have crossed over the depressed sewer grate resulting in the initial disturbance that eventually led to the bus rolling over.

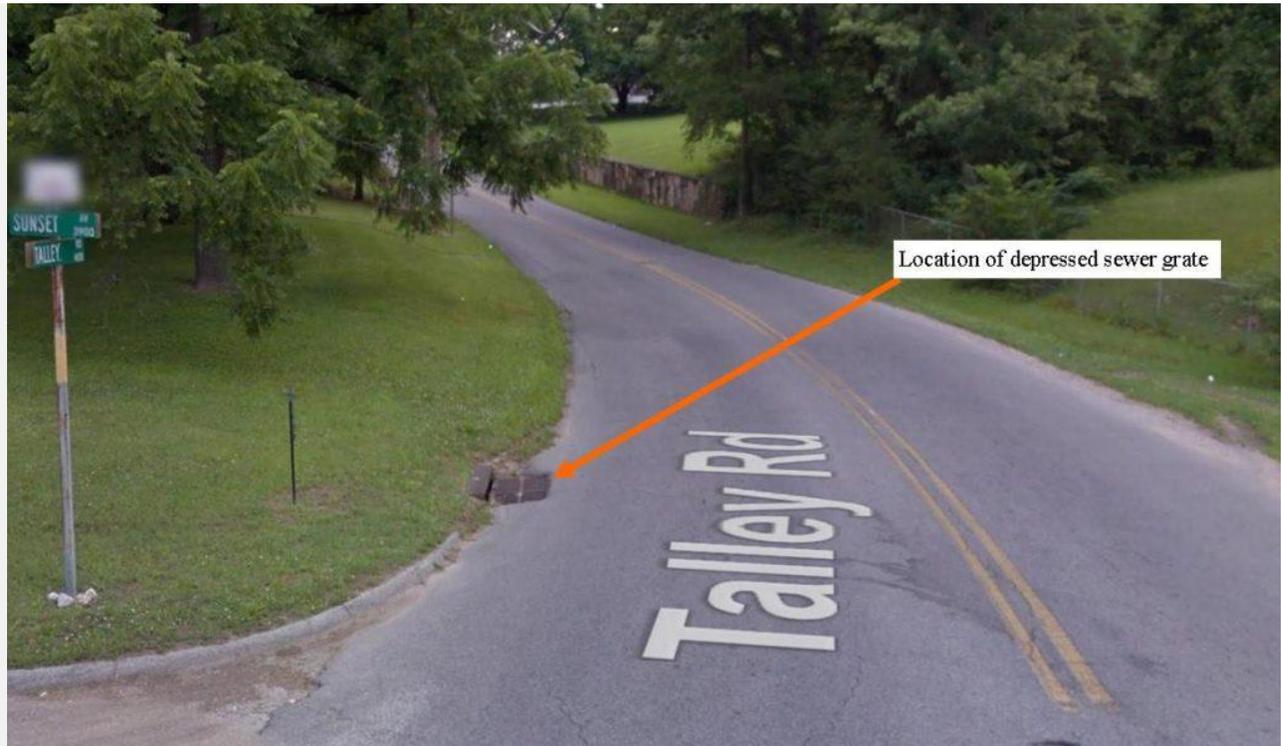
View looking north on Talley Road just north of the intersection with Sunset Avenue. The location of the depressed sewer grate is indicated by the orange arrow.

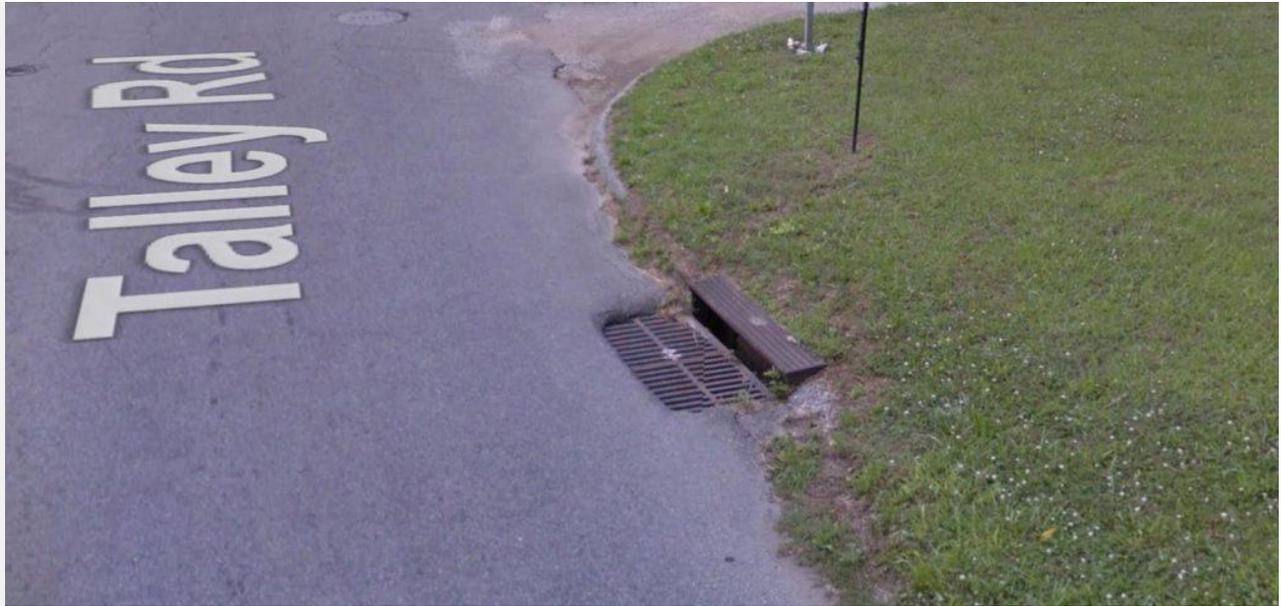
View looking south at the depressed sewer grate.

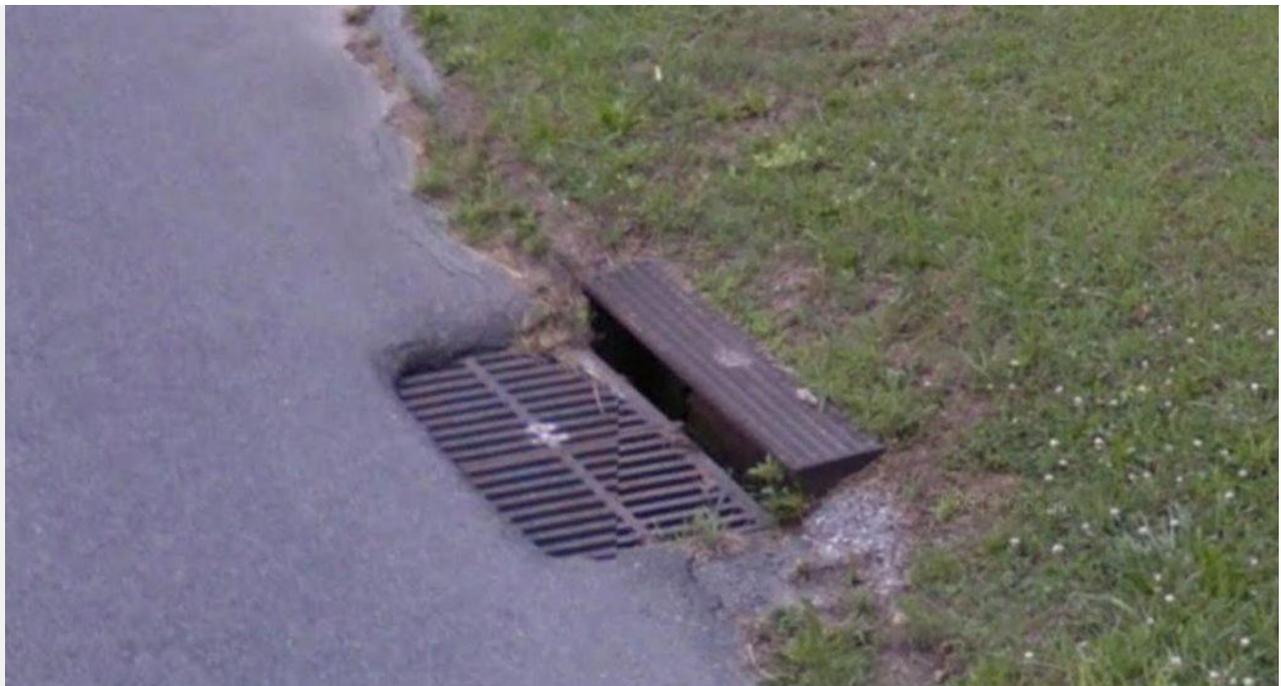
Close-up view of the depressed sewer grate. Note the dark shadow at the edge of the grate indicating the extent of its depression.

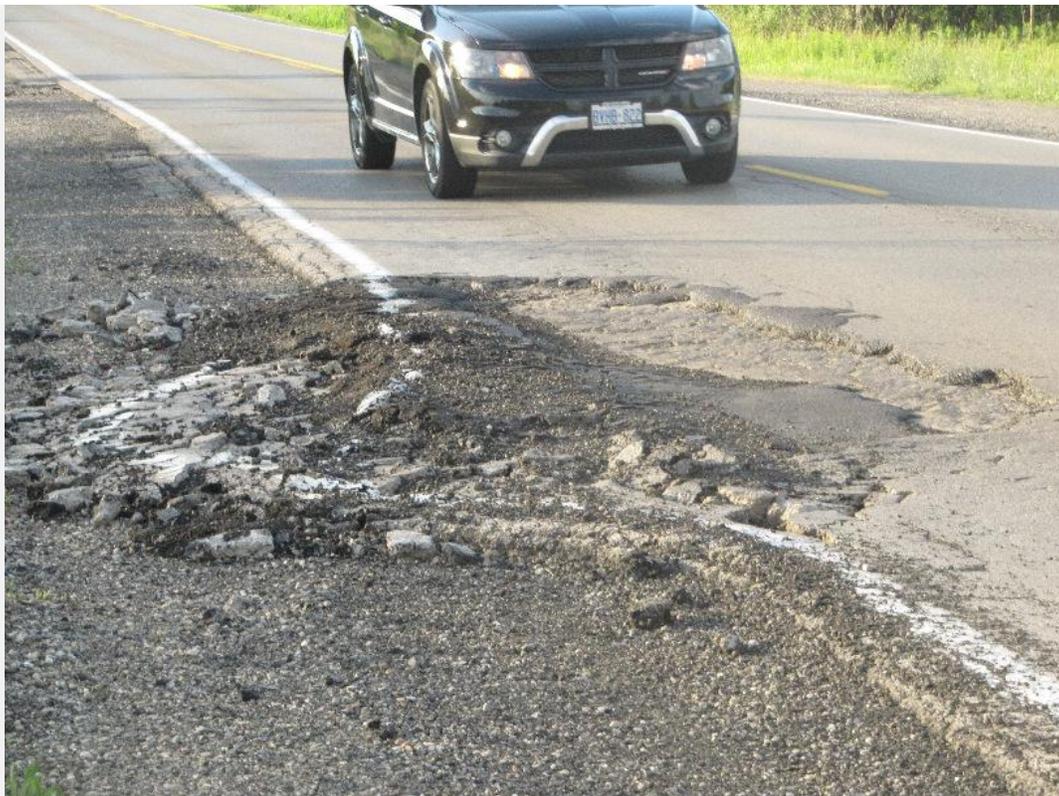
Road surface problems on Wonderland Road have prompted Gorski Consulting to conduct testing to determine the extent of the problem.

It was also apparent that the old surface of Wonderland Road was disintegrating, as can be seen in the photo at the top of this news segment. The photo shows that some patching was attempted resulting in a total failure of the surface.

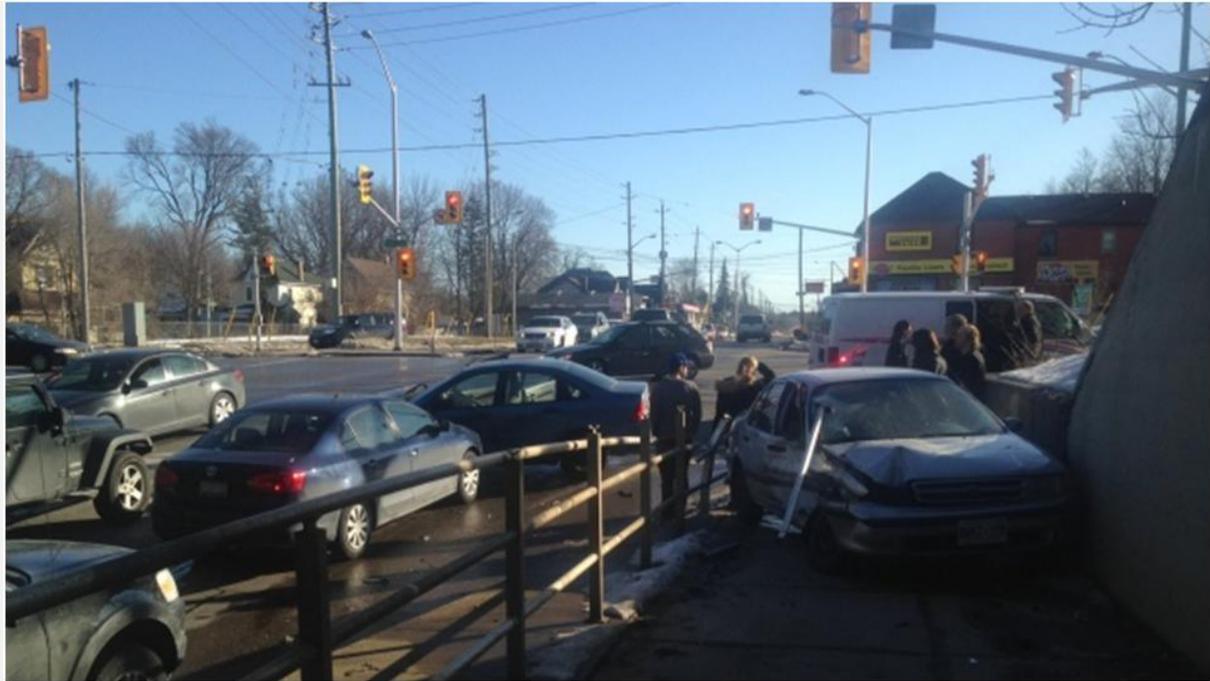
News media photo from February 21, 2016 of a car that was harpooned by a horizontal railing at the intersection of Horton Street and Wharncliffe Road in London, Ontario

As an example, the above photo was taken by a local news agency describing an unimportant collision that resulted in no major injuries. Yet no one focused on the fact that a horizontal pole from a roadside railing had penetrated the right portion of the

vehicle's windshield. If there had been a right-front occupant present, and if the circumstances were lined up, the end of the penetrating pole could have struck the occupant in the head and the result would have been deadly. But because this did not occur no one took notice of this potential.

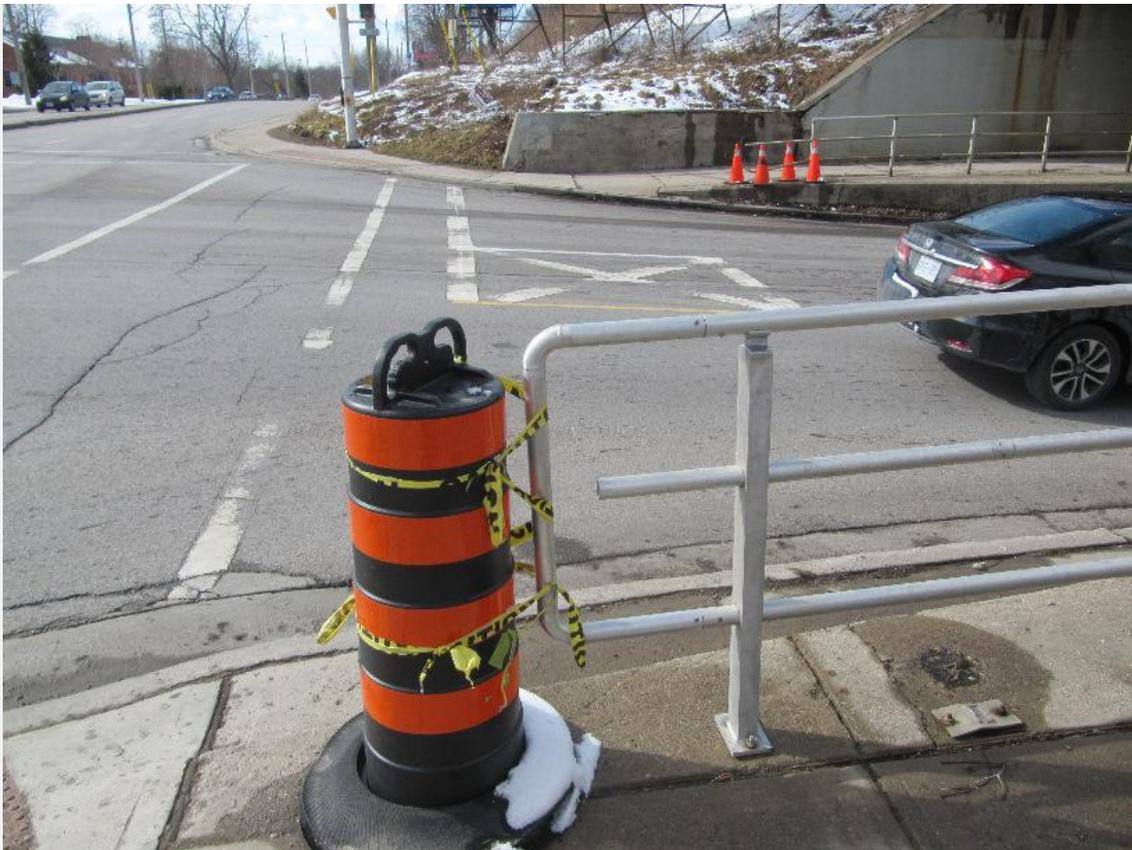
View taken on February 26, 2016, of non-struck railing in the foreground and the struck railing in the background.

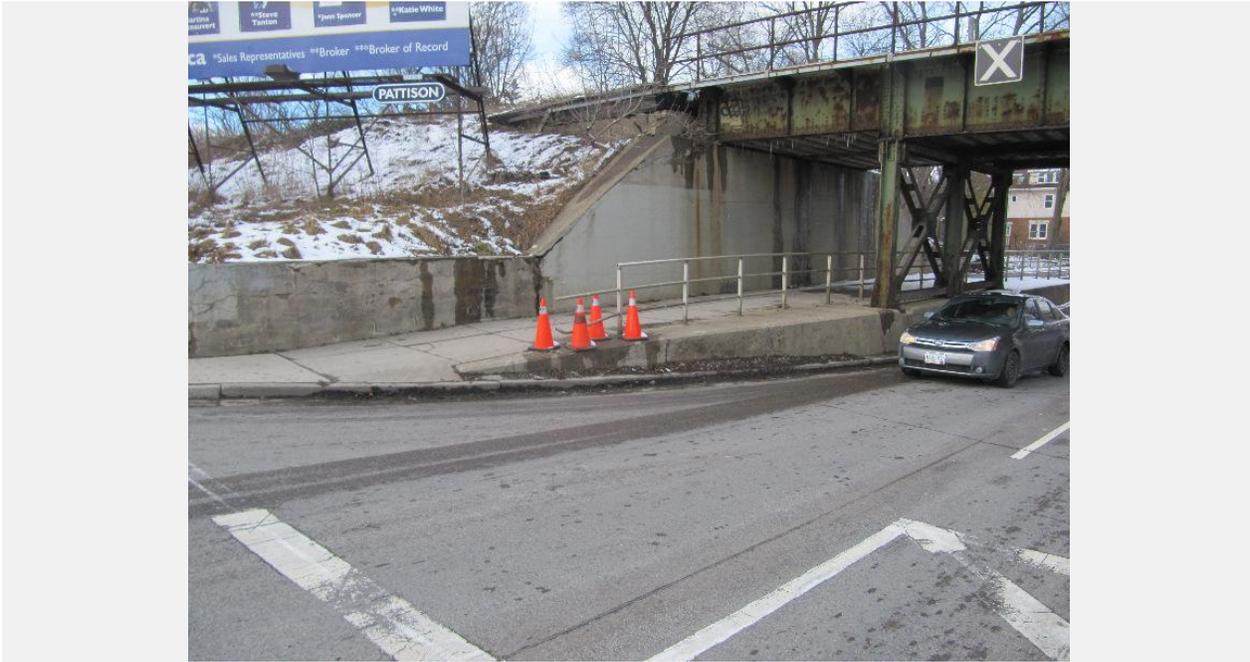
Overall view of the north-west corner of the intersection looking at the damaged railing.

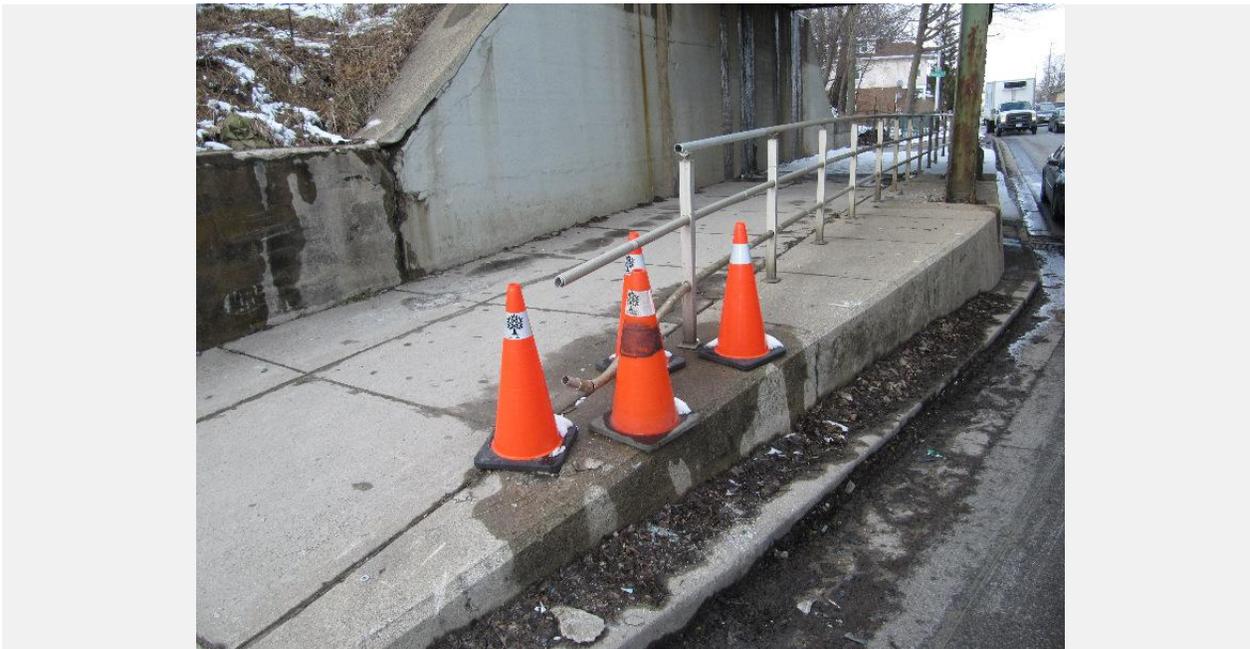
Closer view of the damaged end of the railing.

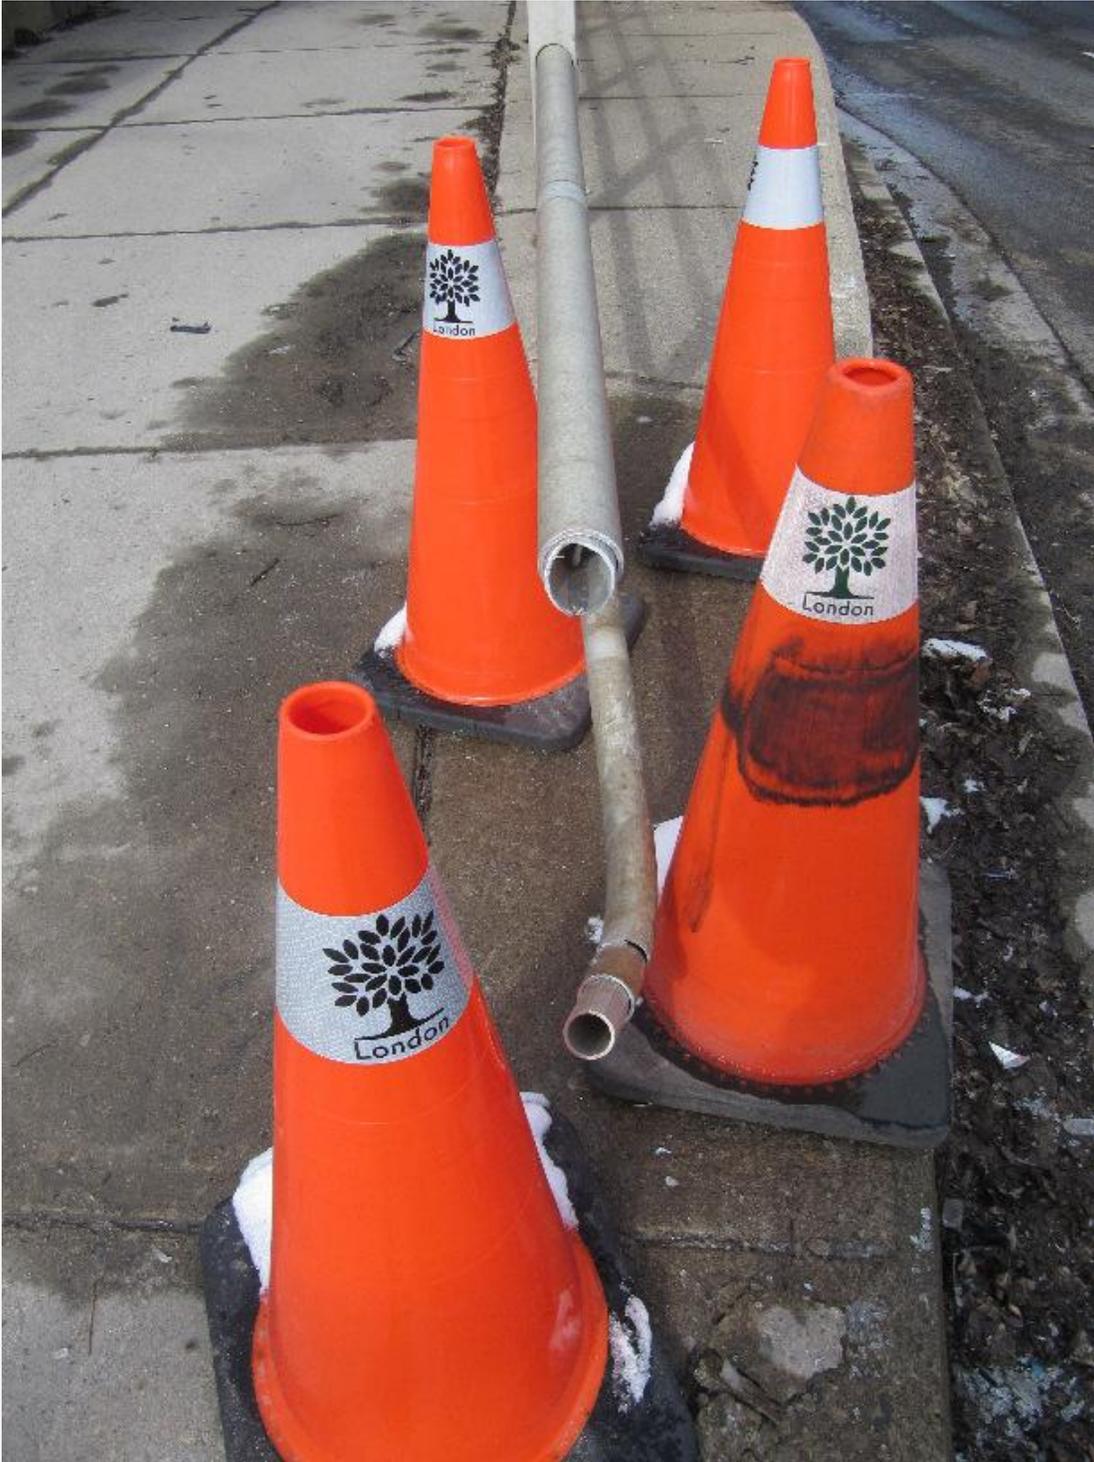
View of deformed ends of the damaged railing.

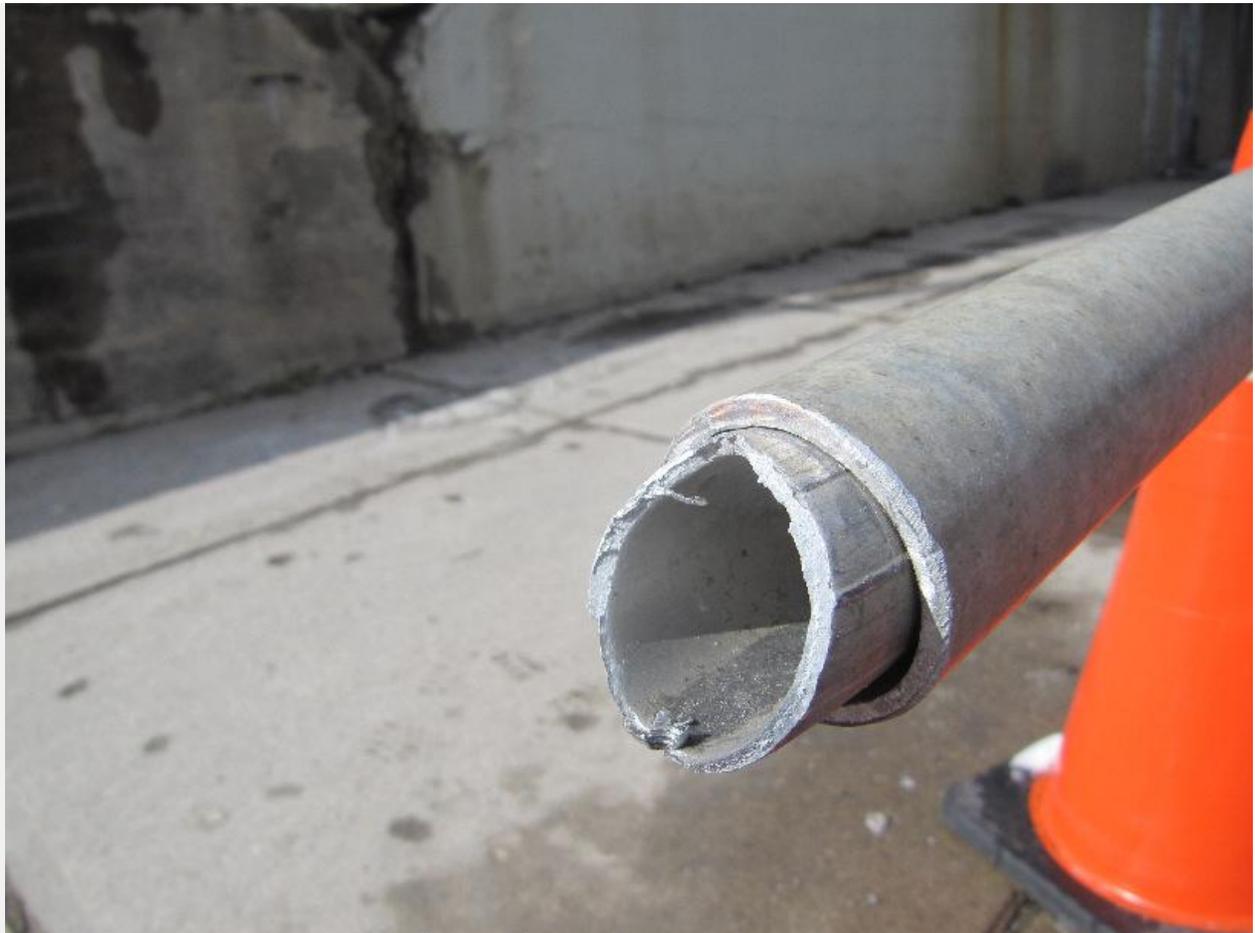
Photo showing the damaged end of one of the horizontal poles of the damaged railing.
