Gorski Consulting Website

Archived News - 2013 - September

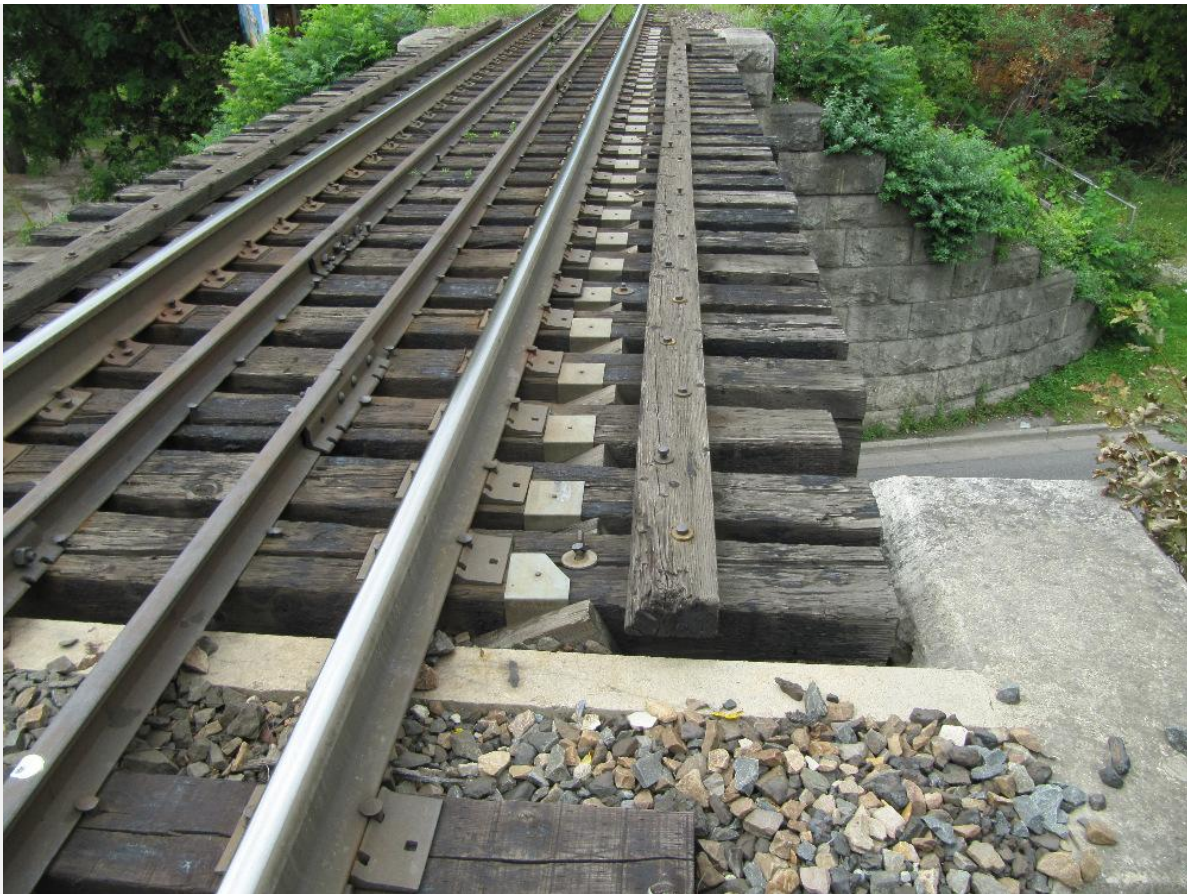
View upon climbing onto the CP rail truss on August 28, 2013 to explore why and how the wood had fallen.

If you follow the most right rail in the above photo you will find a number of wooden “spacers” that appear to be on a diagonal, pointing downward, and exist between the railway ties. Presumably these spacers are there to insure that the railway ties do not move out of position. So if you follow that right rail in the above photo, and you see all those spacers, you will come to a point where suddenly one of the spacers is missing –

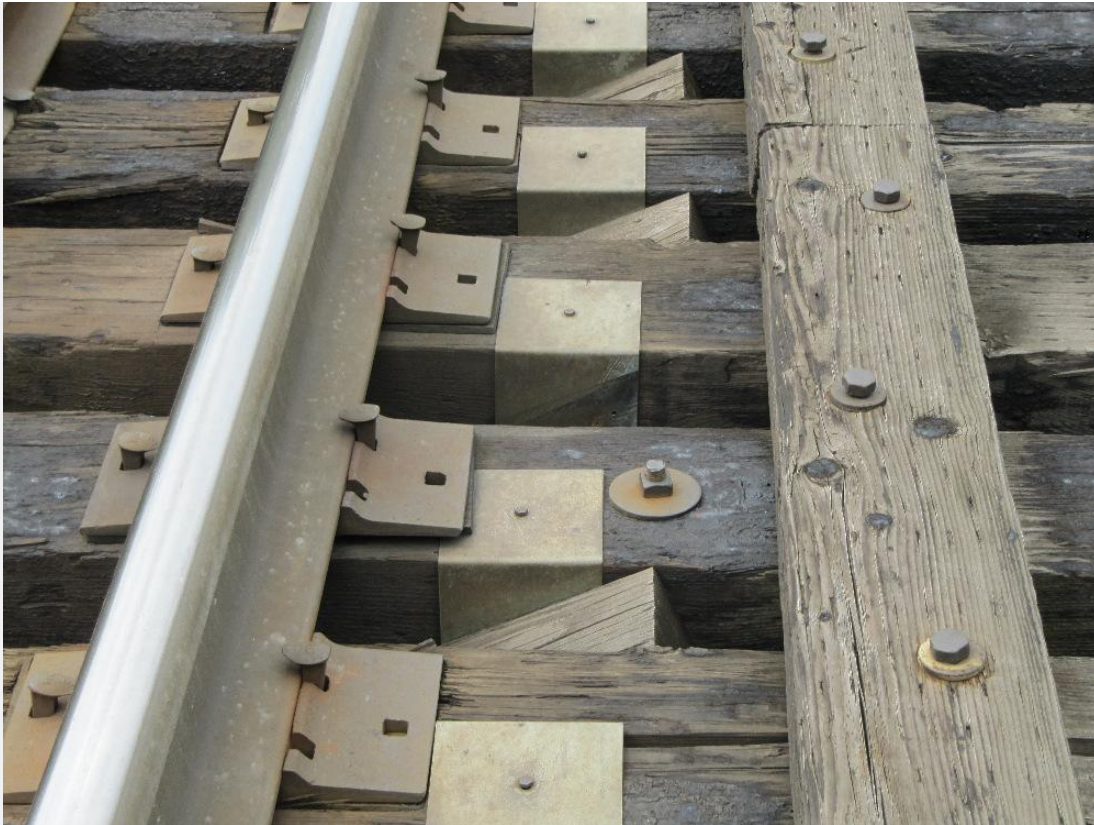
that is the one that fell onto the road. The photo below shows a closer view of the area where the spacer is missing.

Closer view of missing “spacer” between the railway ties of the CP rail truss spanning Western Road in London.

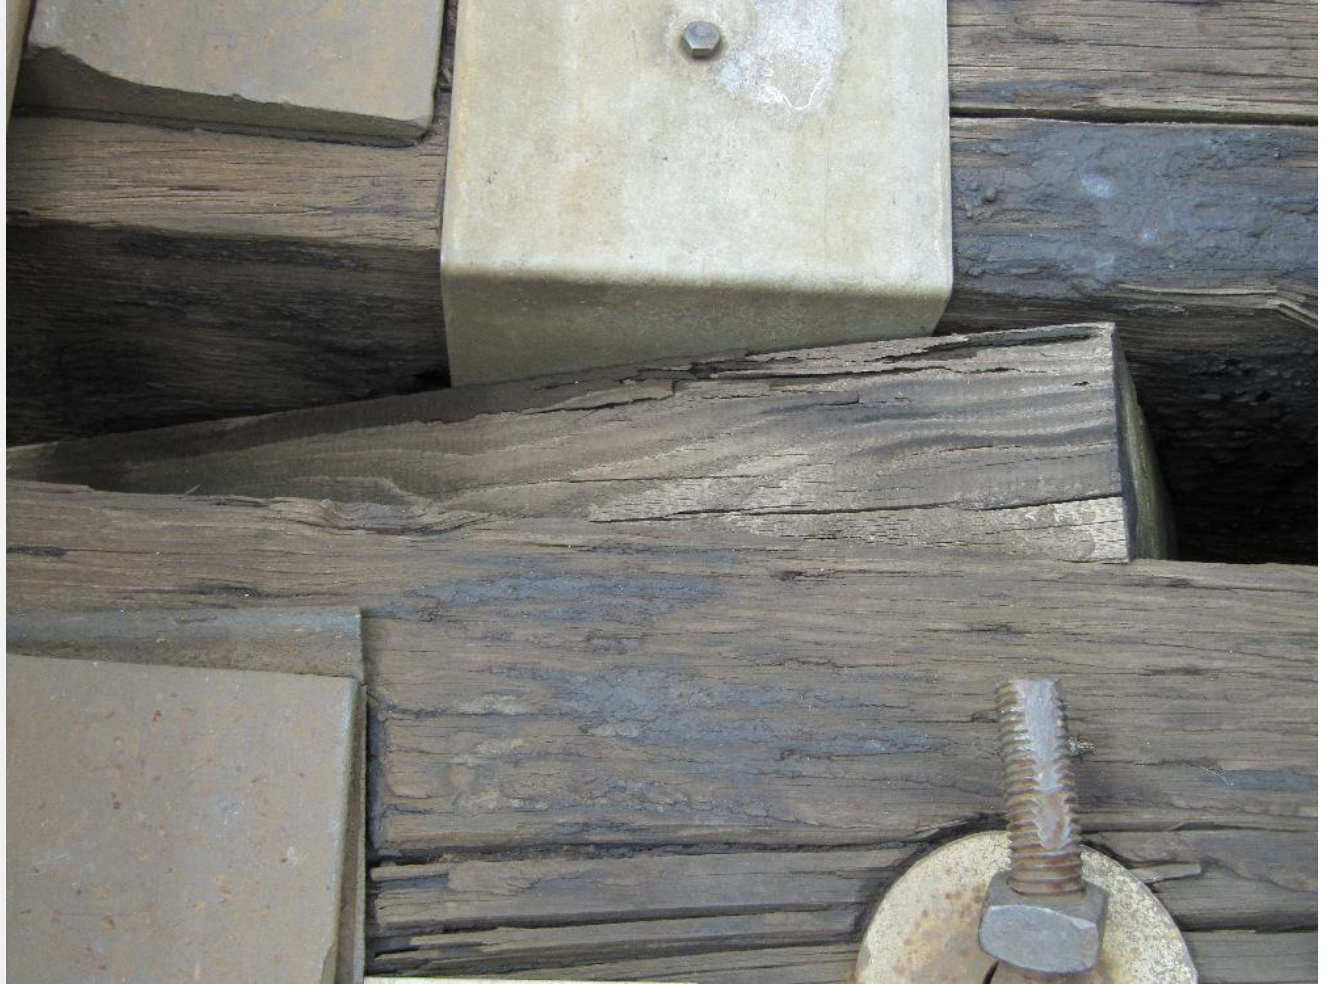
As we looked more closely at the spacers still attached to the truss we observed that there was a metal bracket at each spacer location that was anchored to the top of the railway tie and then (presumably) was also anchored to each spacer, as shown in the photo below.

View of metal bracket that is anchored to the top of the railway tie and (supposedly) is also anchored to the “spacer” preventing it from falling onto the road.

If a proper inspection was done by CP rail representatives then they would want to be assured that the spacers were actually solidly attached to each of these brackets. But one of the important matters would seem that they look at the wooden spacer that had fallen and it is not clear that they actually found that block of wood because it was still lying where we last saw it.

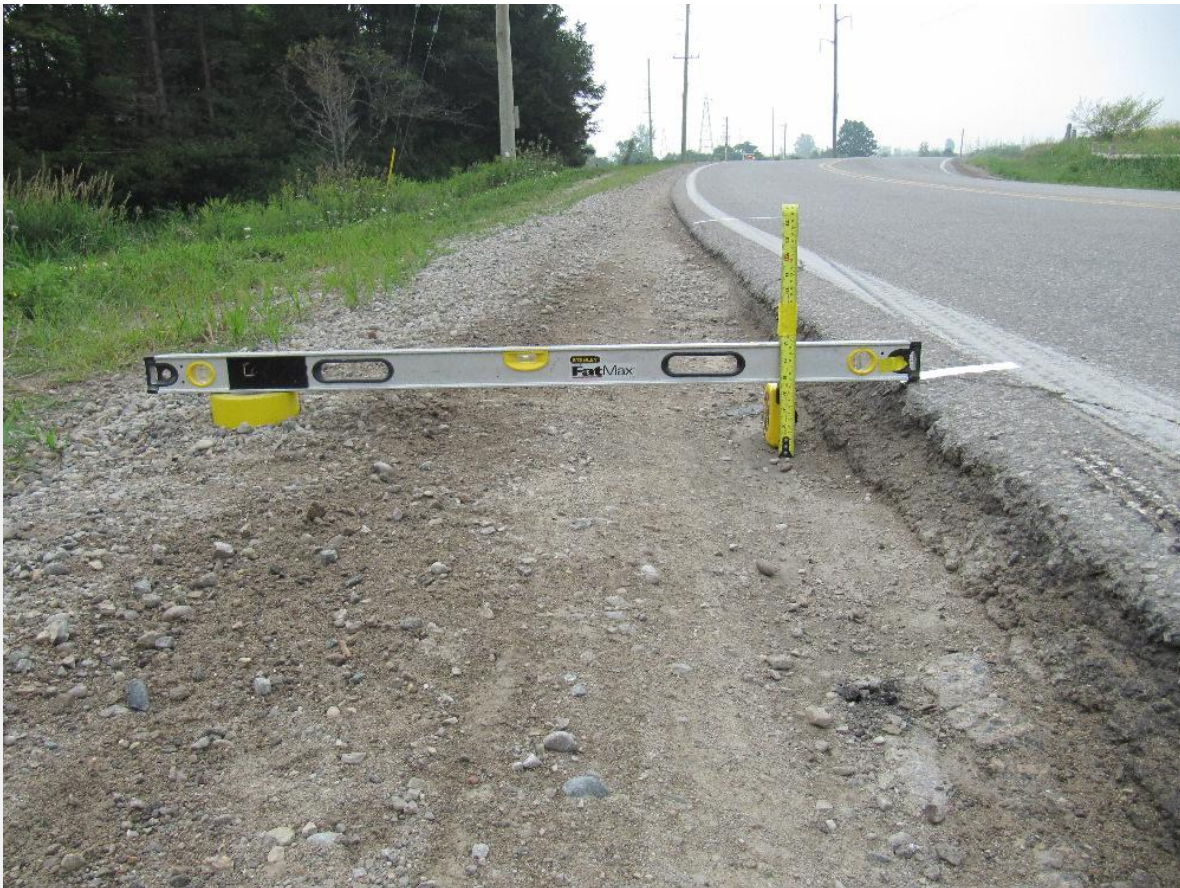
We have continued to monitor various road locations in southwestern Ontario. This includes sites such as the S-curve on Clarke Road north of Fanshawe Park Road in north-east London, Ontario. We have been documenting this site extensively for the past four years. Each fall brings the problem of an excessive edge drop-off for northbound traffic at the north end of the S-Curve. The photo below shows the procedure we have used over the years to document this problem.

View of procedure used to measure edge drop off on Clarke Road north of Fanshawe Park Road (Circa Aug 2011).
