## 2012 Ford Fusion Brake Testing With iPhone Accelerometer - Test #17 Partly on Gravel Shoulder

This article is the third in a series of four articles discussing emergency braking tests performed by Gorski Consulting with a 2012 Ford Fusion passenger car equipped with multiple video cameras and the tri-axial acceleration displayed from an iPhone 4S cell phone. In the first article of this series we introduced the instrumentation that was used in the testing and analysis of the data. In the second article we discussed the results of a simple emergency braking test on a dry, tar and chip road surface. The present article and a fourth one will discuss the results of a more complicated braking test where the right side wheels of the test vehicle are riding on the right gravel shoulder of a rural highway when the braking begins.

The test being discussed in the current article took place while travelling westbound on Medway Road, a few kilometres east of Clarke Road, just north-east of London, Ontario, Canada. The test was performed on the afternoon of February 24th, 2013 when the outside temperature was near zero degrees Celsius. The test speed was at 71 km/h.

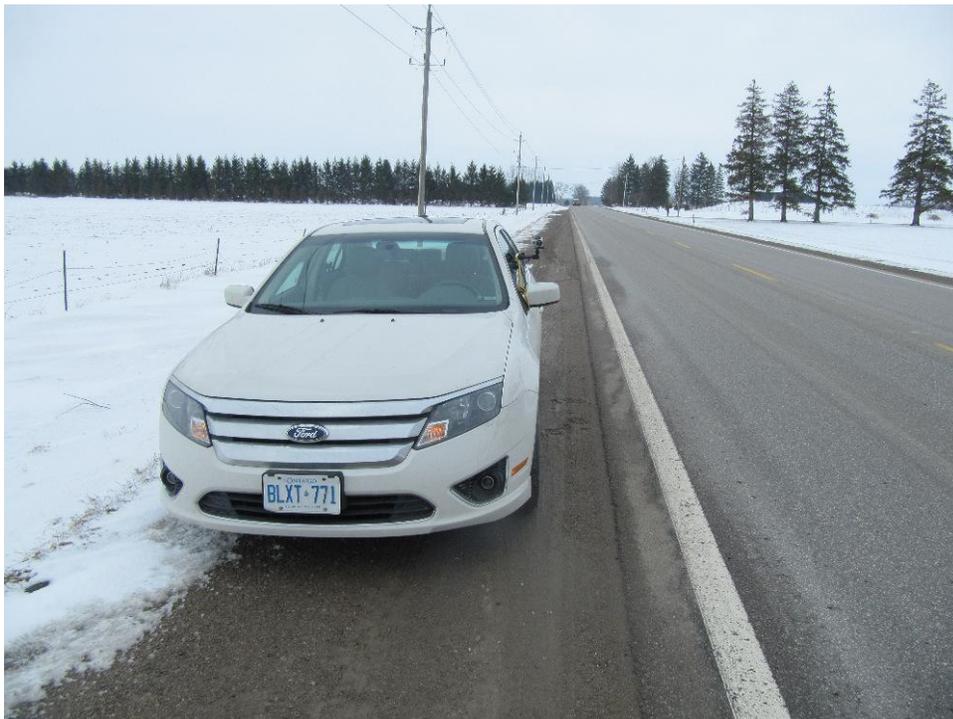
The photo below shows a front view of the rest position of the 2012 Ford Fusion test vehicle after the braking test was performed and the vehicle was steered off the road surface to prevent interference with road traffic.

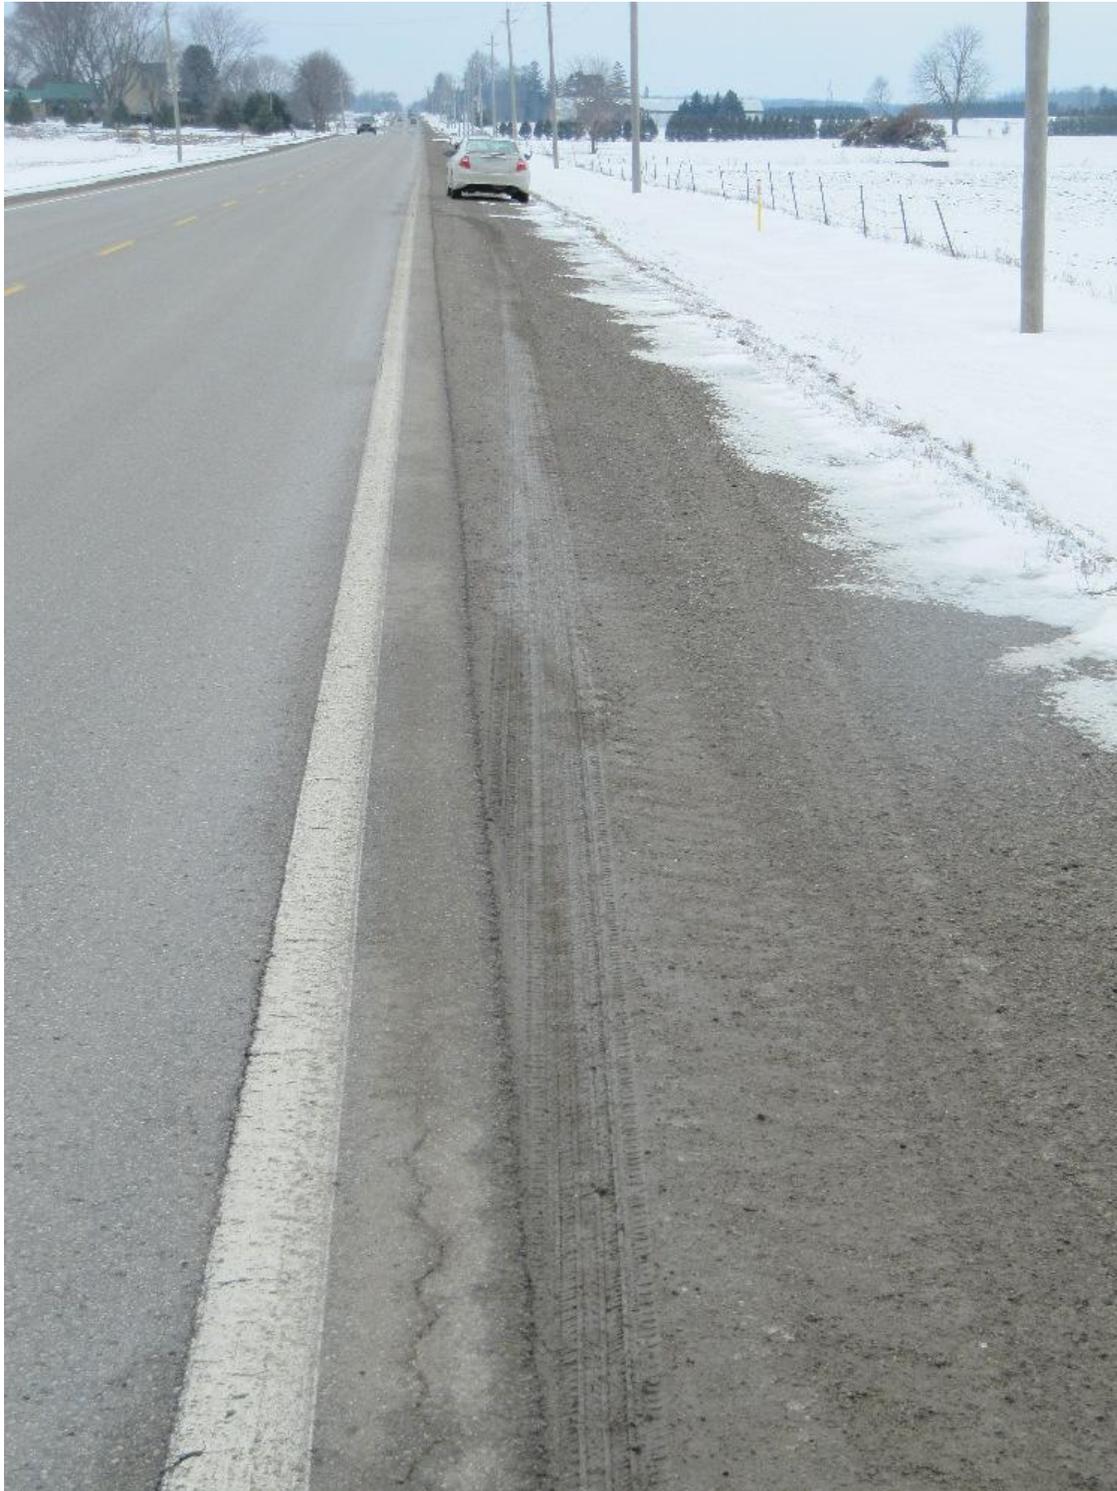
The photo below shows a westbound view along the north asphalt edge of the highway. The foreground shows the location where the right side tires of the vehicle exited the paved road surface prior to the braking test.

A tire mark in the middle of the gravel shoulder of the above photo was pre-existing and not relevant to the testing. The photo below shows an easterly view looking toward the point where the two right side tires of our test vehicle exited from the paved road surface. When our vehicle is steered the right front tire exits first, followed by the right rear, so that the two tires do not follow the same path, so we see the marks from both tires on the shoulder.

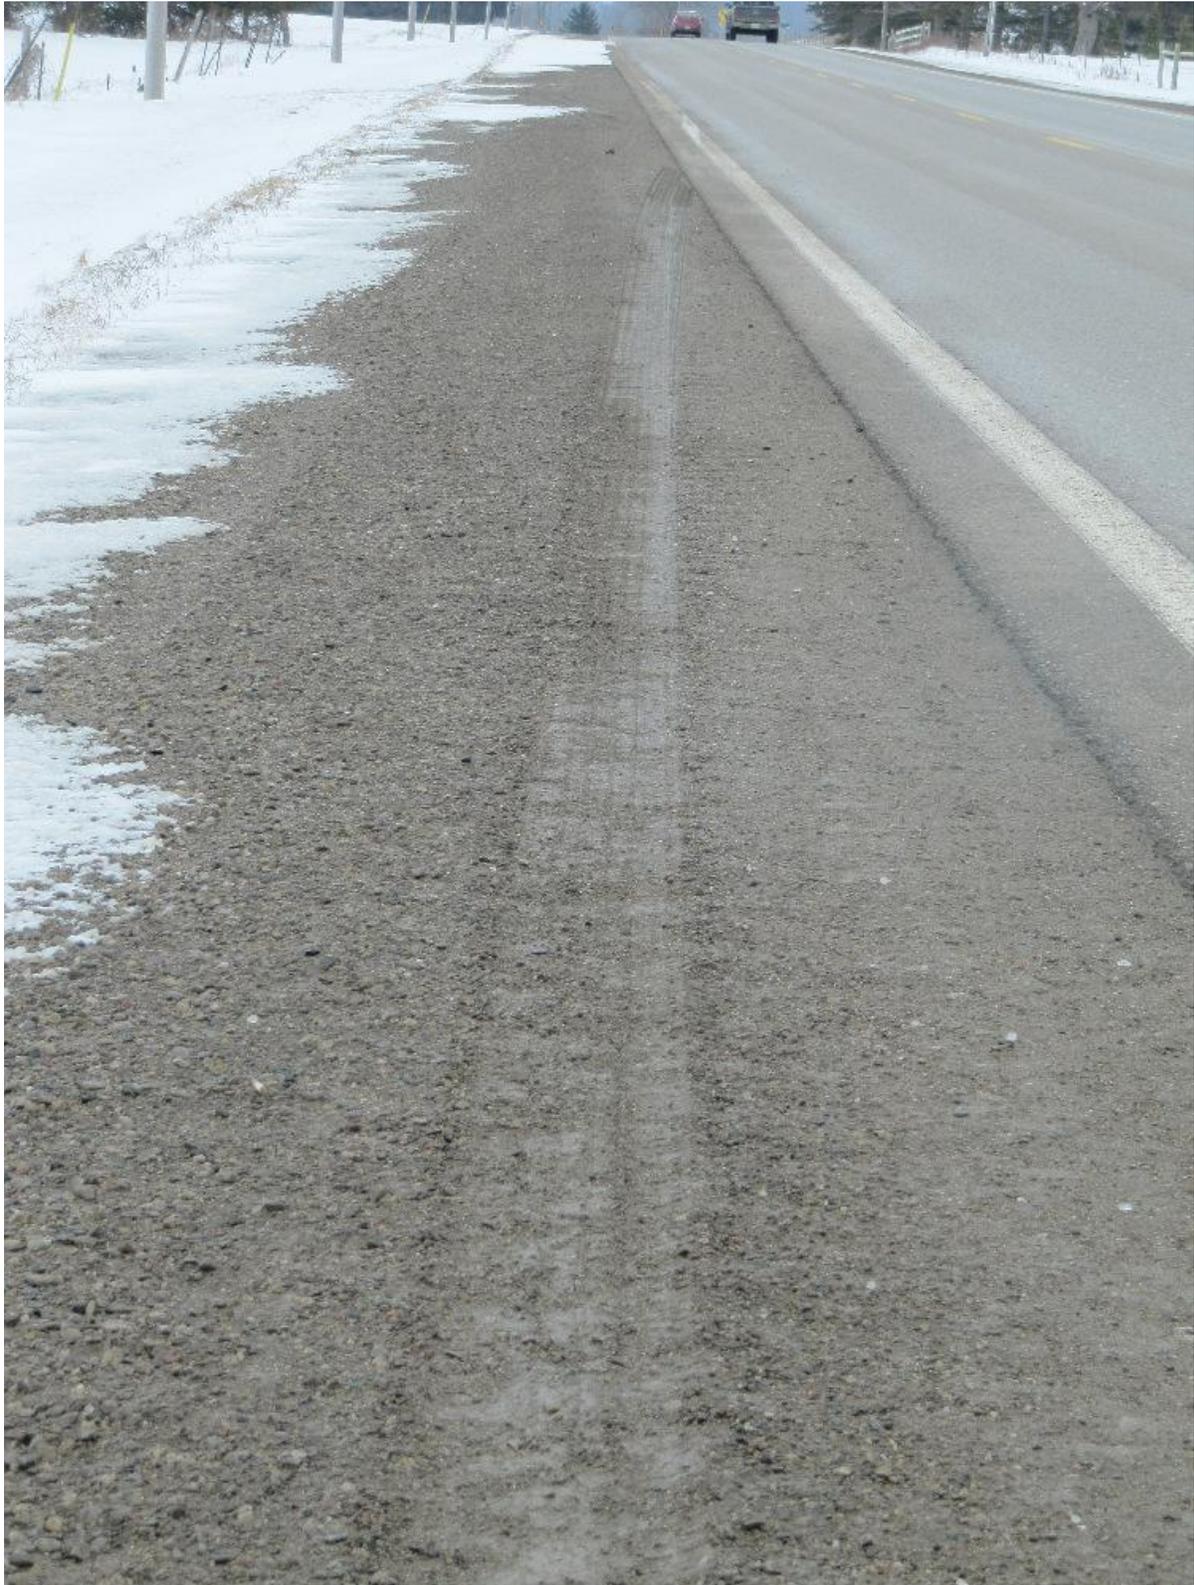
Stepping back further to the west, the photo below shows another view looking east at the marks caused by the two right side tires.

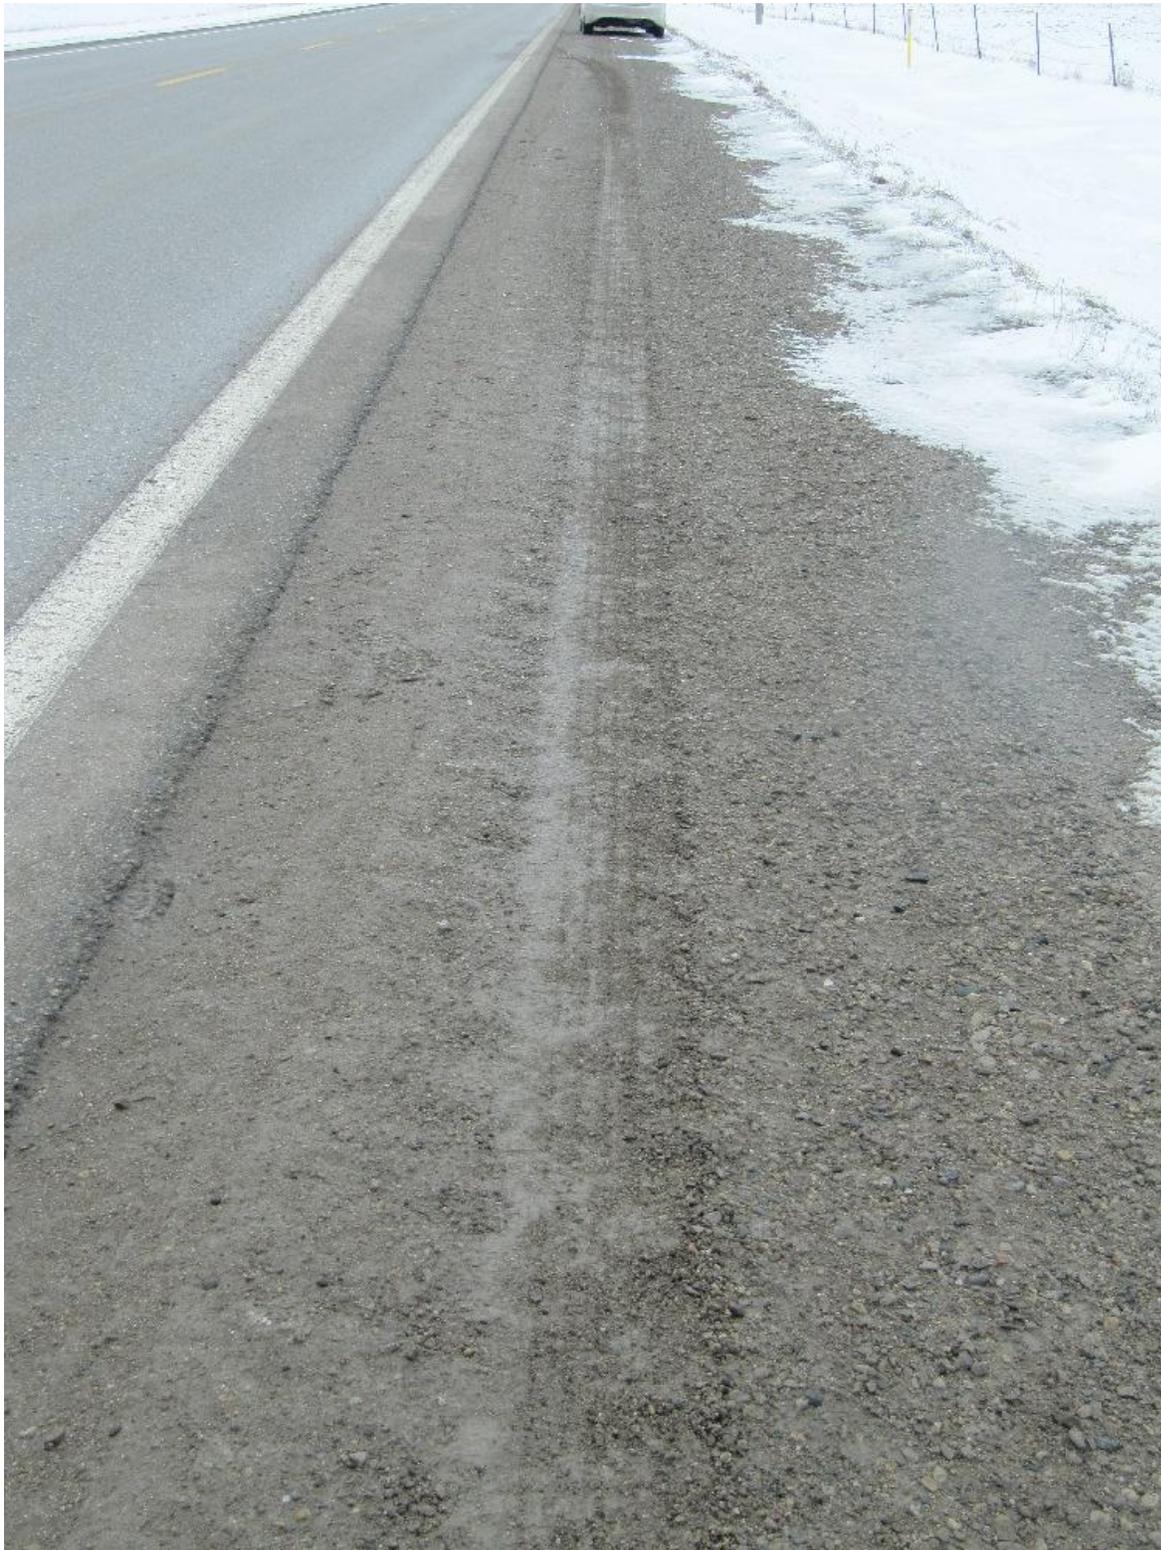
Turning around to face westward again, the photo below shows the tire marks on the right shoulder at a location where the vehicle has now been positioned squarely in a parallel direction to the road and the braking can begin.

Looking at the previous photo it might be difficult to detect where the braking commenced. But by zooming in and using a longer focal length the tire mark can be compressed in length as shown below, and differences in the character of the tire marks might be better visualized.

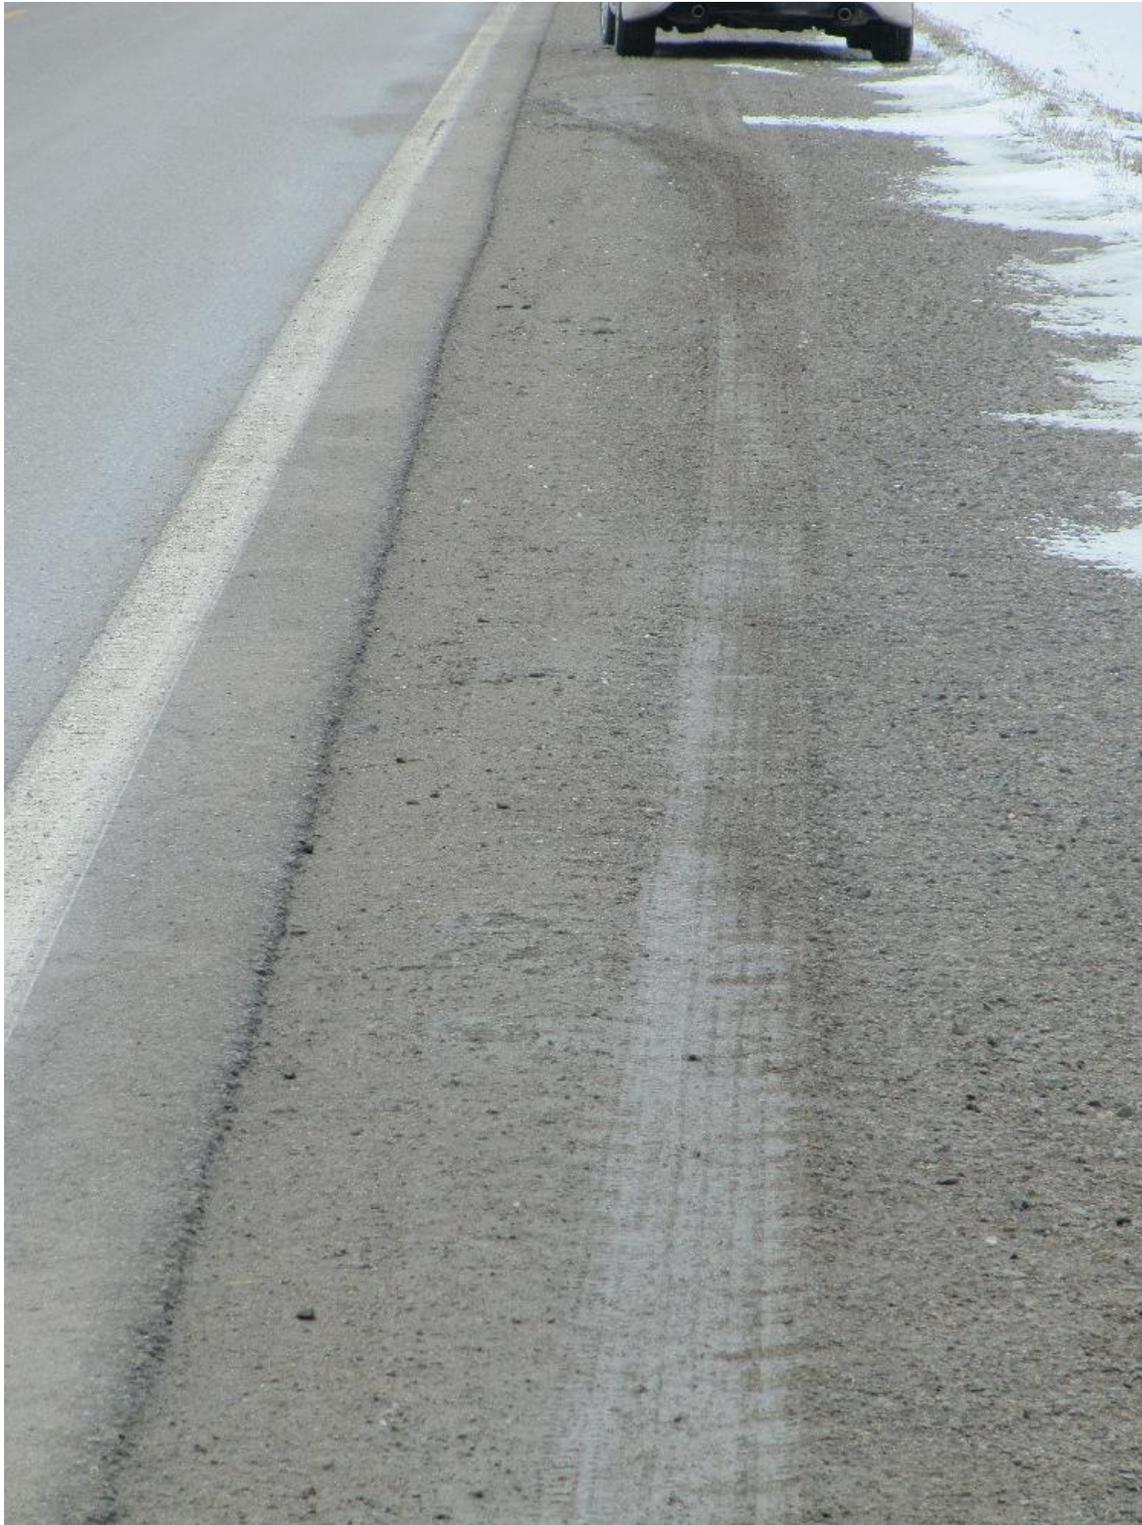
Certainly, in the foreground of the above photo the tire marks maintain the visible treads within them, then as we look further into the background we can recognize some disruption within the tire marks. The photo below gets us closer to that area of disruption.

Roughly in the middle of the above photo we can still see some remnants of the tread pattern but we also see some lifting and disruption of the resting position of the gravel. The photo below shows a closer view of the disruption and we can see how the gravel has been turned up while the tire tread is difficult to detect.

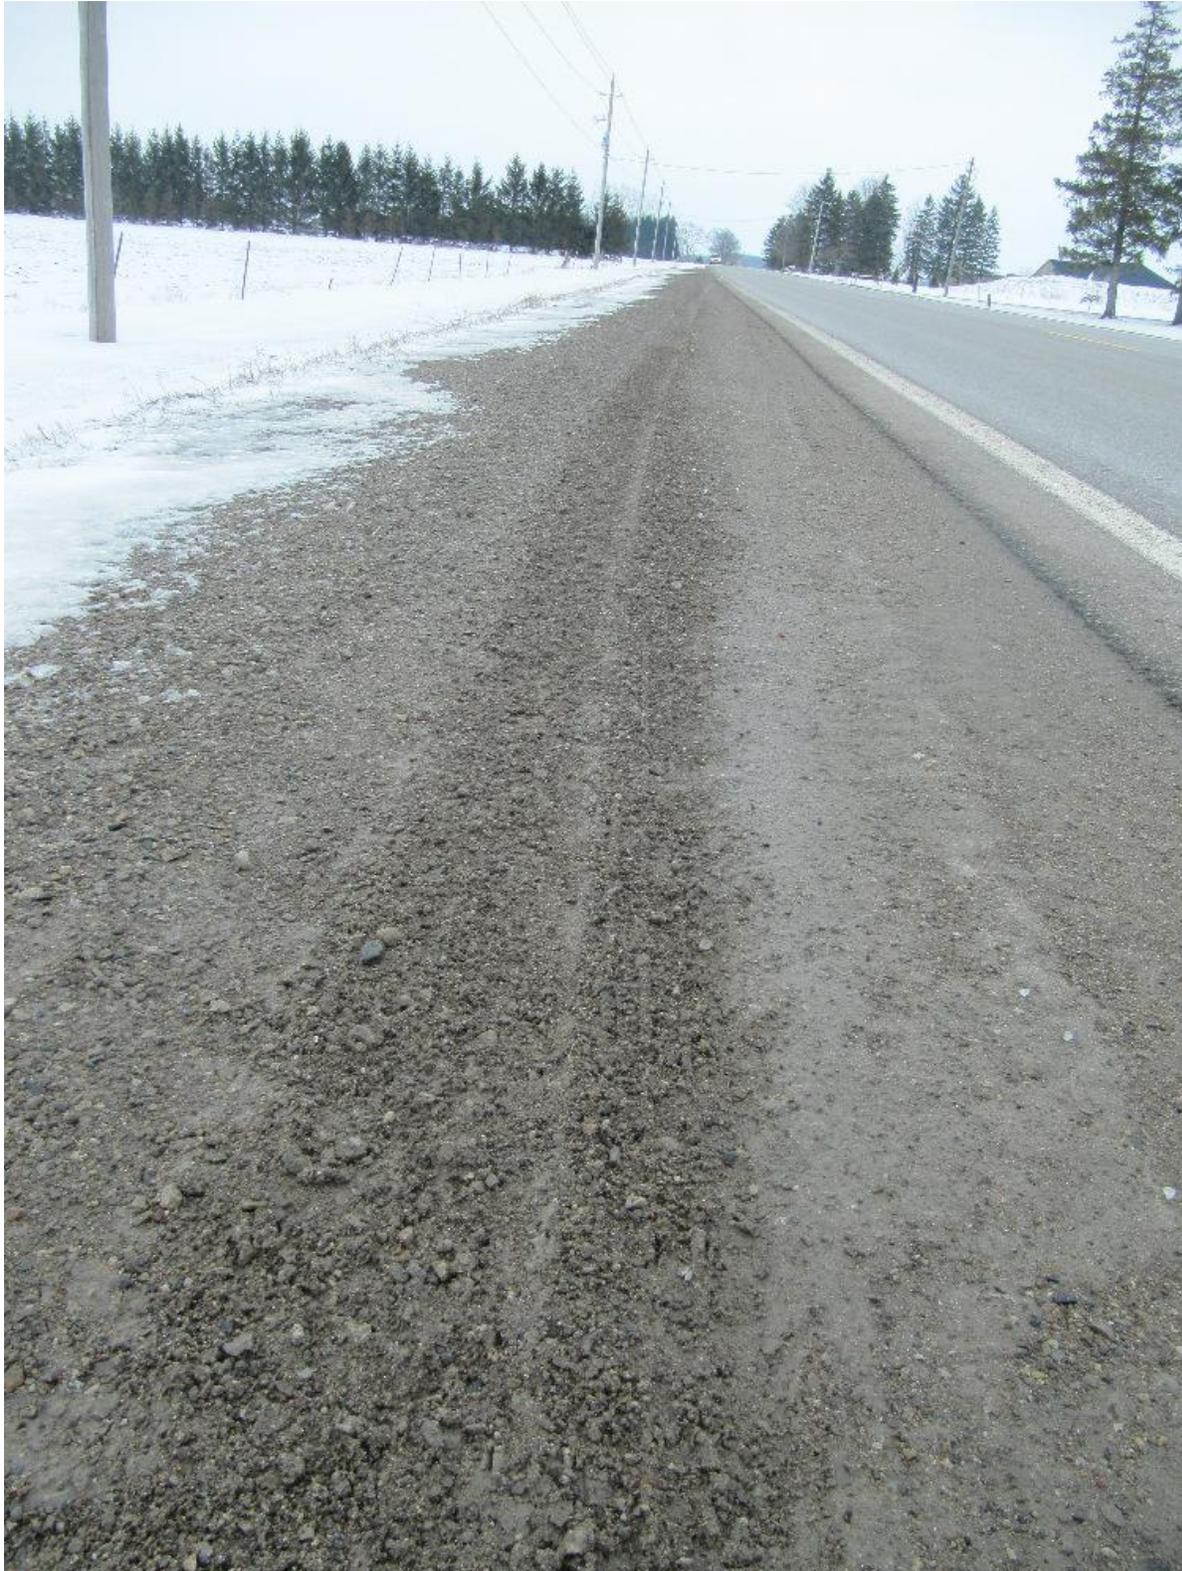
As the braking proceeded the test vehicle began to rotate counter-clockwise. Thus the right rear tire began to track along a different path from the right front tire. Evidence of this action can be seen in the photo below.

In this photo it may be possible to detect the tracking of the right rear tire which displays a disruption of the gravel which is the full tread width. Just to its right is the partial width of disruption caused by the right front tire. The reason for this happening is that the mark produced by the right front tire is driven over top of by the right rear tire. Although these observations are not easily detected it is possible to decipher them with some close study of the photo. The separation of the tire marks may be more visible in the photo below which shows them at a location further to the west.

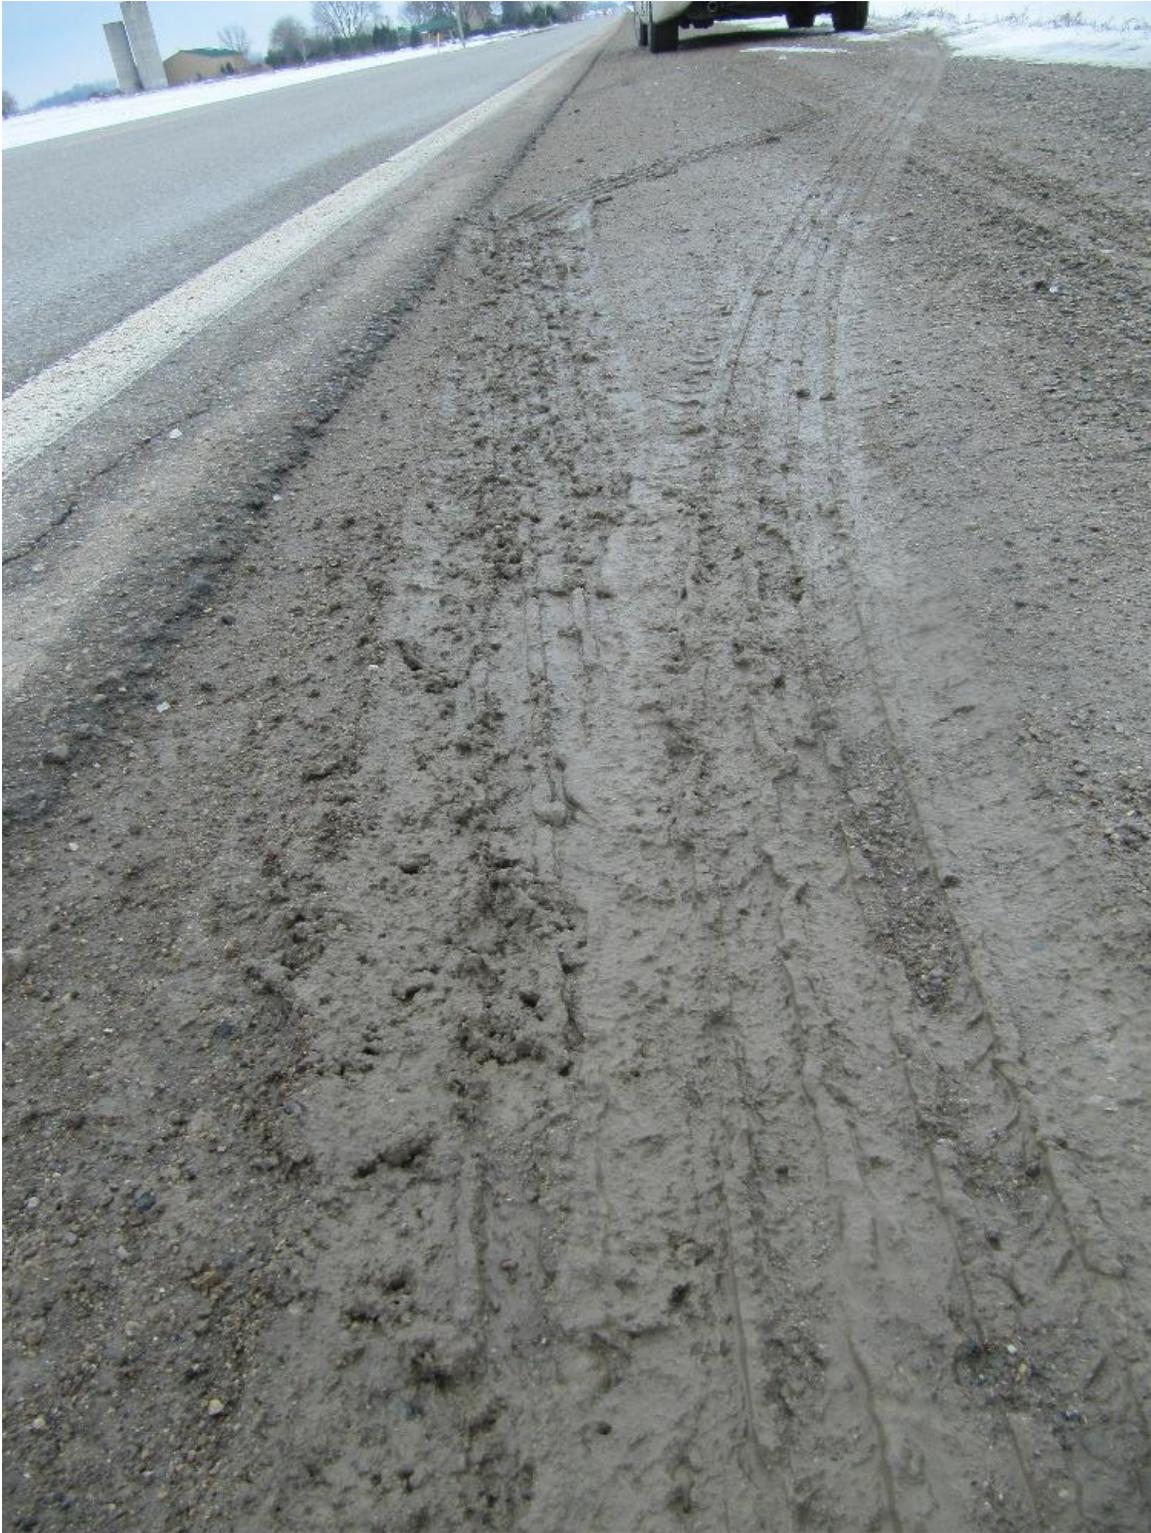
As we rotate around to look westward again the photo below shows the paths of the two right side tires near the end of the braking test with the mark of the right front tire on the left and that of the right rear tire on the right.

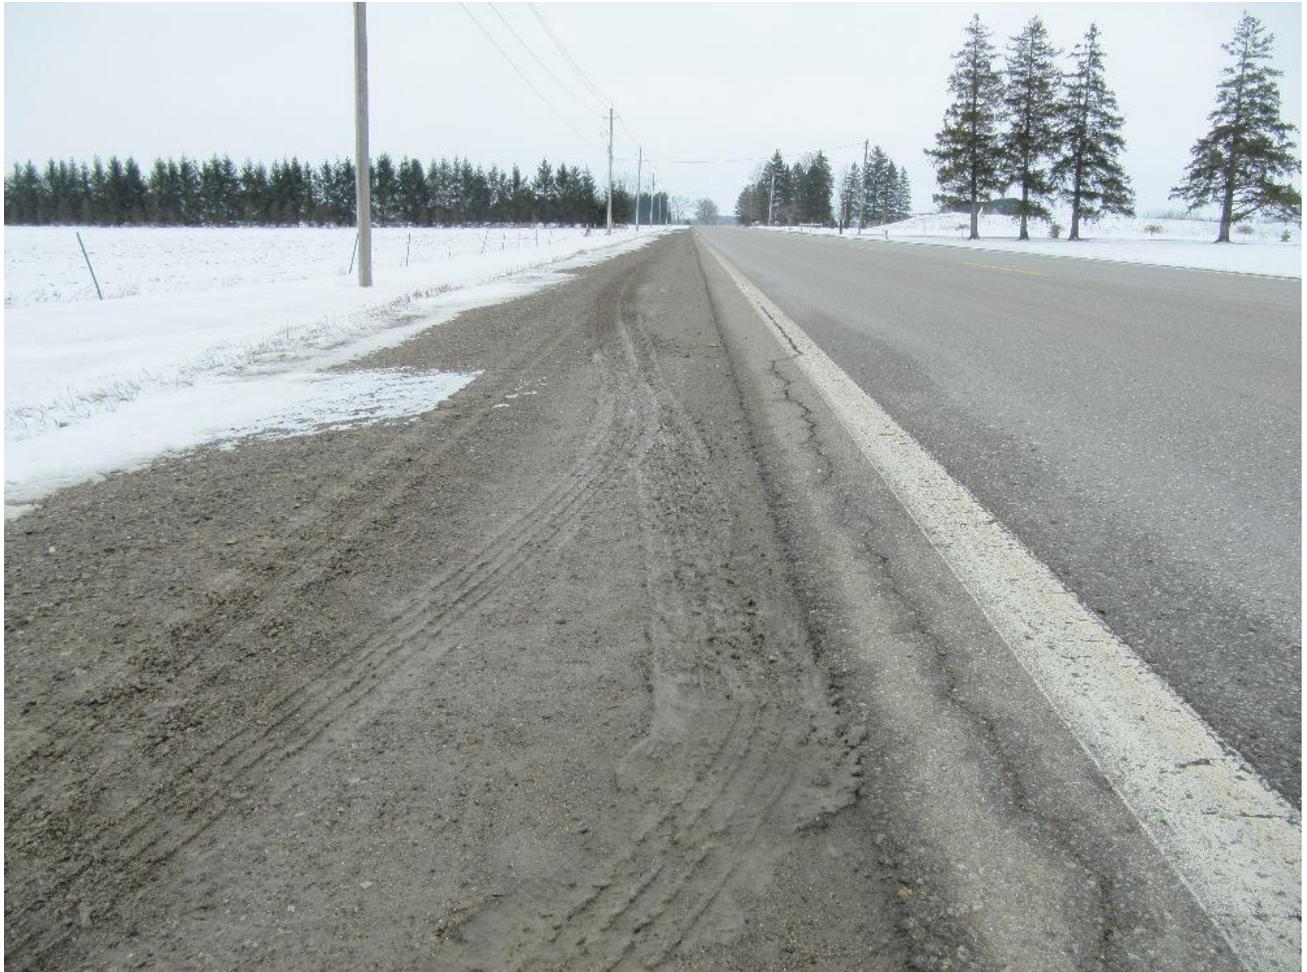
The photo below is taken from the point where the right front tire came to a halt in the foreground, near the asphalt edge. The gentle curving path of the right rear tire mark travels toward the bottom left corner of the photo. An unrelated, pre-existing tire mark is also visible to the left of that right rear tire mark.

It can be seen above how the softened mud of the shoulder was "squeezed" to the outside edges of the right front tire mark at the point where it came to rest. Then there is a sharp change in direction of the right front tire mark as we steer to the right to park our vehicle off the road surface. The disruption of the tire tread pattern is visible in the portion of the right front tire mark where braking was taking place and we can contrast that with the clearly delineated tread pattern that is visible in the tire mark in the portion where the vehicle is steered, without braking, to a parked position.

Similarly, the characteristics of the right rear tire mark in the foreground are of a rolling tire because the right rear tire came to a halt further to east in the background. So in the foreground the right rear tire is rolling as part of the action of being steered to a parked position. Thus the tire tread is clearly delineated within this tire print.

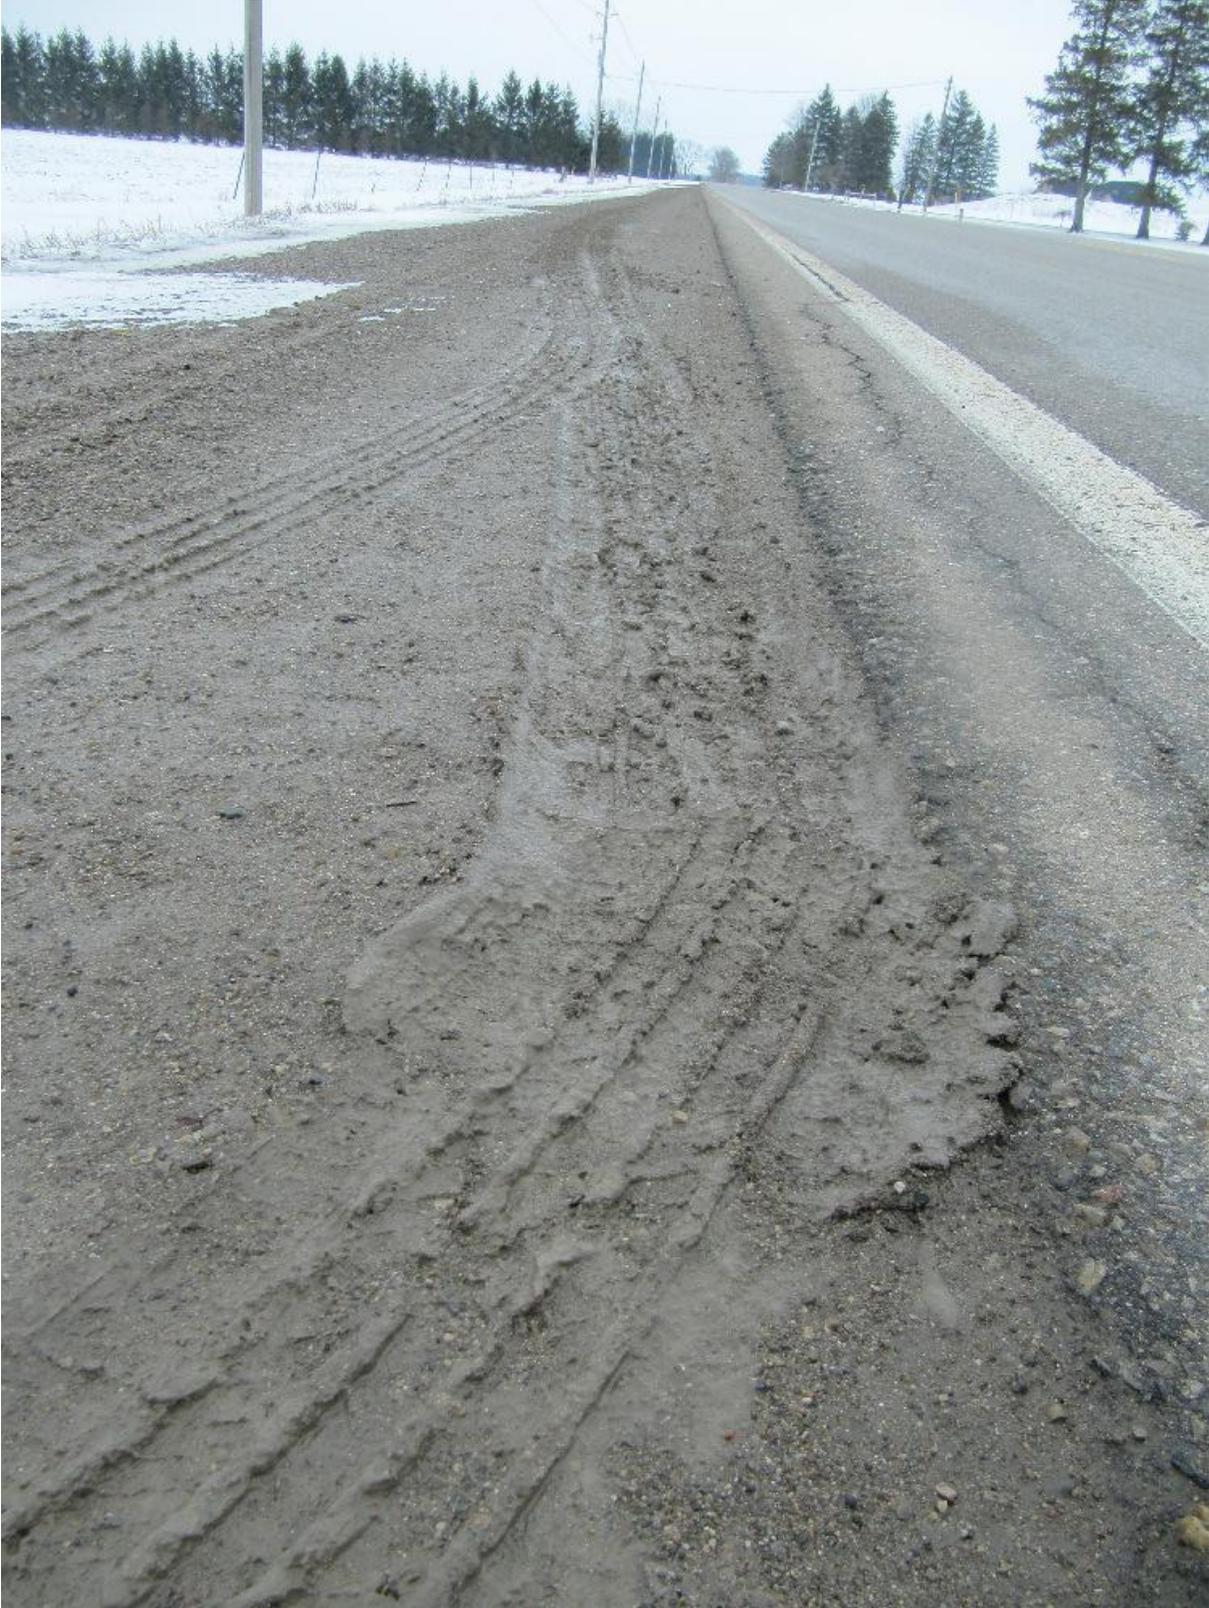
When we look closely at the point where the right front tire came to a stop at the end of the braking test the characteristics are shown in the photo below.

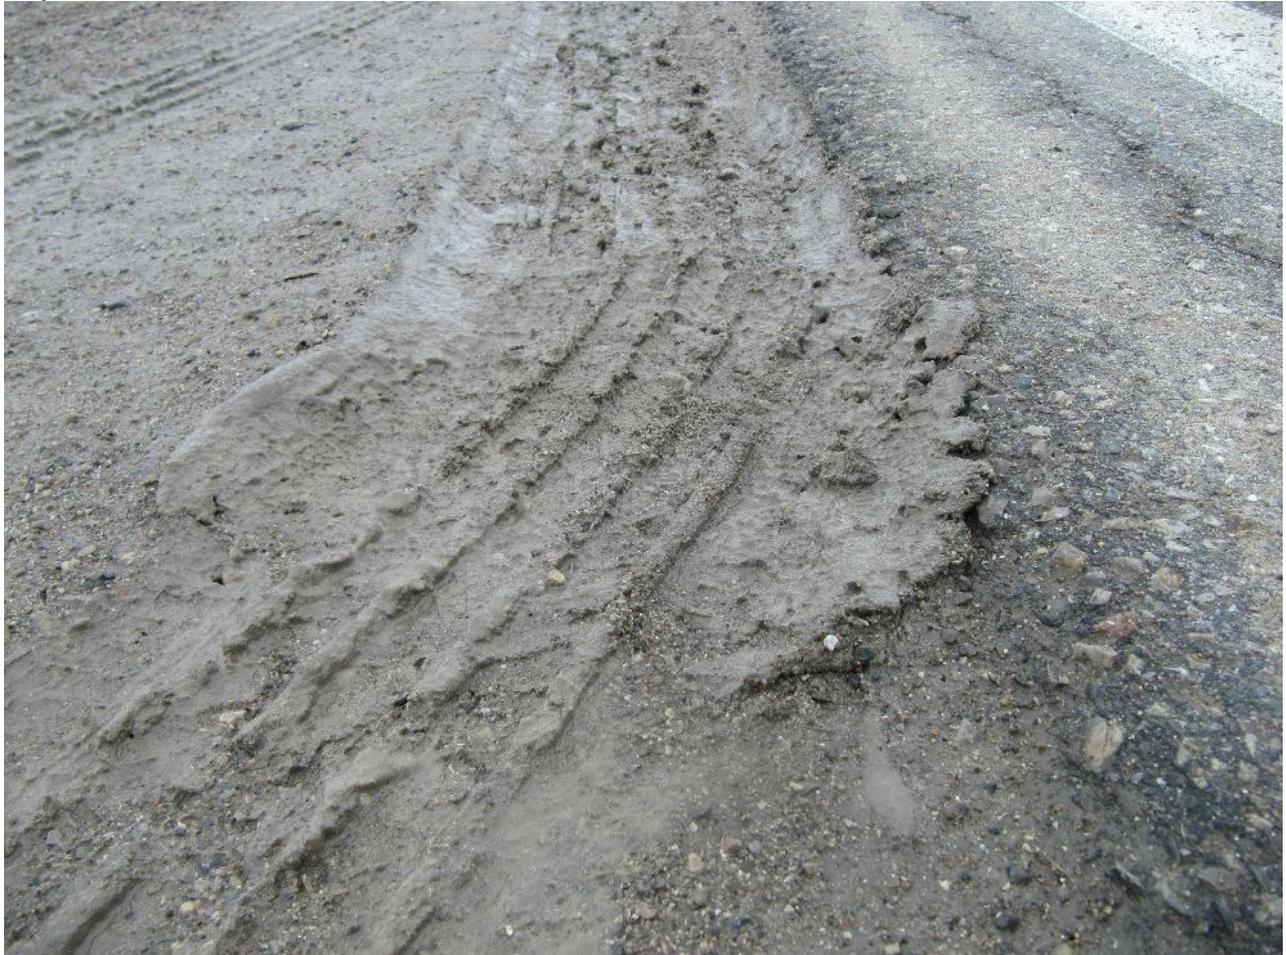
And again in the photo below it is possible to see the mud being squeezed to the outside edges of the tire mark. We can also see the transition between the end of the skidding and the point where the change in direction occurs from steering the vehicle to its parked location.

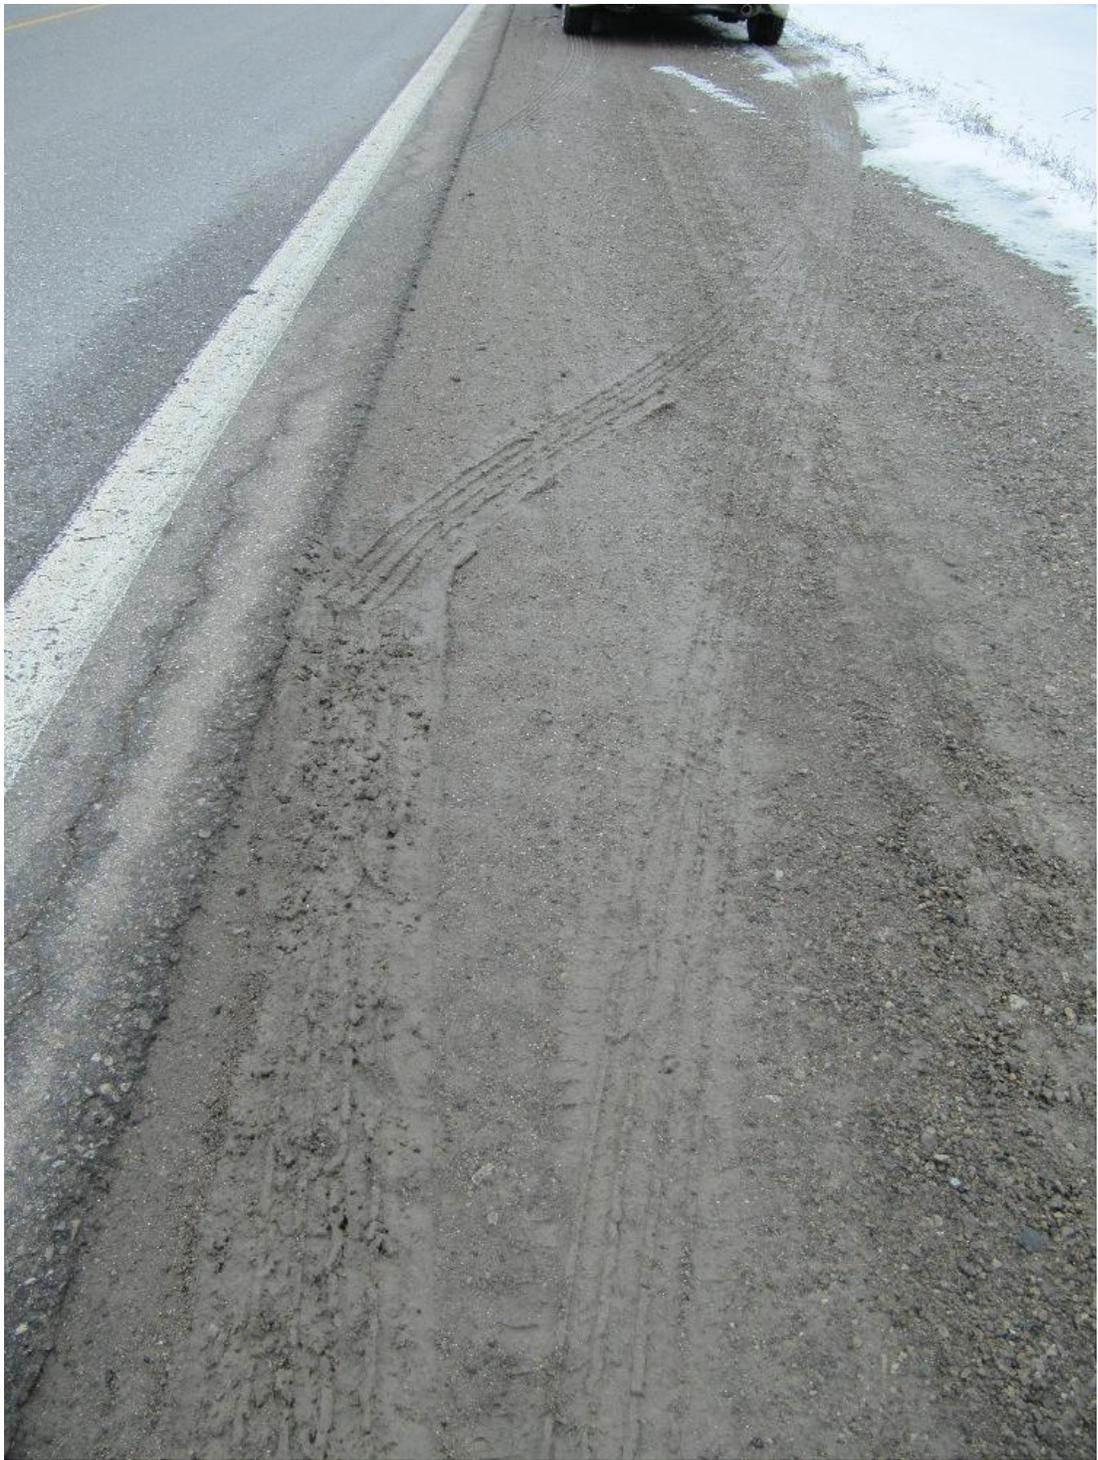
The photo on Page 15 is a westward view showing the right side tire marks at the end of the braking test as well as beyond to the point where we see the rear end of the parked test vehicle. By following the path of the two right side tire marks west of where they came to a stop it can be seen how they converge and then match up to the right side tires of the parked vehicle in the background.

So it is clear from examining the tire mark characteristics that they show how the test vehicle rotated counter-clockwise as the braking was taking place. This is not surprising as the two left side tires were on the more aggressive surface of the asphalt pavement. During emergency braking the right side of the vehicle wanted to slide further forward than the left side and therefore this rotation occurred. The rotation was sufficient to take the front end of the vehicle back toward the paved road surface. One might also present a good argument that the tire marks may also show that the total mass of the vehicle was directed back toward the paved road surface. This result is interesting particularly when we look at the steering employed in the test as demonstrated in some of the video footage which will now be studied in the Premiere video project.

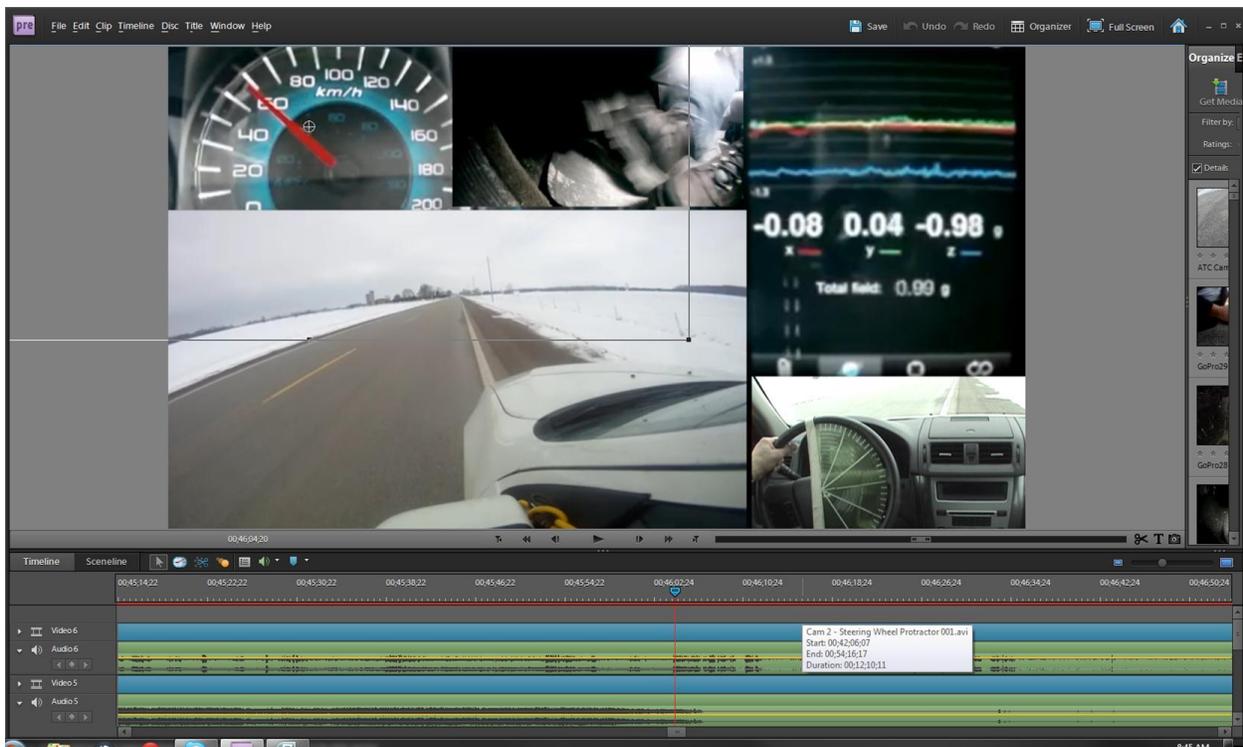
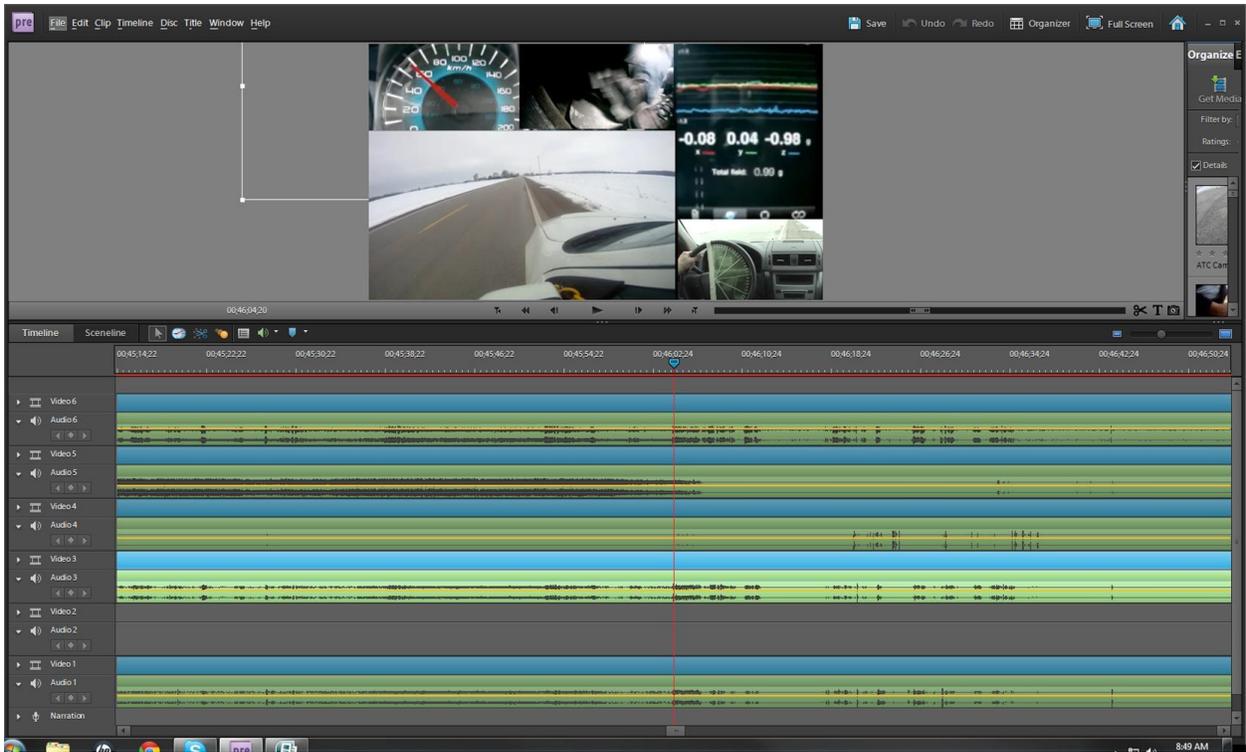
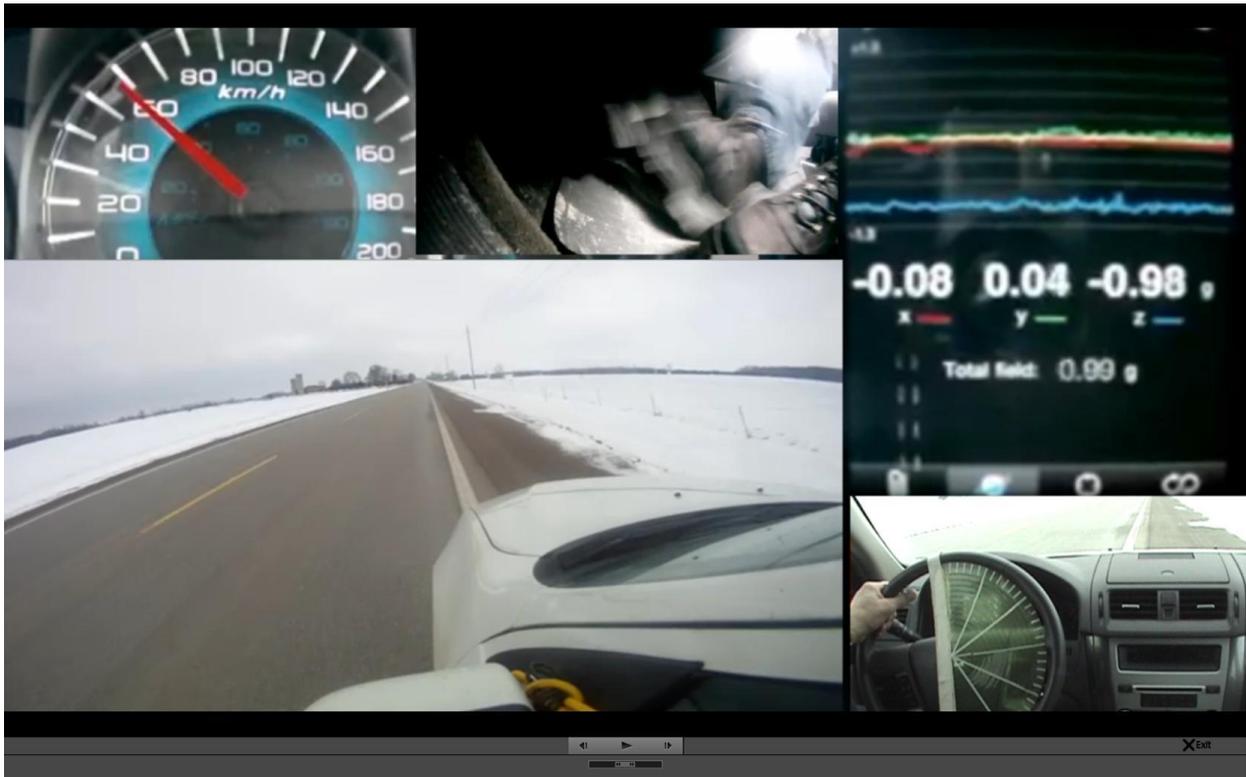
Below is a Print-Screen capture of our computer screen on which we have uploaded the Adobe Premiere video-editing project from our testing. Another screen capture at the top of Page 17 shows the same information as the photo below. These two views demonstrate how we can adjust the size of the area showing the videos versus the area showing the tracks. In the photo below the area showing the video has been reduced while the area showing the tracks at the bottom has been increased. The green/blue linear bands at the bottom of the photo are the individuals tracks representing the video and audio from all five cameras. Conversely the photo at the top of Page 17 shows how the area showing the videos has been enlarged while the area showing the individual tracks has been reduced. This adjustment allows us to study either the content of the videos or the content of the tracks, or a little bit of both depending on our specific interests.

The screen capture view at the bottom of Page 17 shows how a "Full Screen" adjustment can be employed where everything on the computer screen is removed except the views from the five video cameras.
