## 2012 Ford Fusion Brake Testing With iPhone Accelerometer - Test #17 Partly on Gravel Shoulder

This article is the third in a series of four articles discussing emergency braking tests performed by Gorski Consulting with a 2012 Ford Fusion passenger car equipped with multiple video cameras and the tri-axial acceleration displayed from an iPhone 4S cell phone. In the first article of this series we introduced the instrumentation that was used in the testing and analysis of the data. In the second article we discussed the results of a simple emergency braking test on a dry, tar and chip road surface. The present article and a fourth one will discuss the results of a more complicated braking test where the right side wheels of the test vehicle are riding on the right gravel shoulder of a rural highway when the braking begins.

The test being discussed in the current article took place while travelling westbound on Medway Road, a few kilometres east of Clarke Road, just north-east of London, Ontario, Canada. The test was performed on the afternoon of February 24th, 2013 when the outside temperature was near zero degrees Celsius. The test speed was at 71 km/h.

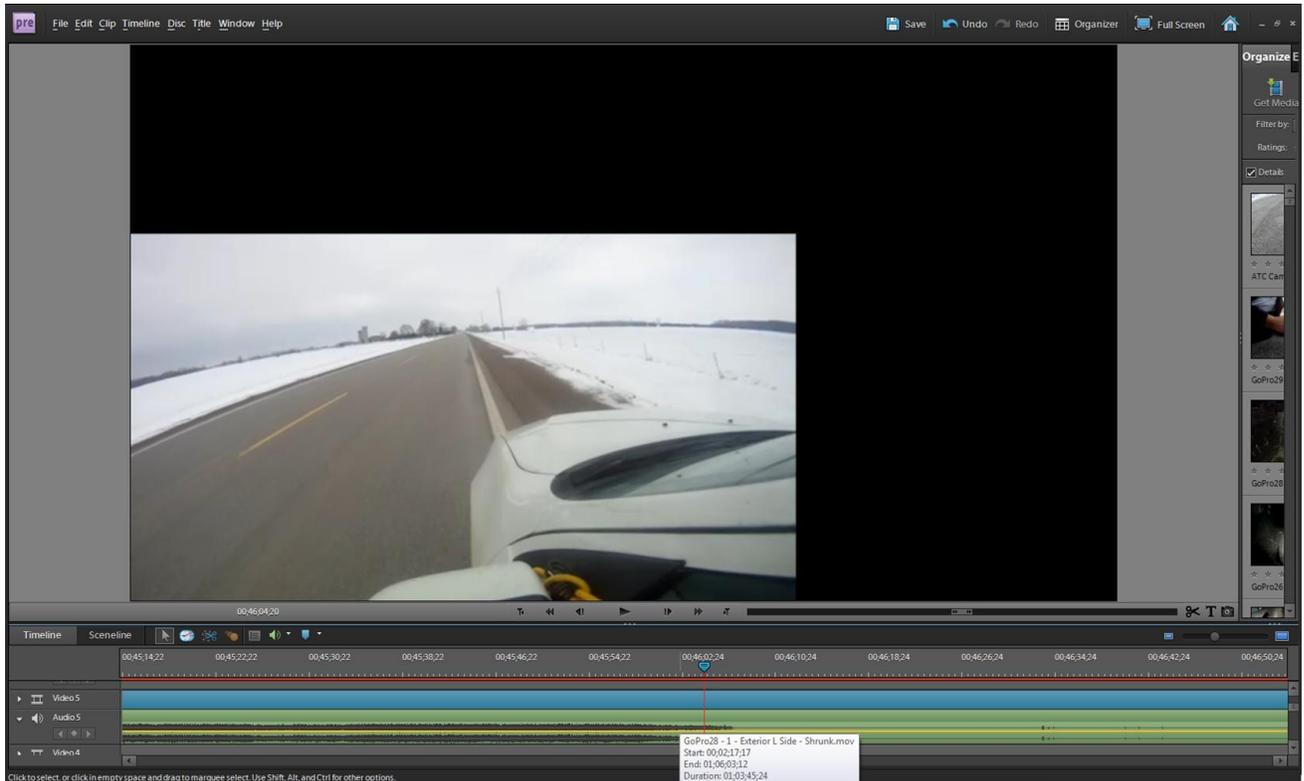
Furthermore, adjustments can be made to display the view from just a single video camera by shutting of the views of the other four and then enlarging the view from the single camera. For example below we see the computer screen as we shut off the views from four of the cameras so that the single video from the exterior of the driver's window is the only one that is active.

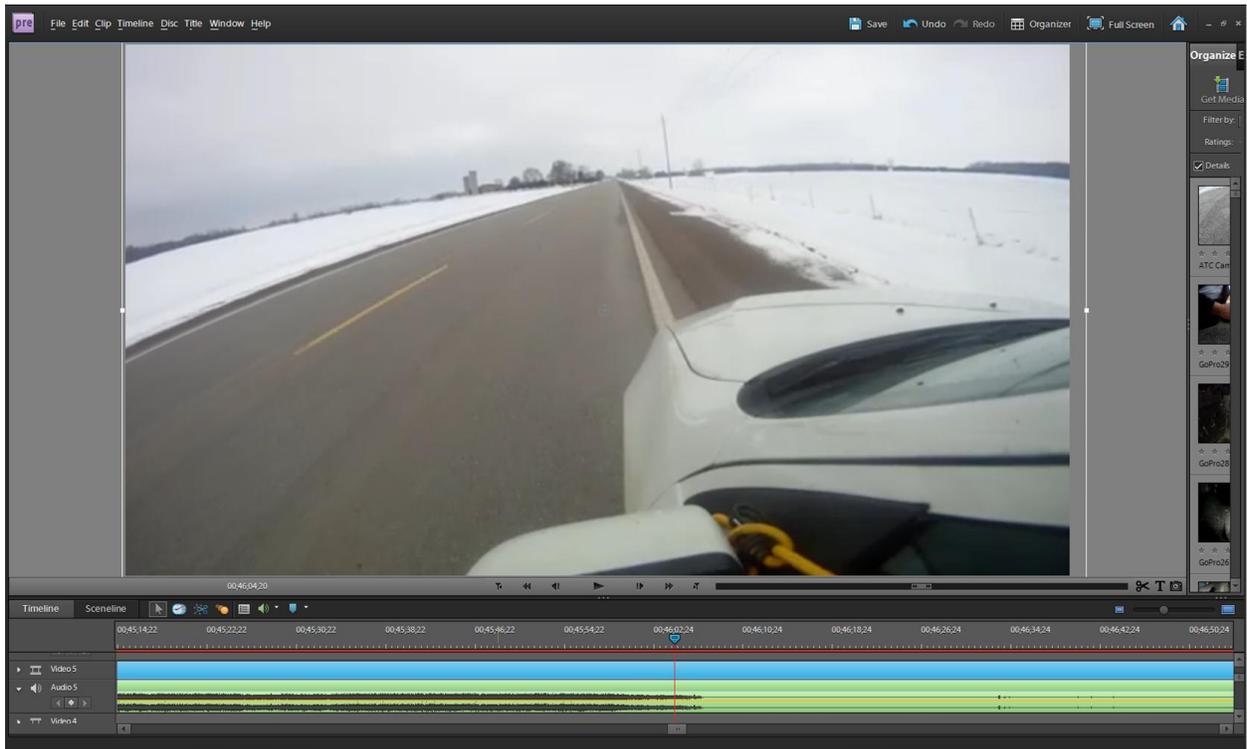
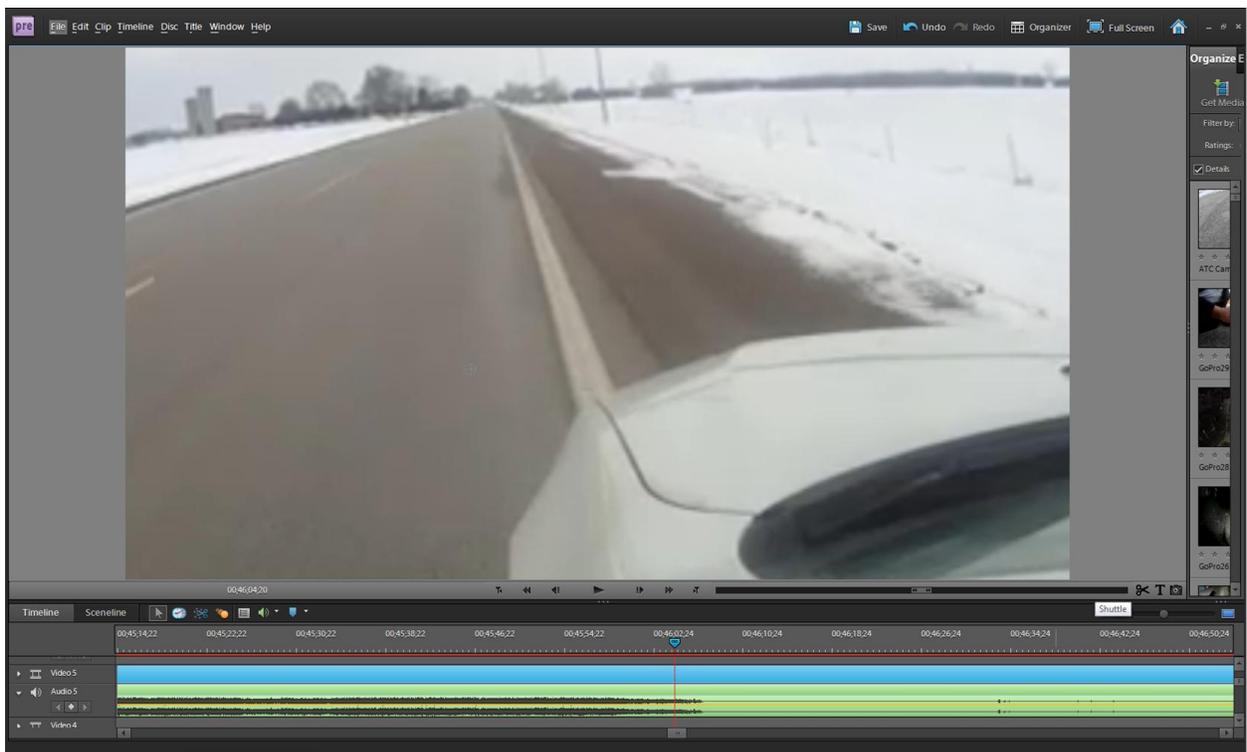
Next, at the top of Page 19 we show how the view from the single remaining camera can be enlarged to fill the computer screen.

Additionally, the remaining video can be enlarged even more to highlight some portion of the video that we might be interested in, as shown in screen capture view at the bottom of Page 19. This view might be of importance because as the vehicle begins to rotate during our braking test we would be interested to know when the rotation begins. This close-up view shows us the white edge line of the westbound lane and how it lines up with the left hood edge of the vehicle. Now, as the vehicle begins to rotate those two references will change such that the left edge of the vehicle's hood will no longer be in line with that white edge line. So this is how we can track various actions by studying certain portions of a single video in detail, or by looking at the videos from several cameras.

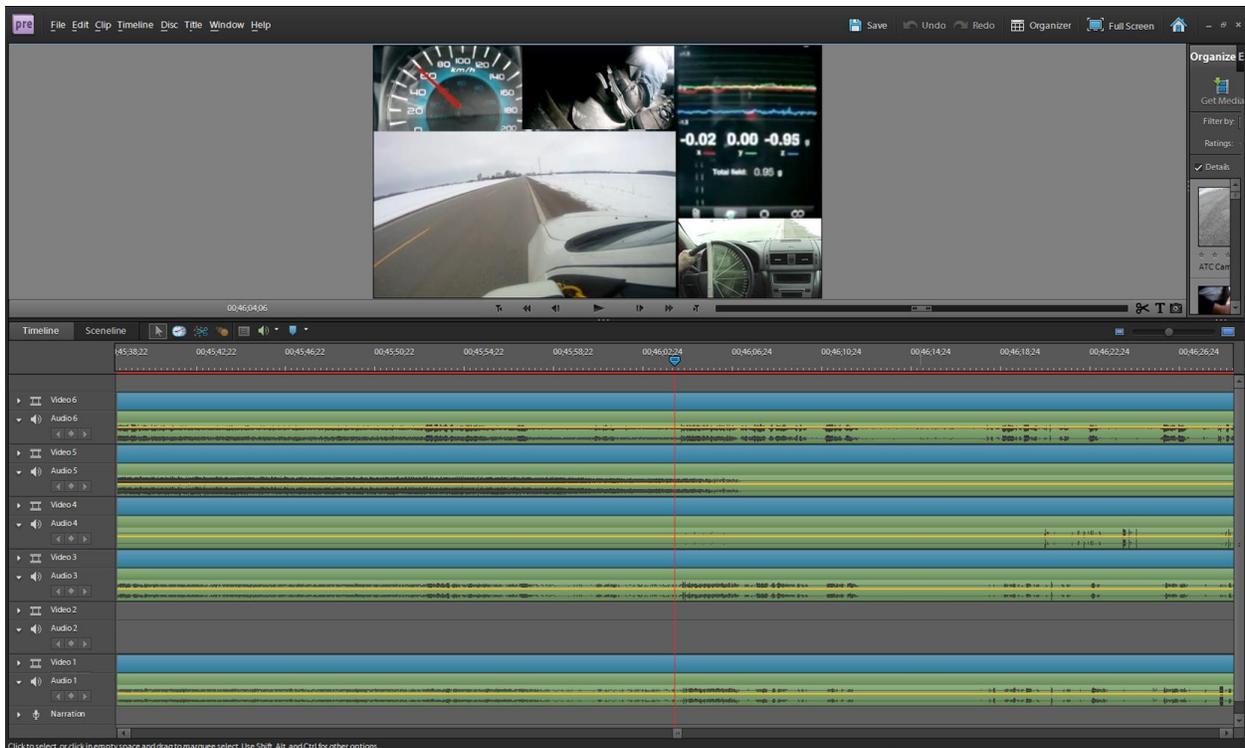
Not only this, but we can also look at the information in the audio tracks to give us further information about some aspects of the testing. At the top of Page 20 we show how the area showing the tracks from each of the video cameras can be expanded so that we can see the tracks from each of the five video cameras.

If you look closely in the middle of the green/blue tracks in the above screen capture view, you will be able to see a red vertical line. This red line indicates the present position along the tracks that is being displayed in the video area above. The light green horizontal bars are the audio tracks and some black markings within those audio tracks are the audio "noise" that has been recorded on each camera.

The above view is the condition just before the brake pedal is depressed in our test. So the red vertical line is just approaching an area of recorded noise from the braking action that can be seen in the tracks of three of the cameras. Looking from the top, the three tracks that display that noise is the top track, the fourth track and the fifth track. Note that the recorded noise has an identical signature in the audio tracks of all three cameras. That area of noise can be expanded to show more details and this expansion is shown in the screen capture view at the top of Page 21. And we expand the detail even further in the screen captures shown at the bottom of Page 21 and at the top of Page 22. The precise method we use to synchronize all the video cameras is to line up these specific signatures of recorded noise so that they all occur at the same time in each of the tracks shown above.

Different cameras will record different noise depending on their location on the test vehicle and the study of the details of this noise can provide additional evidence to the analyst about certain aspects of the testing. After some experience the analyst is able to recognize the noise that is typically generated from human voices, the passing of other vehicles, indications of braking, etc. without even looking at the content of the video recordings shown in the upper portion of the screen.
