## 2012 Ford Fusion Brake Testing With iPhone Accelerometer - Test # 5 On Bare Tar & Chip Surface

*Posting Date: 11-Mar 2013*

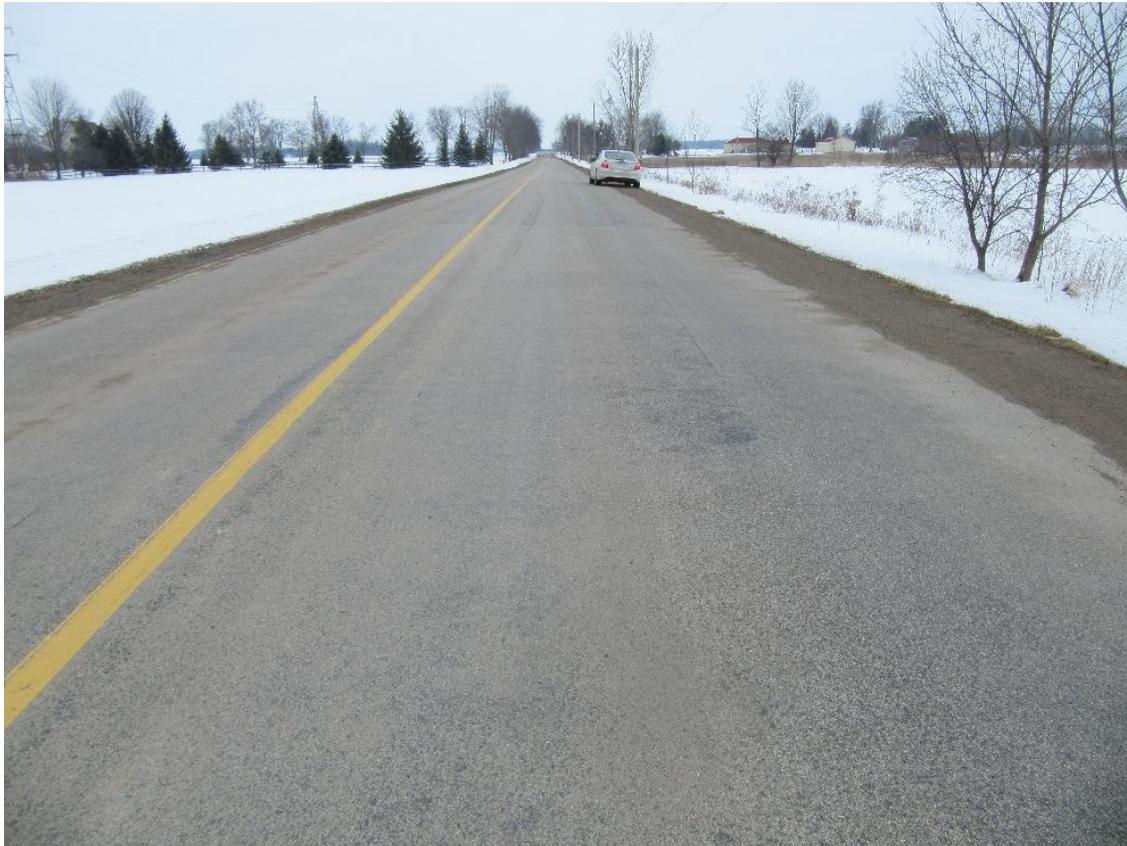
The current test was performed while travelling northbound on Clarke Road north of Medway Road on the north-east outskirts of London, Ontario, Canada. The test was performed on a relatively mild, February 24th day in 2013 while the ambient temperature was near zero degrees Celsius. The pre-braking speed of the vehicle was 80 km/h. The photo below shows a northward view of the road just after the braking test was completed and the test vehicle was driven onto the right shoulder.

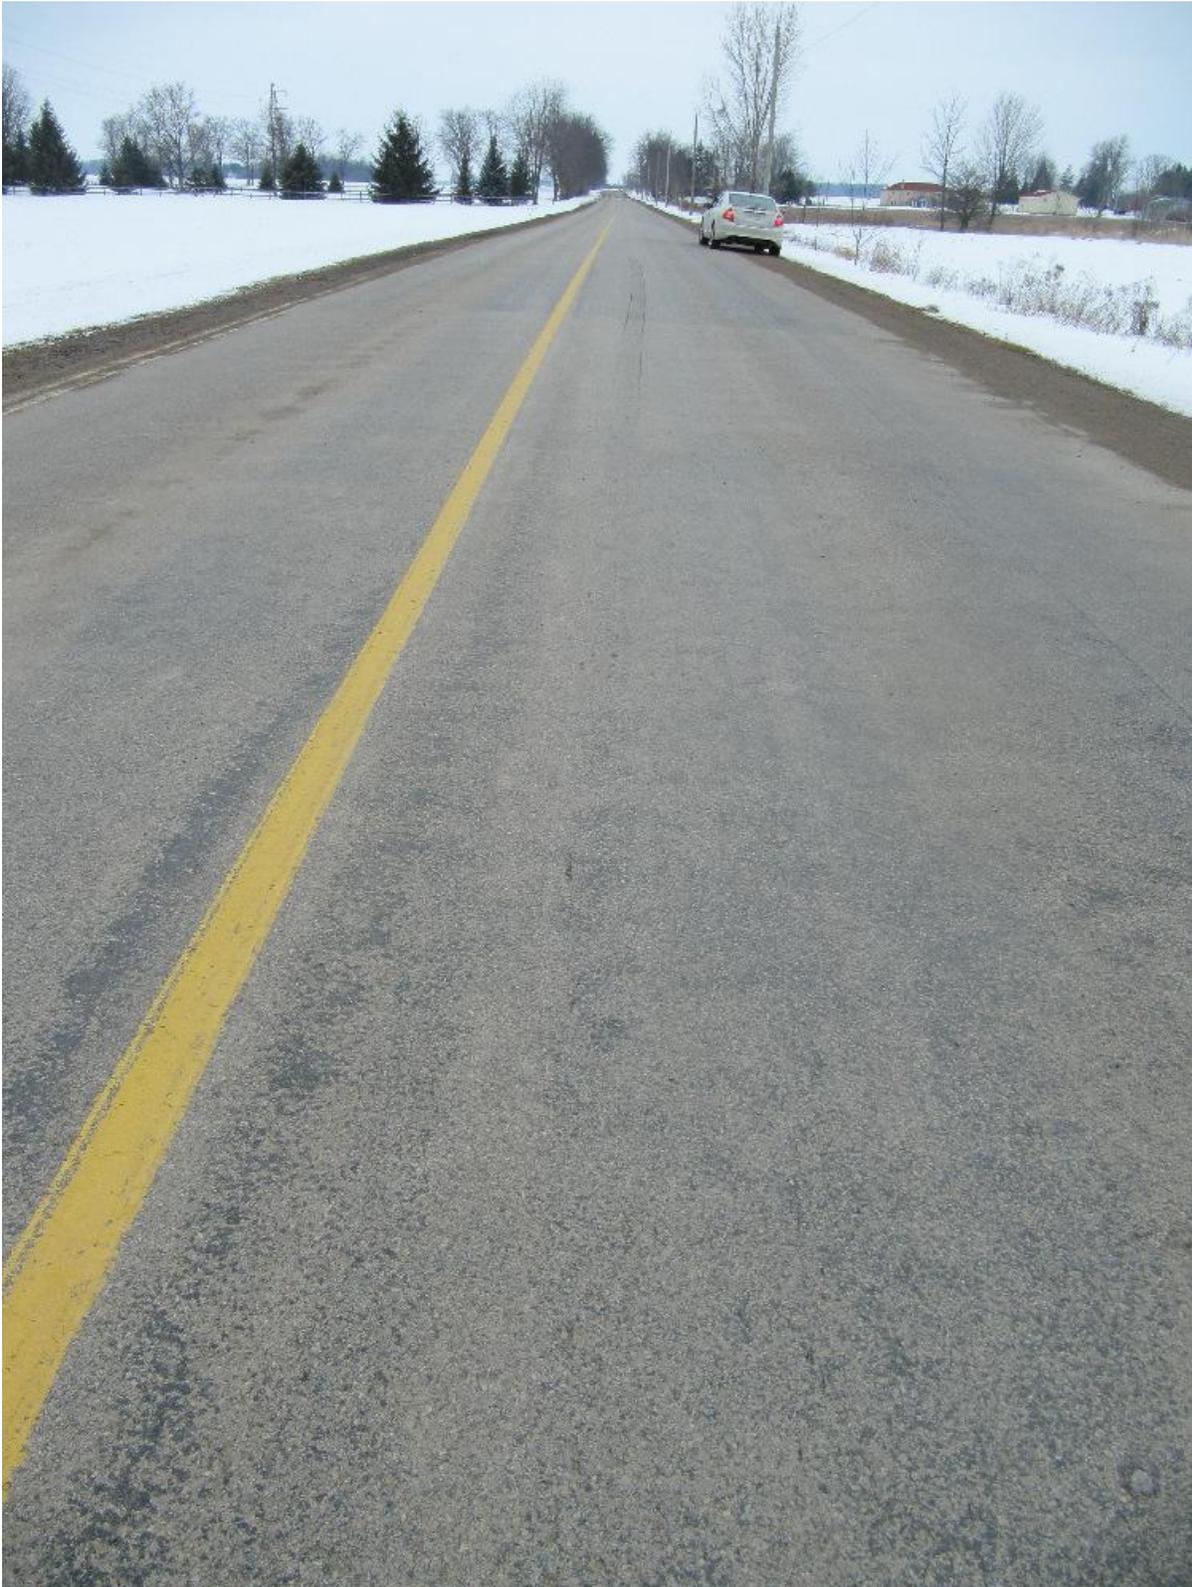
The photo below shows the view along the left skid mark which appears to be faint in the foreground but becomes more visible in the background.

When looking at the characteristics of the braking skid marks one can appreciate that there is some evidence of pulsation of the anti-lock braking system as the black mark contains periodic darker and lighter segments along its length. We can indicate that, unlike older anti-lock braking systems this newer one did not give the vibration sensation of the brake pedal as it was in the anti-lock mode.

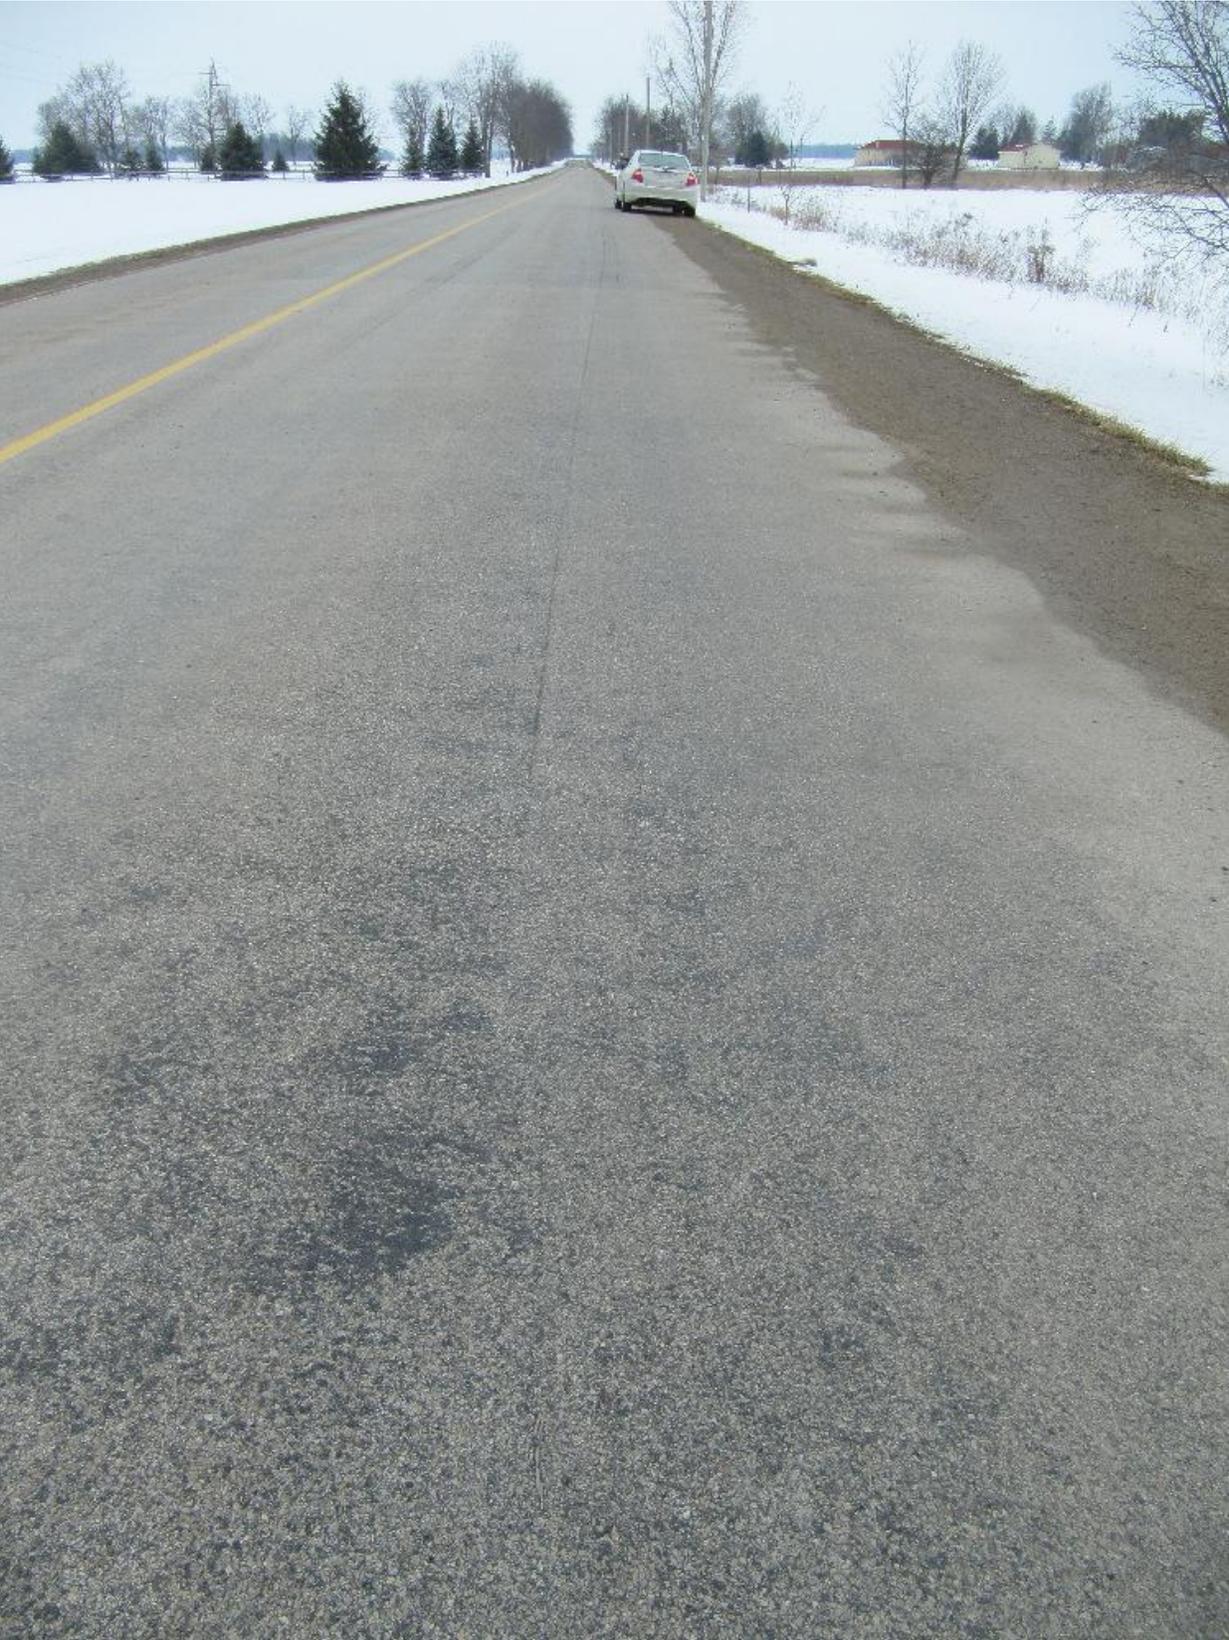
Similarly, the photo below shows a northward view along the right skid mark.

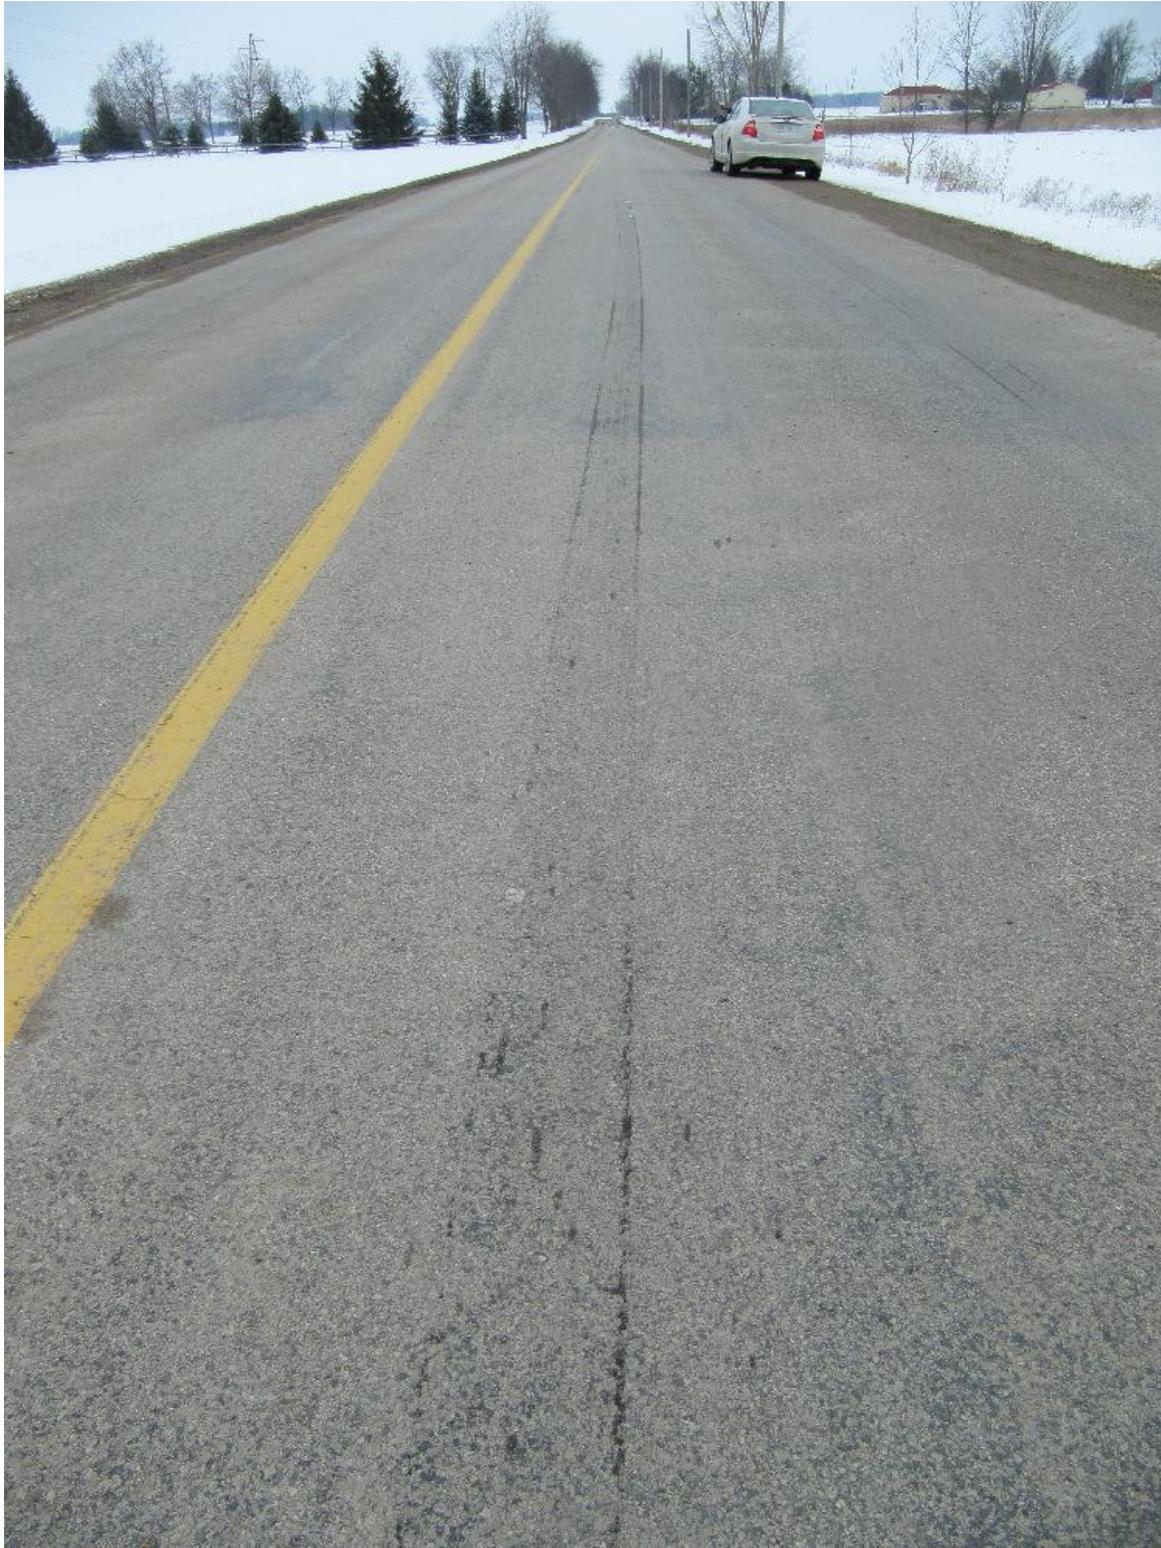
The photo below shows the characteristics of the left skid mark after we have walked about halfway toward its point of termination. It can be seen that the skid mark becomes quite visible.

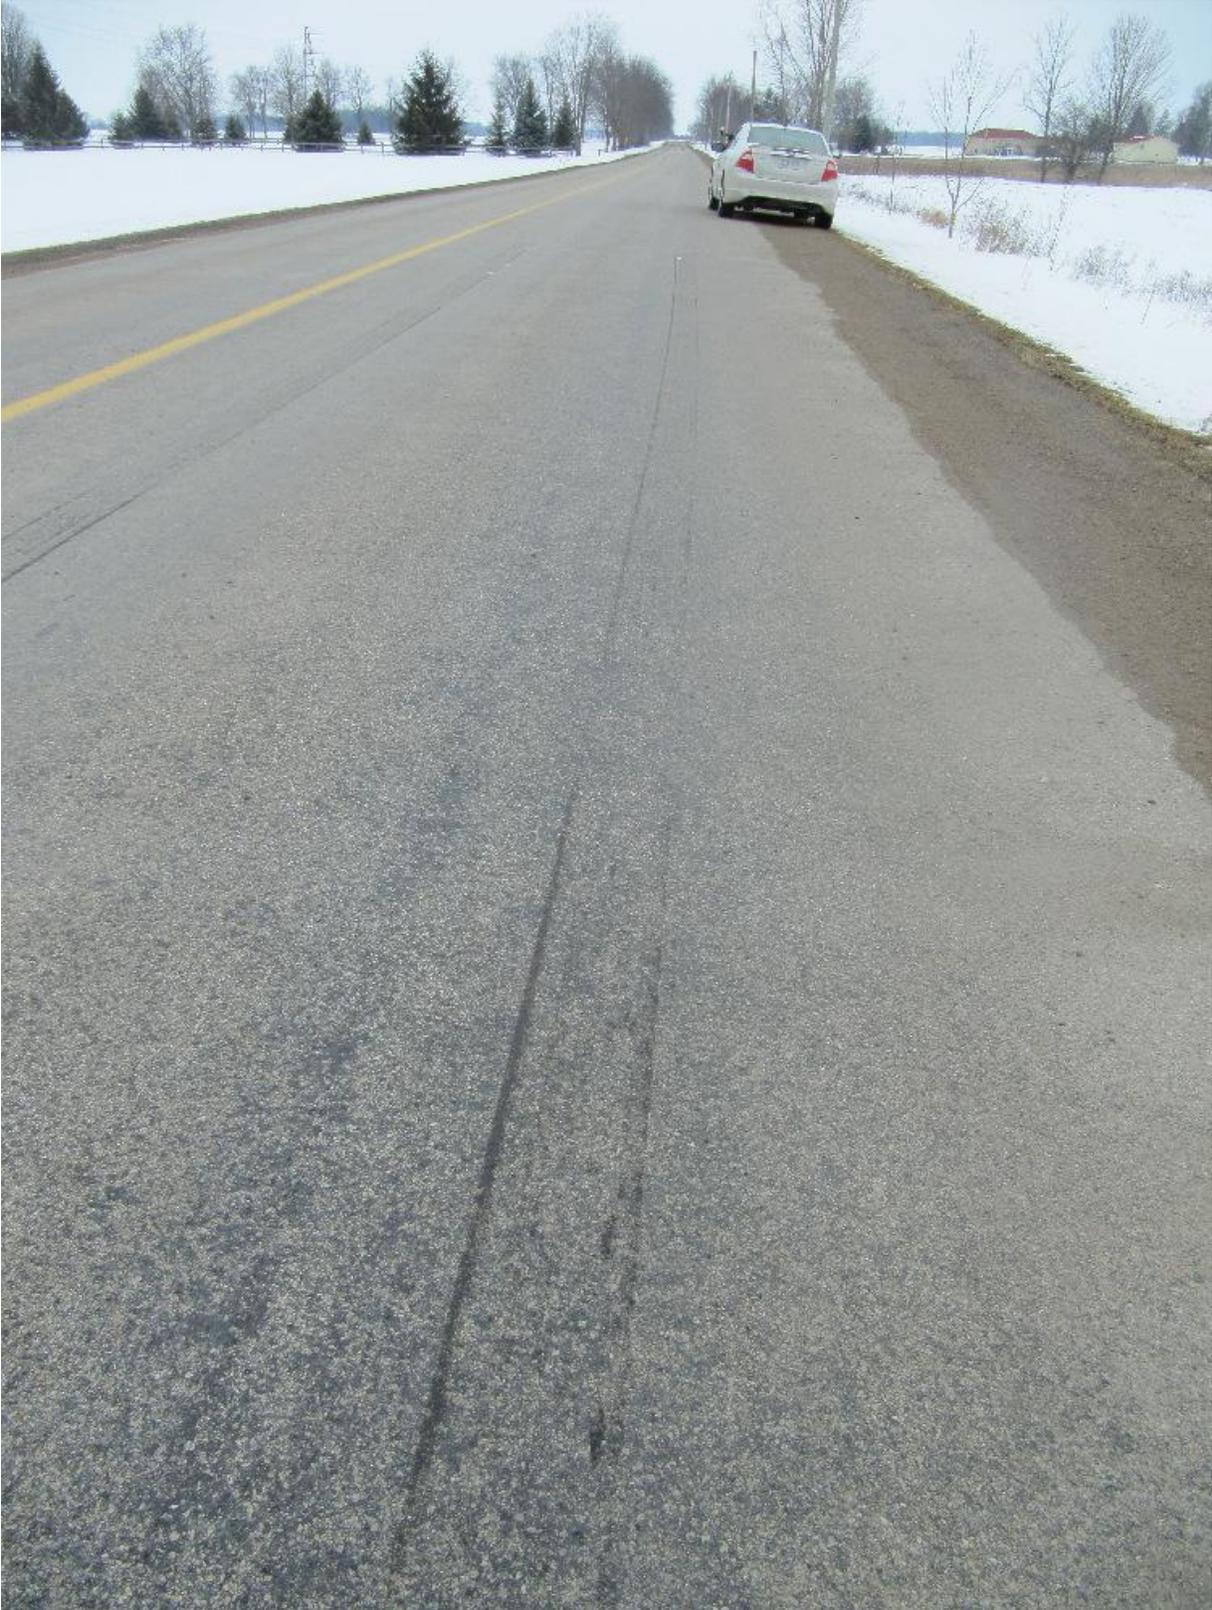
Similarly the photo below shows the right side skid mark from about its half-length. Again the skid mark is quite visible.

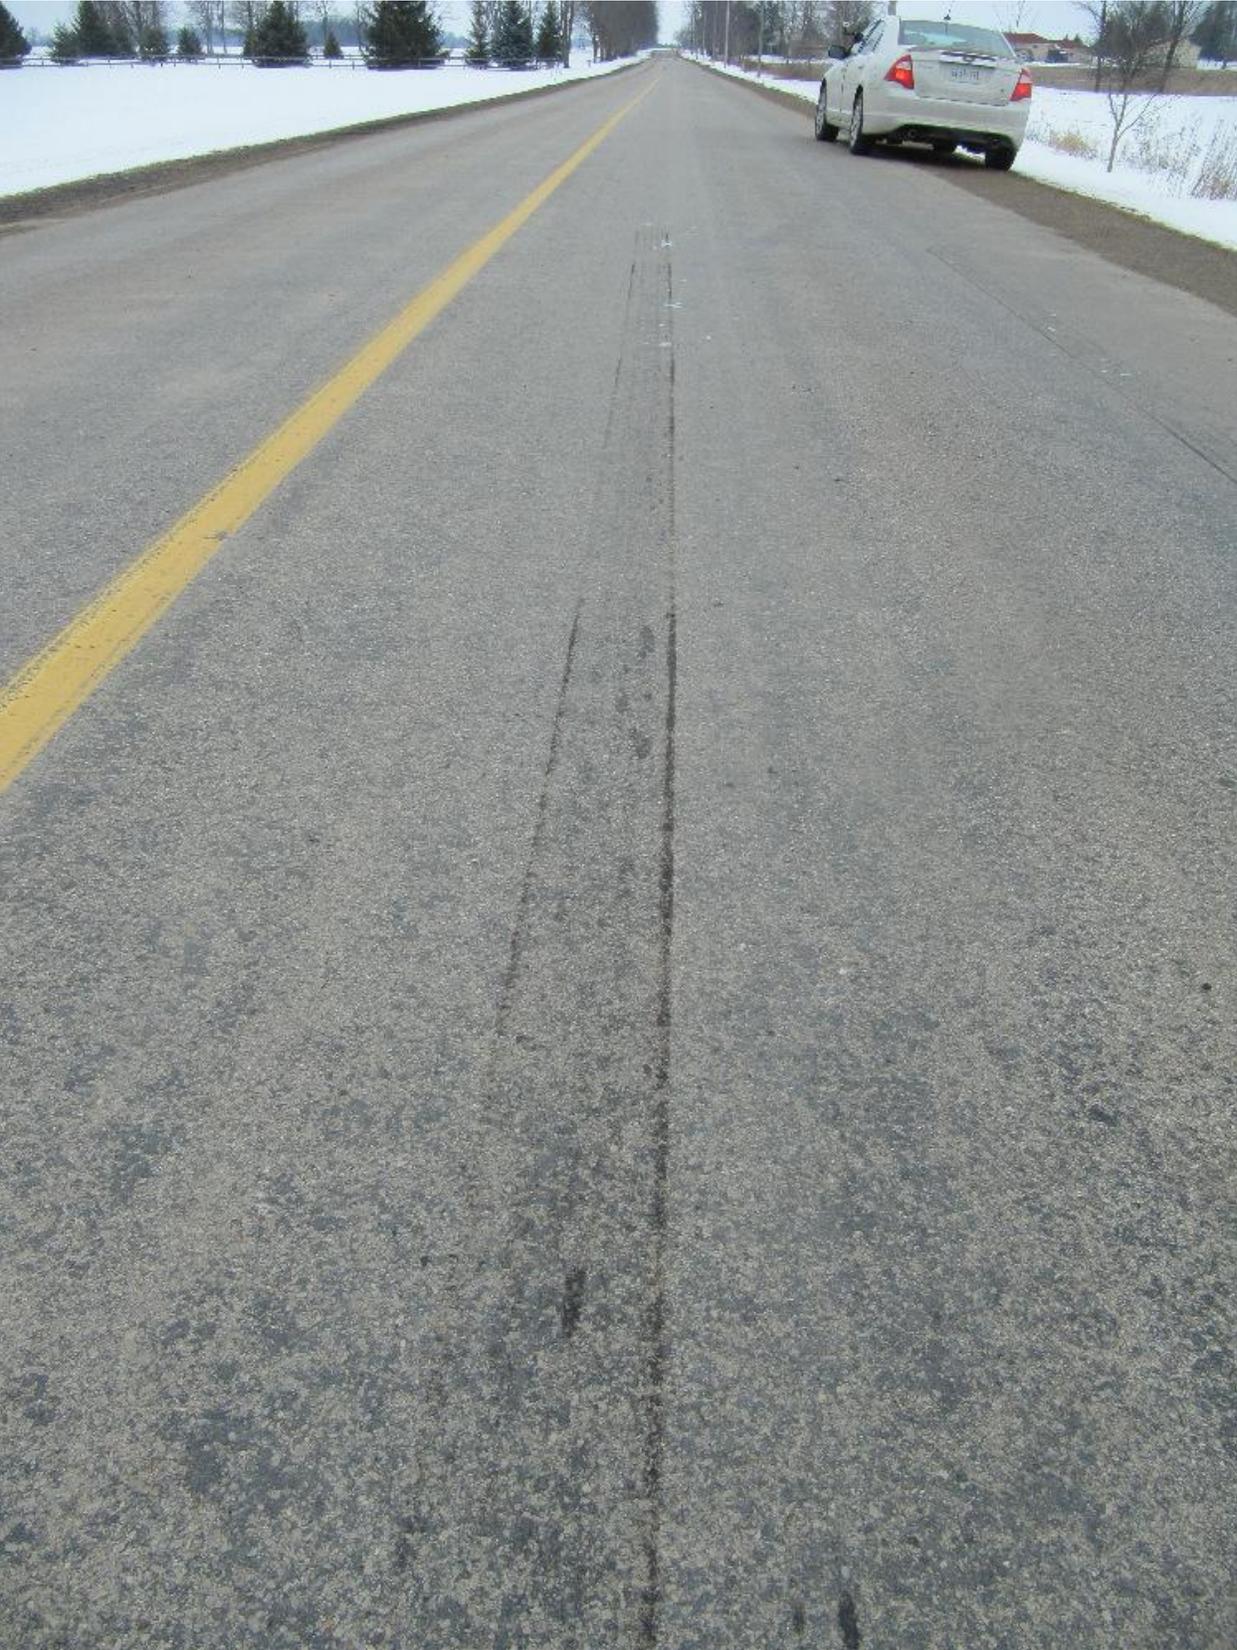
The photo below now takes us closer to the north termination point of the left skid mark.

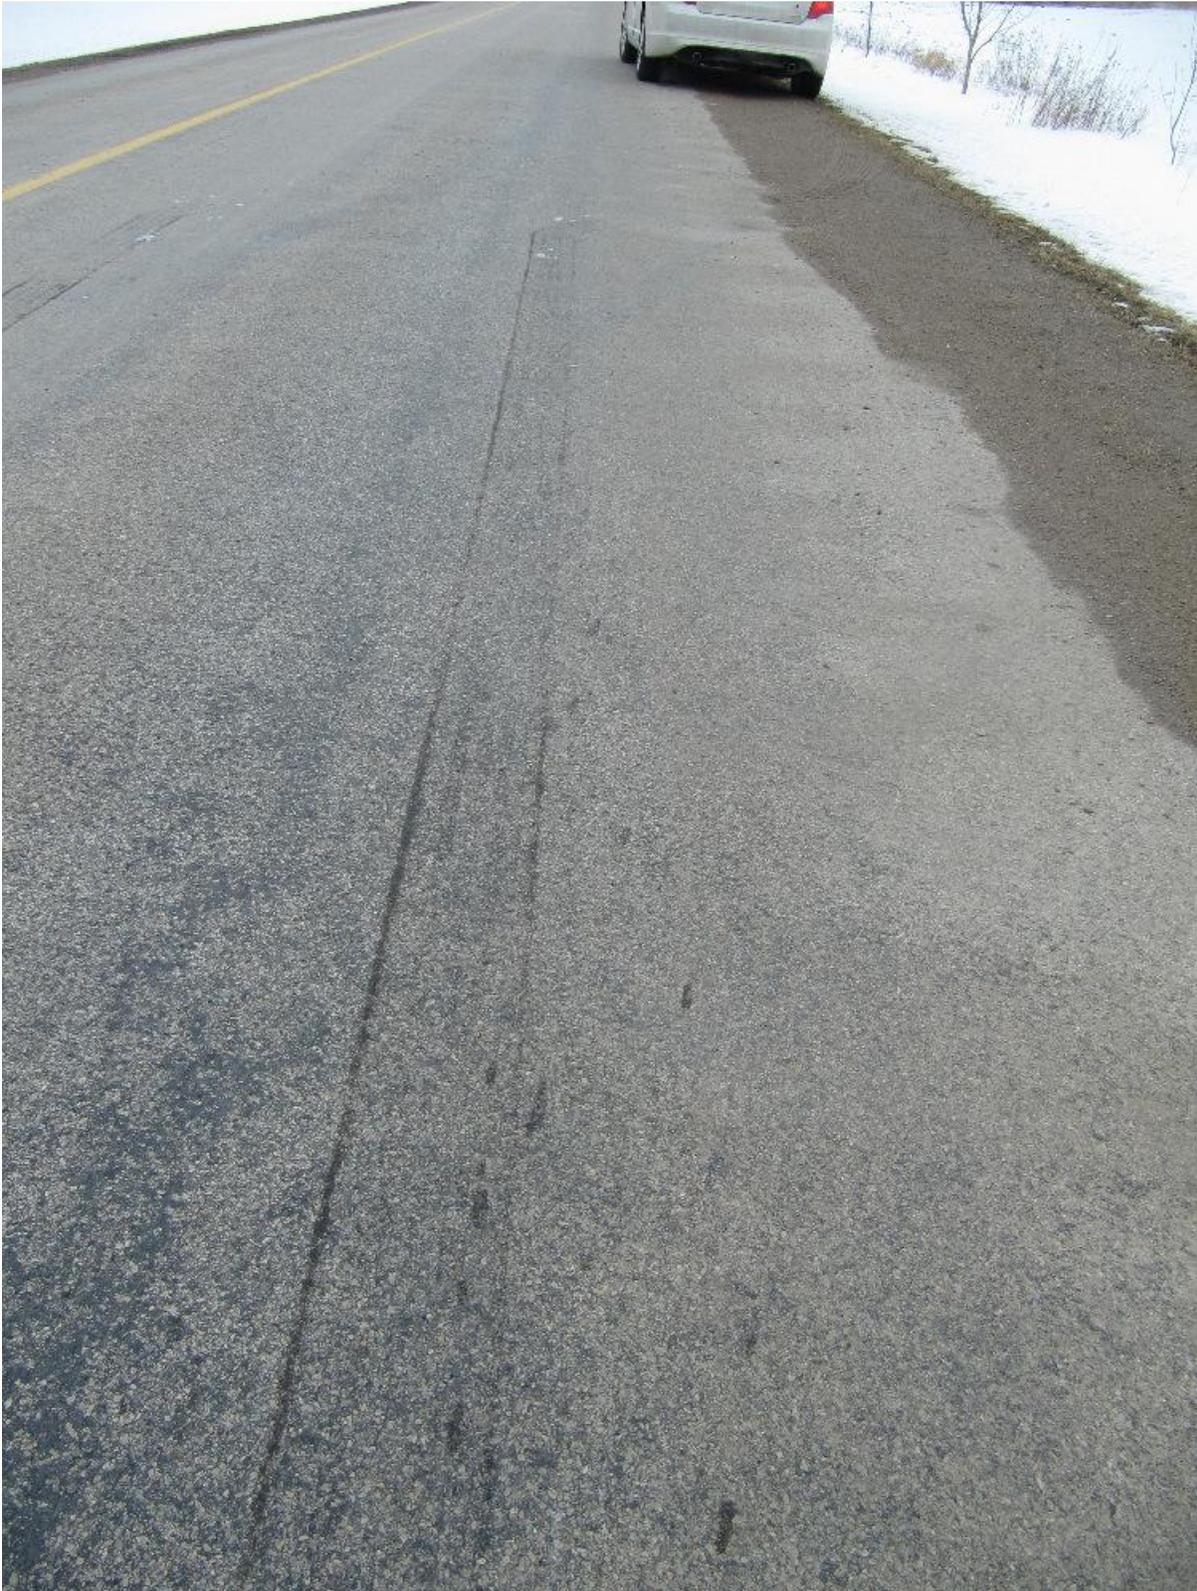
And similarly, the photo below shows the right skid mark to the north end of its termination point.

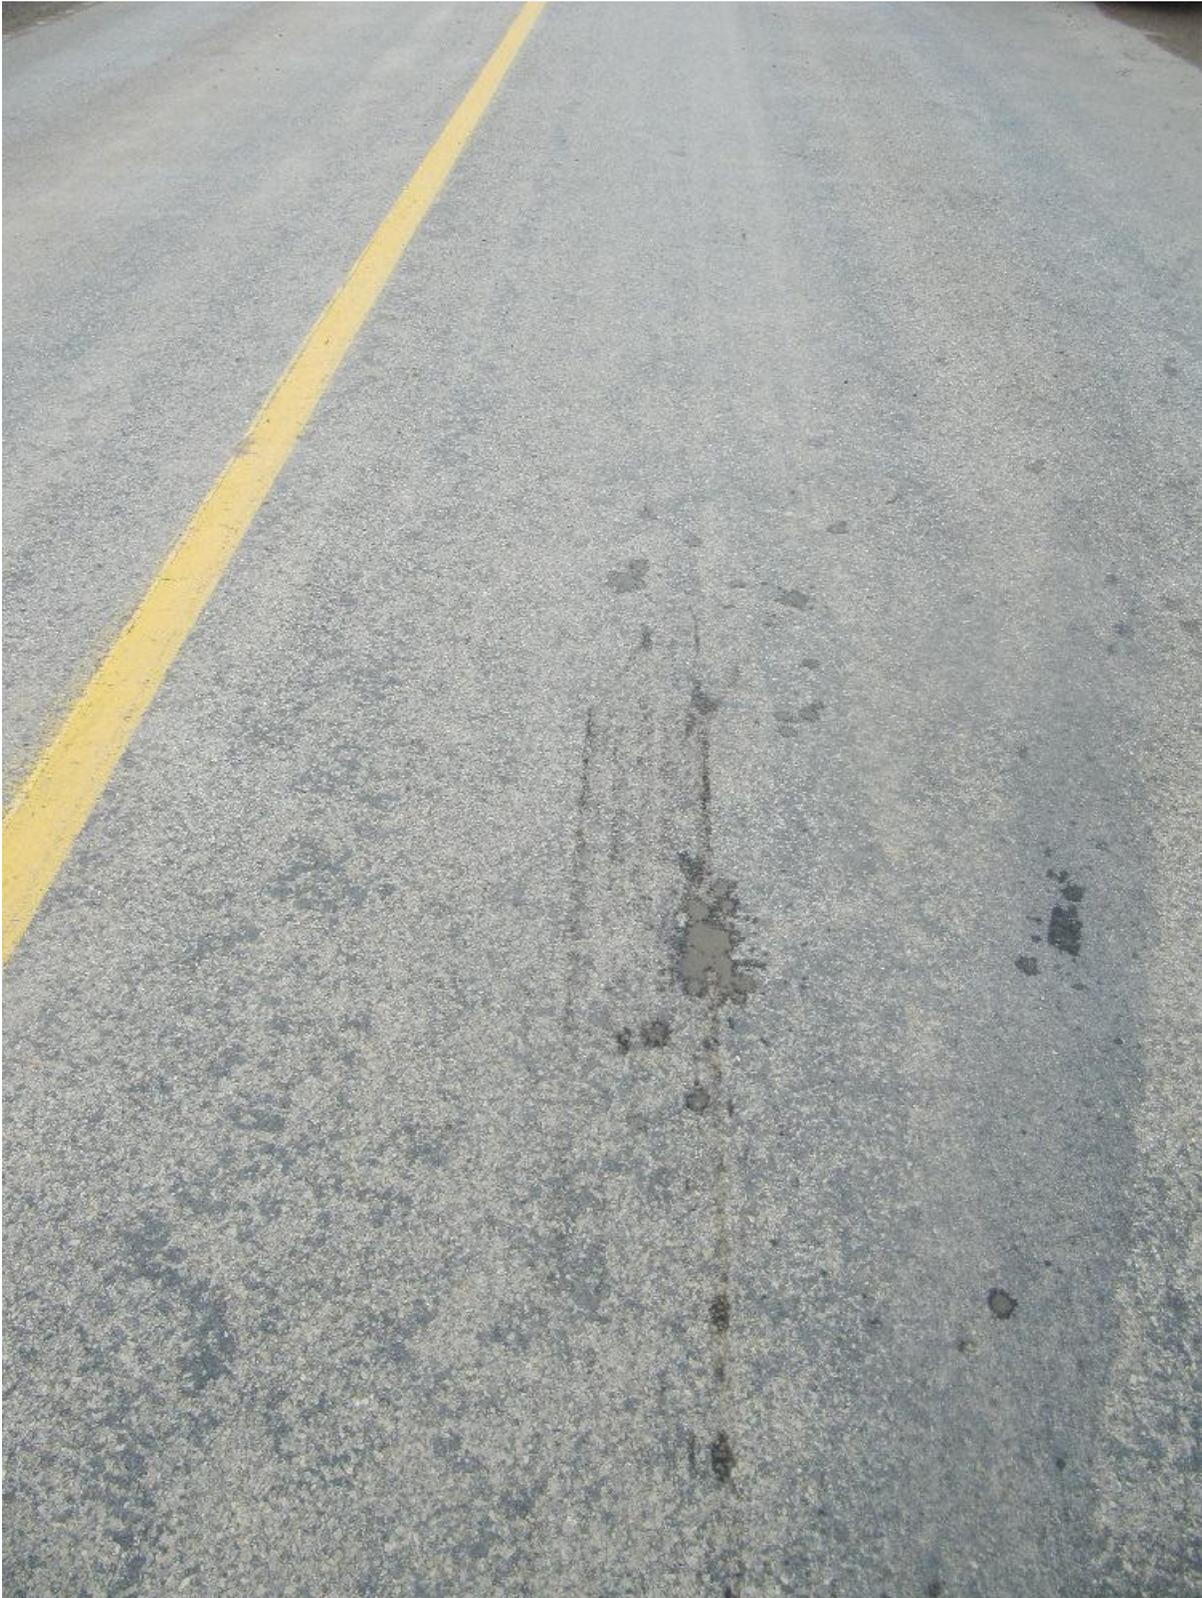
The photo below shows a northward view of the left skid mark near its north termination point.

If you look closely at the last two photos you should be able to detect the evidence of our rolling tires as they move from the stop position of the brake test as we steer hard to the right to park our test vehicle on the right shoulder. This might be helpful to make a further comparison between a skid mark and a rolling tire mark that was made within seconds after the vehicle came to a halt from the braking test.

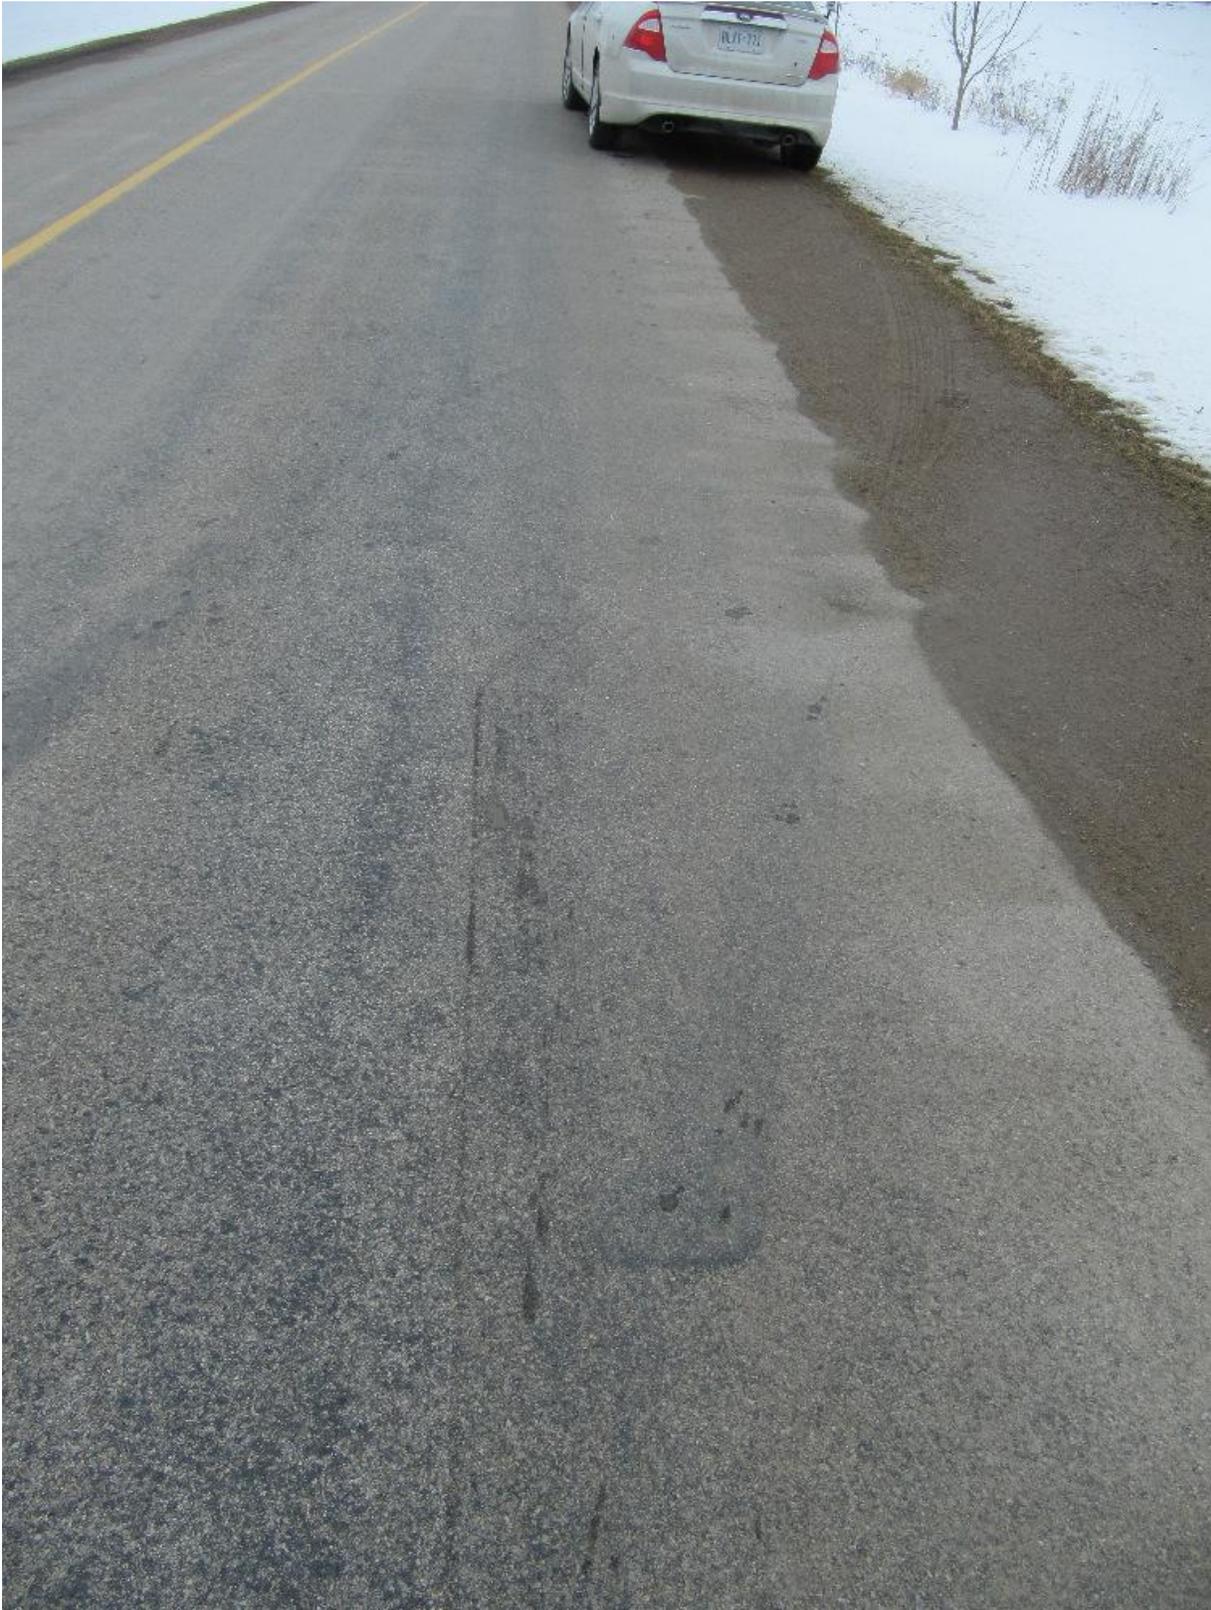
And the photo below shows the same northward view of the right skid mark near its termination point.

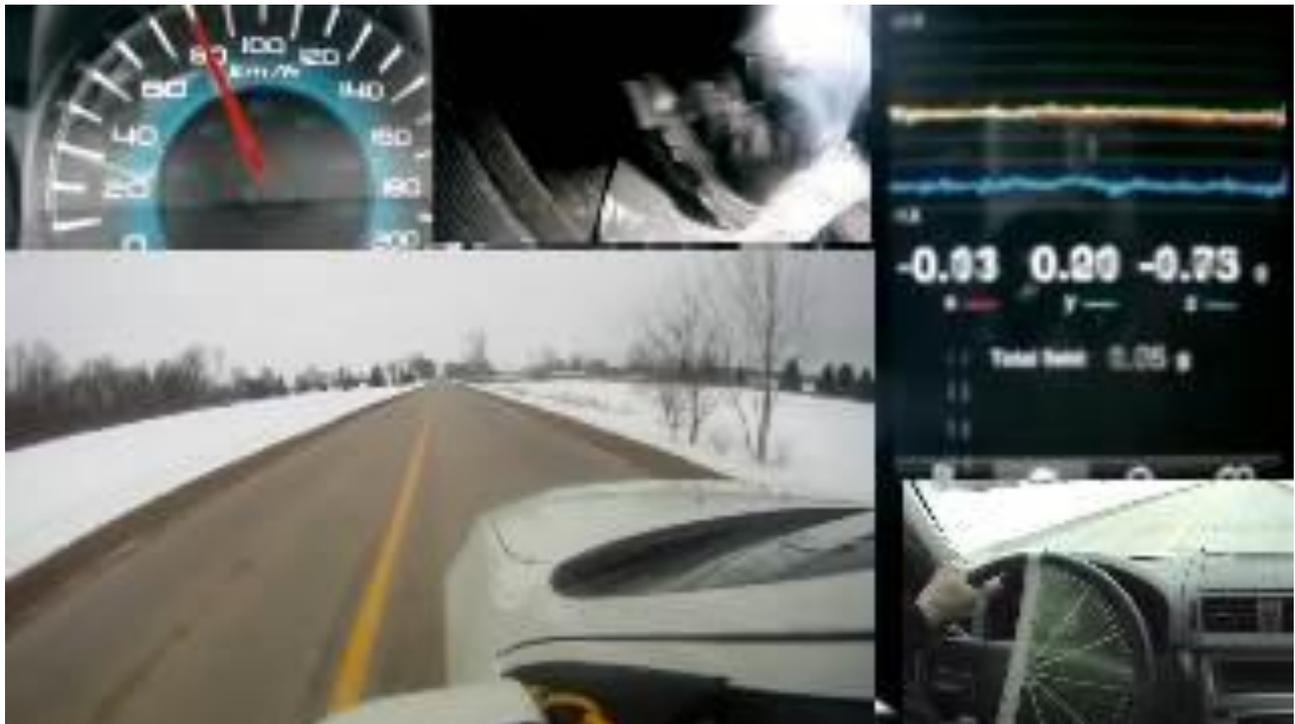
The video cameras installed around our vehicle recorded some interesting data which was visible in the Adobe Premiere project that was created from this testing. Below is a screenshot taken from our monitor showing the Premiere project with five camera views.

The above shot is taken precisely when the driver's foot began pressing on the brake pedal. The view of the driver's foot can be seen in the centre-top view.

In the upper left corner we can see the view from GoPro22 which shows the speedometer indicating "80 km/h" just before the vehicle began its deceleration.

The larger view in the lower left is taken from the camera mounted on the exterior of the driver's side window and we can see the roadway centre-line and front end of the

vehicle. It is possible to compare the position of the centre-line to various contours of the vehicle to determine whether the vehicle is moving laterally or rotating during the braking test.

The image in the lower right of the screenshot shows the steering wheel and protractor attached to it. We can view this video to assess whether any steering was applied during the braking test and whether that might have affected the test results.

At the upper right of the screenshot is the display from the iPhone 4s which shows the tri-axial acceleration of the vehicle during the test. The first number ("-0.13") indicates the longitudinal acceleration or "deceleration" of the vehicle. The second number (0.20) indicates the lateral acceleration.

The third number (-0.73) indicates the vertical acceleration with a normal resting position indicating "-1.00" meaning that the vehicle is experiencing a -1.00 g acceleration from the earth's gravitational pull.

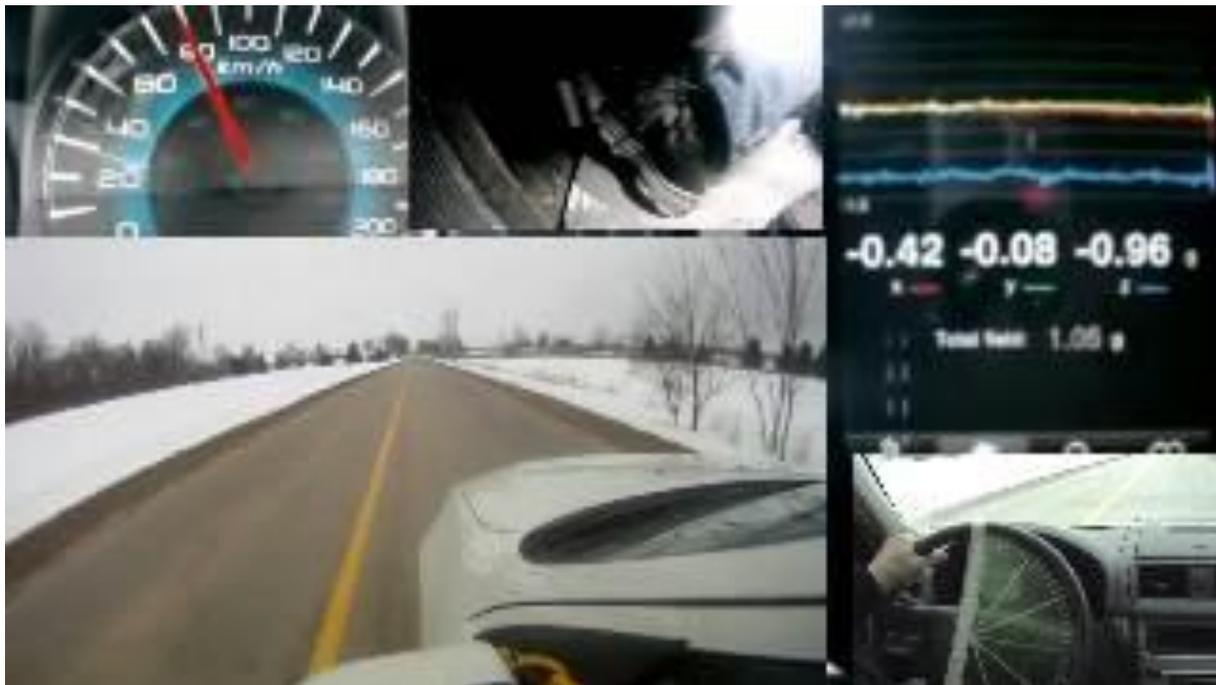
Below is the status at the first documented deceleration value at the beginning of the braking test. The driver's foot has now fully depressed the pedal and we see the "x" deceleration is "-0.42" whereas the other two (lateral and vertical) values show minor magnitudes. This condition is only about 0.10 seconds after the first contact of the brake pedal.

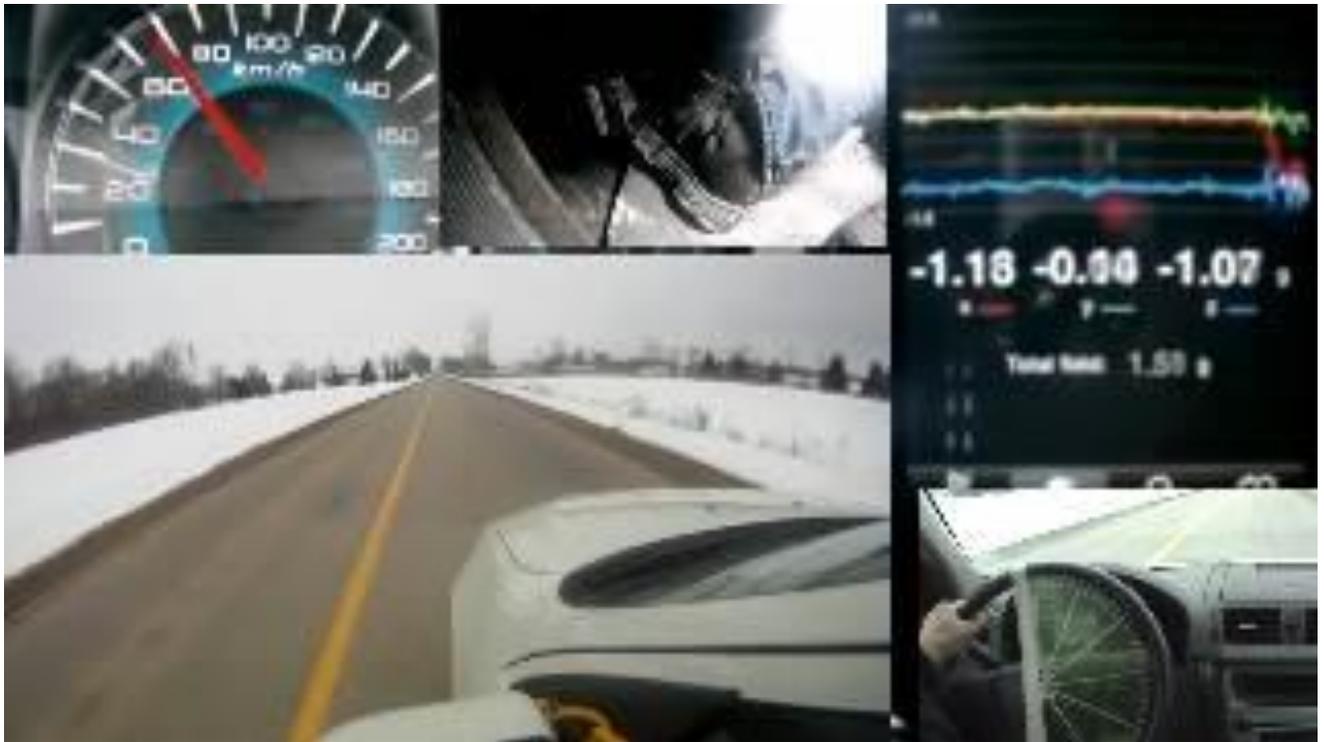
Below (top of Page 12) we show a screenshot about 0.53 seconds after initial brake pedal contact. Here we attain one of the spikes of high deceleration of "1.18" g.

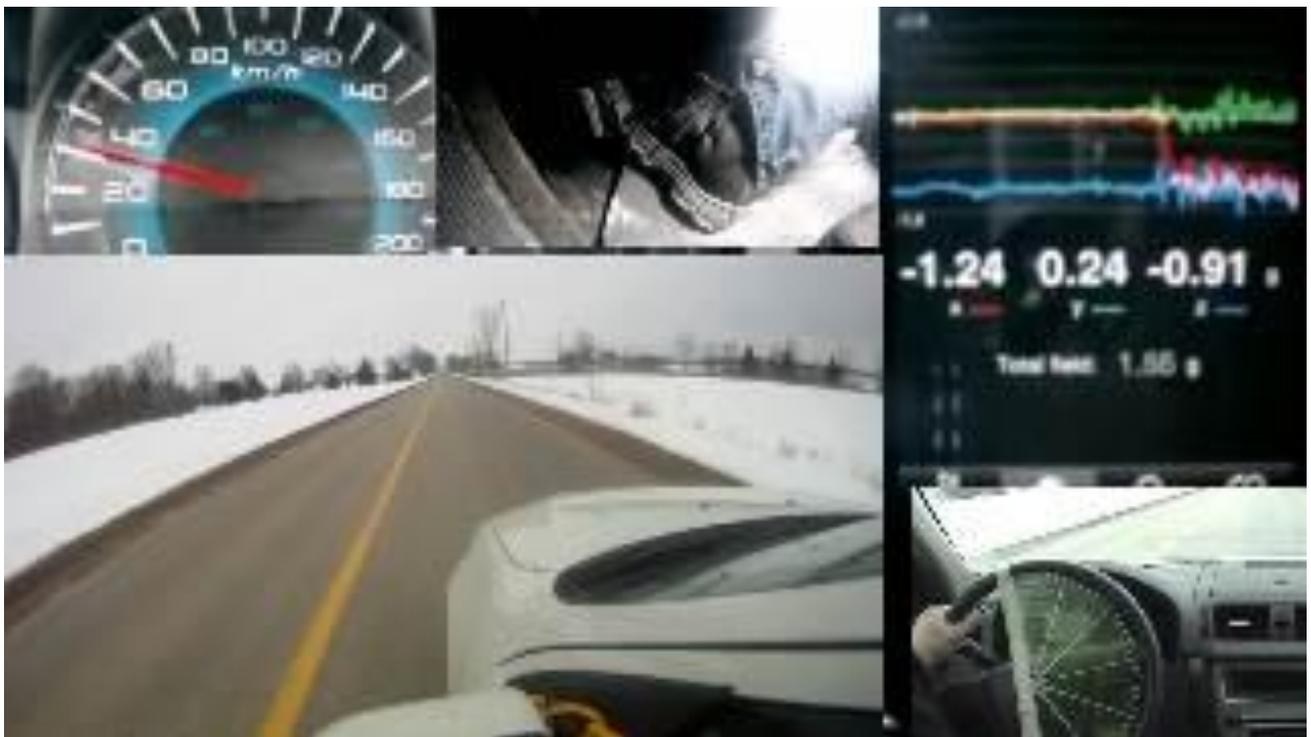
And the screenshot below is of another spike when the deceleration reaches "1.24" g at about 1.73 seconds after the initial brake pedal contact. Here you can see that the speed has dropped to about 32 km/h.

Also, by comparing the location of the centre-line with respect to the edge of the driver's mirror, or perhaps the left side of the vehicle we can see that the vehicle has moved slightly to the right. Obviously this view could also have occurred if there was a slight rotation of the vehicle and one would have to examine other evidence to determine which of these actually occurred. This why it is helpful to have a number of different cameras to compare the vehicle's position to various land marks. The present set-up has used a minimal number of cameras however in other tests we have set up cameras at individual tires as well as a view from behind the vehicle by a camera attached from a bicycle rack.

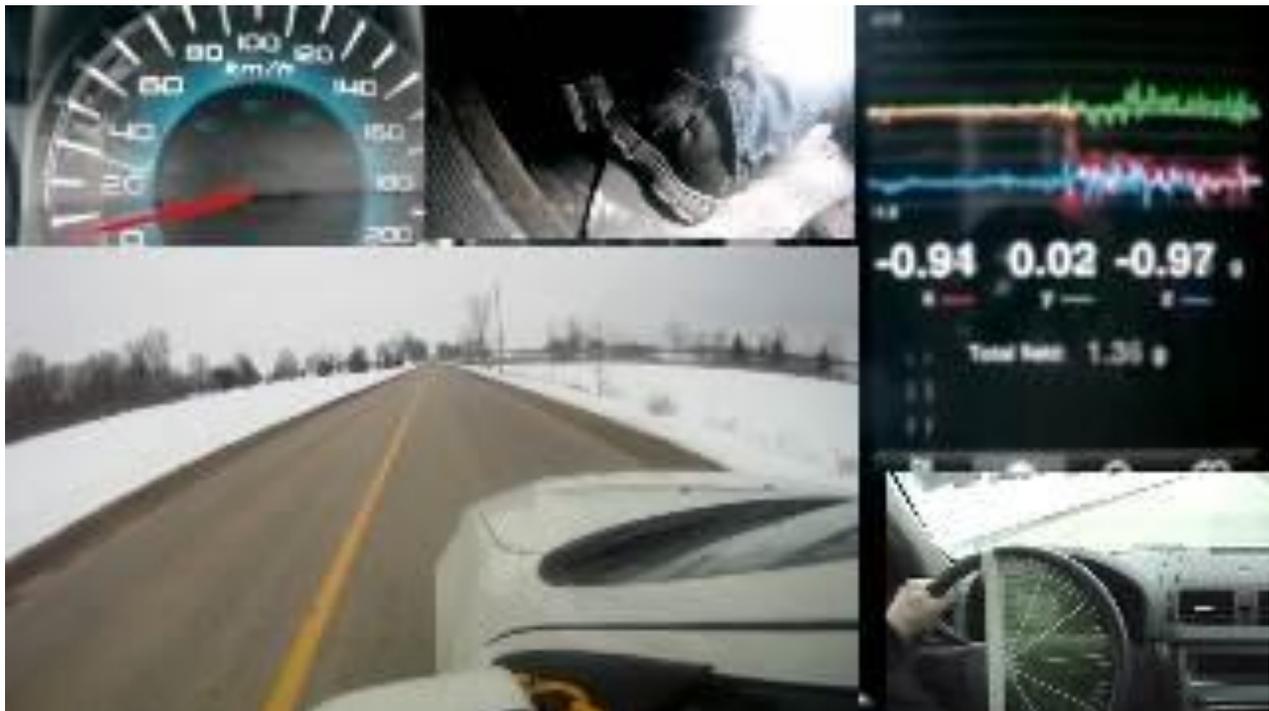
The screen shot below is the status at the end of the braking test just as the vehicle comes to a halt.

Although the video cameras show that the motion of the vehicle has been completed the speedometer is still reading as speed of about 5 km/h. So such a delay in the response of the speedometer has to be kept in mind when using this as the only source of documenting speed. We have considered attaching a scanner to document the internal data being provided by the wheel speed sensors and this is something we may do in the future. For now it is useful to just document how the speedometer functions and how this relates to information from the other instruments/cameras.
