## 2012 Ford Fusion Brake Testing With iPhone Accelerometer - Test # 5 On Bare Tar & Chip Surface

*Posting Date: 11-Mar 2013*

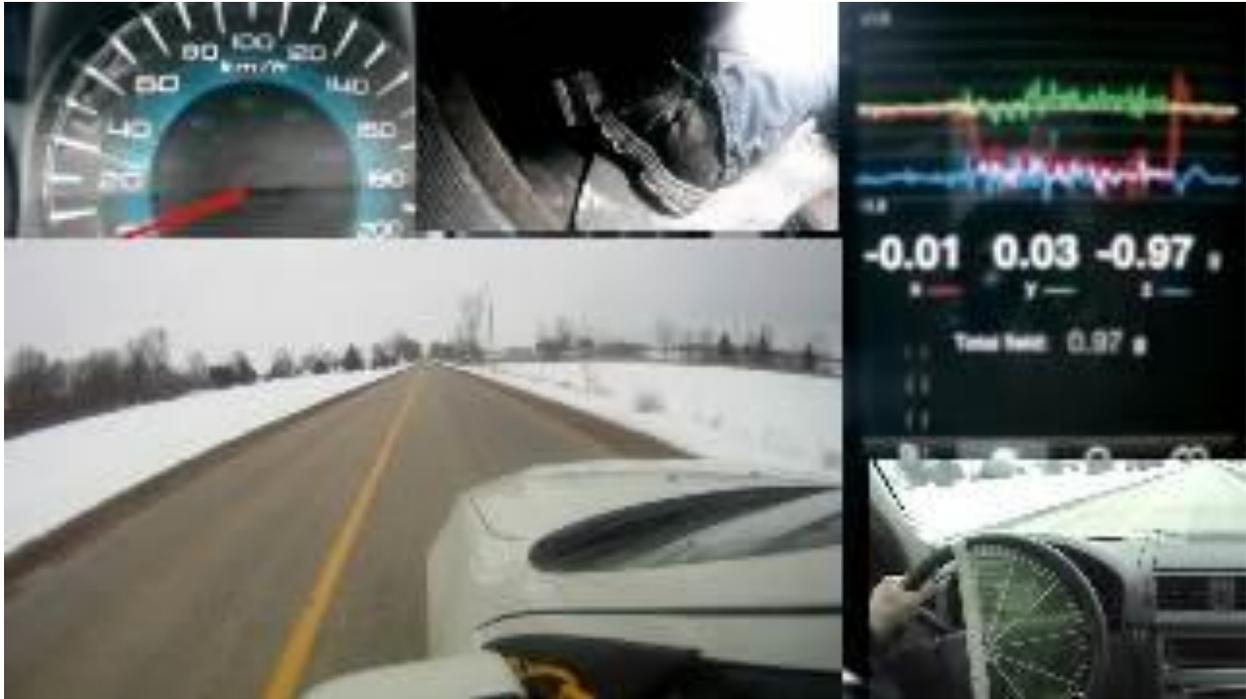
If you look at the display from the iPhone you should be able to see the display of the raw data being graphed. It is not easy to see the full extent of these vibrations until we proceed past the end of the test so at the top of the next page (Page 14) we have shown a screenshot that is 1.0 second past the end of the braking test and here we can see how the graphing of the accelerations shows minimal vibrations to the left and right while in the middle we see the complete test.

In particular the red line shows the status of the "x" or longitudinal acceleration. It can be seen how that red line drops down during the test so that its values have migrated to the blue line which is showing the vertical acceleration. This condition is a little clearer in the close-up view shown in the screenshot below.

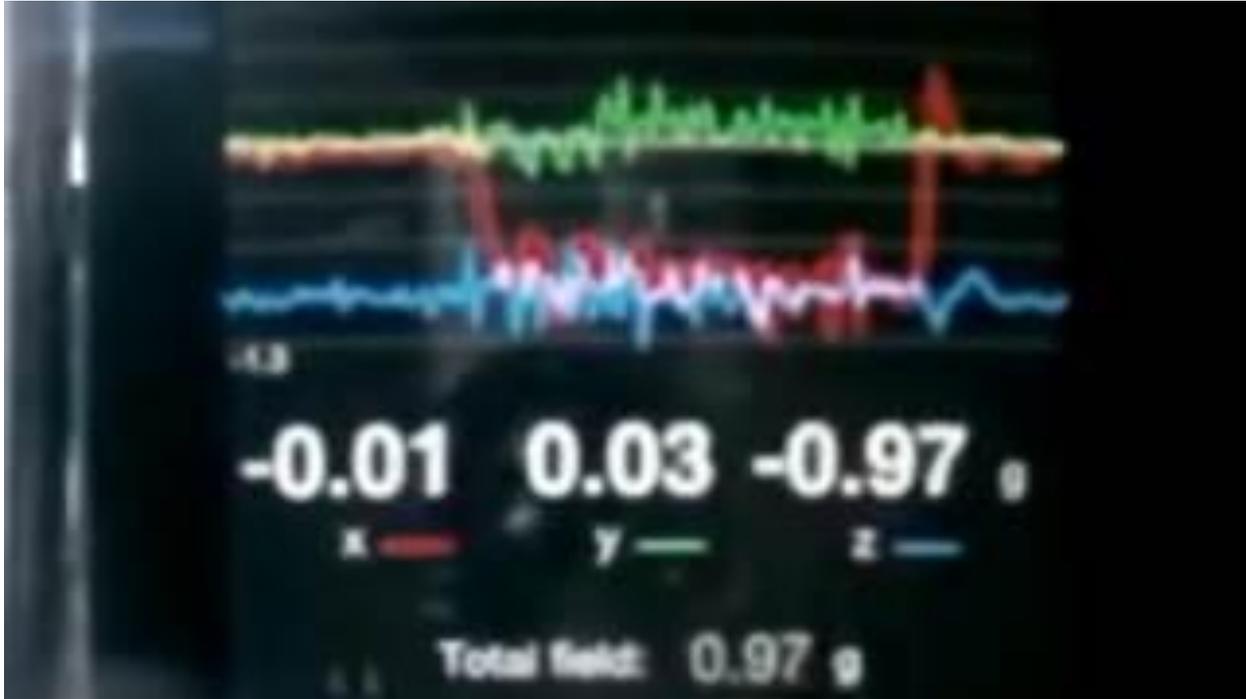
It is interesting that the lateral acceleration line is yellow before the test begins but then turns green as the vibrations of the test are displayed and then it returned to its yellow

colour after the test is completed. Similarly we see a white line intermixed with the red line (longitudinal acceleration) and the blue line (vertical acceleration). It is not clear at this time if either the red line or the blue line is temporarily being displayed as white. The reason why these changes in colour occur is still being evaluated. However we see no reason to believe that the reliability of the displayed values is being compromised.
