Dr. Shaughnessy Collision Site - Additional Line of Sight Testing on Jan 13, 2011

Posting Date: 16 Jan 2011

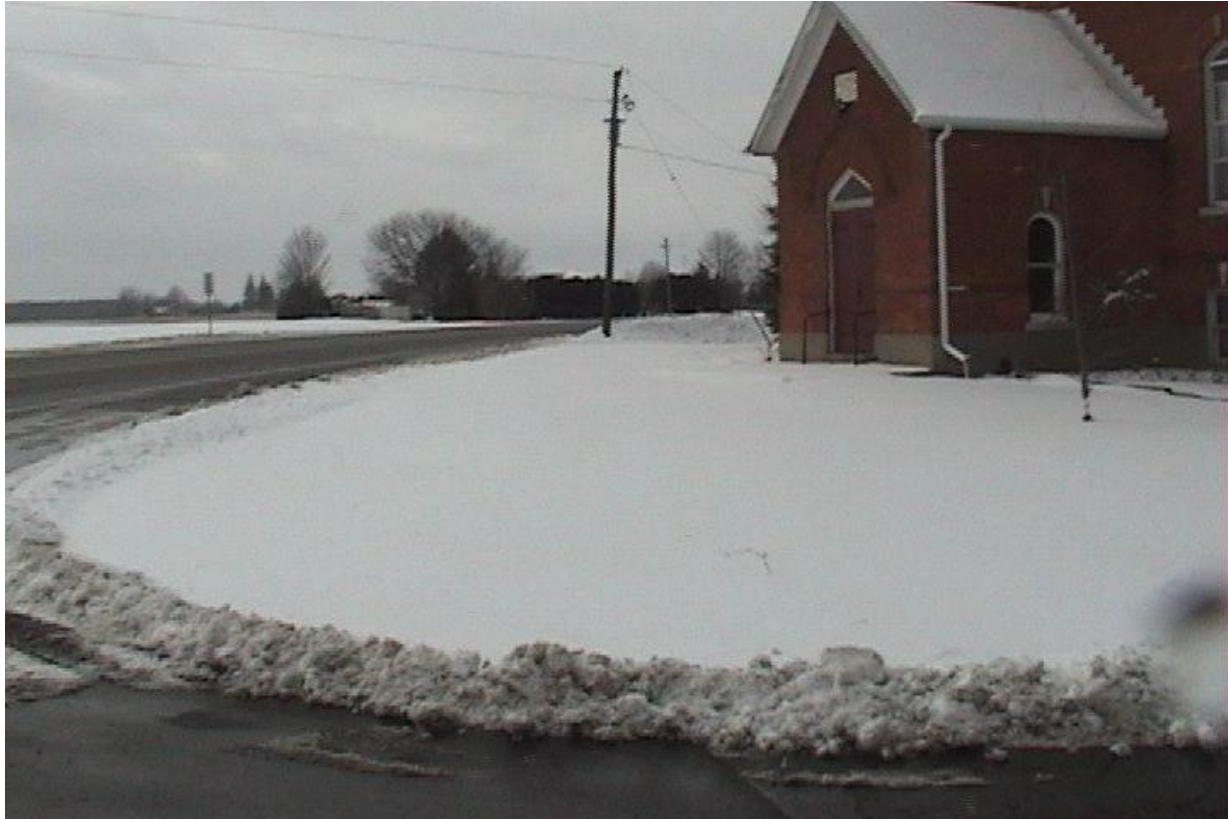
First, the photo below shows the situation from 2 metres north and at the 170 centimetre height. You should be looking just to the left of the wall of the church to see if you can see any orange cones or my car. I think you will agree that none are visible.

What should be interesting to you however is that a snowbank is visible just the left of the wall of the church. I can tell you that the amount of snow on the ground is not excessive and there was much more snow in the area in the past month. So the snowbank is often taller than what you see in the above photo.

What you also may not realize is that the snow bank is actually not at the edge of the road. It is located on private property which is several metres north of the road edge. There is a wide, paved shoulder on this north side of the road that has been plowed clear by about 3 to 4 metres. So the snow bank is actually quite distant from the road edge. But it appears to be close from this viewing angle because of the way that County Road 55 curves to the right in the background - and this makes the line-of-sight issue even more important. The snow bank is actually created by the owner of a wide, paved driveway. As the owner clears his driveway he pushes the snow over to the east and thus the snow bank that is created, but not along the edge of County Road 55. So what is happening during winter conditions is that this snow bank is blocking the line of sight even more than the wall of the church. Let's look at some other views.

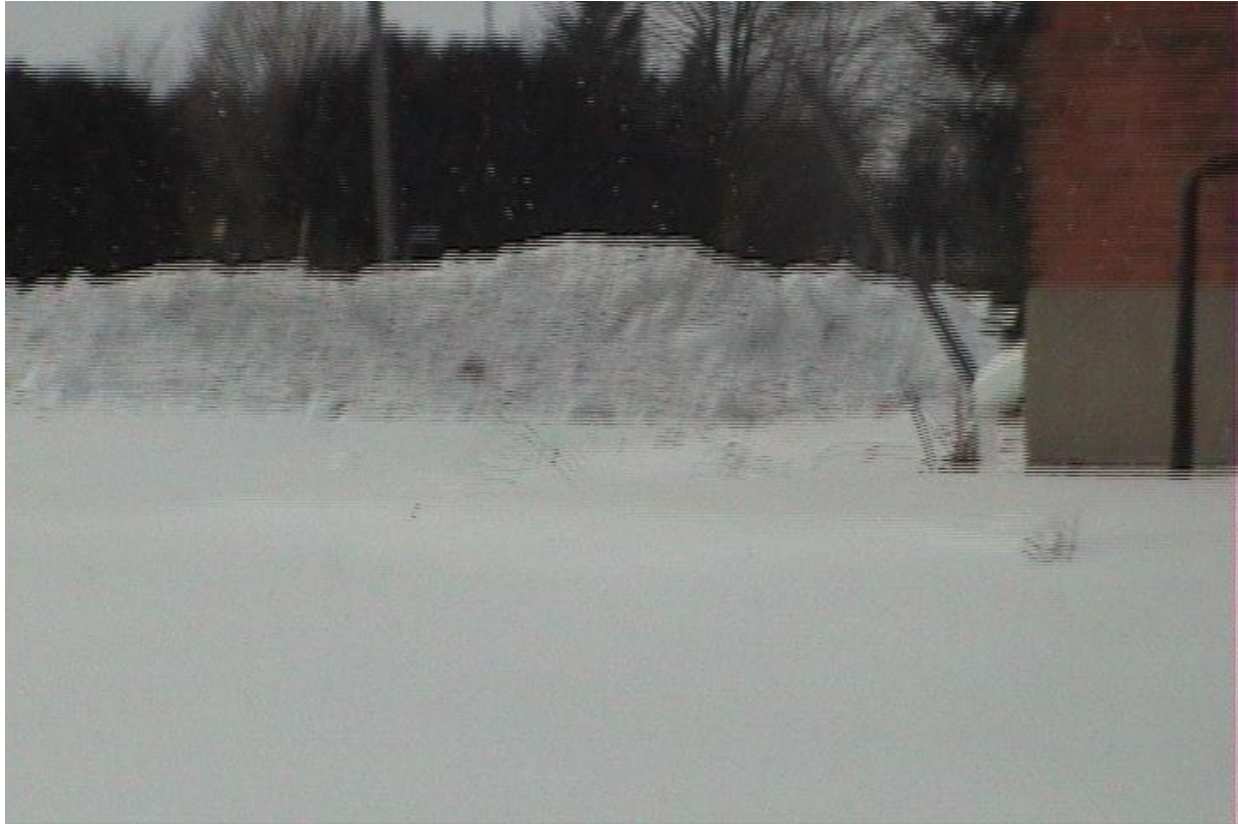
Below is the same viewing position as the previous photo but the view is zoomed in and I have dropped down to the 120 centimetre height. The view looks a little fuzzy because it is exported from the video and therefore the zoomed view has a low resolution. But surely you should see no sign of my parked car or any of my cones.

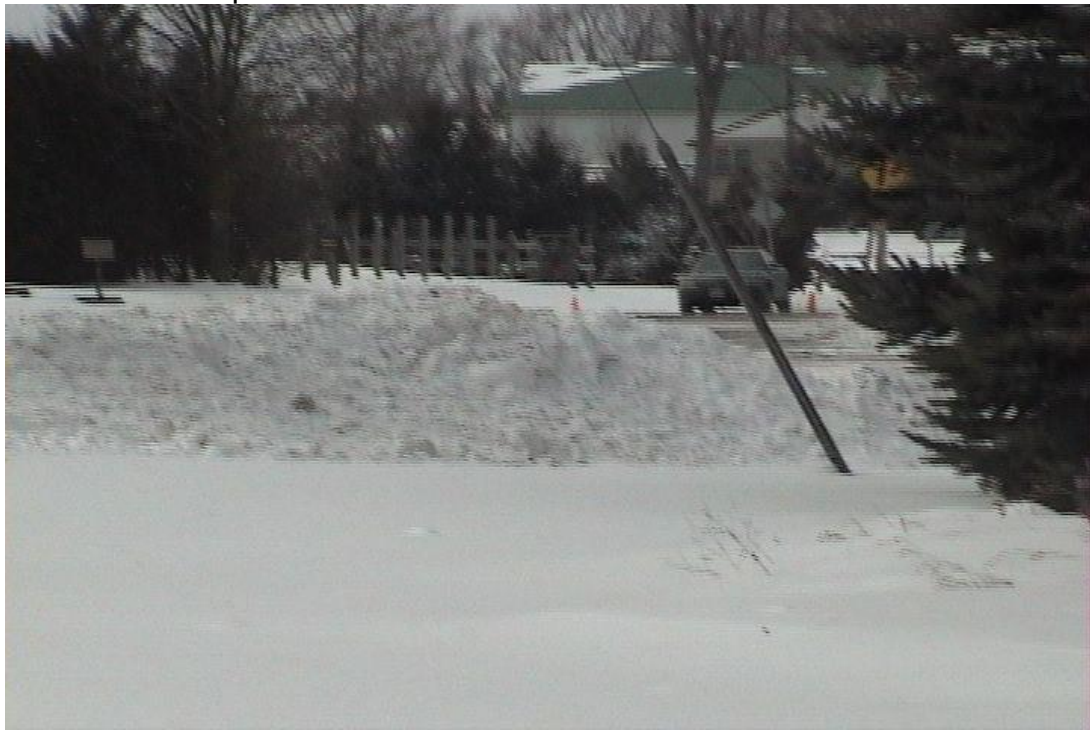
We can get you to appreciate this further by showing you at what point the cones, and my vehicle are actually visible. To do this I needed to stand on top of the traffic stop bar as shown in the photo below.

Again, the exported frame from my video is somewhat fuzzy. The view in the above photo is at a 170 centimetre height at the stop bar. Now you should be able to see my vehicle on the shoulder. You should also be able to see the 175-metre-cone and the 200-metre-cone (next to the vehicle).

But where is the 150-metre-cone in the above photo? Well, it is behind the snow bank. Invisible. Much like any eastbound car would be. Remember that this is from a height of 170 centimetres. You need some background to appreciate this significance. Road design standards use a height of only 105 centimetres as the bench mark for all their visibility testing. Why? Because that takes into account the eye height of a driver sitting in the lowest car - a Corvette perhaps, or something similar. The testing I'm giving you at 120 centimetres is more like the eye height of an average passenger car driver. And the 170 centimetre height that I am showing you in the above photo is actually slightly higher than almost all Pick-up trucks and Vans. So if something cannot be seen from a height of 170 centimetres you are really taking in a large part of the driving population that will not be able to see beyond the noted snow bank.

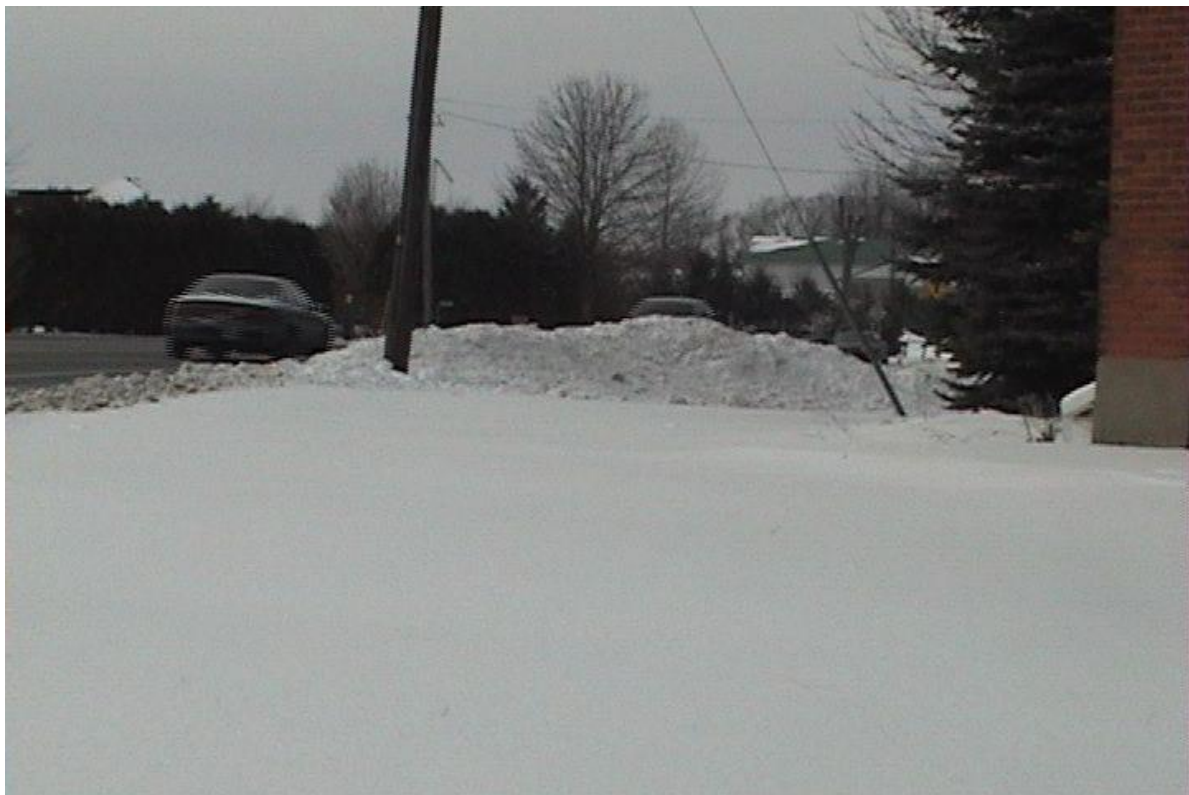
As an example, the photo below shows two westbound vehicles passing the snow bank and my camera is still at the 170 centimetre height. Note how the leading vehicle is almost invisible as only its roof can be seen above the snow bank.

But remember that the above photo shows what can be seen from a height of 170 centimetres, not from the typical driver's eye height of 120 centimetres. Clearly we have a problem.

It means that, in winter time, an eastbound vehicle travelling along Oxford County Road 55 will be blocked from view even though a southbound driver has pulled the front end of his car or light truck about 2 metres past the traffic stop bar. And that line of sight likely means that the eastbound vehicle could easily be invisible to a southbound driver until it is in the range of perhaps 130 metres or less from the intersection, depending on the height of the snowbank.

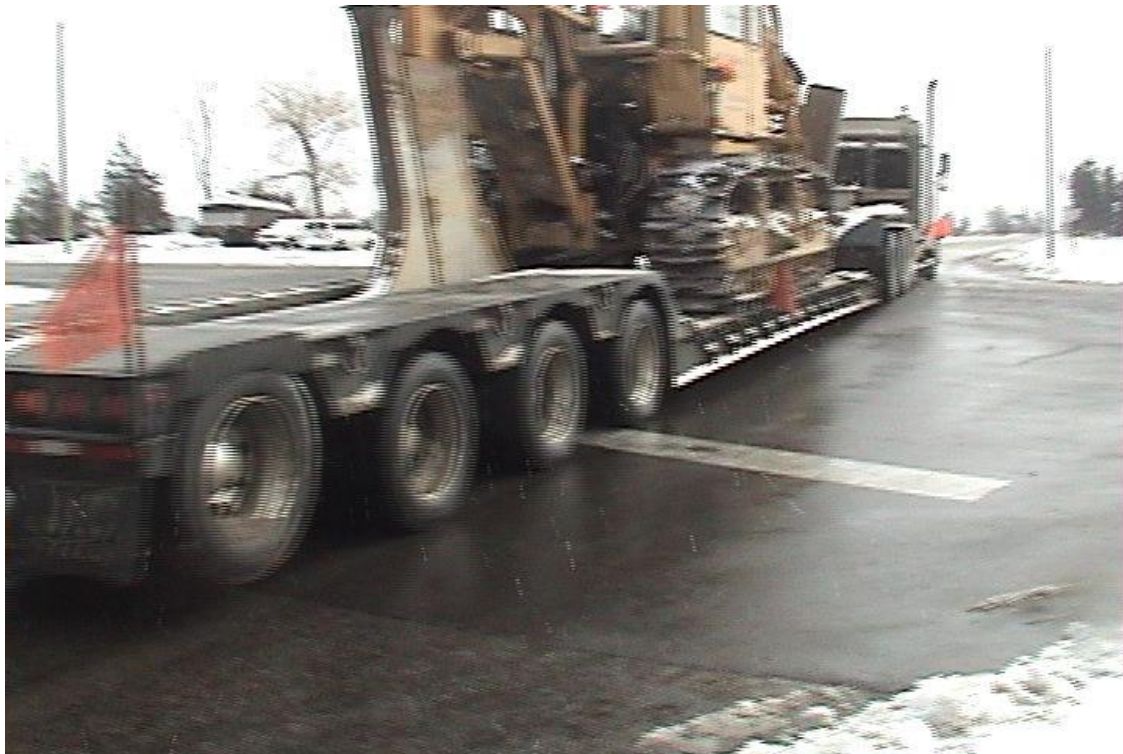
Take this scenario. Let us say the eastbound vehicle becomes visible at 125 metres from the intersection. At 90 km/h (25 metres per second) this eastbound vehicle reaches the intersection in about 5 seconds. Can a southbound driver commence his passage through the intersection and clear it in five seconds? I already know that answer but let's look at a couple of observations anyway. Below is a photo of a large truck hauling some heavy equipment on a trailer as it makes its crossing of County Road 55.

I have not examined the video in detail but it took about 11 seconds for this truck to complete its crossing. Do we have a problem. Yes, but the truck driver's eyes are a lot higher off the ground. So maybe it's not exactly comparable. But let me say that in the short time I was at the site, I made only three observations of southbound vehicles and 2 of those observations involved large trucks with trailers. The other large truck was hauling a standard semi-trailer and it also took about 12 seconds to make its crossing.

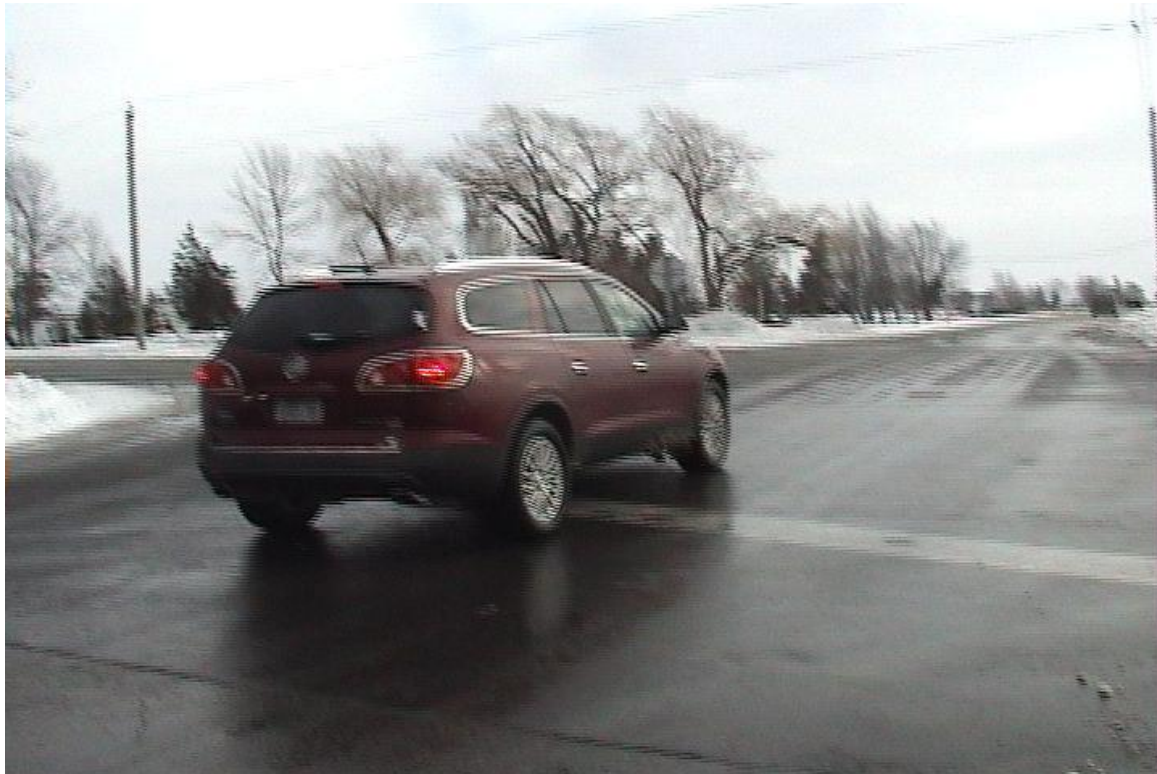
But let me show you my third observation below - a typical SUV.

Just to show you that all problems are not related to roads, as this gentleman crossed my viewing point I could see he was looking down at a cell phone or blackberry in his lap. Scary, when you consider he is attempting to cross this intersection. Anyway, without any detailed analysis I estimated that it took this SUV just over 5 seconds to clear the intersection.

Now let's go back to what I calculated previously. If our eastbound vehicle is only visible for 5 seconds and this southbound driver needs over 5 seconds to clear the intersection, don't we think there is a problem?

But there is more. The time estimate I gave you for the southbound driver was only for the vehicle motion. It does not include the delay required to scan the intersection before pulling out. Standard guidelines typically use a 2 second delay for such a scan. Add that 2 seconds to the previous 5 and you get a total of 7 seconds to clear the intersection. And we all know that in an 80 km/h zone there are persons who drive at speeds higher than 90 km/h.
