Evaluation of Loss of Control Tire Marks on a Gravel Shoulder

Posting Date: 03-August 2013

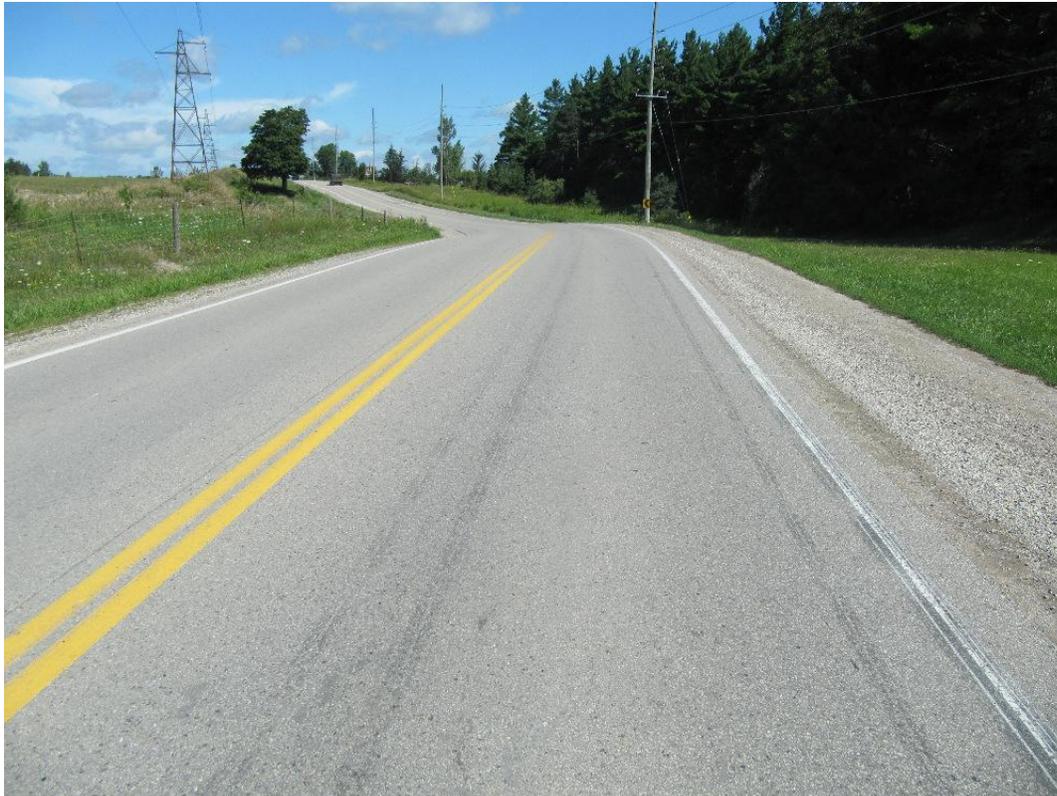
The opening photo we show of the site (on Page 2) is a view looking north toward the sharp left curve which is the second of the two portions of the S-curve for northbound drivers. Interestingly, the photo shows a set of long, skid marks, unmistakable from a large truck, in the northbound lane just as the truck was approaching the sharp left curve. Those tire skid marks are not the subject of our discussion but they high-light that even drivers of large trucks may become surprised by the extent of the curvature or perhaps the driver needed to deal with some kind of obstacle that developed. The tire marks we are actually interested in are not visible in Figure 1 but they exist on the east

Figure 1: View, looking north, toward the left (north) curve portion of the S-curve on Clarke Road.

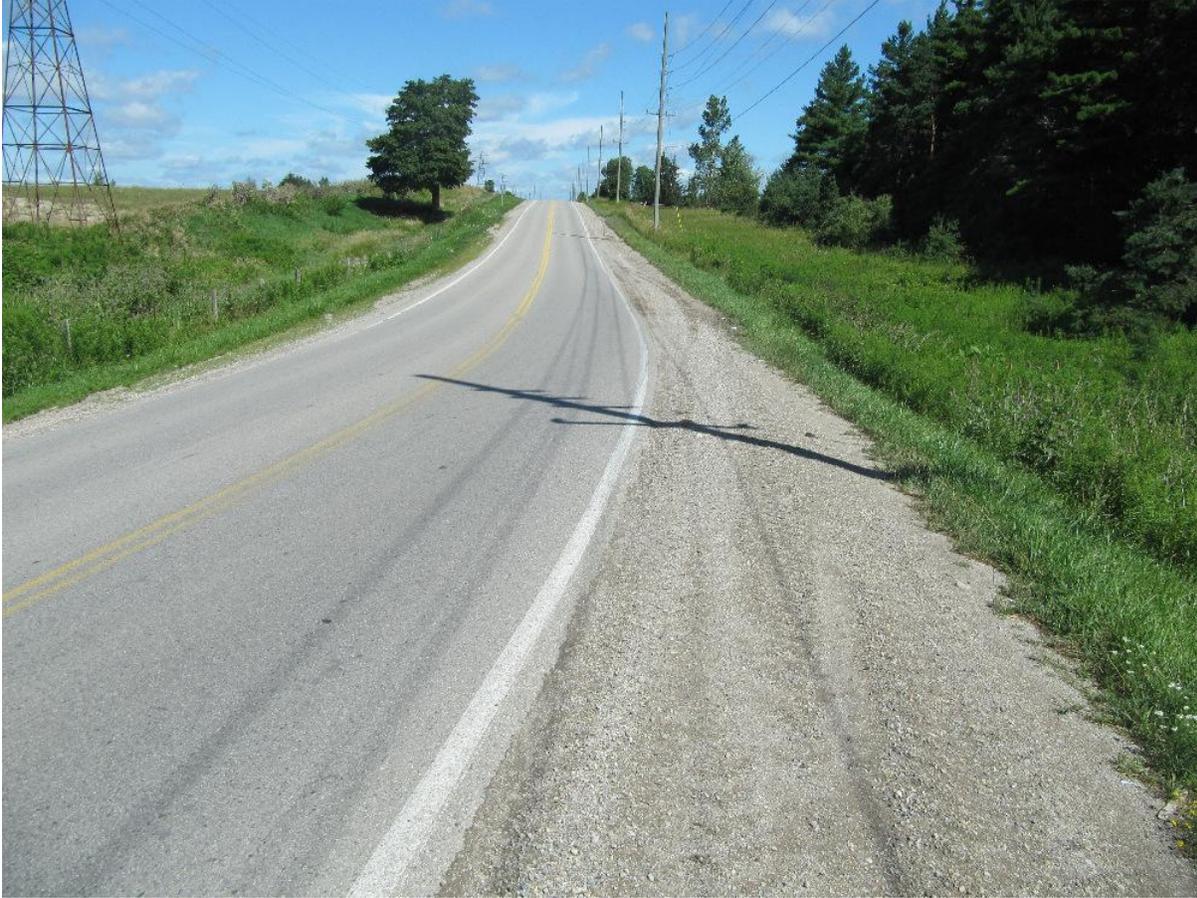
Figure 2 brings us further into the left curve and now we can see the surface of the road as well as the east gravel shoulder where the loss-of-control tire marks exist. The loss-of-control tire marks are not particularly visible in Figure 2 and this gives us an opportunity to comment on this fact whenever we take photos or examine photos of such marks.

Figure 2: View, looking north, along the east shoulder of Clarke Road in the vicinity of the loss-of-control tire marks on the gravel shoulder.

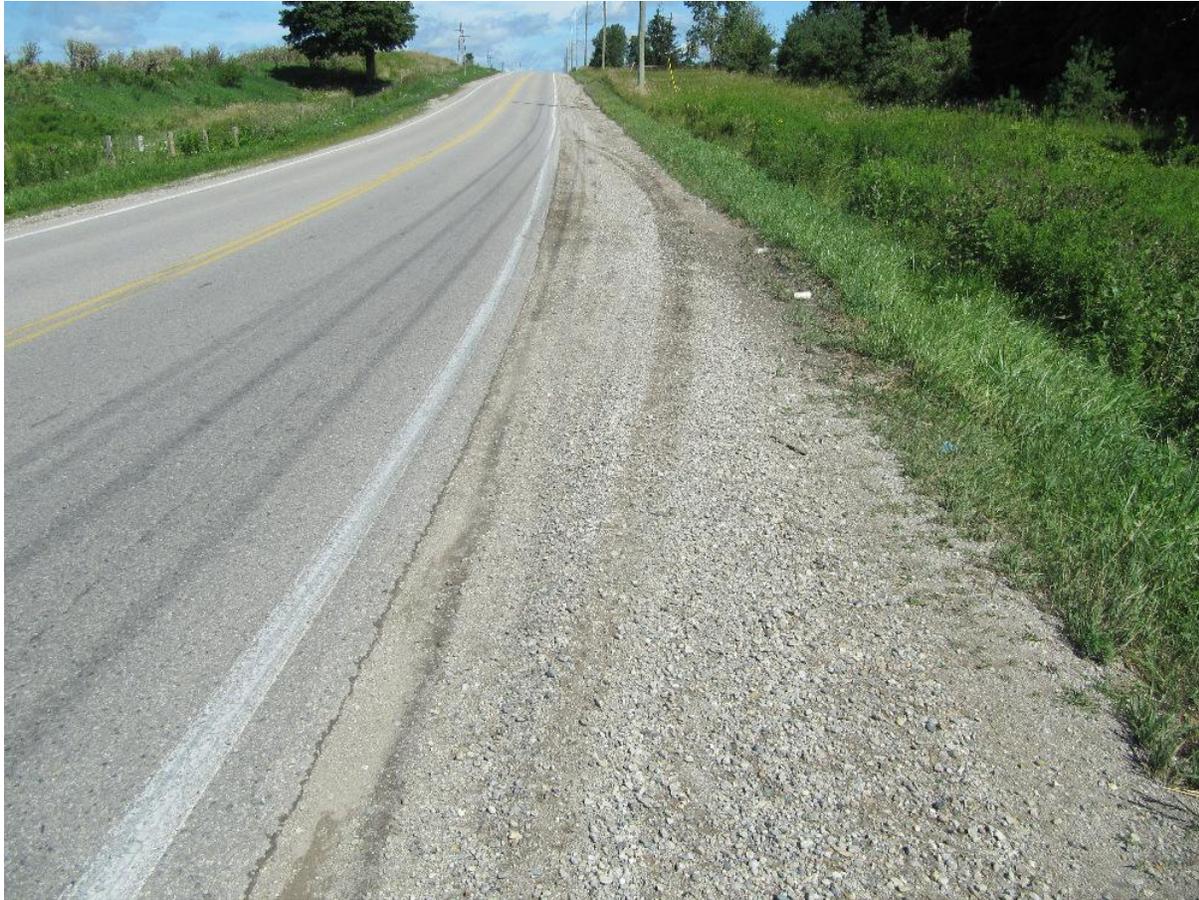
However, as we move slightly further north into the curve, Figure 3 demonstrates that the loss-of-control tire marks on the east shoulder suddenly become much easier to see. We suggest that, as the vehicle begins to change direction, and the tires begin to slip sides more and more, more contrast is developed between the monotone shade of the gravel and the freshly turned up gravel where the tire sideslip occurs and this makes the tire mark more visible.

Unmistakably, and very commonly, the initial portion of the visible tire mark is just a single mark that is difficult to detect in the foreground of Figure 3. But as the vehicle begins to rotate counter-clockwise that single tire mark, which comes from the two right side tires, begins to diverge into two separate tire marks. This characteristic can be appreciated by looking into the background of the shoulder shown in Figure 3.

Now, look in Figure 3 at how far the right side wheels of the vehicle have moved off the road surface and onto the gravel shoulder. This is not just a small amount of mis-judgment . At the apex of this curved tire mark the left side tires would be very close to also coming off the pavement and onto the gravel shoulder.

Figure 3: View, looking north, along the east shoulder where the curved, loss-of-control, tire mark becomes more visible.

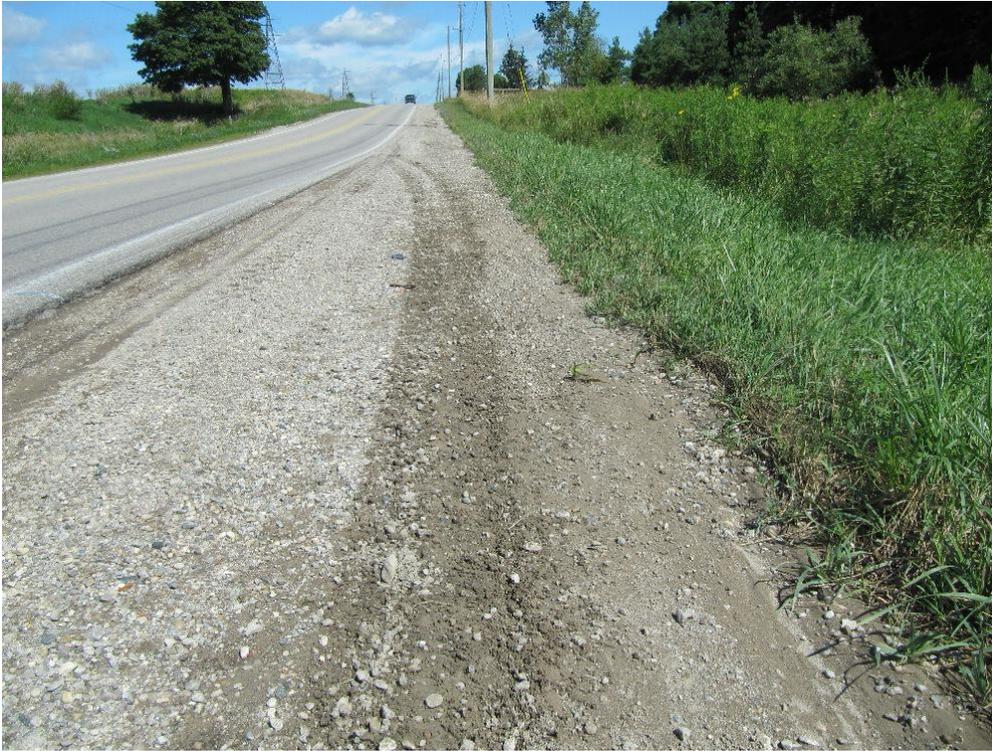
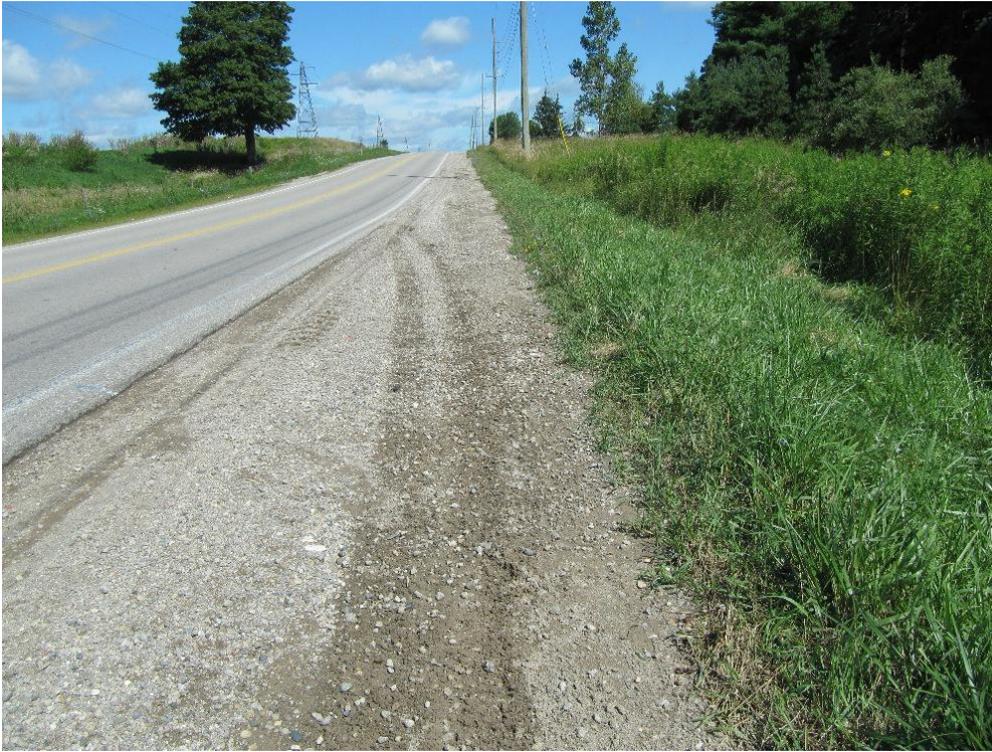
In Figures 4 and 5 we are looking north further along the loss-of-control tire marks on the east shoulder. Now the divergence of the right side tires into two tire marks is quite visible. We can see that the driver is obviously steering to the left and attempting to bring the vehicle back onto the pavement as the tire marks curve back toward the pavement.

Figure 4: View, looking north along the loss-of-control tire marks.

Figure 5: View, looking north, along the loss-of-control tire marks.

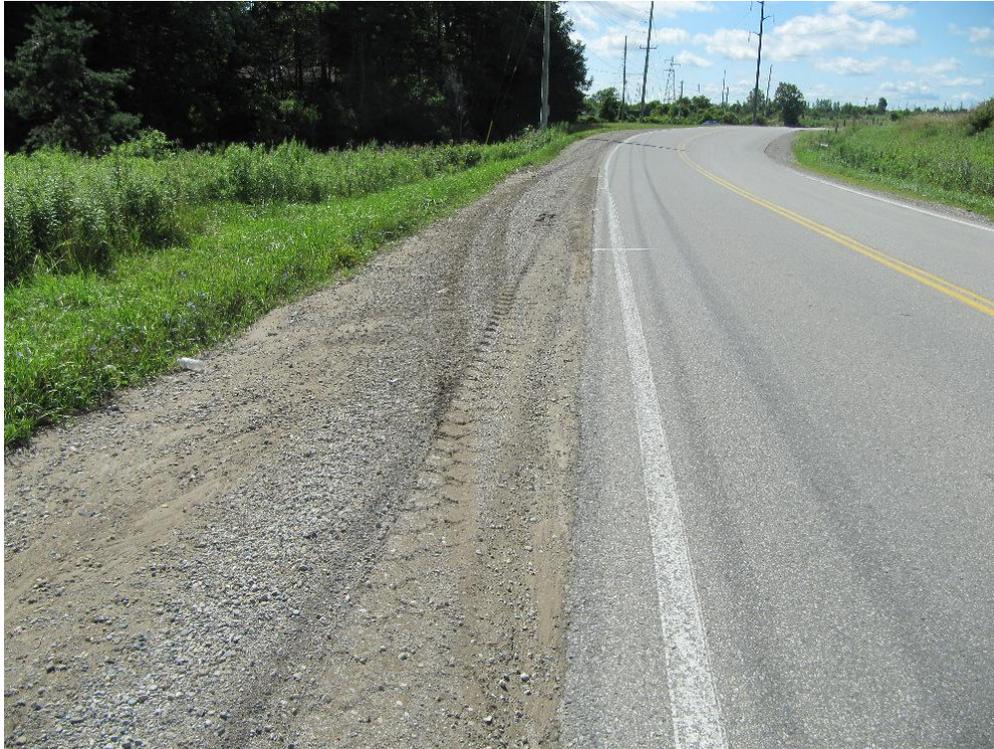
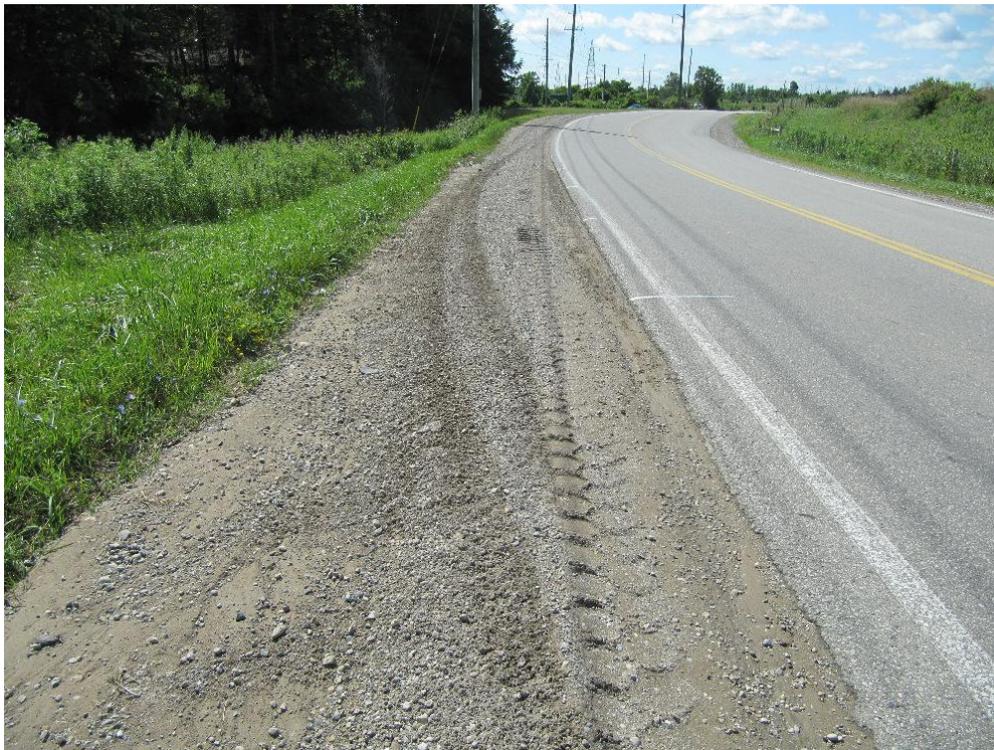
In Figures 6 and 7 we reverse the direction of view, and we are now looking south along the east shoulder and back in the direction from which the loss-of-control vehicle came. Interestingly we can obtain some indication of the timing of the occurrence by noting that another tire mark, likely from a farm-tractor-type vehicle crosses over and obliterates our tire marks as can be seen in the foreground of Figures 6 and 7. The evaluation of how one set of tire marks crosses over and destroys a previously-made set of marks is one of the tools we use to understand the timing of what occurred at an accident site.

Figure 6: View, looking south, showing the loss-of-control tire marks in the east gravel shoulder.

Figure 7: View, looking south, showing the loss-of-control tire marks in the east gravel shoulder.

Interestingly, recall those farm-tractor-type tire marks that we discussed in Figures 6 and 7? Well, those same farm-tractor-type tire marks can be seen again in the foreground of Figure 8 and, once again, they are seen obliterating our loss-of-control tires marks near the asphalt edge. So this is another indication that both sets of loss-of-control tire marks were created at a similar time.

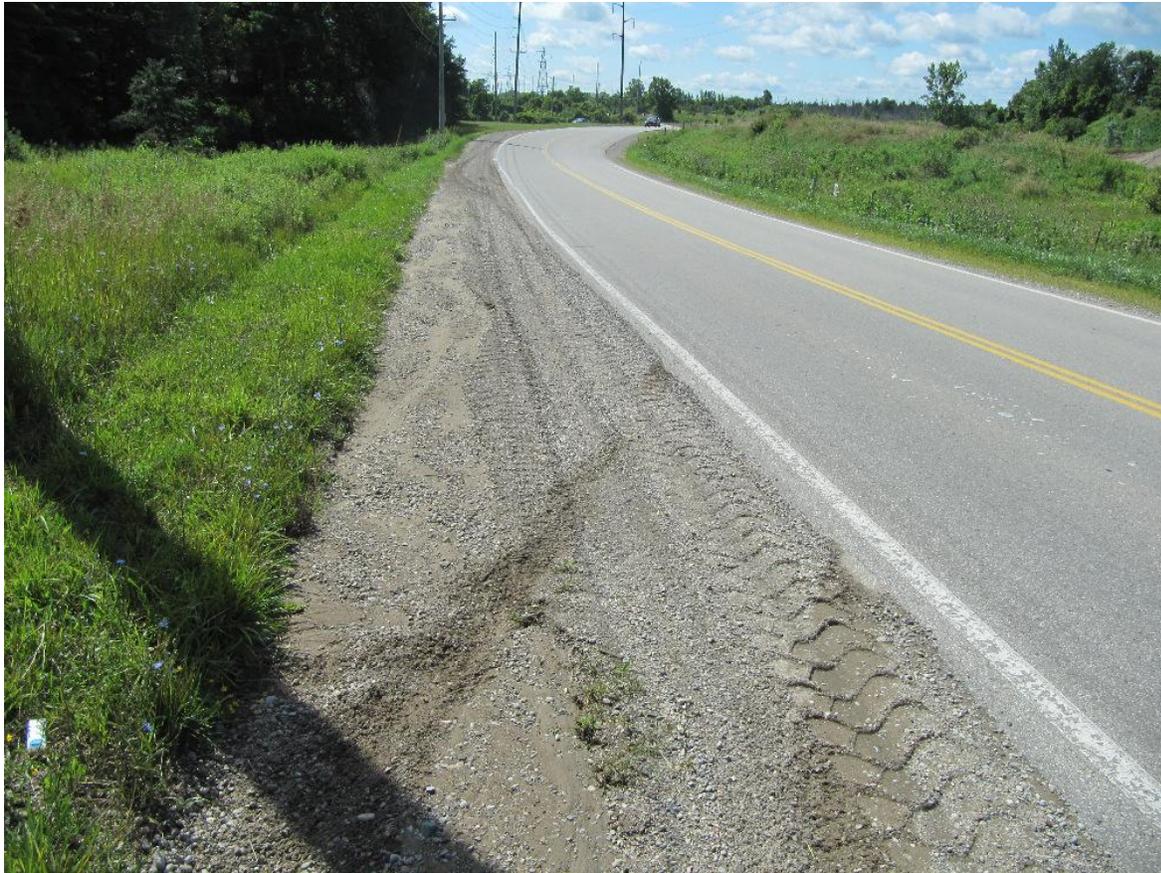
Figure 8 is also a view looking south but the camera's location is further north of Figures 6 and 7 and here we see another set of interesting tire marks on the east shoulder. For comparison, you can look into the background of Figure 8 and find the previously-discussed tire marks. So why does this new set of tire marks exist? Could they be related the tire marks we have already discussed? Well, yes, they are.

Figure 8: View, looking south, showing a new set of loss-of-control tire marks in the foreground of the east shoulder.

On the day and night of July 31st and August 1st it had been raining and the road surface was wet. So when our mystery vehicle came back onto the road surface after producing its first set of tire marks in the shoulder the wet road surface prevented the creation of any visible yaw marks on the pavement which would have clarified its motion for us, and this is a common scenario. Upon re-entering the roadway the driver had successfully brought the vehicle out of the counter-clockwise rotation and the driver then counter-steered to the right to prevent the vehicle from crossing the road into the opposite (west) roadside. But we cannot see this action because the wet road has prevented the yaw marks from being seen. So the tire marks in the foreground of Figure 8 are caused by the same vehicle that caused the tire marks in the background of Figure 8. So, in the foreground of Figure 8 our loss-of-control vehicle is now headed toward the camera and back into the east shoulder again.

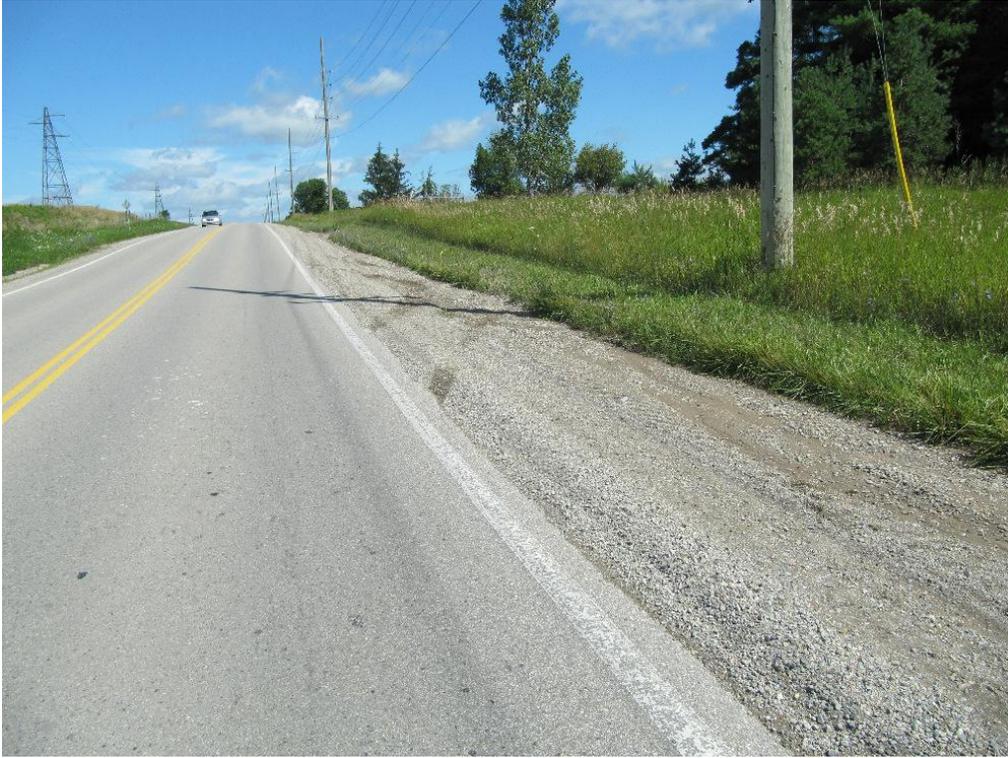
If we turn the camera around to face northward Figures 9 and 10 show the second set of loss-of-control tire marks as our mystery vehicle slides back into the east shoulder.

Figure 9: View, looking north, at the second set of loss-of-control tire marks.

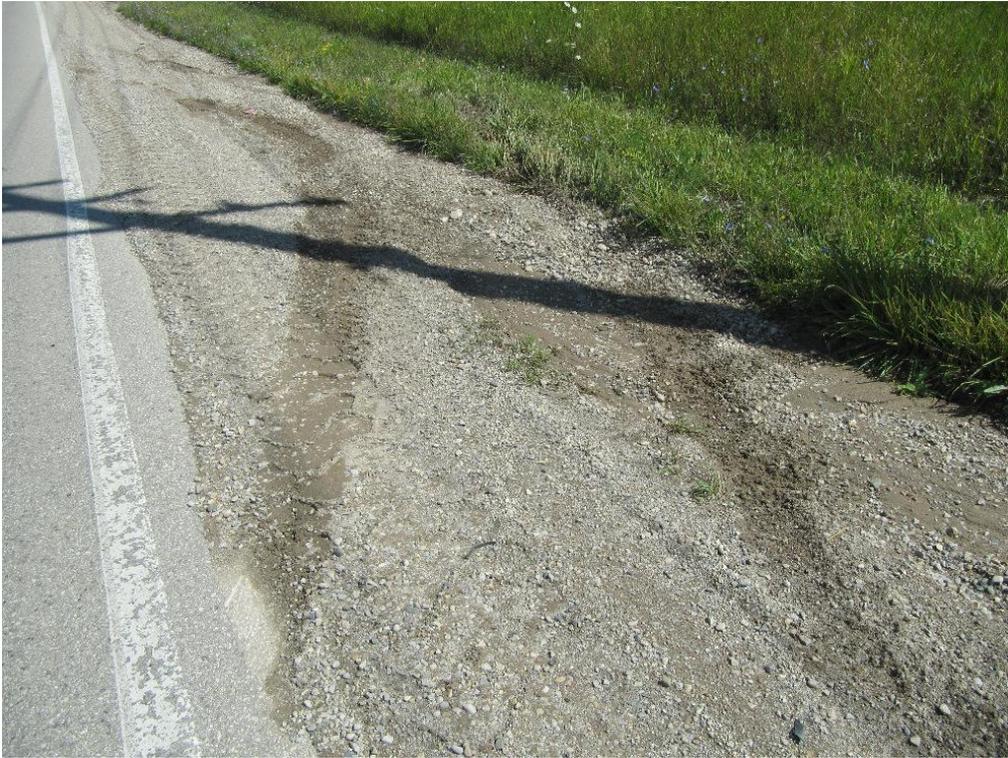
Figure 10: View of second set of loss-of-control tire marks as the vehicle re-enters the east shoulder.

Fortunately, our mystery driver lost a substantial amount of speed during his travel up to the point where the vehicle re-enters the east shoulder and we can see in Figure 10 that once again the tire marks curve back toward the road surface and we will see shortly that the driver then accelerates under control and "scoots off into the sunset", never to be seen again. However it is important to understand the difference between the situation in this second set of tire marks where the driver regains traction and is no longer side-slipping versus the condition in the first set of tire marks where the vehicle was side-slipping. So let us look more closely at some of the characteristics of this second set of tire marks which demonstrate a controlled acceleration at the latter end of the marks.

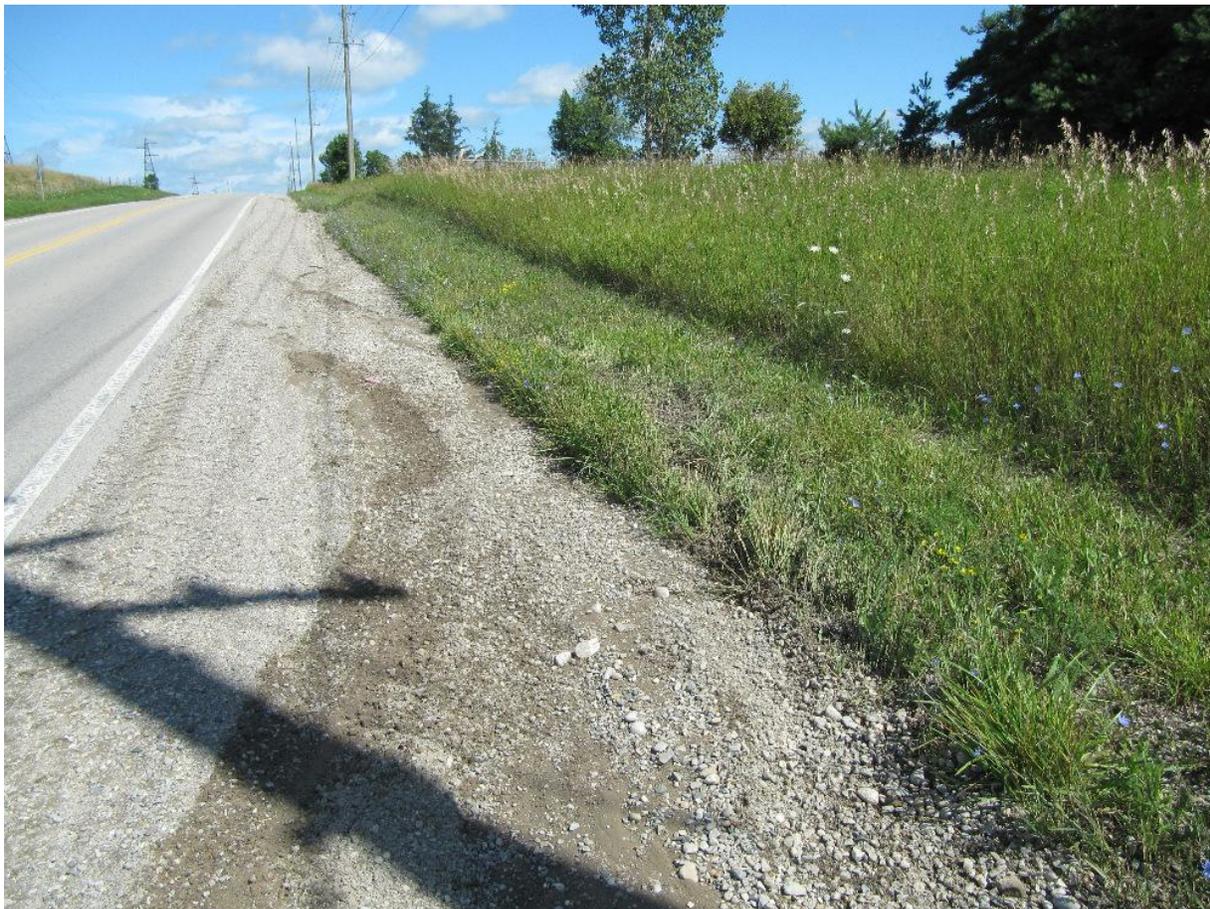
Let us follow those tire marks as they pass through the shoulder and then exit it. Figure 11 takes us further along the tire marks as the right side tires enter the edge of the grass. The vehicle is still side-slipping at this point and just completing its clockwise rotation as the tires begin to gain hold of the surface.

Figure 11: View, of the second set of tire marks showing side-slipping in the early portion of the tire marks.

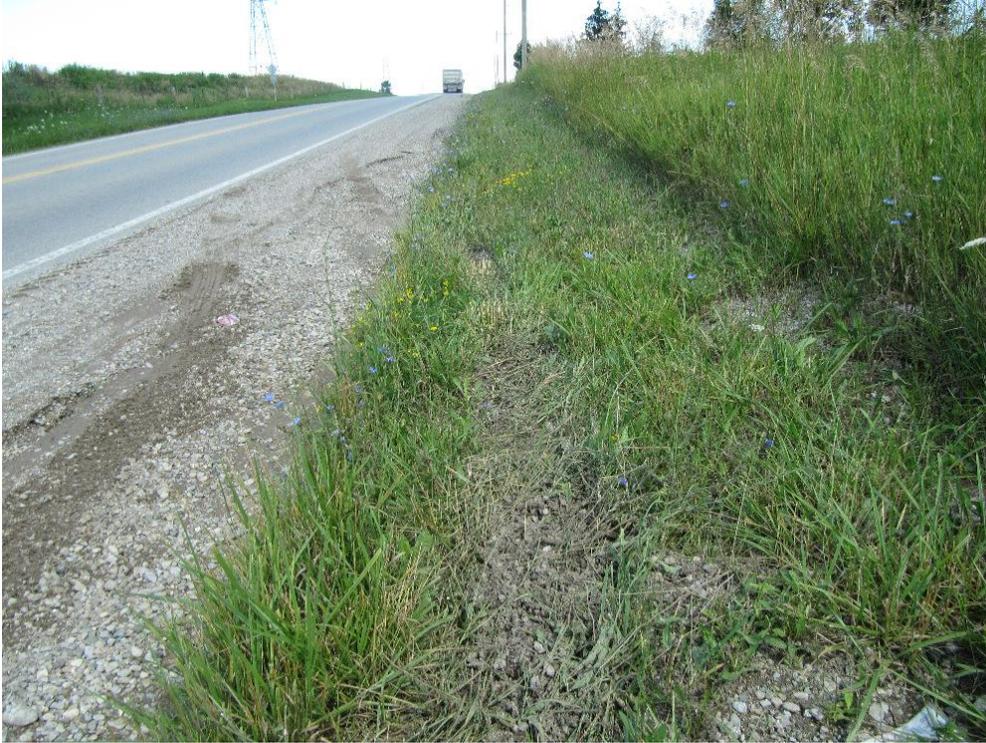
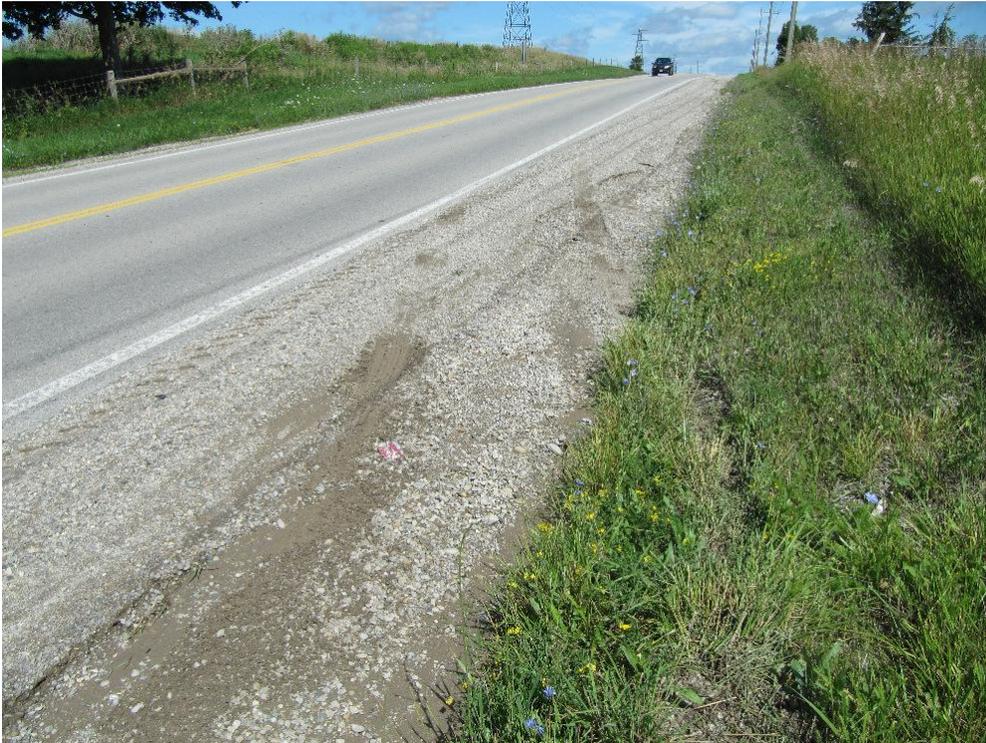
In Figure 12 we proceed further north and we can see how the grass is torn up by the sliding tires indicating the existence of the side-slipping action, then Figure 13 shows how the side-slipping begins to dissipate as the vehicle travels toward back toward its lane.

Figure 12: View of tearing of grass indicating the tires are side-slipping as they pass over it.

Figure 13: View showing the tire marks as they progress back toward the northbound lane.

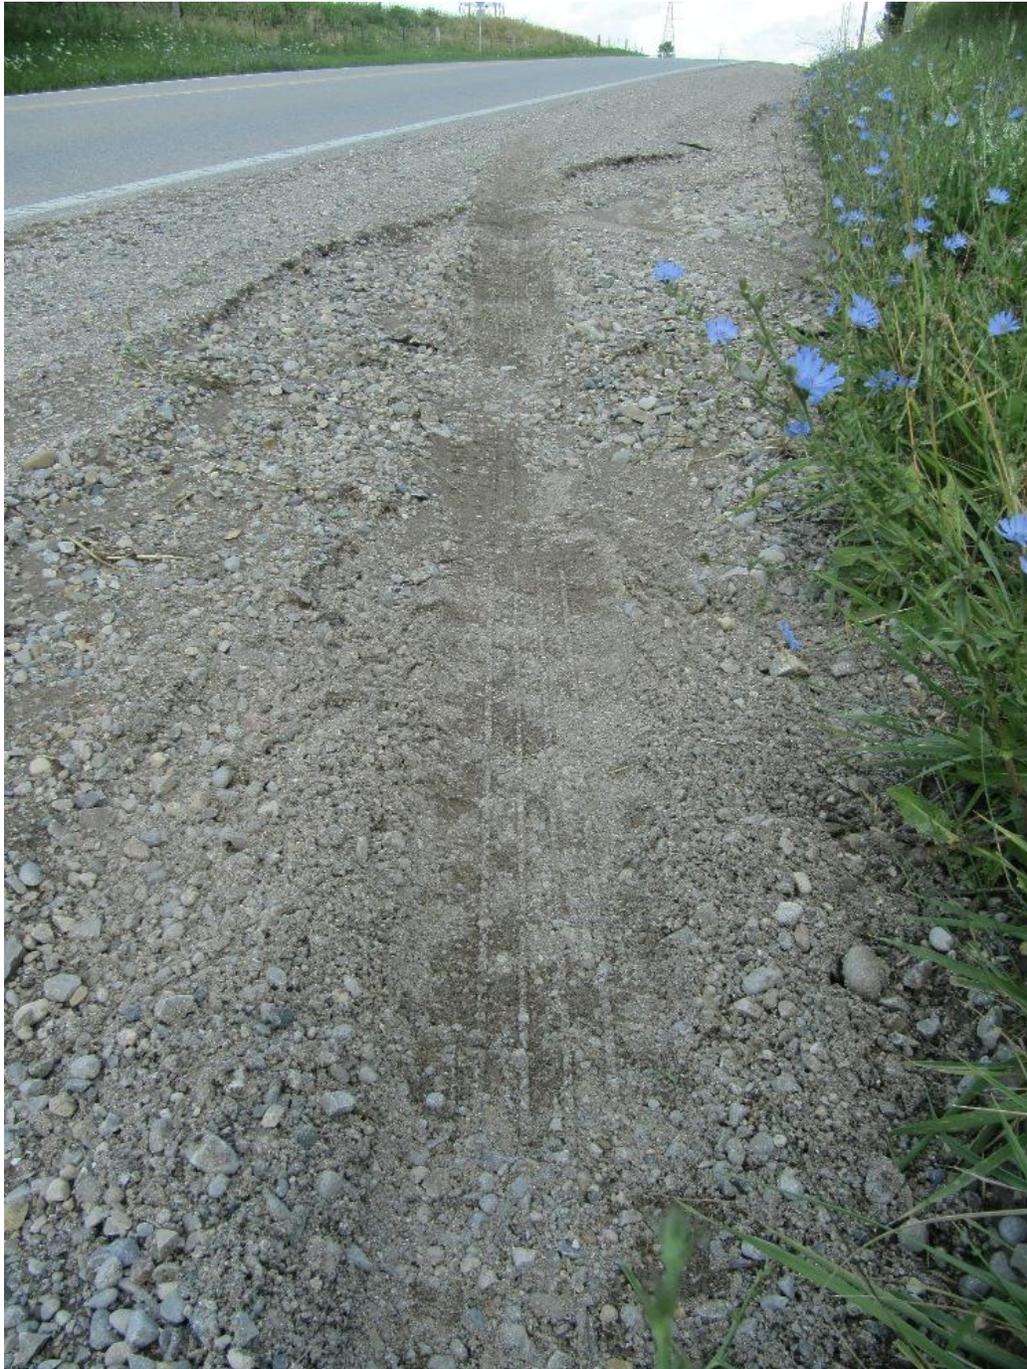
Figure 14 is a close-up view of the tire mark produced by the right side tires of the vehicle and in the foreground you can see the tread pattern in the mark indicating that the tires are no longer side-slipping. Yet, you can also see how the gravel to the left and right of the tire mark is being disbursed as the tires are "plowing" into the gravel as the tire is accelerating and "moving" the gravel.

Figure 14: Close-up view of the right side tire mark.

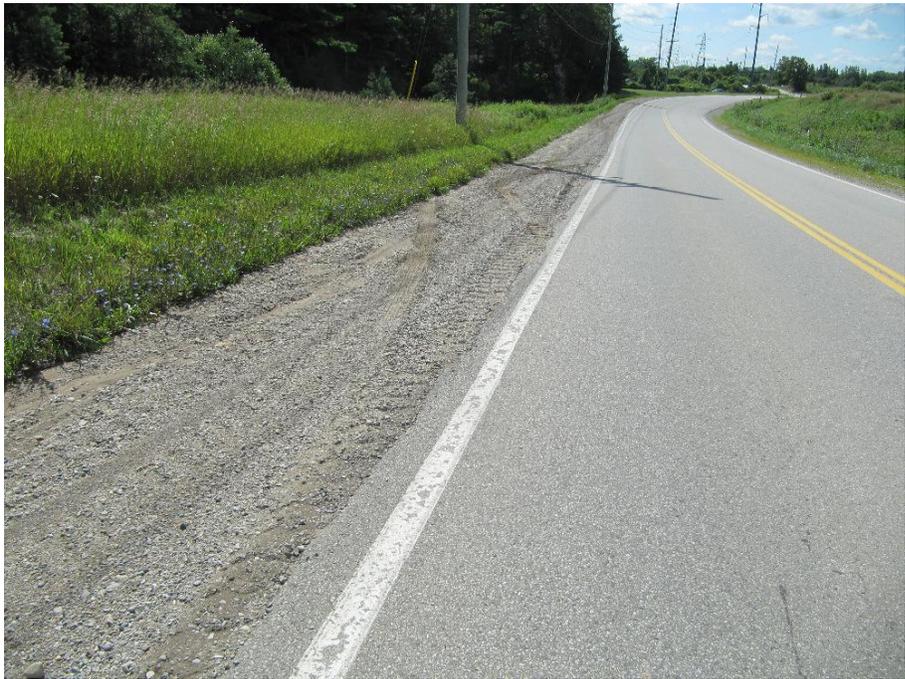
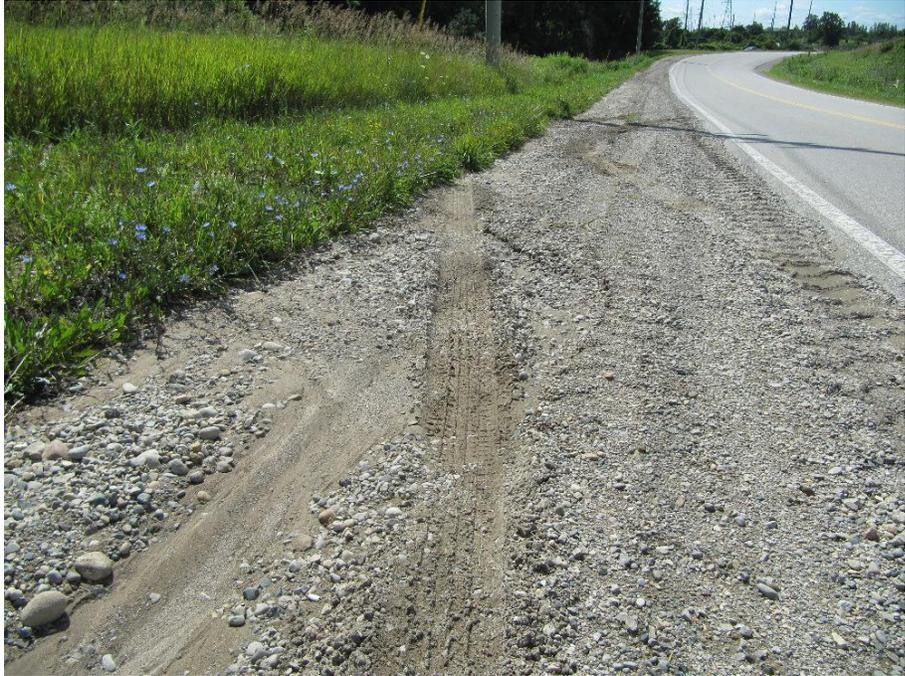
Figure 15 shows a view of the tire marks looking south from where the vehicle has accelerated back into the northbound lane. And Figure 16 shows a closer view of those marks.

Figure 15: View looking south, toward the second set of tire marks.

Figure 16: View, looking southbound, showing a closer view of second set of tire marks.

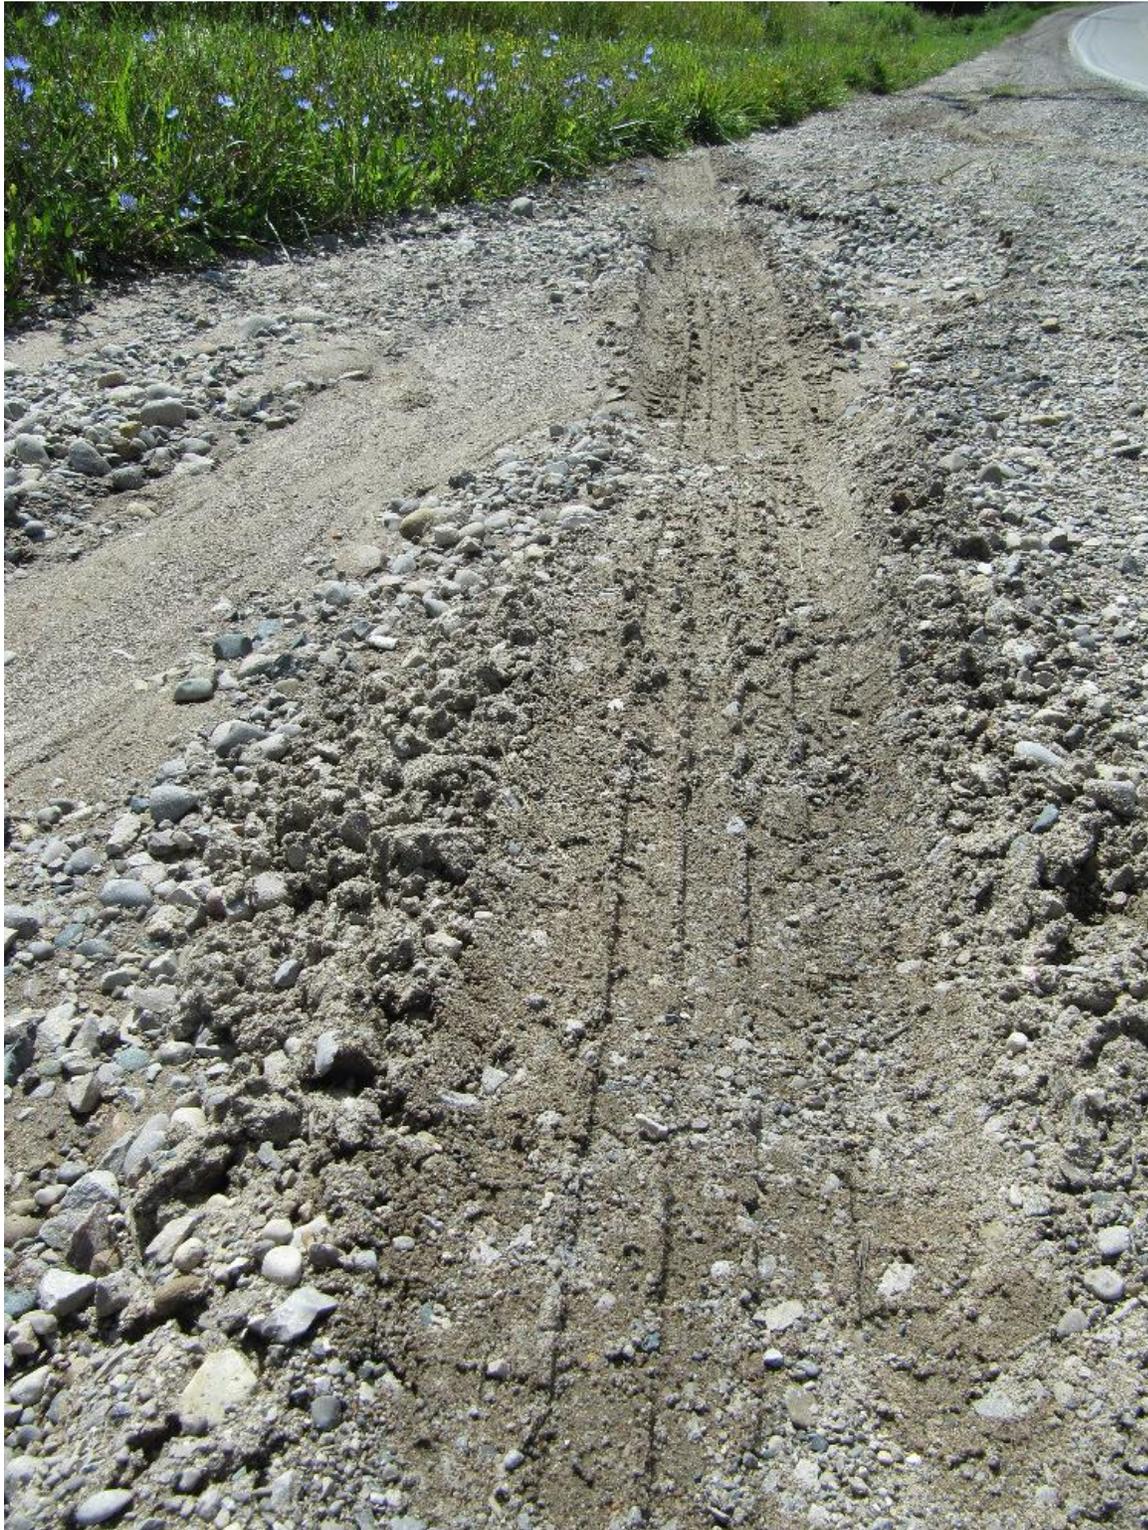
Let us take several closer views of the characteristics of these marks. Figure 17 brings us close to the tire mark caused by the right side tires.

Figure 17: Close-up view of the characteristics of the tire mark caused by the right side tires.

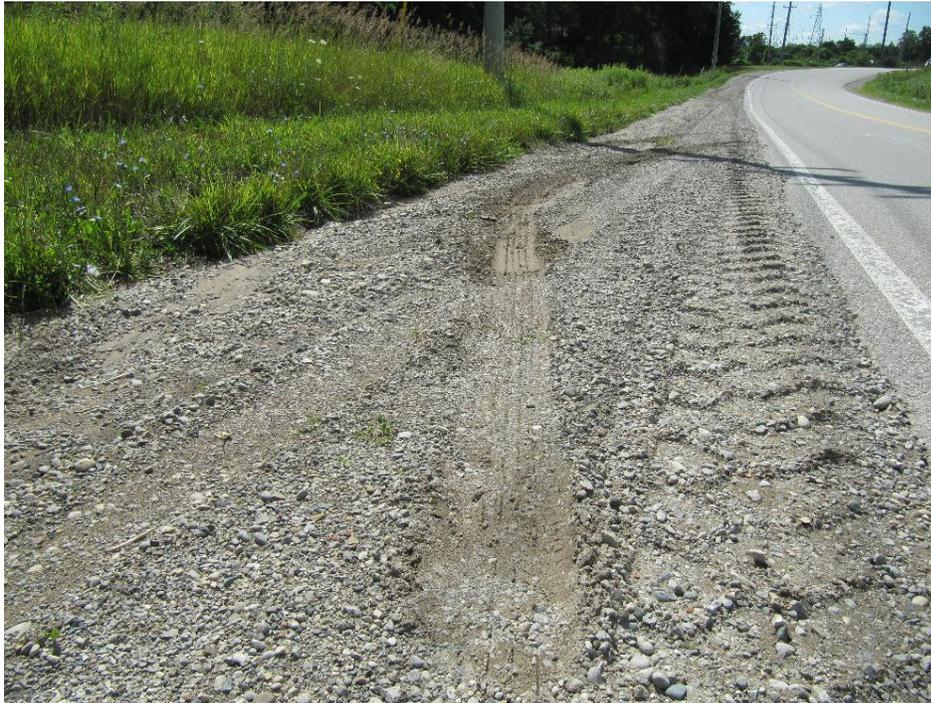
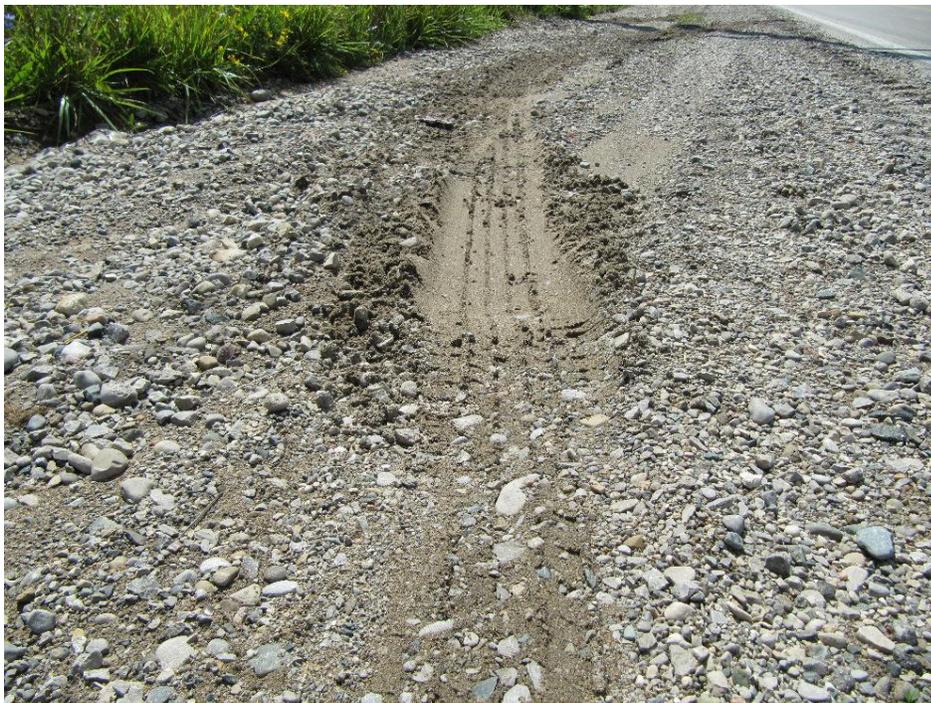
Similarly, Figure 18 shows a view of the mark produced by the left side tires, and Figure 19 shows a closer view of the mark.

Figure 18: View, looking south along the tire mark produced by the left side tires.

Figure 19: View, looking north, showing a closer view of the left side tire mark.

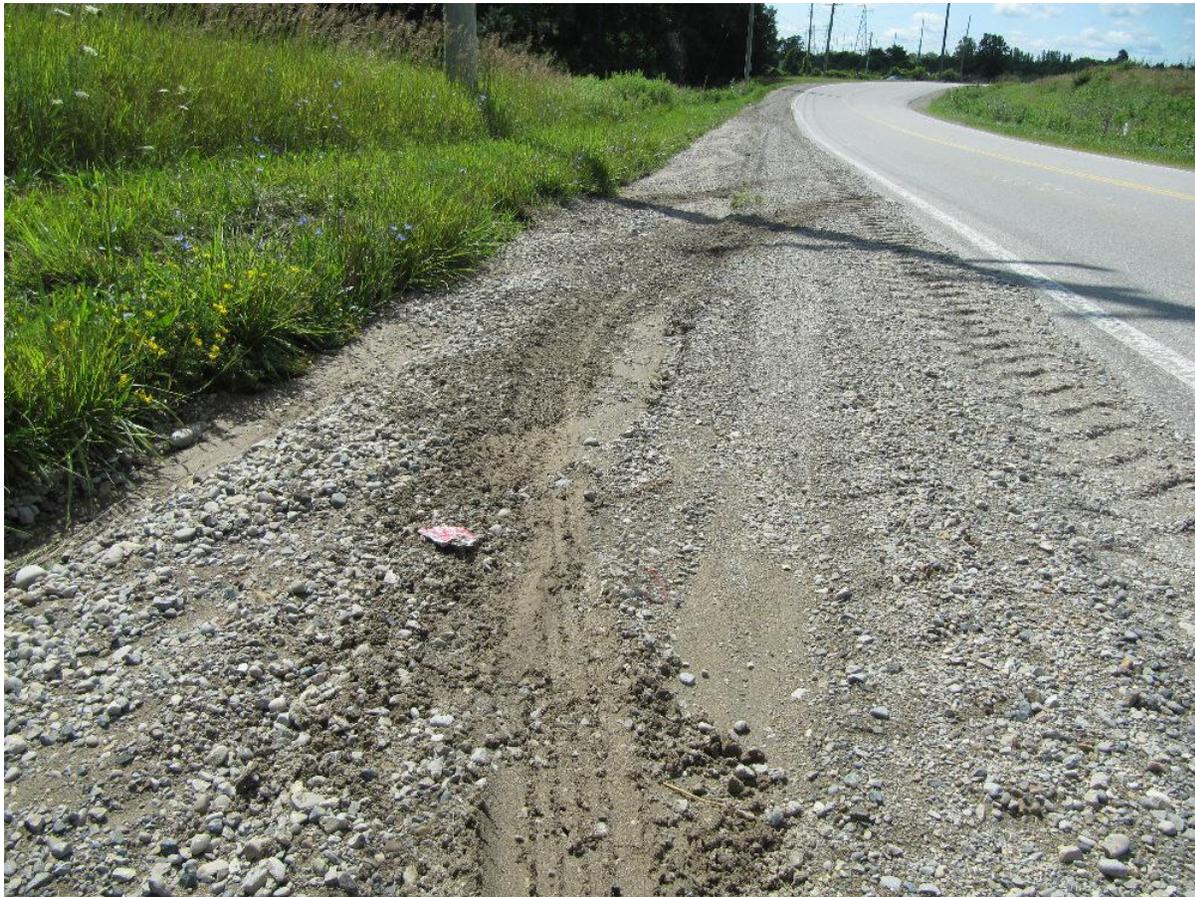
Figure 20 shows us the point of transition in the left side tire mark where the tires change from side-slipping rotation to forward acceleration. You should be able to see within the mark how there is a disturbance of the gravel within the mark in the background and then toward the foreground that disturbance changes into a condition where we can see the tread of the tire in the mark, as the side-slipping is ceased and the acceleration commences. You might also be able to detect how, during side-slipping, a majority of the disturbed gravel is thrown to one side of the tire mark whereas in acceleration the gravel and earth are "squashed" to both sides of the mark.

Figure 20: View, looking south, along the left side tire mark showing its transition from side-slipping in the background to acceleration in the foreground.

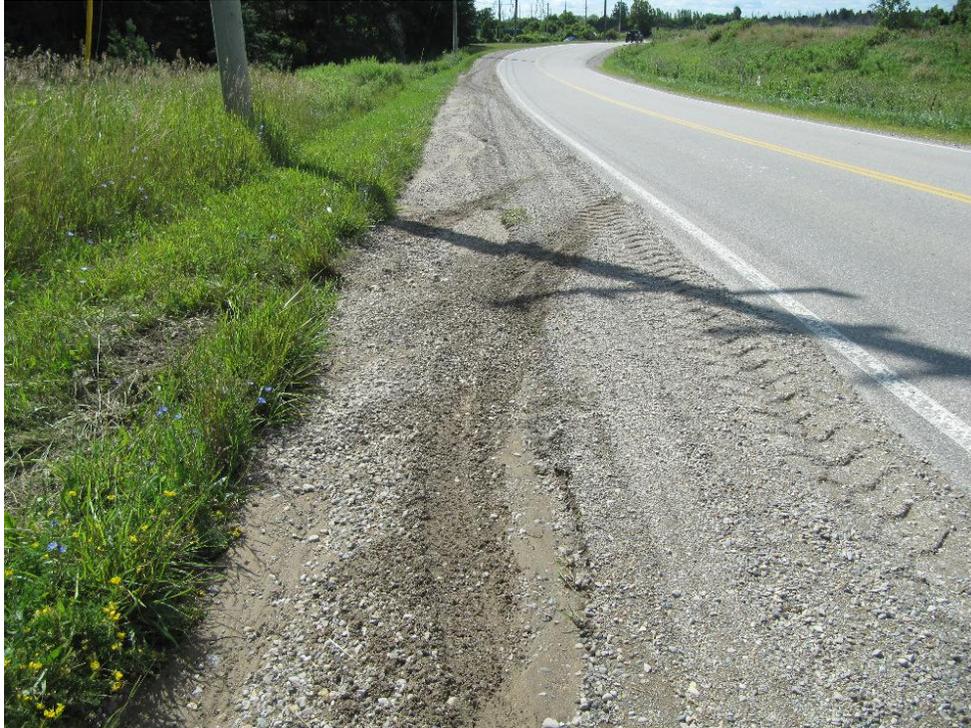
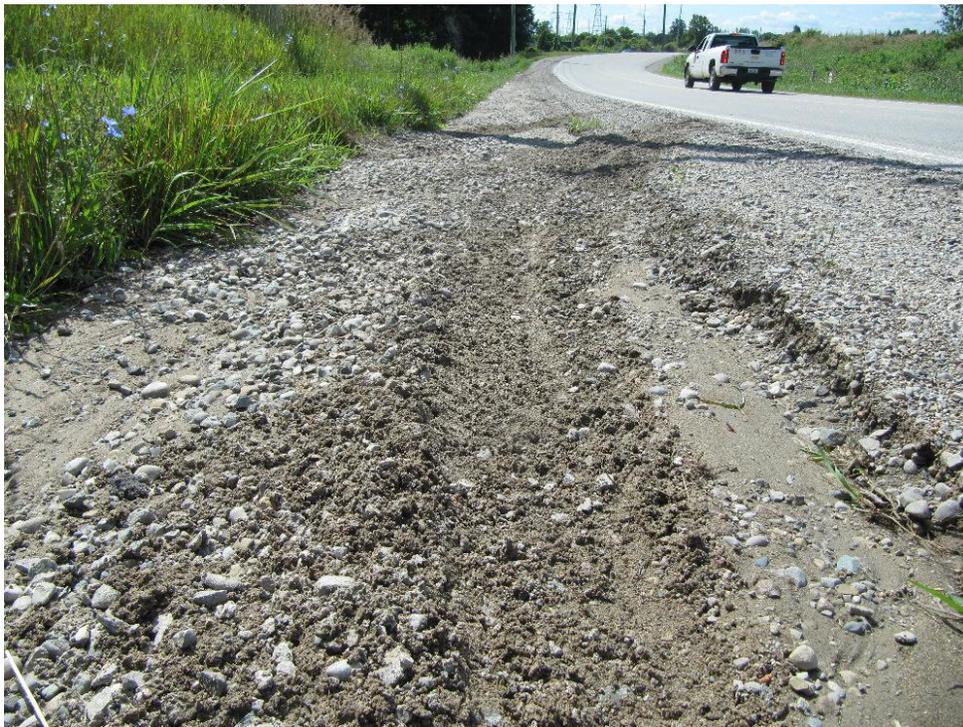
The side-slipping portion of the tire marks is further evidenced in Figure 21 and in the closer view of the left side tire mark shown in Figure 22.

Figure 21: View of side-slipping portion of tire marks.

Figure 22: Closer view of the left side tire mark showing its side-slipping portion.
