Fall Crops And Intersections Pose Line of Sight Problems

Posting Date: 31-Oct 2011

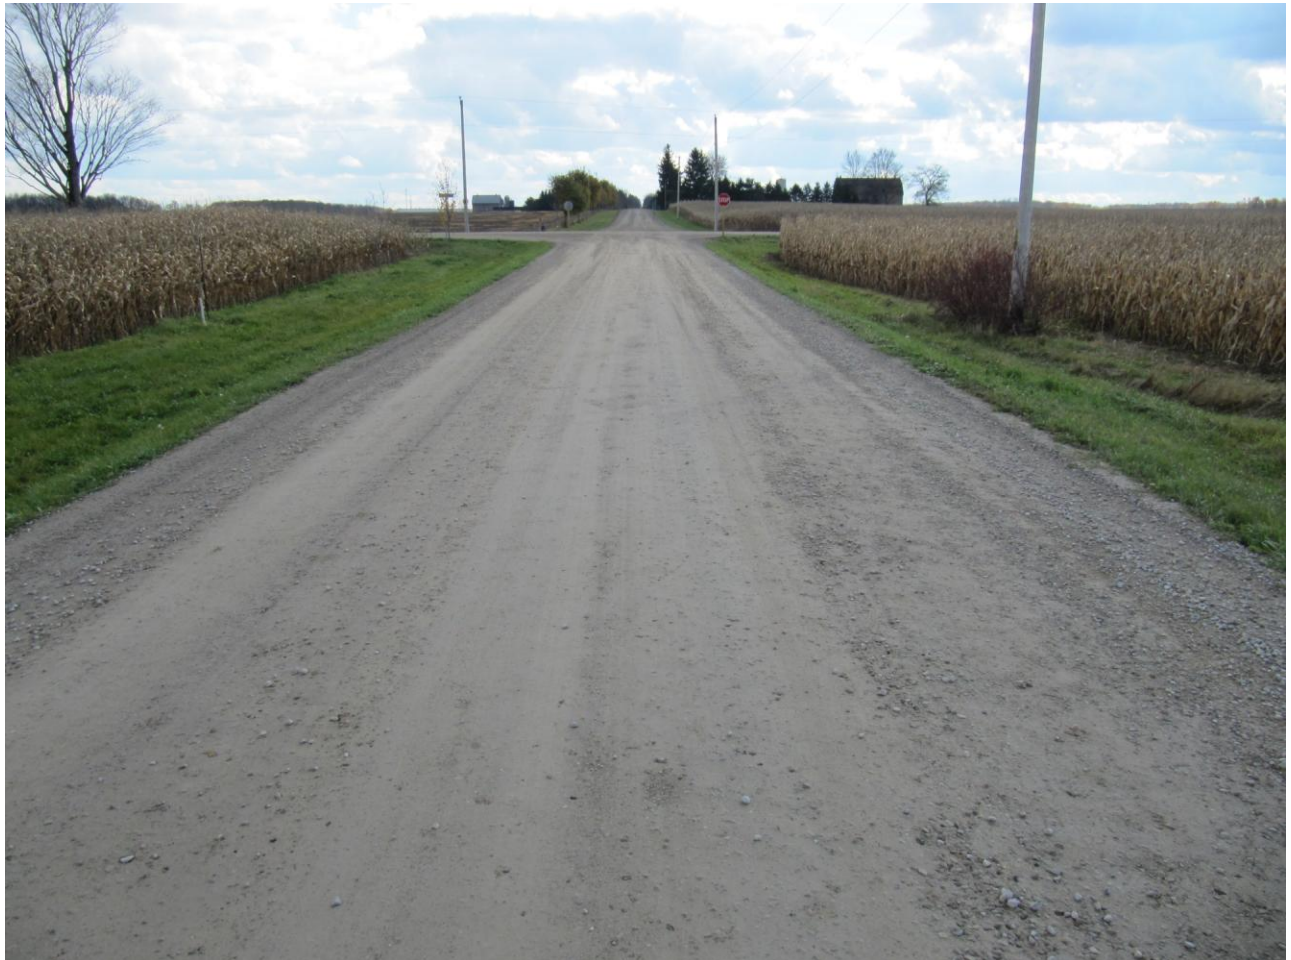
The site of the ATV collision is an example of what can happen when corn and a poor understanding of visibility issues are combined at an intersection. Below is a view of the subject intersection, looking south along the 11th Line as you approach the intersection with Cassel Side Road which travels east/west (left/right in this view).

The photo above is the view that would have been available to a driver travelling southward in same direction as the young ATV rider. An eastbound vehicle would have been travelling from right to left in this view and you can see the crop of mature corn that is soon to be harvested. The issue of concern is how close the edge of the corn is to the right-of-way of the road. Let's get a little bit closer (south) as shown in the photo at the top of the following page. And then as we get closer, we show another view (bottom of the page) showing the view toward the east around the corn crop.

obstruct our line of sight so that when someone does miss seeing a stop sign a collision can still be avoided through braking and steering by either or both drivers. I will not go into the details but a visibility triangle must be ensured so that the driver on the main road has about a 3 second opportunity to see the offending vehicle. Such a limited time is often enough so that the driver on the main road can apply braking and delay their entrance into the intersection and thereby allow the offending vehicle to pass ahead. Of course there is no guarantee of success since the offending driver might also apply his/her brake and a collision might still occur. But the altered collision would still be at a lower speed and the collision severity might be reduced. So the comment that "nothing can be done" is simply an uninformed comment.

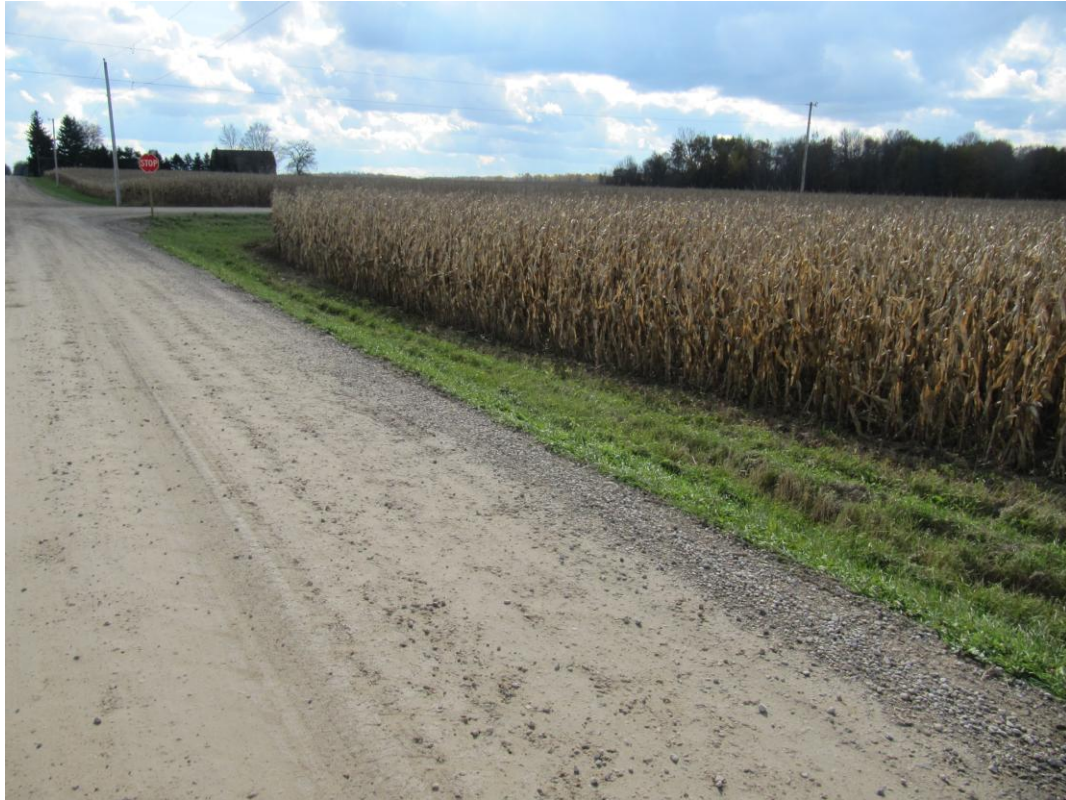
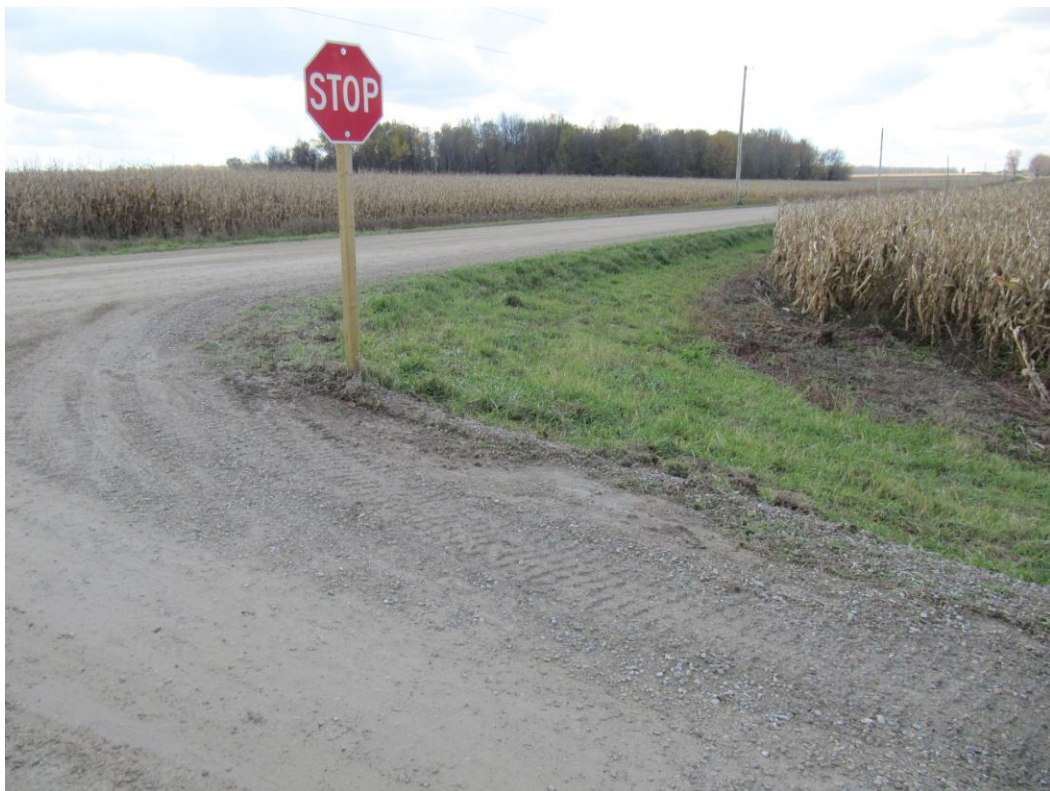
Now, these are the views that might be available to our road inspector who is sitting in his/her large pick-up truck because these photos were taken with me standing up. If you

look closely at the last photo it would appear that you can see a considerable distance along Cassel Side Road above the crop. But the view of a passenger car driver would be similar to the scenario where I would kneel down on one knee when taking the photo. You can imagine what would happen to this view if I had taken the photo from that lowered position.

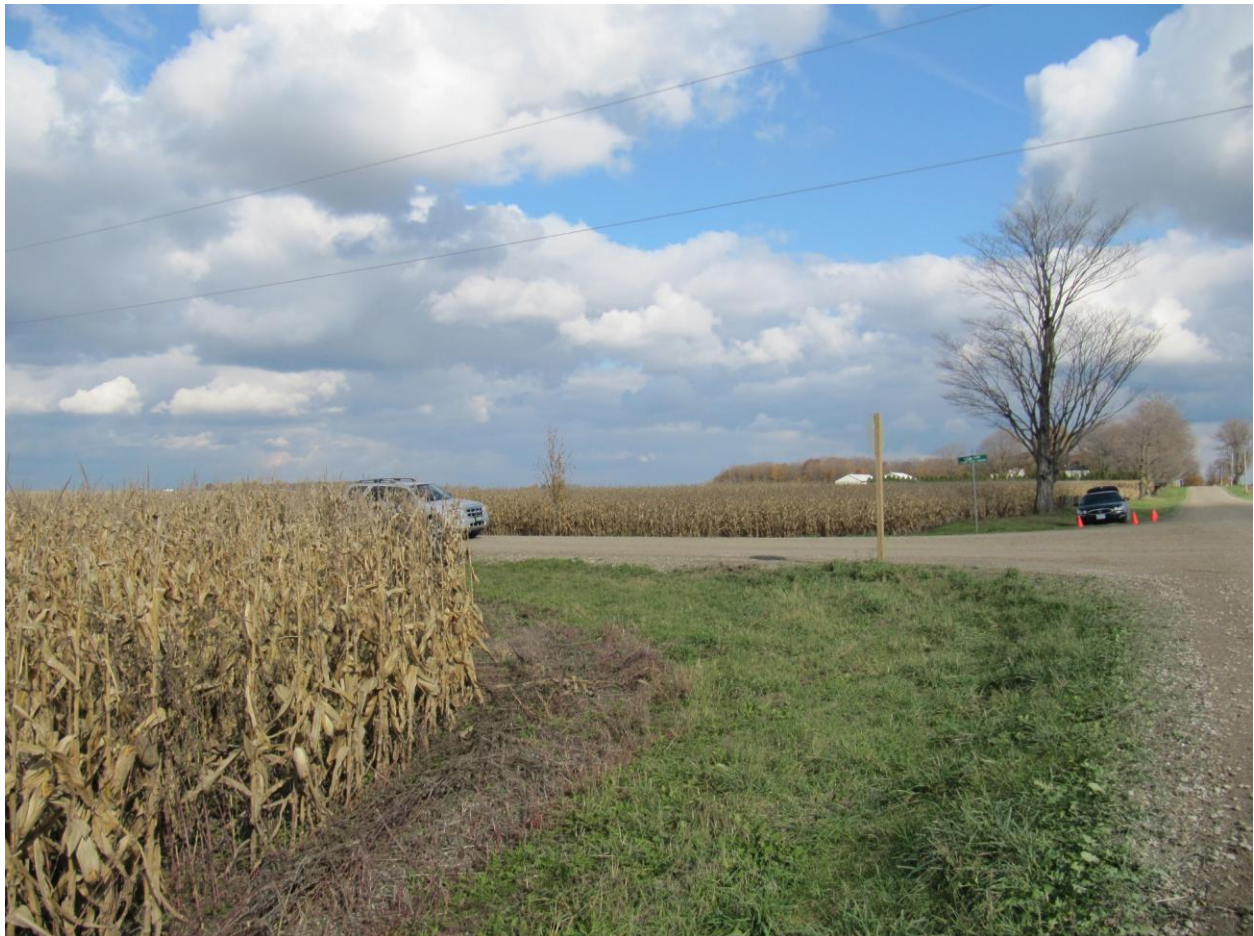
Similarly, looking from the eastbound driver's perspective, the view below is taken from about 25 metres west of the intersection and standing on the north road edge, and looking generally northeast toward the intersection. If you look closely at the edge of the corn crop you will just be able to see the front end of a southbound SUV. Remember, I am standing, not kneeling down to a passenger car driver's position.
