Farm Machinery On Highway Exceptional Danger In Fall Season

Posting Date: 22 Sep 2010

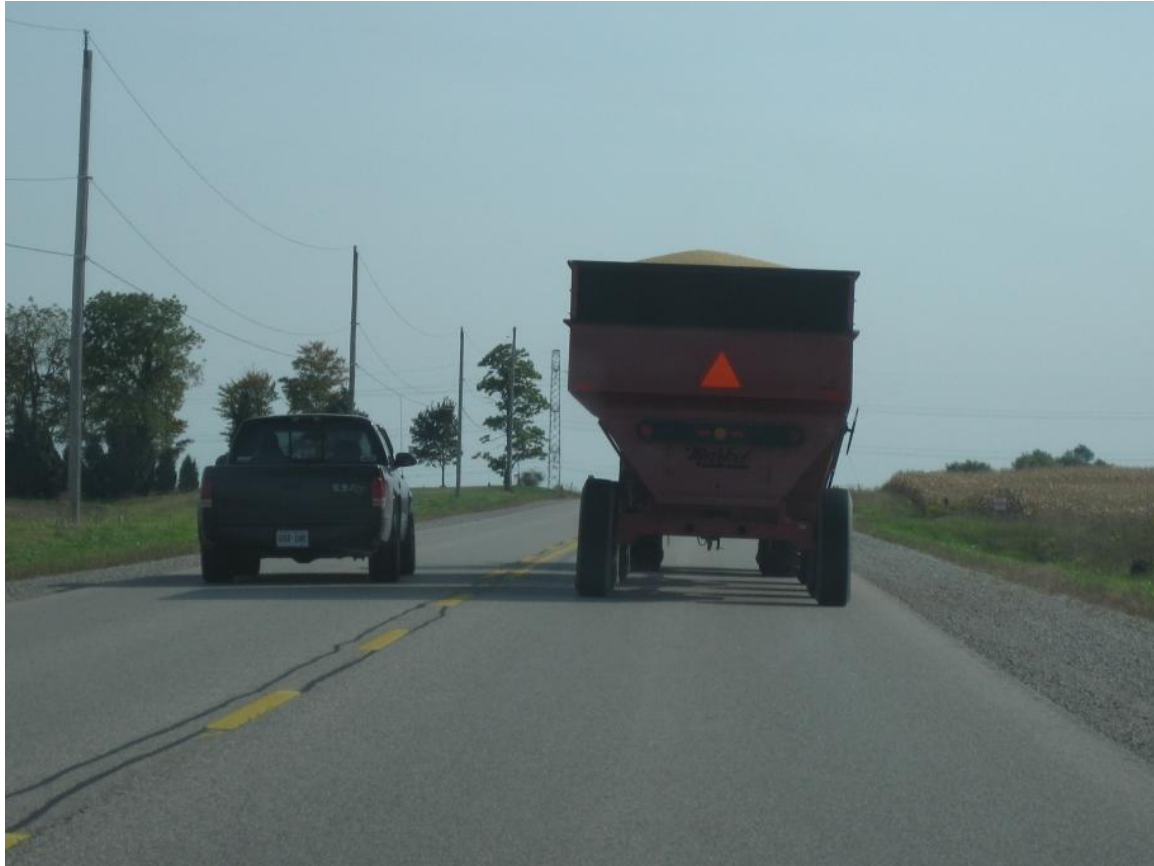
The grain (gravity) trailer in the above photo was being hauled by a slow tractor in the centre of the lane of a fairly busy rural highway. Note that the gravel shoulder is fairly wide and unobstructed and could have been used by the farm vehicle. Note at the top of the trailer that the grain is above the top edge line of the trailer indicating that it is completely full with grain and therefore the reason for travelling so slowly.

If you look at the centre-line marking you will note that the "passing allowed" zone is coming to an end and the "No Passing" zone has commenced. Yet, you can also see a pick-up truck that is passing the trailer and is parallel to it at the location of the no passing zone. So there had been ample distance to pass this trailer a few seconds before but the Pick-up truck driver was unable to do so because of traffic approaching in the opposing lane. With the opportunity to pass nullified the Pick-up driver would have

to wait a considerable time and distance before reaching the next zone where passing is allowed. Rather than wait the driver has decided to pass anyway.
