Fatal Loss-of-Control Collision on Gideon Drive Is A Testimony For Seat Belt Use

Posting Date: 13 Jul 2010

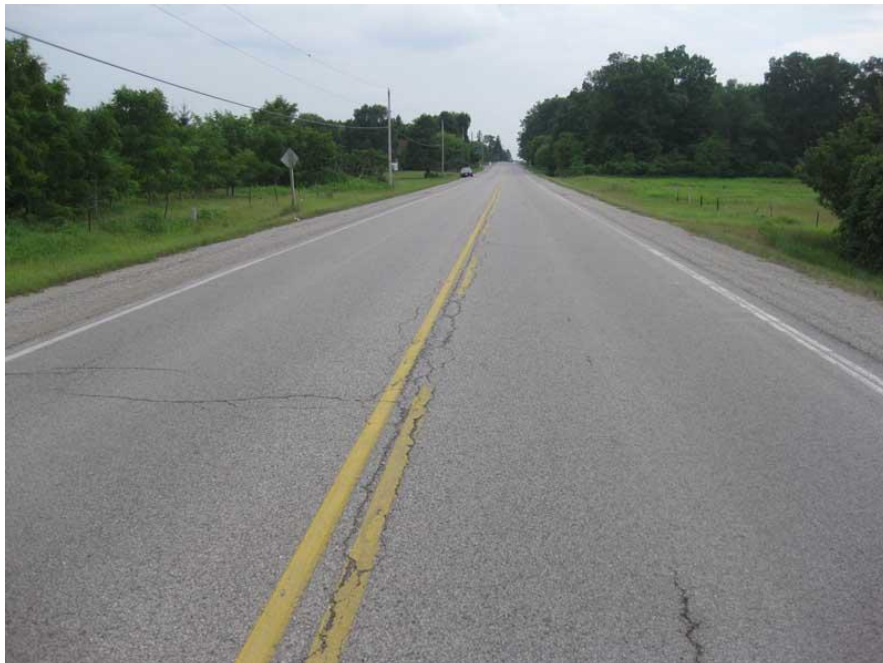
First, here is a photo of the accident site, looking west, taken from several hundred metres east of the final rest position (FRP) of the vehicle.

The Pick-up truck travelled off the road surface just behind my car which is parked on the south shoulder of the road. What is not apparent is that just behind the camera is a curve in the road such that the Pick-up truck would have travelled perhaps 300 to 400 metres past the curve before it finally left the road.

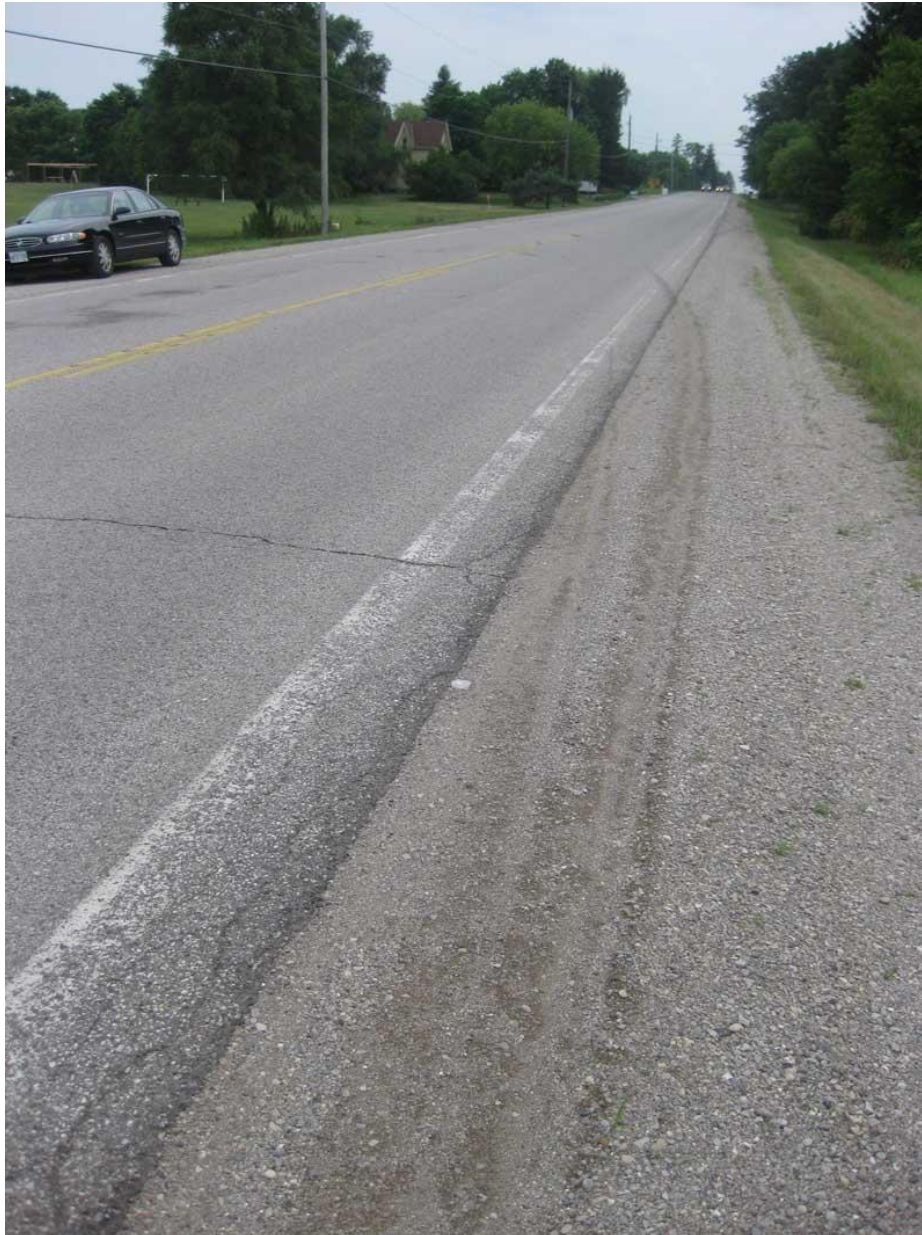
Below is another westward view but showing the tire marks on the north shoulder where the Pick-up truck travelled before crossing the road toward its eventual rollover on the south roadside.

The presence of such tire marks is fairly routine as this is the most common manner in which vehicles begin their loss of control.

What is unusual is that at this point the Pick-up truck is not travelling very quickly. This can be observed by noting the angle of the "yaw" marks as they cross the road. When a vehicle is travelling very quickly it cannot change its travel direction "very much" in a short distance. This means that tire marks are generally more parallel to the road length as opposed to being at a considerably angle to the length of the road. Certainly one could take a chord and middle ordinate of the yaw mark and make a calculation which would demonstrate this but that is not always needed. Simply looking at the angle of the tire marks to the length of the road can provide an experienced investigator with a clue as to the vehicle's general speed. Besides that, you will also note in the following photos that, once the vehicle began its rollover it did not travel very far to its final rest position - another sign of the vehicle's speed.

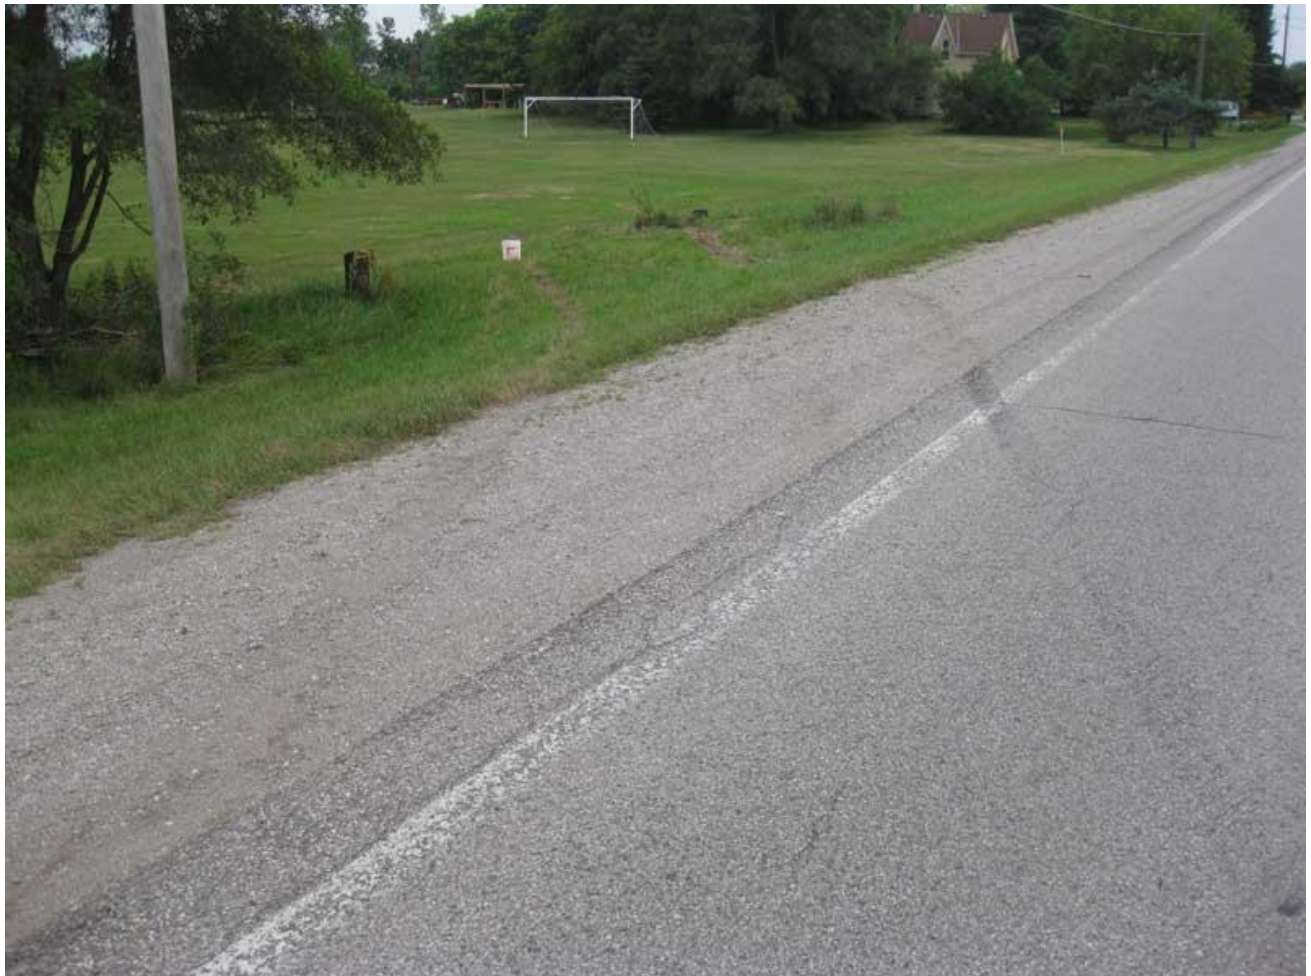
So the photo below shows the tire marks as they cross the roadway and head toward the south roadside.

You can see from the tire marks that the Pick-up truck is upright and leading with its right side as it heads off the road. The tire marks end abruptly as the vehicle encounters a small elevation change just before the vehicle enters onto the soccer field. This is

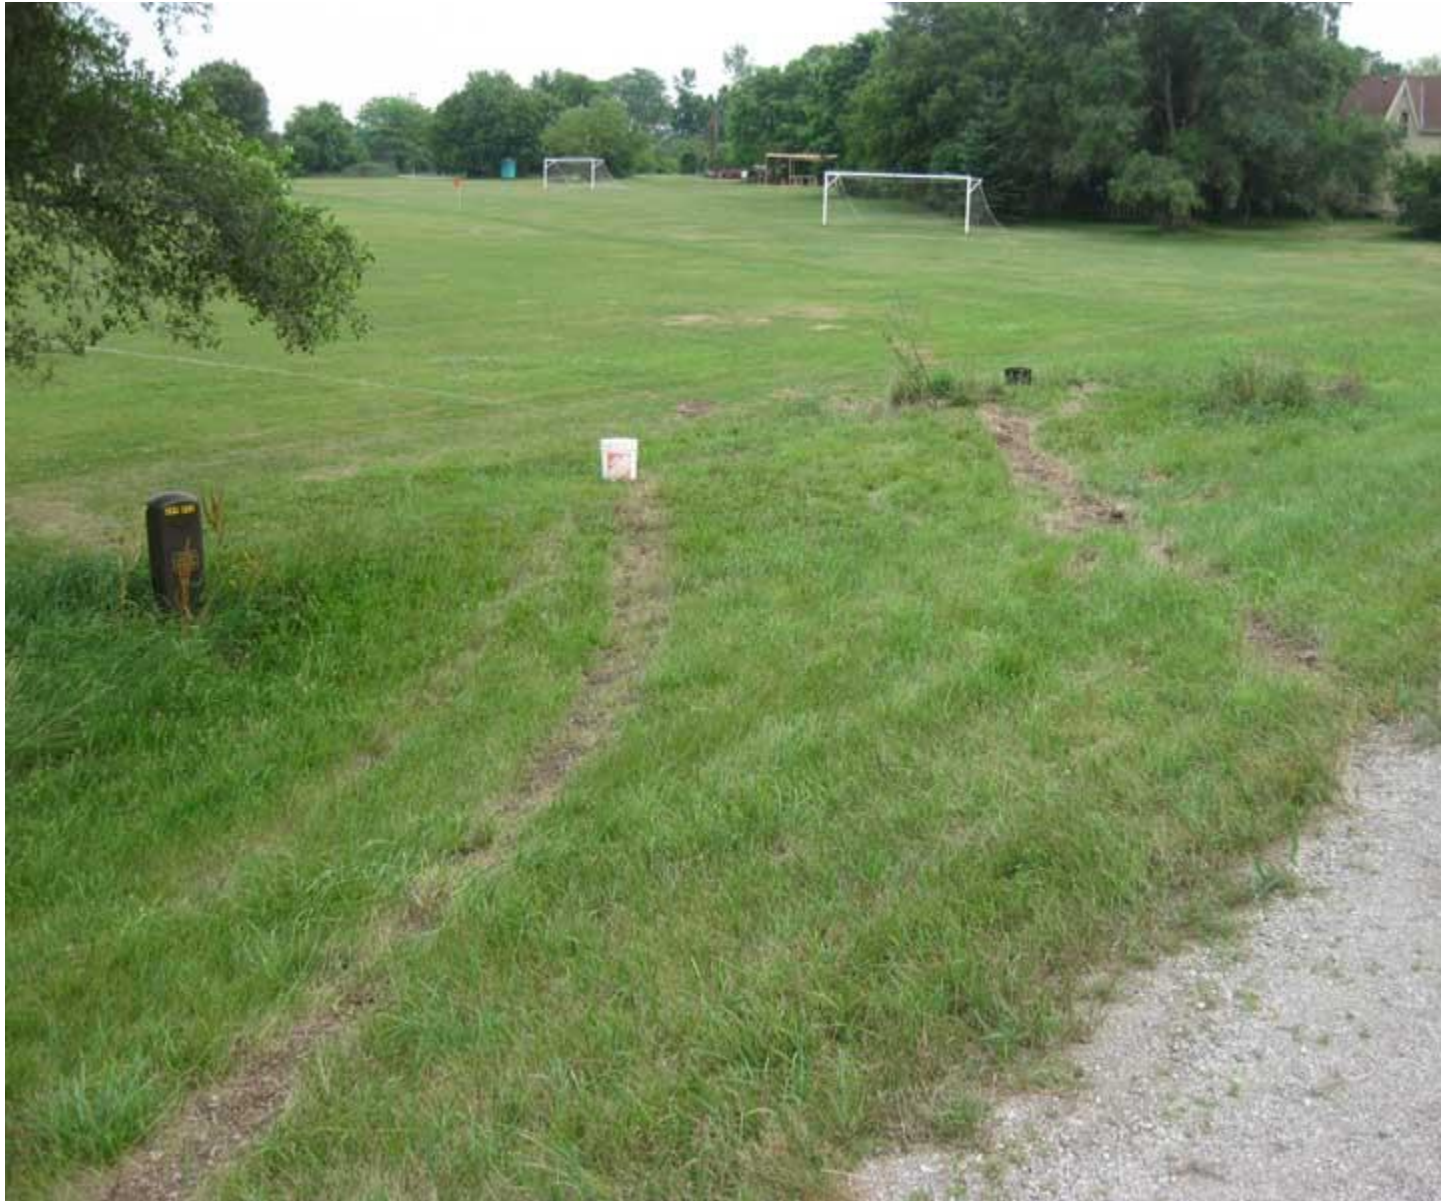
where it began to rollover. Below is a further view along the vehicle's path to its final rest position.

Someone placed some plastic bins at the points where the tire marks terminated and the rollover began. You can note the final rest position of the Pick-up truck by the dead (yellow) patch of grass in the background. The fluids such as battery acid, coolant, oil, etc. seep out of the vehicle at its rest position and this is what kills the grass - it is fairly simple to locate the final rest position of a vehicle by recognizing such evidence.

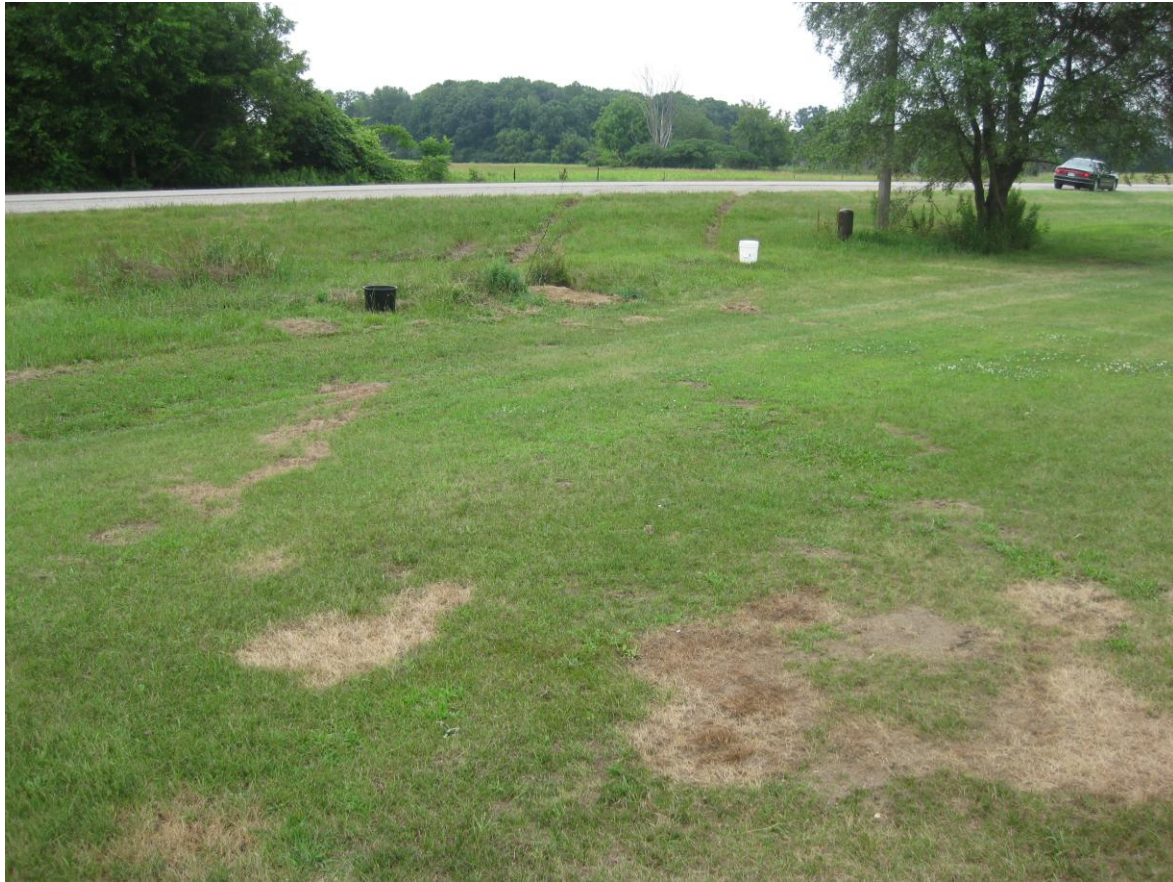
The final photo shows the view from the opposite direction, looking north-east from where the Pick-up truck came to rest.

What should be obvious to you is that the vehicle did not travel very far after beginning its rollover - certainly less than 20 metres. This is the tragedy of this event. This was a simple rollover that would likely have resulted in minimal or no injury had the driver stayed inside the cab. A rollover at this speed would not result in any roof crush or anything that would harm a driver as long as a seat belt was properly (snugly) worn. Unfortunately, as happens so often in these events, a person does not think of using a seat belt and this is the tragedy that results.
