## Felecia Ann Pearson Fatally Injured And Possible Cause Not Discussed

*Posting Date: 05 May 2011*

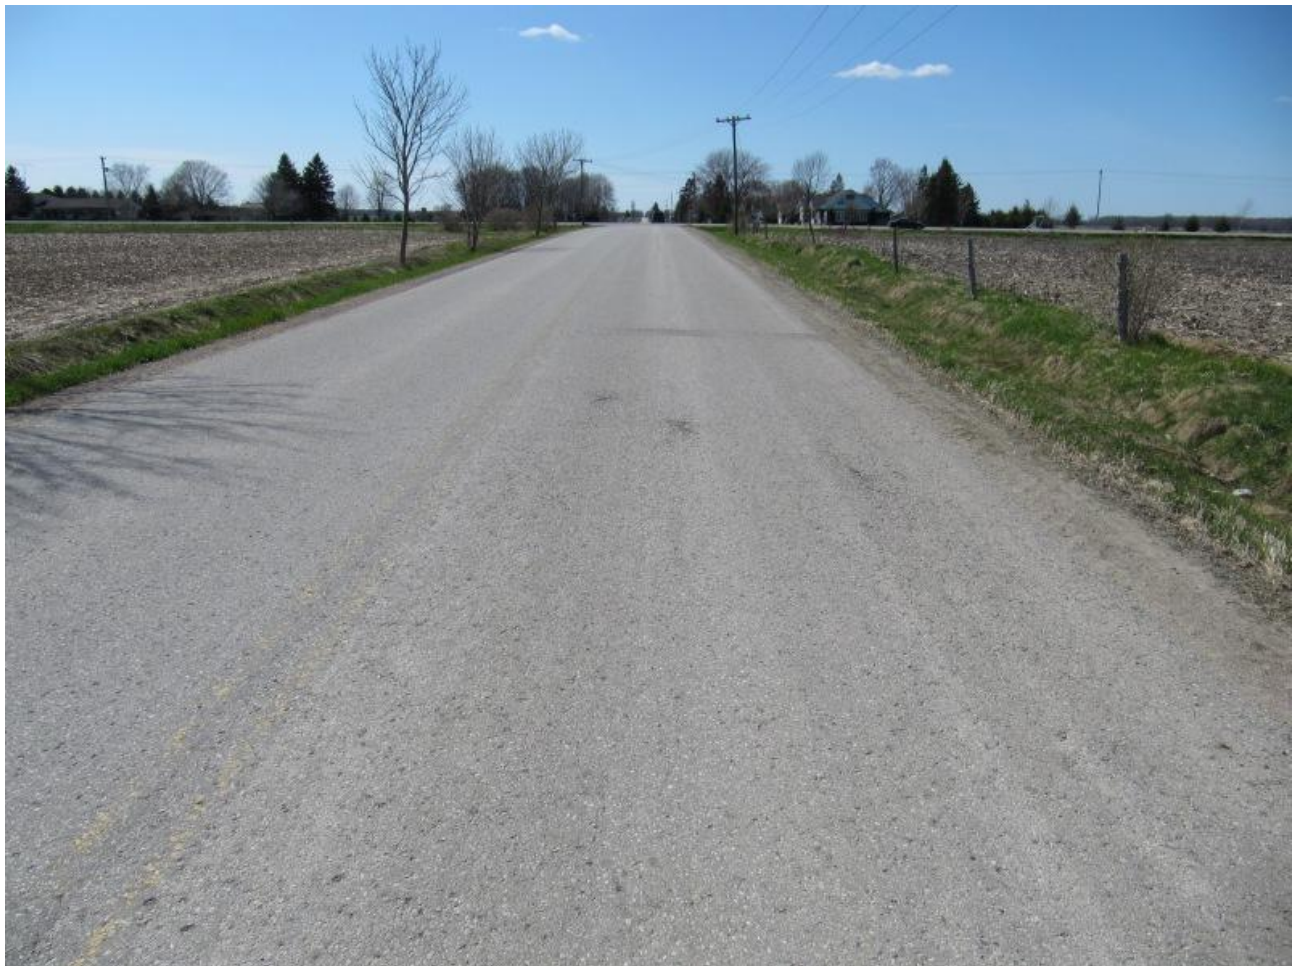
The photo below is looking west and was taken from 150 metres east of the intersection. Pearson was westbound on this Concession Road and this view shows that the line of sight to the north or south along Wellington Road #9 appears to be relatively unobstructed.

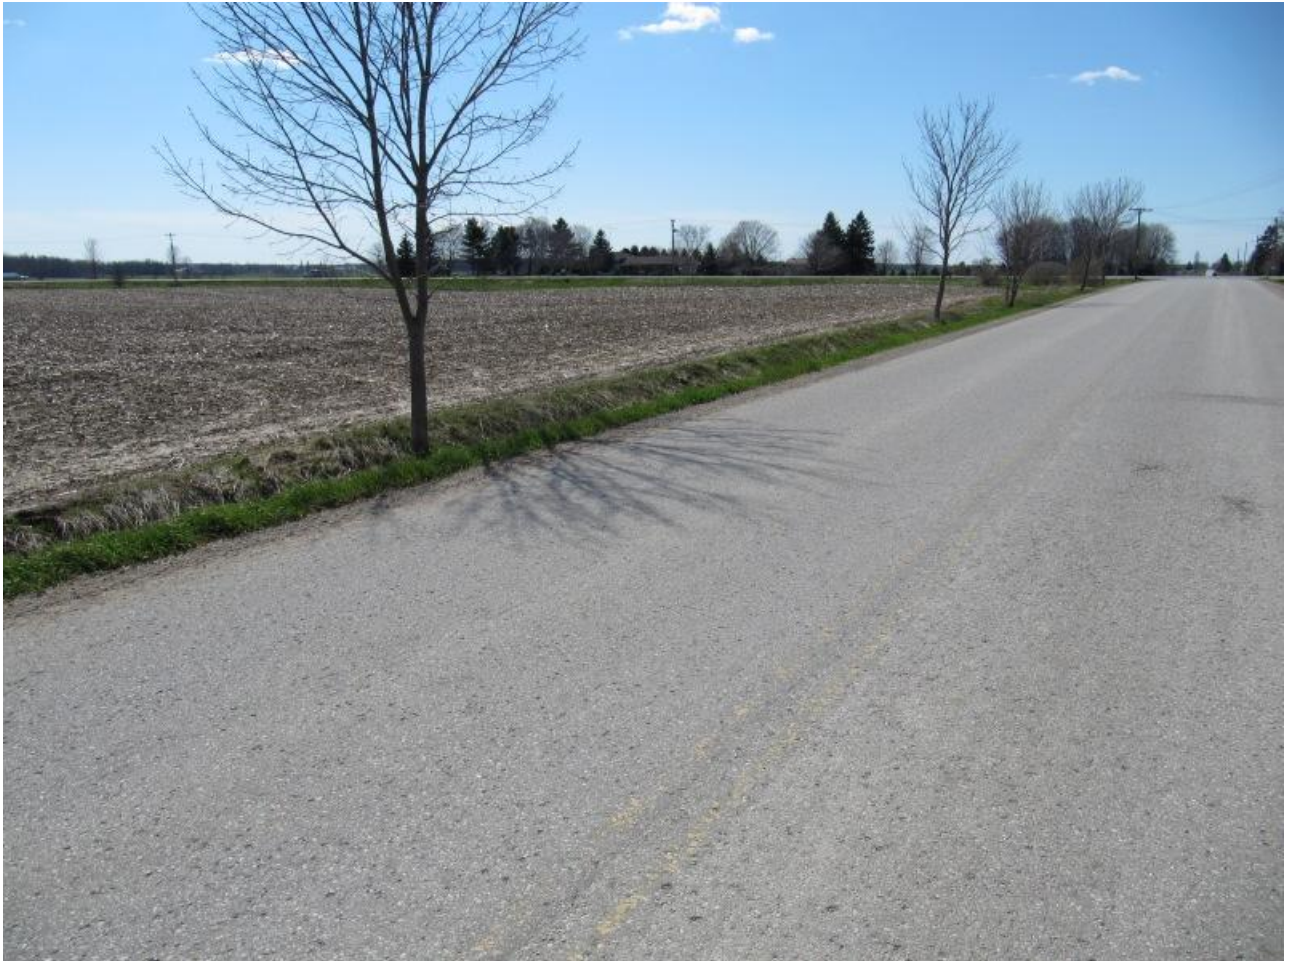
The photo below is also from 150 metres east of the POI but I turned my camera more to the south so that you can appreciate the relatively open view on approach to the intersection. The Pick-up truck that struck Ms. Pearson's vehicle was northbound on that intersecting road.

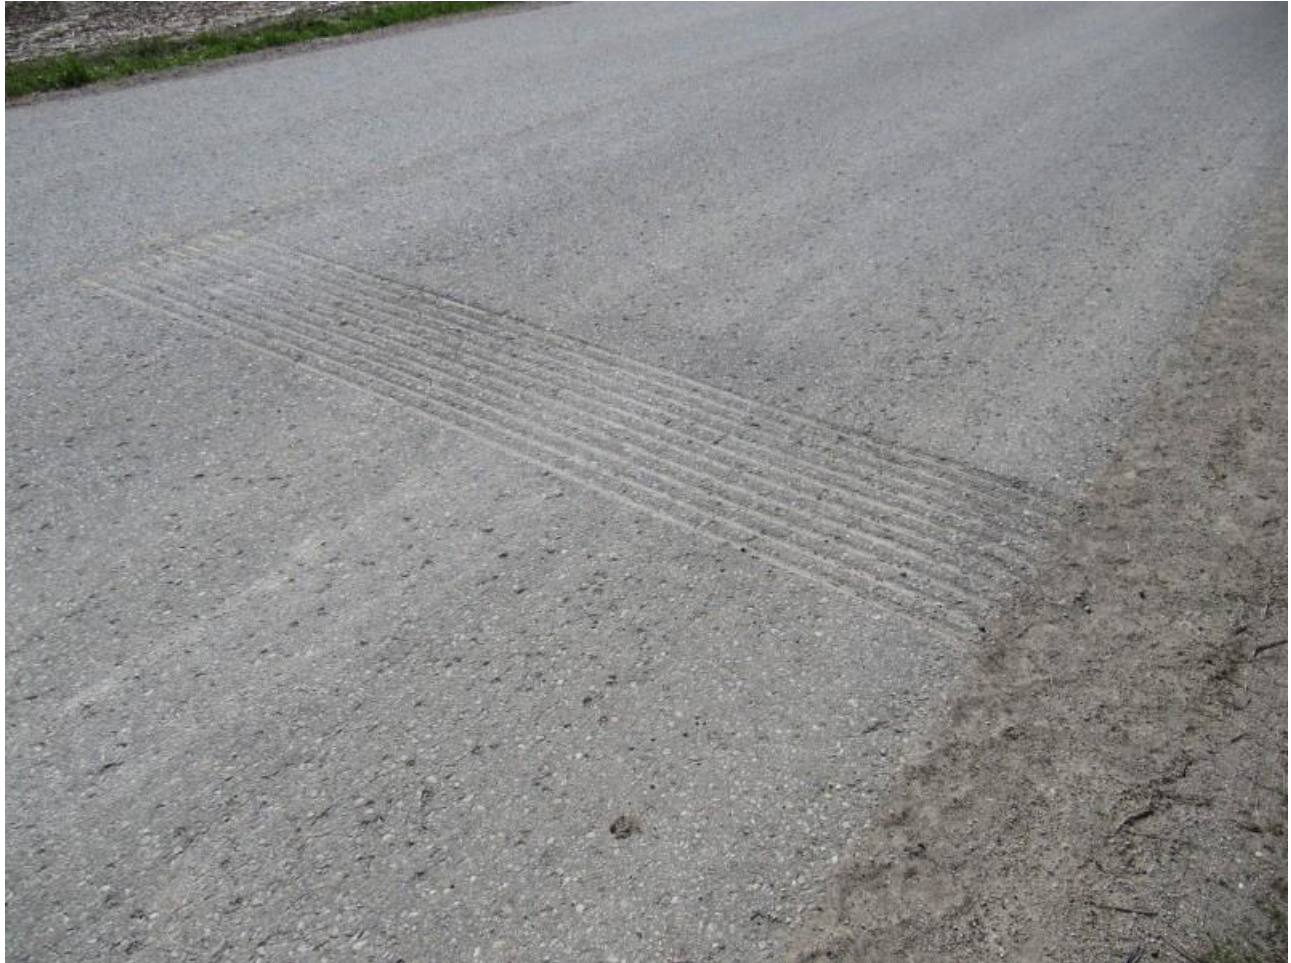
In the photo below I show you the characteristic rumble strip located at 136 metres east of the point of impact (POI).

My experience has been that these rumble strips do an excellent job of waking up a driver and I believe that very few drivers actually drive through a stop sign whenever such rumble strips are in place. So I am rather skeptical when I hear the news media indicate that Ms. Pearson travelled through the stop sign without stopping.

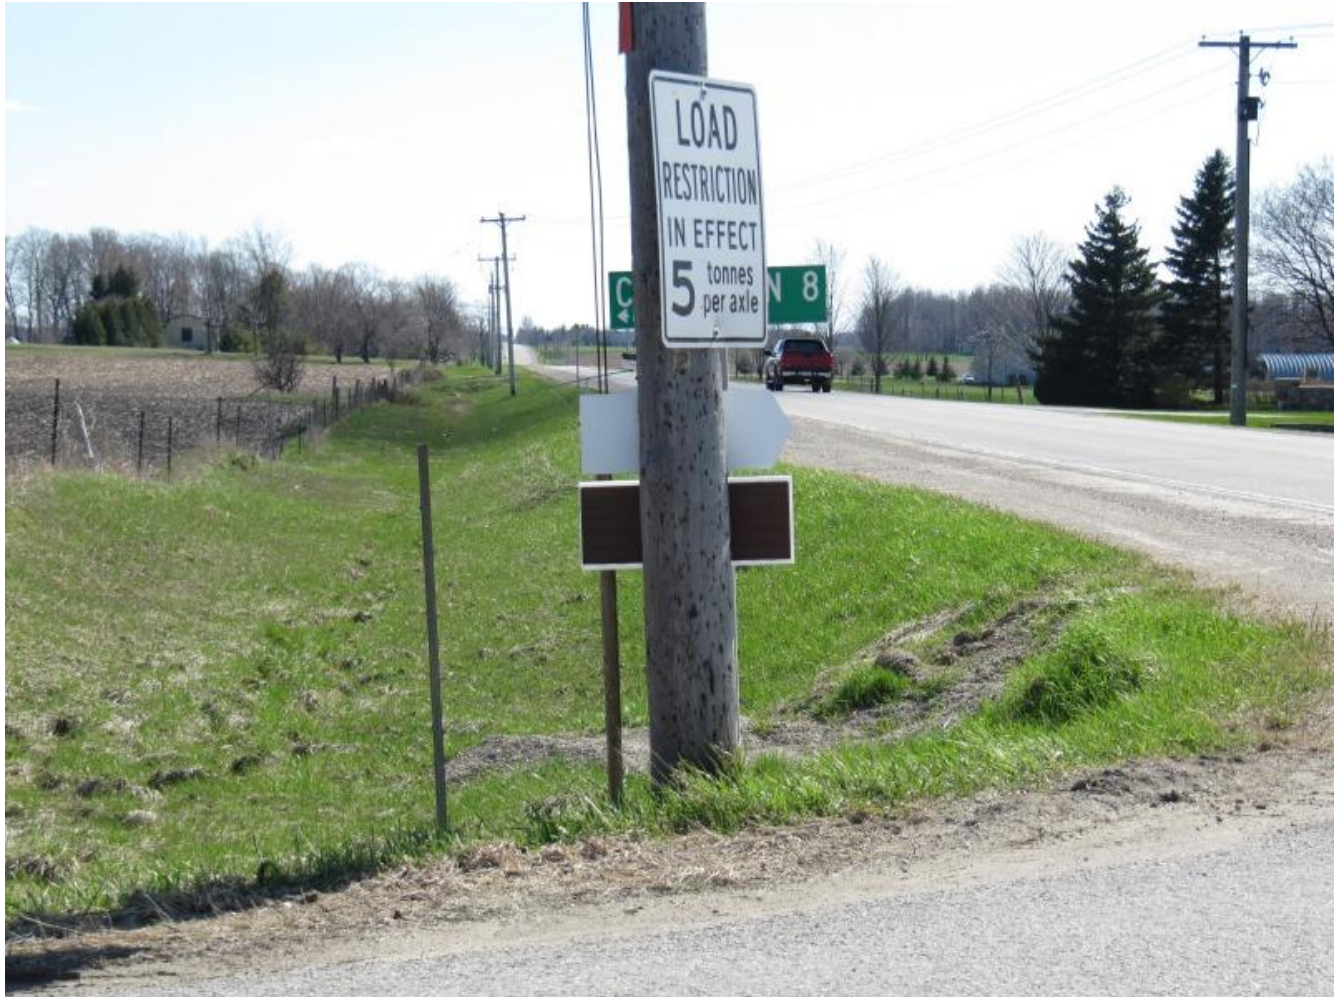
I become more skeptical when I get to the intersection and look to the south in the manner that Ms. Pearson would likely have to do in order to determine whether it was safe to enter the intersection. The photo below shows what she might have seen as she looked to her left (south).

Depending on the actual vertical position of her eyes the post, and more importantly, the signs on the post could have obscured her vision of northbound vehicles along a considerable time and distance.

But here is an issue where this young woman may be blamed for "not yielding the right of way" as is done so often in police investigations, yet roadway flaws, whether geometric, signage or maintenance, are simply whisked aside as if they never existed. Why are these signs located on this post. Why is the post there? Does no one understand that you cannot block a driver's line of sight at an intersection? Will the signs remain there until the next victim comes along because no one has bothered to identify their existence and relevance?

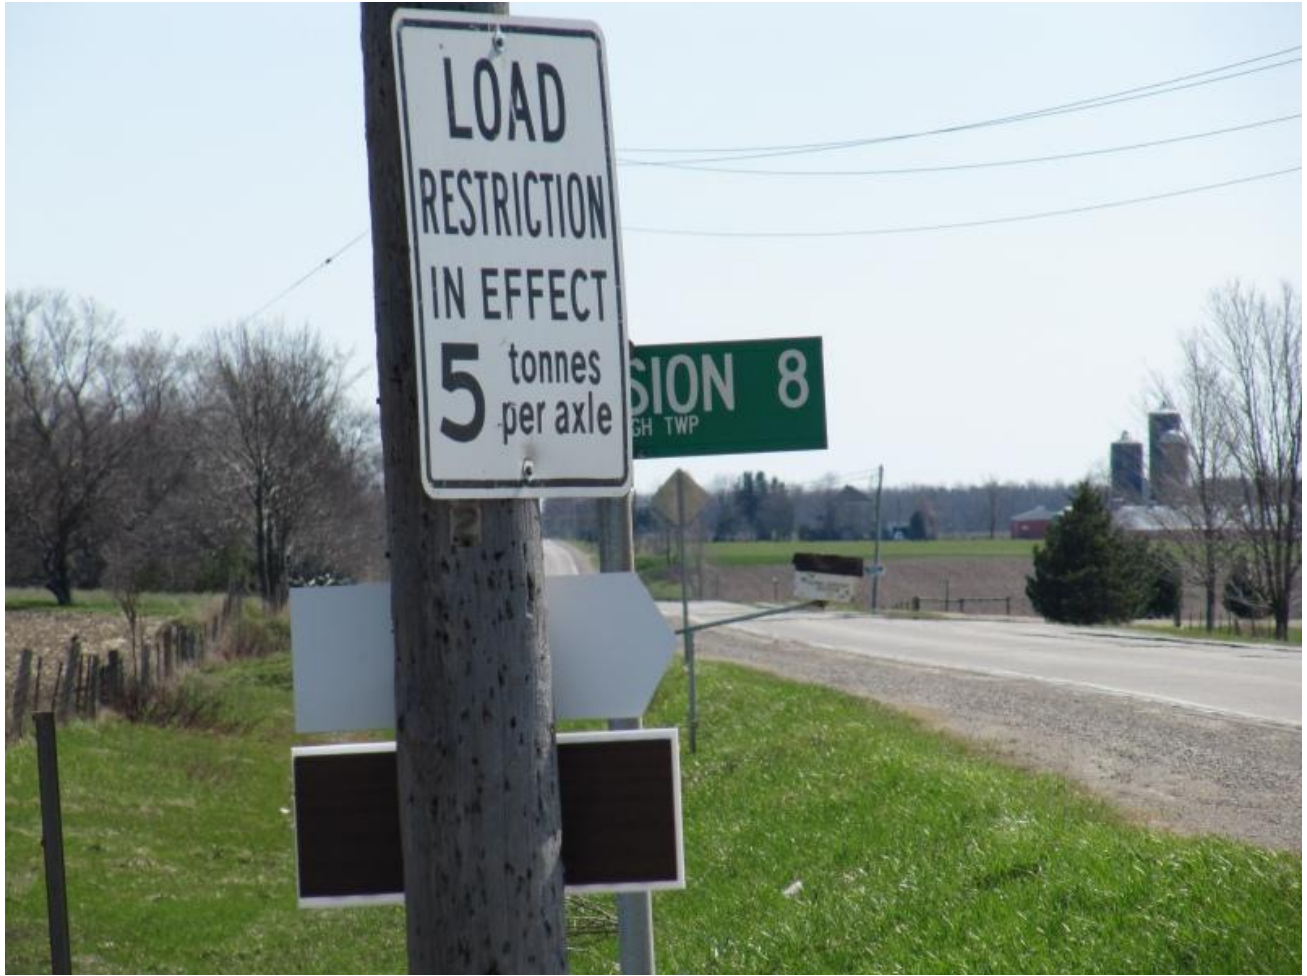
Below is another view of the post and signs.

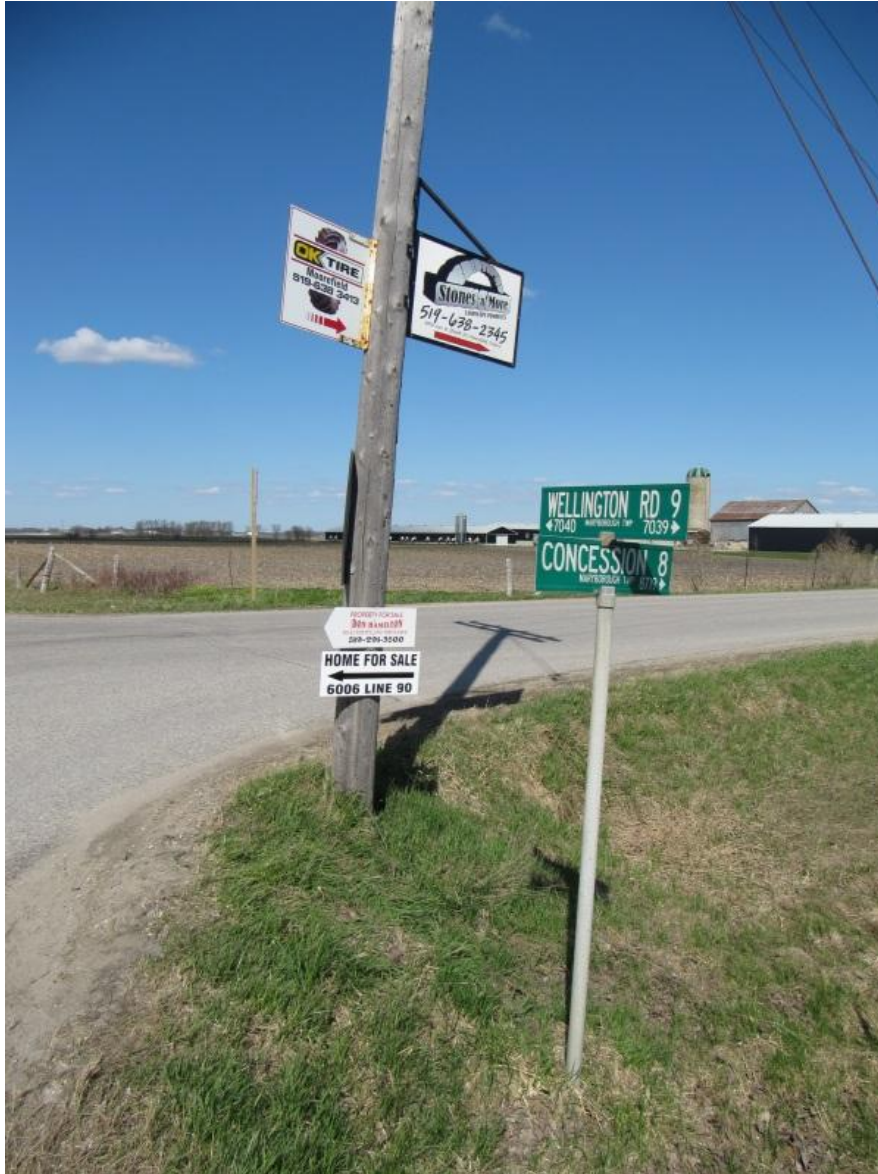
And finally a slightly different view.
