Good and Bad Roads Detected with Apple iPhone's Accelerometer and Gyros

Original Posting Date: 27-Oct 2012, Revised 25-Nov 2012

Gorski Consulting
London, Ontario, Canada

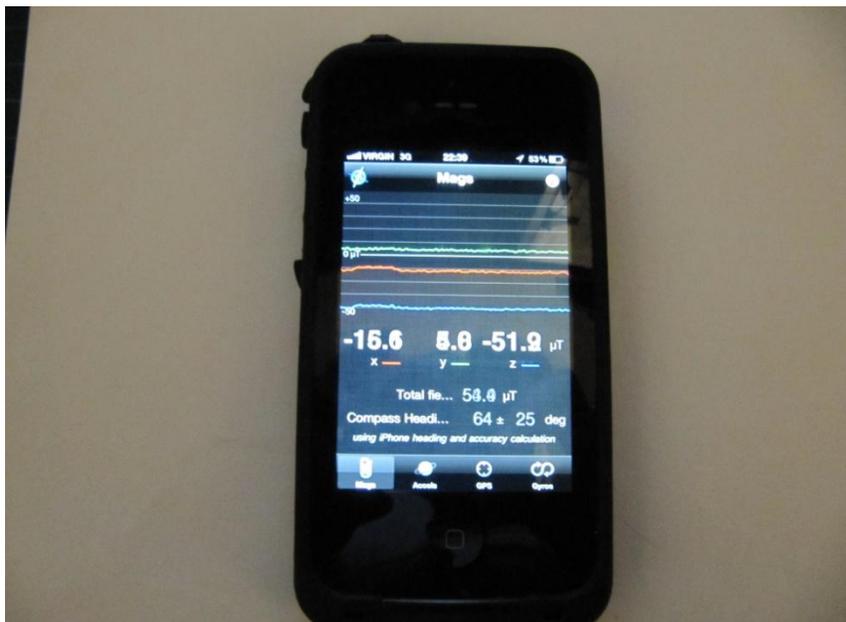
Figure 1: The XSensor app display on the Apple iPhone 4S

As an example, the XSensor app by Crossbow Inertial Systems provides the user with the ability to send a file that can be imported into an excel spreadsheet. The data can be captured at either 4, 16 or 32 samples per second. It can report data from four separate screens: Mags, Accels, GPS and Gyros.

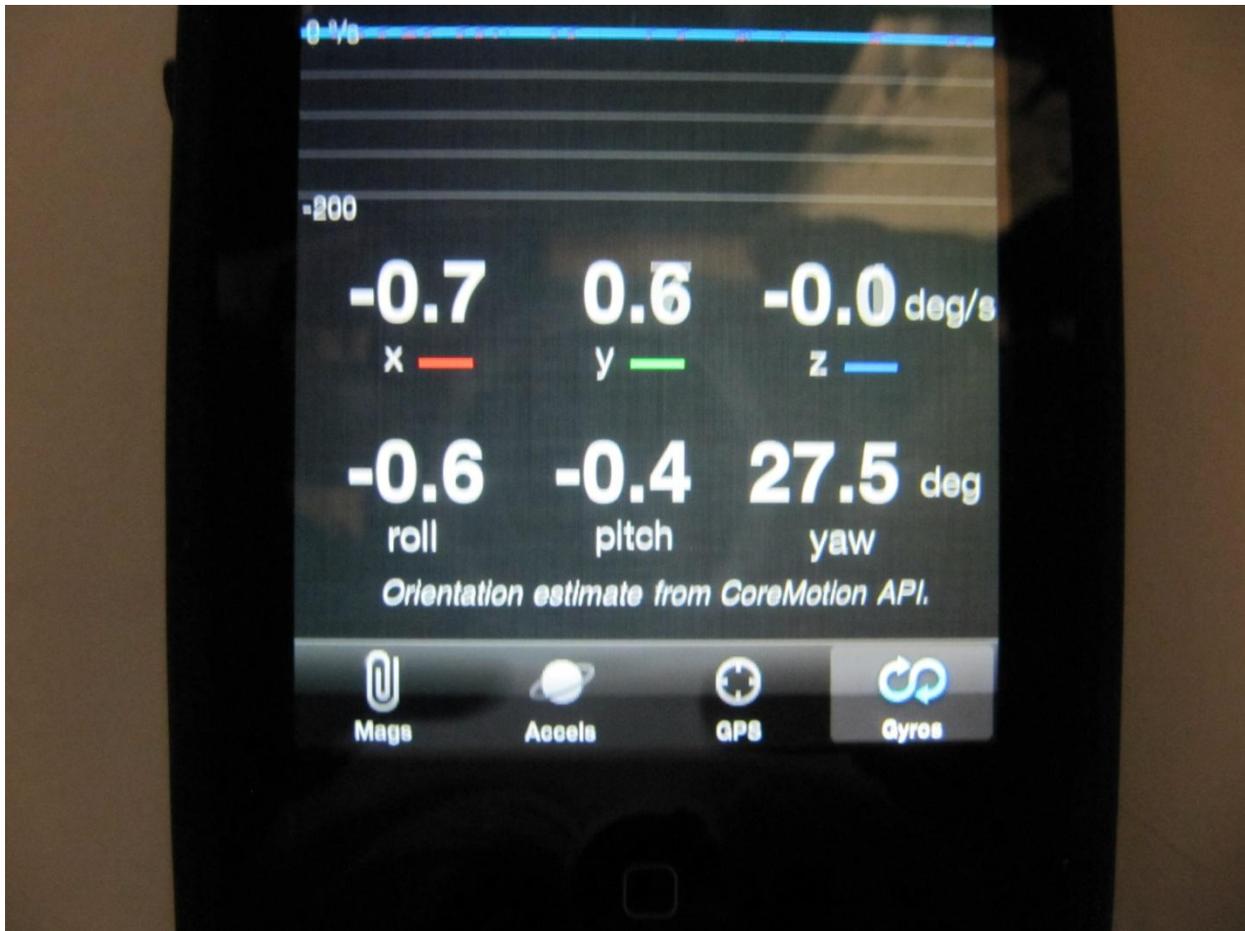
Figure 2: View of Gyros screen of the XSensor app.

The bottom row of numbers (roll, pitch and yaw) identify the present position of the iPhone with respect to its predefined axes. We are experimenting with the phone's placement however we found a solid position on our vehicle's centre console, with the screen facing upward and the top pointing to the right. There is a Society of Automotive Engineers (SAE) practice that defines the positions of axes with respect to a vehicle and we are exploring how that convention fits with the XSensor terminology. It appears that our current placement of the phone results in the mis-naming of the axes on the screen. However, the more important matter for our testing is to attain a secure position of the phone so that it is solidly anchored to the vehicle structure. The fact that the axes are mis-named, may be confusing but this is of secondary importance. For now we can say that, when placed in the above-noted position, the X-axis of the iPhone is a line that passes through the centre of a vehicle from front to rear thus rotation about this line would involve the rolling of the vehicle, for example, if the left side were to drop while the right were to rise. Thus the "pitch" variable is the one that signifies roll in this orientation of the phone. Similarly, the Y-axis is a line that passes across from left to right such that rotation about this axis would cause the front/rear of the vehicle to "rise" or "fall" and this is the "roll" variable. Finally the Z-axis is a vertical line passing through the centre of the vehicle such that rotation would occur if one were to turn a steering wheel sharply and cause a fish-tailing or yawing motion. This is the "yaw" variable

displayed on the screen. Therefore each value along the bottom row of the Gyro display informs the viewer about the extent of the phone's (and vehicle's) rotation with respect to each axis.

The top row of values (x, y and z) provides an indication of how quickly the present position of the iPhone is changing in degrees per second. In the present orientation the "x" value indicates how quickly the vehicle is moving side-to-side, the "y" value indicates how the ends of the vehicle "rise" or "fall" with respect to its centre-of-gravity and the "z" value indicates how quickly the vehicle is changing its pointing angle. All this detailed information can be helpful when a reconstructionist wants to study what road features might have contributed forces on a vehicle, such as in a scenario where a driver has lost directional control of a vehicle and crashed.

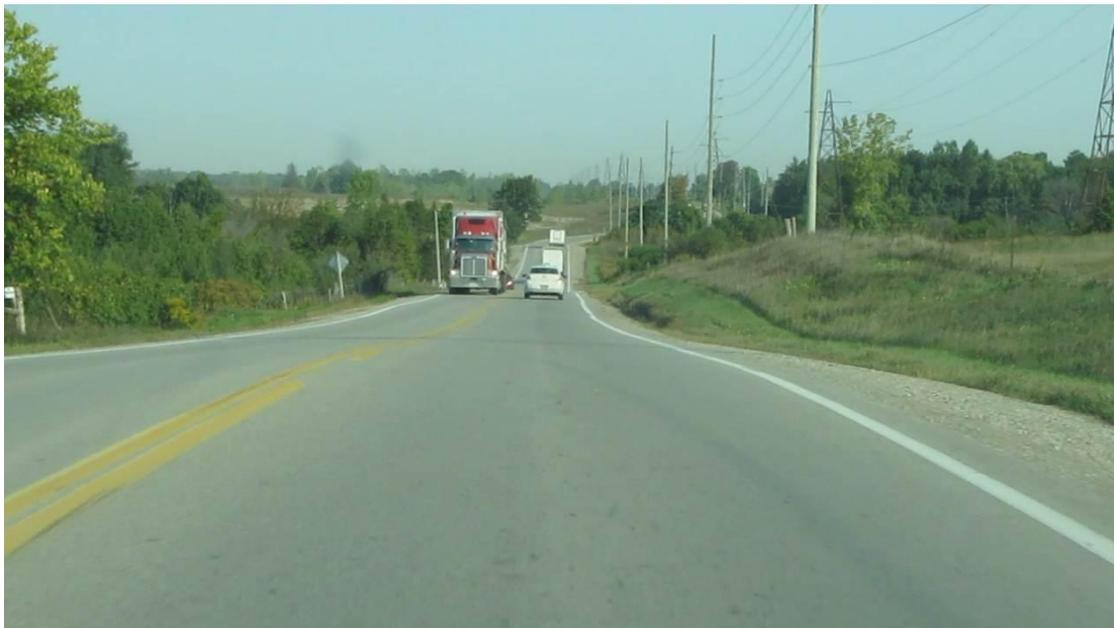
Figure 3: Looking north from several hundred metres south of the S-Curve.

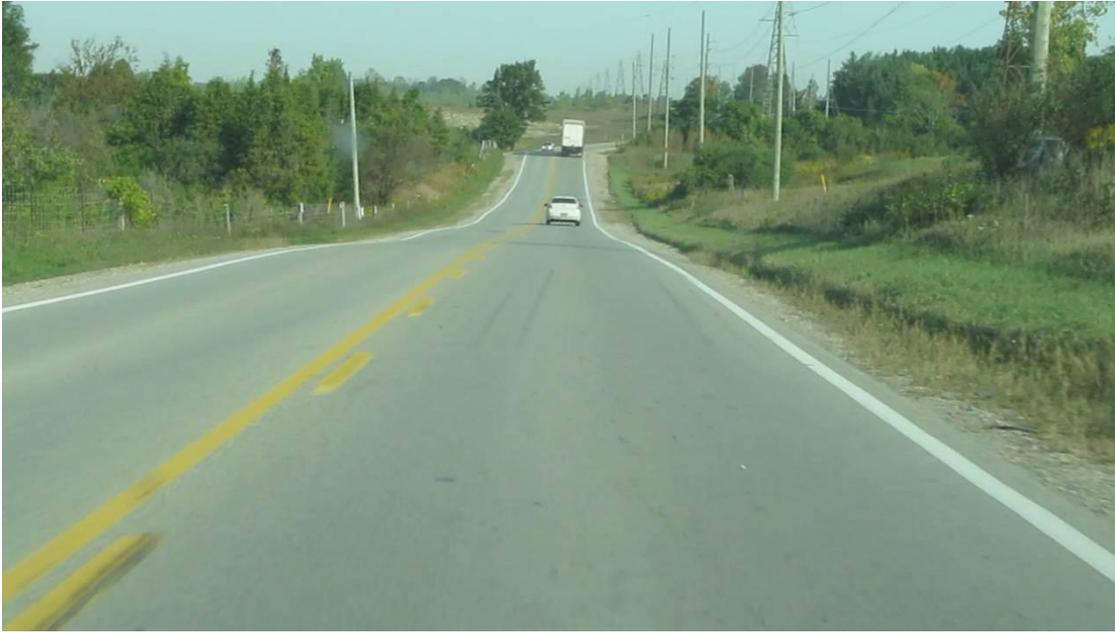
Figure 4: Northbound view, while travelling on the downgrade toward the S-Curve.

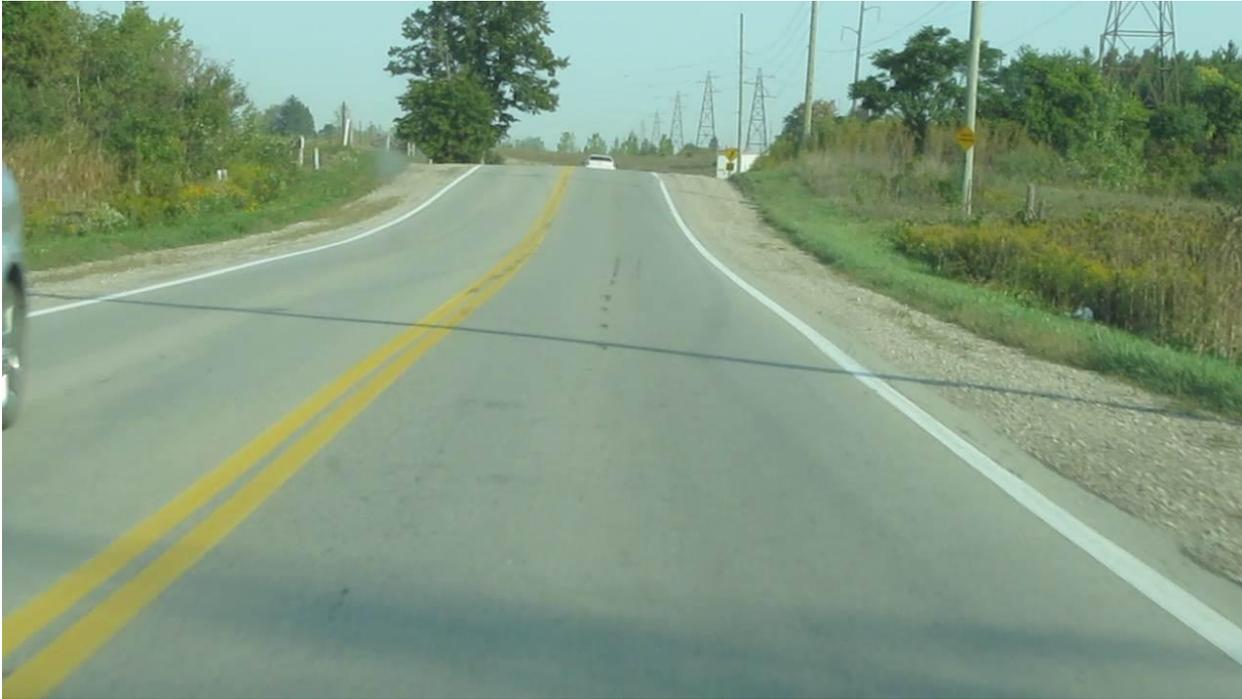
Figure 5: Northbound view, just prior to reaching the location of a manhole cover just south of the S-Curve.

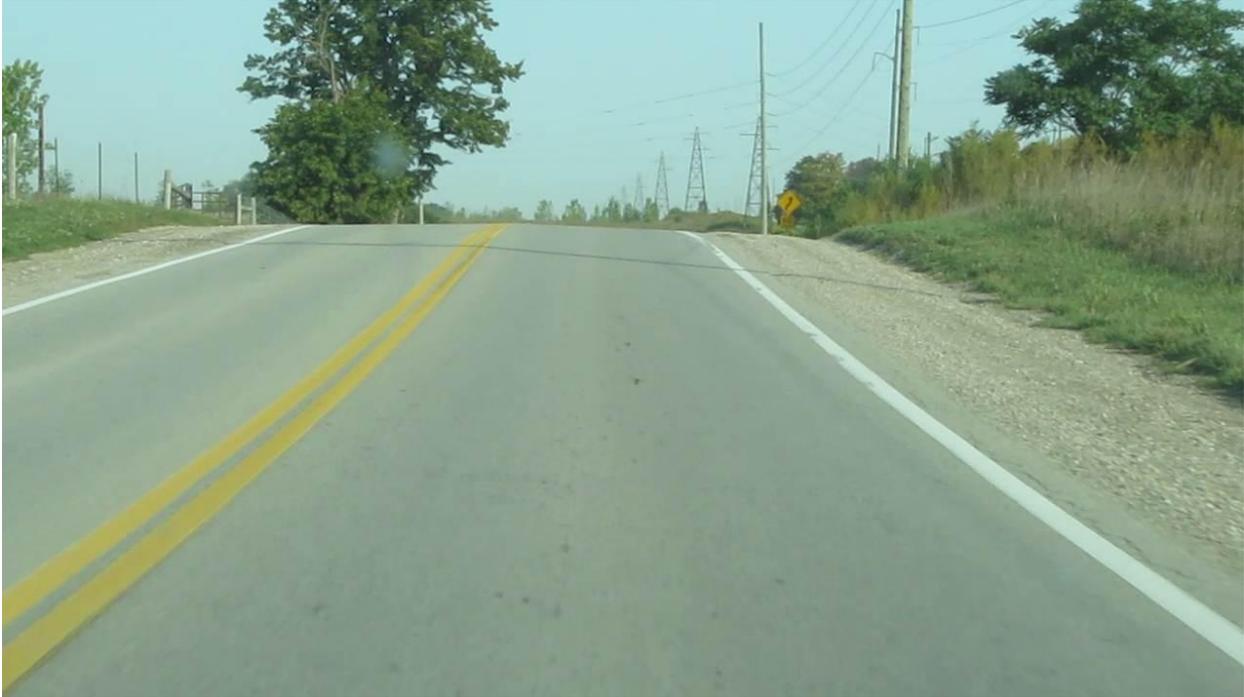
Figure 6: Note the yellow, curve-warning sign on the right roadside as we climb the small knoll just before reaching the manhole cover.

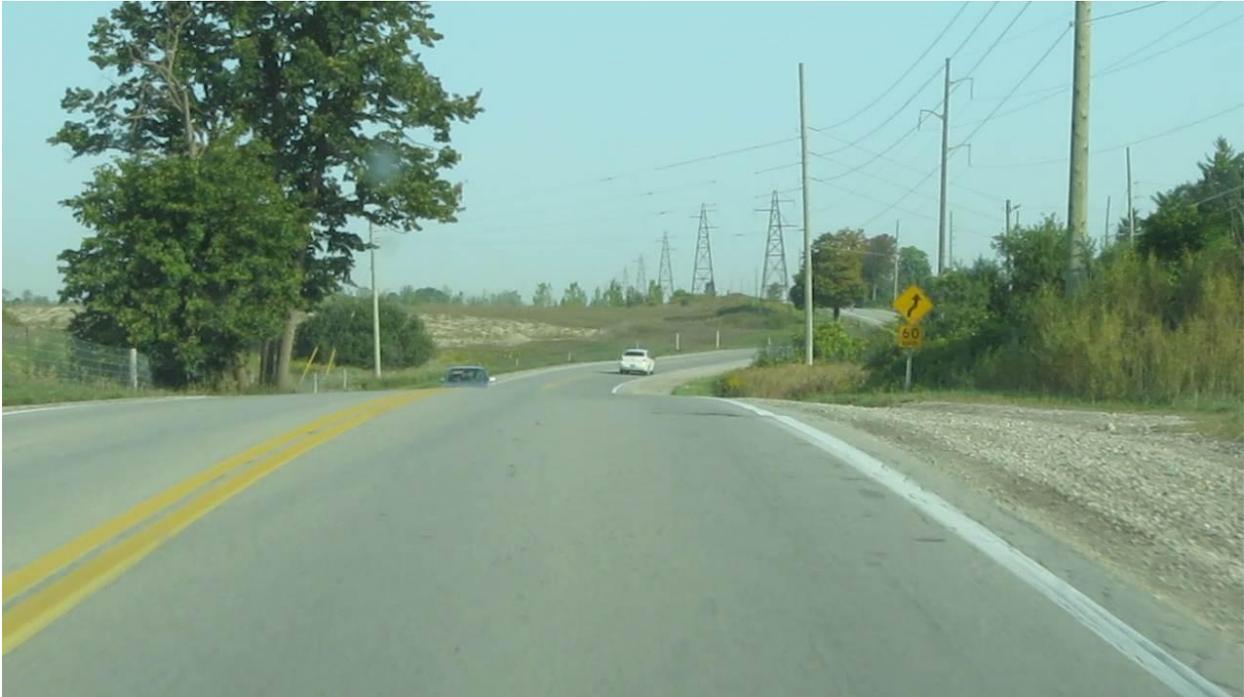
Figure 7: We began our data collection just before the test vehicle travelled over top of a manhole cover in the northbound lane. The manhole cover just begins to come into view in the foreground as the S-Curve reveals itself in the background.

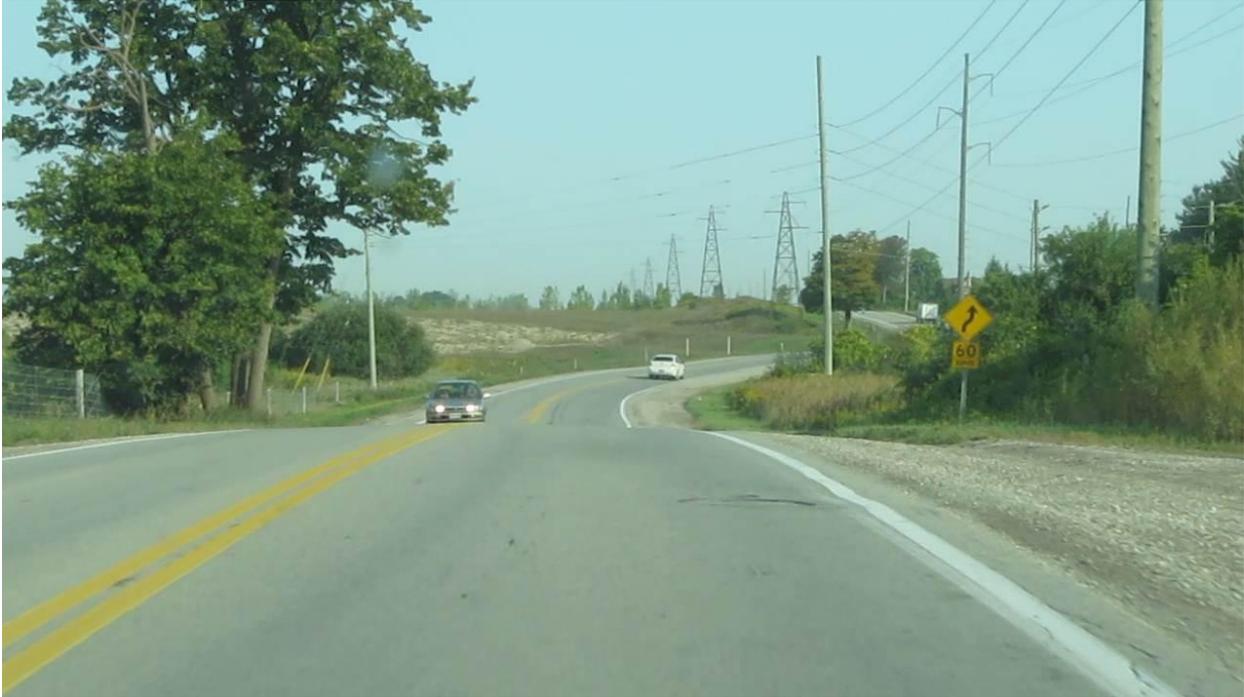
Figure 8: The manhole cover becomes more visible toward the right portion of the northbound lane in the foreground.

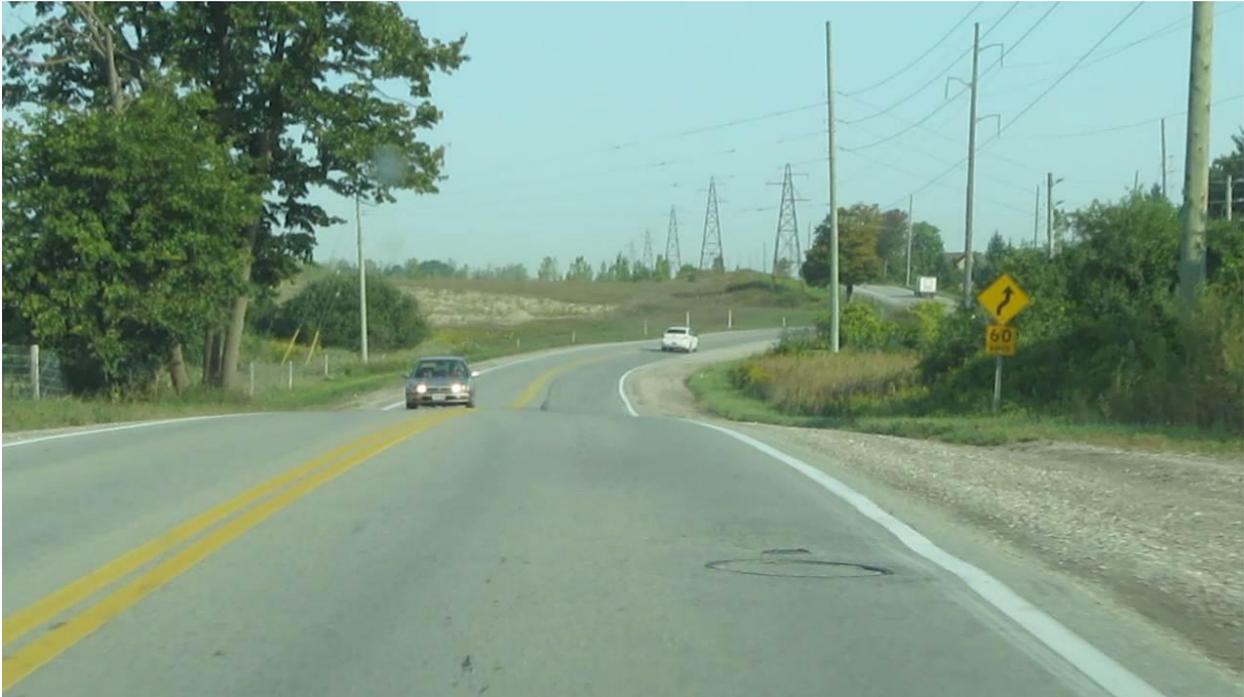
Figure 9: The manhole cover is now clearly visible on the right portion of the northbound lane as we see further details of the S-Curve in the background.

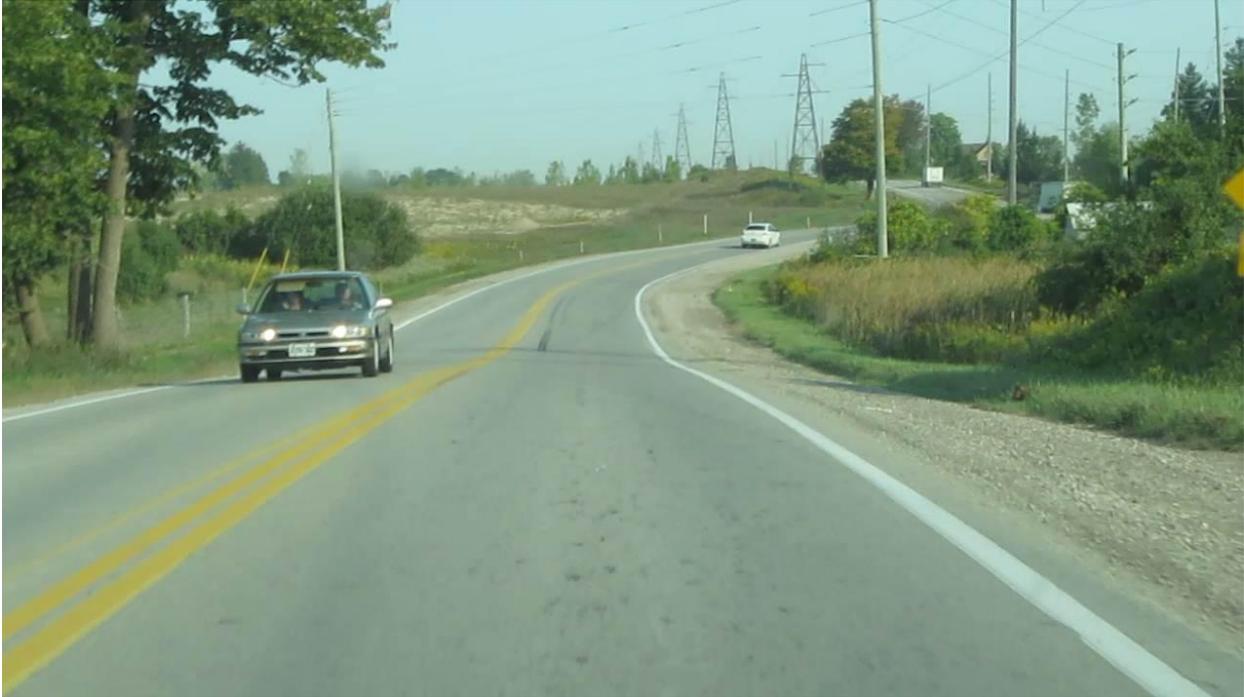
Figure 10: As we pass the manhole cover we can see the first portion of the S-Curve which is a curve to the right.

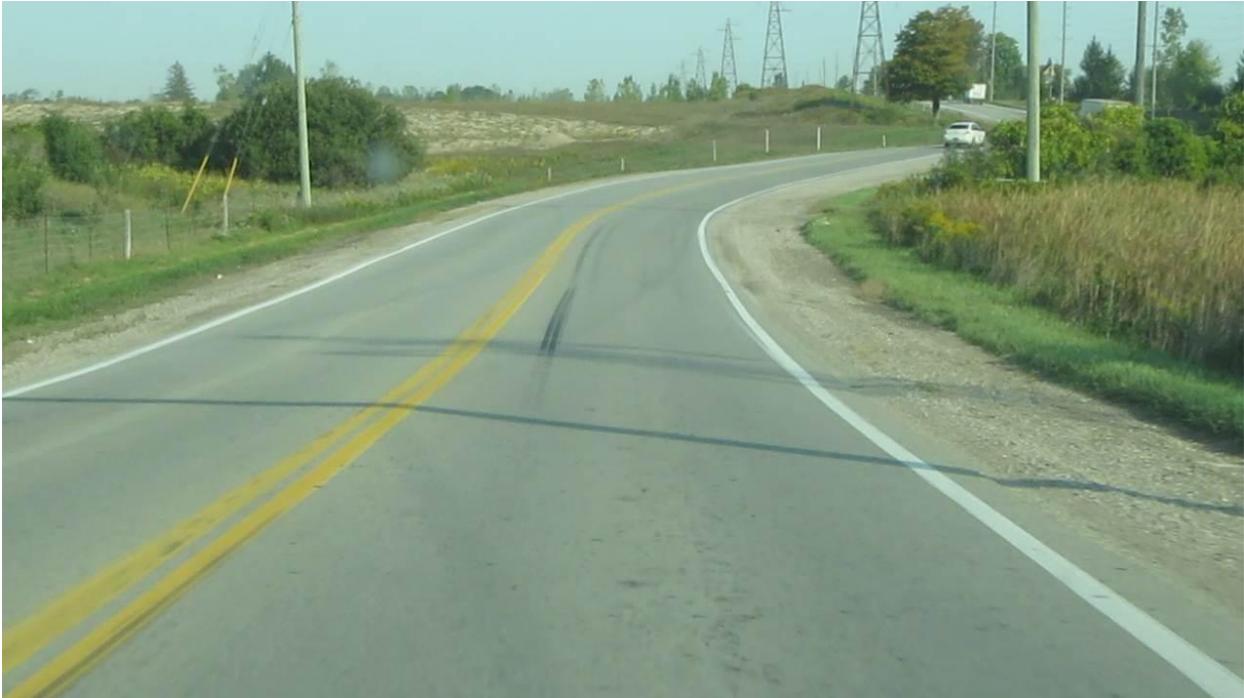
Figure 11: As we approach the right curve portion of the S-Curve we begin to see the opposing left curve begin to emerge in the view in the distant background.

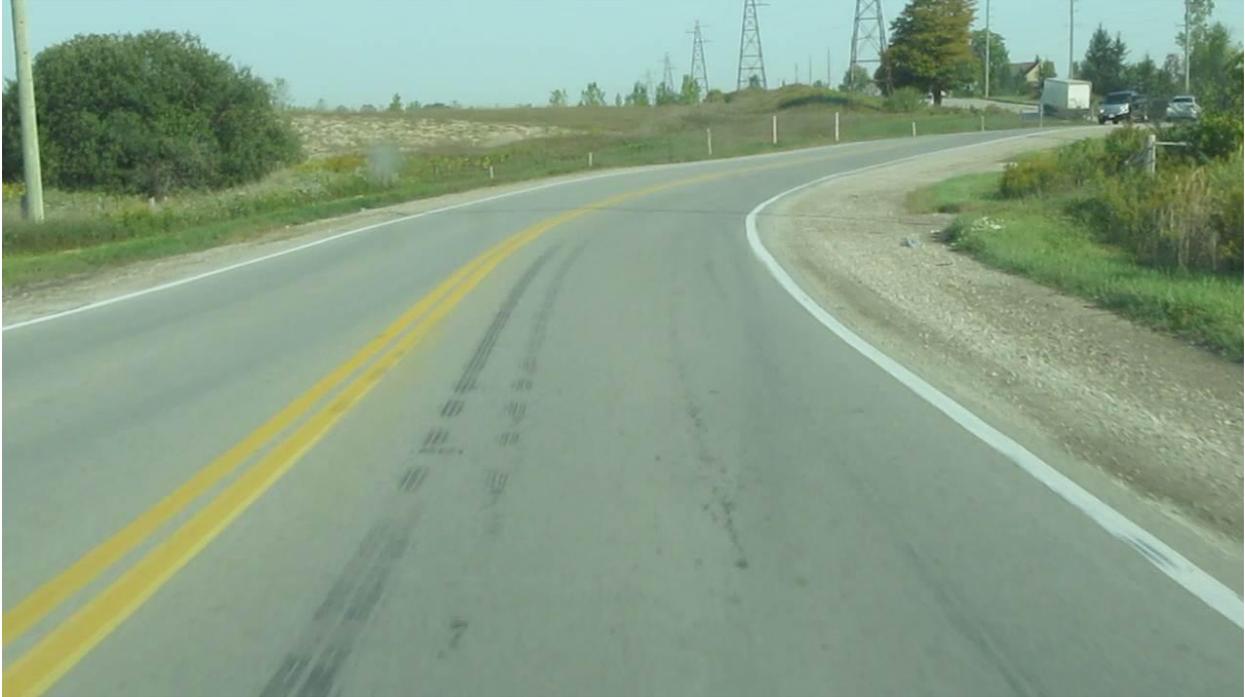
Figure 12: Upon entering the right curve we can now see the short distance of straight roadway before the commencement of the left curve in background.

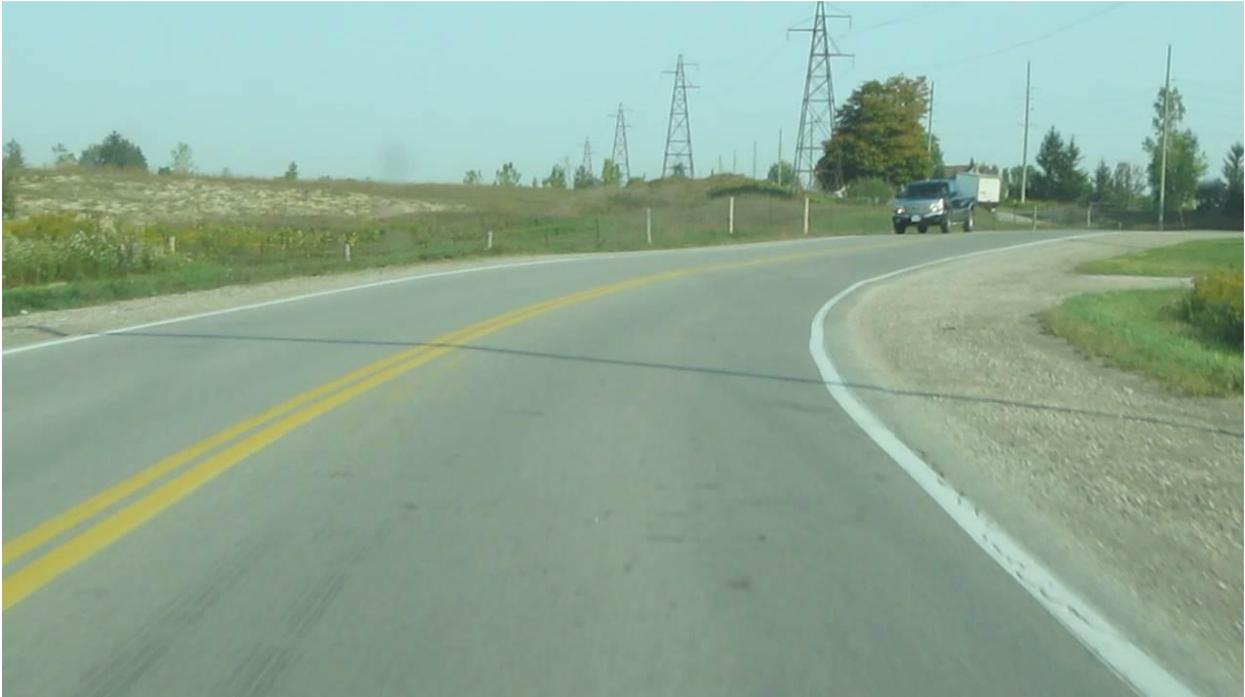
Figure 13: As we pass through the right curve we notice the elevation change as the left curve disappears from view because it is located in a sag of the road.

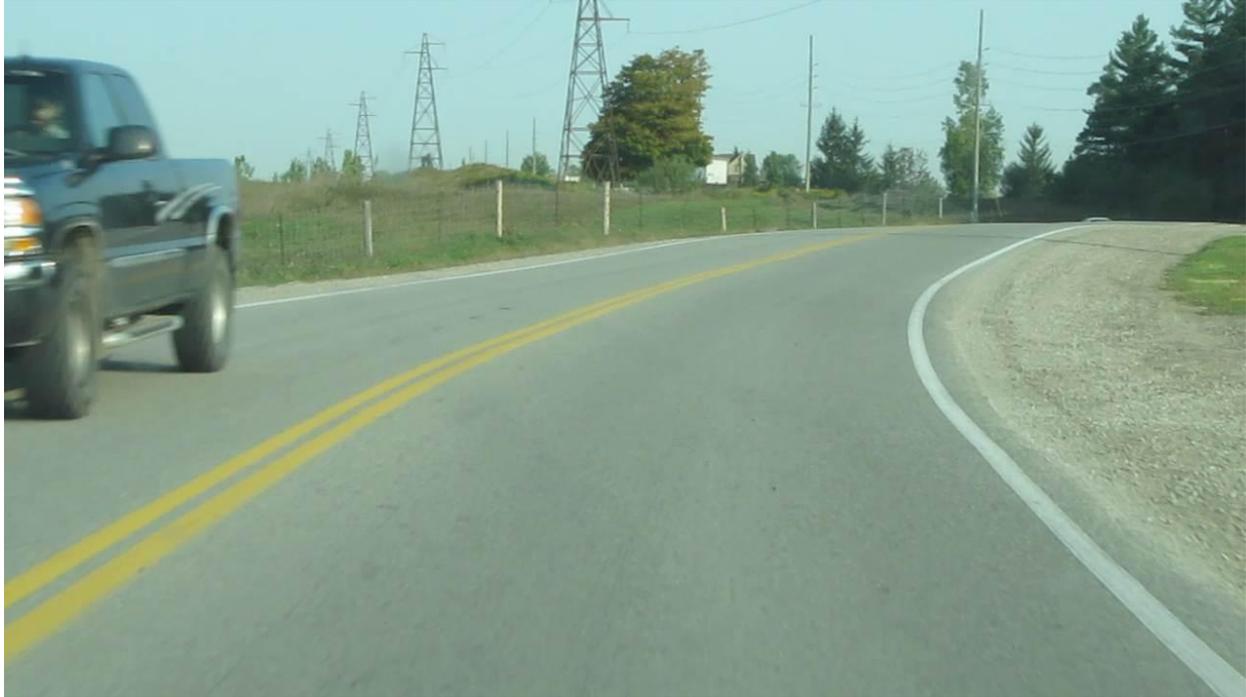
Figure 14: The elevation change and sag in the road is evidenced as we travel further into the right curve while the left curve completely disappears from view.

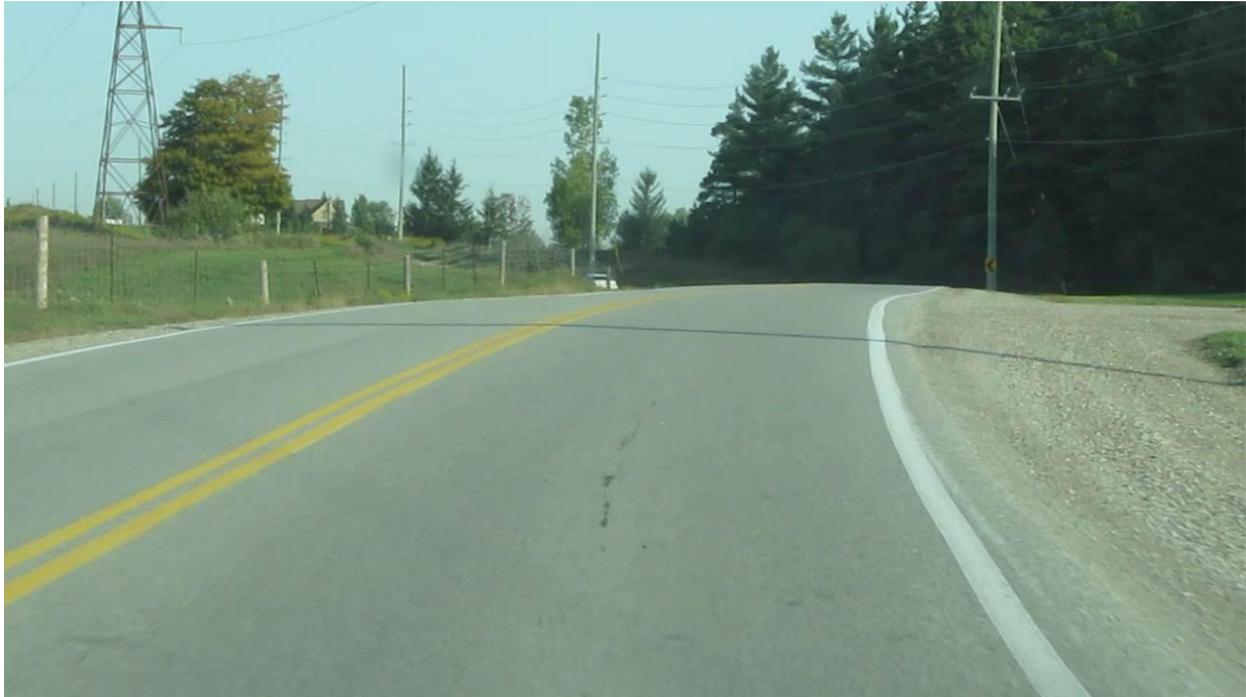
Figure 15: As we approach the end of the right curve we enter into a short segment of roadway that is straight and relatively level before entering the left curve.

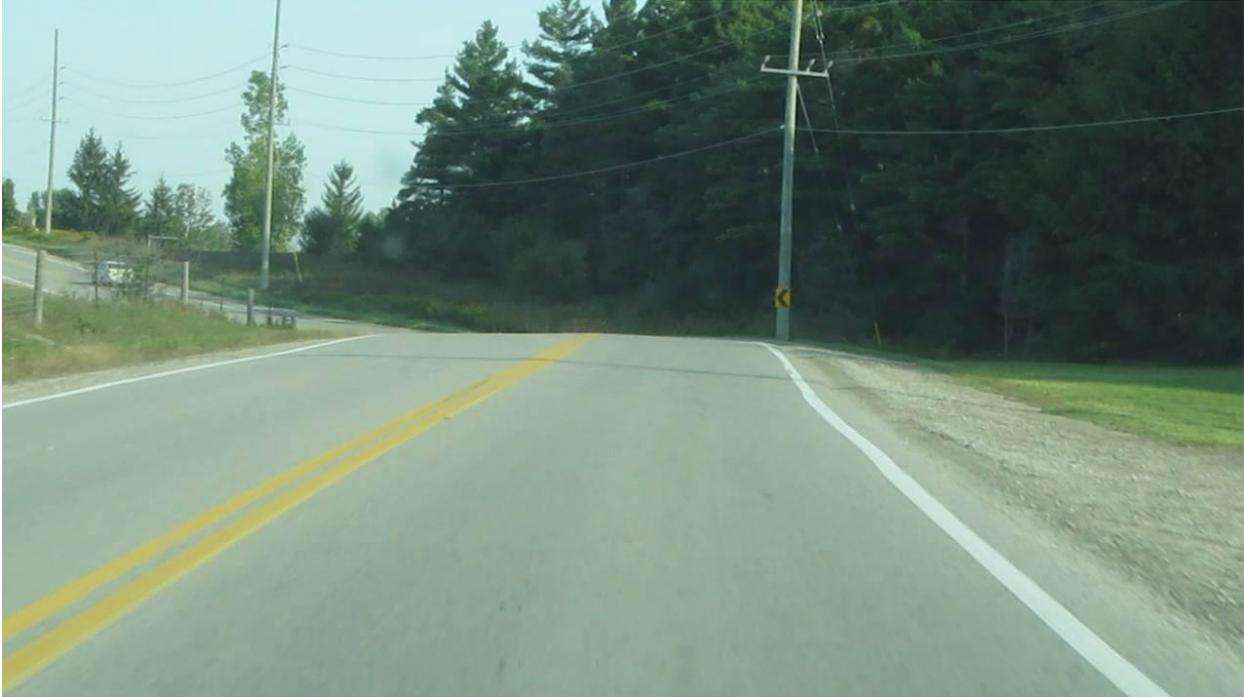
Figure 16: As we pass through the short, straight section of the road the left curve begins to come into view in the background.

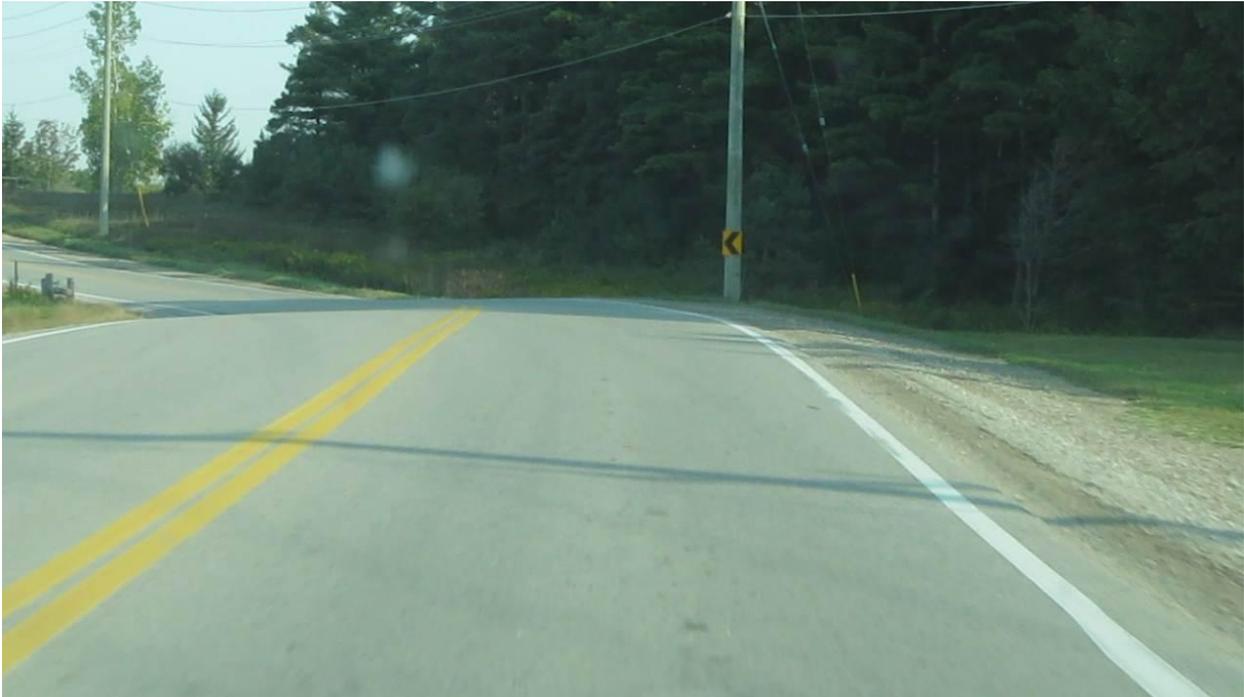
Figure 17: As we approach the left curve we note the elevation drop as we cannot see the surface of the road ahead.

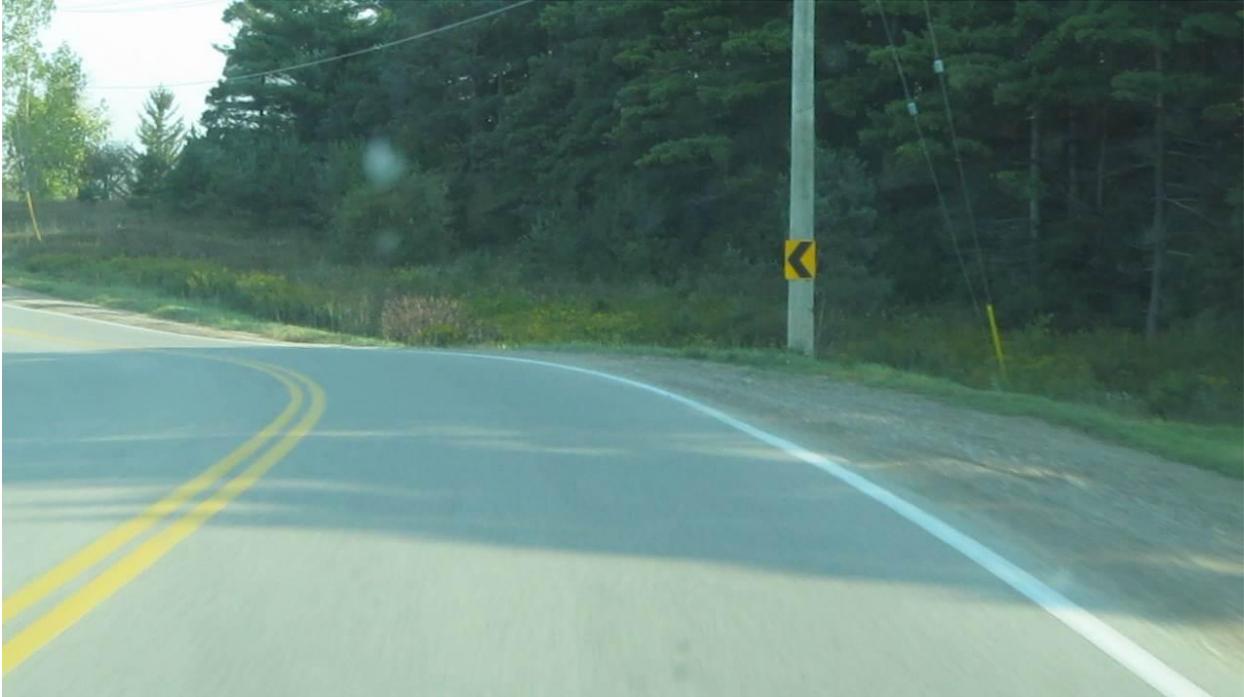
Figure 18: As we enter the left curve its surface begins to be revealed and we note that this curve is sharper (i.e. has a smaller radius) than the preceding right curve.

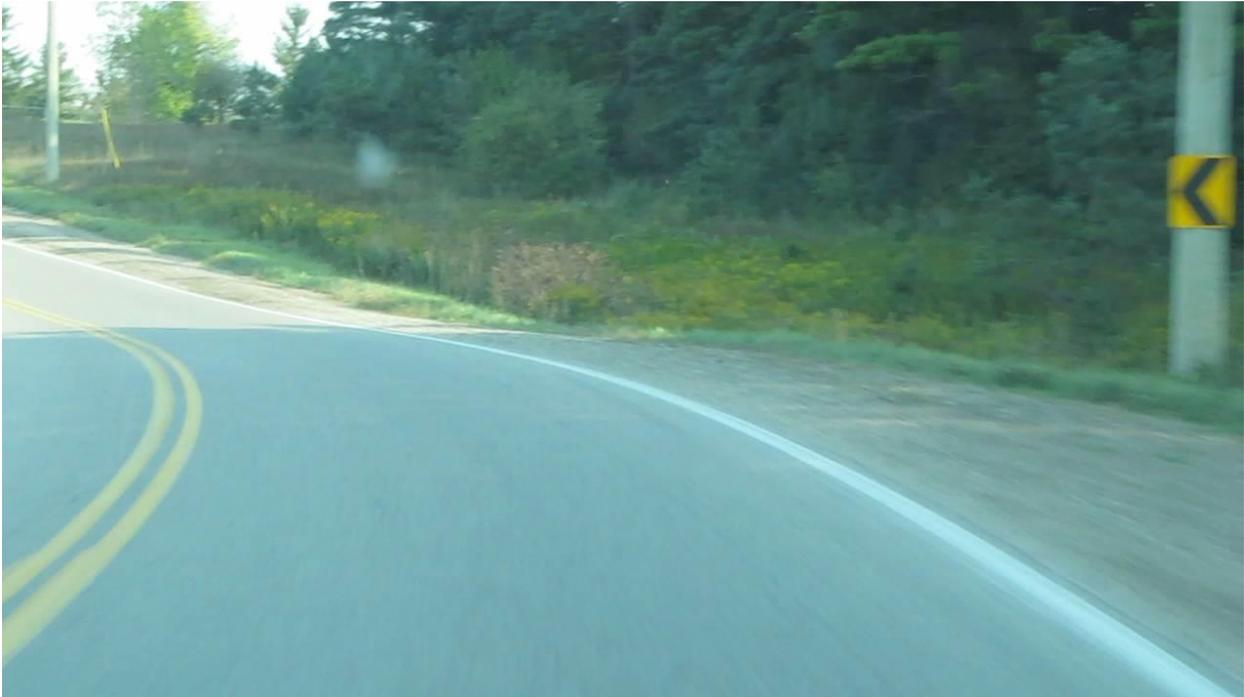
Figure 19: As we continue through the left curve we appreciate the severity of its change in direction.

However, as we examine the results for the left curve the appropriateness of the advisory speed comes into question. Note how the lateral acceleration (red line) reaches values of 0.4 g. This is much higher than the recommended 0.15 g. Even if we reduced the speed of our test vehicle by 10 km/h, thus bringing it match the 60 km/h speed advisory, it is highly unlikely that the lateral acceleration would drop to the degree that would fall in the range of 0.15 g. Thus this is an example where test results using the iPhone can help to establish that the signing of a curve may be inappropriate.

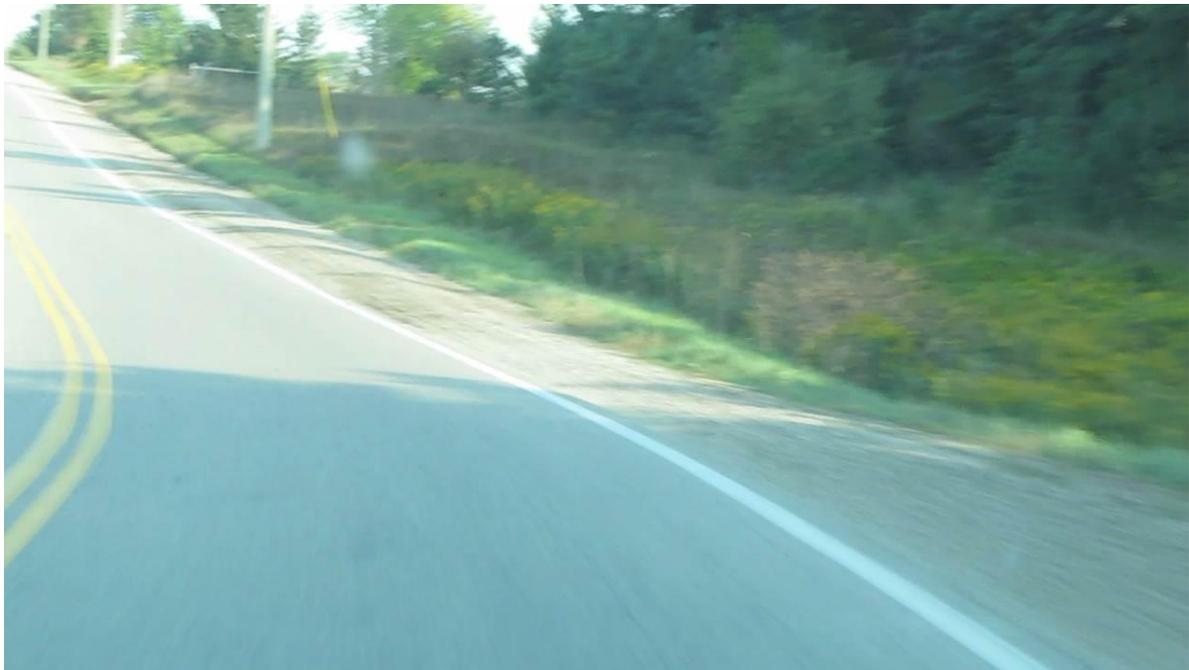
Figure 20: As we approach the latter part of the left curve we see that the straight road ahead contains an upgrade.

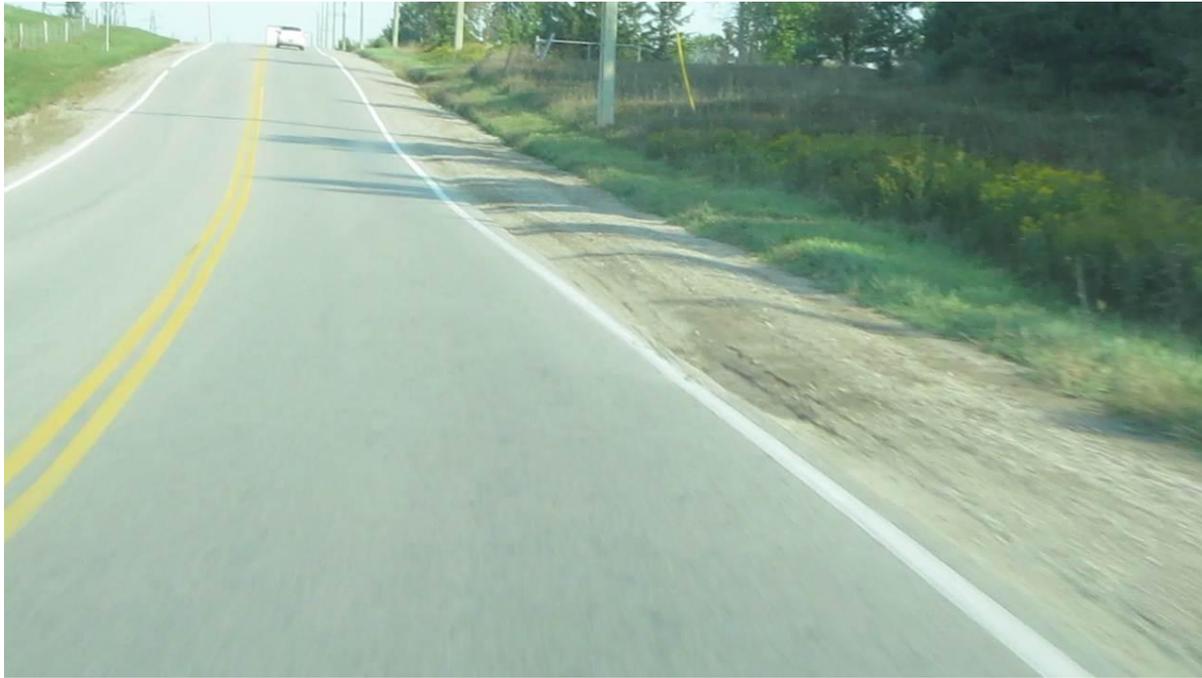
Figure 21: As we drive out of the left curve we see how the straight road ahead contains an upgrade and this is where our data collection was stopped.

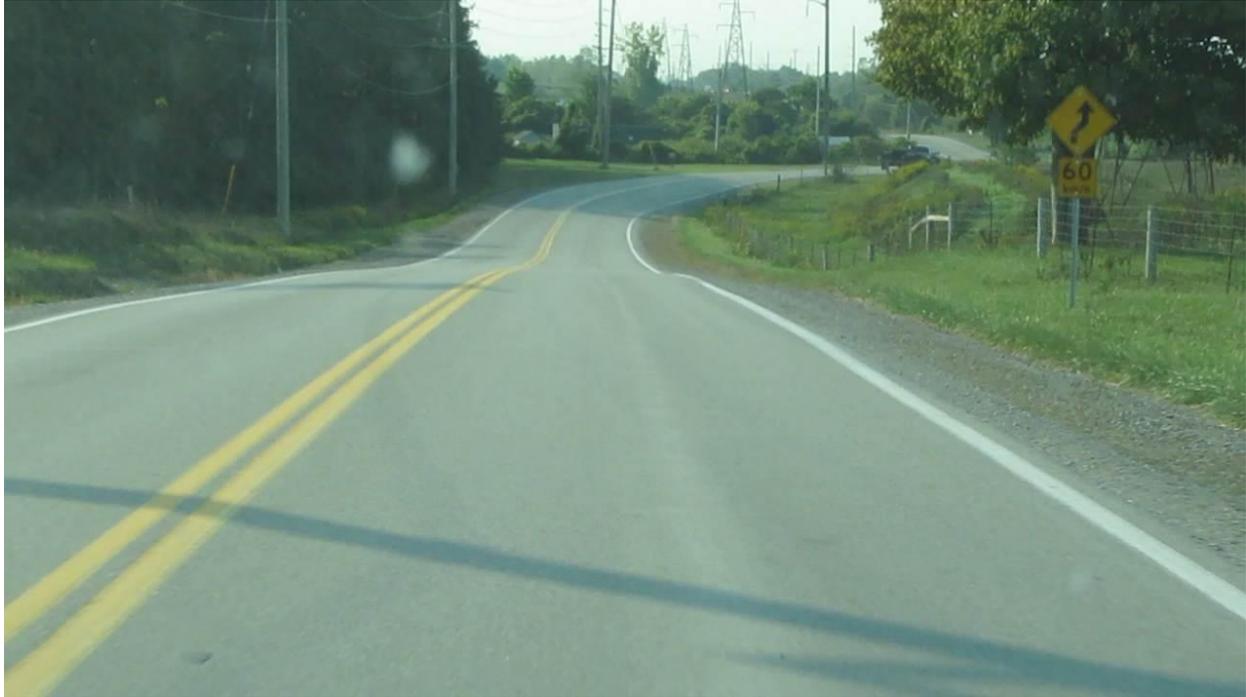
Figure 22: To complete our description of the S-Curve this photo shows a southbound view just north of the S-Curve, so we are now looking in the opposite direction from all the previous photos.
