Guidelines For Interpretation of Gorski Consulting Road Data From iPhone Testing - March 2014 Version

Posting Date: 17-Mar 2014

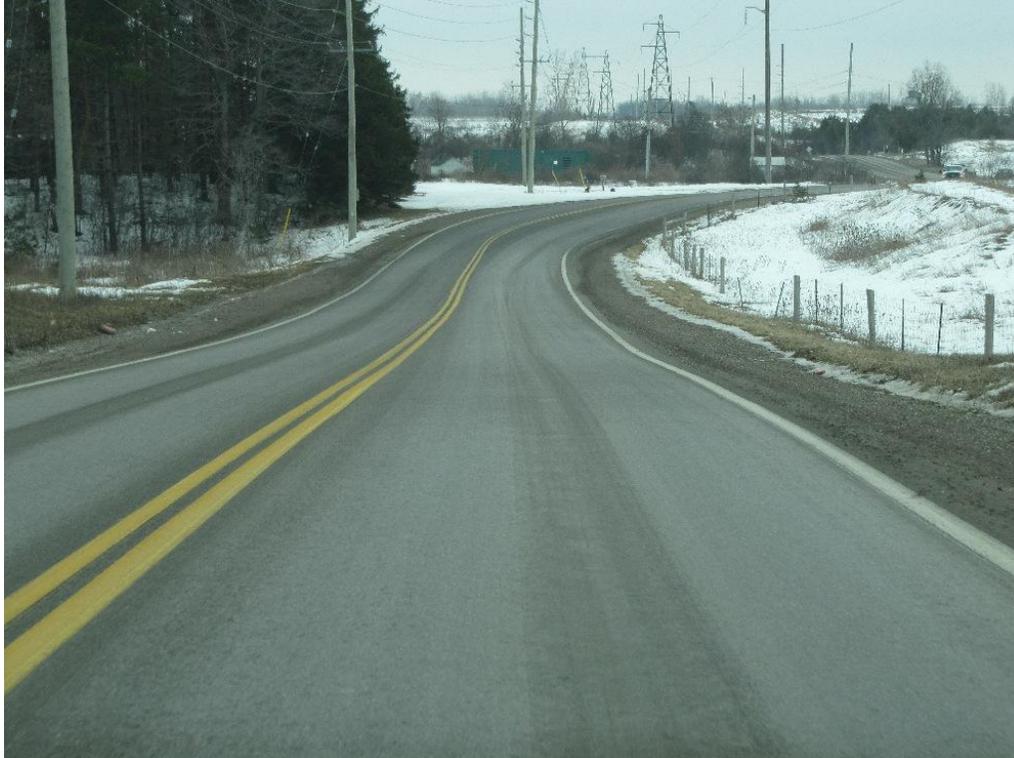
Figure 1: View, looking southbound at the S-Curve of Clarke Road north of Fanshawe Park Road in London, Ontario, showing the horizontal and vertical alignments of the road.

For example, there are several records on the S-curve of Clarke Road in London Ontario that provide an indication of the effect of horizontal and vertical alignments.

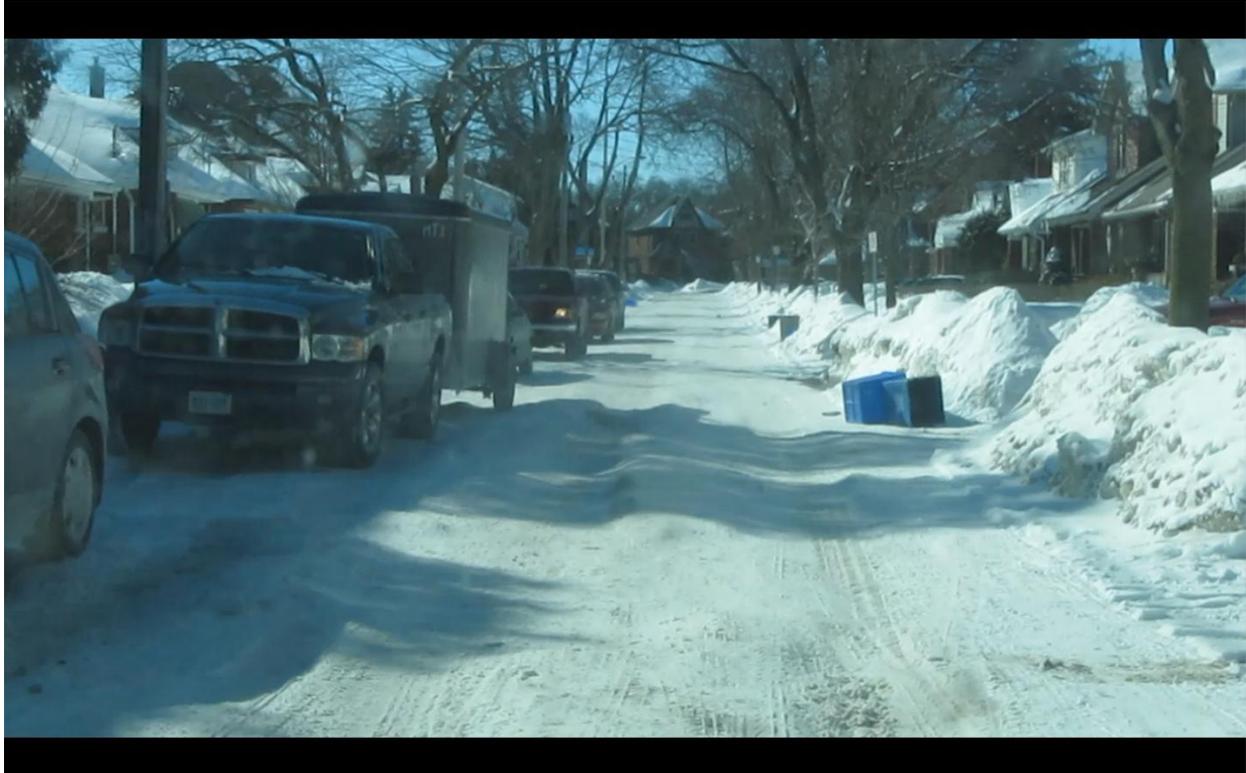
Figure 2: View, looking west, along McKenzie Avenue in Old-South, London, Ontario, showing the deep ruts caused by unplowed snow that had been compressed into solid ice and snow on the road surface. This was the condition of the road at the time that the data was captured.

There are also several records incorporating situations where the road surface was covered, or partially covered, by snow or ice. Interestingly, these show just how much disruption in the vehicle motion can occur when a hard crust of snow or ice is formed in an irregular fashion in the travel path of a vehicle's tires. The most extreme conditions of vehicle motion to date were documented on McKenzie Avenue in London, Ontario where the road had not been plowed for an extended time and this caused a thick layer of hardened snow and ice that was rutted, as shown in Figure 2 below. The test vehicle travelled through this local road at speeds of just 20 km/h yet it registered the highest motion readings of all the sites to date.

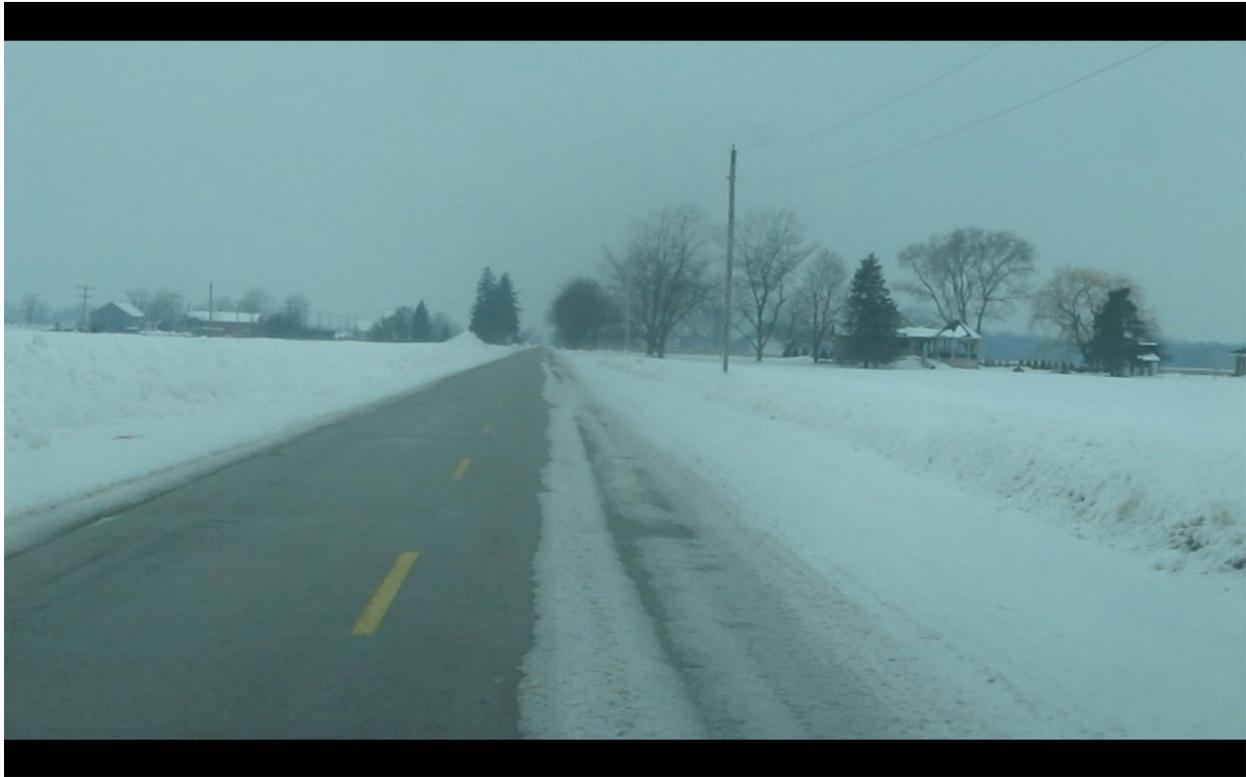
Figure 3: View, looking west, along Oil Springs Line showing the hardened snow and ice located on the right half of the westbound lane. This was the condition of the road at the time that the motion data was obtained with the test vehicle.

Similarly, though less severe, conditions were noted on Oil Springs Line, in Lambton County, where an irregular layer of hardened snow and ice existed mostly on the right portion of the westbound travel lane, as shown in Figure 3. The test vehicle's speed was reduced to just 30 to 40 km/h on this rural highway that had a maximum posted speed limit of 80 km/h, yet high values of motion of the test vehicle were registered.

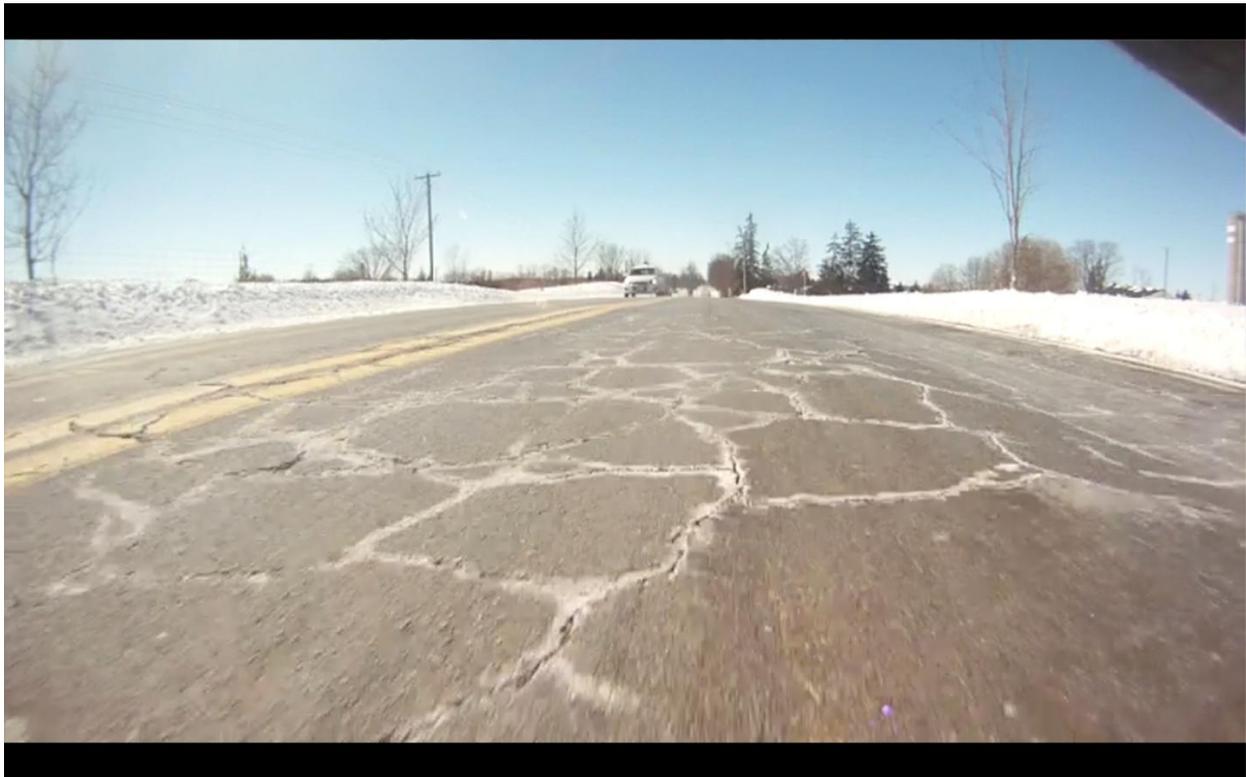
Figure 4: View, looking westbound, at the road surface of Sunningdale Road in London, Ontario, taken by the video camera located beneath the front bumper of the test vehicle.

Overall, it is expected that the Lateral and Longitudinal Motion columns in the database will provide enough preliminary information about the condition of a road segment that those who would like further information will be motivated to request it. Beyond the additional data available from the iPhone, there was extensive video data that accompanied it. For example a video camera mounted beneath the front bumper of the test vehicle captured the condition of the road surface from just a few inches above it, as shown in Figures 4 and 5.

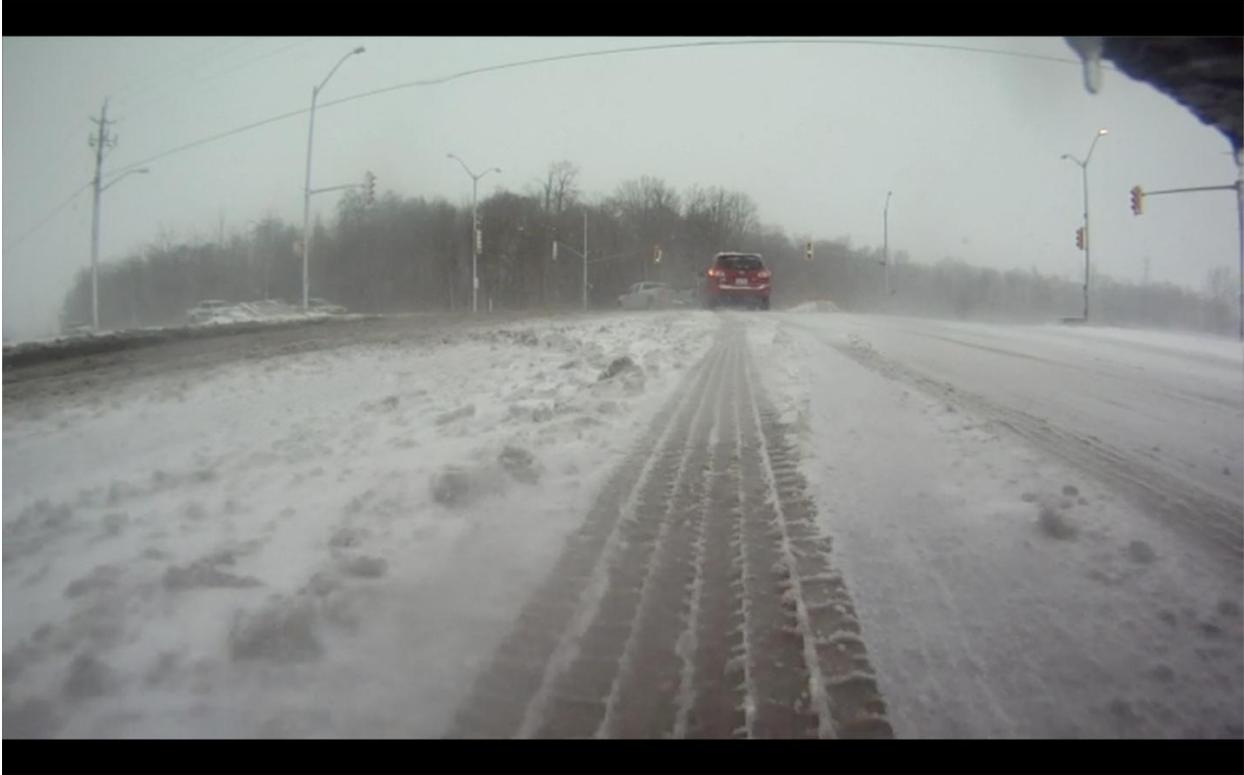
Figure 5: View looking west near Highbury Ave and Wilton Grove Road, from the video camera mounted beneath the front bumper of the test vehicle.
