How Many Incidents Do Not Become Reported In Police Collision Data?

1.0 Background

2.0 Review of Gorski Consulting Research at the Clarke Road Site

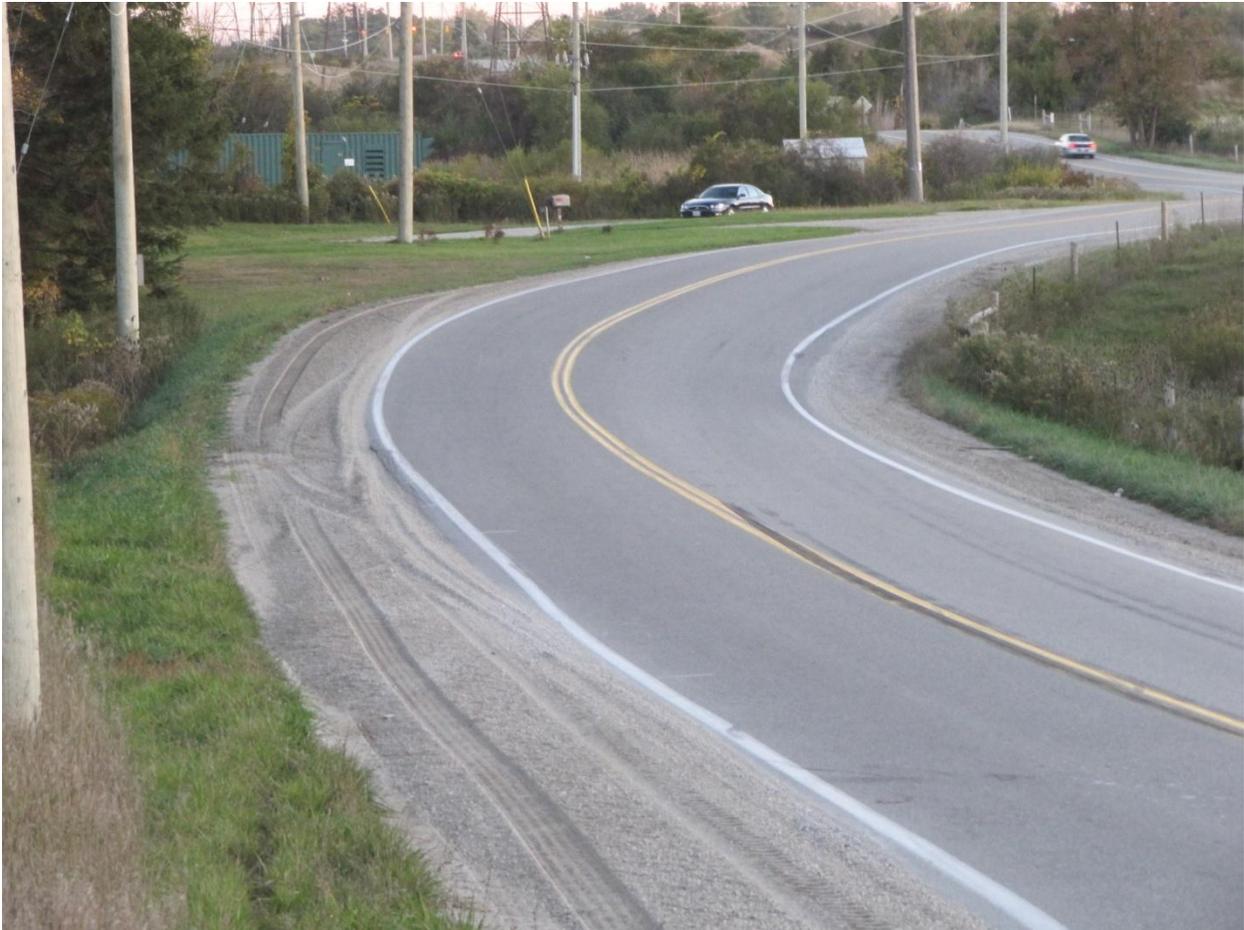
Figure 1: View, looking south, of the S-Curve on Clarke Road on October 11, 2013.

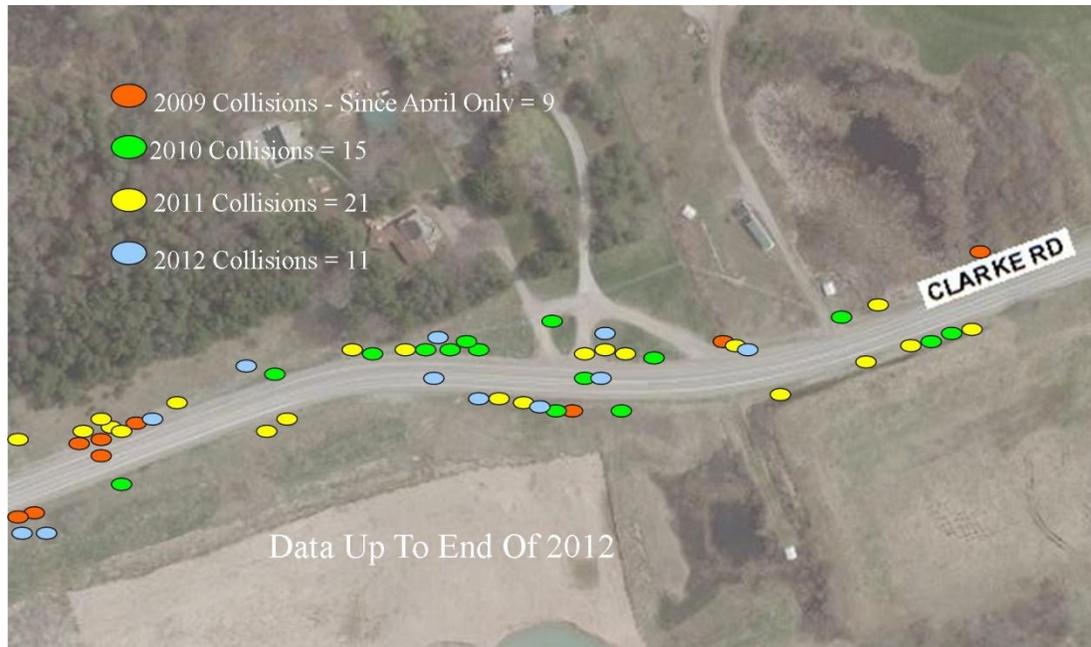
Figure 2: Location of collision events at Clarke Road S-curve, 2009 to 2012.

Figure 2 shows the location of physical evidence of incidents documented by Gorski Consulting that occurred at the S-curve of Clarke Road between the fall of 2009 through to the end of 2012.

The vast majority of these incidents involved the loss-of-control of a single vehicle. When such an event occurs the physical evidence exists over a long stretch of roadway such that it becomes subjective as to where, within the curve, the physical evidence exists. At best this figure suggests that the physical evidence of vehicle loss-of-control appears to be random at this level of study and given the small number of observations. Thus after presenting the data shown in the above figure, the illustration of the incidents in this fashion was discontinued.

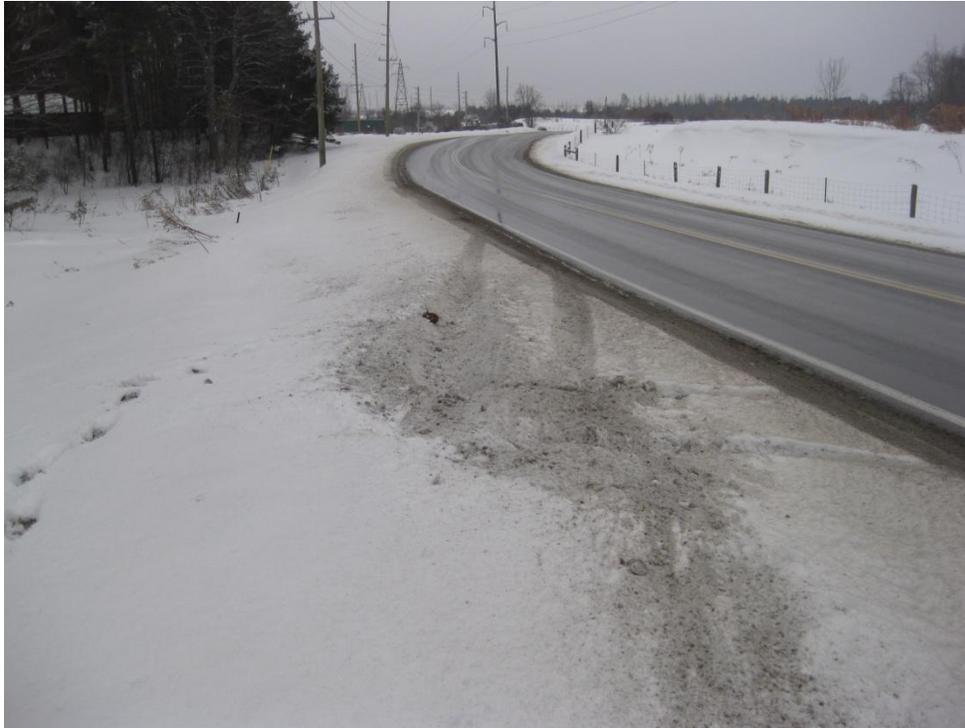
Figure 5: View of an incident on January 25, 2011 where a vehicle slid off the pavement, entered the east roadside, and then backed out and drove away.

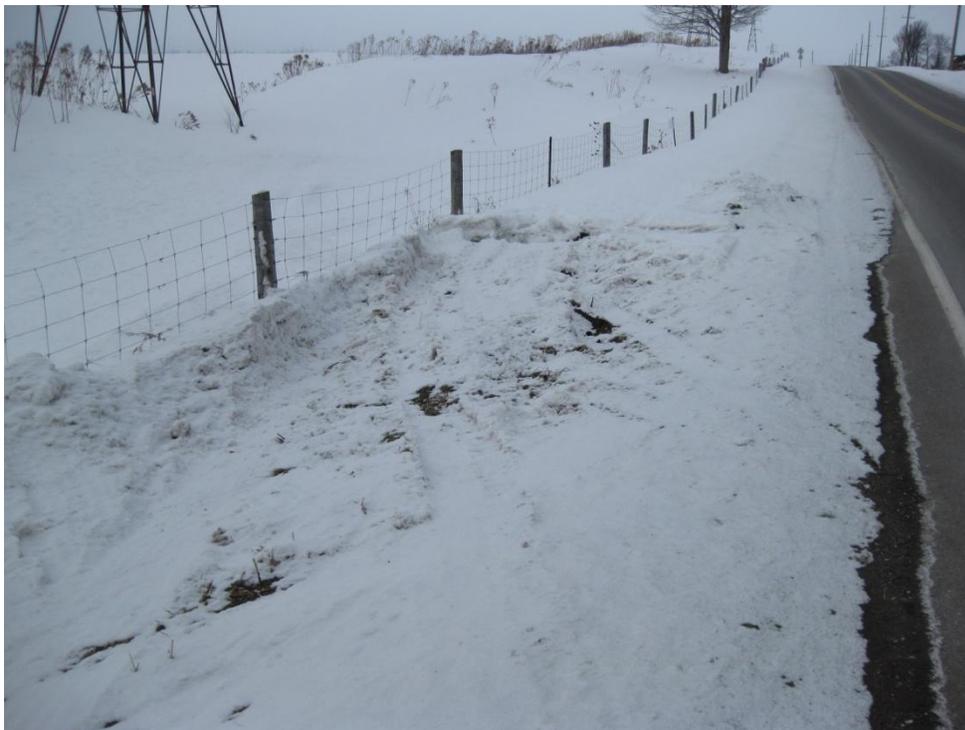
Figure 6: View of incident from January 31, 2011 where a northbound vehicle slid against the west fence.

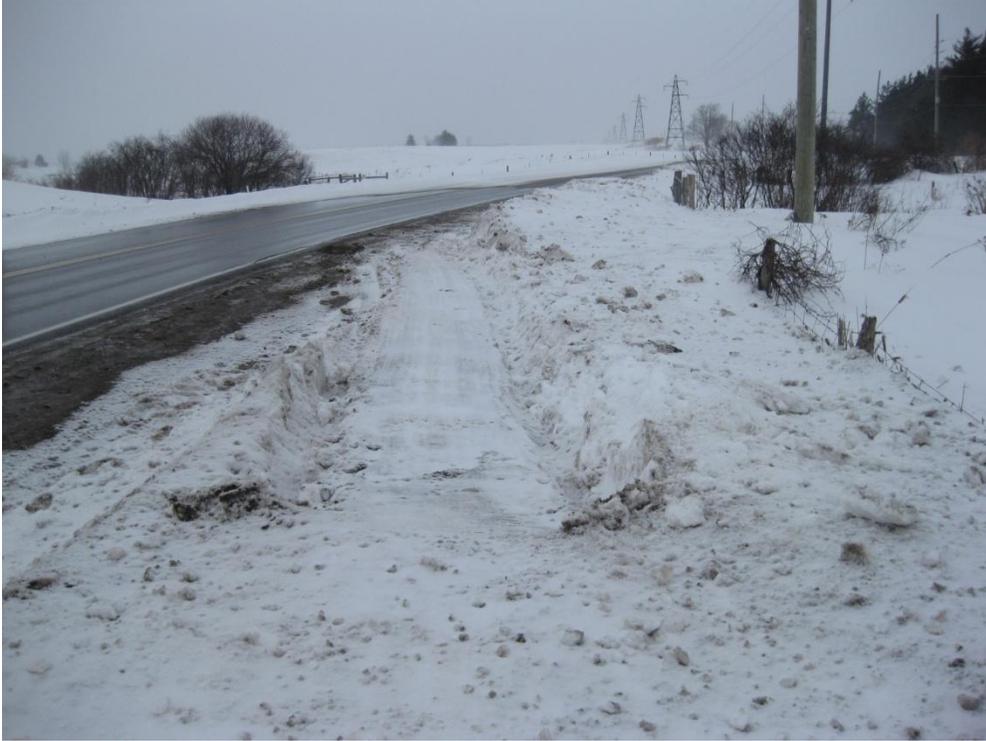
Figure 7: Incident from February 12, 2011 where a southbound vehicle slid into the deep snow of the roadside.

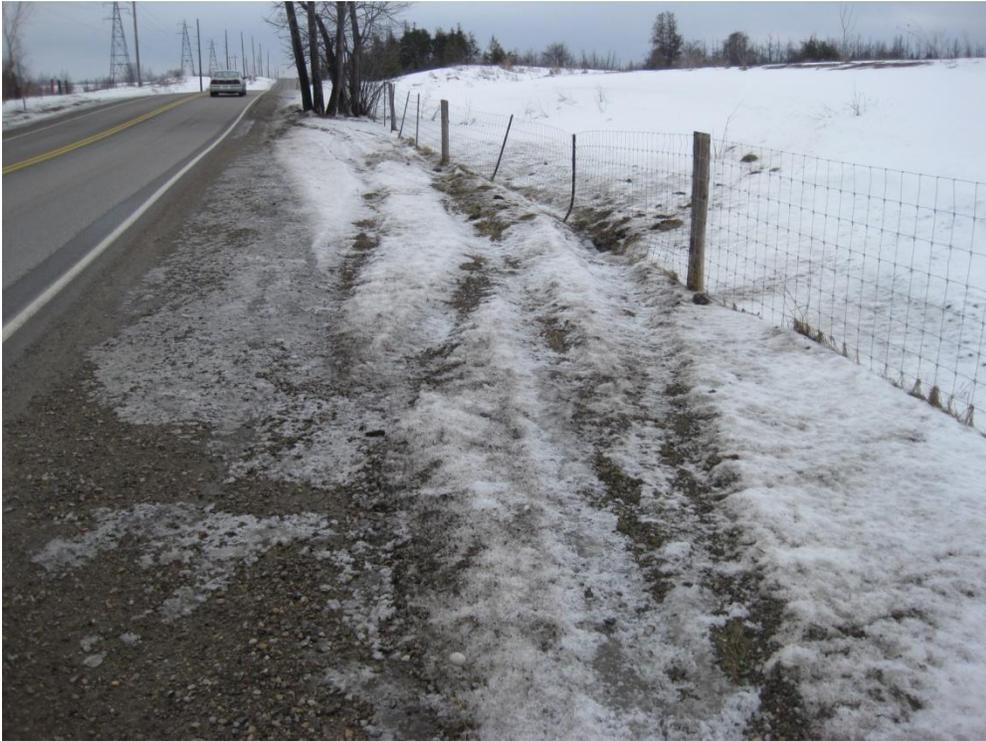
The incident of February 28 however was slightly more substantial. As shown in Figure 8 a southbound vehicle slid into the west fence at the south portion of the S-curve and caused damage to the fence. Some minor parts of the vehicle could be seen next to the fence. Tire marks indicated how the vehicle then left the site. As we know from the police data this incident was never reported to police.

Figure 8: Incident of February 28, 2011 where a vehicle slid into the west fence causing damage to it.

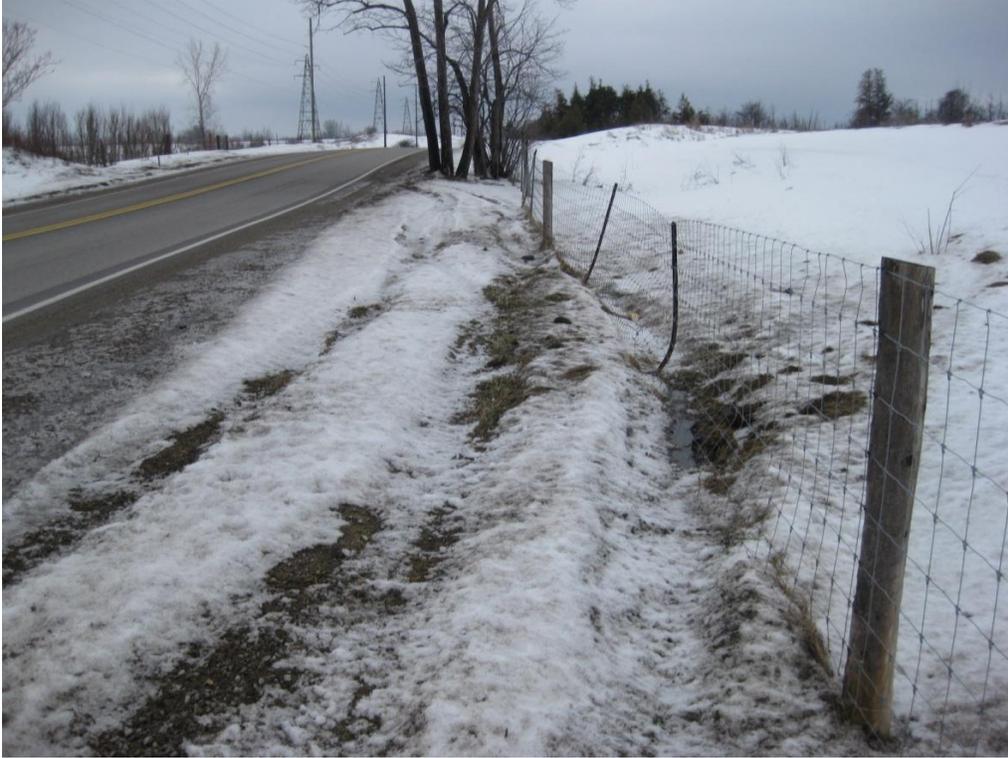
Figure 9: Incident of February 28, 2011. Small parts of the striking vehicle were still located near the fence.

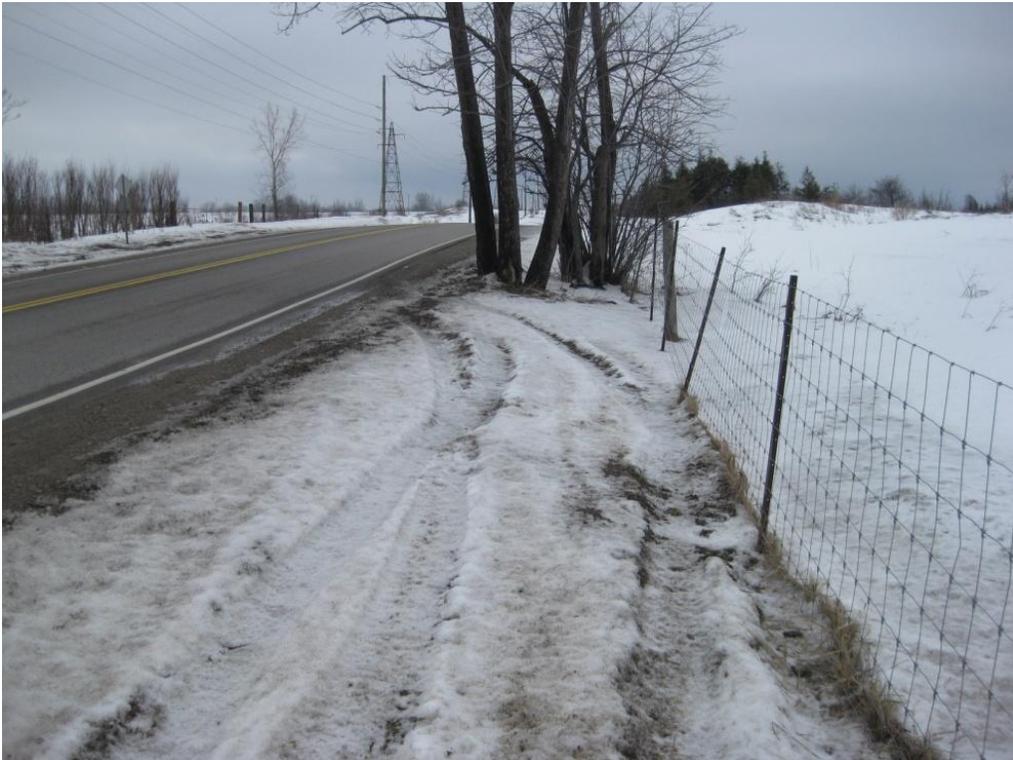
Figure 10: Incident of February 28, 2011. Tire marks indicated that the striking vehicle drove away after this impact.

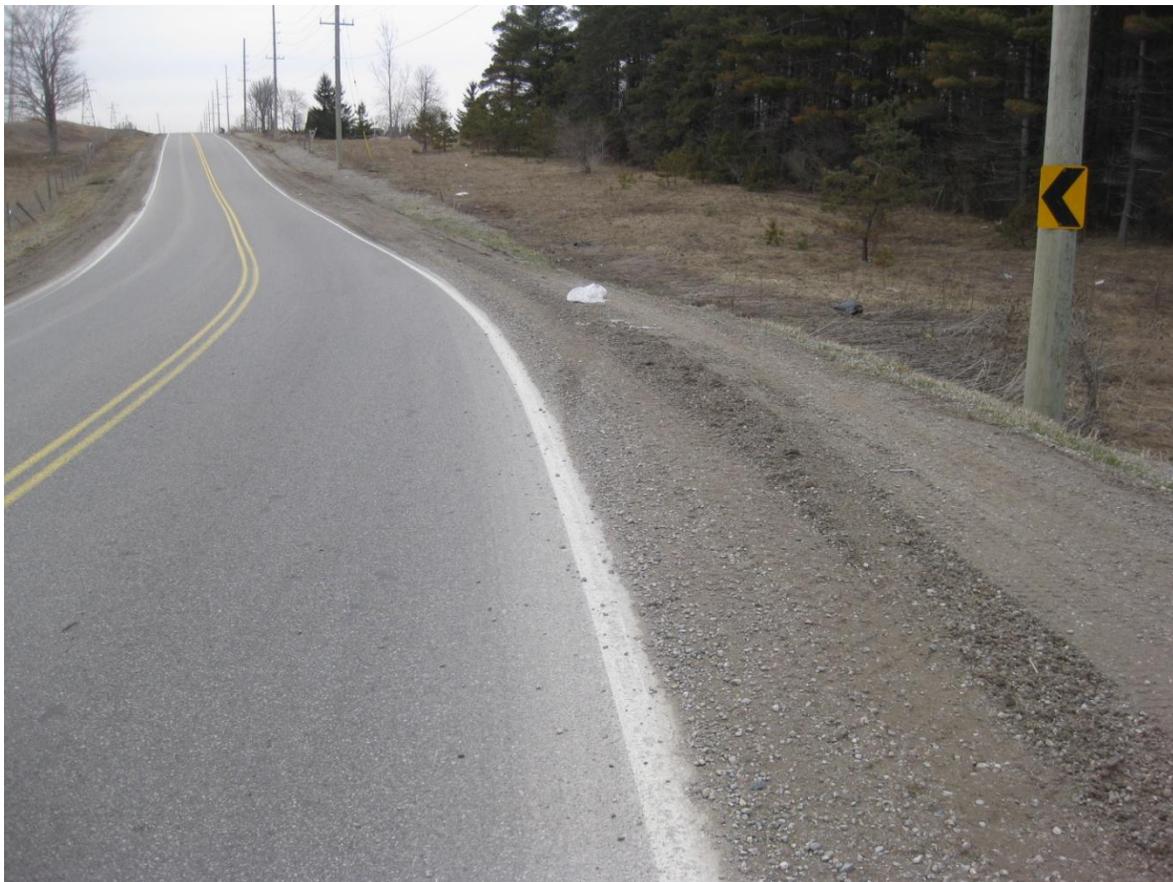
The incident from April 8th becomes a little more interesting. Figures 11 through 25 show that a northbound vehicle entered the north portion of the curve, began to yaw into the east shoulder and then dropped down into the east ditch. The vehicle then accelerated out of the east ditch, travelled across the road, and collided with a fence in the west ditch. Acceleration marks on the west shoulder showed how the vehicle then exited the west ditch and fled the accident site. This collision did not become part of the police accident records because the vehicle fled the site. Physical evidence indicates there would have been damage to the vehicle's undercarriage and a substantial amount of scratching to the front and sides of the vehicle from the fence contact. Other damage included separation of the vehicle's exterior mirror. While not preventing the vehicle from being driven the damage costs to the vehicle would have been substantial.

Figure 11: View looking north at the north portion of the curve. It may be difficult to detect however, a yaw mark exists on the east shoulder and passes through the area of the white bag, then continues past the bag and into the east ditch.

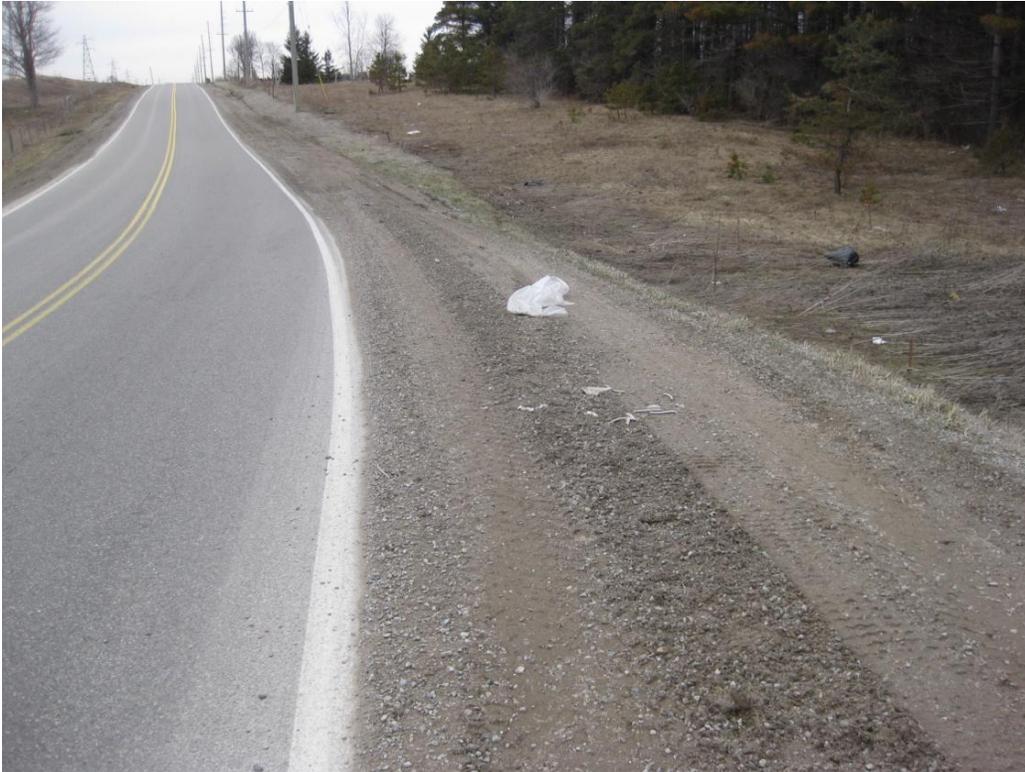
Figure 12: Closer view of the yaw mark passing through the area of the white bag and proceeding into the east roadside.

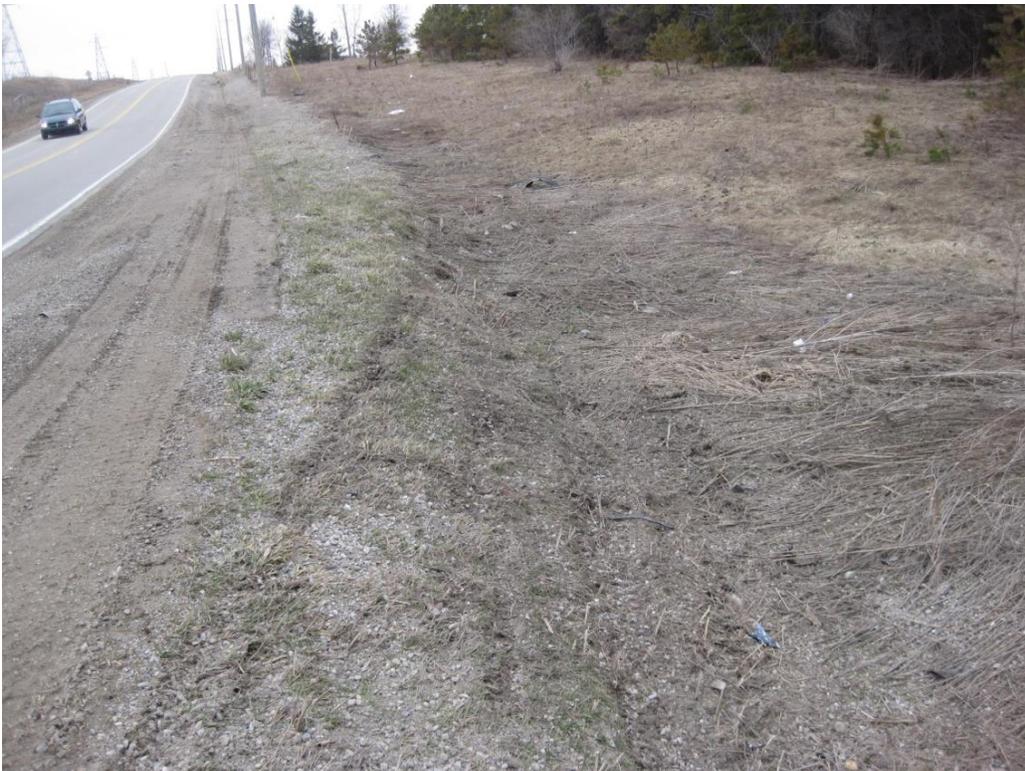
Figure 13: View of yaw mark at the bottom left, travelling in an arc, into the east roadside

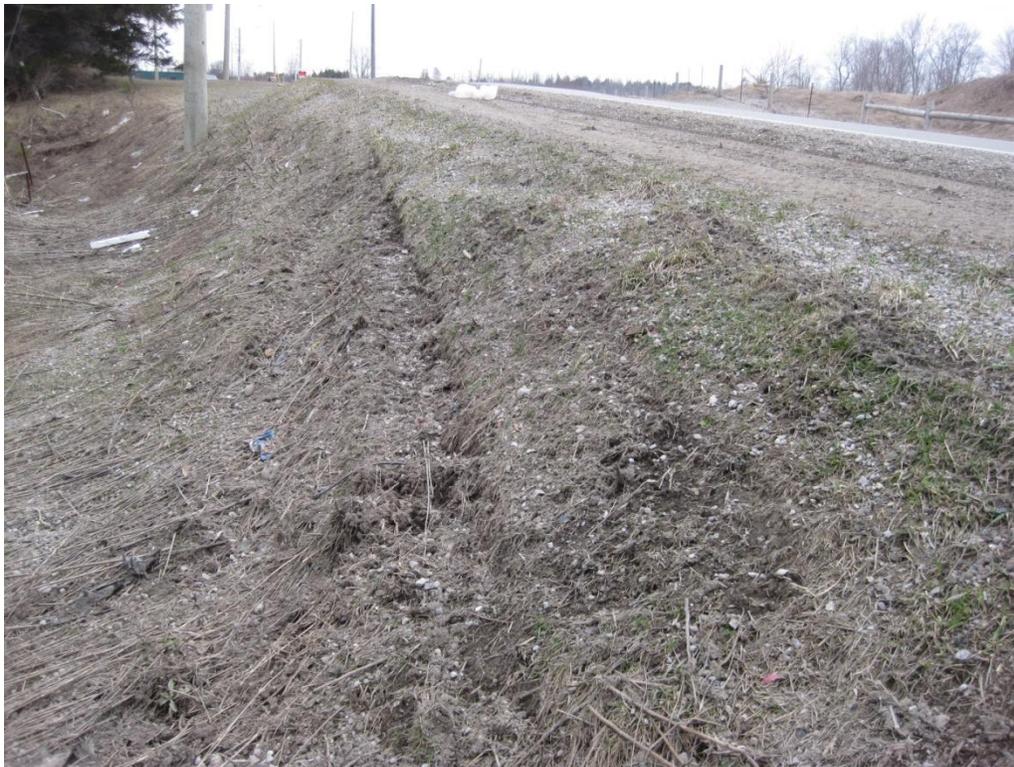
Figure 14: View looking south at one of the tire marks on the steep slope of the east roadside.

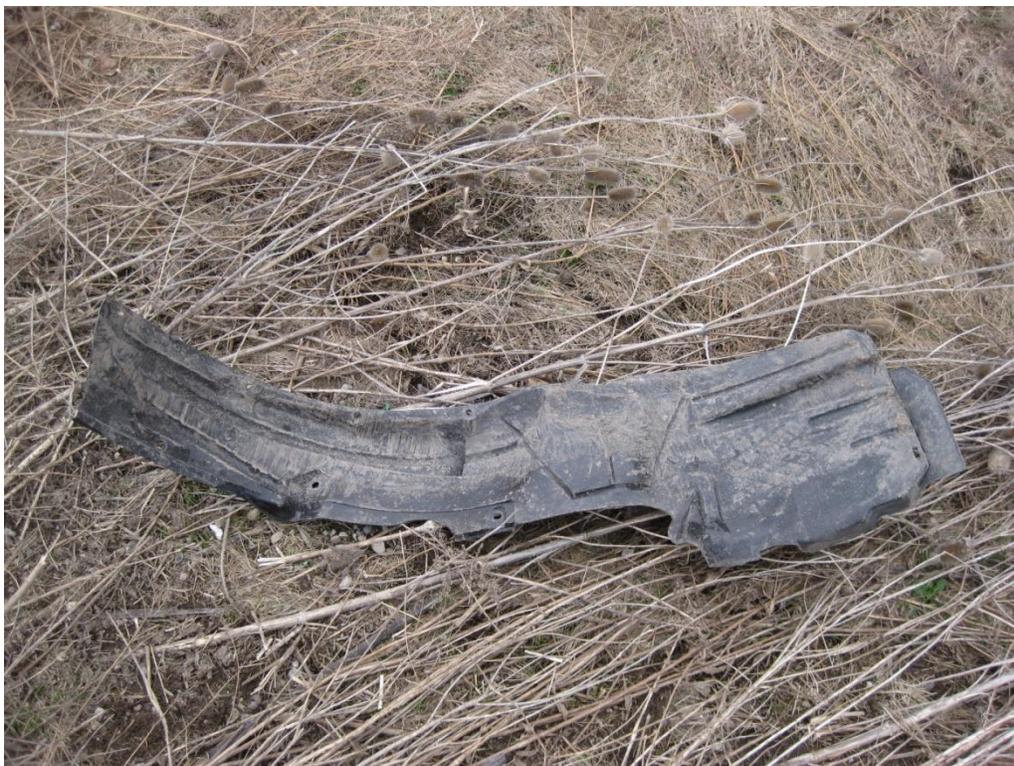
Figure 15: View of the plastic skirt front a wheel-well that was ripped off the vehicle as it travelled into the east ditch.

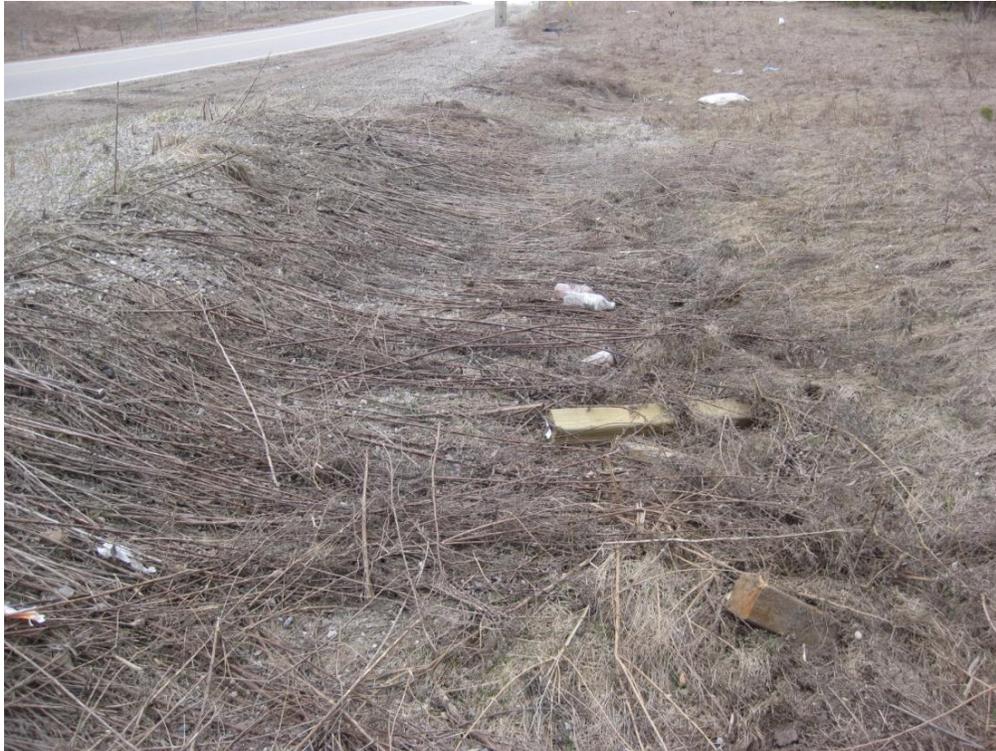
Figure 16: View some wooden posts lying in the east ditch. Evidence of the vehicle's passage can be observed by a fresh contact visible at the end of the post in the foreground.

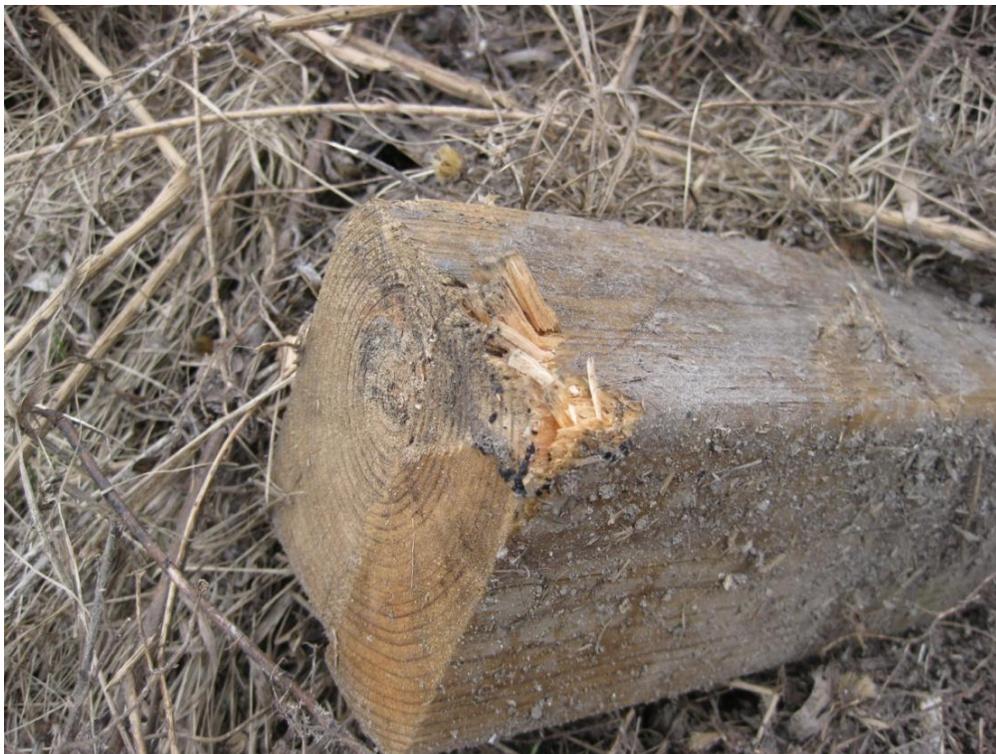
Figure 17: Close-up view of the fresh contact made to the end of the wooden post in the east roadside.

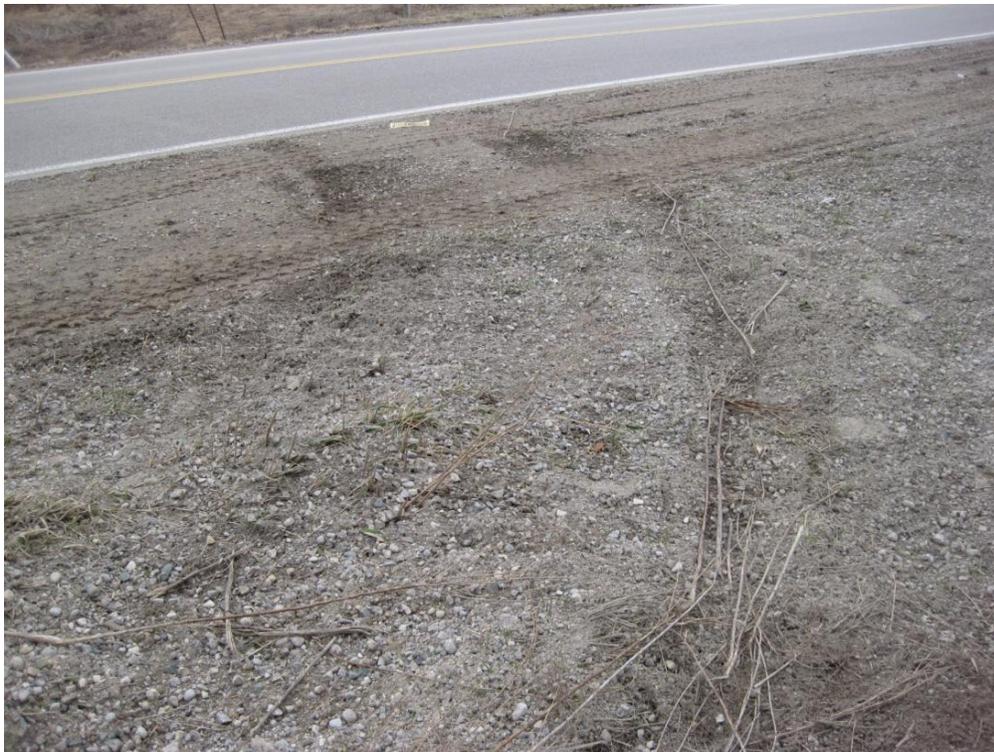
Figure 18: View of the evidence that the vehicle accelerated out of the east ditch and entered back onto the pavement.

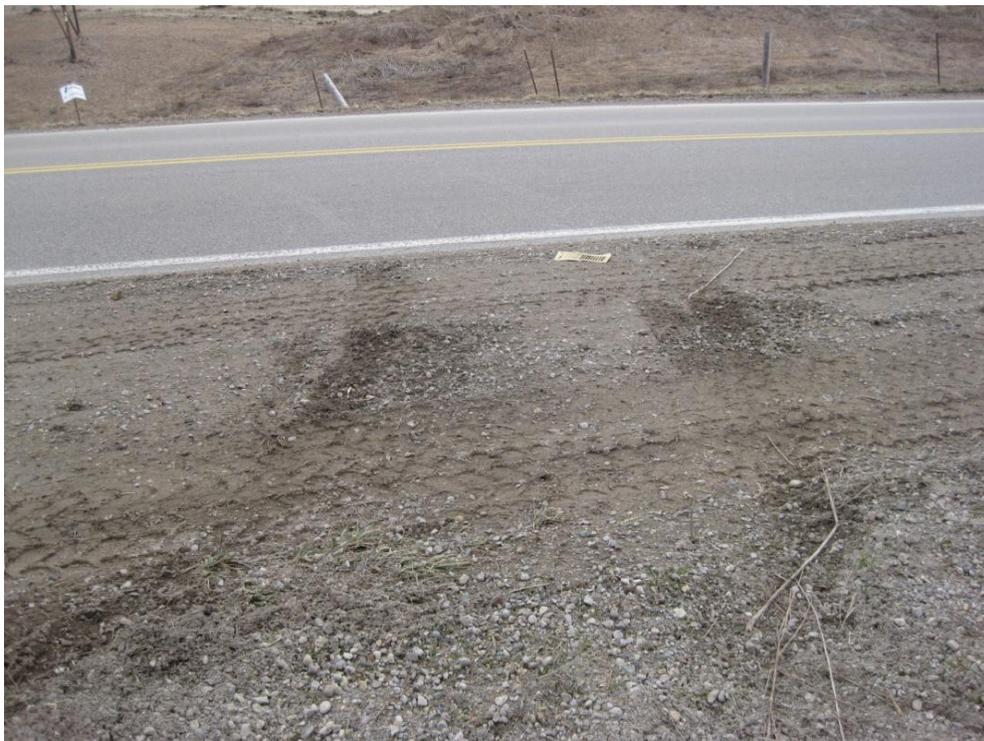
Figure 19: View of the tire mark evidence as the vehicle travels toward the pavement but then travels across the road and strikes the fence of the west ditch in the background.

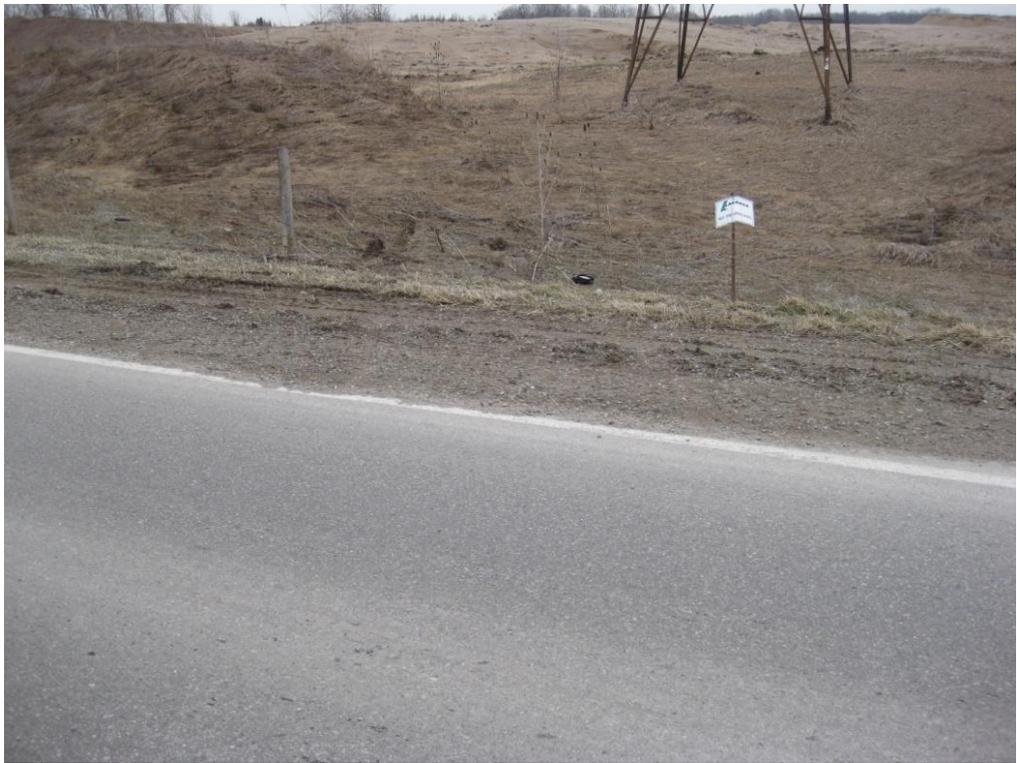
Figure 20: View looking toward the west ditch where the vehicle impacted the fence in the background.

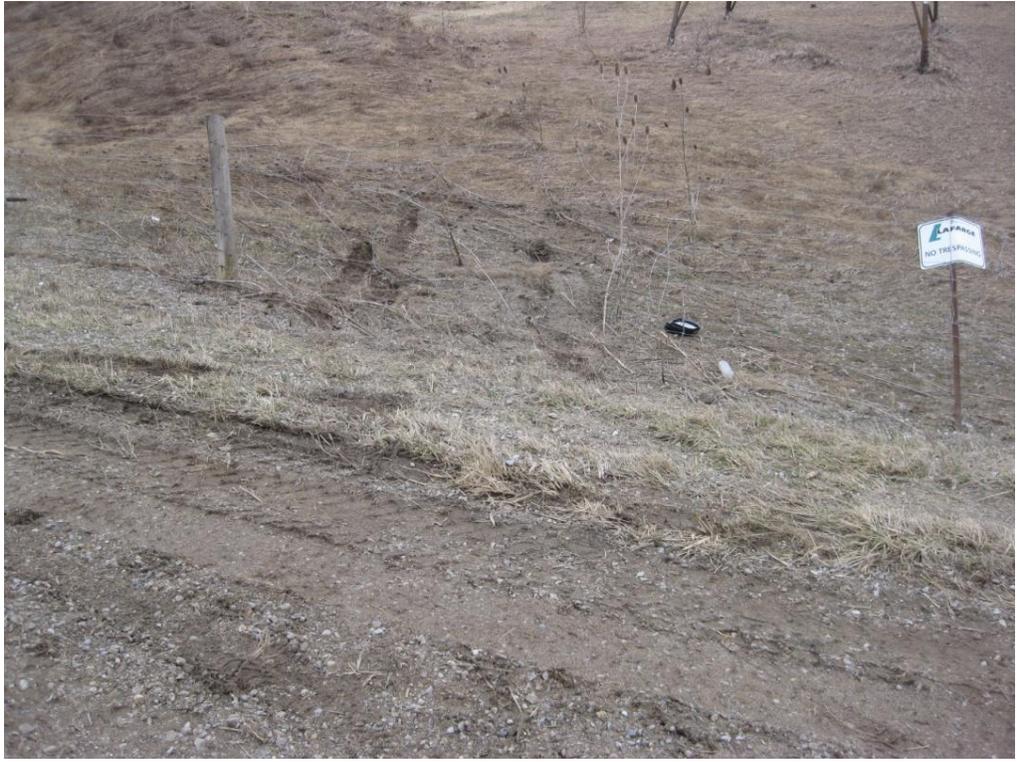
Figure 21: View showing that the vehicle crashed through the west fence.

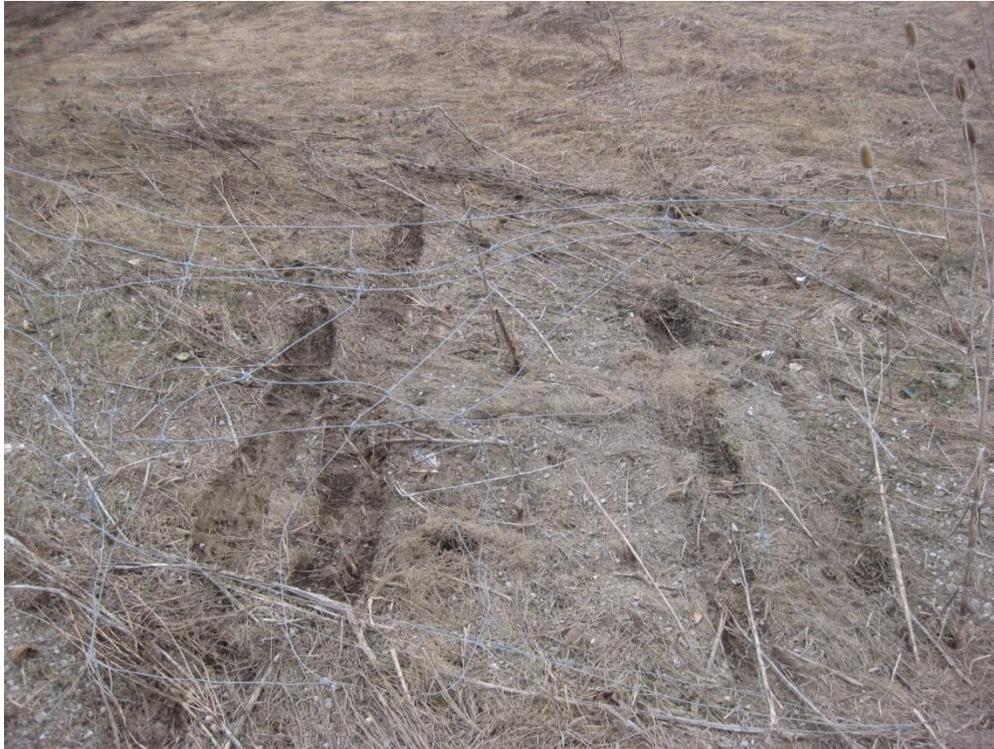
Figure 22: View of the tire marks of the vehicle where it crashed through the west fence.

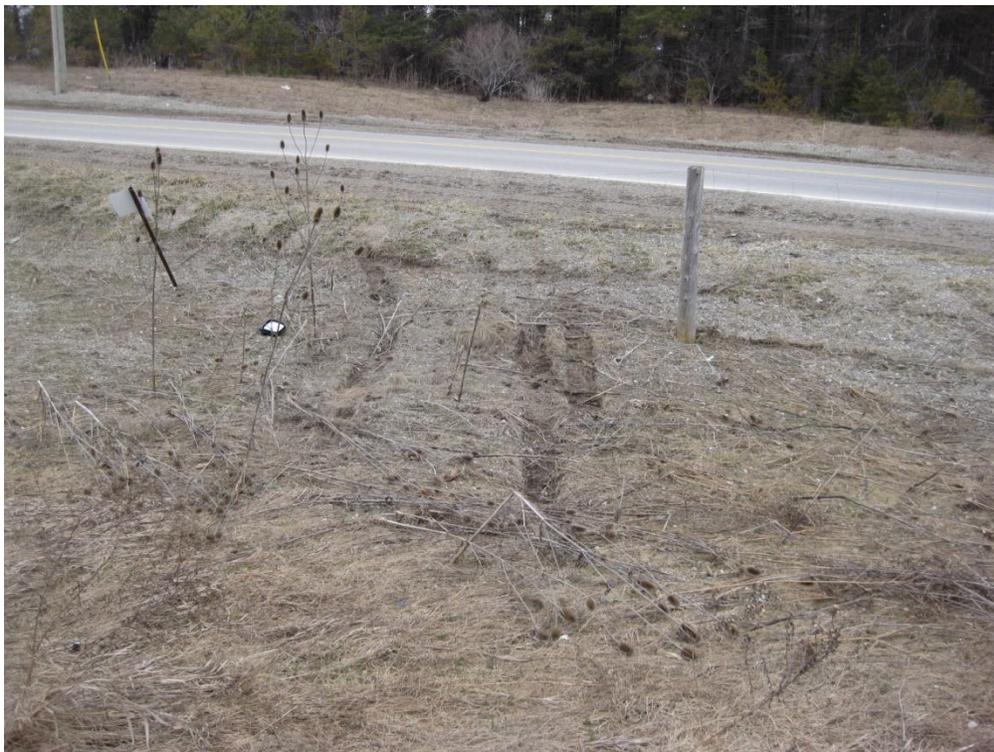
Figure 23: View looking east at the tire marks in the west ditch where the vehicle crashed through the fence.

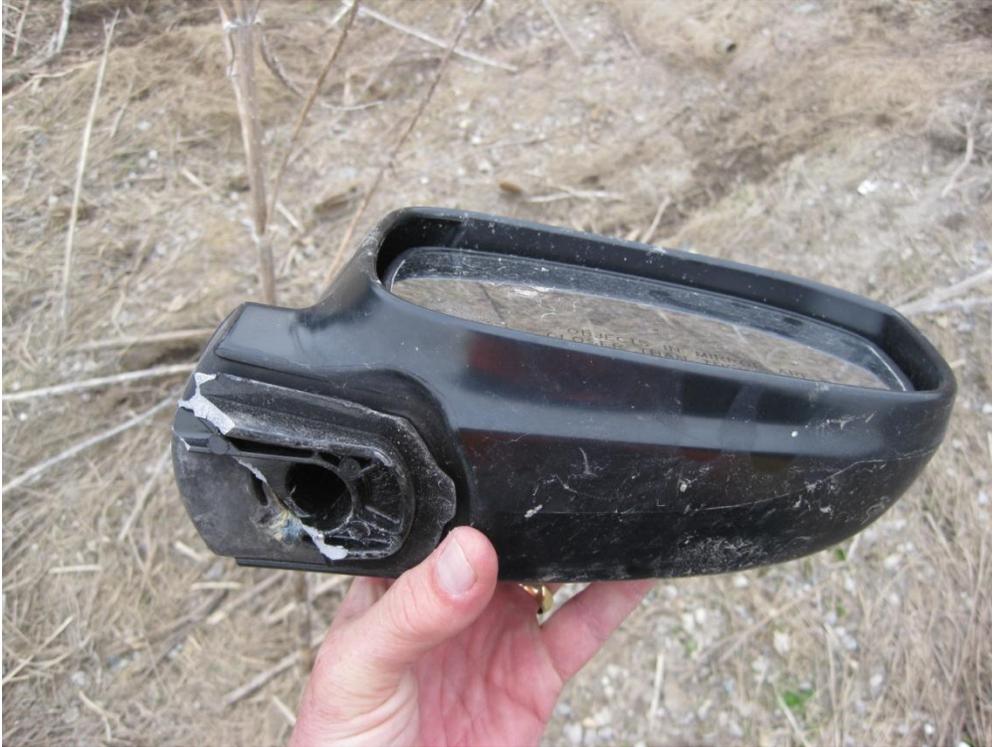
Figure 24: An example of the vehicle parts left at the accident site.

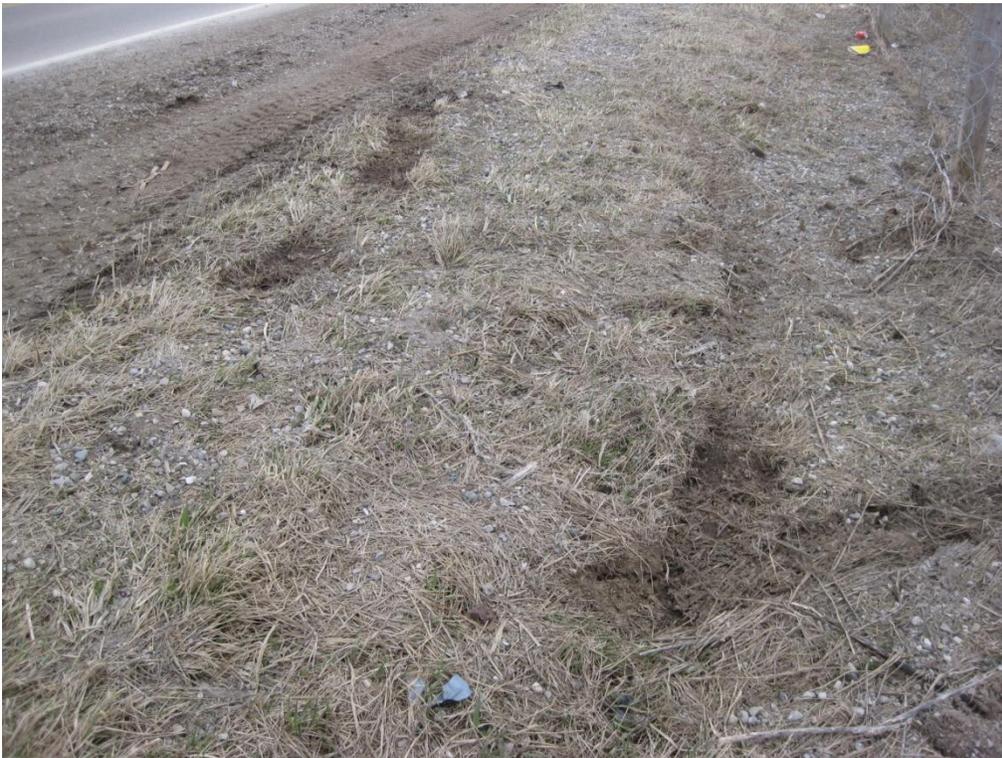
Figure 25: View looking south at the acceleration marks on the west shoulder where the vehicle fled the collision site.

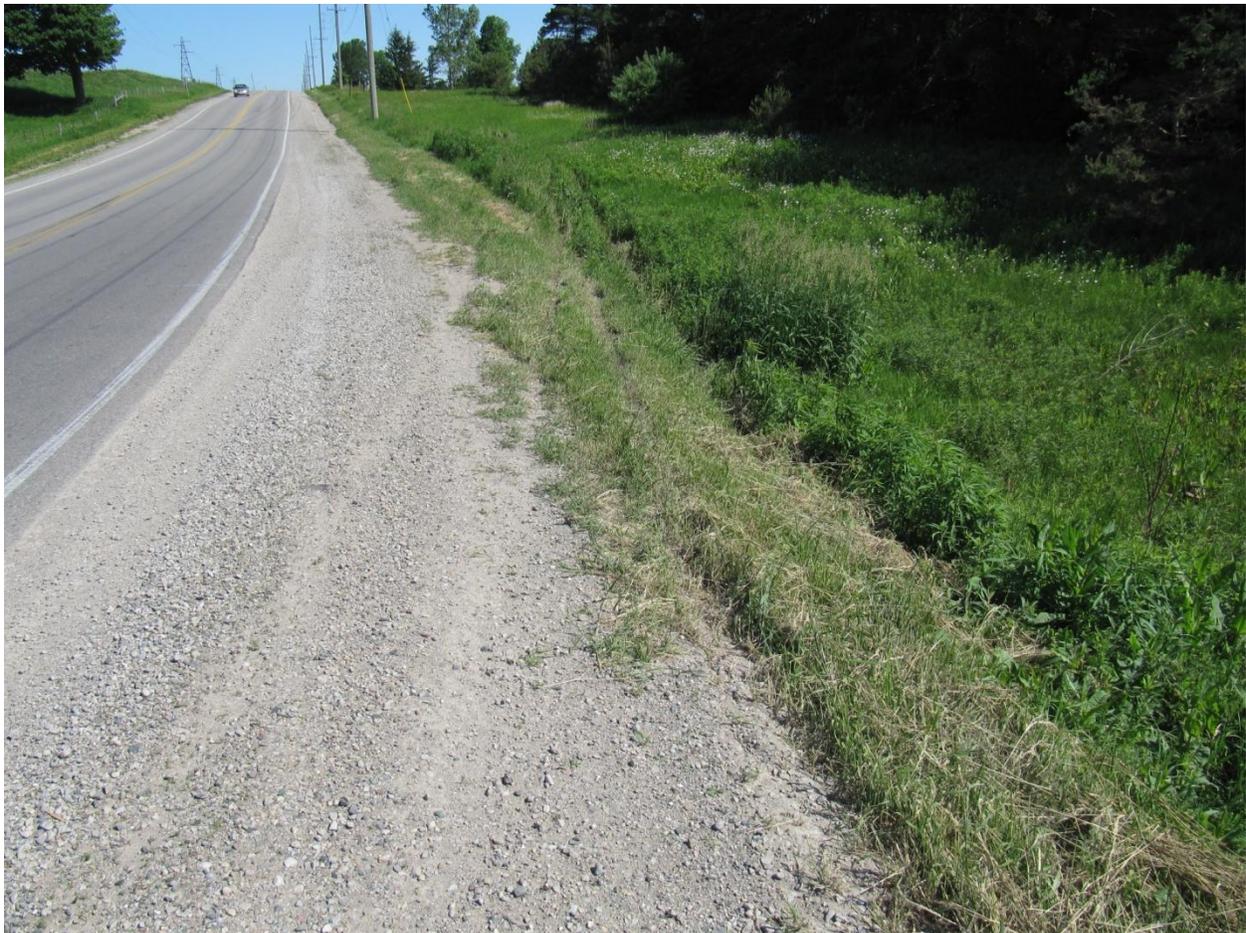
In comparison, the Gorski Consulting dataset also showed that physical evidence was located on June 13th of a northbound vehicle that travelled into the east roadside of the north curve, made contacts with the earth, and came to rest against an evergreen tree in the grounds of an adjacent golf course. However it can be noted that the police data never indicated that the collision occurred at the S-Curve. Figures 26 through 34 show some of the evidence documented by Gorski Consulting on the east roadside at the north portion of the S-curve.

Figure 26: Incident documented by Gorski Consulting on June 13, 2011. Tire marks can be seen on the east shoulder and in the east ditch of the north portion of the curve where a northbound vehicle travelled into the ditch.

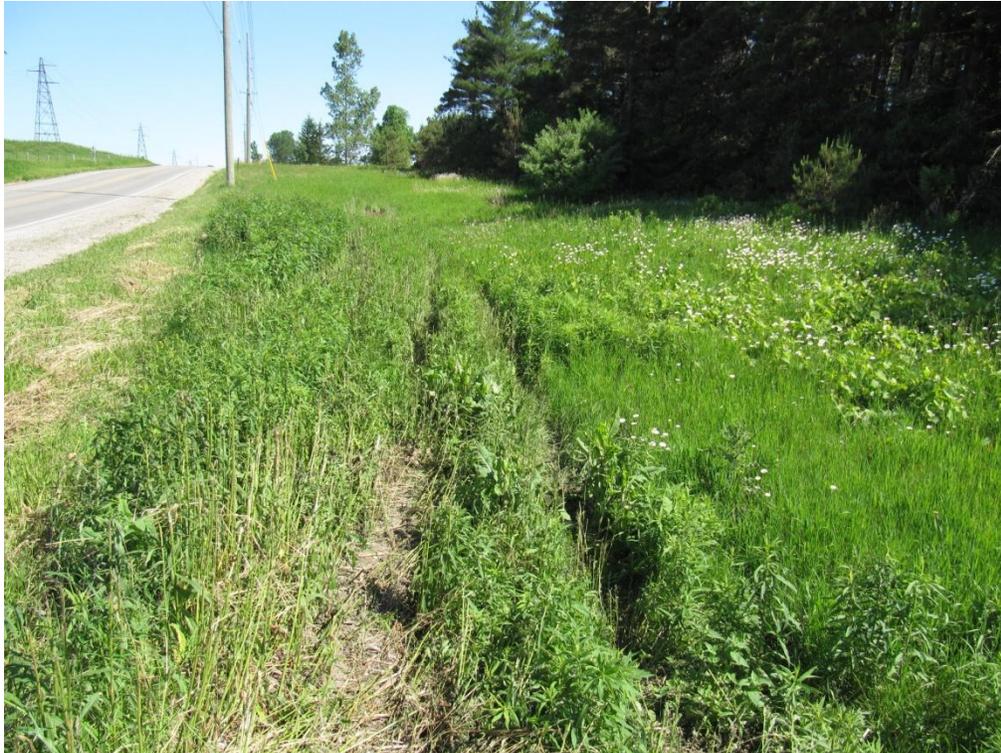
Figure 27: Tire marks show that the northbound vehicle travelled through the tall grass of the ditch where it made ground contact in the background.

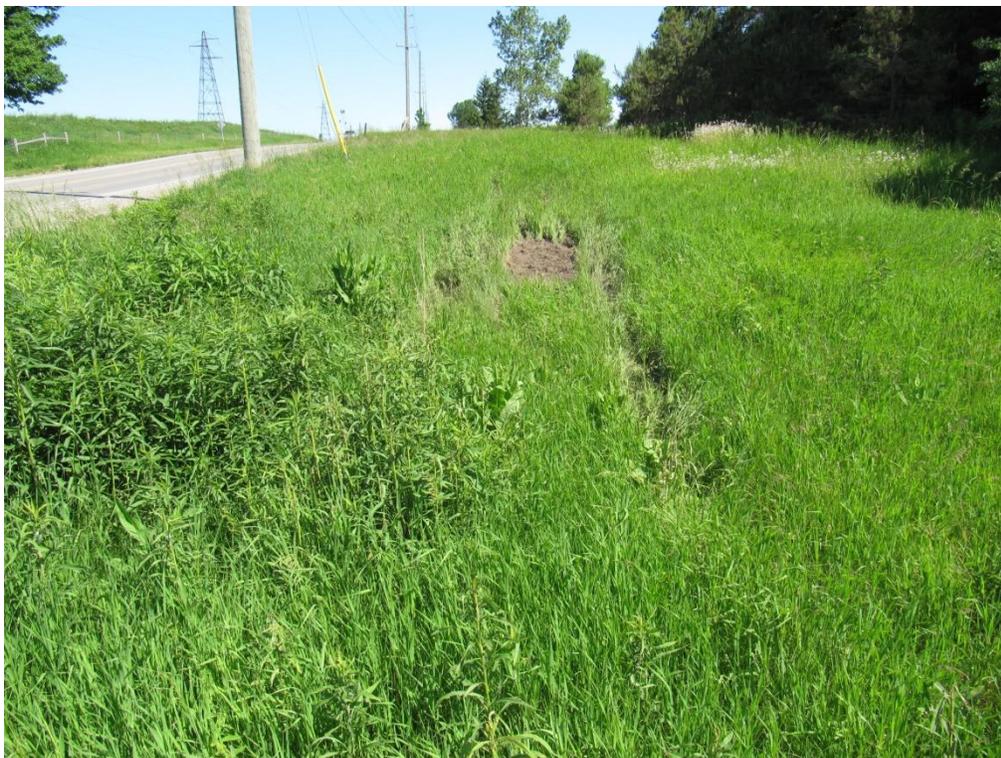
Figure 28: View looking north showing the location where the northbound vehicle made contact with the earth on the upslope of the east ditch.
