How Many Incidents Do Not Become Reported In Police Collision Data?

1.0 Background

2.0 Review of Gorski Consulting Research at the Clarke Road Site

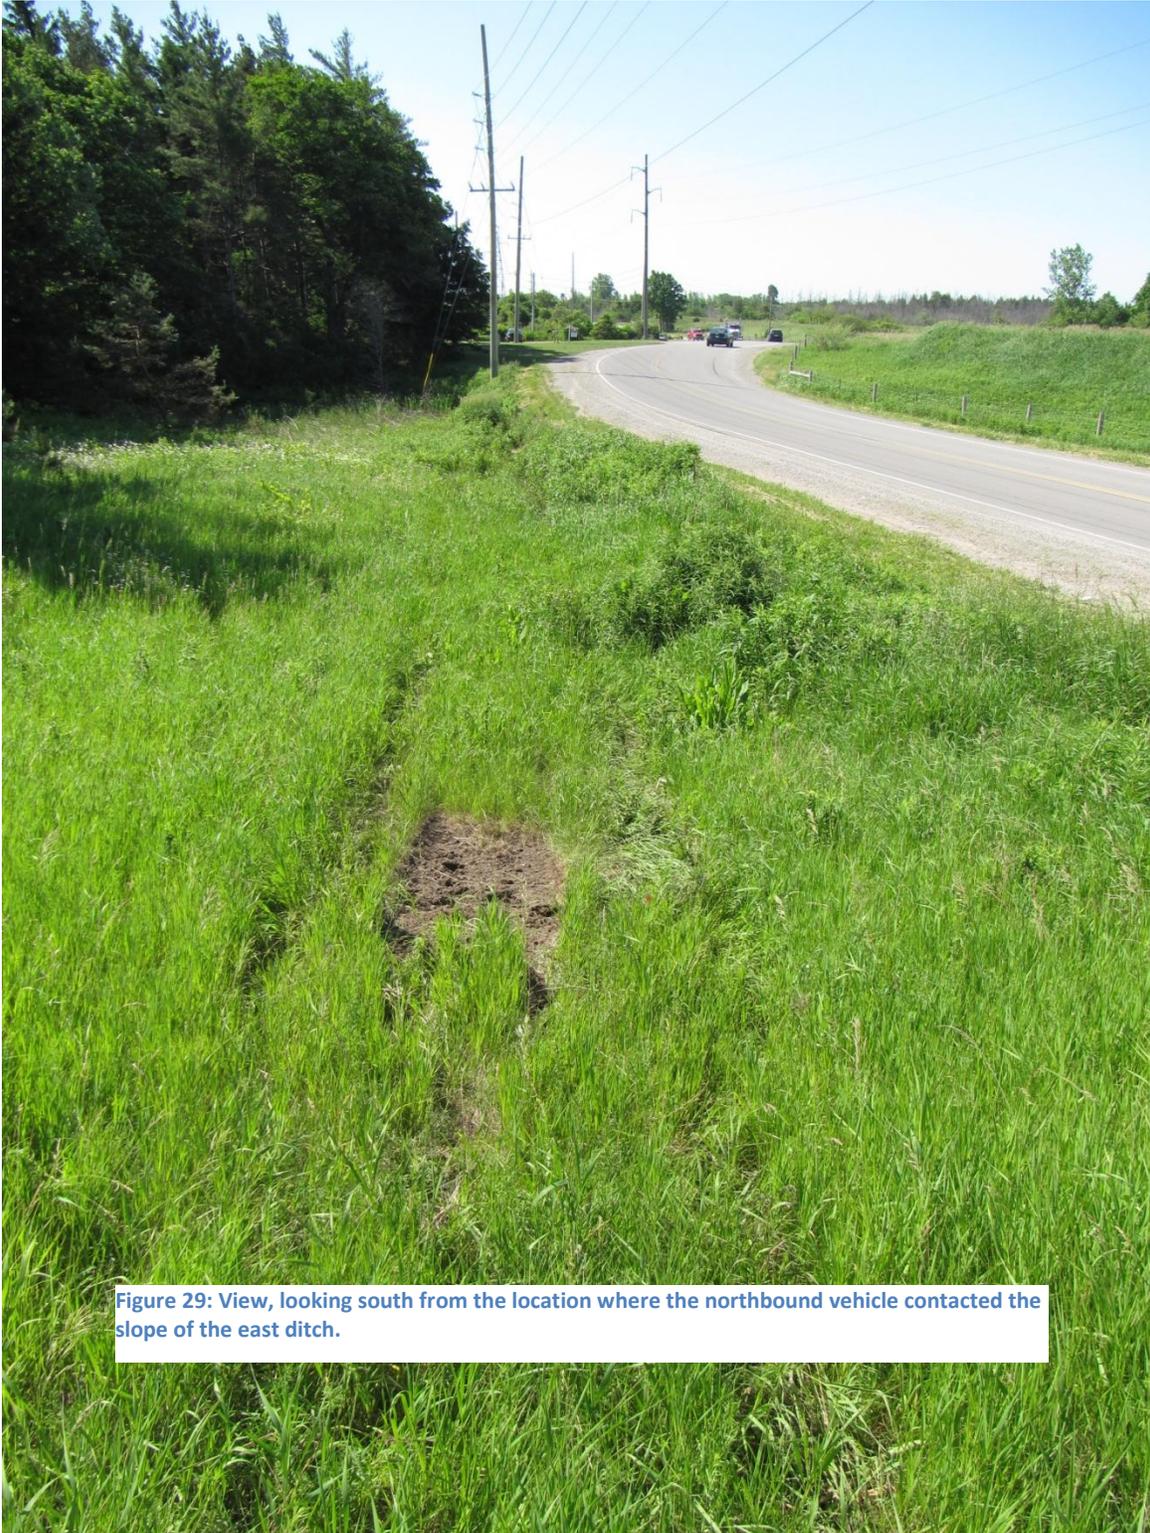
Figure 29: View, looking south from the location where the northbound vehicle contacted the slope of the east ditch.

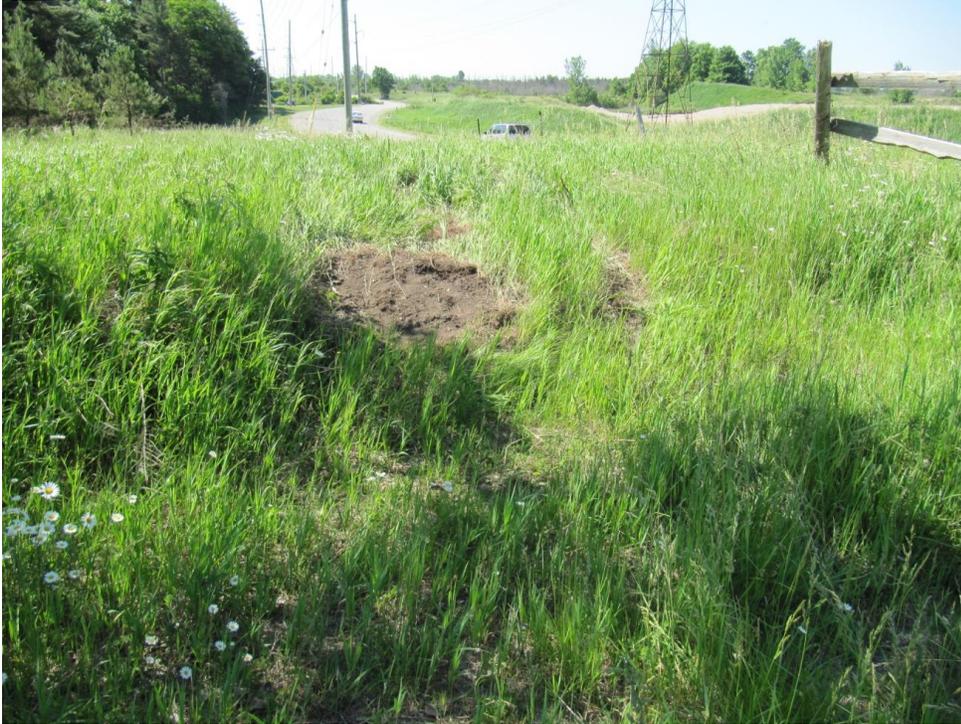
Figure 30: View, looking south at a second location of earth contact at border of the property of a golf course located north of the S-curve. The S-Curve can be seen in the distant background.

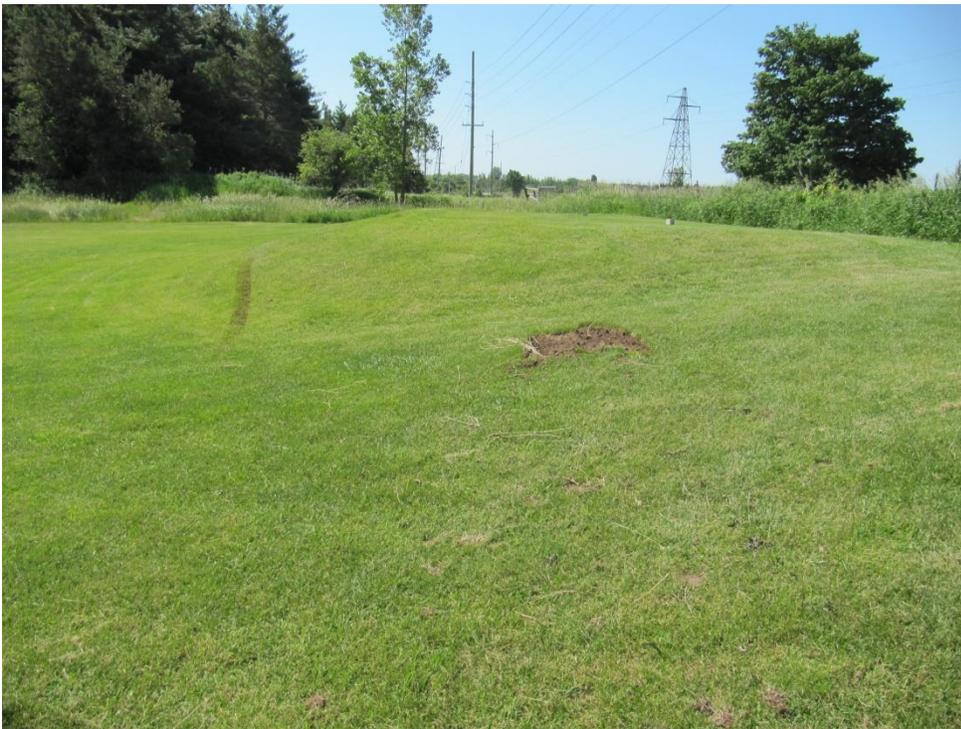
Figure 31: View looking south, on the grounds of the golf course showing a tire marks and the third contact with the earth as the vehicle continued its northbound travel.

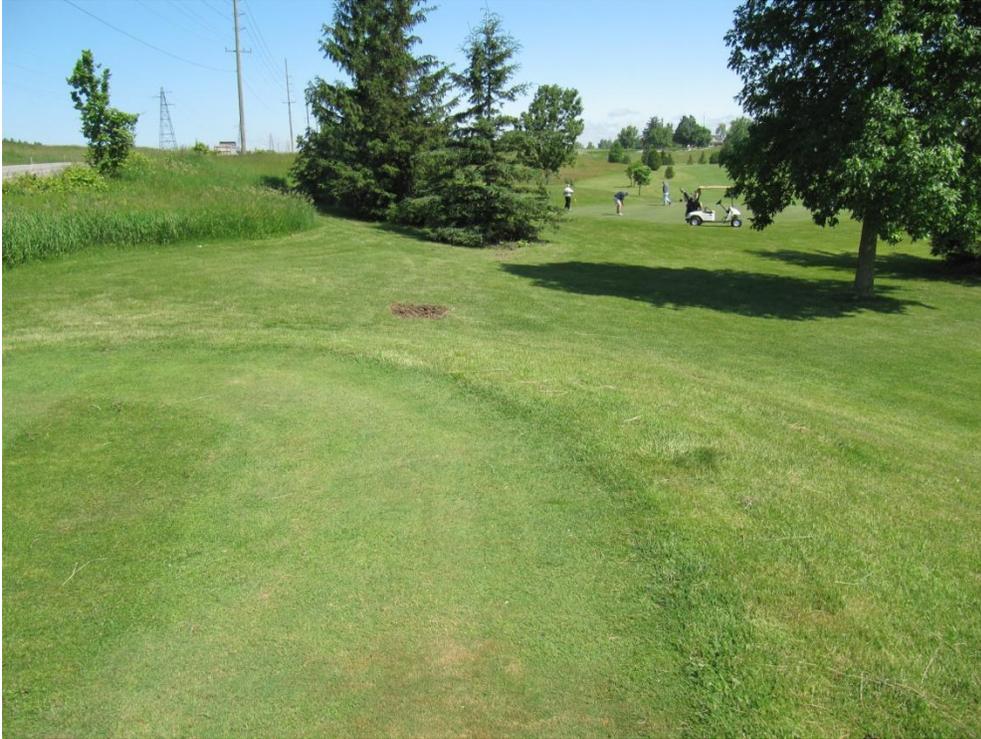
Figure 32: View looking north on the grounds of the golf course where a fourth ground contact is visible in the background.

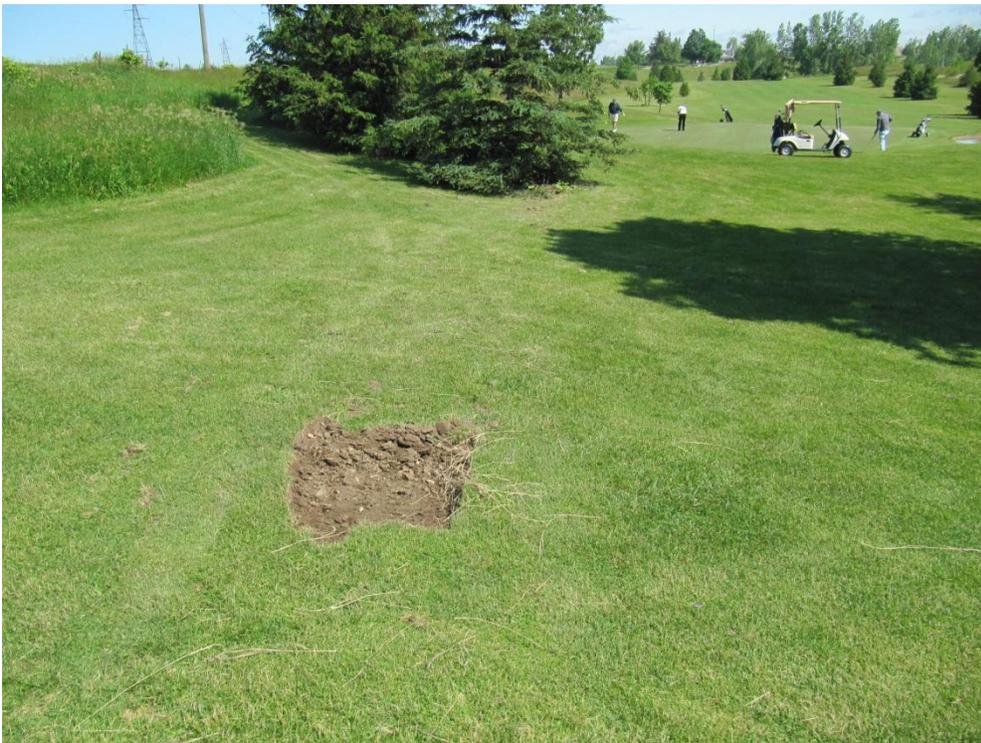
Figure 33: View looking north from the fourth ground contact. The vehicle finally came to rest against the small evergreen tree in the background.

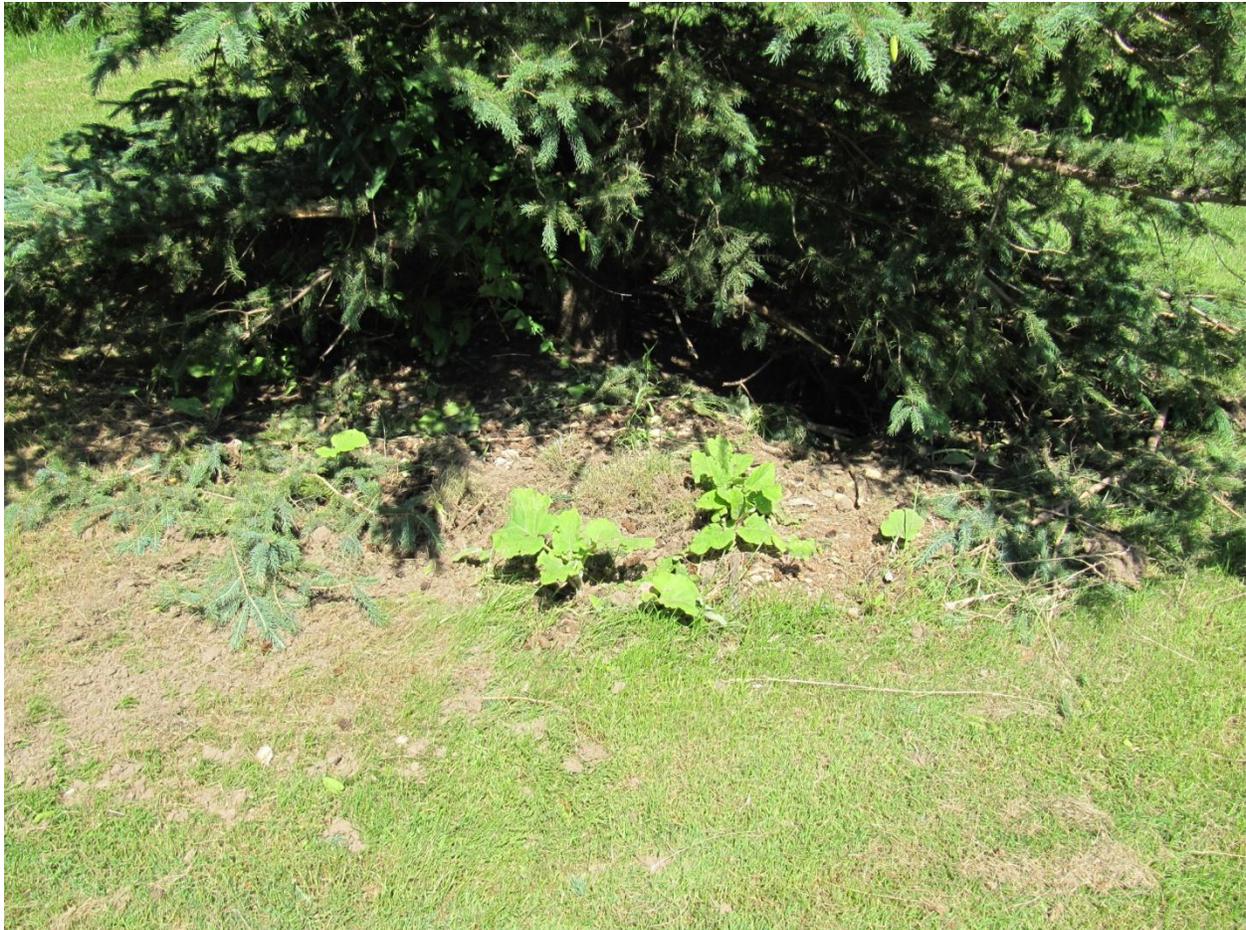
Figure 34: View of ground contact and small amount of damage to the evergreen tree where the northbound vehicle finally came to rest.

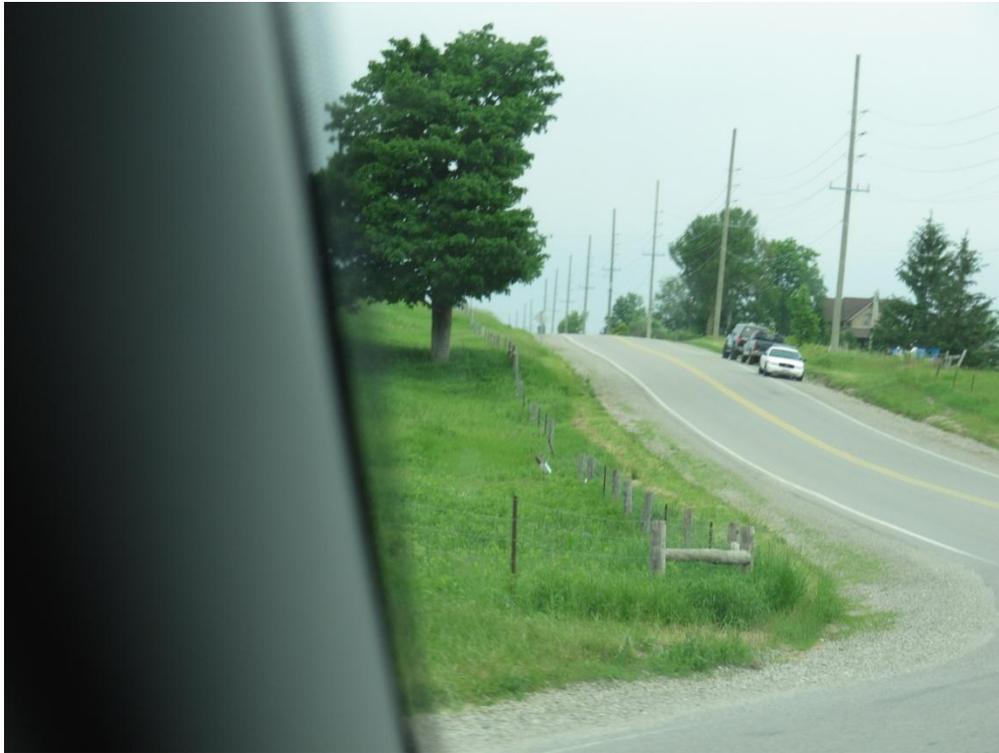
Figure 35: View, looking north, taken at approximately 0930 hours of June 11, 2011, showing some vehicles stopped on the east shoulder just north of the S-curve.

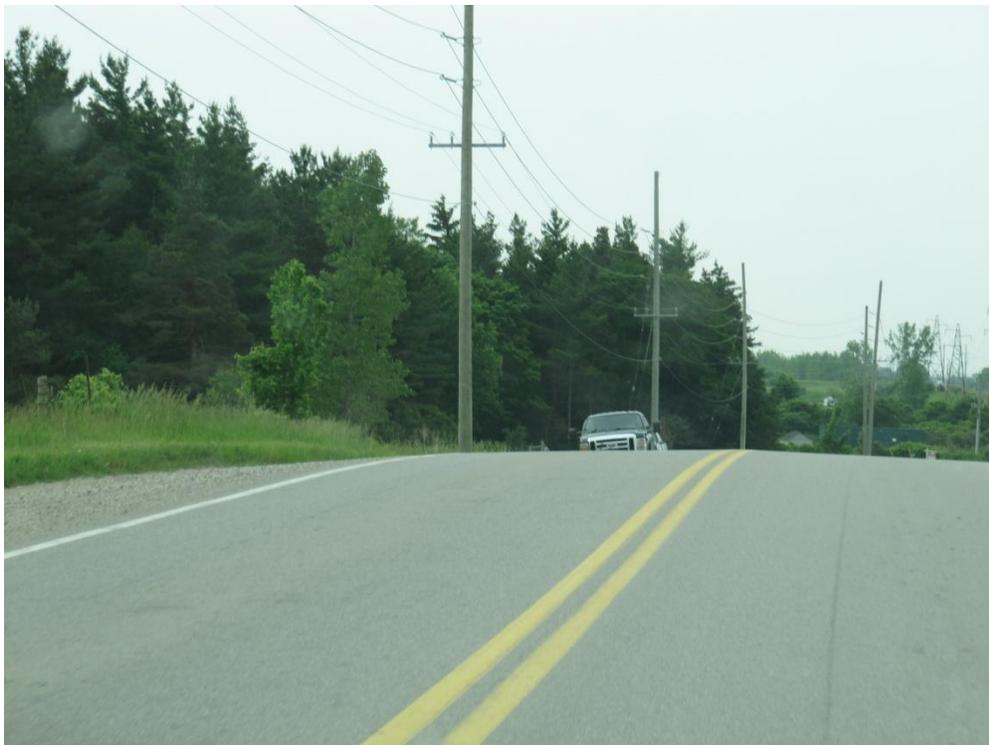
Figure 36: View looking south just north of the S-curve showing some vehicles stopped on the east shoulder.

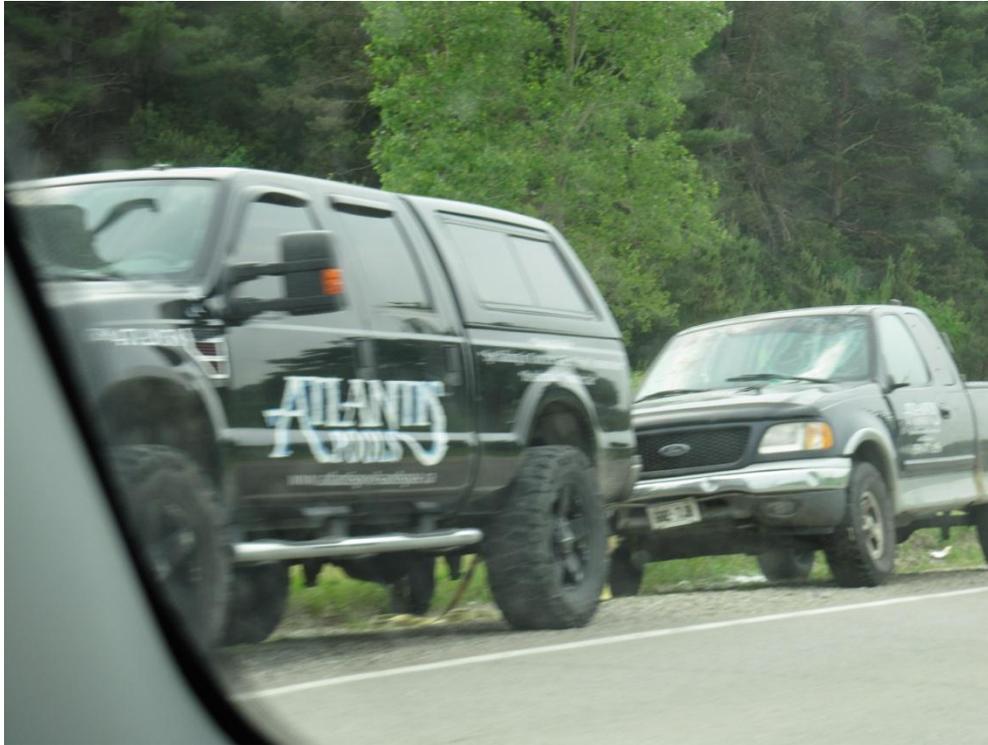
Figure 37: View showing that there appears to be damage to the front end of the pick-up truck stopped behind the first one.

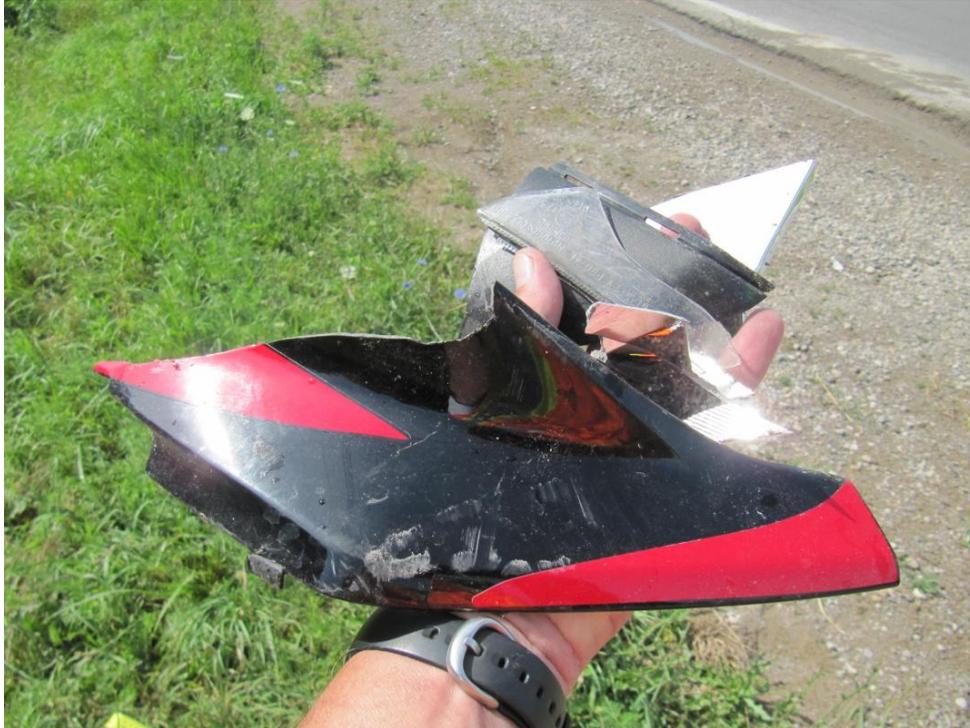
Figure 38: View of motorcycle parts found on the east roadside of the north portion of the S-curve on July 18th. This evidence would match the police information that a north motorcycle crashed on Clarke Road on July 3rd.

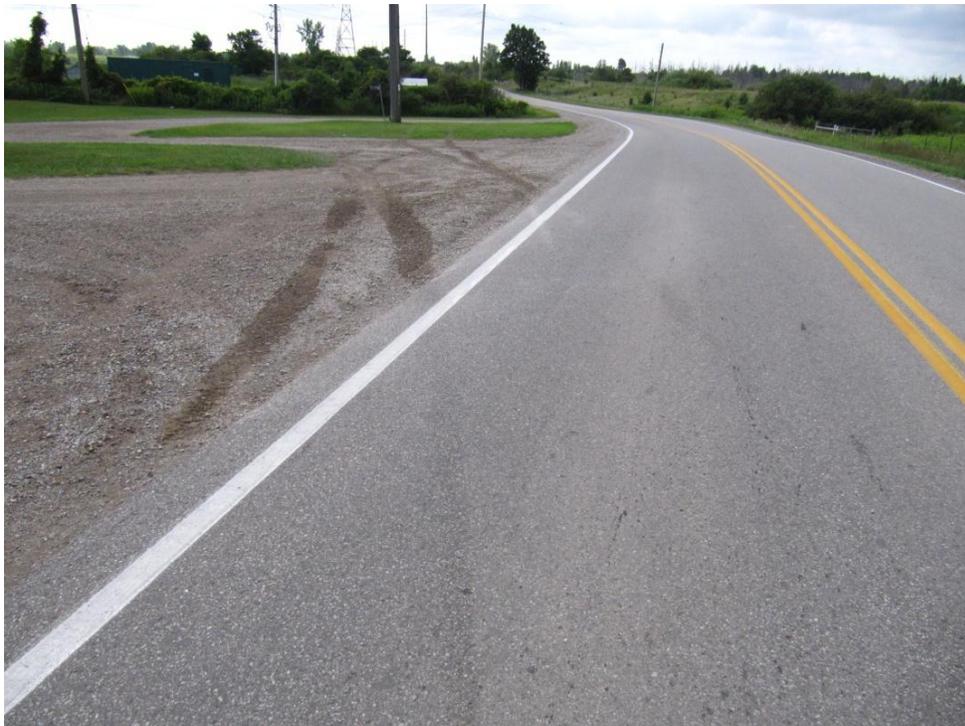
Figure 39: Incident from August 8th. This is a view looking south toward the east roadside between the two parts of the S-curve. Yaw marks from a southbound vehicle show its counter-clockwise rotation.

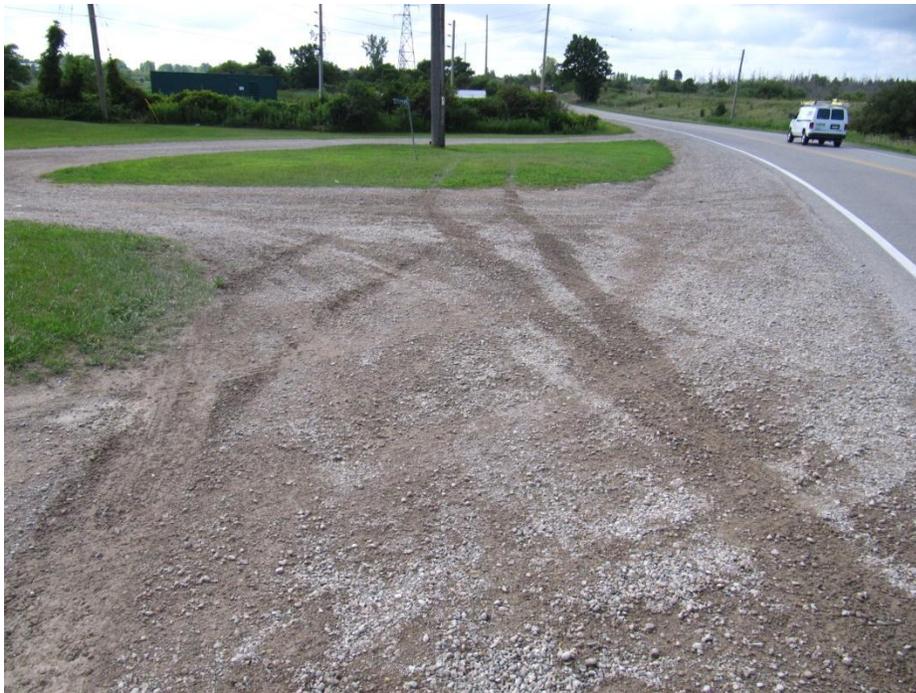
Figure 40: View of the yaw marks. The vehicle was sliding sideways, leading with its right at the approximate bottom of the photograph. As the vehicle continued its rotation it began sliding backwards as it entered the grass in the background.

The Gorski Consulting dataset indicated that there was a loss-of-control event that occurred in the S-curve on August 8th and this was not noted in the police dataset. Figures 39 to 41 show the evidence that was documented. These figures show that a southbound vehicle passed through the north portion of the curve and subsequently went into a counter-clockwise rotation, passed through the northbound lane and slid onto the east grass roadside between the two portions of the curve. The only reason why a collision did not take place is because a northbound vehicle was not travelling in the lane at the time that the southbound vehicle slid through it. While this was not a reportable collision for police purposes it was an event that could easily have resulted in a serious collision.

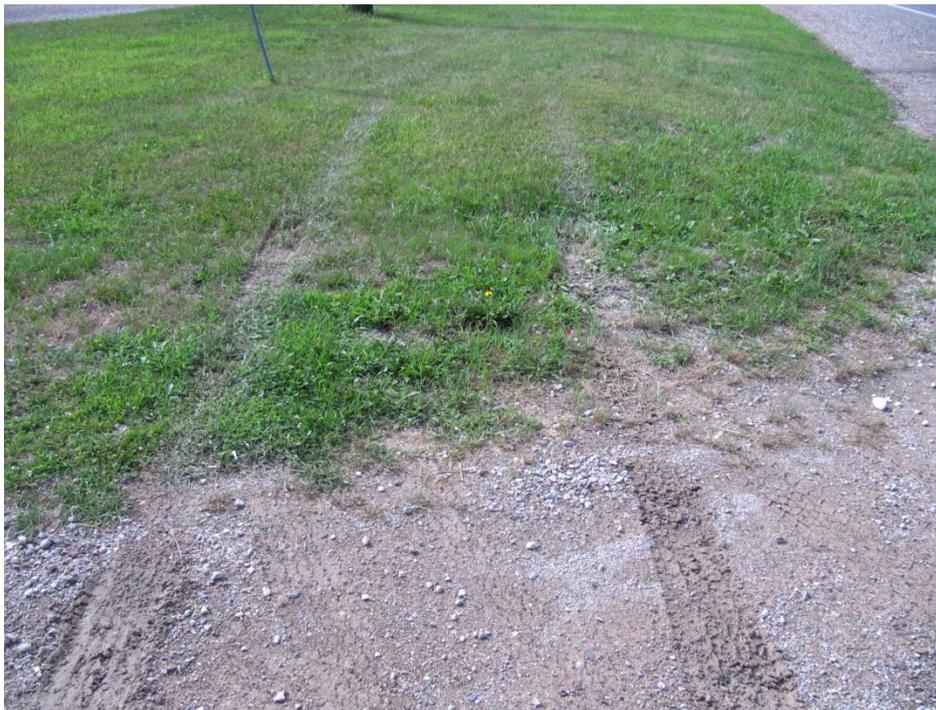
Figure 41: The vehicle was sliding backwards as it came to rest on the grass in the background. The driver subsequently accelerated forward over top of the sliding marks and exited the area.

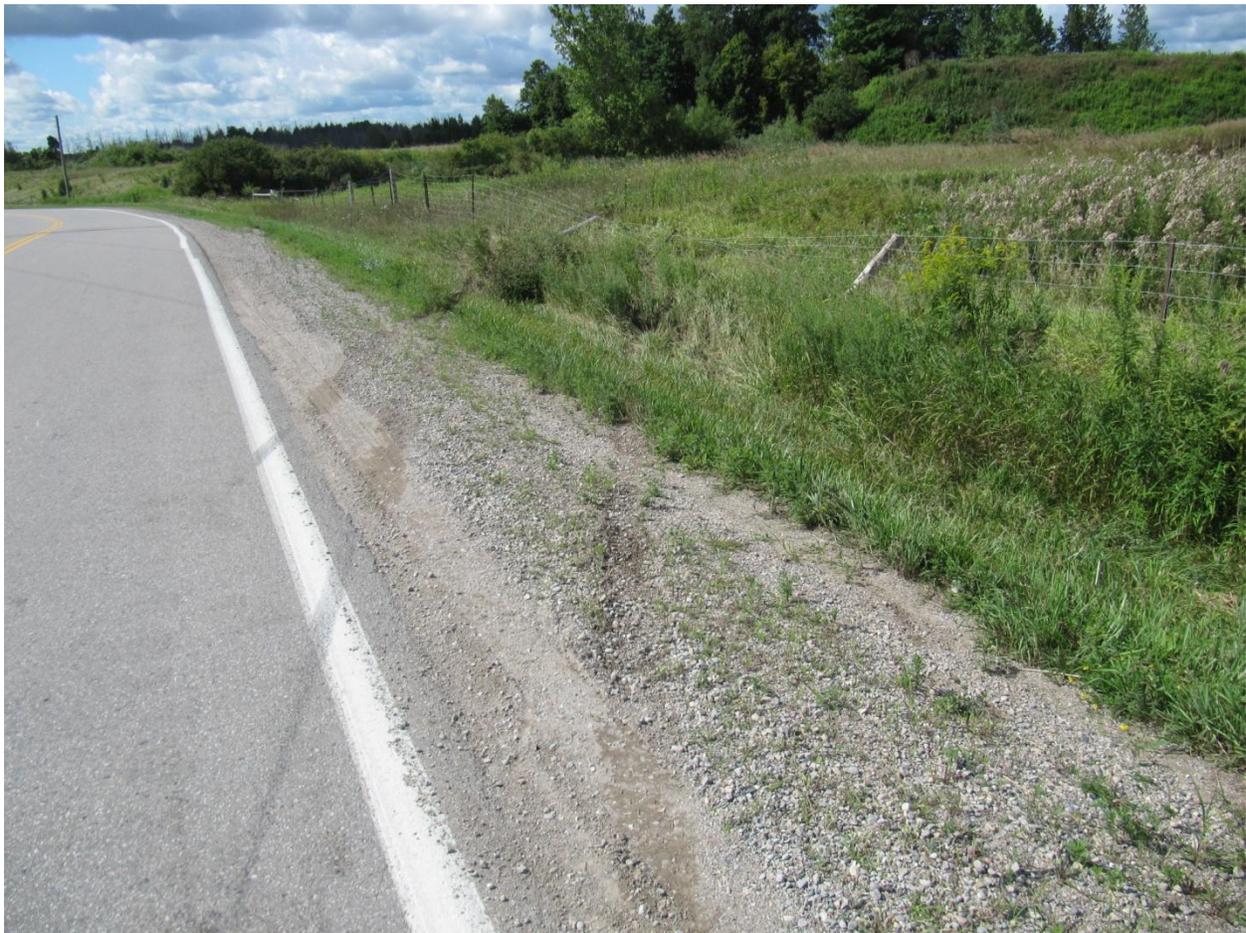
Figure 42: One of two incidents from August 10th. Here tire marks from a southbound vehicle indicate a clockwise rotation as the vehicle impacts the wire fence.

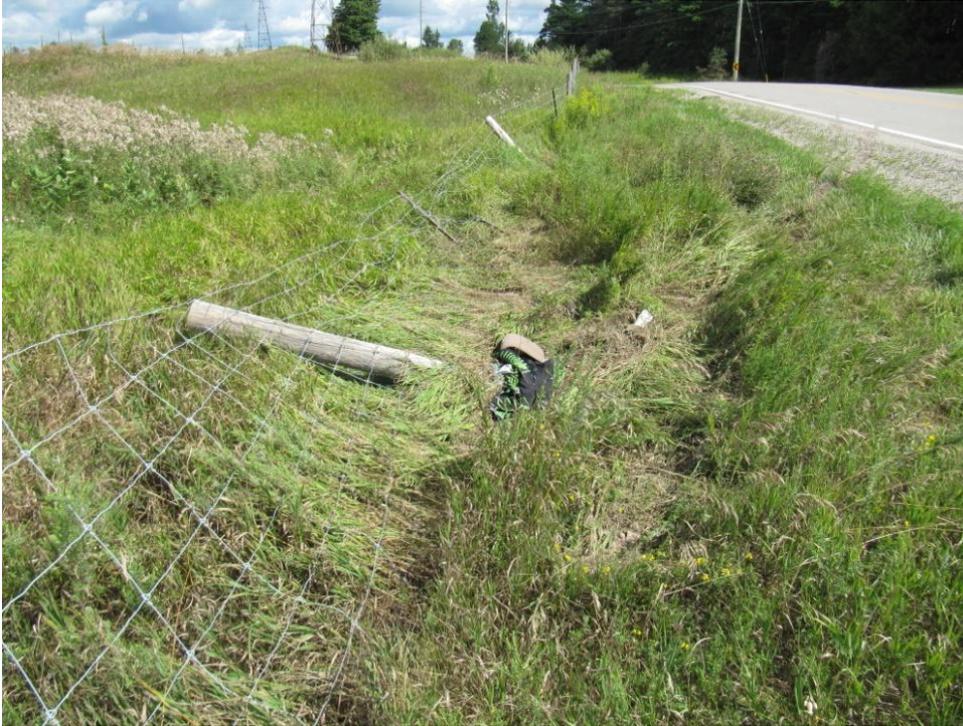
Figure 43: View looking north at the damage to the wire fence on the west roadside. Vehicle parts are also shown on the grass.

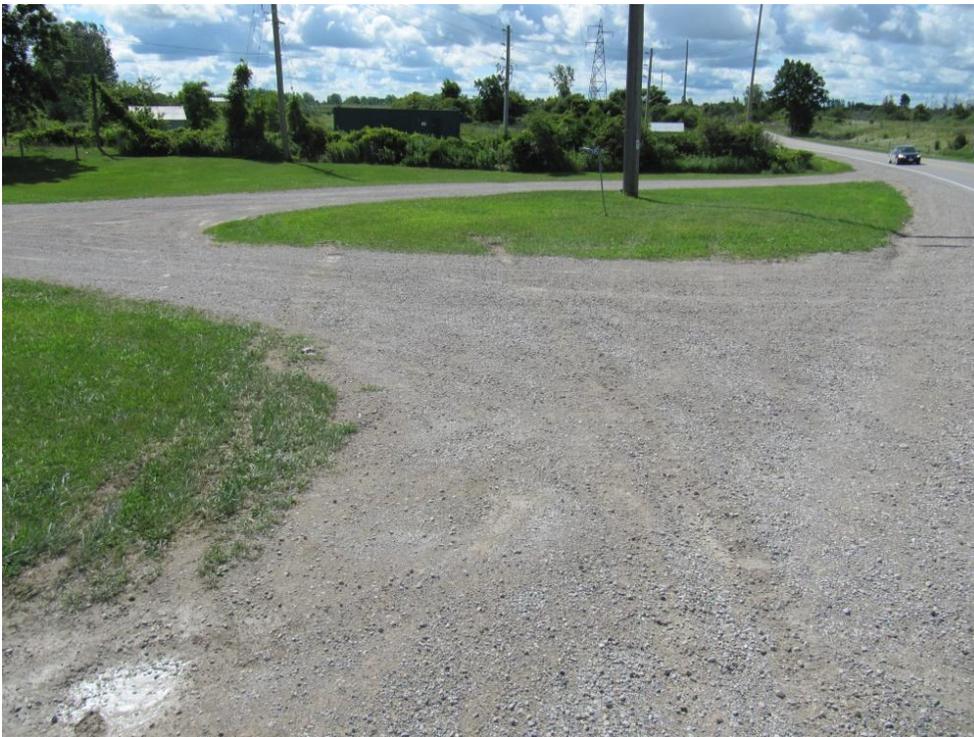
Figure 44: In the second incident of August 10th a southbound vehicle slid sideways through the gravel driveways between the two portions of the S-curve and came to rest at the edge of the grass.

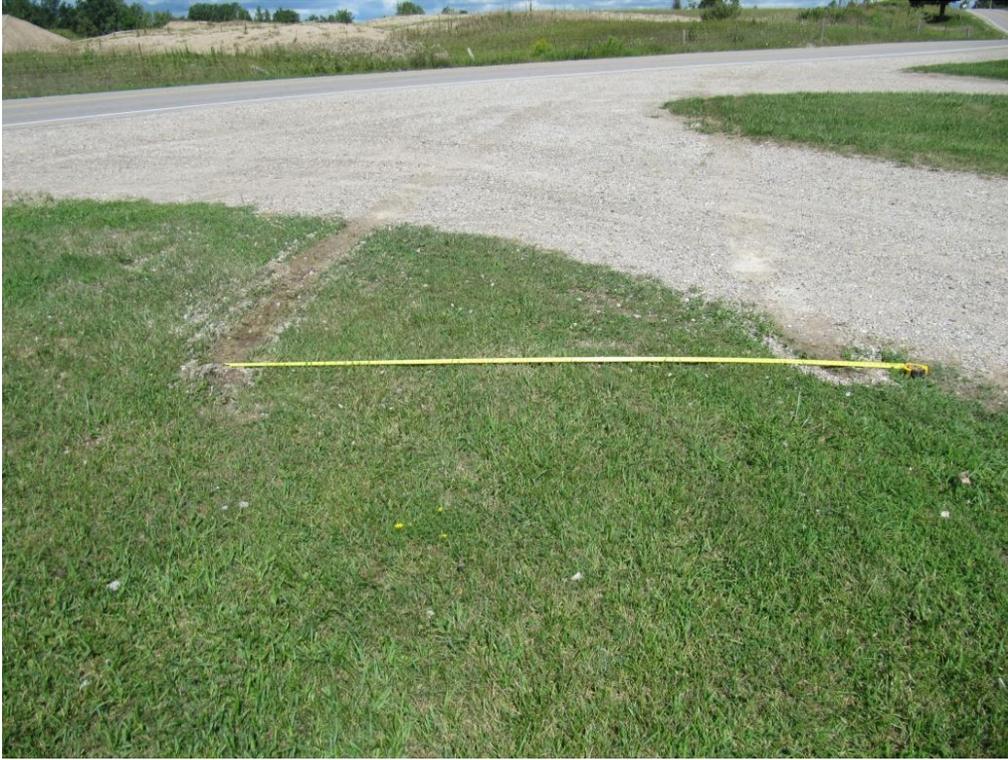
Figure 45: View of a tape measure spanning the tire marks of the vehicle that came to rest sideways on the east roadside. Determining the wheelbase of a vehicle like this can sometimes be helpful in estimating what kind of vehicle was involved.

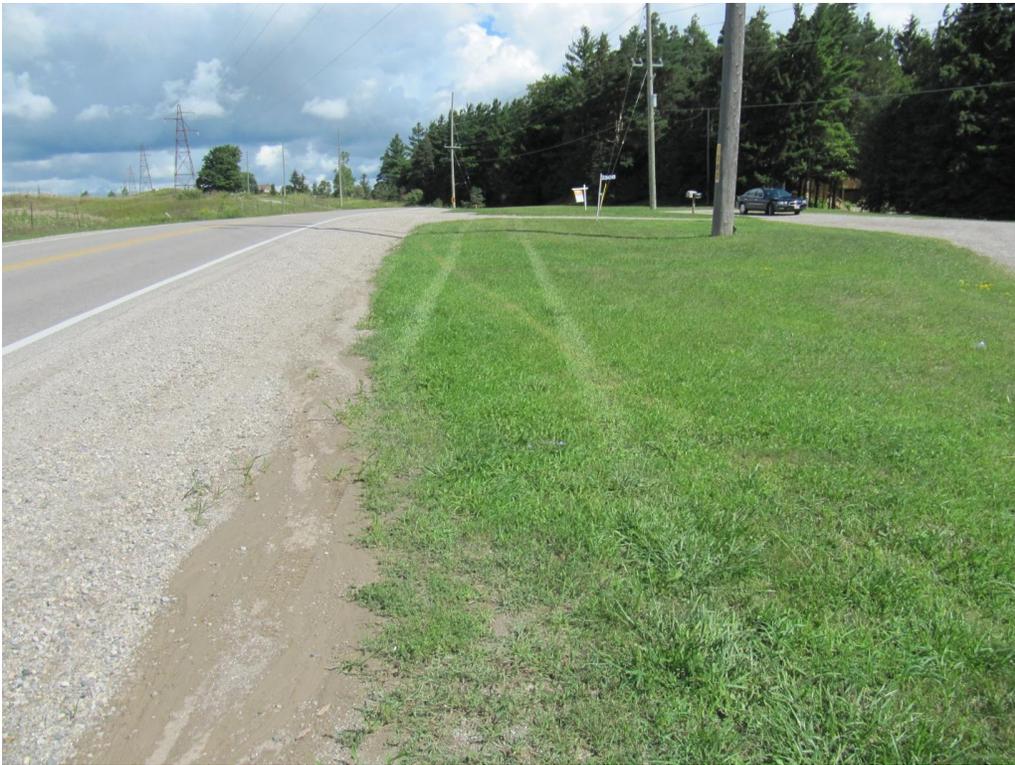
Figure 46: View of tire marks on the east roadside from two additional vehicles.

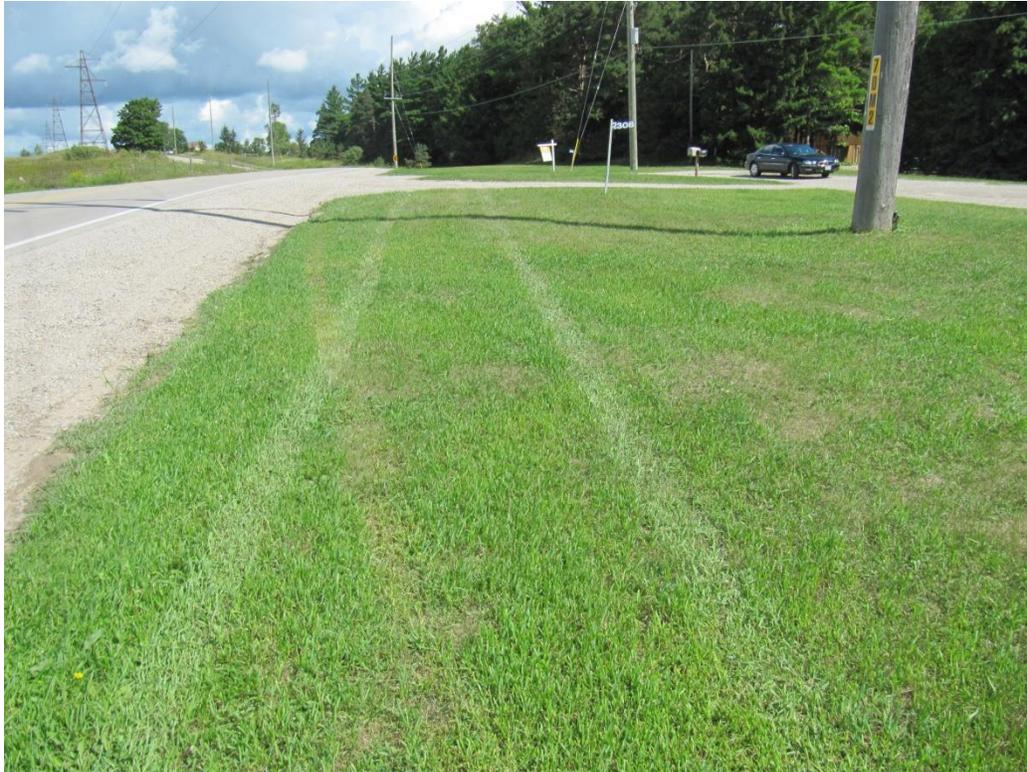
Figure 47: When tire marks cross each other as shown in this view it is possible to look at their intersection to determine which tire mark was created first.

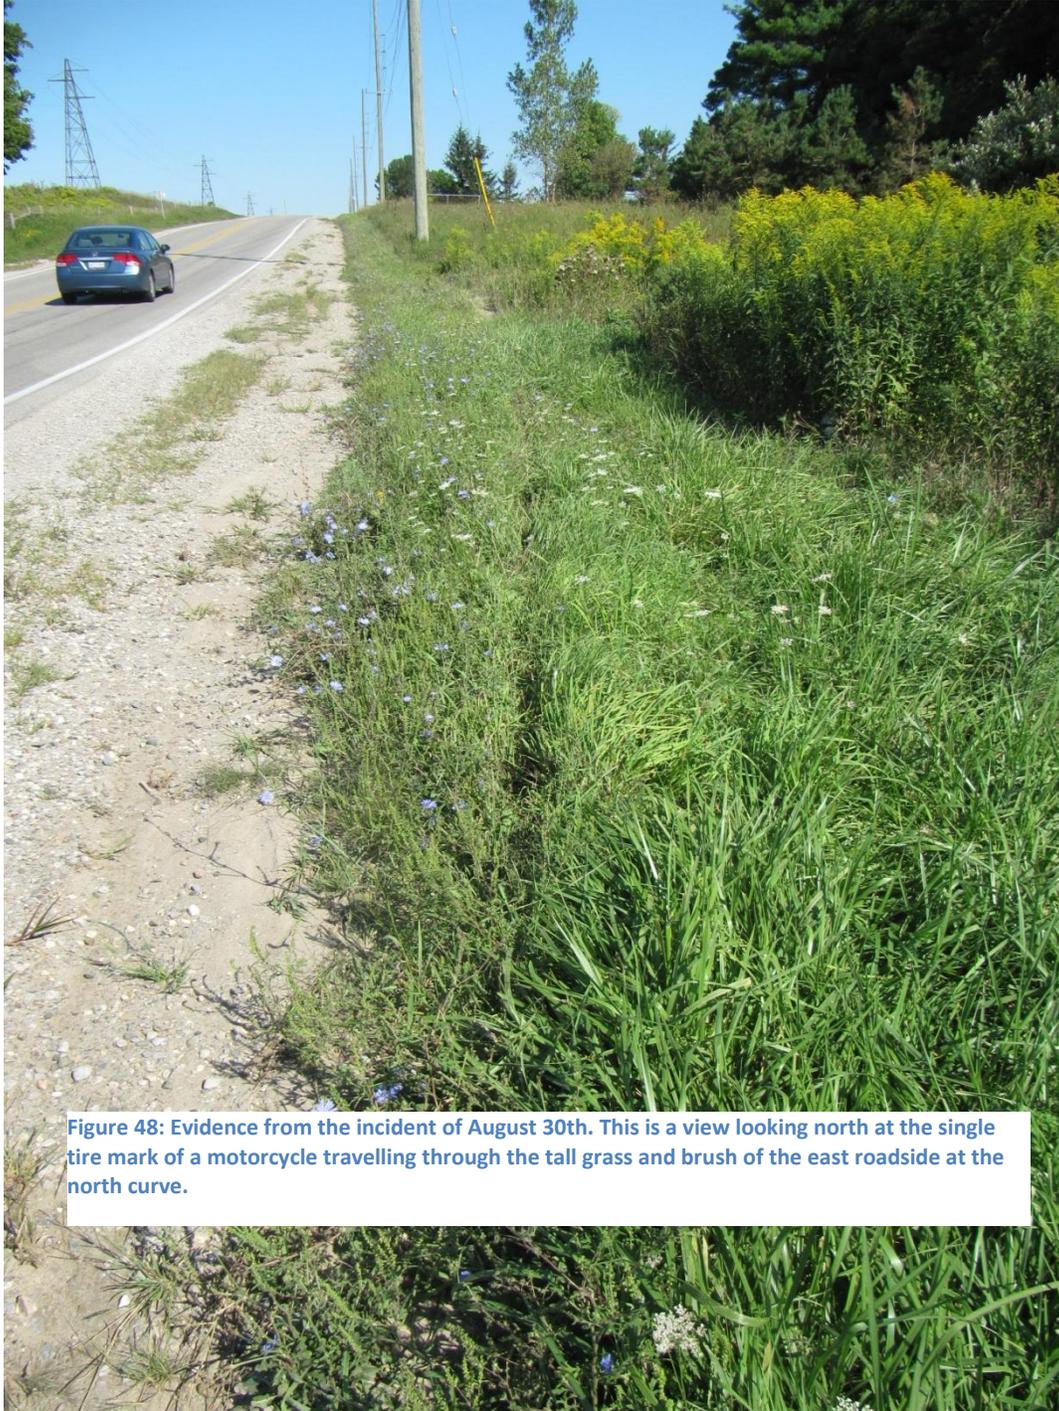
Figure 48: Evidence from the incident of August 30th. This is a view looking north at the single tire mark of a motorcycle travelling through the tall grass and brush of the east roadside at the north curve.

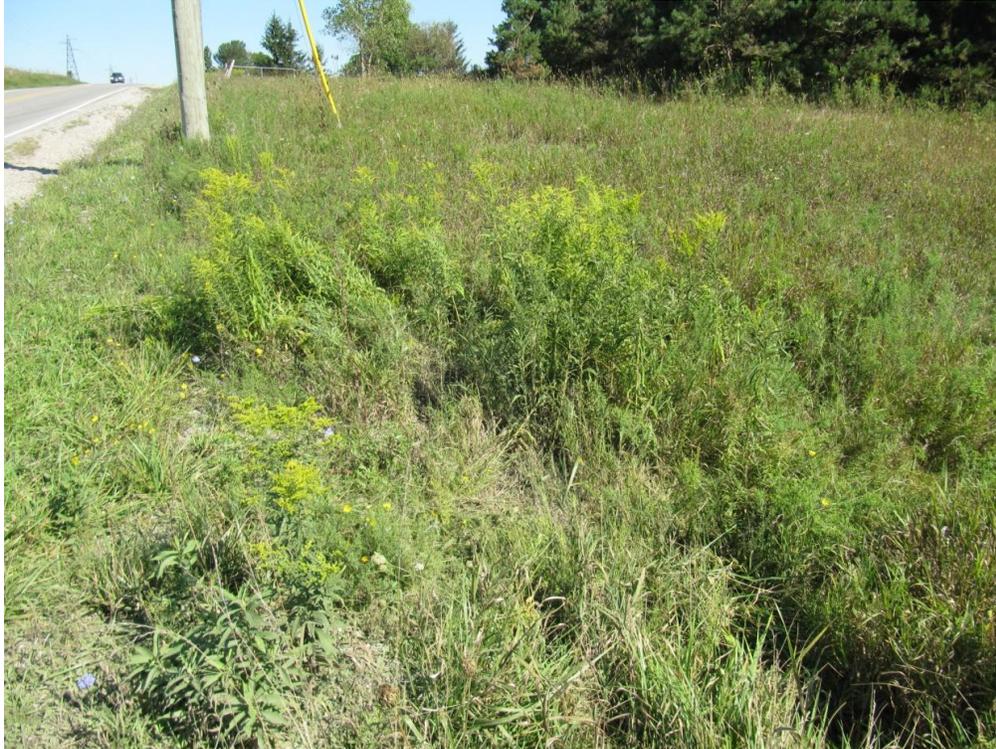
Figure 49: View of the likely rest position of the motorcycle in the tall brush of the east roadside.

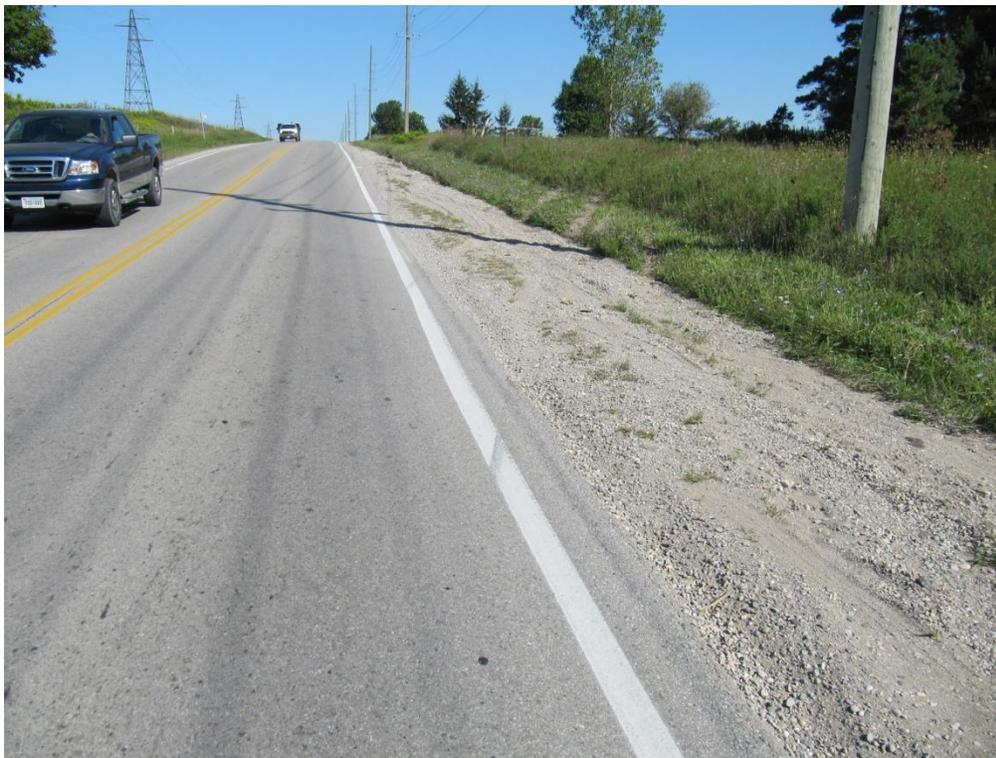
Figure 50: View of the loss-of-control yaw marks of a vehicle that has rotated clockwise into the east roadside just north of the north portion of the S-curve.

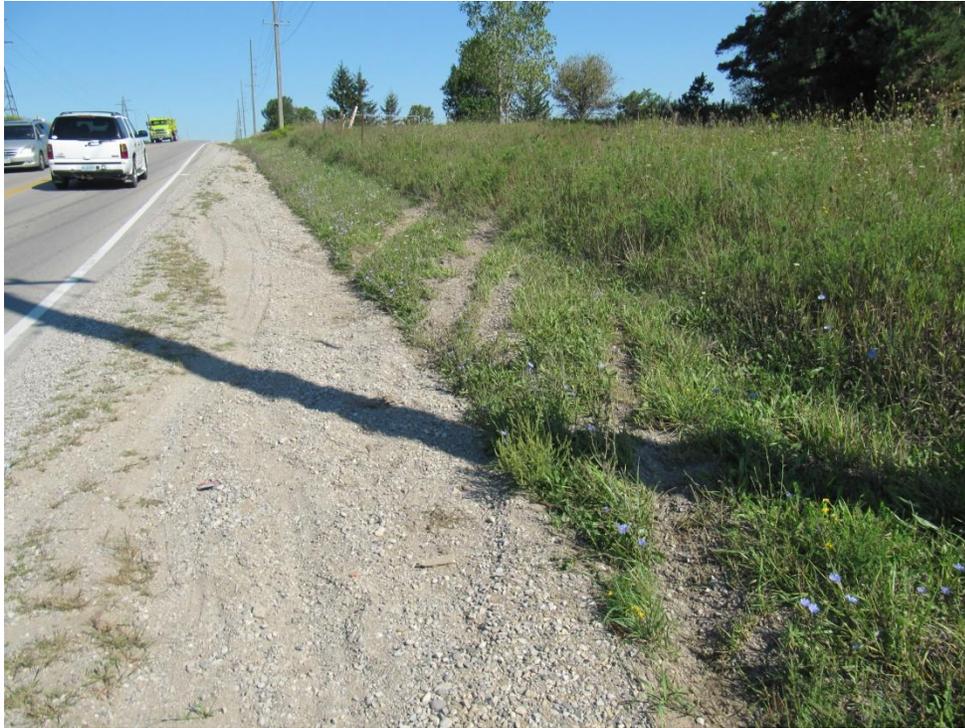
Figure 51: View of the tire marks of the northbound vehicle as it rotates into the embankment of the east roadside.

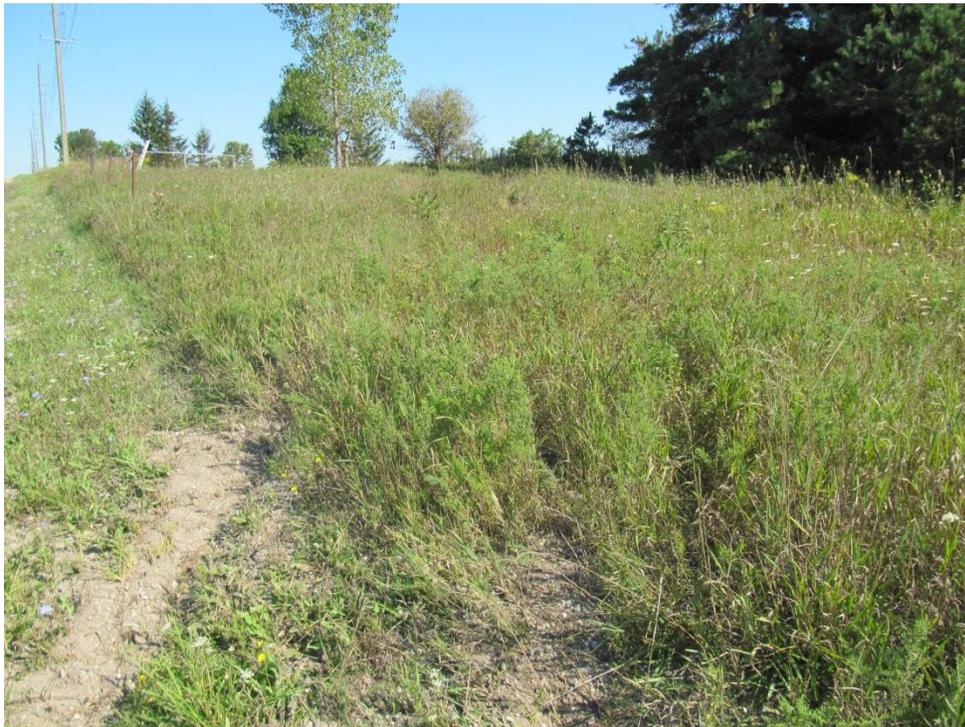
Figure 52: As the tire marks end at the top of the embankment this indicates that the loss-of-control vehicle has become airborne as it travels further into the roadside.

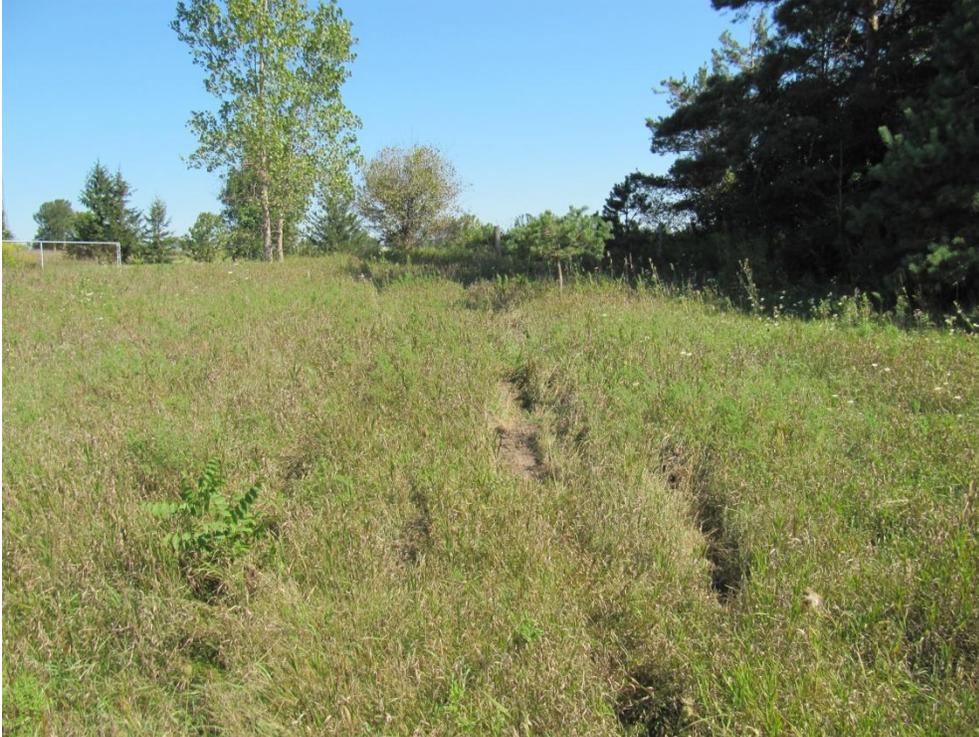
Figure 53: View of the gouges into the earth and flattening of the grass and brush as the vehicle travels further into the east roadside.

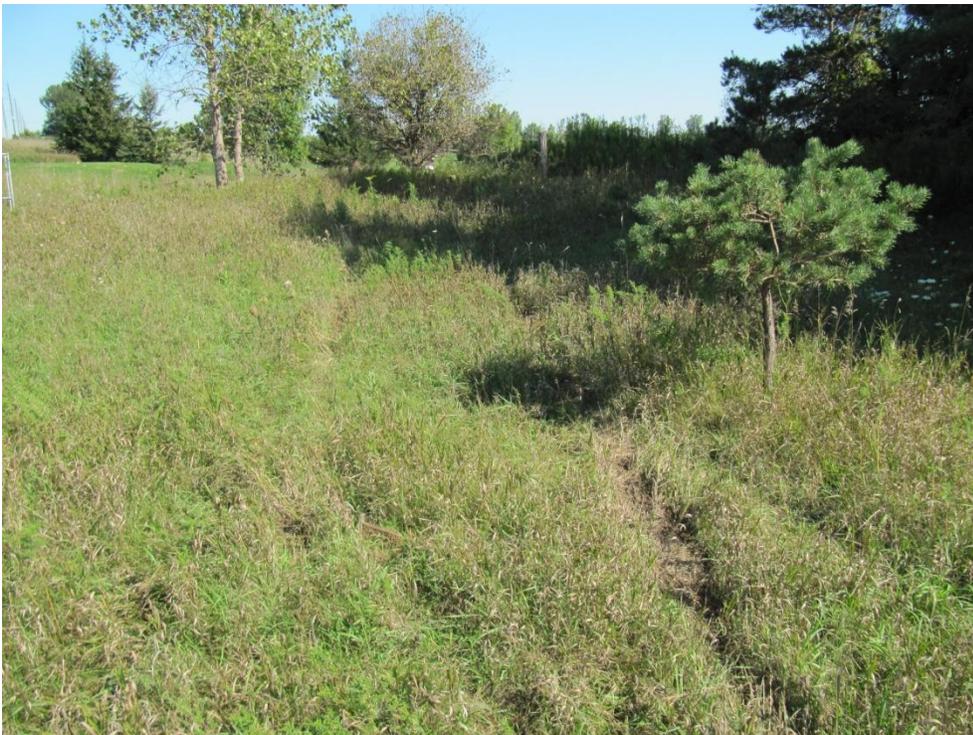
Figure 54: View of additional tire marks as the vehicle continues further and comes to rest near the small trees in the background.
