How Many Incidents Do Not Become Reported In Police Collision Data?

1.0 Background

2.0 Review of Gorski Consulting Research at the Clarke Road Site

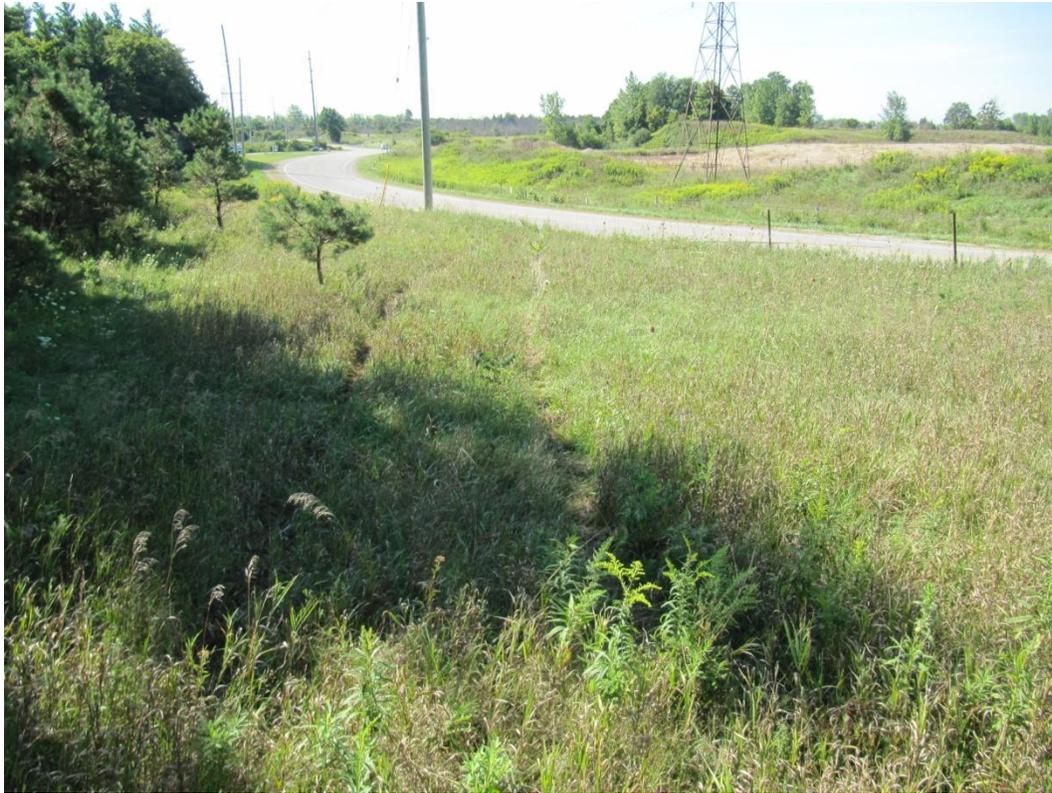
Figure 55: This is a reverse view, looking back toward the south, while positioned near the final rest position of the vehicle. Clearly the vehicle has travelled a long distance and far from the final rest position of the motorcycle.

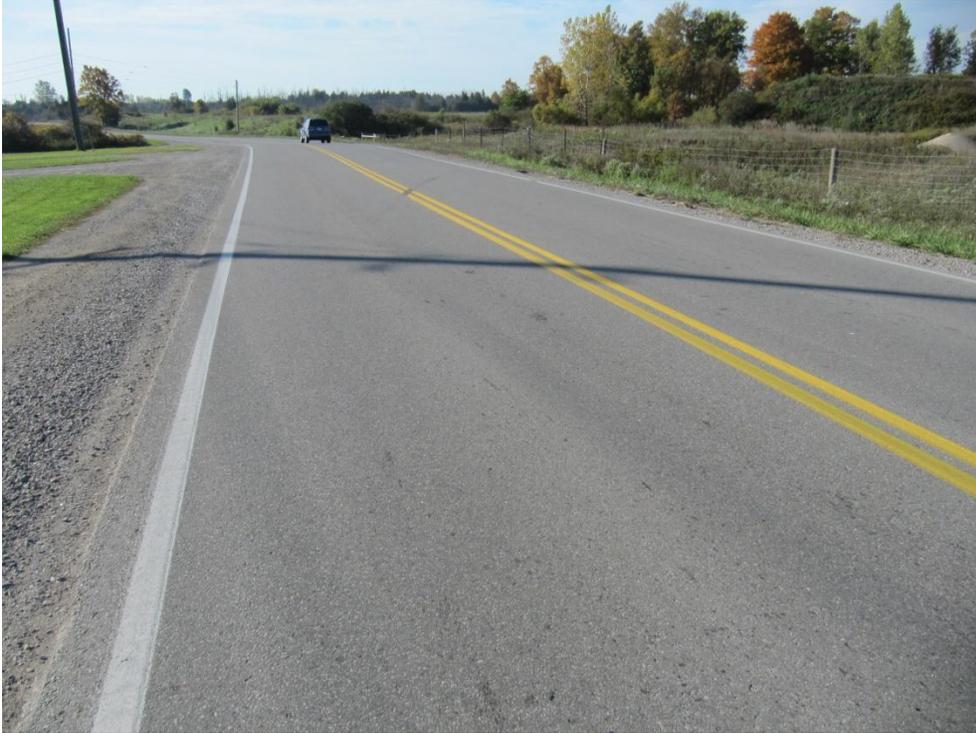
Figure 56: Incident of October 10, 2011. This is a southward view of the northbound lane of Clarke road between the two segments of the S-curve. Yaw marks from a southbound vehicle can be seen near the centre-line in the background.

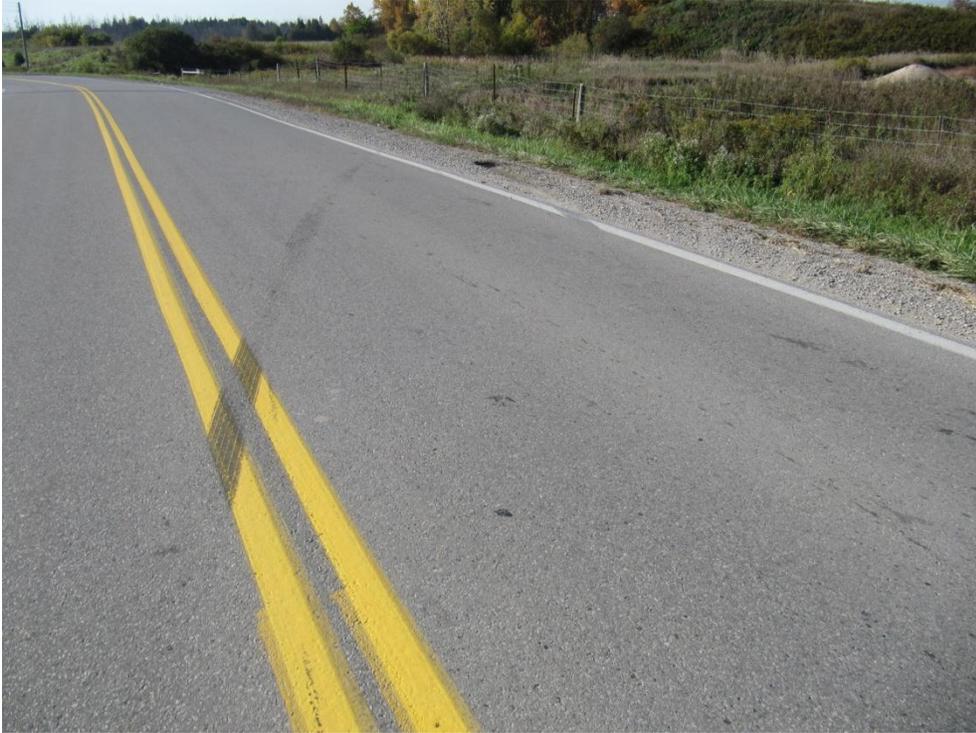
Figure 57: Closer view of the yaw marks from the southbound vehicle as it rotates clockwise toward the west shoulder.

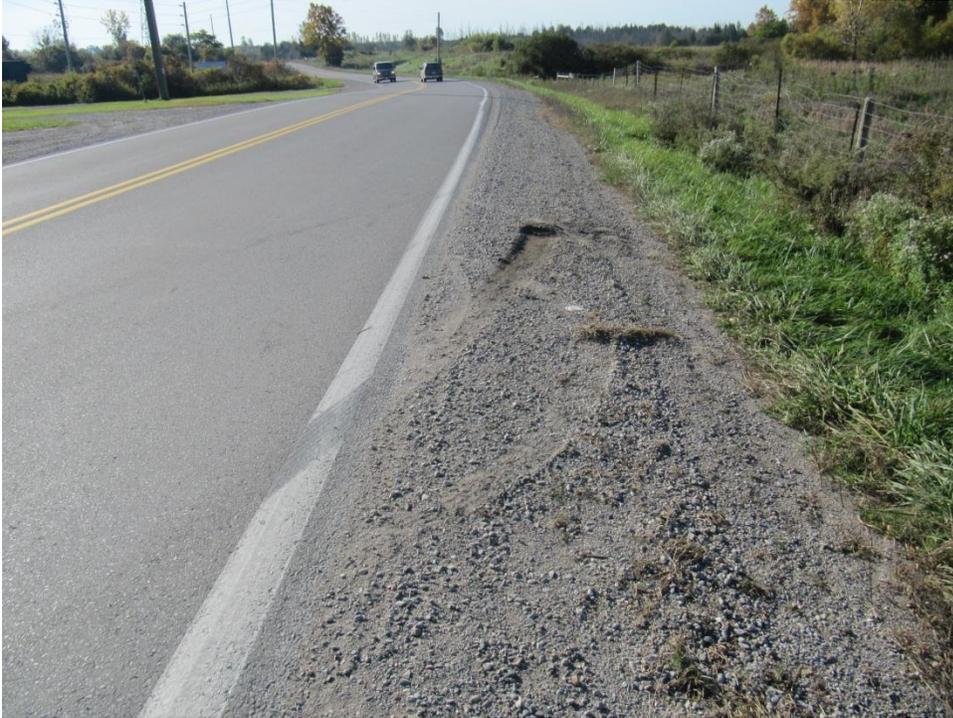
Figure 58: View of the tire mark evidence as the vehicle came to rest on the west shoulder. Evidence indicates that the vehicle then drove away.

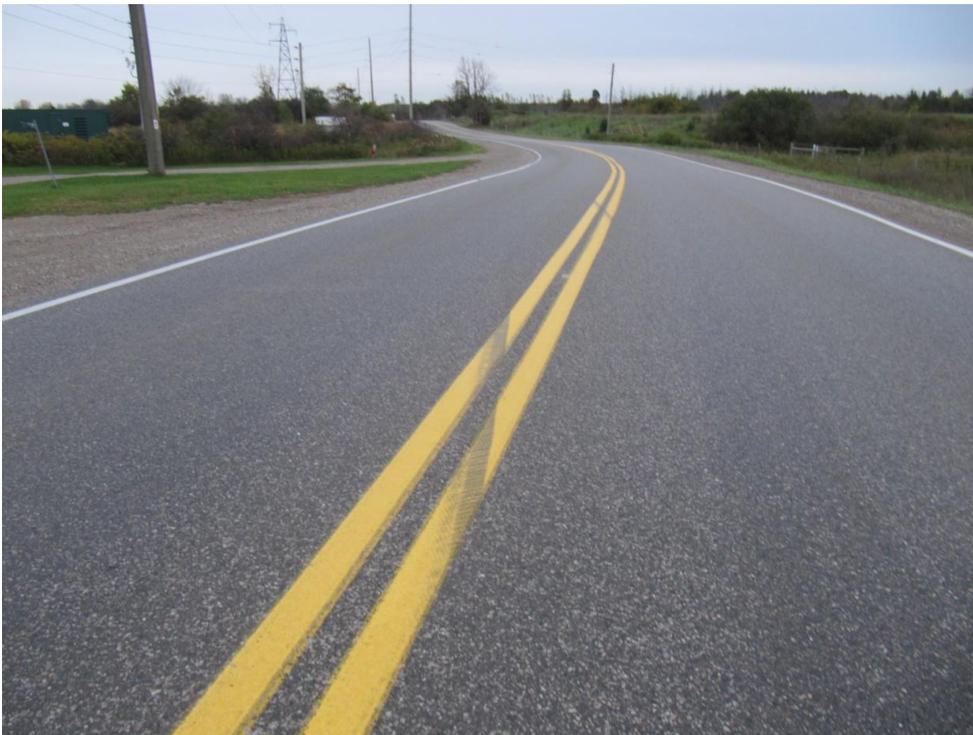
The incident on October 16th involved a southbound vehicle that produced yaw marks at the centerline between the two segments of the S-curve. The vehicle then slid into the east roadside where it struck down a fence, a small tree and a telephone junction box before coming to rest in a field. There was evidence that the telephone junction box was repaired therefore official notice of the incident should have been passed onto the police. Thus it is not readily explainable why police would not have a record of the incident. Figures 59 through 62 provide views of the physical evidence of this incident.

Figure 59: Incident of October 16th, 2011. This is a view looking south between the two segments of the S-curve. Yaw marks can be seen on the centre-line where a southbound vehicle travelled off the road and into the east roadside in the background.

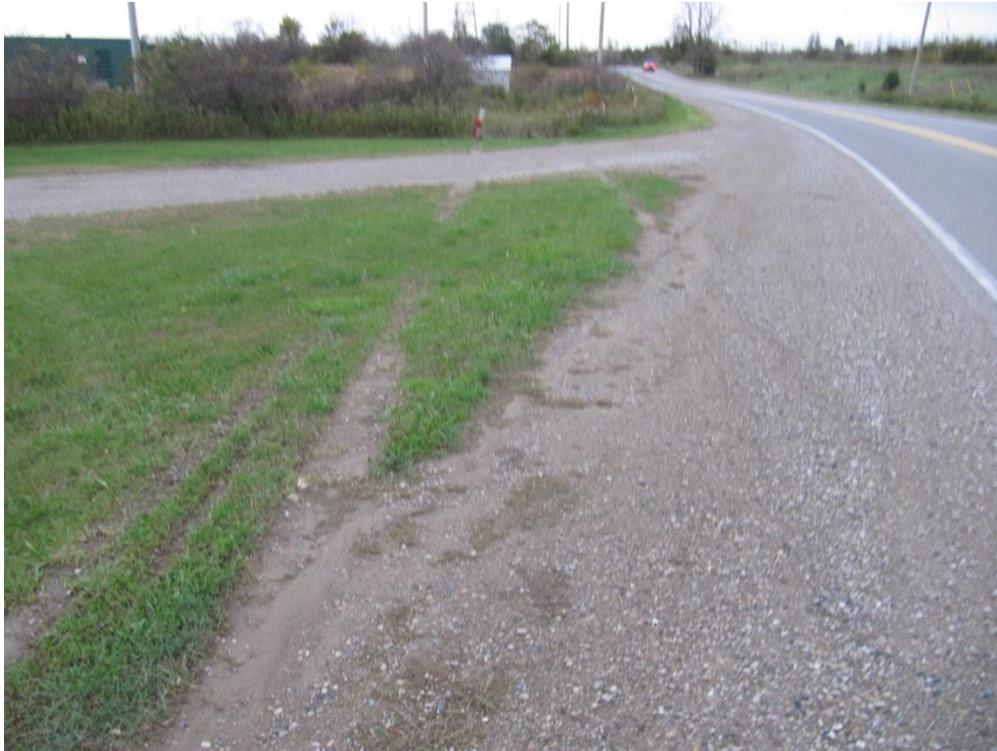
Figure 60: View of the tire marks caused by the southbound vehicle as it slid through the grass and driveways and into the fence and brush in the background.

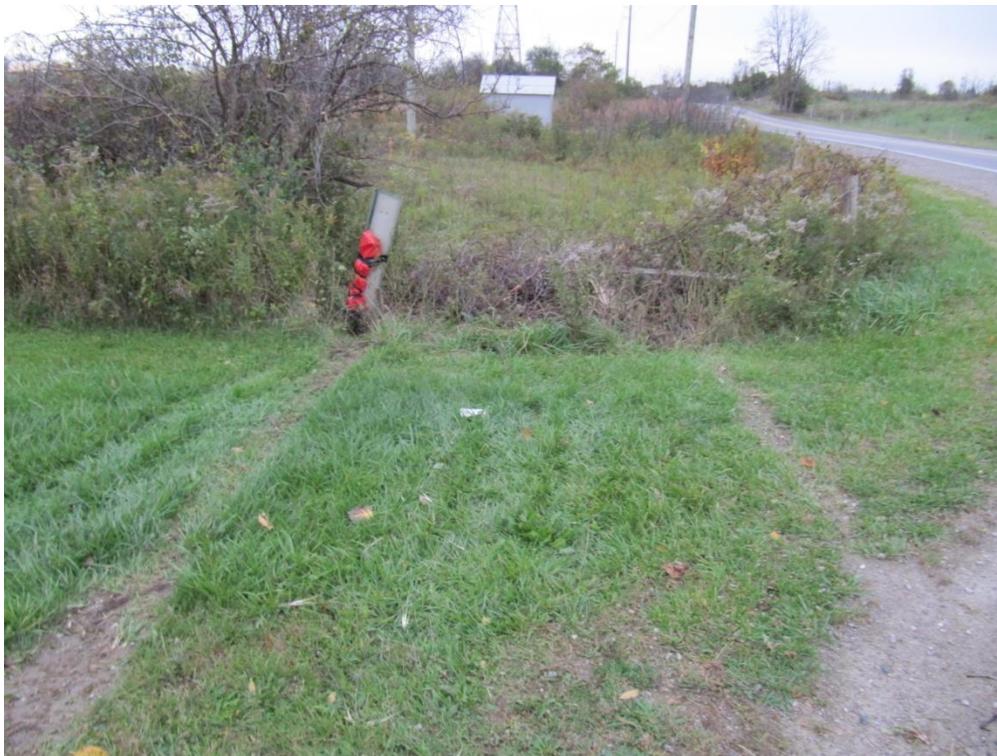
Figure 61: View of the location where the southbound vehicle struck the fence, small tree and telephone junction box before passing through these and then into the field in the background.

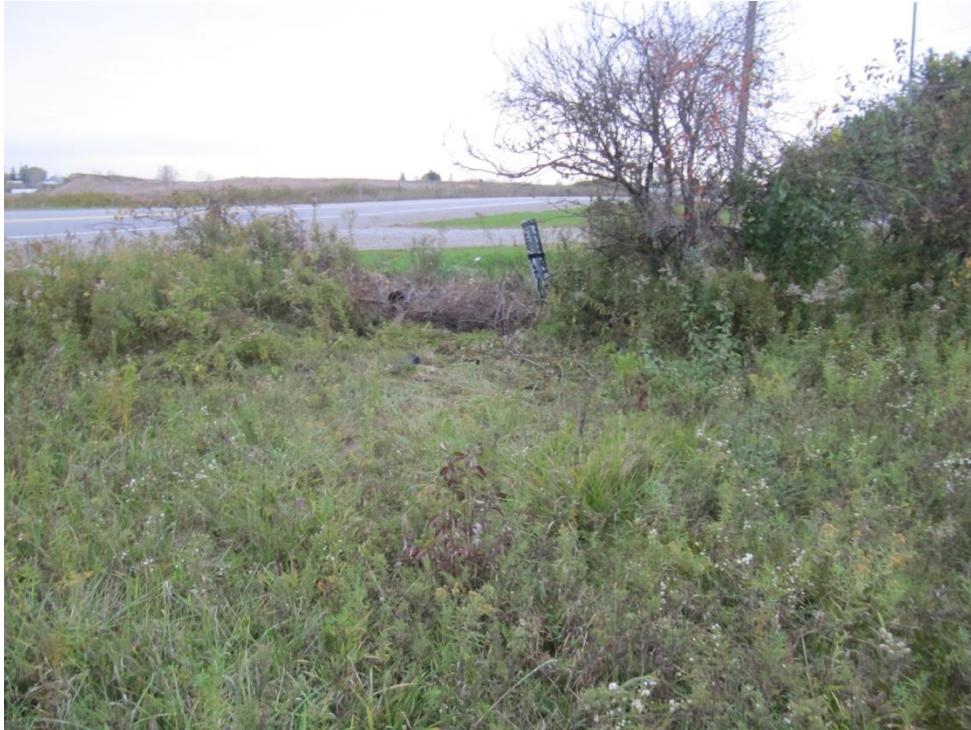
Figure 62: View looking north from the field where the southbound vehicle came to rest.

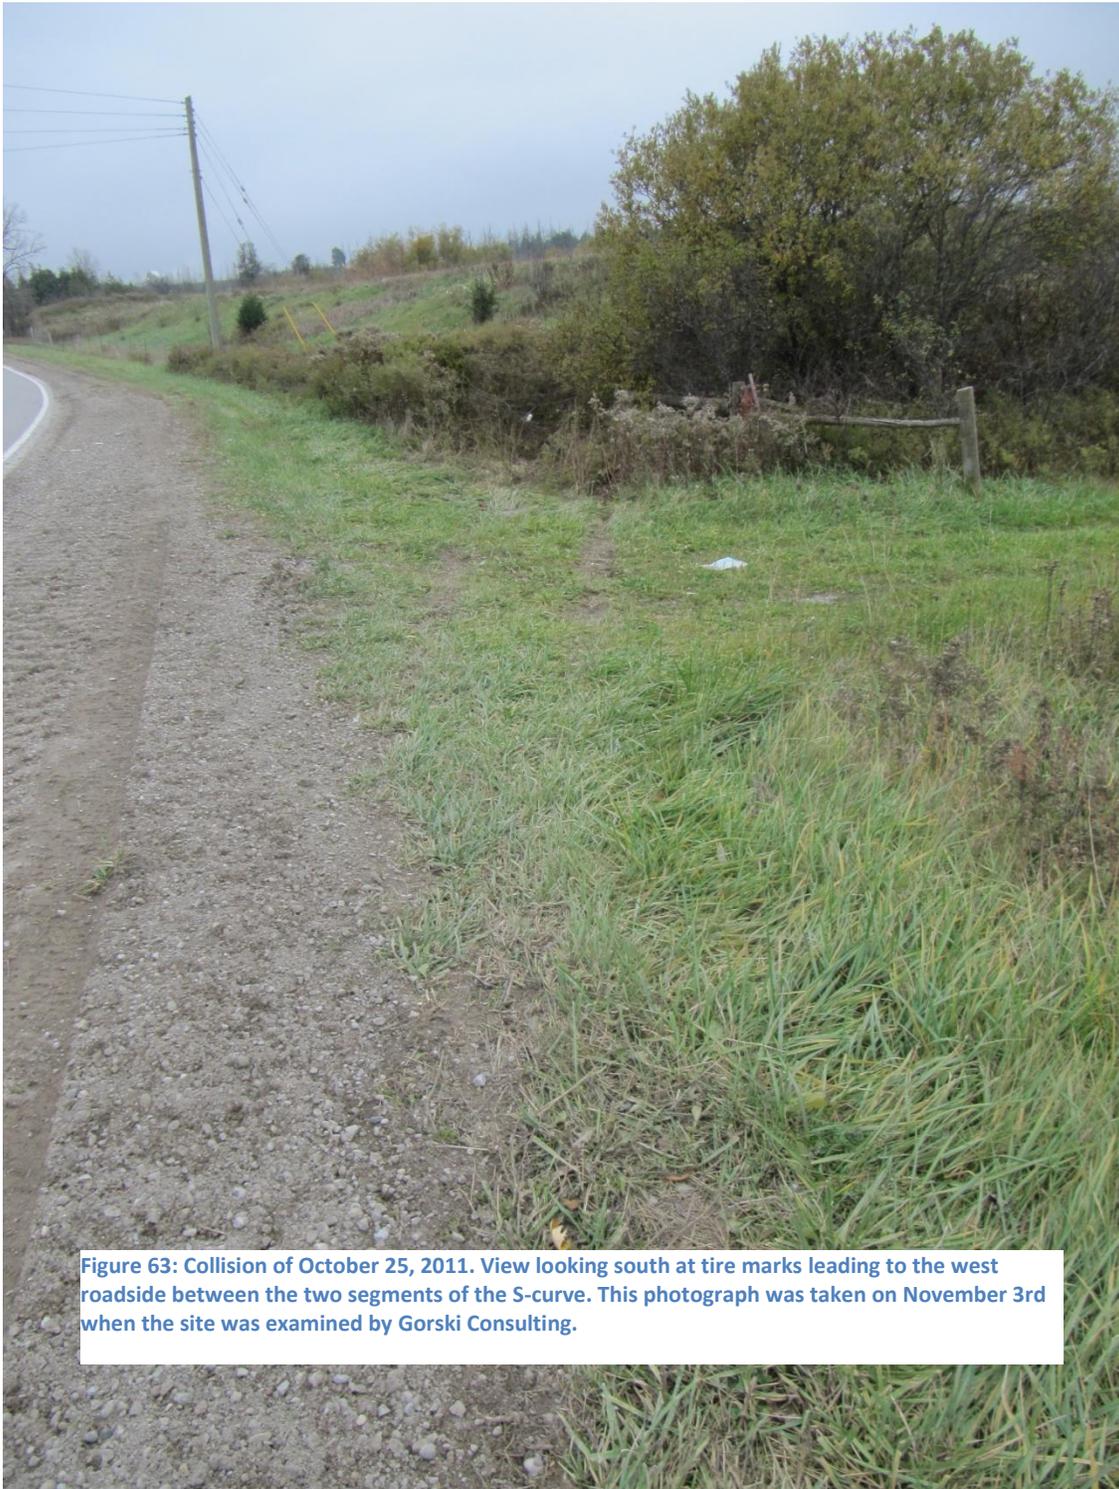
The Gorski Consulting dataset indicates that the S-curve as examined on November 3rd. The description indicates that evidence was found of a southbound vehicle going out of control between the two segments of the S-curve. The vehicle travelled into the west roadside where it struck the wire fence. Figures 63, 64 and 65 show the evidence of that incident.

Figure 63: Collision of October 25, 2011. View looking south at tire marks leading to the west roadside between the two segments of the S-curve. This photograph was taken on November 3rd when the site was examined by Gorski Consulting.

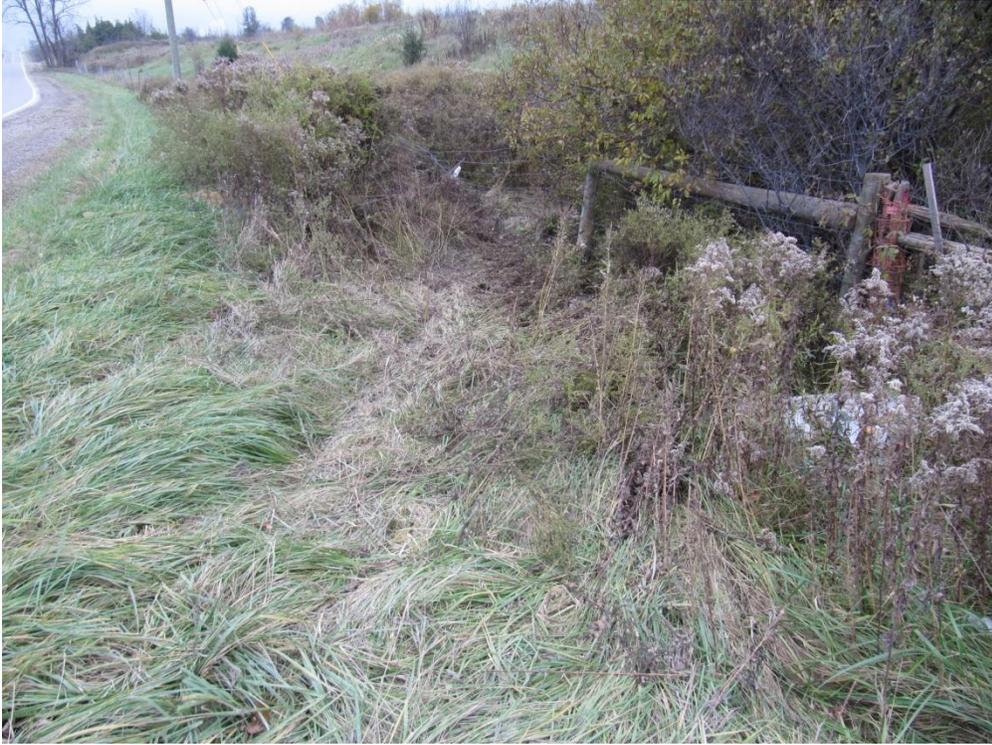
Figure 64: View of evidence of an impact to the west fence.

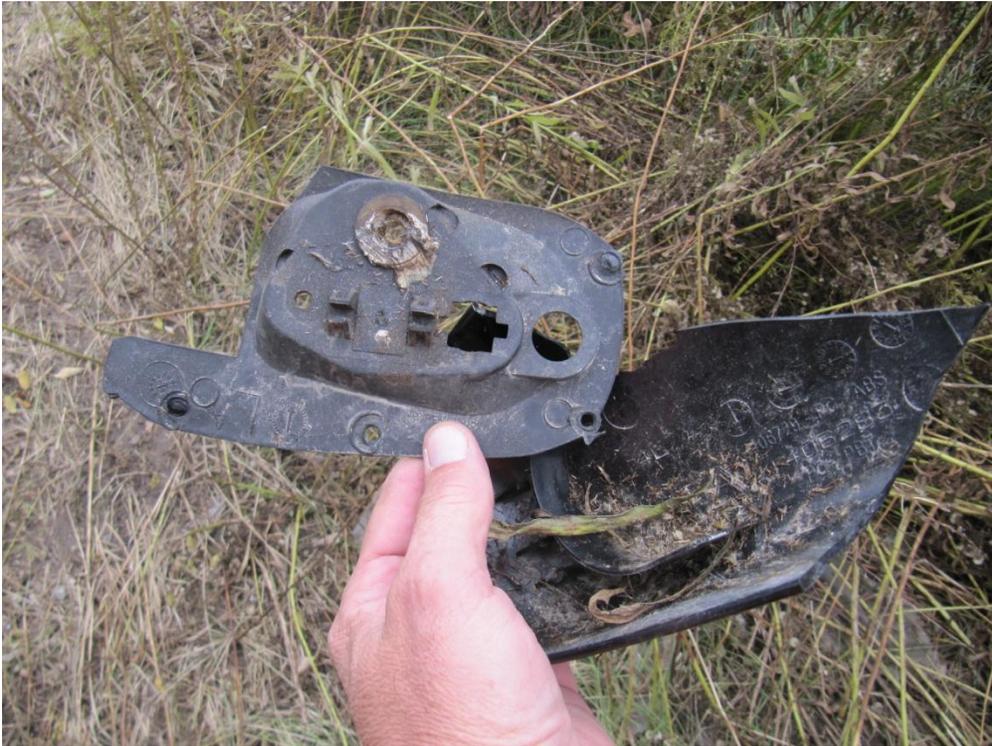
Figure 65: View of various damaged parts of a vehicle strewn at the fence impact.

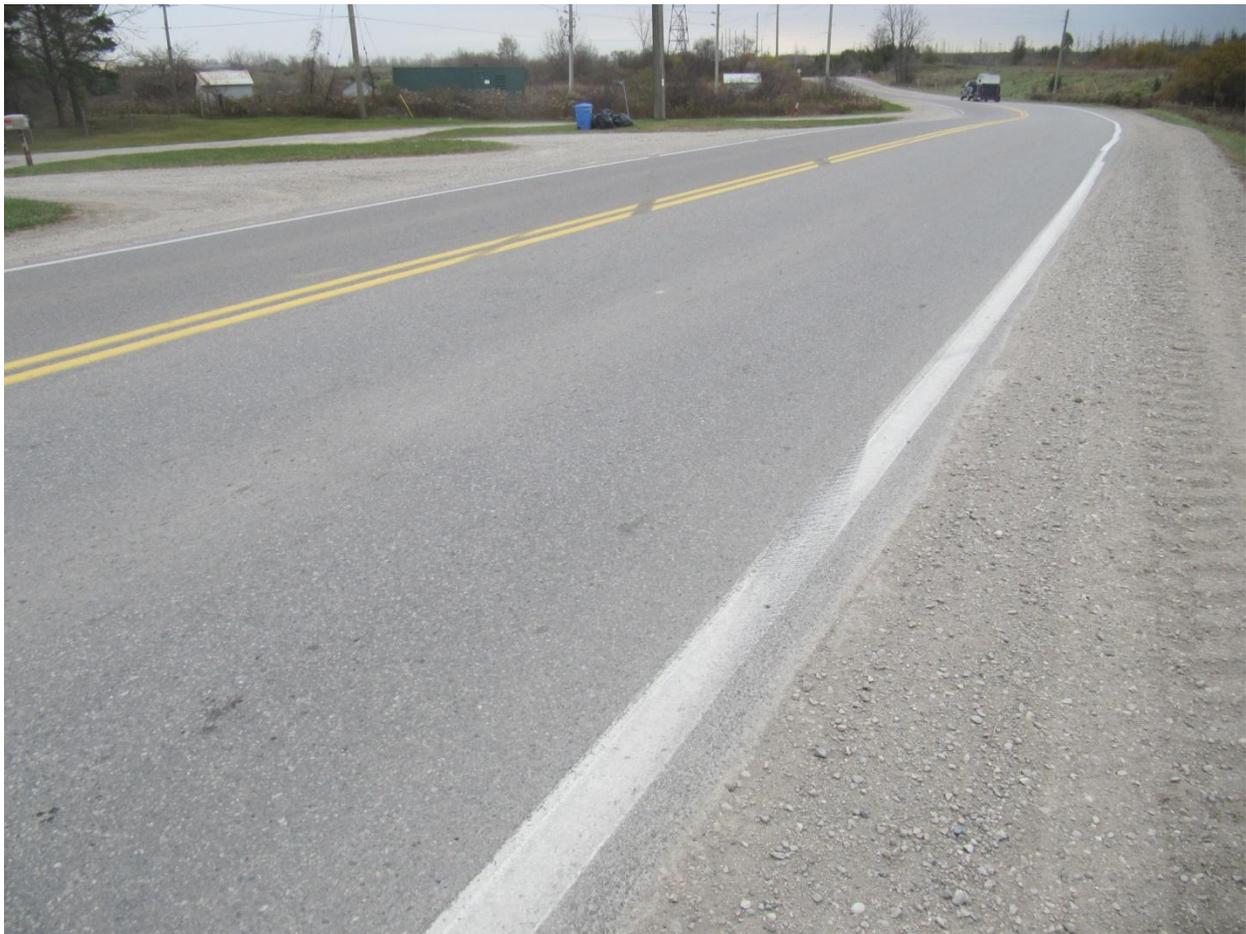
Figure 66: Incident of November 7th, 2011. This is a view looking south in the segment between the two curves of the S-curve. A yaw mark can be seen the white edge-line indicating that a southbound vehicle is leaving the right shoulder. In the background are more yaw marks on the centre-line indicating that the southbound vehicle reached an advanced stage of rotation as it moved into the northbound lane.

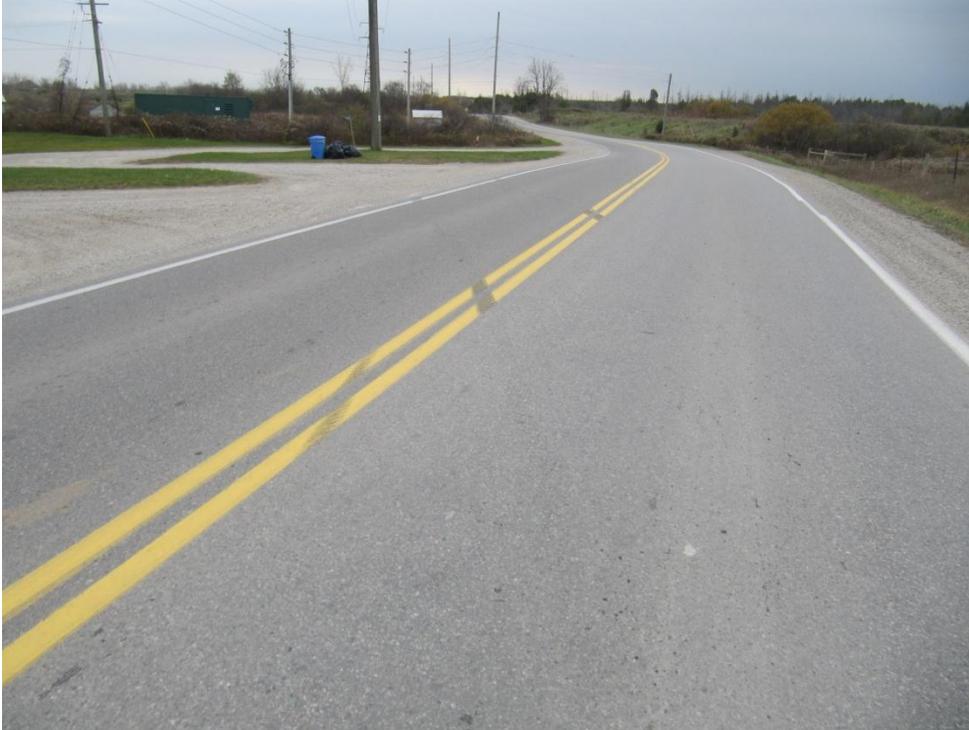
Figure 67: View of the yaw marks at the roadway centre-line indicating that the southbound vehicle was in an advanced stage of rotation as it passed through the northbound lane.

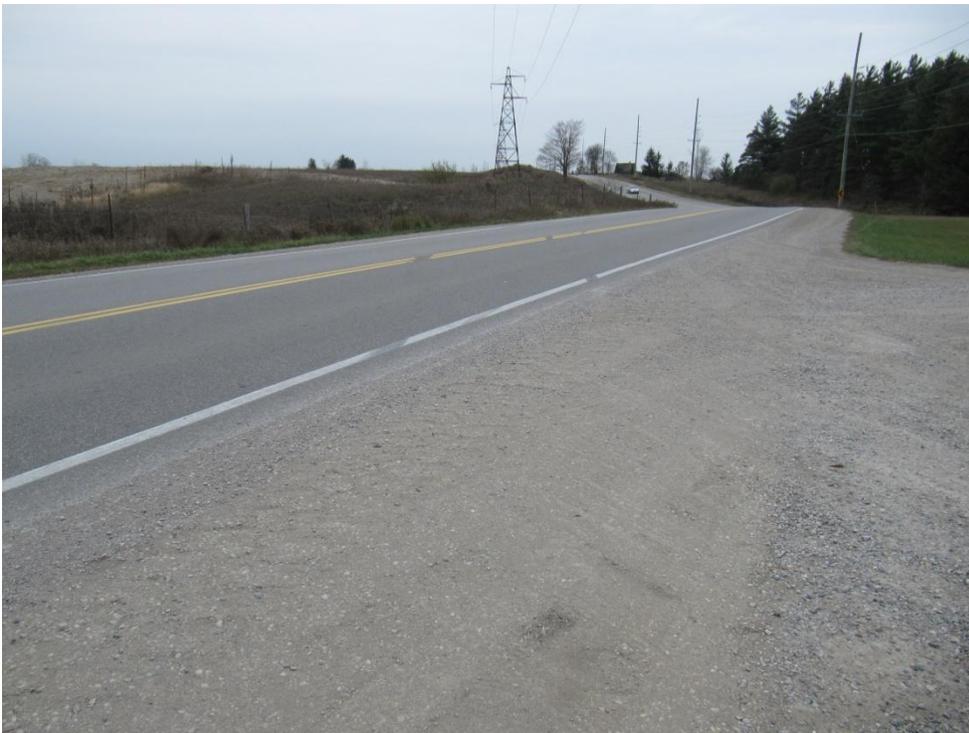
Figure 68: View looking north from the east roadside where the yaw marks are shown coming toward the camera. Evidence of recent scraping on the east shoulder indicates that someone removed the physical evidence of the southbound vehicle's motion in this vicinity.

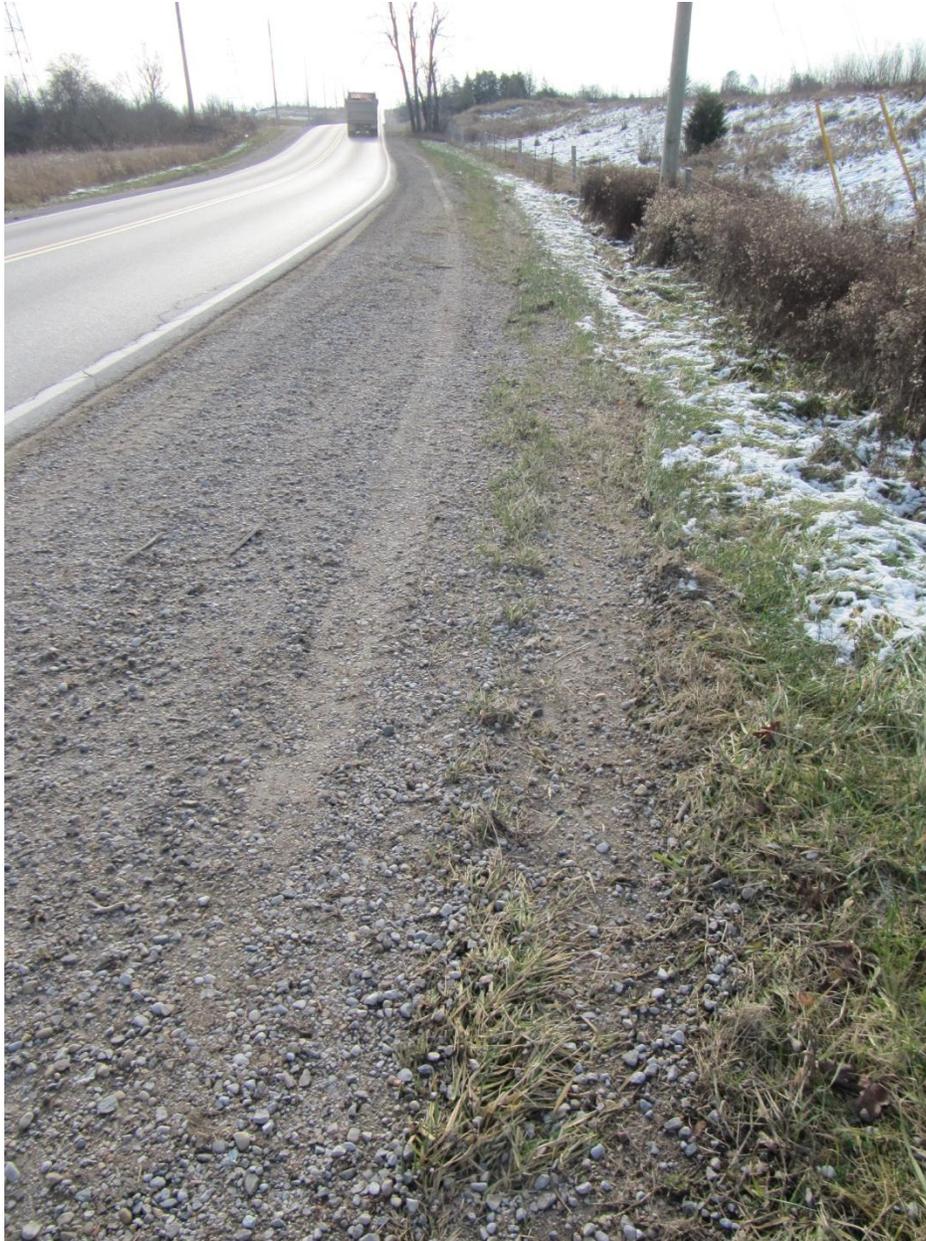
Figure 69: Incident of December 8, 2011. This is a view looking south at the west shoulder at the south portion of the S-curve. Tire marks can be seen in the grass where a southbound vehicle rotated counter-clockwise and then re-entered the southbound lane.

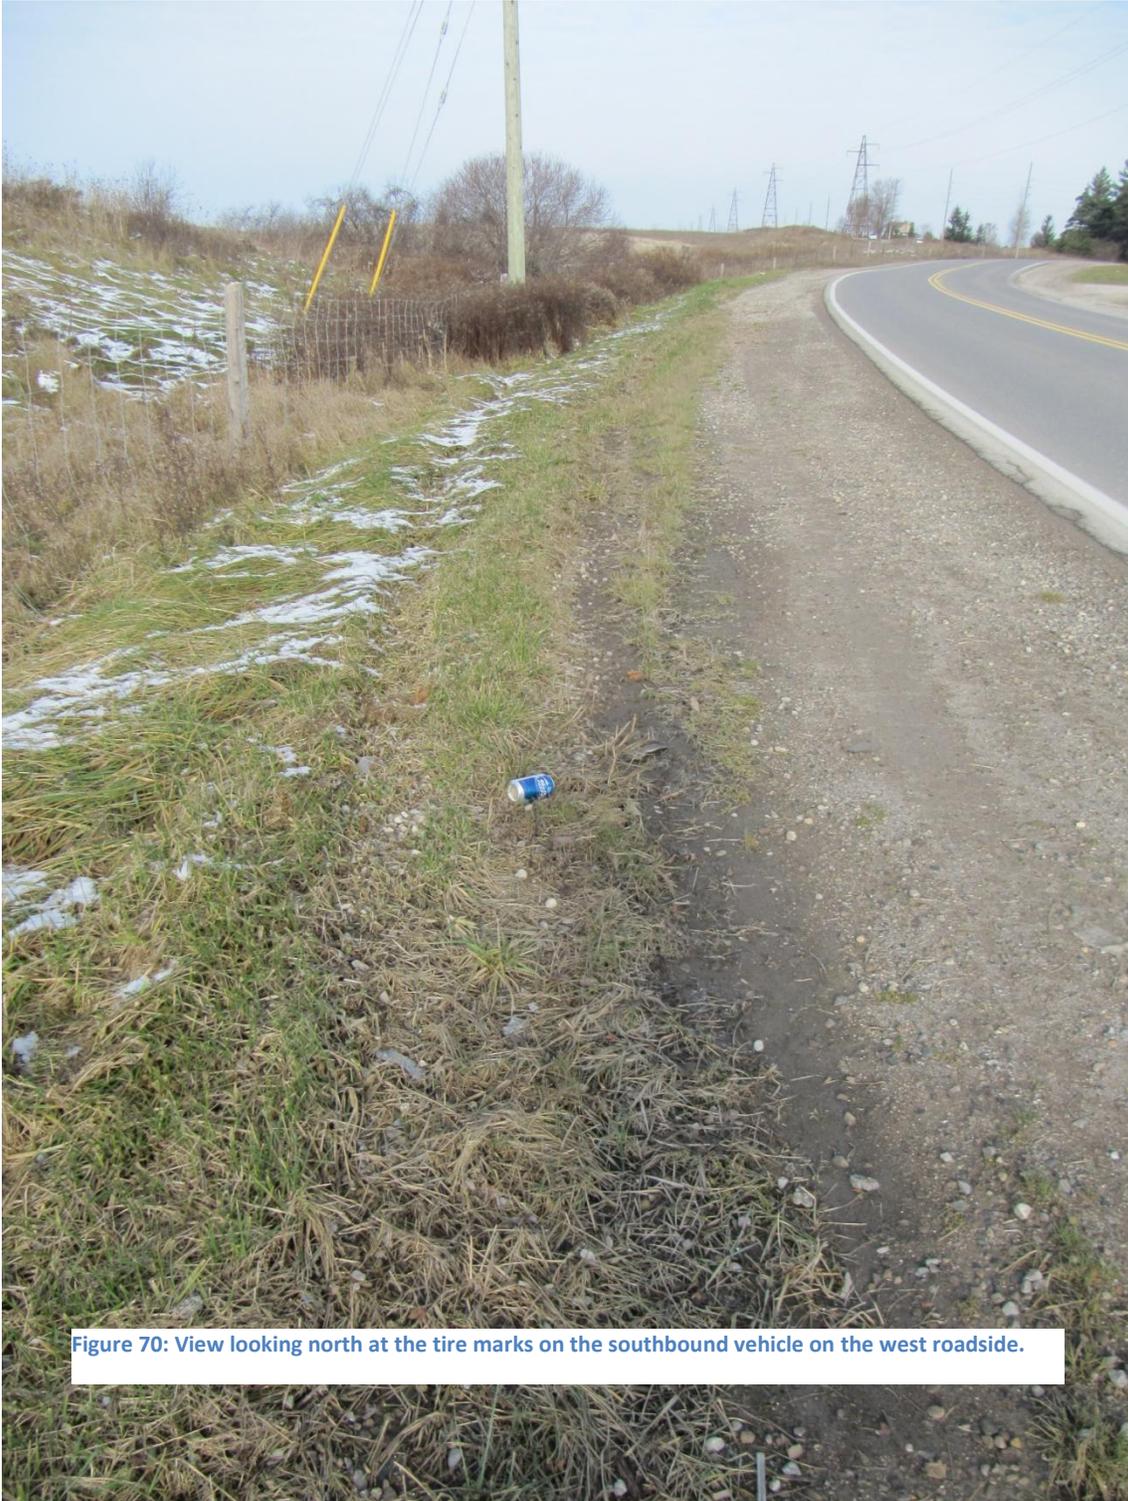
Figure 70: View looking north at the tire marks on the southbound vehicle on the west roadside.

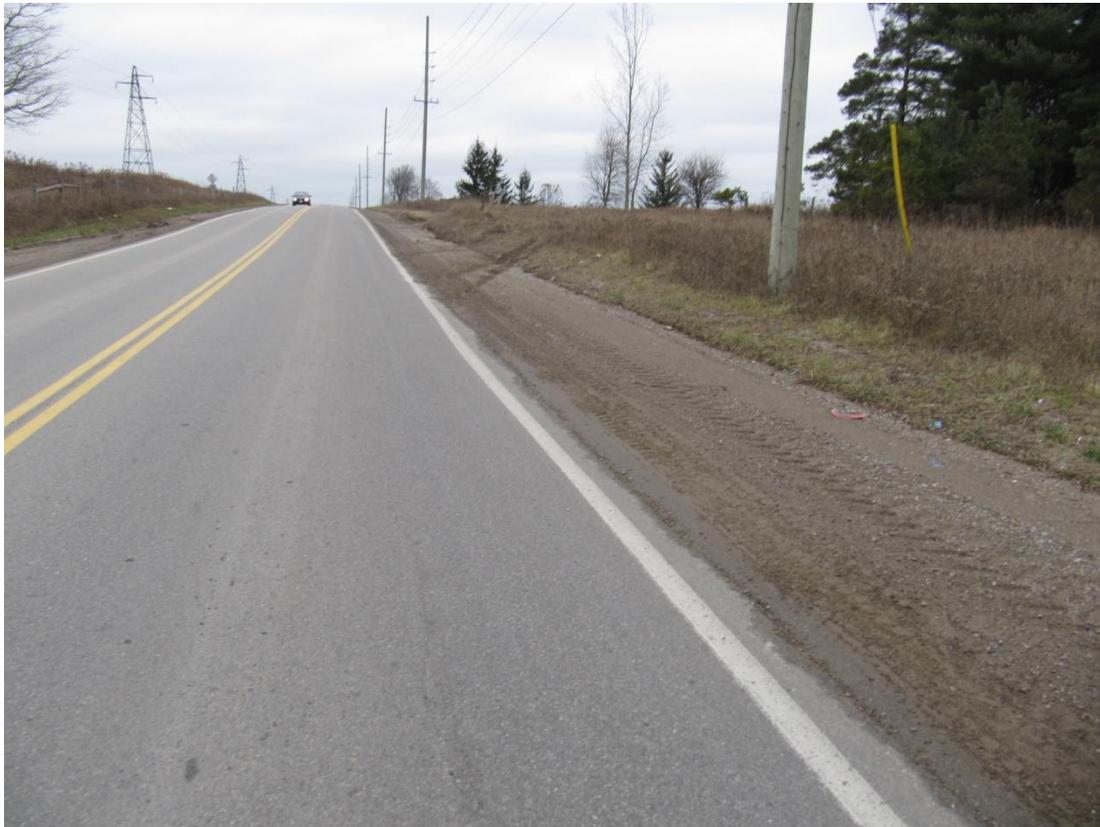
Figure 71: Incident of December 20, 2011. This is a view looking north just past the north portion of the S-curve. A northbound vehicle produced loss-of-control yaw marks that can be seen on the east shoulder just beyond the utility pole.

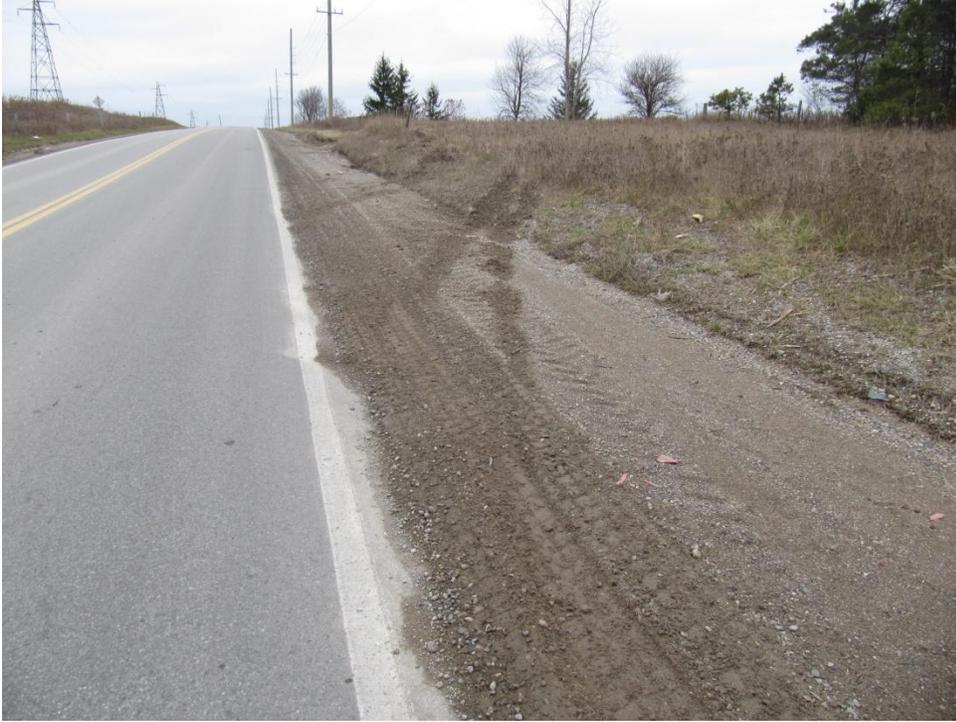
Figure 72: View of the yaw marks on the east shoulder indicating the northbound vehicle was rotating clockwise and was sliding approximately sideways, leading with its left side, when it struck the earth embankment.

Another collision occurred that was documented by Gorski Consulting on December 20th and was not reported in the police dataset. The evidence indicated that the driver of a northbound vehicle lost control resulting in the vehicle’s clockwise rotation and impact with the earth embankment on the east roadside just north of the north portion of the S-curve. Because the evidence indicated that the vehicle partially mounted the embankment that was several feet high it suggests that the impact was not just a minor affair. Figures 71 through 75 show the evidence of that impact.

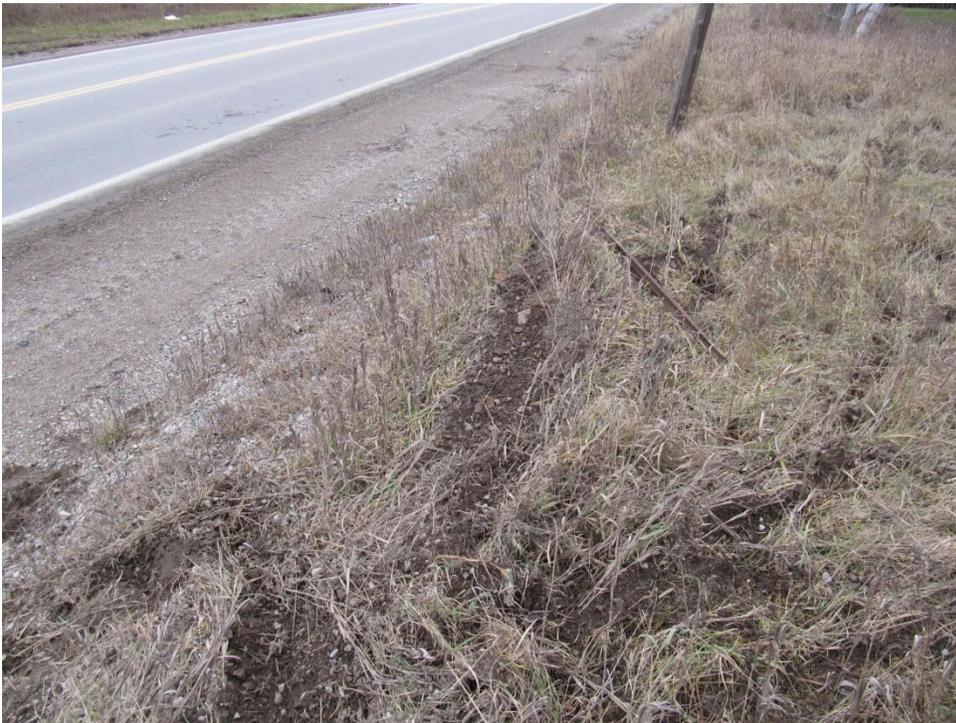
Figure 73: View looking north at the top of the earth embankment indicating that the striking vehicle mounted the embankment and came to rest near its edge.

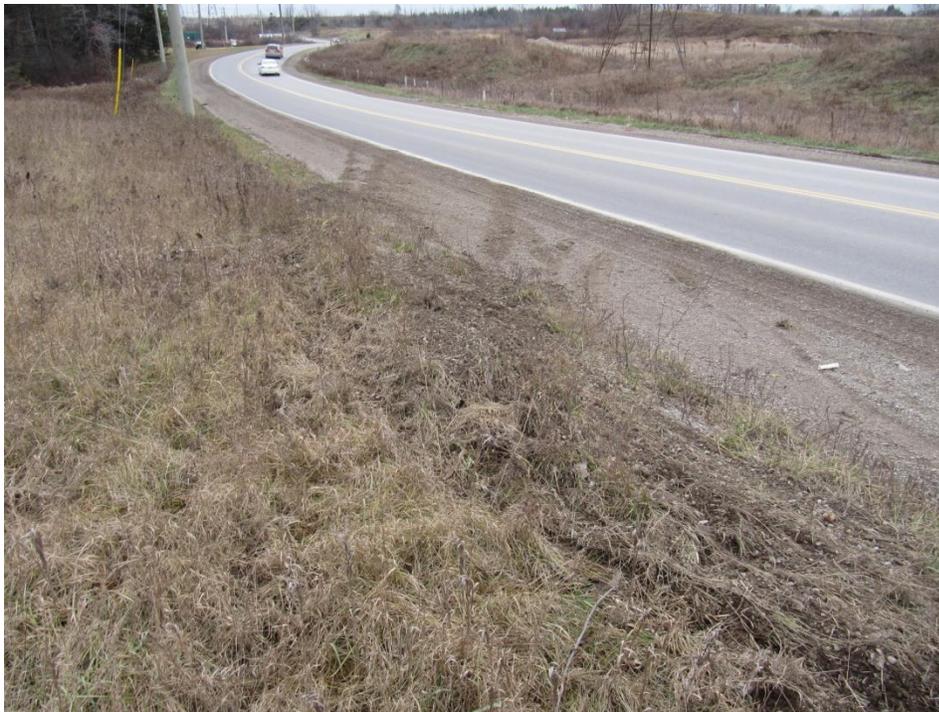
Figure 74: View looking south from the top of the earth embankment showing the relationship of the tire marks and the north portion of the S-curve in the background.

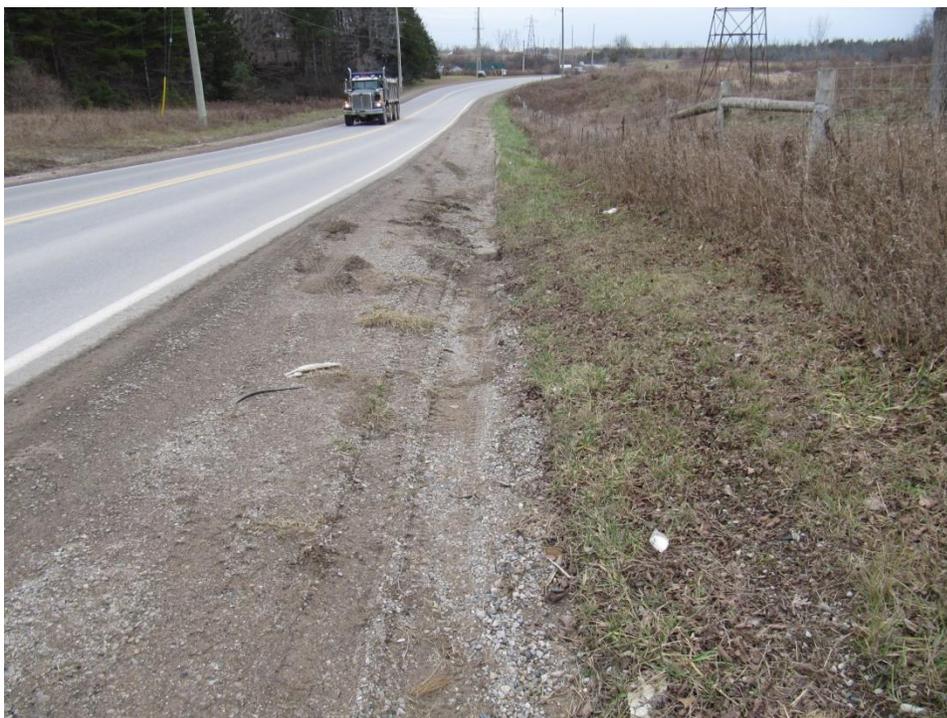
Figure 75: View looking south showing evidence of an additional disturbance on the west shoulder adjacent to where the vehicle struck the embankment. It is likely that this evidence relates to towing activities related to the original impact.

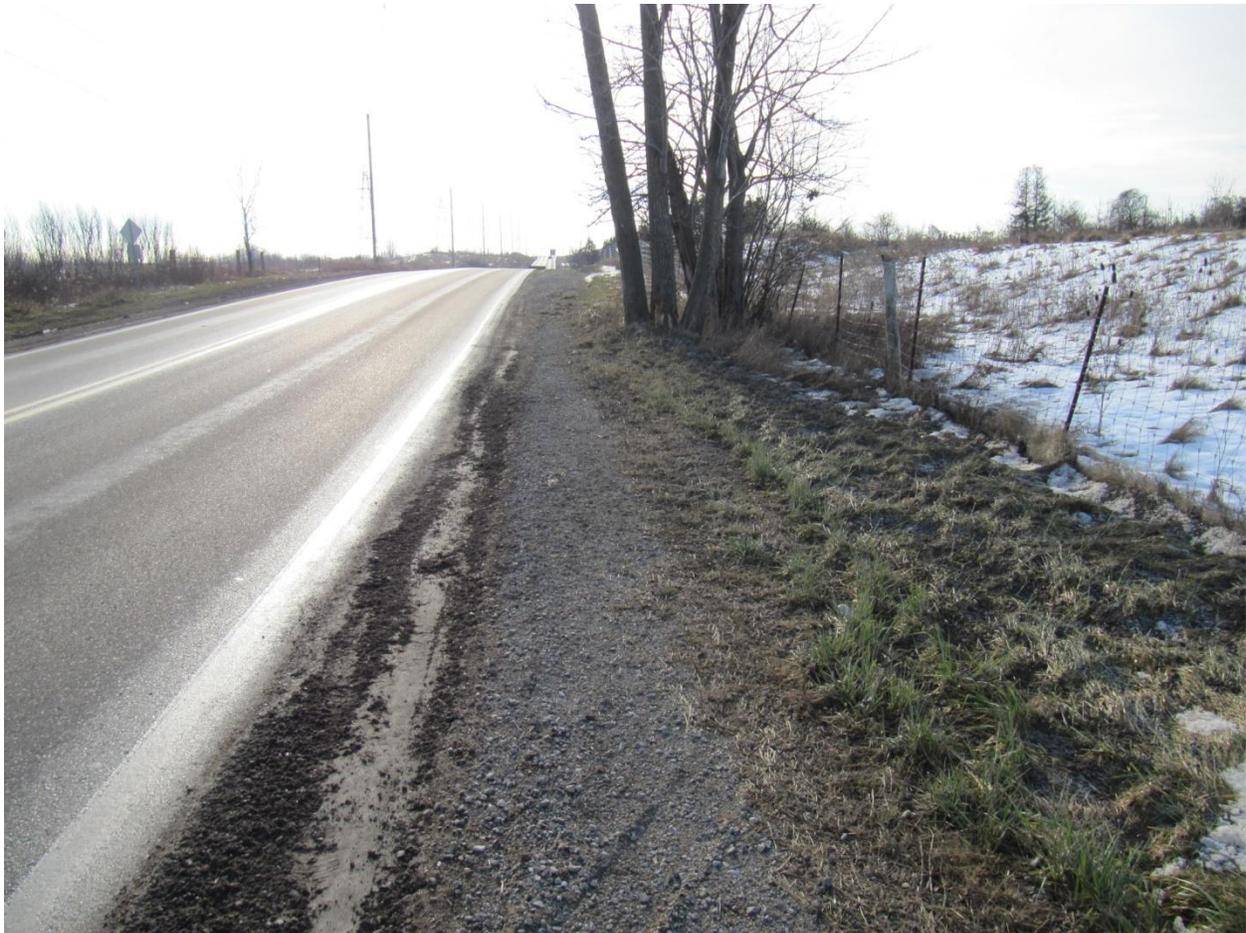
It would appear that the Gorski Consulting dataset did not locate any evidence with respect to this collision. However this dataset only referred to inspections of the S-curve in the year 2011. Because the collision occurred only 3 days before the end of the year there could be evidence reported in examinations of the S-curve by Gorski Consulting in the early part of January of 2012. This possibility was explored and it was noted that during an examination of the site on January 12th, 2012 evidence was observed that a southbound vehicle struck a tree on the west roadside at the south portion of the S-Curve. Evidence of that collision is shown in Figures 76 and 77.

Figure 76: Collision of December 28th, 2011. This is a view looking south at a clump of trees located on the west side of Clarke Road just south of the south portion of the S-curve. This photograph was taken on January 12, 2017. There is evidence of a recent impact to base of one of the trees that likely occurred on December 28th as reported in the police dataset.

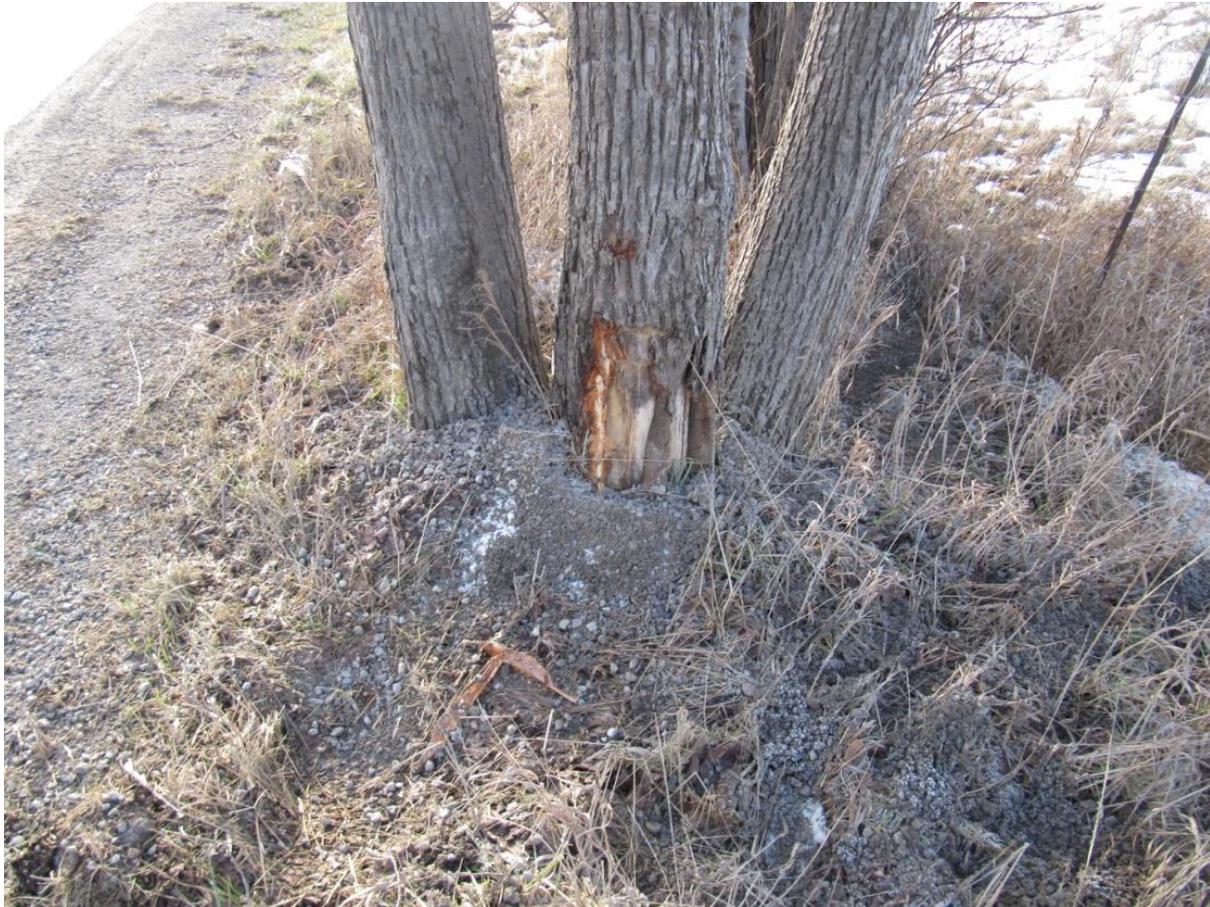
Figure 77: View of the evidence of a fresh impact to the base of the trees located on the west side of Clarke Road at the south end of the S-curve.
