# How Many Incidents Do Not Become Reported In Police Collision Data? – Part 4

## 1.0 Background

Since the fall of 2009 Gorski Consulting has been involved in a research project involving documentation of collision and loss-of-control incidents at an S-Curve of Clarke Road north of Fanshawe Park Road at the north-eastern outskirts of the City of London, Ontario, Canada. By the end of 2016 89 incidents were documented.

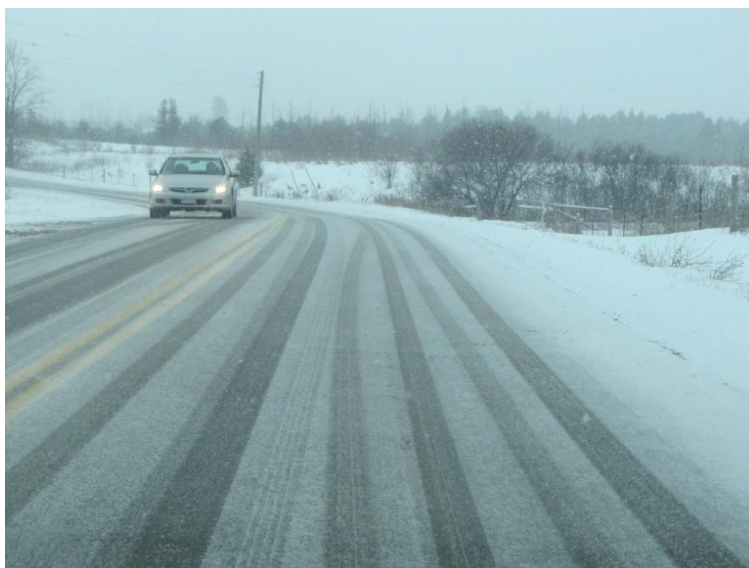
The police dataset indicated that at 1647 hours of January 16<sup>th</sup> a northbound passenger went out of control and was involved in a personal injury collision. On January 17<sup>th</sup> Gorski Consulting drove through the S-curve and no collision evidence was observed. However the road conditions were poor as shown in Figure 4. Gorski Consulting also drove through the site on January 20<sup>th</sup> and no collision evidence was found. Then on January 21<sup>st</sup> while walking the site, evidence was found indicating that a northbound vehicle had slid into the west ditch, as shown in Figures 5 and 6. Although no evidence was found with respect to a collision it is conceivable that such a collision occurred between two vehicles on the road resulting the northbound vehicle’s travel into the ditch. Given the snow cover the existence of pieces of debris could have been undetected. However this is insufficient evidence to conclude, one way or another, whether the collision referred to by police was related to the loss-of-control evidence found on the west roadside.

Figure 4: View looking south on January 17<sup>th</sup> from the dash camera of the Gorski Consulting vehicle as it passes by the area where the loss-of-control evidence was found on January 21<sup>st</sup>. Given the extent of snow cover is it conceivable that a collision occurred here on the previous day but the evidence was obscured. It simply cannot be determined.

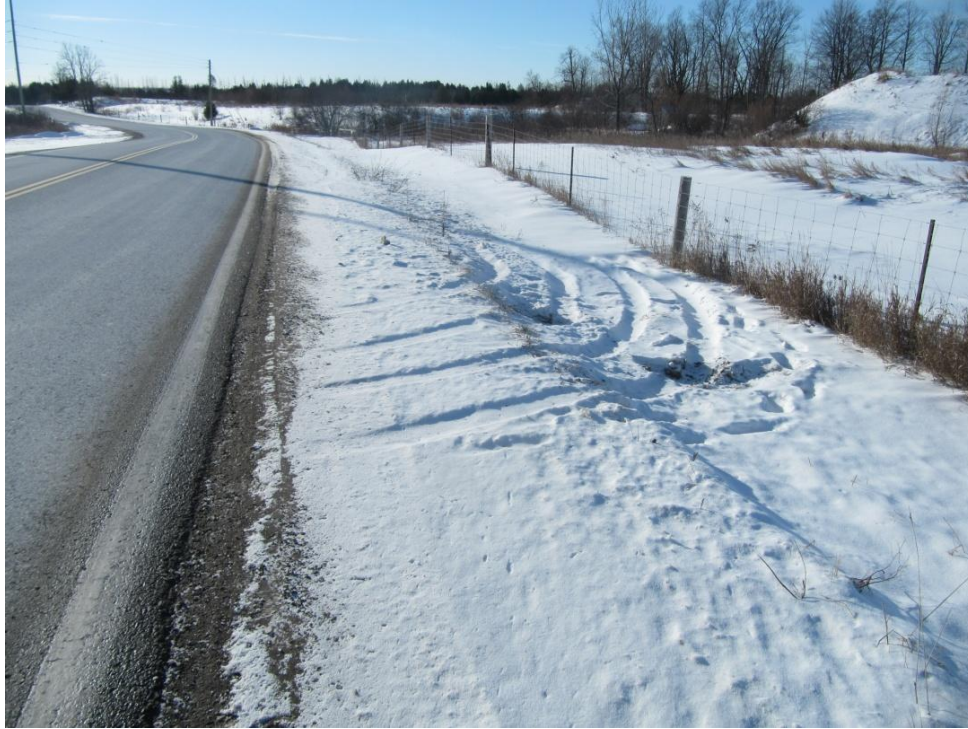
Figure 5: Incident documented on January 21st, 2014. This is a view of the evidence of a loss-of-control incident whereby a northbound vehicle slid into the west roadside. It is conceivable that his action occurred because of an impact with another vehicle on the road however the lack of further information from the police data makes it not possible to draw a conclusion one way or the other.

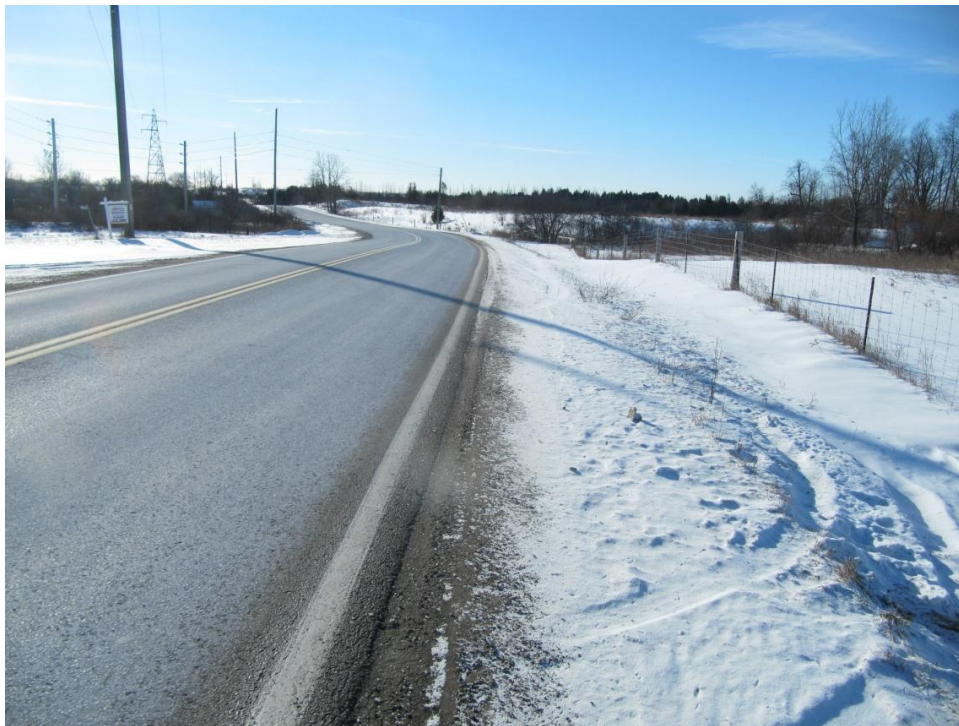
Figure 6: View looking south toward the roadway from the location of the loss-of-control evidence in the west ditch. No evidence of a collision was found in the vicinity of this loss-of-control incident.

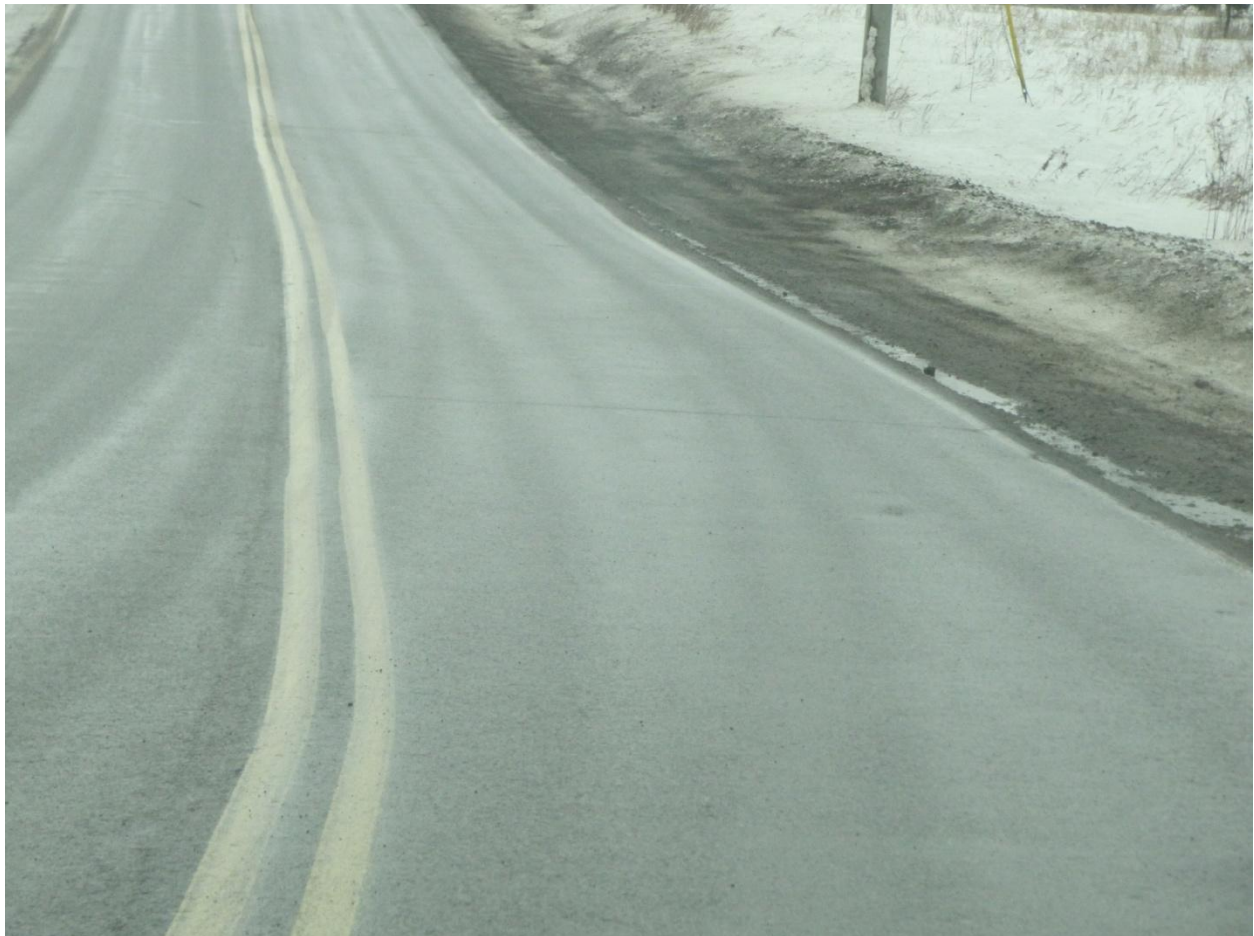
The police dataset indicated that on January 31, 2014 at 1137 hours a northbound passenger car struck a deer resulting in property damage. Gorski Consulting drove through the curve at approximately 0900 hours on January 31<sup>st</sup> and again at approximately 1350 hours on February 2<sup>nd</sup>. No collision evidence was found on February 2<sup>nd</sup>. In comparing the road conditions with January 31<sup>st</sup> it was noted that the road surface was wet with snow cover on the roadsides and it was noted further that a snowplow has plowed the snow on the shoulders sometime between the two dates. Thus, it is conceivable that if there was fragile evidence of an impact in the S-curve the evidence could have been obliterated by the snow-plowing operations. Figure 7 shows an example of the road conditions on January 31<sup>st</sup> whereas Figure 8 shows the conditions on February 2<sup>nd</sup>. Even without the snow plowing operations it can be appreciated that a typical impact with a deer will not leave a substantial quantity of evidence on the road unless the impacting vehicle becomes destabilized and the driver loses control.

Figure 7: View, looking north near the north curve showing the road conditions on January 31<sup>st</sup>. The condition of the right snow bank can be compared to the same location from February 2<sup>nd</sup> in Figure 8 to demonstrate that a snowplow plowed the snow sometime between those dates.

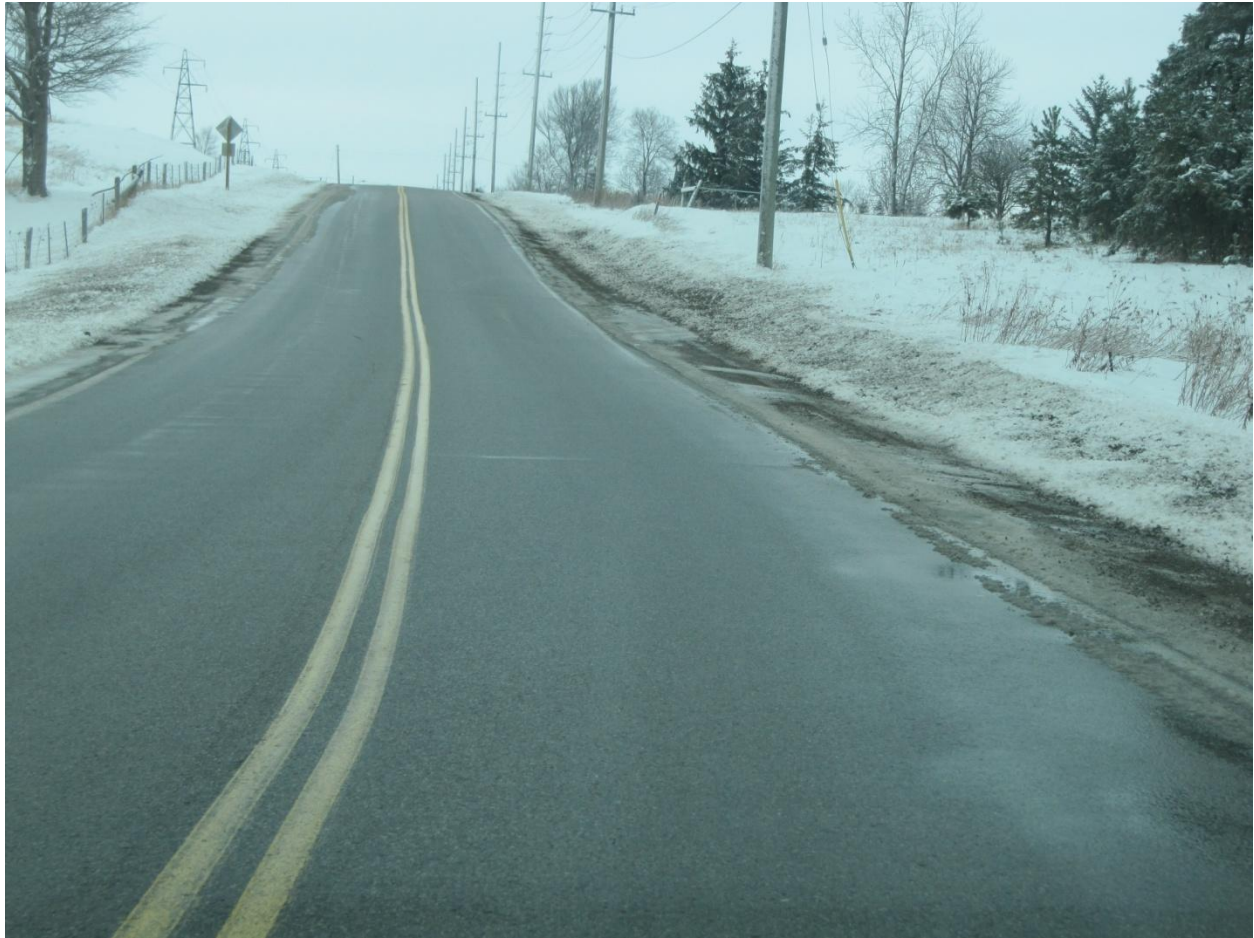
Figure 8: View looking north at the north curve taken on February 2nd, 2014. The right (east) snow bank has been freshly plowed in comparison to the condition of January 31st shown in Figure 7.

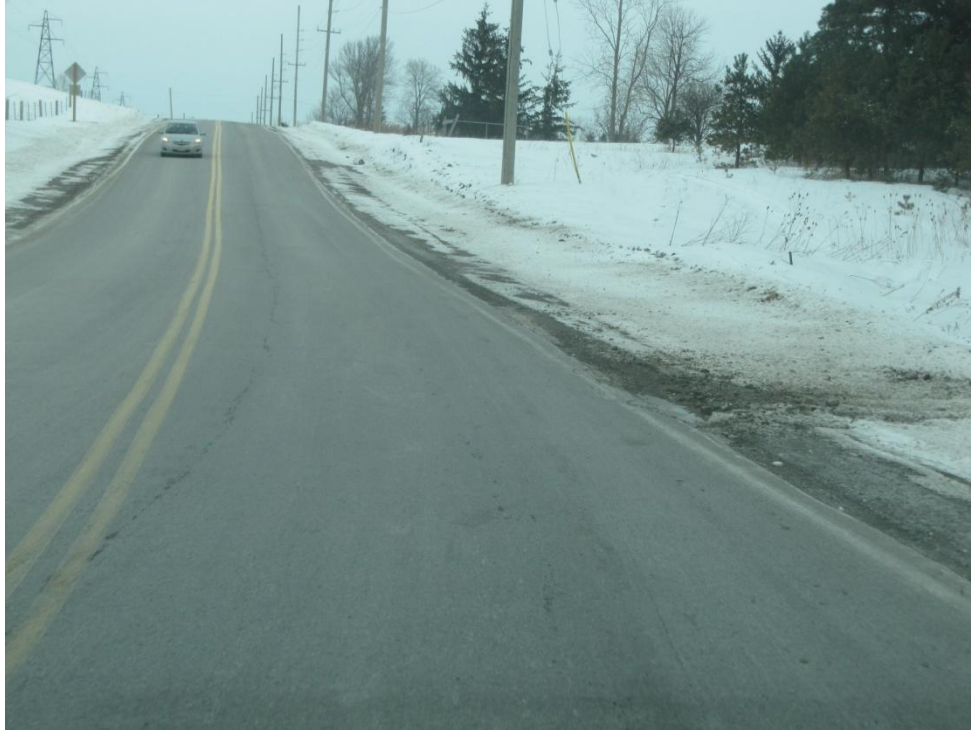
The police dataset indicated that at 1145 hours on March 5<sup>th</sup> another northbound passenger car struck a deer resulting in property damage. Gorski Consulting drove through the S-curve at approximately 0850 hours on March 4<sup>th</sup> and then again at 1425 hours on March 7<sup>th</sup>. No evidence of a collision was observed within the S-curve. Comparing the road conditions of March 4<sup>th</sup> shown in Figure 9 with the conditions on March 7<sup>th</sup> in Figure 10 it can be noted that there was some snow in the shoulders and ditch and that some melting took place in the time between those dates. There was no evidence of any snow plowing thus if there was collision evidence on the roadsides there was the opportunity to identify it in the photographs of March 7<sup>th</sup>. However, as stated above, impacts with deer can potentially leave little physical evidence of that occurrence. When combined with the inability of police to provide more specific information about the collision locations it cannot be determined either way if the deer impact occurred within the bounds of the S-curve or somewhere outside of those bounds.

Figure 9: View, looking north at the north end of the north curve on March 4th, 2014, showing the road conditions.

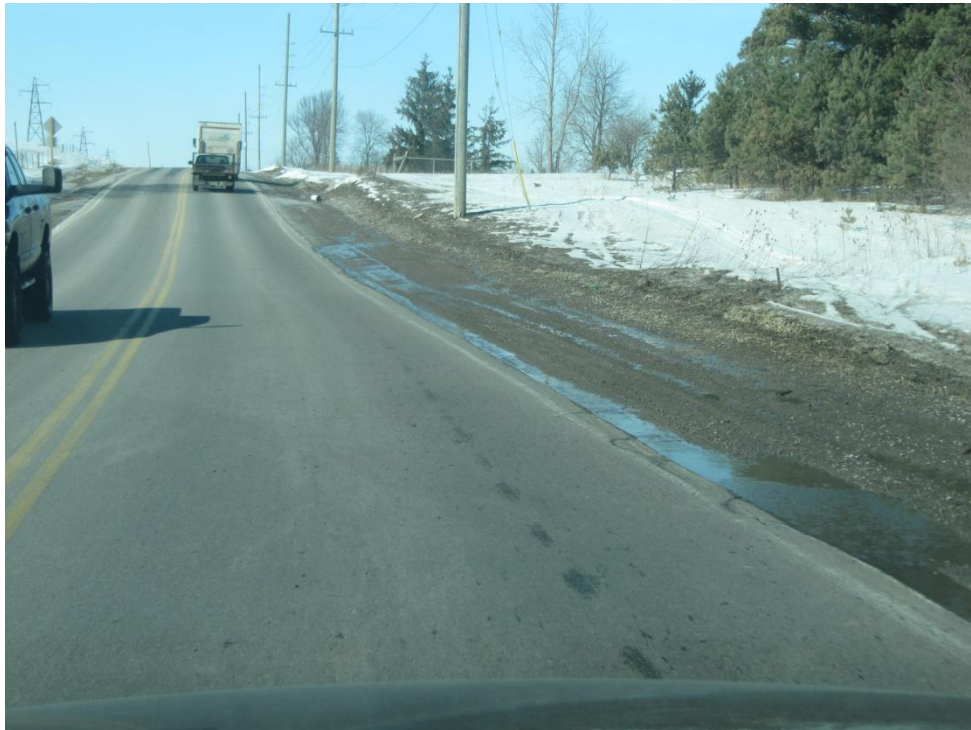
Figure 10: View, looking north at the north end of the north curve on March 7th, 2014, showing the road conditions.

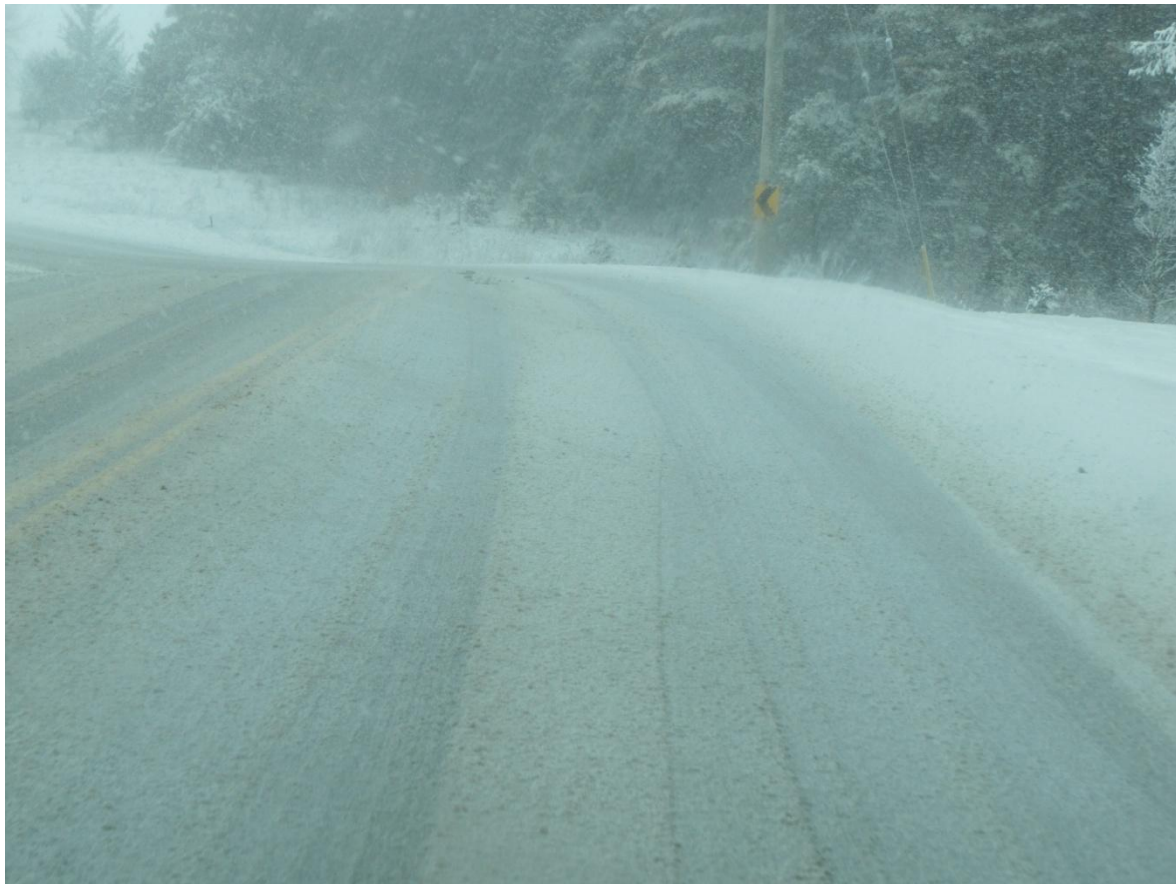
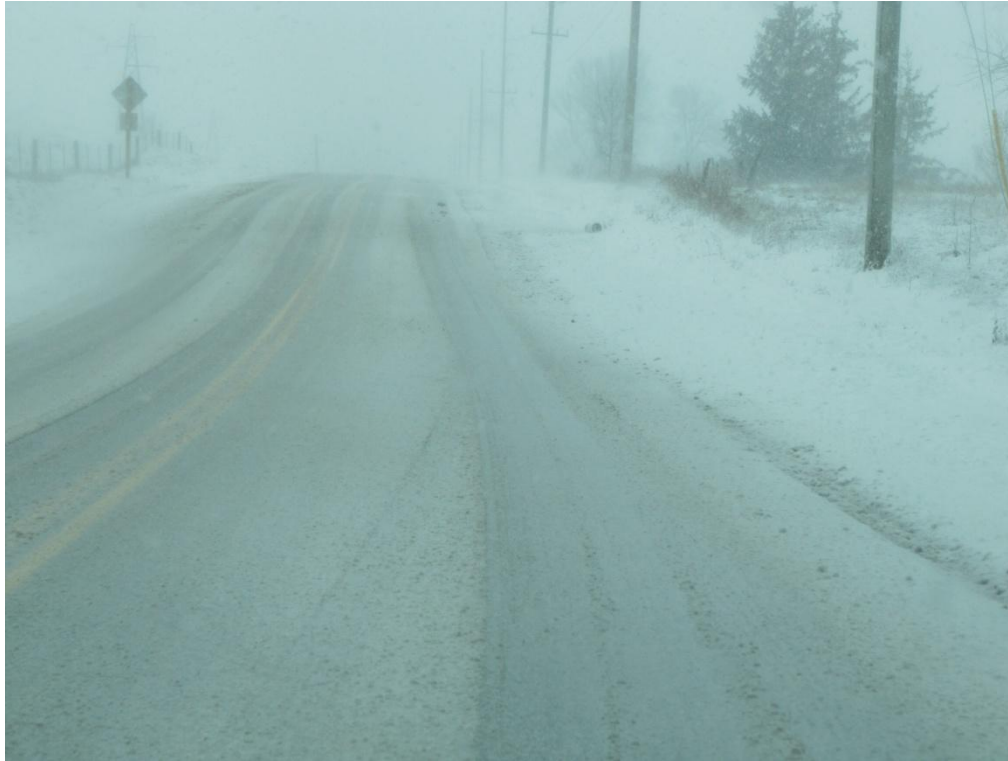
Figures 11 and 12 are photos taken from the Gorski Consulting dash camera while travelling through the north curve on March 12<sup>th</sup>. It is possible to understand how a vehicle might go out of control in the poor road conditions.

Figure 11: View, looking north while travelling around the north curve at approximately 0940 hours on March 12, 2014.

Figure 12: View looking north while travelling northbound at the north curve on March 12, 2014.

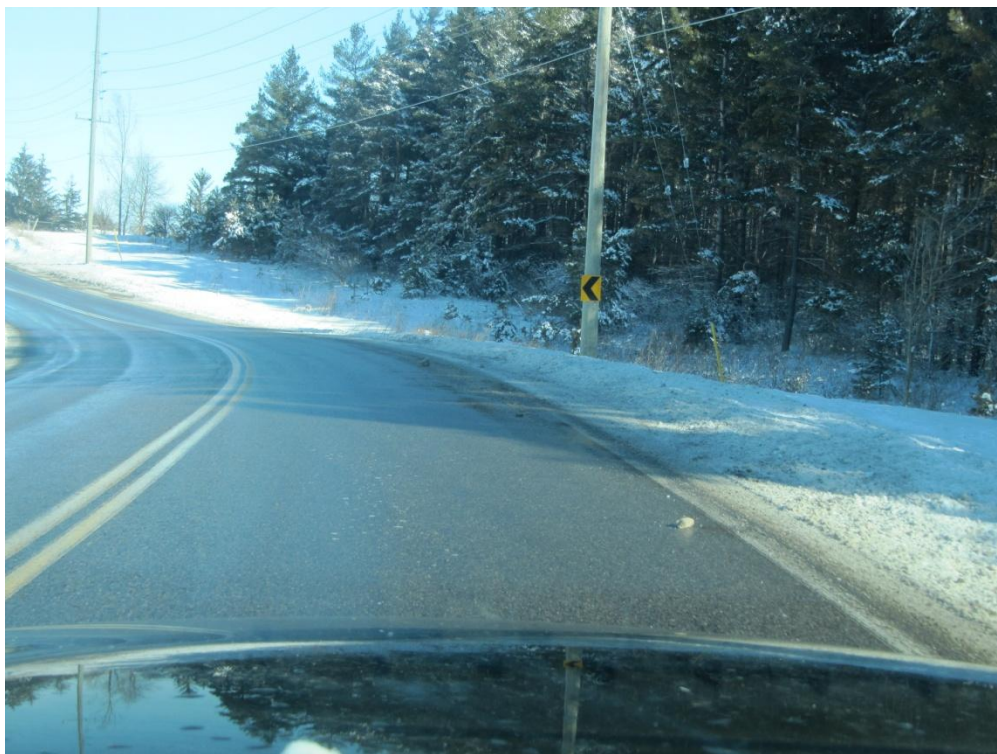
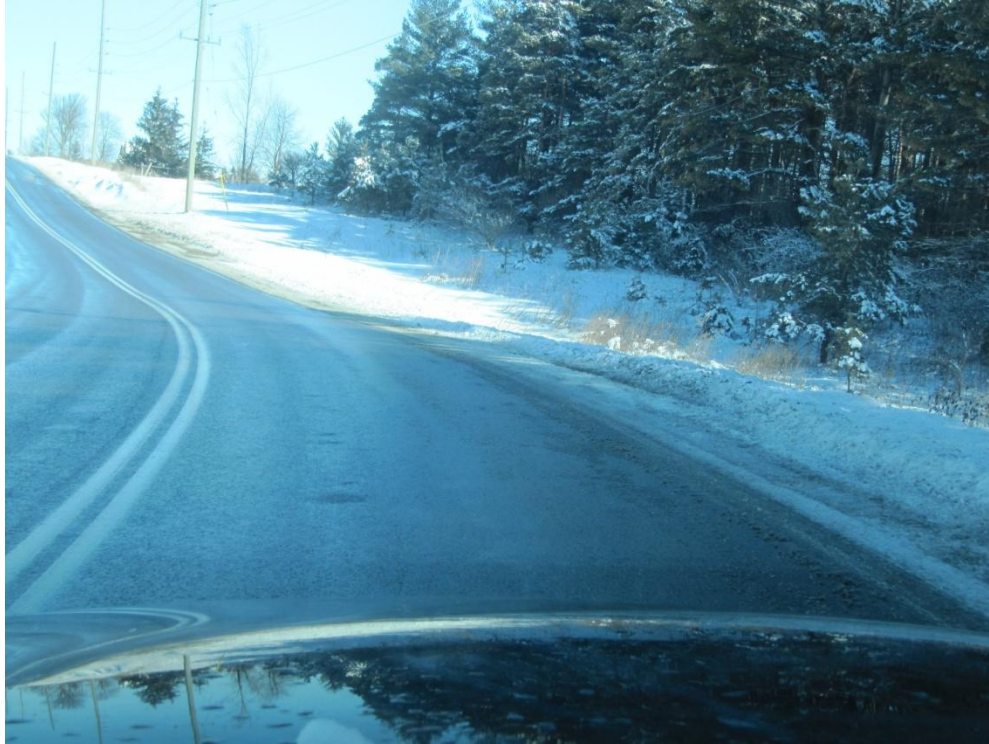
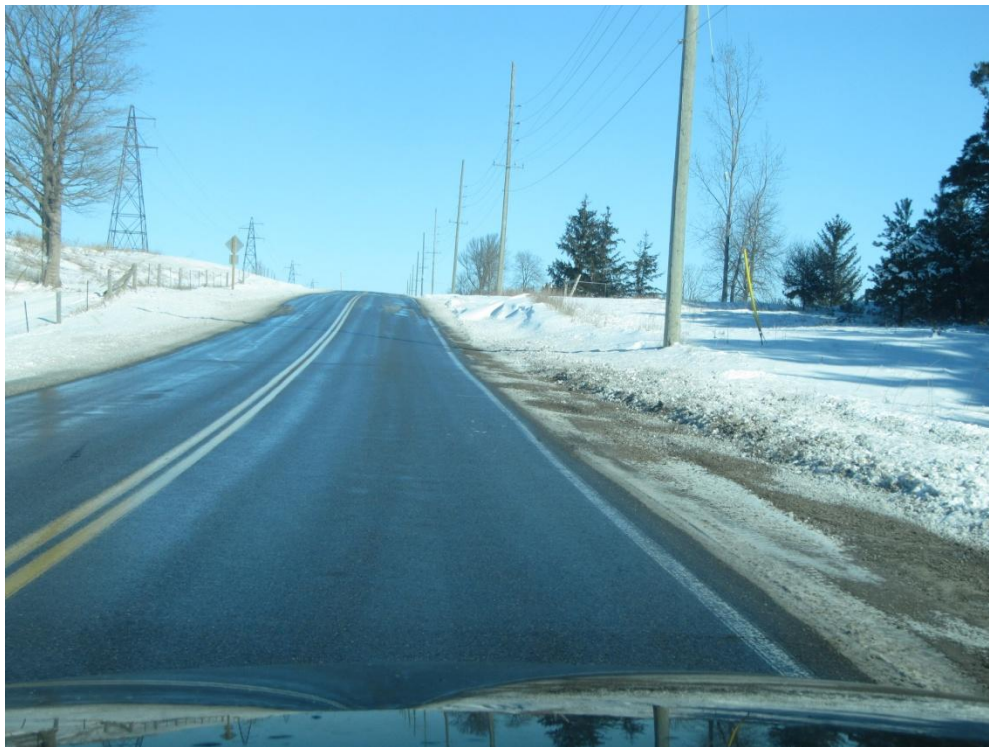
Figures 13, 14 and 15 provide similar northbound views taken from the dash camera on March 13<sup>th</sup>. The weather conditions are much better and the road surface is wet. The roadside suggests that some snow plowing has occurred that could have destroyed any collision evidence if that existed in the north curve of the S-curve. Therefore it can be understood how the physical evidence of the collision reported by police could not be detected.

Figure 13: View looking north while travelling northbound at the north curve at approximately 0930 hours on March 13, 2014.

Figure 14: View looking north while travelling northbound at the north curve on March 13th, 2014.

Figure 15: View looking north while travelling northbound at the north curve on March 13th, 2014.

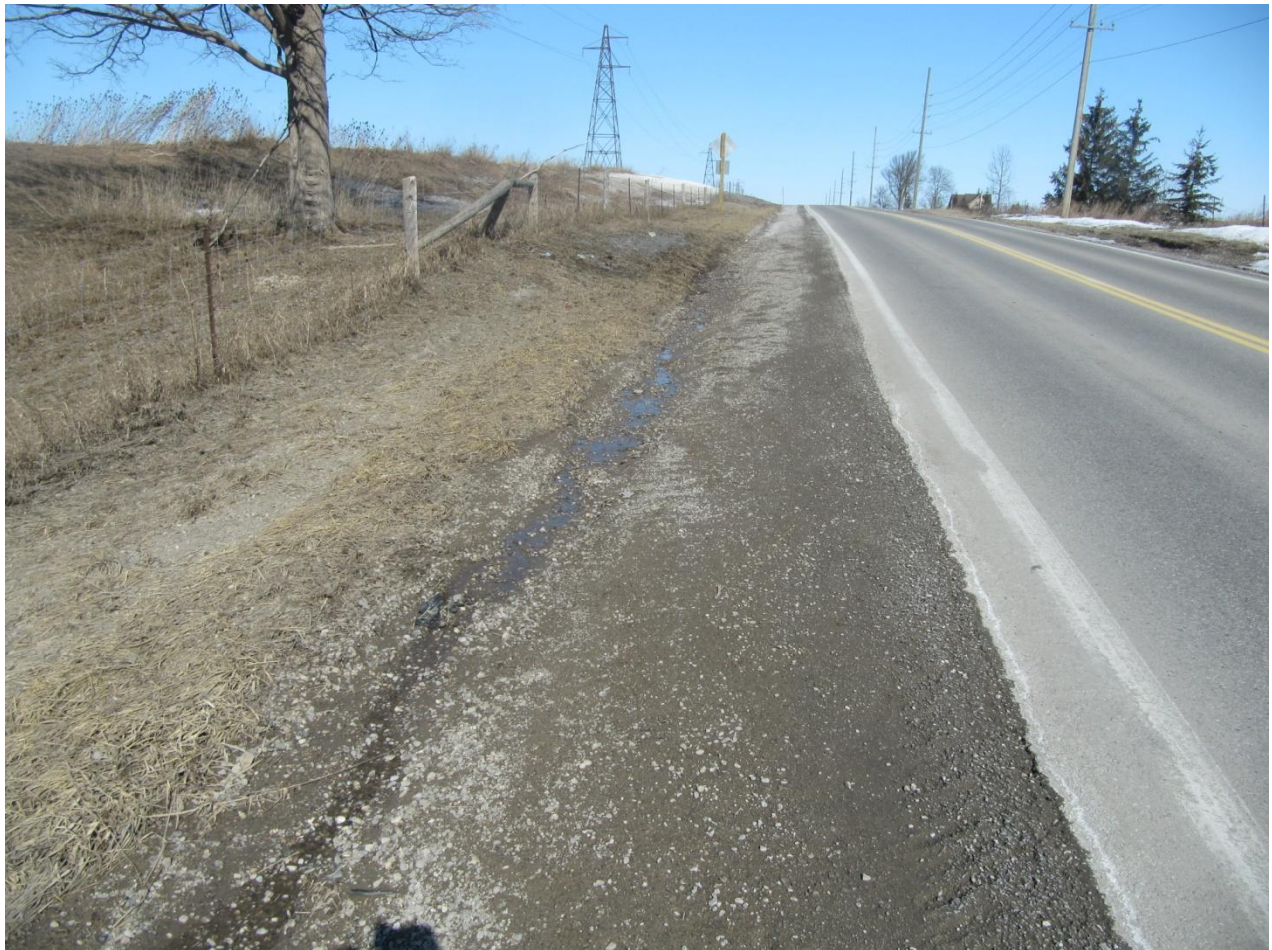
In the first incident, collision debris was found against a fence post of the west fence past the north end of the north curve. Faint tire marks suggested that a northbound vehicle crossed into the west ditch and struck the fence post with one of the corners of its front end. Figures 16, 17 and 18 show the collision evidence that was found at this first of two incidents on March 18<sup>th</sup>.

A reasonable question to ask is whether this collision was the one noted in the police dataset that occurred on March 12<sup>th</sup>? In both instances it involved a northbound vehicle and the both incidents are located at the “2<sup>nd</sup> curve”. Both events involved the loss-of-control collision of a vehicle. This combination of facts suggests that one could draw the conclusion that the two collisions are the same but there is insufficient evidence to be certain.

Figure 16: Collision documented on March 18th, 2014. This is a view looking north along the west shoulder and ditch. In the background, adjacent to the large tree are a set of wooden posts. Vehicle parts were found at the base of one of these posts. Faint tire marks were also observed indicating that a northbound vehicle collided at this location.

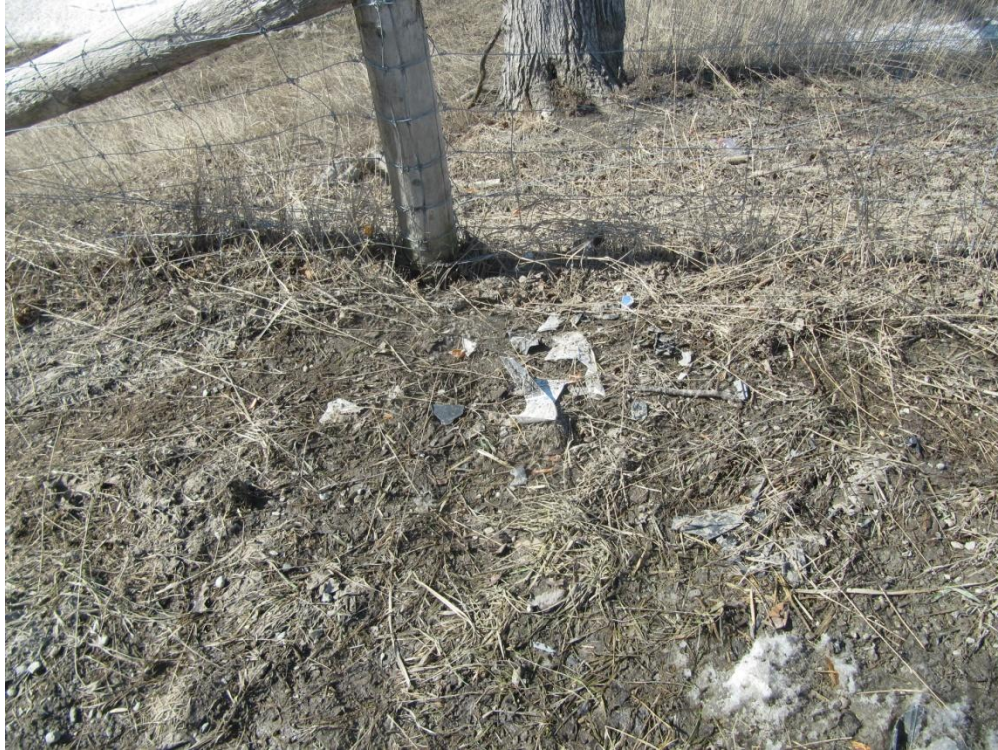
Figure 17: View looking west toward one of the fence posts showing the vehicle debris indicating that a collision occurred here.

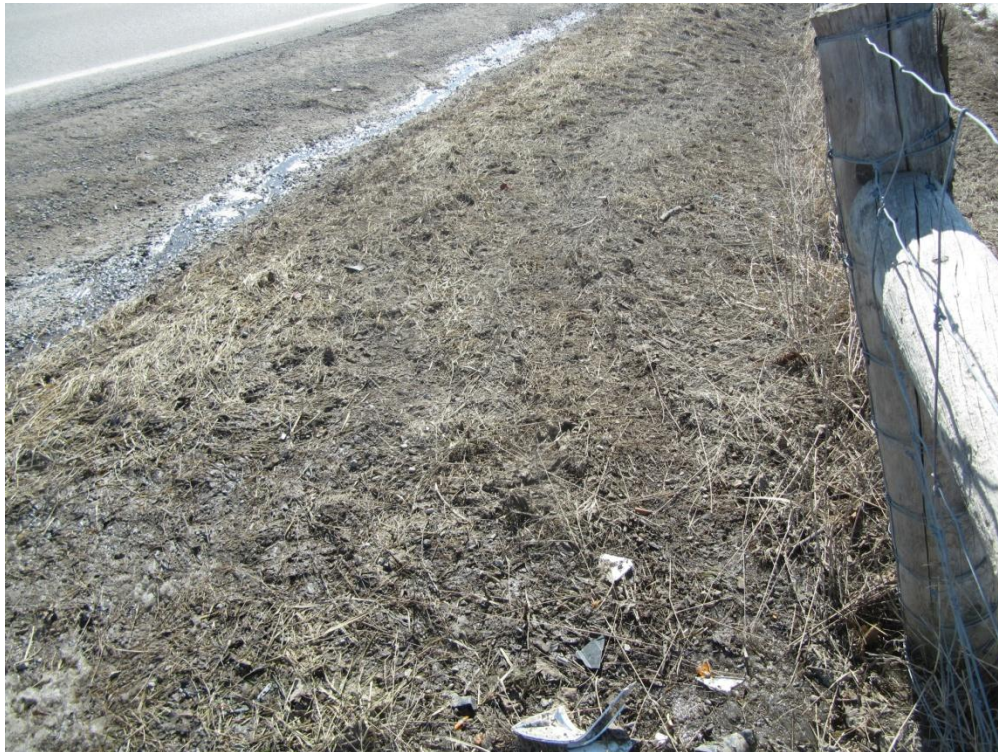
Figure 18: View looking south from the struck fence post. Faint tire marks are visible in the ditch indicating that the colliding vehicle was northbound.

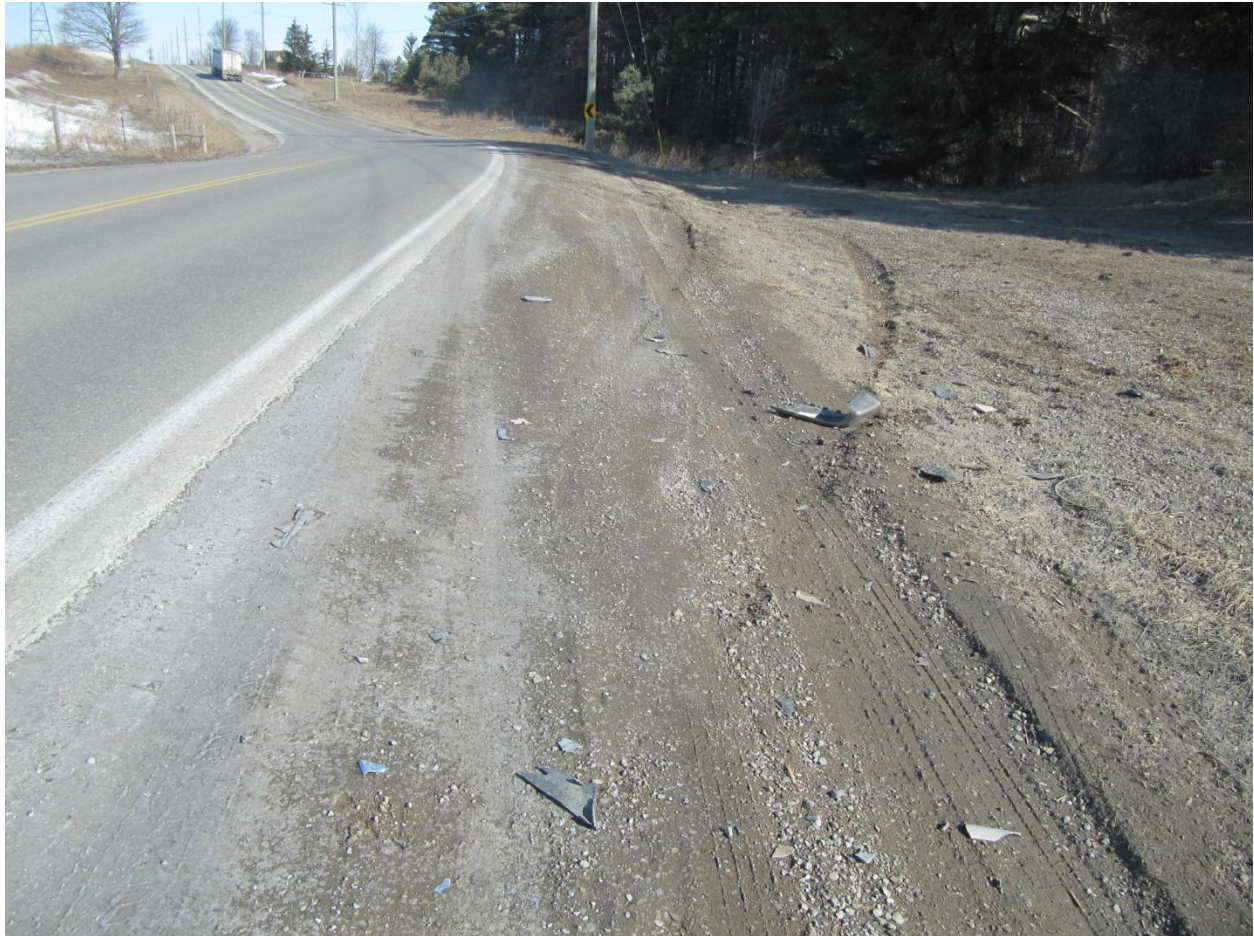
In the second incident documented by Gorski Consulting on March 18<sup>th</sup>, the dataset reports that a northbound vehicle produced loss-of-control tire marks on the east roadside between the two curves. A comment is attached that reads “Obvious collision but unknown circumstances”. Having reviewed the photographs in detail the conclusion drawn is that there is doubt about the travel direction of the vehicle however it was definitely rotating while on the east roadside. There was also vehicle debris strewn throughout the vicinity of the tire marks indicating that an unknown collision occurred. This collision was not reported in the police dataset. Figures 19, 20 and 21 provide views of the physical evidence that was found.

Figure 19: Collision documented by Gorski Consulting on March 18th, 2014 this is a view looking north along the east roadside. Loss-of-control yaw marks can be seen in the grass of the roadside and on the gravel shoulder in the foreground. For official purposes the evidence has been reported as caused by a northbound vehicle. However there is some doubt about that conclusion. Vehicle parts can be seen strewn around the vicinity of the tire marks indicating there was a collision but no further conclusions can be drawn.

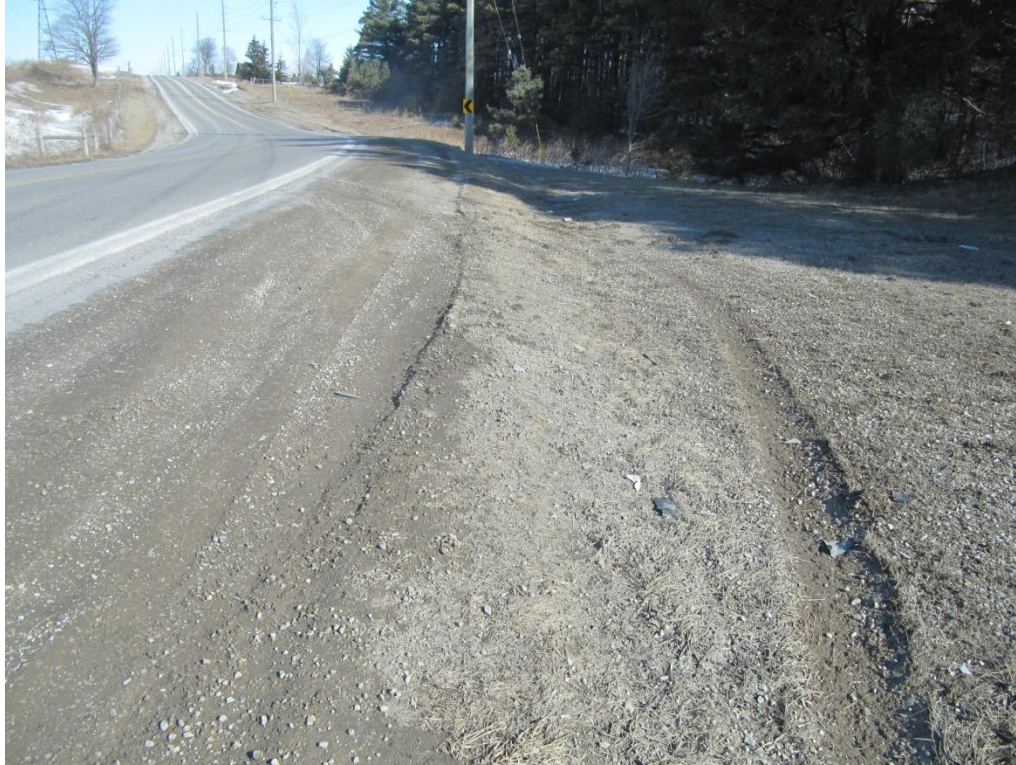
Figure 20: View looking north along the yaw marks located on the east roadside.

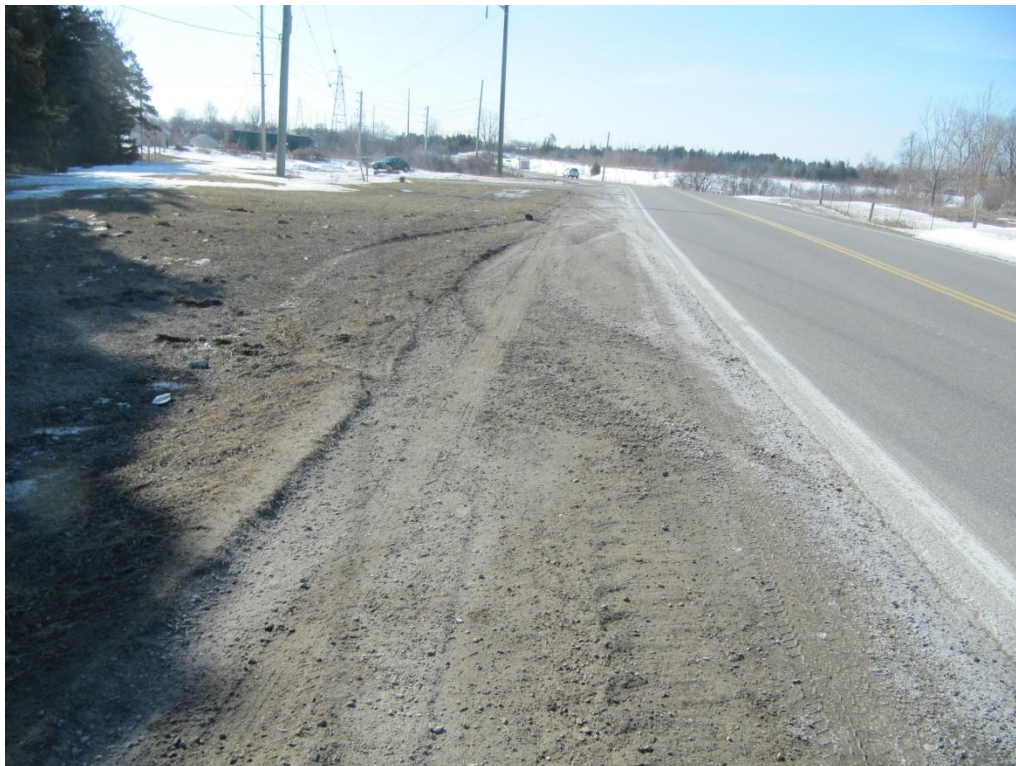
Figure 21: View looking south along the yaw marks on the east roadside.

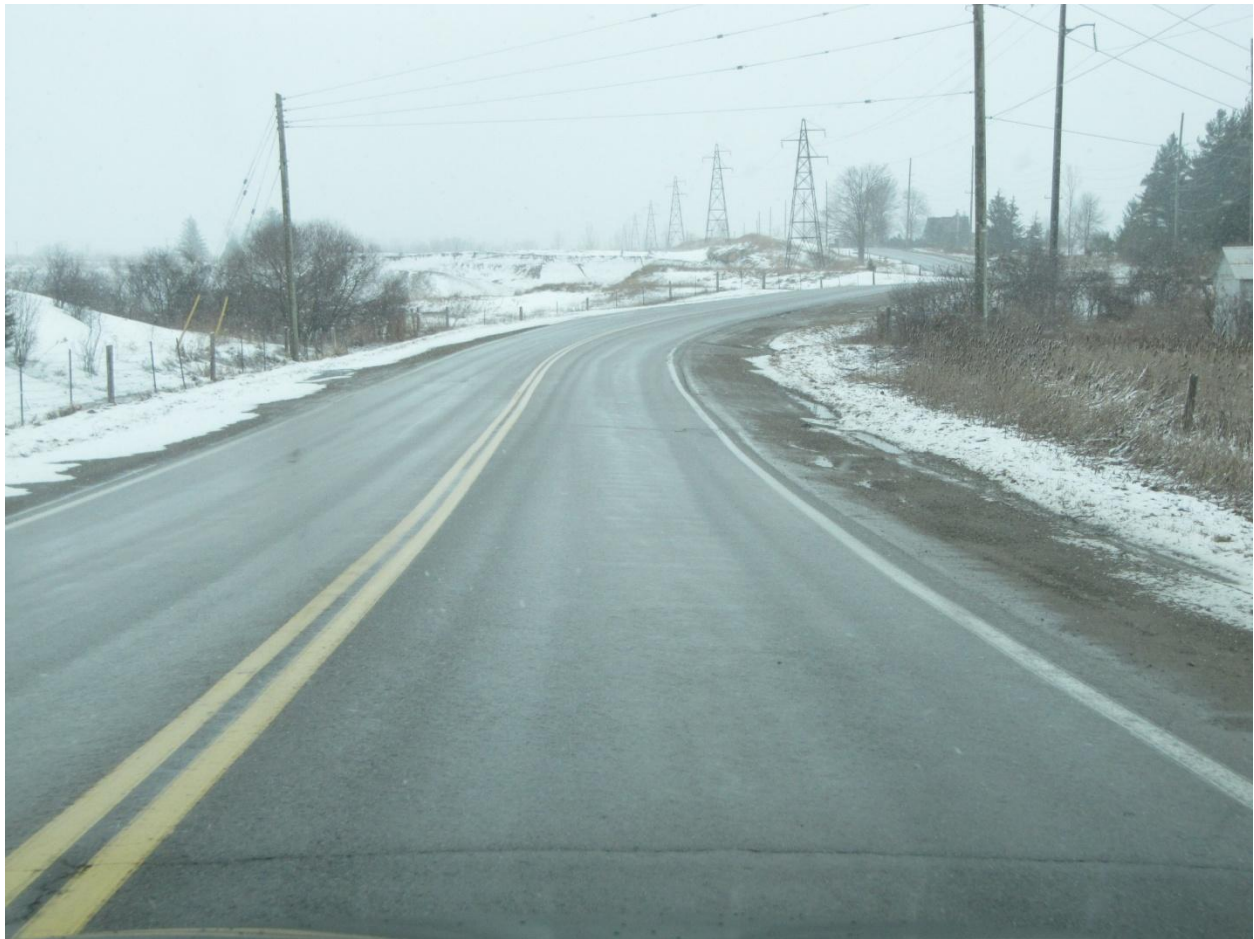
The police dataset indicated that at 2100 hours on March 19<sup>th</sup>, 2014, a northbound passenger car was involved in a loss-of-control collision that resulted in property damage but no injuries. Gorski Consulting drove through the S-curve on the morning of March 20<sup>th</sup> when the road surface was wet and then again on March 22<sup>nd</sup> when the road surface was dry. On both instances no evidence of a collision was noted within the S-curve. The road conditions can be appreciated by examining Figure 22 which provides a view from the dash camera of the Gorski Consulting vehicle as it was northbound at passing through the S-curve on March 20<sup>th</sup>.

Figure 22: View looking north along the S-curve taken at approximately 0930 on March 20th or approximately 11 hours after the collision reported in the police dataset.

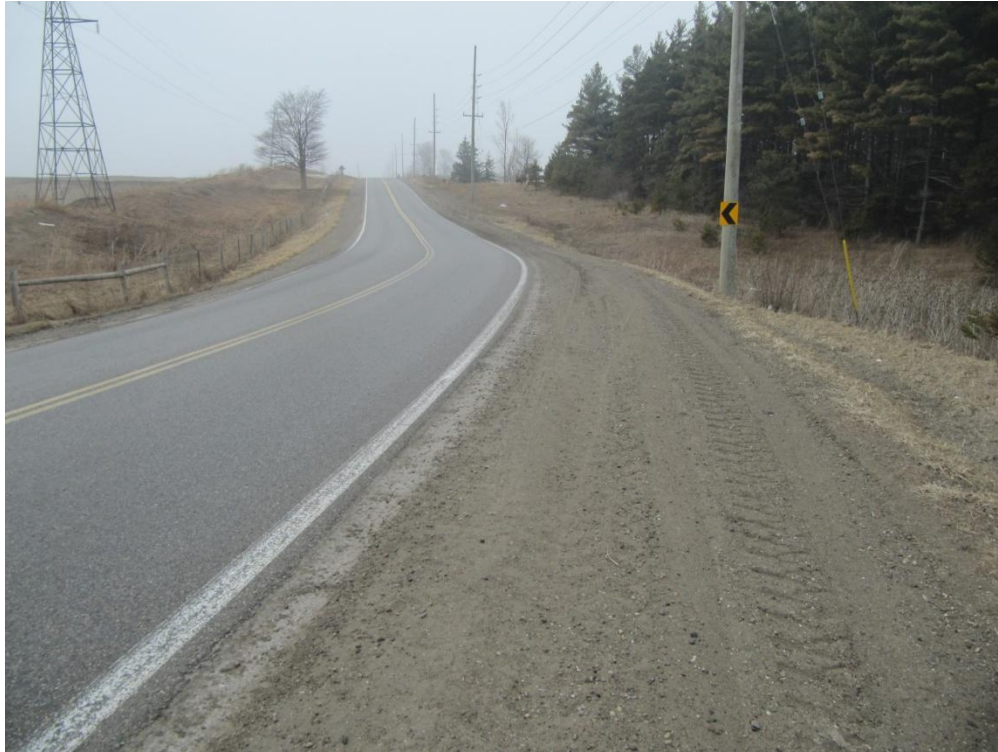
The Gorski Consulting dataset indicated that an incident was documented on April 4, 2014 indicating that a northbound vehicle produced loss-of-control tire marks and that vehicle debris was located on the east roadside at the north curve. The debris indicated that, upon falling down a steep embankment, the northbound vehicle made ground contact with the bottom of its front end. Pieces of the front bumper and fascia that was strewn at the end of the tire marks indicated that vehicle damage was sufficient that the collision should have been reported to police. Tire marks along the east roadside also suggested that a tow truck attended the site with respect to that collision. Figures 23 through 26 provide details of the physical evidence that was found.

Figure 23: Collision that was documented on April 4th, 2014. This is a view looking north along the east shoulder at the north curve. Just past the utility pole a northbound vehicle travelled down the embankment and collided with the ground below.

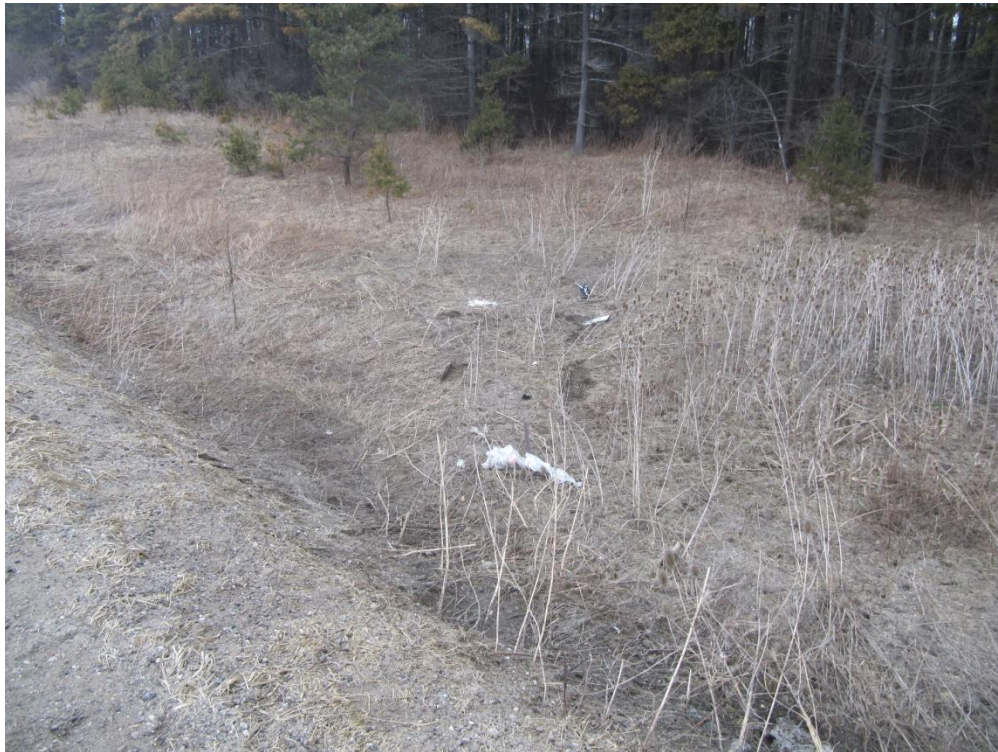
Figure 24: View looking down from the top of the embankment showing tire marks and vehicle parts where the northbound vehicle collided with the ground and came to rest.

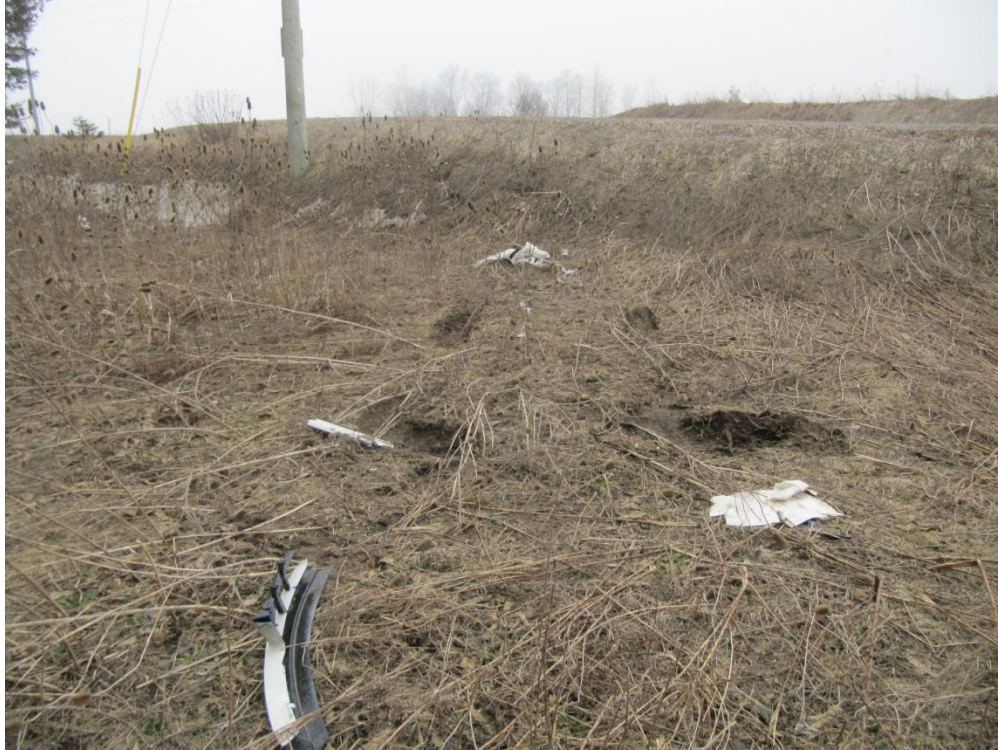
Figure 25: View from the final rest position of the northbound vehicle to the embankment from which vehicle the vehicle fell.

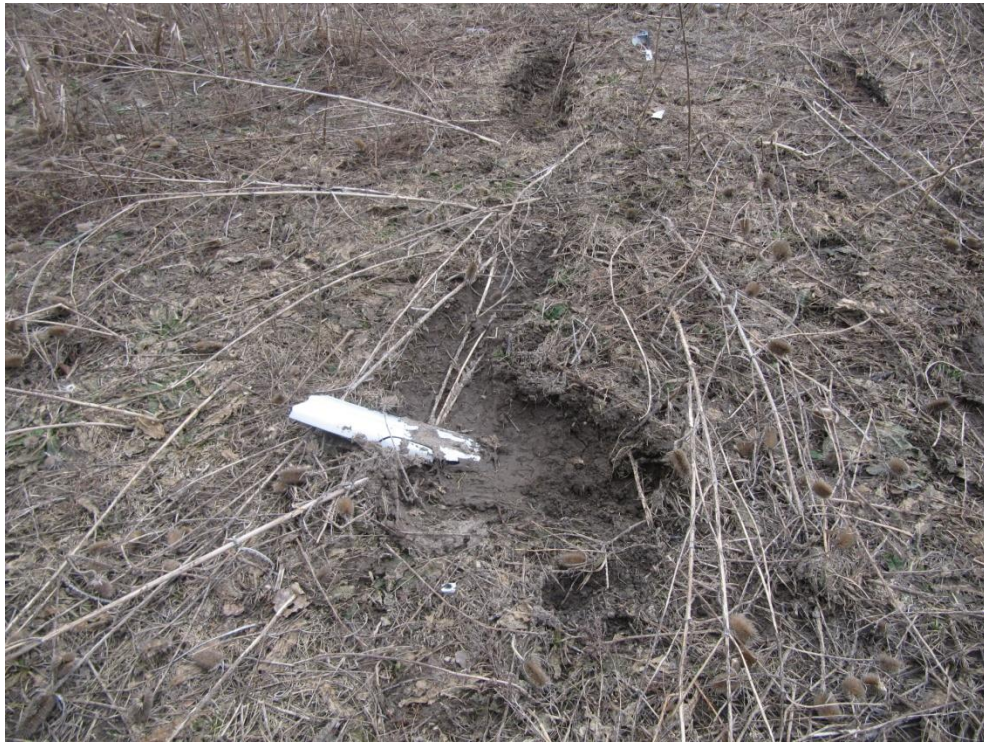
Figure 26: View of the tire marks and vehicle debris at the bottom of the embankment where the northbound vehicle came to rest.
