# How Many Incidents Do Not Become Reported In Police Collision Data? – Part 4

## 1.0 Background

Since the fall of 2009 Gorski Consulting has been involved in a research project involving documentation of collision and loss-of-control incidents at an S-Curve of Clarke Road north of Fanshawe Park Road at the north-eastern outskirts of the City of London, Ontario, Canada. By the end of 2016 89 incidents were documented.

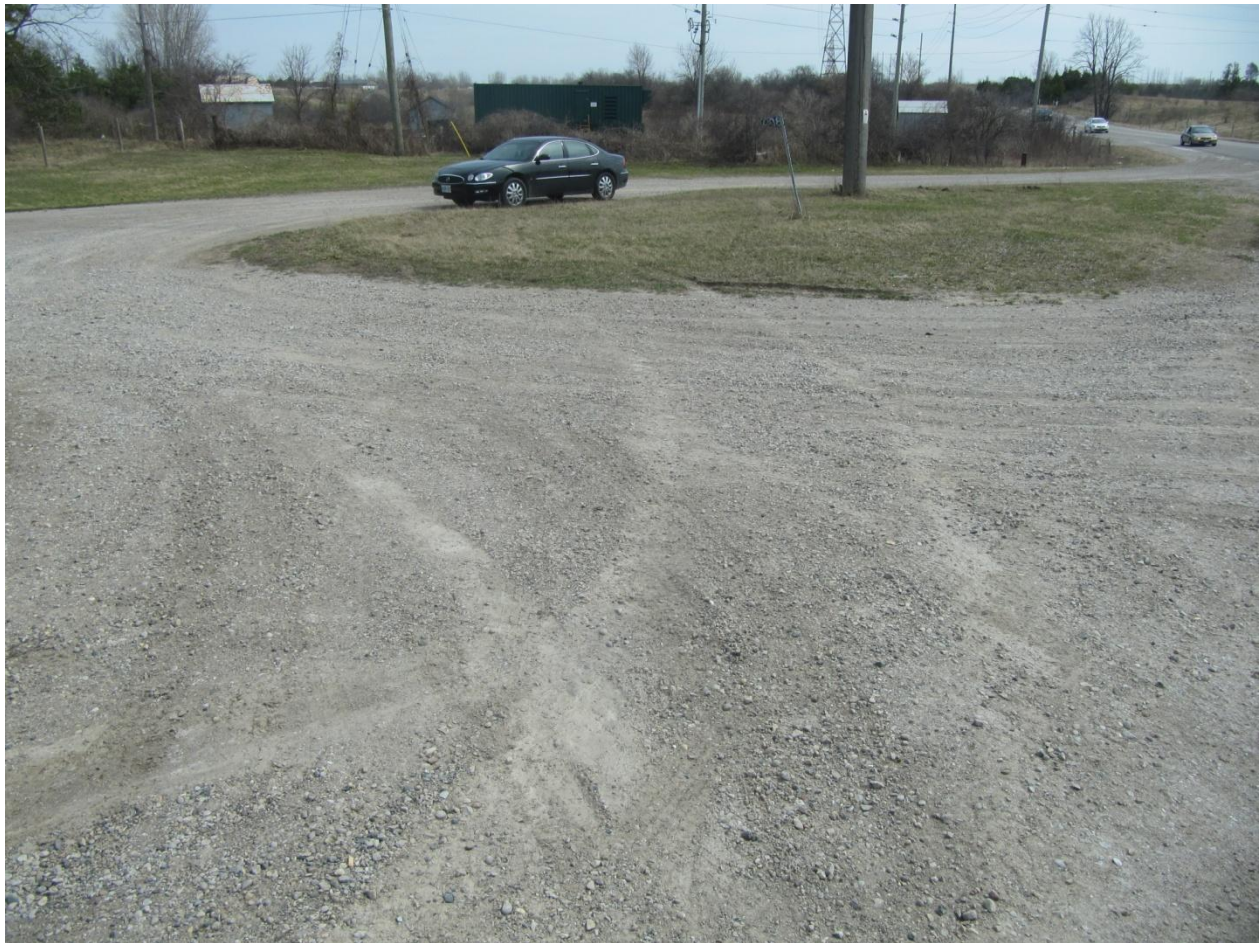
The Gorski Consulting dataset documented an incident on April 21<sup>st</sup>, 2014 where a southbound vehicle slid sideways and came to rest on the grass roadside between the two curves of the S-curve. There was no reference to this incident in the police records likely because it did not involve a collision. Other tire marks existed in the vicinity suggesting that a vehicle was under prolonged acceleration. It became questionable whether all the marks were related to the same incident and whether the marks were created under intentional acceleration. That question has not been resolved. Figures 27 through 33 show some of the tire mark evidence. Although most of the marks suggest acceleration was involved it does not necessarily lead to the conclusion that the acceleration was intentional as there are numerous incidents where unintended sudden acceleration occur resulting in significant collisions and consequences. For this reason this physical evidence has been included in the summary of incidents.

Figure 27: Incident documented on April 21, 2014. This is a view looking south within the driveway on the east side of Clarke Road between the two curves of the S-Curve. Curved yaw marks are seen travelling toward the parked car in the background. It is questioned whether these marks are intentional acceleration marks similar to others found in the driveway and on the east shoulder.

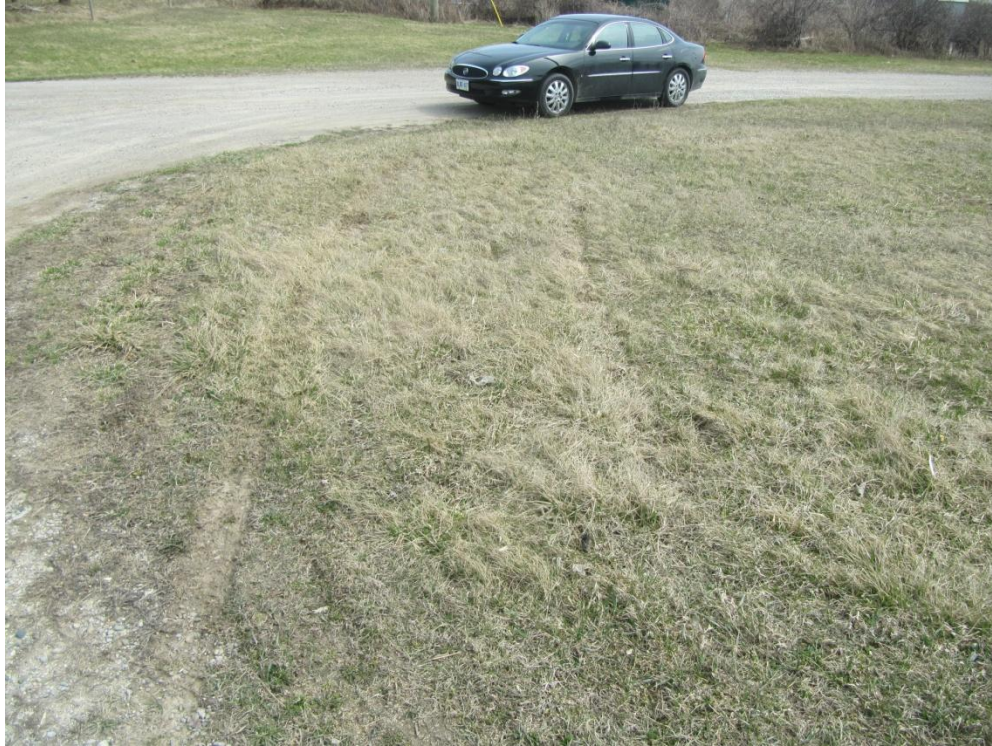
Figure 28: View of the loss-of-control tire marks on the grass of the east roadside. The vehicle causing the marks would have come to rest just before reaching the area of the parked car.

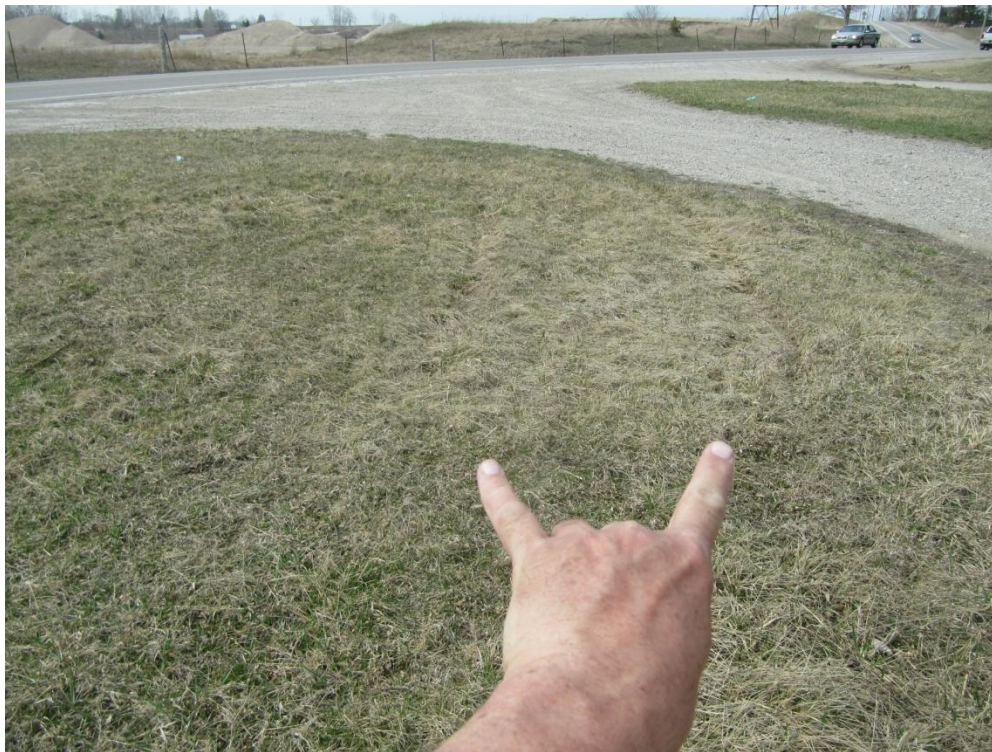
Figure 29: View looking northwest with the investigators fingers pointing out the location of the faint loss-of-control tire marks in the grass roadside.

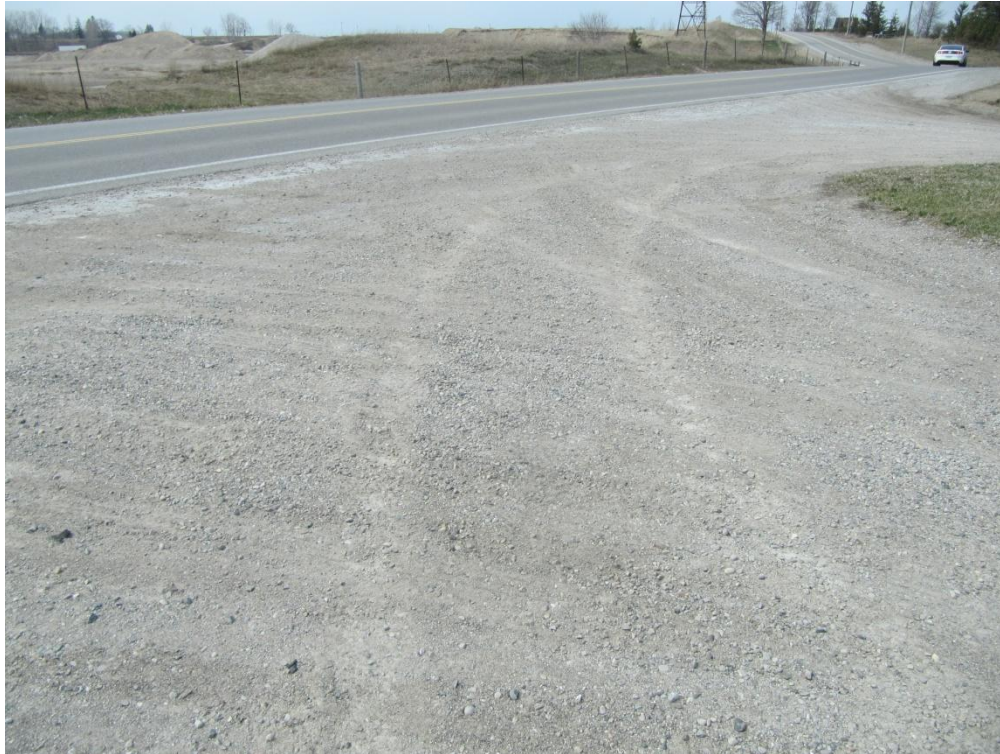
Figure 30: View looking north at the loss-of-control tire marks on the gravel of the driveway. Closer examination suggests that the vehicle approached the camera from the other driveway in the background and not from the roadway. This would suggest that the marks were created from acceleration, and possibly intentional acceleration.

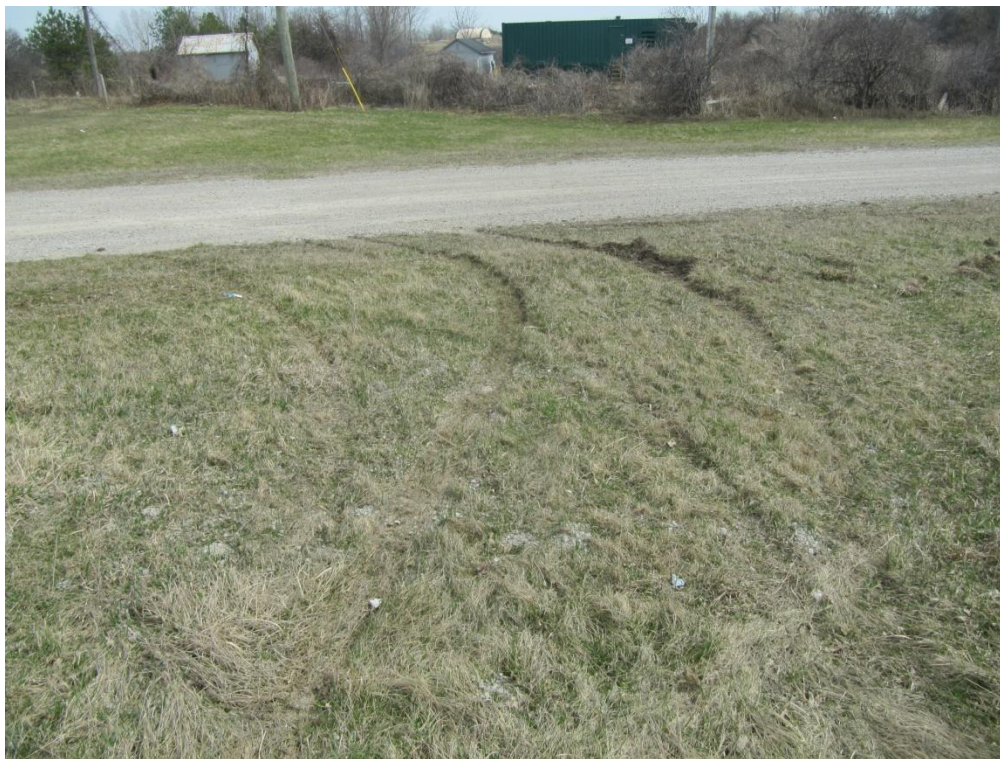
Figure 31: View of other tire marks in the grass roadside which show clear indications of acceleration.

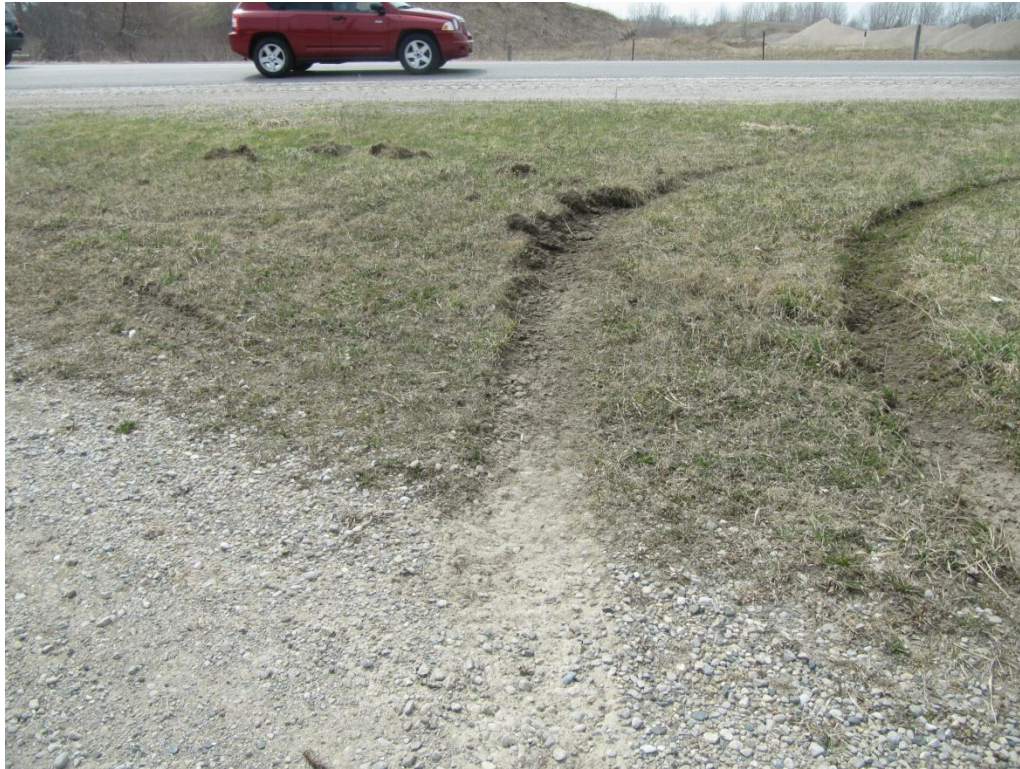
Figure 32: View of tire marks on the east roadside which show clear signs of powered acceleration with hard steering.

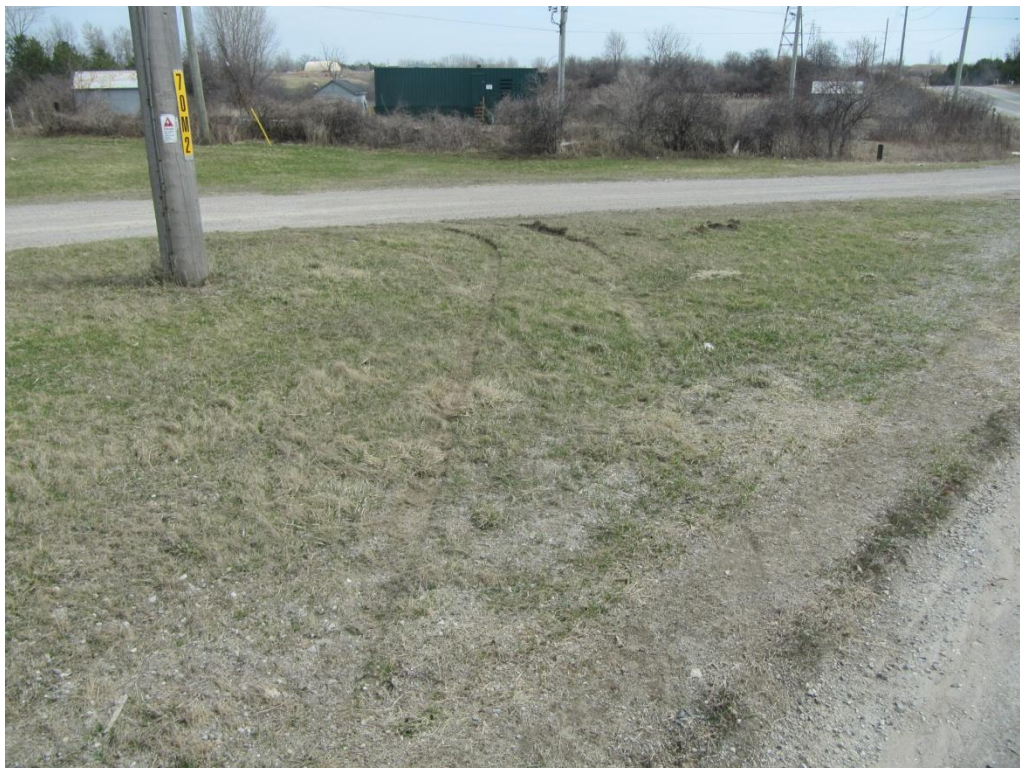
Figure 33: View of tire marks on the east roadside showing an exit from the road by a southbound vehicle which is then steering hard to the left under high acceleration in the background.

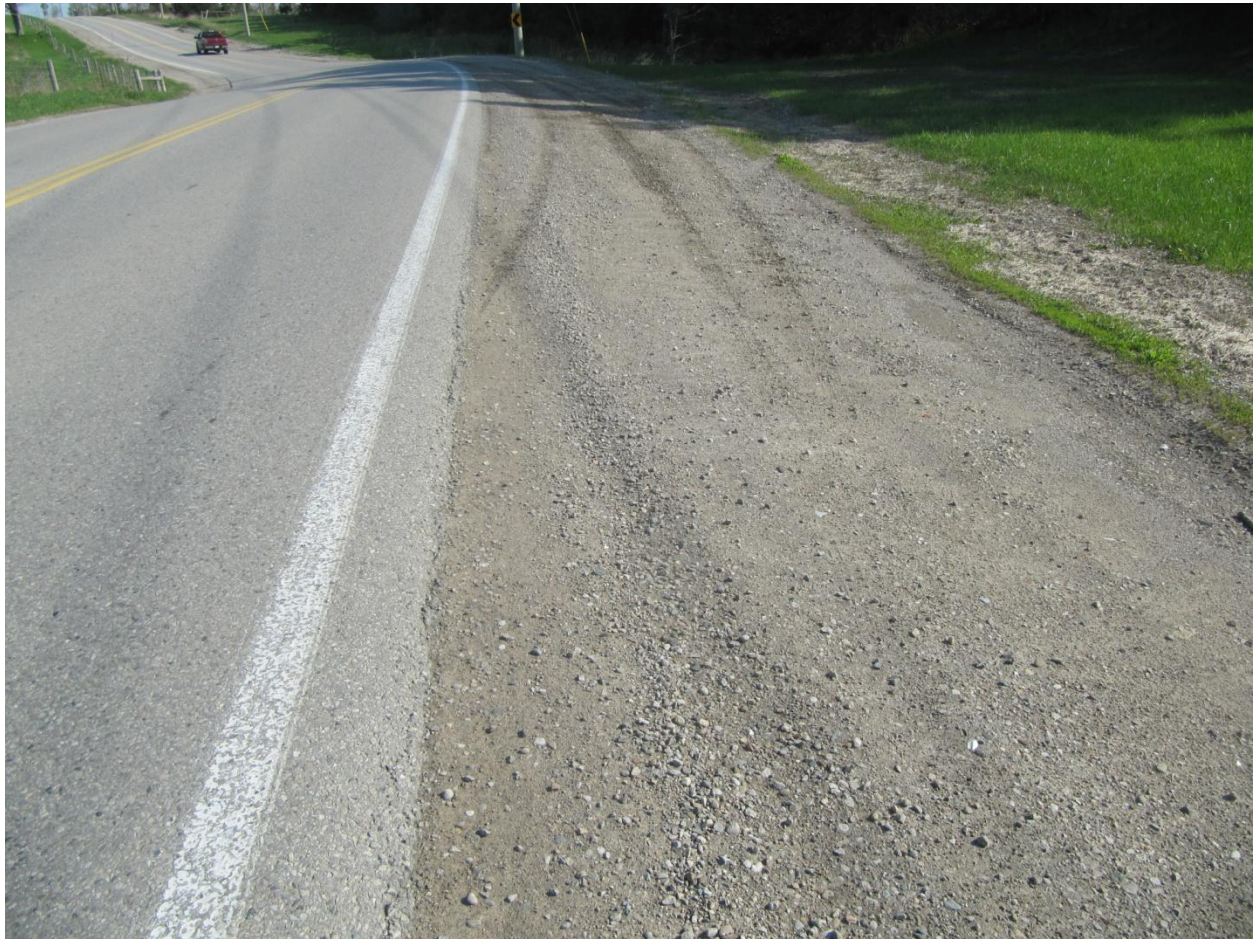
The Gorski Consulting dataset indicated that an incident was documented on May 19<sup>th</sup>, 2014, involving a southbound vehicle that produced yaw marks on the east roadside between the two curves of the S-curve. The yaw marks were terminated as the driver of the vehicle regained control and there was no collision. This incident was understandably not included in the police dataset. Figures 34, 35 and 36 provide indications of the evidence that was found.

Figure 34: Incident documented on May 19th, 2014. This is a view looking north along the east shoulder between the two curves of the S-Curve. Yaw marks in the shoulder show that a southbound vehicle rotated clockwise as it approached the camera. The driver regained control in the foreground thus the yaw marks are no longer visible.

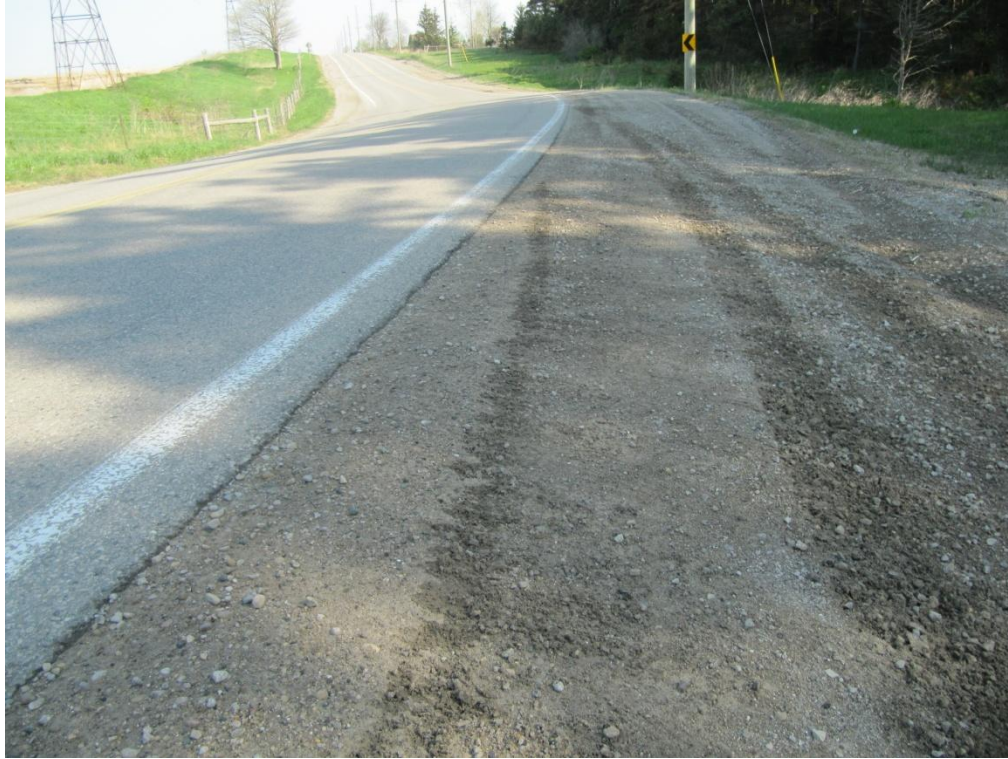
Figure 35: View looking north along the east shoulder showing the yaw marks as a southbound vehicle travelled toward the camera while rotating clockwise.

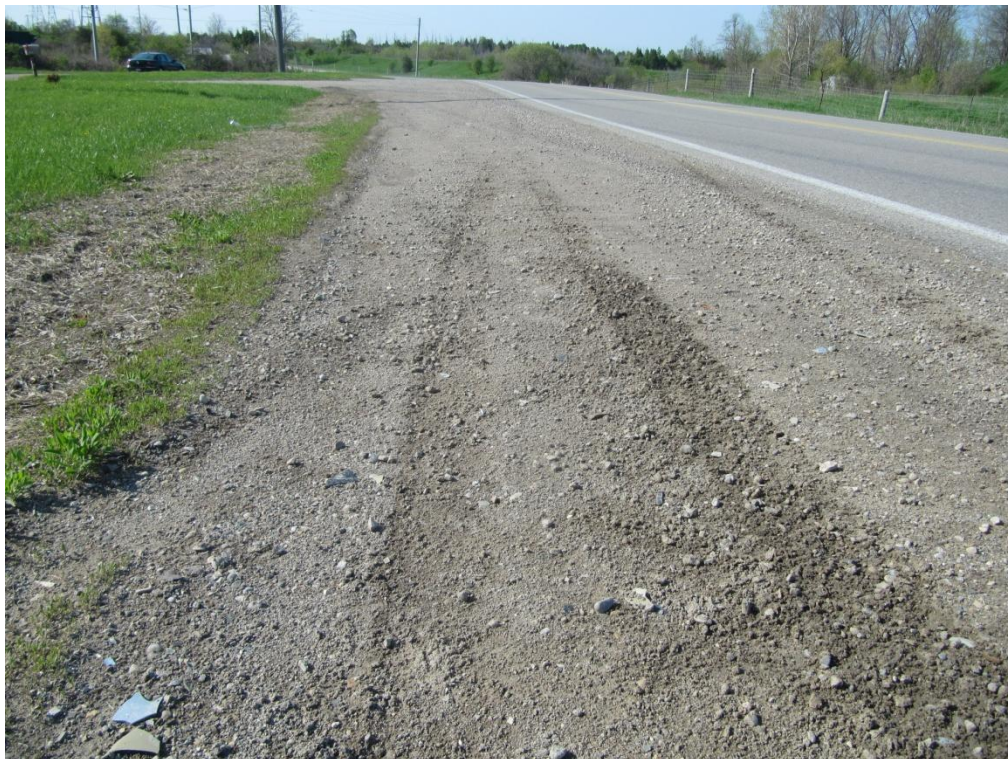
Figure 36: View looking south along the east shoulder showing how the yaw marks fade out as the driver regains control of the vehicle and continues southbound back onto the road.

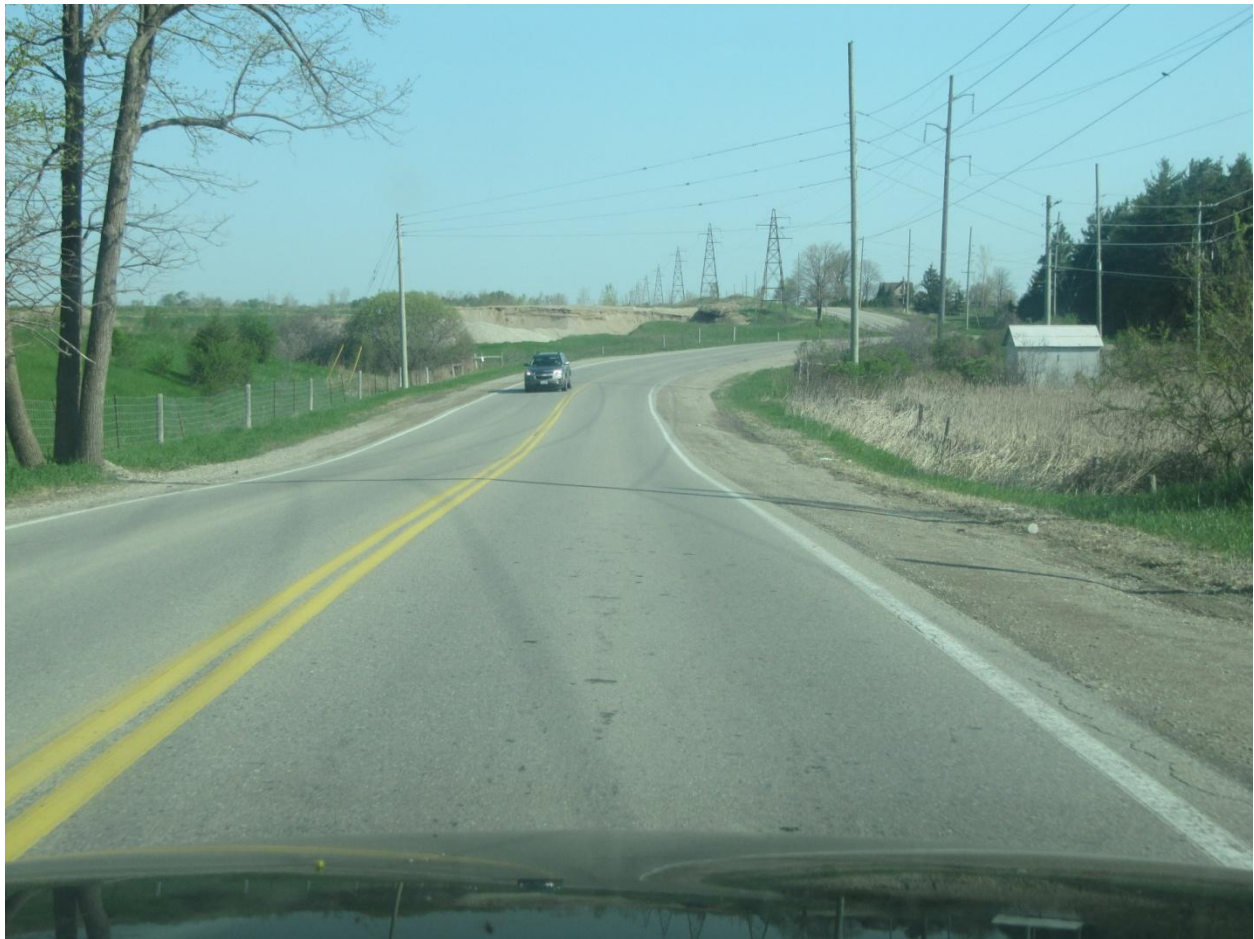
The police dataset indicated that at 0813 hours on June 21<sup>st</sup>, 2014 a northbound passenger car struck a deer resulting in property damage but no injuries. Gorski Consulting conducted an examination of the S-curve at approximately 1410 hours or 6 hours after the reported collision occurred. No evidence was found that a recent collision occurred within the bounds of the S-curve. Figures 37 and 38 provide general views of the curve to illustrate the conditions at that time.

Figure 37: View looking north taken from the Gorski Consulting dash camera at approximately 1410 hours of June 21, 2014. This is upon approach to the south portion of the S-curve.

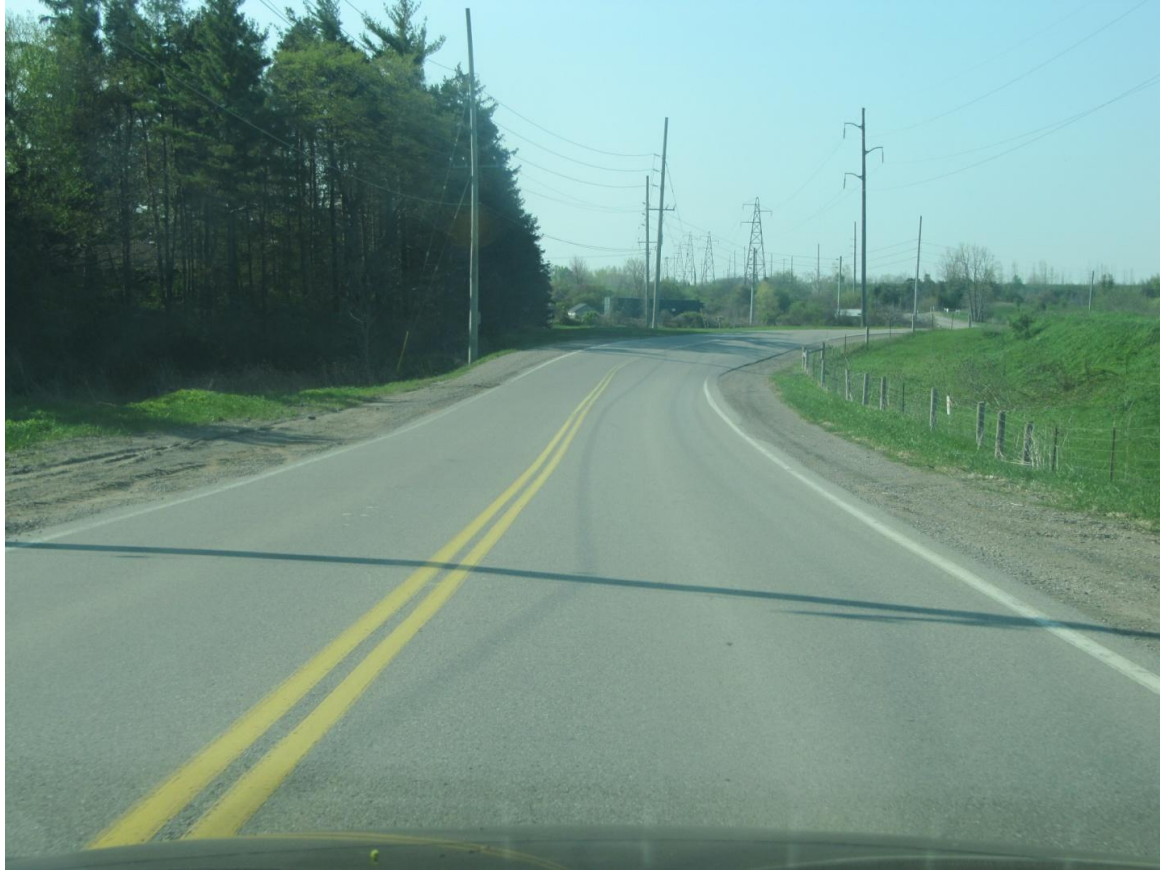
Figure 38: View looking south while approaching the north curve of the S-curve.

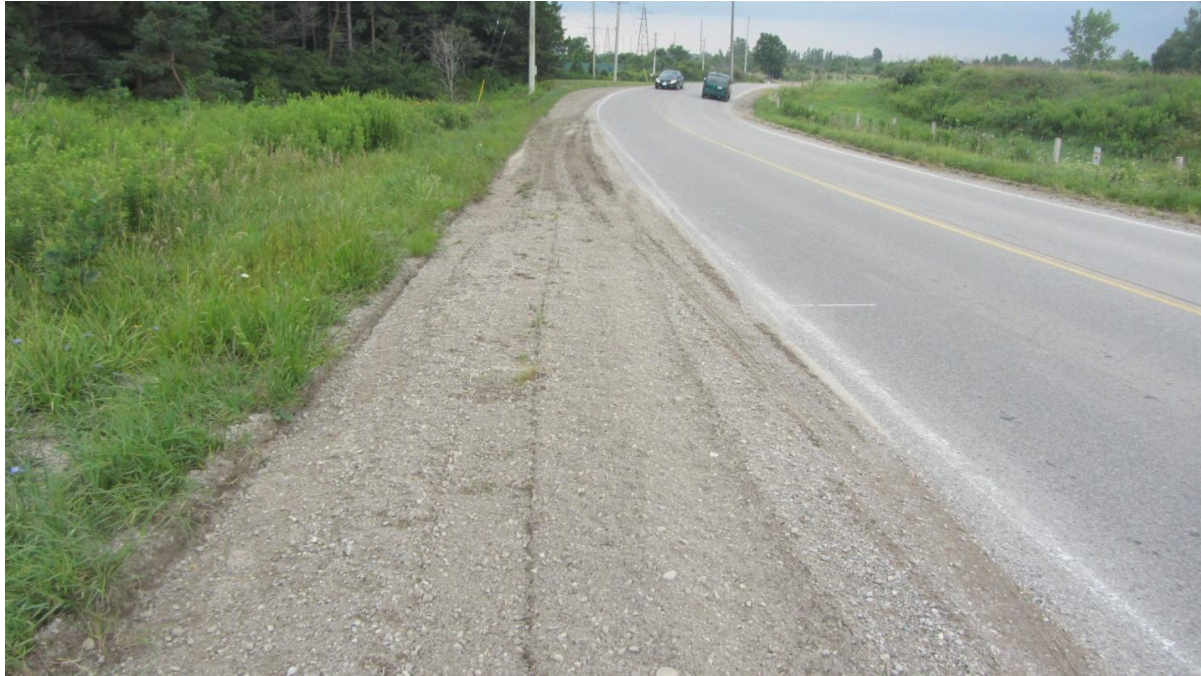
The Gorski Consulting dataset documented an incident on August 5<sup>th</sup>, 2014 in which a northbound vehicle produced yaw marks on the east shoulder followed by more yaw marks on the west shoulder. These marks were located at the north curve as well as just north of the north curve. As there was no physical evidence that the marks were associated with an impact it is understandable why the police dataset does not make mention of this incident. Figures 39 through 44 show the evidence that was found.

Figure 39: Incident documented on August 5th, 2014. This is a view looking south along the east shoulder at the north curve. Yaw marks from as northbound vehicle can be seen in the shoulder as the vehicle began to rotate counter-clockwise. The tire marks show the vehicle returning to the road surface in the foreground as it continues its rotation.

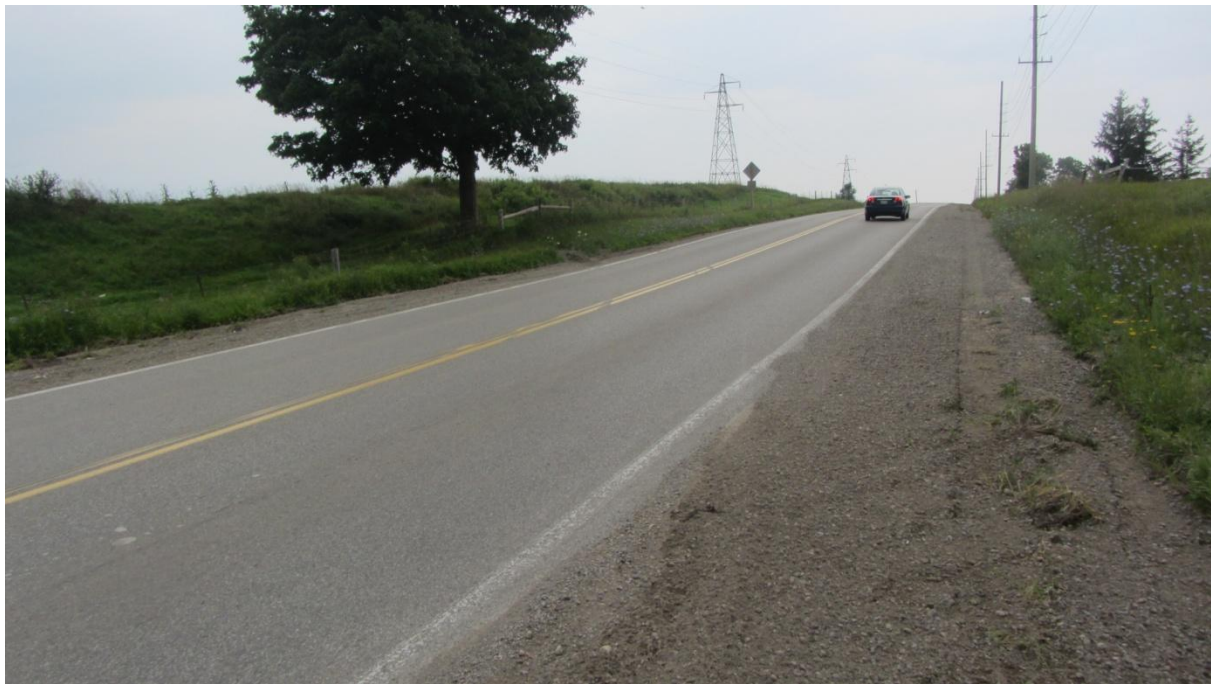
Figure 40: View looking north from the north end of the yaw marks in the foreground as the rotating, northbound vehicle returns to the road surface. At the centre-line, in the centre of the view, are some black transfers of rubber with striations within them indicating that these are from the continued yaw mark produced by the northbound vehicle. The vehicle eventually comes to rest on the west shoulder adjacent to the tree in the background.

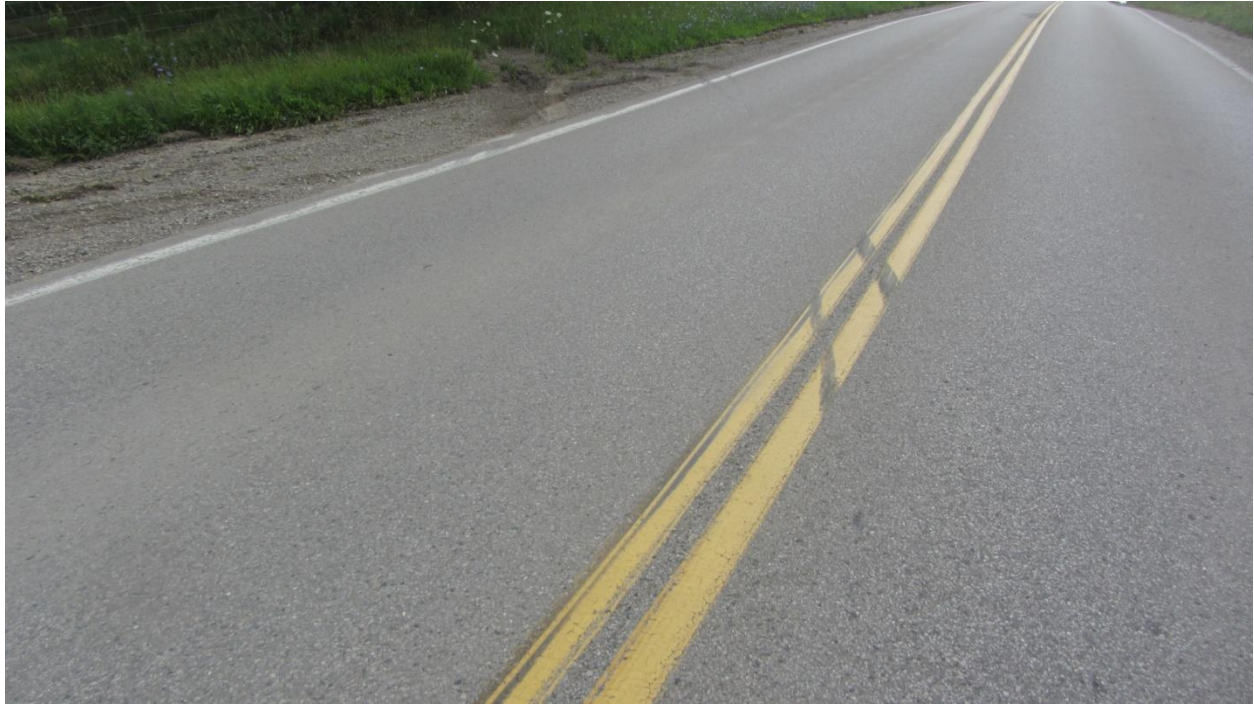
Figure 41: View looking northwest at the black yaw marks on the centre line and the tire marks on the west shoulder in the background where the northbound vehicle came to rest.

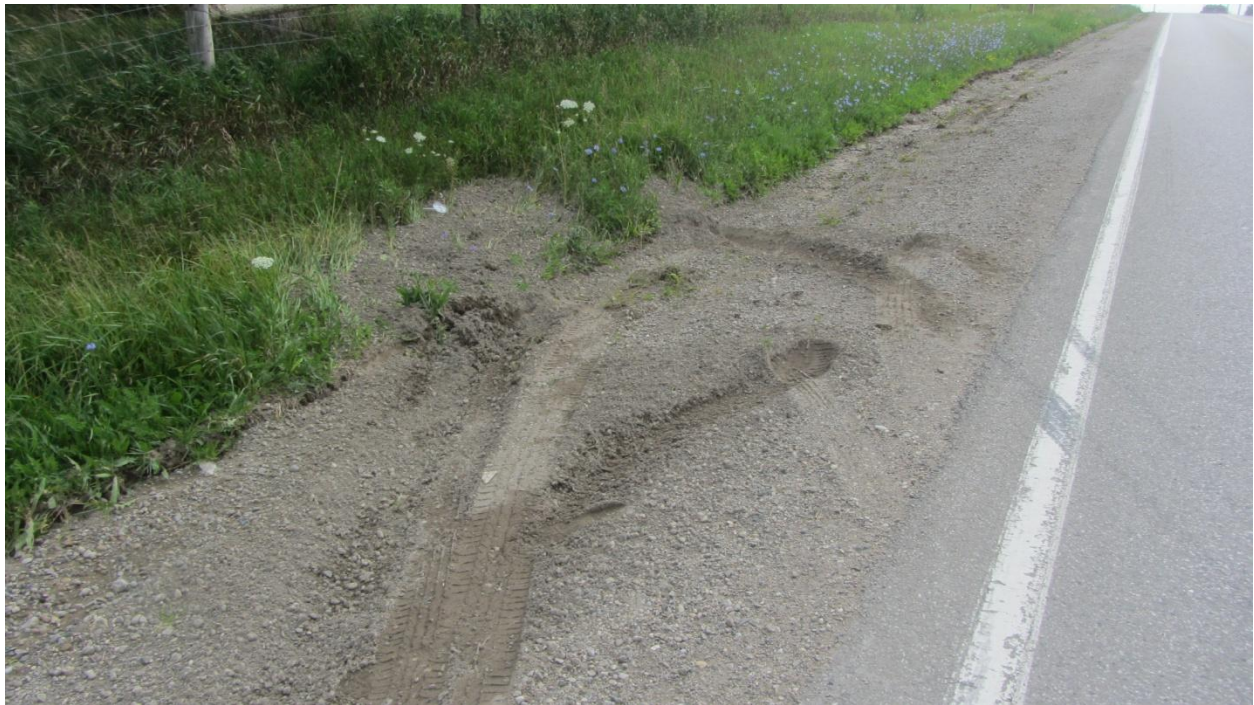
Figure 42: View of the tire marks at the final rest position of the northbound vehicle at the west shoulder.

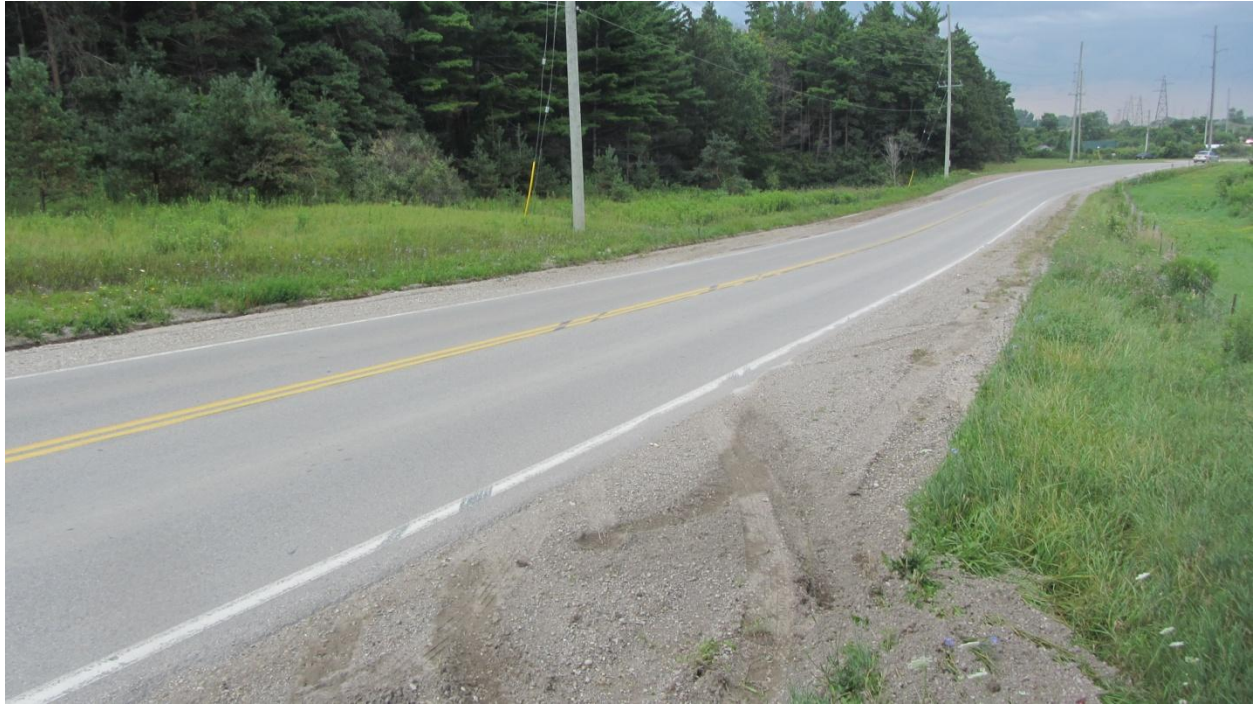
Figure 43: View looking south-east from the final rest position of the northbound vehicle.

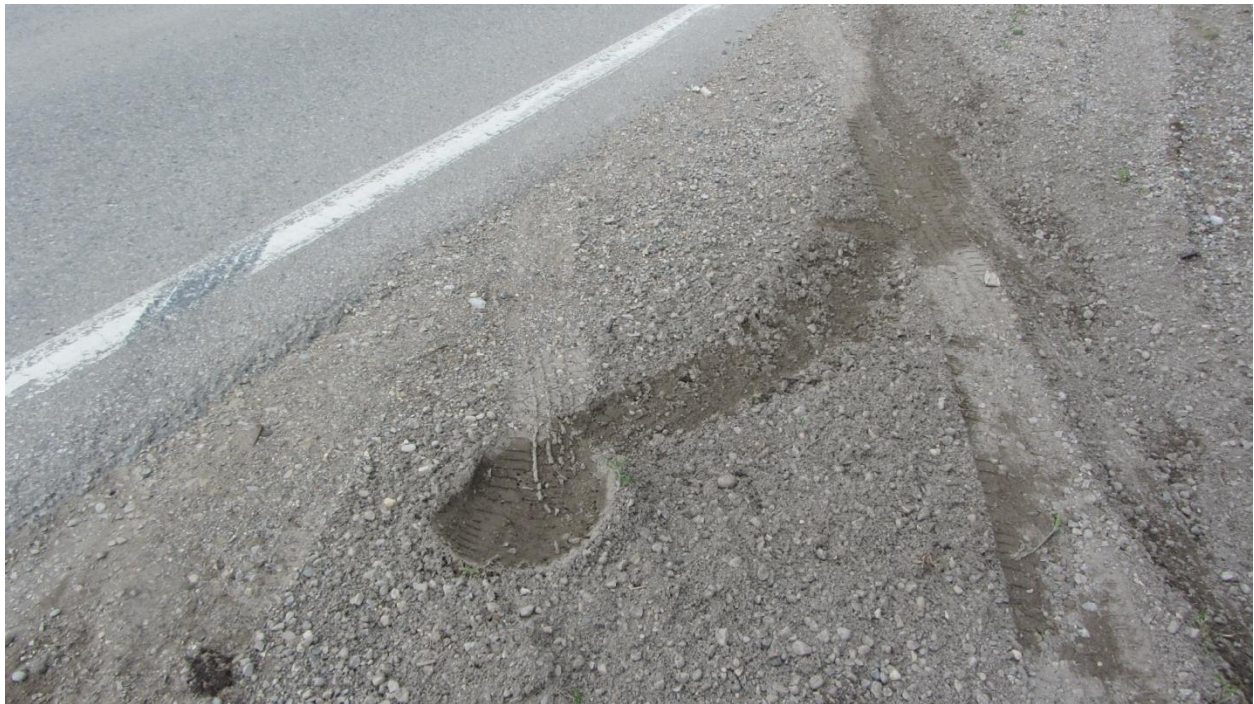
Figure 44: Close-up view of the tire marks at the final rest position of the northbound vehicle. The tire marks show how the vehicle slid to rest and then tread marks shows how the vehicle then exited and drove away.

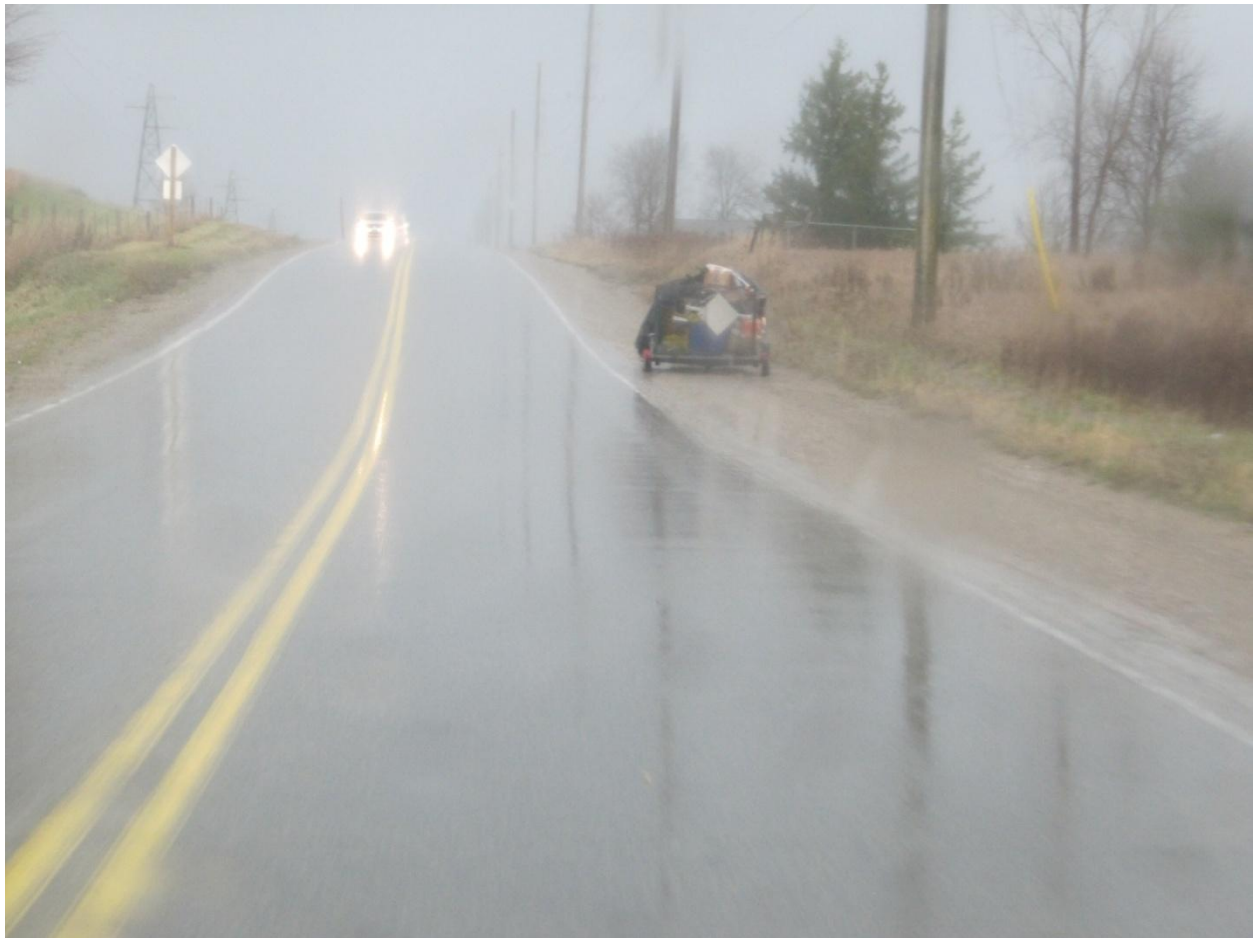
The police dataset identified that at 0555 hours on November 22, 2014, a northbound passenger car struck a deer resulting in property damage but no injuries to the vehicle occupants. Gorski Consulting drove through the site on November 24<sup>th</sup> and a small, disabled utility trailer was found parked on the east shoulder north of the north curve. On November 25<sup>th</sup> Gorski Consulting conducted a walk through the S-curve and no collision evidence was found.

Figure 45: View from the dash camera of the Gorski Consulting vehicle while northbound near the north end of the north curve. A small utility trailer is seen parked on the east shoulder and there is no towing vehicle in sight.

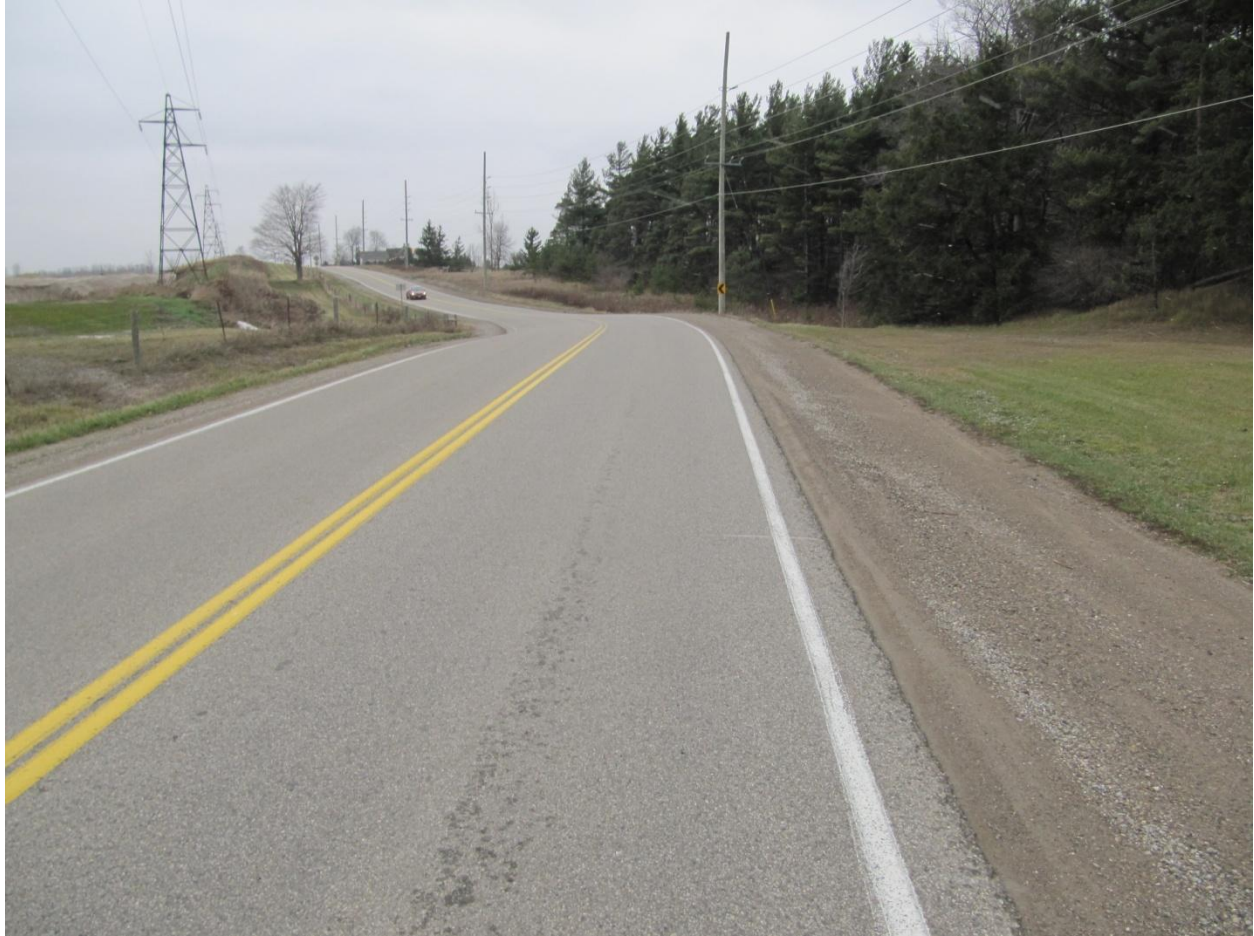
Figure 46: View looking north toward the north curve demonstrating the type of road conditions that existed that the time of the examination of the S-curve on November 25th, 2014.
