Impact of Rear Wheel of Trailer South of Amberlee Ontario on May 25, 2011

Posting Date: 27 May 2011

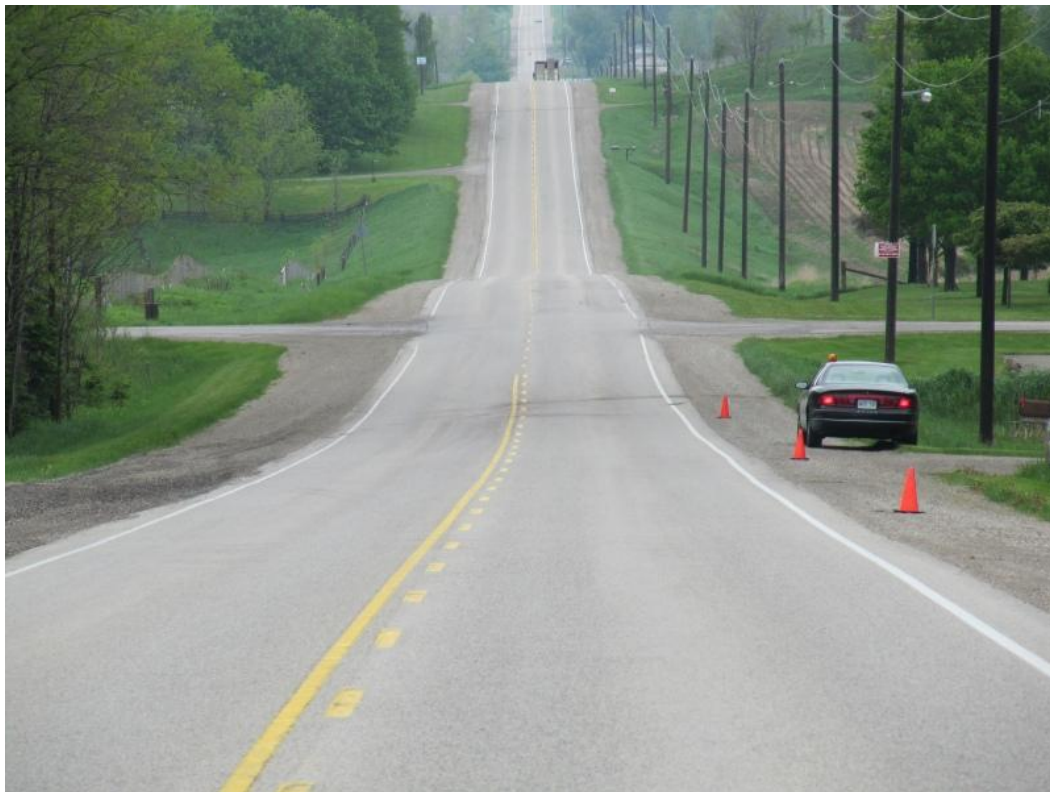
Below is a general view of the accident site, looking north, from about 200 metres south of the point of impact (POI).

My orange cones on the right side of the road are spaced 50 metres apart. The furthest cone is where the impact occurred. You can see my vehicle parked on the roadside at about 50 metres south of the POI.

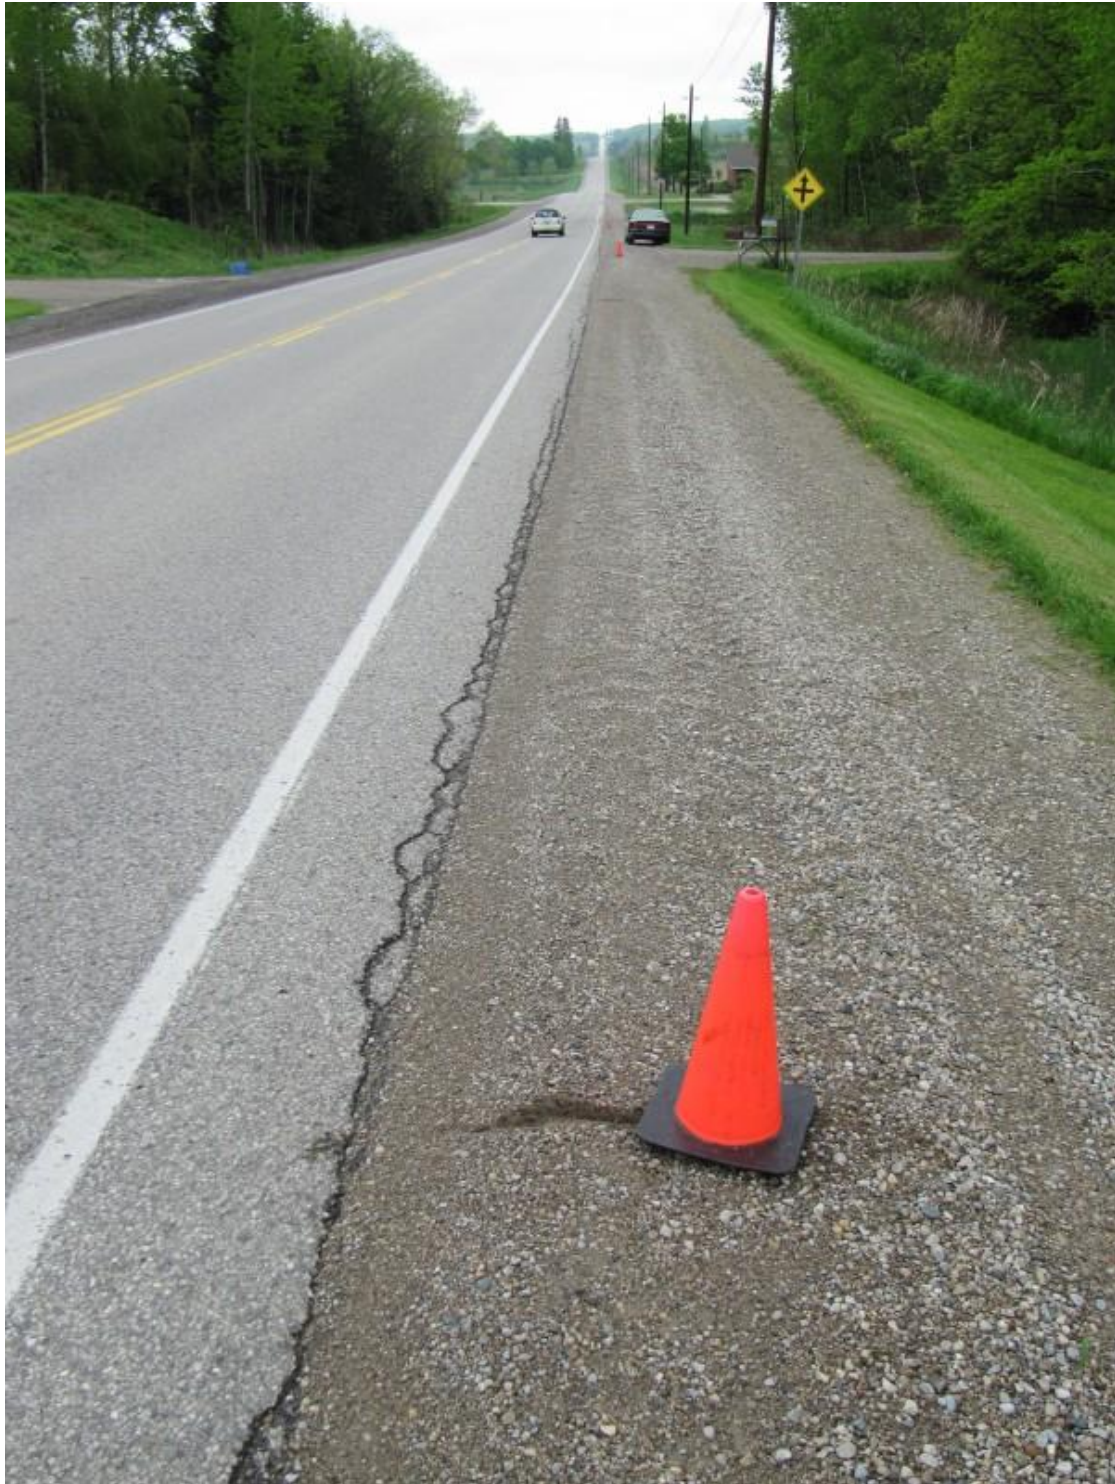
The photo is looking north and shows the east asphalt edge of the road confirming that there is no edge drop off and there are no tire marks on the shoulder to indicate that the

vehicle initially left the road surface and lost control. Note that these photos were taken less than 24 hours after the collision so such tire marks on a shoulder, if they had existed, would still have been visible.

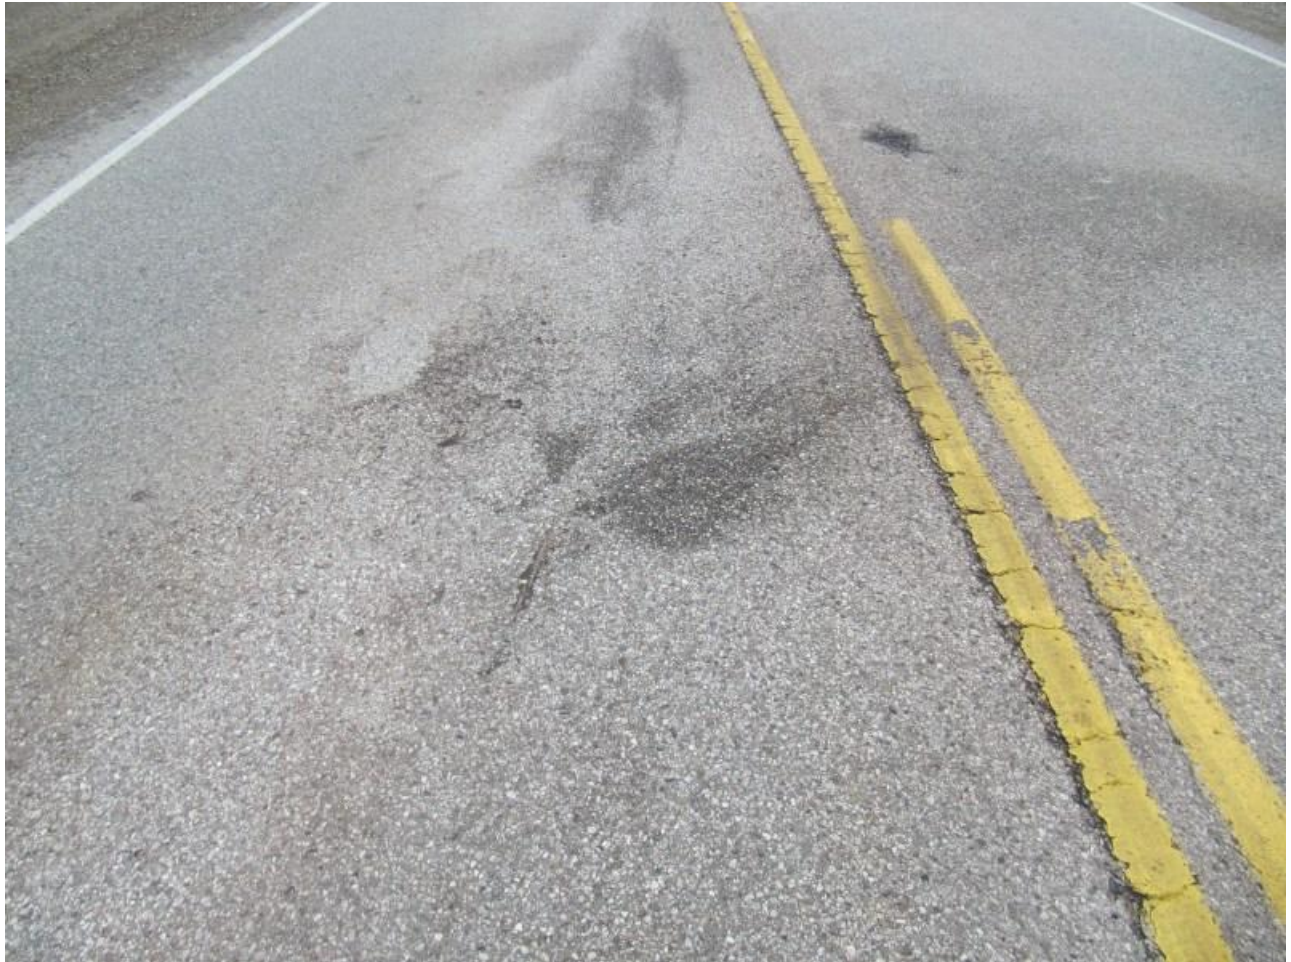
As we reach the area of impact you can see that most of the collision evidence in the southbound lane of the Tractor Trailer as shown in the northbound view below.

If you have followed my many previous articles the POI should be fairly clear to you as evidenced by the fluid spray and gouging. Note the gouge in the pavement in the foreground. If you look carefully at the yellow centre-line you will see a tire mark on it and this is high-lighted in the northbound view below.

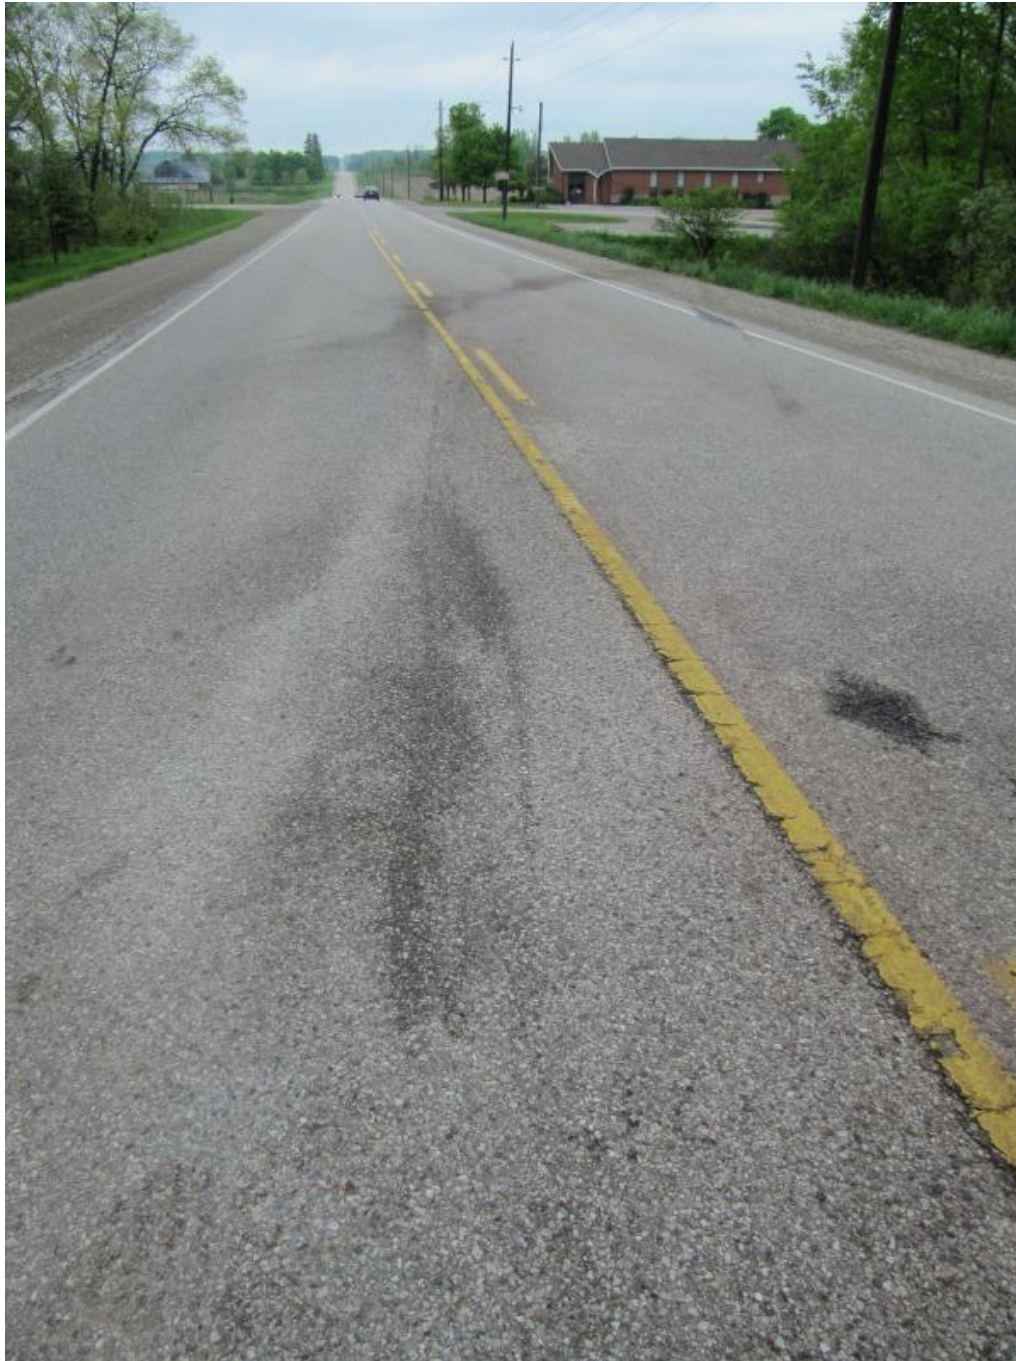
Post-impact the car rotated counter-clockwise and began to sliding sideways, leading with its right side, toward the right ditch. Evidence of that post-impact rotation on the road is visible in the northbound view below, which is just north of the POI.

In the background of the above photo you should see the fluid spray and tire marks indicating the vehicle's motion toward the east ditch.

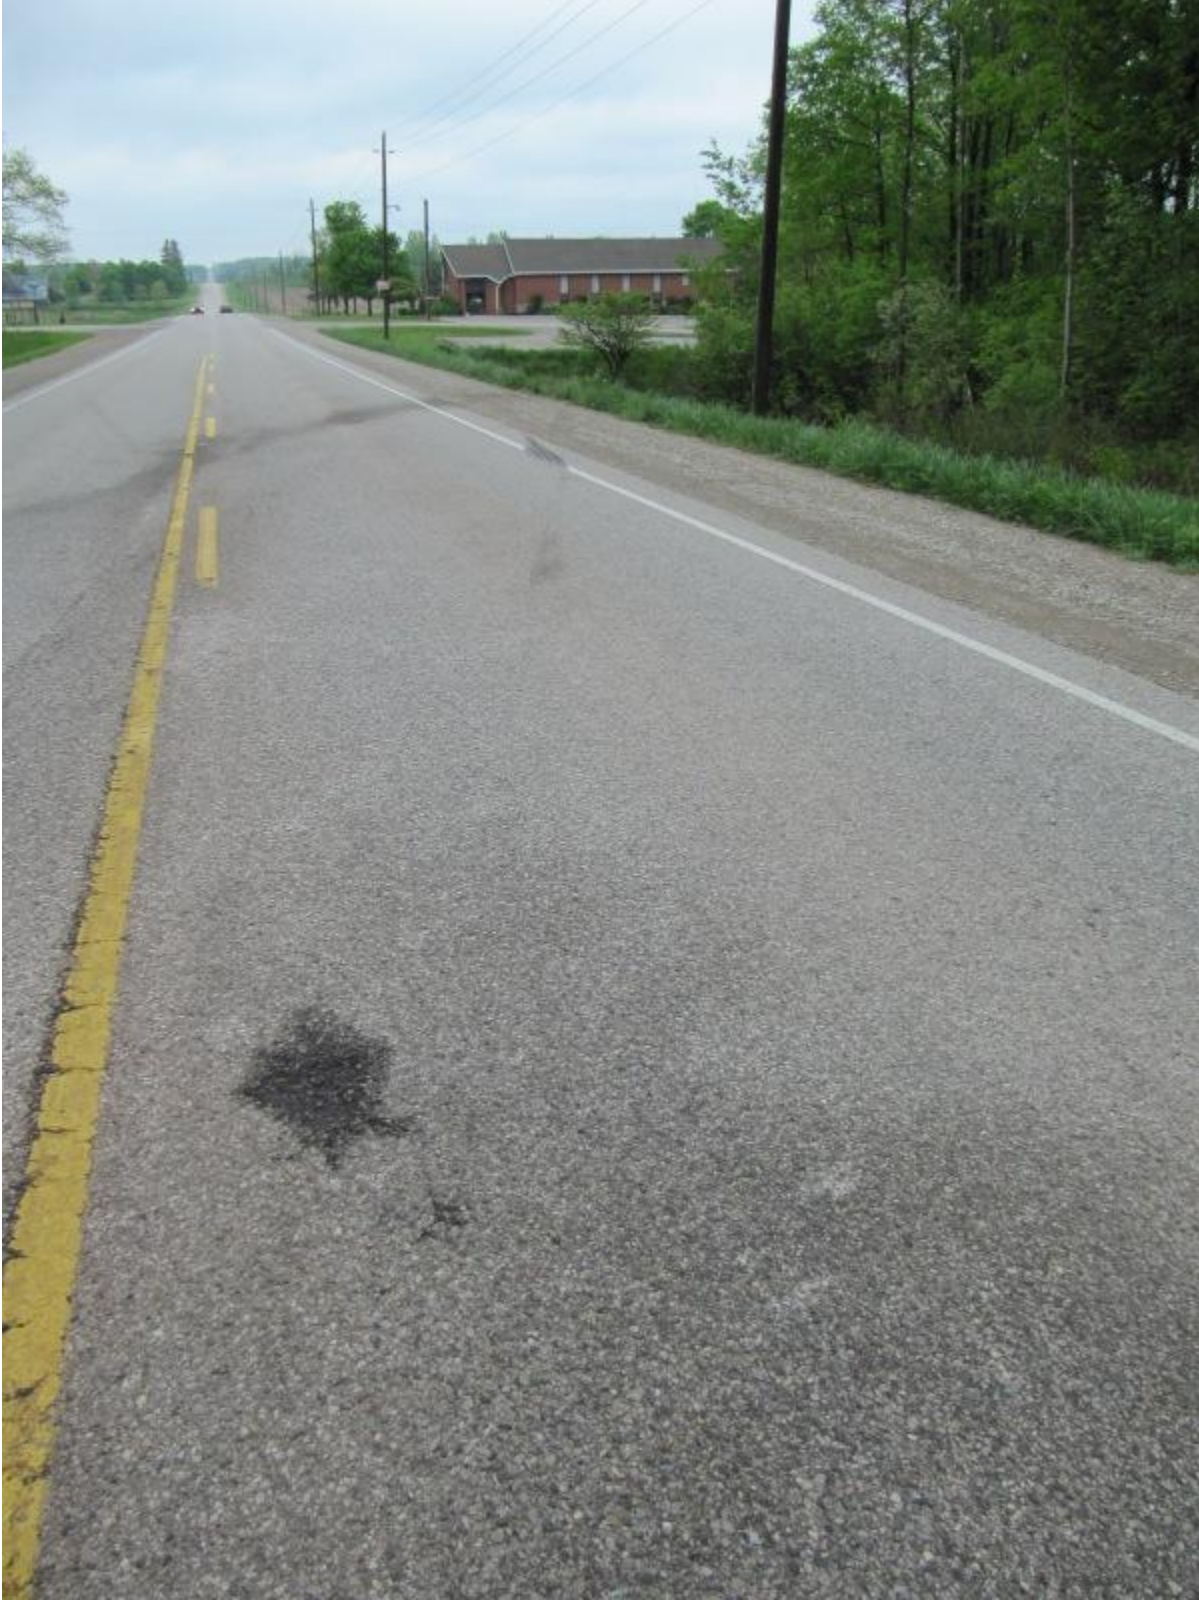
The photo below shows those markings further north as the vehicle slides sideways toward the ditch.

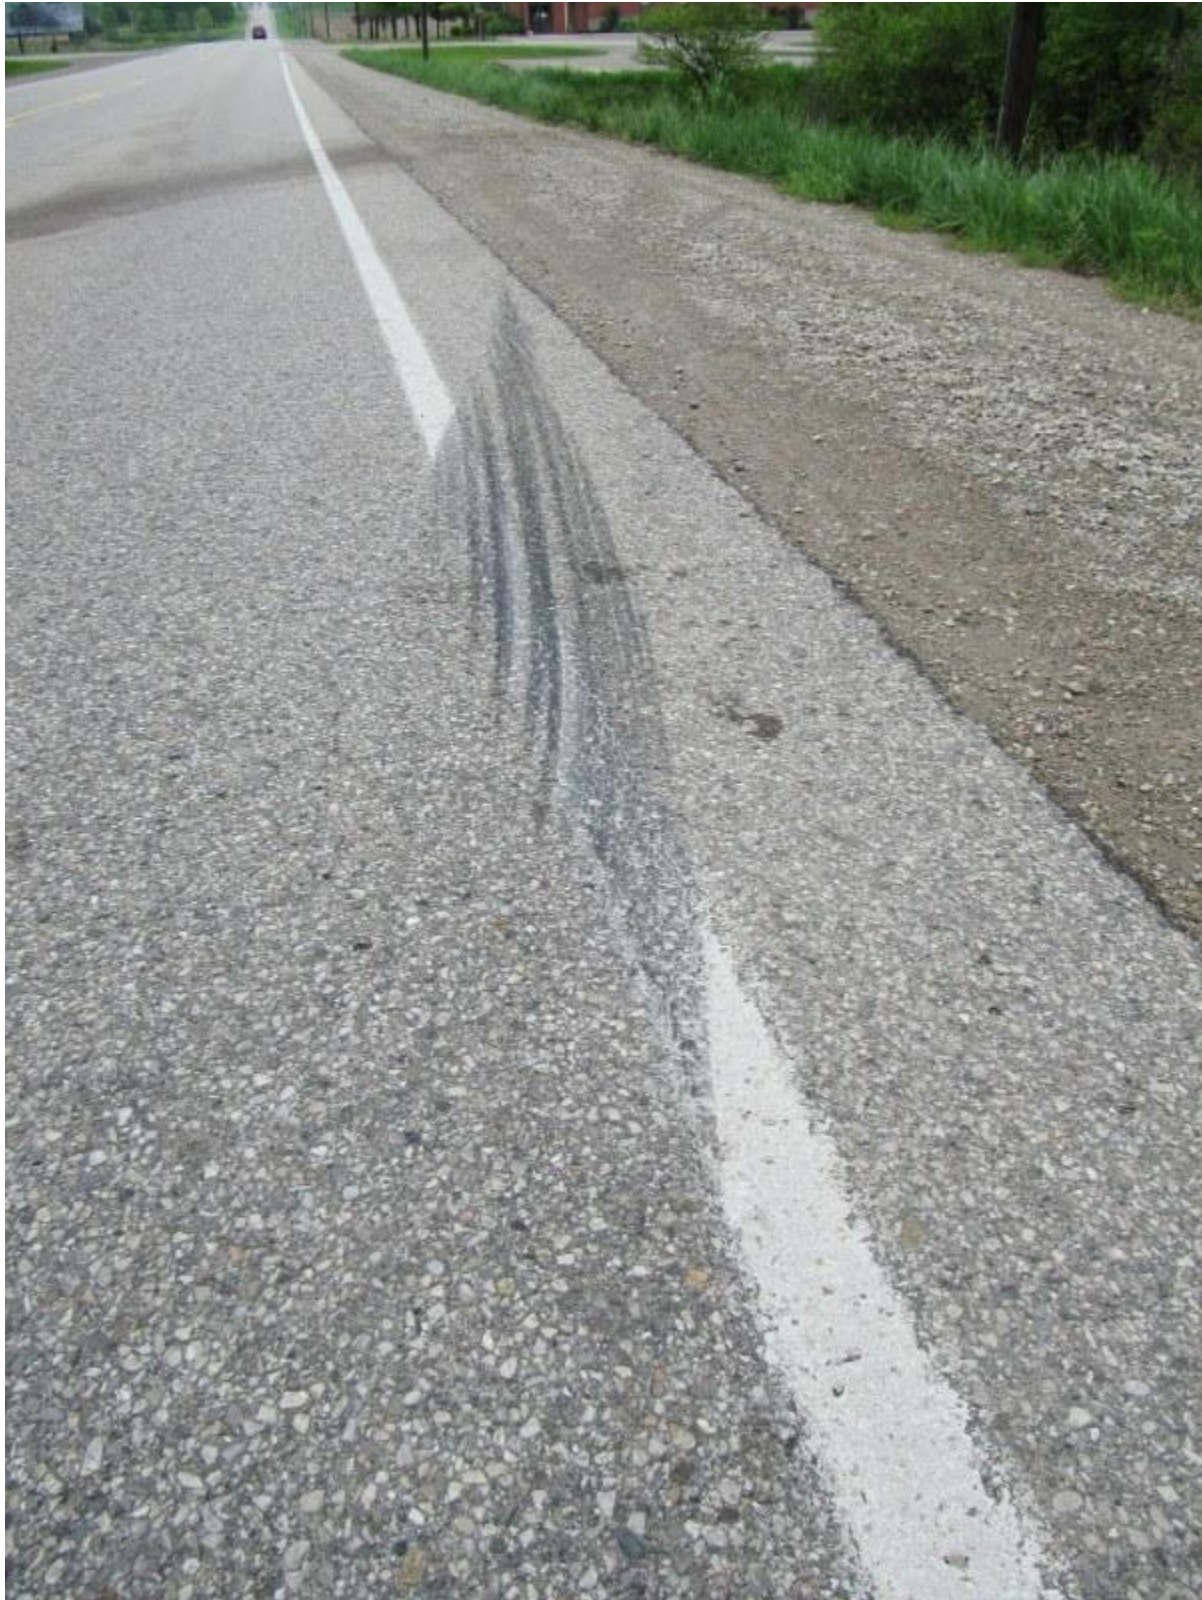
Evidence of the side-ways slide of the right-rear tire of the car is seen in the northbound view below. This is a close-up view of that tire mark on the east edge of the road.

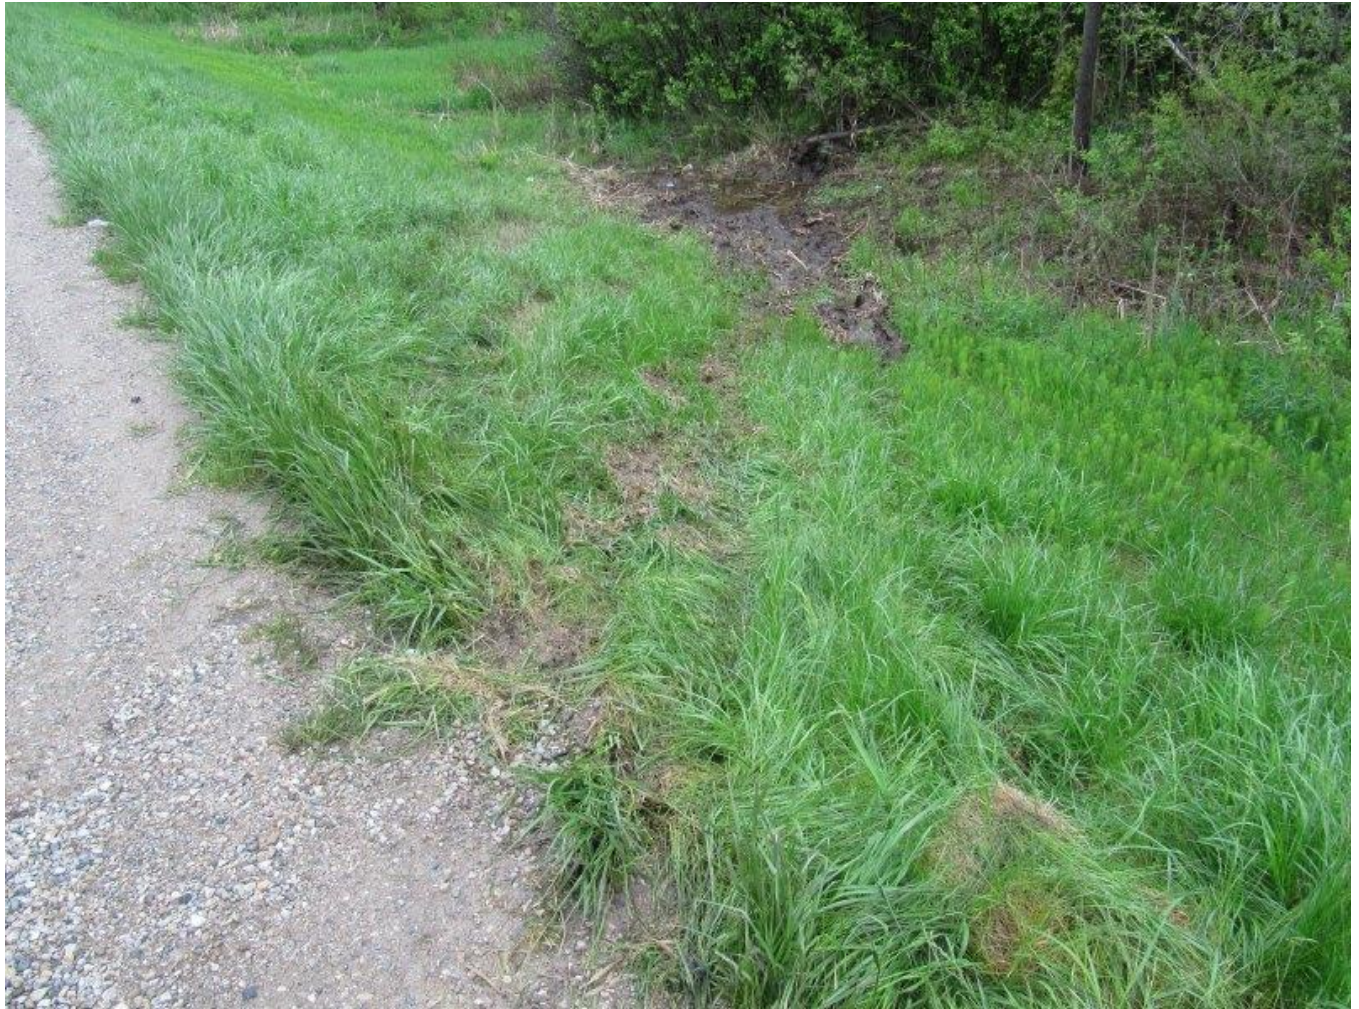
As the vehicle leaves the roadway it slides down into the east ditch as indicated in the photo below.

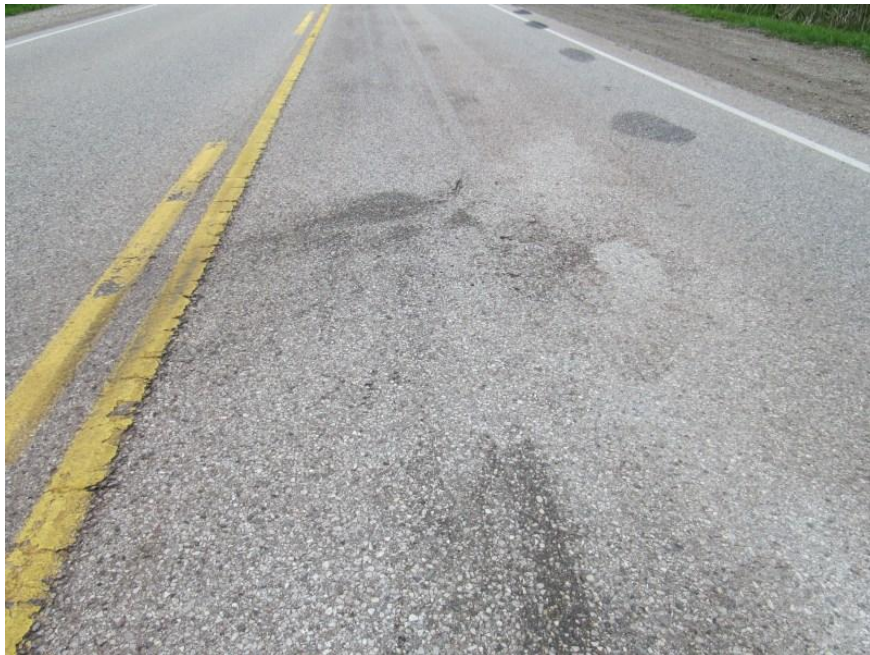
Coming back to the area of impact, the photo below is now a view looking southbound, or in the travel direction of the truck. If you look to the upper right of the photo below you should see the tire "skip" marks of the trailer just after impact as the trailer is pushed to the right (west) shoulder.

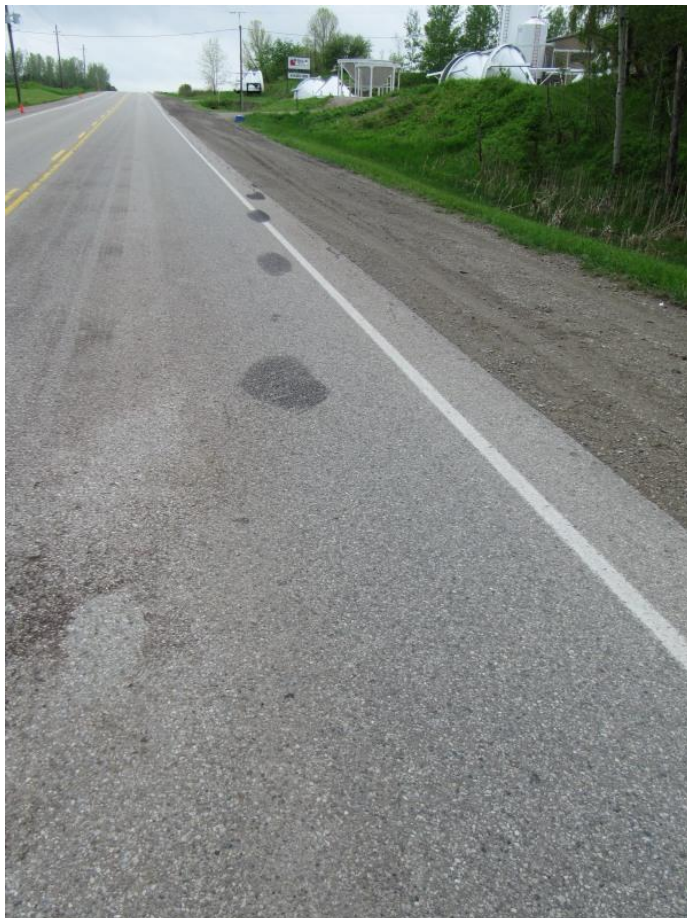
Those skip marks can be seen more clearly in the southbound view shown in the photo below.
