# Inter-City Transit Bus Rollovers - A Continued Threat To Passenger Safety

*Posting Date: 16-Oct-2016*

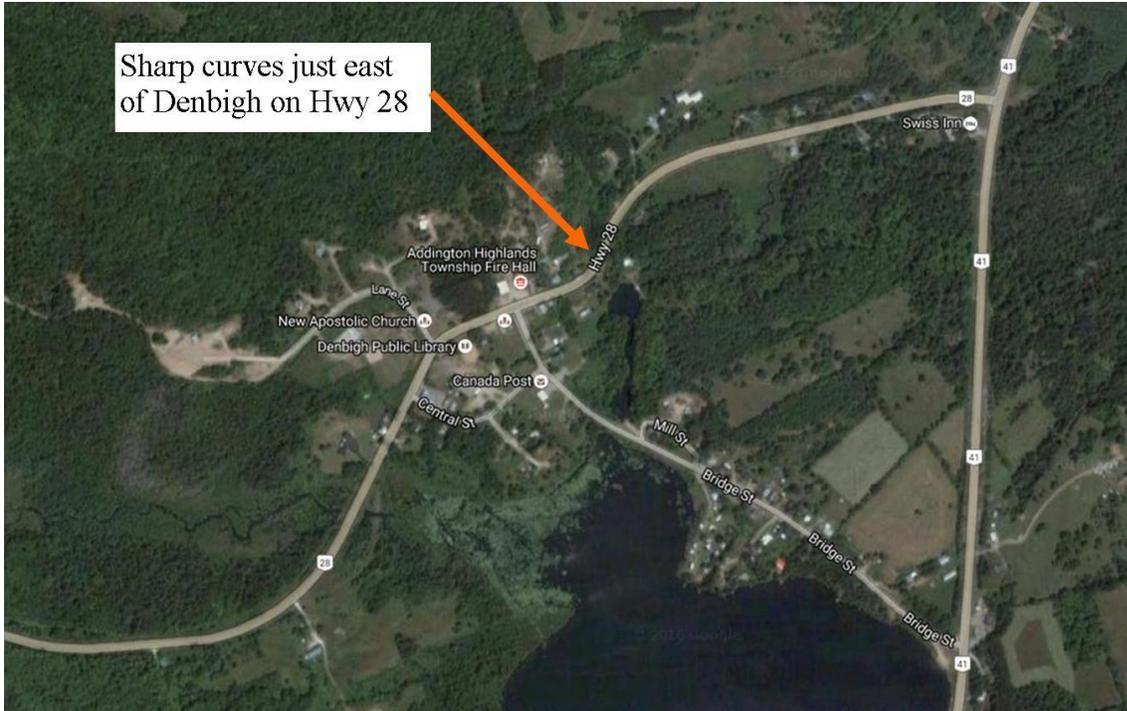
Without any specifics about what happened we can only examine the general location of the event and comment on the probabilities. A look at Google Maps shows the area around Denbigh in Figure 1. Without specific information we would suspect that the most likely location for a bus rollover would be at the most challenging curves, those being just east of Denbigh as high-lighted in Figure 1.

Figure 1: Google Maps view of the Denbigh showing the sharper curves on the east edge of the town.

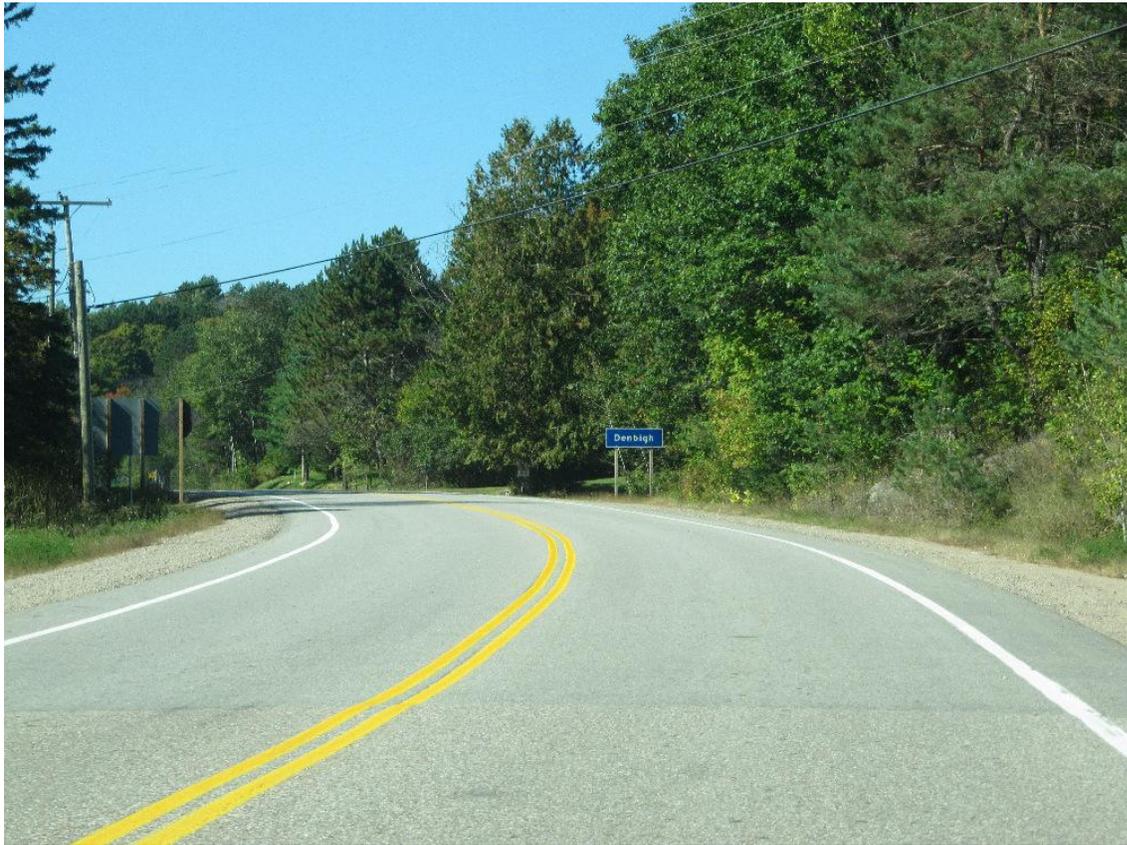
Figure 2 shows a view looking west as one approaches Denbigh on Highway 28. We can see the left curve that exists. Figure 3 shows an additional view looking west further along the highway and here we also see a guardrail with a Trinity ET Plus terminal.

Figure 2: View looking west of the left curve of Highway 28 at the east edge of Denbigh.

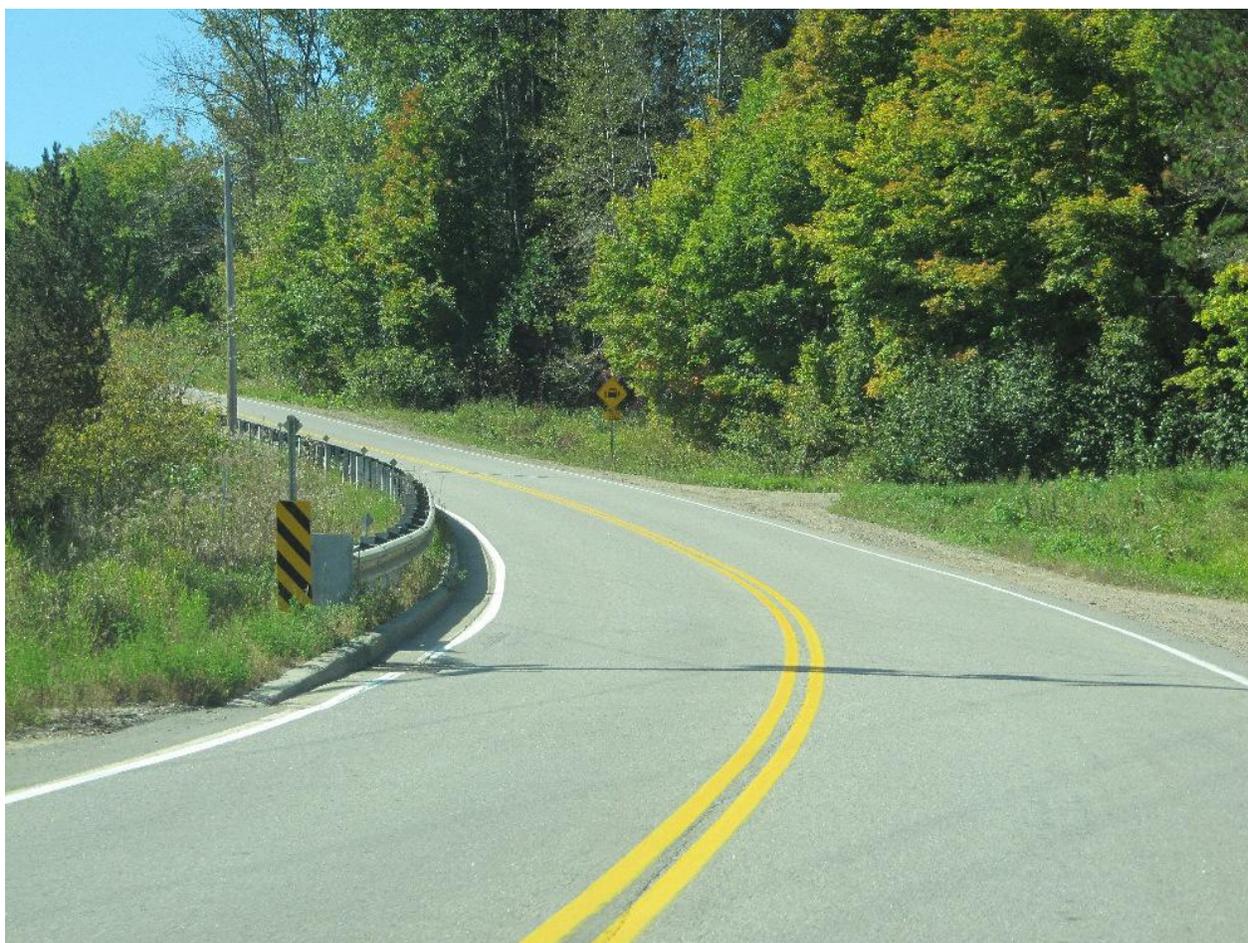
The Google Maps view shows the area at the time that the roadway was freshly paved and the guardrail and terminal look like they were recently installed. The view in Figure 3 was taken in late September of 2015 and we can see that the pavement no longer looks as fresh and the guardrail looks more aged. Therefore the Google Maps view was taken perhaps a year or more earlier than what is seen in Figure 3.

Figure 3: View looking west at a left curve on the eastern outskirts of Denbigh.

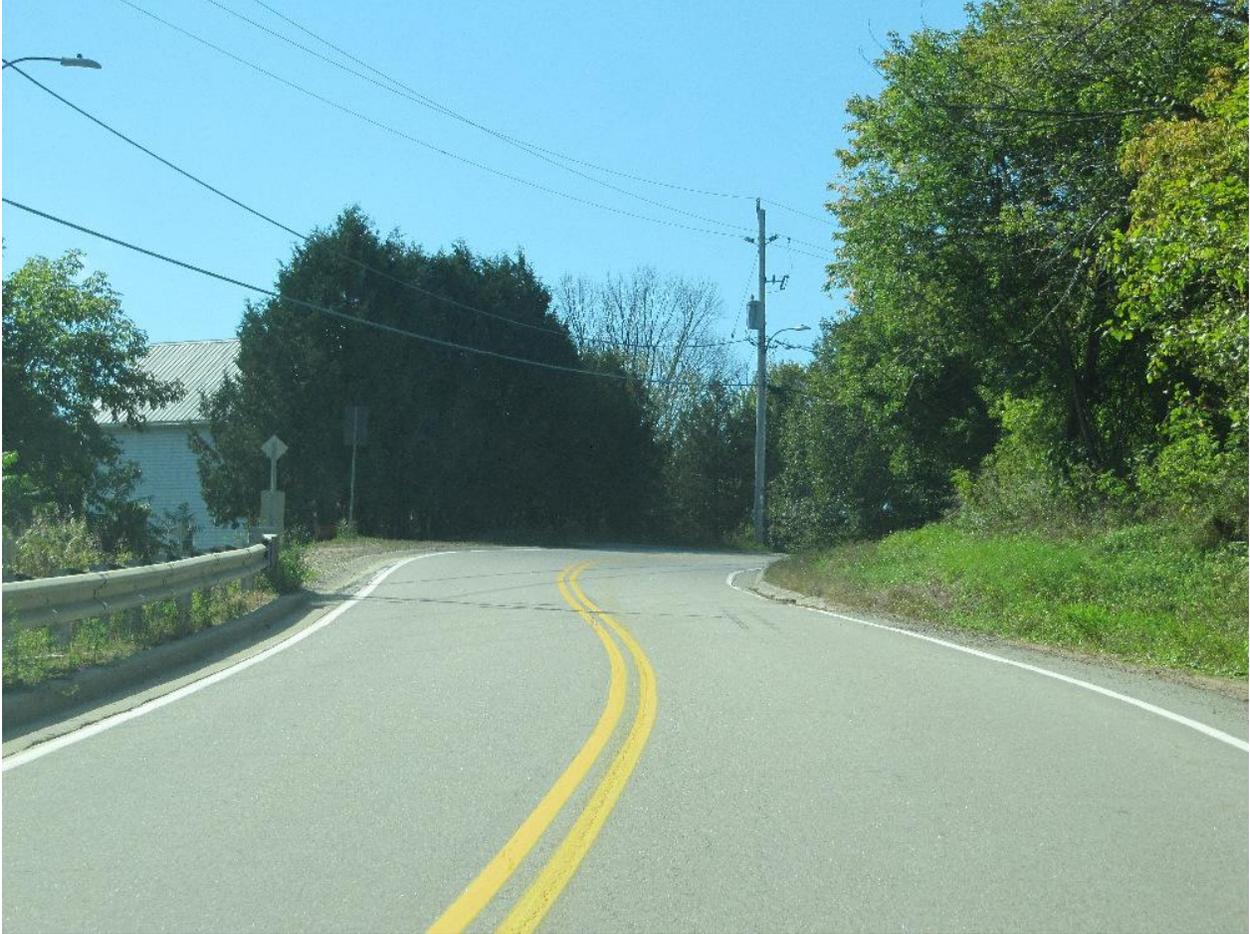
Figure 4 shows a view looking west further up the highway and we see the western end of the guardrail with another ET-Plus terminal. While some authorities claim that there is no evidence that ET-Plus terminals are any less safe than others, it is clear that many municipalities in Ontario are replacing the units with ones from different manufacturers. If a large vehicle such as a bus were to strike this terminal there is no doubt, in our opinion, that the terminal would not perform in the manner under which it was tested in controlled conditions. Generally the controlled testing was with smaller cars and light trucks. Even if a bus struck the guardrail itself at a speed of over 50 km/h it is highly likely that the bus would roll over top of the rail. Thus the presence of the guardrail would do little in protecting passengers from a rollover, in fact, it might even accentuate the probability of a rollover.

Figure 4: View looking further west along Highway 28 toward the end of the guardrail is which equipped with an ET-Plus terminal.

This presents a concern that has been expressed by Gorski Consulting on a number of previous occasions. The present state of guardrails, terminals and other roadside barriers and attenuators is not compatible with large trucks and buses. An impact at any significant speed by a large truck or bus will cause that vehicle to plow through the device or will cause such a taller vehicle to rollover.

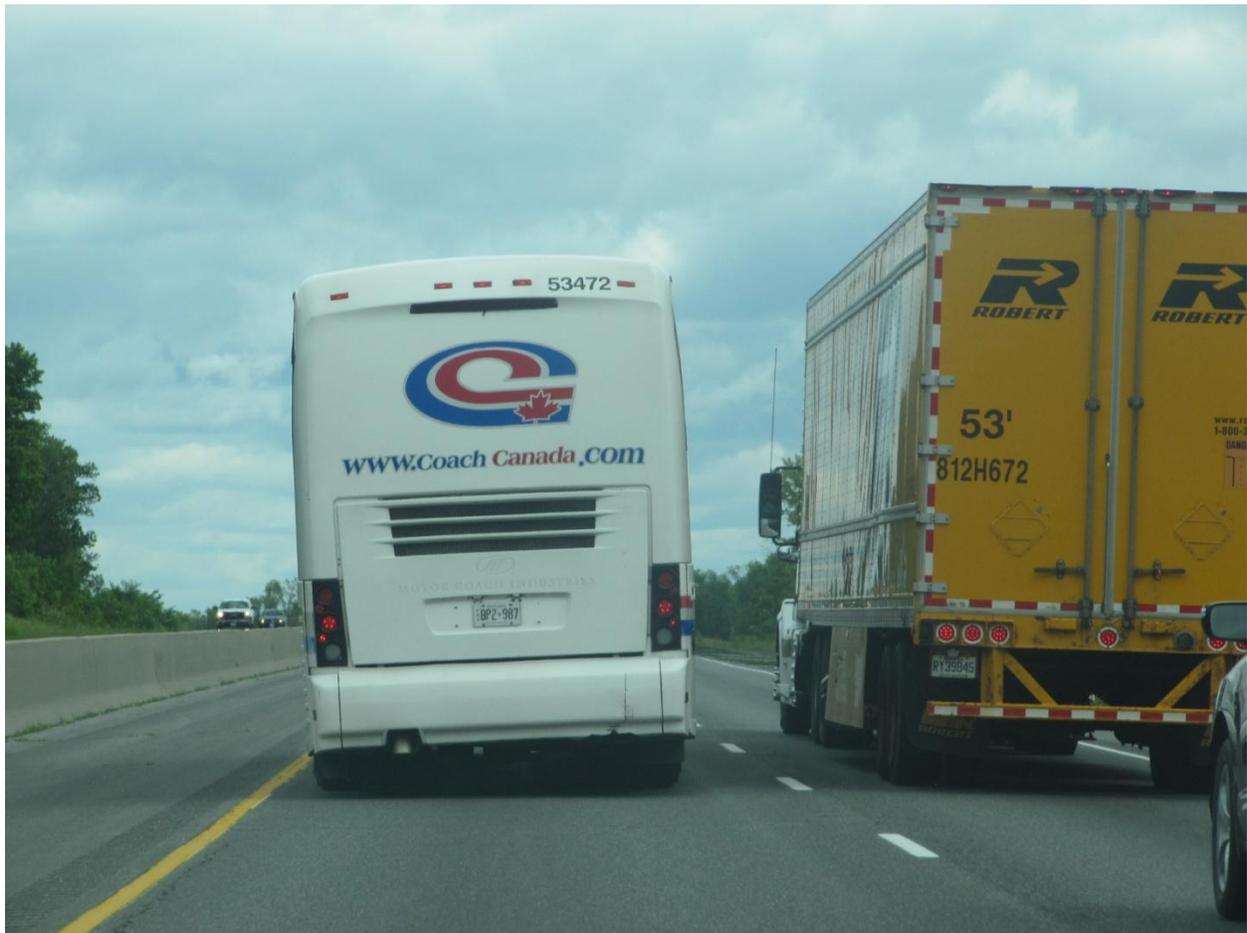
As an example, Figure 5 shows a view of an inter-city bus travelling along Highway 401 in eastern Ontario. Strangely the bus is tilted to the left side. Does the bus have a major

suspension problem? Is it over-loaded on one side? Whatever the reason this cannot be a good scenario if this bus ever travels around a significant curve at highway speed.

Figure 5: View of an inter-city bus leaning toward its left side as it travels along Highway 401 eastern Ontario.

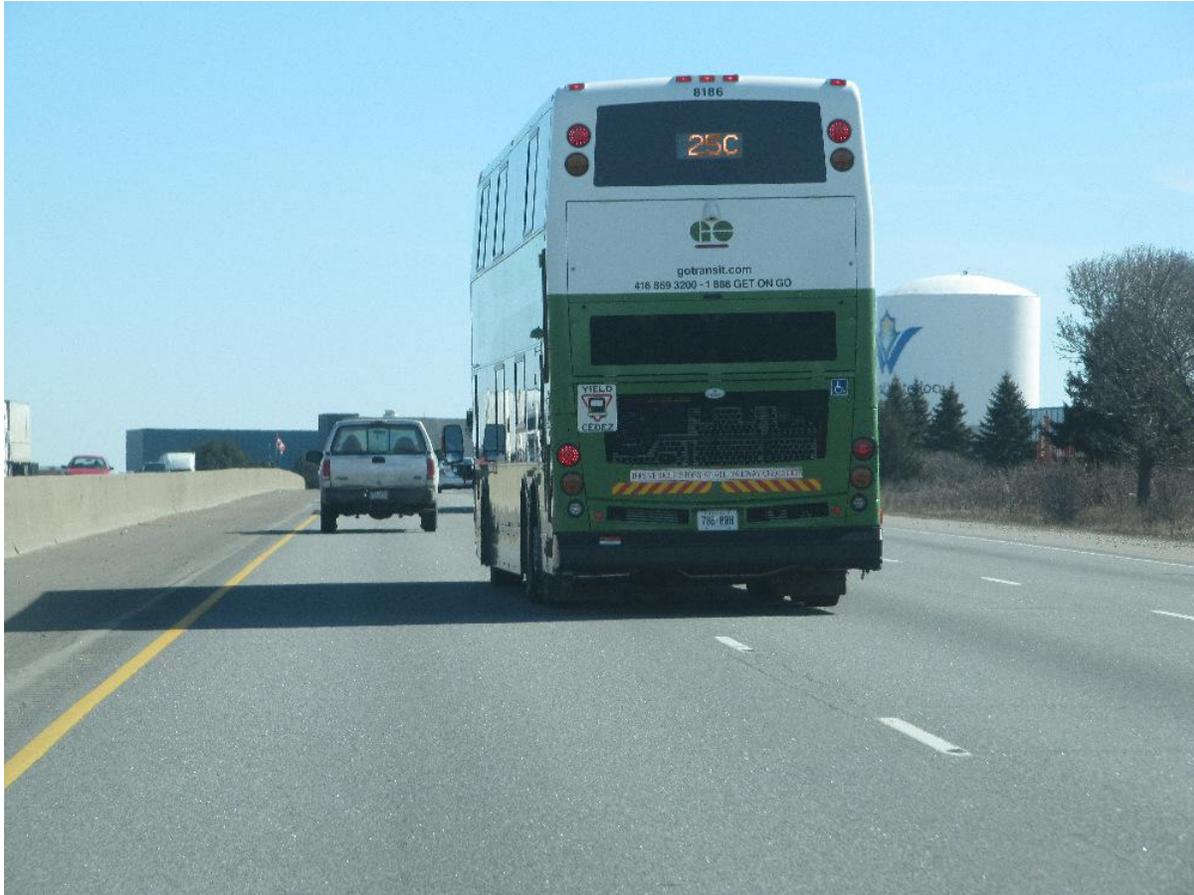
As another example, a Go transit bus is seen in Figure 6, also travelling along Highway 401. However the bus is a double-decker. At highway speeds this vehicle could easily tip over in any marginal emergency were a rapid change in direction might be required. Driving such a vehicle at highway speeds where no infrastructure is compatible with its high centre-of-gravity is a recipe for disaster.

Figure 6: View of a Go Transit bus changing lanes on Highway 401. Such vehicles with high centres of gravity are not compatible with the roadsides of such a highway and the high speed can only increase the danger.
