Jogger Struck by Unfortunate Circumstance

Posting Date: 11 Sept 2011

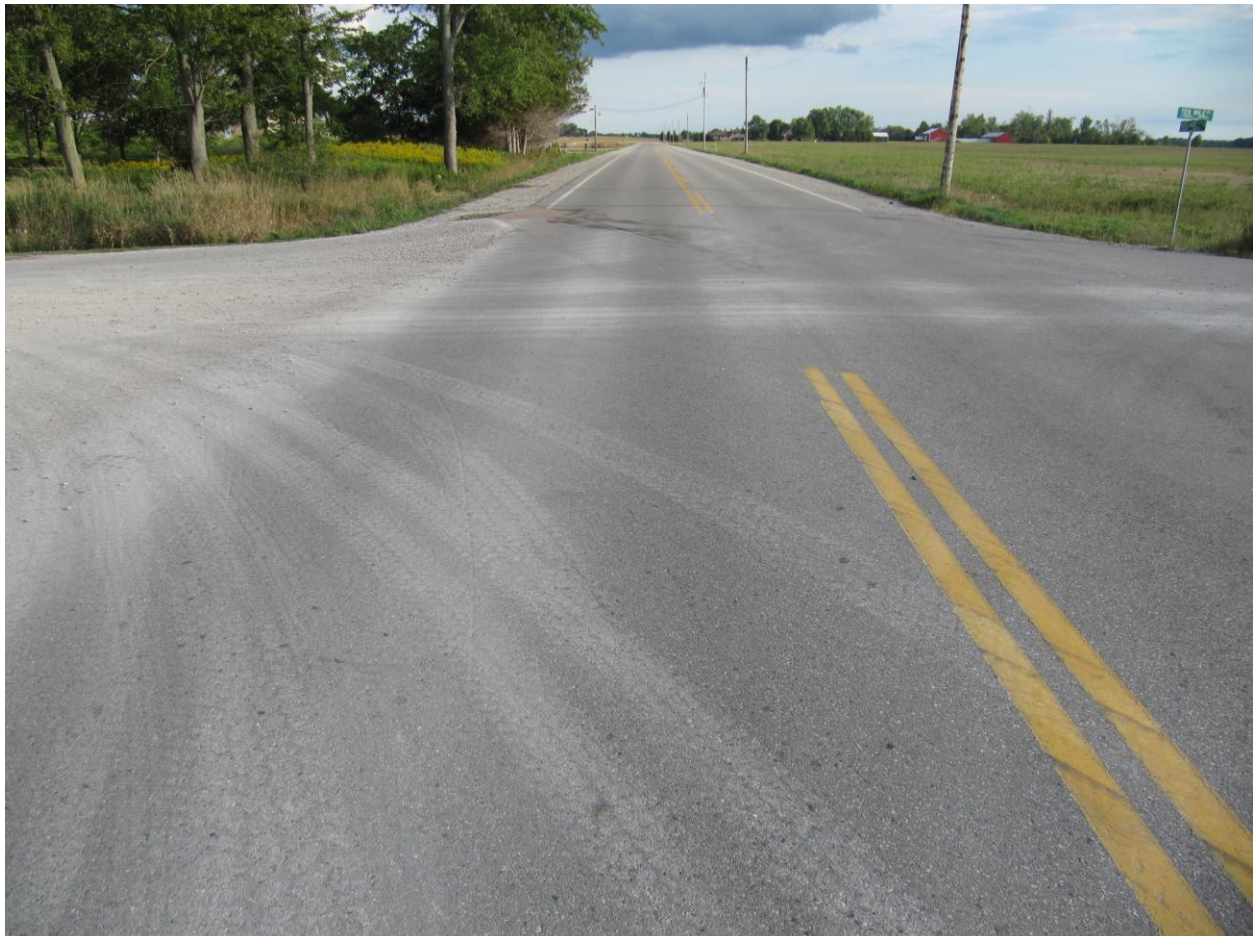
A Montana van reportedly driven by a 38-year-old driver had been eastbound on Ten Mile and stopped at the stop sign at Adelaide. He allowed the jogger to pass through the intersection and then pulled out. A southbound Chevrolet Pick-up, travelling through on Adelaide reportedly struck the van and then carried off toward the north side shoulder where the truck struck the jogger. Below is a southbound view of Adelaide Street at the intersection with Ten Mile. Tire marks from the Chevrolet Pick-up are seen just past the intersection and carry into the east roadside.

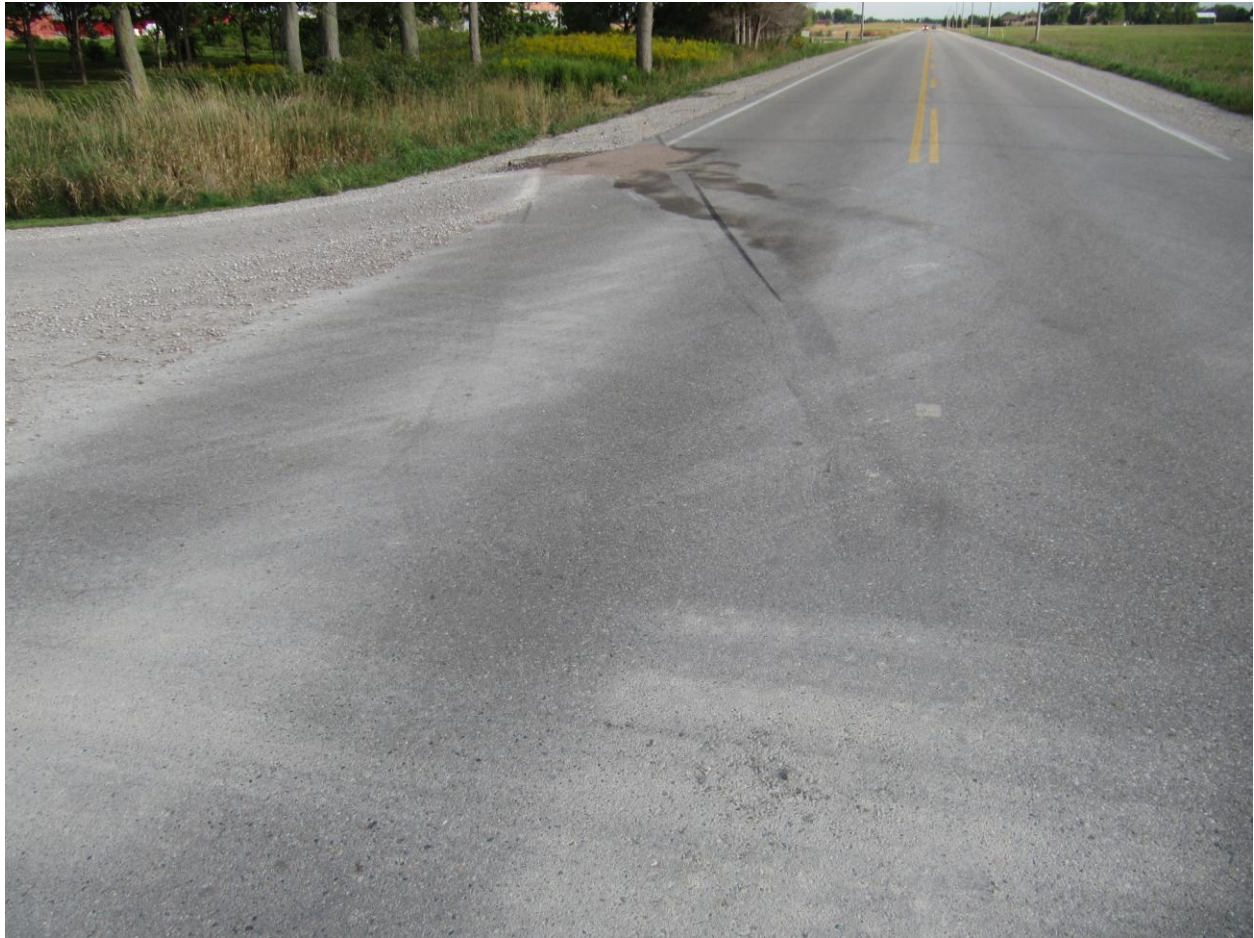
Below is a closer view of the evidence from the initial impact with the van. The tire marks heading toward the road side are from the Chevrolet Pick-up as it travelled into the east ditch.

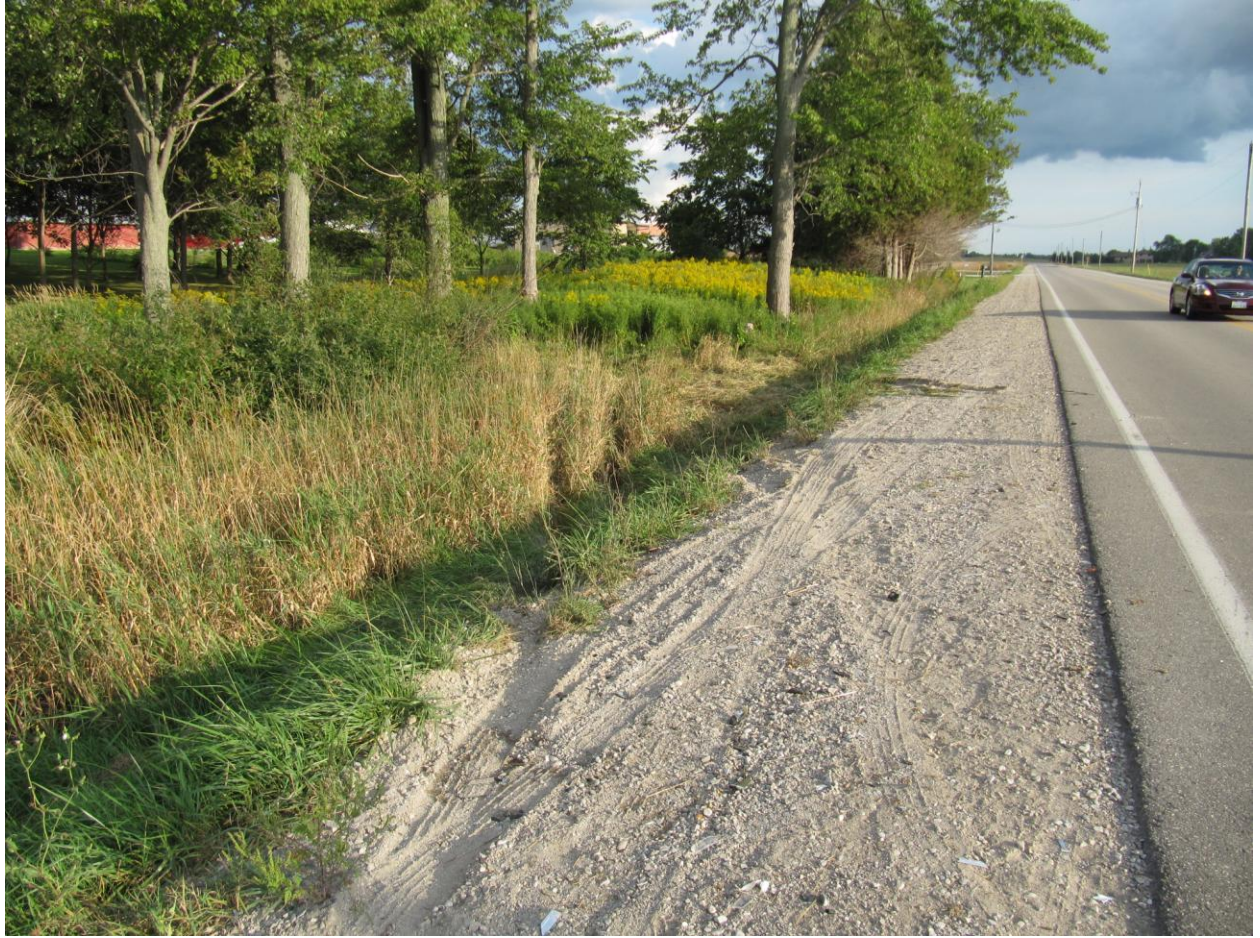
The photo on the following page shows the markings in the grass ditch where the pick-up came to rest. It would appear that the struck jogger was also carried into the ditch by the impact. Judging by the distance travelled by the pick-up as it left the shoulder area it is not surprising that the news media are indicating she has life-threatening injuries.
