## Kitchener Experiences Traffic Chaos In A Roundabout Way

*Posting Date: 30 October 2011*

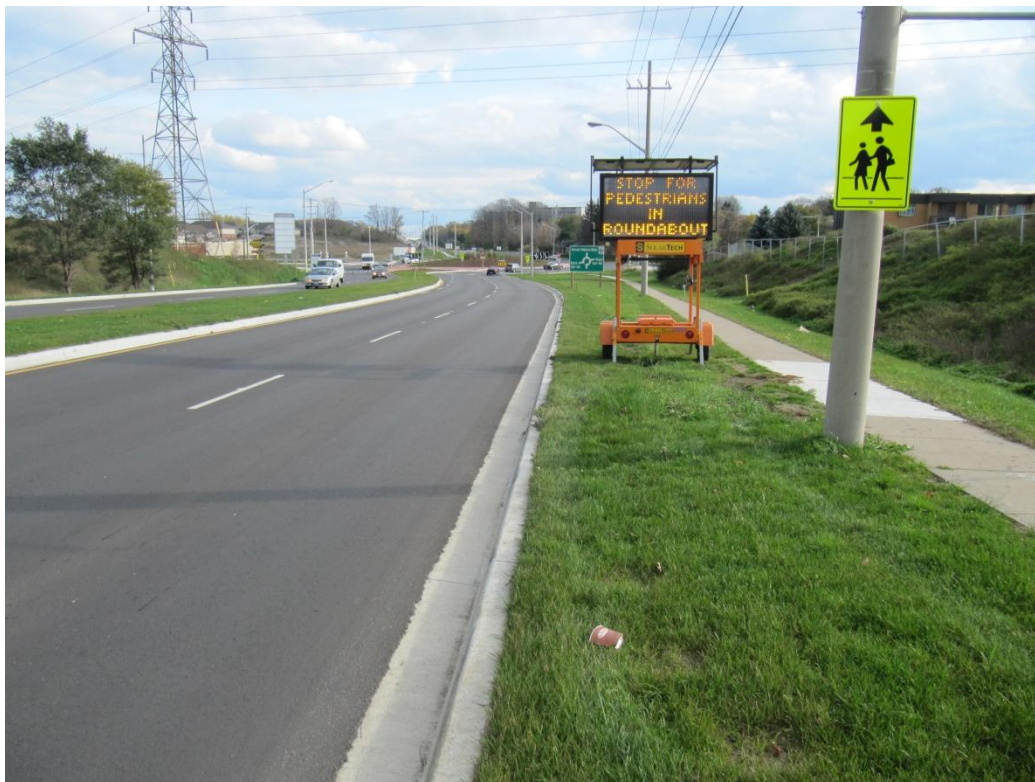
When we arrived to noted that the Regional Municipality of Waterloo had already taken additional steps to try and get a handle on the problem. The photo below is a view looking south along Homer Watson Boulevard from just north of the new roundabout and you can see that a large, electronic display panel has been set up to remind drivers of the need to yield to pedestrians.

A nice, lime-green, pedestrian crossing sign is also posted just before the large electronic panel.

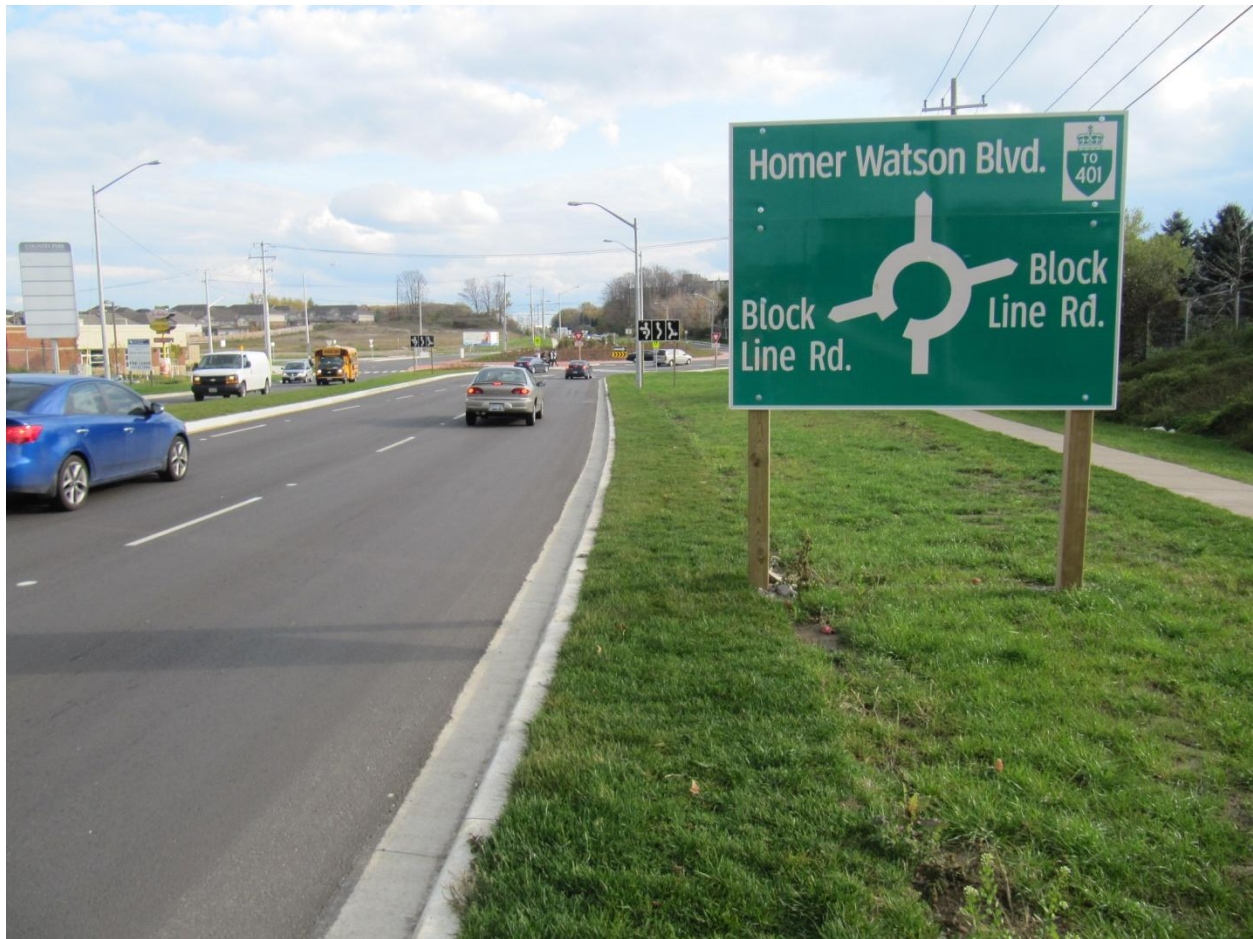
As we proceed further southward we see (photo below) the typical green sign illustrating the layout of the roundabout ahead.

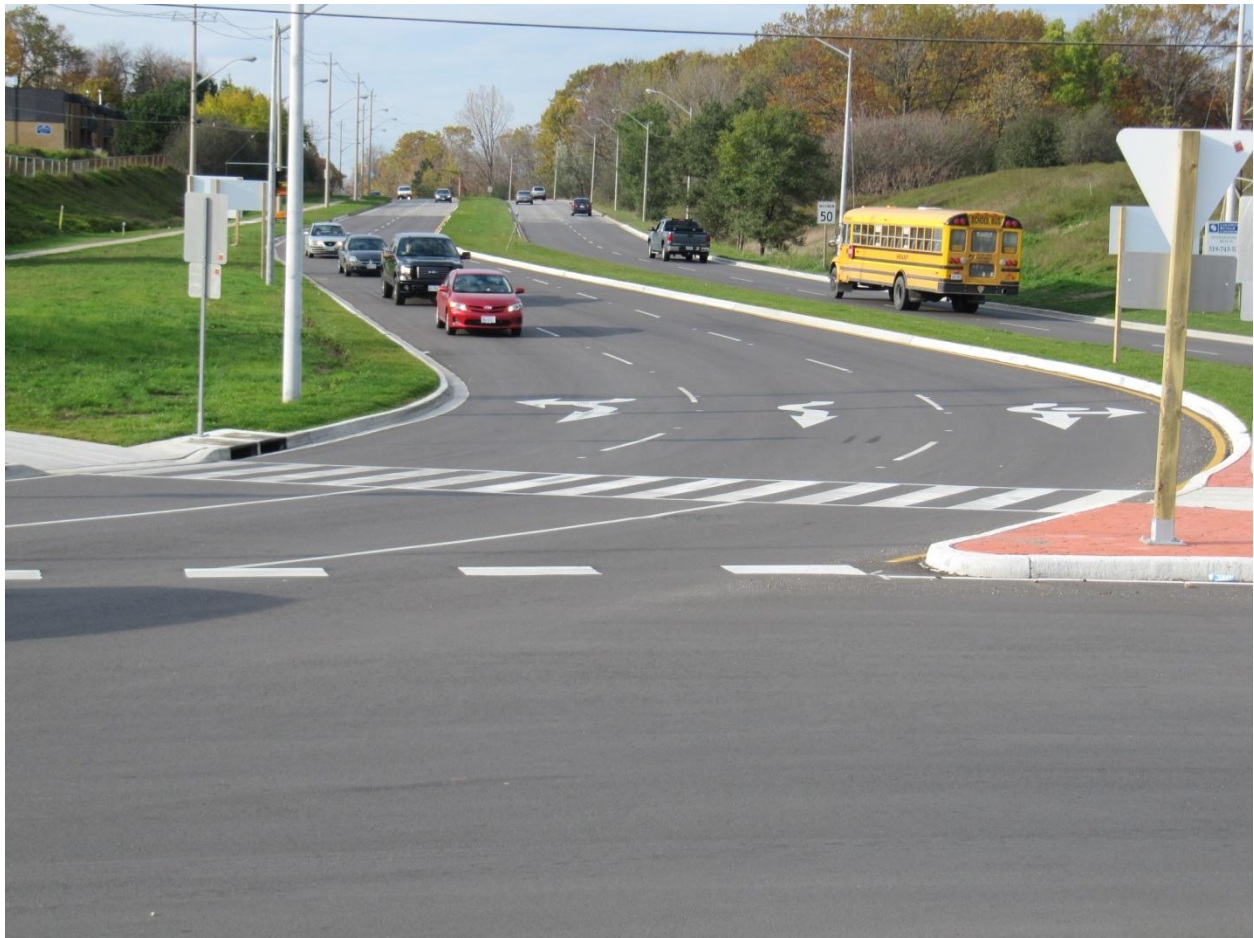
The photo at the top of the following page shows a north view of that southbound traffic viewed from the roundabout and we can see how these three lanes spill into the intersection. While the view only shows a group of just four southbound vehicles this photo was taken during less traffic just so that you could see the painted arrows in each lane informing the drivers which lane they should choose depending on where they want to go. Well, there are a lot of painted arrows. Just at a location when the driver must steer the vehicle around a brief curve at the entrance to the roundabout. And if you are new to the area and you are approaching this confusion for the first time you may be in

the wrong lane to begin with and must make a quick decision to move over, in dense traffic and trying to get around this designed curve before you even enter the roundabout.

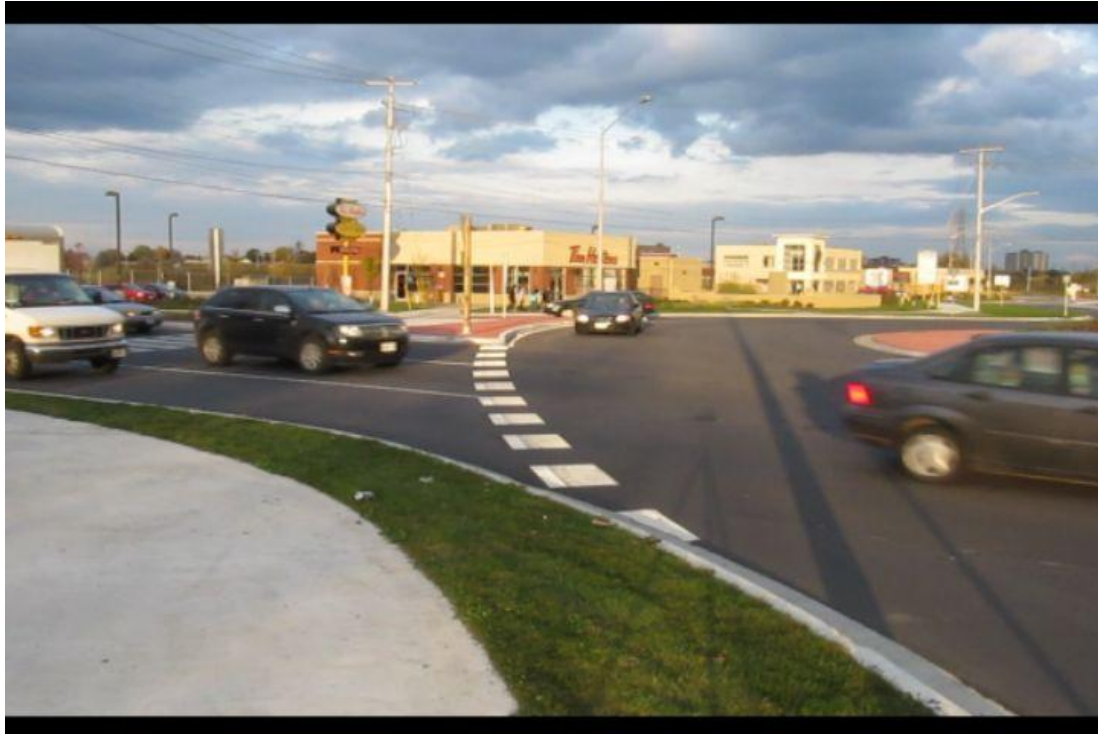
First, we set up the scenario in the photo at the top of the following page. This will be a set of frames exported from the videotape from one of our cameras that is pointing generally eastbound. The frames show the action taken a half second intervals. So the first frame at the top of the following page shows the southbound traffic of Homer Watson entering the roundabout from the left and you can see a charcoal-coloured car coming around the roundabout in the background. You can see that a southbound car has already entered the roundabout and is just passing out of the view to the right. So the rules at this roundabout state that vehicles entering the roundabout must yield to the traffic that is already in the roundabout. So the vehicle that is in the roundabout and is approaching the video camera has the right-of-way and all those southbound vehicles that you see to the left, that are trying to enter the roundabout must wait until the vehicle in the roundabout passes by. But note that there is just a single vehicle within the roundabout and (although you cannot see them yet) there are many southbound vehicles coming into the roundabout from three lanes.

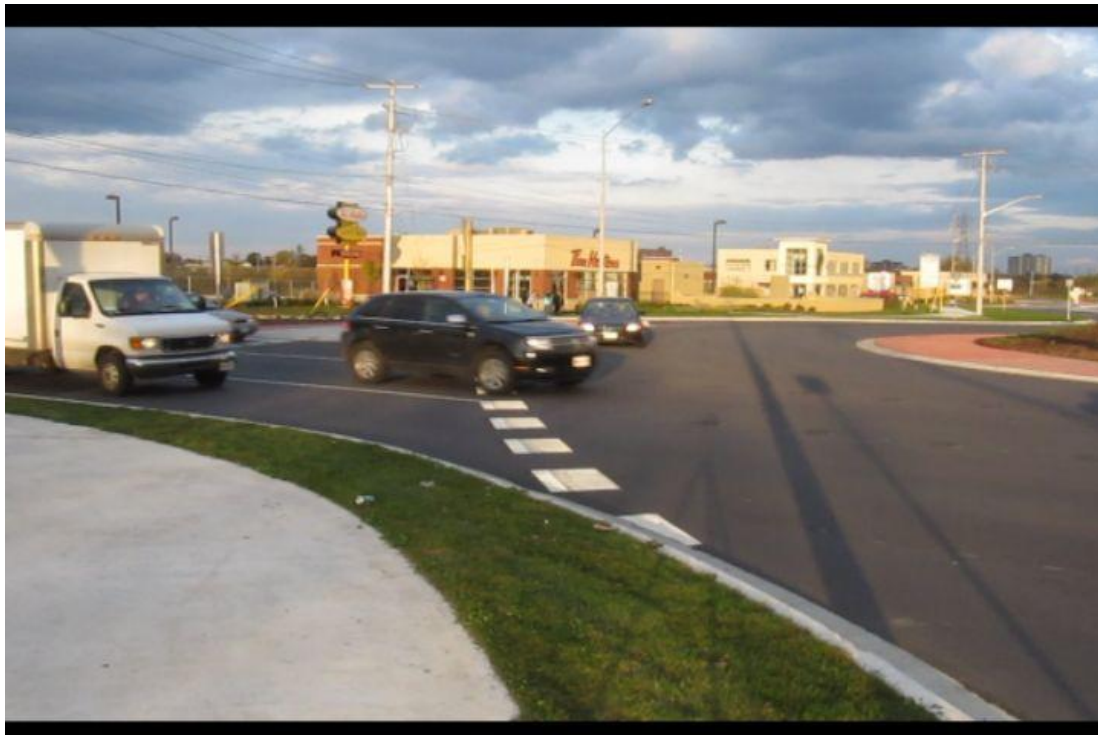
In the next frame below we see what transpires half a second after the first frame (above).

You can see that the dark-colour station wagon or SUV has entered the roundabout in front of the car that is already in the roundabout - but it gets worse. Next frame please...

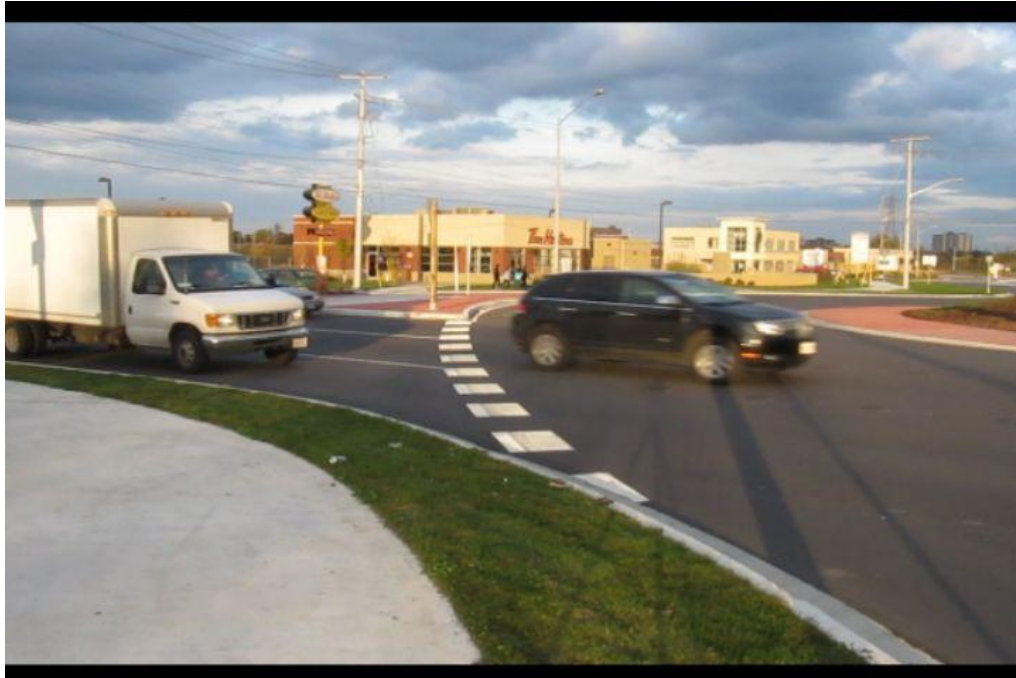
The dark coloured vehicle passes through the roundabout while the white truck beside it is essentially stopped and is waiting. Next frame please...

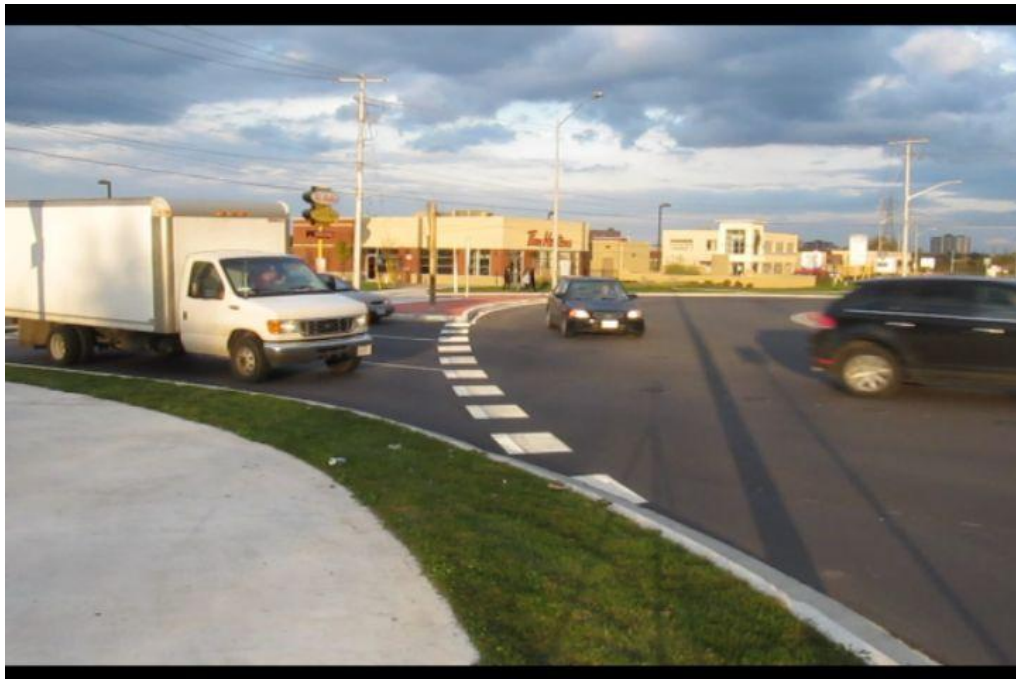
And notice in the frame above that our little charcoal-coloured car is still coming toward our camera. ...and the white truck is still where it should be...and there are no other cars anywhere else...or are there? Next frame please.

Suddenly, out of nowhere, we see the front end of a blue car emerging past the front end of the crawling white truck.

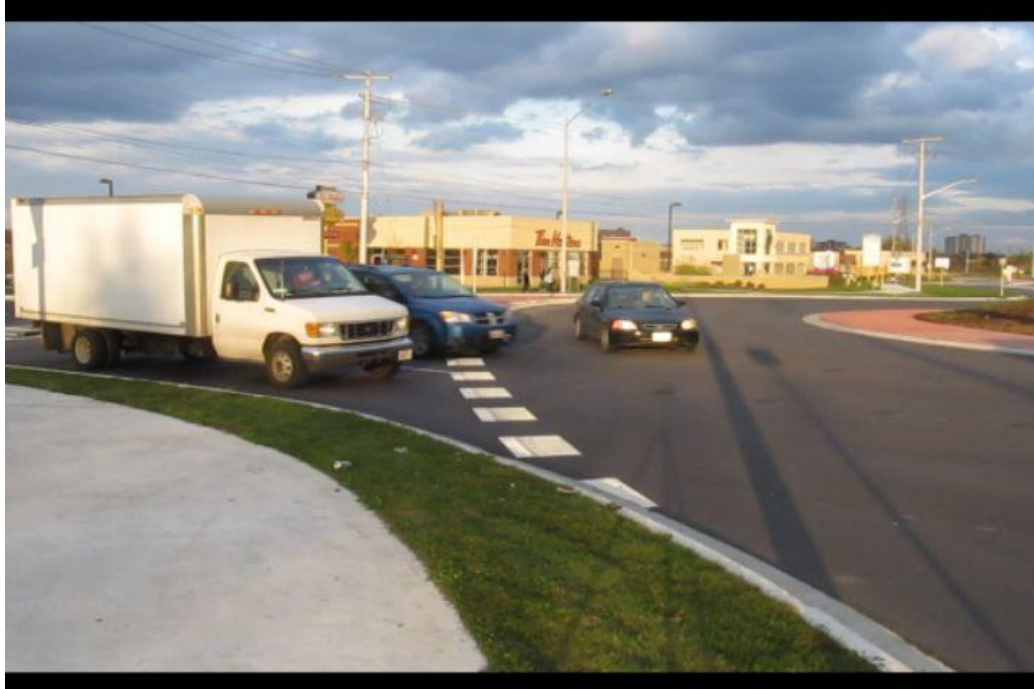
Wait a minute, that is not supposed to happen. Our charcoal-coloured car is already there and coming toward the camera. There is no room for this blue car to enter the roundabout, or is there? Next frame please.

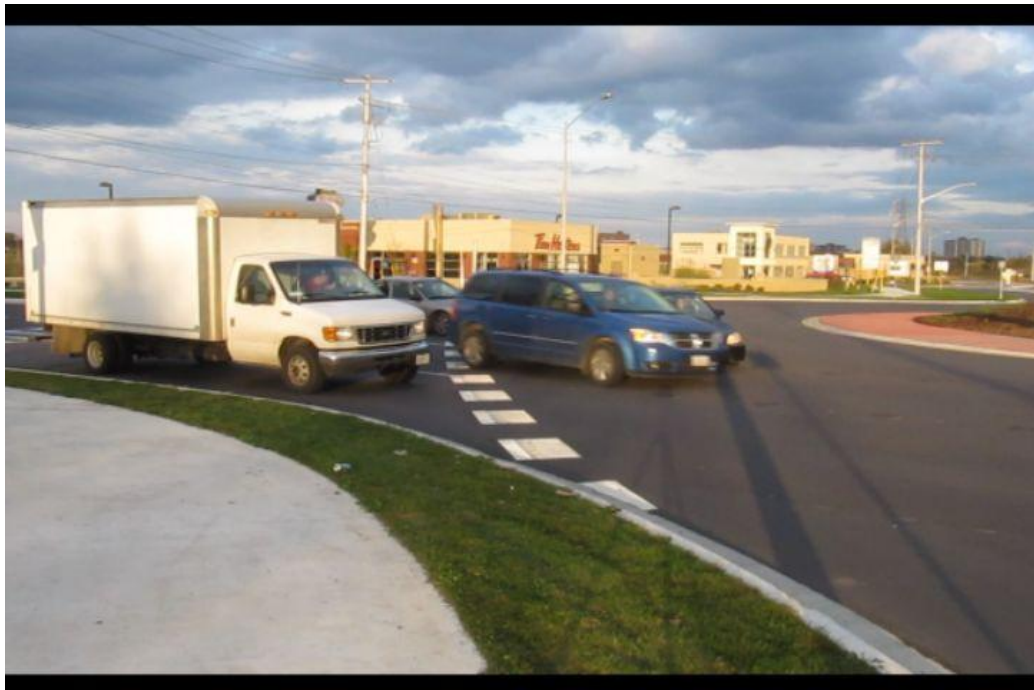
Well, wait a minute, it just do so...look at the frame above...it just drove directly in front of our charcoal-coloured car. If you had been there like I was you would have heard the very loud screeching of tires as the driver of our charcoal-coloured car hammered on the brakes and came to a stop within an inch two off the right side of that blue car.

And then you can see (below) how the driver of the blue car just kept going. Leaving chaos and meyhem in his/her midst.

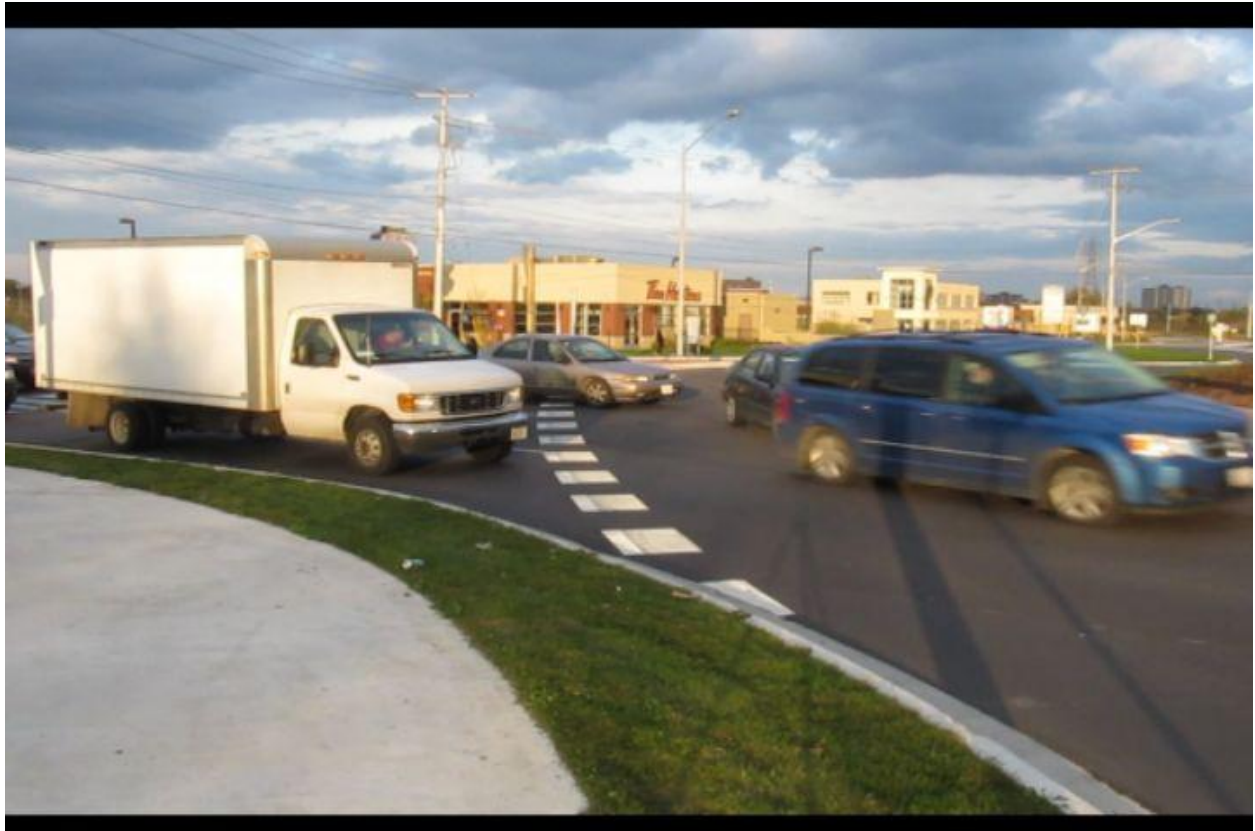
The young female driver of the charcoal-coloured car could be seen shortly afterwards as she flung both arms in the air and then dropped her head into her steering wheel at the realization that she just missed a collision with the shortest possible time and distance. She sat there for a few seconds in a stopped position and composed herself as shown in the past frame on the following page.

In examining the scenario again, the above frames were shown at half second intervals. So from the time that the blue car first emerged beyond the front end of the white truck up to the time shown in the above frame, the elapsed time was only about 1 second. Surely not enough time for the driver of the charcoal-coloured vehicle to avoid a collision. The only fact that prevented this collision is that the driver of the charcoal-coloured car must have seen the blue car approaching the roundabout and she realized this blue car was not going to stop. In fact that is the case because, just before the blue car entered we could hear a car horn sound and this was likely the driver of the charcoal-coloured car blowing her horn before the blue car entered - but to no avail.

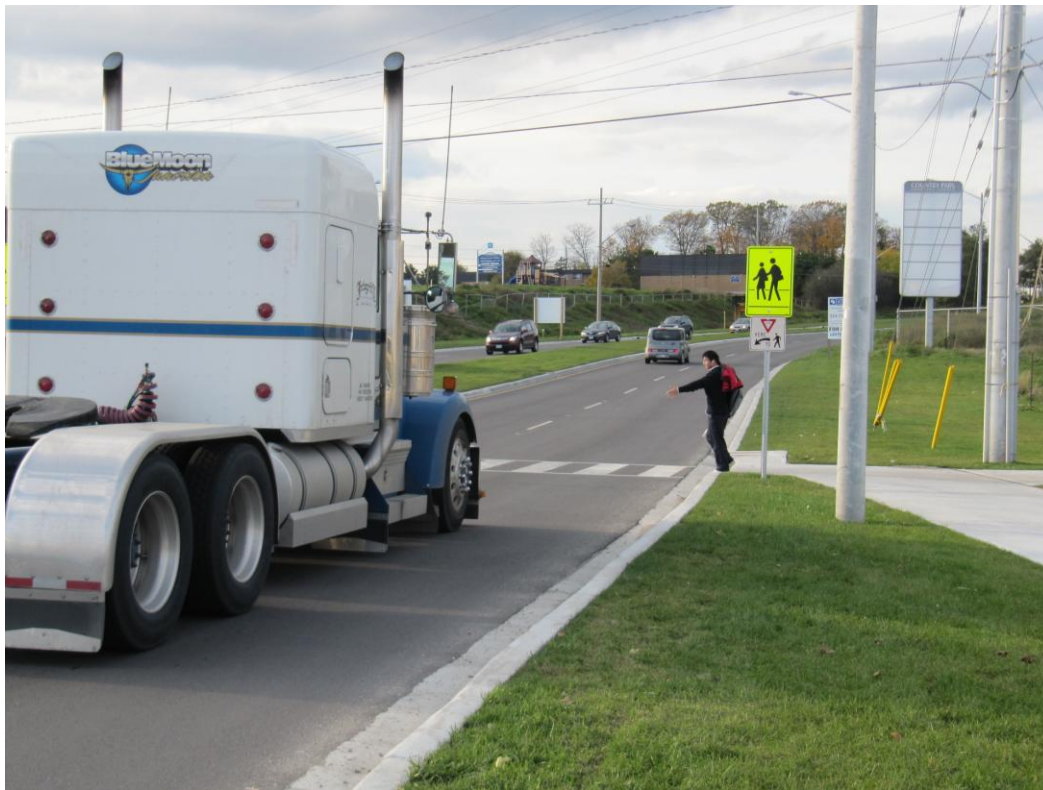
The photo below shows another common instance that happens at this roundabout. We see a pedestrian raising his arm to indicate to the truck driver that he is intending to cross.

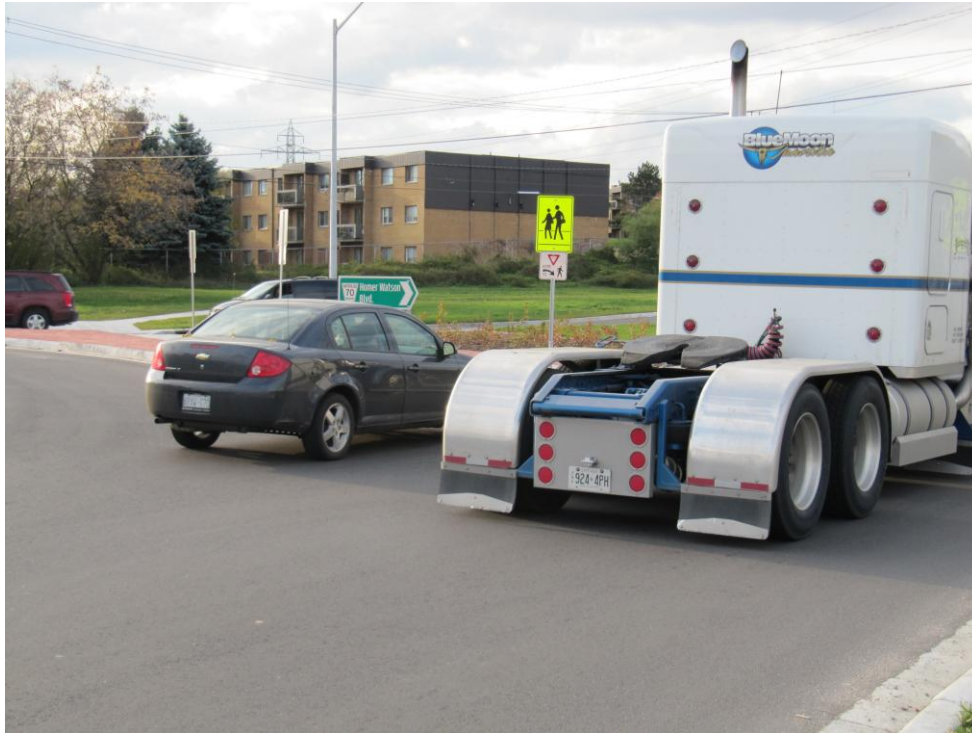
Yet in the next frame (below) we show you what is positioned to the right of the truck - a small car.

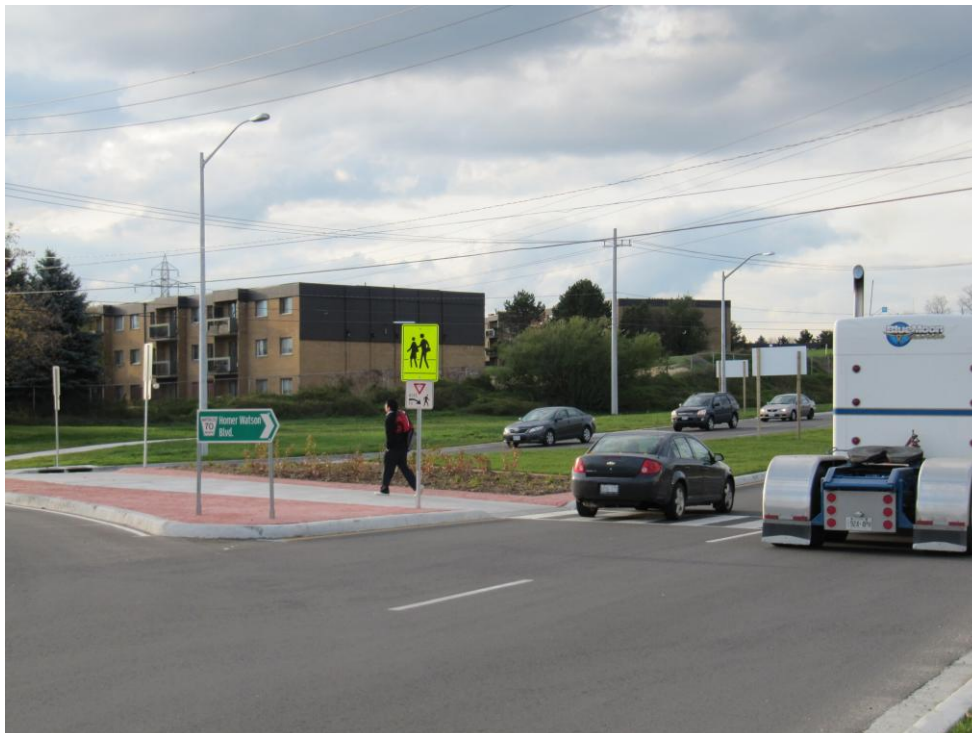
It can be seen in the frame below that the pedestrian made it safely across but that will not be the case in many situations.

In many such instances the car driver's vision is blocked by a large truck to such a degree that the car driver simply passes the truck without realizing that a pedestrian is attempting to cross. It makes for a dangerous situation. This is partly due to the positioning of the stopped truck with respect to the pedestrian crossing. To understand we must look at the signage that was placed next to the cross walk, as shown below.

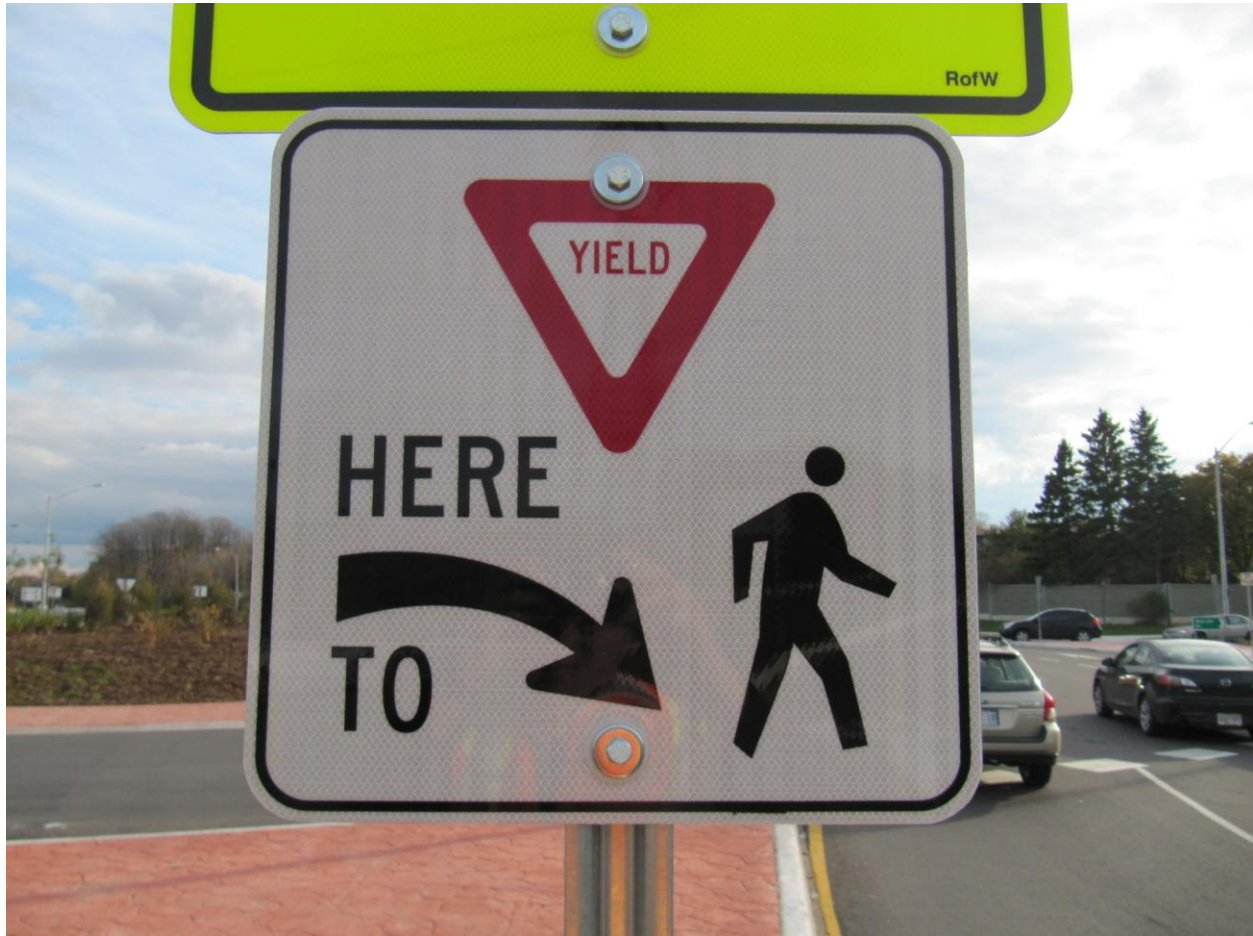
The above is a typical sign that has been placed to supposedly to guide drivers about how they should deal with crossing pedestrians. The drivers are instructed to yield to pedestrians by stopping "Here". But where is "Here"? The photo on the following page shows where the sign is located. Notice that the sign is located right next to the edge of the pedestrian crossing line. So if the driver does what he/she is told the front of the vehicle will come to a stop directly at the edge of the pedestrian crossing zone. And if a driver is coming along in the adjacent lane he/she will not know if there is a pedestrian in that crossing area because the view will be blocked by the stopped, or stopping vehicle.

And this is not the only problem. Look at the size of the instructions on the yield sign. The writing is so small that, by the time a driver can read it the vehicle is almost upon the crosswalk. Certainly many drivers will be familiar with the area and sign and they will

have seen it before, but what about a driver who is new to the roundabout? New drivers will receive no help or instruction was a sign that has writing that is this small.

The newspaper article further indicates that "...regional council voted to reduce the speed limit on Homer Watson Boulevard to 50 km/h in the vicinity of the roundabout, and to change signs reading 'Yield to Pedestrians' to 'Stop for Pedestrians'".

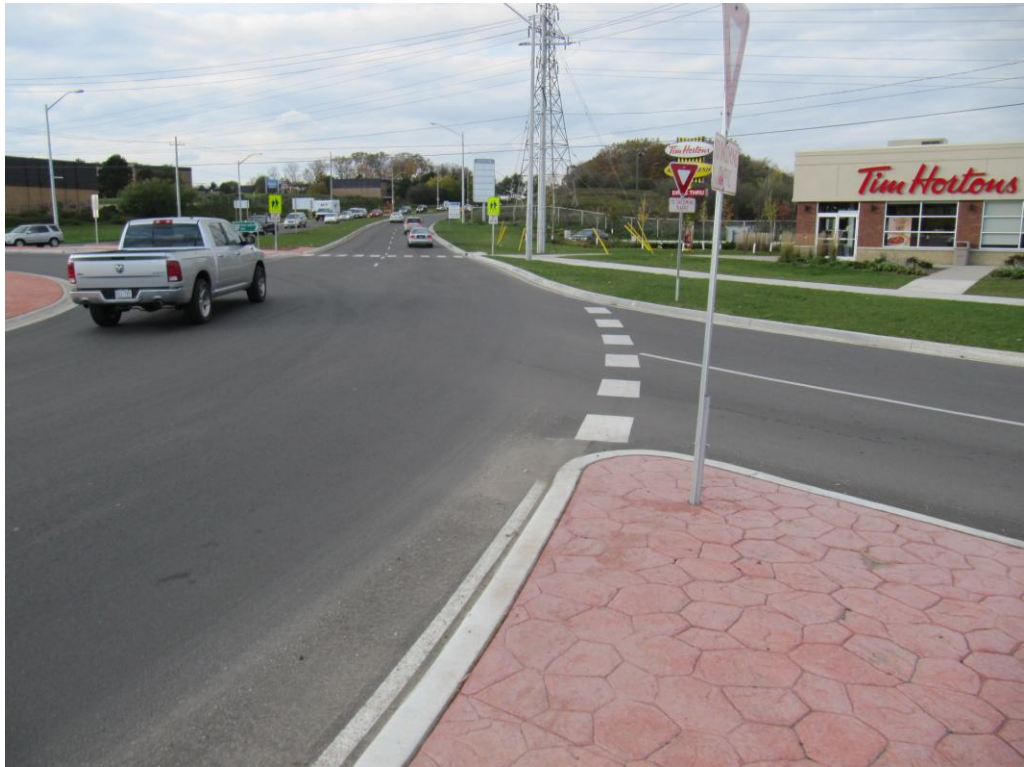
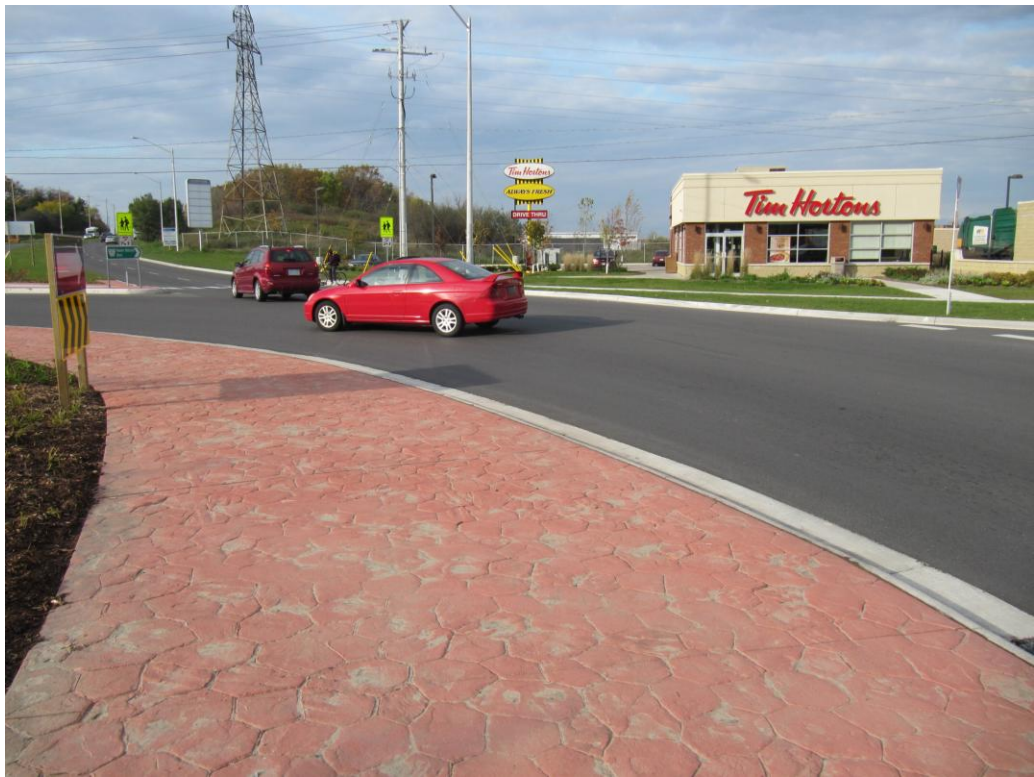
Let us also show you a final example of bad planning. Below is a photo of a Tim Horton's outlet that has been built at the edge of the roundabout. If you are not familiar with Canada, a Tim Horton's outlet is a very popular, coffee and donut retail outlet. It is so popular that at almost every outlet one can see traffic problems as vehicles attempt to come in and out of the driveways. The planners thought they could alleviate the problems by creating no driveways that lead to the outlet in the vicinity of the roundabout, as shown in the two photos on the following page.

So, if there are no driveways then they believe there will be no traffic problems caused by the outlet. But everyone in Canada knows that when they approach a Tim Horton's outlet there will be a convenient driveway into which they can pull in.

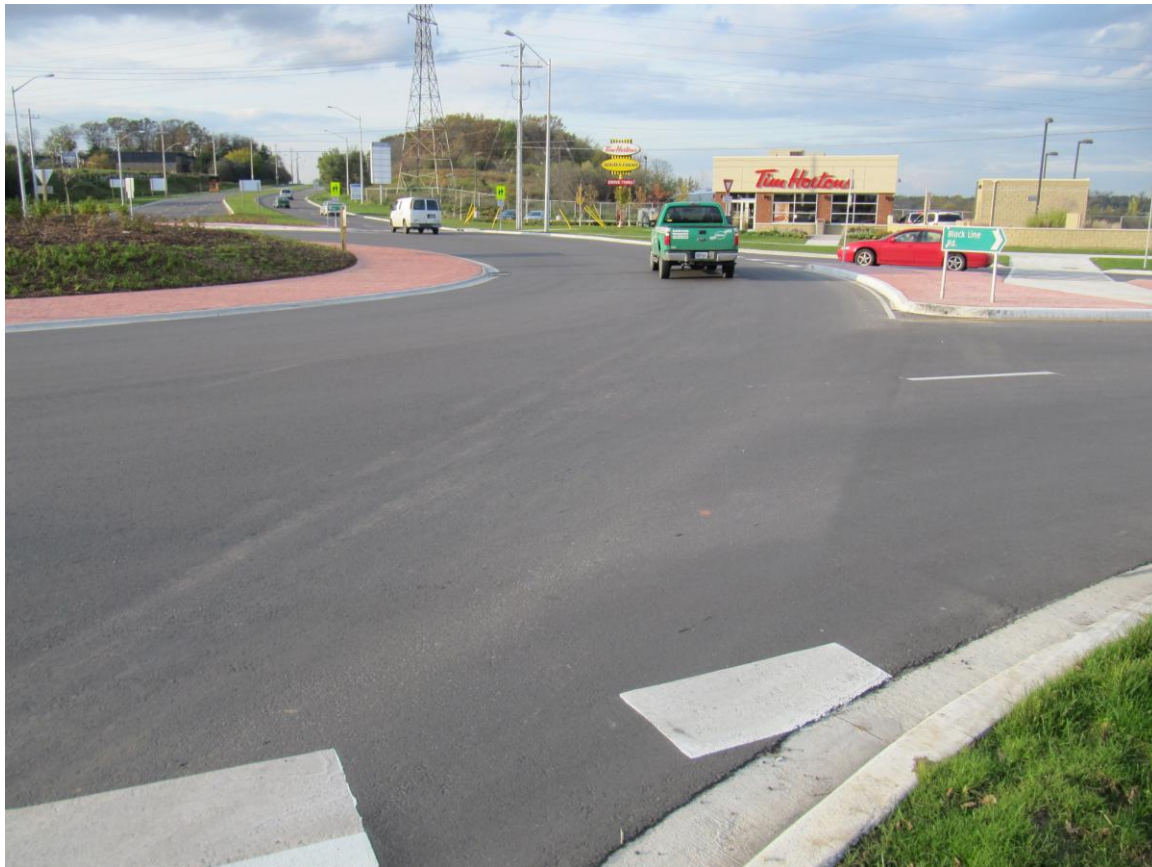
A driver not familiar with the roundabout will start searching for the driveway as they are moving through the roundabout. But the driveway is some distance away along Block Line Road. So drivers are busy searching for this driveway that does not exist. Is this a good and safe idea? Look again at the roundabout leading up to the Tim Hortons outlet as shown in the additional photo below. Look at the wide expanse of the roundabout and recognize that there are two "lanes" without any roadway markings to tell drivers where they should be.

When you have drivers who are not familiar with the roundabout, the circular road is crowded with traffic, the drivers are looking for a Tim Horton's driveway that does not exist and you do not paint any lines on the circular road to guide drivers, are you not going to cause collisions? Are vehicles going to be wandering about the width of the circular road? Most certainly they are. And if that is not enough, they approach a pedestrian crossing immediately at the Tim Horton's outlet. Look at how many students use that pedestrian crossing at peak times of the day, as shown in the frame below taken from one of our video cameras.

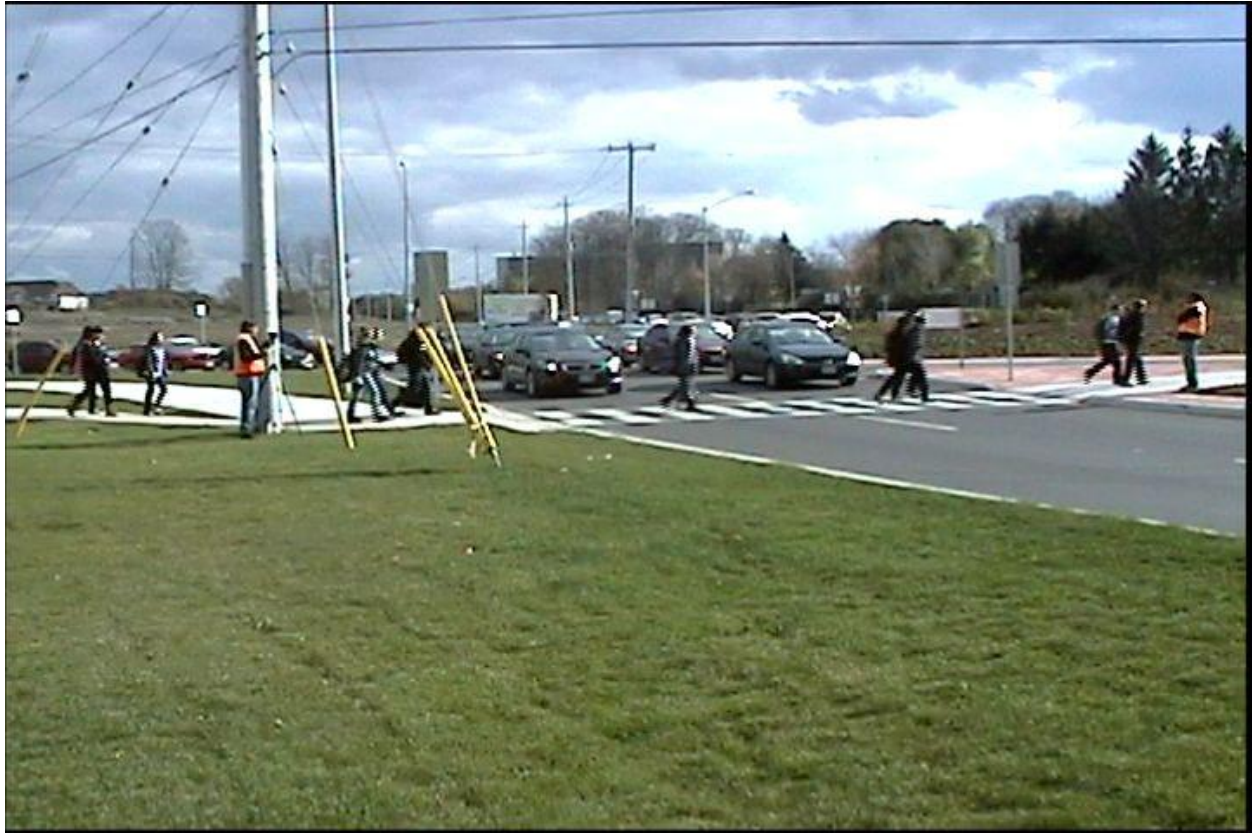
What are the chances that distracted drivers will hit a pedestrian? In fact this has already happened.
