Lessons Learned From Tire Marks On Freshly Re-Graded Gravel Shoulders

Posting Date: 04-January 2013

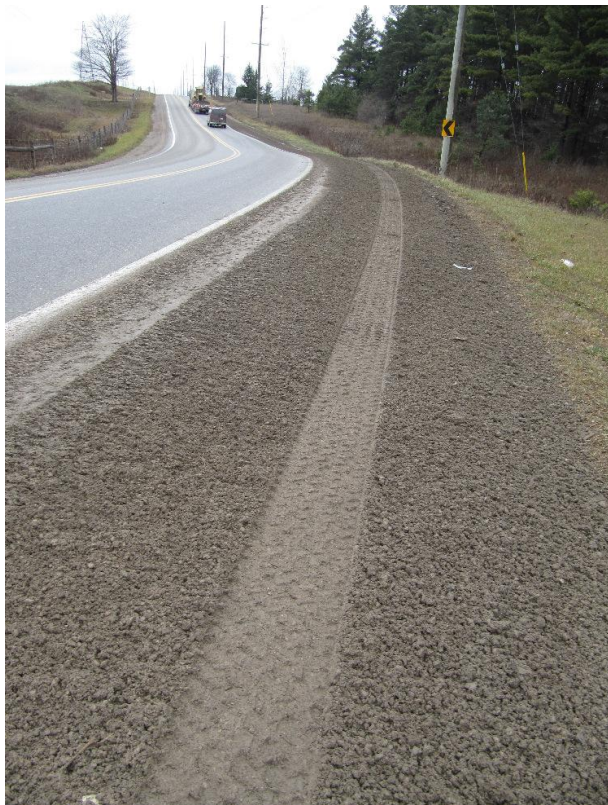
Figure 1 shows the northward view of an east gravel shoulder that was freshly re-graded about 2 hours before the photo was taken. The tire mark visible in the middle of the shoulder was produced by the right side tires of the road grader that passed through the site and re-graded the shoulder. The softness of the gravel can be appreciated by noting the imprint of the shoe of an investigator next to that tire mark, as shown in Figures 2, 3 and 4 on the following pages.

Figure 1 - Tire mark of road grader on freshly re-graded gravel shoulder

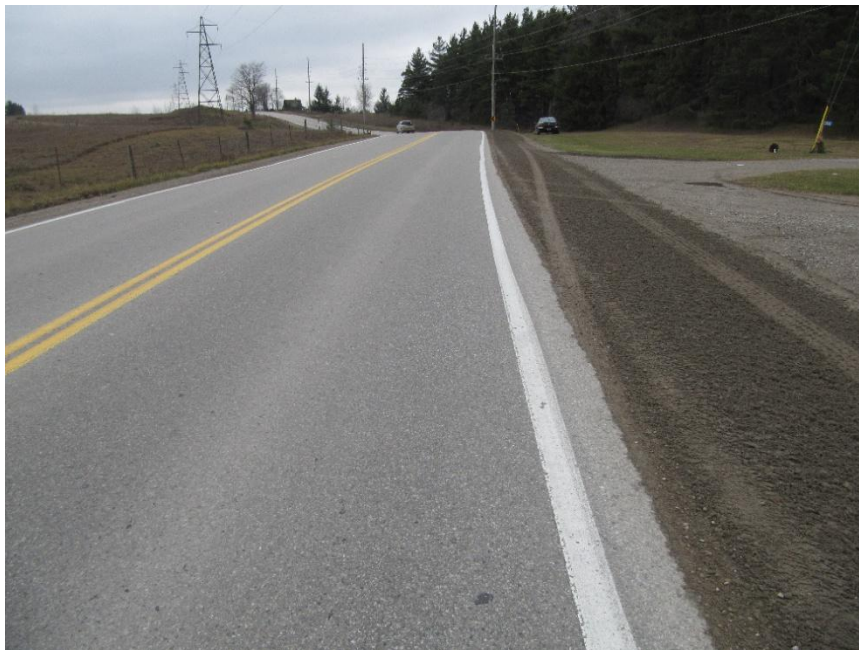
A few hours after these photos were taken we returned to this location and performed a test by purposely driving our test vehicle onto the shoulder, applying hard braking to a stop, and then steering off the shoulder to a parked position on the east roadside. Figure 5 shows the general scenario, looking north along the path of the test vehicle, just after the test was completed and our test vehicle can be seen in the background.

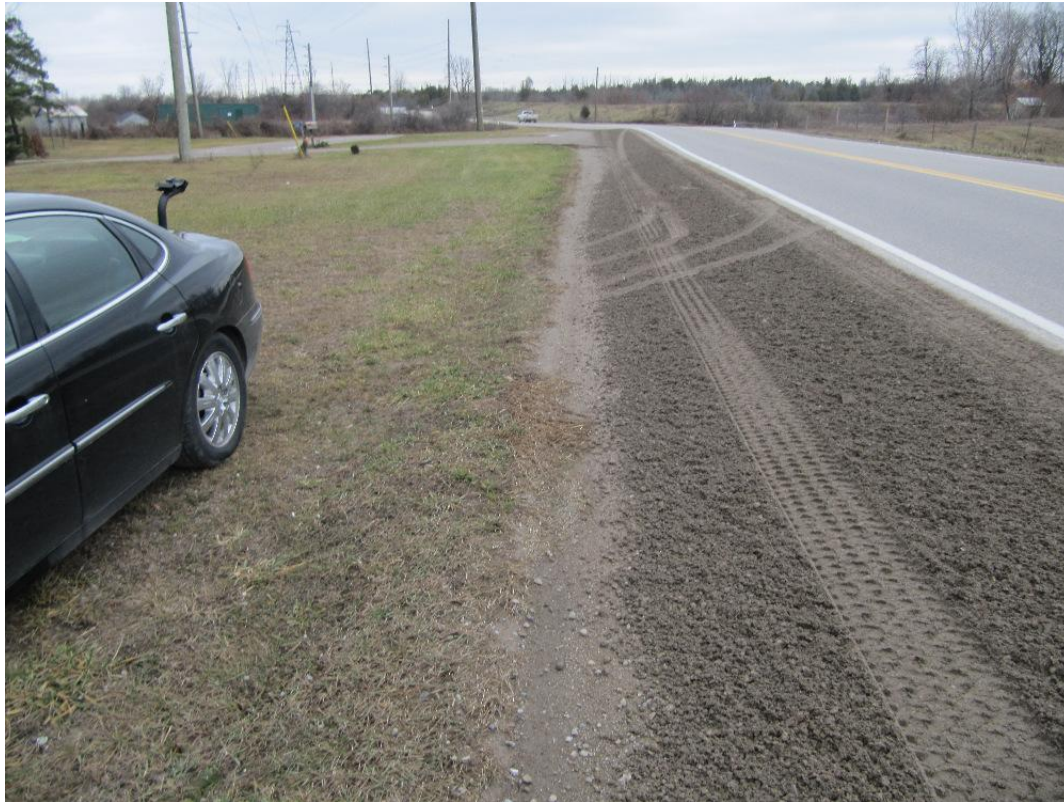
Figure 6 shows a southward view with our test vehicle shown parked on the roadside after it was steered off the shoulder.

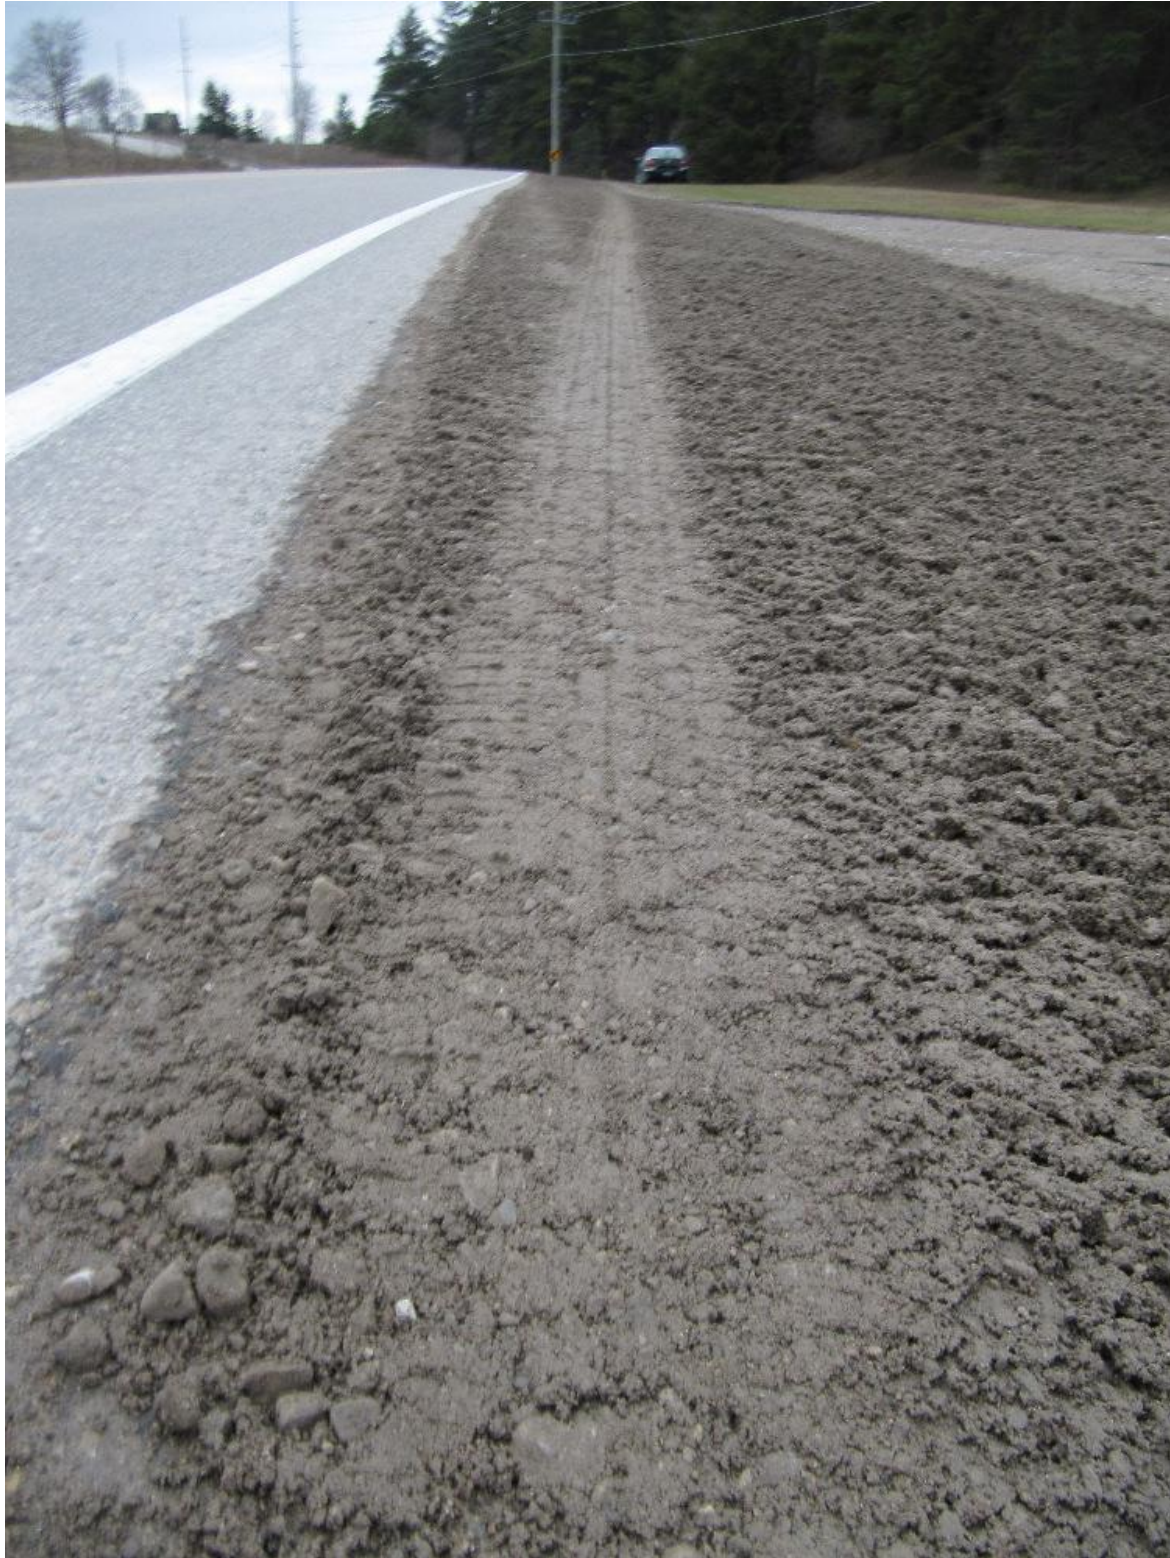
Figure 7 shows the mark produced by the right side tires of the vehicle shortly after it had been steered onto the shoulder and before any braking occurred. Not unexpectedly the loose gravel has been compressed down as the tires rode over it and we can see the imprint of the individual pattern of the tire tread. Note also that the gravel has not been disburled (sprayed) to the left and right of the tire mark as this would be one of the signs indicating that sliding was taking place between the tire and gravel.

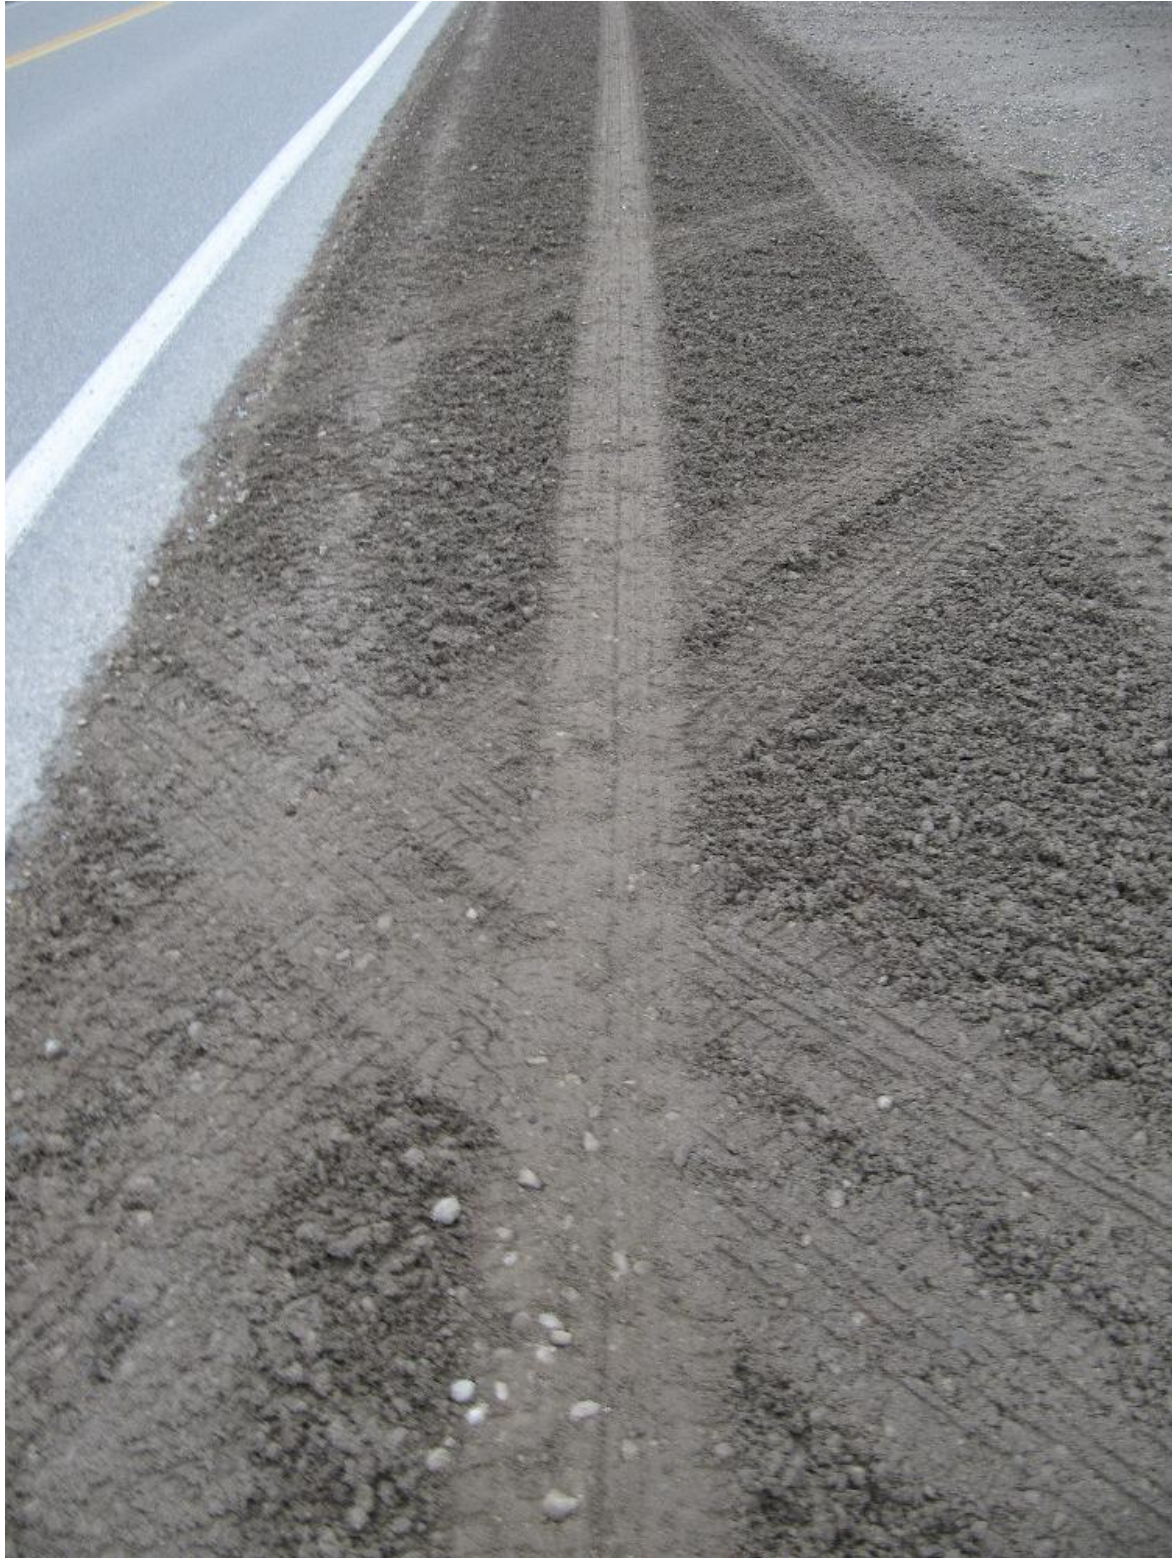
As we proceed further north along the tire mark we pass by a local driveway and we see in Figure 8 how the tire mark from our test vehicle has ridden over the diagonal tire marks caused by previous vehicles that entered/exited the driveway. The straight tire mark from our test vehicle can be seen on the left (west) while the straight tire mark from the road grader can be seen on the right (east) portion of the gravel shoulder.

It should not be difficult to comprehend that, studying the area in Figure 8 where the tire marks intersect, one can easily distinguish between which tire mark was caused first by noting how the tire mark from our test vehicle has removed the features of the crossing tire marks while the features from our tire mark remain in those areas of intersection. Figure 9 provides a close-up of one of those areas of intersection and we can see how our tire mark has erased the features of the diagonal tire marks that were caused previous to our test.

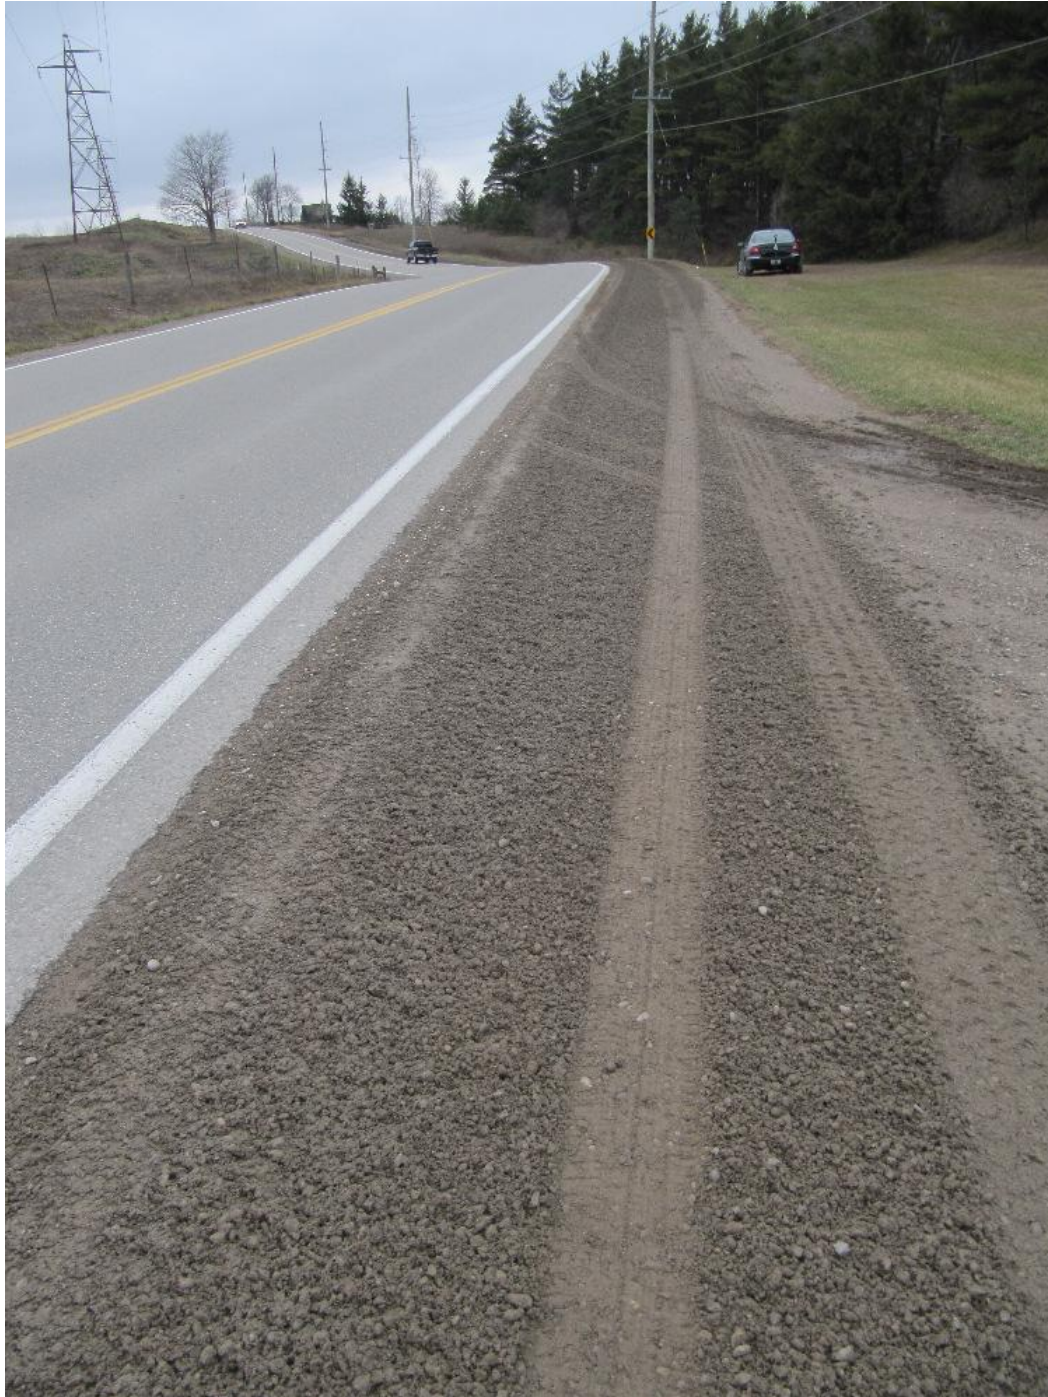
Figure 10

Progressing further northward we can see how the tire mark from the right side of our test vehicle continues to veer toward the right and closer to the tire mark of the road grader in the background. The braking test did not take place until much closer to the resting position of the test vehicle in the background so the characteristics of our tire mark in the foreground are of a rolling tire on loose gravel.

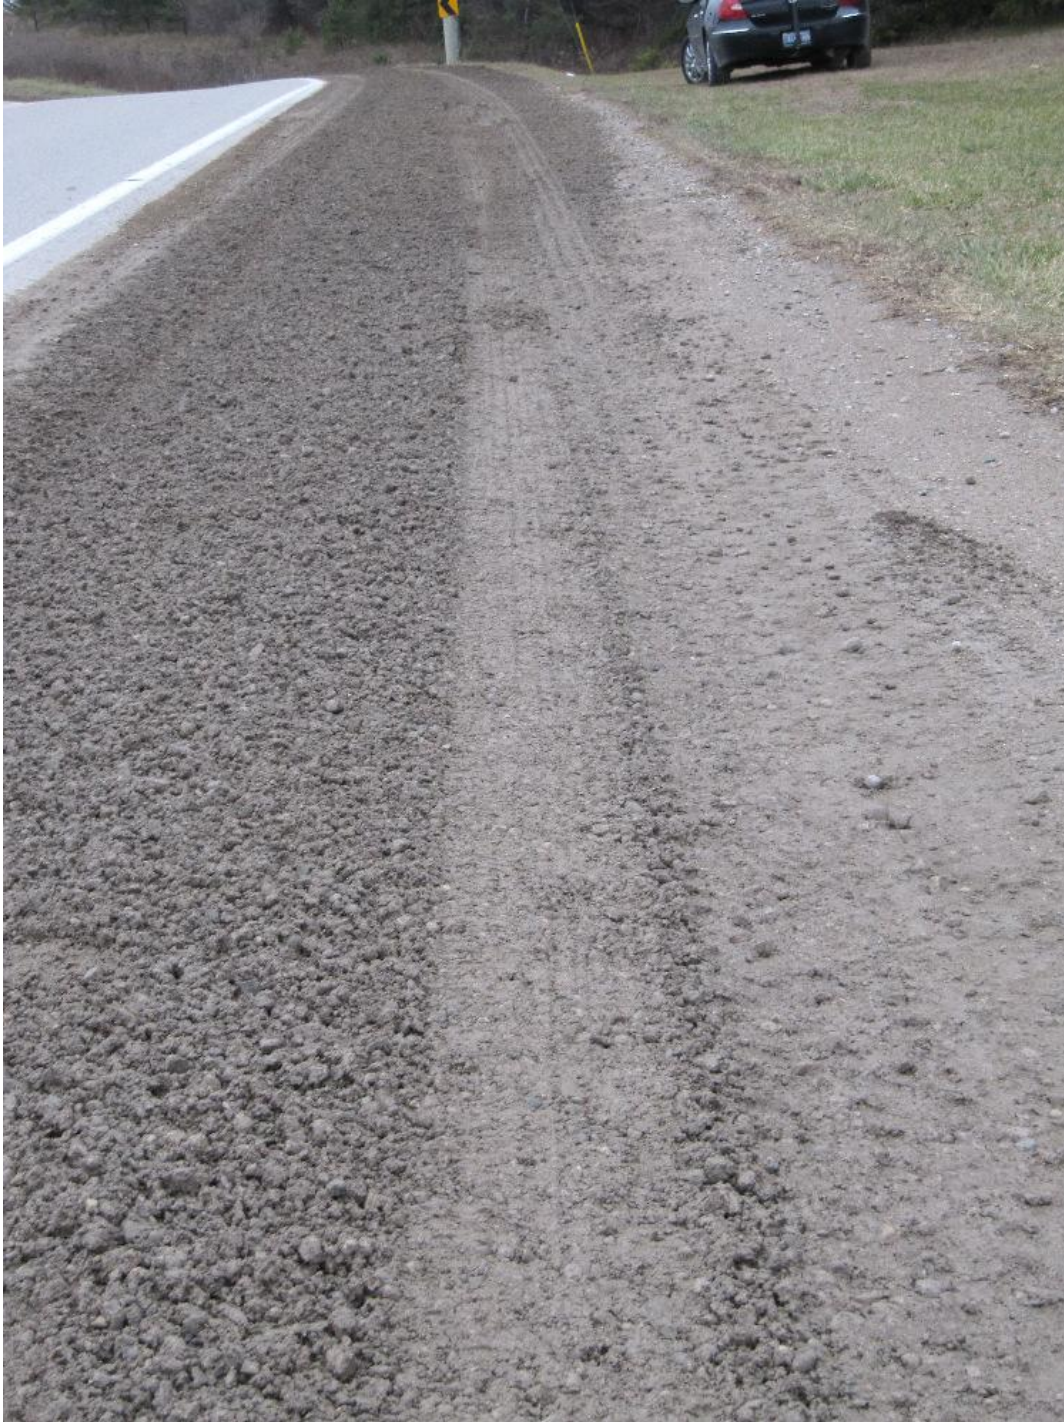
As we approach closer to the point where the braking commenced we can see in Figure 11 that the right side tire mark of our test vehicle comes right along side of the tire mark from the road grader. However, the tire mark from our test vehicle is still to the left (west) and the mark from the road grader is to the right (east).

However, as we look closer in Figure 11 at the tire mark from our test vehicle you should be able to see that the tire mark changes its character and direction at the point where the braking occurs. Figure 12 below shows a closer view of the point where this change in the tire mark occurs. The tire mark from the test vehicle begins to show some "roughening" or displacement of the gravel within the tire mark and the tread of the tire print is no longer clearly visible. The tire has also travelled partly onto the tire mark caused by the road grader.

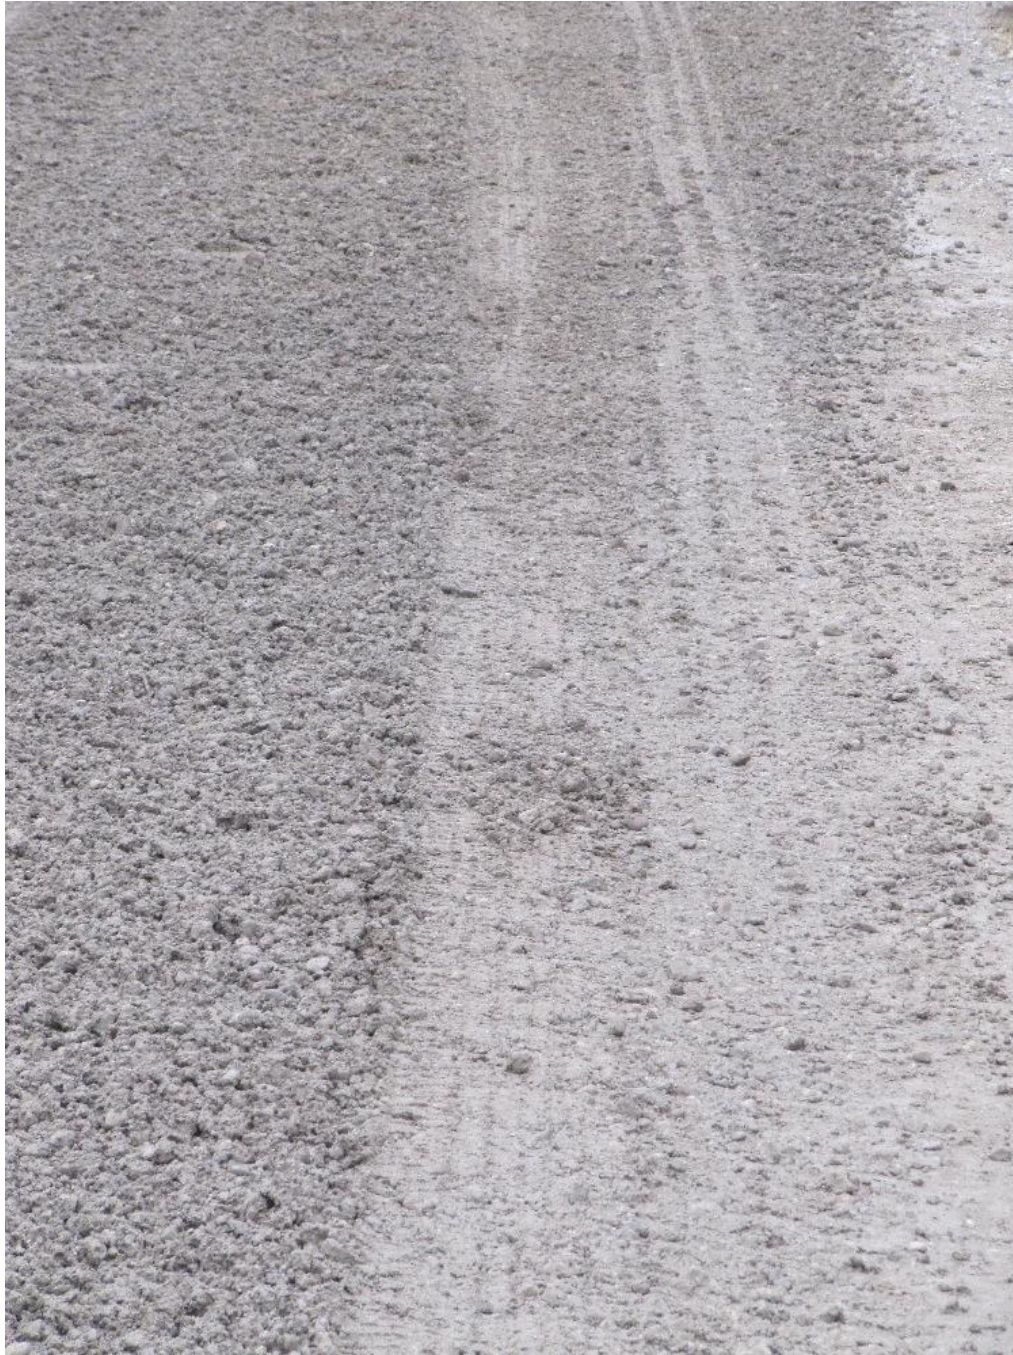
What may be difficult to detect is that the right rear tire of our test vehicle has begun to move to the right during the brake test and no longer tracks along the same path as the right front tire. Thus, if you look toward the very top of Figure 12 you might be able to see a portion of the right front tire mark which contains some of the characteristics of a rolling tire while the right rear tire mark passes between the right front tire mark and the tire mark of the road grader. So this is evidence that our test vehicle has begun to rotate slightly counter-clockwise during the braking test as our rear wheels began to lock and our front wheels continued rolling. This occurrence was despite the fact that our test vehicle (2007 Buick Allure) was equipped with anti-lock braking.

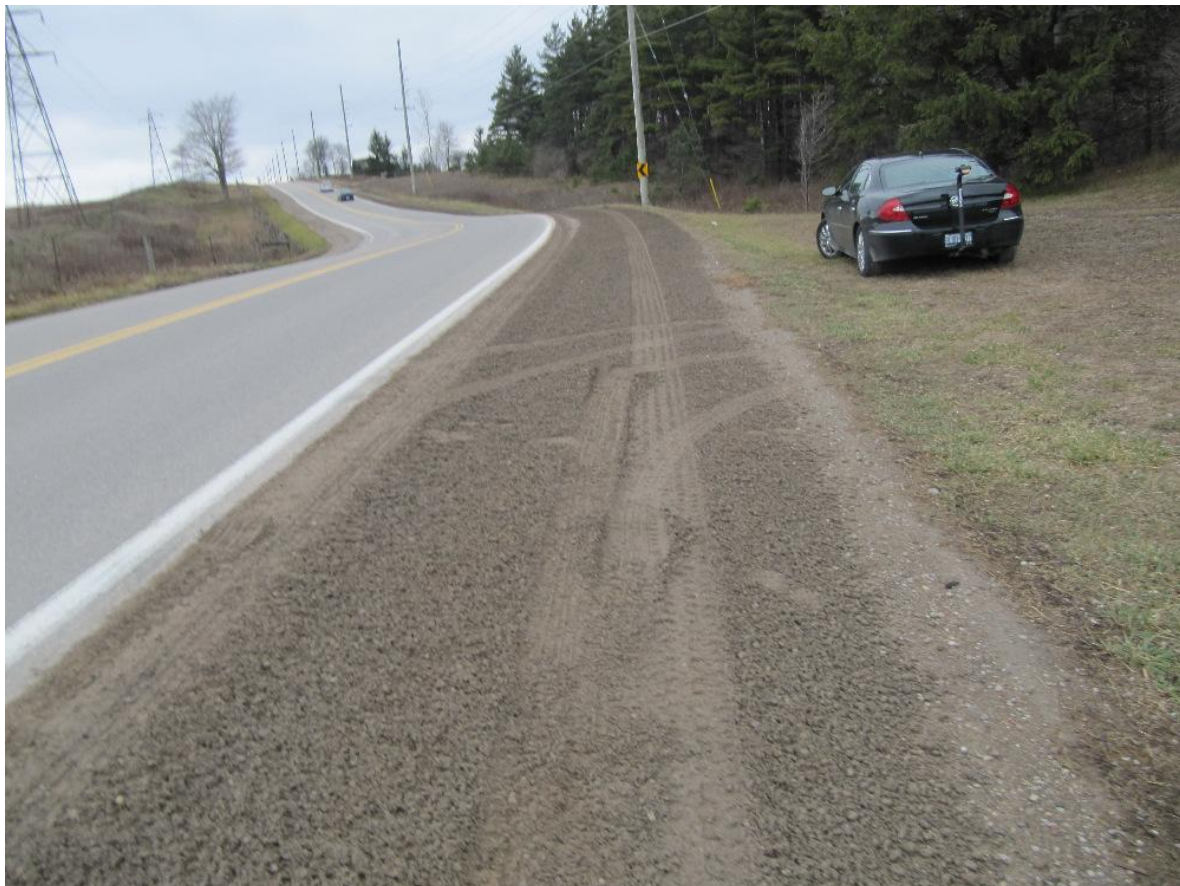
The extent of the counter-clockwise rotation during braking can be seen more clearly in Figure 13 which takes us close the point where our vehicle came to a stop at the end of our brake test. The curved tire marks show how we turned our steering wheel after the vehicle stopped and then rolled onto the grass where we parked our vehicle. The stop position of our vehicle at the end of braking can be detected by noting the mounds of gravel that were built up and sprayed or squished to the side near the stop location of each tire.

Note in Figure 13 how the right rear tire mark has followed a path more to the right (east) of the path of the right front tire mark indicating that our vehicle began to rotate counter-clockwise during the braking test.

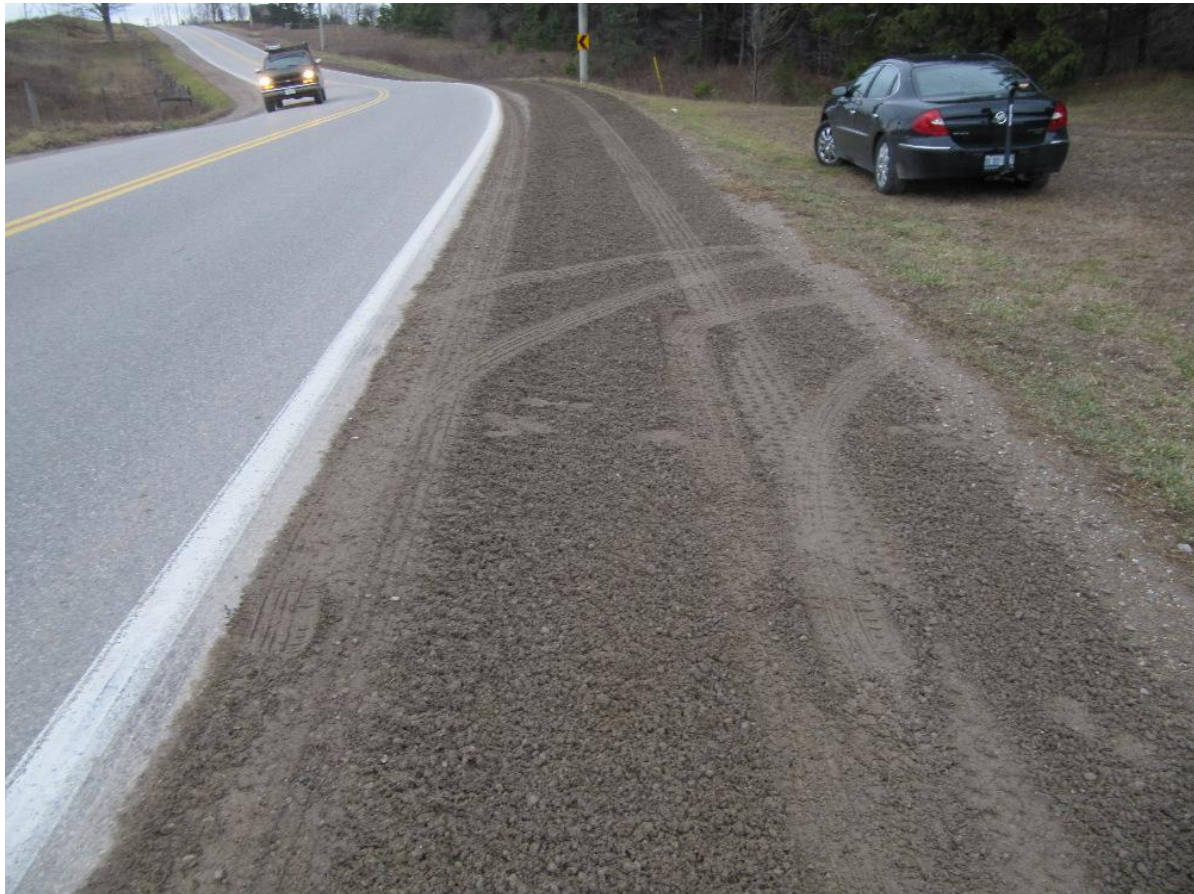
Figure 14 below shows a closer view of the tire marks near the point where the vehicle came to a halt. Note how the left rear tire also slid to the right such that it came off of the asphalt pavement and began to slide on the loose gravel while the left front tire continued to slide on the asphalt, albeit near the edge of the pavement.

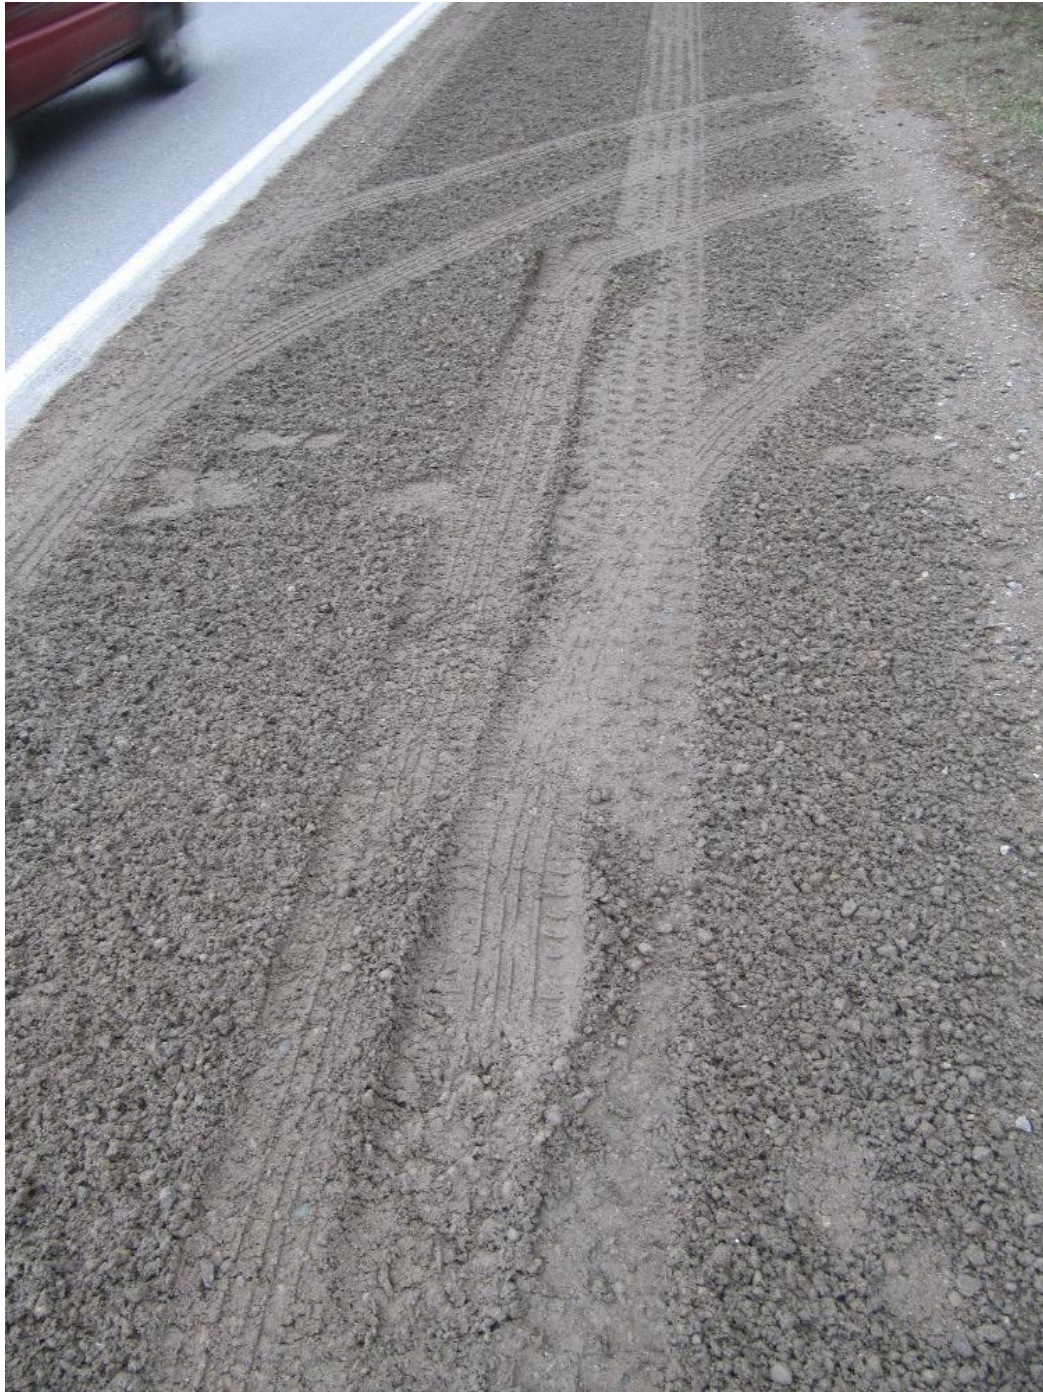
Figure 15 shows a closer view of the marks caused by the two right side tires of the vehicle and we can clearly see how the right rear tire followed a path to the right of the right front tire near the point where the vehicle came to rest. The curved tire marks continuing from that rest position are simply those that were created after the test was completed and the vehicle was steered to the right and onto the grass roadside.

The tire mark caused by the road grader can also be seen in Figure 15 travelling in a straight line next to the tire marks from the braking test and we can see how the features of that tire mark have been erased in the intersection where our test vehicle passed over the tire mark.

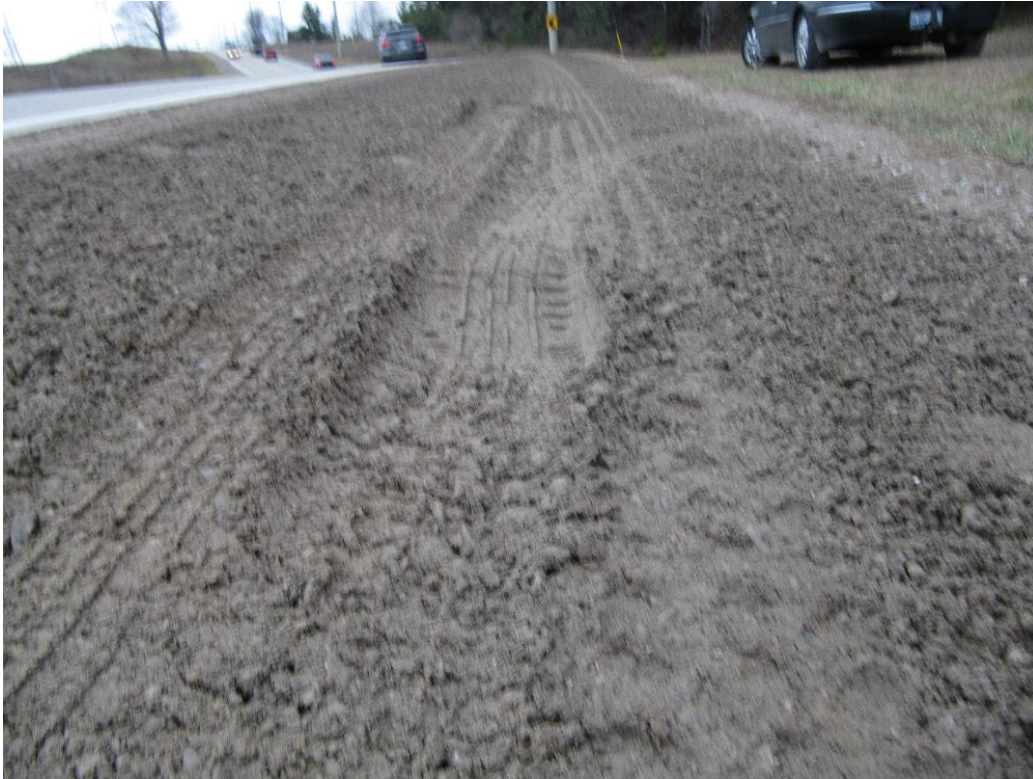
In Figure 16 we can see a close-up view of the point where the right rear tire mark came to rest and how the loose gravel was built up and disbursed to the sides of the mark. Figure 17 provides a southward view of the tire marks at the end of braking test.

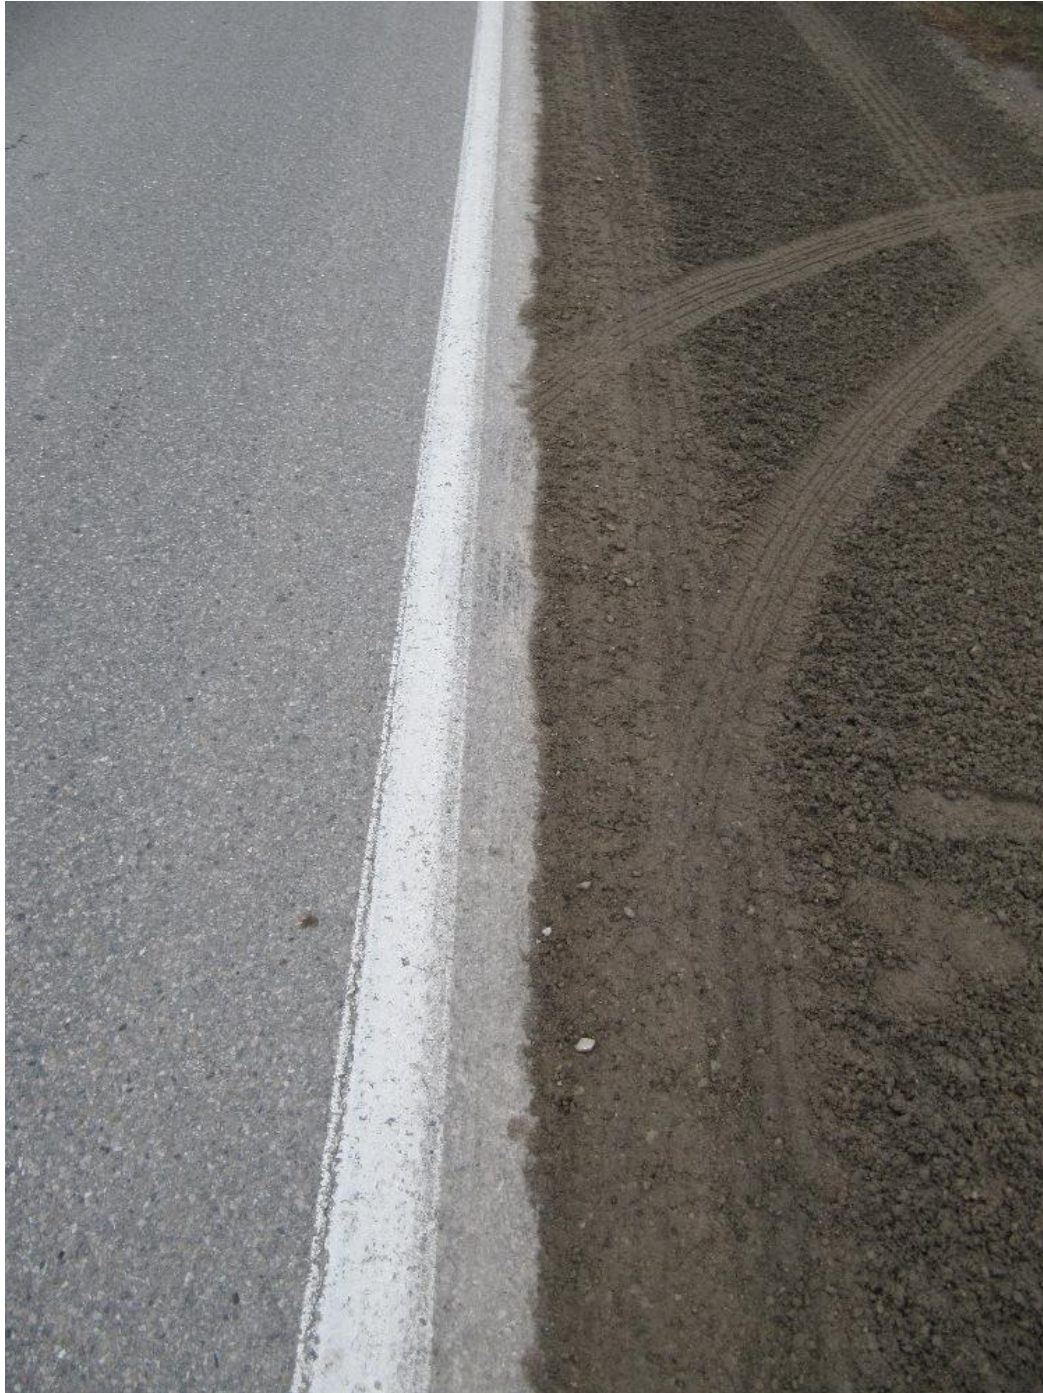
Figure 18 clearly shows the black skid mark on the edge of the pavement caused by the left front tire while it can be seen that the left rear tire had moved to the right and was sliding on the gravel near the end of the brake test. The tire mark caused by a previous vehicle can also be seen passing straight through on the gravel near the edge of the pavement.
