# Local Road Maintenance Jurisdictions Quietly Replacing Trinity Highway Products ET-Plus Terminals

*Posting Date: 26-Nov-2015*

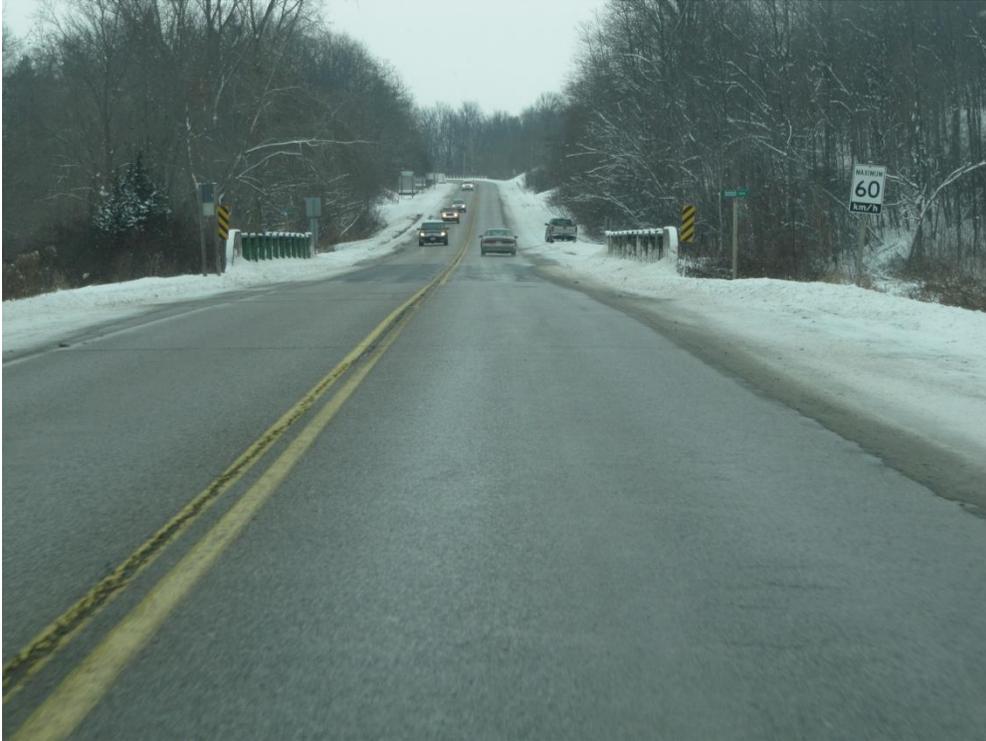
Figure 1: View, looking north, on Wellington Road toward the bridge over Dodd Creek. This photo from December 15, 2013 shows that a guardrail did not exist at that time.

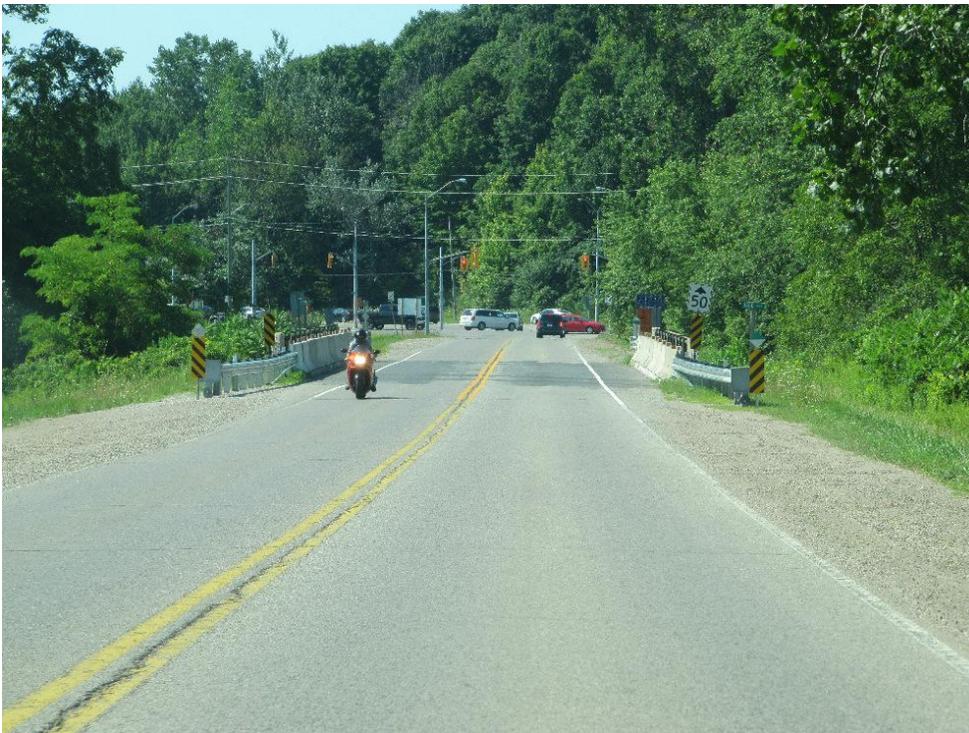
Figure 2: View, looking south, toward the bridge at Dodd Creek showing the newly installed guardrail and terminals. This photo was taken on August 16, 2015.

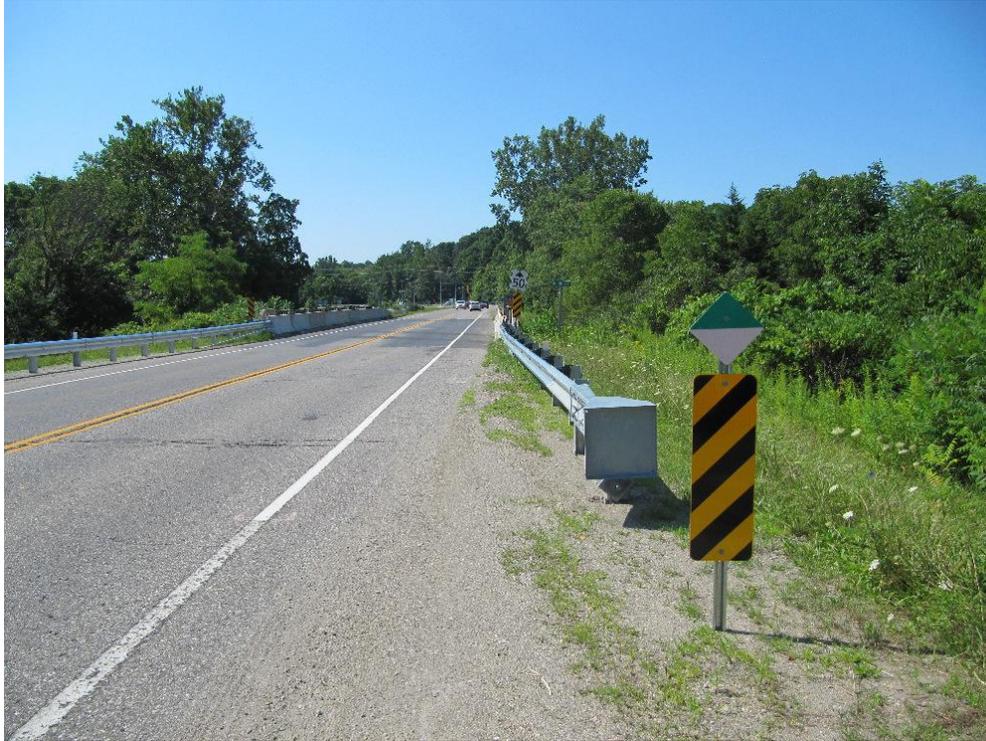
Figure 3: View, looking south, at the newly installed guardrail and terminals at the Dodd Creek Bridge. This photo was taken on August 16, 2015.

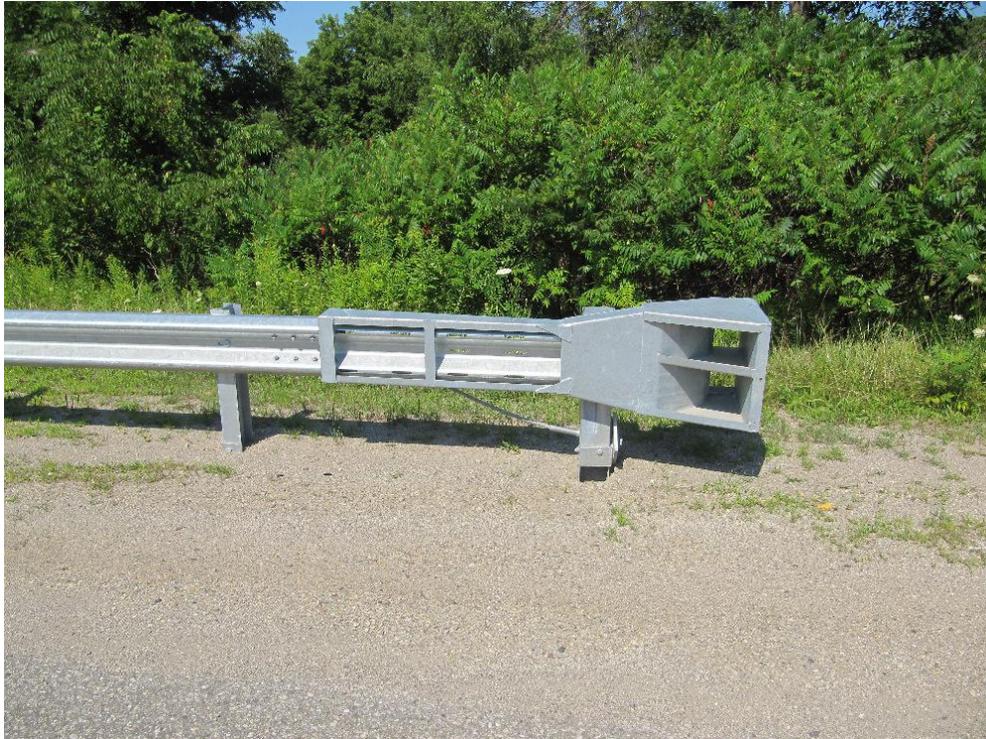
Figure 4: Roadside view of one of the terminals located at the Dodd Creek Bridge.

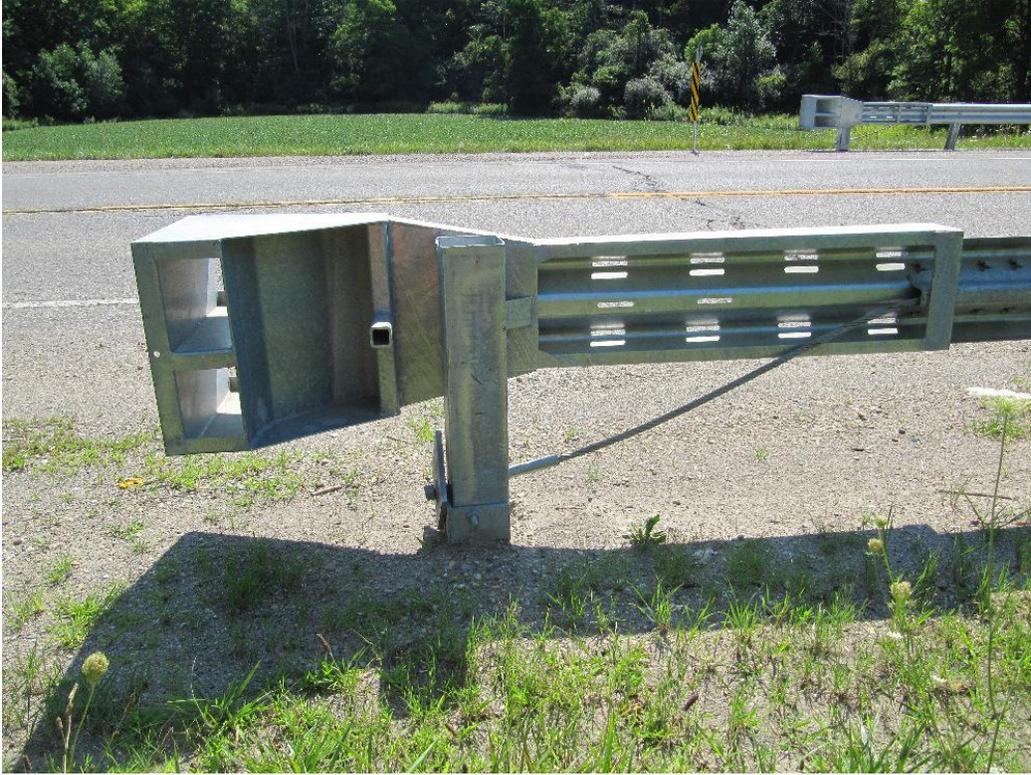
Figure 5: Ditch-side view of one of the terminals at the Dodd Creek Bridge.

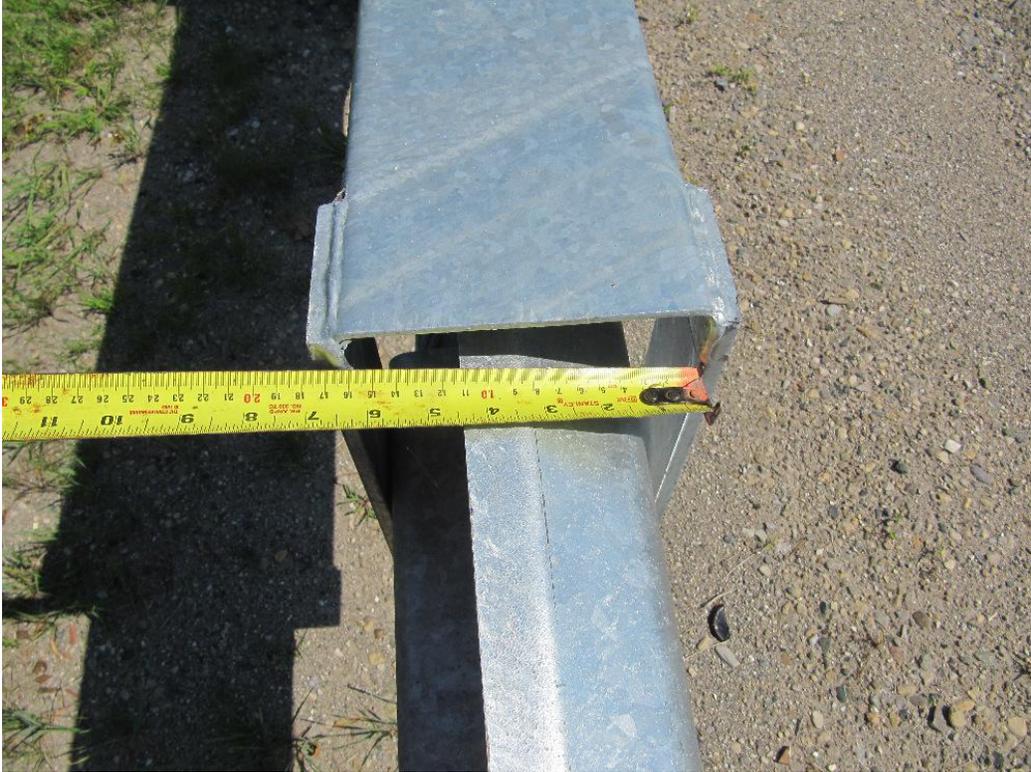
Figure 6: View of the much-wider channel of the new terminal at the Dodd Creek Bridge.

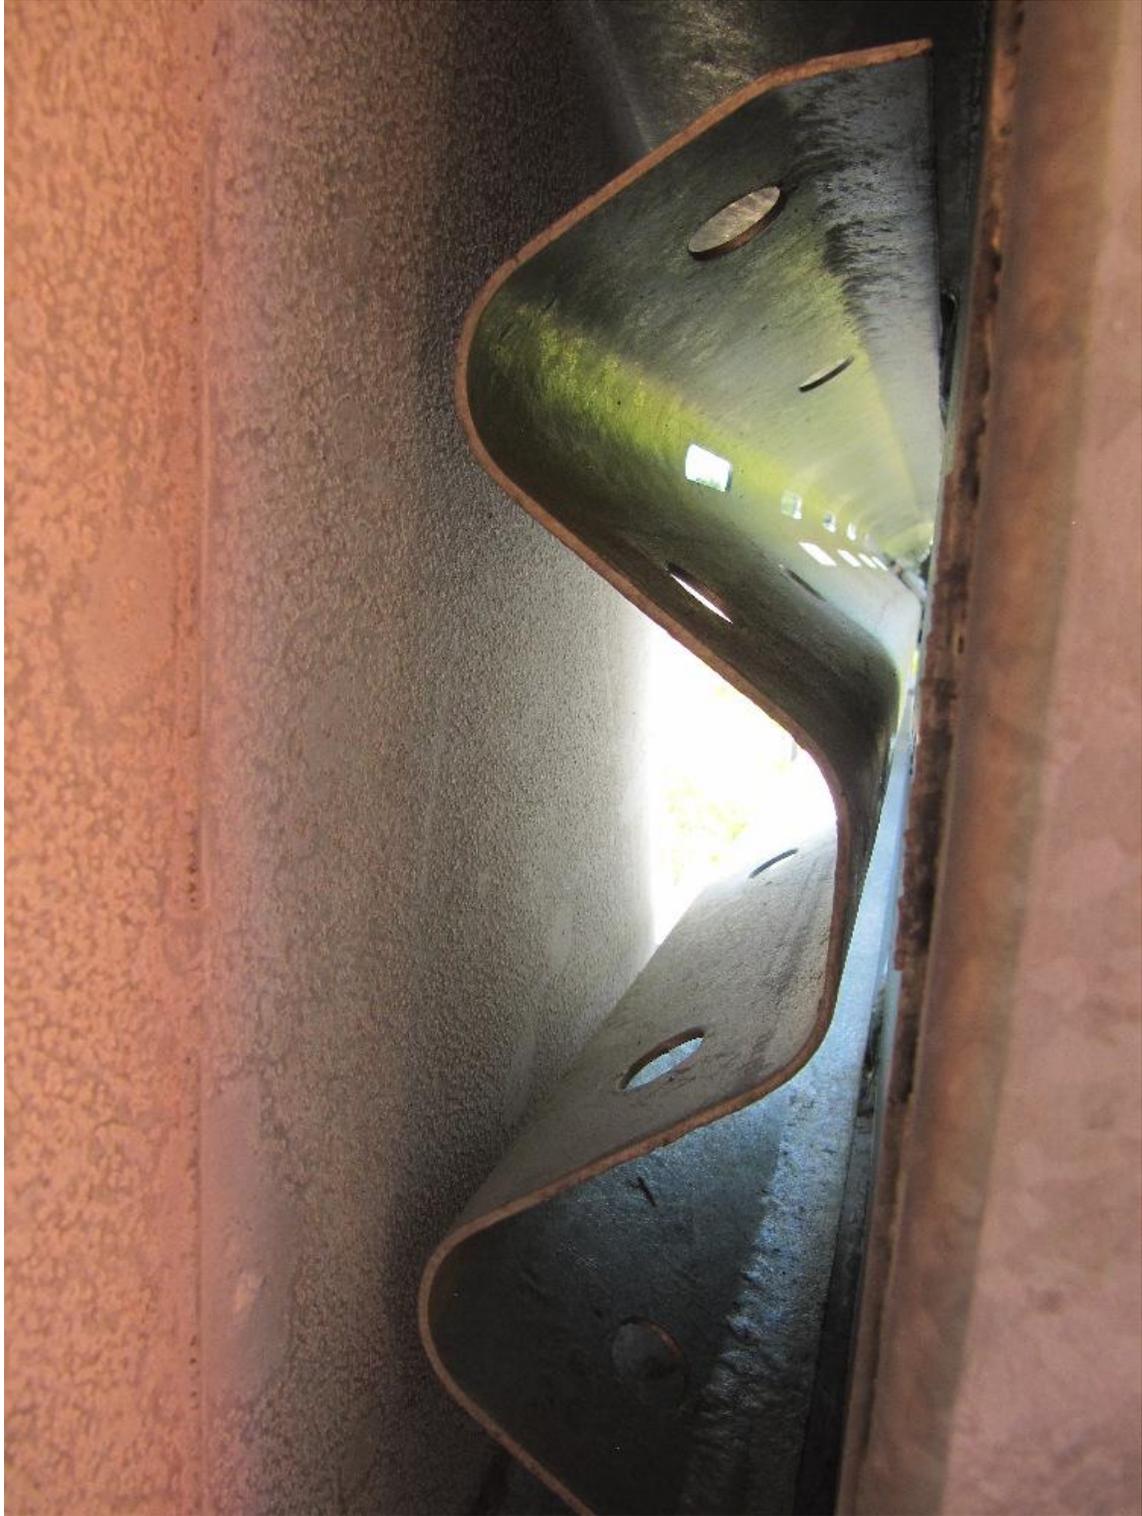
Figure 7: View of the end of the guardrail as it rests within the head of the terminal at the Dodd Creek bridge.

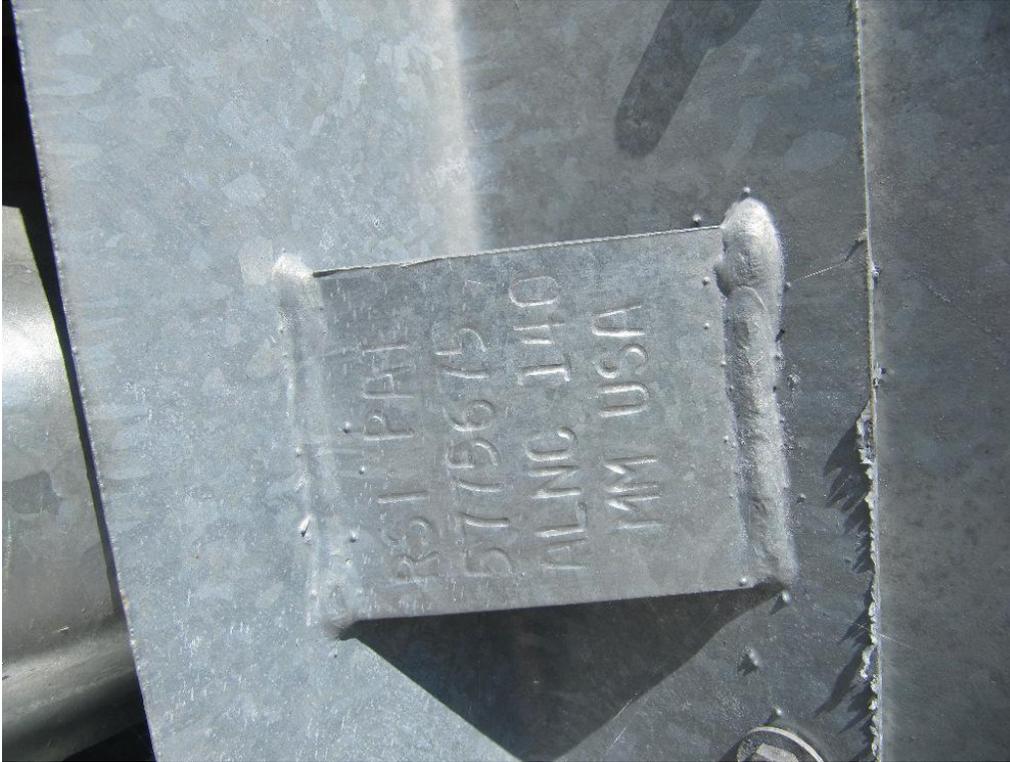
In the meantime, without any announcement or information to the public, a different type of terminal began to be installed in the vicinity of London Ontario in 2015. The first installation identified by Gorski Consulting was located on St. Thomas, Ontario on Wellington Road at the bridge that crosses the Dodd Creek, near the intersection with Sunset Drive. In Figure 1 below we can see a northward view of the bridge taken on December 15, 2013 when there was no guardrail attached to the bridge. Sometime before August, 2015 a guardrail and terminals were installed as shown in Figures 2 through Figure 8. The terminals located here were likely manufactured by Road Systems Inc. of Big Spring, Texas and they are called "SKT" terminals.

Figure 8: View of the "RSI" designation on the terminal at the Dodd Creek bridge indicating that this is probably a SKT terminal manufactured by Road Systems Inc. of Big Spring, Texas.

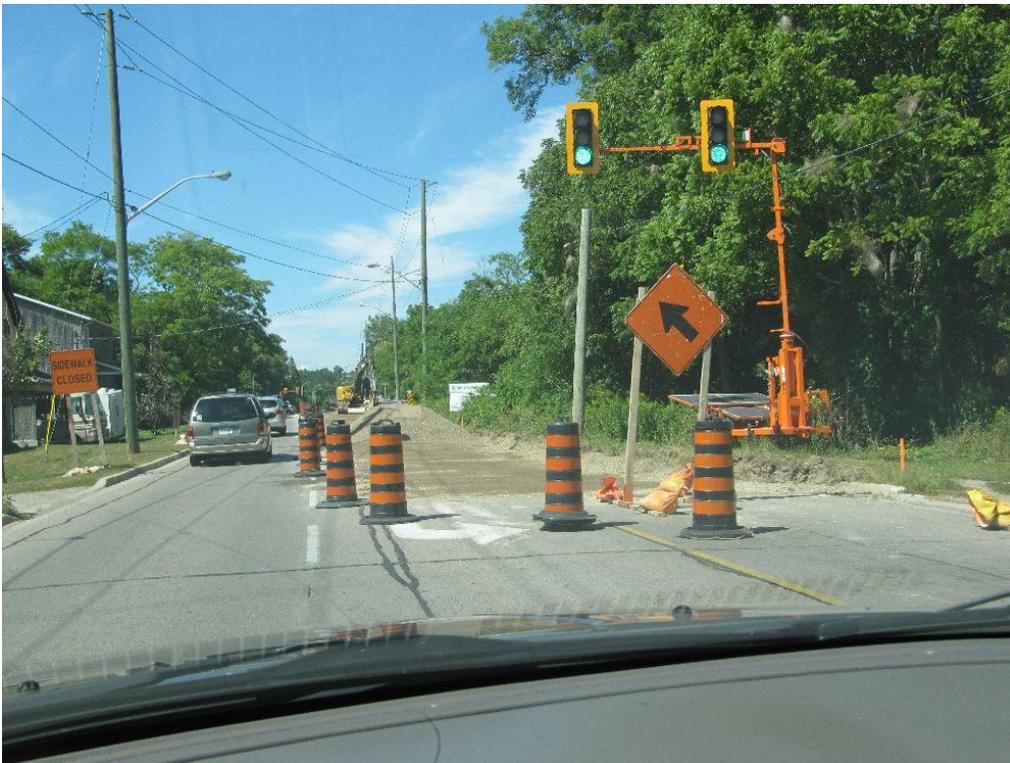
Another new installation of the SKT terminals occurred during the spring and summer of 2015 on Sunset Drive, in St. Thomas, Ontario, again at another bridge crossing Dodd Creek, as shown in Figures 9 and 10.

Figure 9: View of reconstruction over the Dodd Creek bridge on Sunset Drive in St. Thomas on August 23, 2015.

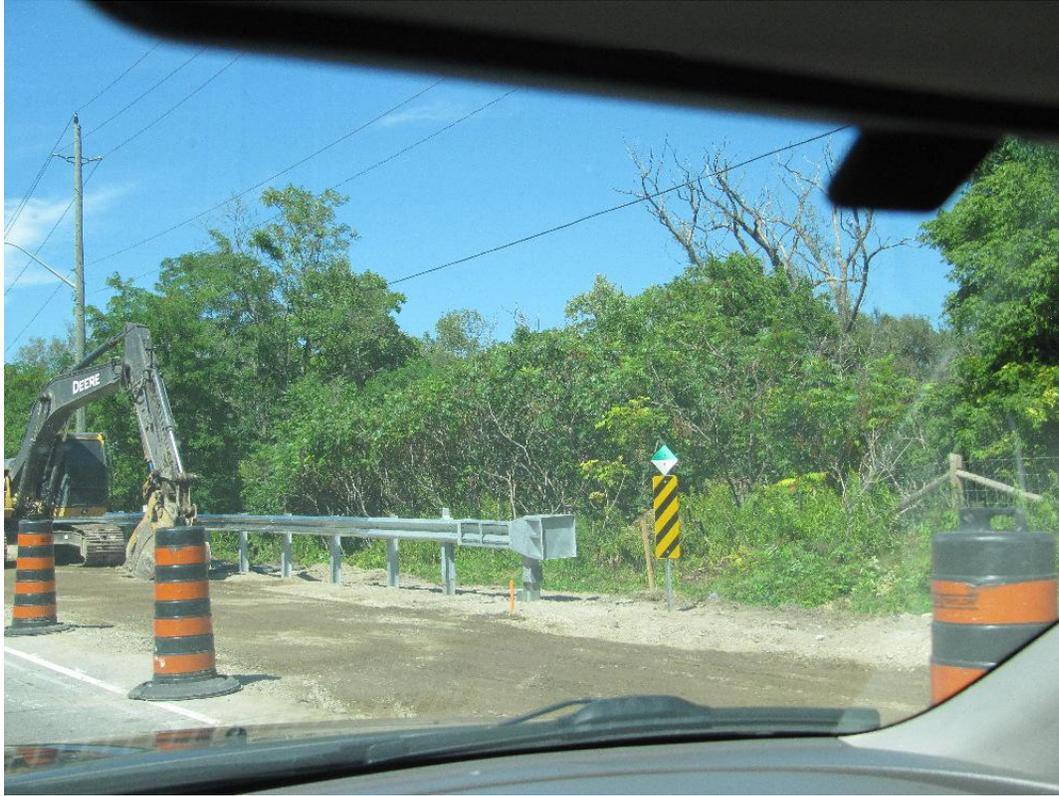
Figure 10: View of the newly-installed SKT terminal at the Dodd Creek bridge on Sunset Drive. This photo was taken on August 23, 2015.

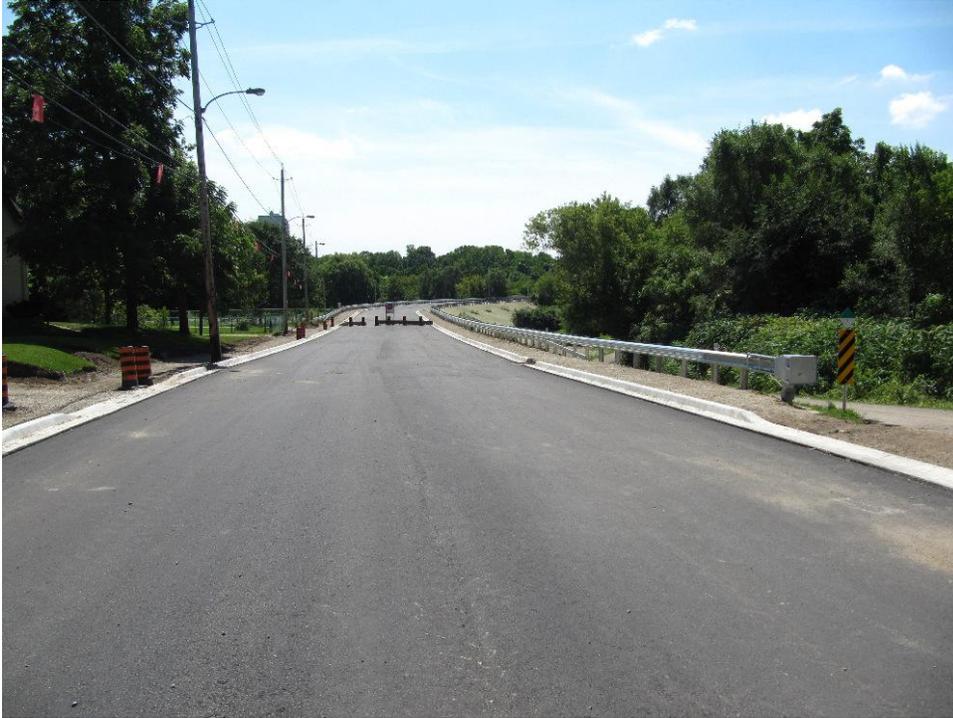
New SKT terminal installations also occurred in London, Ontario. For example, a re-development of the Egerton Road Bridge over the south branch of the Thames River occurred in the summer of 2015, as shown in the overall view, looking south, in Figure 11 and the closer view of the SKT terminal in Figure 12.

Figure 11: View, looking south, along Egerton Road toward the Thames River bridge. SKT terminal can be seen at the end of the guardrail on the right edge of this photo which was taken on August 15, 2015.

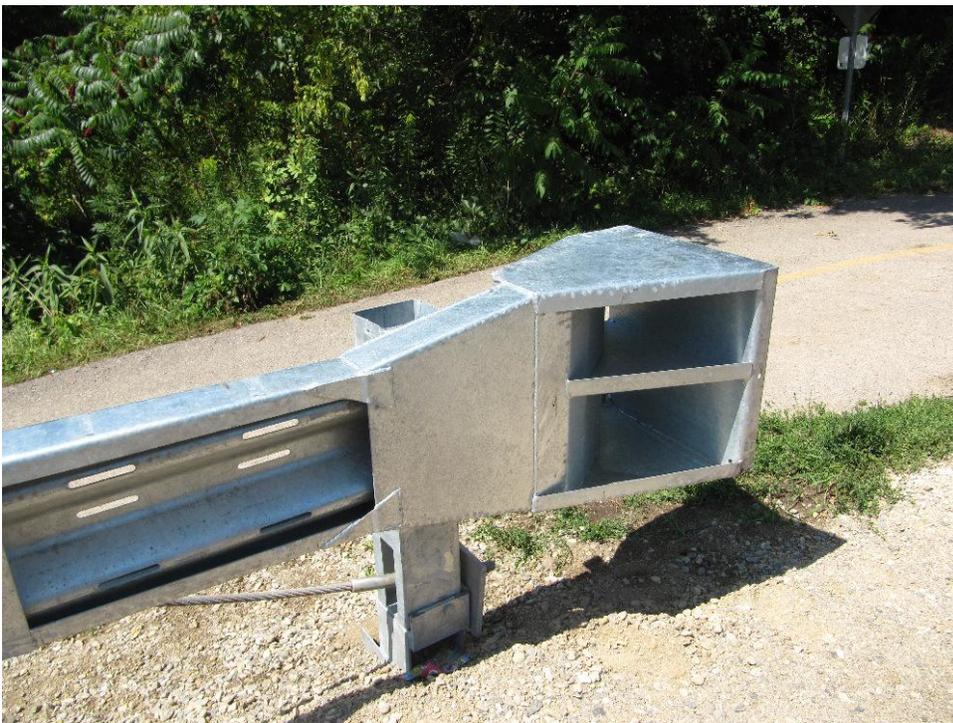
Figure 12: View of the new SKT terminal located on the south end of the guardrail of the Egerton Road bridge in London.

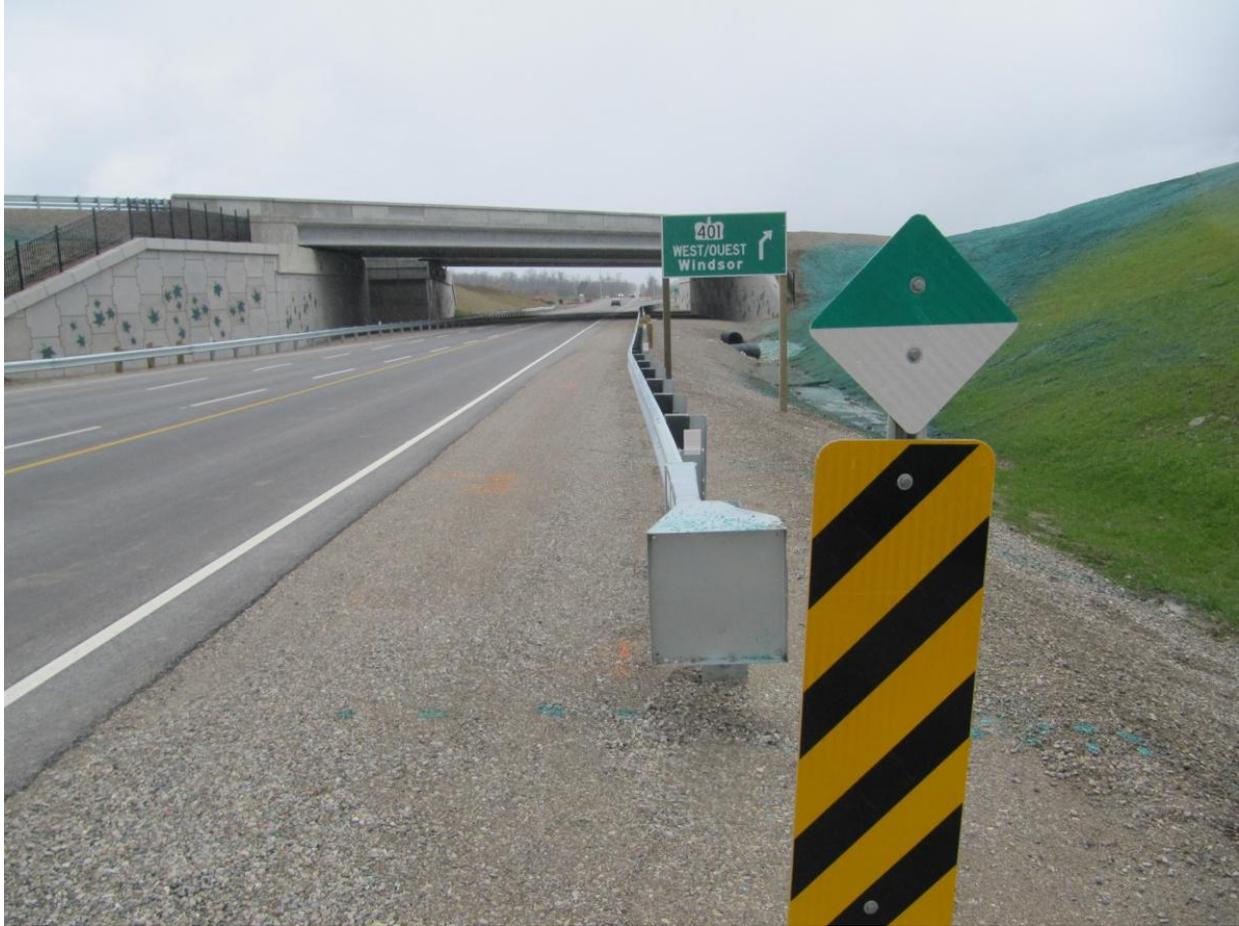
Ontario's Ministry of Transportation has also begun to install SKT terminals as evidenced at the newly completed Wonderland Road interchange to Highway 401 in south-west London, shown in Figure 13.

Figure 13: View, looking north, at one of several SKT terminals installed on Wonderland Road at its newly built interchange with Highway 401.
