Maximum Braking On Snow-Covered Asphalt Roads - Tests From February 25, 2012

Posting Date: 5 Mar 2012

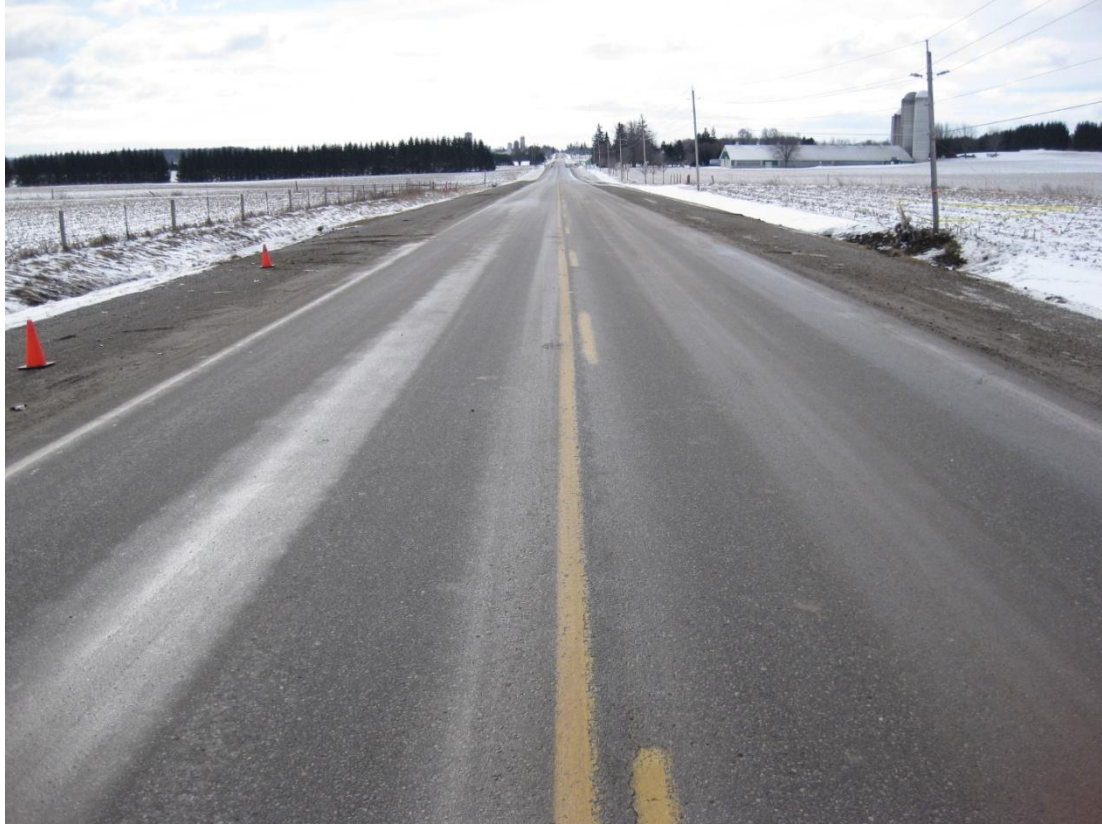
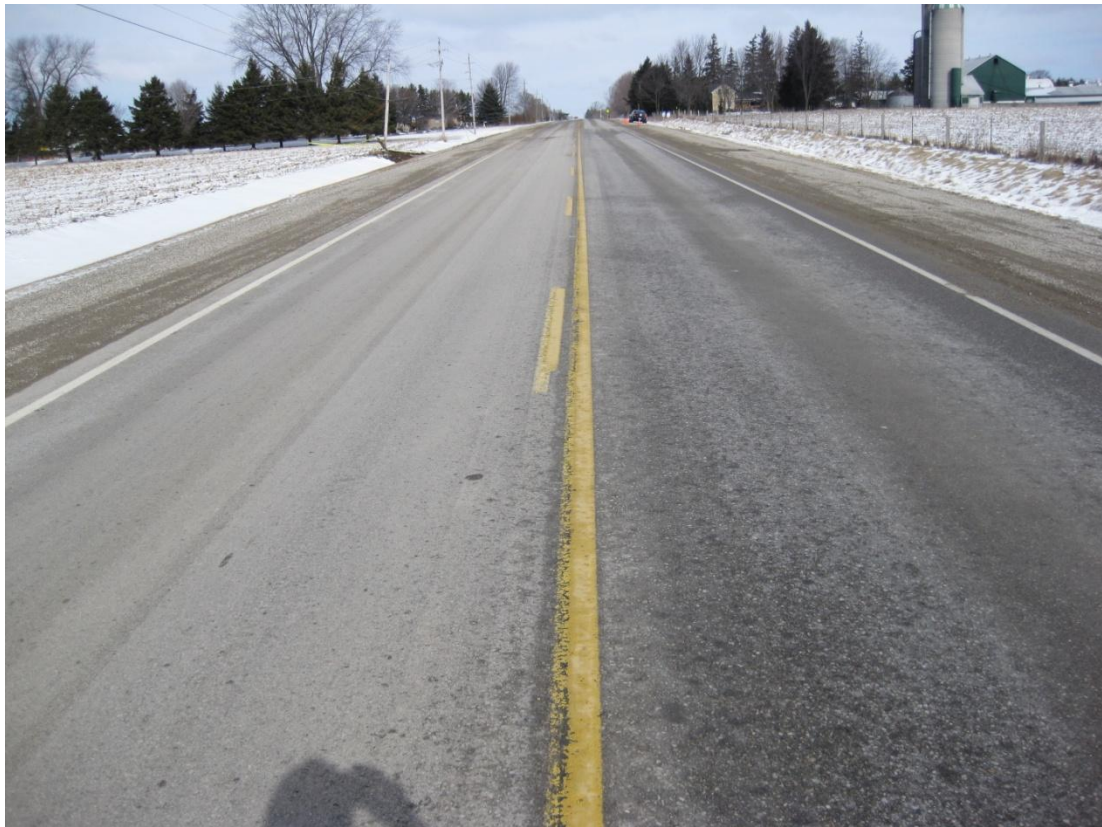
Photos on the following page show the general accident characteristics from the north looking south (top photo) and from the south looking north (bottom photo). These photographs were taken the day after the collision.

A photograph was available, taken by news media on the day of the collision, while the two vehicles were still at their final rest positions. This photograph was taken from the south looking north, similar to the view shown in the bottom photograph shown on the following page. The news photograph showed an obvious area of snow that had blown onto the road just south of the area of impact between the vehicles. However the rest of the road surface remained bare and dry. The character of the snow drift indicated that it had blown onto the road from the west to the east and that the majority of the snow was located in the southbound lane. There was only partial snow-cover in the northbound lane where the Avalanche was travelling. From that finding one would find it curious that the driver of the Avalanche would lose control of the vehicle since his lane was not in the worst condition since there was likely more snow in the southbound lane. We will discuss this issue further after we have reported the findings from our braking tests.

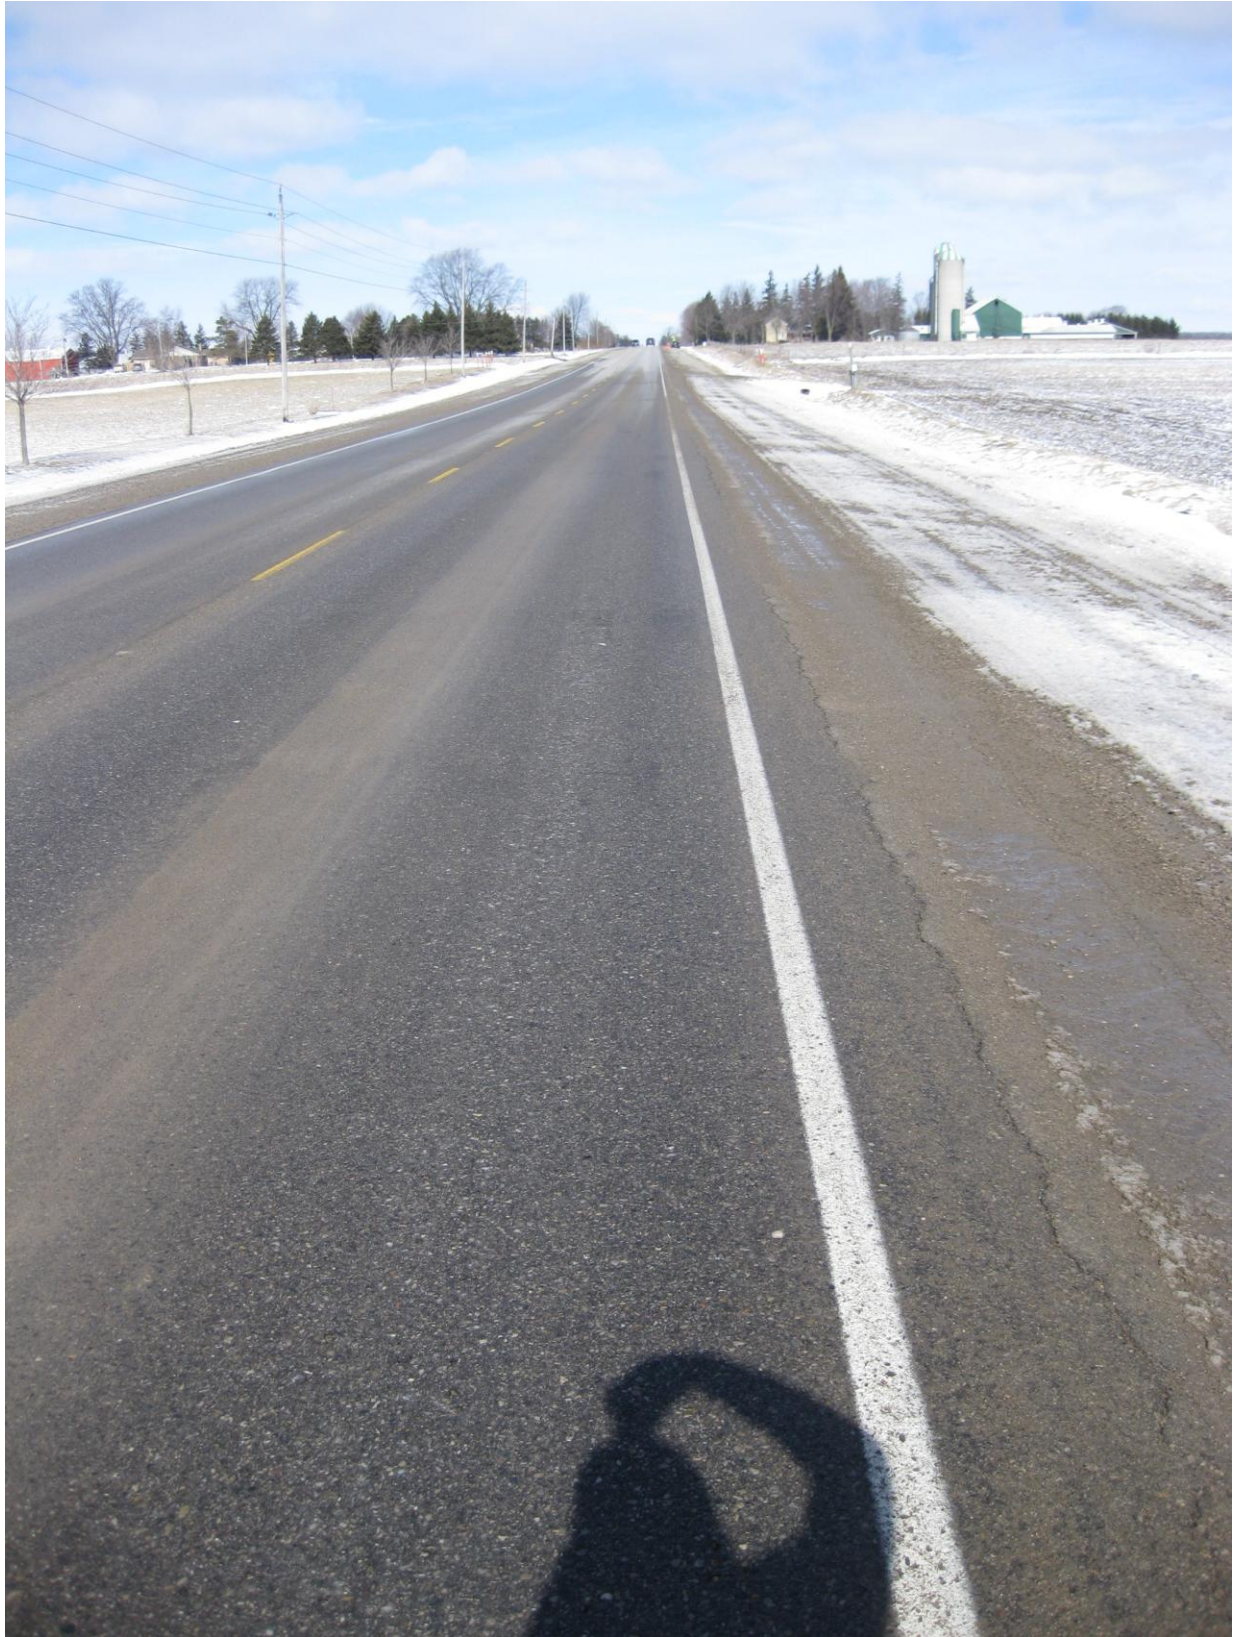
In the photograph shown on the following page we show a view looking northbound from several hundred metres south of the area of impact. Note that the road surface in the foreground is damp or wet and in the distance it becomes dry.

The road is damp because this is approximately where the snow drift was located and there was not enough time to dry out the surface before we took this photograph on the following day. If we were involved in an official investigation we would confirm this through proper measurements and observations of the positioning of the hatched lines of the centre-line. But for now this is a reasonable conclusion.

If the wind direction at the time of the collision was from west to east then a snow drift would have developed from the open field on the west side of the highway. This is not completely speculation because the photograph of the accident site taken by the news media while the vehicles were still at their rest positions showed that such a snow drift existed. This snow was deeper in the southbound lane than it was in the northbound lane.

The photograph also showed that the north edge of this snow drift was about 4 to 5 hatched lines south of the point where those hatched lines of the centre-line terminated. We know from previous investigations that a single hatched line is about 3 metres long and that the gap between each of those lines is usually about 6 metres long. If we added four of those hatched lines and four gaps we would get a distance of about 36 metres. So we could estimate that the snow drift ended about 36 metres south of where the hatched lines came to an end.
