# Multiple-Fatal Highway Transit Bus Collisions - The Facts No One Wants To Know

*Posting Date: 22-Mar-2016*

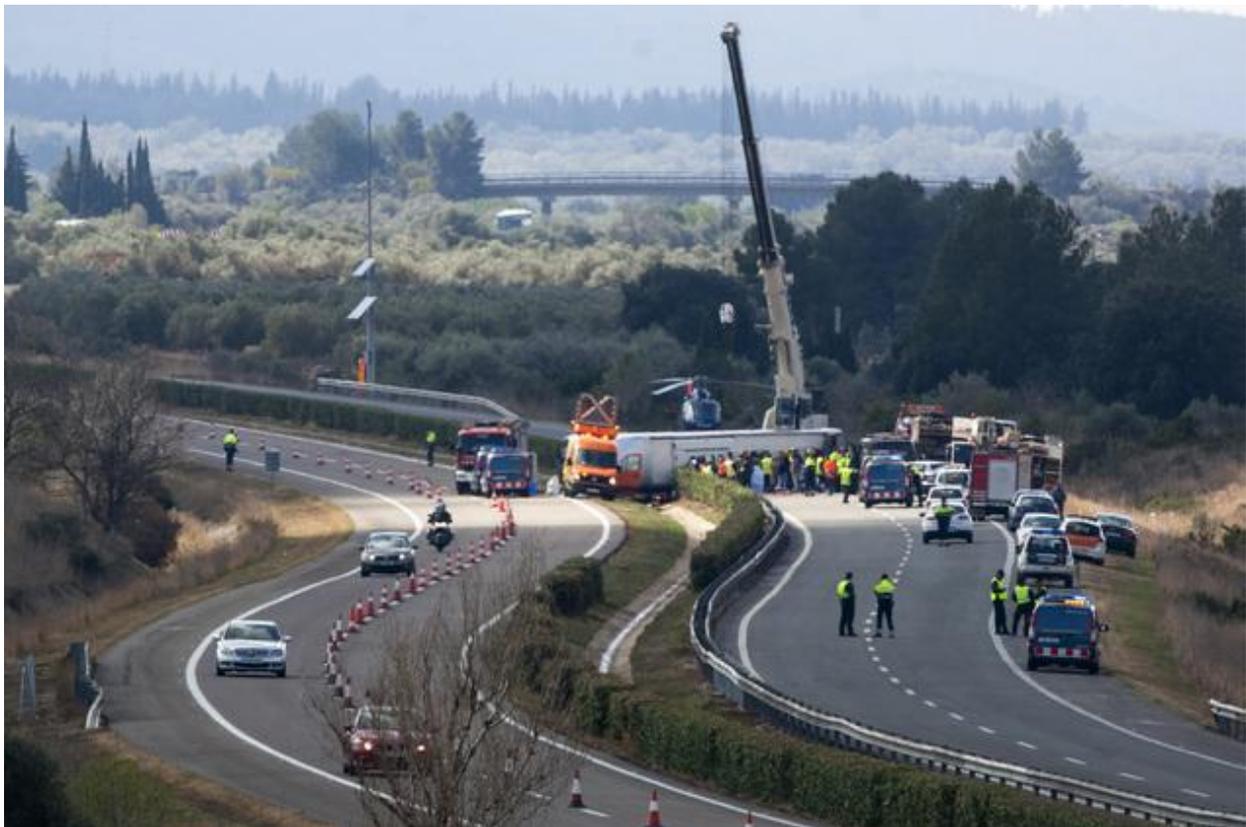
Figure 1: View of the multiple-fatal bus crash site taken by an unidentified Associated Press photographer.

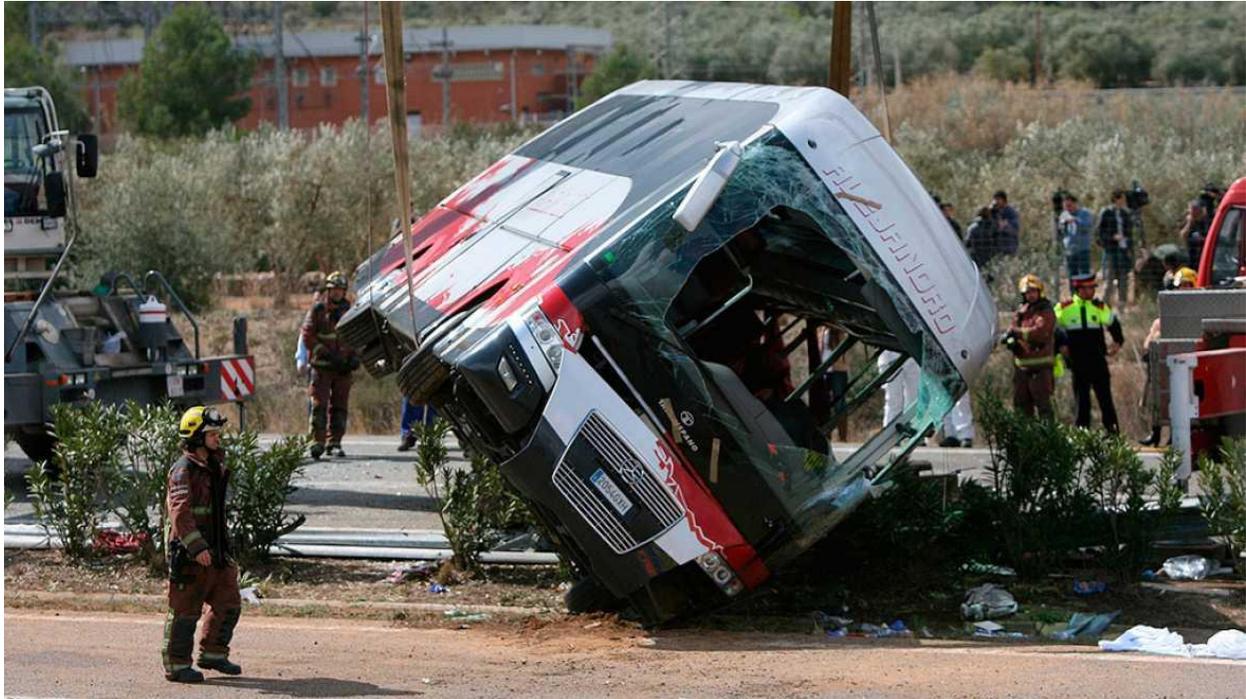
Figure 2: View of the front end of the damaged bus as it is lifted from its rest position on its side.

Clearly, when we examine the exterior of the bus as shown in Figure 2 we see essentially no damage, not even to its corners where the damage should be most evident.

So, returning to the real-life collision of the bus crash and looking at Figure 2, we must ask where is the evidence that indicates that this bus was involved in a severe, injury-producing, life-threatening impact? Where is all the evidence of crush and deformation that indicates that this vehicle was involved in a high, change-in-velocity impact?

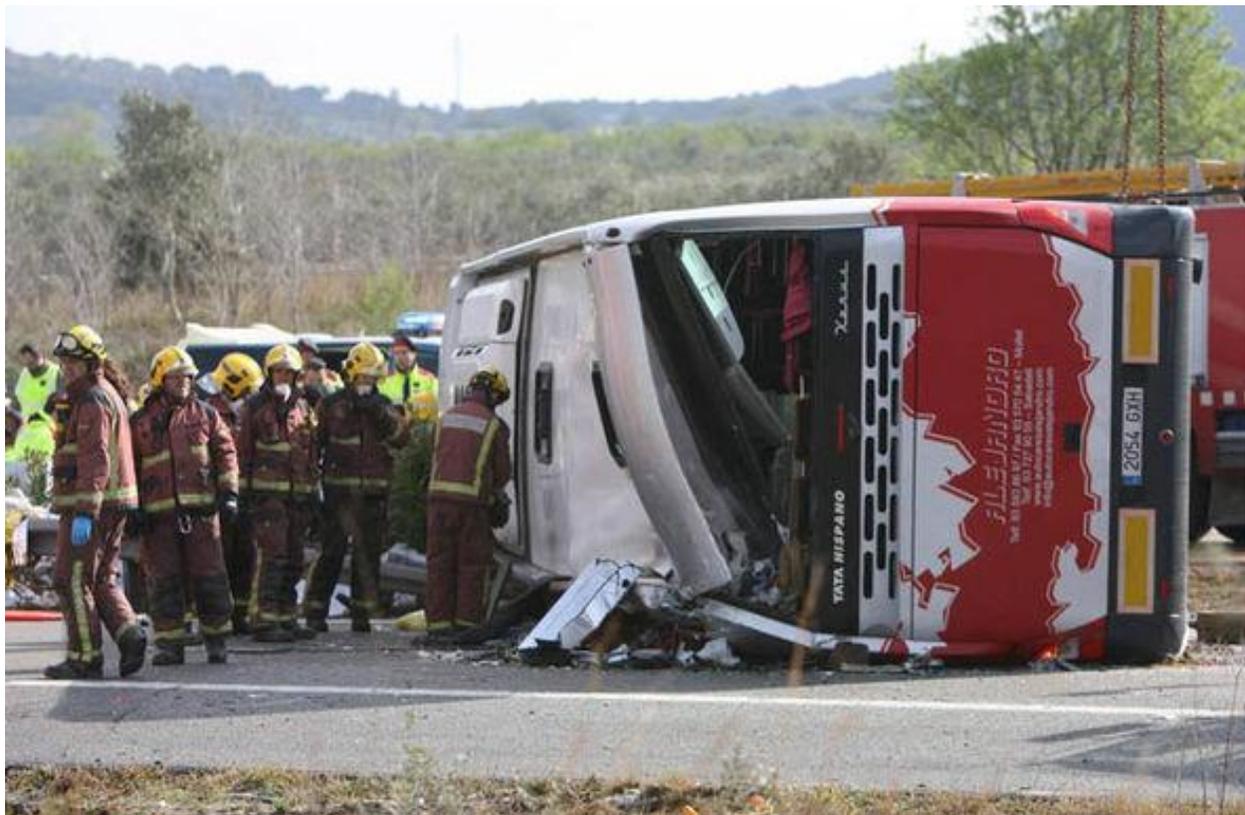
Certainly the bus did experience some crush. As we look to the back of the bus, as shown in Figure 3, we confirm that this was not just an undamaged bus that fell onto its side. There is substantial crush to the rear corner of the roof that could be life-threatening in certain instances.

Figure 3: View of the crush exhibited to the rear corner of the roof of the bus.

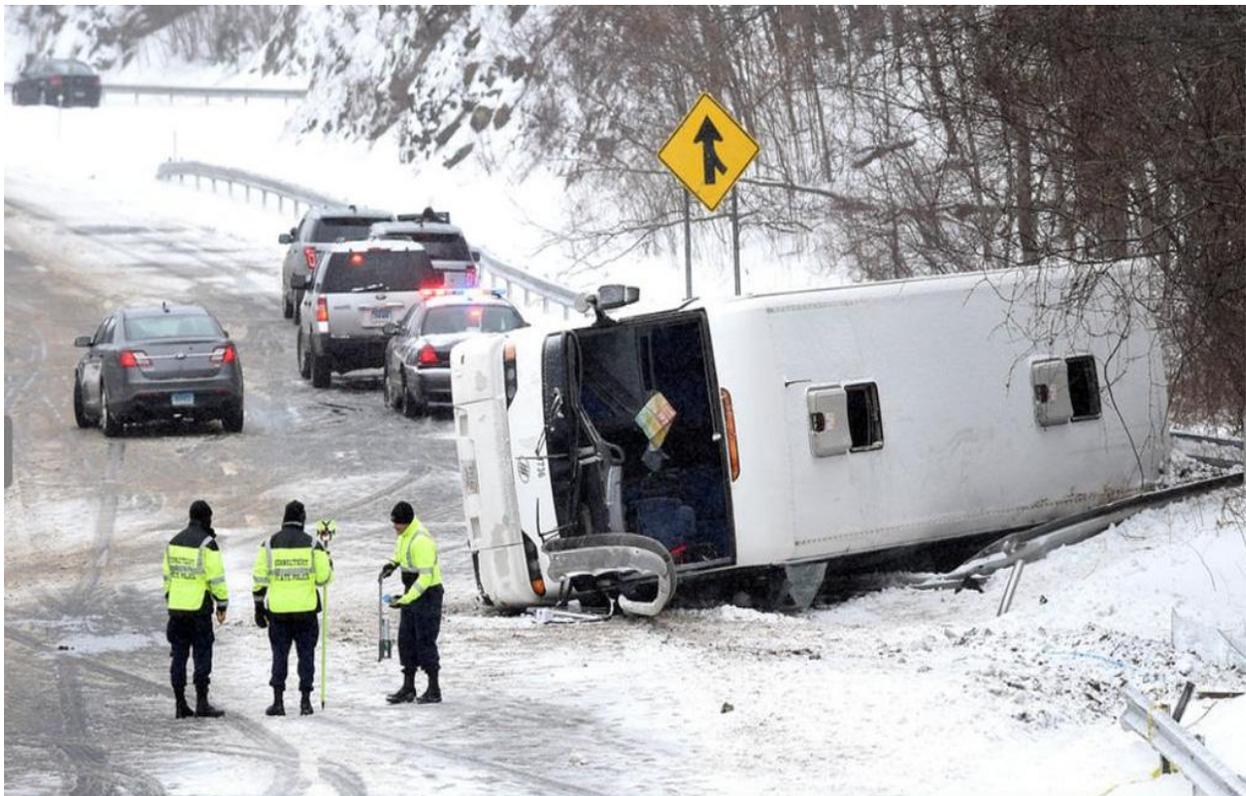
In a February 9, 2016 News item that was uploaded to the Gorski Consulting website News page we discussed a similar bus rollover (See Figure 4) that occurred on February 8, 2016 on I-95 near Madison Connecticut. Approximately 30 of the 55 passengers on the bus were injured. Conflicting reports indicated that several passengers sustained critical injuries and these conflicting accounts were never properly sorted out. Again, it would appear that the bus was tripped by the guardrail that it struck and had it remained upright the collision consequences would like have been much less. As part of our review of that tragedy we made the following comments:

Figure 4: View of an intercity bus that rolled over onto its side on Interstate I-95 in Connecticut.

*Secondly the roof structures of large buses need to be strengthened. This is a very important change that needs to be done very soon.*

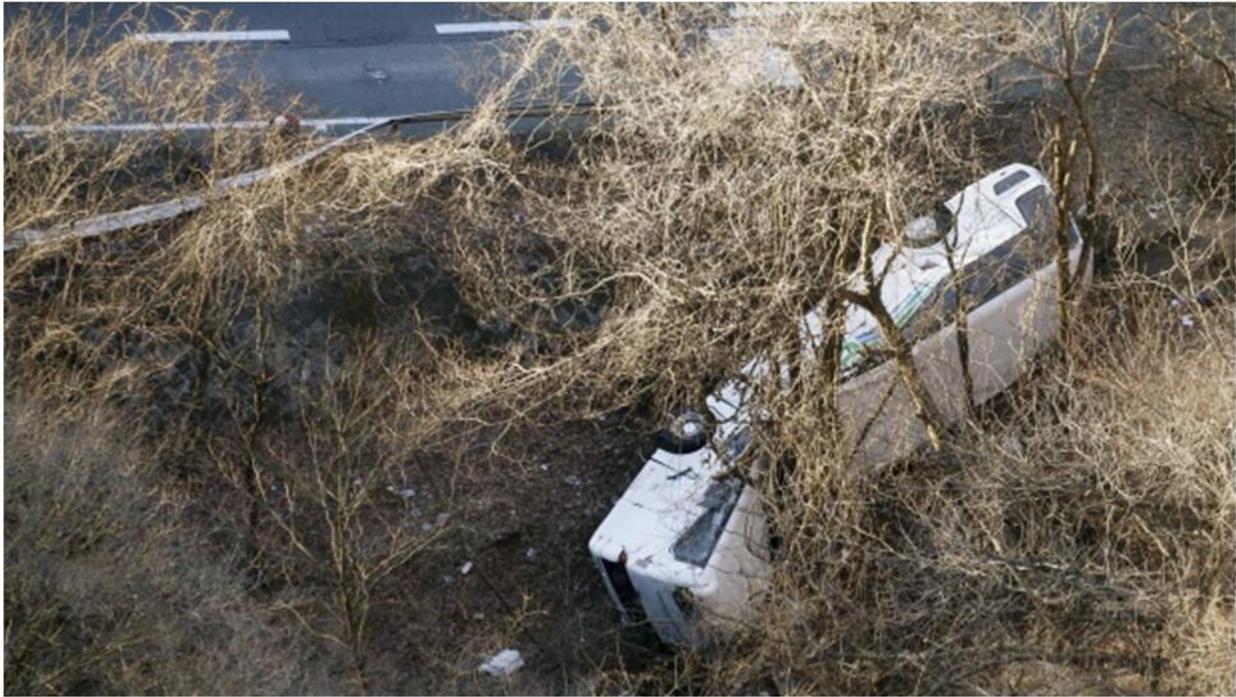
Figure 5: View of bus rollover in Japan that resulted in multiple fatalities.

In this incident the roof crush was severe. Figure 5 shows the portion of the guardrail that was damaged as the bus crashed through it. Again had the bus been retained on the roadway the collision consequences would have been much less. Even if the bus was not retained on the road but remained upright the collision consequences would also have been much less. The critical factor was the rolling of the bus onto its side and the exposure of the soft roof to the non-yielding tree was the principal cause of the roof intrusion. These obvious facts were never mentioned in any news media accounts or by any official entities involved in the investigation.
