Ontario Regulation Allows Existence of Dangerous Drop Offs at Edge of Asphalt Rural Roads

Posting Date: 09 Aug 2011

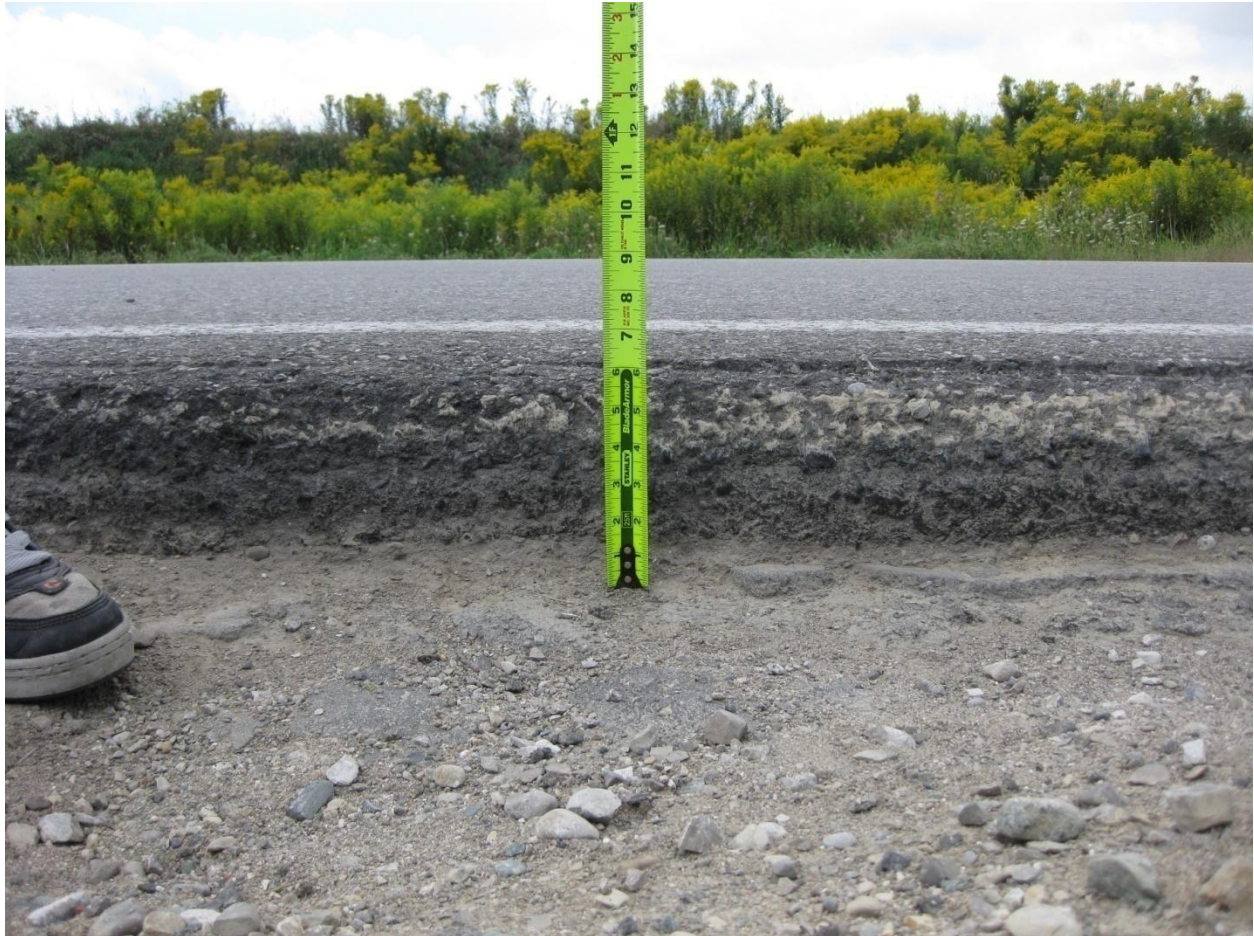
Figure 2: Example of a dangerous edge drop-off

Edge drop off refers to the condition of the interface between the edge of the pavement and the gravel shoulder that abuts that edge. As vehicles slip off the asphalt edge the tires push the gravel away from the asphalt edge thereby creating a gully that often includes a sharp drop in elevation between the pavement edge and the reformed surface of the gravel shoulder below.

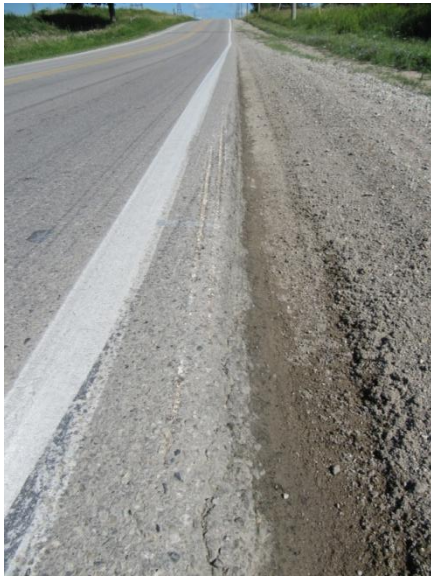
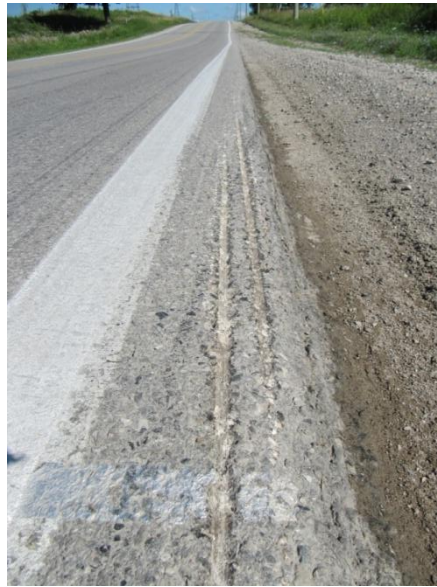
So let us look at some recent photographs of the edge drop off at the Clarke Road site to see if the existing conditions appear reasonably safe. On August 4th, 2011 we attended the site and found deep scrapes along the asphalt edge as shown in the two photos below.

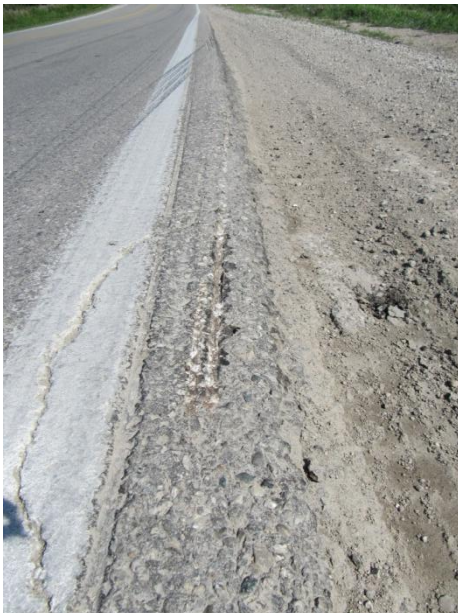
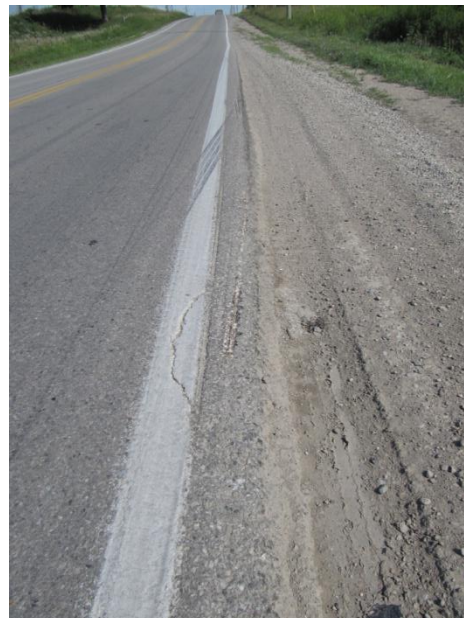
And again on August 5th, 2011 we observed an additional set of deep scrapes as shown in the photos below.

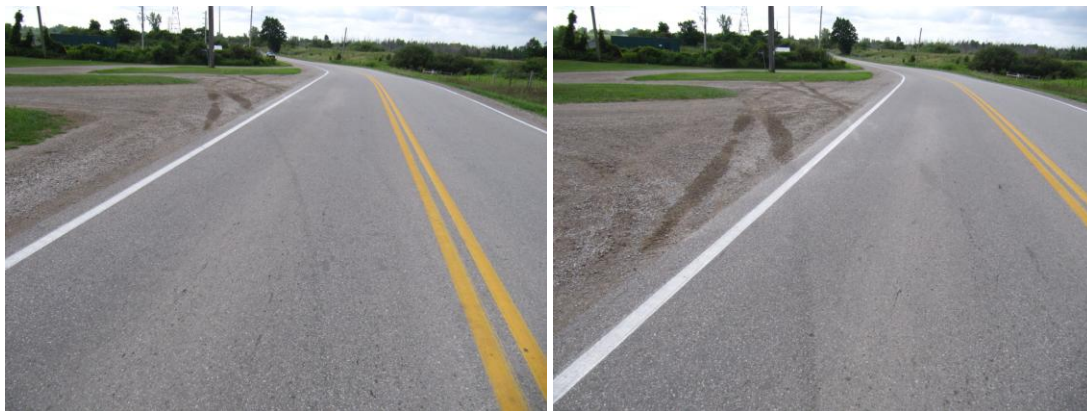
As an example, the following is a typical scenario that just occurred on the evening of August 8th, 2011. As shown in the photos below, a southbound vehicle came out of the subject curve on Clarke Road and we can see the typical loss-of-control yaw marks as the vehicle spins onto the east roadside.

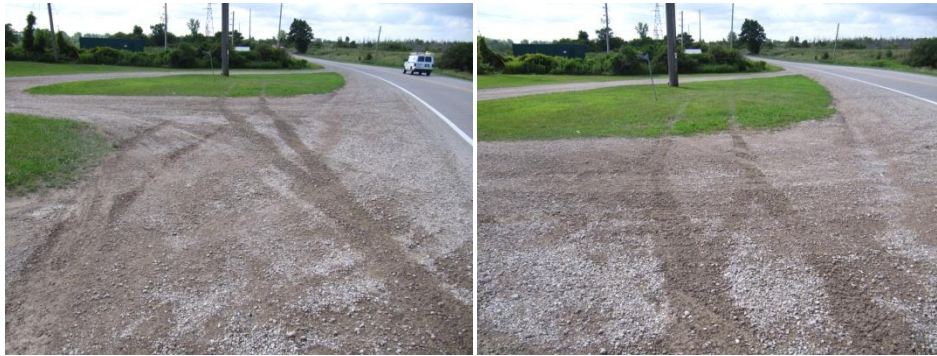
As we draw nearer to the point where the vehicle came to rest the tire marks demonstrate that the vehicle rotated a complete 180 degrees and came to a halt facing opposite to the direction it was travelling.

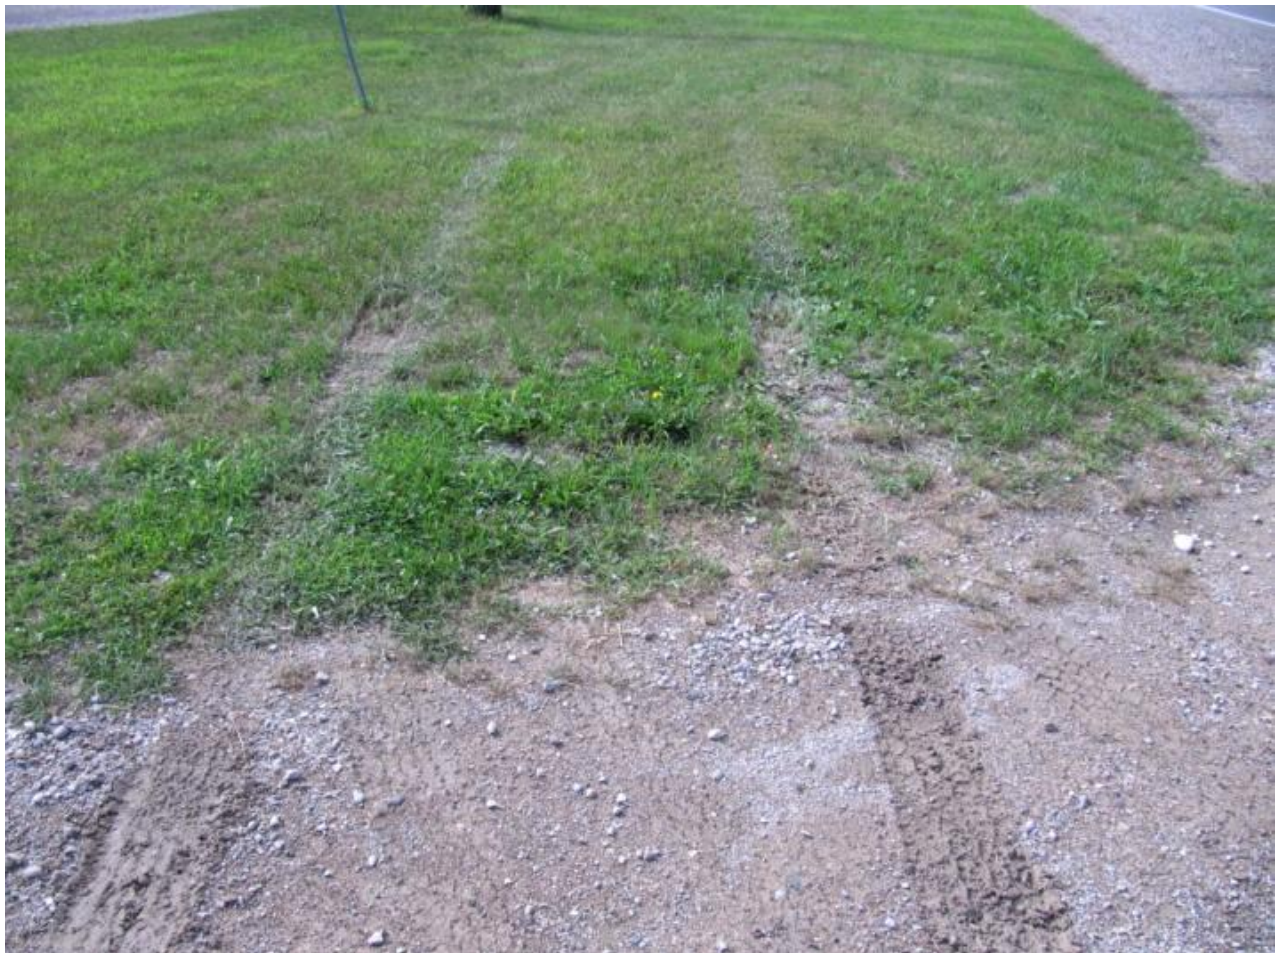
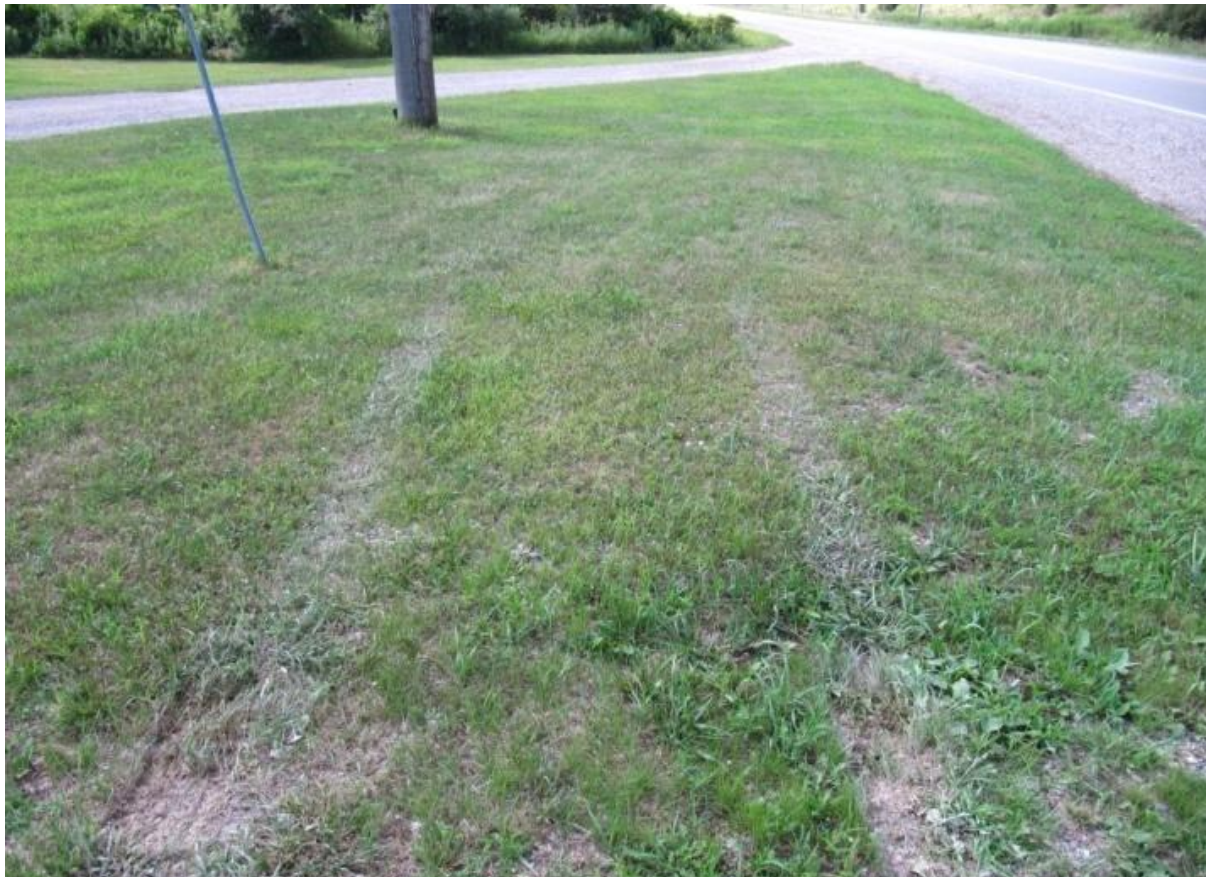
As we look in the photos below we can see the tire marks near the point where the vehicle came to rest. Here we can see how the grass has been torn out and the loose grass has been thrown backwards indicating that the driver has pressed hard on the accelerator. The driver then accelerates forward onto the road and disappears.
