Results From iPhone 4S Gyro Testing On A Freshly-Graded Gravel Shoulder To Evaluate It's Safety

Posting Date: 02-August 2013

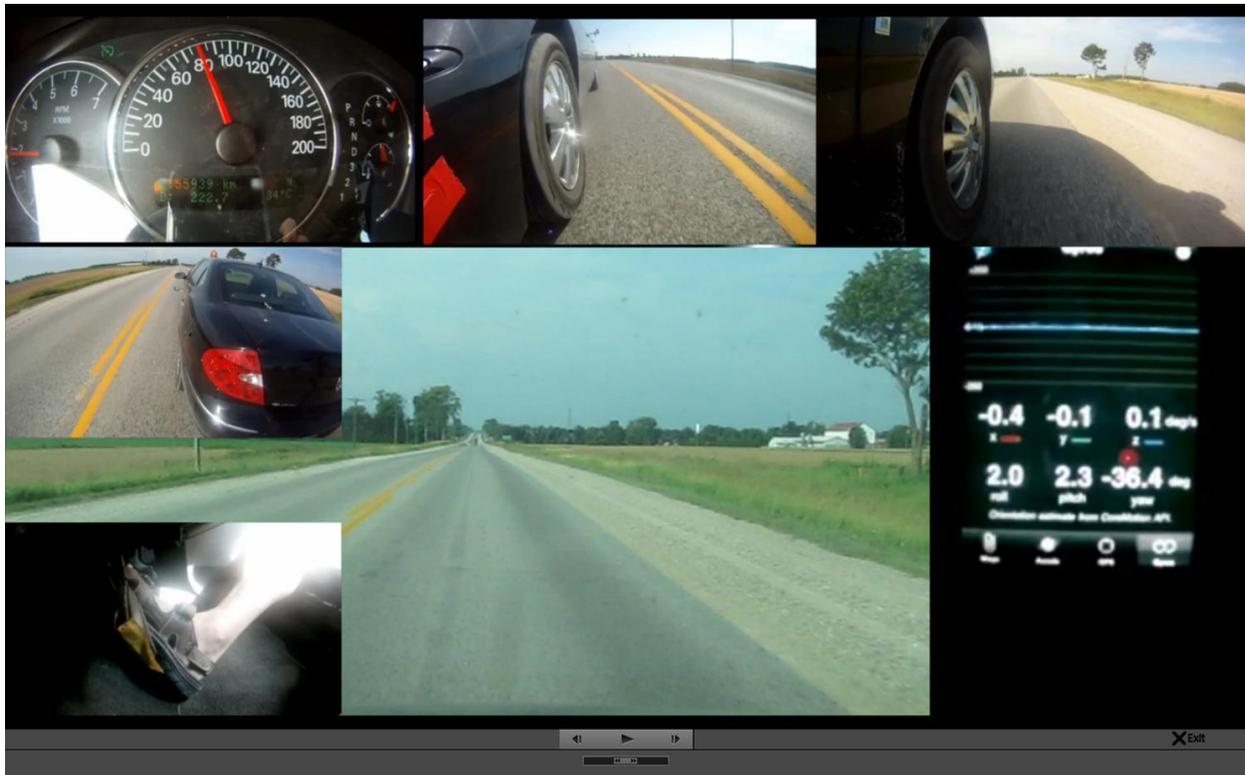
We need to identify what is shown in each camera in Figure 1. At the upper left is a view of the test vehicle's speedometer and tachometer. Just below that is a view from the camera mounted from the bike rack, extended from a lateral pole to a position behind the left rear of the vehicle, and pointing forward to show the left side of the vehicle. In the bottom left corner is a view from the left, showing driver's left leg and brake pedal. The view at in the upper middle shows a rearward view of the left front wheel. The view in the centre of the screenshot is from a camera mounted from the dash of the vehicle and pointing forward through the windshield. In the upper right corner of the screenshot is a forward view of the right front wheel. The view at the bottom right is of the face of the iPhone displaying the Gyro app.

In the camera displaying the Gyro app it can be seen that the rates of change in angle (in degrees per second) are displayed along the top row. So the "-0.4" indicates that, at the present time, the angle of the vehicle along the X axis is changing at a rate of -0.4 degrees per second, or that the front end of the vehicle is diving toward the ground slightly. Similarly, the "-0.1" value in the middle of the top row indicates that the angle of the vehicle along the Y axis is changing at the very small rate of -0.1 degrees per second, or that there is almost no lateral rolling of the vehicle. And finally, at the right end of the top row the value of "-0.1" indicates that there is minimal movement of the vehicle's angle with respect to its fish-tailing or yawing about its vertical (Z) axis.

Figure 1: Screenshot At Timecode 00;07;28;15 of Test #1, of July 18, 2013 Testing With iPhone 4S

Figure 1 on Page 3 shows a screenshot of our computer screen showing the Premiere project opened up at the beginning of Test #1 where we can see synchronized views from the seven video cameras.

Of course, we explained in the previous article that the second row of values contains the current angle of the vehicle with respect to the three axes.

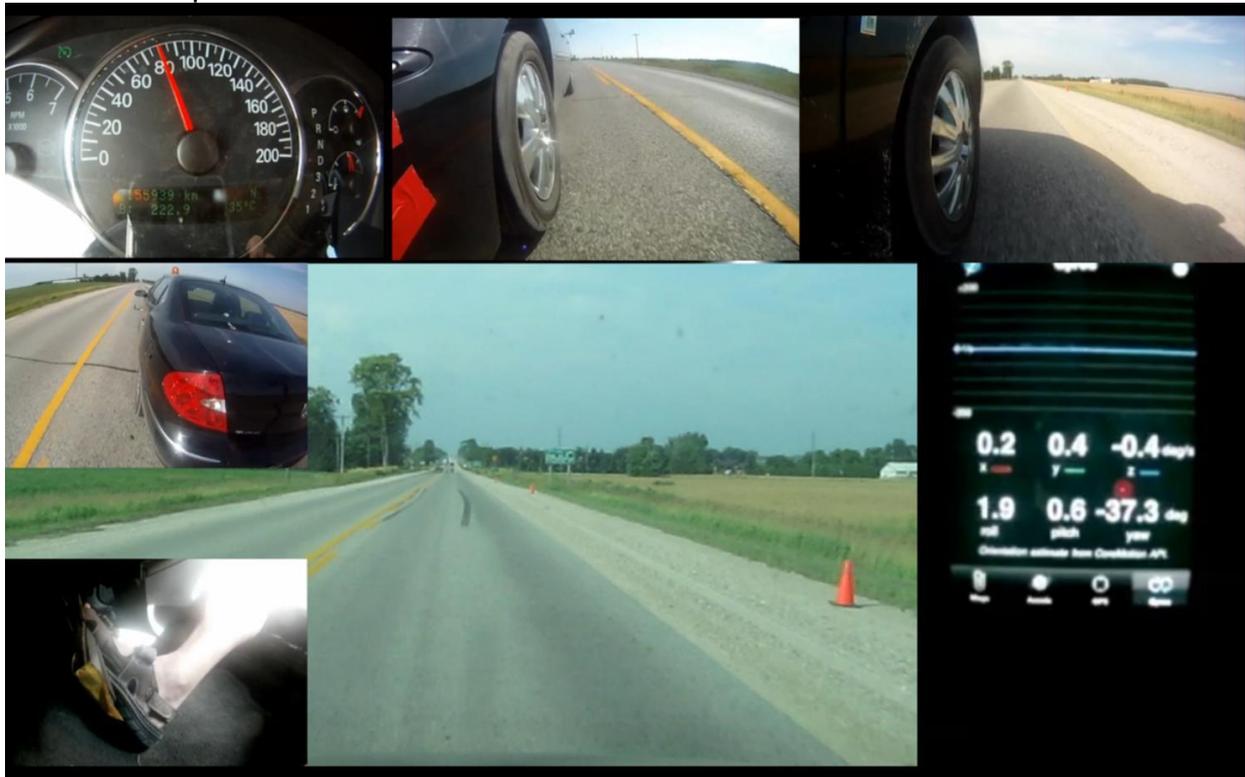
Figure 2 shows the view from our Test #1 when our test vehicle is approaching the 200 metre cone which can be seen near the right edge of the view of the camera pointing through our windshield. Similarly Figure 3 shows the view when our test vehicle is passing the 100 metre cone, and Figure 4 shows the view when our test vehicle is approaching the location where the tire marks of the accident-involved vehicle exited the paved road surface. You can note in Figure 4 that there is an warning sign visible on the east shoulder indicating the symbol for an intersection ahead. When this sign was exiting the right edge of the camera view we terminated the documentation of the data

Figure 2: Screenshot At Timecode 00;07;36;27 of Test #1, of July 18, 2013 Testing With iPhone 4S Gyro App

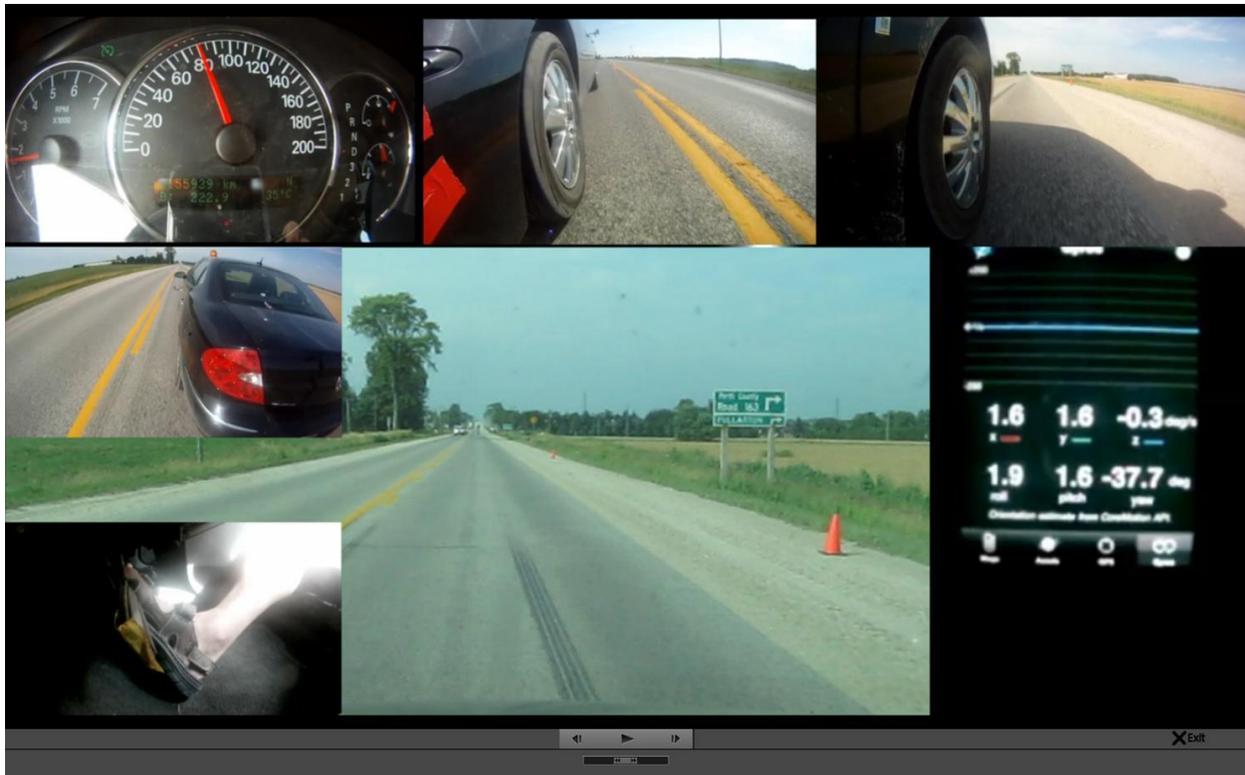
Figure 3: Screenshot At Timecode 00;07;39;09 of Test #1, of July 18, 2013 Testing With iPhone 4S Gyro App

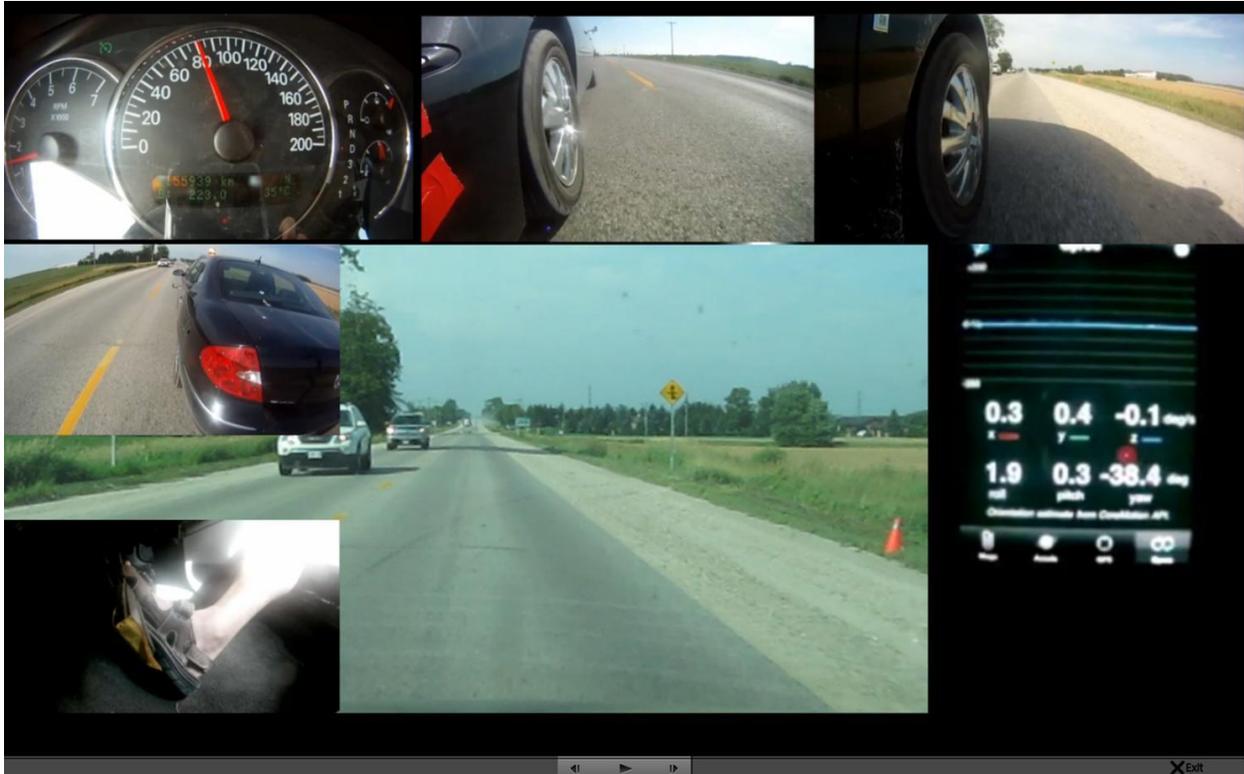
Figure 4: Screenshot At Timecode 00;07;43;27 of Test #1, of July 18, 2013 Testing With iPhone 4S Gyro App

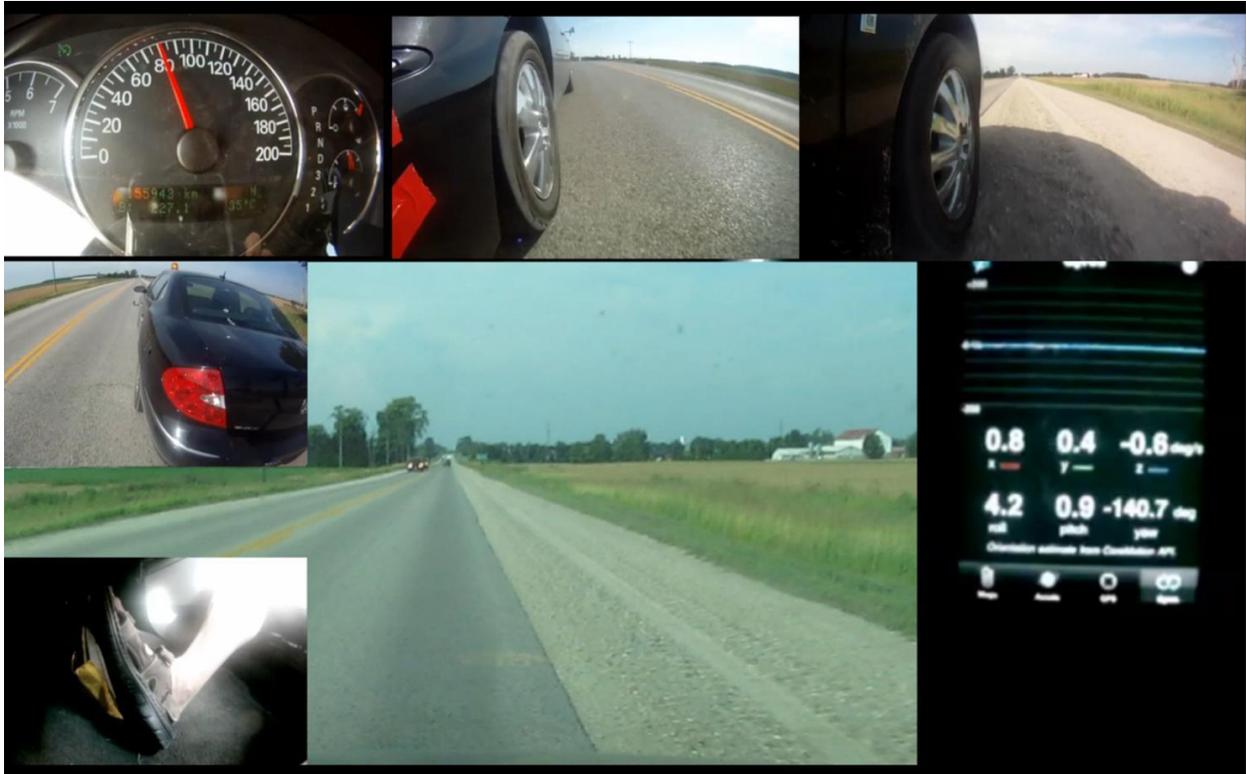
Figure 5 on Page 7 shows a screen shot taken of our test vehicle during Test #5 at timecode 00;12;56;27. Our documentations of this test commenced at timecode 00;12;55;09 so it can be seen that this time is about 1.5 seconds into the documentations or shortly after the test vehicle was steered into its test position. The view from the camera shown in the upper right corner of the screenshot is a view looking forward along the right side of the test vehicle and pointing at the right front wheel. Looking past that wheel one might be able to detect the edge of the asphalt and therefore appreciate that the tire is travelling very close to that asphalt edge. In attempting to stay near that asphalt edge the right front tire sometimes mounted the edge and then dropped back into the gravel shoulder. Upon averaging the values of the rates of change in the x, y and z axes contained in our spreadsheet we obtained the following for the 17 seconds of data:

Figure 5: Screenshot At Timecode 00;12;56;27 of Test #5, of July 18, 2013 Testing With iPhone 4S Gyro App

When comparing the results from the two tests it can be agreed that there are slightly higher rates of change in angle for the x and z axes but those are relatively small when compared to the larger difference in the values of the y axis. Recall in Test #1 that the average rate of change in angle of the y axis value was 0.513 degrees per second, whereas in Test #5 the value is 1.129 degrees per second.

In a nutshell, the test vehicle appears to be rolling left and right more when it is on the loose gravel shoulder than when it is travelling on the pavement and not much else appears to be different. In fact, when we drove along in the test vehicle the experience we felt was that the vehicle was being pulled left and right, as evidenced by our commentary which was captured by the video cameras as we progressed through the test. But otherwise we were not particularly alarmed by the resultant effects. However it was a different story in Test #6 when we drove half of our vehicle into the loose gravel shoulder.

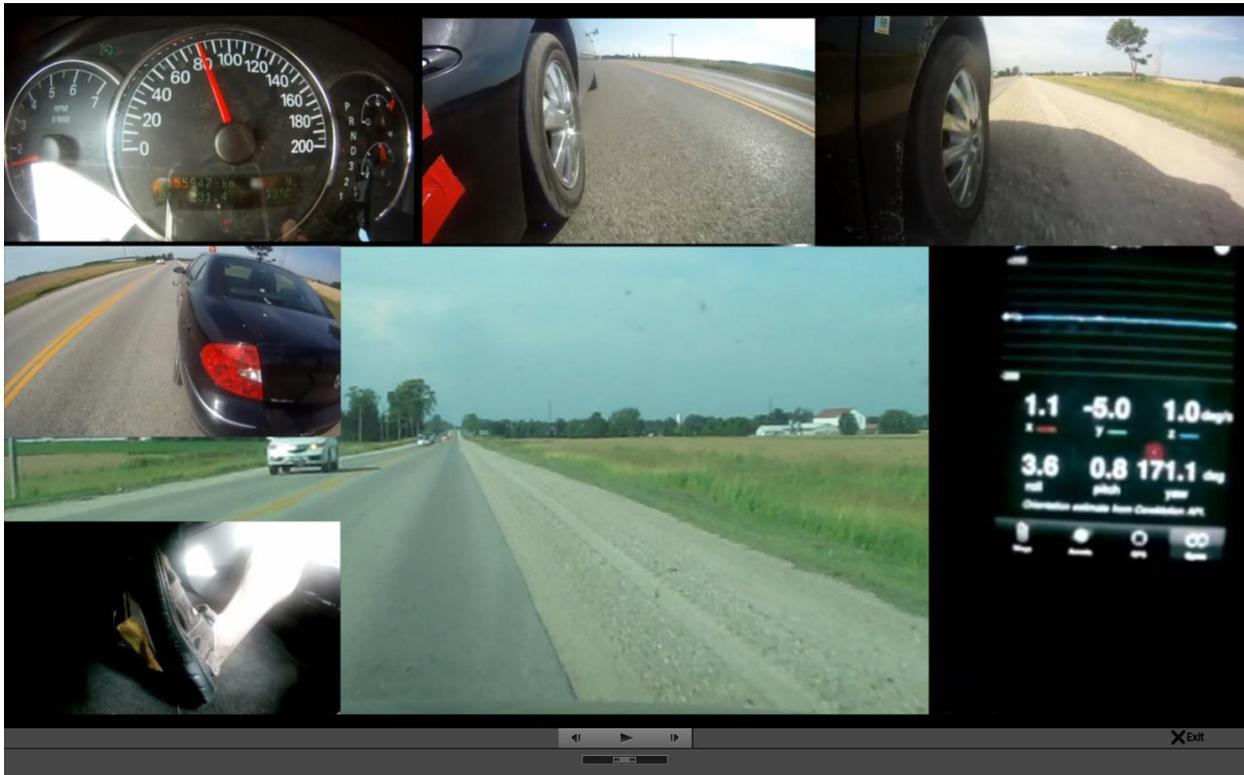
Figure 6 is a screenshot from our video project at timecode 00;18;42;07. We started documenting this data at 00;18;41;19 or less than a second prior to what is visible in this screenshot. It became clear shortly after entering half of our vehicle onto the loose gravel that the experience was quite different and more hazardous than simply riding near the asphalt edge as in Test 5. So much so that by timecode 00;18;45;01 we can be seen gradually applying the brake pedal in a decision to abort the run. Thus that decision was made after only riding onto the shoulder for less than 4 seconds. After gentle brake application and applying minimal steering we reduced our speed to about

Figure 6: Screenshot At Timecode 00;18;42;07 of Test #5, of July 18, 2013 Testing With iPhone 4S Gyro App

So what was so alarming that we decided to terminate our test? One consideration was the amount of opposing traffic in the vicinity as can be observed in Figure 6. We recognized that any significant instability of the test vehicle could send it into opposing traffic and it was not worth the risk. But also, the effect on the vehicle was also alarming to us. We truly sensed that there was sufficient lack of contact between the tires and a solid surface that the vehicle might enter a state of loss of control. So what did the Gyro data tell us?
